Your Ref: TP/IP/65989/2019  
Our Ref :CI/TPD19022291/N

**Fatal Accident Investigation Team**

**INSPECTION REPORT OF MOTORCYCLE FBF 3707U**

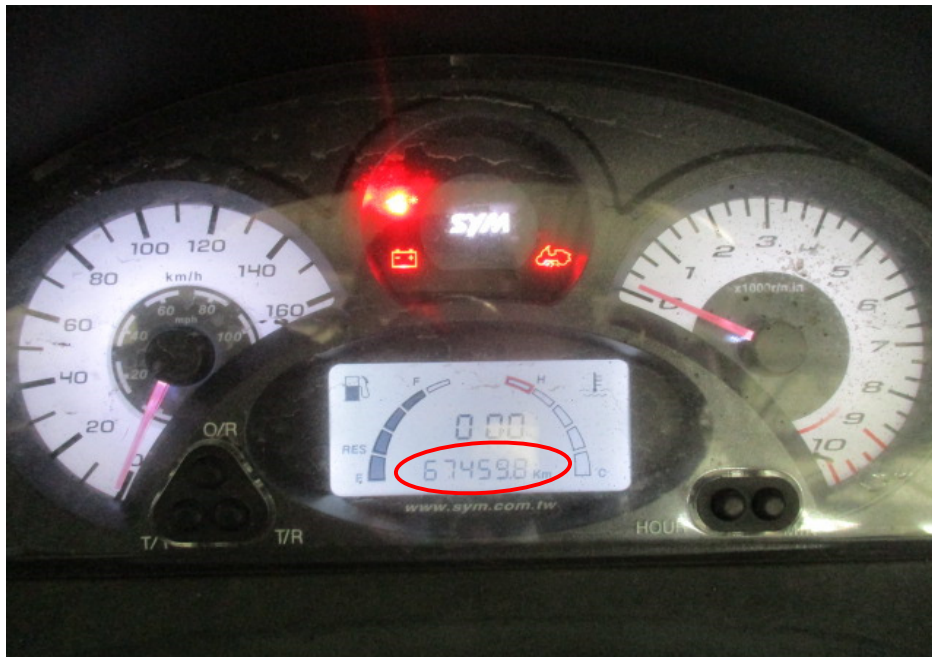
**Photo 1** shows the speedometer gauge of the Motorcycle where the mileage recorded at the time of our inspection was 67, 459km (circled).

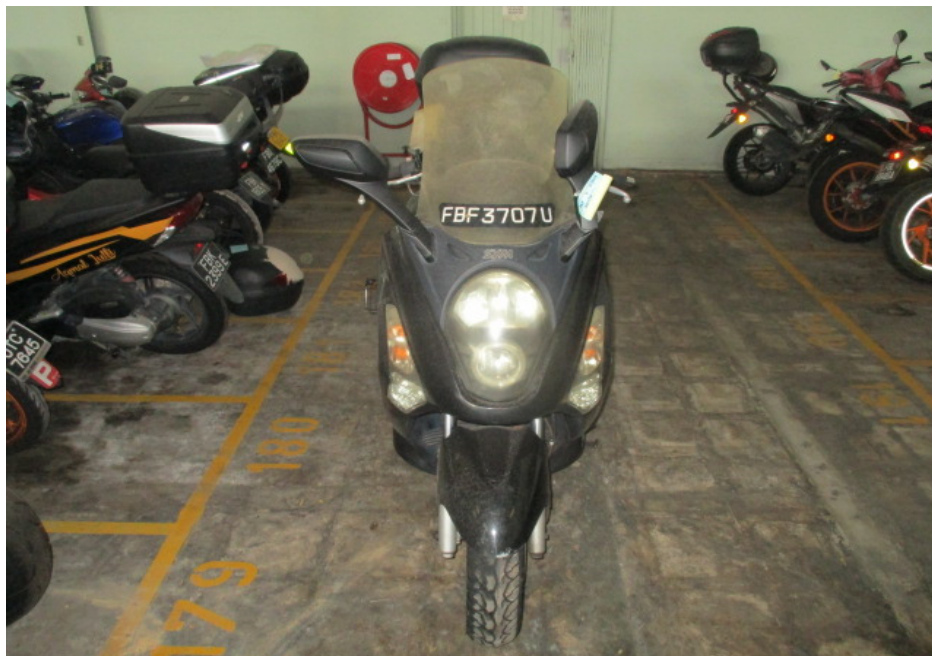
**Photo 2** shows a general view of the front body of the Motorcycle at the time of our inspection. The Motorcycle was observed to have sustained minor damages at the frontal and left portion.

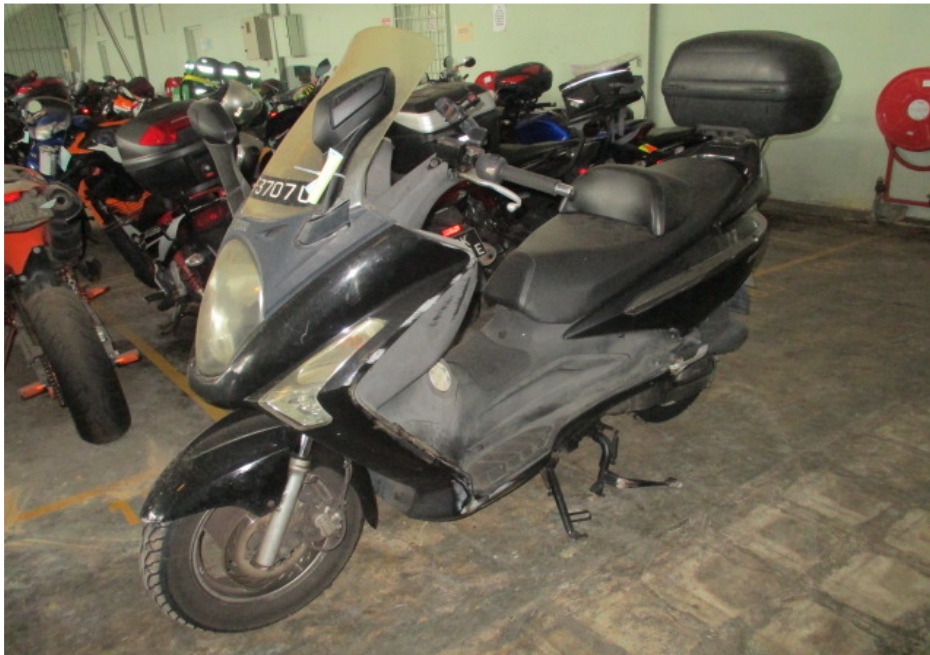
**Photo 3** shows a general view of the left front body of the Motorcycle at the time of our inspection. The Motorcycle was observed to have sustained minor damages at the frontal and left portion. The body parts that were found to have been damaged include its front mudguard, rear brake lever, left side mirror, left cowling, left rear side cover, left pillion foot rest, main stand and top box, amongst others as a result of the accident.

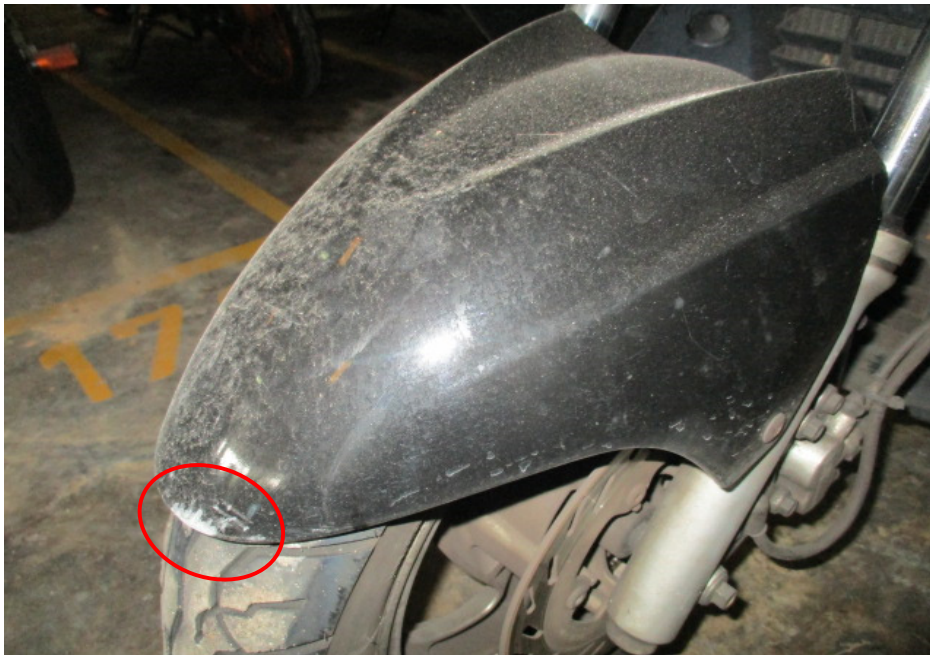
**Photo 4** shows a closer view of the front mudguard (circled) which was amongst the body parts at the front body of the Motorcycle that had sustained damage as a result of the accident.

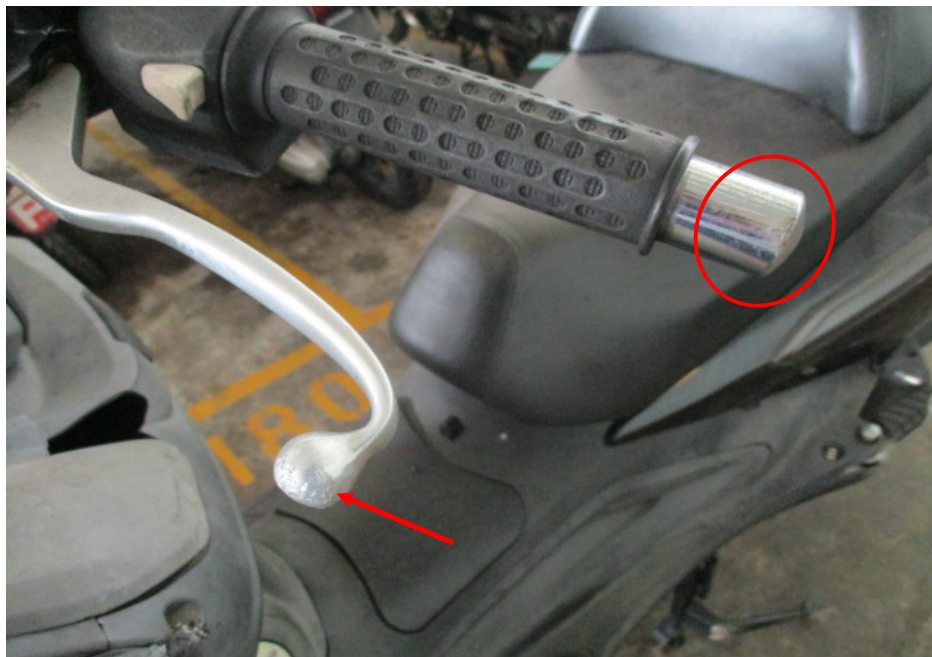
**Photo 5** shows a closer view of the rear brake lever (arrowed) and left handlebar end (circled) of the Motorcycle which were observed to be damaged due to the accident.

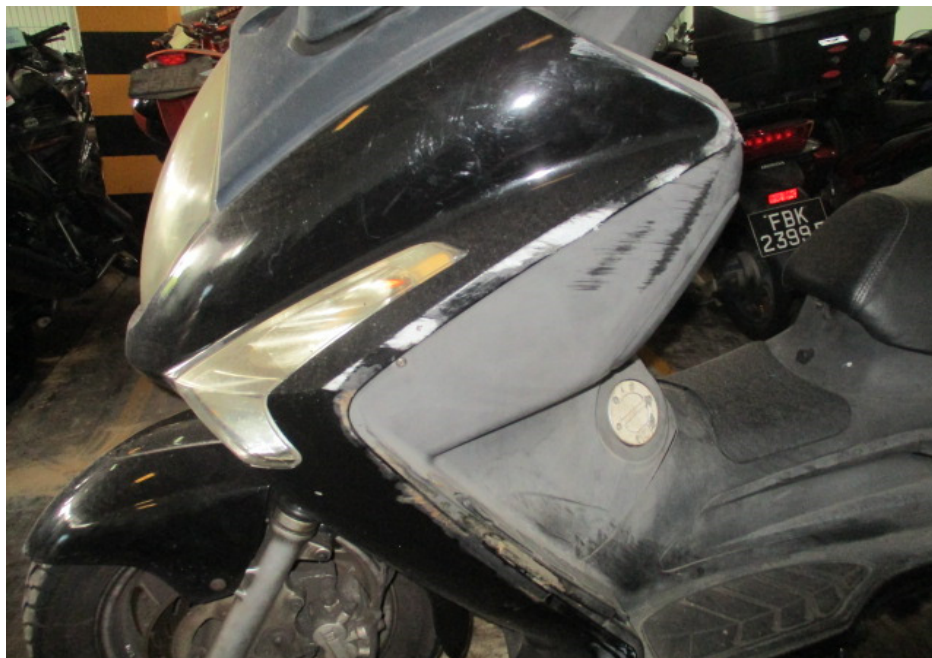
**Photo 6** shows a closer view of the left cowling which was amongst the body parts at the front body of the Motorcycle that had sustained damage as a result of the accident.

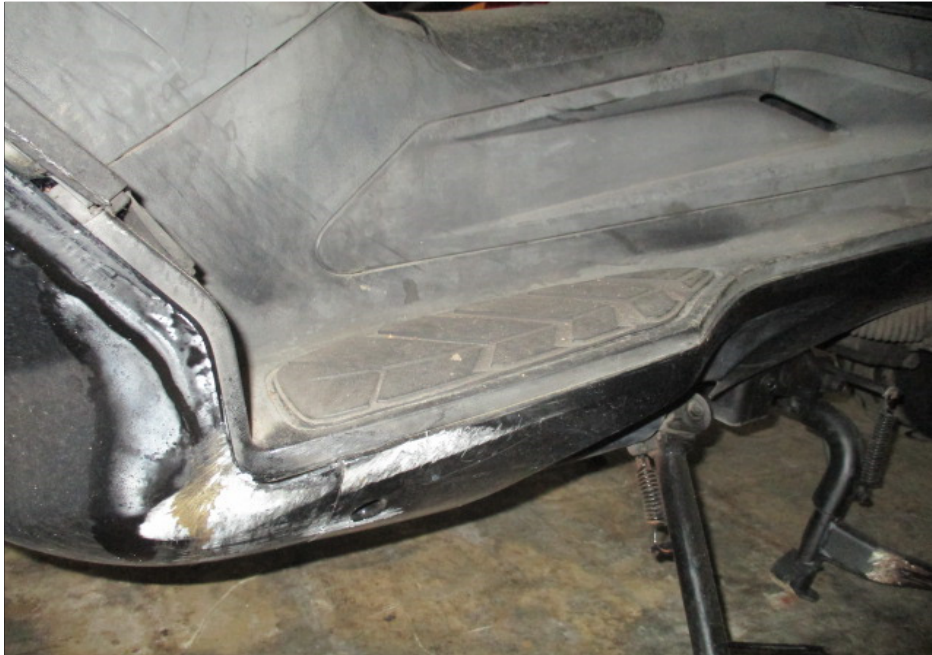
**Photo 7** shows a closer view of the left bottom cowling of the Motorcycle which was observed to be damaged due to the accident.

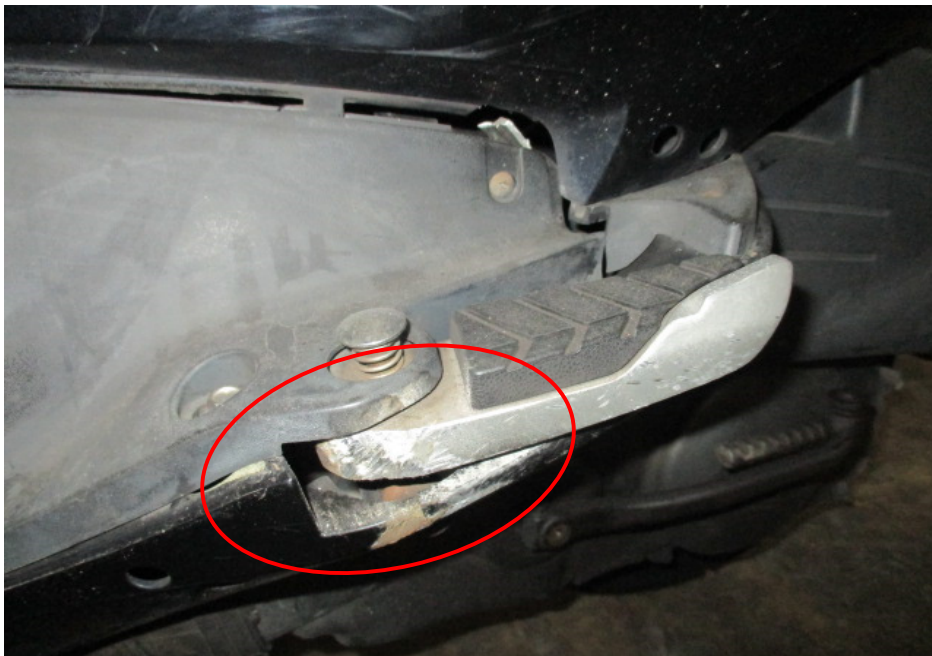
**Photo 8** shows a closer view of the damaged left pillion footrest (circled) of the Motorcycle at the time of our inspection.

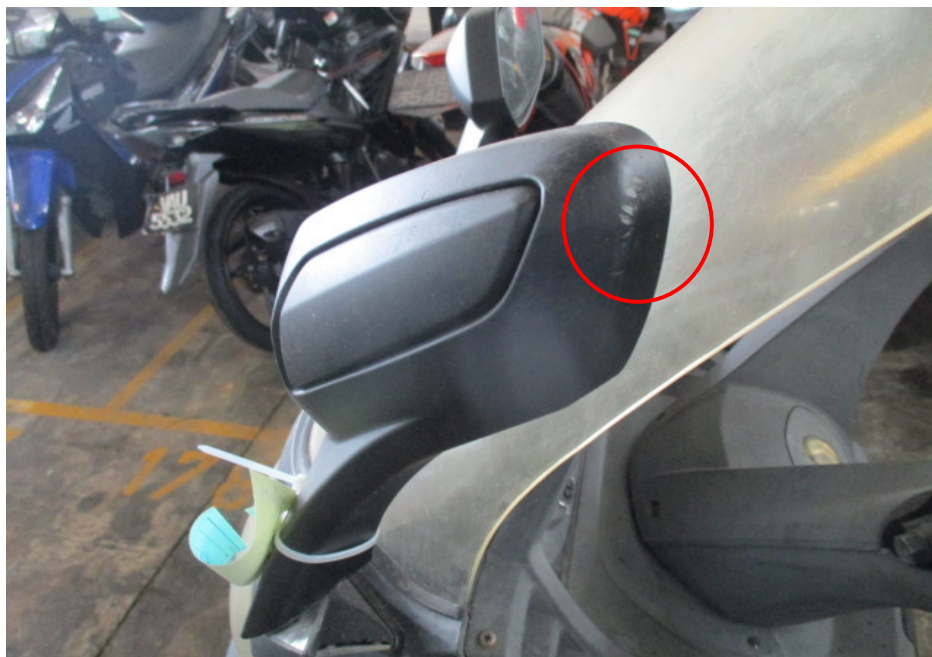
**Photo 9** shows a closer view of the left side mirror of the Motorcycle which had sustained damage due to the accident (circled).

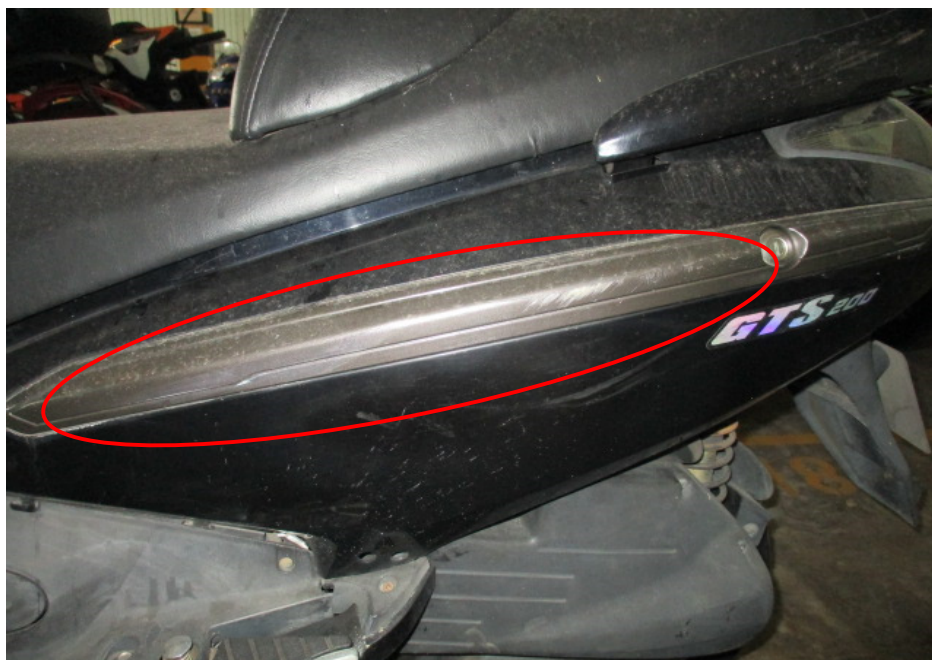
**Photo 10** shows a closer view of the damaged left rear side cover of the Motorcycle which was observed to have sustained scratches due to the accident (circled).

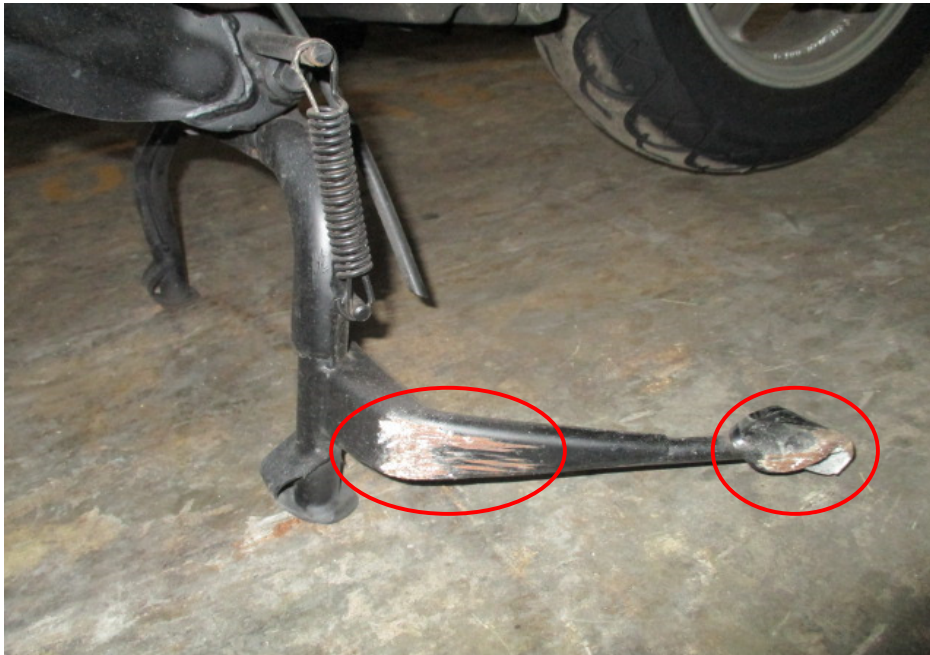
**Photo 11** shows a closer view of the main stand of the Motorcycle which was observed to have sustained damages of grazing nature due to the accident (circled).

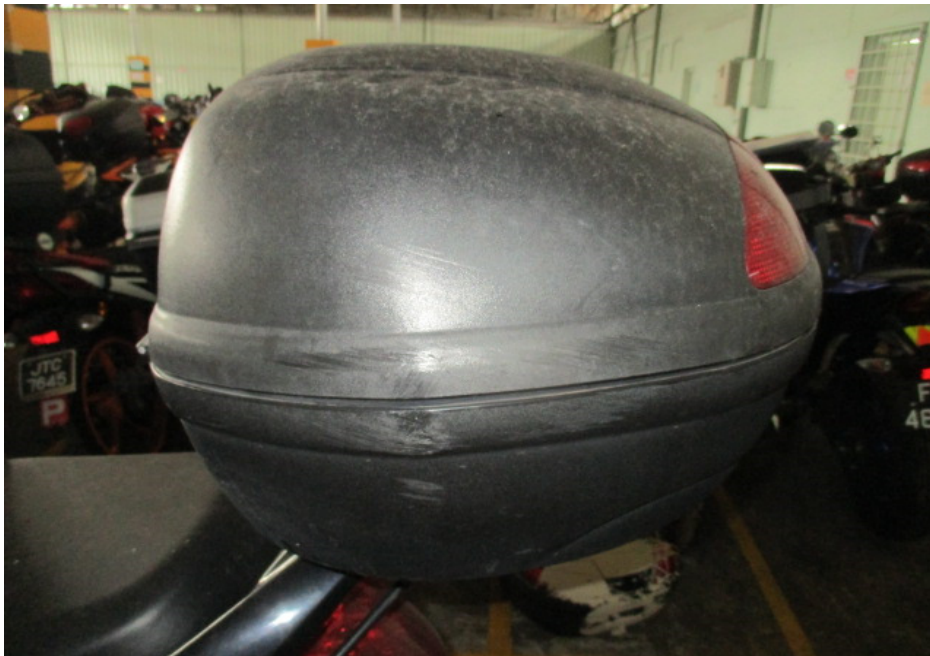
**Photo 11** shows a closer view of the top box of the Motorcycle which was observed to have sustained damages of grazing nature due to the accident.

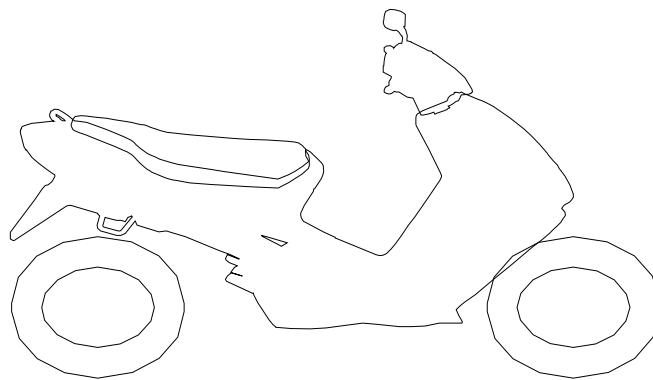
6. The condition of the Motorcycle's 2 tyres was observed to be in serviceable condition. The tread pattern of the 2 tyres was clearly visible. We did not observe any tear, burst mark(s) and/or punctured hole(s) on the sidewalls as well as across the tread of the 2 tyres. The 2 tyres were both observed to be sufficiently inflated for vehicular operation. The tyre brand, tyre size and remaining tread depth of the 2 tyres were recorded as follows:-

Shinko 130/70 - 12 (4mm)

Shinko 110/90 - 13 (4mm)

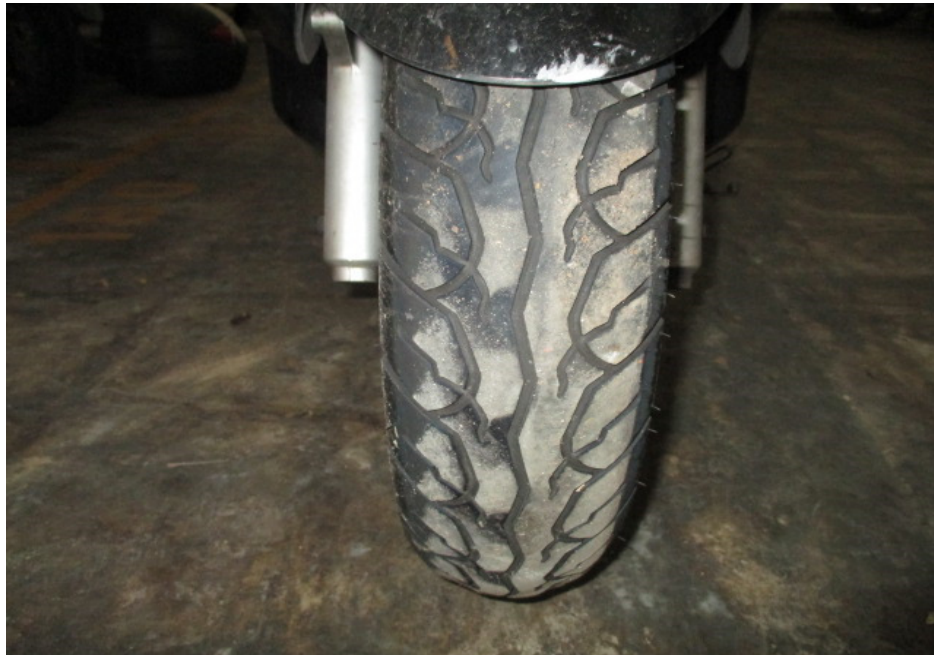
**Photo 12** shows the condition of the Motorcycle's front tyre. The front tyre was observed to be in serviceable condition with remaining tread depth of approximately 4mm. There was no tear, burst mark(s) and/or punctured hole(s) on the sidewalls as well as across the tread of the front tyre.

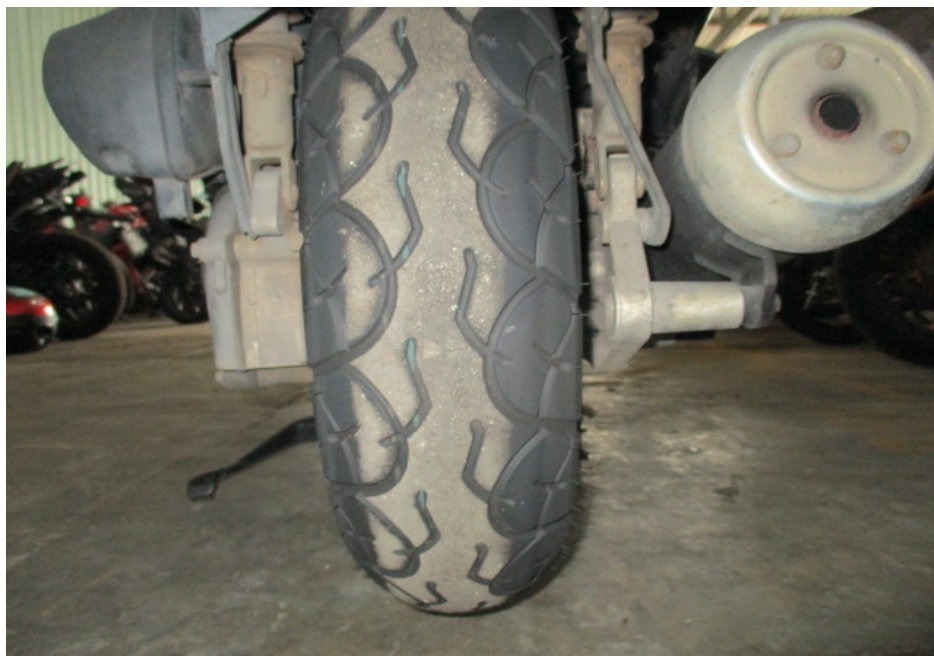
**Photo 13** shows the condition of the Motorcycle's rear tyre. The rear tyre was observed to be in serviceable condition with remaining tread depth of approximately 4mm. The tyre was also observed to be sufficiently inflated for vehicular operation. We did not observe any tear, burst mark(s) and/or punctured hole(s) on the sidewalls as well as across the tread of the rear tyre.

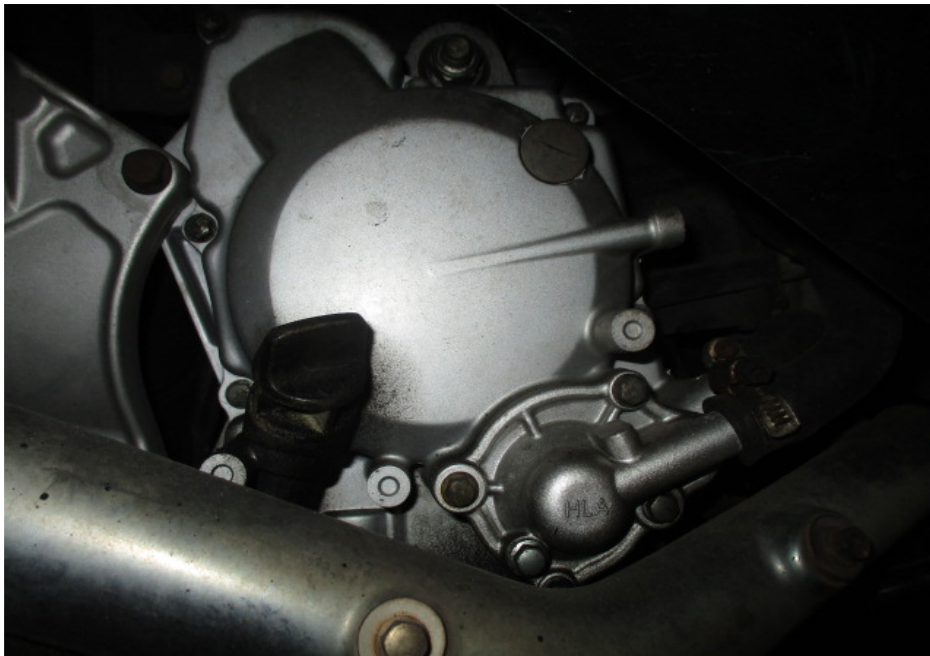
**Photo 14** shows the right side of the engine of the Motorcycle at the time of our inspection. The various engine related parts and components were found to be intact with no visible damage. There was also no sign(s) or indication(s) of fluid leak observed around the right engine area of the Motorcycle.

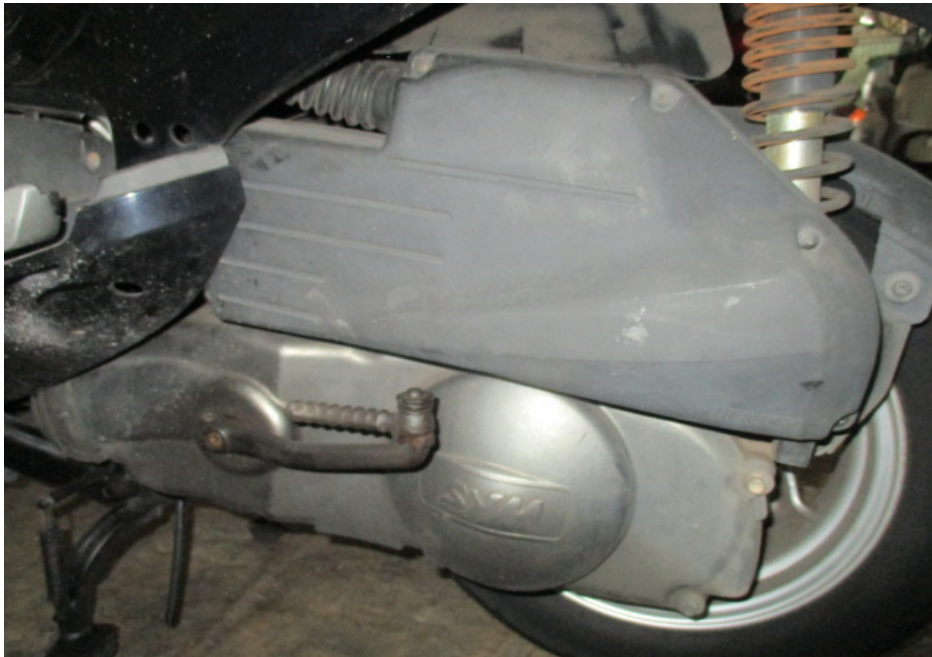
**Photo 15** shows the drive train of the Motorcycle which was found to be intact without any misalignment.

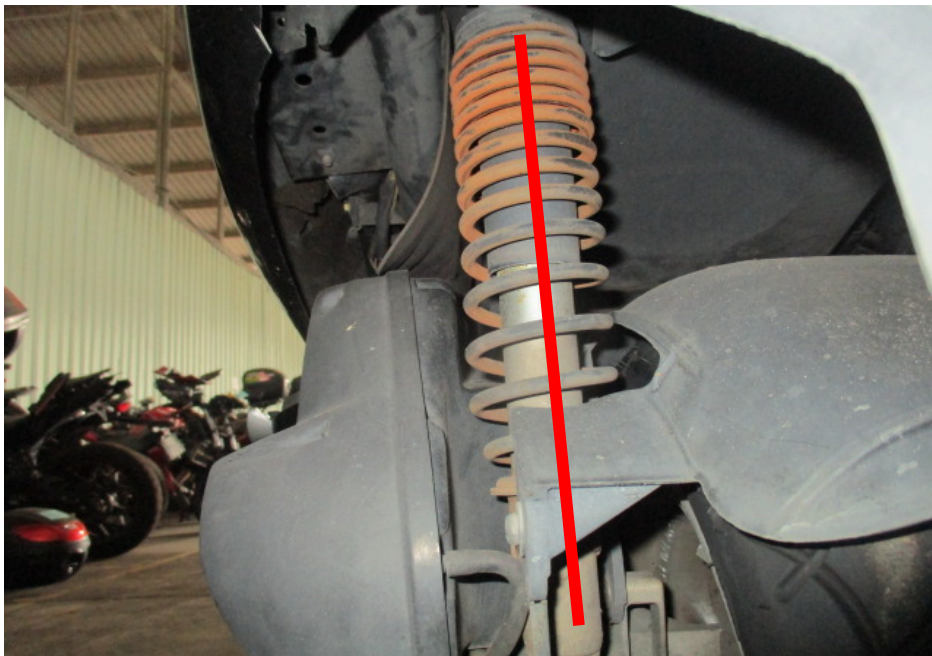
**Photo 16** shows the left shock absorber of the motorcycle which was found to be intact however slightly misaligned as a result of the accident.

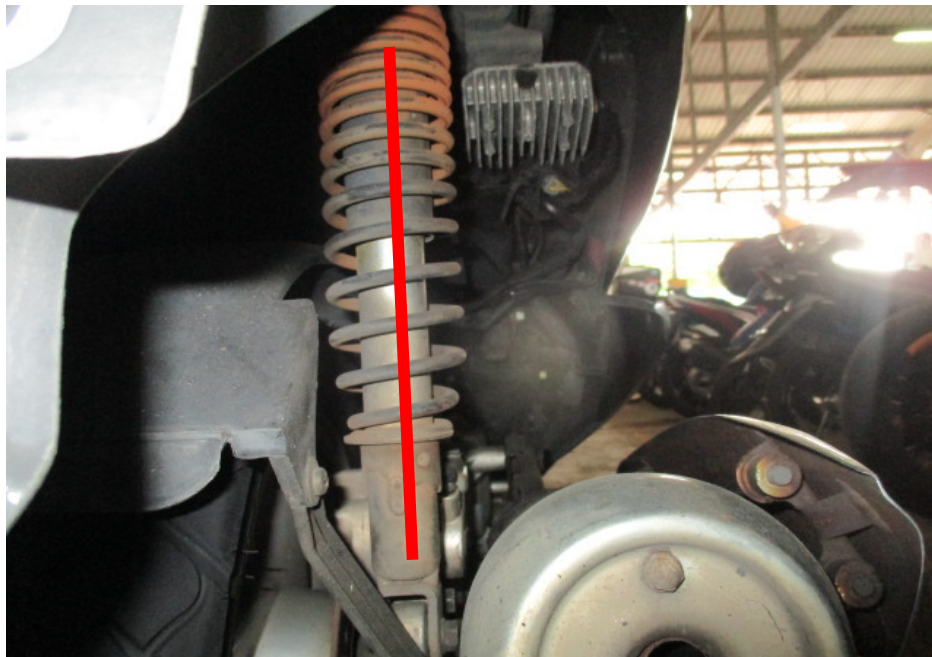
**Photo 17** shows the right shock absorber of the motorcycle which was found to be intact without any misalignment.

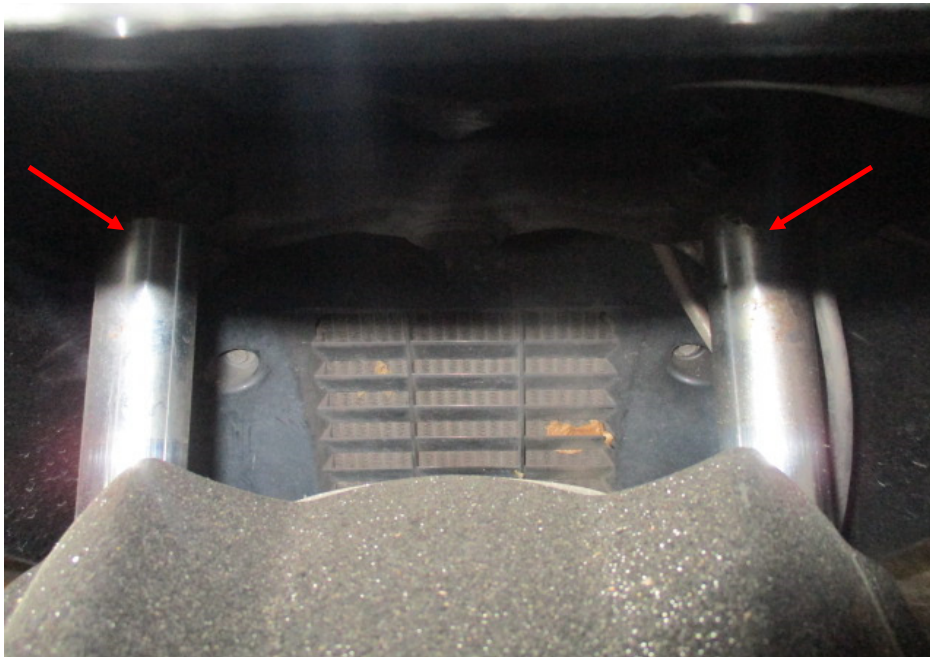
**Photo 18** shows the front forks (arrowed) of the Motorcycle. The front forks and fork brackets of the Motorcycle were both found to be intact and undamaged. Turning the Motorcycle's handle bar towards the left and right did not produce any abnormal free play and/or resistance. The steering system of the Motorcycle was in serviceable condition at the time of our inspection.

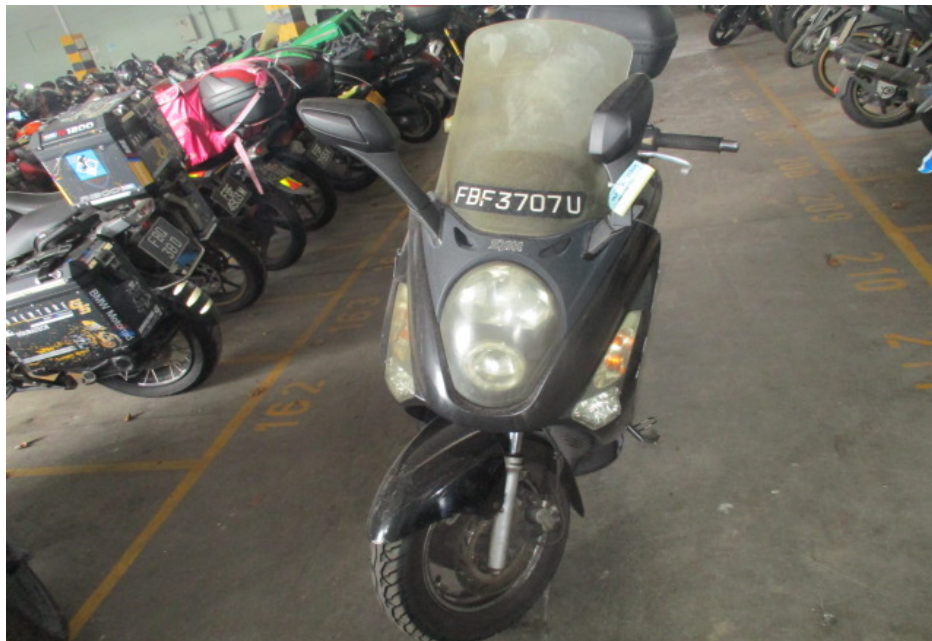
**Photo 19** shows the front wheel of the Motorcycle turned towards its full right. Turning the Motorcycle's handle bar towards the left and right did not produce any abnormal free play and/or resistance. This would indicate that the steering system of the Motorcycle was in serviceable condition at the time of our inspection.

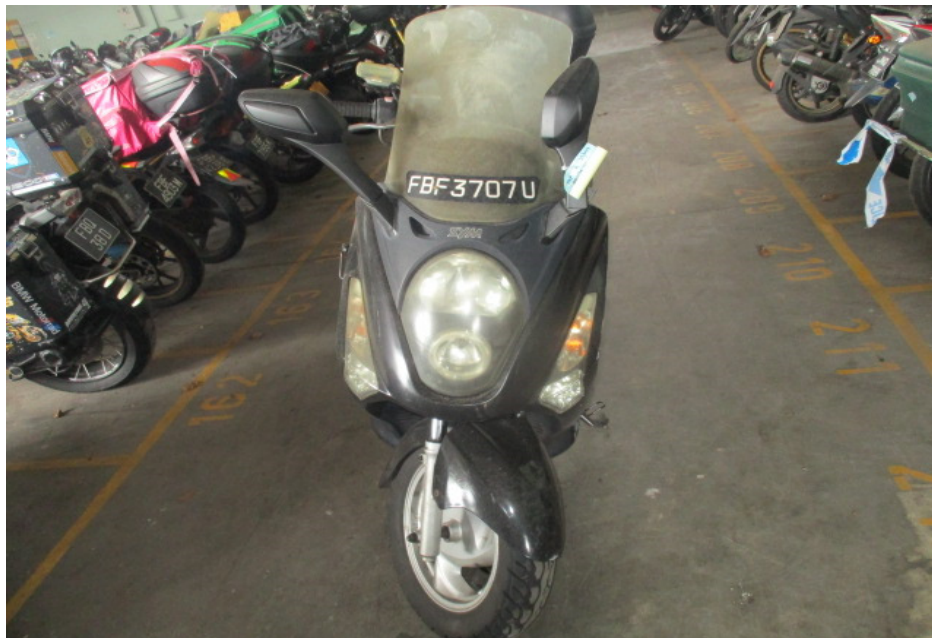
**Photo 20** shows the front wheel of the Motorcycle turned towards its full left. Turning the Motorcycle's handle bar towards the left and right did not produce any abnormal free play and/or resistance. This would indicate that the steering system of the Motorcycle was in serviceable condition at the time of our inspection.

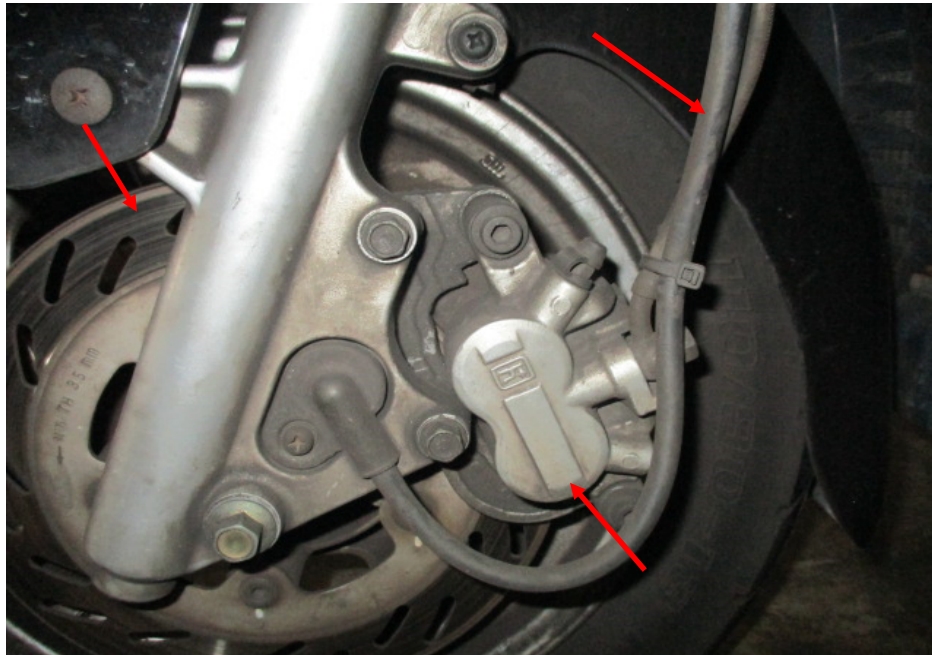
**Photo 21** shows a close up view of the front brake caliper, front brake disc and front brake hose (arrowed) of the Motorcycle, which are all part of the components in the hydraulic front brake system of the Motorcycle. Our visual checks of these various components had revealed all to be intact with no visible damage. No leakage of brake fluid was also observed.

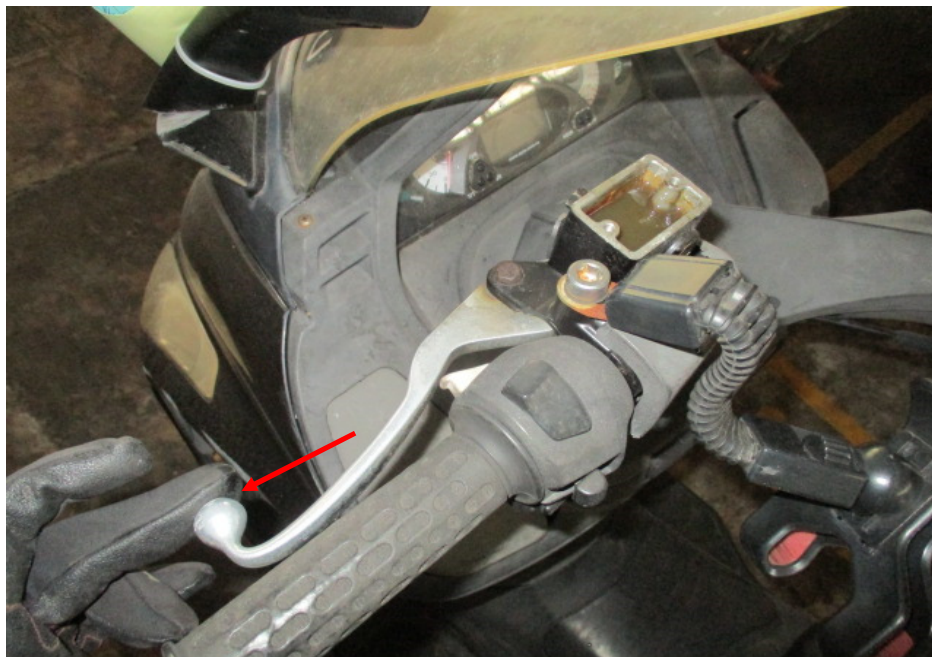
**Photo 22** shows the rear brake lever being depressed. There was some resistance felt (spongy like feel) upon pressing the rear brake lever (arrowed). This would indicate that there is no leakage of pressure/vacuum in the brake system.

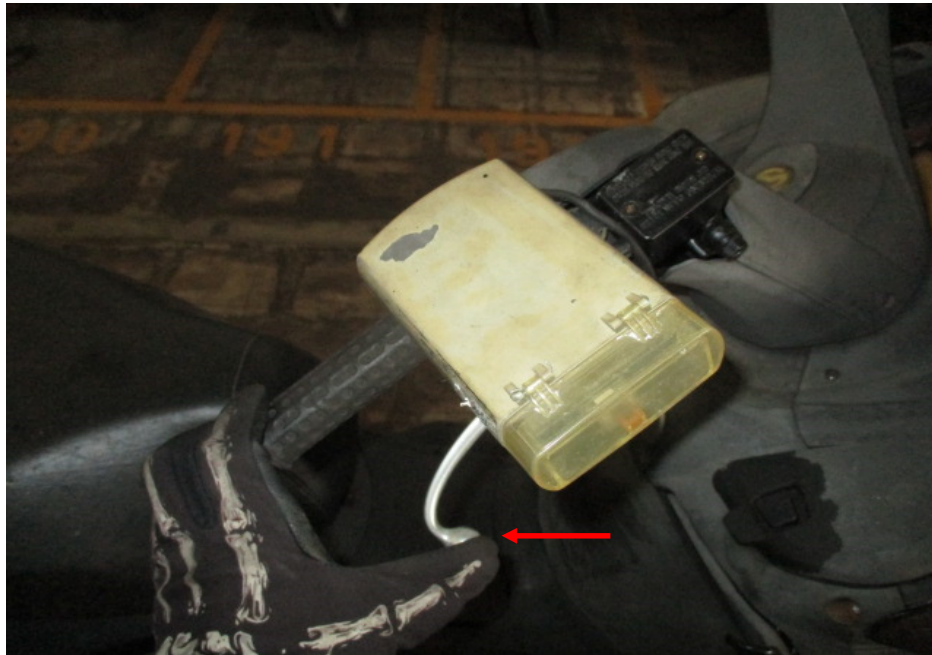
**Photo 23** shows the front brake lever being depressed. There was some resistance felt (spongy like feel) upon pressing the front brake lever (arrowed). This would indicate that there is no leakage of pressure/vacuum in the brake system.

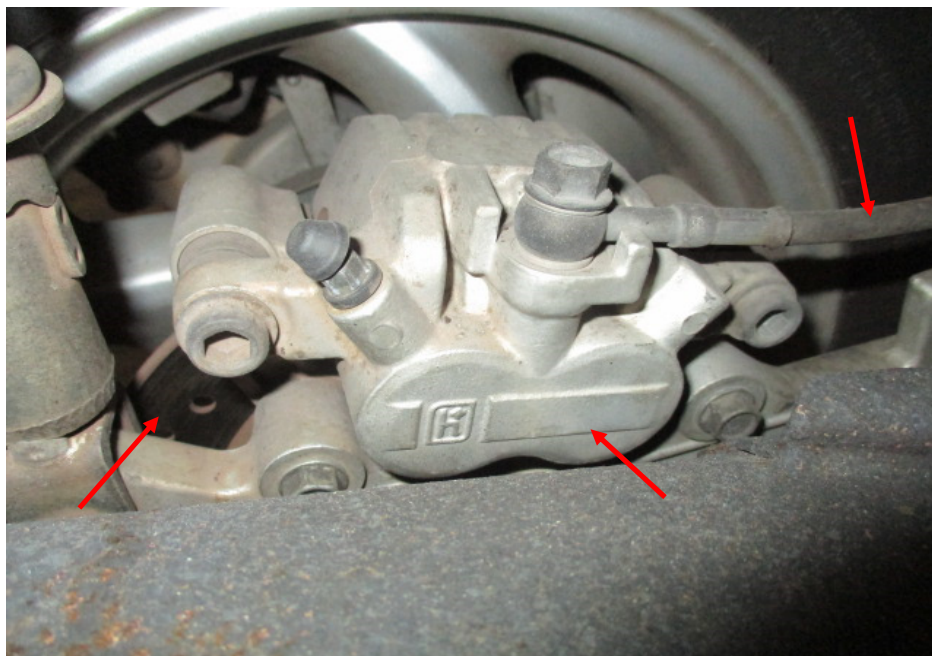
**Photo 24** shows a close up view of the rear brake caliper, rear brake disc and rear brake hose (arrowed) of the Motorcycle, which are all part of the components in the hydraulic rear brake system of the Motorcycle. Our visual checks of these various components revealed all to be intact with no visible damage. No leakage of brake fluid was also observed.
