Your Ref: TP/IP/65989/2019
Our Ref :CI/TPD19022291/N

31 December 2019

INSPECTION REPORT OF MOTORCYCLE FBF 3707U

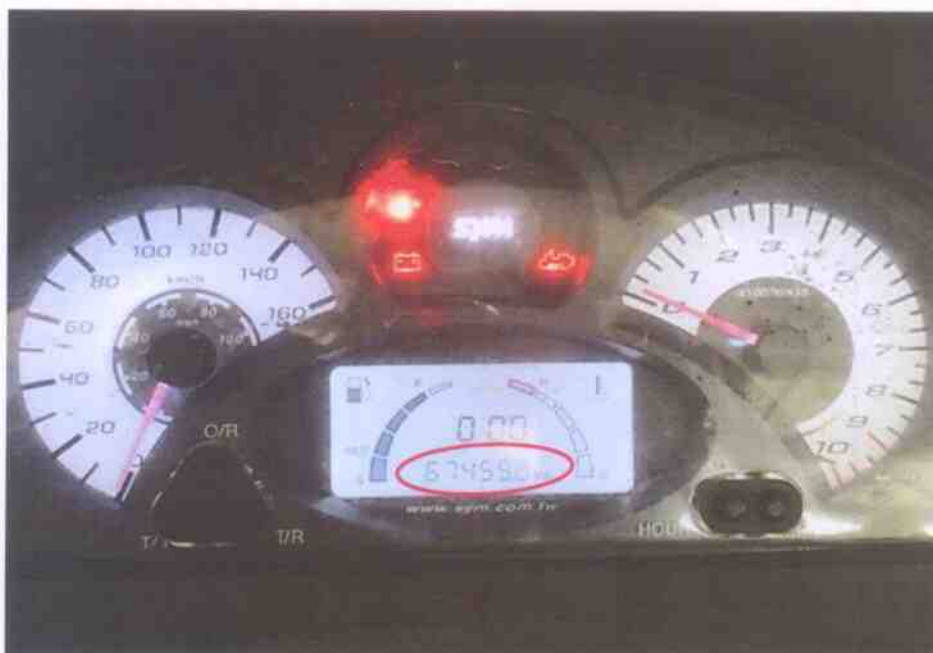
Photo 1 shows the speedometer gauge of the Motorcycle where the mileage recorded at the time of our inspection was 67, 459km (circled).

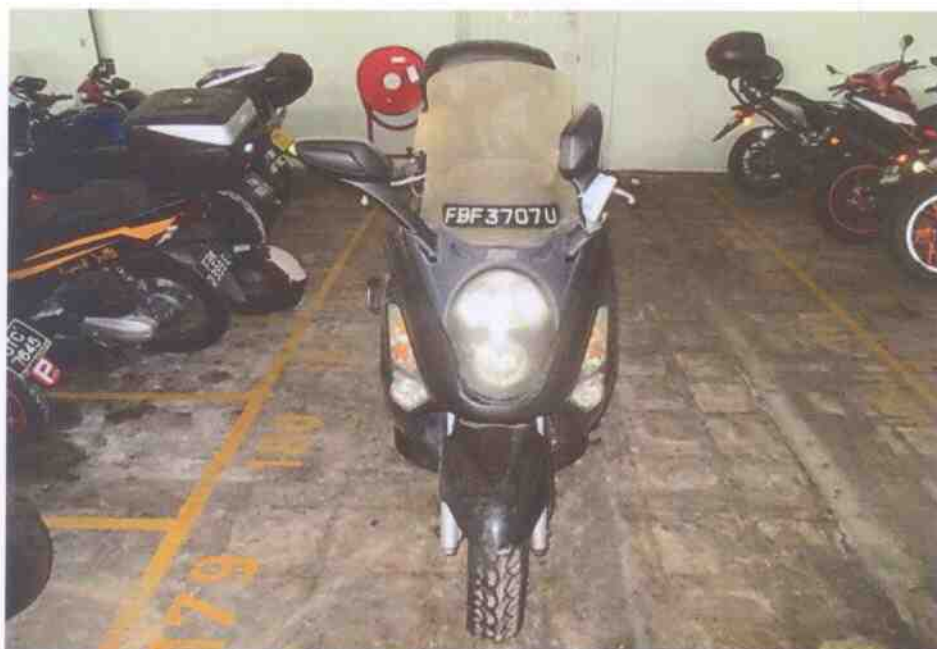
Photo 2 shows a general view of the front body of the Motorcycle at the time of our inspection. The Motorcycle was observed to have sustained minor damages at the frontal and left portion.

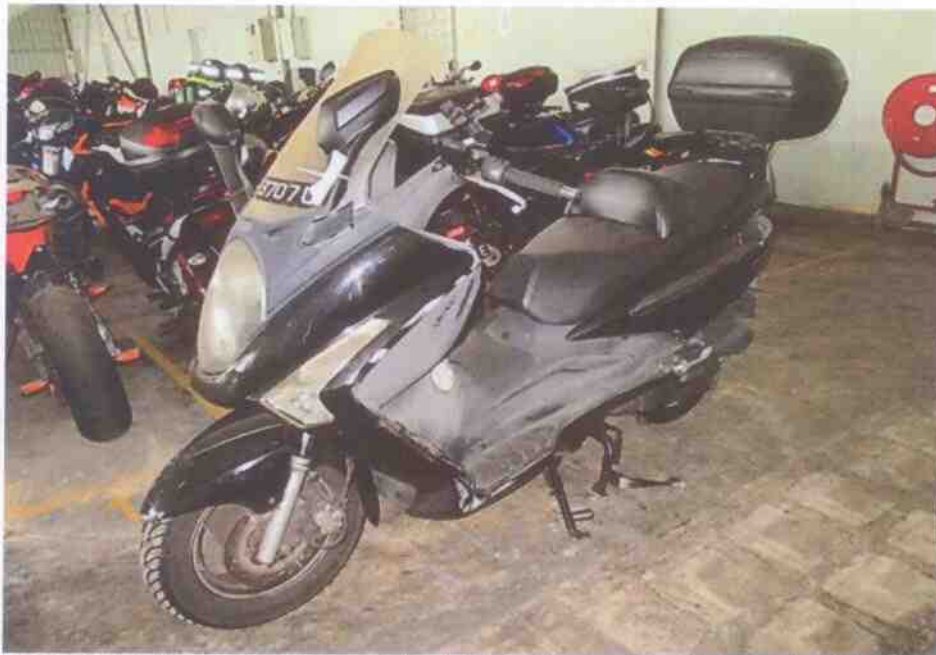
Photo 3 shows a general view of the left front body of the Motorcycle at the time of our inspection. The Motorcycle was observed to have sustained minor damages at the frontal and left portion. The body parts that were found to have been damaged include its front mudguard, rear brake lever, left side mirror, left cowl, left rear side cover, left pillion foot rest, main stand and top box, amongst others as a result of the accident.

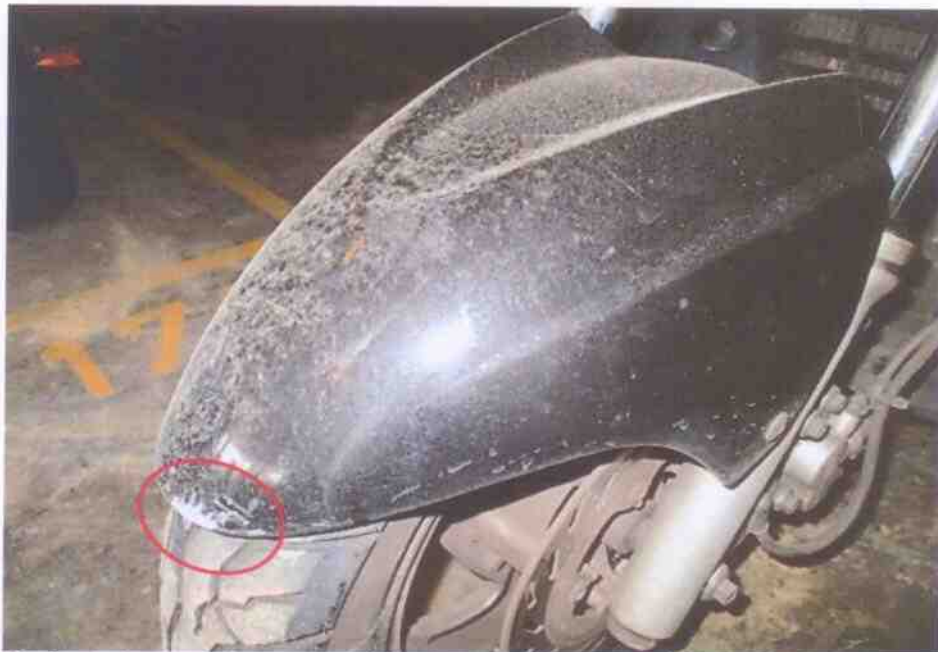
Photo 4 shows a closer view of the front mudguard (circled) which was amongst the body parts at the front body of the Motorcycle that had sustained damage as a result of the accident.

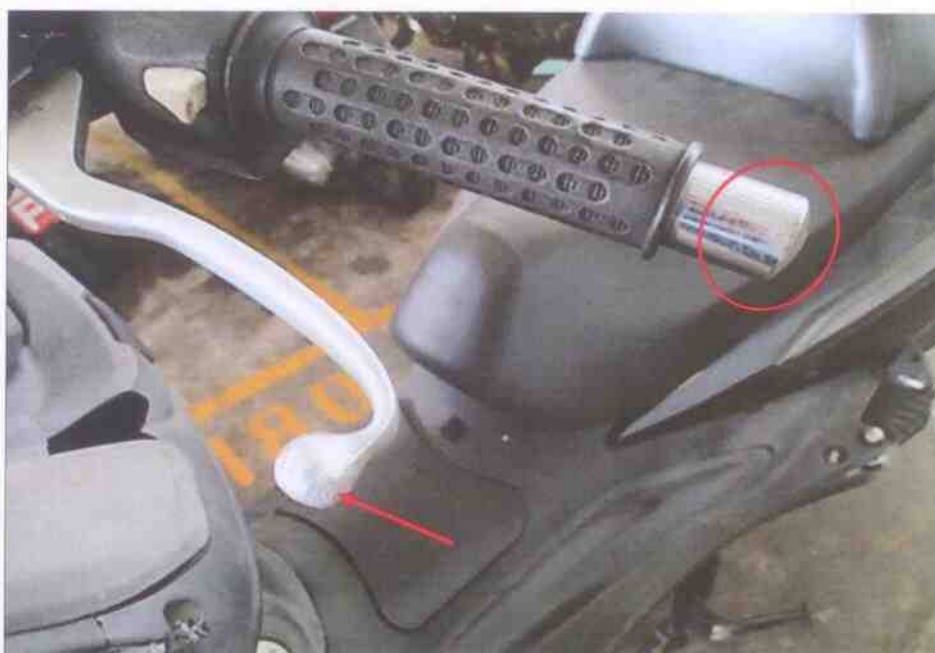
Photo 5 shows a closer view of the rear brake lever (arrowed) and left handlebar end (circled) of the Motorcycle which were observed to be damaged due to the accident.

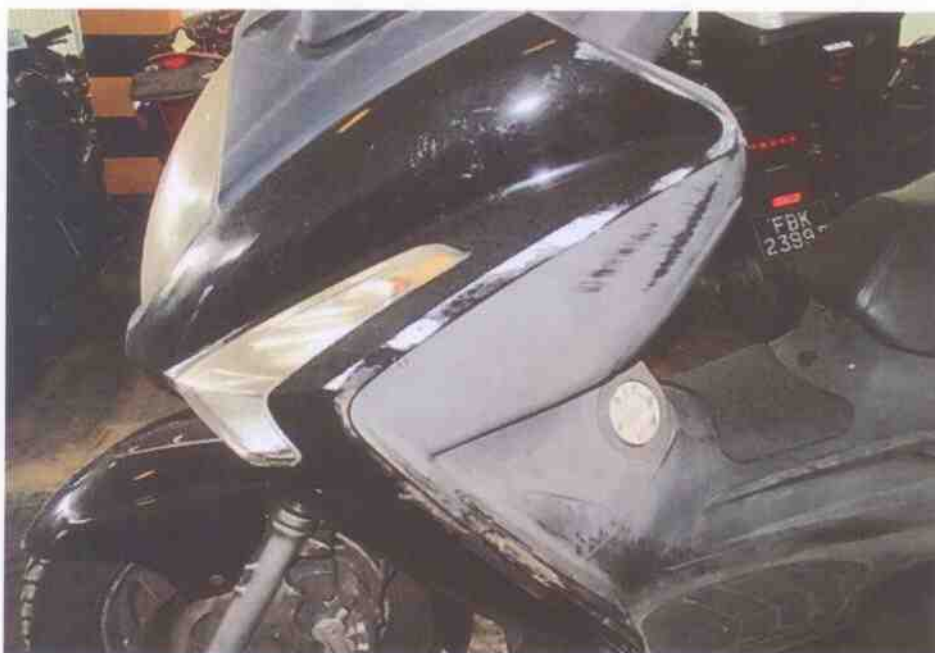
Photo 6 shows a closer view of the left cowling which was amongst the body parts at the front body of the Motorcycle that had sustained damage as a result of the accident.

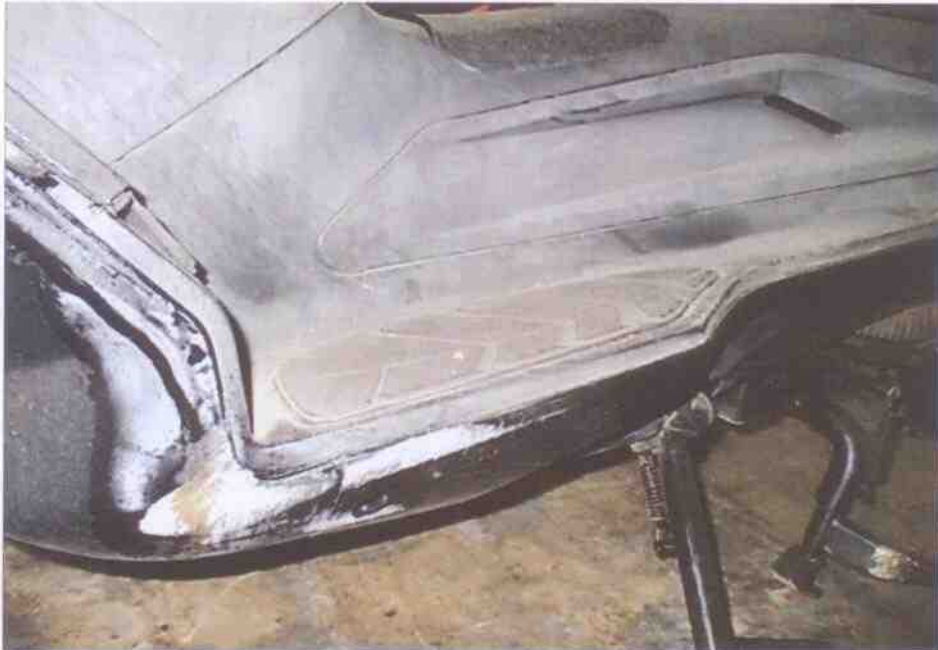
Photo 7 shows a closer view of the left bottom cowling of the Motorcycle which was observed to be damaged due to the accident.

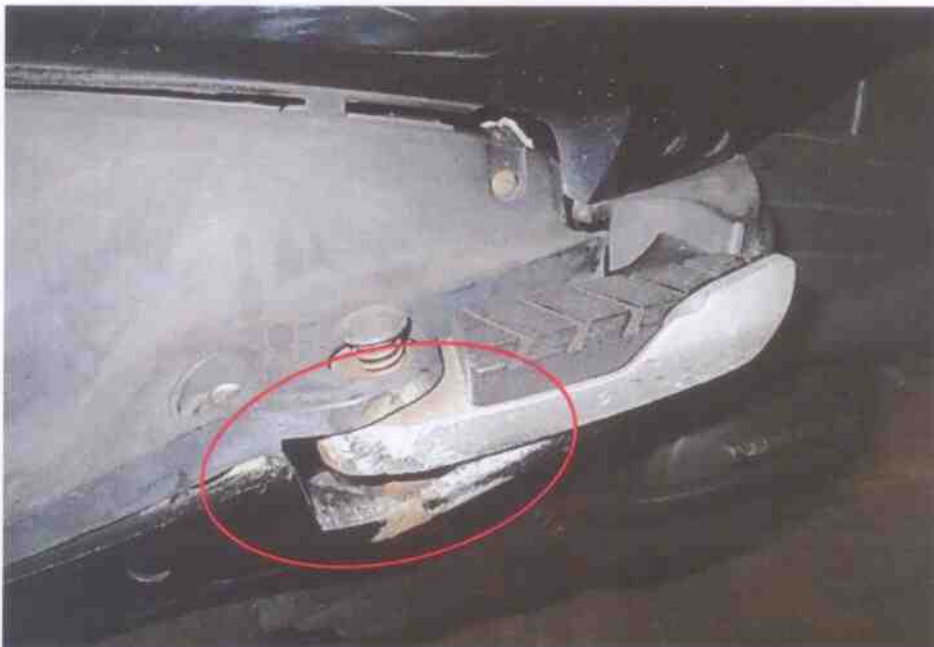
Photo 8 shows a closer view of the damaged left pillion footrest (circled) of the Motorcycle at the time of our inspection.

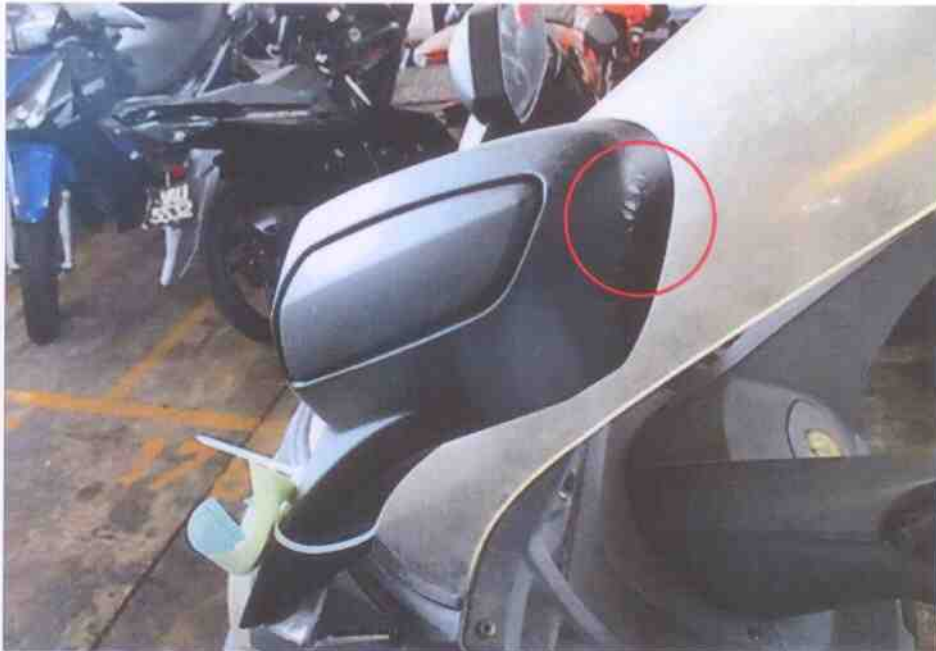
Photo 9 shows a closer view of the left side mirror of the Motorcycle which had sustained damage due to the accident (circled).

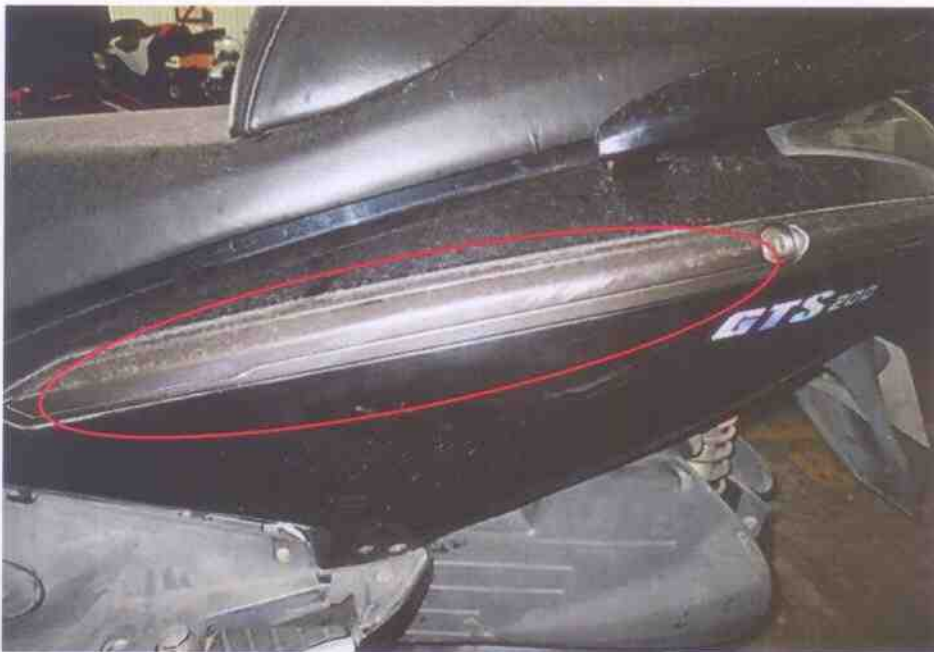
Photo 10 shows a closer view of the damaged left rear side cover of the Motorcycle which was observed to have sustained scratches due to the accident (circled).

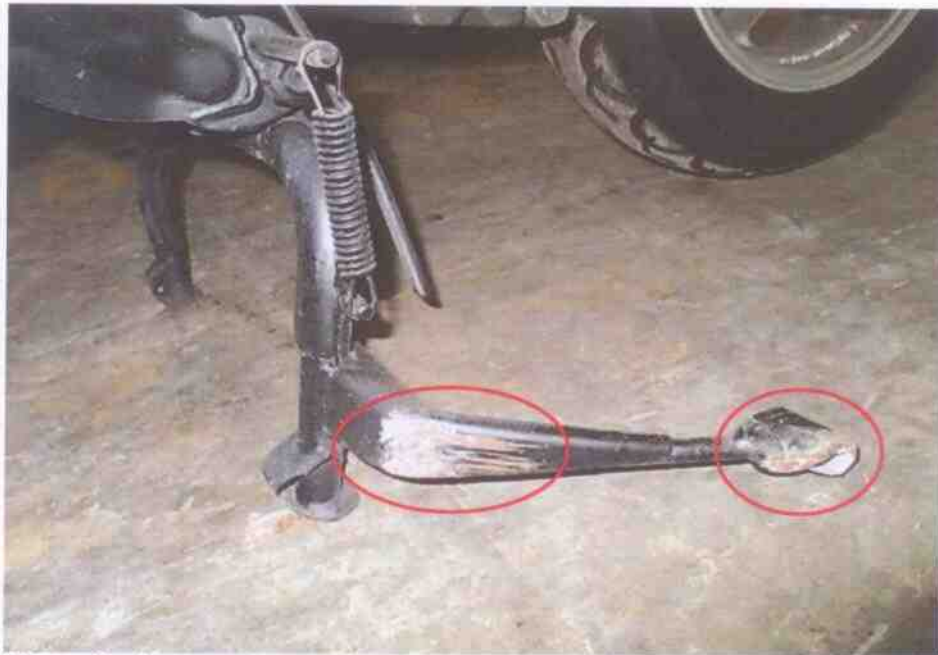
Photo 11 shows a closer view of the main stand of the Motorcycle which was observed to have sustained damages of grazing nature due to the accident (circled).

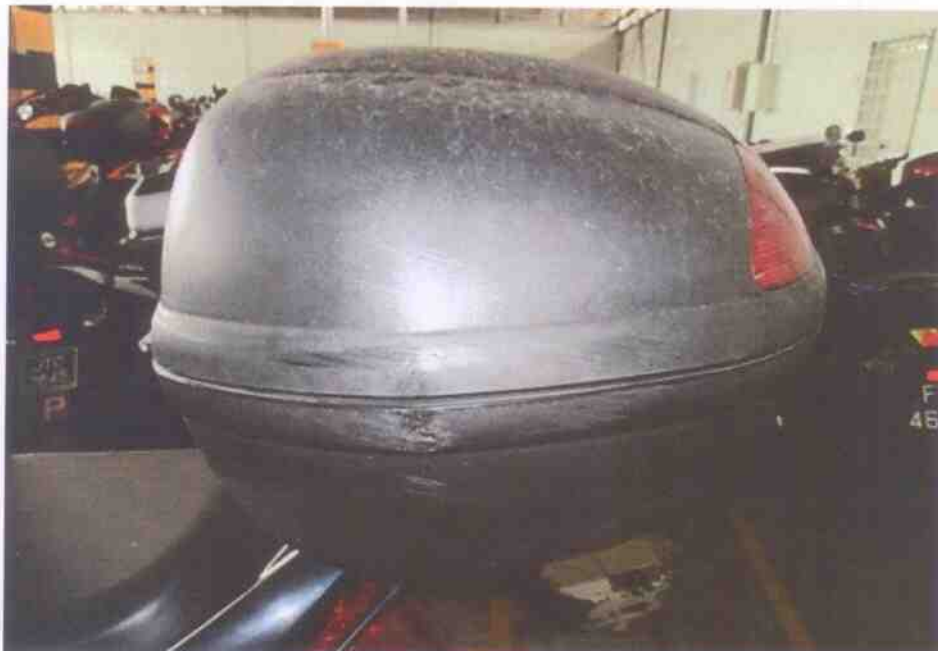
Photo 11 shows a closer view of the top box of the Motorcycle which was observed to have sustained damages of grazing nature due to the accident.

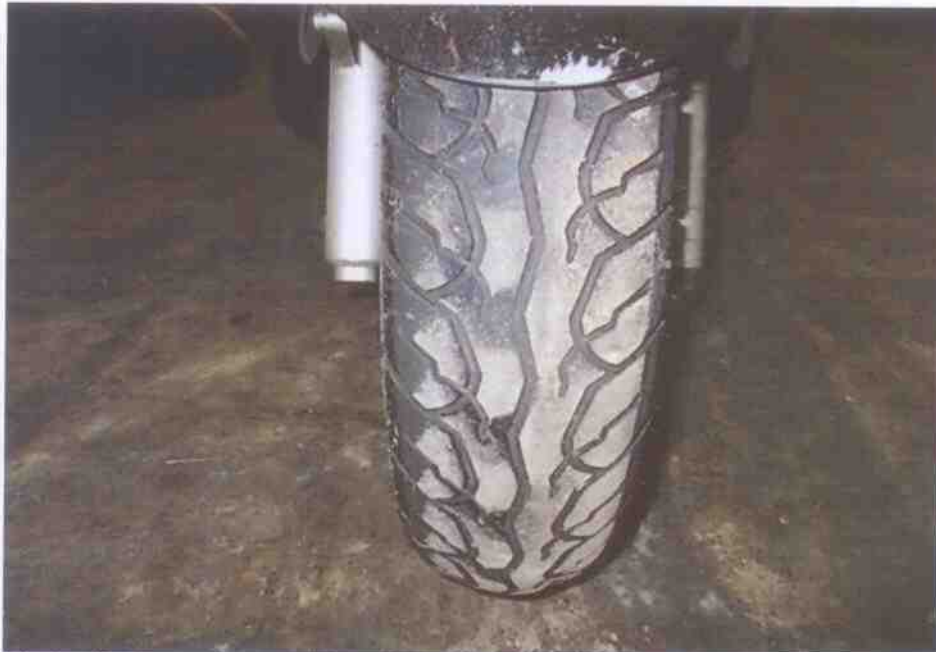
Photo 12 shows the condition of the Motorcycle's front tyre. The front tyre was observed to be in serviceable condition with remaining tread depth of approximately 4mm. There was no tear, burst mark(s) and/or punctured hole(s) on the sidewalls as well as across the tread of the front tyre.

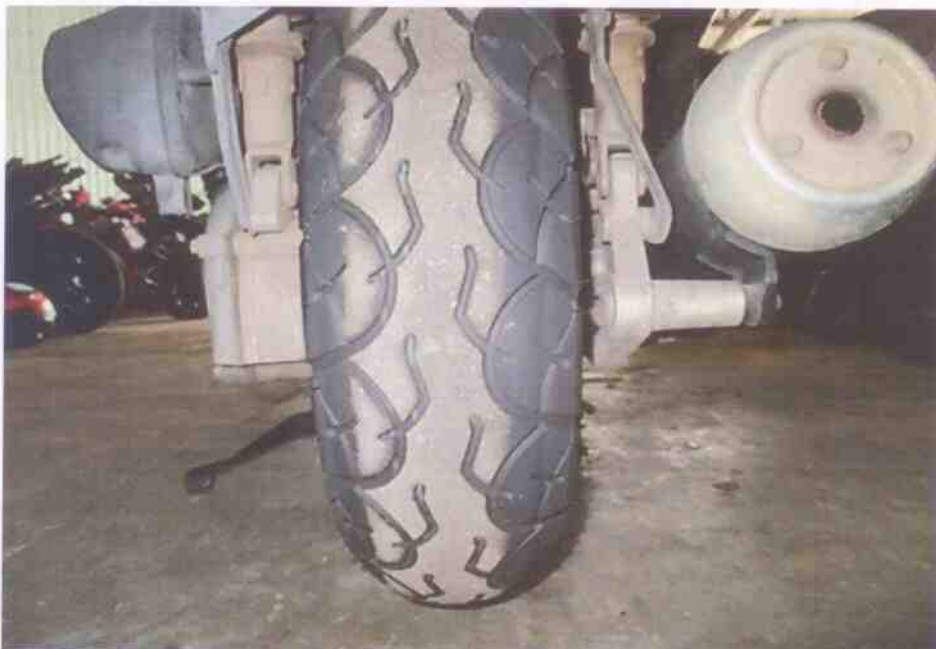
Photo 13 shows the condition of the Motorcycle's rear tyre. The rear tyre was observed to be in serviceable condition with remaining tread depth of approximately 4mm. The tyre was also observed to be sufficiently inflated for vehicular operation. We did not observe any tear, burst mark(s) and/or punctured hole(s) on the sidewalls as well as across the tread of the rear tyre.

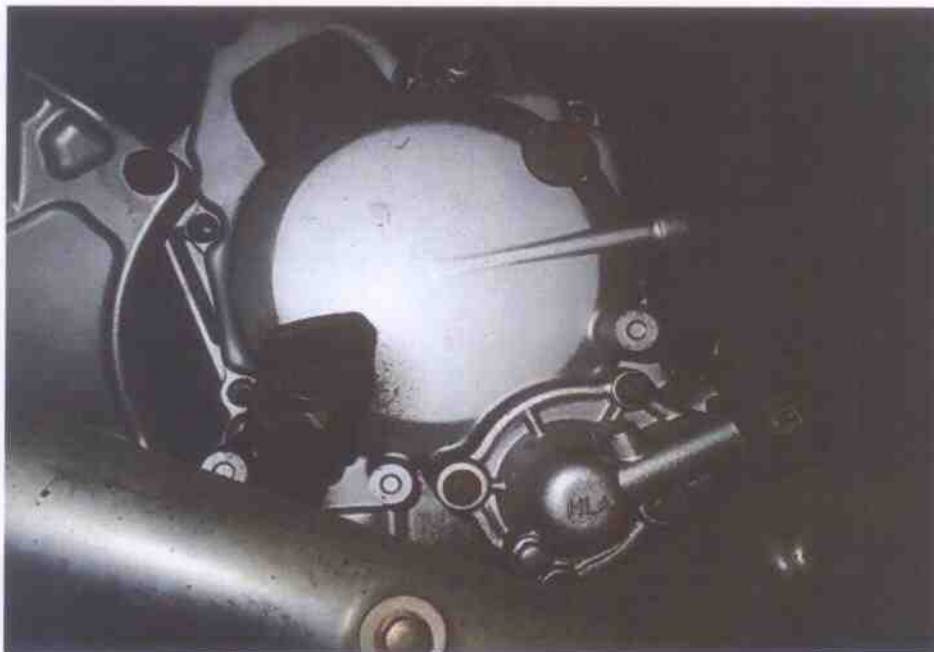
Photo 14 shows the right side of the engine of the Motorcycle at the time of our inspection. The various engine related parts and components were found to be intact with no visible damage. There was also no sign(s) or indication(s) of fluid leak observed around the right engine area of the Motorcycle.

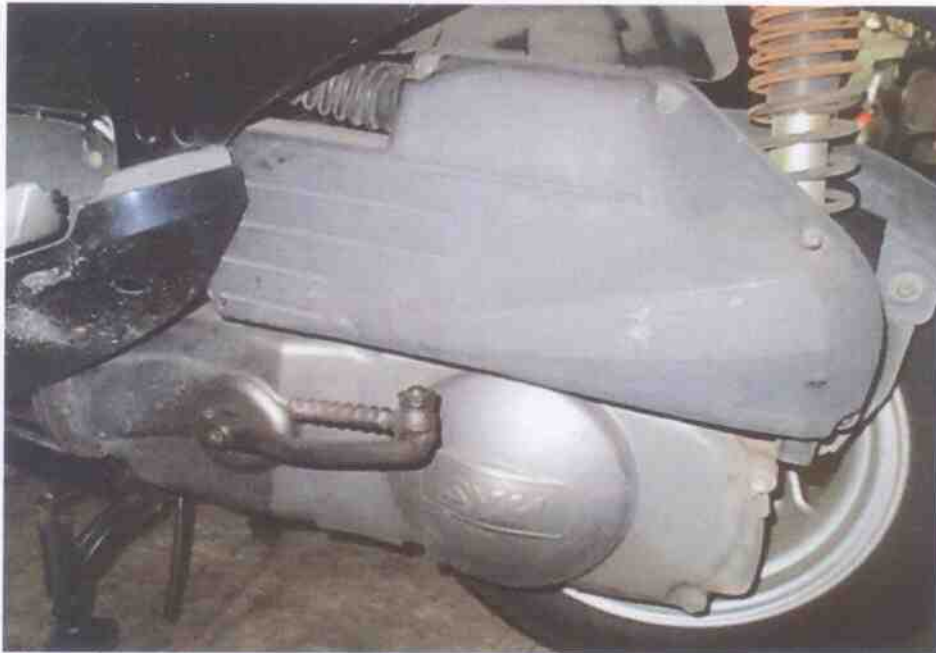
Photo 15 shows the drive train of the Motorcycle which was found to be intact without any misalignment.

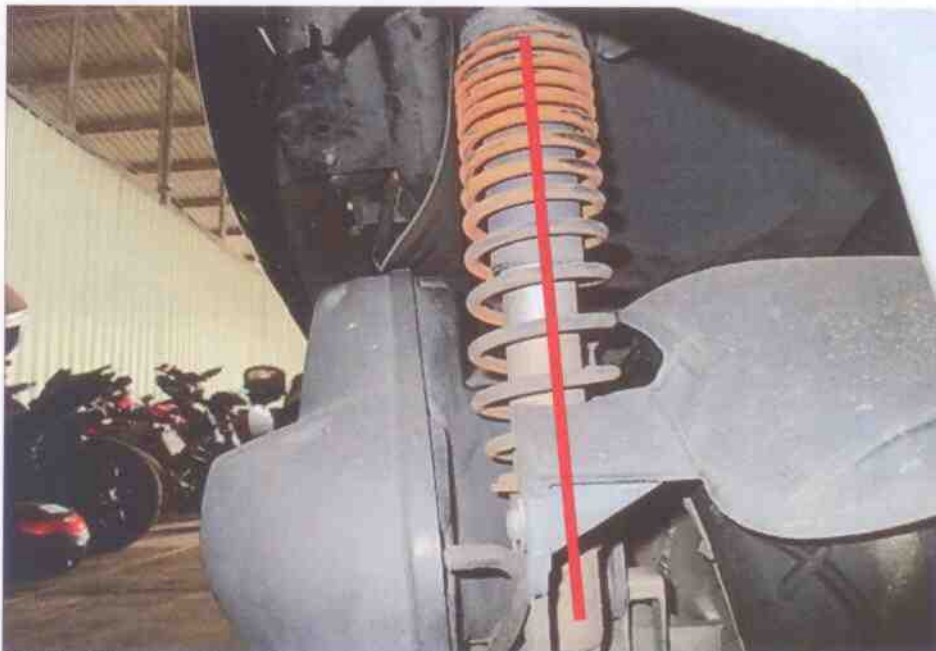
Photo 16 shows the left shock absorber of the motorcycle which was found to be intact however slightly misaligned as a result of the accident.

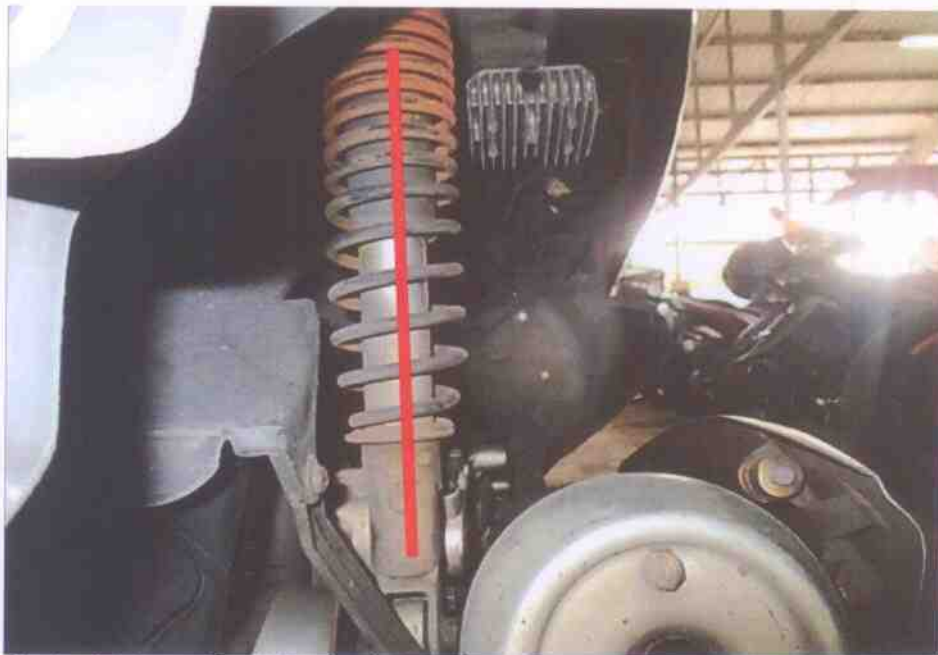
Photo 17 shows the right shock absorber of the motorcycle which was found to be intact without any misalignment.

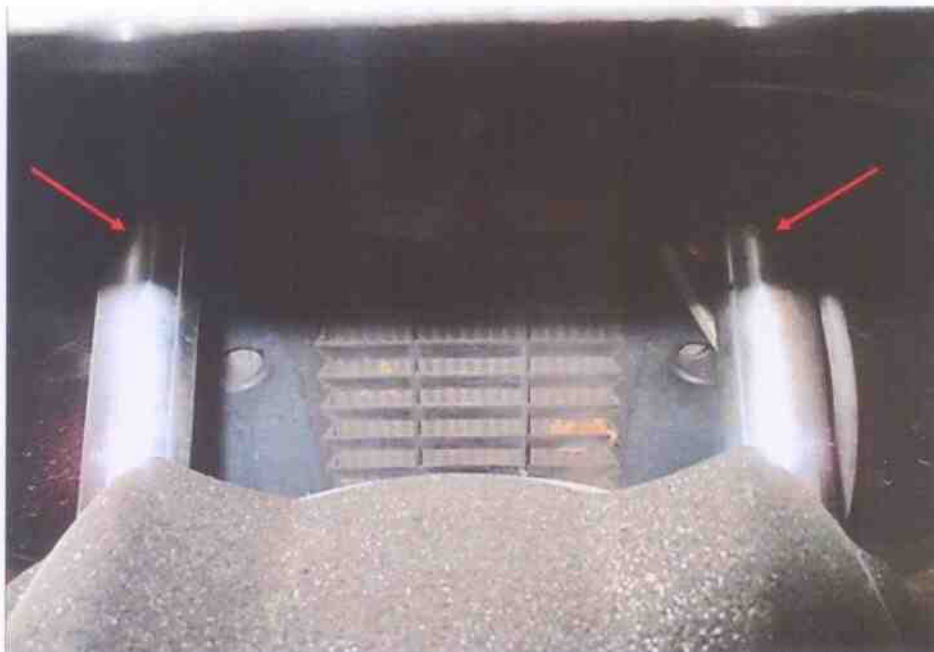
Photo 18 shows the front forks (arrowed) of the Motorcycle. The front forks and fork brackets of the Motorcycle were both found to be intact and undamaged. Turning the Motorcycle's handle bar towards the left and right did not produce any abnormal free play and/or resistance. The steering system of the Motorcycle was in serviceable condition at the time of our inspection.

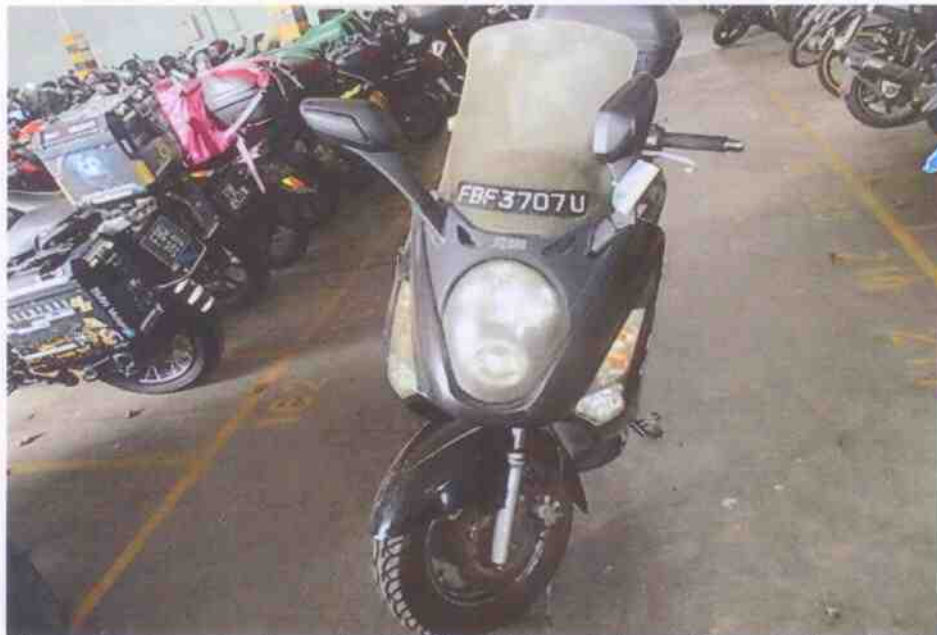
Photo 19 shows the front wheel of the Motorcycle turned towards its full right. Turning the Motorcycle's handle bar towards the left and right did not produce any abnormal free play and/or resistance. This would indicate that the steering system of the Motorcycle was in serviceable condition at the time of our inspection.

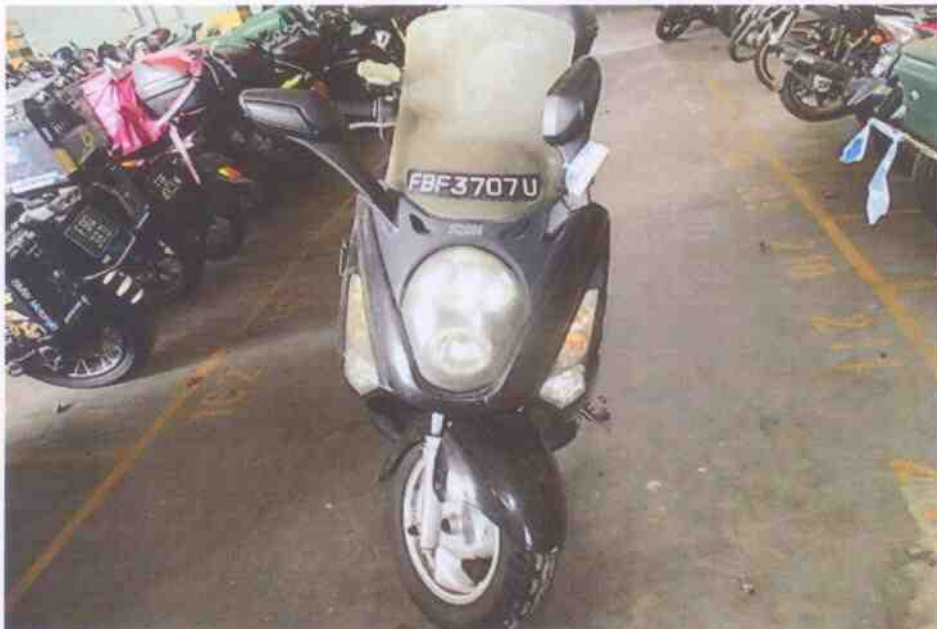
Photo 20 shows the front wheel of the Motorcycle turned towards its full left. Turning the Motorcycle's handle bar towards the left and right did not produce any abnormal free play and/or resistance. This would indicate that the steering system of the Motorcycle was in serviceable condition at the time of our inspection.

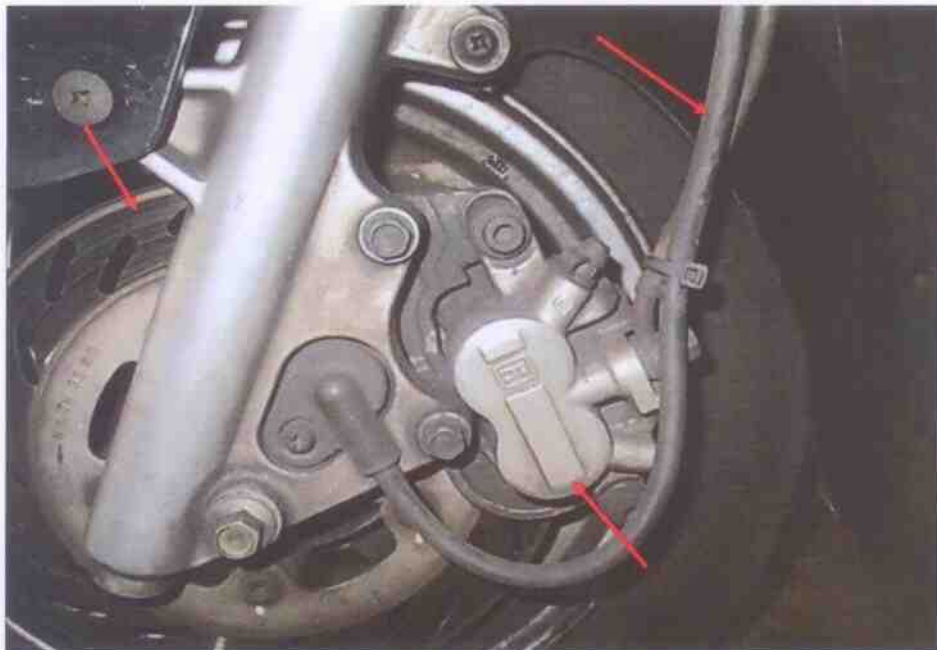
Photo 21 shows a close up view of the front brake caliper, front brake disc and front brake hose (arrowed) of the Motorcycle, which are all part of the components in the hydraulic front brake system of the Motorcycle. Our visual checks of these various components had revealed all to be intact with no visible damage. No leakage of brake fluid was also observed.

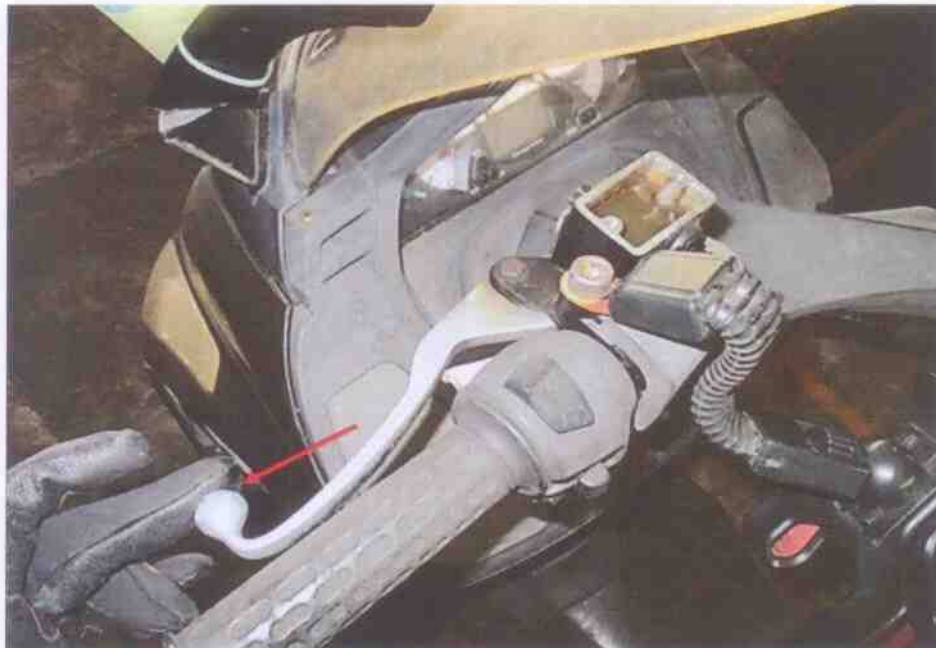
Photo 22 shows the rear brake lever being depressed. There was some resistance felt (spongy like feel) upon pressing the rear brake lever (arrowed). This would indicate that there is no leakage of pressure/vacuum in the brake system.

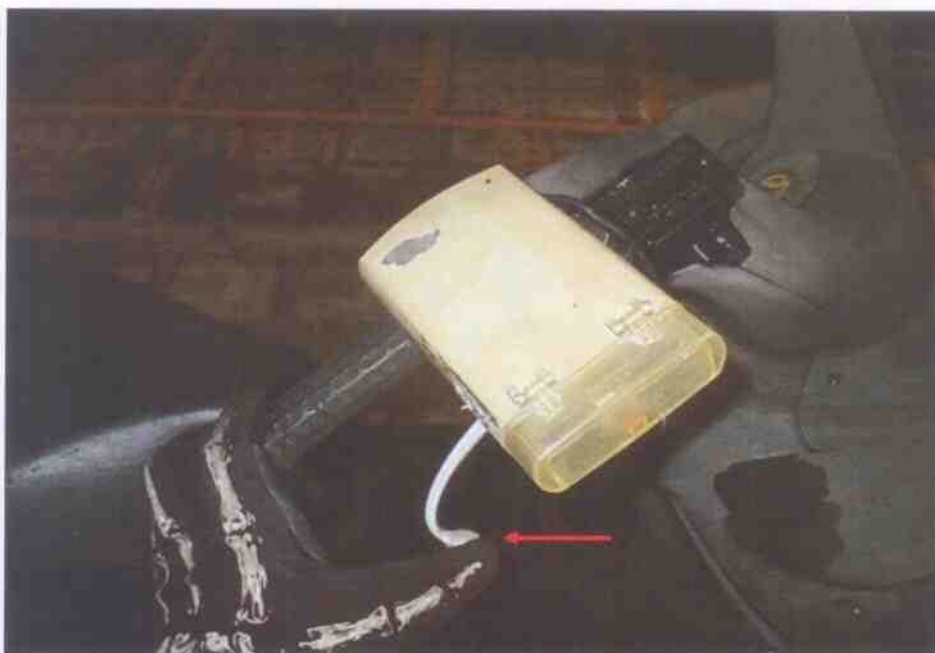
Photo 23 shows the front brake lever being depressed. There was some resistance felt (spongy like feel) upon pressing the front brake lever (arrowed). This would indicate that there is no leakage of pressure/vacuum in the brake system.

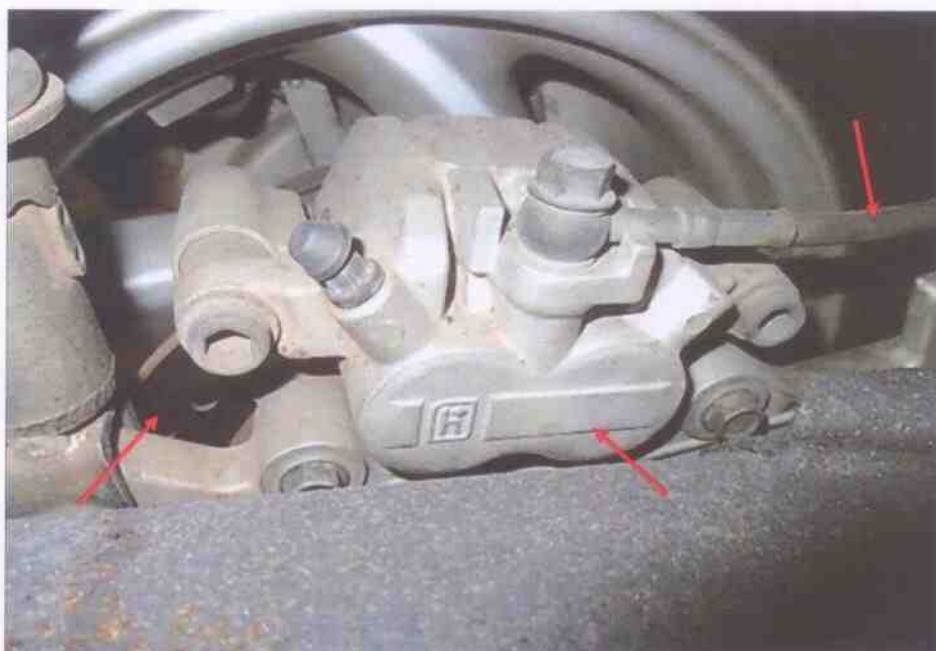
Photo 24 shows a close up view of the rear brake caliper, rear brake disc and rear brake hose (arrowed) of the Motorcycle, which are all part of the components in the hydraulic rear brake system of the Motorcycle. Our visual checks of these various components revealed all to be intact with no visible damage. No leakage of brake fluid was also observed.
