Your Ref: TP/IP/62415/2019
Our Ref : CI/TPD19022293/N

Fatal Accident Investigation Team

MECHANICAL INSPECTION REPORT OF MOTORCYCLE FBH 347J

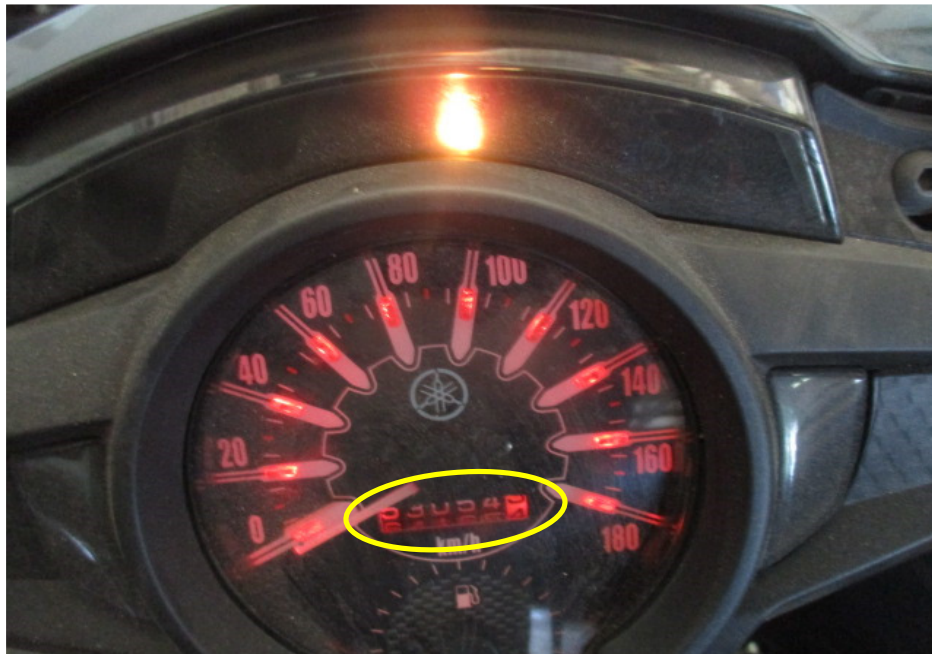
Photo 1 shows the speedometer gauge of the Motorcycle where the mileage recorded at the time of our inspection was 53, 054km (circled).

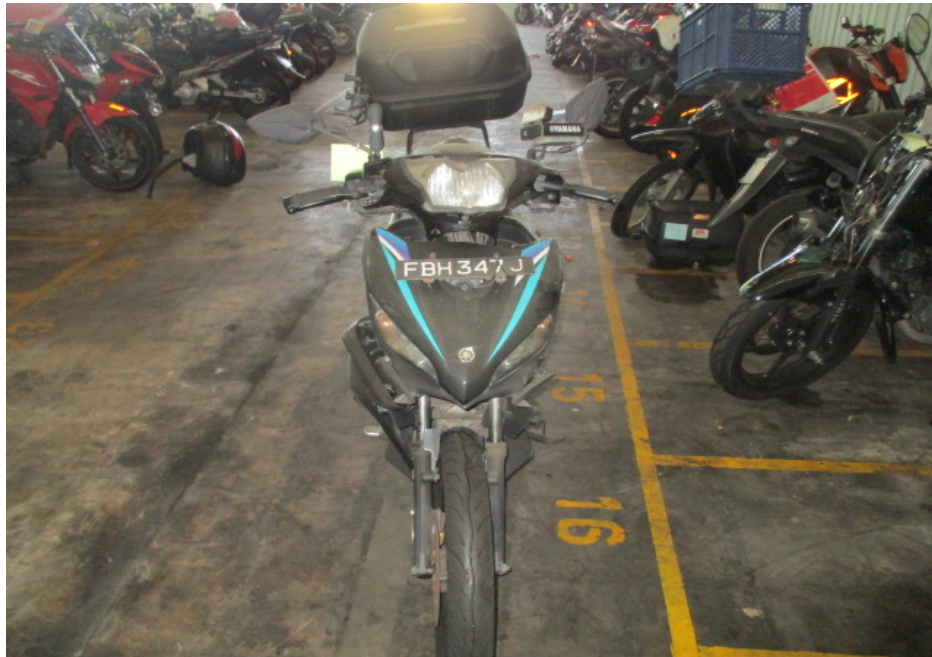
Photo 2 shows a general view of the frontal portion of the Motorcycle at the time of our inspection. The Motorcycle had sustained damages all around.

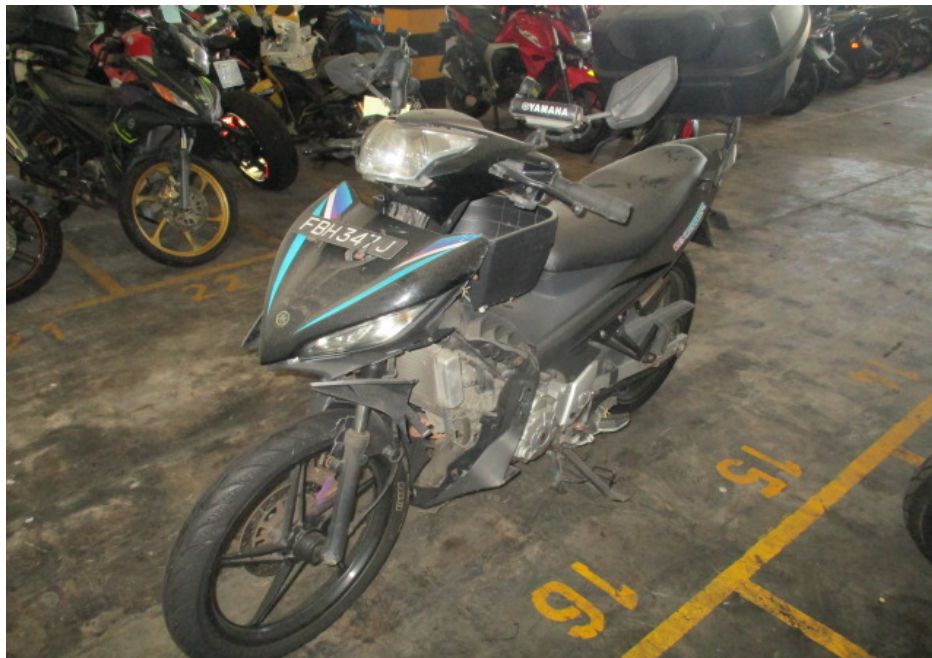
4. The mileage of the Motorcycle at the time of our inspection was 53, 054km.
5. The Motorcycle had sustained damages all around. Body parts that were found to have been damaged include its headlight, head cowl, front fork assembly, steering stem, side cowlings, left side mirror, clutch lever, gear shift pedal, left front footrest, left pillion footrest bracket and rear number plate, amongst others.

Photo 3 shows a general view of the left body of the Motorcycle at the time of our inspection. Body parts that were found to have been damaged include its headlight, head cowlings, front fork assembly, steering stem, side cowlings, left side mirror, clutch lever, gear shift pedal, left front footrest, left pillion footrest bracket and rear number plate, amongst others.

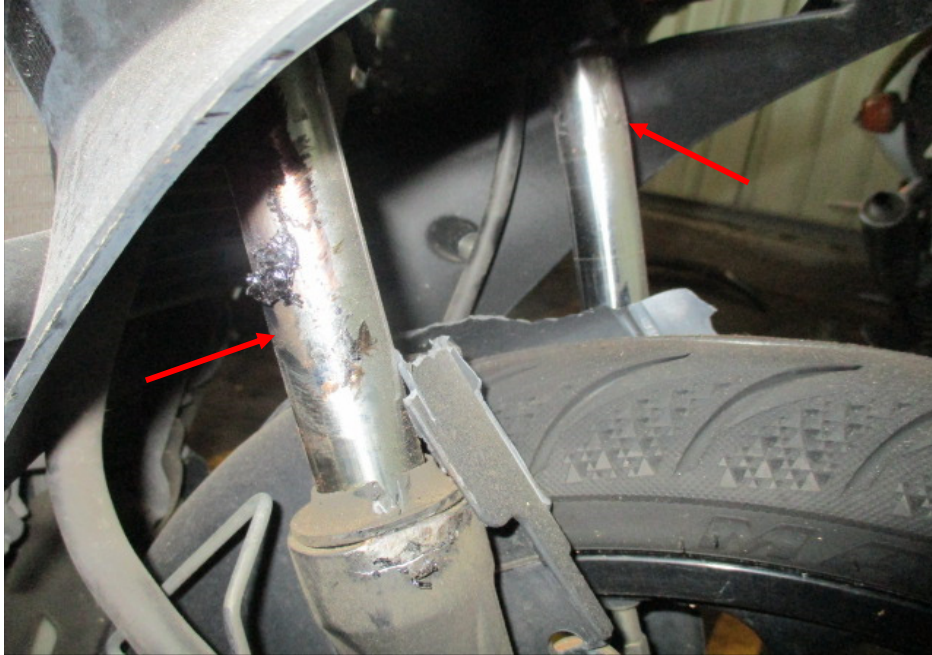
Photo 4 shows a closer view of the front fork assembly (arrowed) which was amongst the body parts at the front body of the Motorcycle that had sustained damage as a result of the accident.

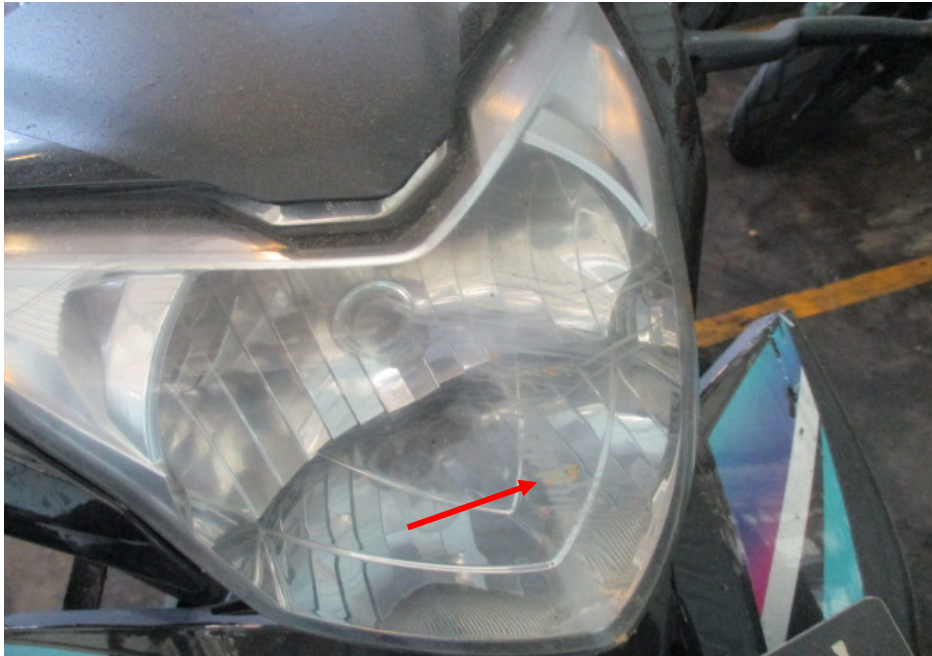
Photo 5 shows a closer view of the headlight which was amongst the body parts at the front body of the Motorcycle that had sustained damages as a result of the accident (arrowed).

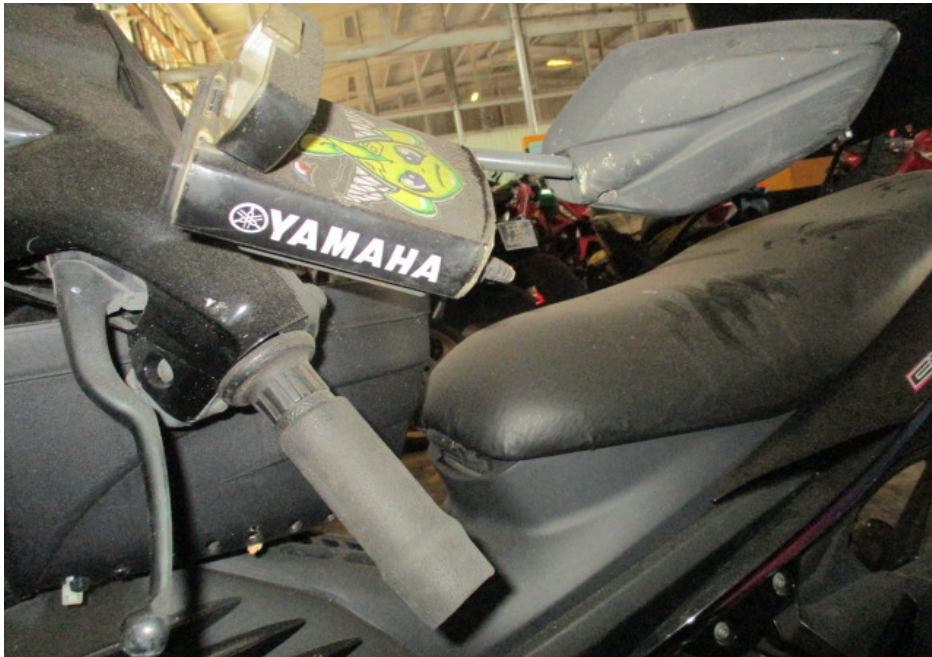
Photo 6 shows a closer view of the clutch lever, left side mirror and left handlebar grip of the Motorcycle. These parts were amongst the body parts of the Motorcycle which were damaged as a result of the accident.

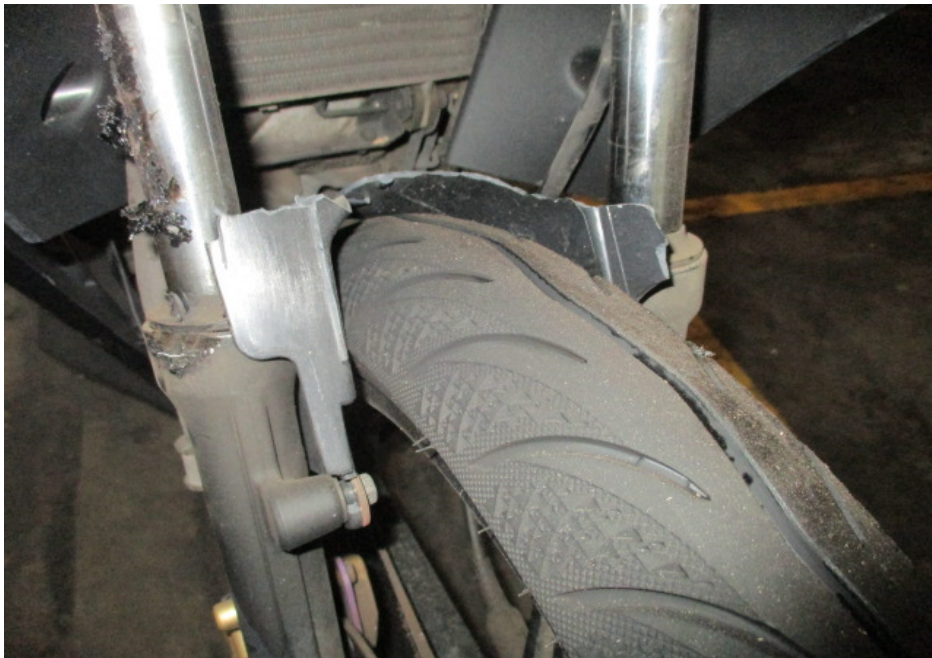
Photo 7 shows a closer view of the front mudguard, which was amongst the body parts of the Motorcycle that had sustained damage as a result of the accident.

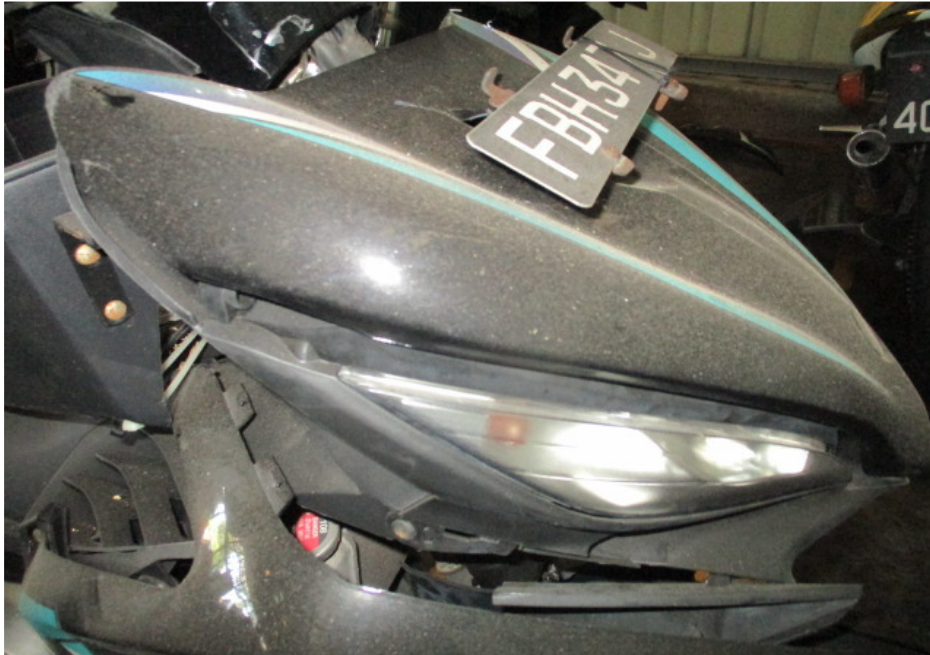
Photo 8 shows a closer view of the head cowl which was amongst the body parts at the front body of the Motorcycle that had sustained damages as a result of the accident.

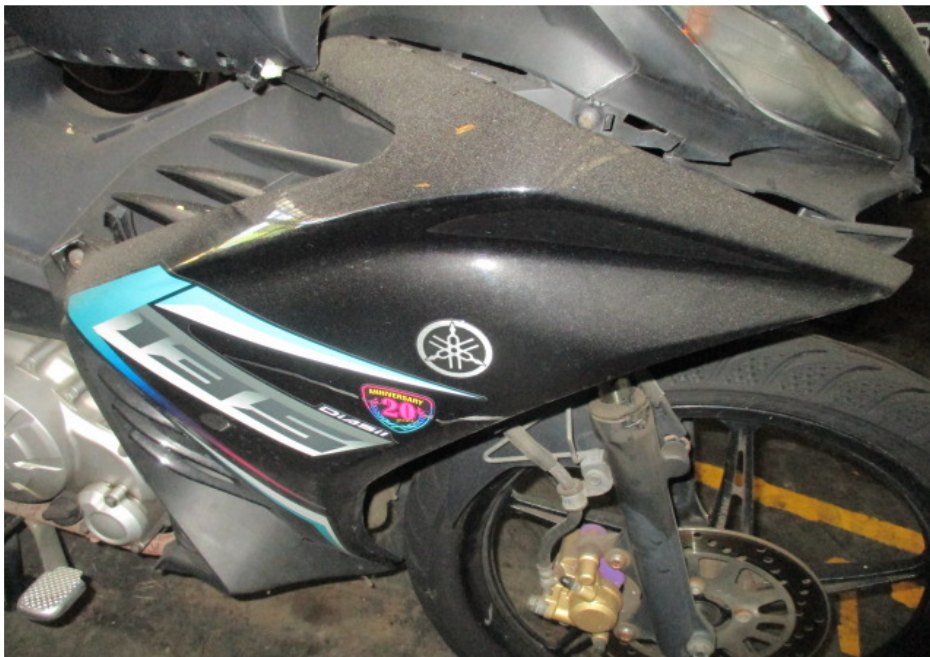
Photo 9 shows a closer view of the right cowl which was amongst the body parts at the front body of the Motorcycle that had sustained damages as a result of the accident.

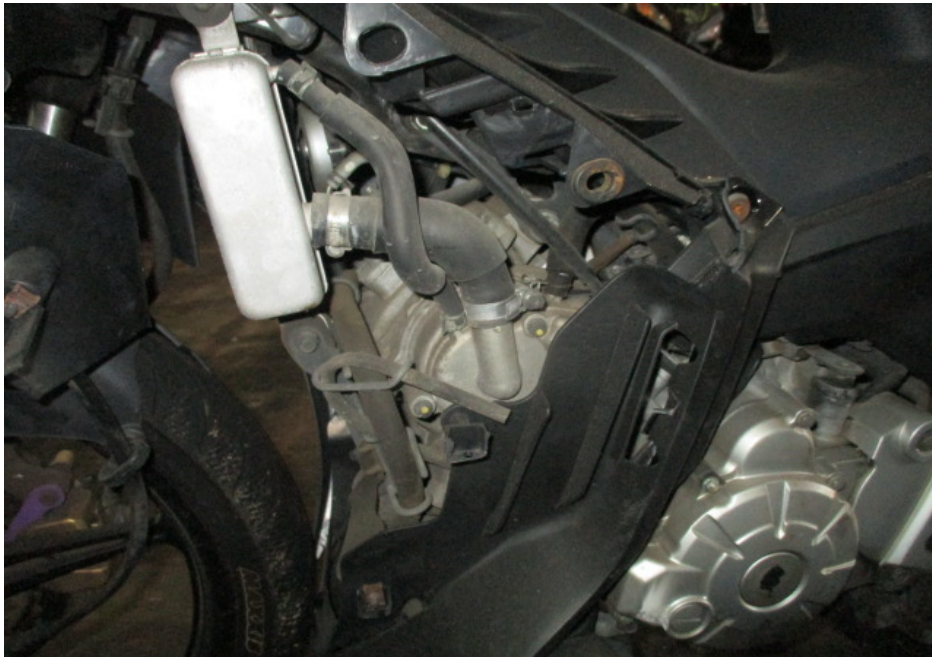
Photo 10 shows a closer view of the broken left cowling which was amongst the body parts at the front body of the Motorcycle that had sustained damages as a result of the accident.

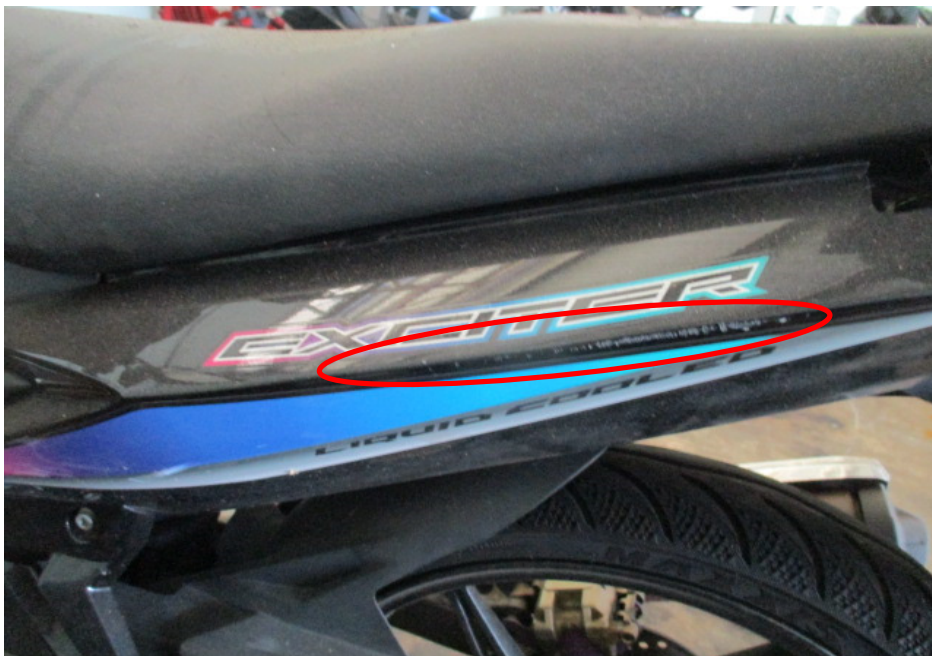
Photo 11 shows a closer view of the left rear side cover which was amongst the body parts of the Motorcycle that had sustained damages of grazing nature as a result of the accident (circled).

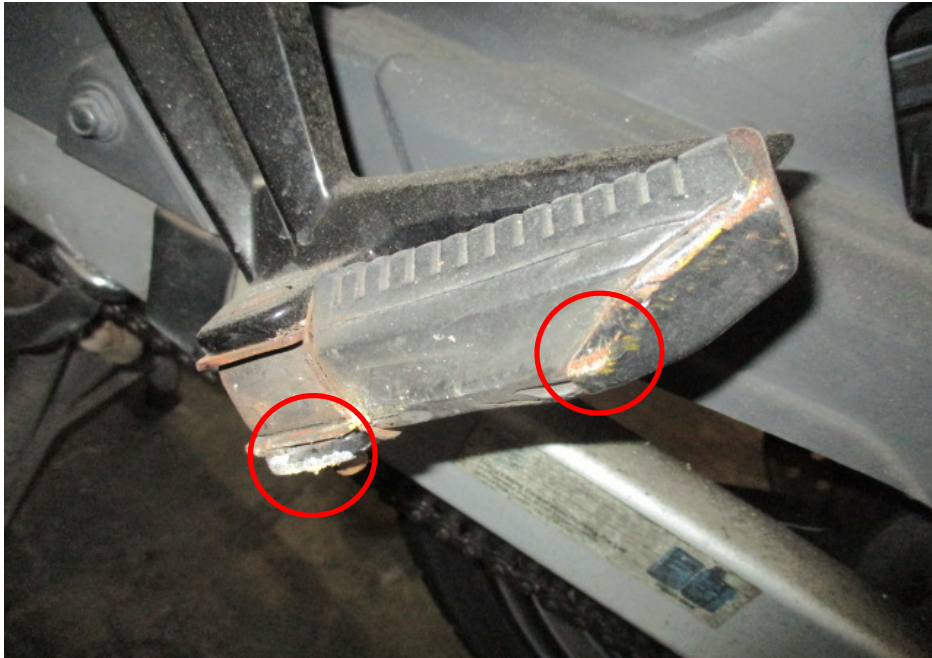
Photo 12 shows a closer view of the left pillion footrest bracket and left pillion foot peg, which were amongst the body parts of the Motorcycle that had sustained damage as a result of the accident (circled).

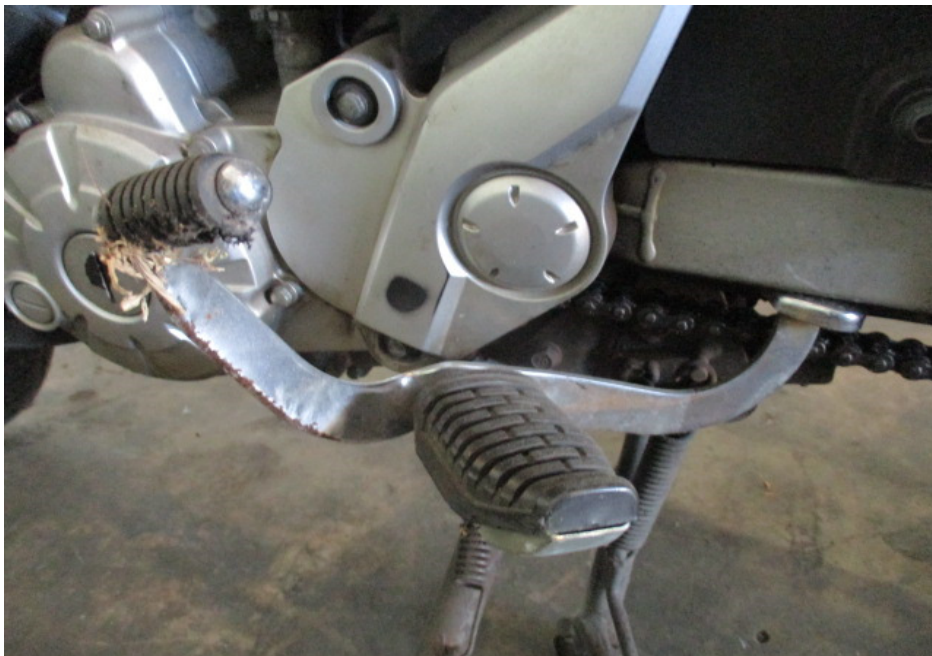
Photo 13 shows a closer view of the gear shift pedal and left front footrest which were amongst the body parts of the Motorcycle that had sustained damage as a result of the accident.

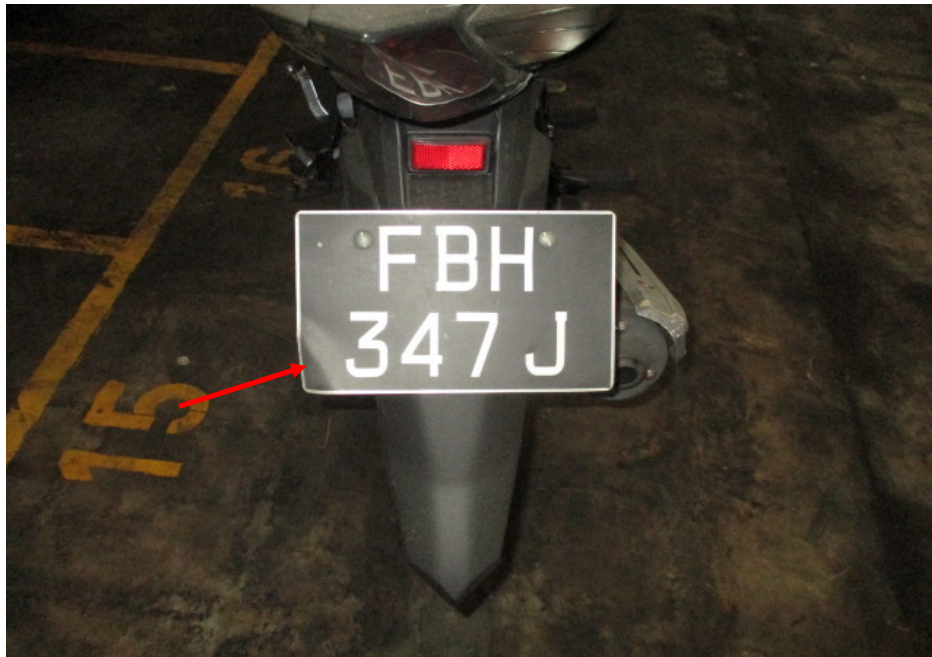
Photo 14 shows the dented rear number plate of the Motorcycle at the time of our inspection (arrowed).

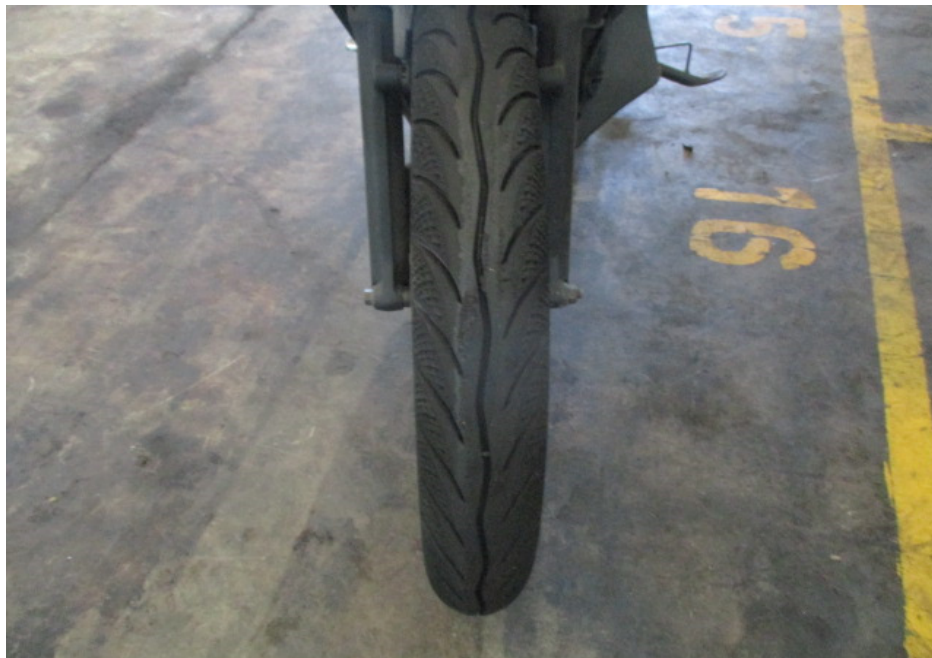
Photo 15 shows the condition of the Motorcycle's front tyre. The front tyre was observed to be in serviceable condition with remaining tread depth of approximately 3mm. The tyre was also observed to be sufficiently inflated for vehicular operation. We did not observe any tear, burst mark(s) and/or punctured hole(s) on the sidewalls as well as across the tread of the front tyre.

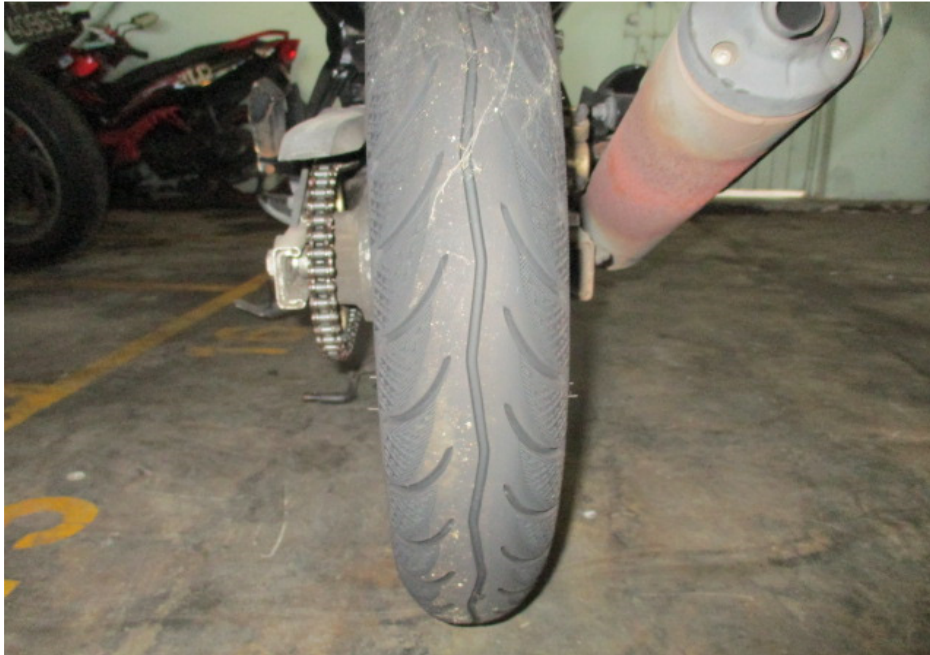
Photo 16 shows the condition of the Motorcycle's rear tyre. The rear tyre was observed to be in serviceable condition with remaining tread depth of approximately 3mm. The tyre was also observed to be sufficiently inflated for vehicular operation. We did not observe any tear, burst mark(s) and/or punctured hole(s) on the sidewalls as well as across the tread of the rear tyre.

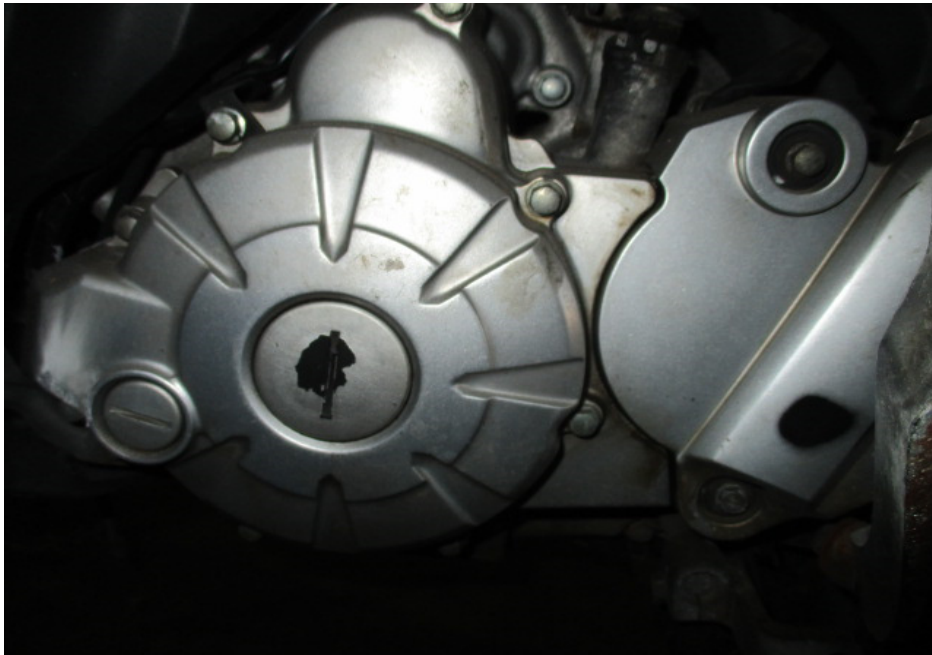
Photo 17 shows the left side of the engine of the Motorcycle at the time of our inspection. The various engine related parts and components were found to be intact with no visible damage. There was also no sign(s) or indication(s) of fluid leak observed around the left engine area of the Motorcycle.

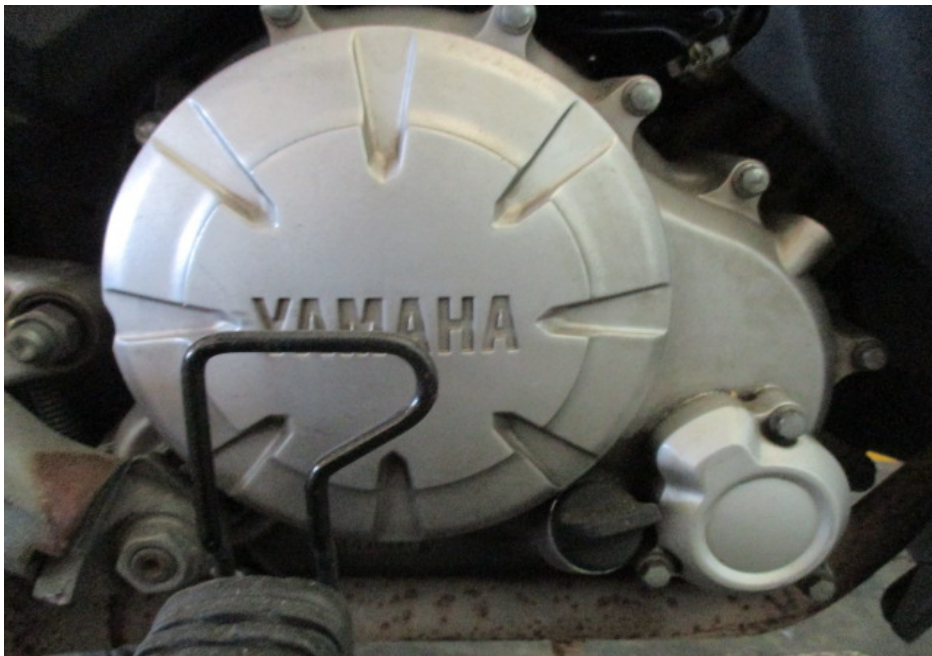
Photo 18 shows the right side of the engine of the Motorcycle at the time of our inspection. The various engine related parts and components were found to be intact with no visible damage. There was also no sign(s) or indication(s) of fluid leak observed around the right engine area of the Motorcycle.

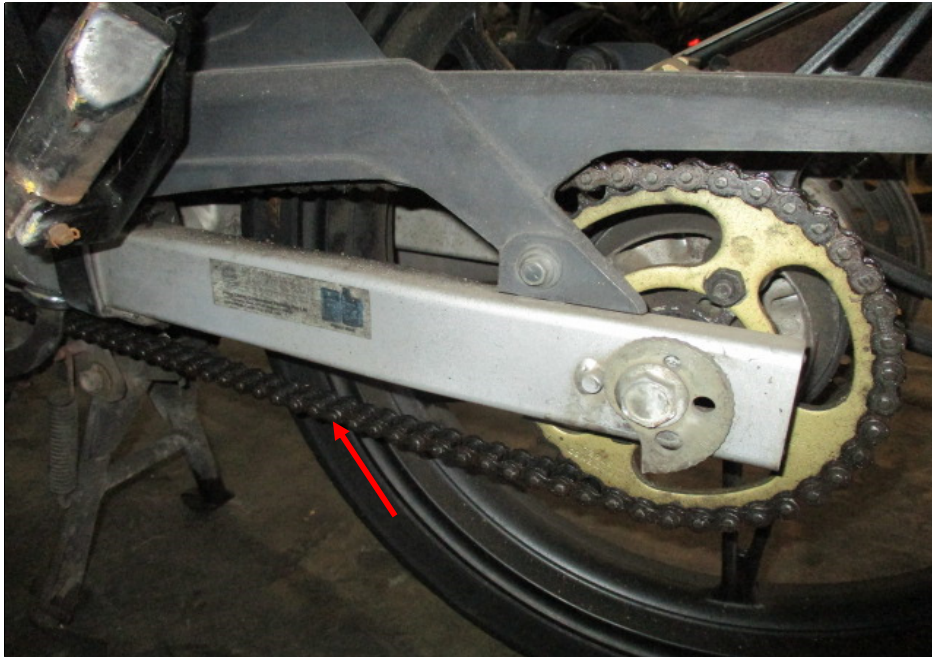
Photo 19 shows the gear chain (arrowed) of the Motorcycle, which was observed to be intact with no misalignment. It was also adequately lubricated for operating purposes. The gear chain rotates the rear wheel of the Motorcycle.

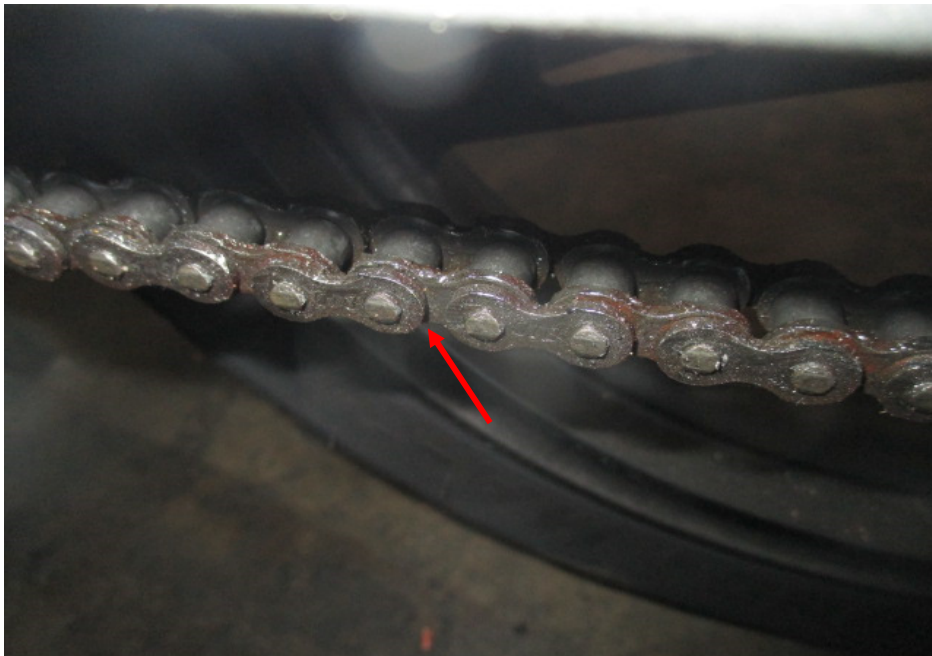
Photo 20 shows the closer view of the gear chain (arrowed) of the Motorcycle, which was observed to be intact with no misalignment. It was also adequately lubricated for operating purposes.

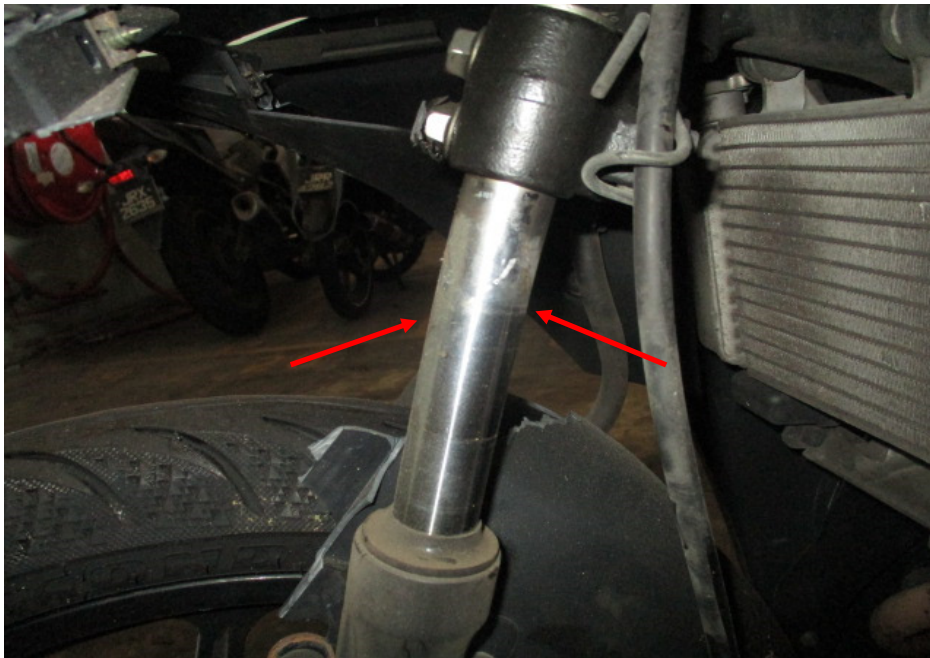
11. For this case, we were not able to conduct any test(s) on the steering system of the Motorcycle due to the damage of its front forks and steering stem. The front forks were found to be bent inwards as a result of the accident. The steering system was observed to be broken as a result of the accident.

Photo 21 shows the front right fork of the Motorcycle. The front right fork (arrowed) was observed to be bent inwards as a result of the accident. We were hence not able to conduct any tests on the steering system of the Motorcycle.

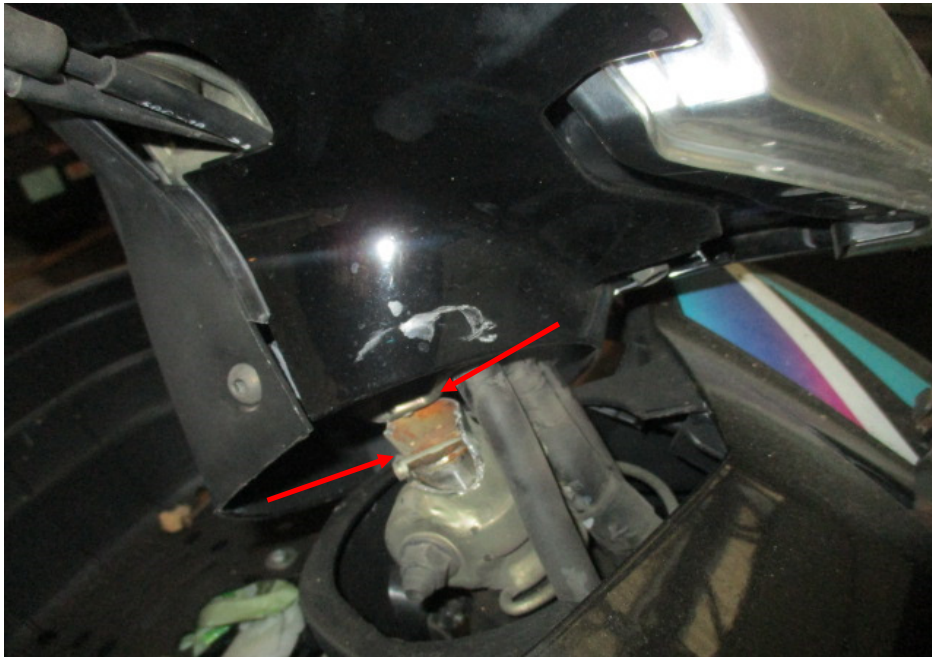
Photo 22 shows the steering stem of the Motorcycle. The steering stem (arrowed) was observed to be broken as a result of the accident. We were hence not able to conduct any tests on the steering system of the Motorcycle.

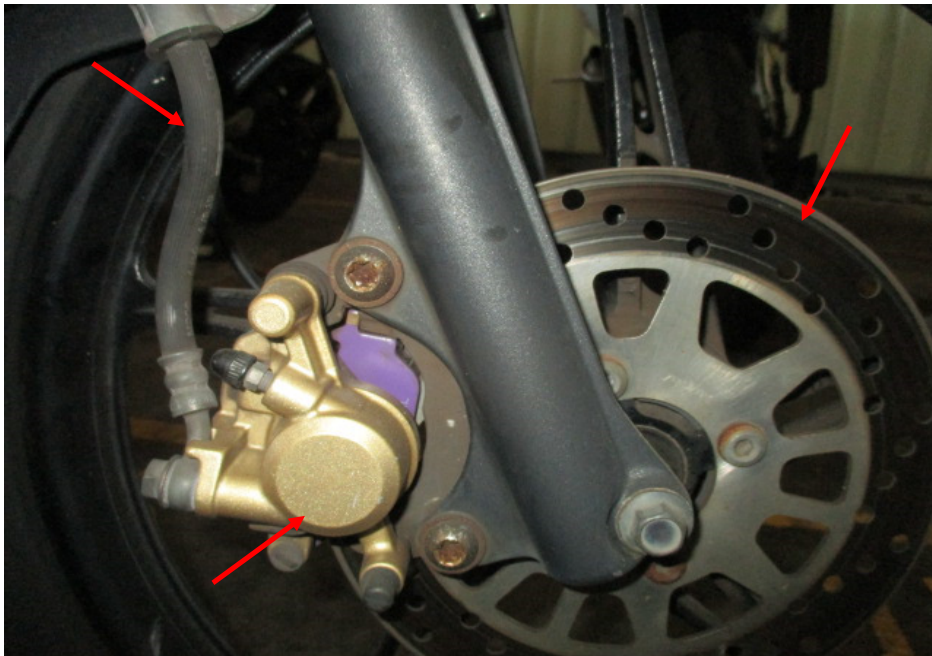
Photo 23 shows a close up view of the front brake caliper, front brake disc and front brake hose (arrowed) of the Motorcycle, which are all part of the components in the hydraulic front brake system of the Motorcycle. Our visual checks of these various components had revealed all to be intact with no visible damage. No leakage of brake fluid was also observed.

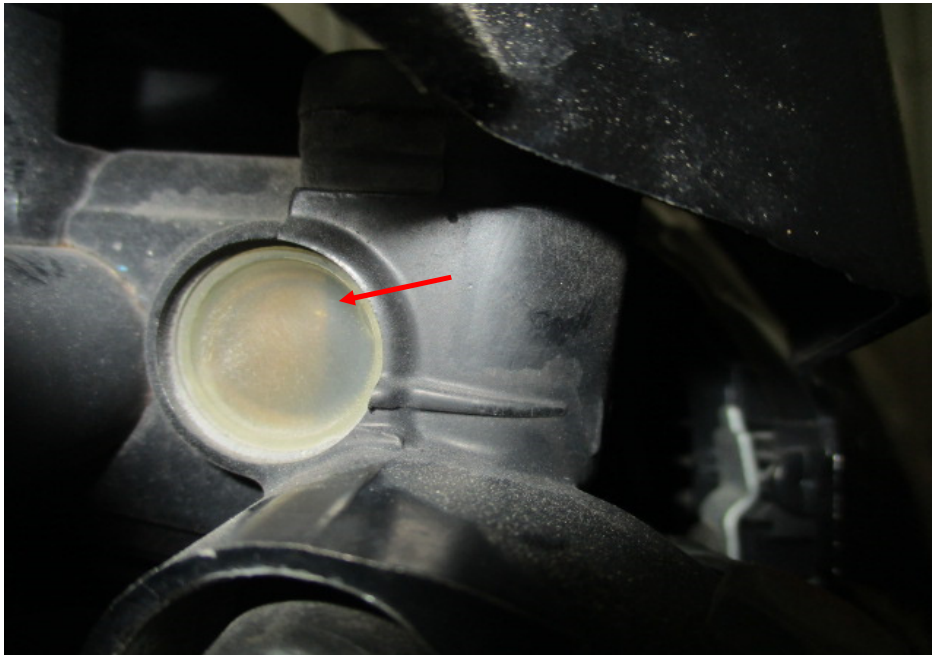
Photo 24 shows the brake fluid reservoir for the front brake of the Motorcycle. The brake fluid was observed to be of sufficient level (arrowed) and without contamination for operational purposes.

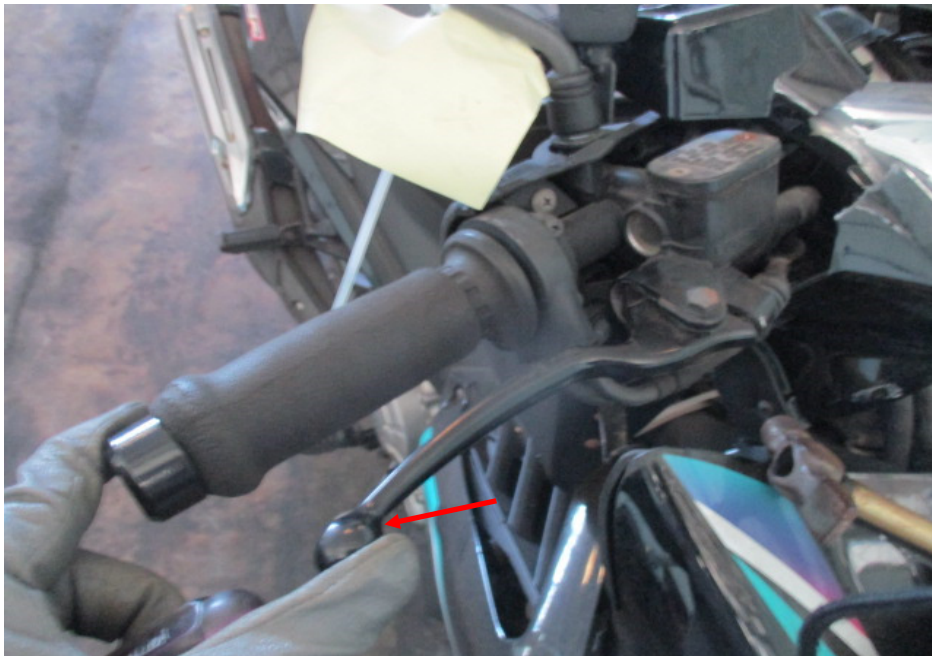
14. Static brake tests conducted on the Motorcycle had appear to indicate that the braking system of the Motorcycle was in serviceable condition. There was some resistance felt (spongy like feel) upon pressing the brake lever and upon stepping the brake pedal. This would indicate that there was no leakage of pressure/vacuum in the braking system.

Photo 25 shows the front brake lever being depressed. There was some resistance felt (spongy like feel) upon pressing the front brake lever (arrowed). This would indicate that there is no leakage of pressure/vacuum in the brake system.

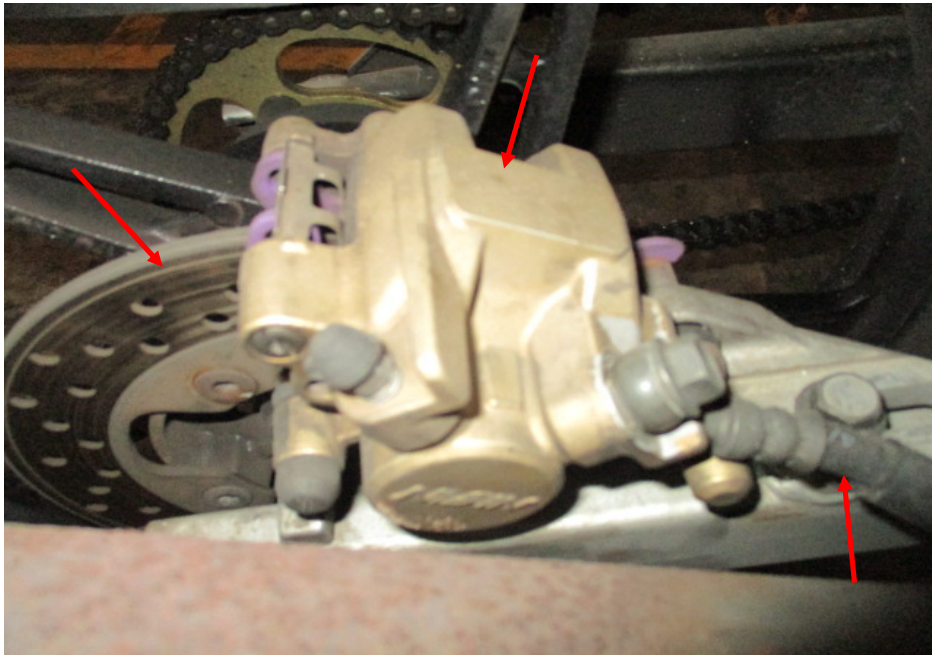
Photo 26 shows a close up view of the rear brake caliper, rear brake disc and rear brake hose (arrowed) of the Motorcycle, which are all part of the components in the hydraulic rear brake system of the Motorcycle. Our visual checks of these various components had revealed all to be intact with no visible damage. No leakage of brake fluid was also observed.

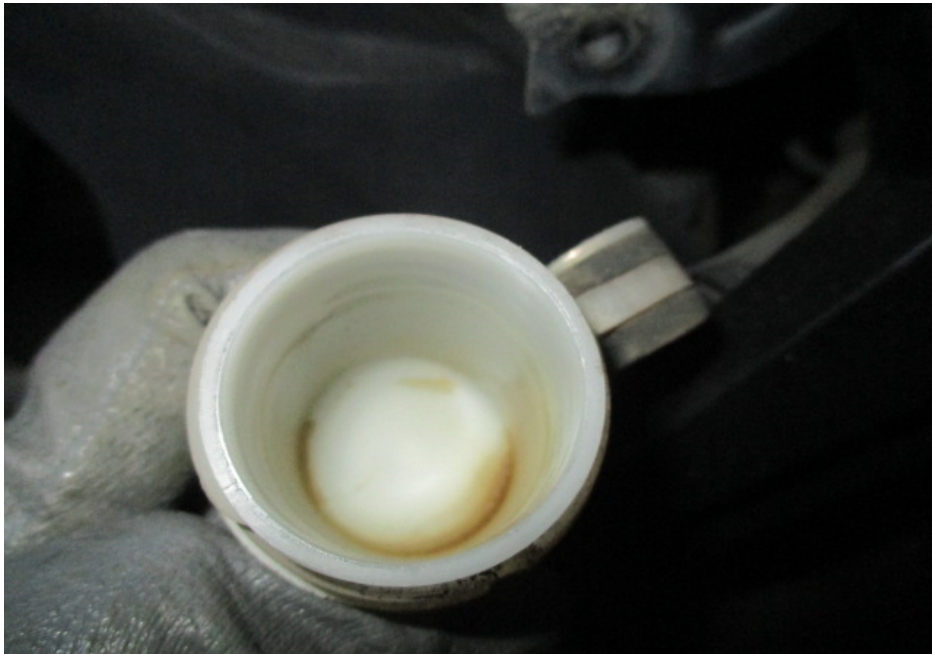
13. Our visual examination of the various components in the Motorcycle's braking system like the brake discs, brake lever, rear brake pedal, brake calipers and brake hoses revealed all to be intact and without damage. There was also no leakage of brake fluid observed along the brake hoses. This was from the respective brake fluid reservoirs to the front brake caliper and rear brake caliper of the Motorcycle. The brake fluid for the front brake was found to be of sufficiently level and without any contamination. However the rear brake fluid reservoir was observed to be empty at the time of our inspection.

Photo 27 shows the brake fluid reservoir for the rear brake of the Motorcycle. The rear brake fluid reservoir was observed to be empty at the time of our inspection.
