Your Ref: TP/IP/62415/2019
Our Ref : CI/TPD19022293/N

MECHANICAL INSPECTION REPORT OF MOTORCYCLE FBH 347J

1. We refer to your request on 21 November 2019 to conduct a physical inspection of a motorcycle bearing registration number FBH 347J (herein referred to as "**Motorcycle**"), which was involved in a fatal road traffic accident on 5 October 2019.
2. The objective of the inspection is to determine if there was any possible mechanical failure to the Motorcycle that may have contributed to the accident.
3. Following the request, we had carried out a physical inspection of the Motorcycle on 28 February 2020 at the premises of Traffic Police vehicle pound, 517 Airport Road Singapore 539942. We now set out below our observations and comments with respect to this inspection.

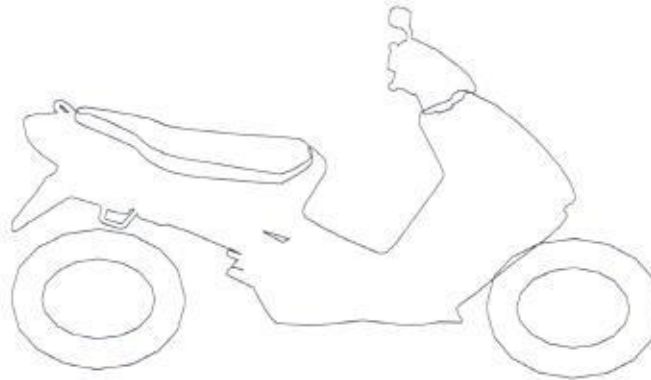
7. The tyre brand, tyre size and remaining tread depth of the 2 tyres of the Motorcycle were recorded as follows:-

Maxxis 90/80 R17 (3mm)

Maxxis 80/90 R17 (3mm)

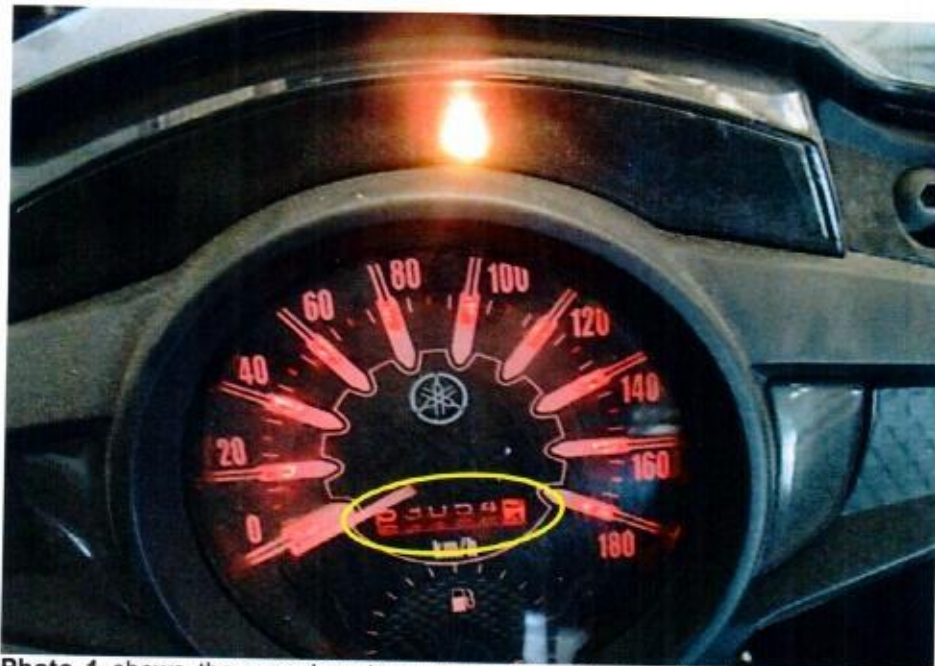
Photo 1 shows the speedometer gauge of the Motorcycle where the mileage recorded at the time of our inspection was 53, 054km (circled).

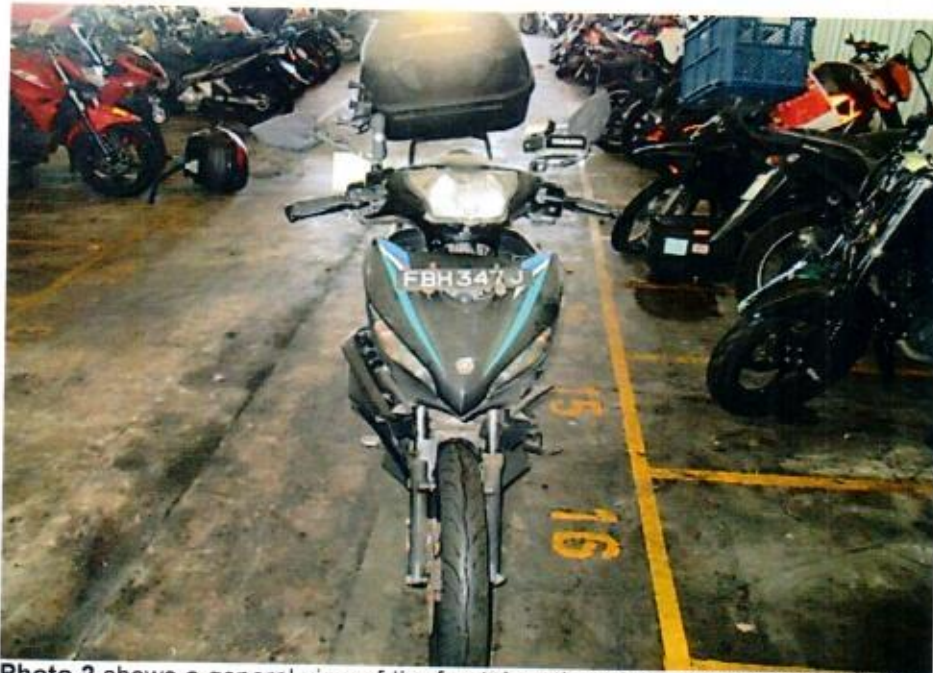
Photo 2 shows a general view of the frontal portion of the Motorcycle at the time of our inspection. The Motorcycle had sustained damages all around.

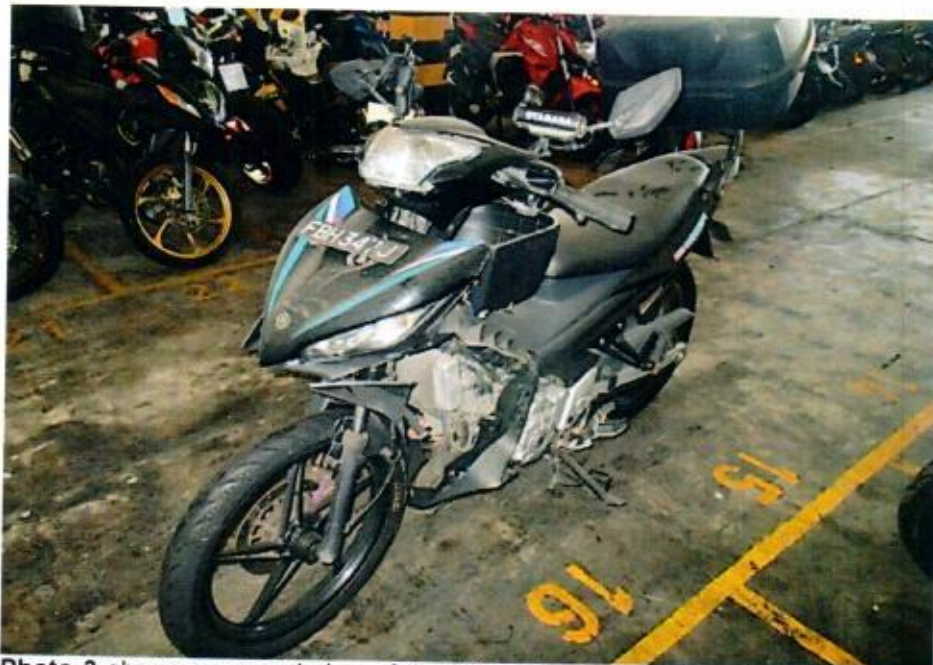
Photo 3 shows a general view of the left body of the Motorcycle at the time of our inspection. Body parts that were found to have been damaged include its headlight, head cowl, front fork assembly, steering stem, side cowlings, left side mirror, clutch lever, gear shift pedal, left front footrest, left pillion footrest bracket and rear number plate, amongst others.

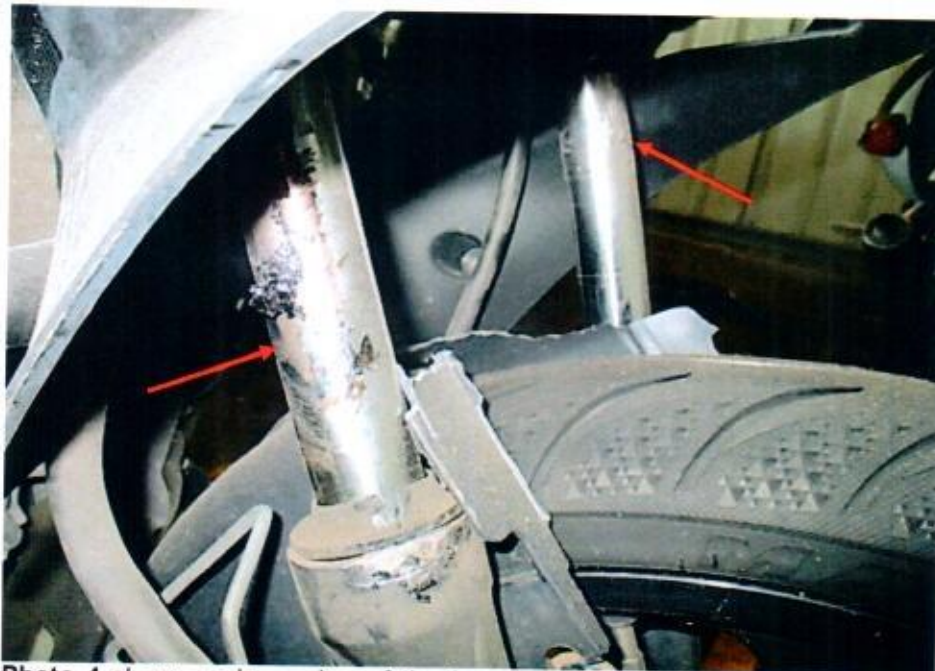
Photo 4 shows a closer view of the front fork assembly (arrowed) which was amongst the body parts at the front body of the Motorcycle that had sustained damage as a result of the accident.

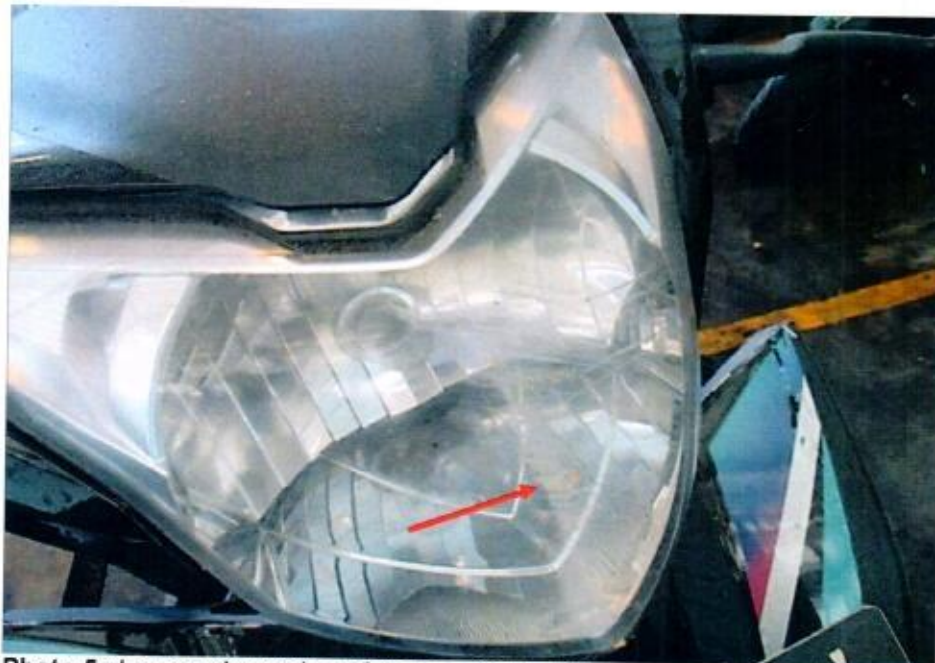
Photo 5 shows a closer view of the headlight which was amongst the body parts at the front body of the Motorcycle that had sustained damages as a result of the accident (arrowed).

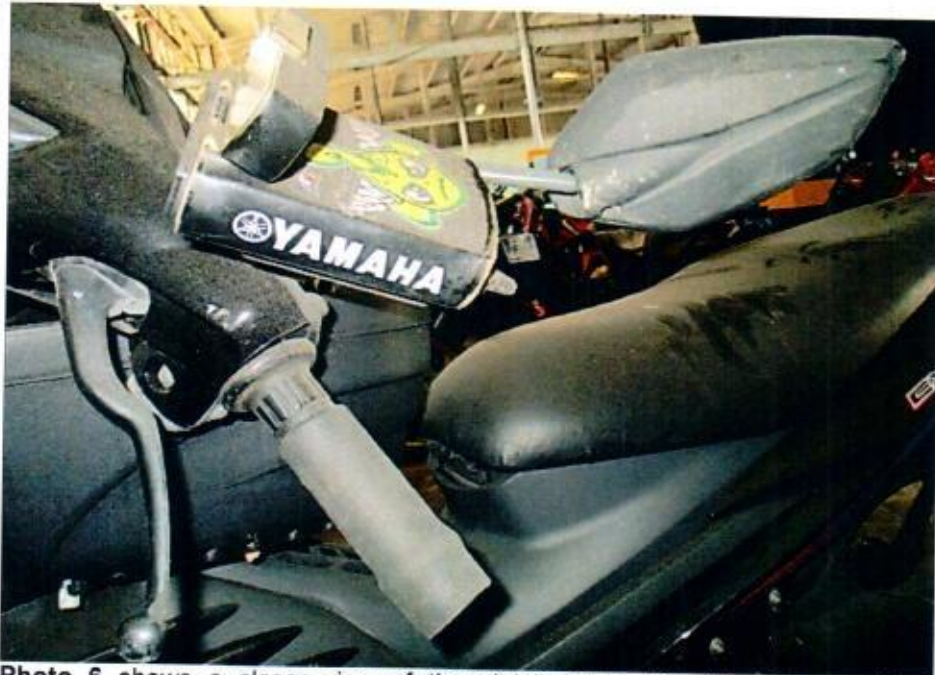
Photo 6 shows a closer view of the clutch lever, left side mirror and left handlebar grip of the Motorcycle. These parts were amongst the body parts of the Motorcycle which were damaged as a result of the accident.

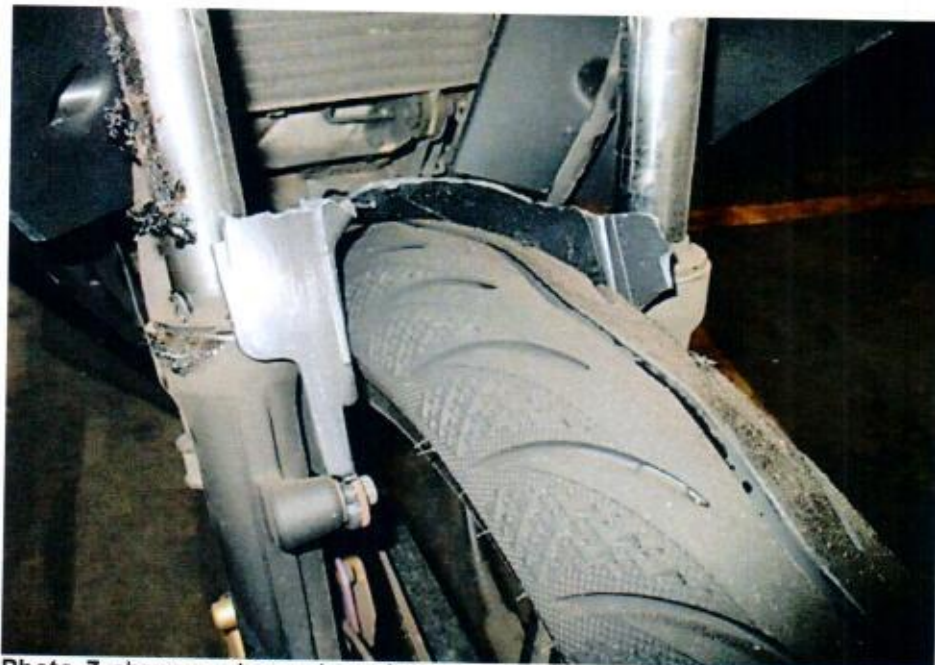
Photo 7 shows a closer view of the front mudguard, which was amongst the body parts of the Motorcycle that had sustained damage as a result of the accident.

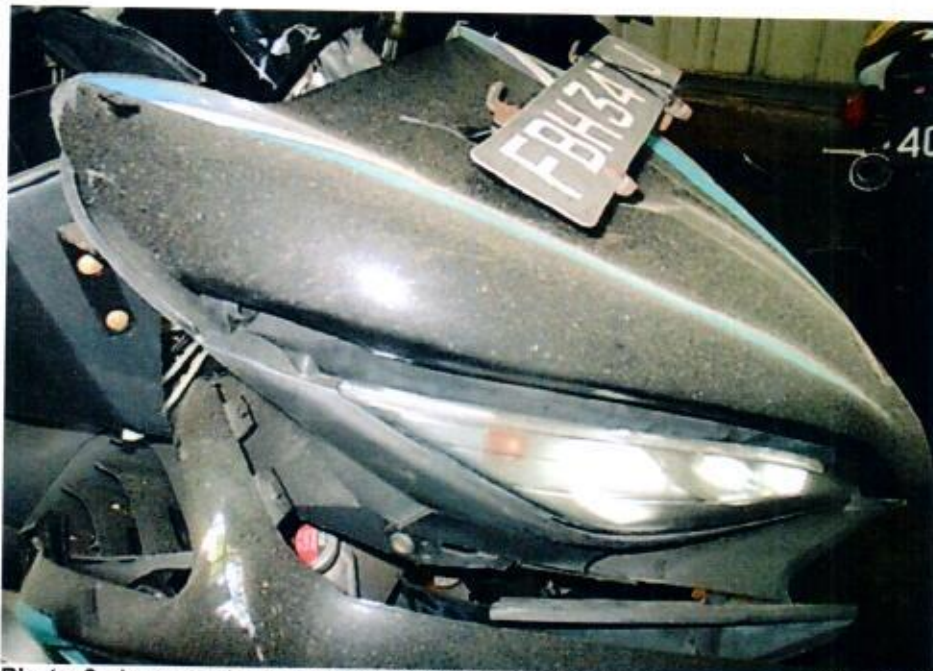
Photo 8 shows a closer view of the head cowl which was amongst the body parts at the front body of the Motorcycle that had sustained damages as a result of the accident.

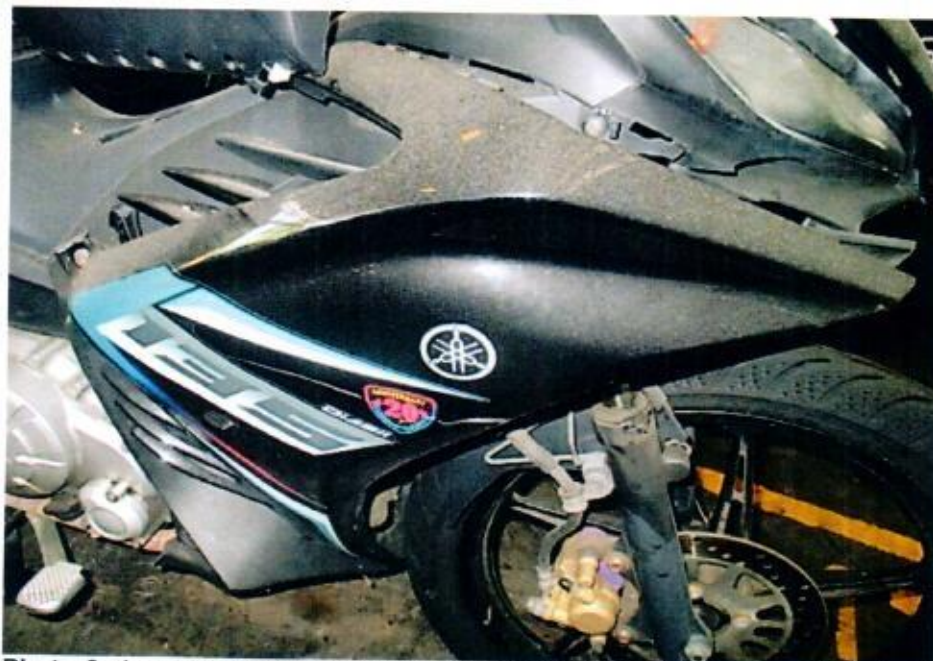
Photo 9 shows a closer view of the right cowl which was amongst the body parts at the front body of the Motorcycle that had sustained damages as a result of the accident.

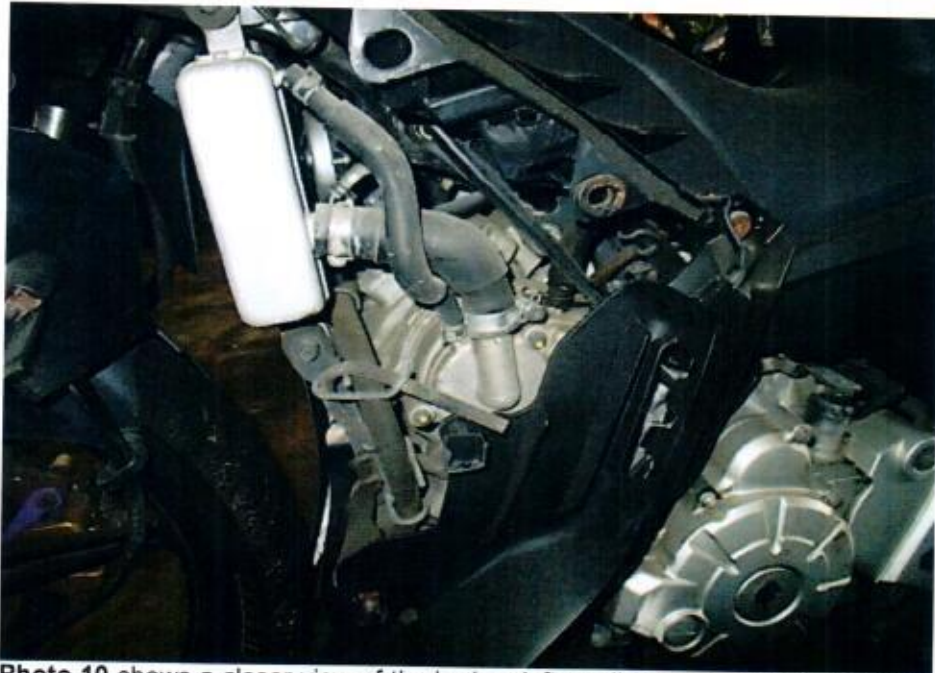
Photo 10 shows a closer view of the broken left cowling which was amongst the body parts at the front body of the Motorcycle that had sustained damages as a result of the accident.

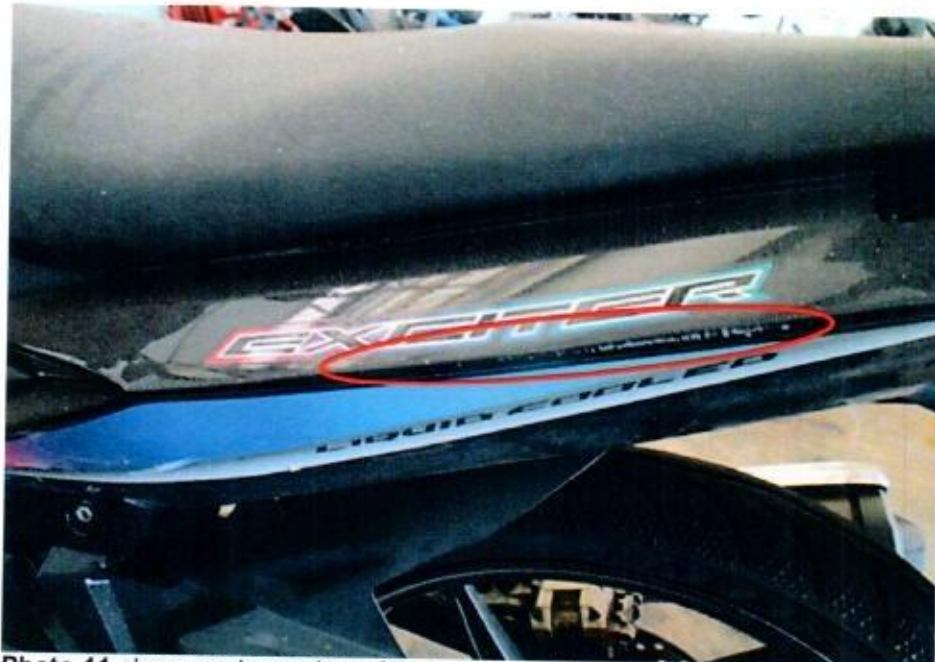
Photo 11 shows a closer view of the left rear side cover which was amongst the body parts of the Motorcycle that had sustained damages of grazing nature as a result of the accident (circled).

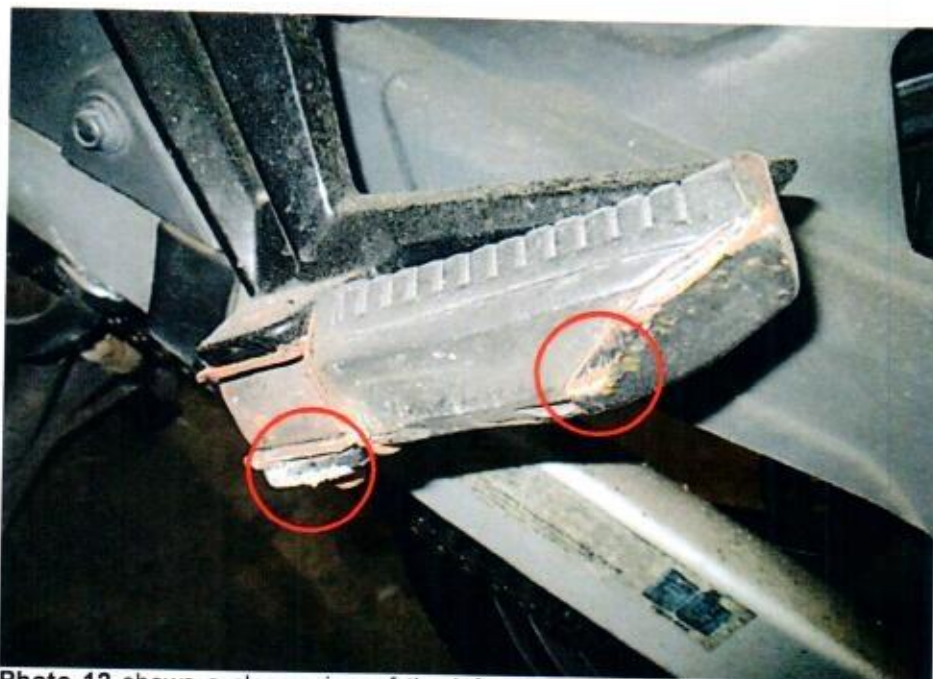
Photo 12 shows a closer view of the left pillion footrest bracket and left pillion foot peg, which were amongst the body parts of the Motorcycle that had sustained damage as a result of the accident (circled).

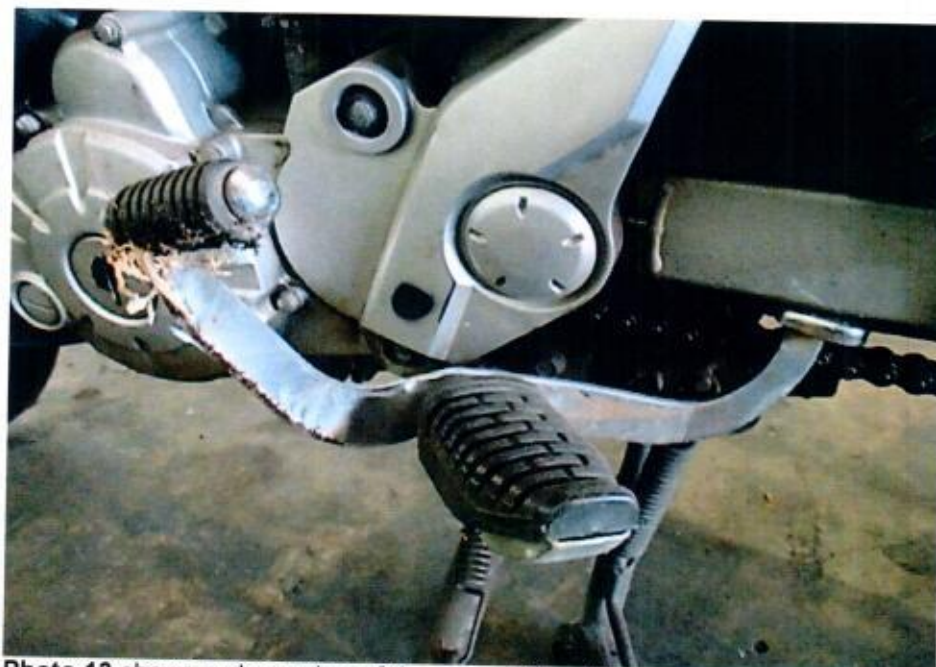
Photo 13 shows a closer view of the gear shift pedal and left front footrest which were amongst the body parts of the Motorcycle that had sustained damage as a result of the accident.

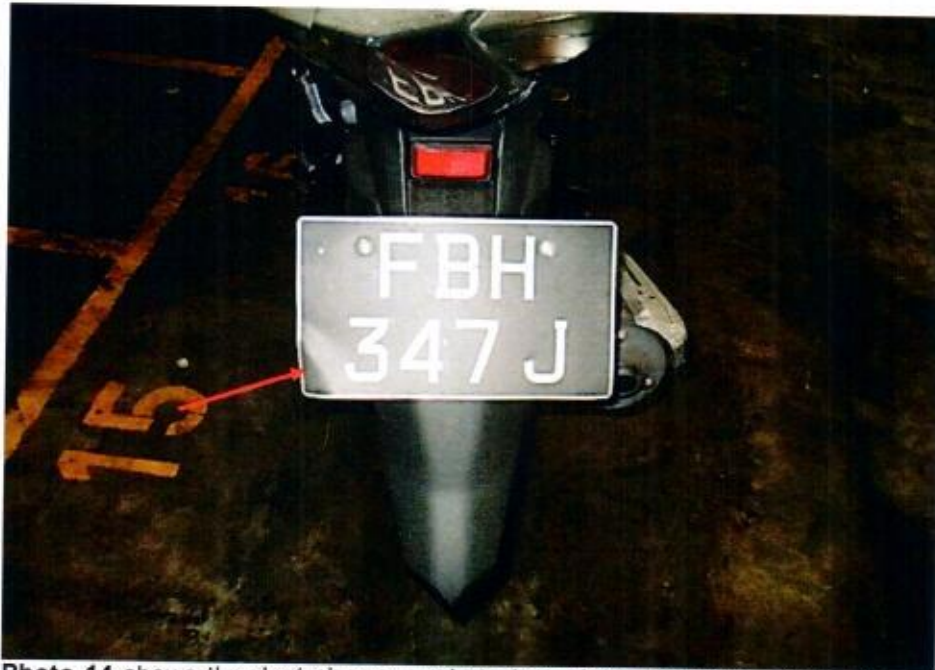
Photo 14 shows the dented rear number plate of the Motorcycle at the time of our inspection (arrowed).

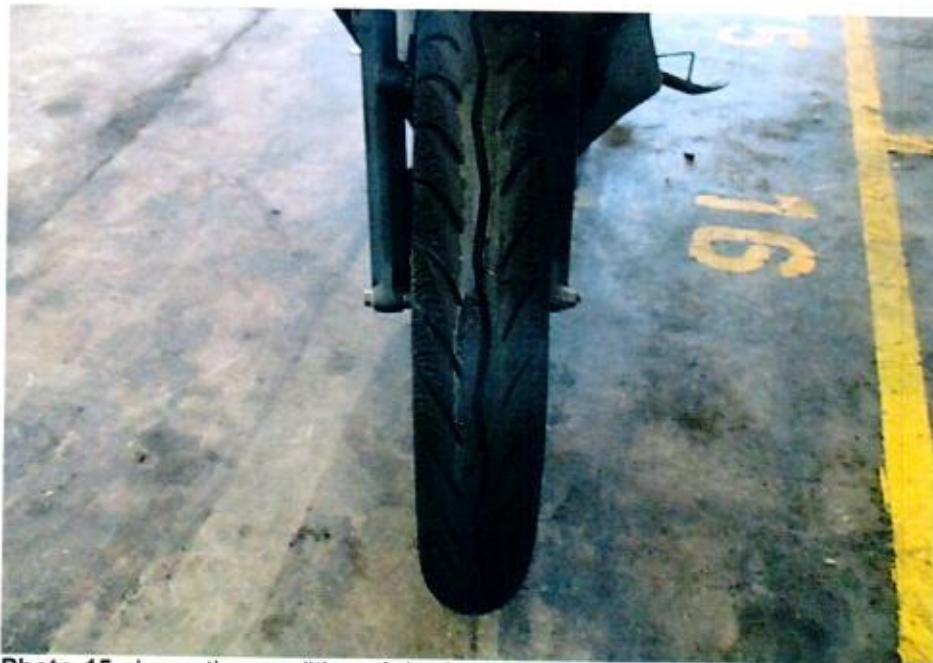
Photo 15 shows the condition of the Motorcycle's front tyre. The front tyre was observed to be in serviceable condition with remaining tread depth of approximately 3mm. The tyre was also observed to be sufficiently inflated for vehicular operation. We did not observe any tear, burst mark(s) and/or punctured hole(s) on the sidewalls as well as across the tread of the front tyre.

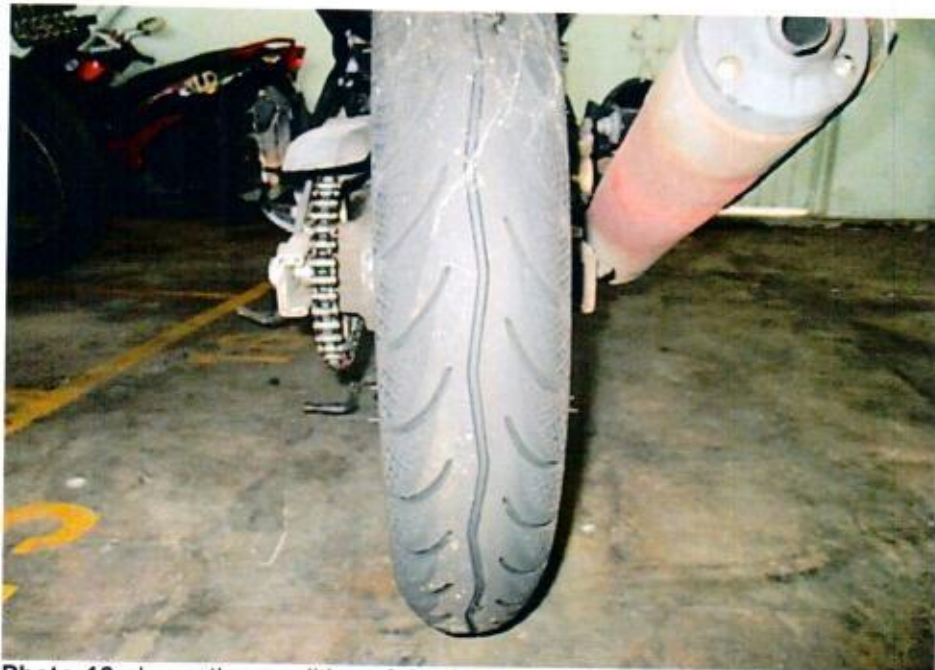
Photo 16 shows the condition of the Motorcycle's rear tyre. The rear tyre was observed to be in serviceable condition with remaining tread depth of approximately 3mm. The tyre was also observed to be sufficiently inflated for vehicular operation. We did not observe any tear, burst mark(s) and/or punctured hole(s) on the sidewalls as well as across the tread of the rear tyre.

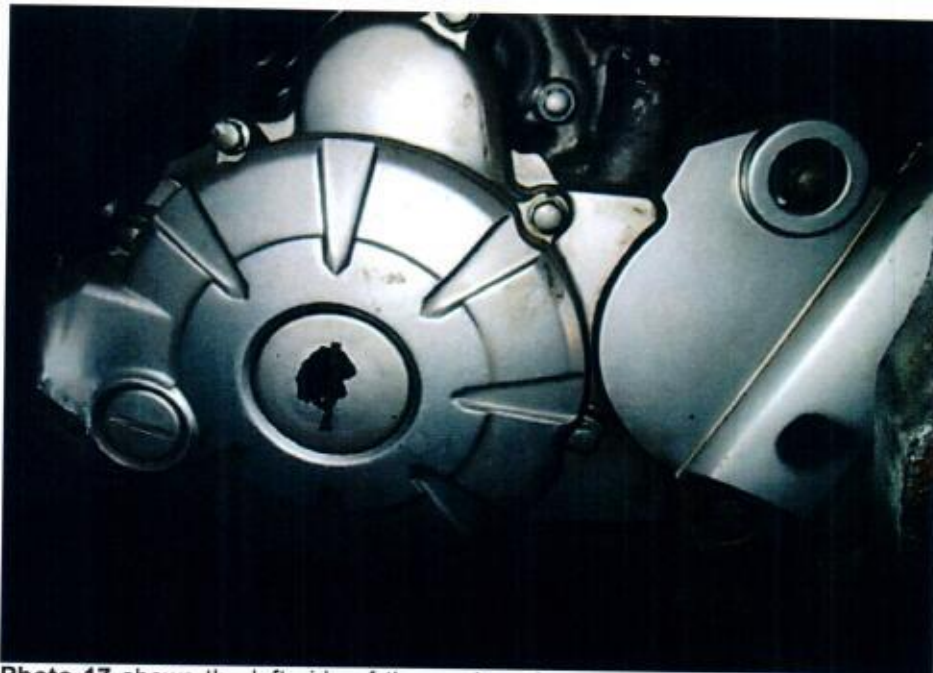
Photo 17 shows the left side of the engine of the Motorcycle at the time of our inspection. The various engine related parts and components were found to be intact with no visible damage. There was also no sign(s) or indication(s) of fluid leak observed around the left engine area of the Motorcycle.

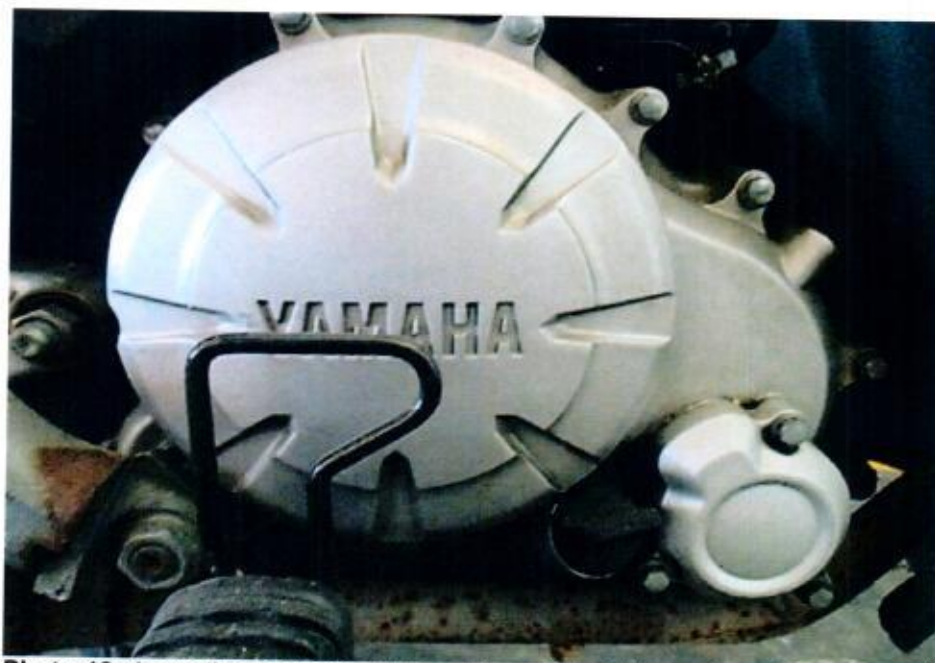
Photo 18 shows the right side of the engine of the Motorcycle at the time of our inspection. The various engine related parts and components were found to be intact with no visible damage. There was also no sign(s) or indication(s) of fluid leak observed around the right engine area of the Motorcycle.

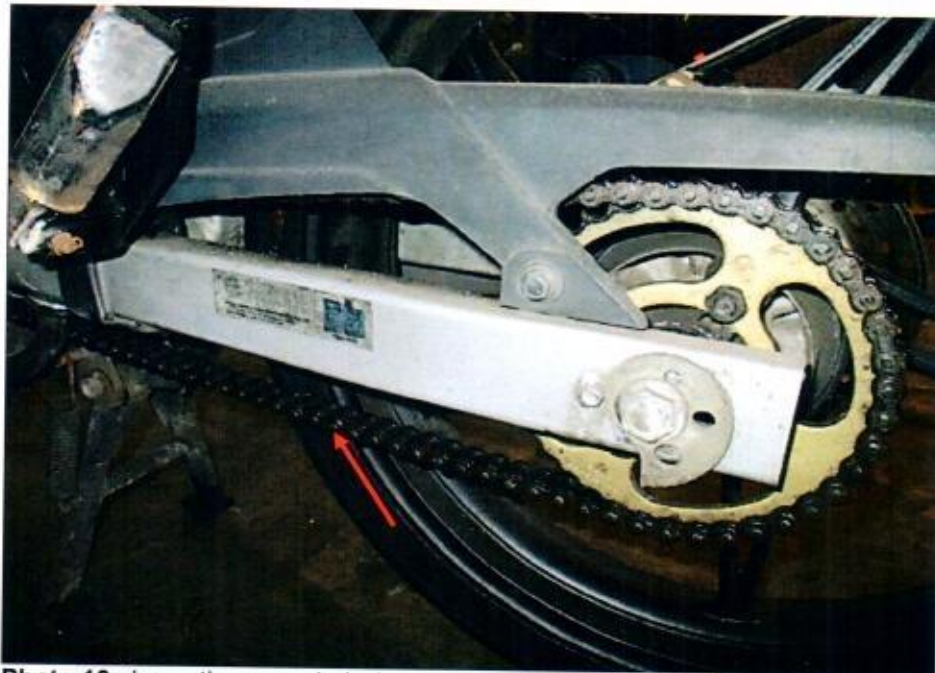
Photo 19 shows the gear chain (arrowed) of the Motorcycle, which was observed to be intact with no misalignment. It was also adequately lubricated for operating purposes. The gear chain rotates the rear wheel of the Motorcycle.

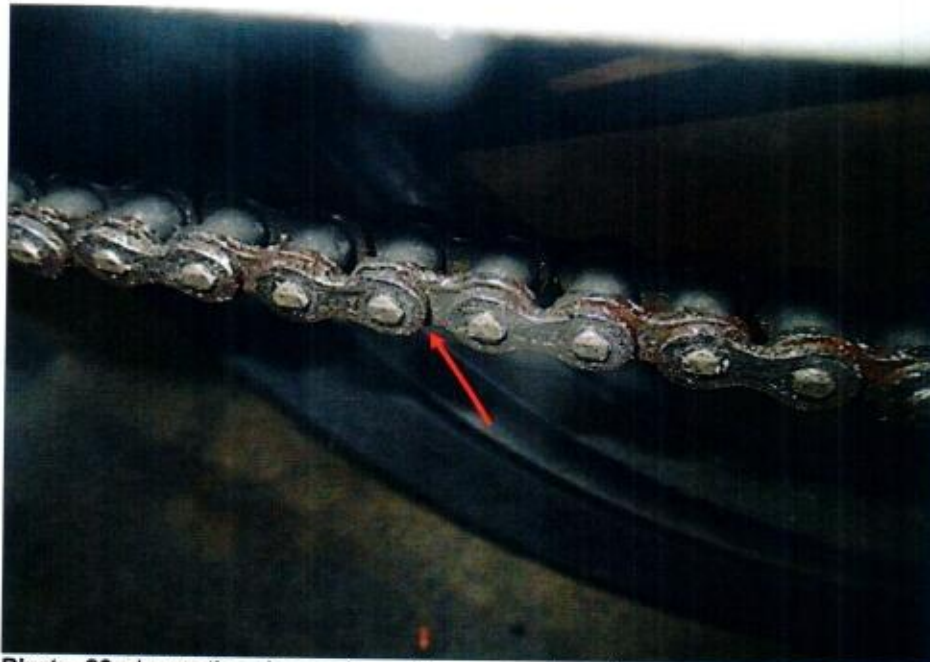
Photo 20 shows the closer view of the gear chain (arrowed) of the Motorcycle, which was observed to be intact with no misalignment. It was also adequately lubricated for operating purposes.

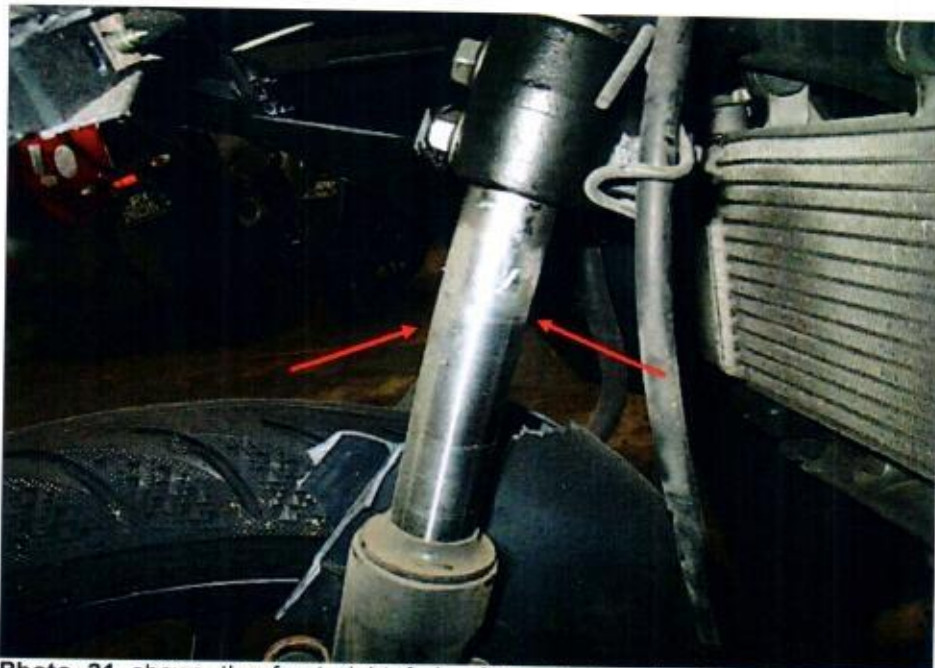
11. For this case, we were not able to conduct any test(s) on the steering system of the Motorcycle due to the damage of its front forks and steering stem. The front forks were found to be bent inwards as a result of the accident. The steering system was observed to be broken as a result of the accident.

Photo 21 shows the front right fork of the Motorcycle. The front right fork (arrowed) was observed to be bent inwards as a result of the accident. We were hence not able to conduct any tests on the steering system of the Motorcycle.

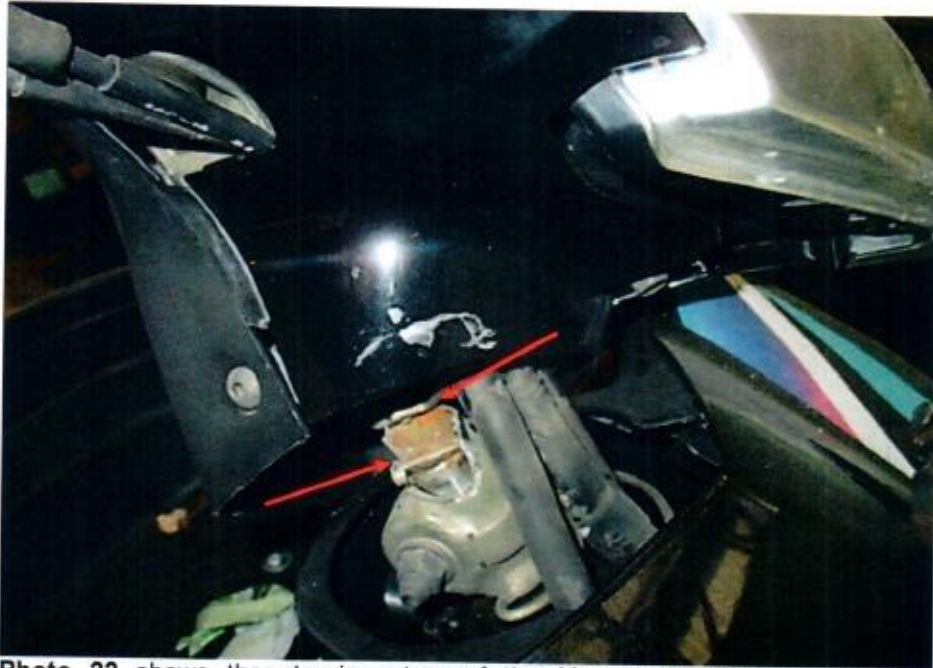
Photo 22 shows the steering stem of the Motorcycle. The steering stem (arrowed) was observed to be broken as a result of the accident. We were hence not able to conduct any tests on the steering system of the Motorcycle.

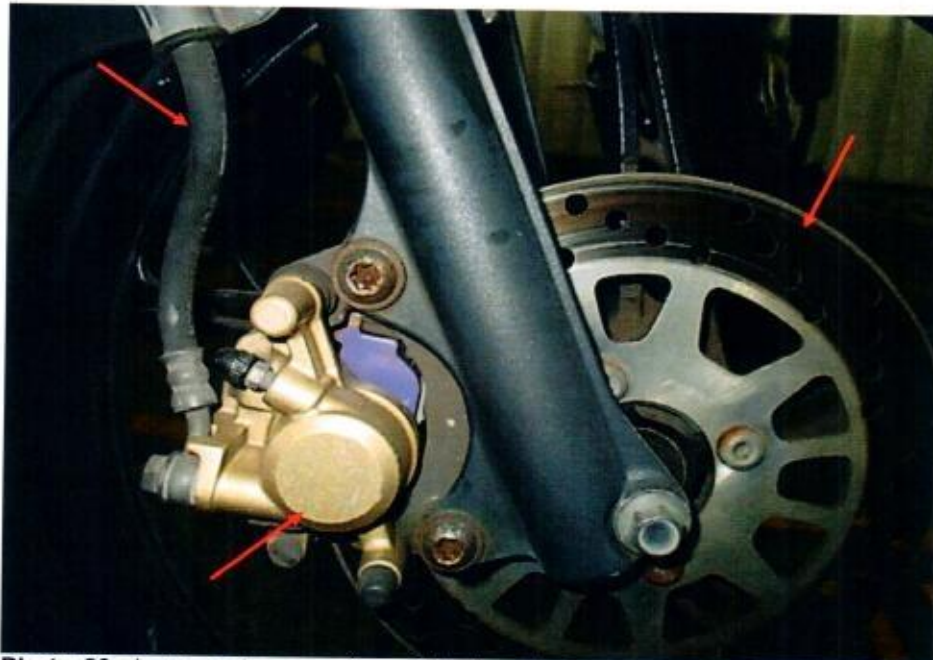
Photo 23 shows a close up view of the front brake caliper, front brake disc and front brake hose (arrowed) of the Motorcycle, which are all part of the components in the hydraulic front brake system of the Motorcycle. Our visual checks of these various components had revealed all to be intact with no visible damage. No leakage of brake fluid was also observed.

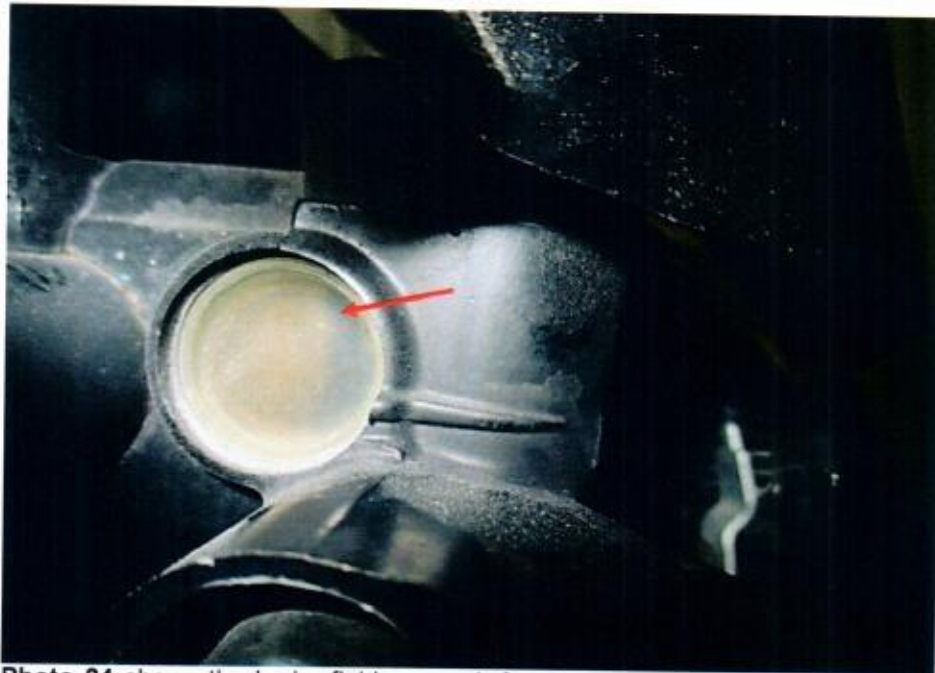
Photo 24 shows the brake fluid reservoir for the front brake of the Motorcycle. The brake fluid was observed to be of sufficient level (arrowed) and without contamination for operational purposes.

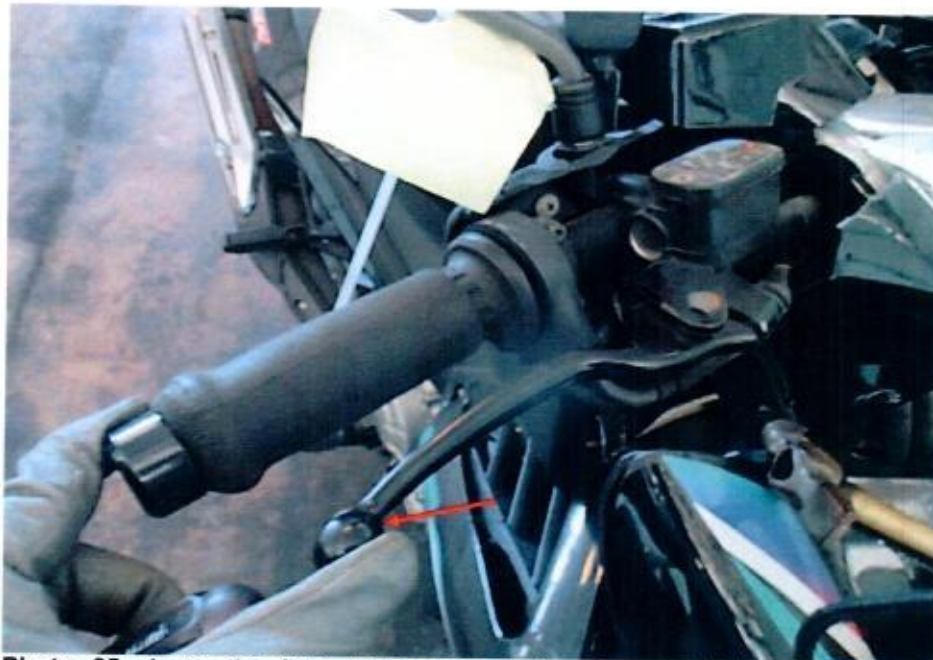
14. Static brake tests conducted on the Motorcycle had appear to indicate that the braking system of the Motorcycle was in serviceable condition. There was some resistance felt (spongy like feel) upon pressing the brake lever and upon stepping the brake pedal. This would indicate that there was no leakage of pressure/vacuum in the braking system.

Photo 25 shows the front brake lever being depressed. There was some resistance felt (spongy like feel) upon pressing the front brake lever (arrowed). This would indicate that there is no leakage of pressure/vacuum in the brake system.

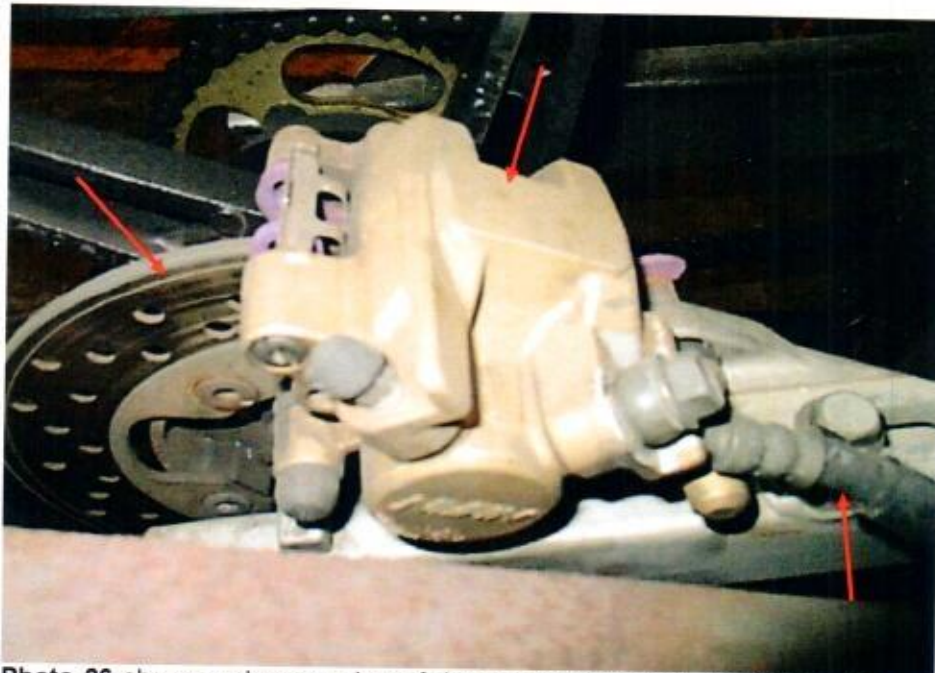
Photo 26 shows a close up view of the rear brake caliper, rear brake disc and rear brake hose (arrowed) of the Motorcycle, which are all part of the components in the hydraulic rear brake system of the Motorcycle. Our visual checks of these various components had revealed all to be intact with no visible damage. No leakage of brake fluid was also observed.

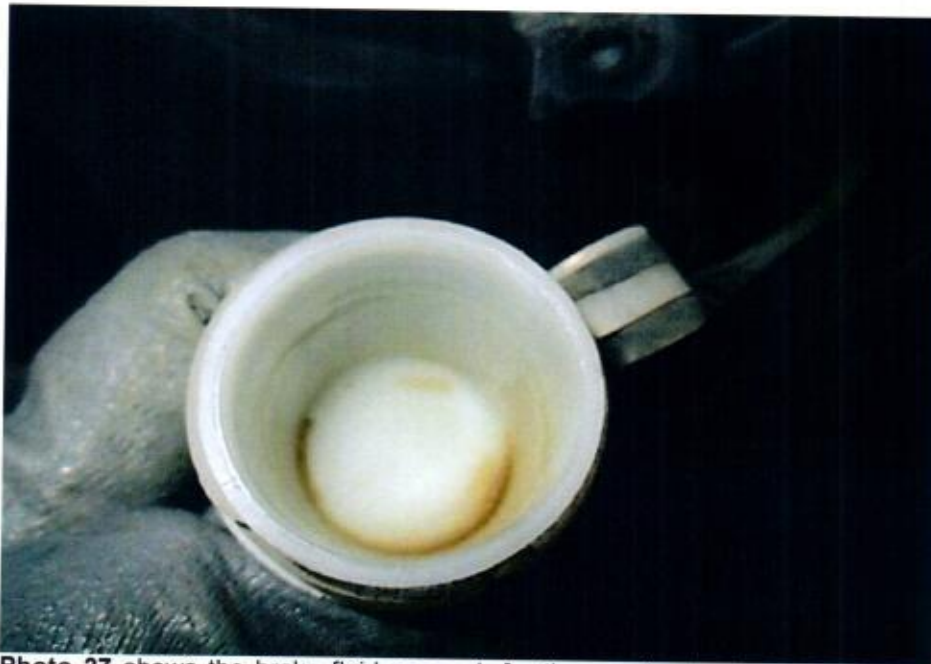
13. Our visual examination of the various components in the Motorcycle's braking system like the brake discs, brake lever, rear brake pedal, brake calipers and brake hoses revealed all to be intact and without damage. There was also no leakage of brake fluid observed along the brake hoses. This was from the respective brake fluid reservoirs to the front brake caliper and rear brake caliper of the Motorcycle. The brake fluid for the front brake was found to be of sufficiently level and without any contamination. However the rear brake fluid reservoir was observed to be empty at the time of our inspection.

Photo 27 shows the brake fluid reservoir for the rear brake of the Motorcycle. The rear brake fluid reservoir was observed to be empty at the time of our inspection.
