Your Ref: TP/IP/61821/2019
Our Ref :CI/TPD19022295/N

Fatal Accident Investigation Team

**INSPECTION REPORT OF BICYCLE (SILVER & BLACK) - TRAFFIC POLICE
POUND REPORT NO. 4085/19**

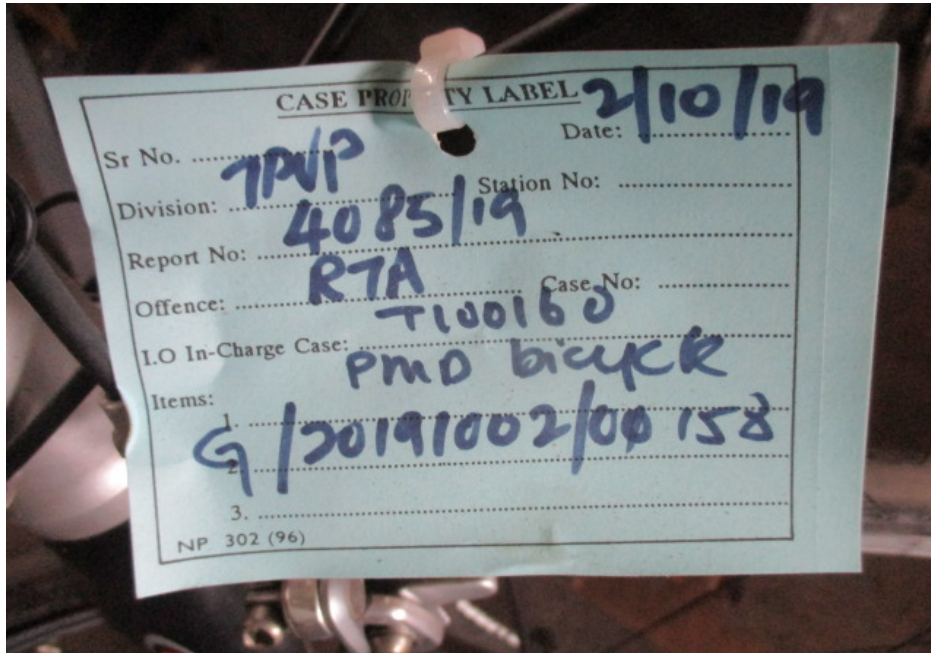
Photo 1 shows the identification of the Bicycle with reference to Traffic Police Pound Report No. 4085/17.

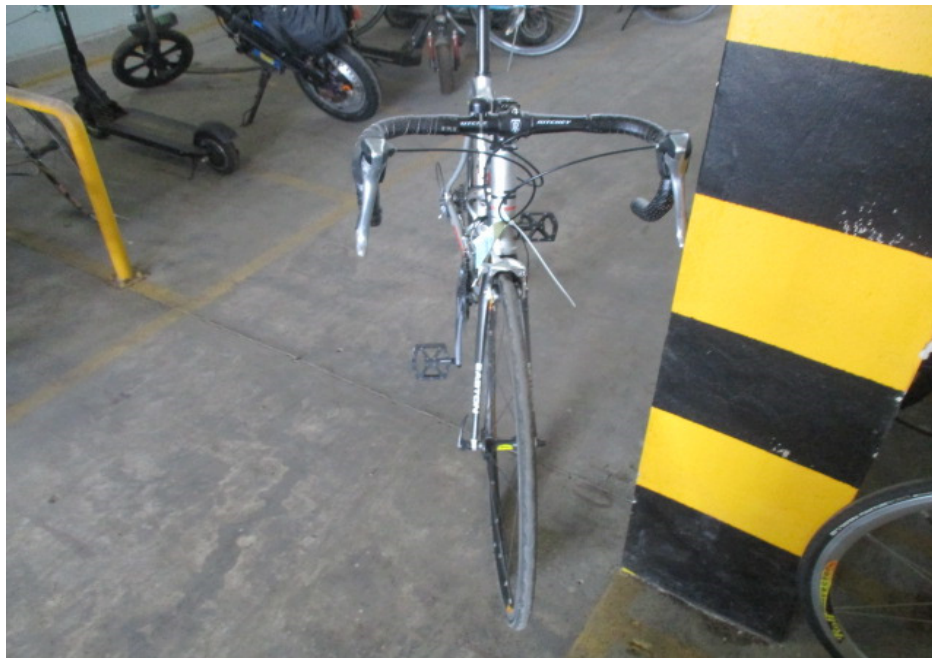
Photo 2 shows the front portion of the Bicycle at time of our inspection. The bicycle had sustained damages to its right body.

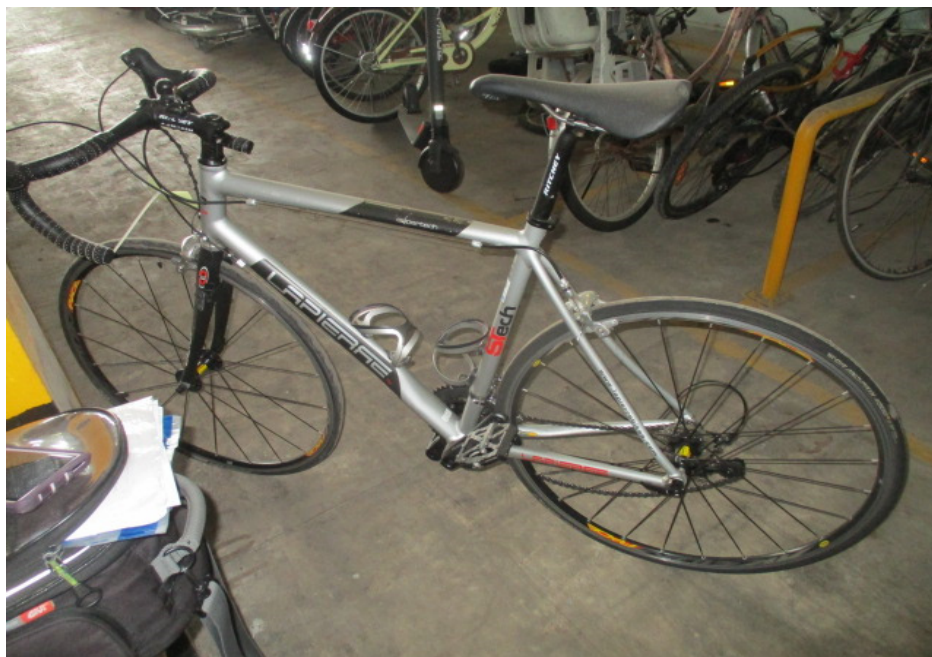
Photo 3 shows the left body of the Bicycle at time of our inspection. The bicycle had sustained damages to its right body.

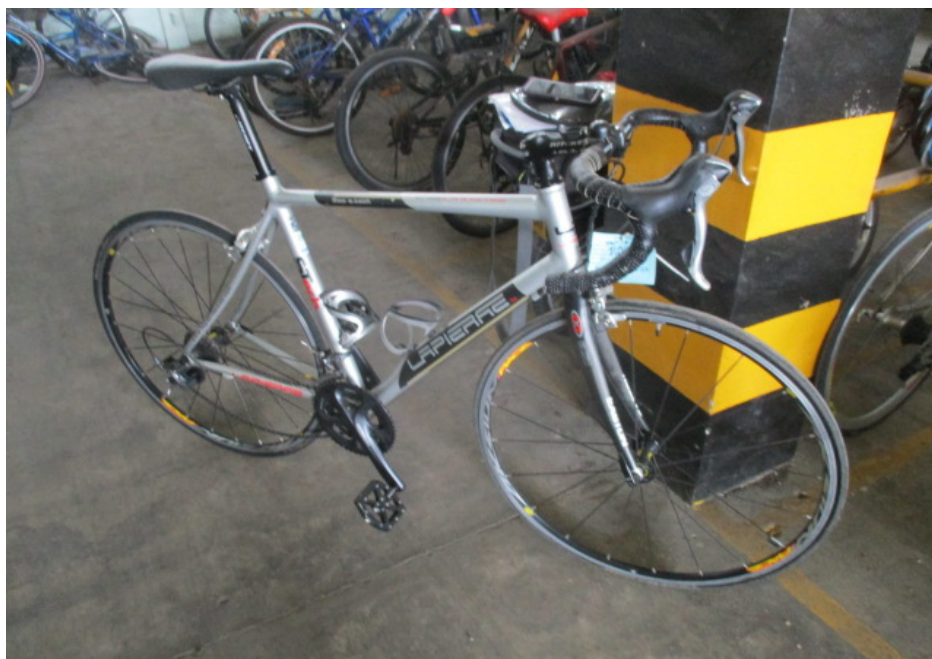
4. The Bicycle was observed to have sustained damages at the right body. The body parts that were found to have been damaged include its rear brake lever, right handlebar, right pedal and right frame, amongst others as a result of the accident. See photos 1 – 10 below.

Photo 4 shows the right body of the Bicycle at time of our inspection. The bicycle had sustained damages to its right body. The body parts that were found to have been damaged include its rear brake lever, right handlebar, right pedal and right frame, amongst others as a result of the accident.

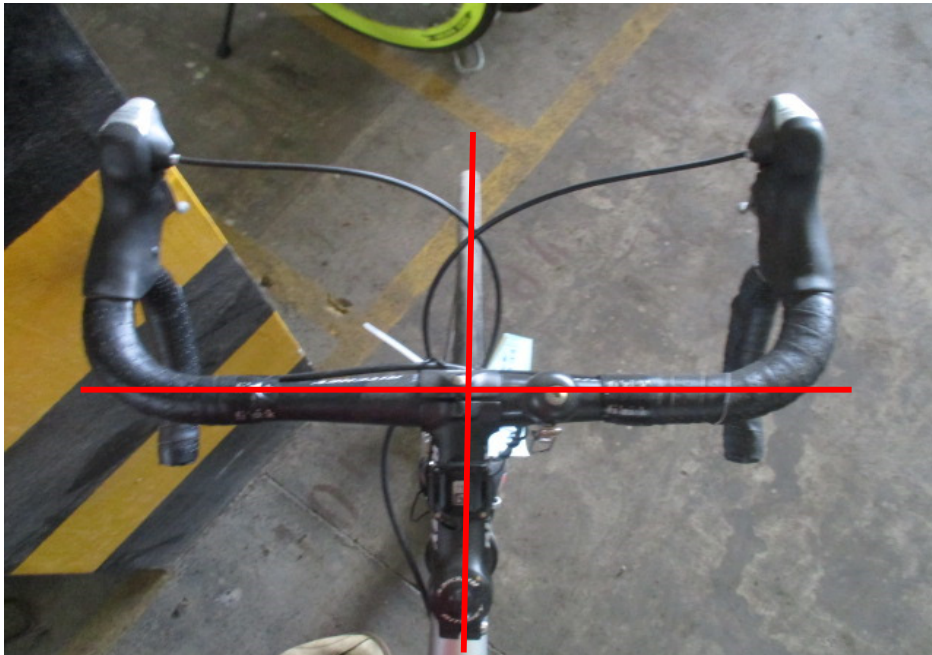
Photo 5 shows the frontal portion of the Bicycle (top view) at the time of our inspection. There was a misalignment of the handle bar & front tyre observed as a result of the accident.

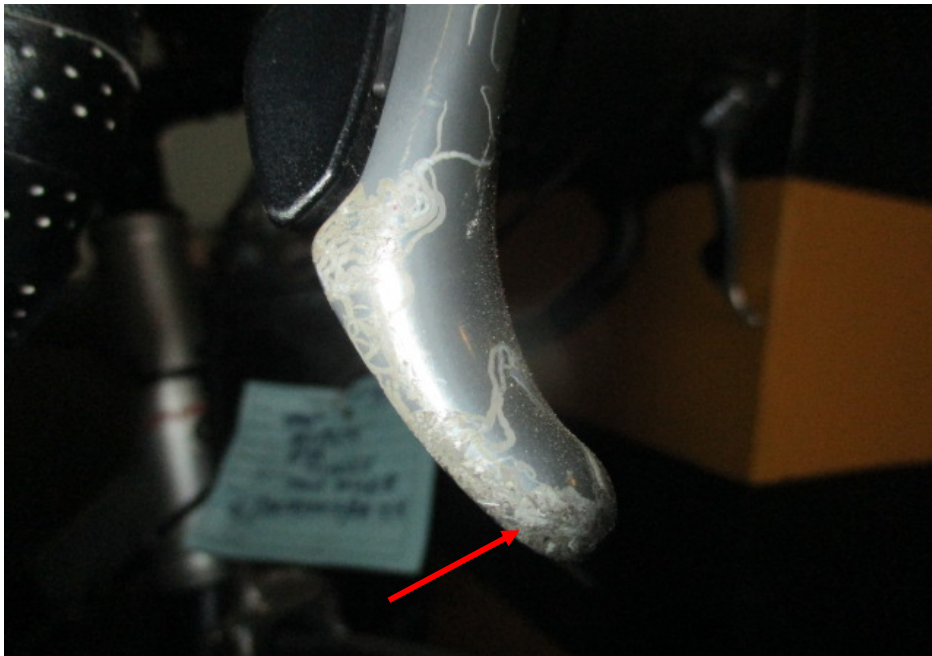
Photo 6 shows the damaged rear brake lever (arrowed) of the Bicycle at the time of our inspection.

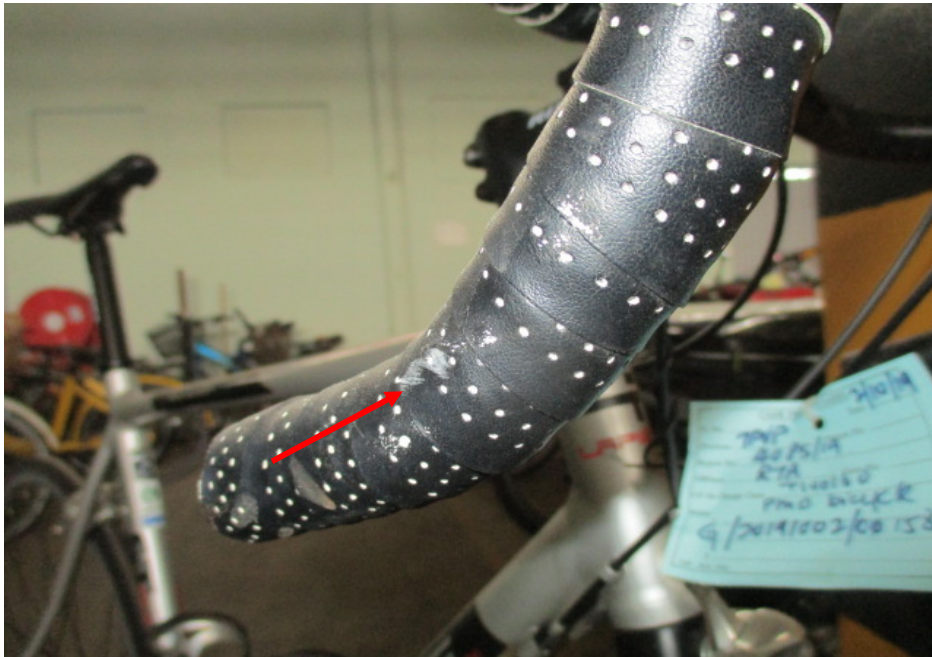
Photo 7 shows the damaged right handlebar (arrowed) of the Bicycle at the time of our inspection.

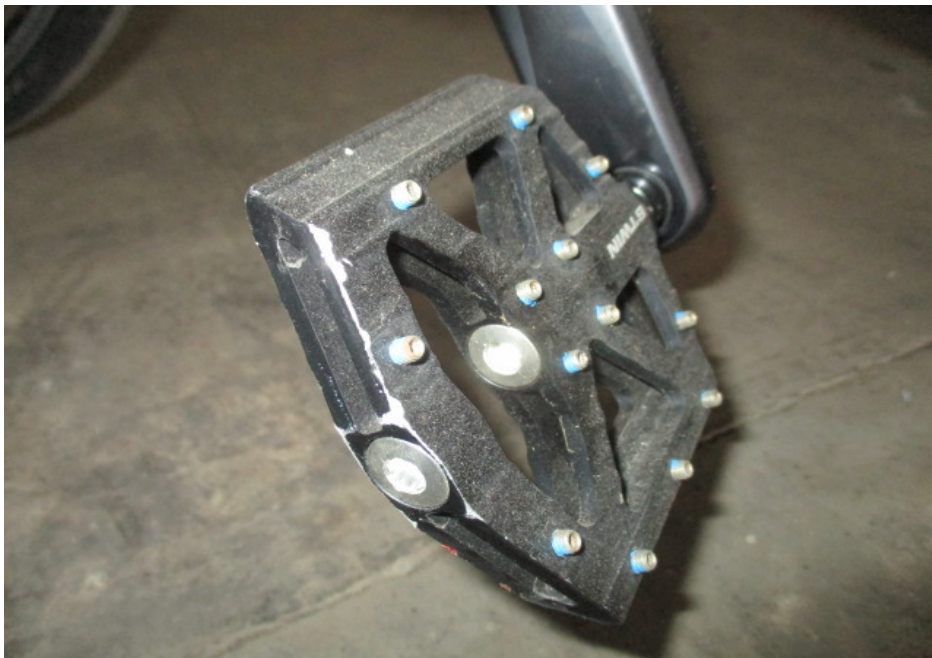
Photo 8 shows the damaged right pedal of the Bicycle at the time of our inspection.

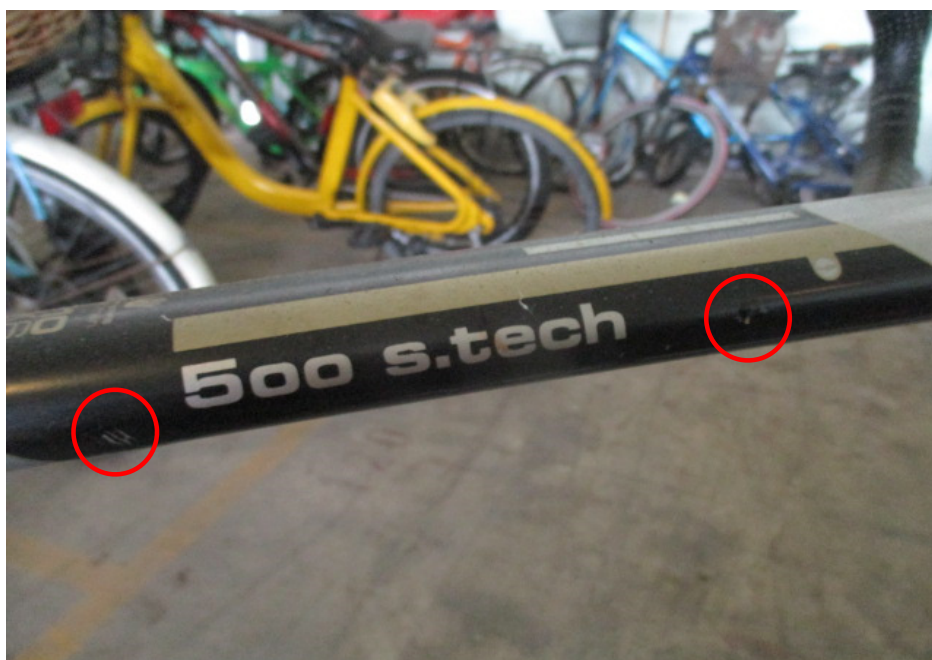
Photo 9 shows the damages of grazing nature on the right frame (circled) of the Bicycle at the time of our inspection.

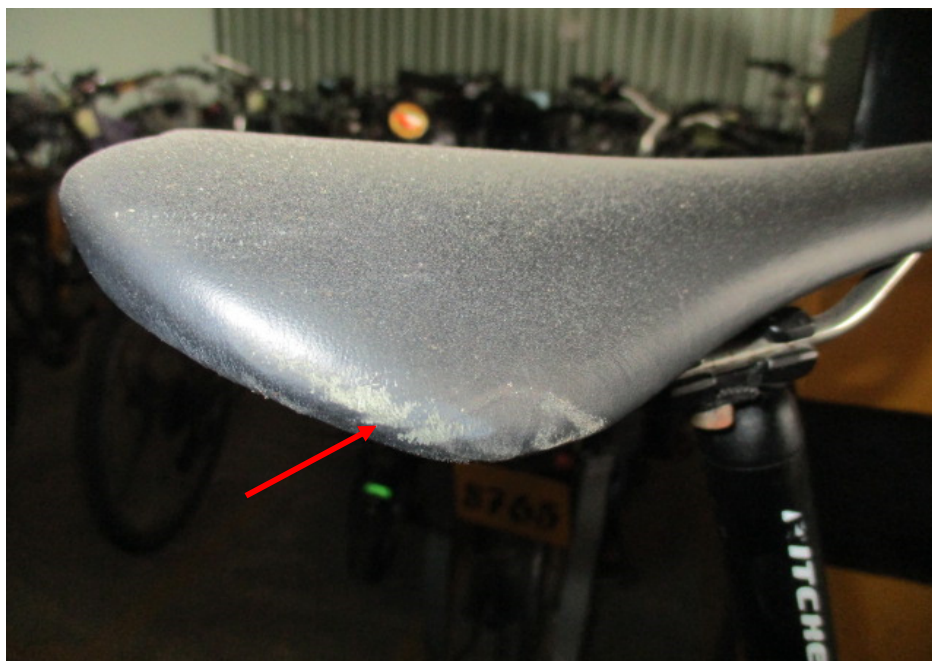
Photo 10 shows a close-up view of the damaged seat (arrowed) of the Bicycle as a result of the accident.

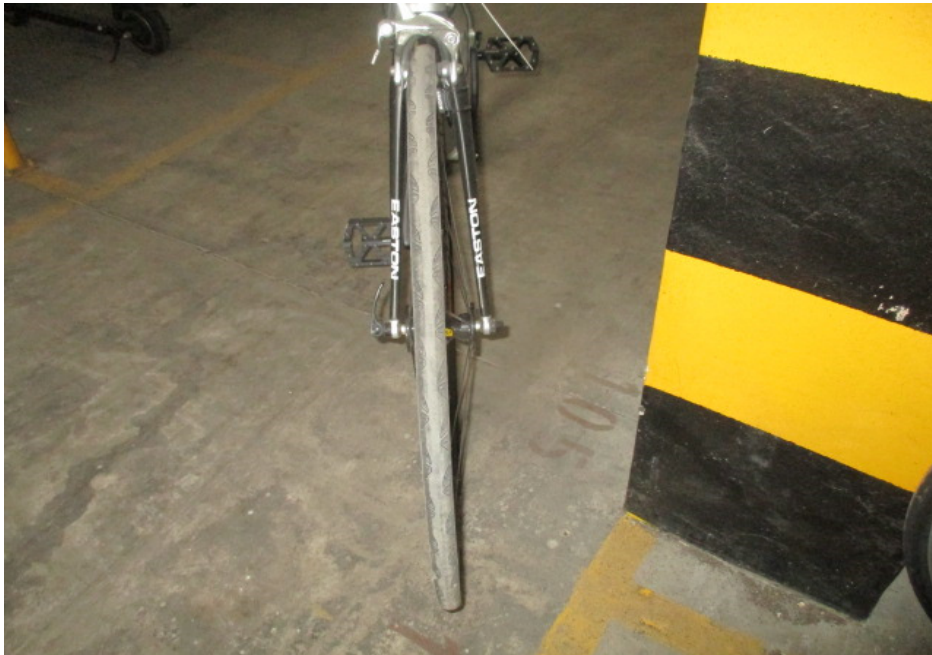
6. Both tyres were wrapped around alloy spoke wheel rims. At the time of our inspection, we did not observe any visible damage on the front and rear wheel rim of the Bicycle. See photos 11 & 12 below.

Photo 11 shows the front tyre of the Bicycle. The pattern of the tread was clearly visible. There was no tear, burst mark(s) and/or punctured hole(s) on the sidewalls as well as across the tread of the front tyre. However the front tyre was observed to be deflated.

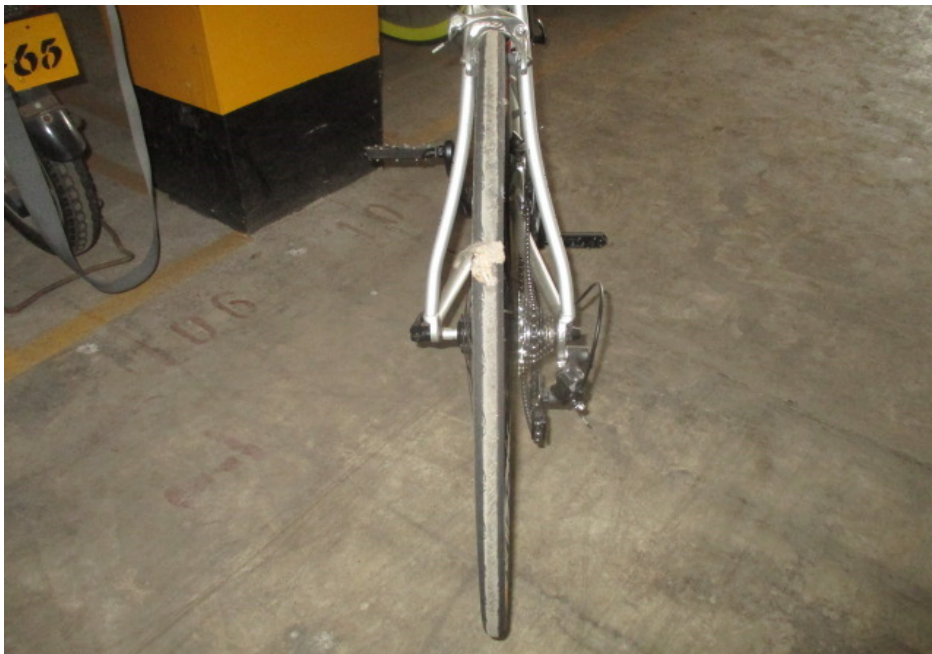
Photo 12 shows the rear tyre of the Motorcycle. The pattern of the tread was clearly visible. There was no tear, burst mark(s) and/or punctured hole(s) on the sidewalls as well as across the tread of the front tyre. However the rear tyre was observed to be deflated.

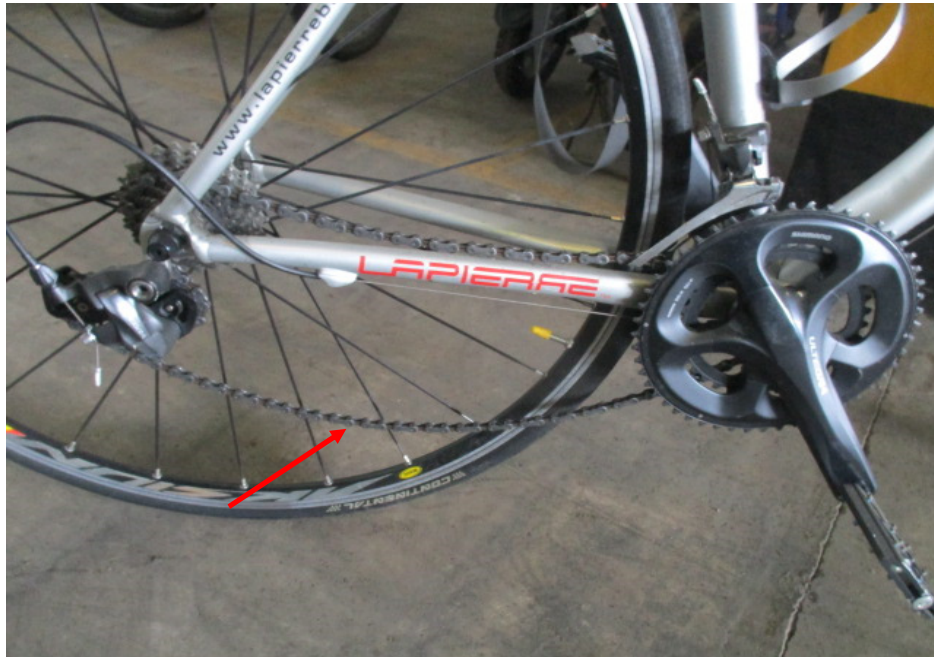
Photo 13 shows the general view of the gear train of the Bicycle, which was observed to be intact with no misalignment. It was also adequately lubricated for operating purposes (arrowed).

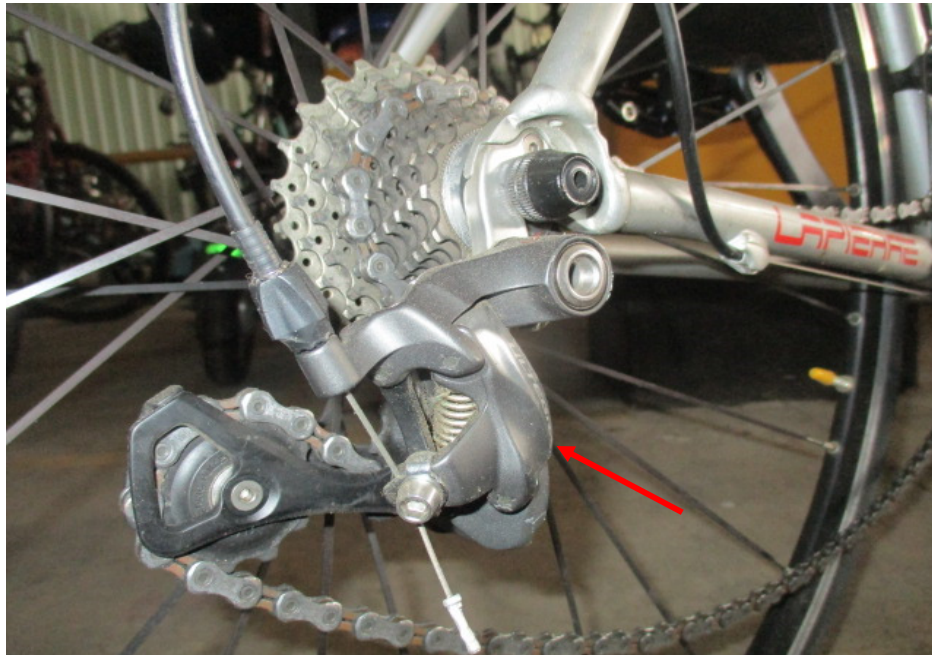
Photo 14 shows a closer view of the gear train (arrowed) of the Bicycle, which was observed to be intact with no misalignment. It was also adequately lubricated for operating purposes.

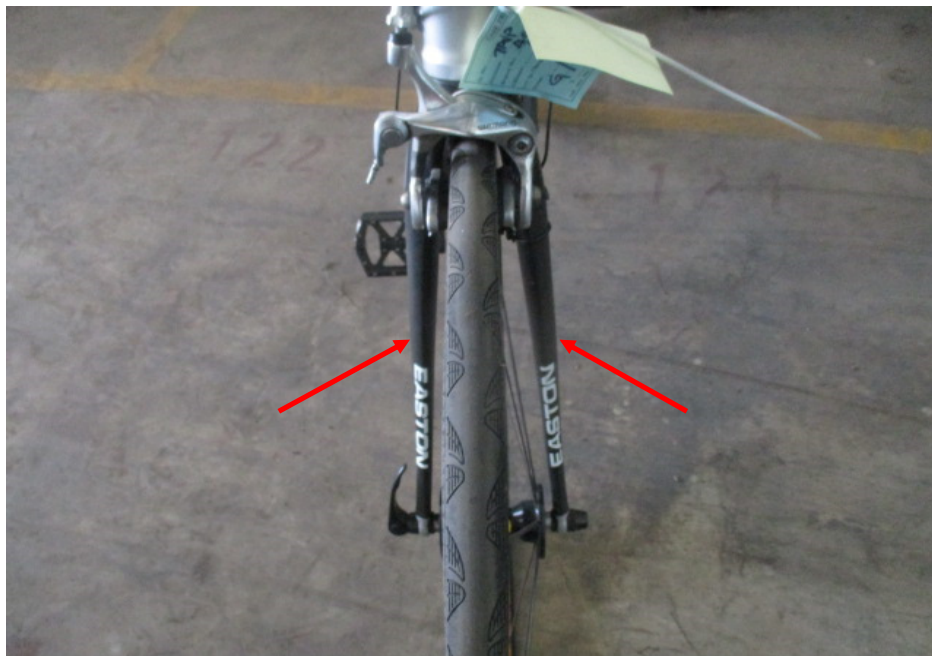
Photo 15 shows the front fork (arrowed) of the Bicycle. The front fork and fork bracket of the Bicycle were both found to be intact and undamaged. Turning the Bicycle's handle bar towards the left and right did not produce any abnormal free play. The steering system of the Bicycle was in serviceable condition at the time of our inspection.

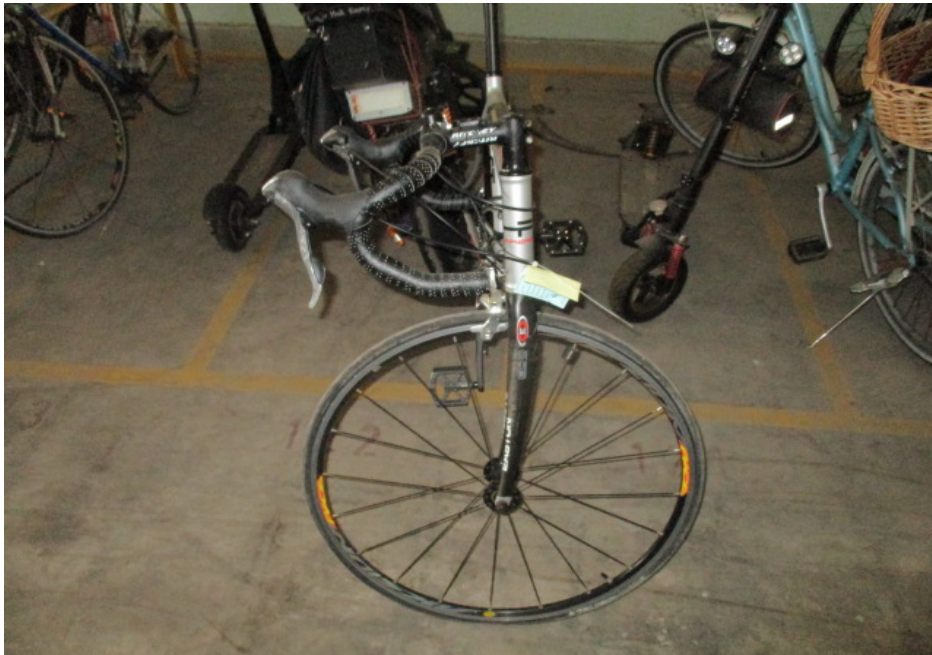
Photo 16 shows the front wheel of the Bicycle turned towards its full right. Turning the Bicycle's handle bar towards the right did not produce any abnormal free play and/or resistance. This would indicate that the steering system of the Bicycle was in serviceable condition at the time of our inspection.

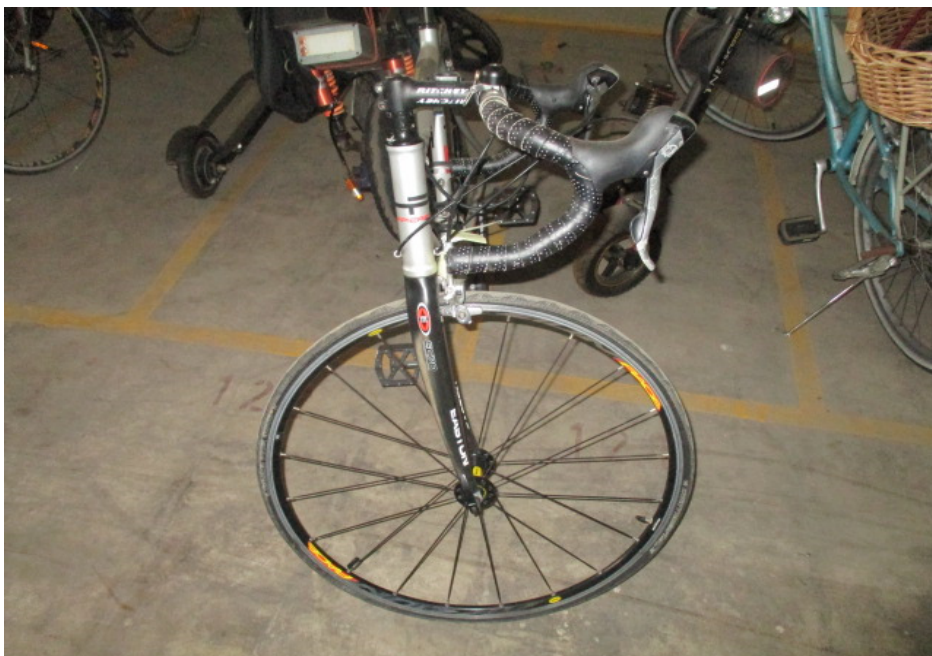
Photo 17 shows the front wheel of the Bicycle turned towards its full left. Turning the Bicycle's handle bar towards the left did not produce any abnormal free play and/or resistance. This would indicate that the steering system of the Bicycle was in serviceable condition at the time of our inspection.

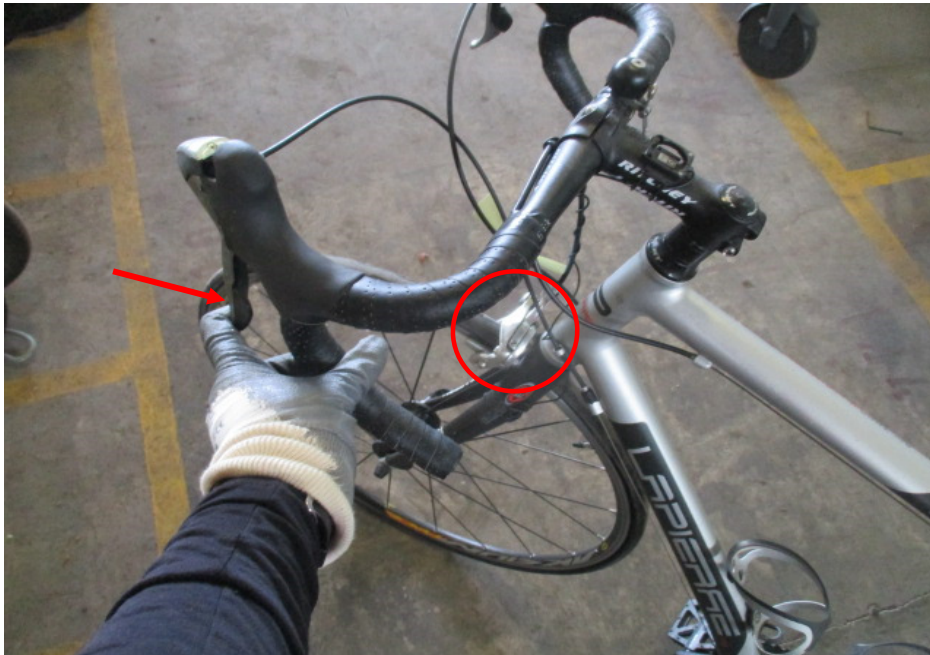
10. A static brake test was conducted on the front brake of the Bicycle. There was some resistance felt upon pressing the left hand brake lever. This was further confirmed by looking at the front brake clamps while we pressed the left hand brake lever. It shows that the front brake clamps responded to the gripping action. The rubber brake blocks pressed against the front wheel rim. This had appeared to indicate that the front brake was in serviceable condition.

Photo 18 shows a static brake test conducted on the Bicycle's front brake. There was some resistance felt upon pressing the left hand brake lever (arrowed). It also shows that the front brake clamps responded to the gripping action (circled) after depressing the left hand brake lever.

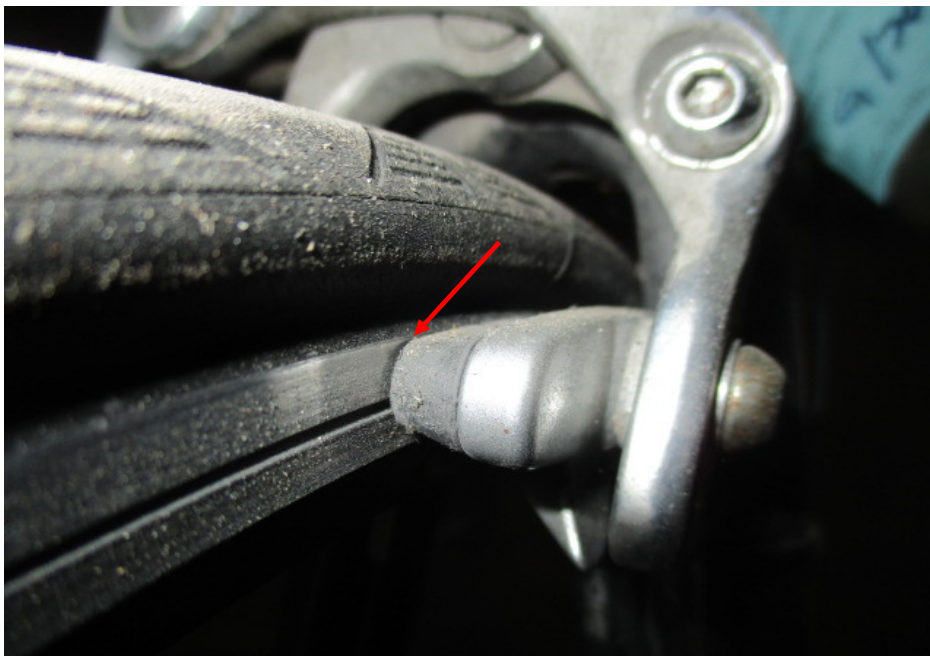
Photo 19 shows a close up view of the front brake clamps responding to the gripping action. The rubber brake blocks pressed against the front wheel rim upon depressing the left hand brake lever (arrowed). This had appeared to indicate that the front brake was in serviceable condition.

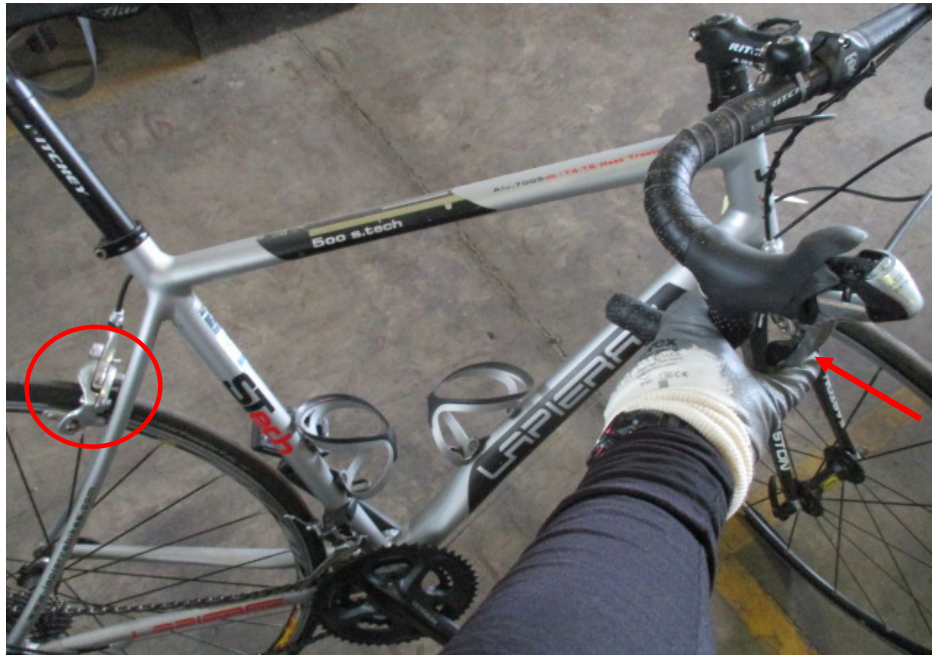
11. A static brake test was conducted on the rear brake of the Bicycle. There was some resistance felt upon pressing the right hand brake lever. This was further confirmed by looking at the rear brake clamps while we pressed the right hand brake lever. It shows that the rear brake clamps responded to the gripping action. The rubber brake blocks pressed against the rear wheel rim. This had appeared to indicate that the rear brake was in serviceable condition.

Photo 20 shows a static brake test conducted on the Bicycle's rear brake. There was some resistance felt upon pressing the right hand brake lever (arrowed). It also shows that the rear brake clamps responded to the gripping action (circled) after depressing the right hand brake lever.

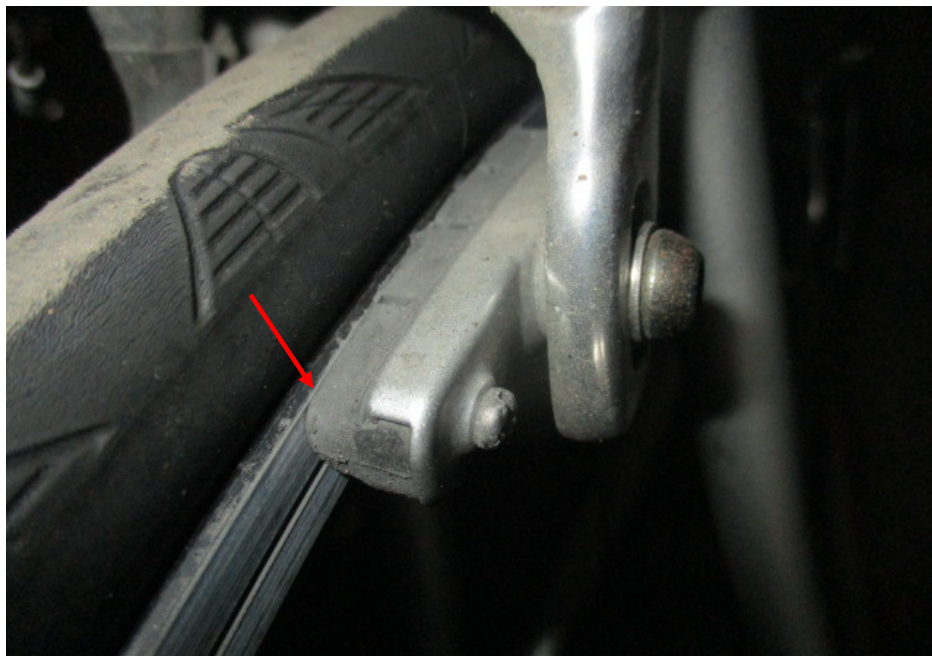
Photo 21 shows a close up view of the rear brake clamps responding to the gripping action. The rubber brake blocks pressed against the rear wheel rim upon depressing the right hand brake lever (arrowed). This had appeared to indicate that the rear brake was in serviceable condition.
