Your Ref: SKS 10R
Our Ref : CI/TP19022304/P

AUTOMOBILE INSPECTION REPORT OF VEHICLE SKS 10R

Vehicle Registration No.	: SKS 10R
Make / Model (CONVERTIBLE)	: BENTLEY CONTINENTAL GTV 8
Chassis No	: SCBGN23W1EC093776

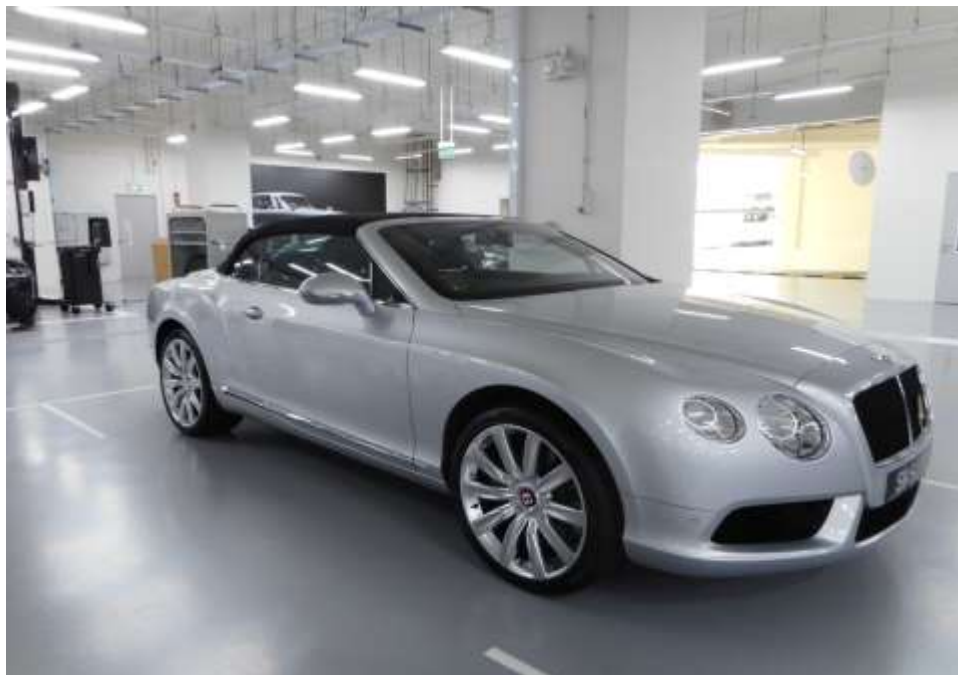
Photo 1 shows the general view of the right portion of the Insured Vehicle at the time of our inspection.

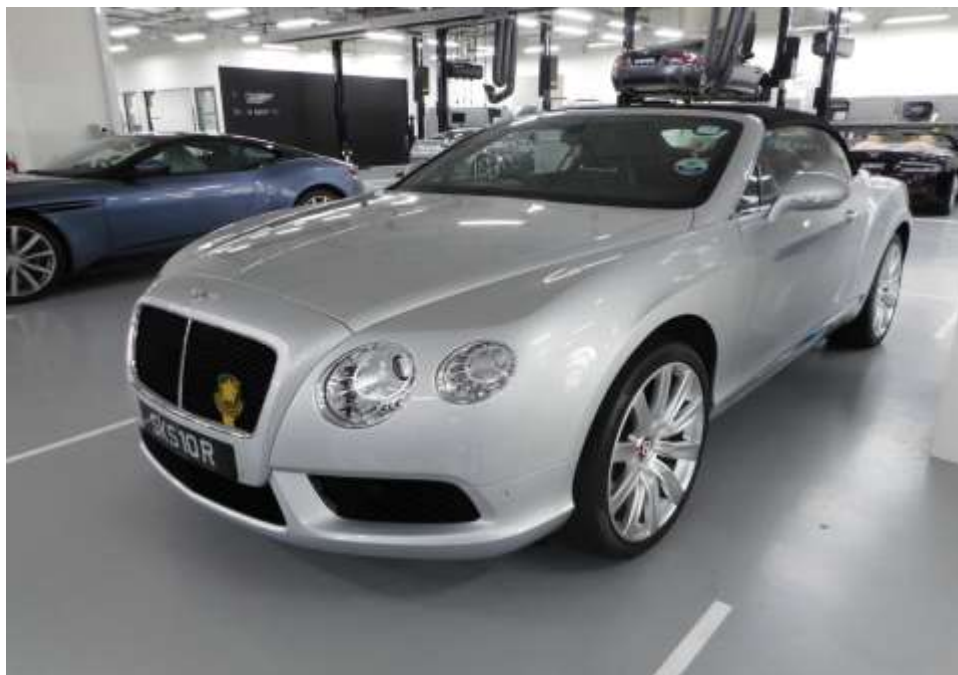
Photo 2 shows the general view of the left portion of the Insured Vehicle at the time of our inspection.

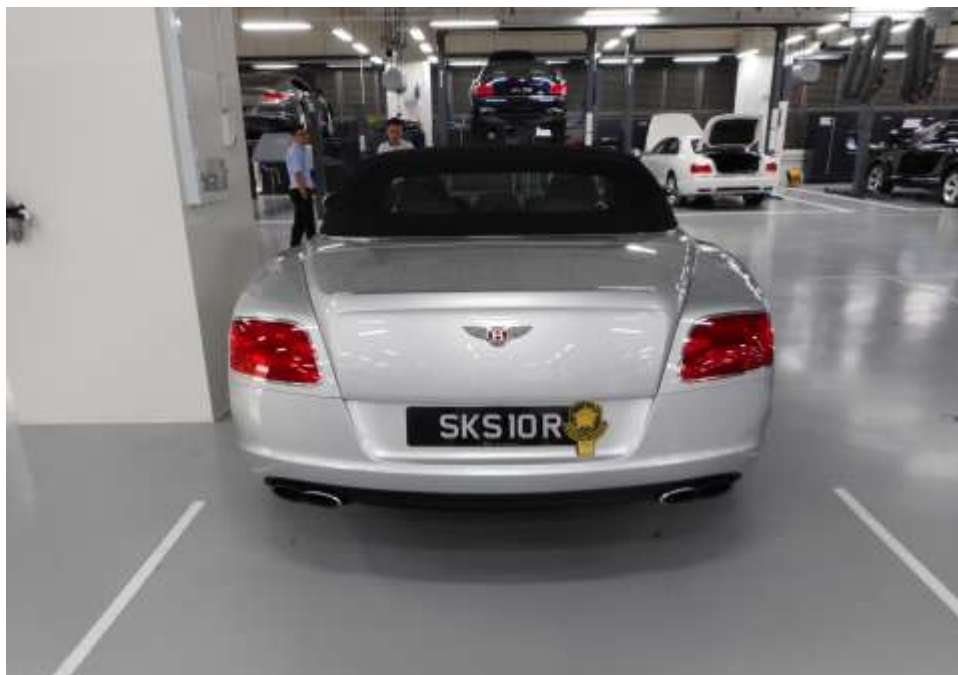
Photo 3 shows the general view of the rear portion of the Insured Vehicle at the time of our inspection.

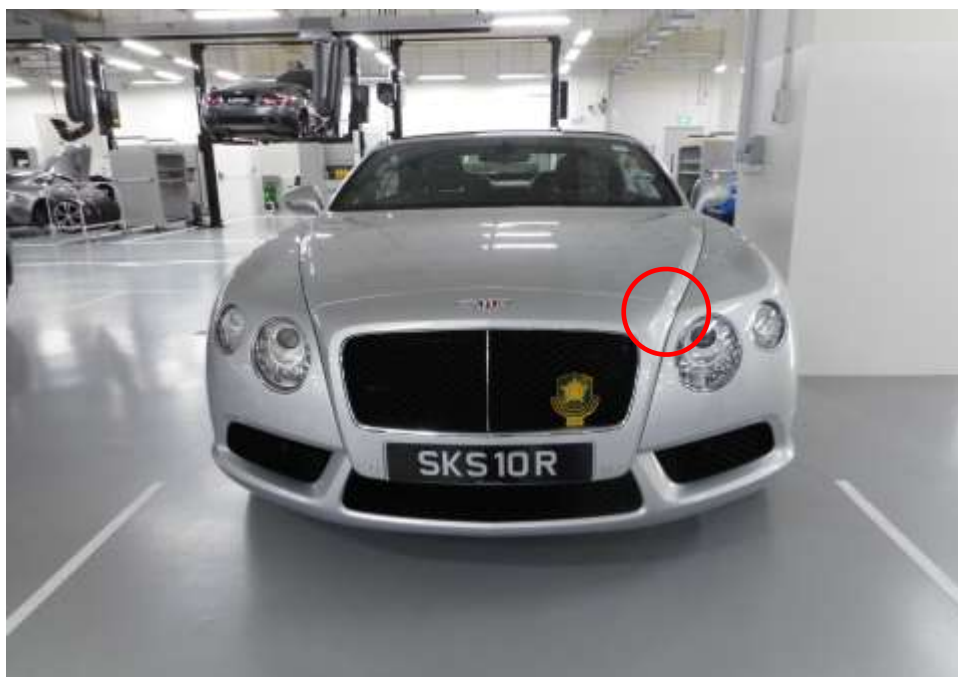
4. The alignment of the front left bumper, front left fender and front bonnet was found to be misaligned at the time of our inspection. See photo 1 -8 below.

Photo 4 shows the general view of the front portion of the Insured Vehicle at the time of our inspection. The alignment of the front left bumper, front left fender and front bonnet (circled) was found to be misaligned at the time of our inspection.

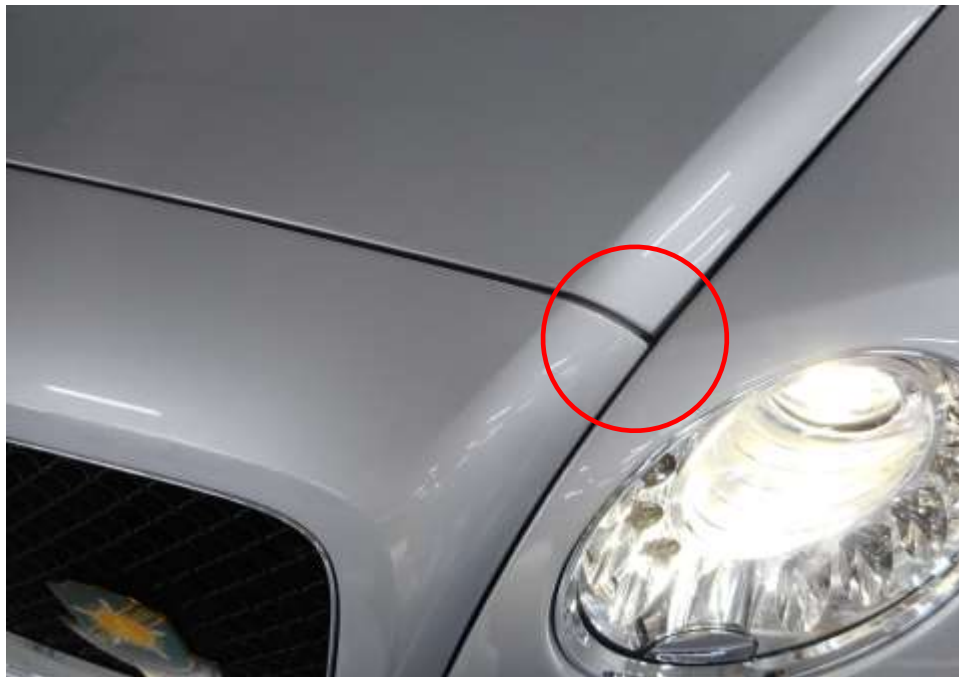
Photo 5 shows the general view of the front left bumper, front left fender and front left bonnet portion (circled) of the Insured Vehicle at the time of our inspection

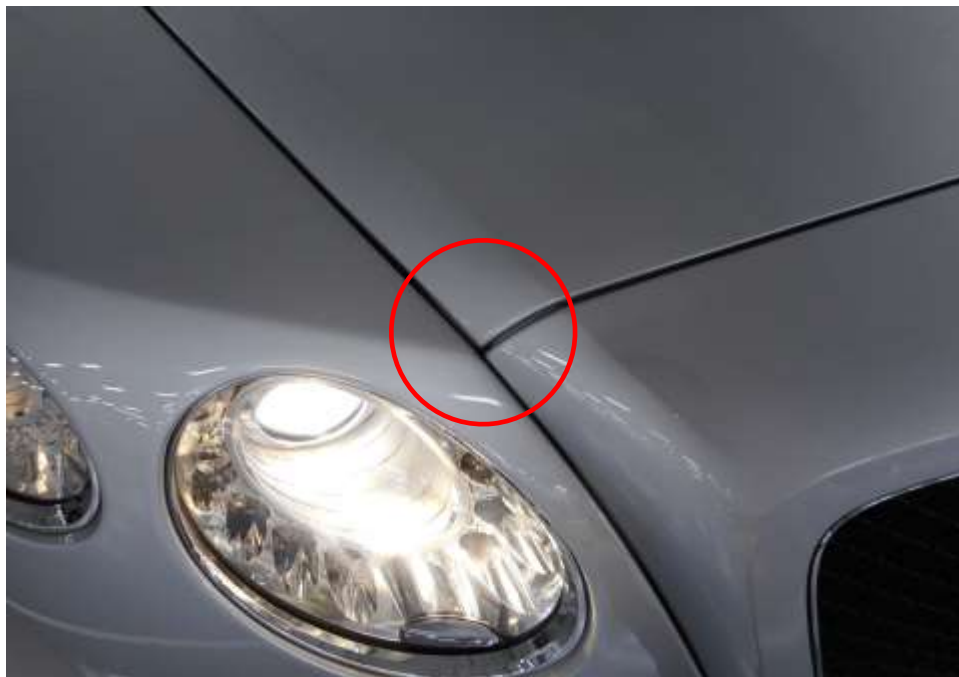
Photo 6 shows the general view of the front right bumper, front right fender and front right bonnet portion (circled) of the Insured Vehicle at the time of our inspection

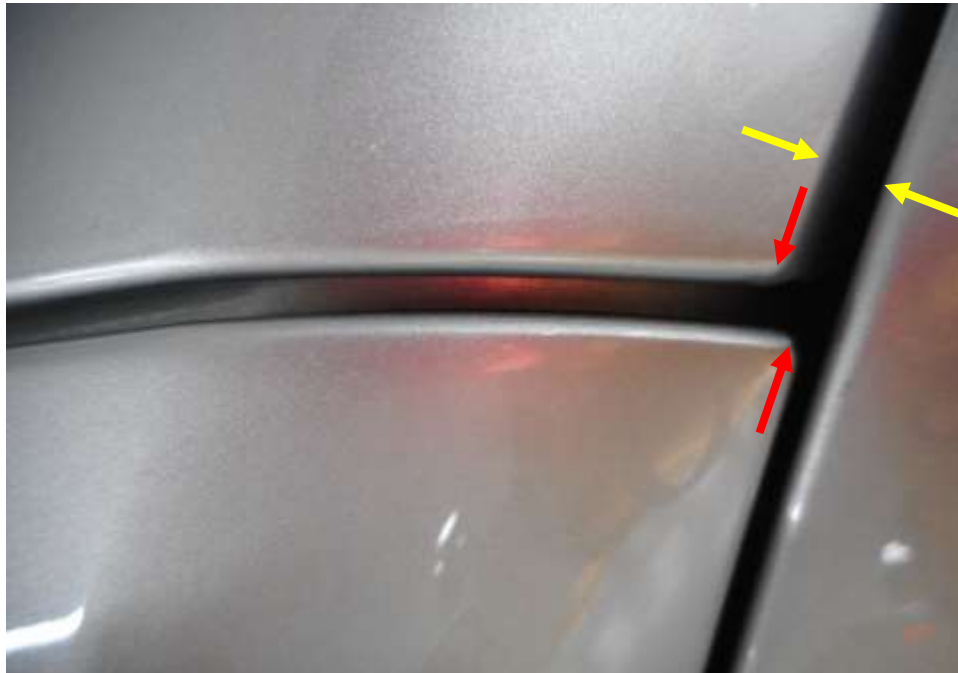
Photo 7 shows the close up view of the front left bumper portion and left fender and left bonnet portion of the Insured Vehicle at the time of our inspection. A alignment differences between the front left bonnet, front left bumper (red arrow) and front left fender, front left bonnet (yellow arrow) as observed.

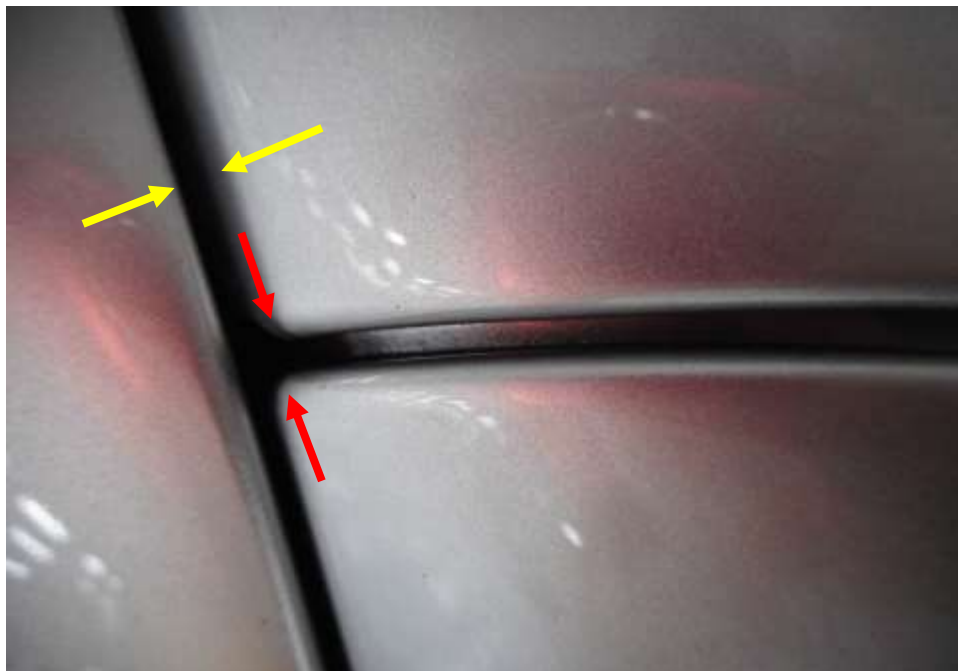
Photo 8 shows the close up view of the front right bumper portion and front right fender and front right bonnet portion of the Insured Vehicle at the time of our inspection. There was no alignment differences between the front left bonnet, front left bumper (red arrow) and front left fender, front left bonnet (yellow arrow) as observed. (Refer to photo 7 above)

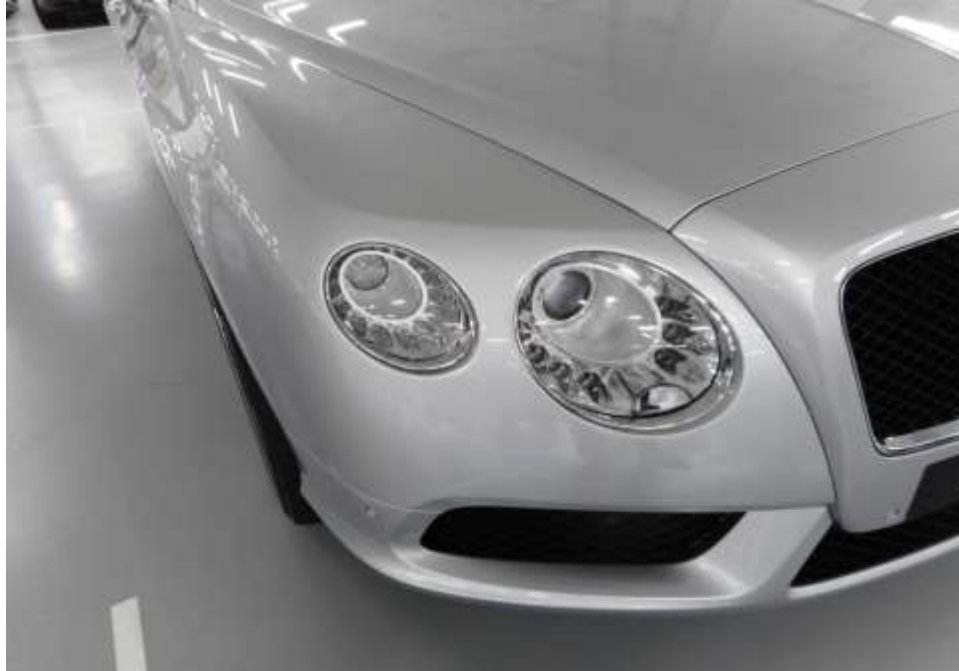
Photo 9 shows the general view of the front right headlights of the Insured Vehicle at the time of our inspection.

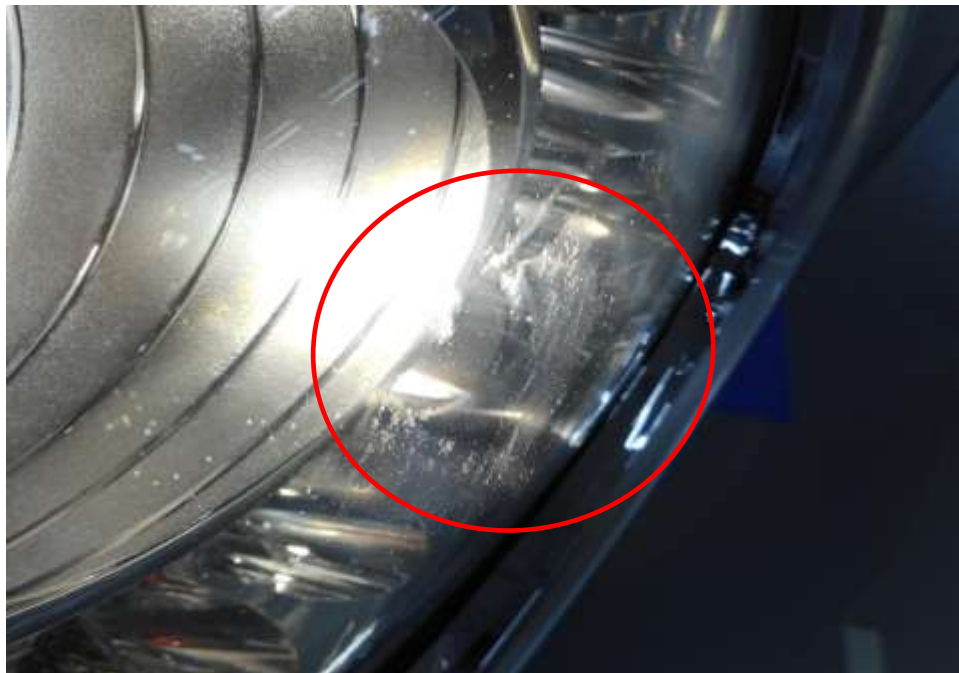
5. The front left headlight inner cover surface was observed to be clear, however the front right headlight inner cover surface was observed with hazy stain marks on it at the time of our inspection. See photo 9-12 below.

Photo 10 shows the close up view of the right portion of the Insured Vehicle at the time of our inspection. The front right headlight inner cover surface (circled) of the Insured Vehicle was observed with hazy stain marks.

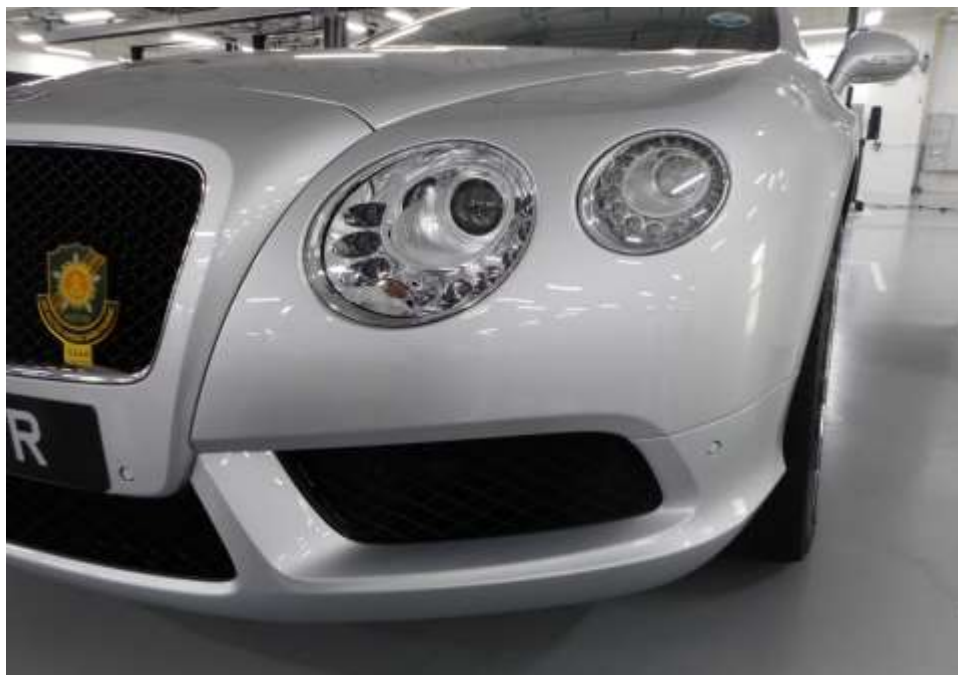
Photo 11 shows the general view of the front left headlights of the Insured Vehicle at the time of our inspection.

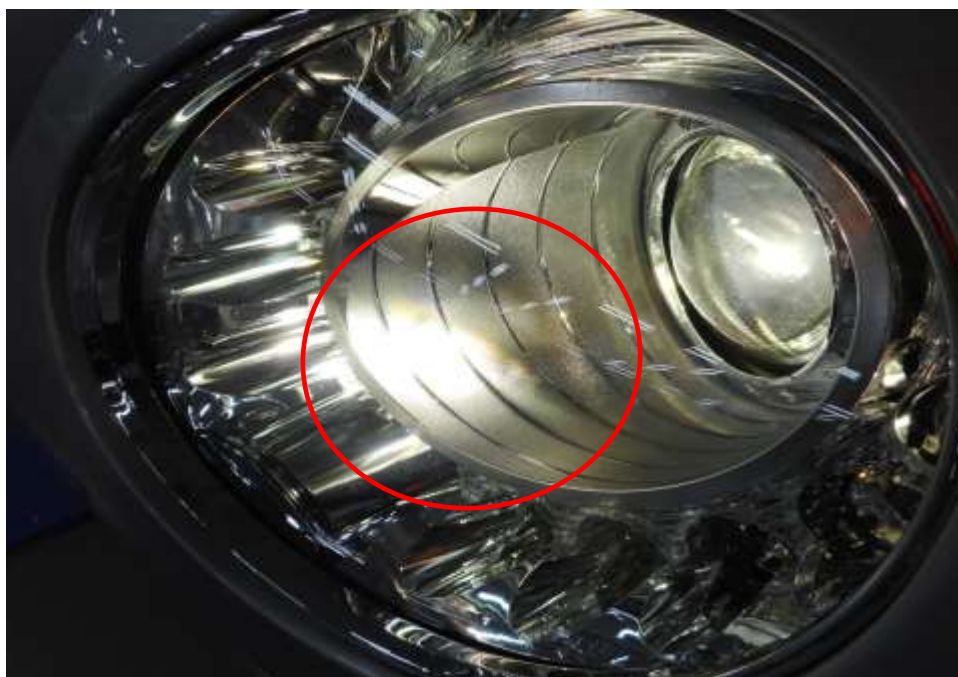
Photo 12 shows the close up view of the left portion of the Insured Vehicle at the time of our inspection. The front left headlight inner cover surface (circled) of the Insured Vehicle was observed to be clear as compared to the front right headlight (Refer to photo 10 above).

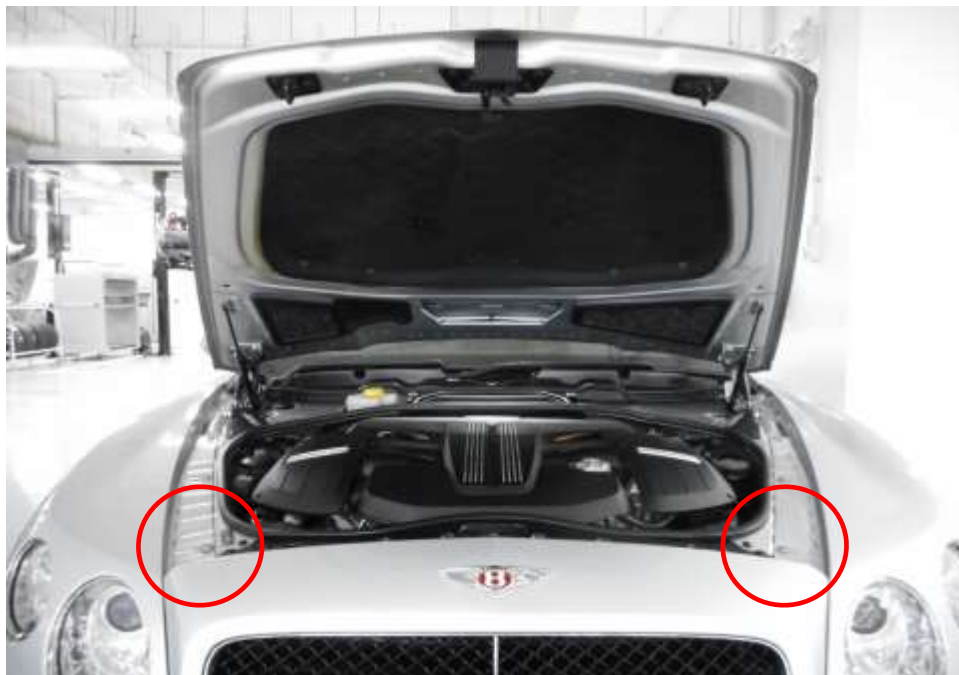
Photo 13 shows the general view of front left and right wheel house panel and the front left and right fender (circled) at the time of our inspection.

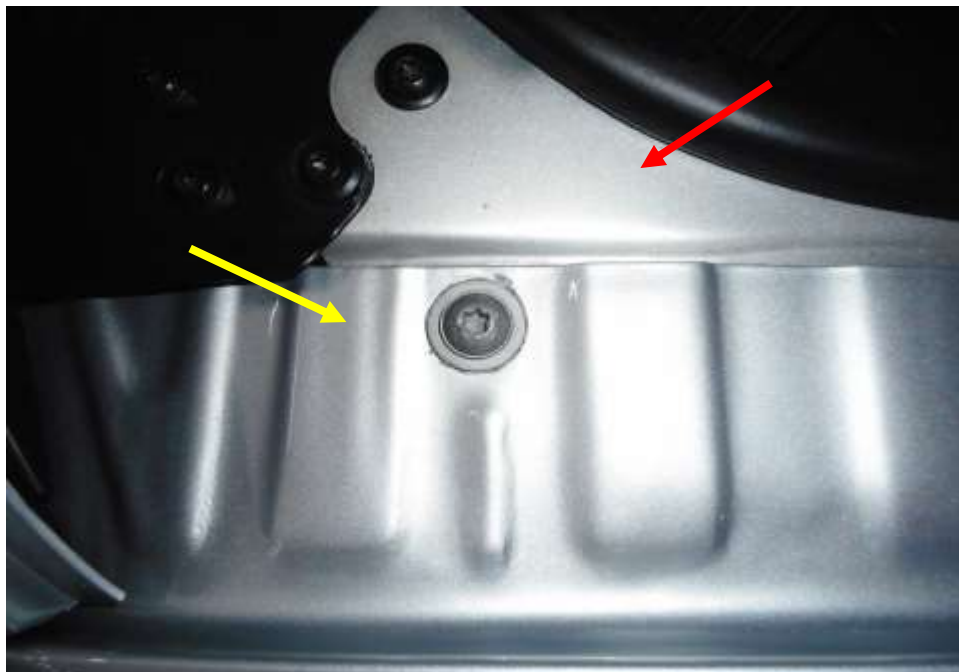
6. The colour tone for the paint at the front left wheel house panel and the front left fender panel was observed to be different at the time of our inspection. See photo 13 -15 below.

Photo 14 shows the close up view of the colour tone for the paint at the front left wheel house panel (red arrow) and the front left fender panel (yellow arrow) of the vehicle was observed to be different at the time of our inspection.

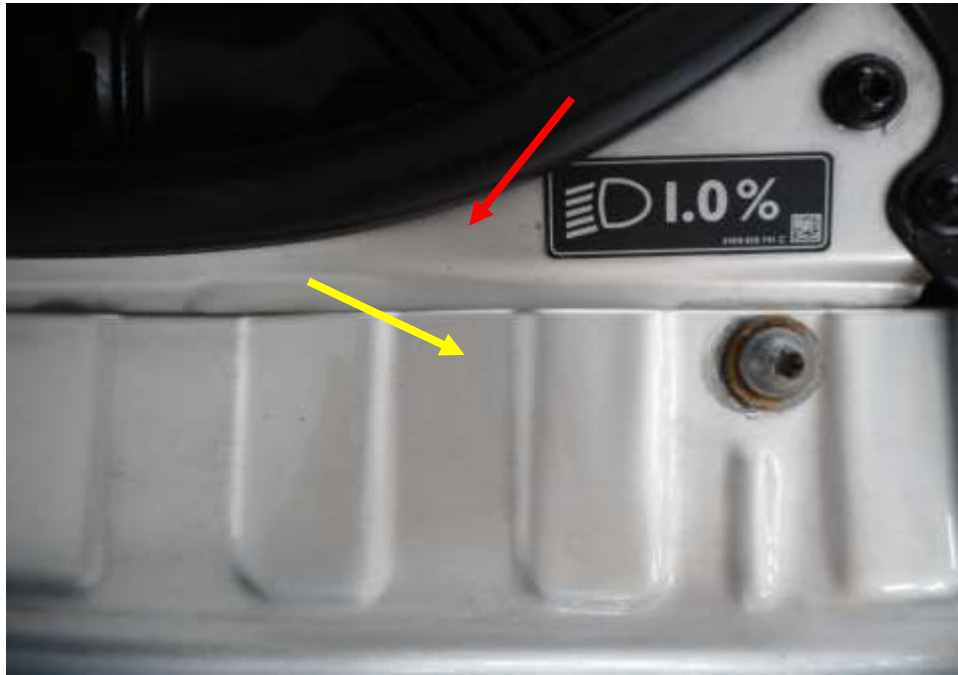
Photo 15 shows the close up view of the colour tone for the paint at the front right wheel house panel (red arrow) and the front right fender panel (yellow arrow) of the vehicle was observed to be the same at the time of our inspection. (Refer to photo 14 above).
