Your Ref : CMTD1905866
Our Ref : CS/SMO19022308/N

17 February 2020

**AUTOMOBILE TECHNICAL INVESTIGATION REPORT OF ACCIDENT
INVOLVING SLQ 4108R AND FBP 5069L ON 14 DECEMBER 2019**

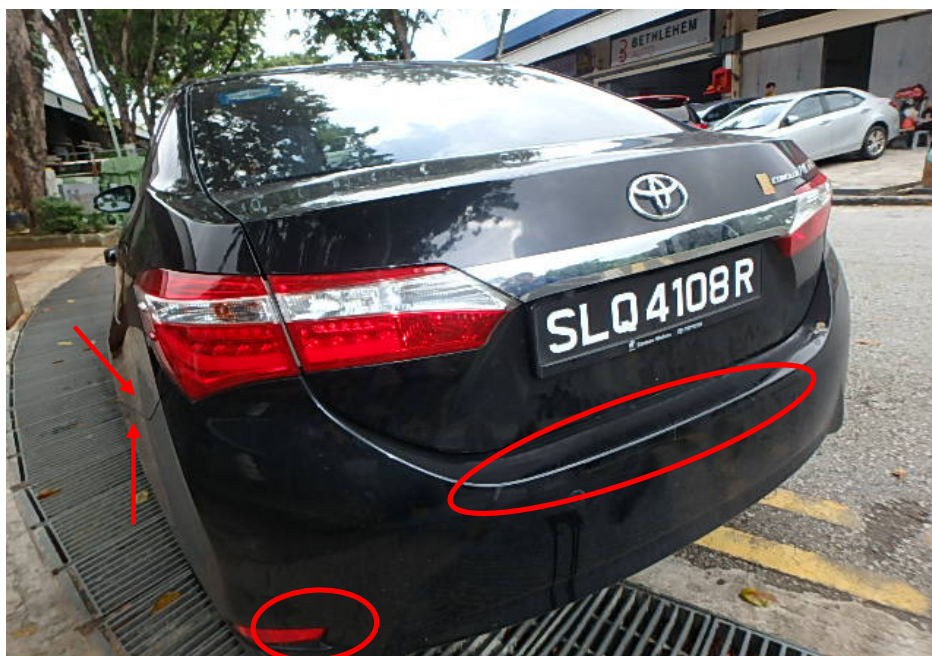
Photo 1 shows the general view of the rear left portion of the Toyota at the time of the Pre- Repair Survey conducted by LKK Auto Consultants Pte. Ltd. The damage to the Toyota was observed to be confined to its rear portion, at the rear bumper (circled). We also noted that the rear bumper was not misaligned at its left corner edges (arrowed).

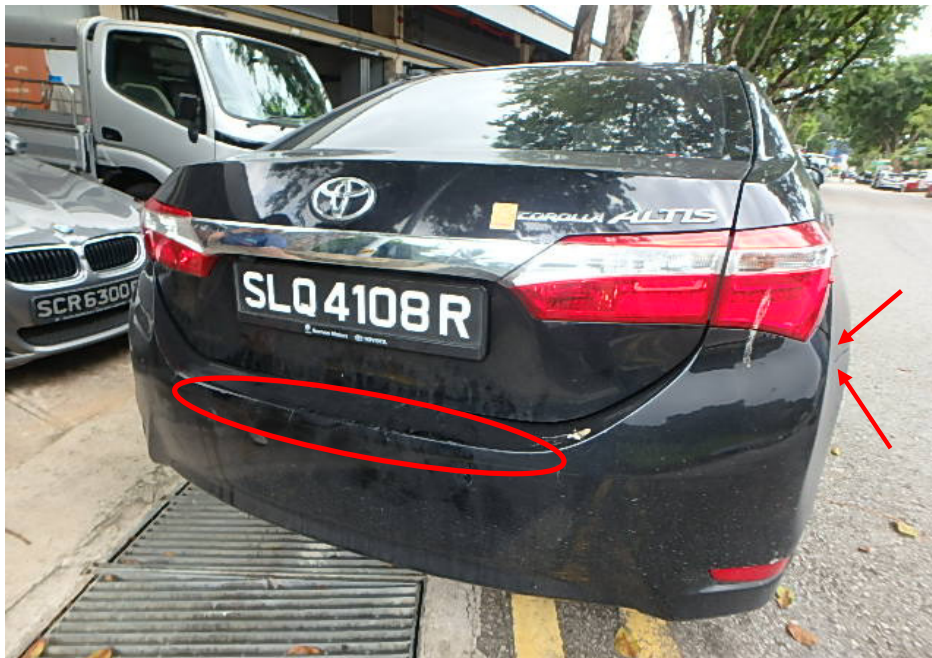
Photo 2 shows the general view of the rear right portion of the Toyota at the time of the Pre- Repair Survey conducted by LKK Auto Consultants Pte. Ltd. The damage to the Toyota was observed to be confined to its rear portion, at the rear bumper (circled). We also noted that the rear bumper was not misaligned at its right corner edges (arrowed).

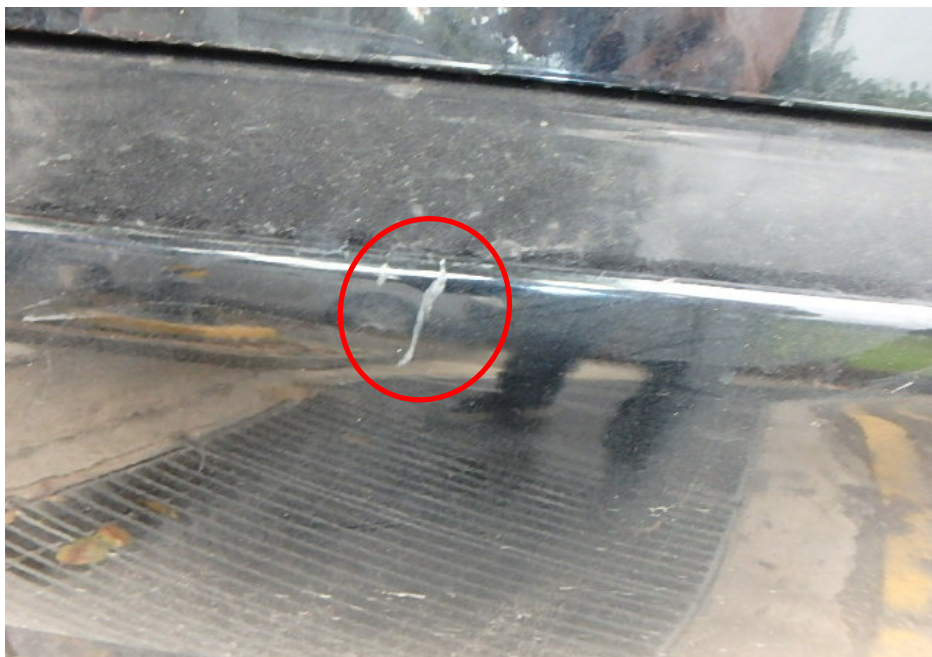
Photo 3 shows a closer view of the centre top portion of the rear bumper. Paint graze marks were observed (circled).

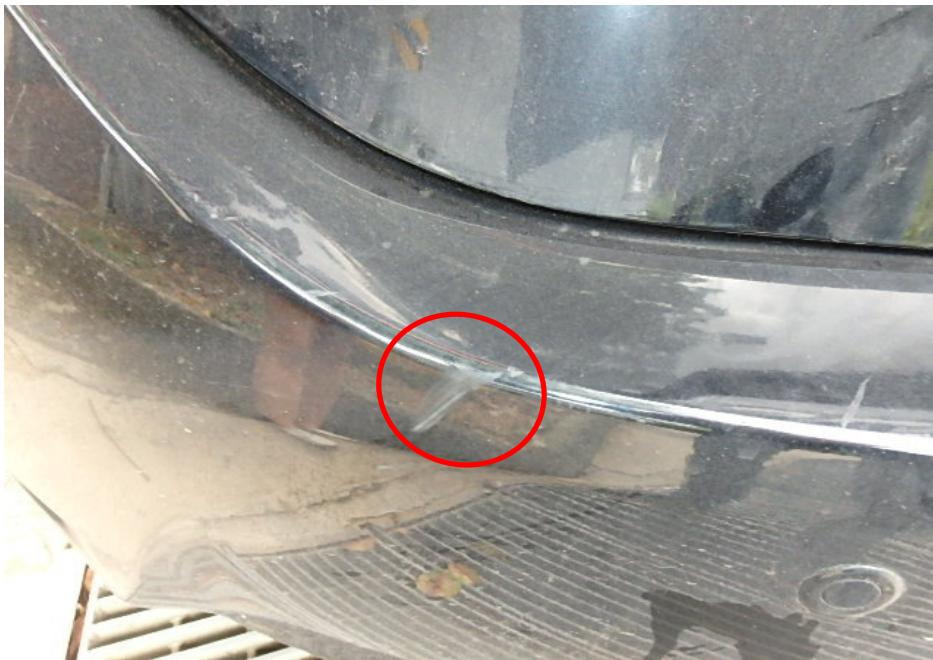
Photo 4 shows closer view of the left top portion of the rear bumper. Paint graze marks were observed (circled).

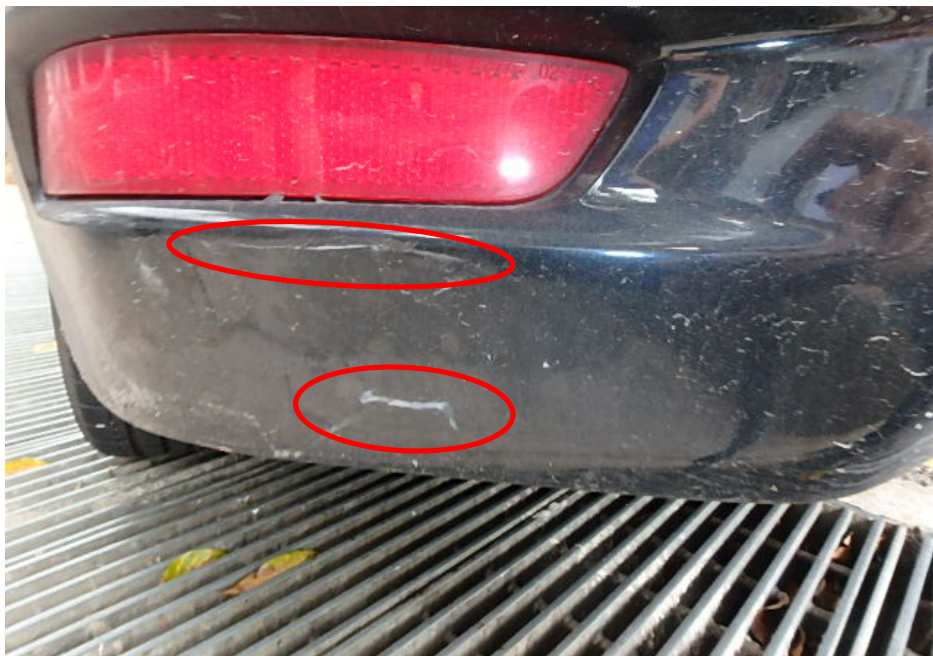
Photo 5 shows a closer view of the bottom left portion of the rear bumper of the Toyota at the time of the Pre- Repair Survey conducted by LKK Auto Consultants Pte. Ltd. We observed horizontal paint graze marks below the left rear bumper reflector (circled).

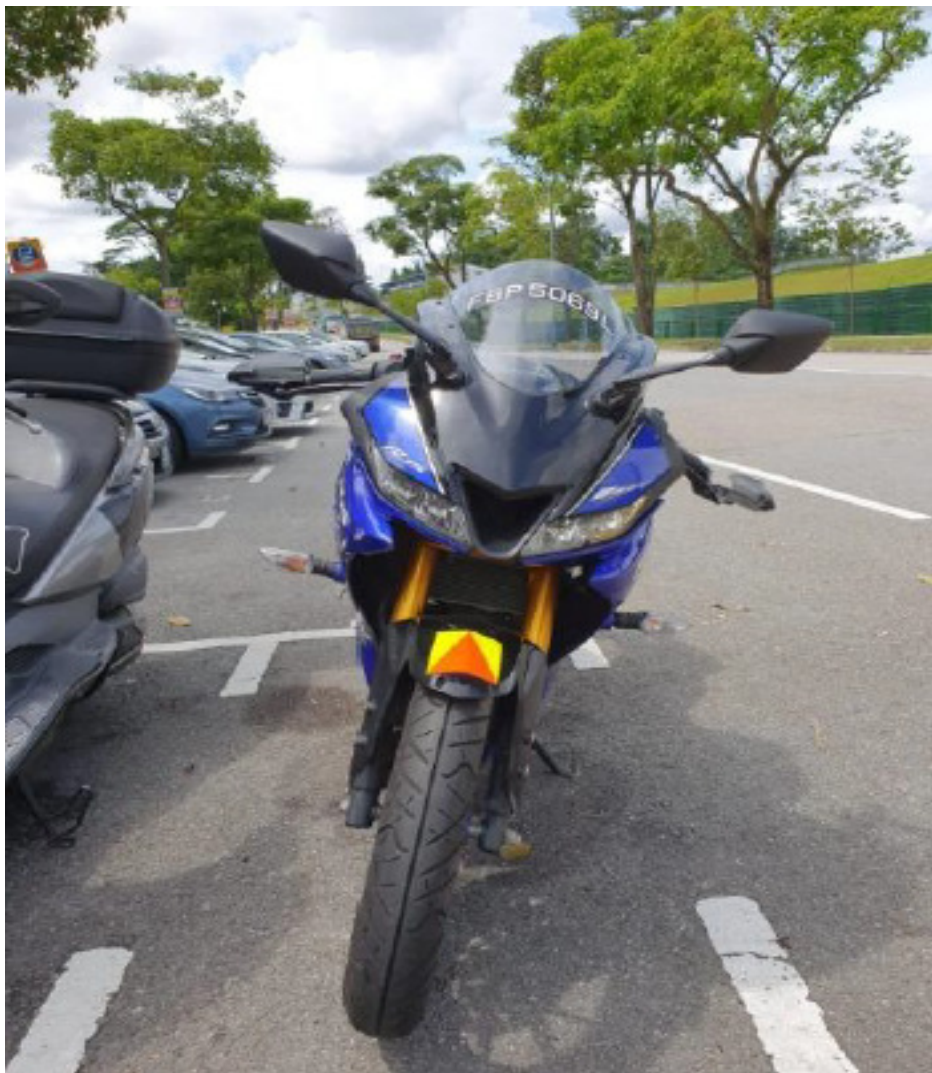
Photo 6 shows a general view of the front portion of the Yamaha at the time of reporting, which was about 2 days after the accident. The damages were observed to be on the left portion of the Yamaha.

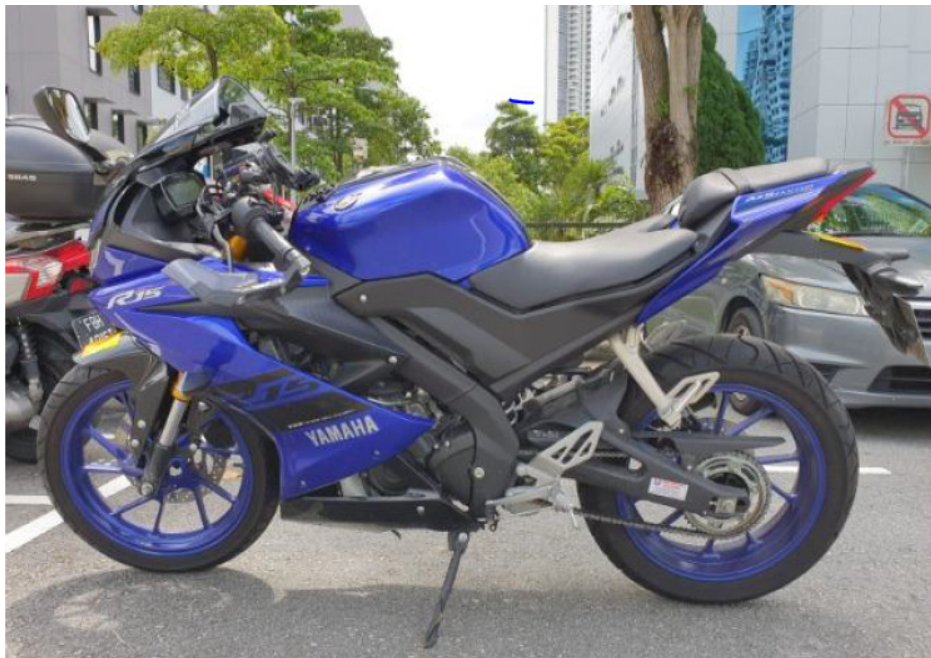
Photo 7 shows the left portion of the Yamaha at the time of reporting, which was about 2 days after the accident. We note that the Yamaha had sustained an impact onto its left portion since Mr Zul had mentioned that he had fallen on his left side.

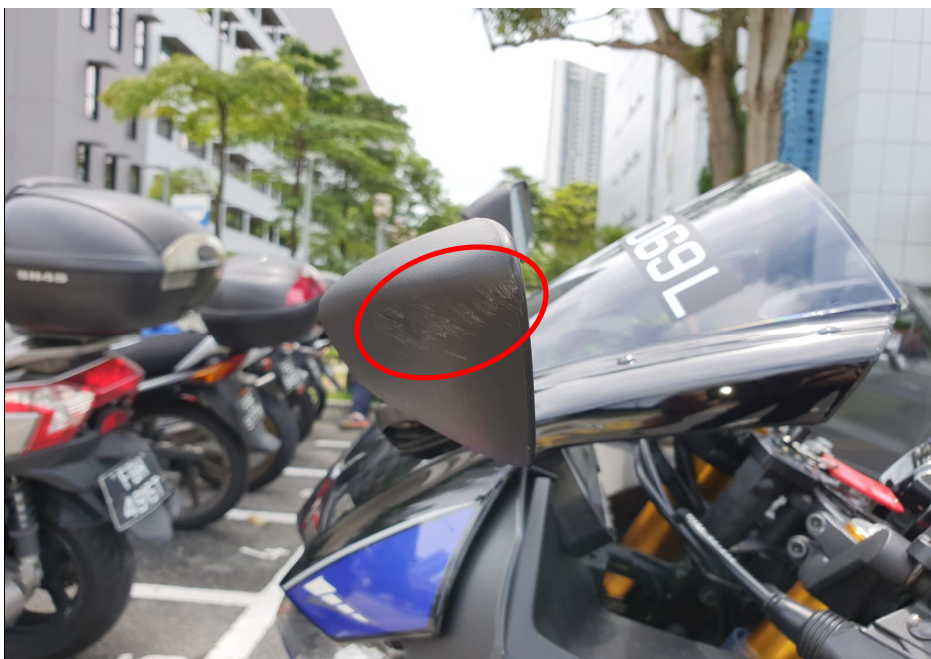
Photo 8 shows a closer view of the left side mirror of the Yamaha at the time of reporting, which was about 2 days after the accident. We observed scratches on the back portion (circled).

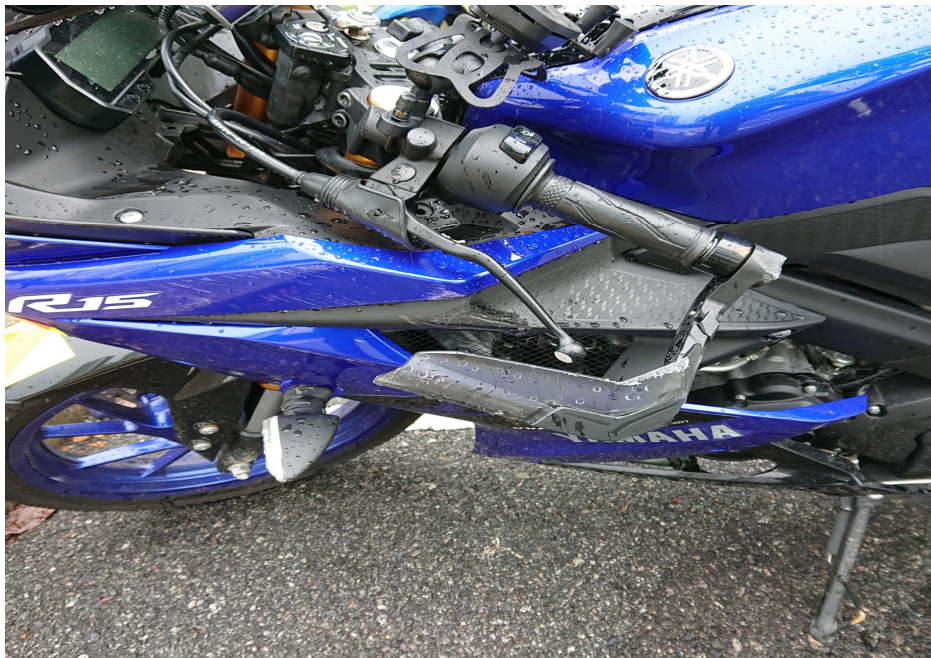
Photo 9 shows a closer view of the damages of grazing nature observed on the left cowling of the Yamaha at the time of reporting, which was about 2 days after the accident.

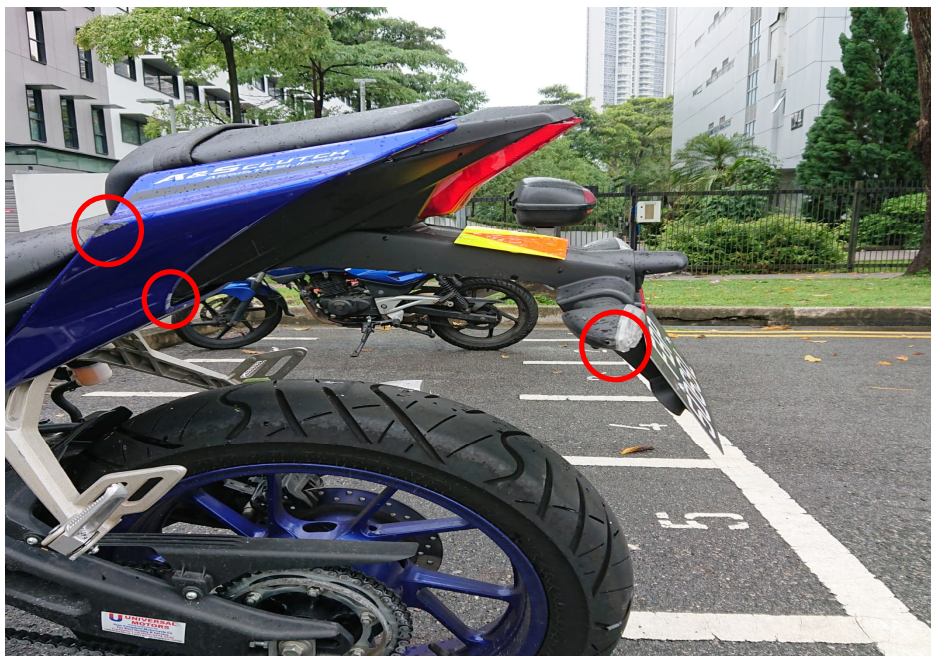
Photo 10 shows a closer view of the damages of grazing nature observed on the left rear side cover and left rear signal lamp of the Yamaha (circled) at the time of reporting, which was about 2 days after the accident.

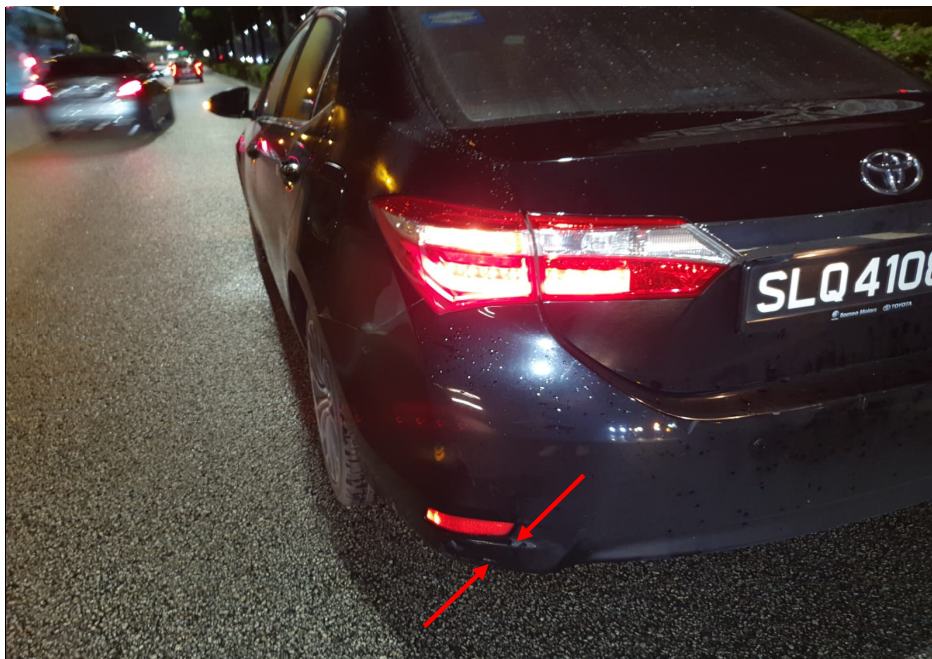
Photo 11 shows a closer view of the rear left portion of the rear bumper of the Toyota post- accident. We observed the same horizontal paint graze marks (red arrows) on the bottom left portion of the rear bumper of the Toyota as per the Pre- Repair Survey conducted by LKK Auto Consultants Pte. Ltd.

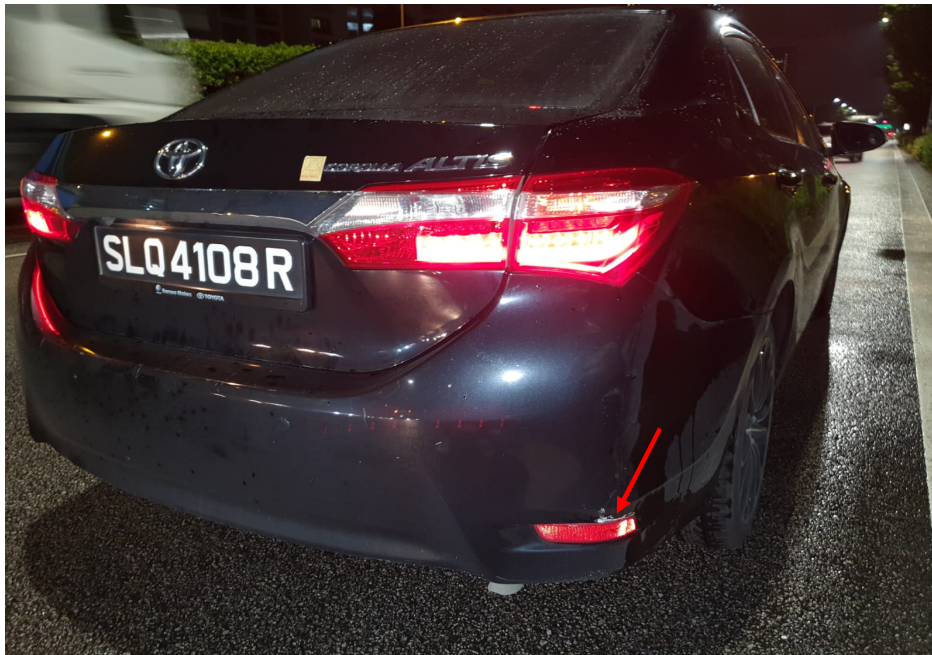
Photo 12 shows a closer view of the bottom right portion of the rear bumper of the Toyota post- accident. We observed paint cracks on the bottom right portion of the rear bumper of the Toyota (arrowed).

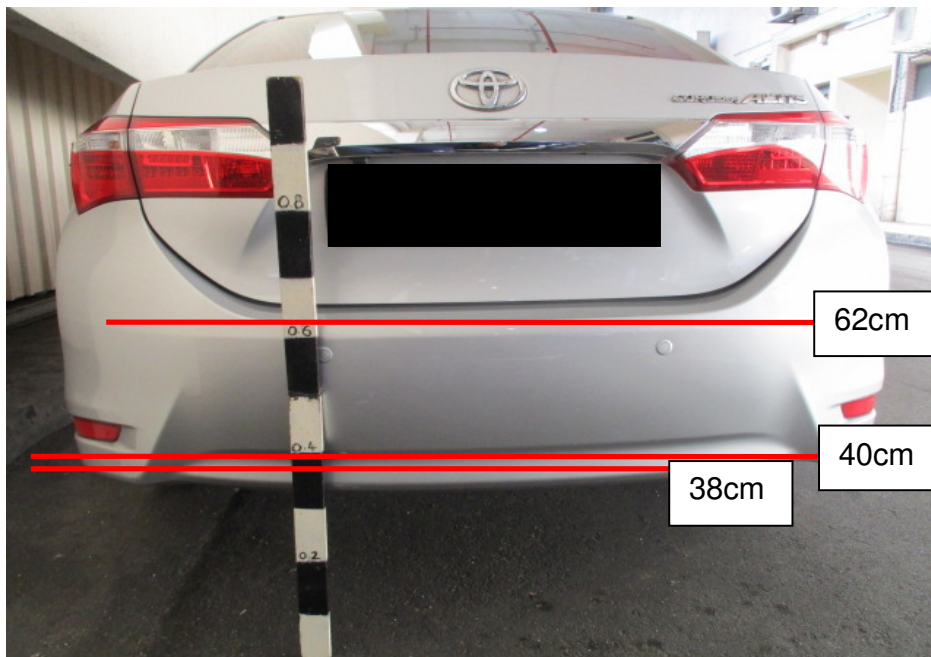
Photo 13 shows the height measurement being conducted on the rear portion of the Toyota (using a similar make and model). The height above ground level of the top portion of the rear bumper of the Toyota, at the area where the paint graze marks were found was measured to be approximately 62cm. The height range of the horizontal paint graze marks on the bottom left portion of the rear bumper of the Toyota were between 38cm to 40cm above ground level.

- a) the height above ground level of the top portion of the rear bumper of the Toyota, at the area where the paint graze marks were found was measured to be approximately 62cm;
- b) the height range of the horizontal paint graze marks on the bottom left portion of the rear bumper of the Toyota were between 38cm to 40cm above ground level;
