## LKK Auto Consultants Pte Ltd

Insured Veh.	SKM 7612P	Veh. Inspected	SHB 9948B
Policy No.	GA00095	Coverage (\$)	0.00
Claim No.	C0314940	Excess (\$)	0.00
Assign From		Assign Date	26/08/2014

## ADJUSTMENT ON REPAIR COST FOR VEHICLE NO. SHB 9948B

PHOTOGRAPHS FOR VEHICLE NO. SHB 9948B

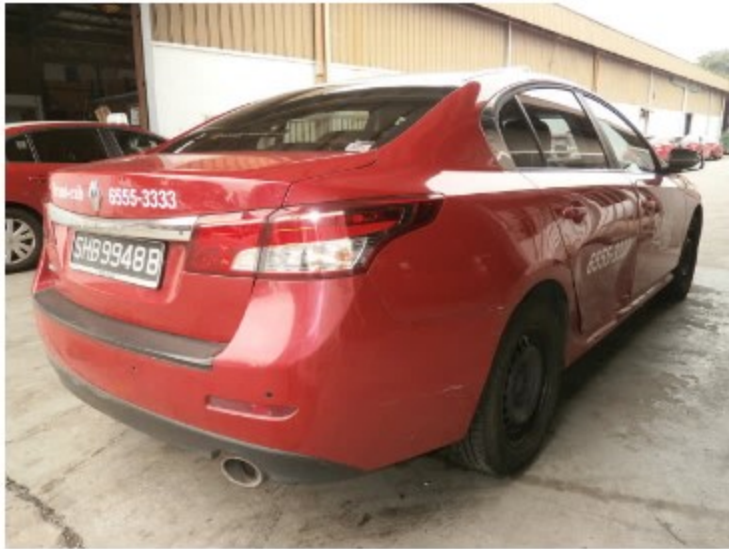
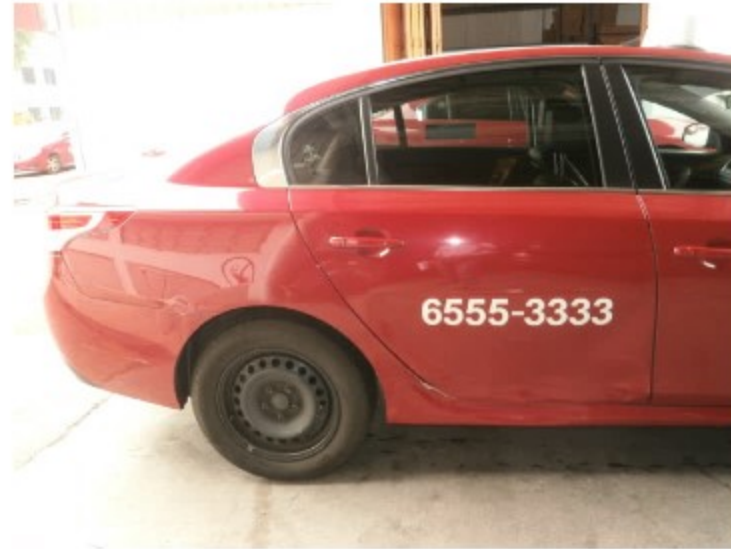
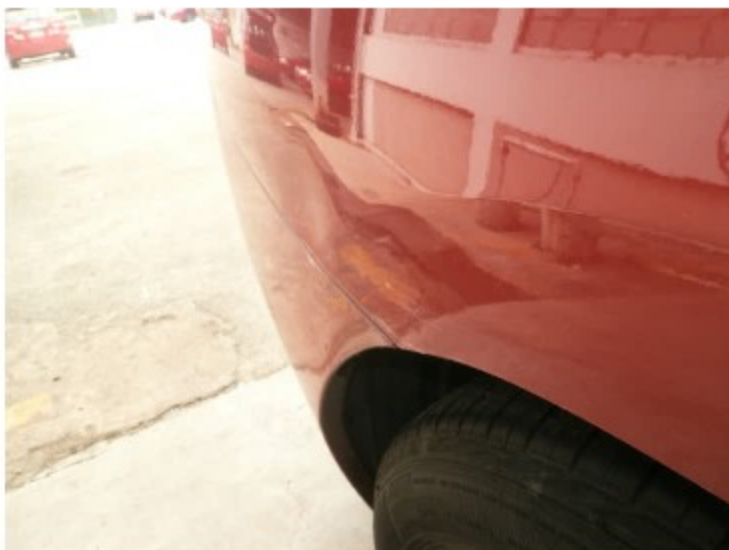
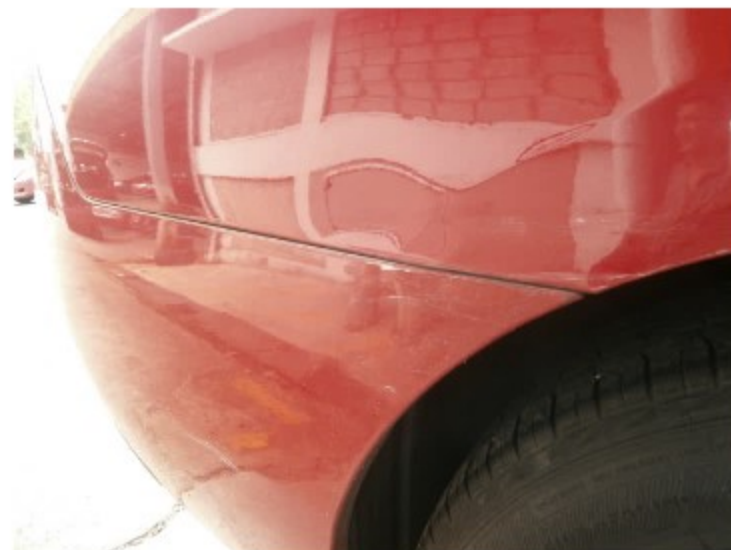
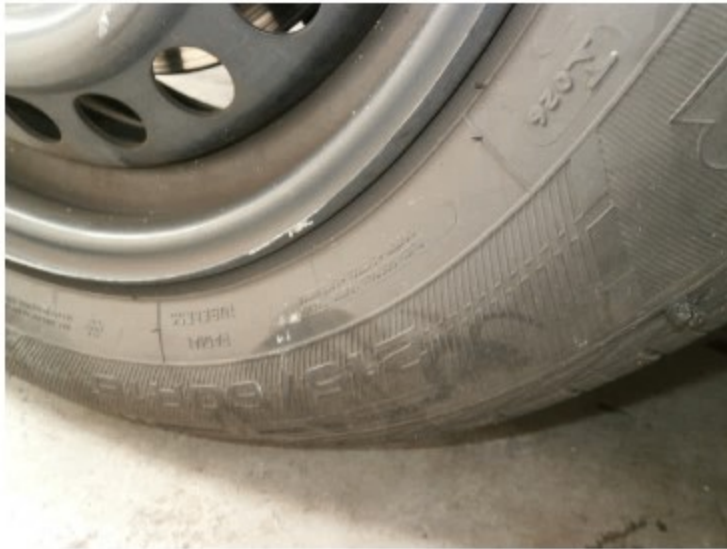
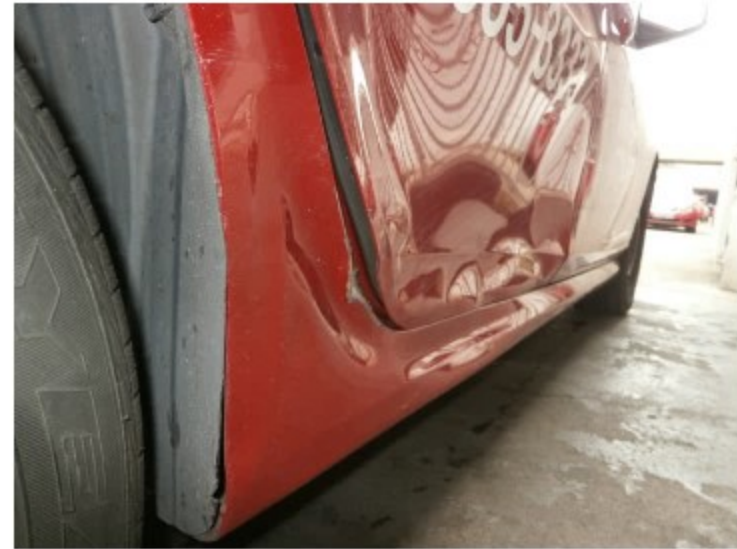
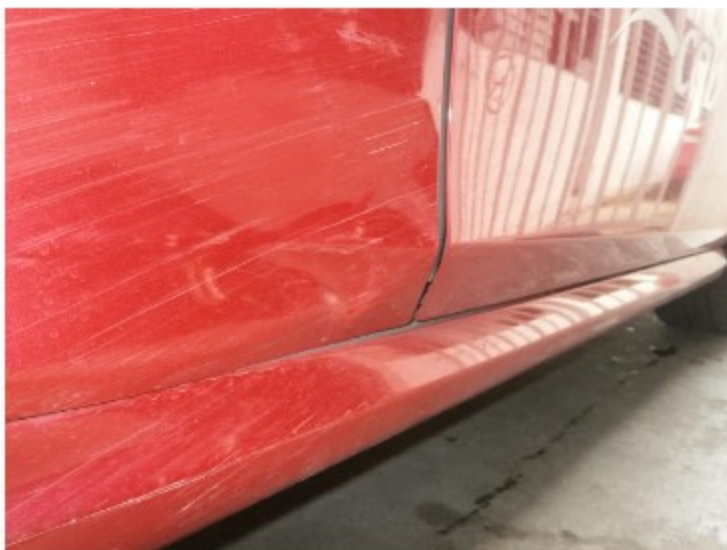
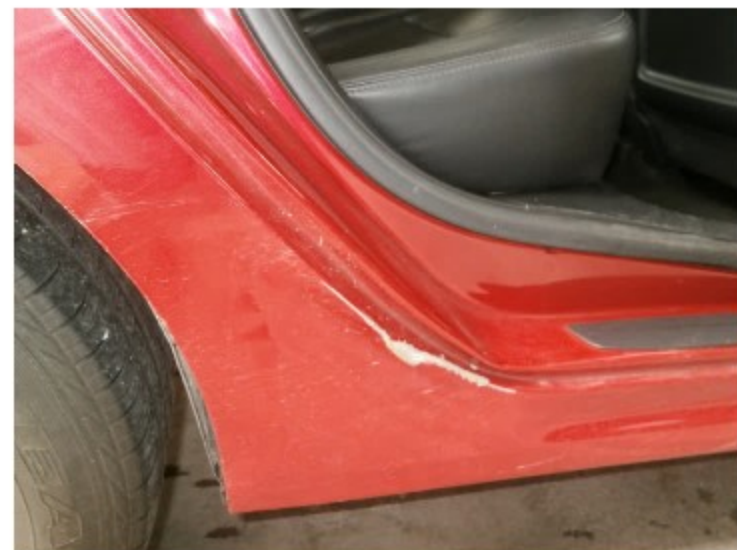
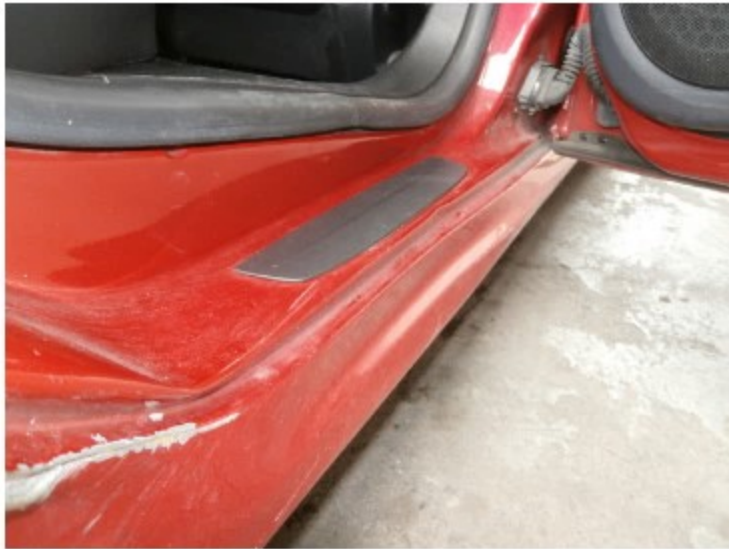
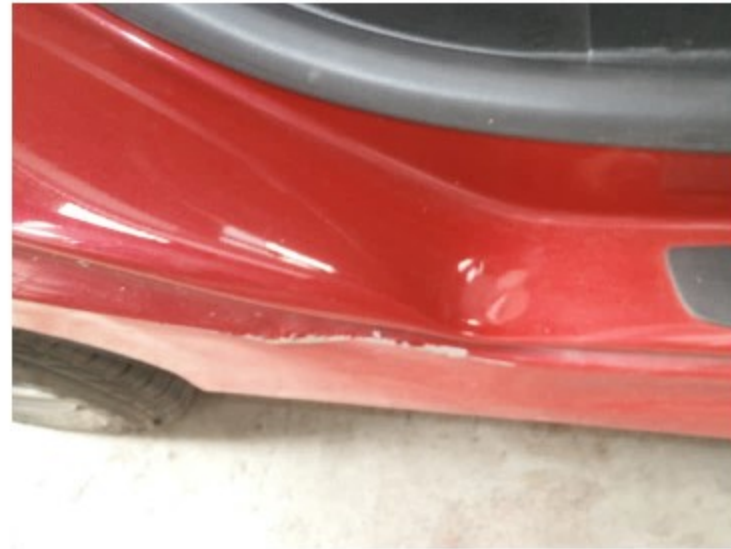
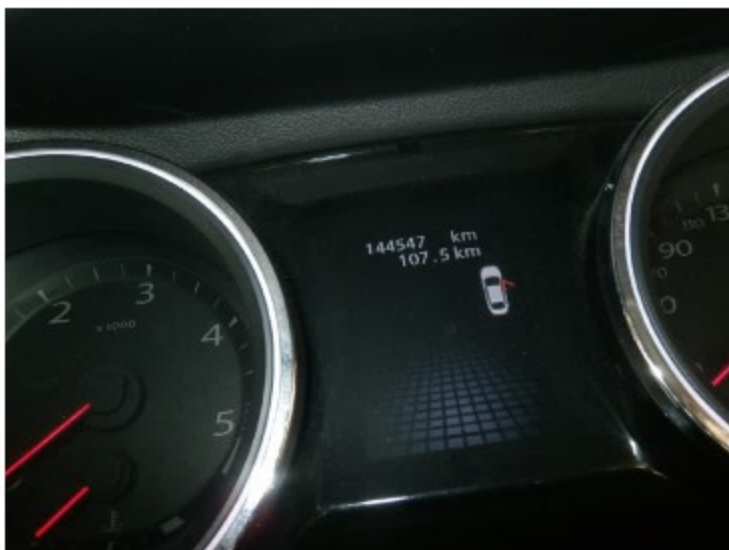
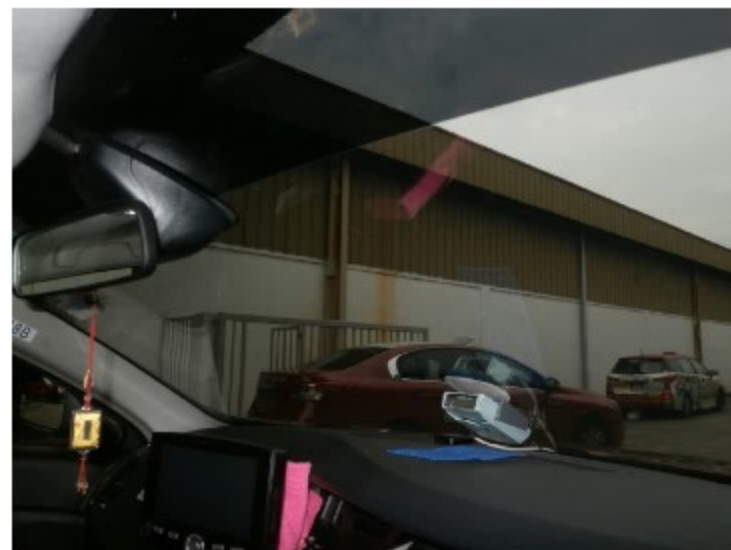
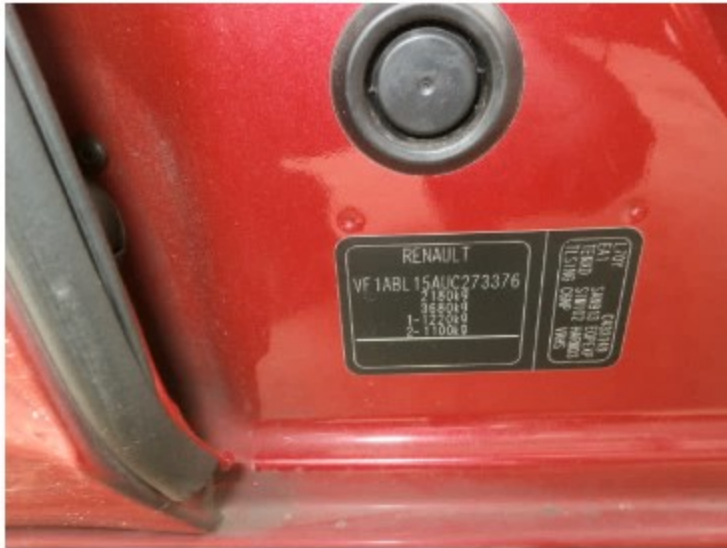
THE VEHICLE SUSTAINED DAMAGES AT THE O/S REAR BODY.
