Vehicle No. SKX 3203E  
Insured Veh. SBZ 2800J  
Claim No. SNM19D205914C02/0  
Policy No. DMPCSN1106131908  
Accident Date 11/12/2019  
Inspection Date 17/12/2019

### 1. Policy Particulars :- THIRD PARTY CLAIM

## ADJUSTMENT ON REPAIR COST FOR VEHICLE NO. SKX 3203E

PHOTOGRAPHS FOR VEHICLE NO. SKX 3203E

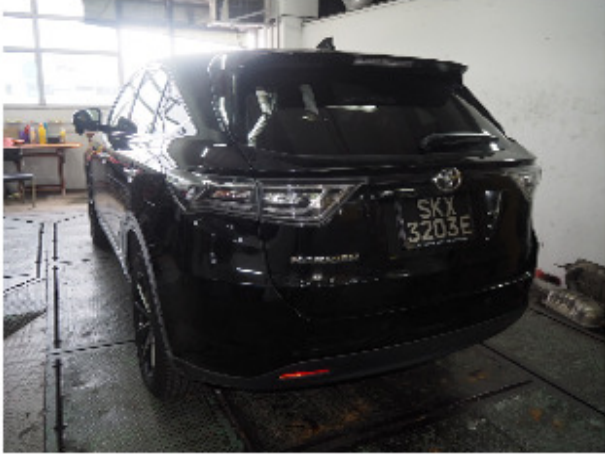
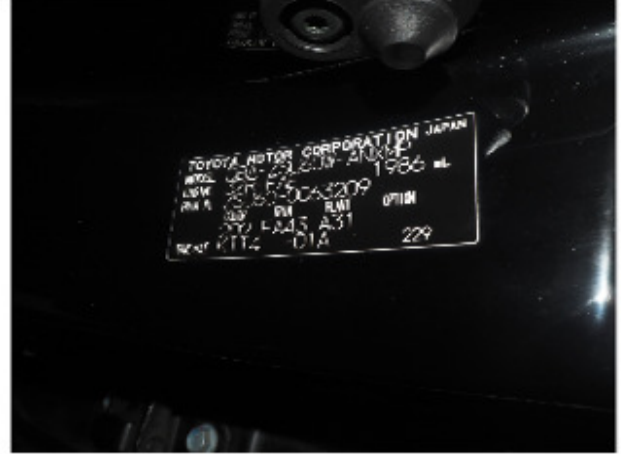
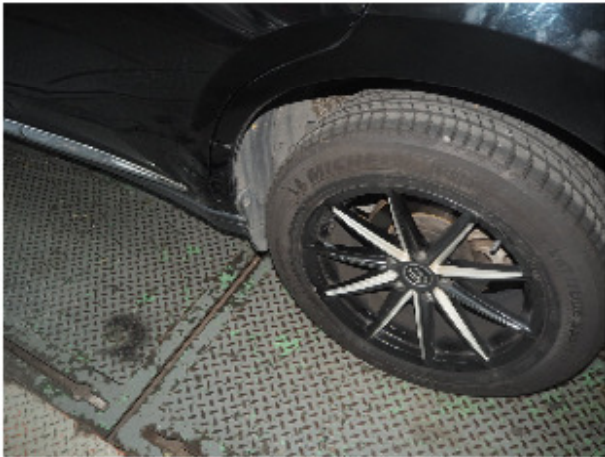
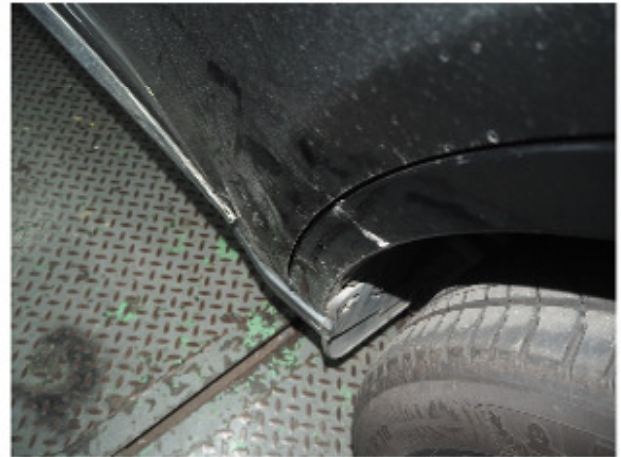
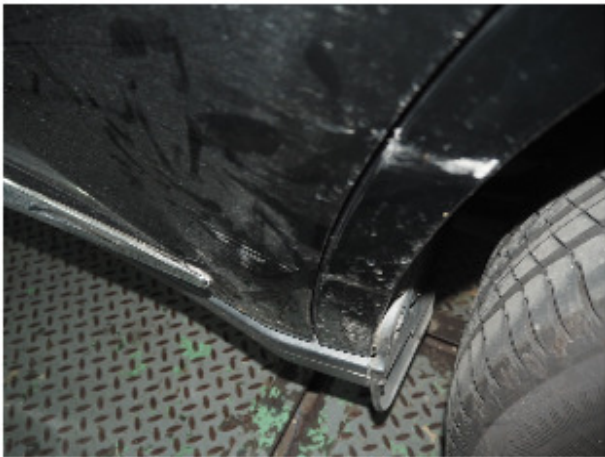
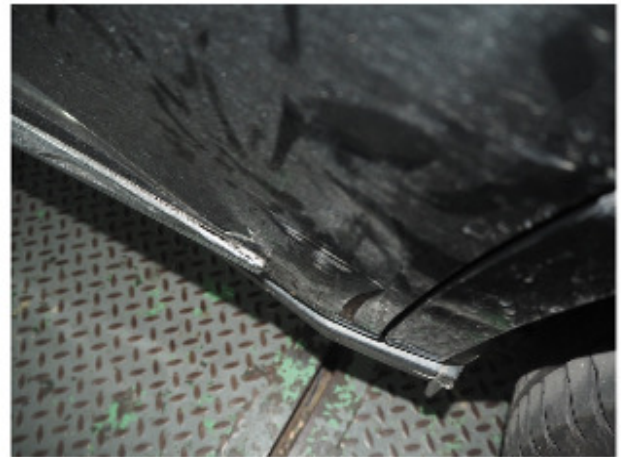
INSPECTION

THE VEHICLE SUSTAINED DAMAGES AT THE N/S BODY.
