Your Ref: SMD 4667A
Our Ref : CI/TP19022932/P

AUTOMOBILE INSPECTION REPORT OF VEHICLE SMD 4667A

Vehicle Registration No.	: SMD 4667A
Make / Model	: SUBARU FORESTER 2.0I-L AWD CVT
Chassis No	: JF1SJ5KC5JG111645
Mileage	: 25,530KM

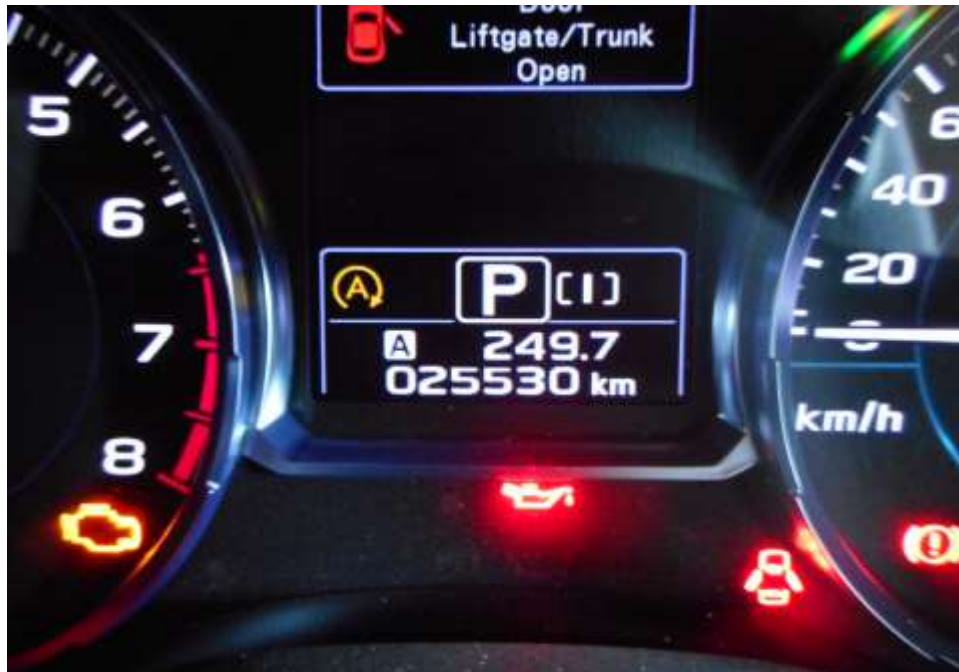
Photo 1 shows a general view of the instrument cluster of the Motor Car at the time of my inspection. The mileage of the Motor Car was 37,171km

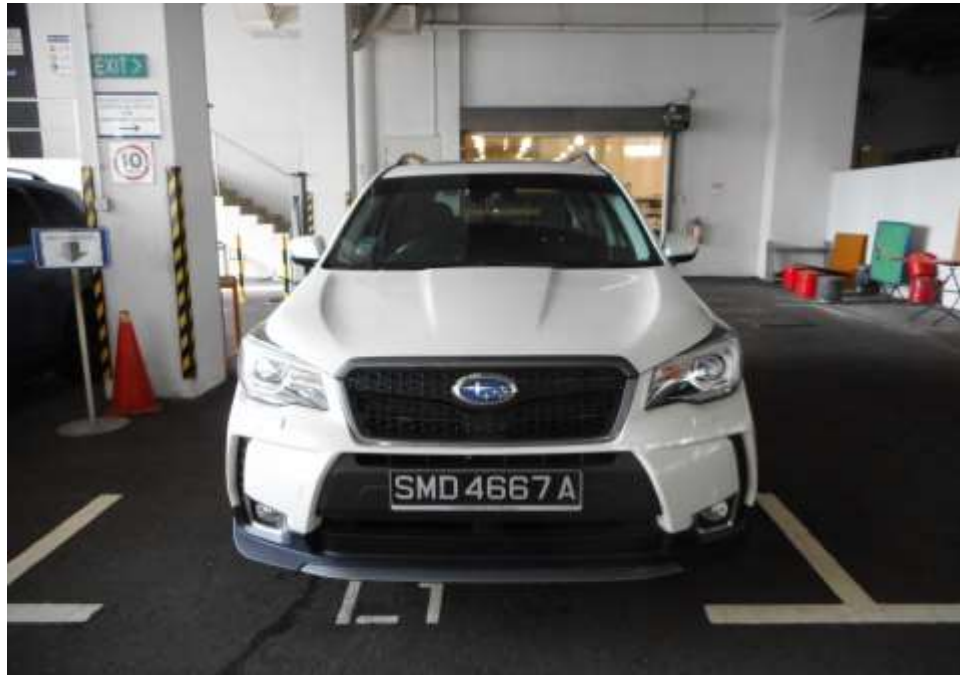
Photo 2 shows a general view of the Motor Car at the time of my inspection. The Motor Car was observed to be intact and unaffected by the accident.

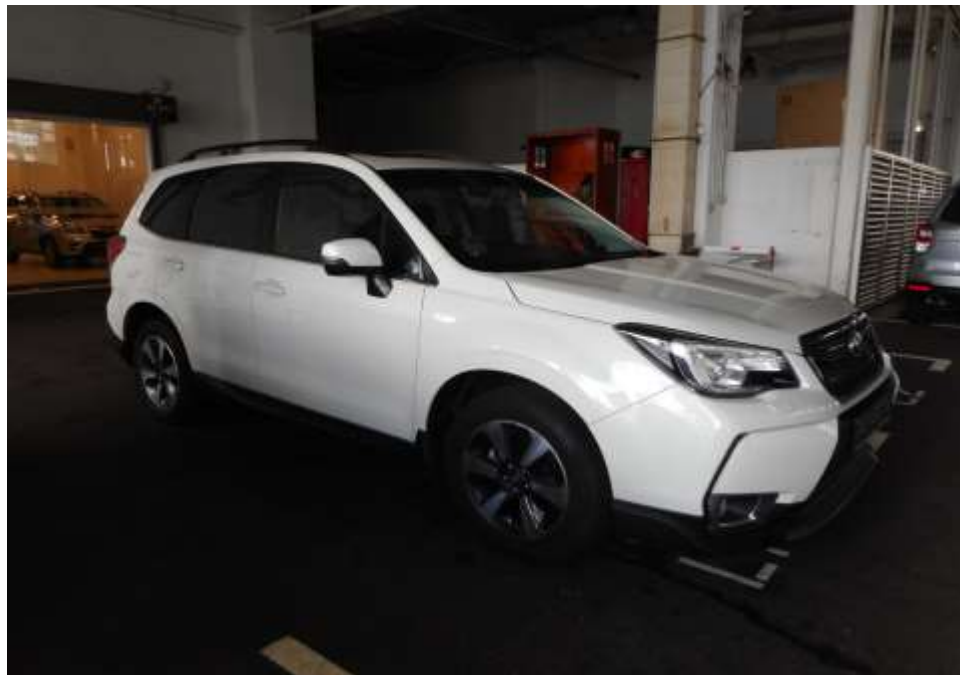
Photo 3 shows a general view of the right body of the Motor Car at the time of my inspection. The Motor Car was observed to be intact and unaffected by the accident.

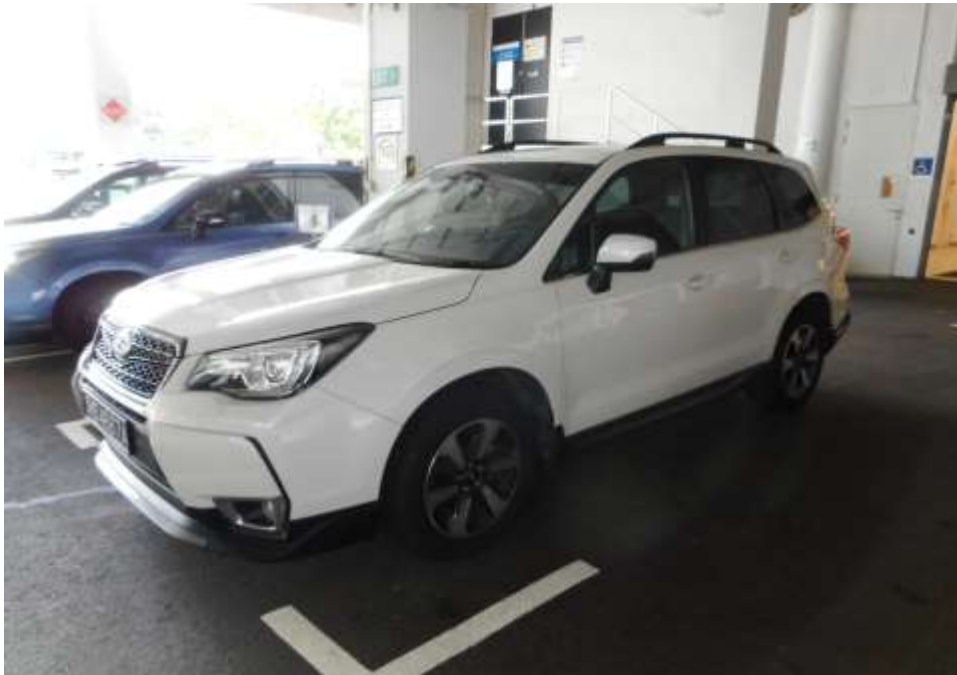
Photo 4 shows a general view of the left body of the Motor Car at the time of my inspection. The Motor Car was observed to be intact and unaffected by the accident.

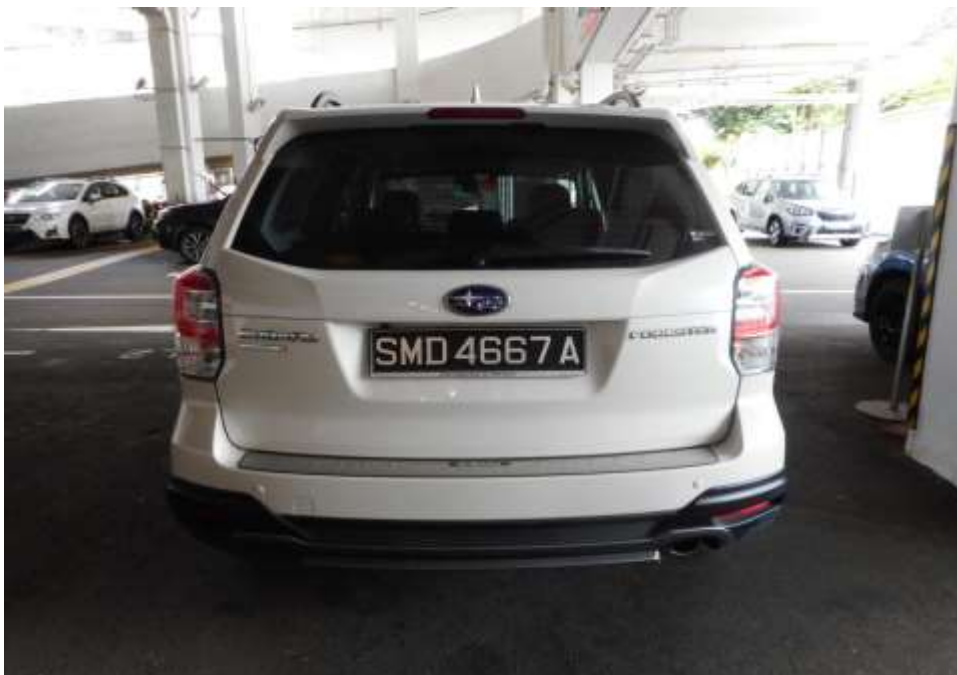
Photo 5 shows a general view of the rear body of the Motor Car at the time of my inspection. The Motor Car was observed to be intact and unaffected by the accident.

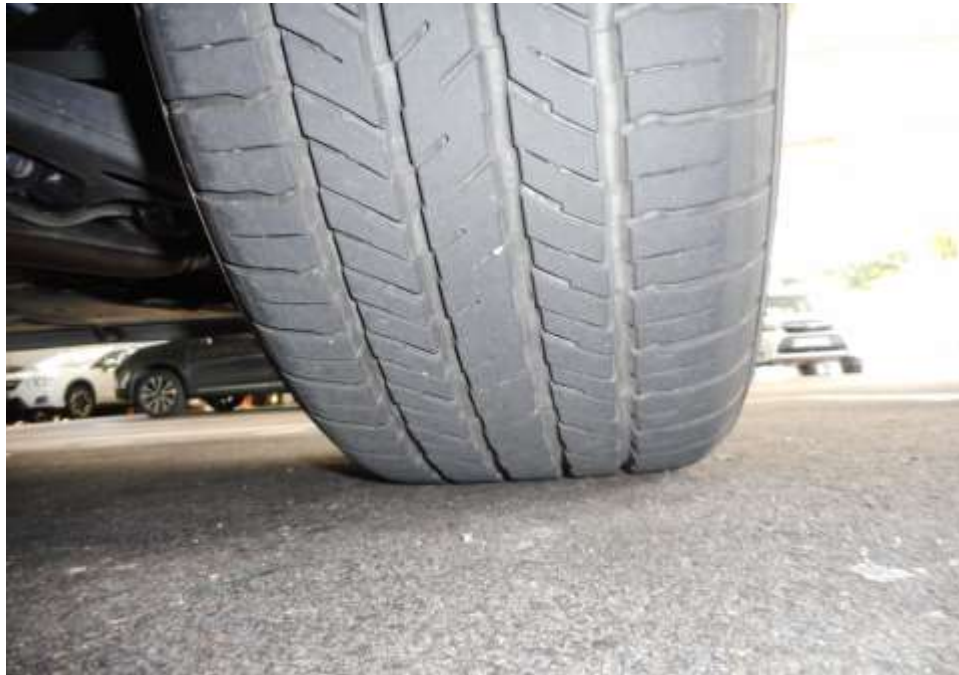
Photo 6 shows the condition of the front right tyre of the Motor Car, which was observed to be in serviceable condition with remaining tread depth of approximately 5.9mm. The tyre, which was wrapped around standard alloy wheel rim, was also observed to be sufficiently inflated for vehicular operation. There was no tear, cut or burst mark(s) on the outer and the inner sidewalls as well as across the tread of the 4 tyres that were fitted on the Motor Car.

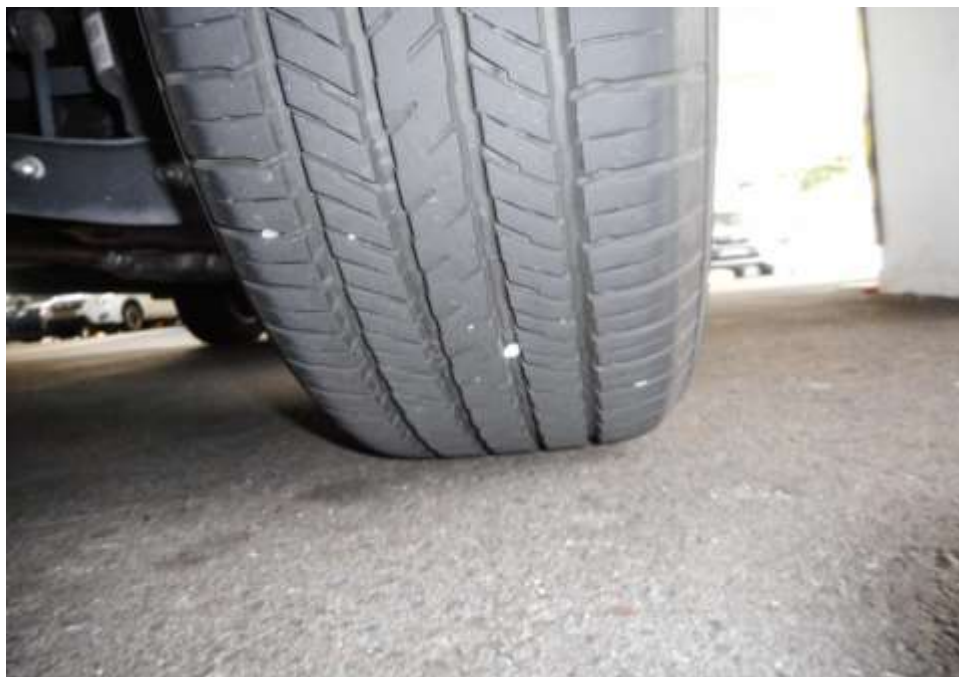
Photo 7 shows the condition of the rear right tyre of the Motor Car, which was observed to be in serviceable condition with remaining tread depth of approximately 6.4mm. The tyre, which was wrapped around standard alloy wheel rim, was also observed to be sufficiently inflated for vehicular operation.

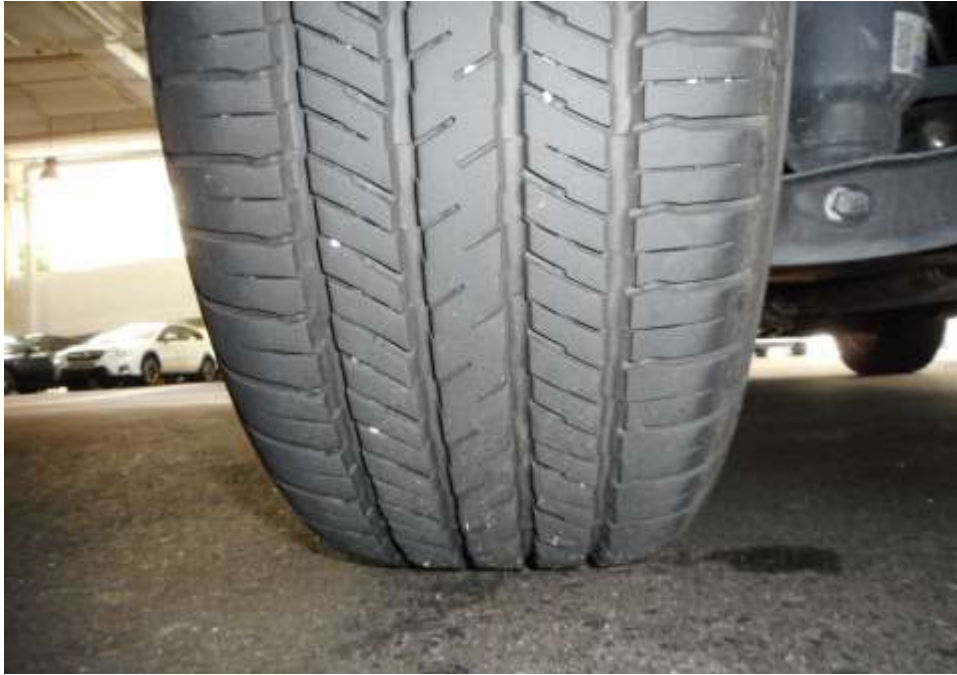
Photo 8 shows the condition of the rear left tyres of the Motor Car, which was observed to be in serviceable condition with remaining tread depth of approximately 6.3mm. The tyres, which were wrapped around standard alloy wheel rim, were also observed to be sufficiently inflated for vehicular operation. There was also no damage found on all 4 alloy wheel rims of the Motor Car.

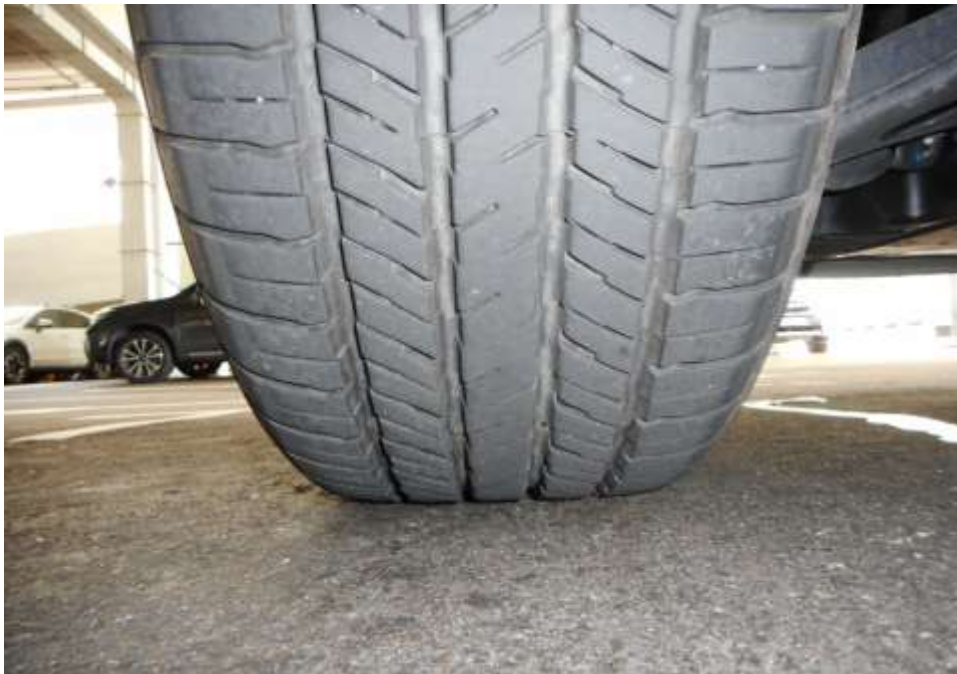
Photo 9 shows the condition of the rear right tyres of the Motor Car, which were observed to be in serviceable condition with remaining, tread depth of approximately 6.3mm. There was also no tear, cut or burst mark(s) on the outer and the inner sidewalls as well as across the tread of the 4 tyres that were fitted on the Motor Car.

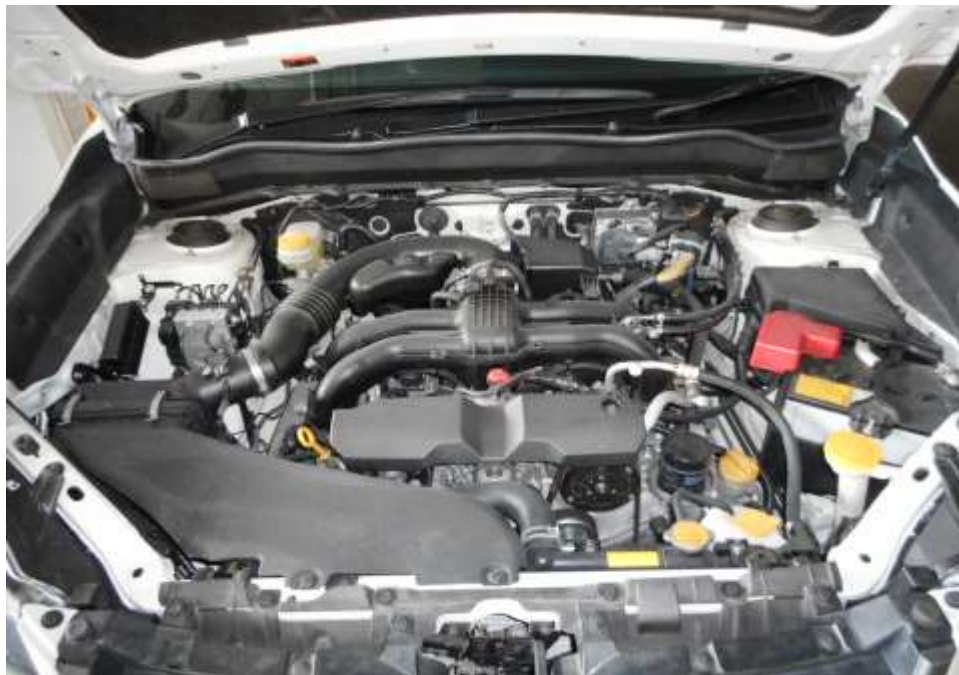
Photo 10 shows a general view of the Motor Car's engine compartment, which was accessed by lifting the front cabin of the Motor Car. The various parts and components inside the engine compartment were unaffected by the accident. There was also no sign(s) or indication(s) of fresh fluid leakage and/or fluid stain within the engine compartment

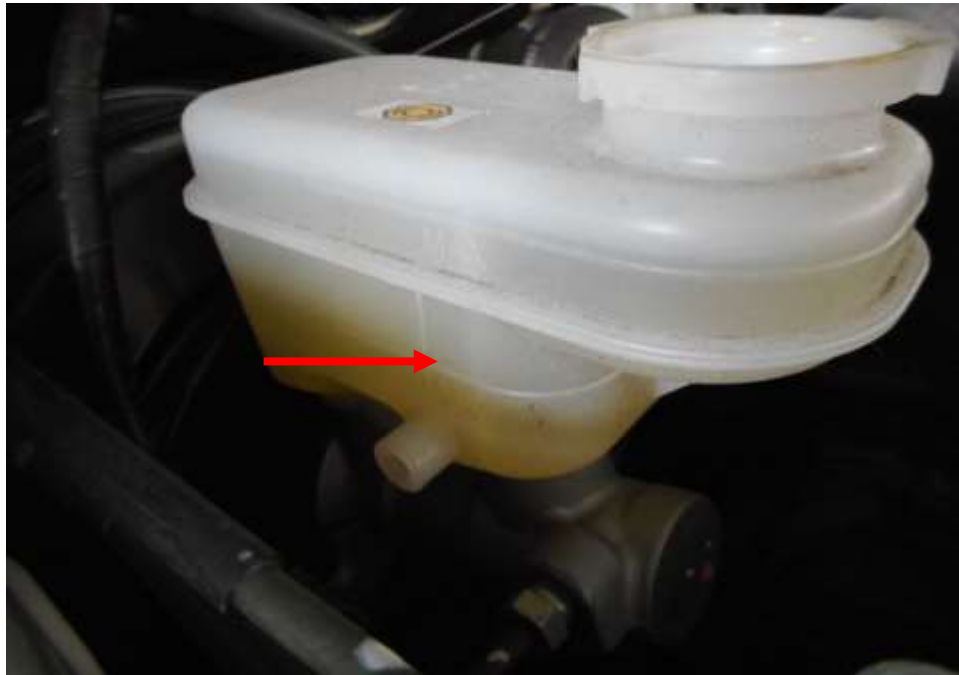
Photo 11 shows the brake fluid reservoir of the Motor Car at the time of my inspection. The brake fluid was observed to be of sufficient level (arrowed) and without any visible contamination.

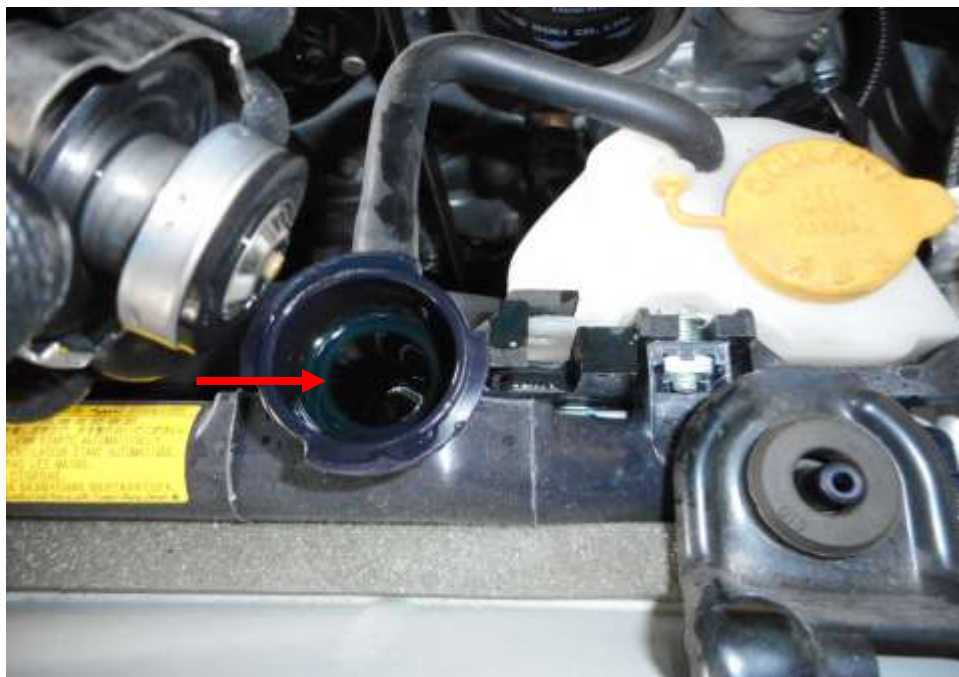
Photo 12 shows the engine coolant reservoir of the Motor Car at the time of my inspection. The engine coolant was observed to be of sufficient level (arrowed) and without any visible contamination.

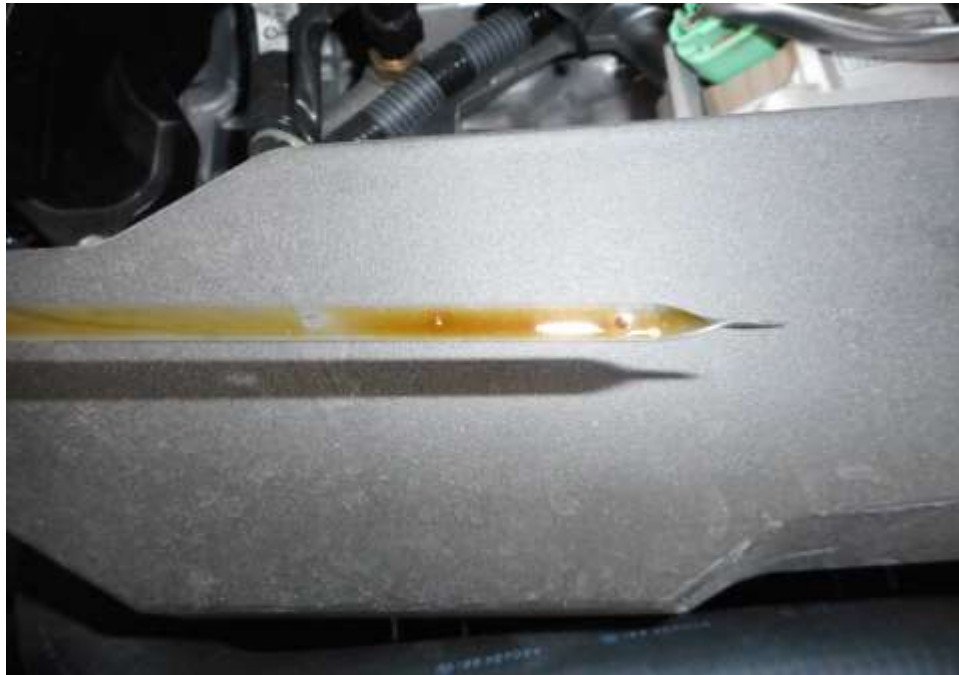
Photo 13 shows the engine oil dip stick of the Motor Car at the time of my inspection. The engine oil was observed to be of sufficient level and without any visible contamination.

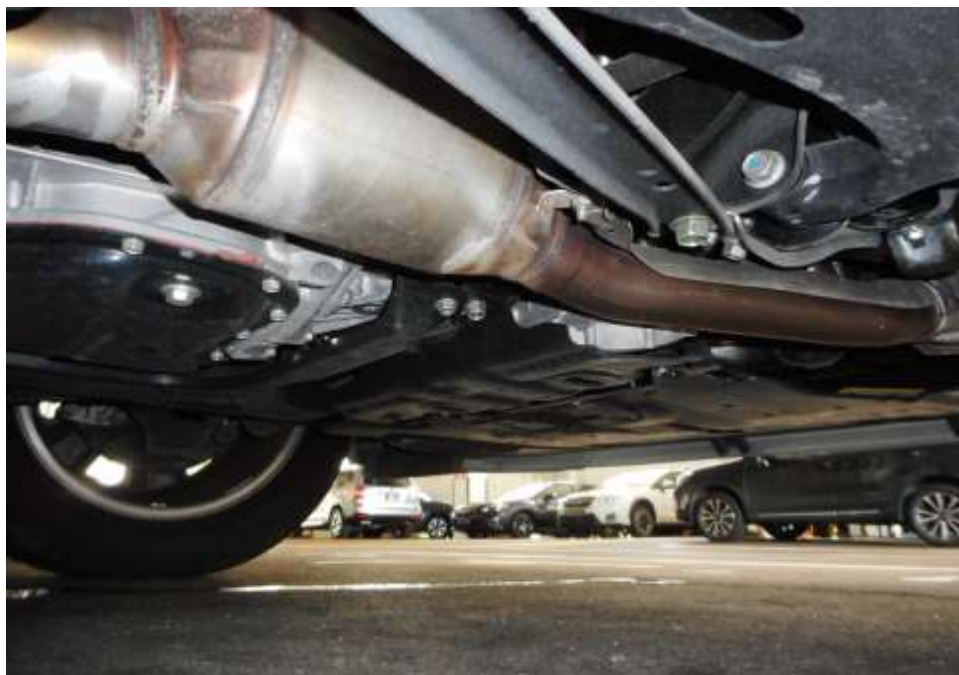
Photo 14 shows the undercarriage of the Motor Car, at the area where the engine housing and transmission housing are located. I did not find any sign(s) or indication(s) of fluid leak and/or fluid stain(s) on the underside of the Motor Car.

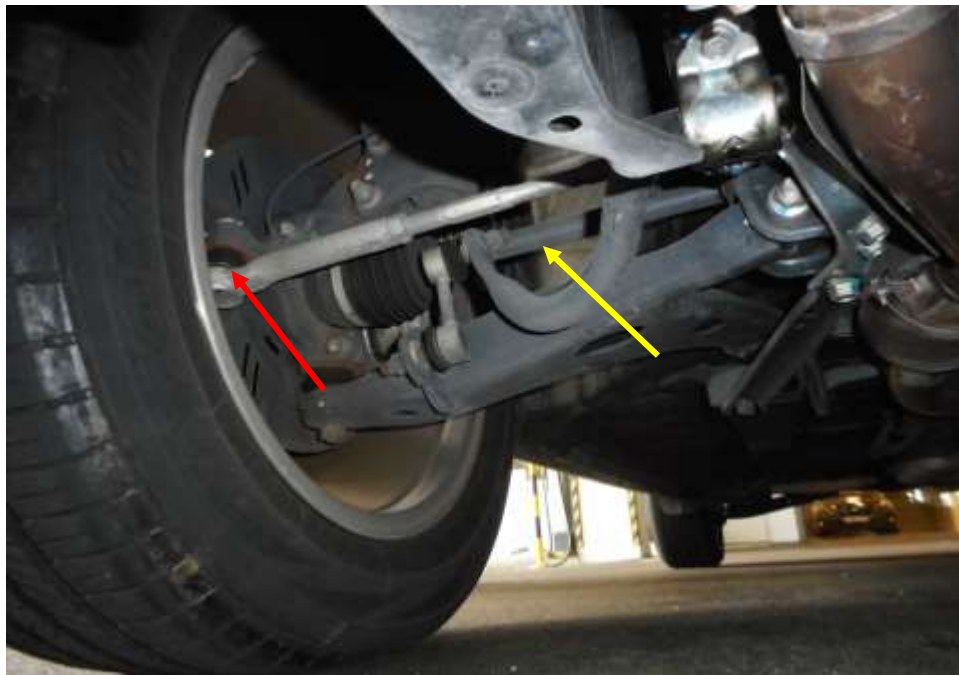
Photo 15 shows the various undercarriage components at the front right wheel of the Motor Car, in particular the steering tie rod end (arrowed) and drive shaft (yellow arrow). The various steering components were all found to be intact, suggesting that the steering system of the Motor Car was likely to be in serviceable condition at the material time of accident. There was also no sign of fluid stain(s) observed on the various undercarriage components.

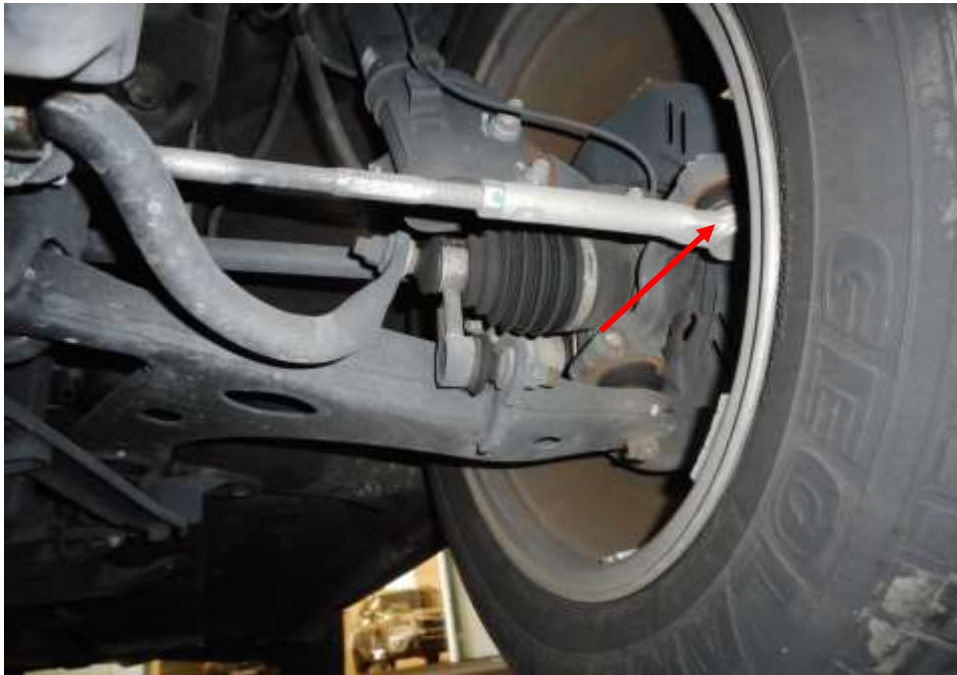
Photo 16 shows the various undercarriage components at the front left wheel of the Motor Car, in particular the steering tie rod end (arrowed). The various Undercarriage components of the Motor Car were all found to be intact without any visible damage. There was also no sign of fluid stain(s) observed on the various undercarriage components.

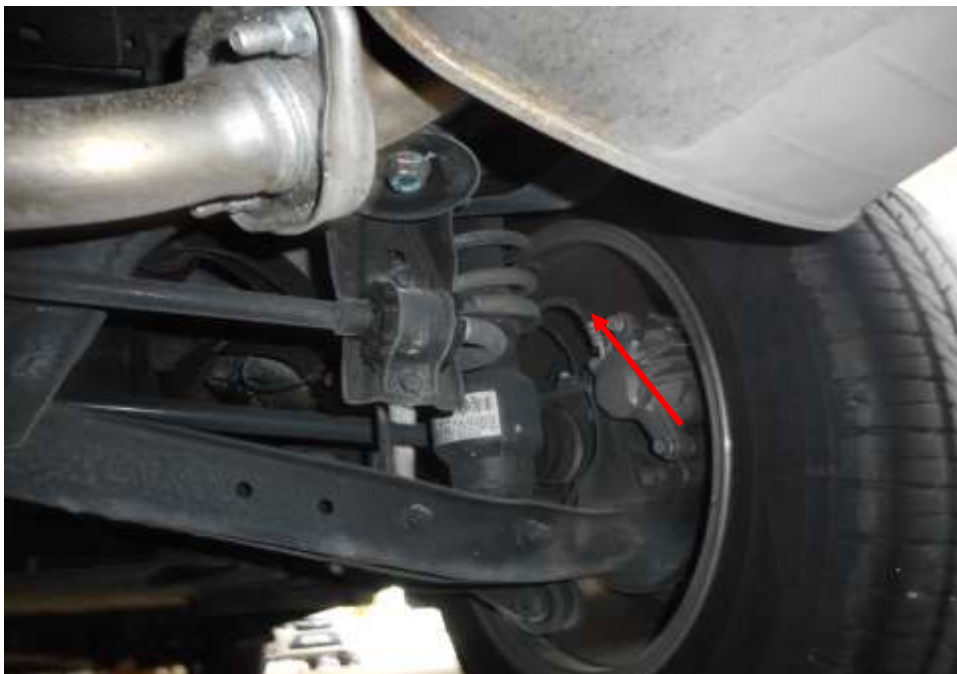
Photo 17 shows the brake pipe (arrowed) at the rear right wheel of the Motor Car. I did not observe any leakage of brake fluid at the time of my inspection of the Motor Car. My static tests of the Motor Car's braking system, along with my visual examination of the various mechanical components in the braking system, had indicated that there was no internal leakage of pressure/vacuum. Hence the braking system of the Motor Car was likely to be in serviceable condition at the material time of accident.

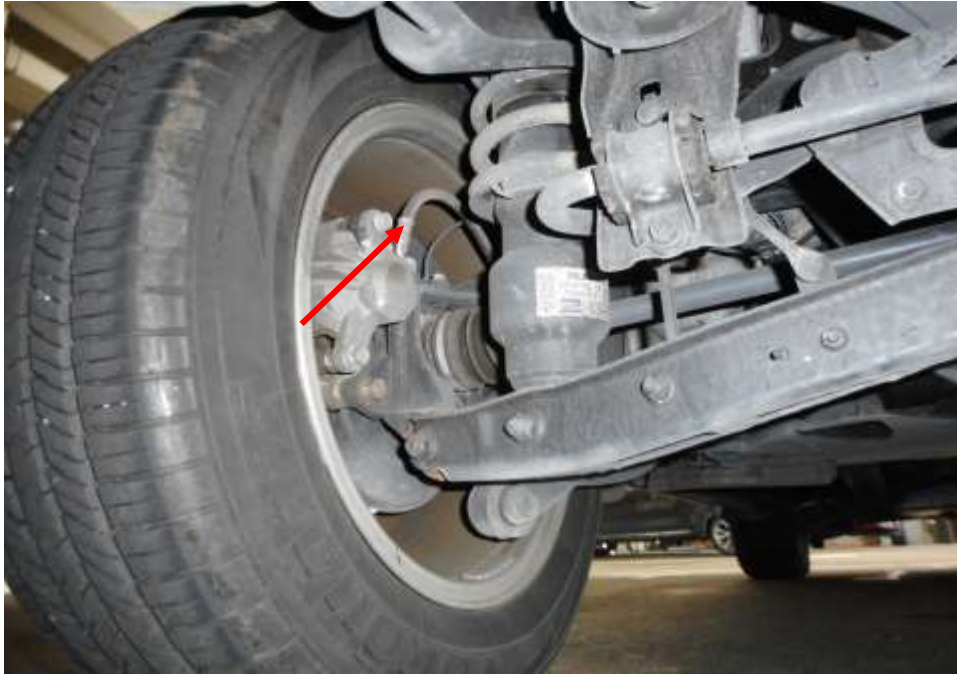
Photo 18 shows the brake pipe (arrowed) at the rear left wheel of the Motor Car. I did not observe any leakage of brake fluid at the time of my inspection of the Motor Car. My static tests of the Motor Car's braking system, along with my visual examination of the various mechanical components in the braking system had indicated that there was no internal leakage of pressure/vacuum. Hence the braking system of the Motor Car was likely to be in serviceable condition at the material time of accident.

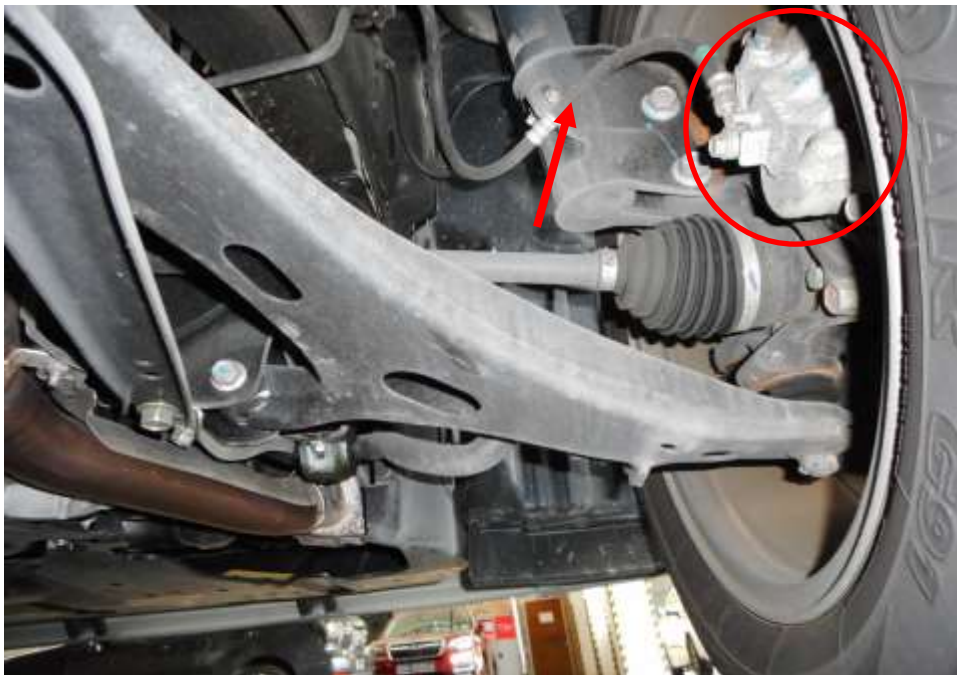
Photo 19 shows the brake hose/pipe (arrowed) at the front right wheel of the Motor Car. No leakage of brake fluid was observed. Visual examination of the various components of the braking system like the brake caliper (circled), brake booster, brake pedal etc had revealed all to be intact and without visible damage at the time of accident. There was also no sign of fluid stain(s) observed on the various undercarriage components.

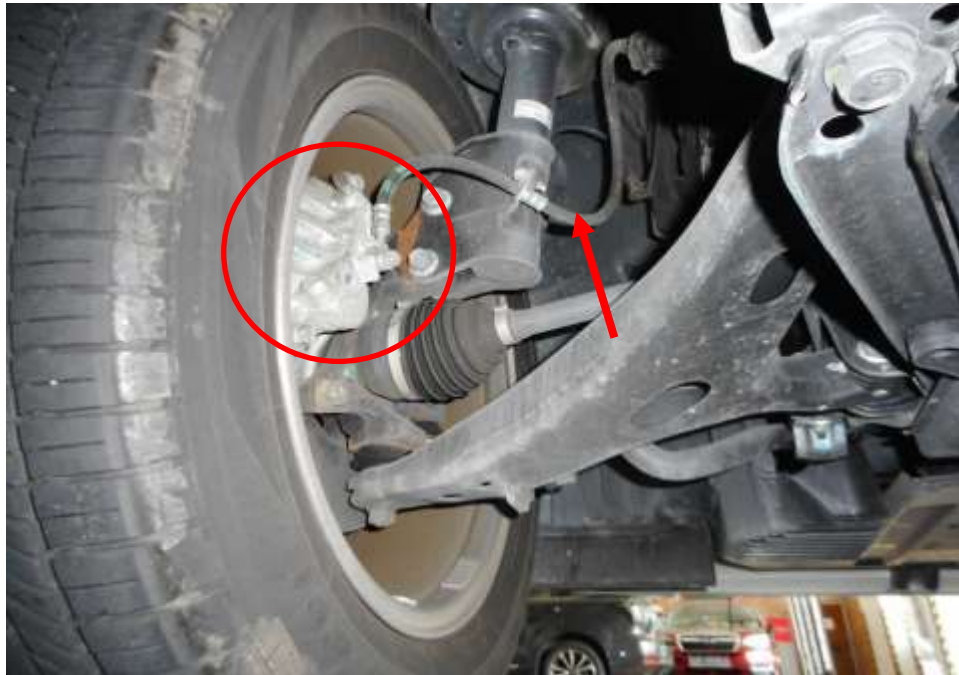
Photo 20 shows the brake hose/pipe (arrowed) at the front left wheel of the Motor Car. No leakage of brake fluid was observed. Visual examination of the various components of the braking system like the brake caliper (circled), brake booster, brake pedal etc had revealed all to be intact and without visible damage at the time of accident. There was also no sign of fluid stain(s) observed on the various undercarriage components.

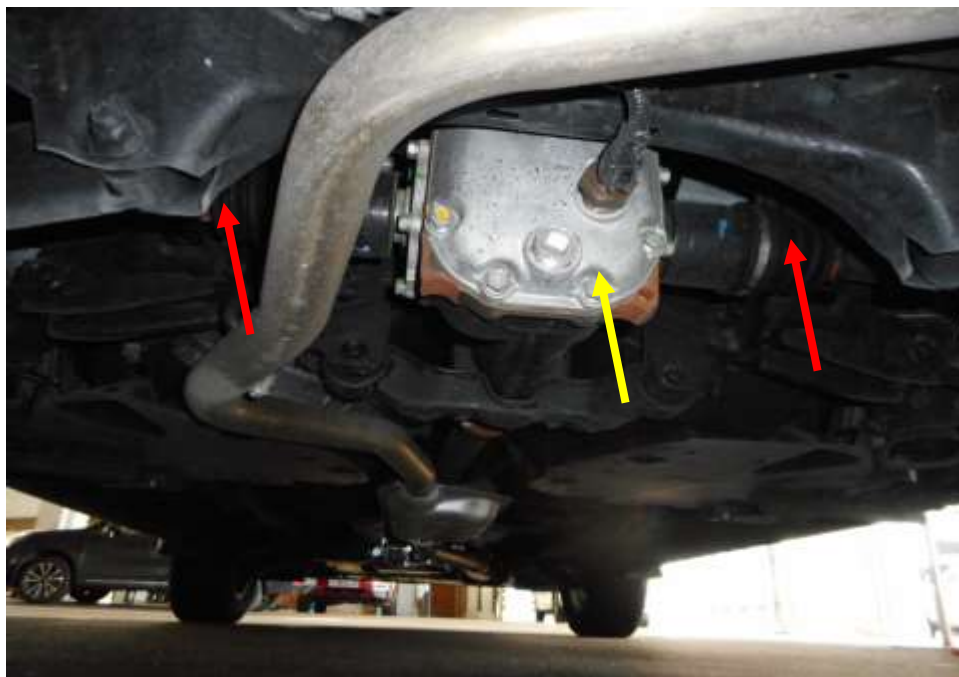
Photo 21 shows the various undercarriage components at the rear transfer case (yellow arrow) and rear driveshaft (red arrow) both for the AWD system of the Motor Car. The various components were all found to be intact, suggesting that the steering system of the Motor Car was likely to be in serviceable condition at the material time of accident. There was also no sign of fluid stain(s) observed on the various undercarriage components.

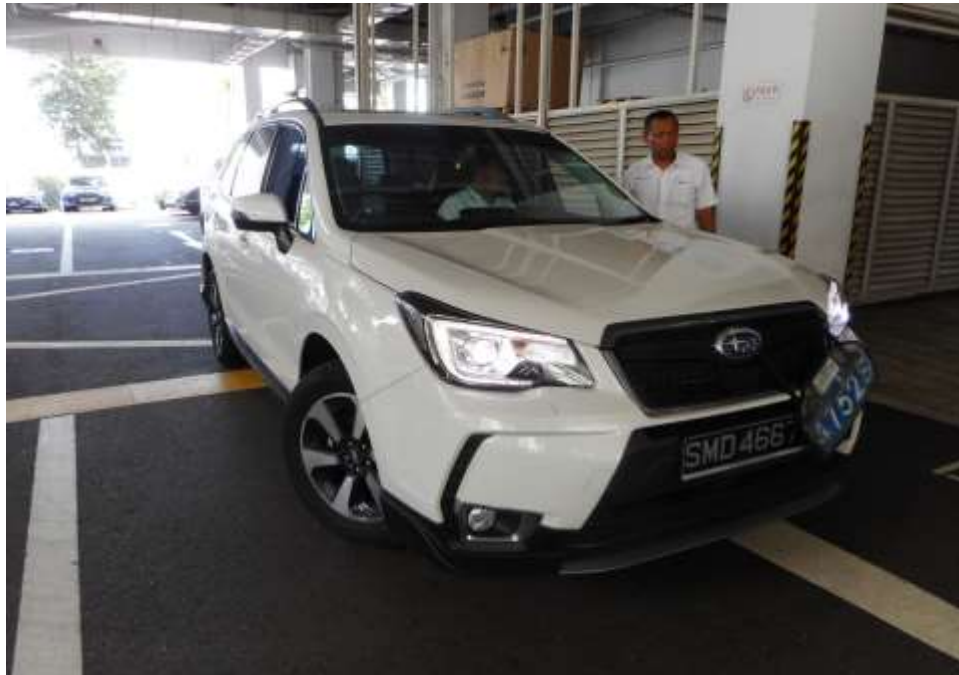
Photo 22 shows the front right wheel of the Motor Car turned to its full left. During my steering system test, I did not experience any abnormal free play and/or resistance when I had turned the steering wheel towards full left and full right. This would suggest that the steering system of the Motor Car was likely to be in serviceable condition at the material time of accident.

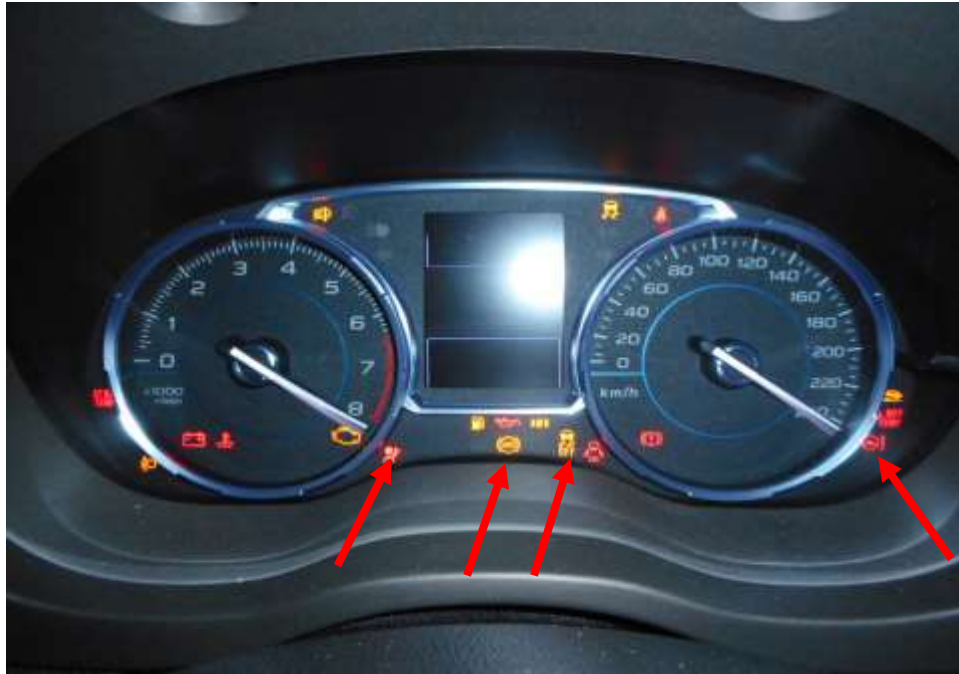
Photo 23 shows the warning light for Anti-Lock Brake System (ABS), Traction Control (TC), Supplemental Restraint System (SRS) and Electric Power Steering System (EPS) appearing on the instrument panel of the Motor Car during the self-test of its various electronic operating systems when its engine was cranked.

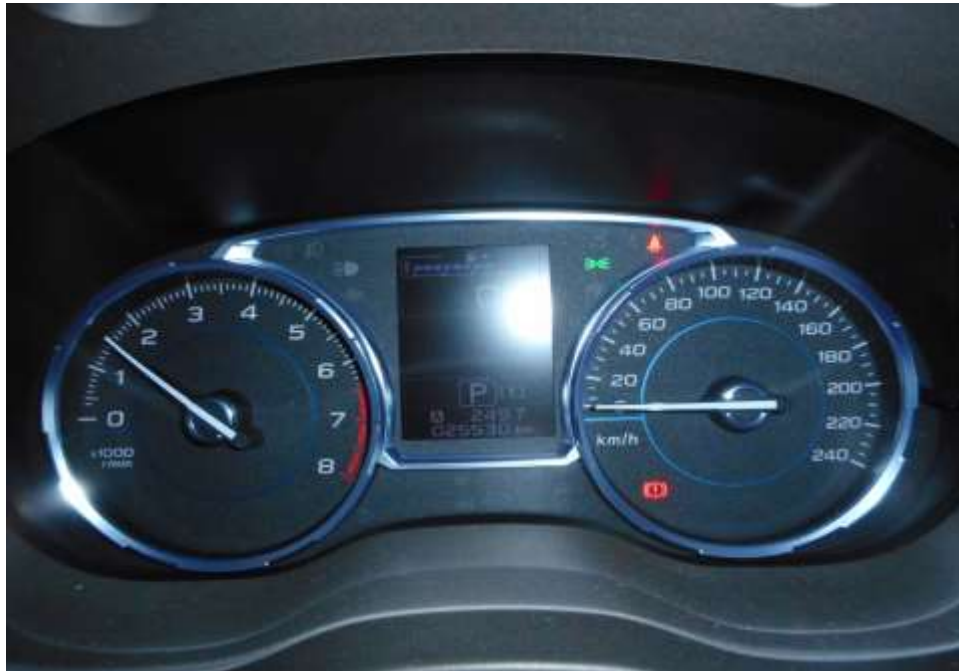
Photo 24 shows no warning lights illuminated on the instrument panel of the Motor Car after the engine was cranked. This would suggest that there was no abnormality to the various electronic operating systems of the Motor Car, like the ABS, TC, SRS and EPS.
