Your Ref: TP/IP/65207/2019  
Our Ref : CI/TPD20000057/N

**Fatal Accident Investigation Team**

**MECHANICAL INSPECTION REPORT OF MOTOR LORRY GZ 8811D**

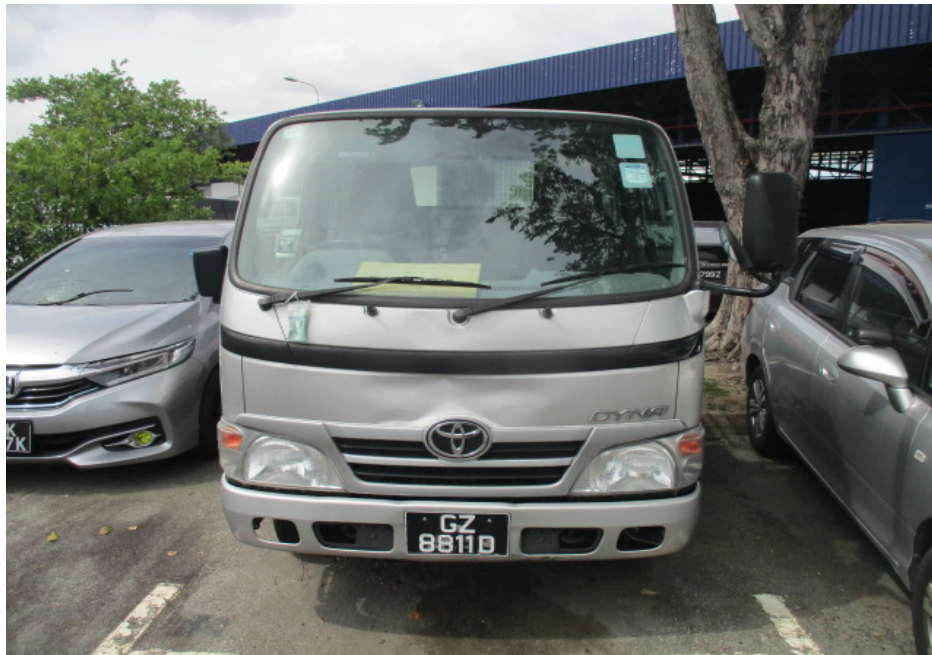
4. The mileage of the Motor Lorry at the time of our inspection was 41, 350km.
5. The Motor Lorry had sustained relatively moderate impact damage that was confined to its frontal portion. Its front panel was observed to have been dented; black marks were observed on its front bumper.

**Photo 1** shows a general view of the front body of the Motor Lorry at the time of our inspection. The Motor Lorry had sustained relatively moderate impact damage that was confined to its frontal portion. Its front panel was observed to have been dented; black marks were observed on its front bumper. The mileage of the Motor Lorry at the time of our inspection was 41, 350km.

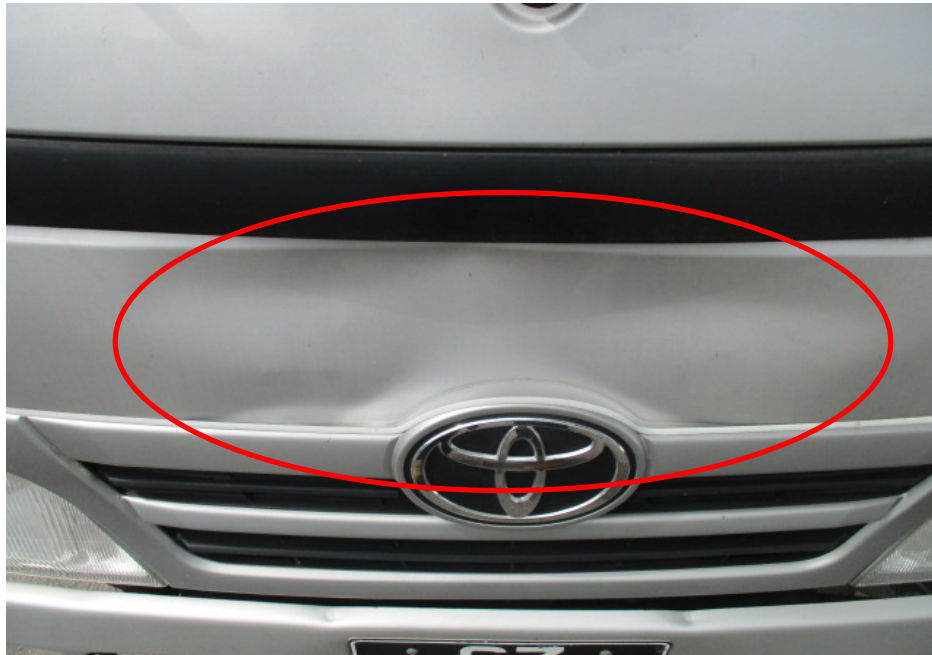
**Photo 2** shows a closer view of the dented front panel (circled) of the Motor Lorry at the time of our inspection.

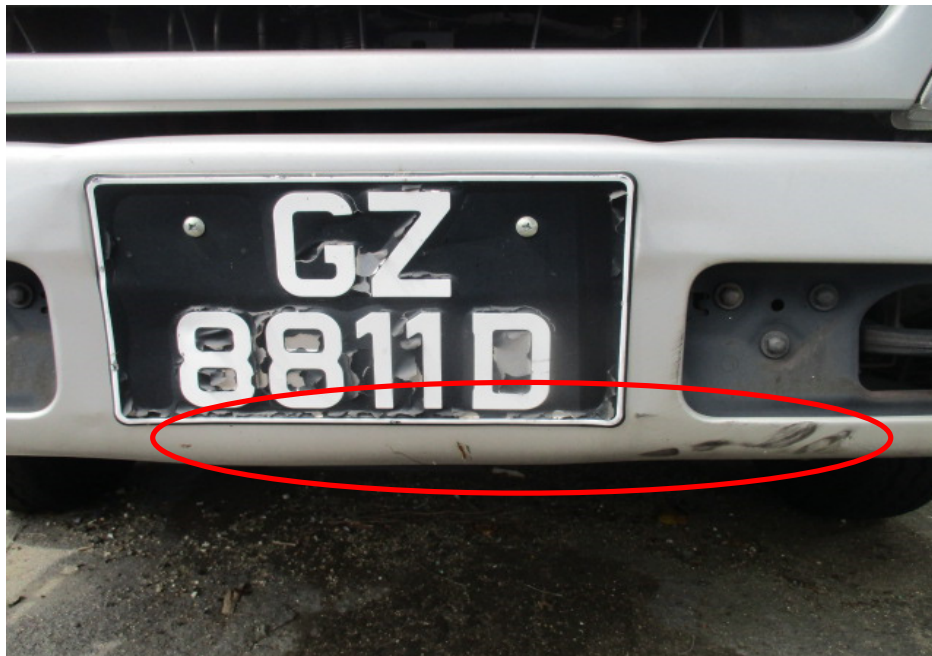
**Photo 3** shows a closer view of the black marks observed on the front bumper (circled) of the Motor Lorry at the time of our inspection.

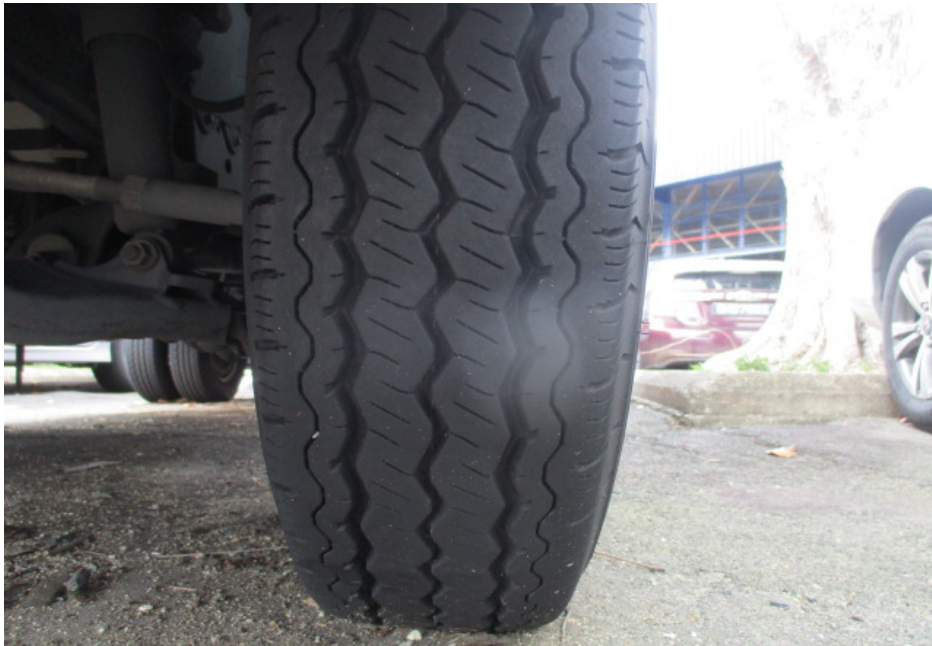
**Photo 4** shows the condition of the front left tyre of the Motor Lorry, which was observed to be in serviceable condition with remaining tread depth of approximately 6mm. The tyre, which was wrapped around standard alloy wheel rim, was also observed to be sufficiently inflated for vehicular operation. There was no tear, cut or burst mark(s) on the outer and the inner sidewalls as well as across the tread of the 6 tyres that were fitted on the Motor Lorry.

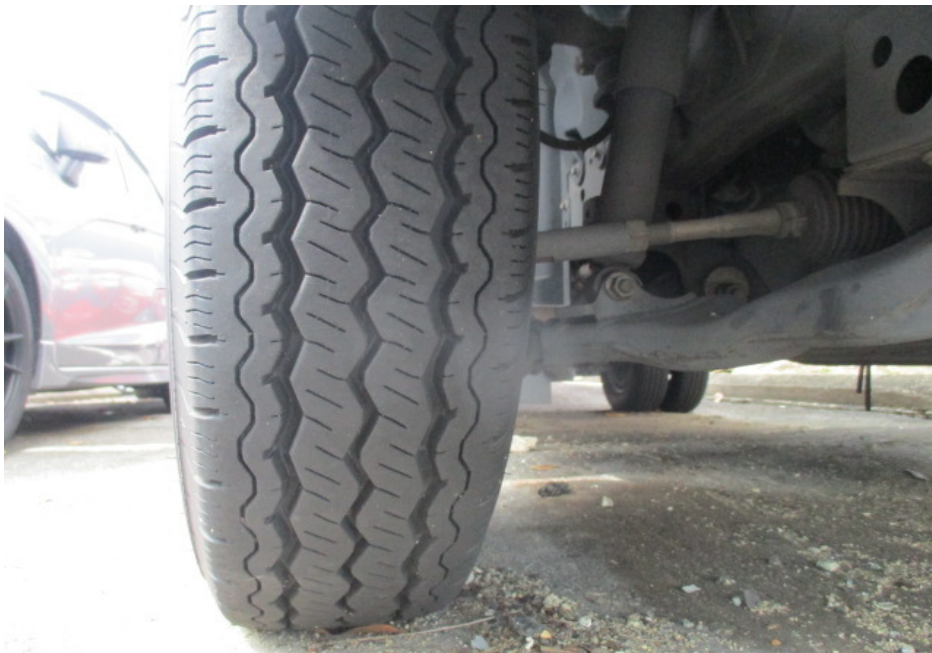
**Photo 5** shows the condition of the front right tyre of the Motor Lorry, which was observed to be in serviceable condition with remaining tread depth of approximately 6mm. The tyre, which was wrapped around standard alloy wheel rim, was also observed to be sufficiently inflated for vehicular operation.

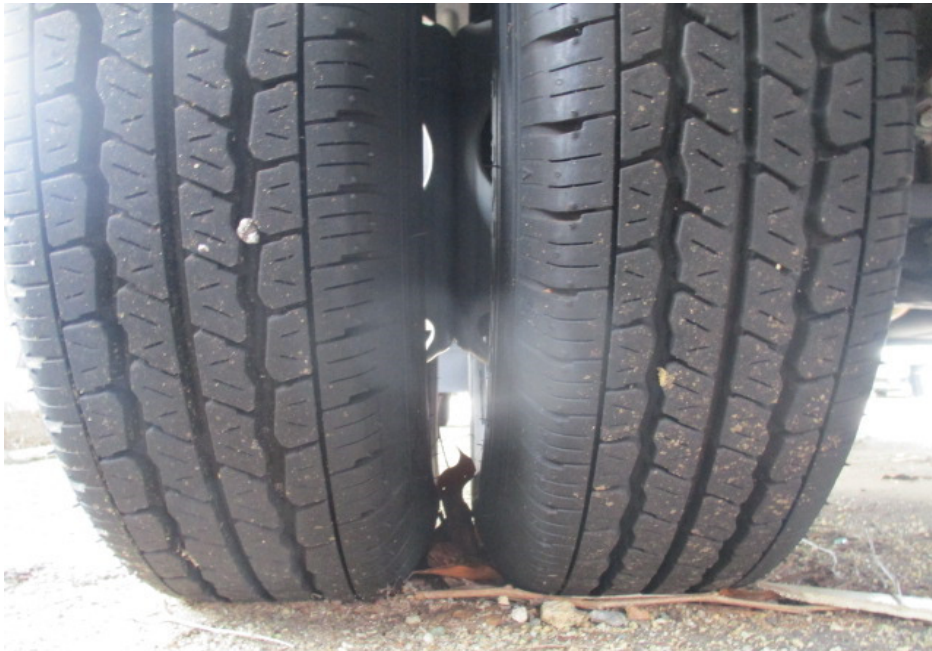
**Photo 6** shows the condition of the rear left tyres of the Motor Lorry, which was observed to be in serviceable condition with remaining tread depth of approximately 6mm. The tyres, which were wrapped around standard alloy wheel rim, were also observed to be sufficiently inflated for vehicular operation. There was also no damage found on all 6 alloy wheel rims of the Motor Lorry.

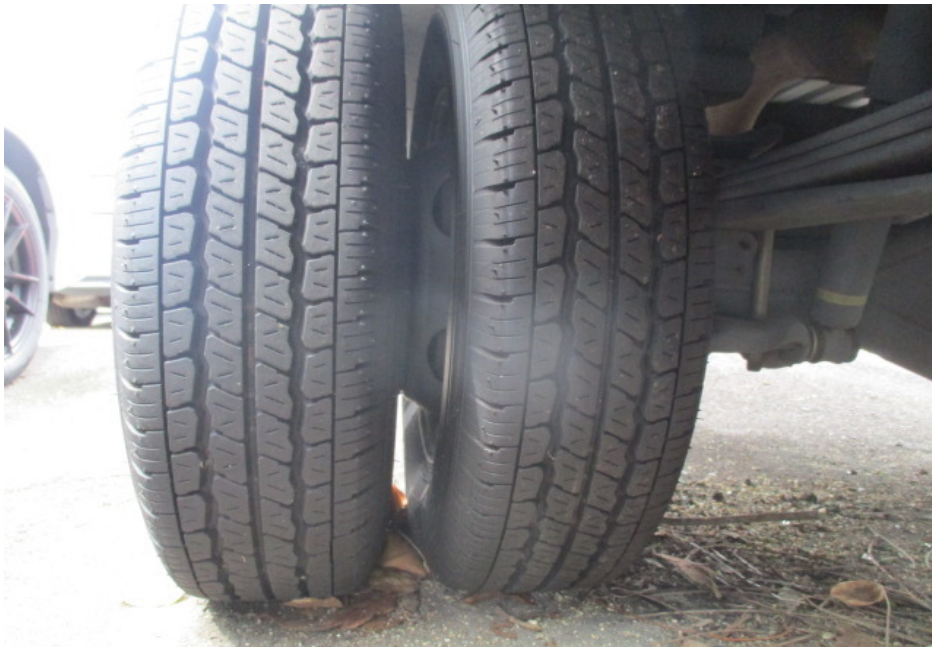
**Photo 7** shows the condition of the rear right tyres of the Motor Lorry, which were observed to be in serviceable condition with remaining tread depth of approximately 6mm. There was also no tear, cut or burst mark(s) on the outer and the inner sidewalls as well as across the tread of the 6 tyres that were fitted on the Motor Lorry.

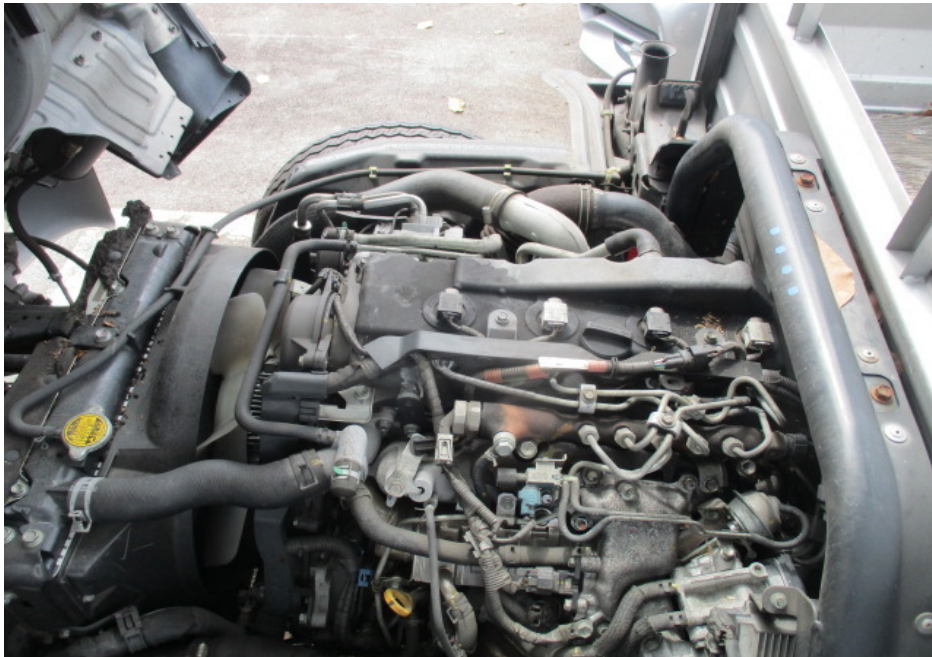
**Photo 8** shows a general view of the Motor Lorry's engine compartment, which was accessed by lifting the front cabin of the Motor Lorry. The various parts and components inside the engine compartment were unaffected by the accident. There was also no sign(s) or indication(s) of fresh fluid leakage and/or fluid stain within the engine compartment (photograph shows the engine compartment as viewed from the left front side of the Motor Lorry).

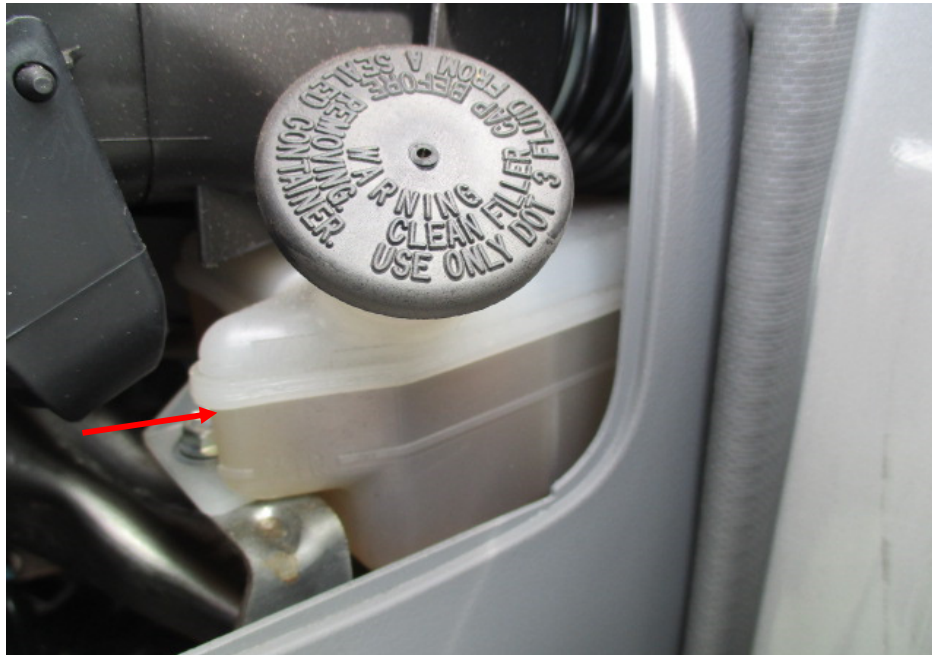
**Photo 9** shows the brake fluid reservoir of the Motor Lorry at the time of our inspection. The brake fluid was observed to be of sufficient level and without any visible contamination (arrowed).

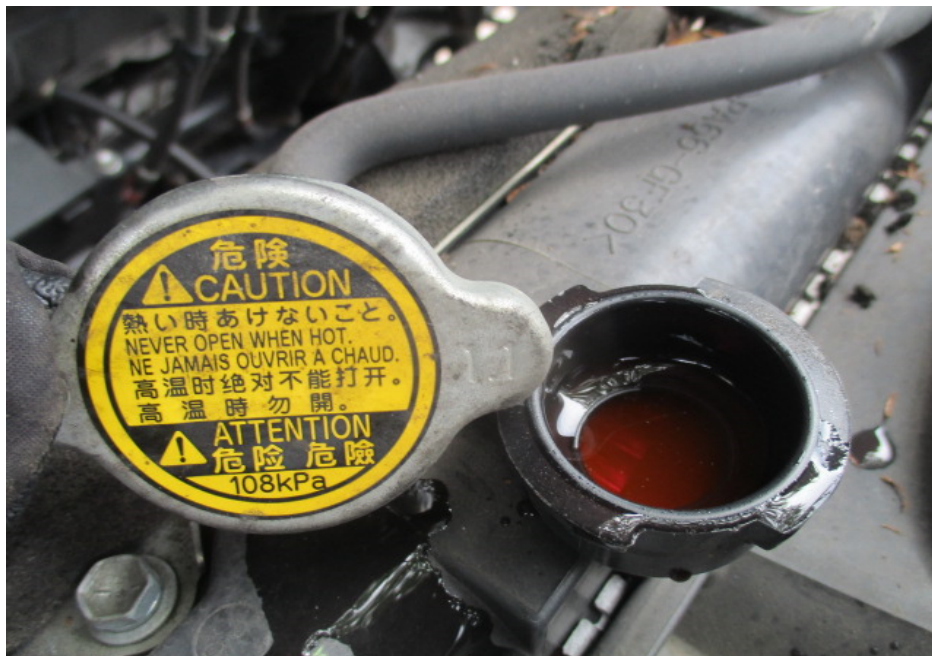
**Photo 10** shows the engine coolant of the Motor Lorry at the time of our inspection. The engine coolant was observed to be of sufficient level and without any visible contamination.

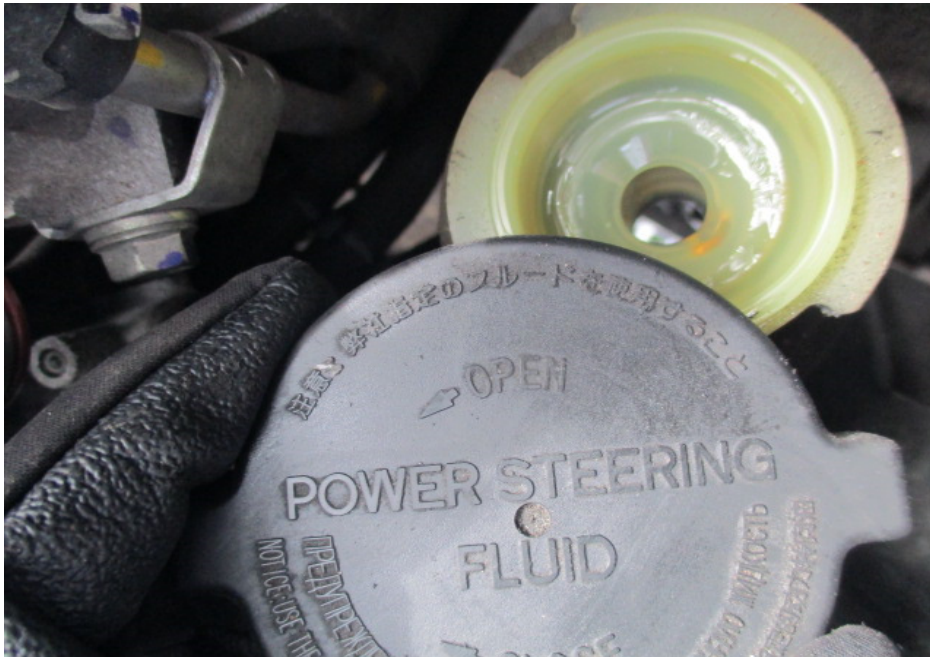
**Photo 11** shows the power steering fluid reservoir of the Motor Lorry at the time of our inspection. The power steering fluid was observed to be of sufficient level and without any visible contamination.

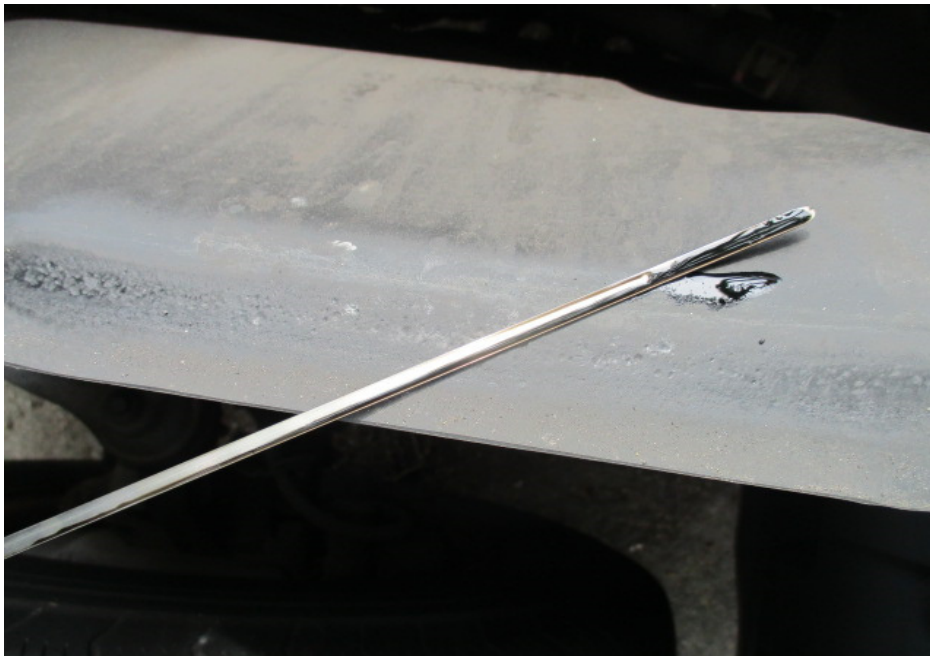
**Photo 12** shows the engine dip stick of the Motor Lorry at the time of our inspection. The engine oil was observed to be of sufficient level and without any visible contamination.

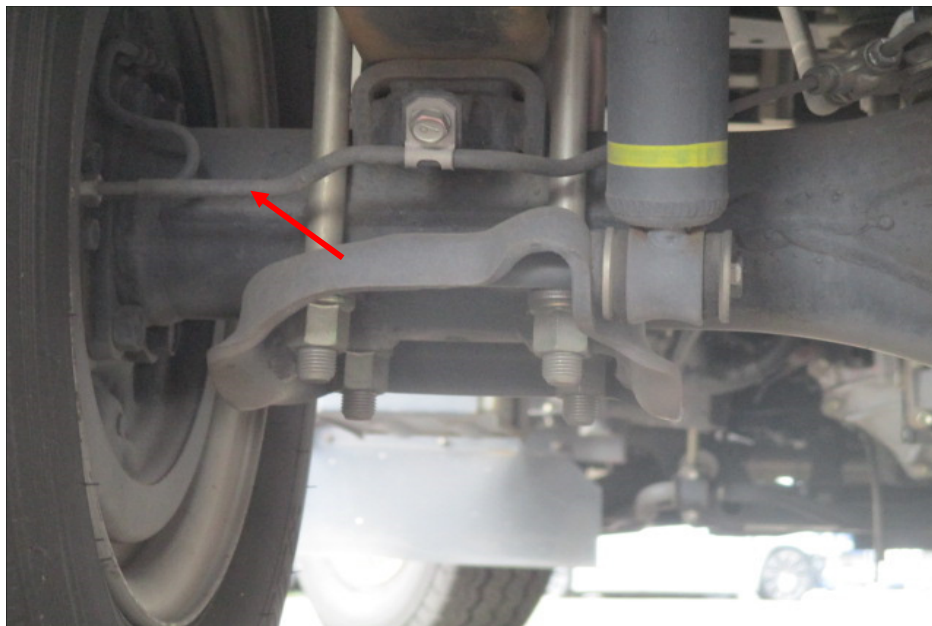
**Photo 13** shows the brake pipe (arrowed) at the rear left wheel of the Motor Lorry. We did not observe any leakage of brake fluid at the time of our inspection of the Motor Lorry. Our static tests of the Motor Lorry's braking system, along with our visual examination of the various mechanical components in the braking system, had indicated that there was no internal leakage of pressure/vacuum. Hence the braking system of the Motor Lorry was likely to be in serviceable condition at the material time of accident.

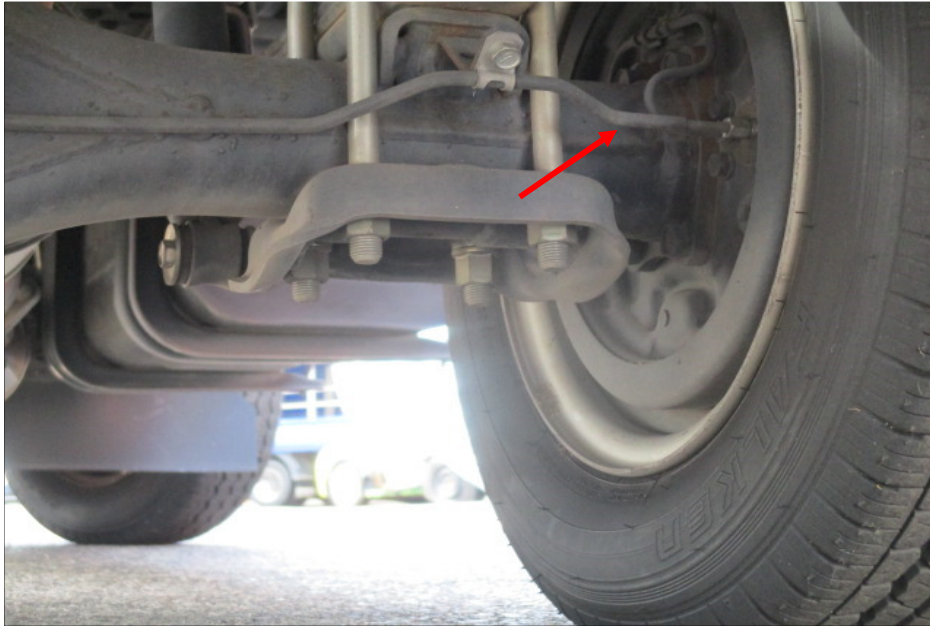
**Photo 14** shows the brake pipe (arrowed) at the rear right wheel of the Motor Lorry. We did not observe any leakage of brake fluid at the time of our inspection of the Motor Lorry. Our static tests of the Motor Lorry's braking system, along with our visual examination of the various mechanical components in the braking system, had indicated that there was no internal leakage of pressure/vacuum. Hence the braking system of the Motor Lorry was likely to be in serviceable condition at the material time of accident.

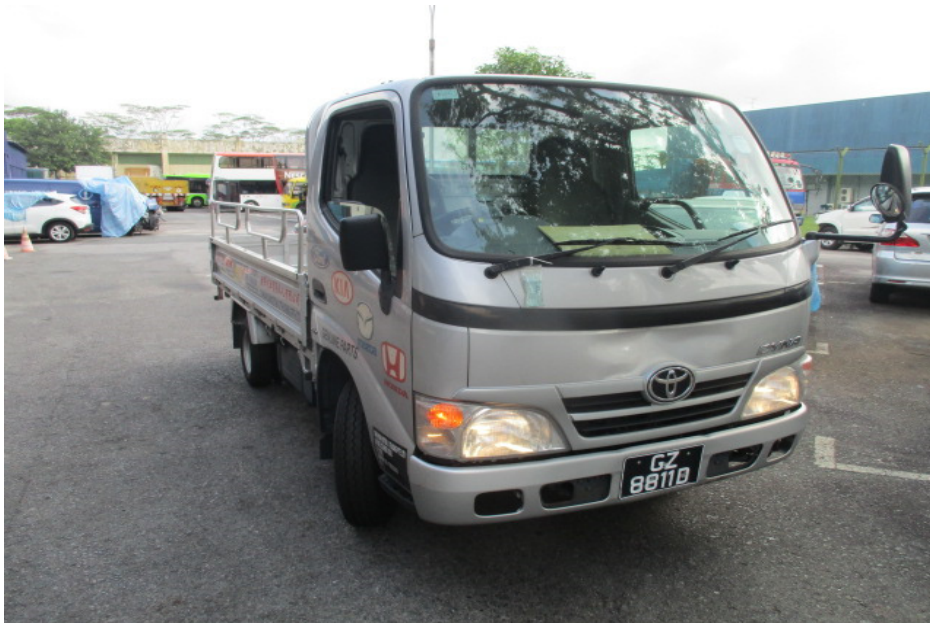
**Photo 15** shows the front right wheel of the Motor Lorry turned to its full right. During our steering system test, we did not experience any abnormal free play and/or resistance when we had turned the steering wheel towards full left and full right. This would suggest that the steering system of the Motor Lorry was likely to be in serviceable condition at the material time of accident.

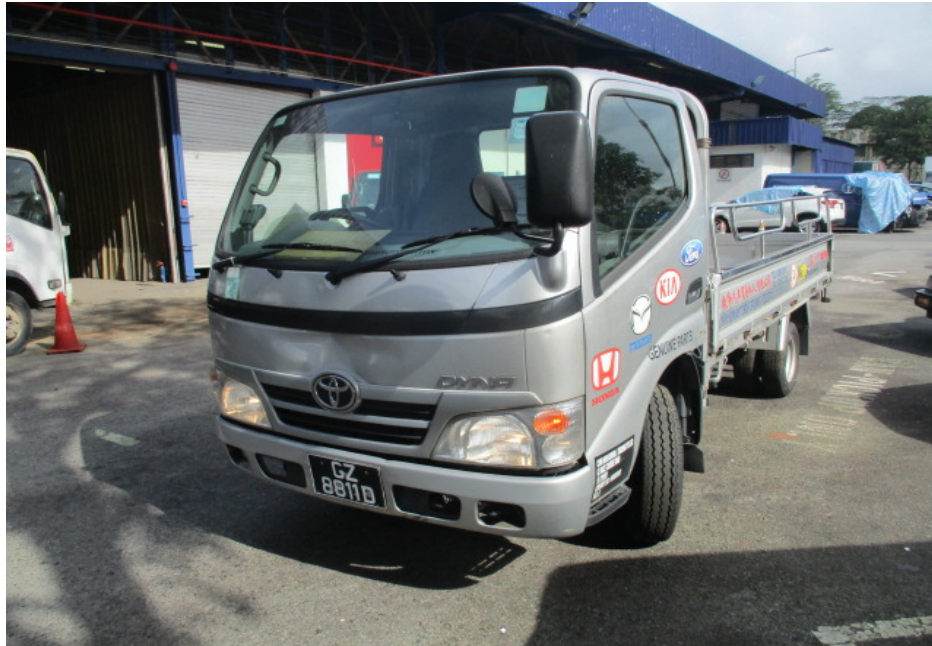
**Photo 16** shows the front left wheel of the Motor Lorry turned to its full left. During our steering system test, we did not experience any abnormal free play and/or resistance when we had turned the steering wheel towards full left and full right. This would suggest that the steering system of the Motor Lorry was likely to be in serviceable condition at the material time of accident.

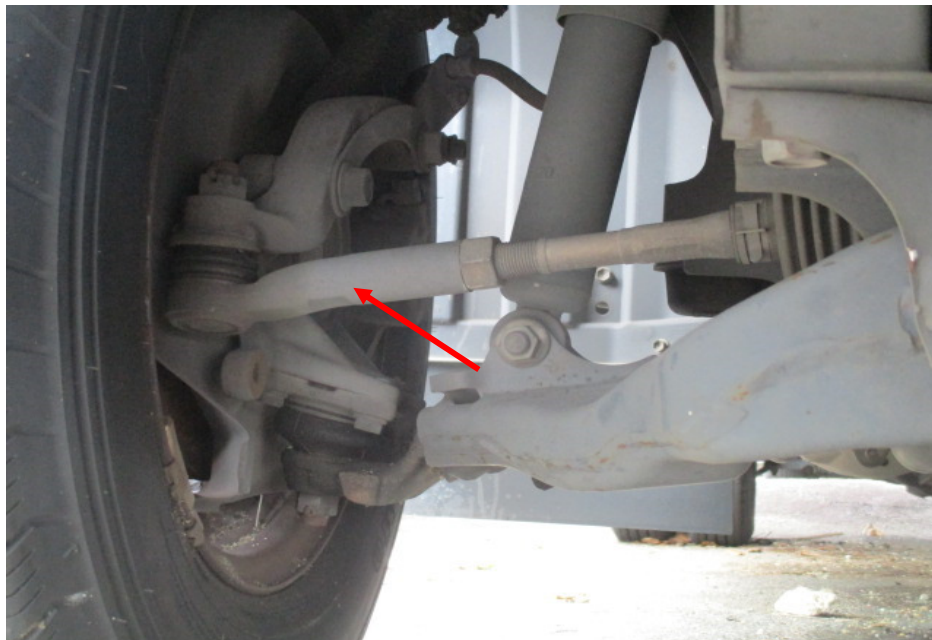
**Photo 17** shows the various undercarriage components at the front right wheel of the Motor Lorry, in particular the steering tie rod end (arrowed). The various steering components were all found to be intact, suggesting that the steering system of the Motor Lorry was likely to be in serviceable condition at the material time of accident. There was also no sign of fluid stain(s) observed on the various undercarriage components.

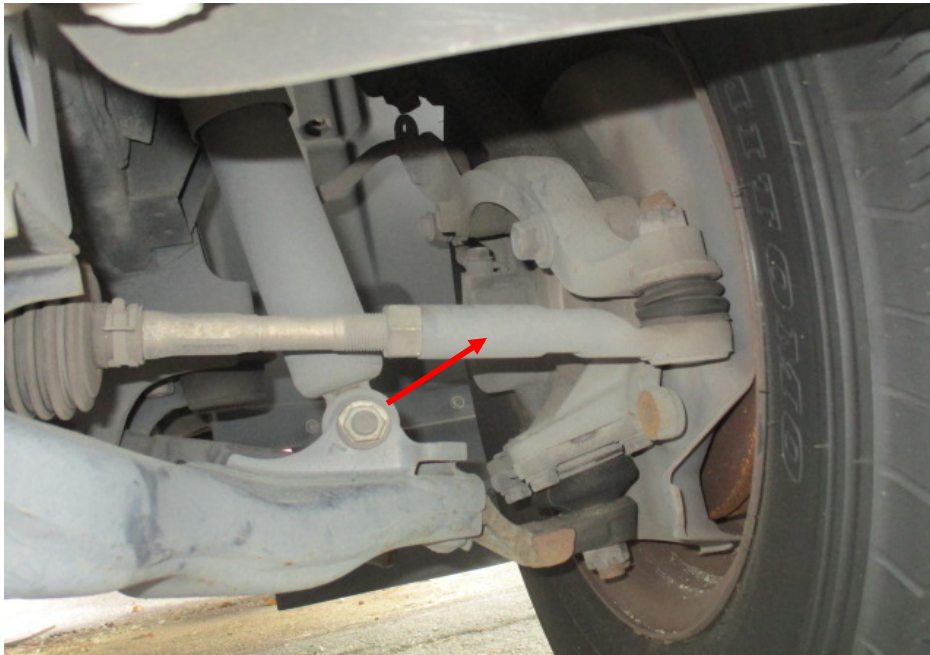
**Photo 18** shows the various undercarriage components at the front left wheel of the Motor Lorry, in particular the steering tie rod end (arrowed). The various undercarriage components of the Motor Lorry were all found to be intact without any visible damage. There was also no sign of fluid stain(s) observed on the various undercarriage components.
