Your Ref: TP/IP/72439/2019
Our Ref : CI/TPD20000112/N

6 January 2020

INSPECTION REPORT OF MOTORCYCLE FBM 4089B

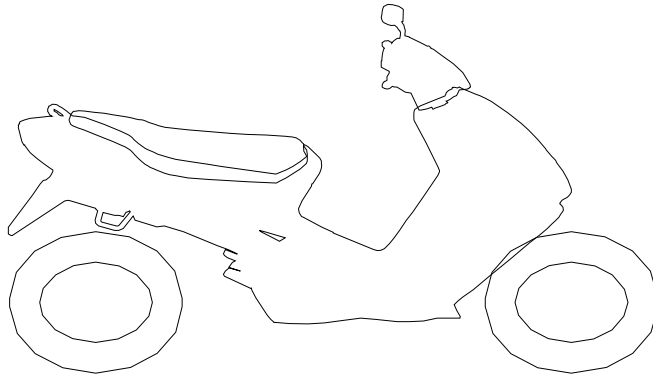
Bridgestone 190/55 - 17 (3mm)

Bridgestone 120/70 - 17 (3mm)

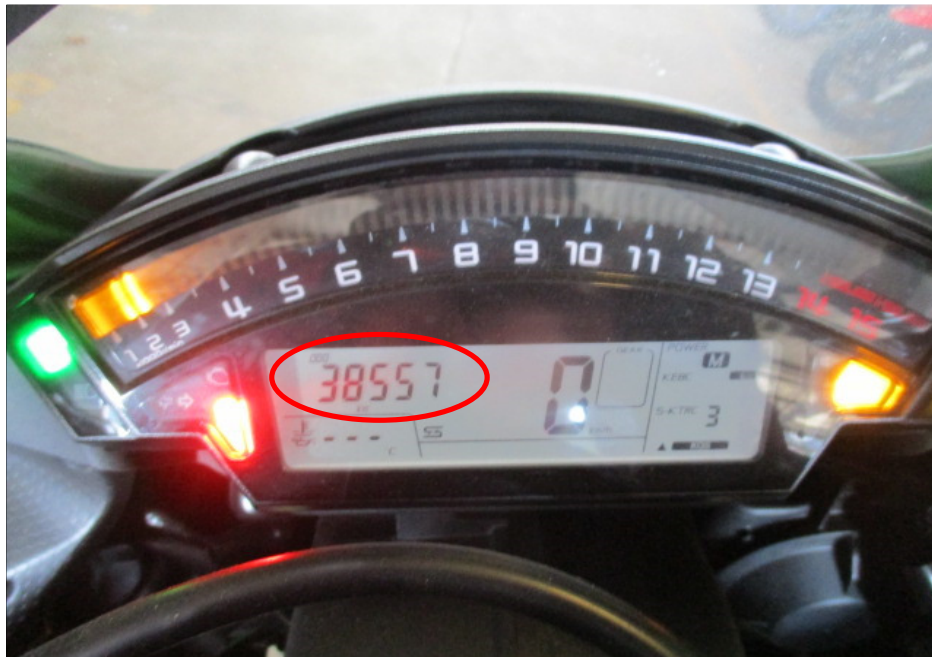
Photo 1 shows the speedometer gauge of the Motorcycle where the mileage recorded at the time of our inspection was 38, 557km (circled).

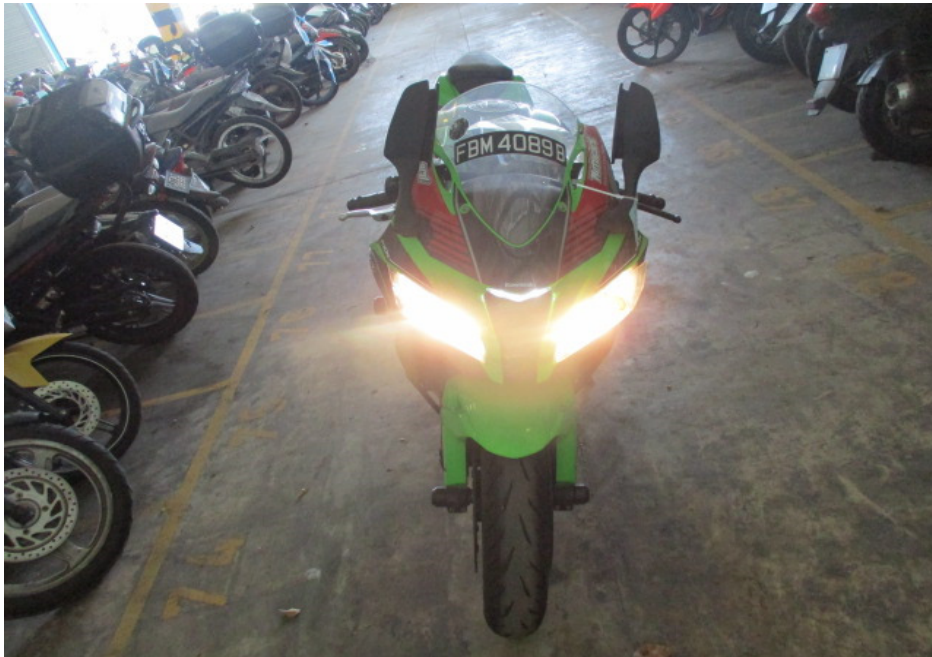
Photo 2 shows a general view of the frontal portion of the Motorcycle at the time of our inspection. The Motorcycle was observed to have sustained damages at its frontal portion and right body.

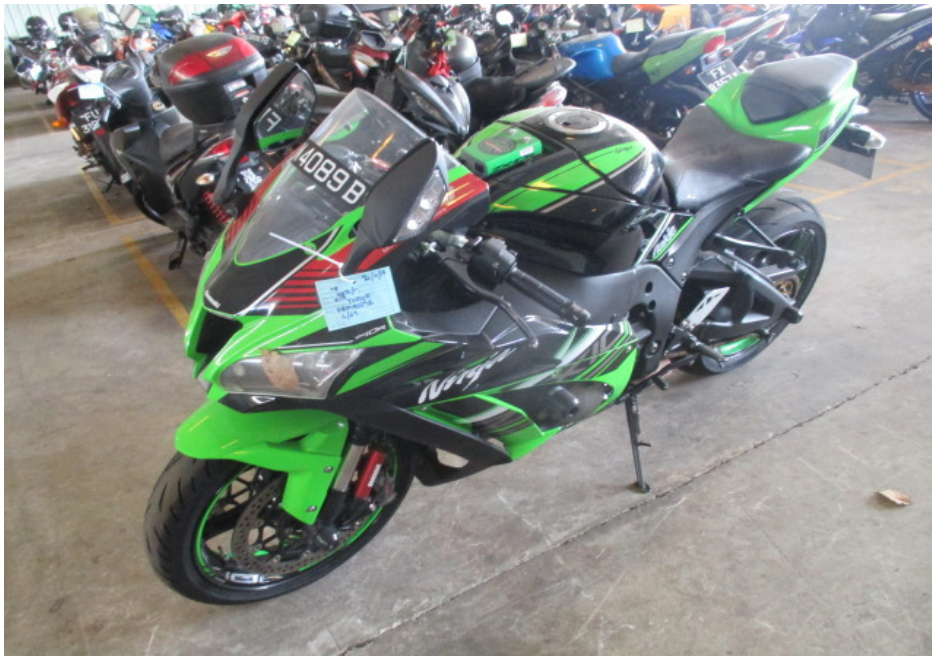
Photo 3 shows a general view of the left body of the Motorcycle at the time of our inspection. The Motorcycle was observed to have sustained damages at its frontal portion and right body.

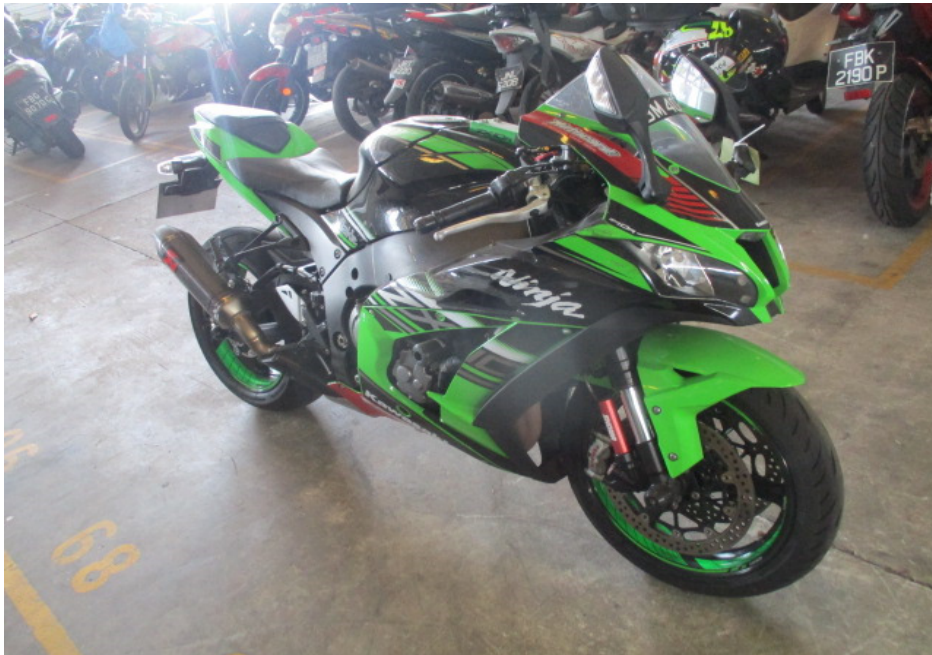
4. The mileage of the Motorcycle at the time of our inspection was 38, 557km.
5. The Motorcycle was observed to have sustained damages at its frontal portion and right body. The body parts that were found to have been damaged include its headlight, head cowling, right cowling, right handlebar end, front brake lever, rear brake pedal, right front footrest, petrol tank, right frame and rear exhaust muffler, amongst others.

Photo 4 shows a general view of the right body of the Motorcycle at the time of our inspection. The Motorcycle was observed to have sustained damages at its frontal portion and right body. Amongst the body parts that were found to have been damaged include its headlight, head cowling, right cowling, right handlebar end, front brake lever, rear brake pedal, right front footrest, petrol tank, right frame and exhaust muffler, amongst others.

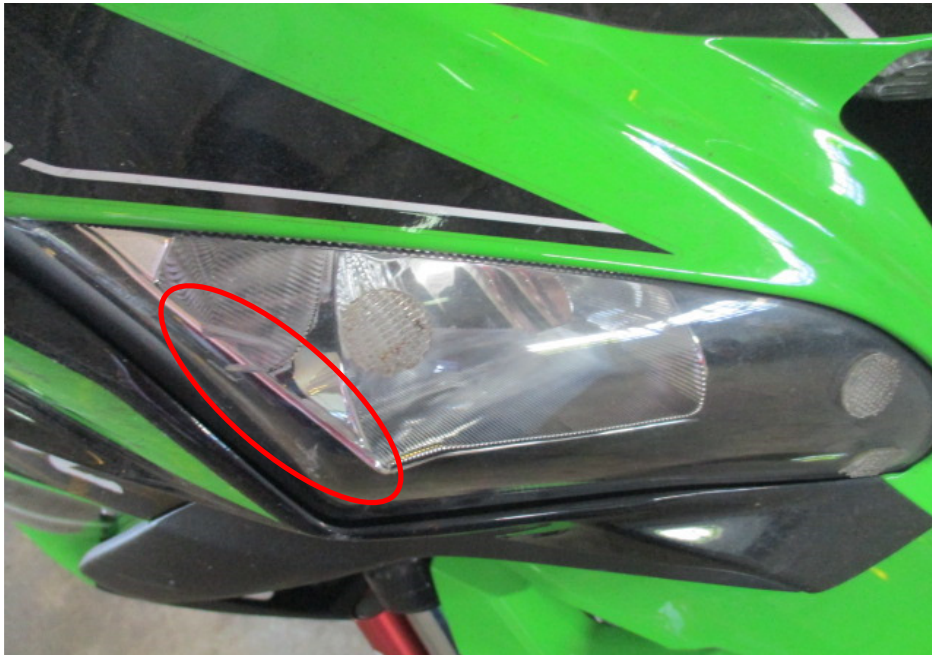
Photo 5 shows a close up view of the right front signal lamp which was amongst the body parts of the Motorcycle that had sustained damage as a result of the accident (circled).

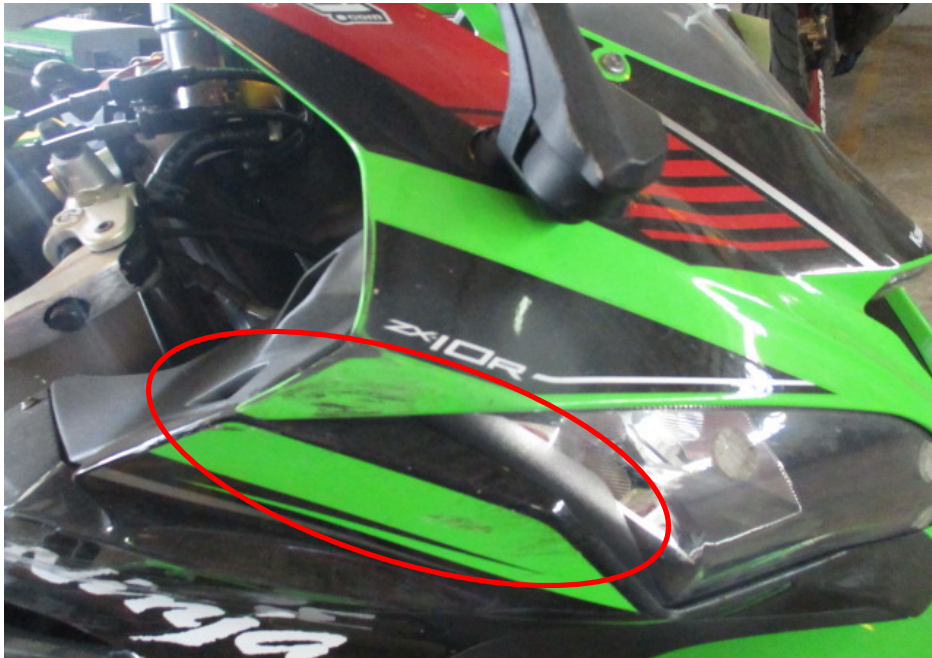
Photo 6 shows a closer view of the head cowl which was amongst the body parts at the front body of the Motorcycle that had sustained damage as a result of the accident (circled).

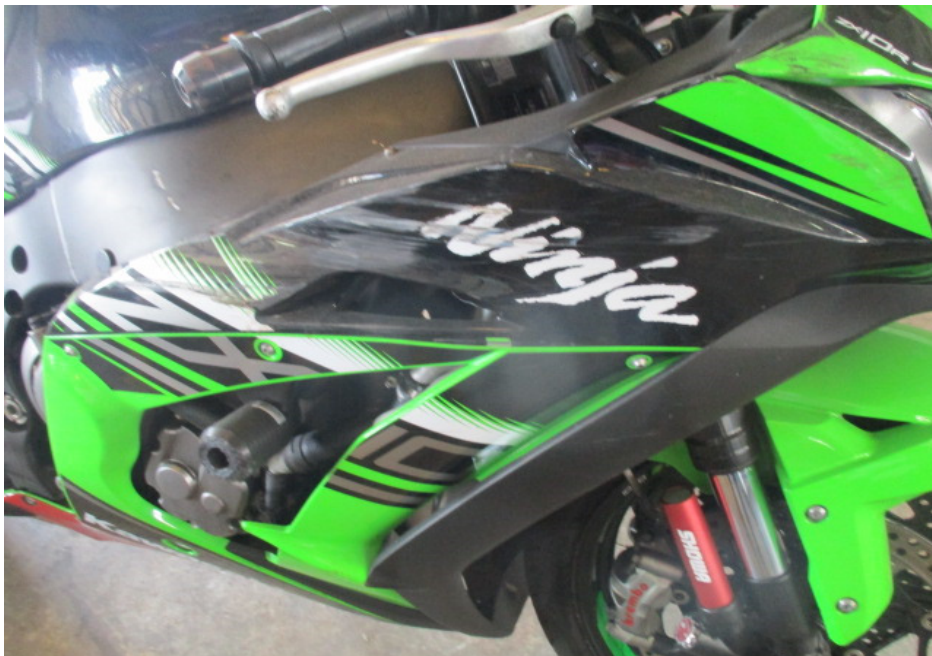
Photo 7 shows a closer view of the right cowl which was amongst the body parts at the front body of the Motorcycle that had sustained damage as a result of the accident.

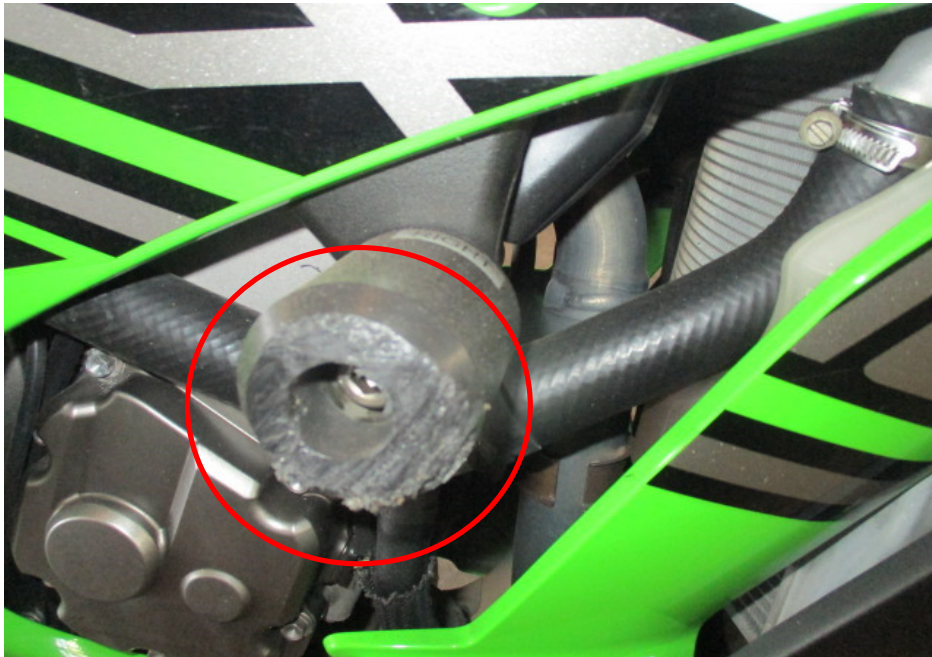
Photo 8 shows a closer view of the right frame slider of the Motorcycle that had sustained damages of grazing nature as a result of the accident (circled).

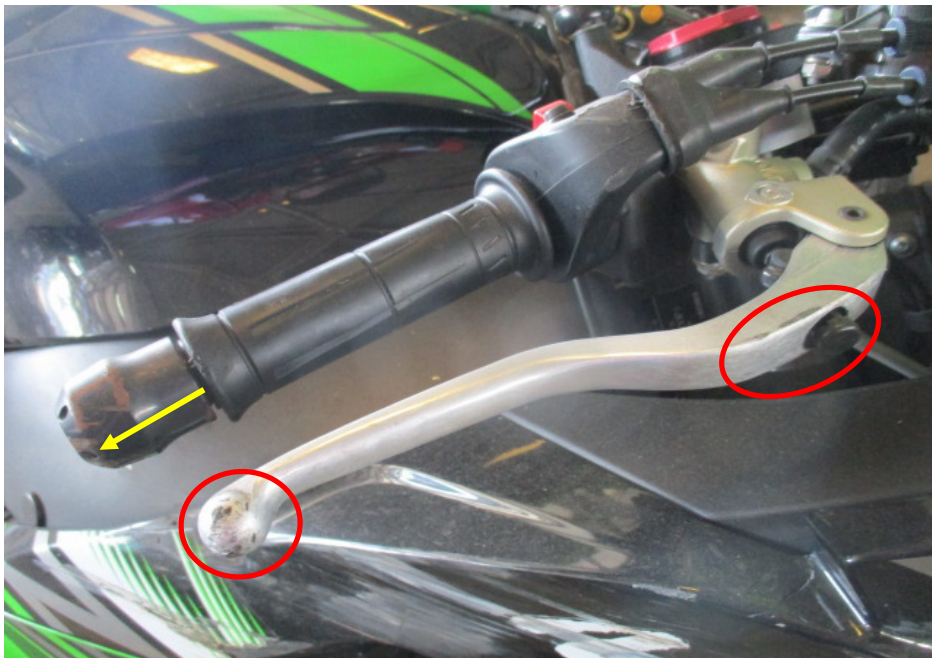
Photo 9 shows a closer view of the right handlebar end (yellow arrow) and front brake lever (circled) which were amongst the body parts of the Motorcycle that had sustained damage as a result of the accident.

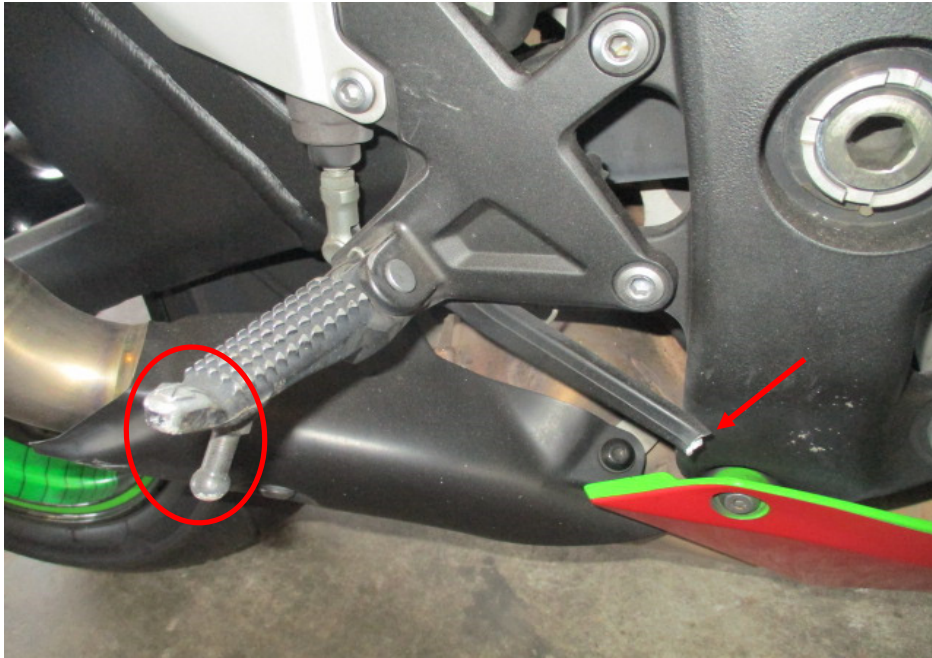
Photo 10 shows a closer view of the broken rear brake pedal (arrowed) and right front footrest (circled) which were amongst the body parts of the Motorcycle that had sustained damage as a result of the accident.

14. However we did observe that part of the brake foot pedal had broken off as a result of the accident. Hence static as well as operational brake tests could not be conducted on the Motorcycle's rear braking system. We were unable to determine if there was any leakage of pressure/vacuum in the rear braking system.

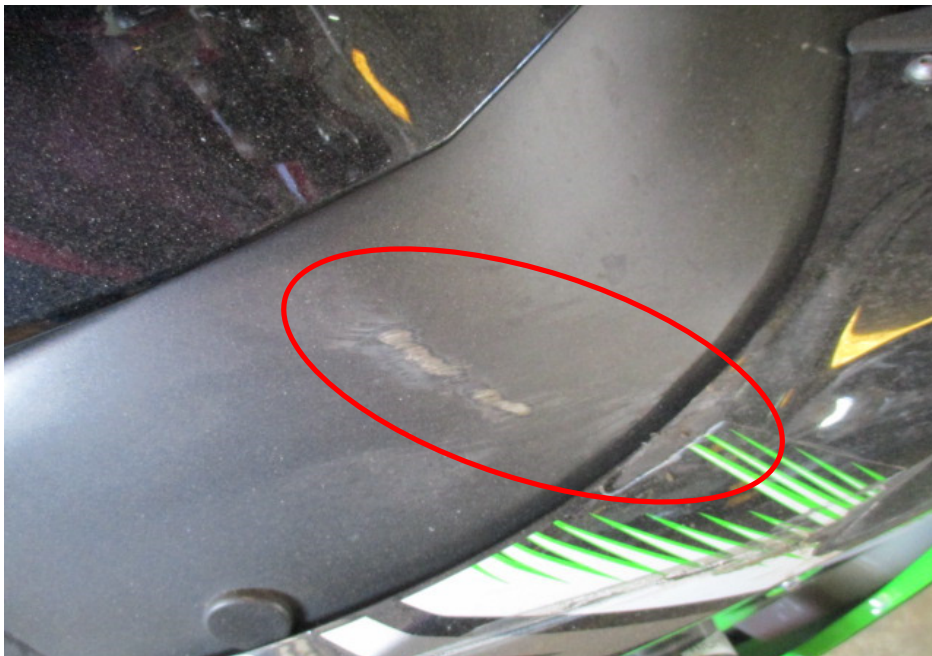
Photo 11 shows a closer view of the right frame which was amongst the body parts of the Motorcycle that had sustained damages of grazing nature as a result of the accident (circled).

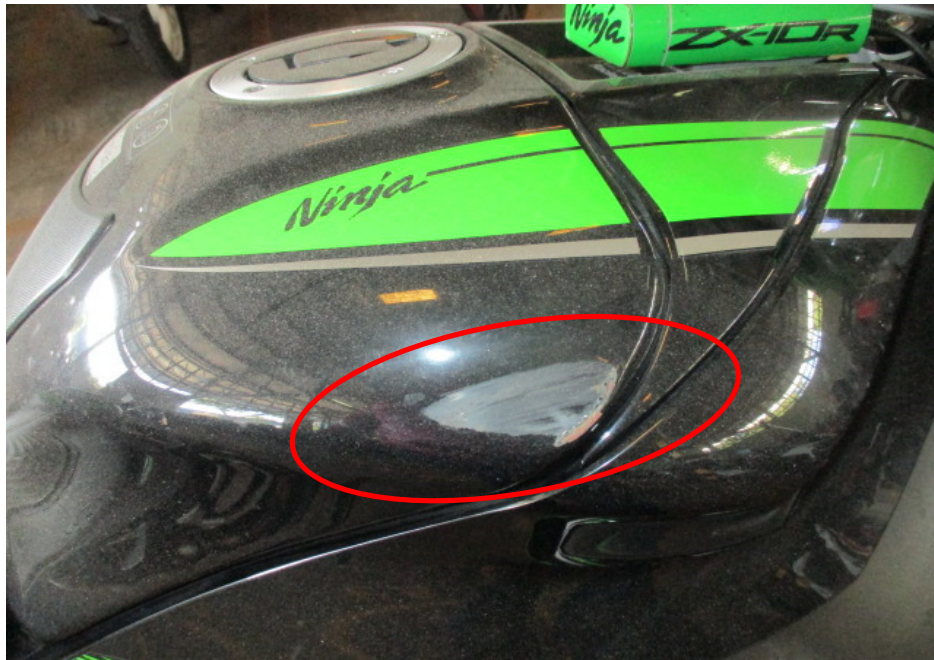
Photo 12 shows a closer view of the petrol tank which was amongst the body parts of the Motorcycle that had sustained damages of grazing nature as a result of the accident (circled).

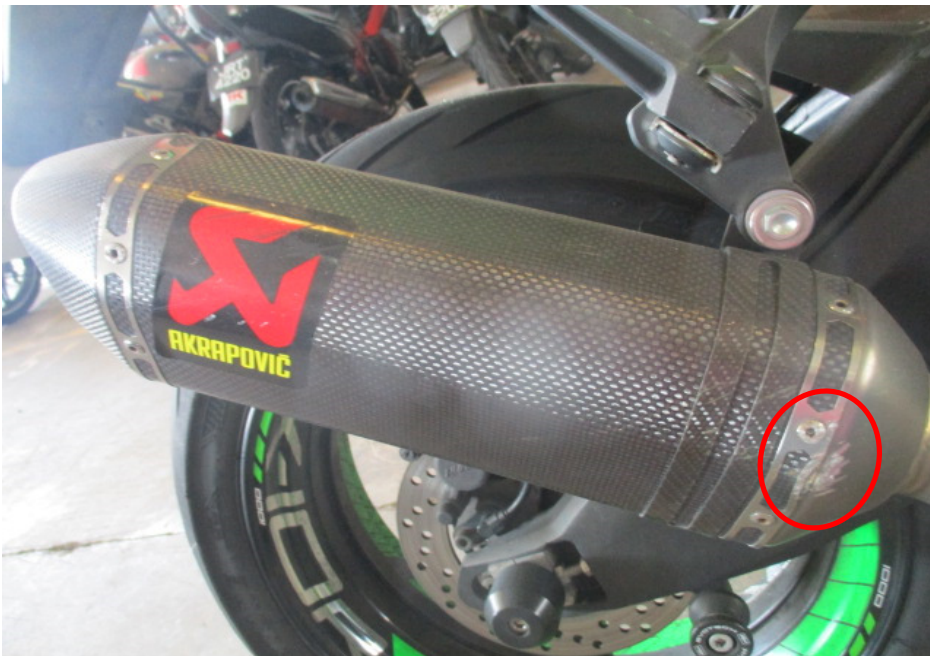
Photo 13 shows a closer view of the rear exhaust muffler of the Motorcycle that had sustained damages of grazing nature as a result of the accident (circled).

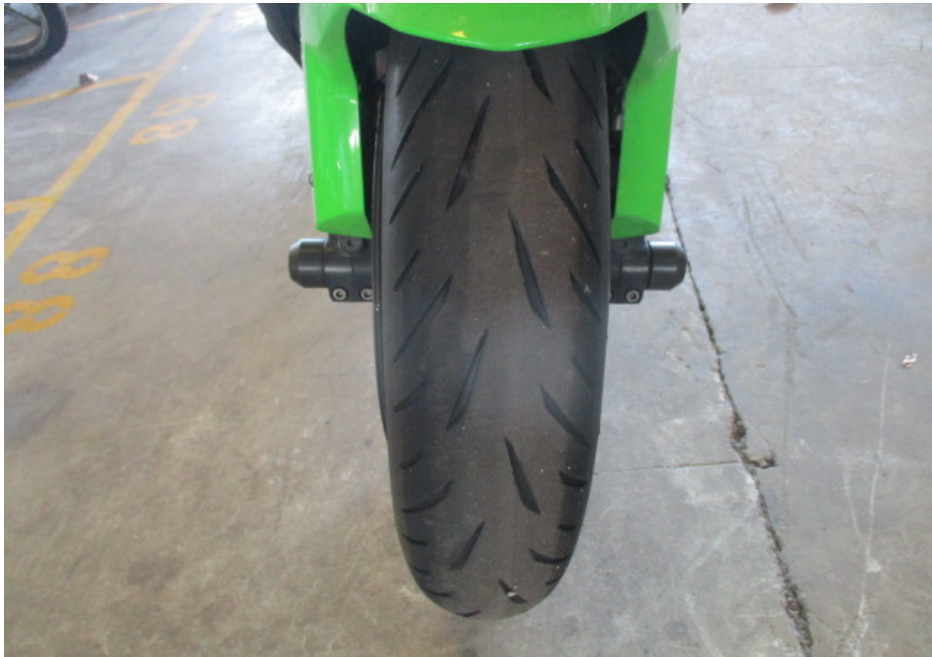
Photo 14 shows the condition of the Motorcycle's front tyre. The front tyre was observed to be in serviceable condition with remaining tread depth of approximately 3mm. There was no tear, burst mark(s) and/or punctured hole(s) on the sidewalls as well as across the tread of the front tyre.

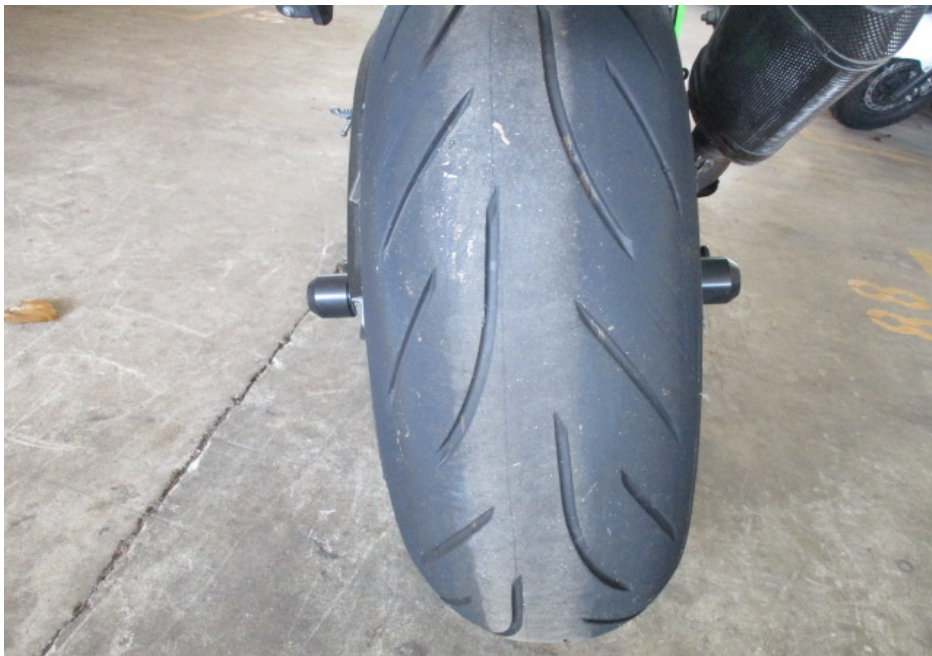
Photo 15 shows the condition of the Motorcycle's rear tyre. The rear tyre was observed to be in serviceable condition with remaining tread depth of approximately 3mm. The tyre was also observed to be sufficiently inflated for vehicular operation. We did not observe any tear, burst mark(s) and/or punctured hole(s) on the sidewalls as well as across the tread of the rear tyre.

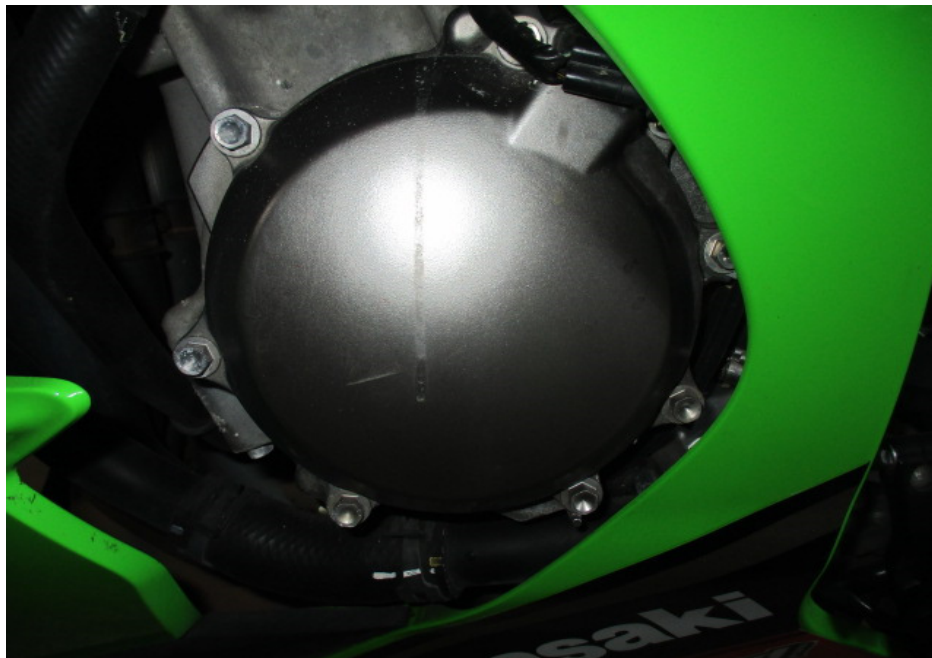
Photo 16 shows the left side of the engine of the Motorcycle at the time of our inspection. The various engine related parts and components were found to be intact with no visible damage. There was also no sign(s) or indication(s) of fluid leak observed around the left engine area of the Motorcycle.

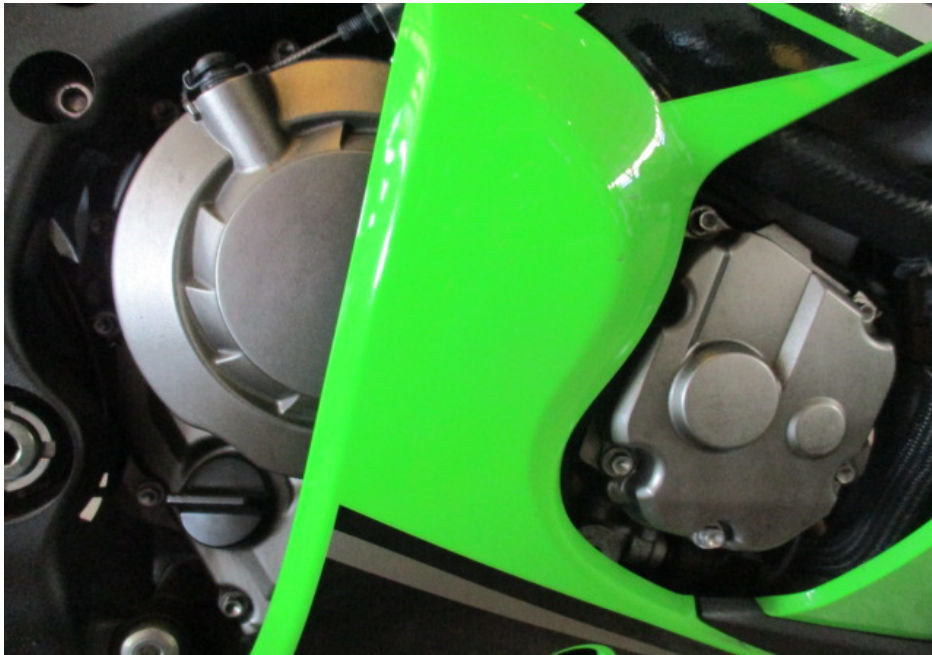
Photo 17 shows the right side of the engine of the Motorcycle at the time of our inspection. The various engine related parts and components were found to be intact with no visible damage. There was also no sign(s) or indication(s) of fluid leak observed around the right engine area of the Motorcycle.

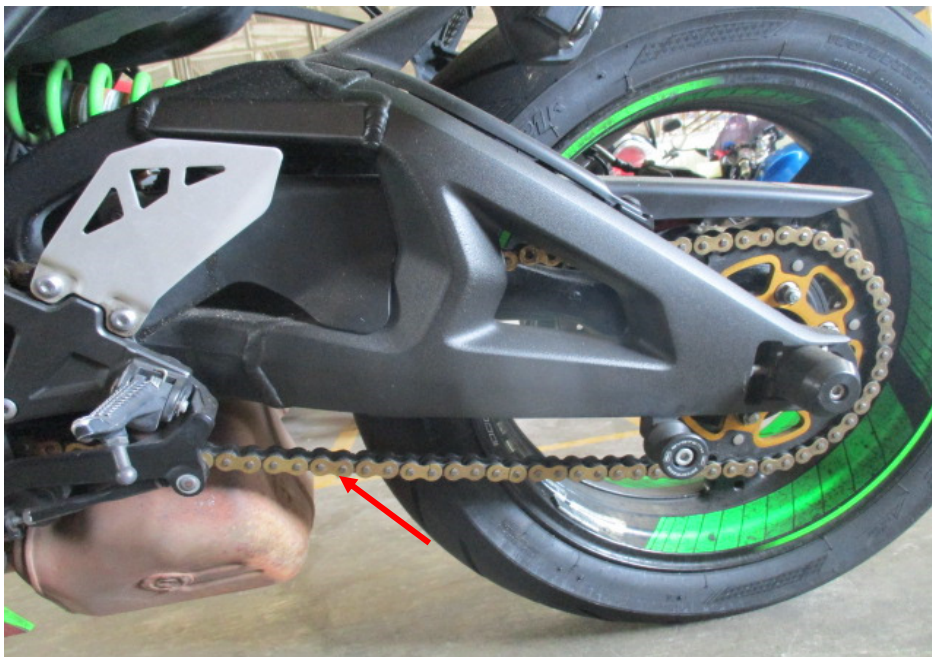
Photo 18 shows the general view of the gear train (arrowed) of the Motorcycle, which was observed to be intact with no misalignment. It was also adequately lubricated for operating purposes.

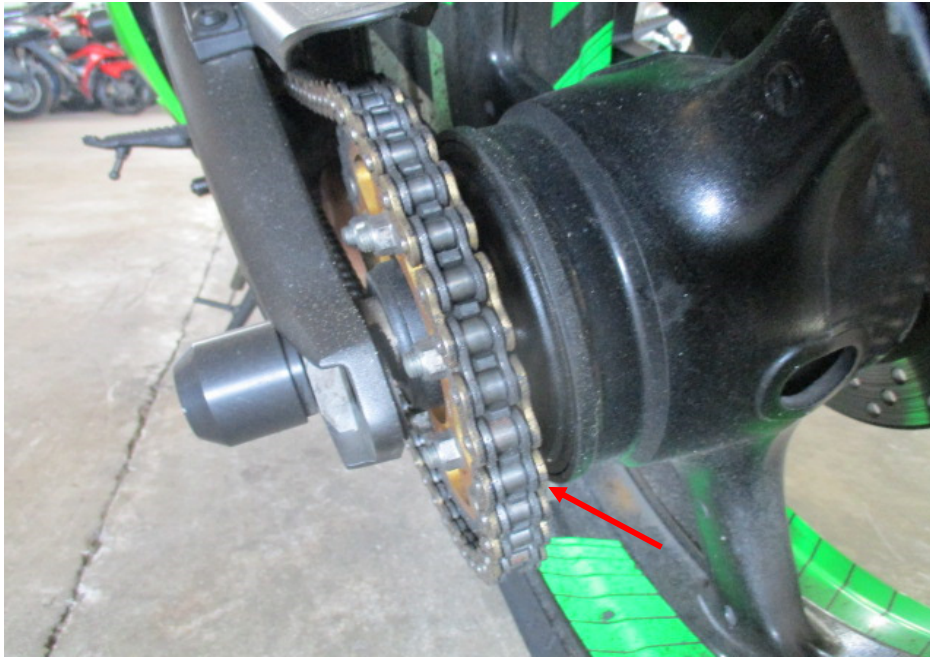
Photo 19 shows a closer view of the gear train (arrowed) of the Motorcycle, which was observed to be intact with no misalignment. It was also adequately lubricated for operating purposes.

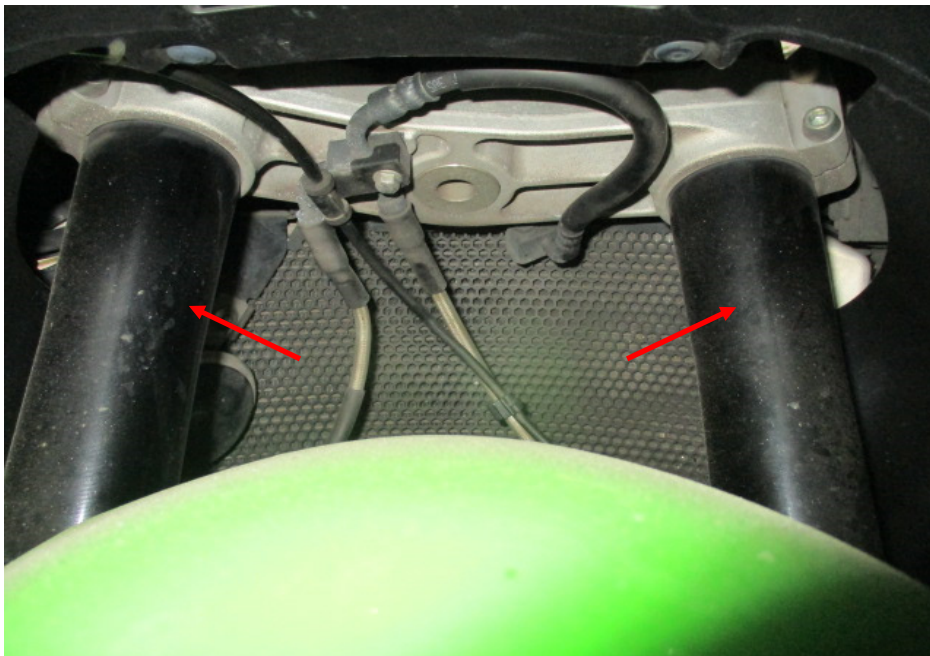
Photo 20 shows the front fork (arrowed) of the Motorcycle. The front fork and fork bracket of the Motorcycle were both found to be intact and undamaged. Turning the Motorcycle's handle bar towards the left and right did not produce any abnormal free play and/or resistance. The steering system of the Motorcycle was in serviceable condition at the time of our inspection.

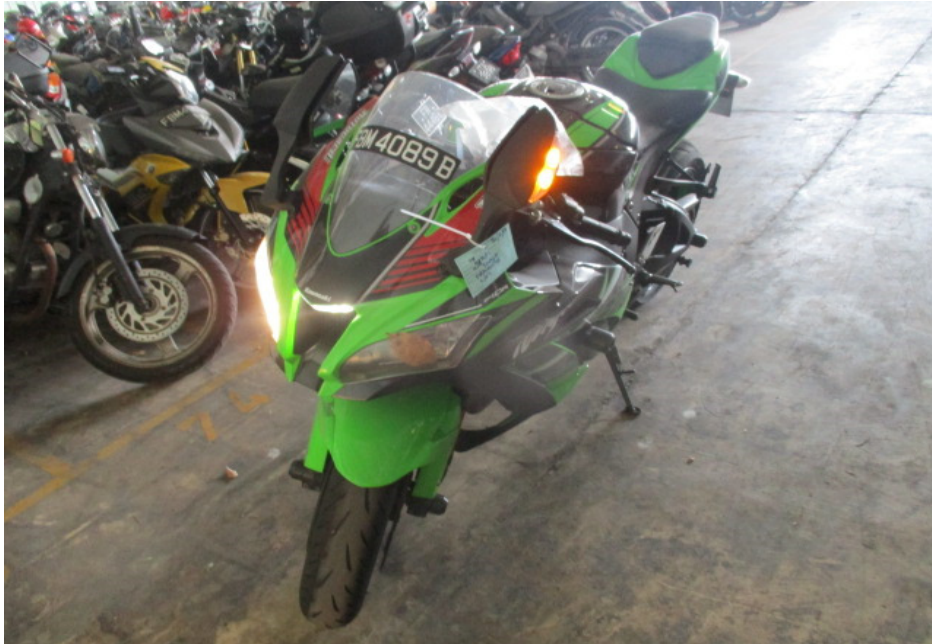
Photo 21 shows the front wheel of the Motorcycle turned towards its full left. Turning the Motorcycle's handle bar towards the left and right did not produce any abnormal free play and/or resistance. This would indicate that the steering system of the Motorcycle was in serviceable condition at the time of our inspection.

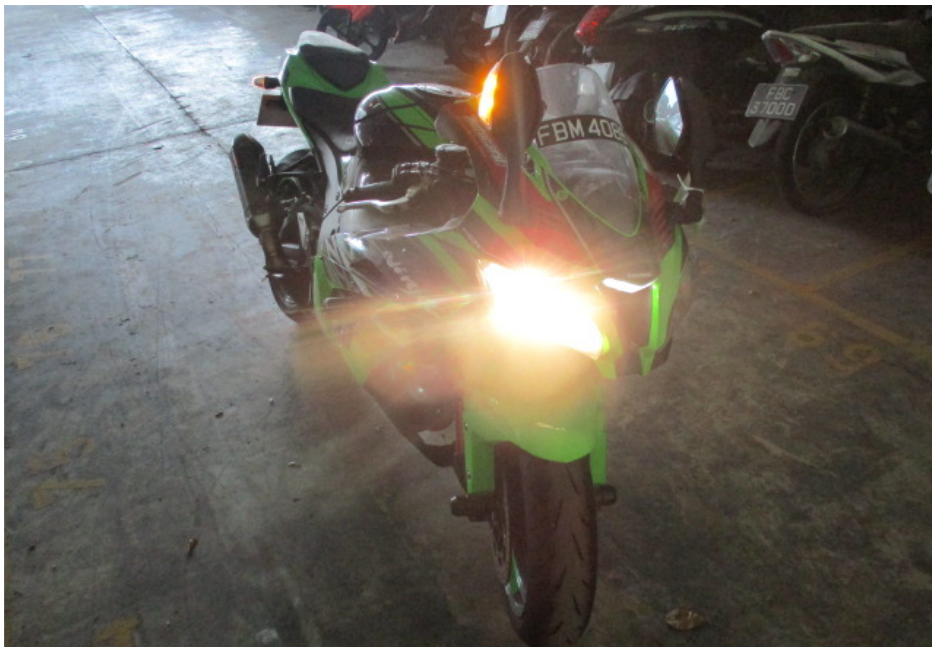
Photo 22 shows the front wheel of the Motorcycle turned towards its full right. Turning the Motorcycle's handle bar towards the left and right did not produce any abnormal free play and/or resistance. This would indicate that the steering system of the Motorcycle was in serviceable condition at the time of our inspection.

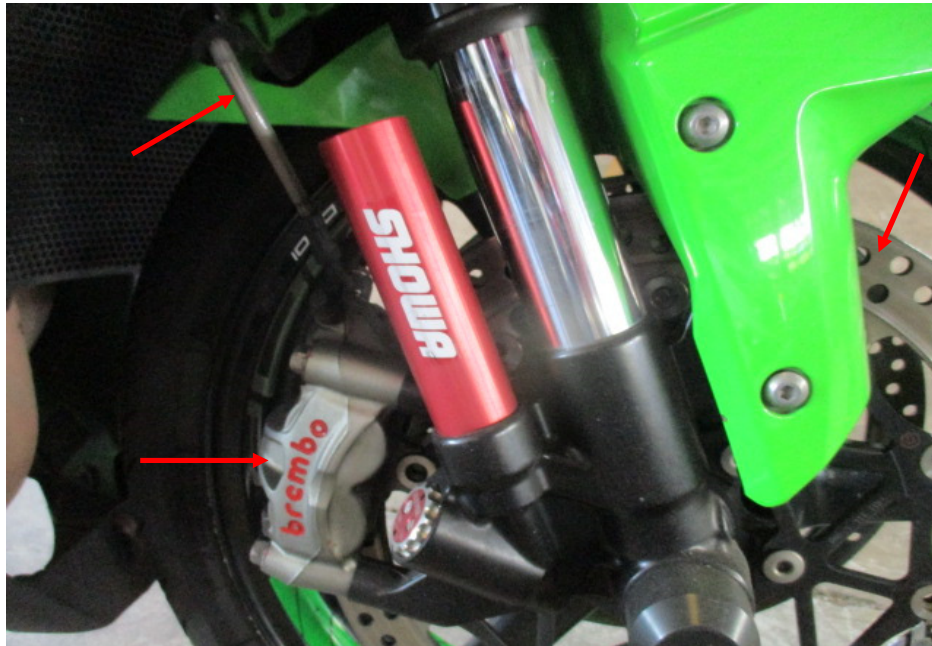
Photo 23 shows a close up view of the front brake caliper, front brake disc and front brake hose (arrowed) at the right side of the Motorcycle's front wheel, which are all part of the components in the hydraulic front brake system of the Motorcycle. Our visual checks of these various components had revealed all to be intact with no visible damage. No leakage of brake fluid was also observed.

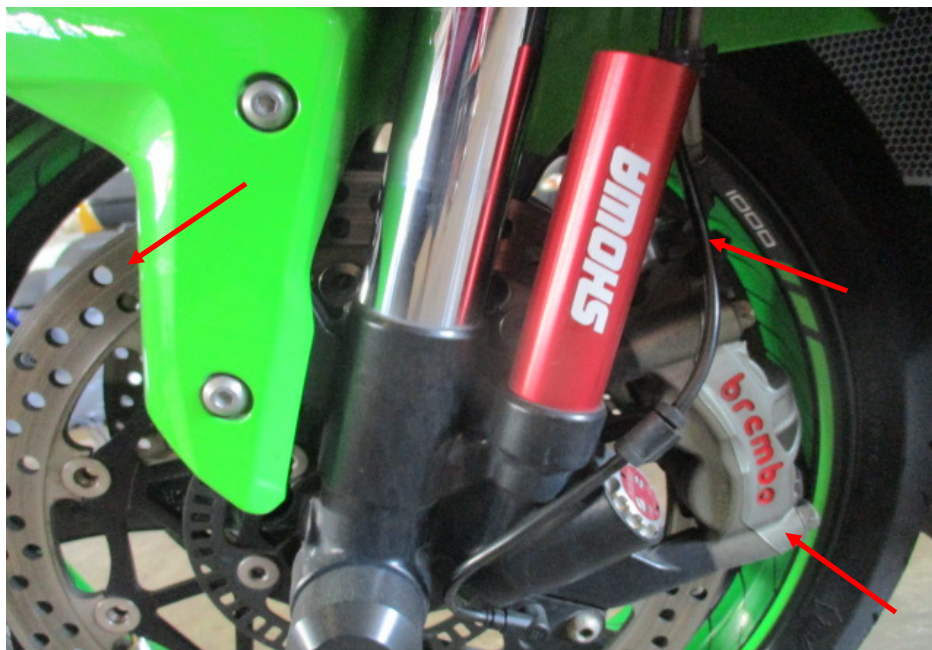
Photo 24 shows a close up view of the front brake caliper, front brake disc and front brake hose (arrowed) at the left side of the Motorcycle's front wheel, which are all part of the components in the hydraulic front brake system of the Motorcycle. Our visual checks of these various components had revealed all to be intact with no visible damage. No leakage of brake fluid was also observed.

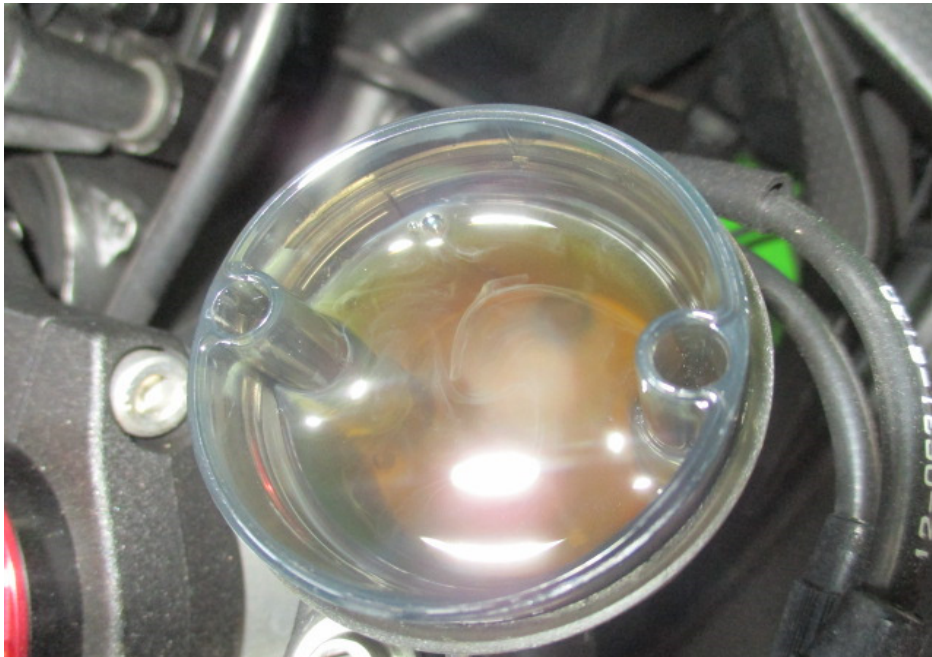
Photo 25 shows the brake fluid reservoir for the front brake of the Motorcycle. The brake fluid was observed to be of sufficient level and without contamination for operational purposes.

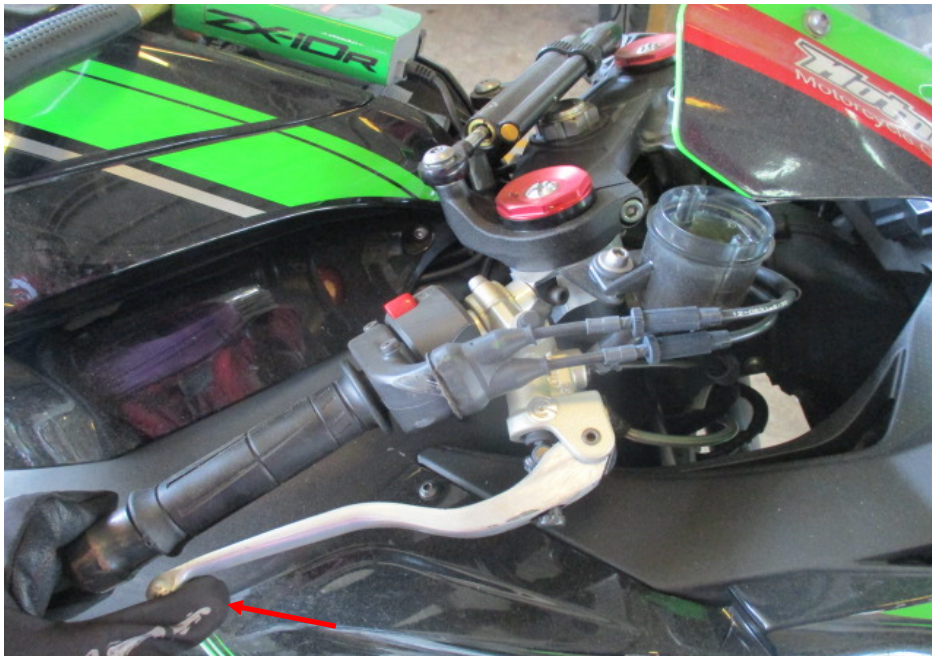
15. Static brake tests conducted on the Motorcycle had appear to indicate that the front braking system of the Motorcycle was in serviceable condition. There was some resistance felt (spongy like feel) upon pressing the brake lever. This would indicate that there was no leakage of pressure/vacuum in the front brake system.

Photo 26 shows the front brake lever being depressed. There was some resistance felt (spongy like feel) upon pressing the front brake lever (arrowed). This would indicate that there is no leakage of pressure/vacuum in the brake system.

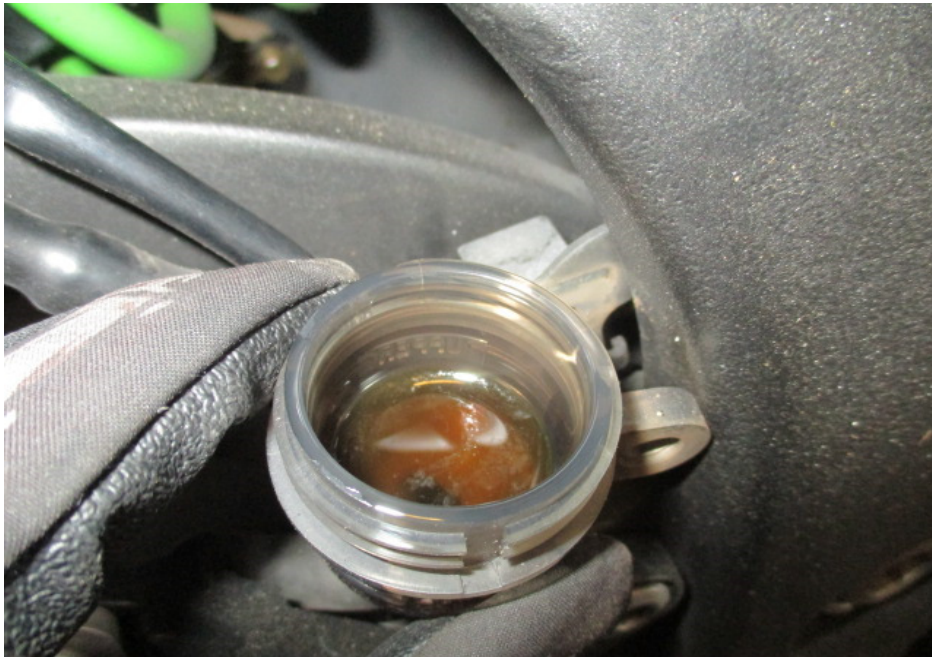
Photo 27 shows the brake fluid reservoir for the rear brake of the Motorcycle. The brake fluid was observed to be of sufficient level and without contamination for operational purposes.

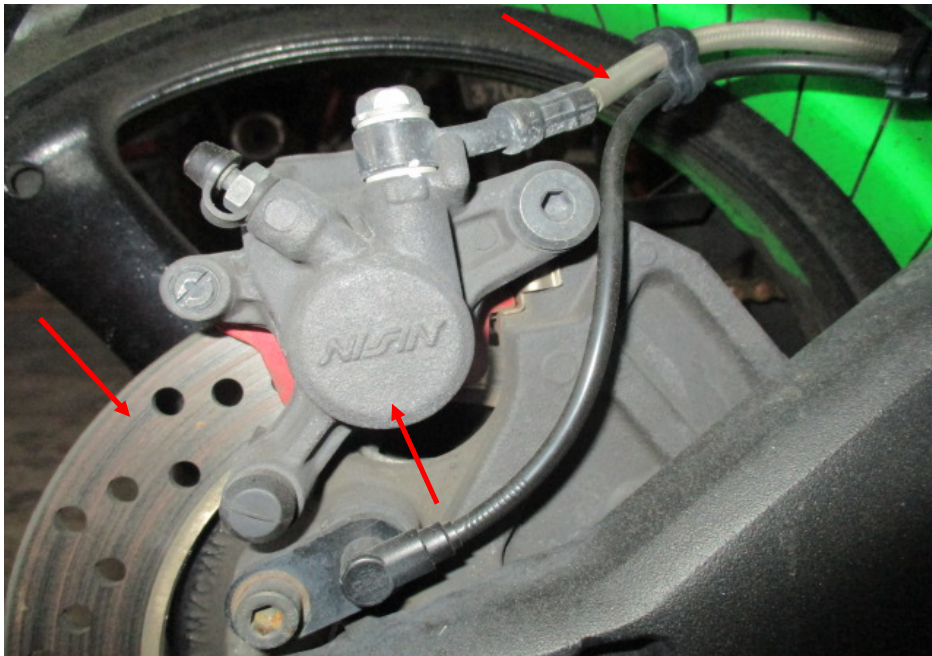
Photo 28 shows a close up view of the rear brake caliper, rear brake disc and rear brake hose (arrowed) of the Motorcycle, which are all part of the components in the hydraulic rear brake system of the Motorcycle. Our visual checks of these various components had revealed all to be intact with no visible damage. No leakage of brake fluid was also observed.
