LKK Auto Consultants Pte Ltd

Affiliated to Federation Internationale Des Experts En Automobile				
MS FIRST CAPITAL INSURANCE LTD 36 ROBINSON ROAD #16-01 CITY HOUSESINGAPORE 068877			Ref: CC4/FCI20000129/Upa3q2	
			Date: 15/01/2021	
			Code: FCI2

ADJUSTMENT ON REPAIR COST FOR VEHICLE NO. SJB 8875K

PHOTOGRAPHS FOR VEHICLE NO. SJB 8875K

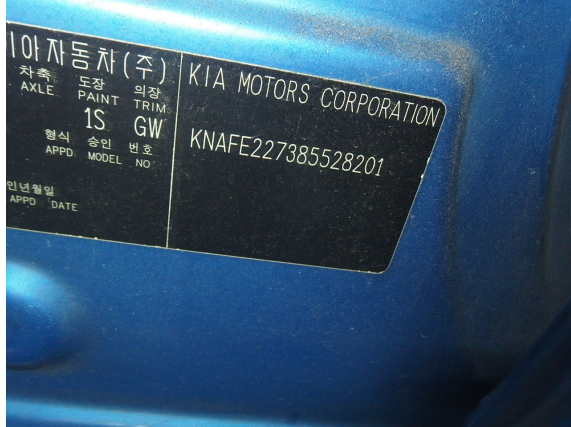
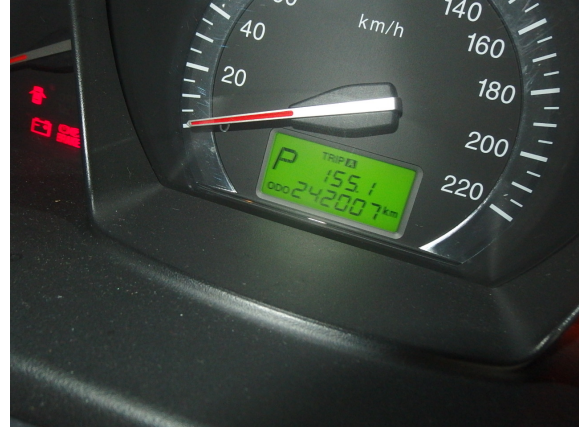
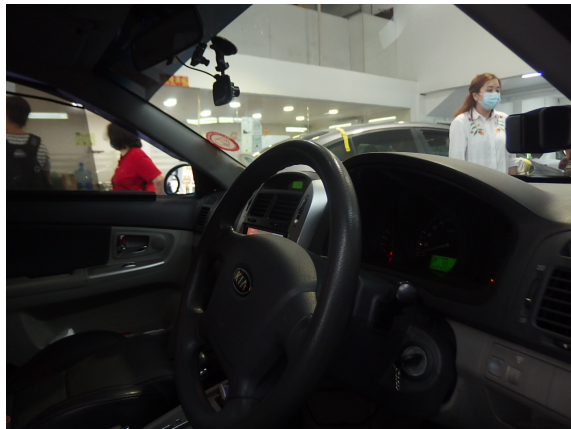
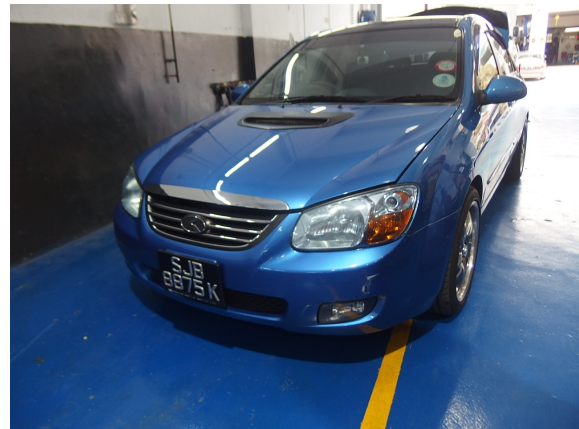
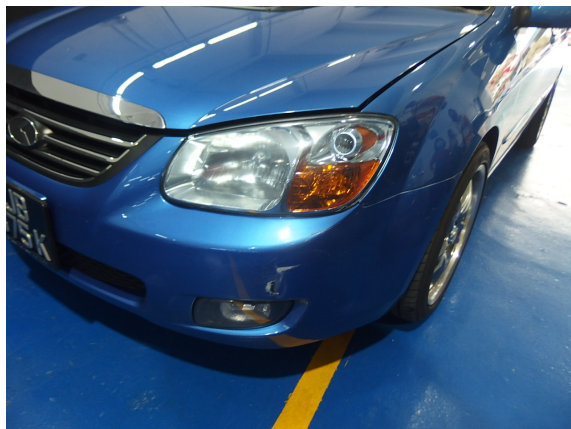
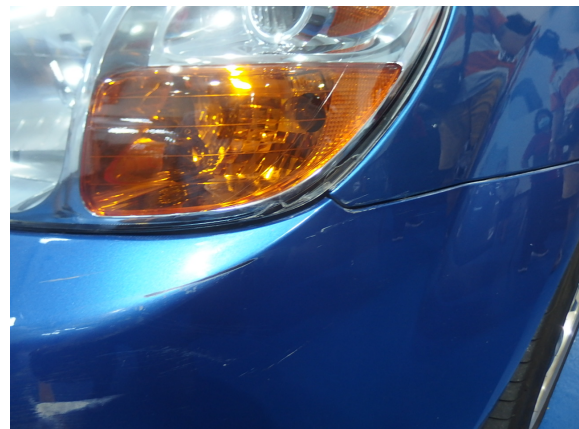
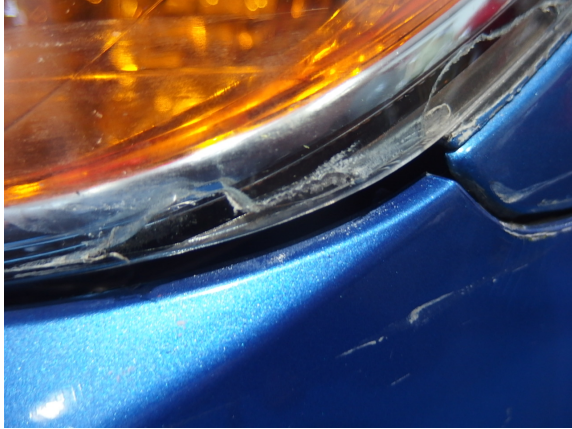
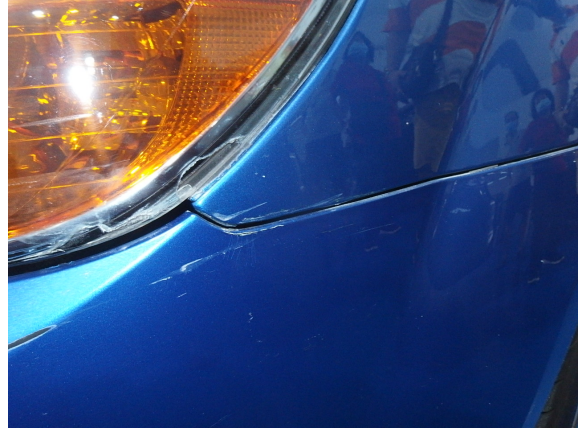
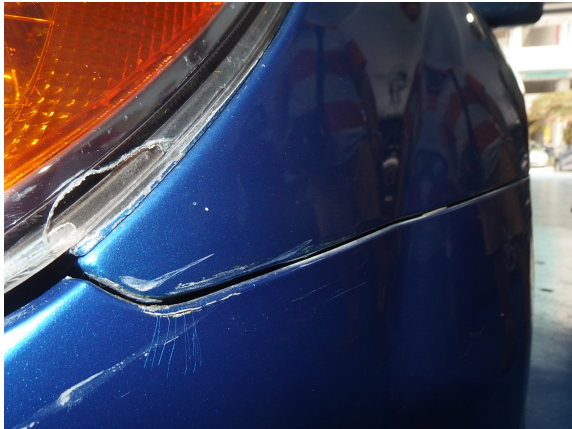
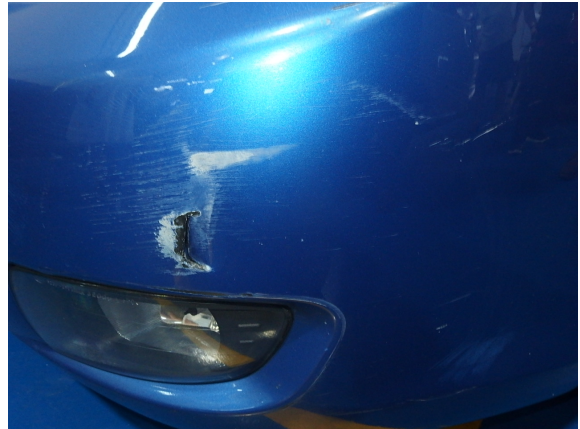
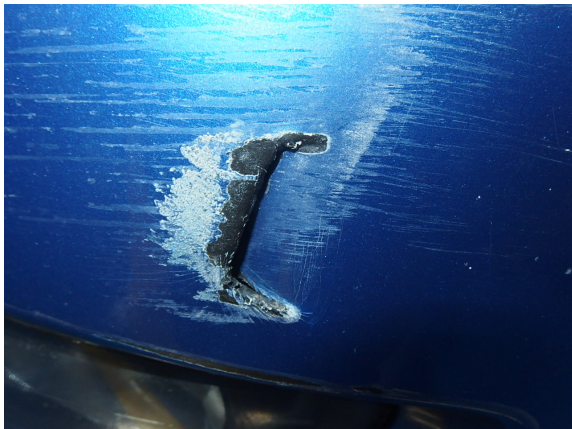
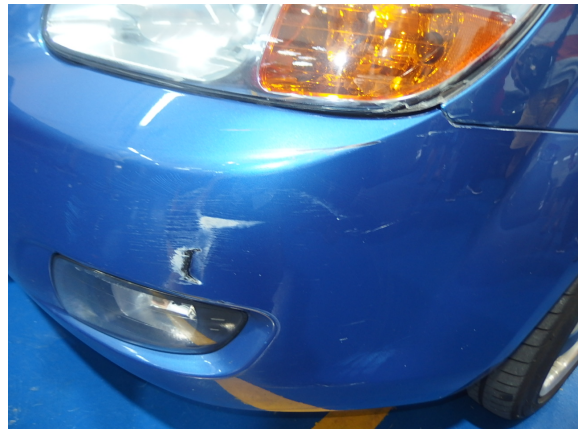
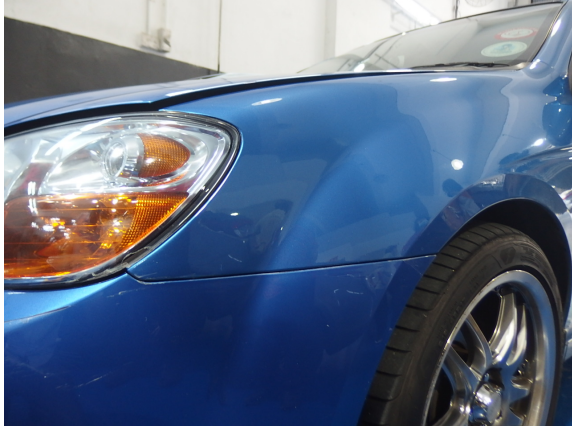
4. Description of Damages				
THE VEHICLE SUSTAINED DAMAGES AT THE N/S FRONT PORTION. DAMAGES SEE DETAILS.				
5. General Information				
Accident Date	02/10/2019	Inspection Date	02/09/2020	
Survey held at	HOCK WAH MOTOR WORKSHOP PTE LTD BLK 8 KAKI BUKIT AVENUE 4 PREMIER @ KAKI BUKIT (GATE 1) #02-54/55 SINGAPORE 415875			
5a. Remarks				
A)THE INSPECTION WAS CONDUCTED ON A"WITHOUT PREJUDICE" BASIS. B)IN ACCORDANCE TO YOUR INSTRUCTIONS, WE HAVE NOT AUTHORISED REPAIRS.				
5b. Estimate Days of Repair				
ESTIMATED NORMAL PERIOD FOR REPAIR:			2 Working Days

Qty	Description of Parts	Condition	Estimate By Workshop (\$)	Our Adjusted (\$)
	<u>REPLACEMENT OF PARTS</u>			
1	FRONT BUMPER	DEFORMED / TORN	416.00	416.00
1	FRONT BUMPER RETAINER LH	NOT NECESSARY	17.00	-
1	FRONT FENDER LH	TO REPAIR SEE LABOUR	257.00	-
1	HEADLAMP LH	CRACKED	404.00	404.00
1	FRONT BUMPER FOG LAMP LH	NOT NECESSARY	155.00	-
	LESS 10% DISCOUNT		-124.90	-82.00
			1,124.10	738.00
	<u>LABOUR</u>			
	LABOUR TO REMOVE & REFIT NECESSARY PARTS.INCLUSIVE OF THE REPAIR OF FRONT FENDER LH .		400.00	200.00
	SPRAY PAINT ON THE AFFECTED AREAS.		400.00	350.00
	ANTI-RUST COATING.	NOT NECESSARY	50.00	-
	WIRING .		40.00	20.00
			890.00	570.00
	GRAND TOTAL		2,014.10	1,308.00

RECOMMENDED COST OF LUMP SUM REPAIRS (TO ITS PRE-ACCIDENT CONDITION)			1,000.00
-----------------------------------------------------------------------------	--	--	-----------------
