LKK Auto Consultants Pte Ltd

ADJUSTMENT ON REPAIR COST FOR VEHICLE NO. SHD 212P

PHOTOGRAPHS FOR VEHICLE NO. SHD 212P

INSPECTION

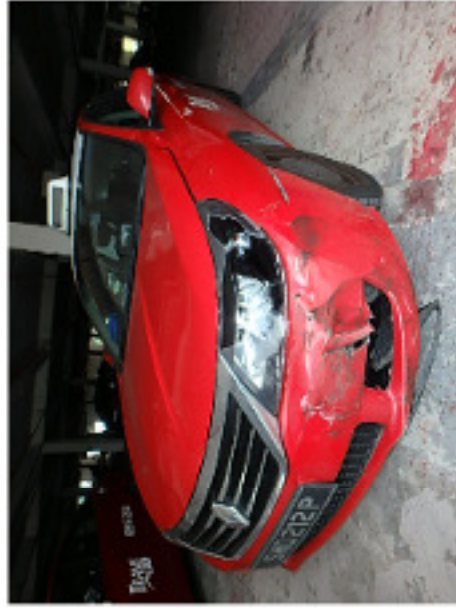
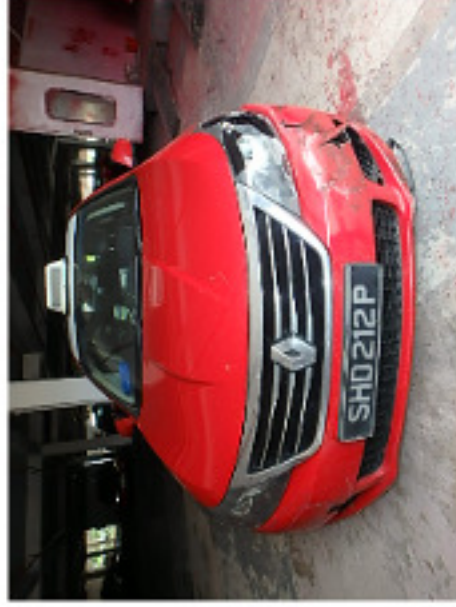
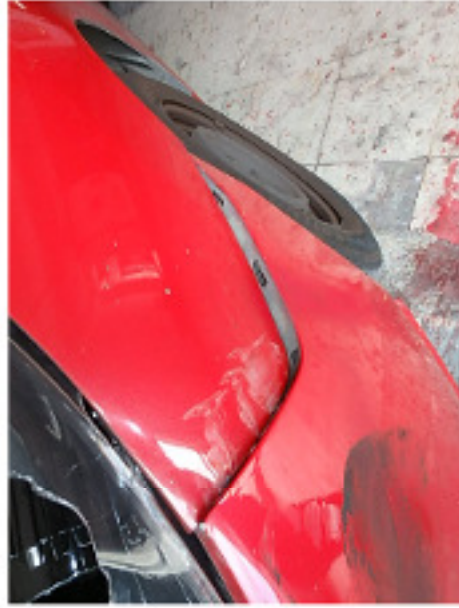
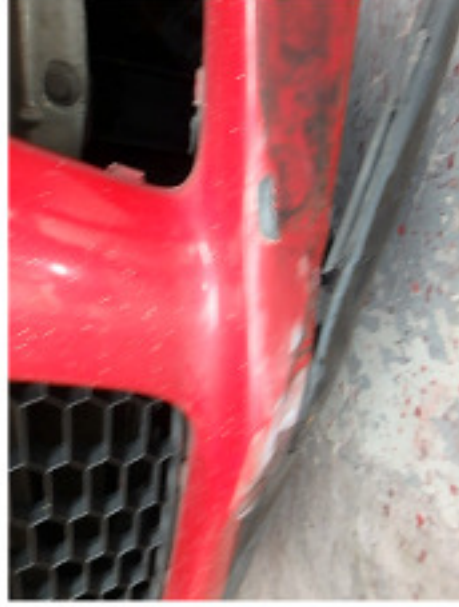
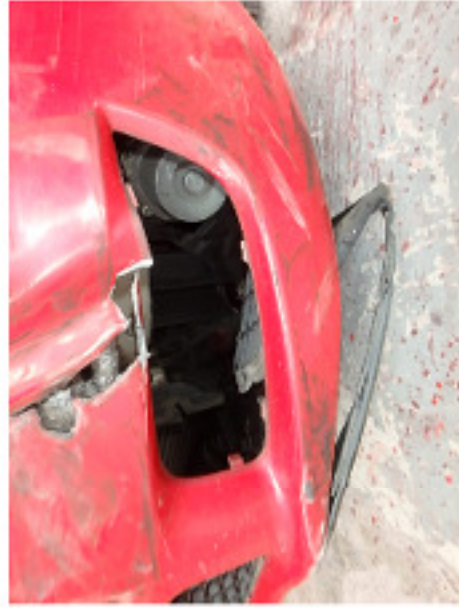
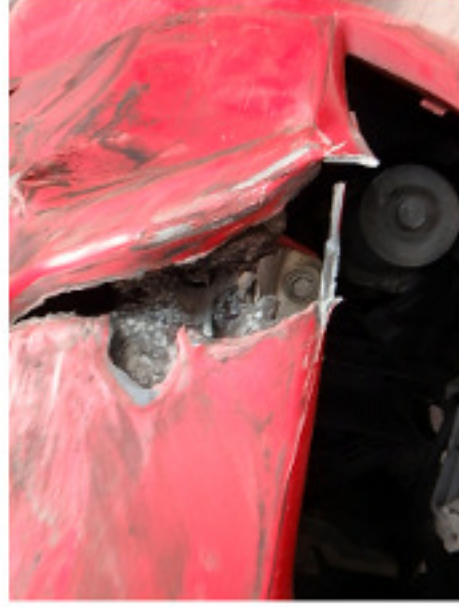
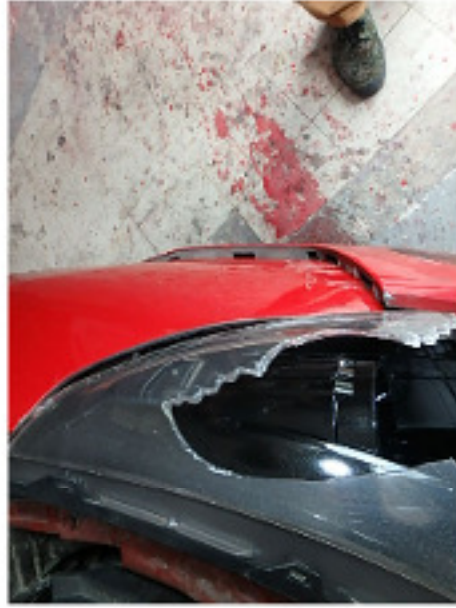
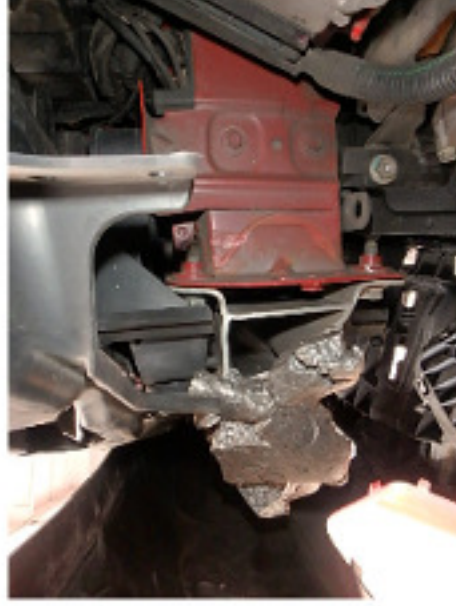
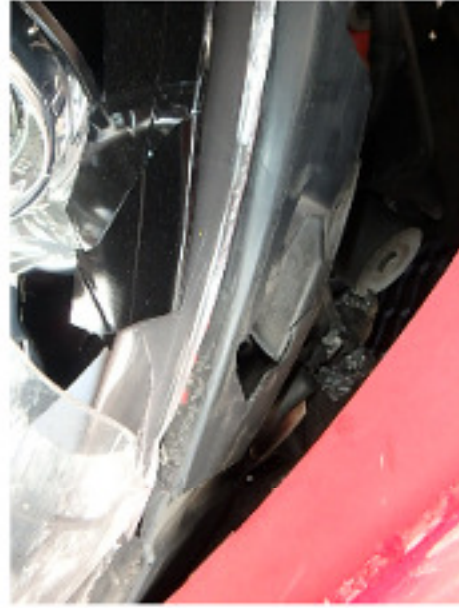
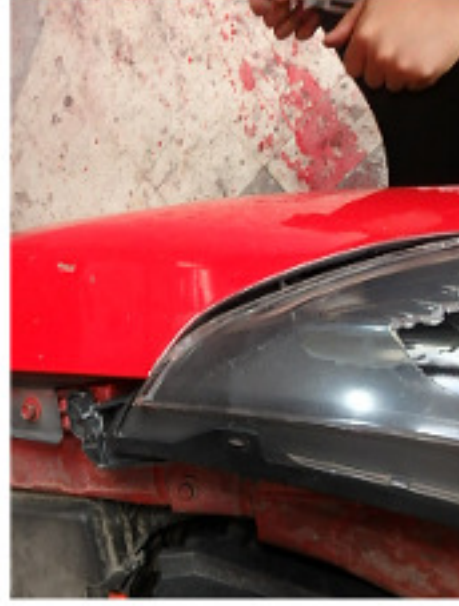
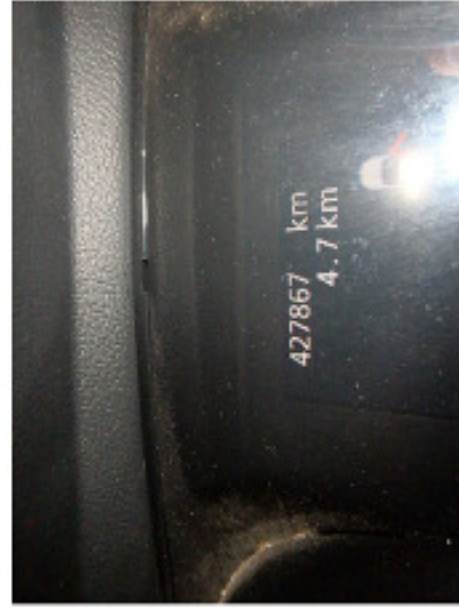
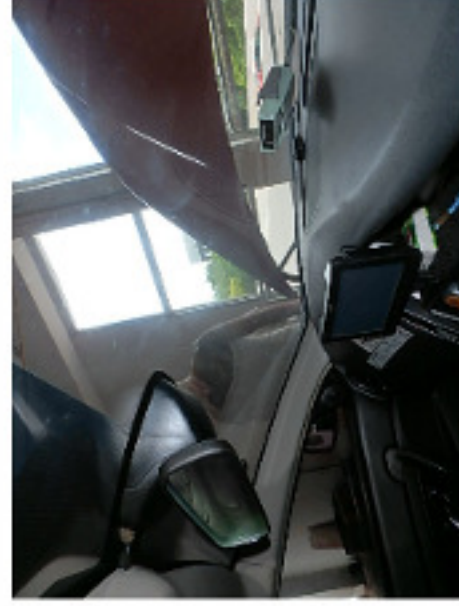
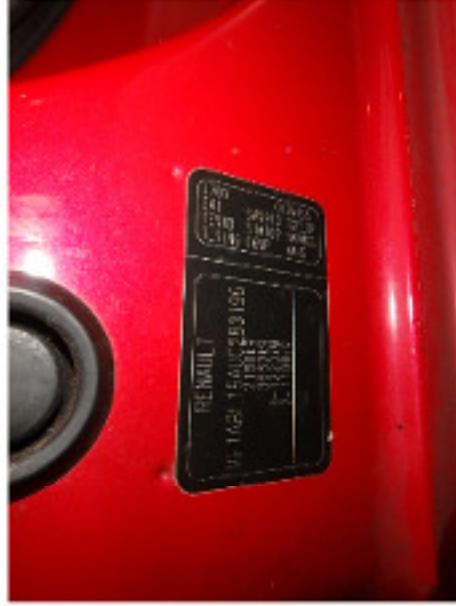
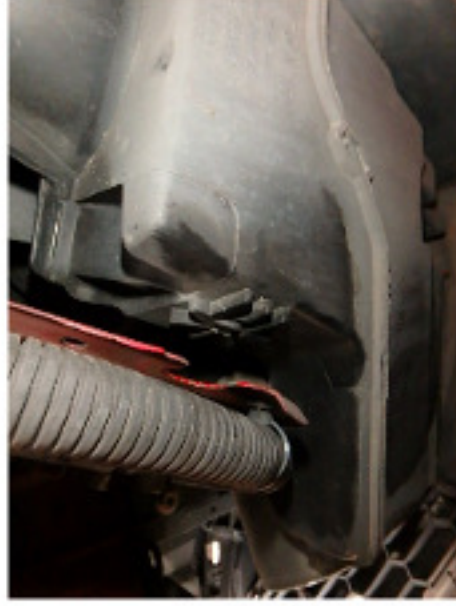
| THE VEHICLE SUSTAINED DAMAGES AT THE FRONT N/S PORTION. DAMAGES SEE DETAILS. |
