Vehicle No. SKN 7952C

#### DAMAGE ASSESSMENT REPORT

NTUC INCOME INSURANCE CO-OPERATIVE LTD Ref: CS/INC20000305/Qqd3n2

#### ADJUSTMENT ON REPAIR COST FOR VEHICLE NO. SKN 7952C

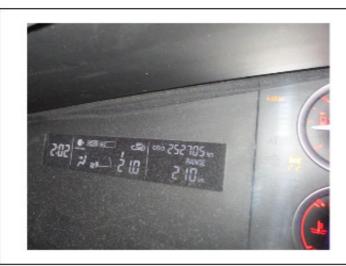
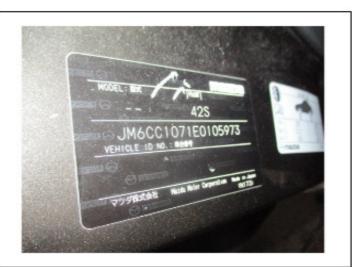
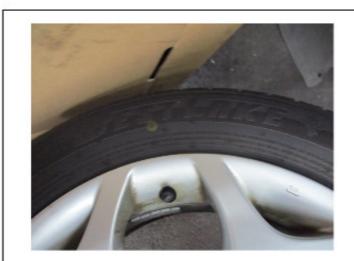
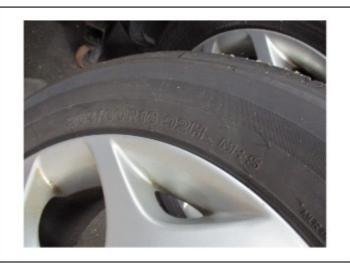
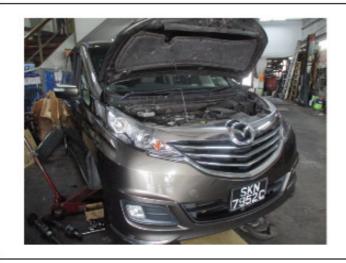
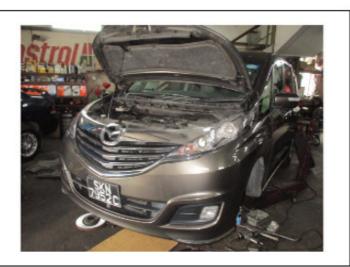
INSPECTION

| #05- | 3 BRAS BASAH ROAD<br>05-01 NTUC TRADE UNION HOUSESINGAPORE<br>89556 | | Date: 28-04-2020 | | | | | | |
|---|---|--|---|---|--|--|--|--|--|
| | THE VEHICLE SUSTAINED DAMAGES AT THE FRONT PORTION. | | | | | | | | |
