Your Ref: S0M02C8S
Our Ref : CS/ASM20000382/P

**TECHNICAL INVESTIGATION REPORT OF FIRE INCIDENT INVOLVING THE
INSURED VEHICLE SGK 8626B ON 31st December 2019**

Vehicle Registration No.	: SGK 8626B
Make / Model	: TOYOTA ESTIMA 2.4A AERAS (A) SR
Chassis No	: ACR500077040
Year of Registration	: DEC 2009
Mileage	: N.A (wiring affected)
5. The Insured Vehicle was noted to have sustained fire damage that was confined to its front right portion. The interior compartment, left, right and rear portion was observed to be unaffected by the fire.
6. The fire had resulted in the body parts at the front right portion of the Insured Vehicle to be burnt. This had included its front windscreen, right headlamp, bonnet, bumper and several parts inside the engine compartment were also observed to sustain heat damage. This includes the timing cover, fuse box, coolant fluid reservoir, brake fluid reservoir and its factory wiring harness. See photos 1 – 12 below.

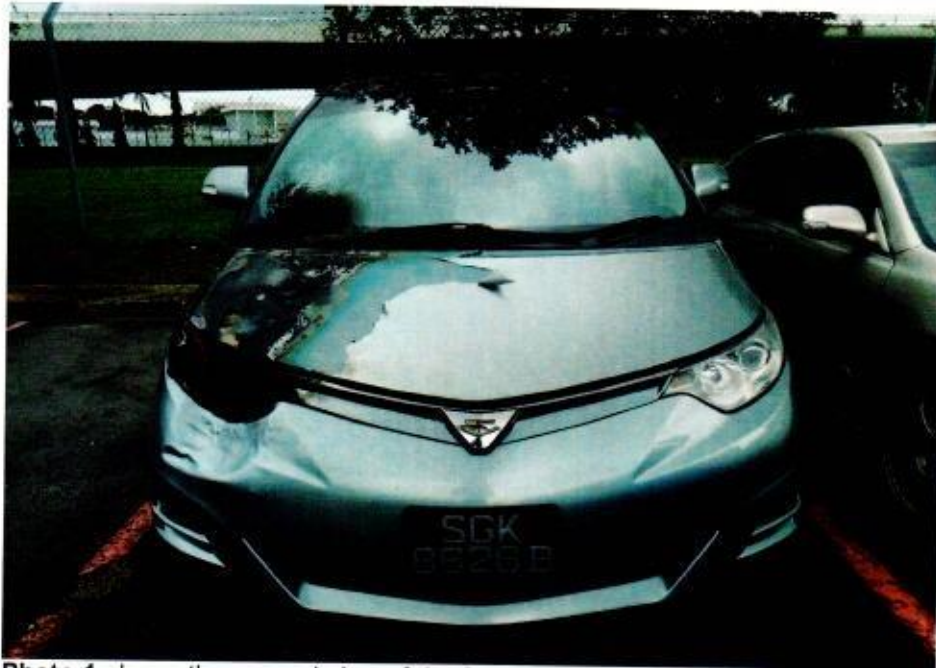
Photo 1 shows the general view of the front portion of the Insured Vehicle at the time of our inspection. The fire damage to the Insured Vehicle was confined to its front right portion. Its front windscreen, right headlamp, bonnet, bumper and several parts inside the engine compartment were also observed to sustain heat damage. This includes the timing cover, fuse box, coolant fluid reservoir, brake fluid reservoir and its factory wiring harness., are amongst the body parts that were found to have been affected as a result of the fire.

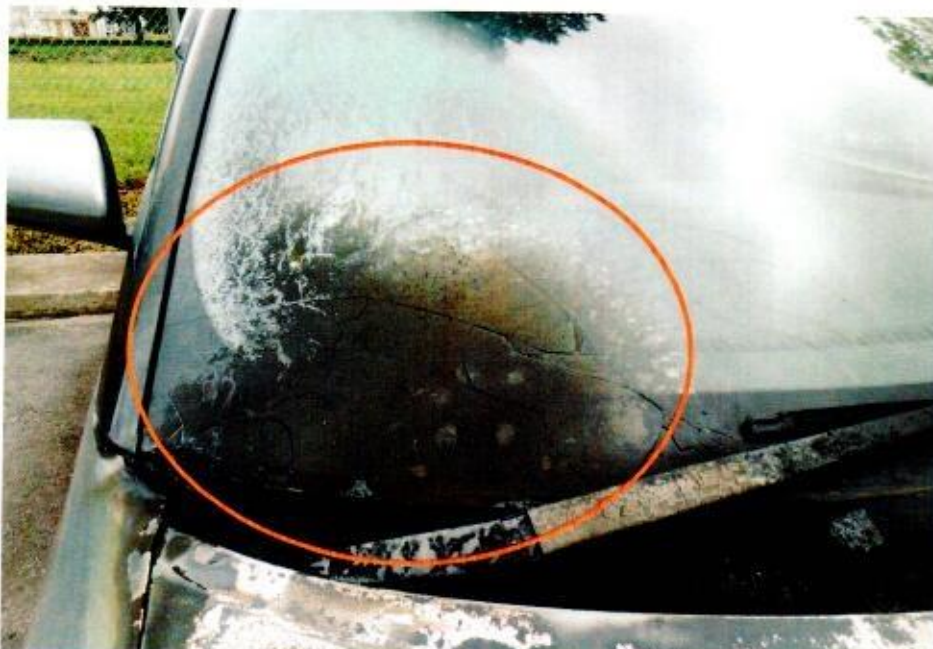
Photo 2 shows the close-up view of the front portion of the Insured Vehicle at the time of our inspection. The fire damage to the Insured Vehicle was confined to its front right portion. As observed its front windscreen (circled) had suffered heat and smoke damage as a result of the fire.

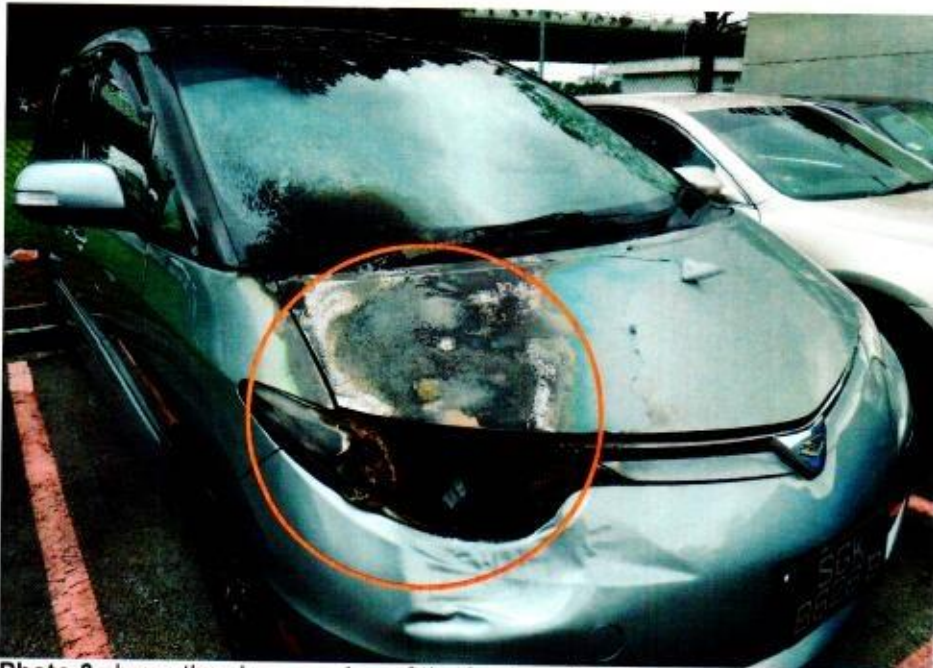
Photo 3 shows the close-up view of the front portion of the Insured Vehicle at the time of our inspection. The fire damage to the Insured Vehicle was confined to its front right portion. As observed whitish burn marks (circled) on the surface are a result of exposure to prolonged heat intensity as a result of the fire.

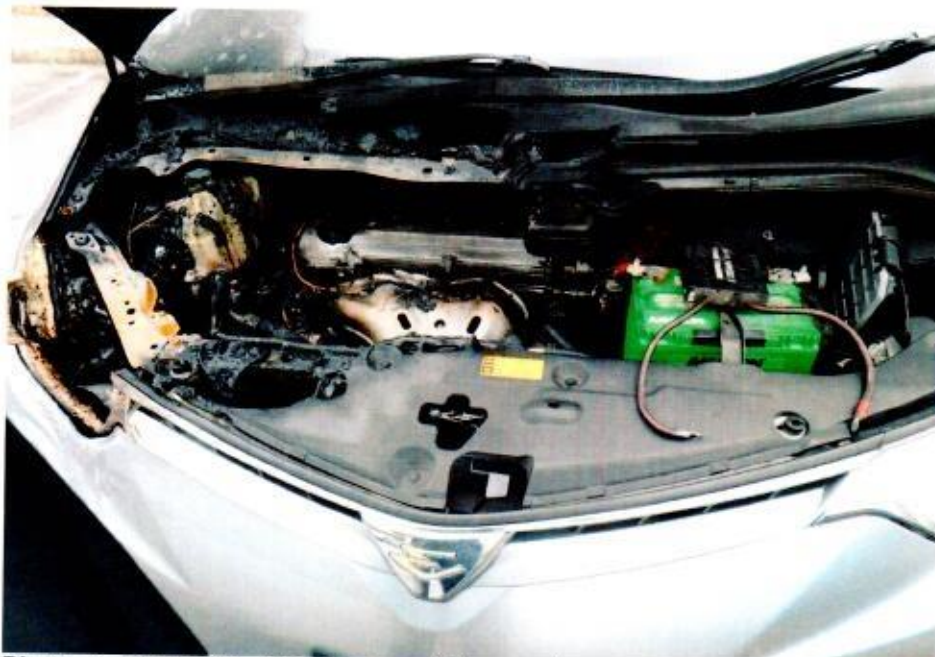
Photo 4 shows the general view of the engine compartment of the Insured Vehicle at the time of our inspection. The fire damage to the Insured Vehicle was confined to its front right portion. Its front windscreen, right headlamp, bonnet, bumper and several parts inside the engine compartment were also observed to sustain heat damage. These includes the timing cover, fuse box, coolant fluid reservoir, brake fluid reservoir and its factory wiring harness, are amongst the body parts that were found to have been affected as a result of the fire.

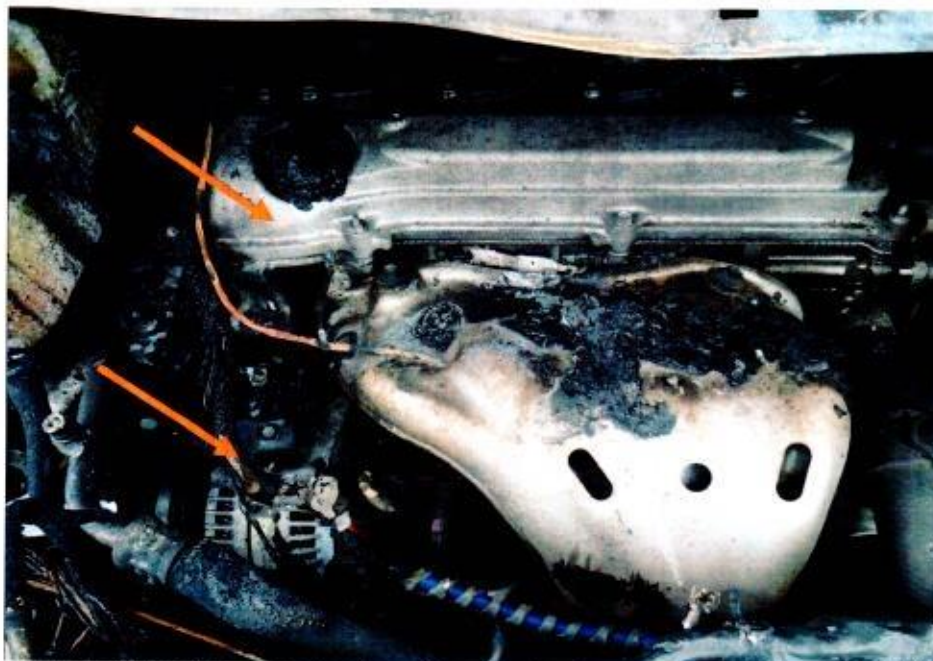
Photo 5 shows the close-up view of the front engine compartment portion of the Insured Vehicle at the time of our inspection. Its timing cover and its factory wiring harness (arrowed) were damaged as a result of the fire.

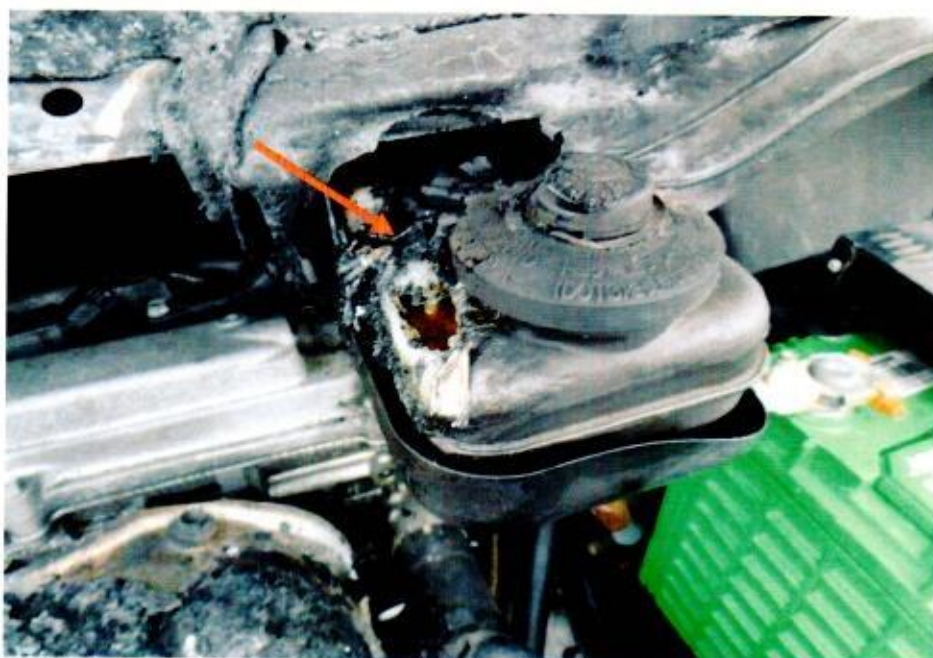
Photo 6 shows the close-up view of the front engine compartment portion of the Insured Vehicle at the time of our inspection. Its brake fluid reservoir (arrowed) was damaged as a result of the fire.

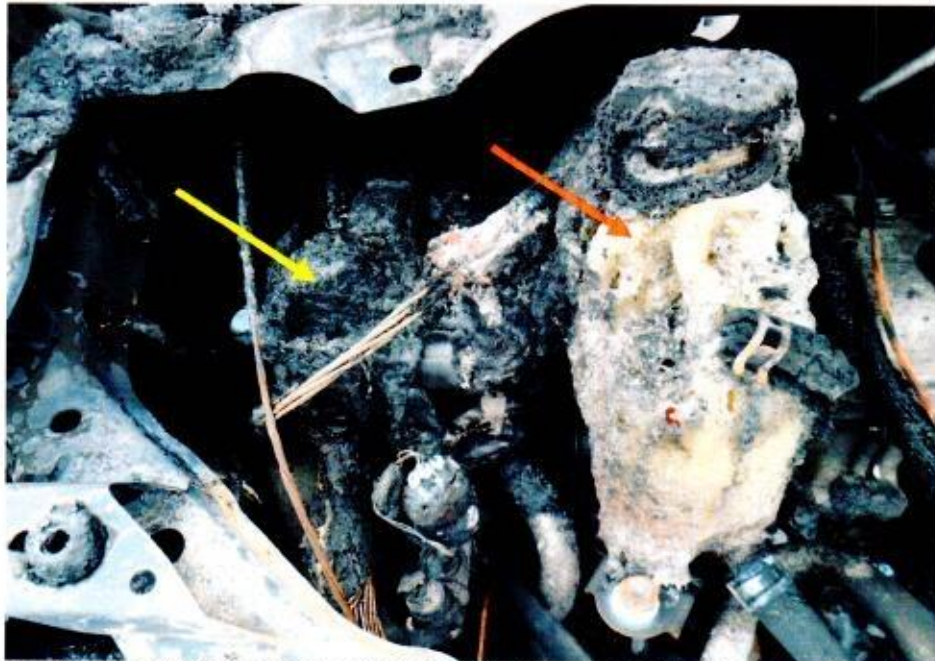
Photo 7 shows the close-up view of the front engine compartment portion of the Insured Vehicle at the time of our inspection. Its coolant fluid reservoir (red arrow) and fuse box (yellow arrow) were damaged as a result of the fire.

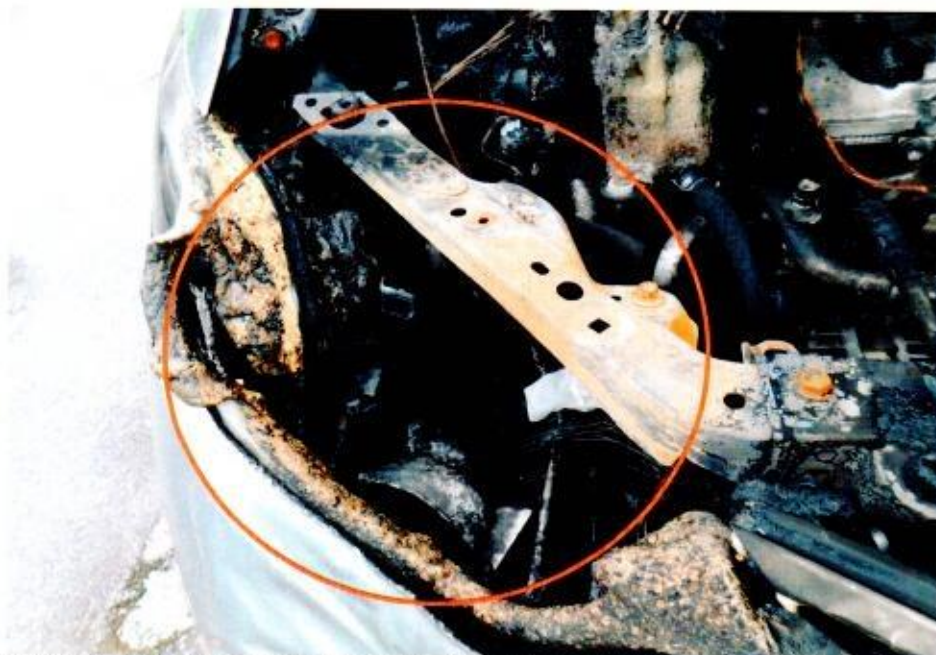
Photo 8 shows the close-up view of the front right head lamp portion of the Insured Vehicle at the time of our inspection. The whole of the head lamp including its housing and its factory wiring harness (circled) were damaged and melted down as a result of the fire.

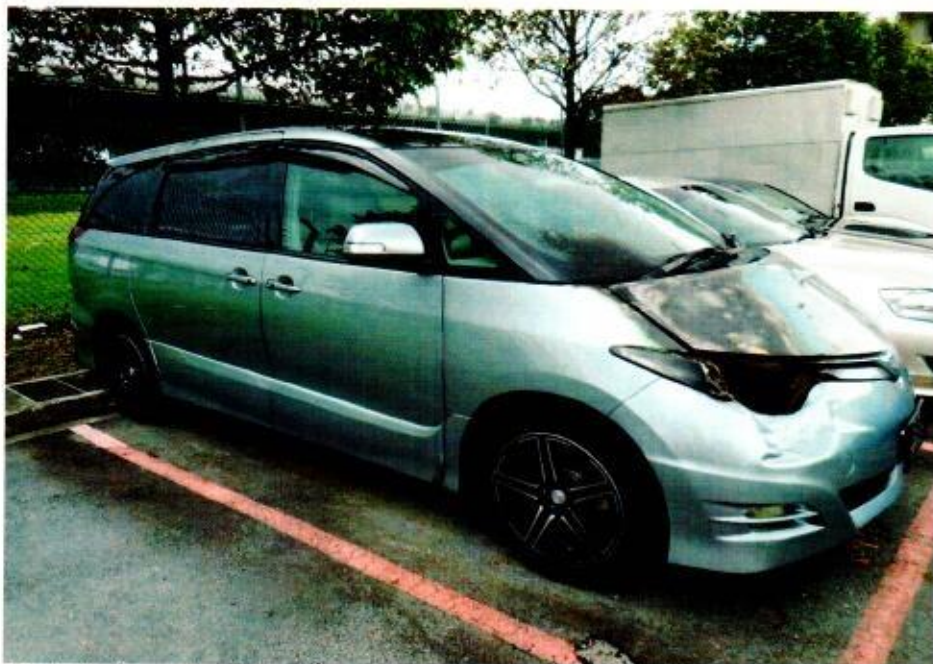
Photo 9 shows the right portion of the Insured Vehicle, which was observed to be unaffected by the fire.

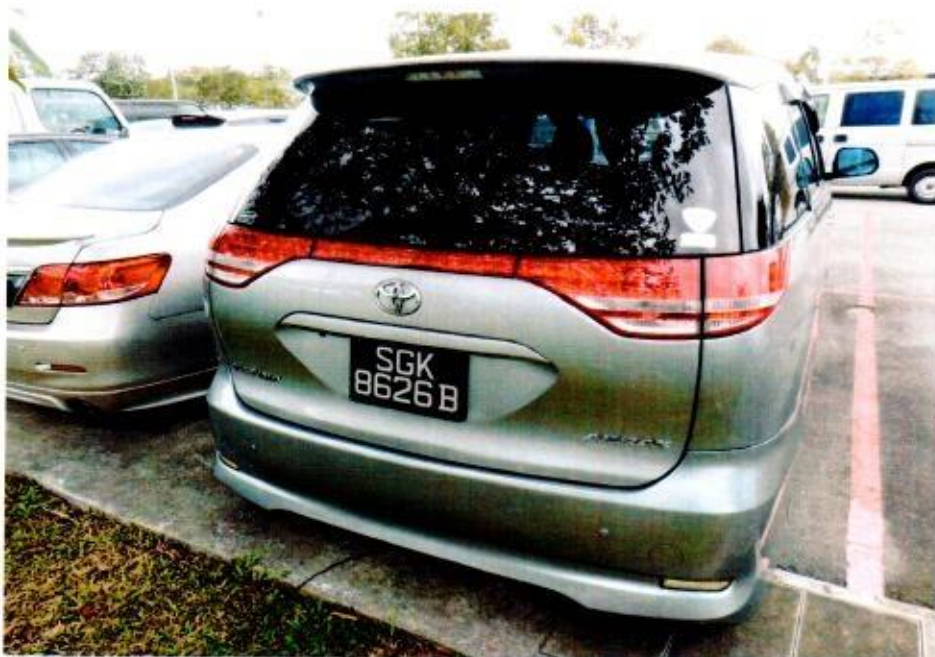
Photo 10 shows the rear portion of the Insured Vehicle, which was observed to be unaffected by the fire.

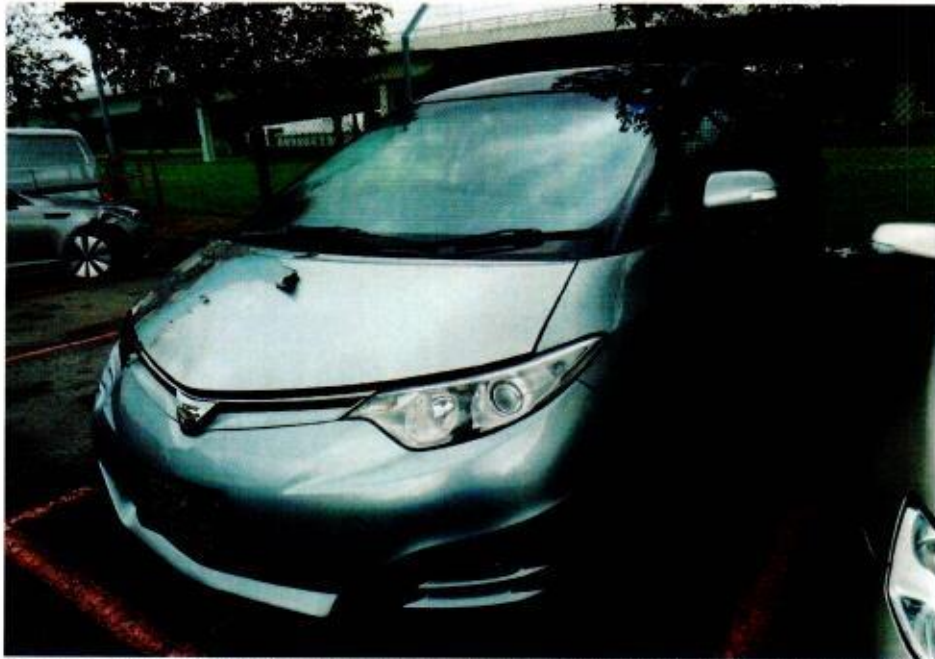
Photo 11 shows the left portion of the Insured Vehicle, which was observed to be unaffected by the fire.

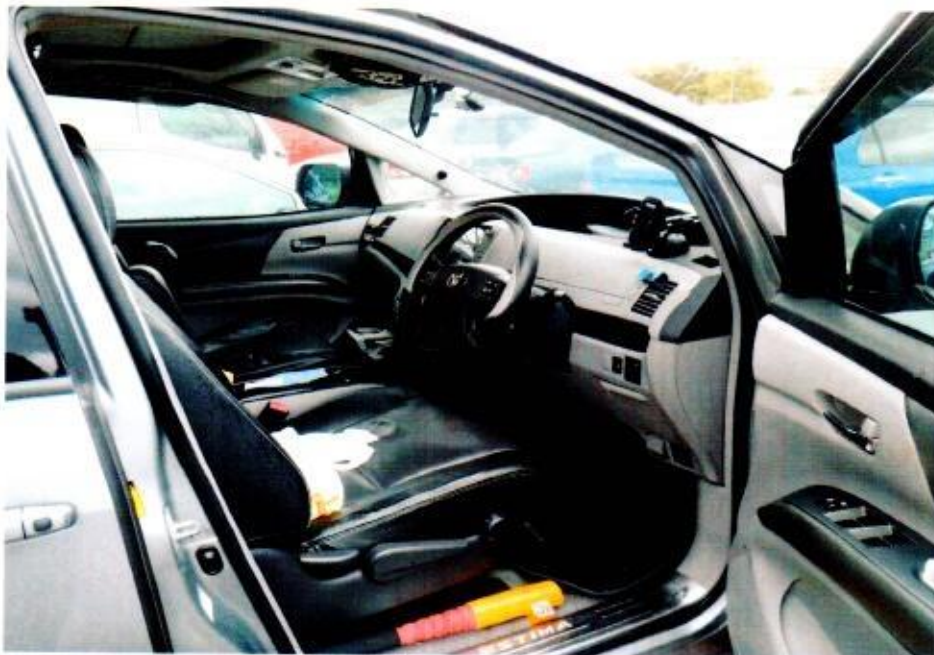
Photo 12 shows the interior compartment of the Insured Vehicle, which was observed to be unaffected by the fire.

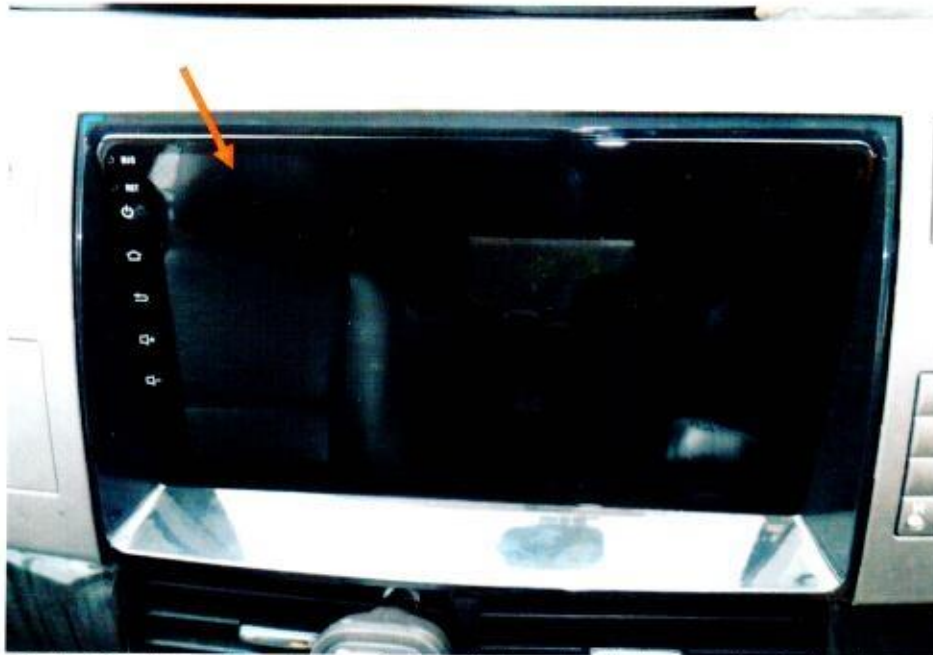
Photo 13 shows the aftermarket audio head unit (arrowed) of the Insured Vehicle, which was observed to be unaffected by the fire.

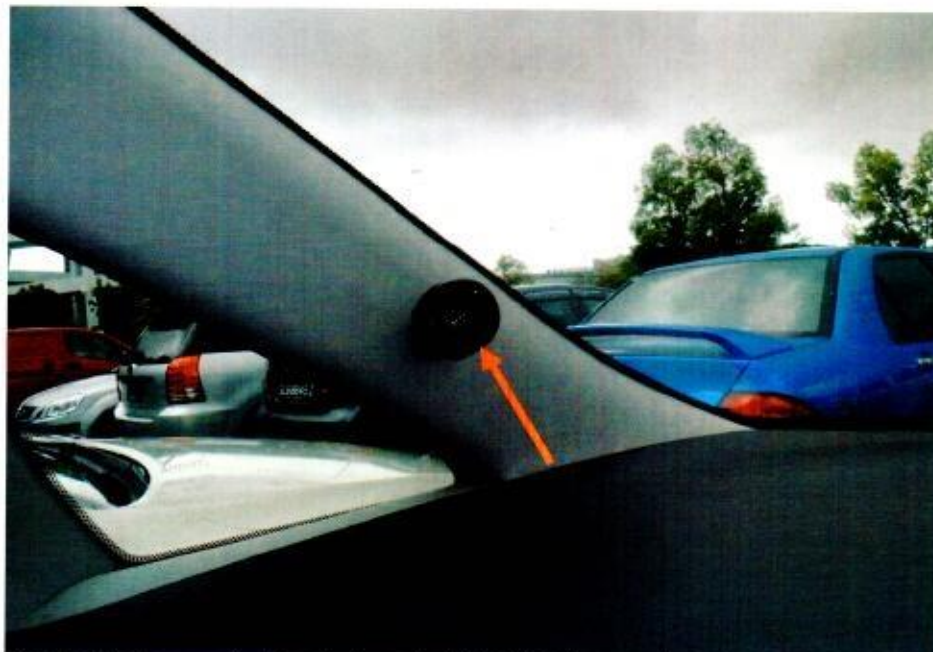
Photo 14 shows pair of audio tweeter (left side) (arrowed) of the Insured Vehicle, which was observed to be unaffected by the fire.

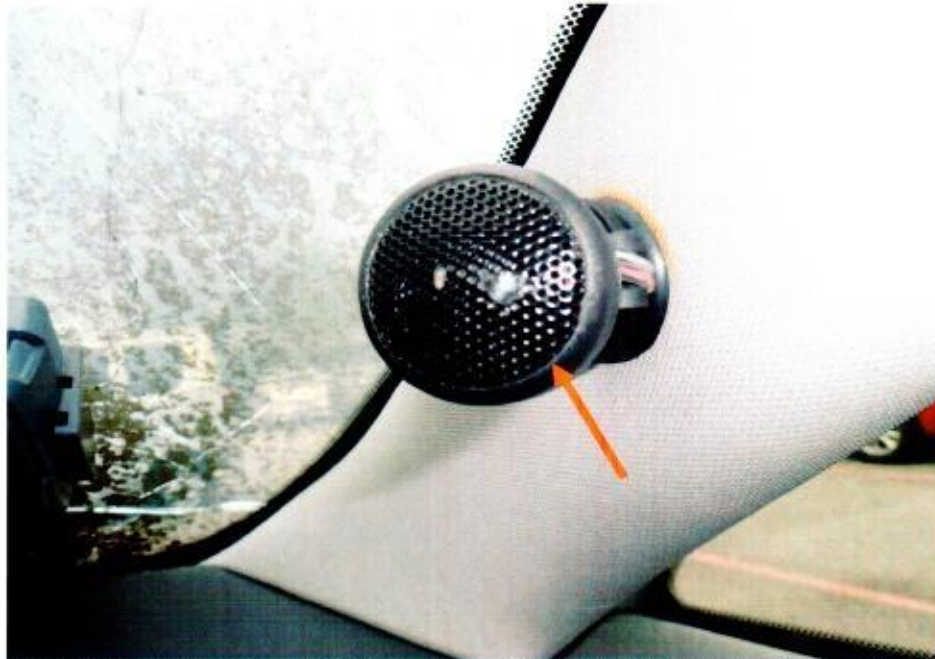
Photo 15 shows pair of audio tweeter (right side) (arrowed) of the Insured Vehicle, which was observed to be unaffected by the fire.

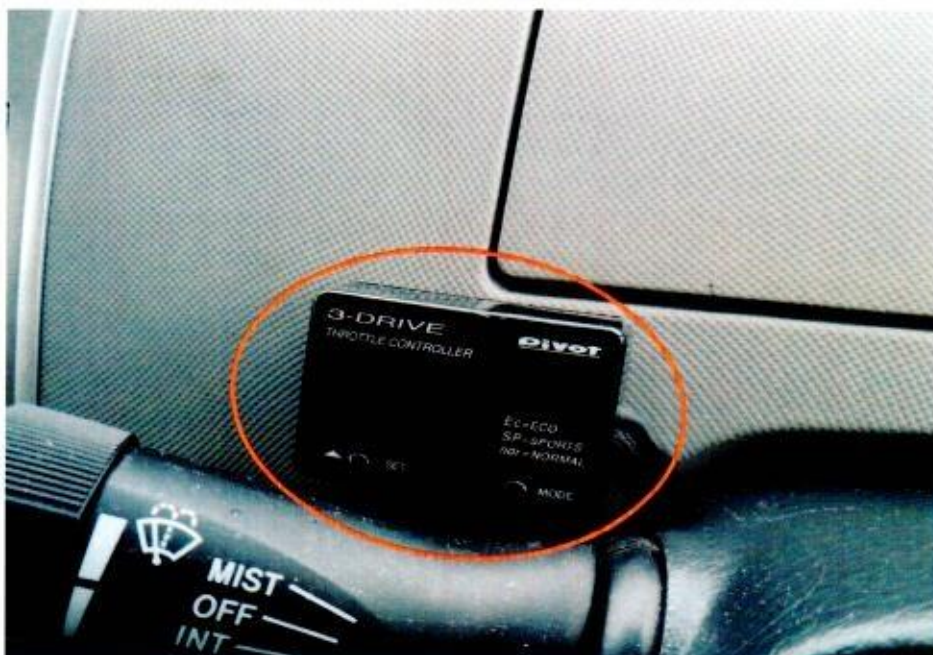
Photo 16 shows aftermarket electronic throttle pedal controller unit of the Insured Vehicle, which was observed to be unaffected by the fire.

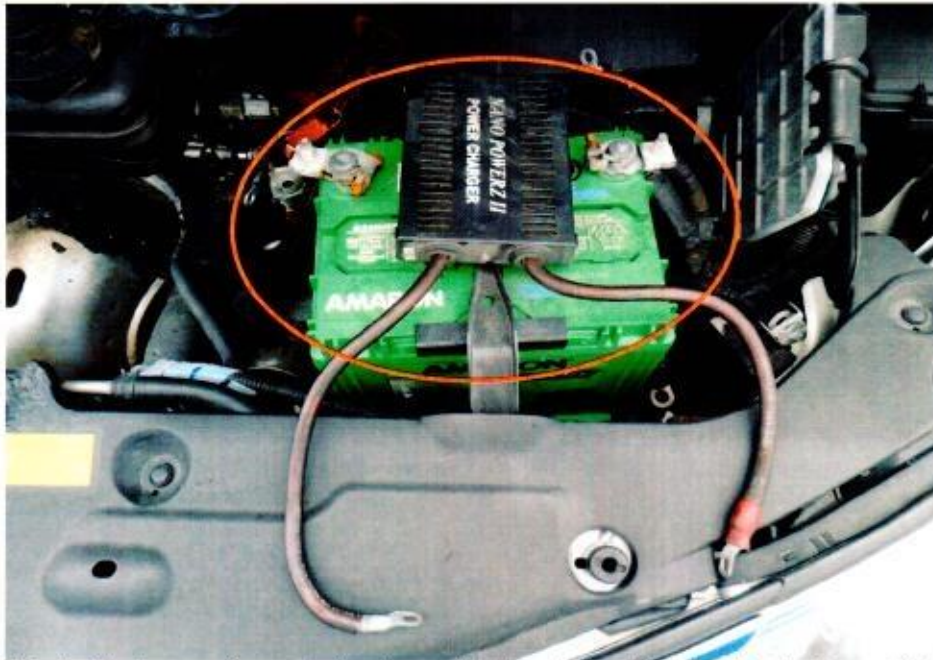
Photo 17 shows aftermarket voltage stabilizer left unfitted on the battery of the Insured Vehicle, which was observed to be unaffected by the fire. At the time of inspection.

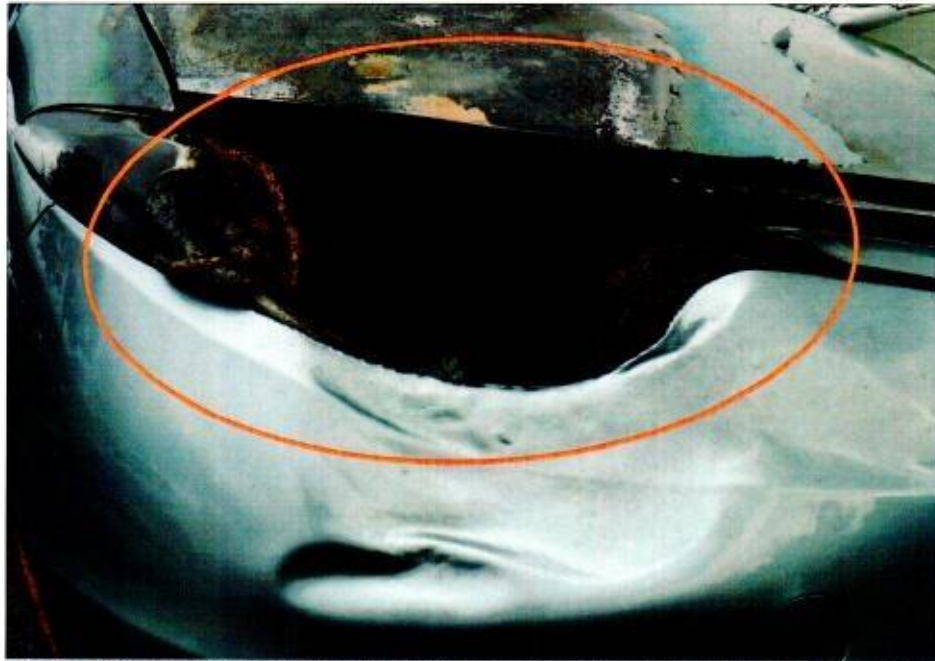
8. For this particular case, the fire appears to have been of electrical nature originated from the right portion of the Insured Vehicle, where the headlamp assembly with the light bulbs are located as the nature of fire damage was confined to these particular areas. This can be determined from the burn pattern of the front right headlamp assembly components which were observed to have been partly melted from the high heat intensity and the high heat intensity burn marks (whitish burn marks) found on the metal parts around the Insured Vehicle. Rust had also developed on these metal brackets.

Photo 18 shows the burnt front right headlamp of the Insured Vehicle at the time of our inspection. The headlamp (circled) was complete burned and melted away. Due to heat rises, the prolonged high heat intensity confined to this area caused high heat intensity the surrounding area has suffered heat damage and melted.

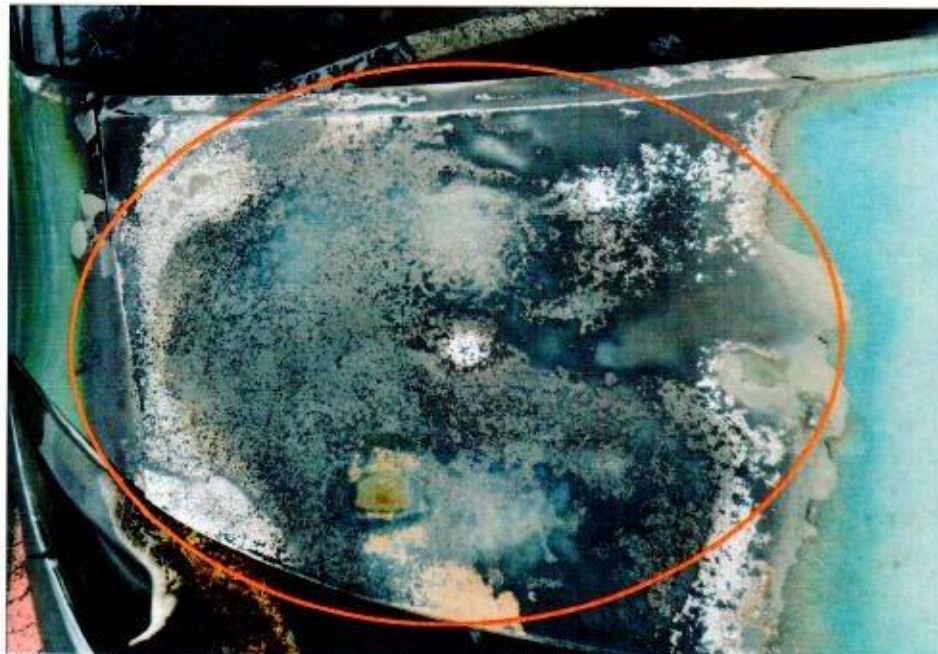
9. The whitish burn marks are a result of exposure to prolonged heat intensity. Rust would normally start to develop around these areas soon after a fire as prolonged exposure to high heat intensity usually causes steel/metal material body parts to be exposed to natural environmental condition. The rust that had developed on the metal brackets is an indication that the front right position of the Insured Vehicle had sustained exposure to prolonged high heat intensity. See photos 18 - 21 below.

Photo 19 shows the exterior front bonnet of the Insured Vehicle, which is situated above the burnt headlamp at the time of our inspection. Due to heat rises, the prolonged high heat intensity confined to this area caused high heat intensity burn marks (whitish burn marks) and rust development on the surface of the metal bonnet of the Insured Vehicle. (circled).

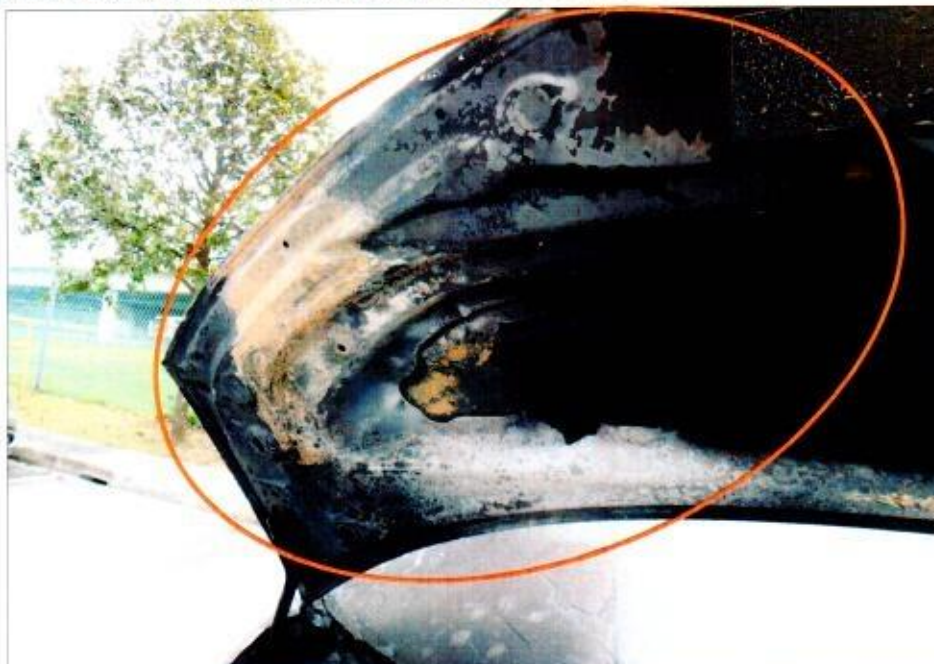
Photo 20 shows the interior front bonnet of the Insured Vehicle, which is situated above the burnt headlamp at the time of our inspection. Due to heat rises, the prolonged high heat intensity confined to this area caused high heat intensity burn marks (whitish burn marks) and rust development on the surface of the metal bonnet of the Insured Vehicle. Rust had also developed on the surface. (circled).

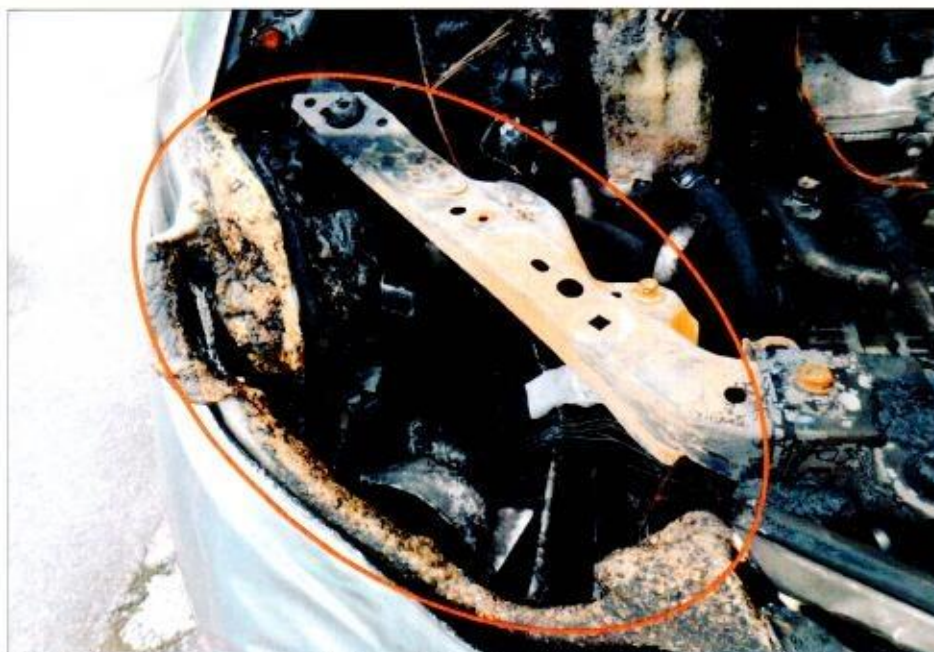
Photo 21 shows a general view of the front right headlamp assembly (circled) and the various surrounding components. The headlamp assembly and various components was observed to be melted from the high heat intensity. Rust development was also observed on the metal brackets of the Insured Vehicle.

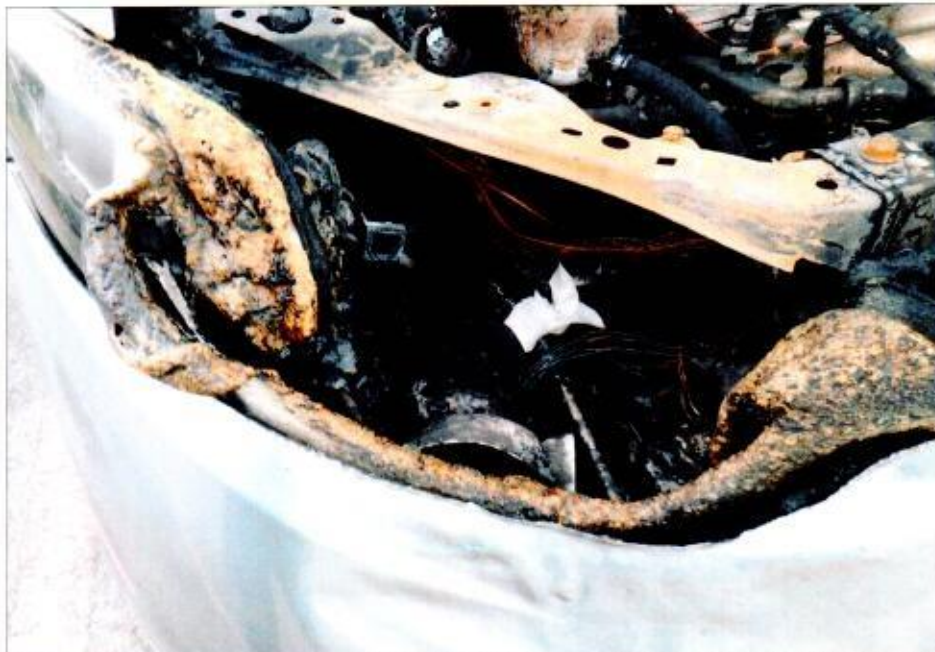
10. Upon closer examination of the front right portion of the Insured Vehicle which was where the fire had likely started, we had found traces of greenish residue on the wirings leading from the halogen light bulb to the fuse box. Both the halogen light bulb and fuse box were factory fitted. The presence of greenish residue indicates internal heating of copper wires, a sign of an electrical short circuit occurring. The greenish residue is normally left behind from oxidation as a result of chemical reaction involving the copper wires. This physical evidence would then appear to suggest that the cause of fire to the Insured Vehicle could have possibly been due to electrical in nature. See photos 22 - 25 below.

Photo 22 shows general view of the wirings leading from the halogen light bulb to the fuse box. Both the halogen light bulb and fuse box were factory fitted. The presence of greenish residue indicates internal heating of copper wires, a sign of an electrical short circuit occurring. The greenish residue is normally left behind from oxidation as a result of chemical reaction involving the copper wires.

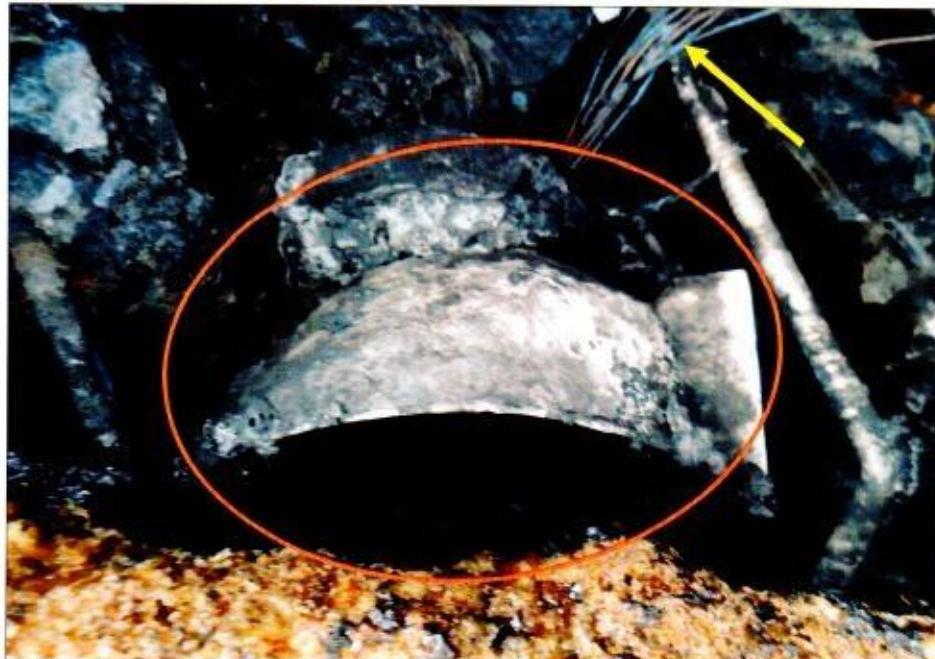
Photo 23 shows the close-up view of the headlamp. Observed was greenish residue on the wiring harness leading (arrowed) from the headlamp light bulb (circled). to the fuse box Observed was greenish residue on the wiring harness. The presence of greenish residue indicates internal heating of copper wires, a sign of an electrical short circuit occurring. The greenish residue is normally left behind from oxidation as a result of chemical reaction involving the copper wires.

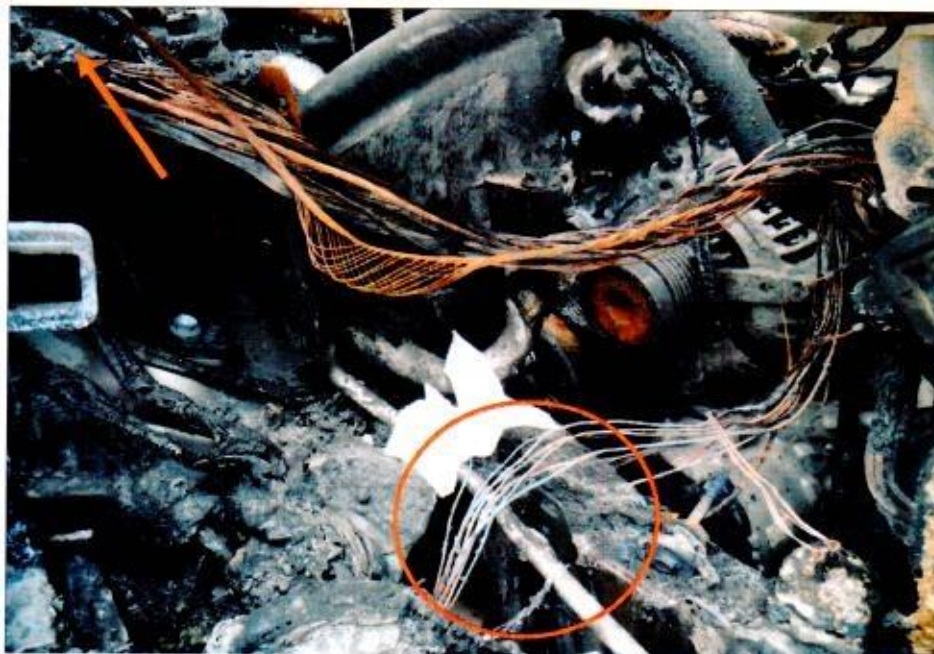
Photo 24 shows the close-up view of the wiring harness from the headlamp. Observed was greenish residue on the wiring harness (circled) leading from the headlamp light bulb to the fuse box (arrowed) Observed was greenish residue on the wiring harness. The presence of greenish residue indicates internal heating of copper wires, a sign of an electrical short circuit occurring. The greenish residue is normally left behind from oxidation as a result of chemical reaction involving the copper wires.

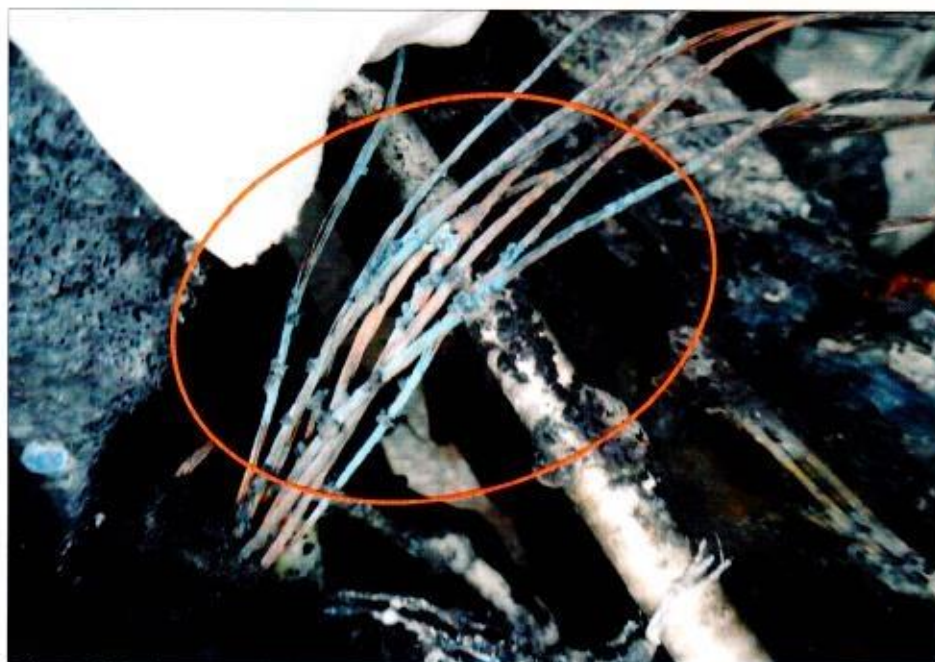
Photo 25 shows a closer view of the greenish residue found on the wirings (circled) of the light bulb leading to the fuse box of the Insured Vehicle. This seems to suggest the occurrence of an electrical short circuit.

22. Having investigated and technically analysed the damages of burnt nature to the Insured Vehicle, we are of the view that the cause of fire to the Insured Vehicle was of short circuit from the halogen light bulbs wirings to the fuse box that caused the fire. For this particular case, the fire had originated from the front right headlight of the Insured Vehicle.
23. We did not find any evidence which had suggested that the cause of fire to the Insured Vehicle was due to poor maintenance and/or recurring electrical problem.
24. Our investigations had also revealed that at the time of writing this report, there is no manufacturer recall to similar make and model vehicle as the Insured Vehicle that may possibly be related to this incident.
