### DAMAGE ASSESSMENT REPORT

## ADJUSTMENT ON REPAIR COST FOR VEHICLE NO. SLE 8868S

PHOTOGRAPHS FOR VEHICLE NO. SLE 8868S

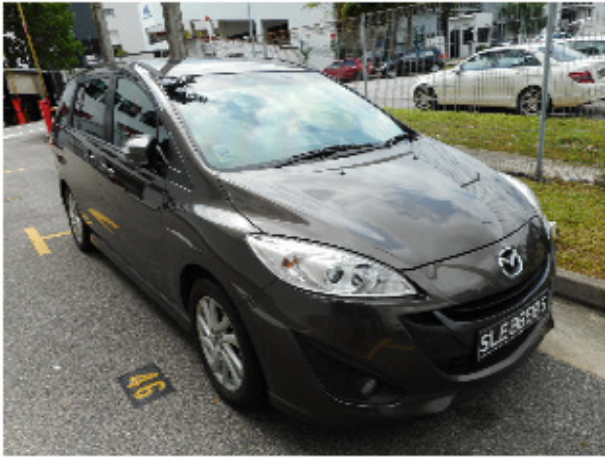
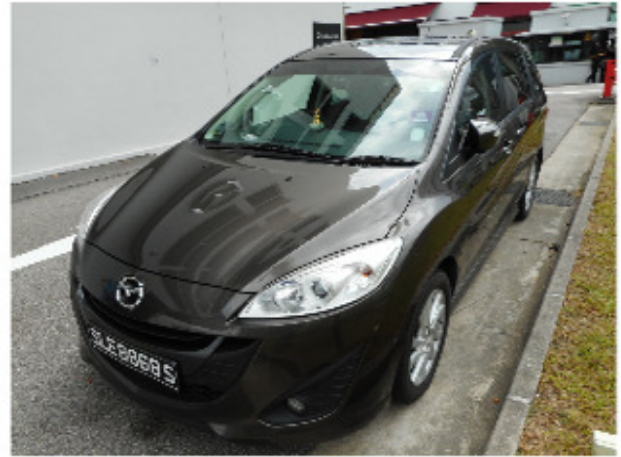
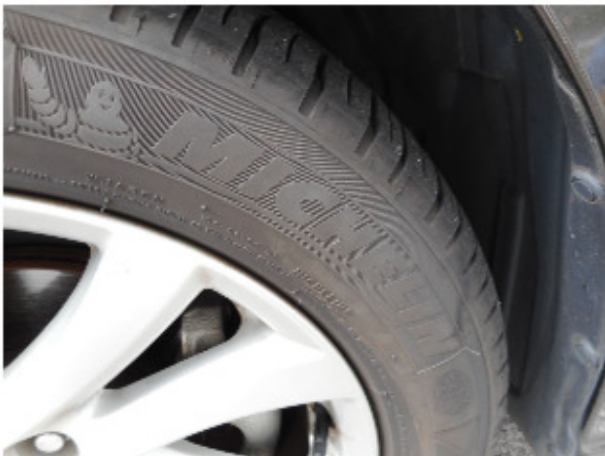
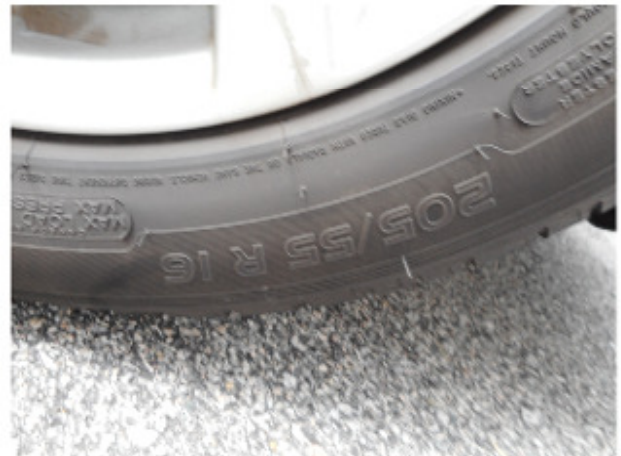
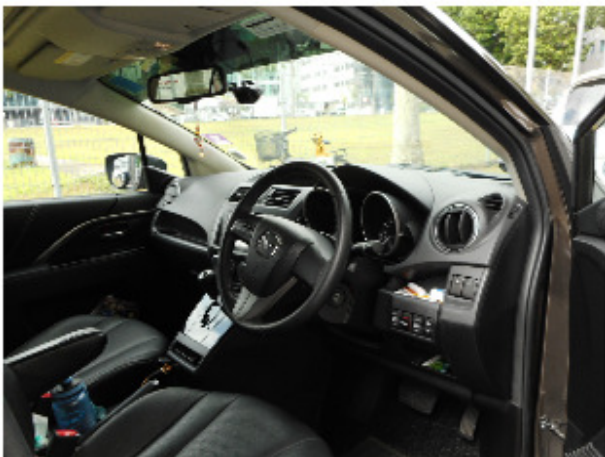
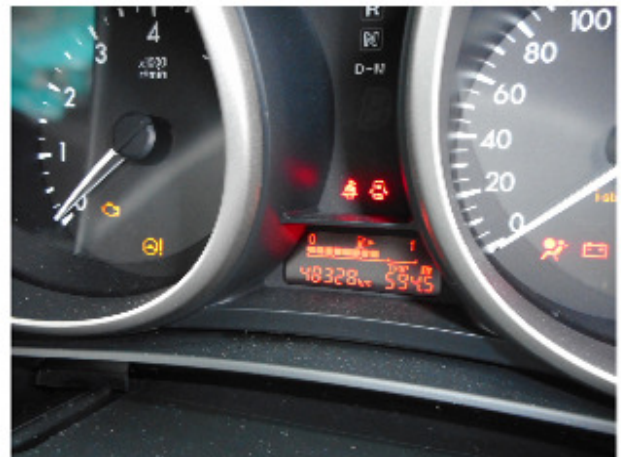
THE VEHICLE SUSTAINED DAMAGES AT THE FRONT O/S PORTION.  DAMAGES SEE DETAILS.
-------------------------------------------------------------------------------------
