CVR Accident Photos

VEHICLE DETAIL

Vehicle No	QX1113Z / SLA2056D	Date Of accident	
Date Booked In		Date of Submission

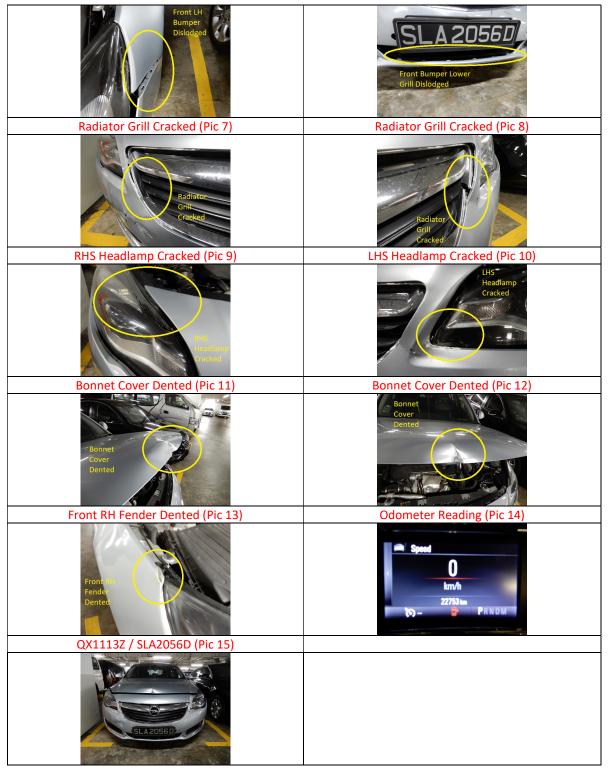
Front LH Bumper Dented & Scratched (Pic 1)	Front LH Bumper Scratched (Pic 2)	
Howal H Bumper Dented & Scratched	Front LH Bumper Scratched	
Front Bumper Cracked (Pic 3)	Front RH Bumper Misaligned (Pic 4)	
Front Cracked	Front RH Bumper Misaligned	
Front LH Bumper Dislodged (Pic 5)	Front Bumper Lower Grill Dislodged (Pic 6)

- 1. Remove Front Bumper (Pic 1-3)
- 2. Remove Front Bumper Reinforcement
- 3. Remove Front RH Bumper Retainer (Pic 4)
- 4. Remove Front LH Bumper Retainer (Pic 5)

- 10. Replace Front Bumper (Pic 1-3)
- 11. Replace Front Bumper Reinforcement
- 12. Replace Front RH Bumper Retainer (Pic 4)
- 13. Remove Front LH Bumper Retainer (Pic 5)

- 18. Replace Bonnet Cover (Pic 11-12)
- 19. Wiring for RHS & LHS Headlamp (Pic 9-10)
- 20. Panel Beating for Front RH Fender (Pic 13)
- 21. Putty & Spray Paint for Front Complete Bumper (Pic 1-3)
