## LKK Auto Consultants Pte Ltd

### ADJUSTMENT ON REPAIR COST FOR VEHICLE NO. SLJ 2624S

PHOTOGRAPHS FOR VEHICLE NO. SLJ 2624S

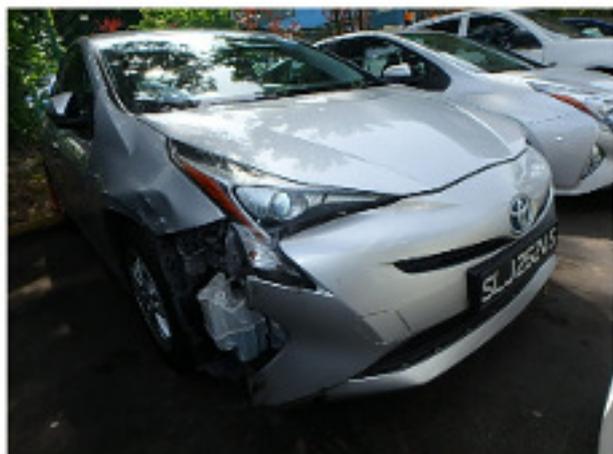
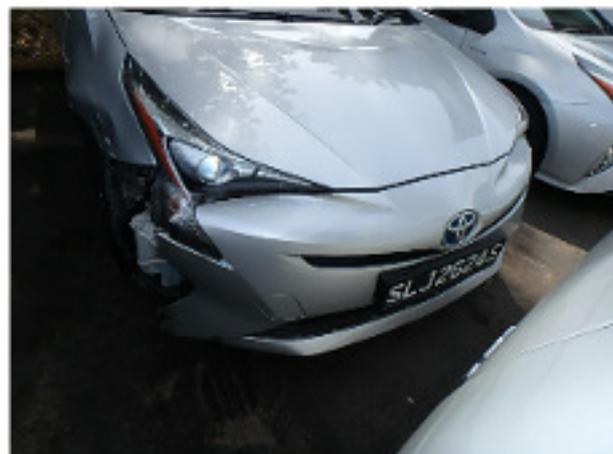
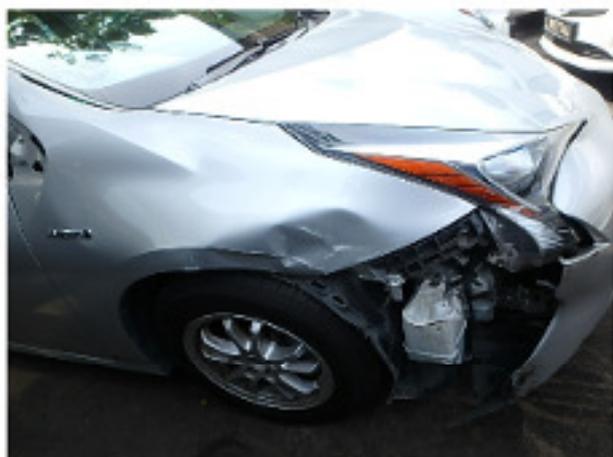
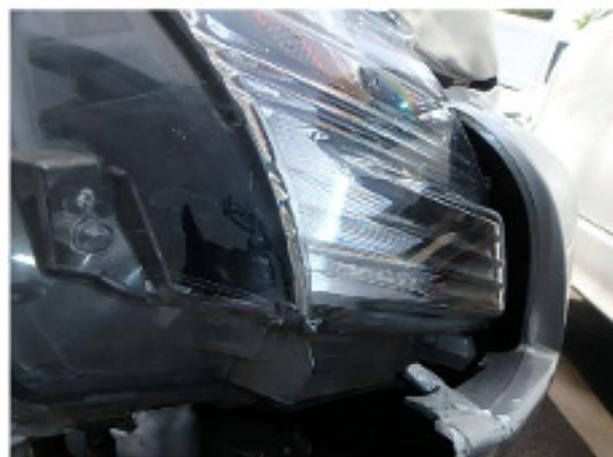
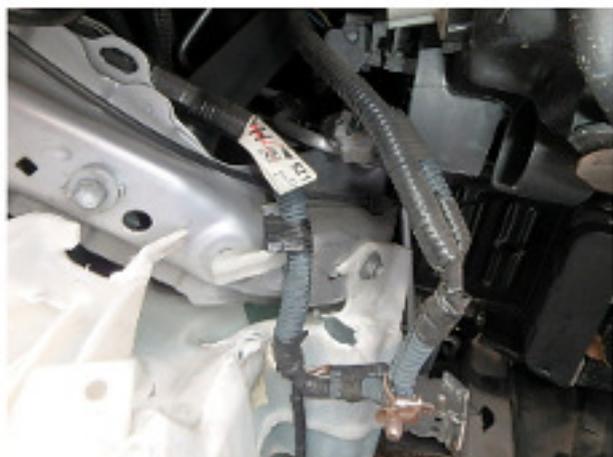
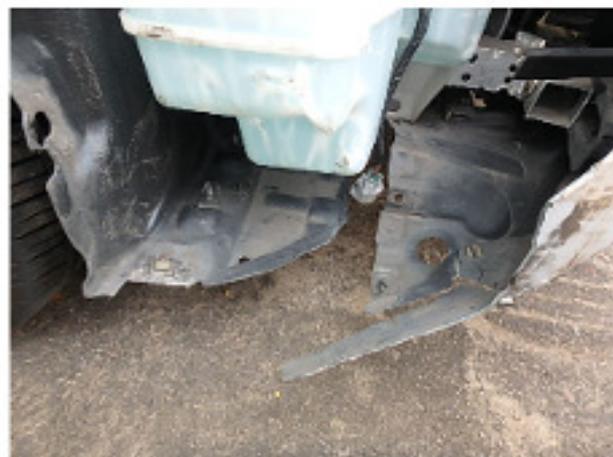
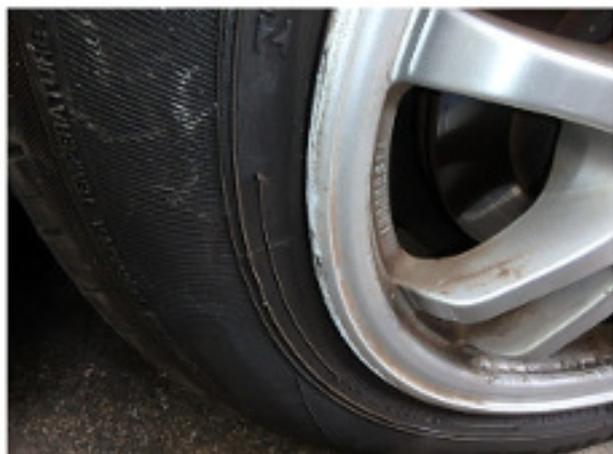
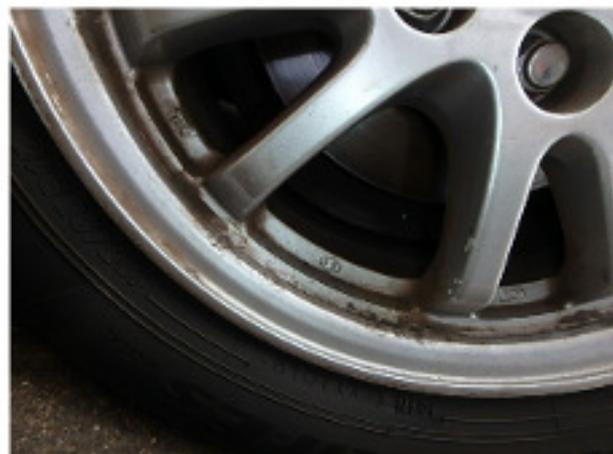
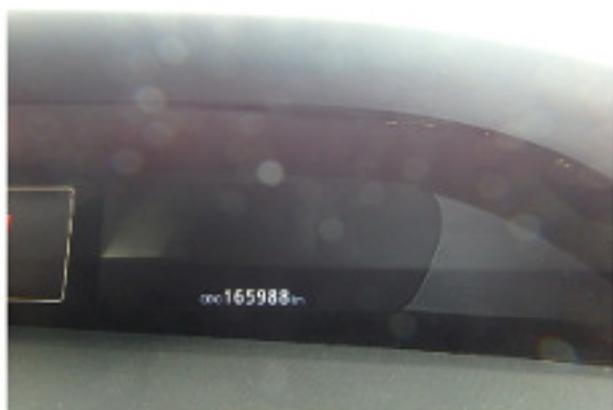
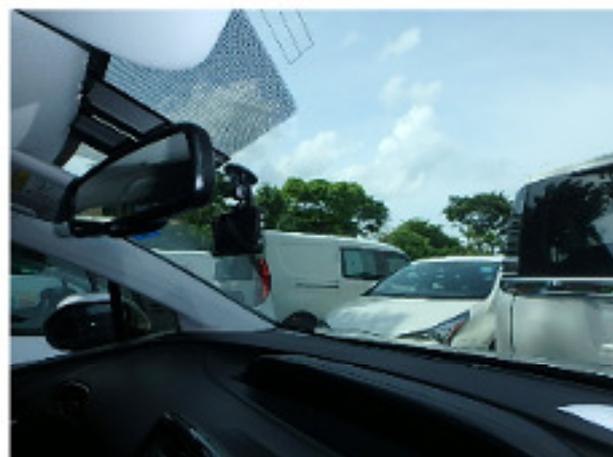
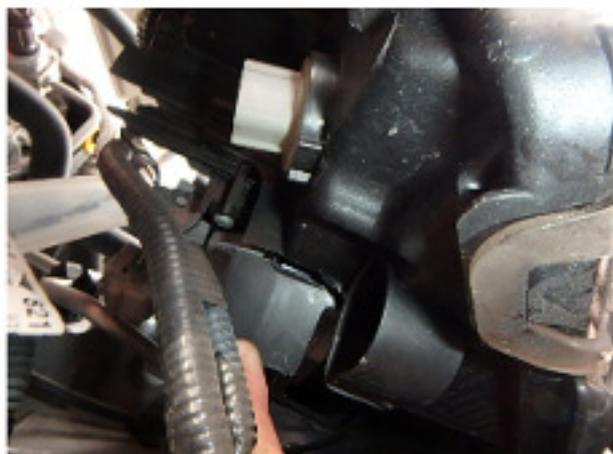
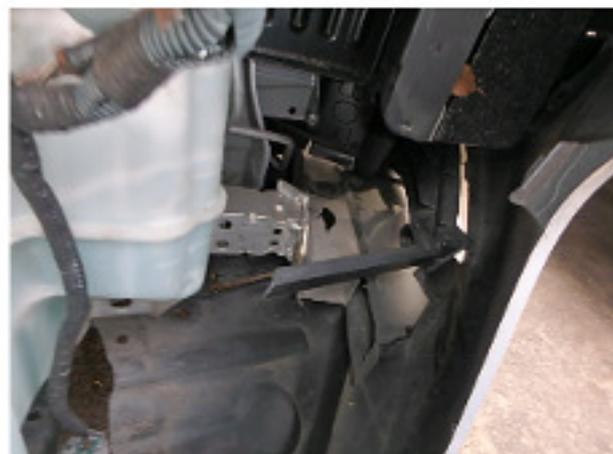
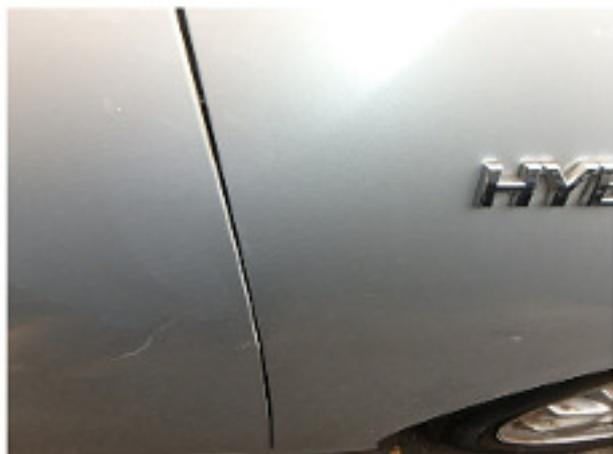
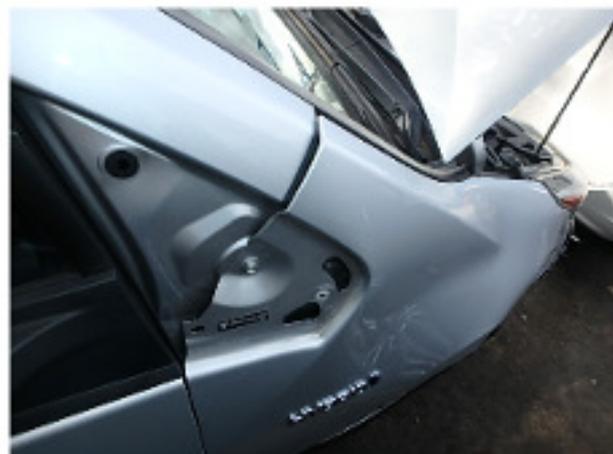
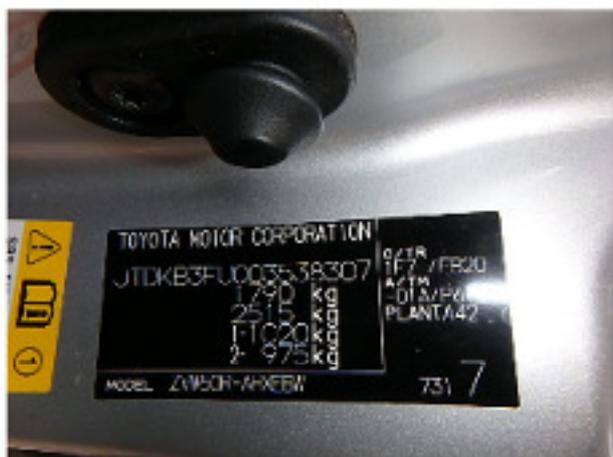
INSPECTION

THE VEHICLE SUSTAINED DAMAGES AT THE O/S FRONT PORTION AND UNDERCARRIAGE. DAMAGES SEE DETAILS.
--	---------------------------------------------------------------------------------------------------
