Your Ref: BMW M4  
(chassis number WBS4Y92040AC60743)  
Our Ref : CI/TP20001008/D

16 January 2020

**INSPECTION REPORT OF AN UNREGISTERD BMW M4 MOTOR CAR WITH CHASSIS NUMBER WBS4Y92040AC60743**

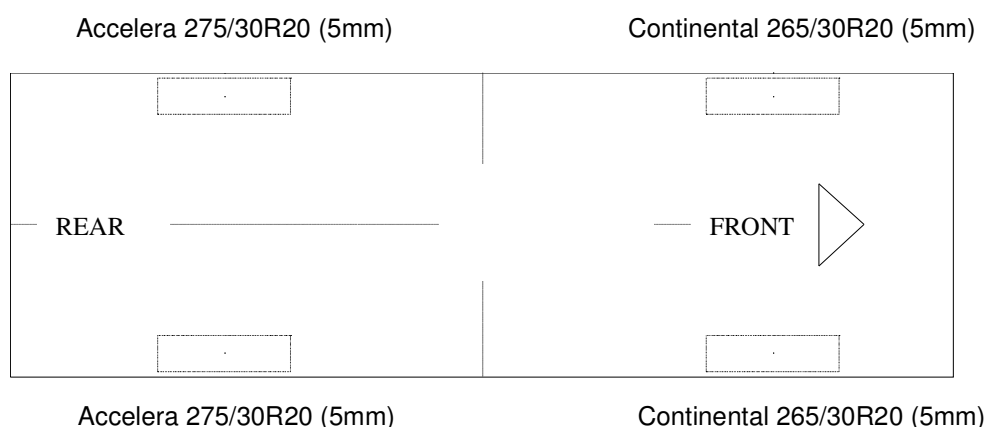
6. It was fitted with 20inch sport wheel rims that were wrapped with tyres that were observed to be of serviceable condition. The tyres were also sufficiently inflated for vehicular operation. The tyre brand, tyre size and approximate remaining tread depth of the 4 tyres of the Motor Car were recorded as follows: -

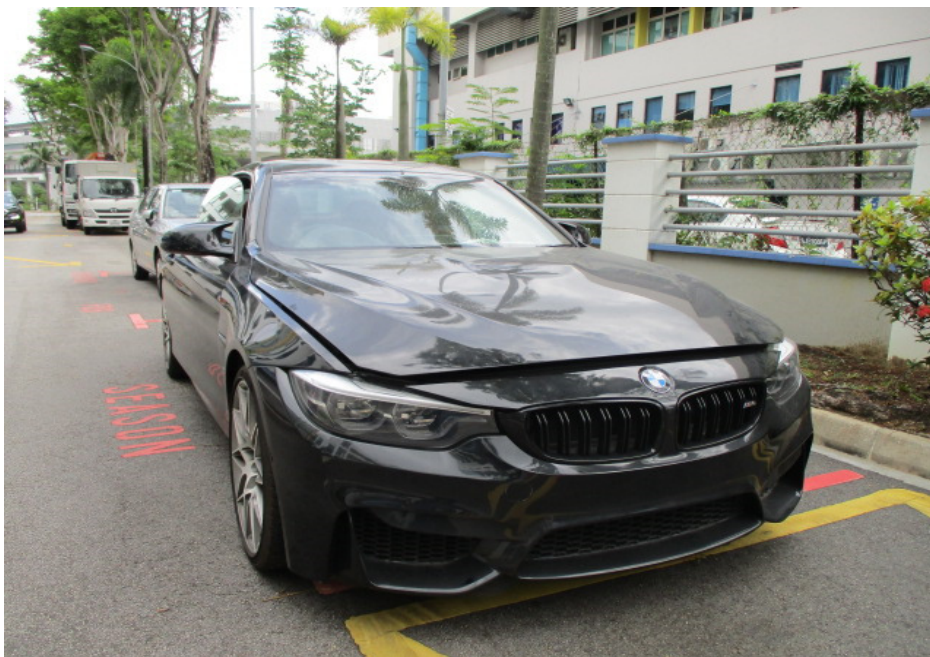
**Photo 1** shows a general view of the front right body of the Motor Car at the time of my inspection. The Motor Car was observed to be in relatively good general condition with no loose exterior fittings observed.

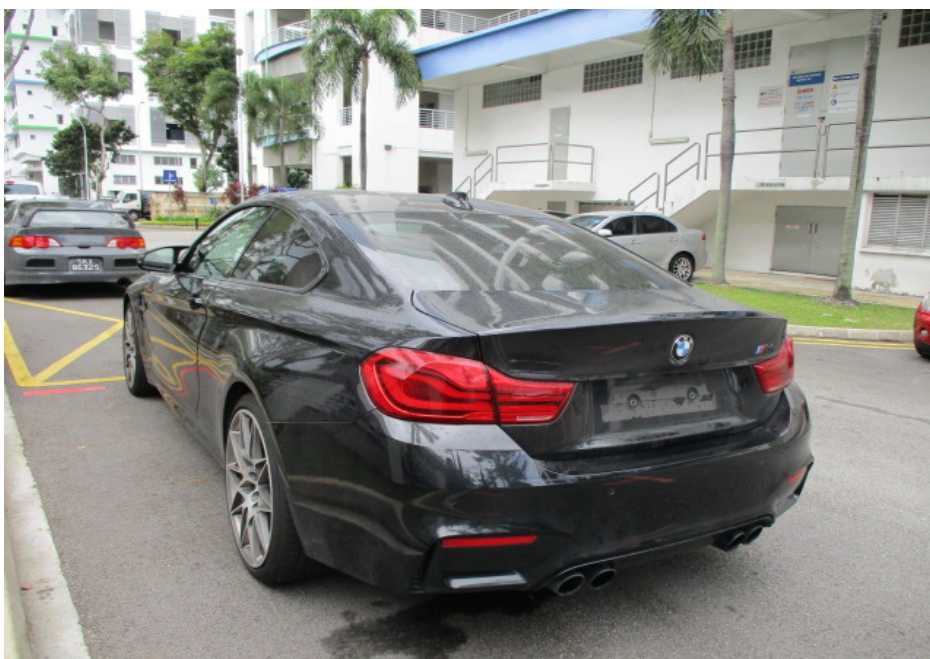
**Photo 2** shows a general view of the rear left body of the Motor Car at the time of my inspection. The Motor Car was observed to be in relatively good general condition with no loose exterior fittings observed.

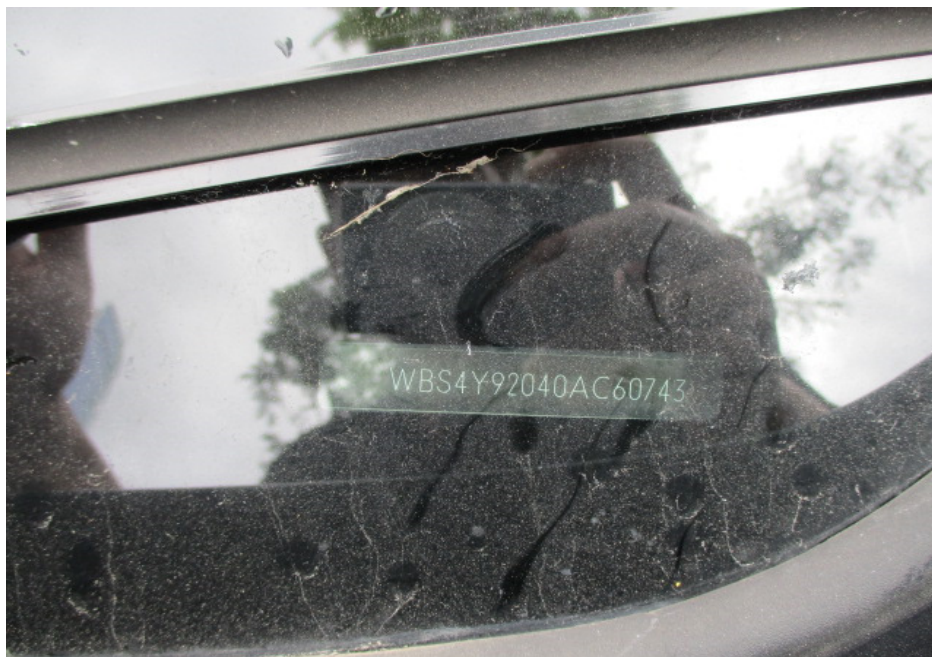
**Photo 3** shows the chassis number of the Motor Car. The chassis number recorded was WBS4Y92040AC60743.

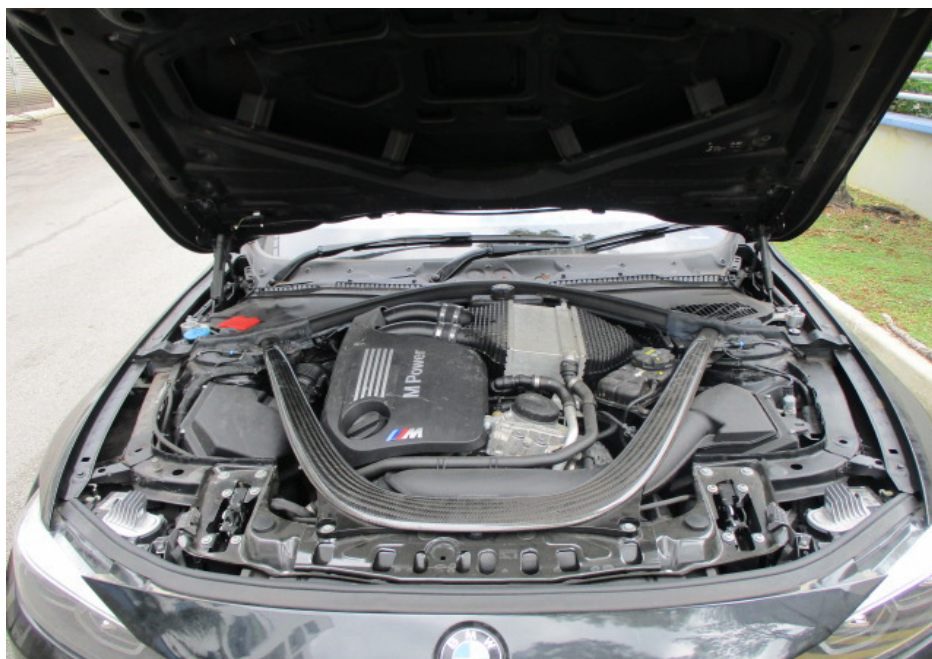
12. My examination of the engine compartment of the Motor Car revealed that the various parts and components inside the engine compartment were all intact and properly fitted. The various operating fluids like the engine oil, brake fluid and engine coolant were all found to be of sufficient level for operating purposes. Visually, there was also no contamination found to these fluids.
13. My checks on the underside of the Motor Car revealed no sign(s) or indication(s) of fluid leakage and/or fluid stain(s). The engine block and automatic transmission assembly were both secured properly. They were not mounted onto the chassis/structural body or any integral body part of the Motor Car. All undercarriage components of the Motor Car were also observed to be intact and secured in an appropriate manner.

**Photo 4** shows a general view of the engine compartment of the Motor Car at the time of my inspection. The various parts and components inside the engine compartment were all observed to be intact and properly fitted. There was also no sign(s) or indication(s) of fluid leak and/or fluid stain found within the engine compartment.

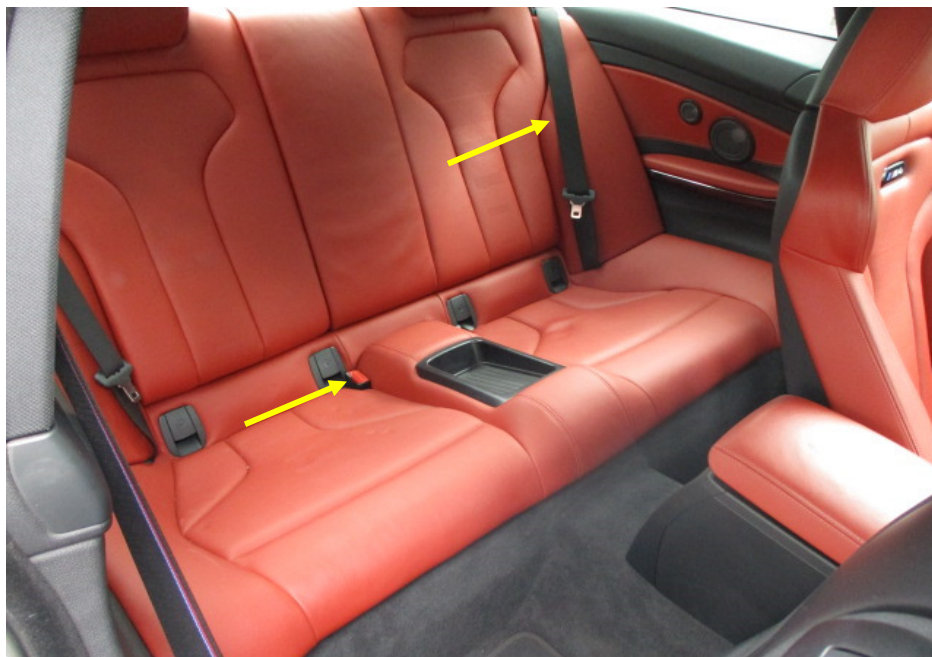
10. The seats of the Motor Car were found to be secured to the floor board of the Motor Car via seat rails bolted onto the floor board. Retractable seat belt reels and pre-tensioners were fitted on all seats of the Motor Car. The seat belt reels were checked and able to be fastened securely to the respective pre-tensioner that was fixed to the side of all the seats.

**Photo 5** shows the rear seats of the Motor Car. All the seats of the Motor Car were secured via seat rails to the floor board. They were also fitted with a retractable seat belt reel and a pre-tensioner (arrowed). The seat belts were checked and able to be fastened securely to the respective pretension that was fitted on the side of each individual seat.

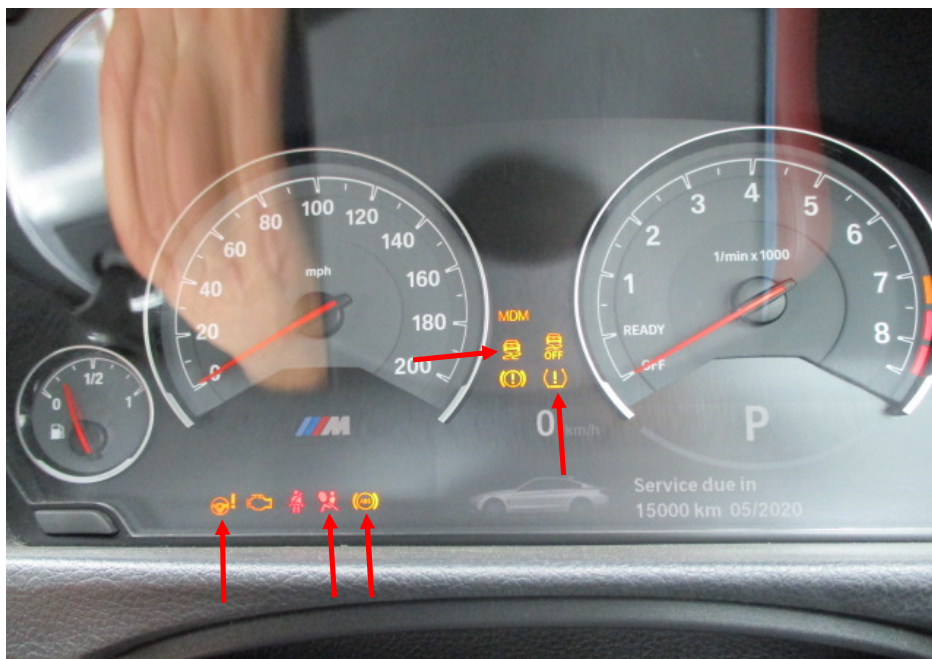
**Photo 6** shows the warning lights for the various electronic safety features appearing on the instrument panel of the Motor Car during its self-test when the engine is cranked, in particular the ABS, SRS, IAS, TPM and DSC lights (arrowed).

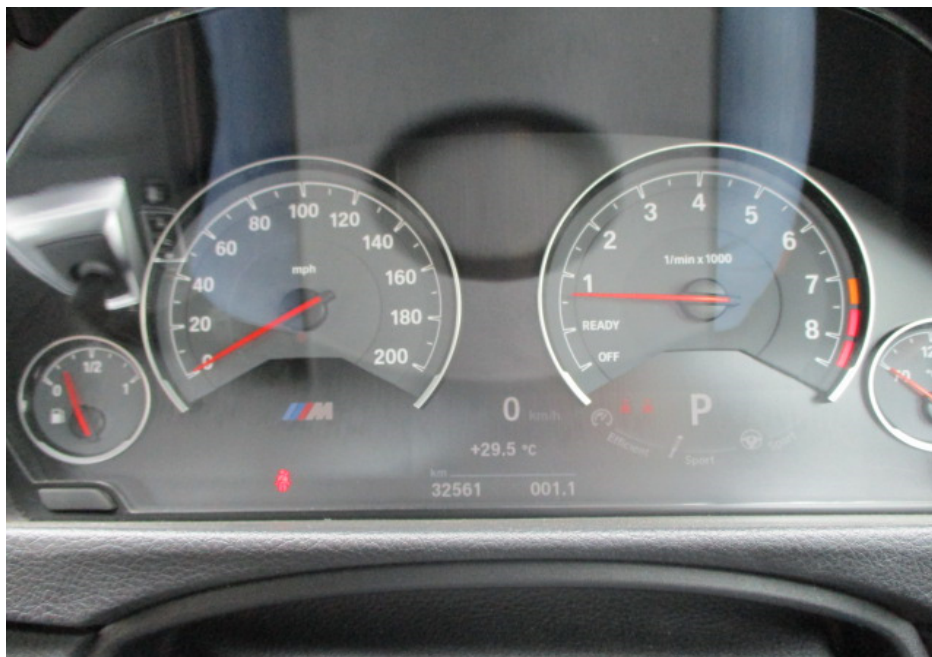
11. The Motor Car's automatic self-test of the functionality of its various electronic safety features like the Anti-Lock Brake System (ABS), Supplemental Restraint System (SRS), Integral Active Steering (IAS), Tyre Pressure Monitor (TPM) and Dynamic Stability Control (DSC) during cranking of the engine had indicated that these electronic systems were in working condition. This was determined from the respective warning lights disappearing from the instrument panel after the self-test.

**Photo 7** shows the respective warning lights no longer illuminated, indicating that there is no fault detected to the ABS, SRS, IAS, TPM and DSC systems of the Motor Car during the self-test. These electronic systems were hence in working condition at the time of my inspection.

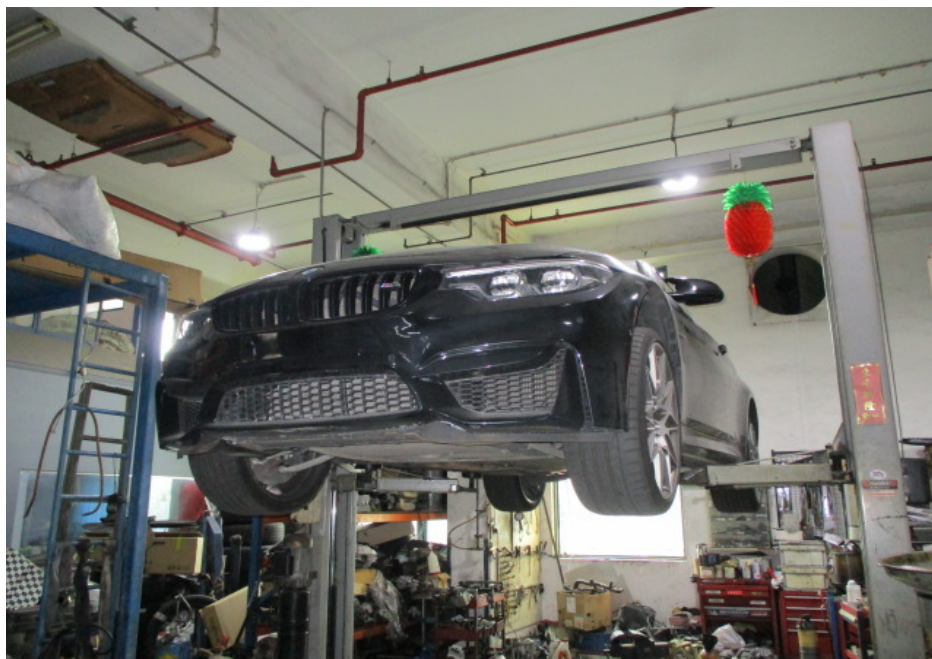
**Photo 8** shows the Motor Car hoisted up for checks on its undercarriage. There was no sign(s) or indication(s) of fluid leakage and/or fluid stain(s). The undercarriage components of the Motor Car were also all observed to be intact and secured in an appropriate manner.

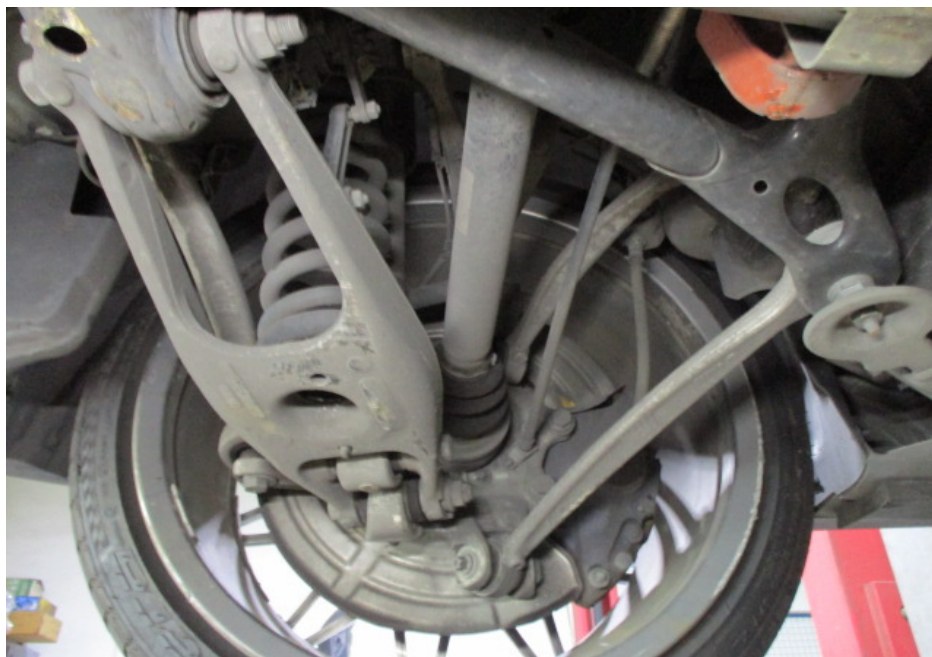
**Photo 9** shows a general view of the control arms and linkages at the rear left wheel of the Motor Car. I did not observe any fluid leak and/or fluid stain on the underside of the Motor Car. All of the Motor Car's undercarriage components were observed to be intact and secured in an appropriate manner.

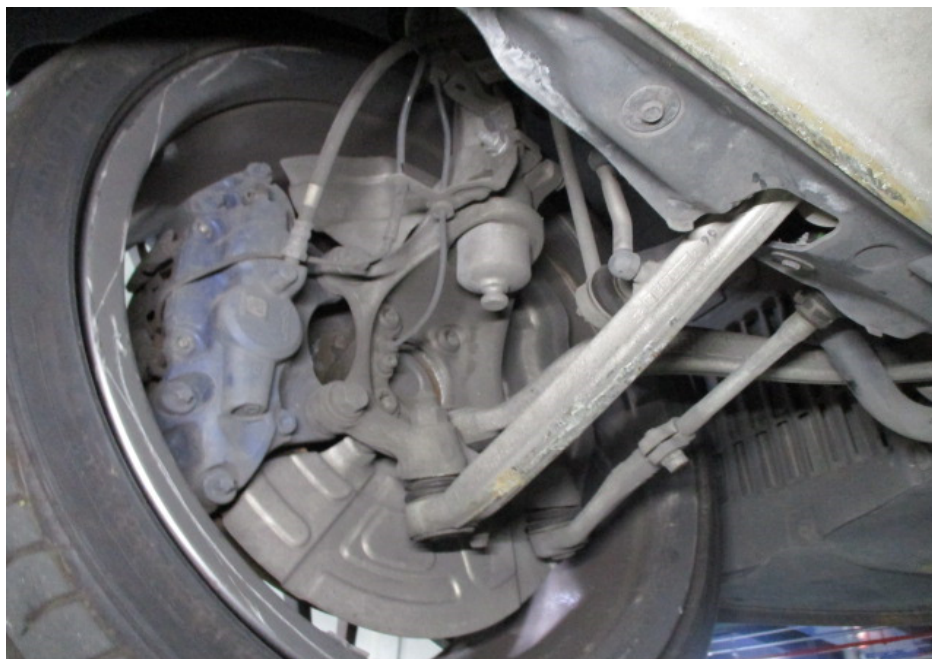
**Photo 10** shows the various undercarriage components at the front left wheel of the Motor Car. The mechanical components, control arms and linkages were all found to be intact and secured in an appropriate manner.

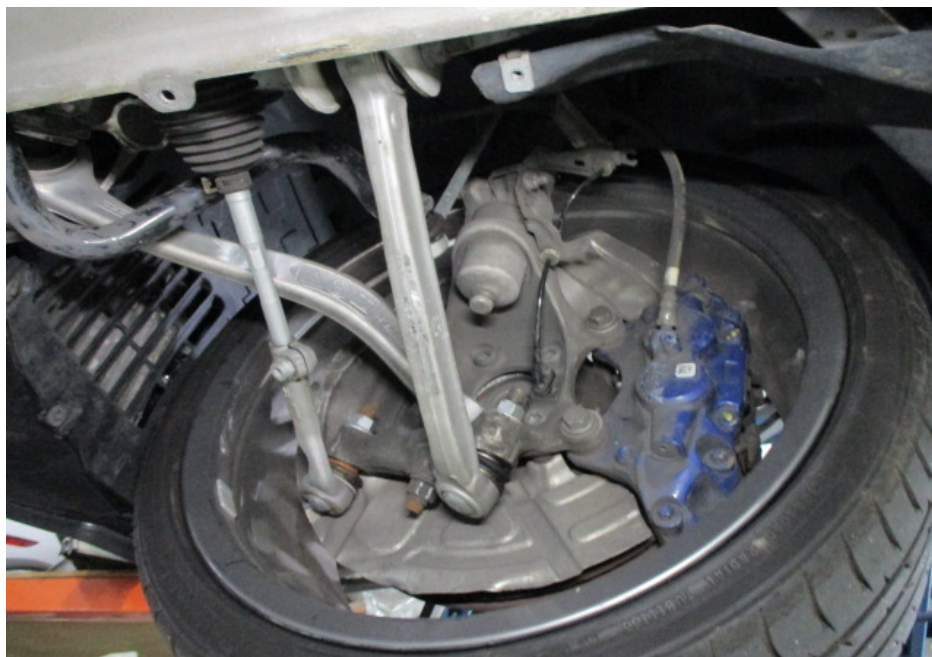
**Photo 11** shows the various undercarriage components at the front right wheel of the Motor Car. The mechanical components, control arms and linkages were all found to be intact and secured in an appropriate manner. All of the Motor Car's undercarriage components were observed to be intact and secured in an appropriate manner.

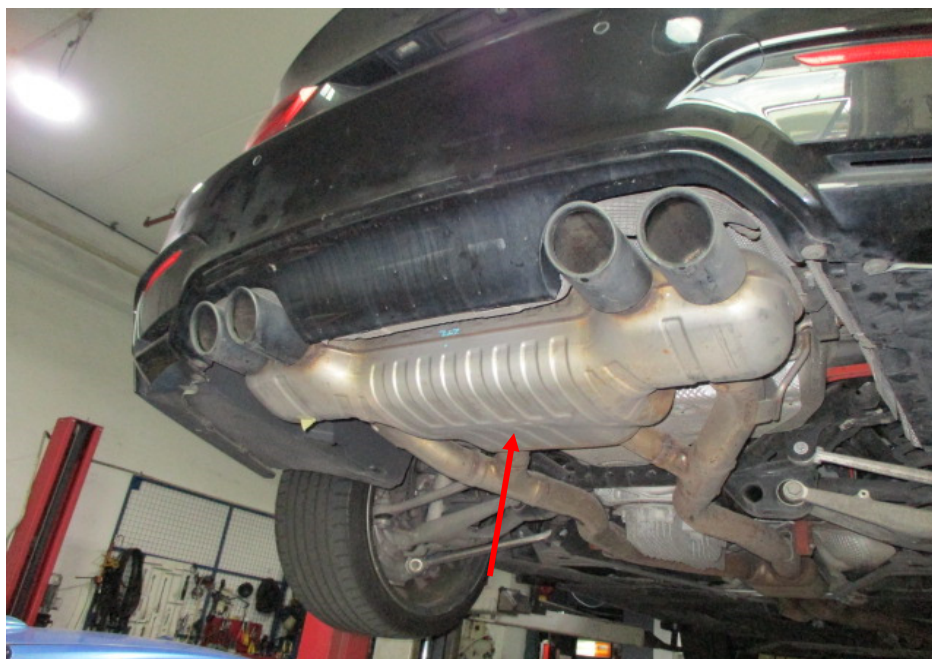
**Photo 12** shows the Motor Car's rear exhaust muffler (arrowed). My examination of the Motor Car's exhaust system revealed no sign(s) or indication(s) of any cut or weld marks along its exhaust pipes and on its rear muffler.

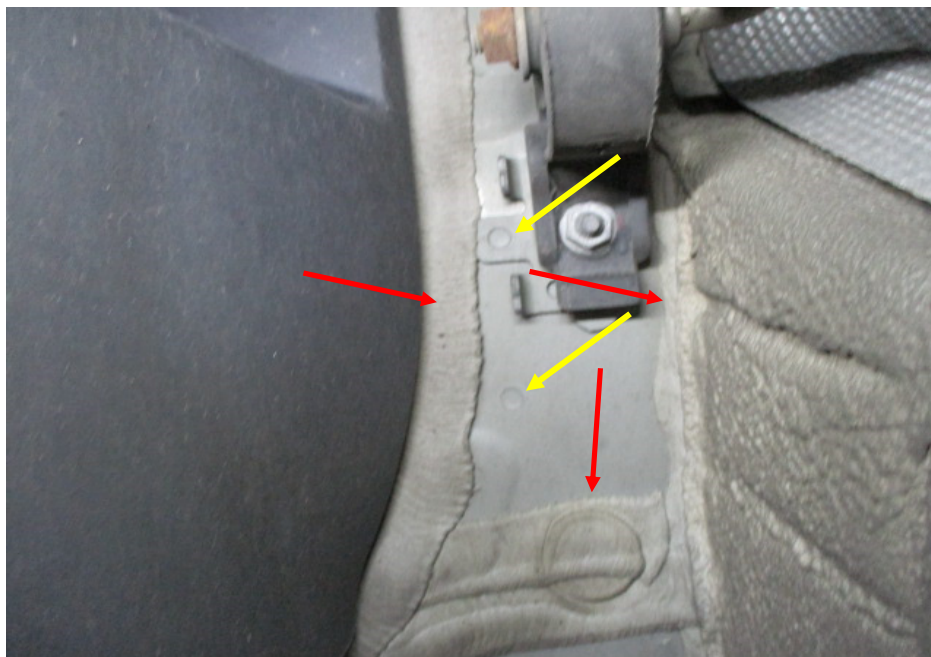
9. Visually, I did not find any weld marks, other than the original spot weld marks, on the chassis/structural body of the Motor Car. The original factory sealant at the joints along the chassis/structural body was also untouched, again indicating that no replacement of the chassis/structural body was carried out; and that the chassis/structural body was originally fitted.

**Photo 13** shows the chassis/structural body at the underside rear left of the Motor Car. Visually, I did not find any weld marks other than original spot weld marks (yellow arrow) on the chassis/structural body of the Motor Car. The original factory sealant (red arrow) at the joints along the chassis/structural body was also untouched, indicating no work was done on the chassis/structural body of the Motor Car and that the chassis/structural body was originally fitted.

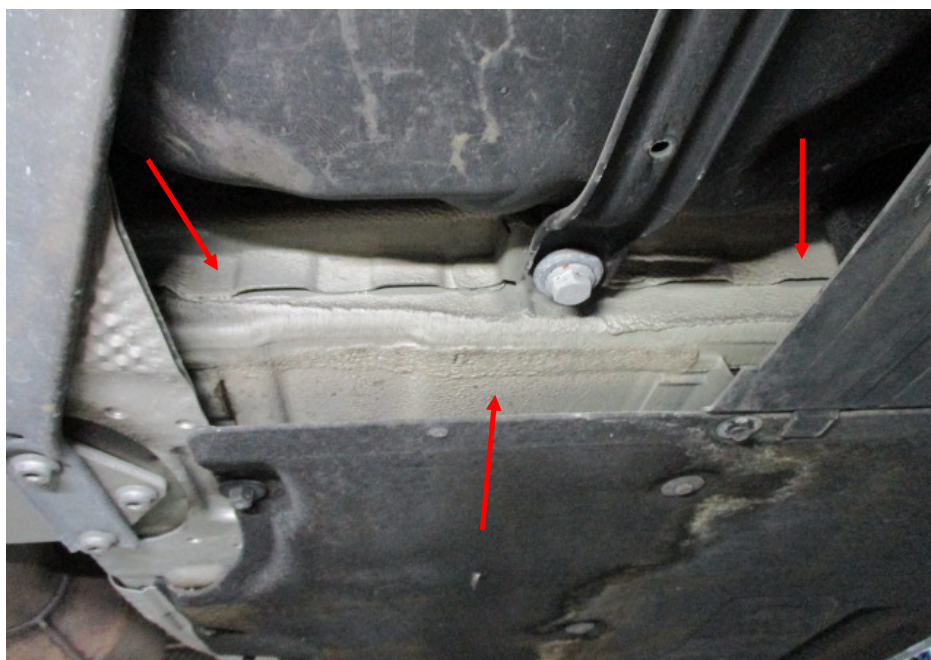
**Photo 14** shows the floor board at the underside centre of the Motor Car. The original factory sealant (arrowed) at the joints of the non-detachable body panels was all untouched indicating no replacement of the non-detachable body panels was carried out;

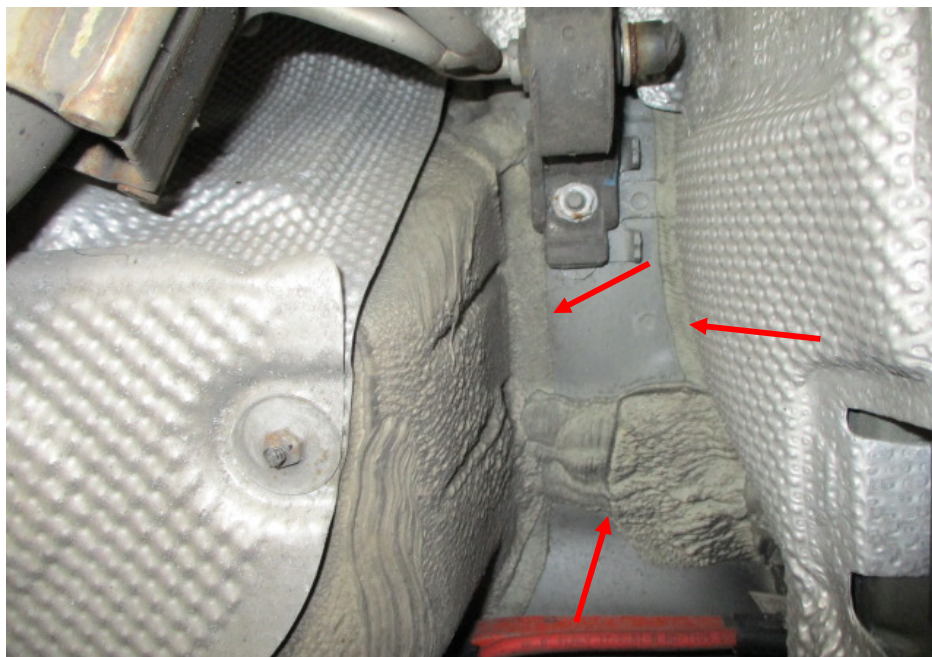
**Photo 15** shows the floor board at the underside rear of the Motor Car. The original factory sealant (arrowed) at the joints along the non-detachable body panels were untouched, indicating no work was done on the non-detachable body panels of the Motor Car; and that the non-detachable body panels were originally fitted.

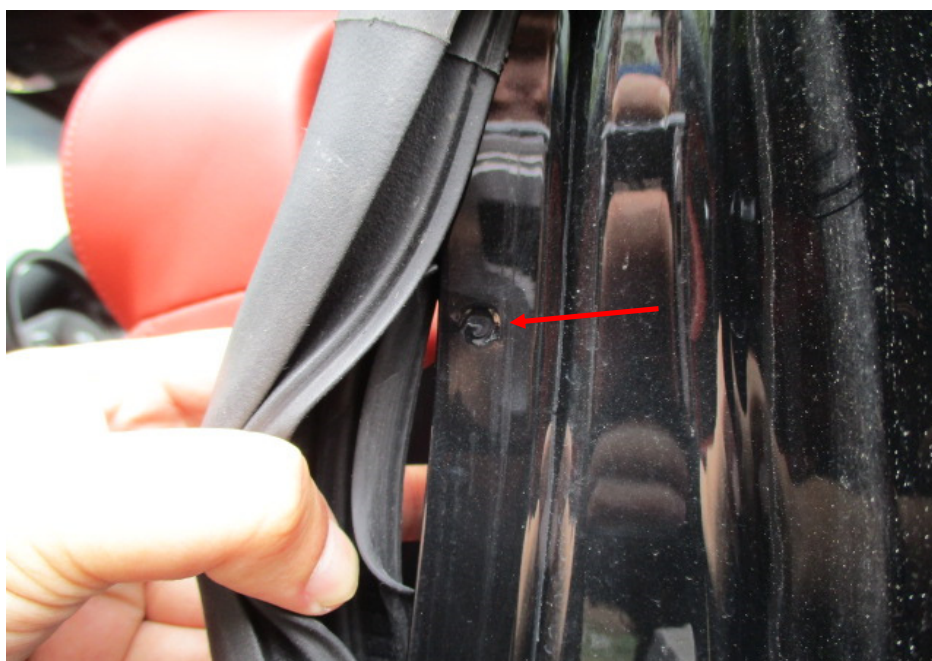
**Photo 16** shows the rear left body panel of the Motor Car. I did not find any weld marks other than original spot weld marks (arrowed) on the non-detachable body panels of the Motor Car, indicating that there was no re-welding works carried out; and that the non-detachable body panels of the Motor Car were originally fitted.

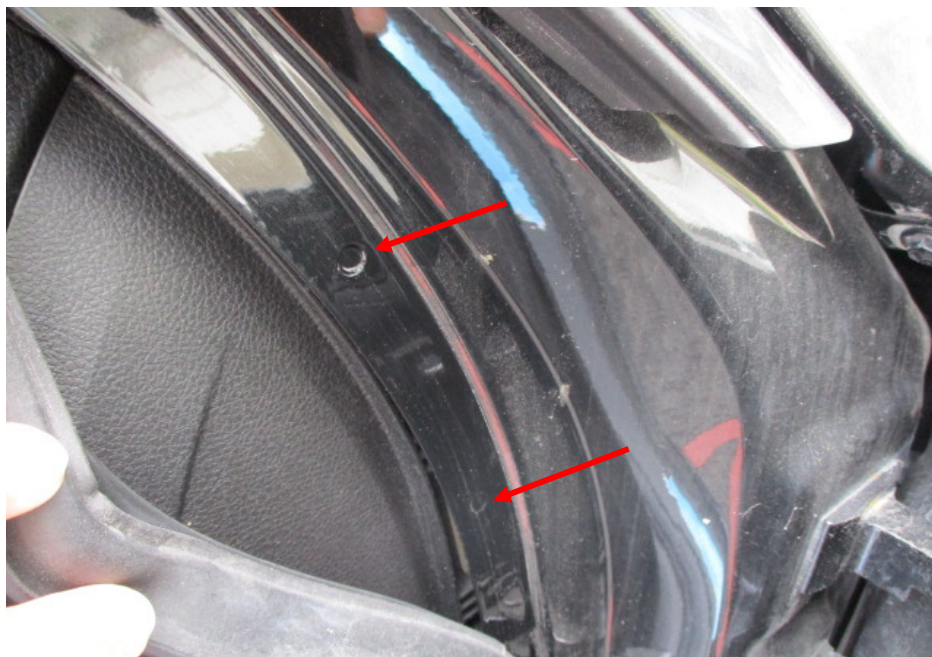
**Photo 17** shows the right “A” pillar of the Motor Car. I did not find any weld marks other than original spot weld marks (arrowed) on the non-detachable body panels of the Motor Car, indicating that there was no re-welding works carried out; and that the non-detachable body panels of the Motor Car were originally fitted.
