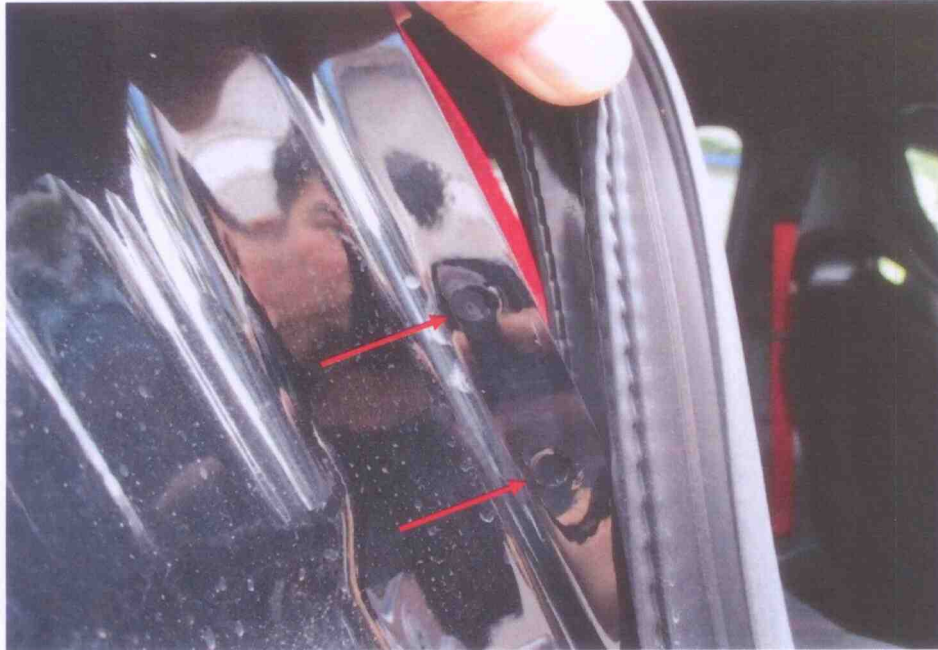
**Photo 17** shows the right "C" pillar of the Motor Car. I did not find any weld marks other than original spot weld marks (arrowed) on the non-detachable body panels of the Motor Car, indicating that there was no re-welding works carried out; and that the non-detachable body panels of the Motor Car were originally fitted.
