Your Ref : ASA.NTUC.0648
Our Ref : CI/LAW20001238/D

20 January 2020

**AUTOMOBILE TECHNICAL INVESTIGATION REPORT OF A ROAD TRAFFIC
ACCIDENT INVOLVING FBG 9259B, GU 1662P AND YL 8454L ON 22 JULY
2016**

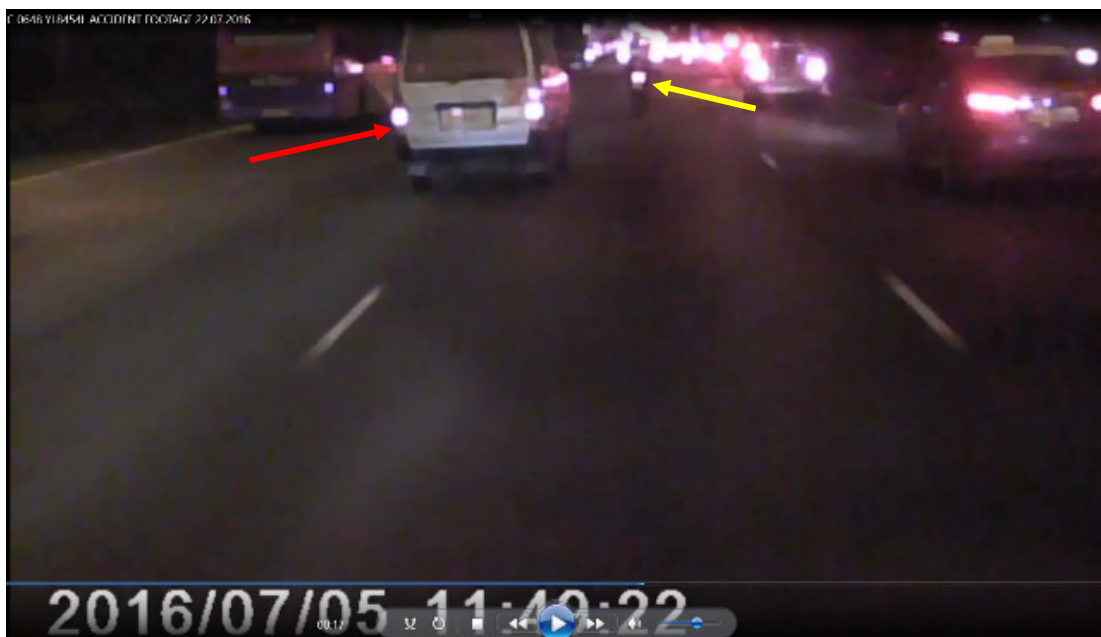
Photo 1 shows the Motor Van (red arrow) filtering into lane 2 prior to the accident. The Motorcycle (yellow arrow) was travelling at or around the centre of lane 2, in front of the Motor Van

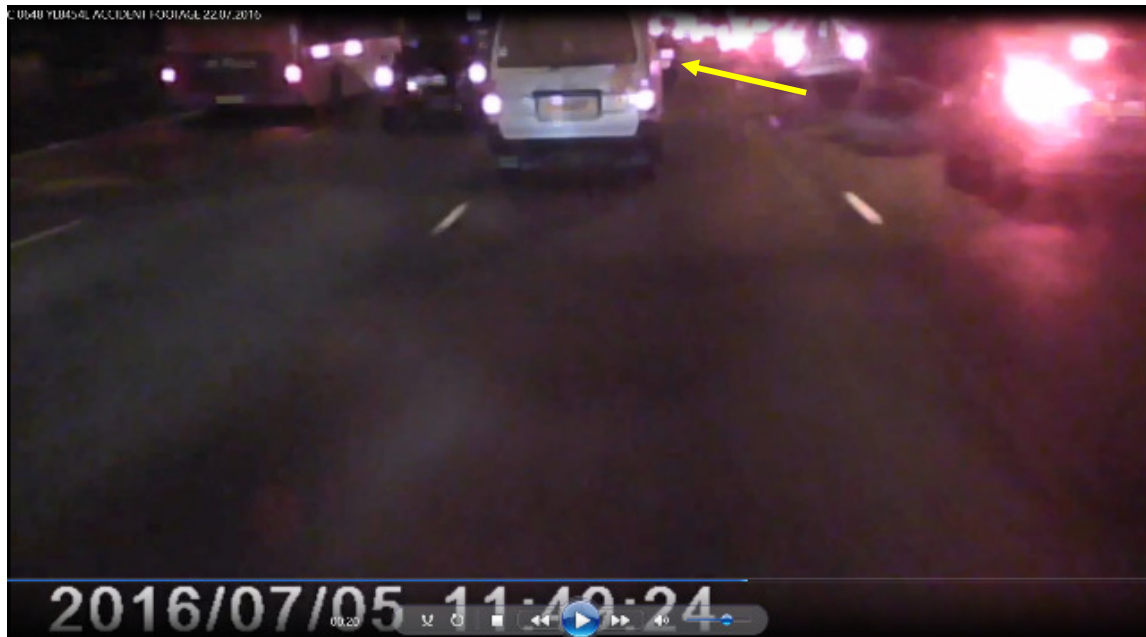
Photo 2 shows the Motor Van almost completed filtering into lane 2. At last sight, the Motorcycle (arrowed) was travelling at or around the centre of lane 2 in front of the Motor Van before it became blocked from view.

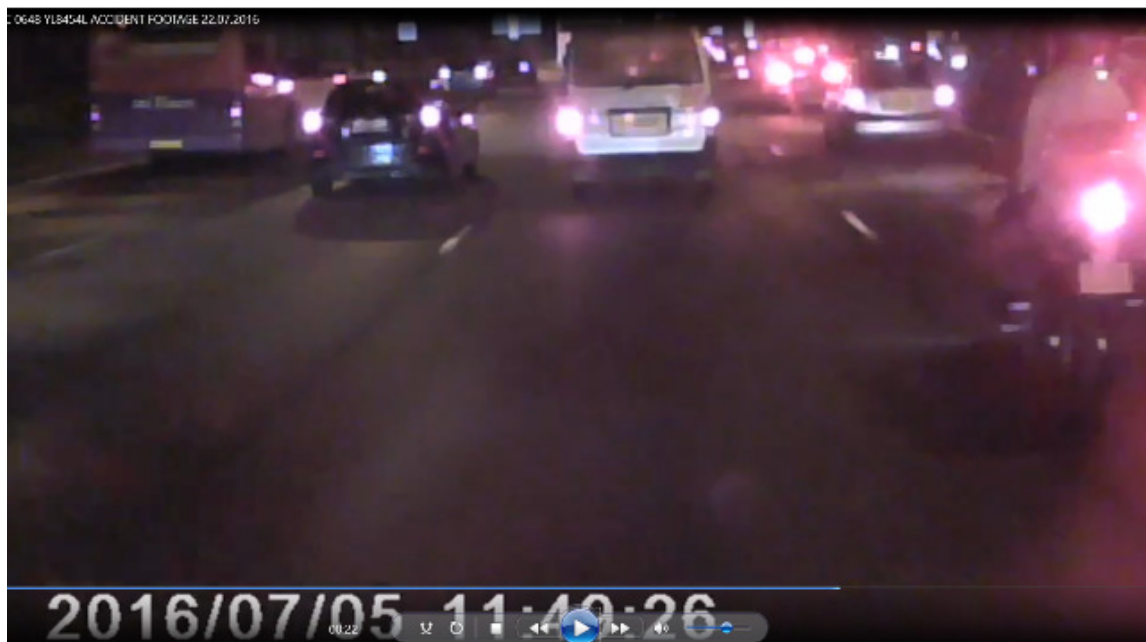
Photo 3 shows the Motor Van's brake lights lighted up (higher illuminance intensity) at the 22 sec mark of the video recording. This was after the Motor Van was seen travelling straight within lane 2 for a short distance.

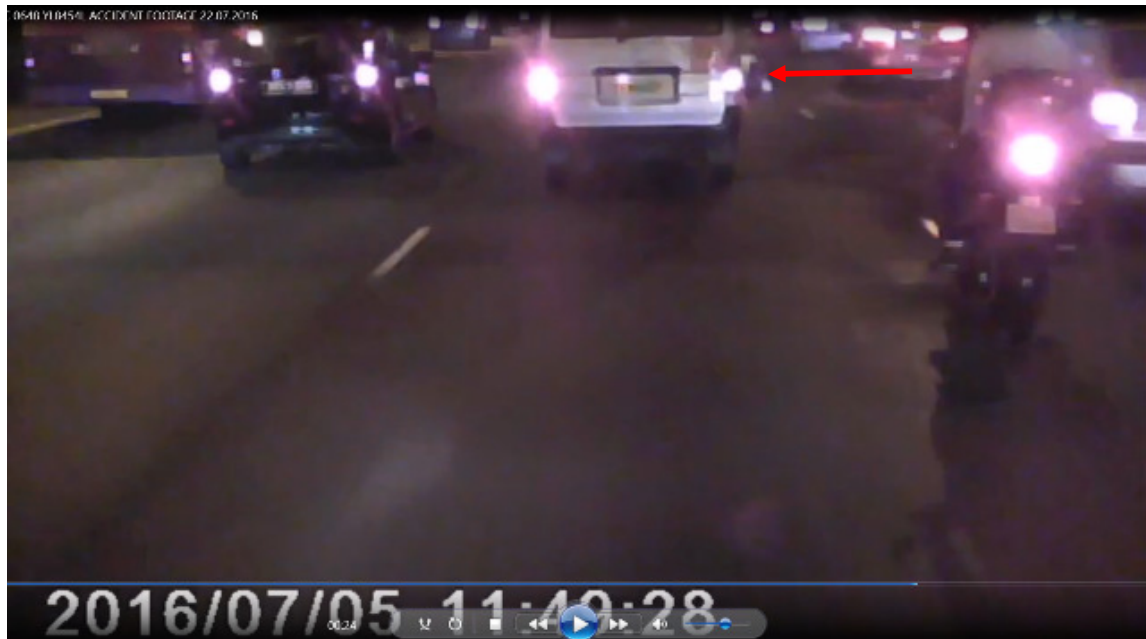
Photo 4 shows the 24sec mark of the video recording. The brake lights of the Motor Van remained lighted up from the 22sec mark onwards and at the 24sec mark of the video recording, the Motorcycle and/or its rider (arrowed) was seen falling at the front right of the Motor Van. At the time when the Motorcycle and/or its rider was seen falling, it would appear to me that there was a distance between the front of the Motor Van and the Motorcycle.

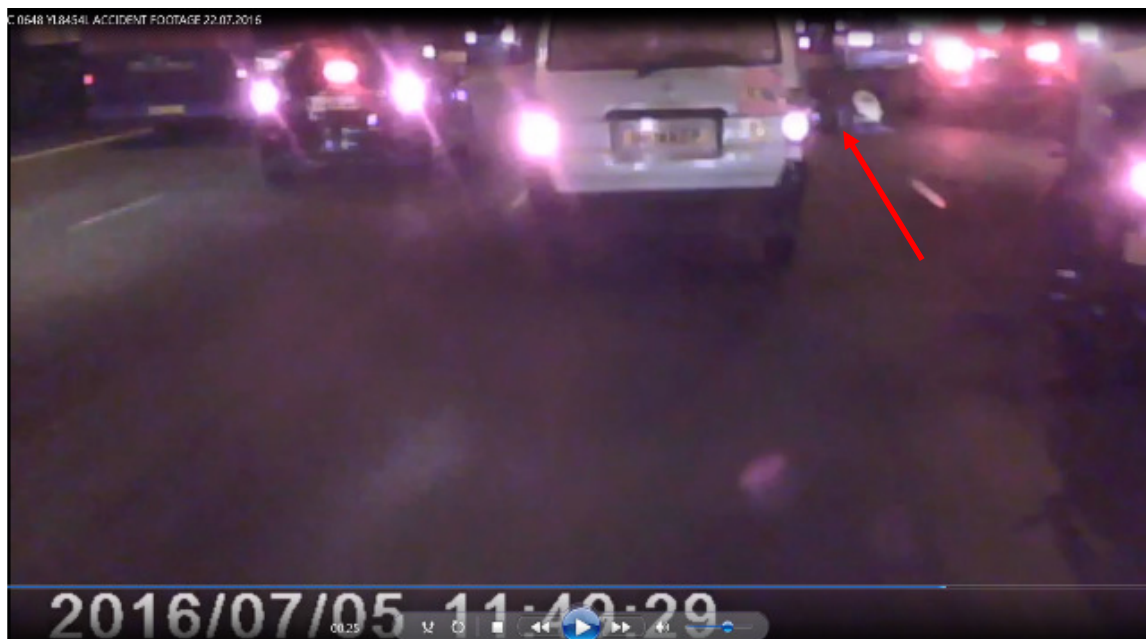
Photo 5 shows the 25sec mark of the video recording. From my observations, the Motor Van appears to have been stationary from the 25sec mark till the Motor Lorry collided into its rear portion at the 27sec mark. It also appears to me that there was a distance between the front of the Motor Van and the Motorcycle (arrowed).

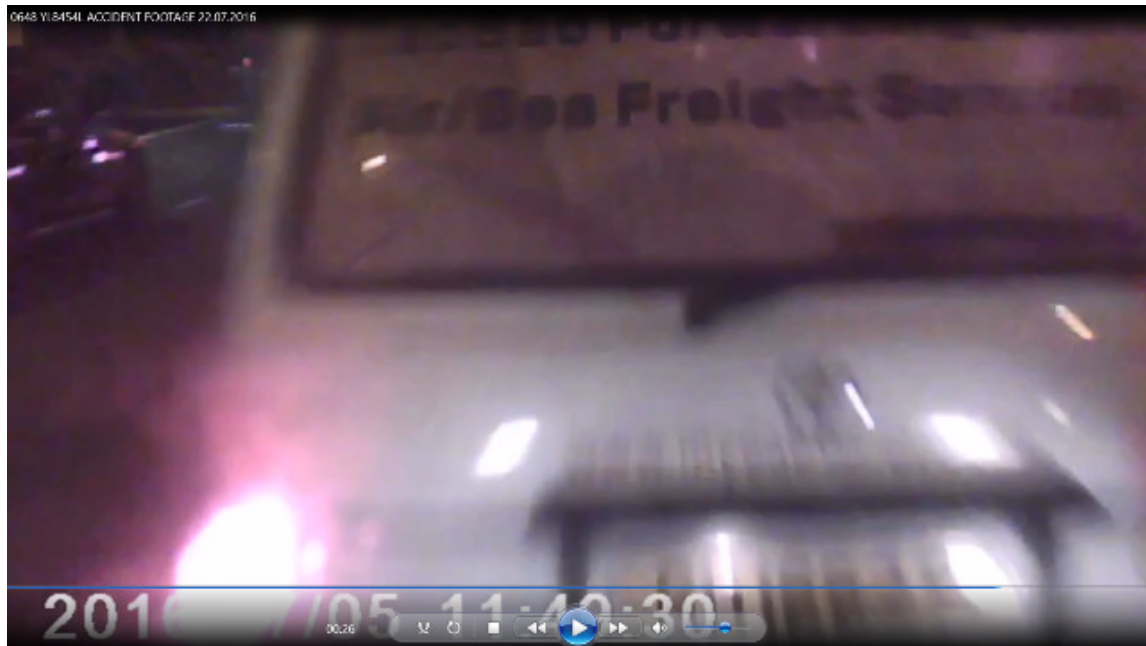
Photo 6 shows the 26sec mark of the video recording. This was just prior to the Motor Lorry colliding into the rear of the stationary Motor Van.

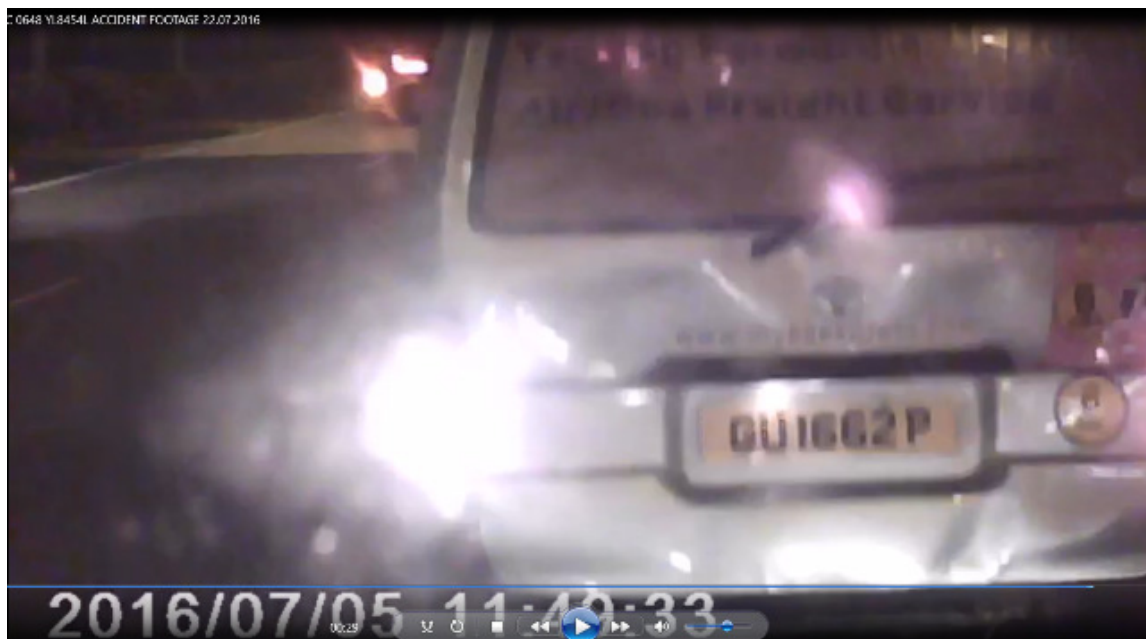
Photo 7 shows the distance between the front of the Motor Lorry and the rear of the Motor Van widened at the 29sec mark of the video recording as compared to the 26sec mark of the video recording, which is shown in photograph 6 above. This would indicate that the Motor Van was pushed forward upon being collided into by the Motor Lorry from the rear.

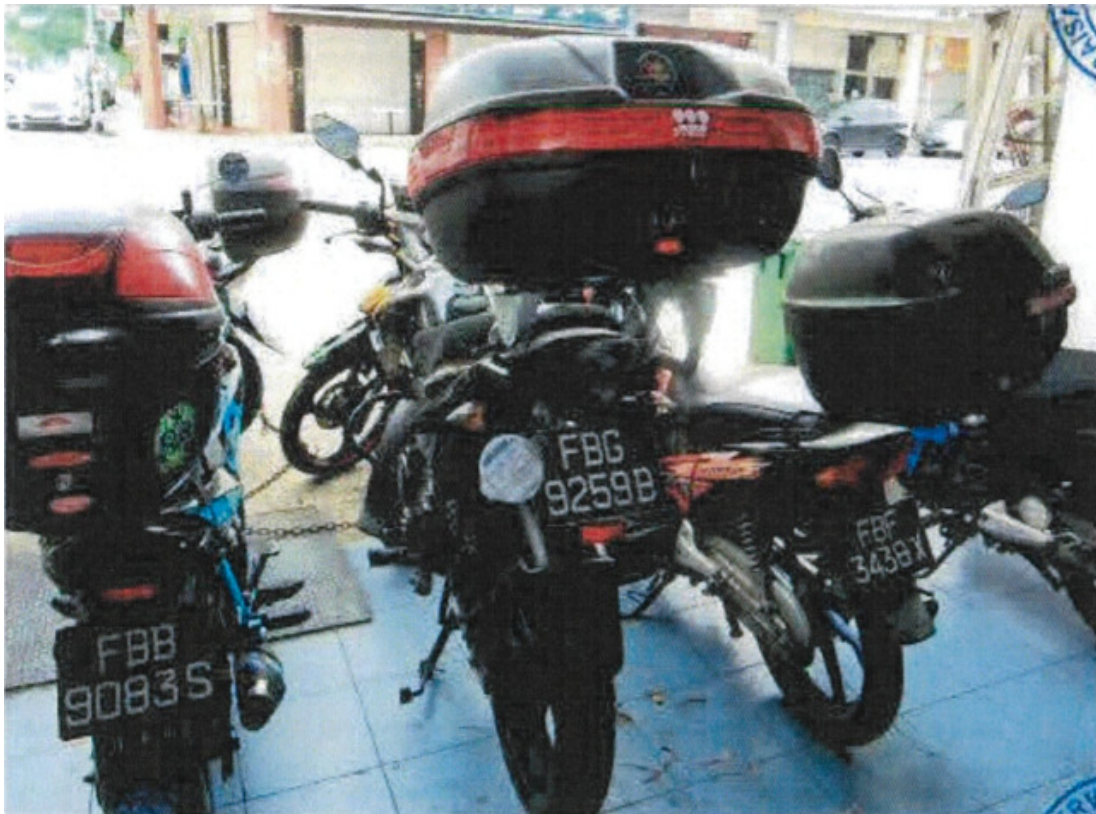
12. The Motorcycle was physically inspected by Ajax Inspection Services Pte Ltd on 26 July 2016 and by Y B Lim Appraisal Services on 28 July 2016. Both subsequently produced reports pertaining to the damage and cost of repair to the Motorcycle. It was noted that Ajax Inspection Services Pte Ltd had indicated in their report that the Motorcycle had sustained damage on the right portion. Y B Lim Appraisal Services had indicated in their report that the Motorcycle had sustained damage at the frontal and right side of the Motorcycle. Notably, both reports did not indicate any damage at the rear portion of the Motorcycle, which is to be expected if the Motorcycle was collided into at its rear portion by the Motor Van.

14. My review of the photographs attached in the reports did not produce any observations of damage to the rear of the Motorcycle. My observations correspond to the observations of Ajax Inspection Services Pte Ltd and Y B Lim Appraisal Services at the time of their physical inspection of the Motorcycle, where there was no part(s) directly at the rear of the Motorcycle found damaged/affected as a result of this accident.

Photo 8 shows the Motorcycle at the time of physical inspection prior to any repairs. From my review of the photographs attached in the reports of Ajax Inspection Services Pte Ltd and Y B Lim Appraisal Services, I did not observe any damage to the rear portion of the Motorcycle. It was also noted that Ajax Inspection Services Pte Ltd had indicated in their report that the Motorcycle had sustained damage on the right portion. Y B Lim Appraisal Services had indicated in their report that the Motorcycle had sustained damage at the frontal and right side of the Motorcycle. Both reports did not indicate any damage at the rear portion of the Motorcycle.

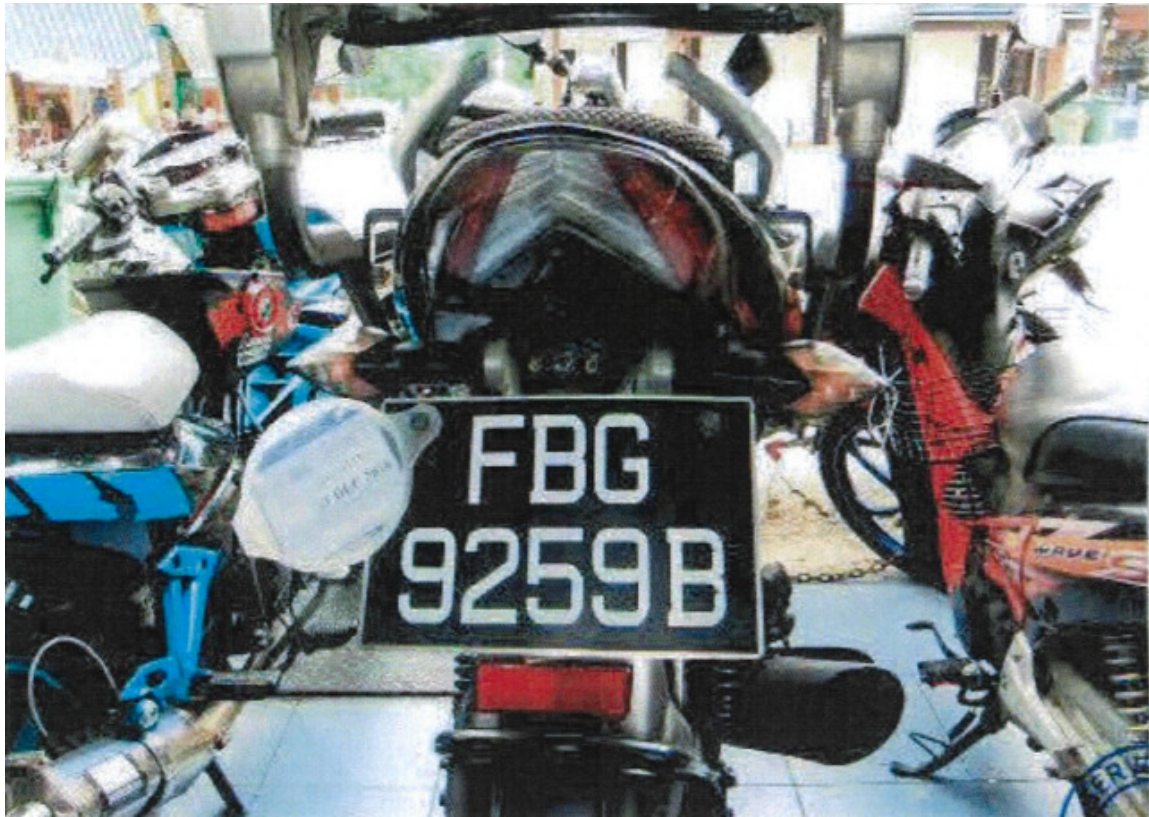
13. Although there were several rear portion parts like the rear signal and the rear side fairing amongst others, listed in the reports, these parts were at the right side of the Motorcycle. Parts directly at the rear of the Motorcycle, like the rear number plate, rear reflector and rear taillamp were not listed as parts damaged and/or affected. These are parts that would typically be damaged if the Motorcycle had sustained an impact at its rear portion.

Photo 9 shows a closer view of the rear portion of the Motorcycle. Parts directly at the rear of the Motorcycle, like the rear number plate, rear reflector and rear taillamp were not observed to be damaged and/or affected. These are parts that would typically be damaged if the Motorcycle had sustained an impact at its rear portion. Even the road tax holder was seen to be undamaged. The lack of damage seen to the parts directly at the rear of the Motorcycle does not seem to suggest that the Motorcycle was collided into at its rear portion by the Motor Van.

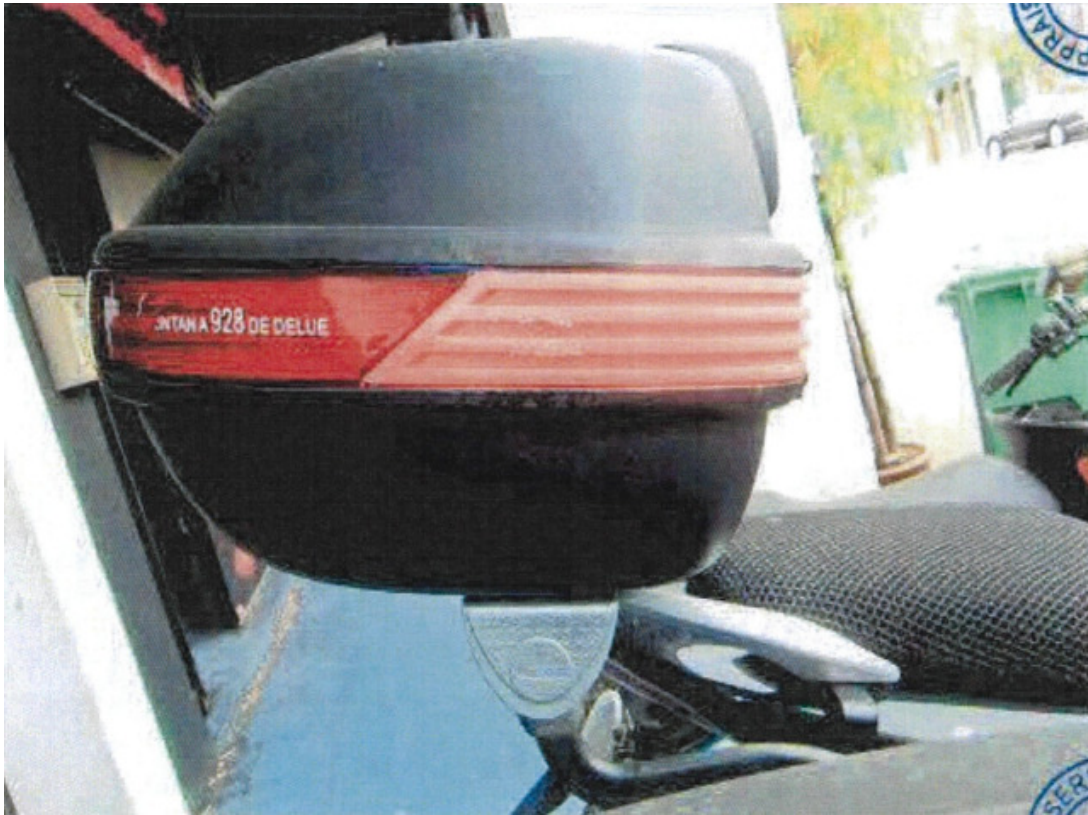
15. I did however note that when the Motorcycle was in an upright position as seen from the photographs that were attached in the reports, its rear box would be the most protruded part at the rear of the Motorcycle. Hence for this case, when the Motorcycle is in an upright position, any impact at the rear of the Motorcycle would result in contact between its rear box and the front body of the Motor Van.

16. Since this accident was a straight-line collision scenario as seen from the video recording, the direction of impact onto the Motorcycle would be from its rear to front. I would expect the rear box to sustain crack, broken or similar nature of damage, or at least be bent upwards. The rear box of the Motorcycle was observed to be damage by Ajax Inspection Services Pte Ltd and Y B Lim Appraisal Services however the description of damage to the rear box indicated in both reports was "grazed". The photographs showing the Motorcycle's rear box also did not show the rear box cracked and/or broken or bent etc. The "grazed" nature of damage to the rear box would have been caused by the Motorcycle falling onto its right side as the damage pattern to the parts at its right side was indicative of this. See photo 8 to 10 below.

Photo 10 shows a side view of the Motorcycle's rear portion. When the Motorcycle was in an upright position, its rear box would be the most protruded part at the rear of the Motorcycle. Hence for this case, when the Motorcycle was in an upright position, any impact at the rear of the Motorcycle would result in contact between its rear box and the front body of the Motor Van. Upon contact, I would expect the rear box to sustain crack, broken or similar nature of damage, or at least be bent upwards. However, this was not the case as seen from the photographs showing the Motorcycle in its damaged condition prior to any repairs. The rear box was observed to be intact.

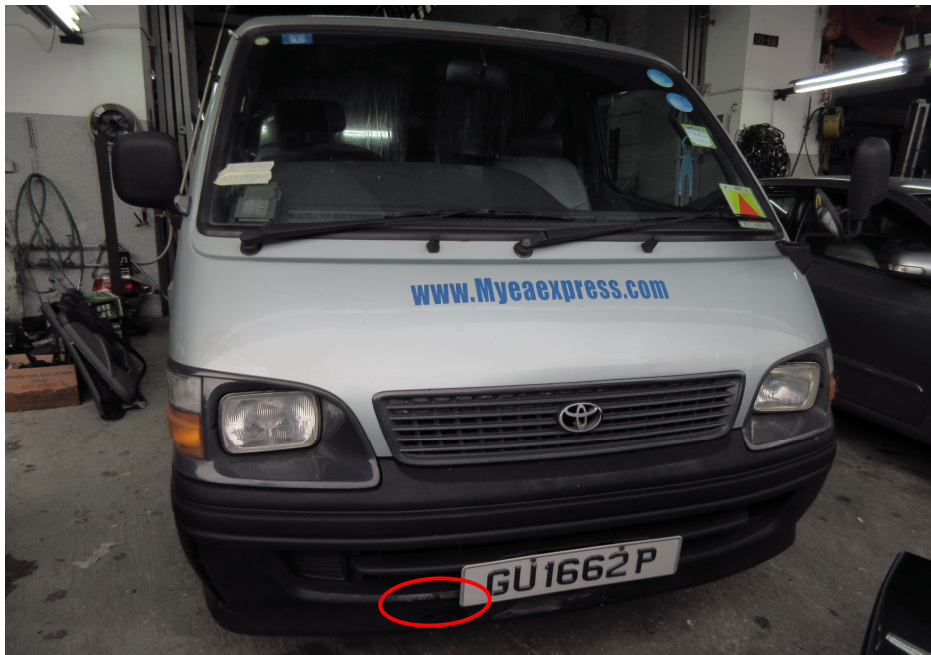
17. The Motor Van was physically inspected by LKK Auto Consultants Pte Ltd on 25 July 2016. A report pertaining to the damage and cost of repair to the Motor Van was put up and it was noted that the Motor Van had sustained damage at its rear portion and front portion. For the purpose of this report, I had only considered the damage to the front portion of the Motor Van as any contact between the Motorcycle and the Motor Van would be at the front portion of the Motor Van.
18. Upon reviewing the photographs, it was observed that the damage to the front portion of the Motor Van was at the lower part of its front bumper, at or below the area where its front number plate was fixed on. There was no damage observed to the part(s) at the front portion of the Motor Van above the front number plate. The Motor Van had sustained a single area of damage at its front portion. See photo 11 to 13 below.

Photo 11 shows the front portion of the Motor Van at the time of physical inspection by LKK Auto Consultants Pte Ltd on 25 July 2016. Upon reviewing the photographs showing the Motor Van prior to any repairs, I had observed damage at the lower part of its front bumper (circled), at or below the area where its front number plate was fixed on. There was no damage observed to the part(s) at the entire front portion of the Motor Van above the front number plate.

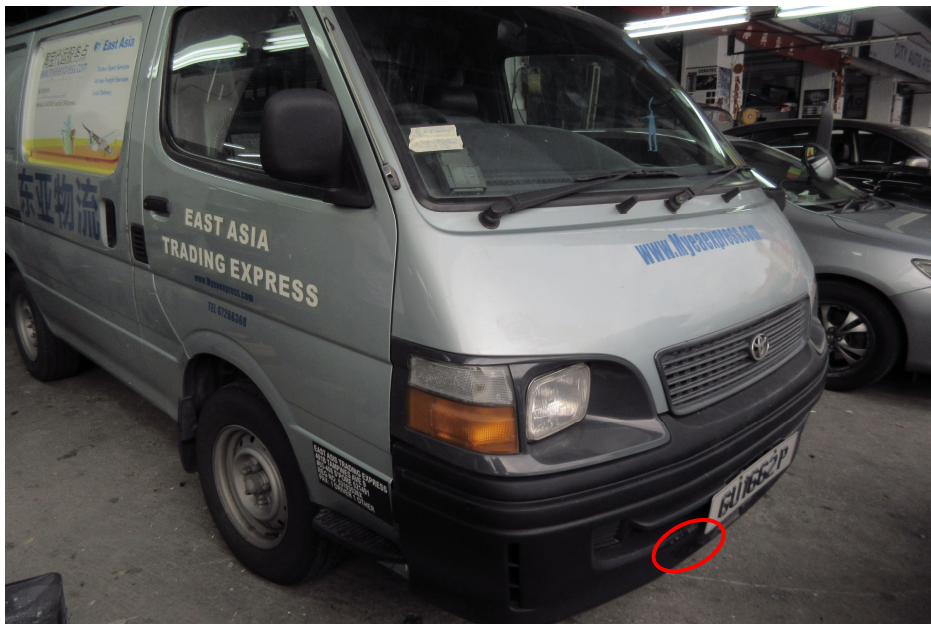
Photo 12 shows the front portion of the Motor Van. From the photographs showing the Motor Van prior to any repairs, I had observed damage at the lower part of its front bumper (circled), at or below the area where its front number plate was fixed on. There was no damage observed to the part(s) at the entire front portion of the Motor Van above the front number plate.

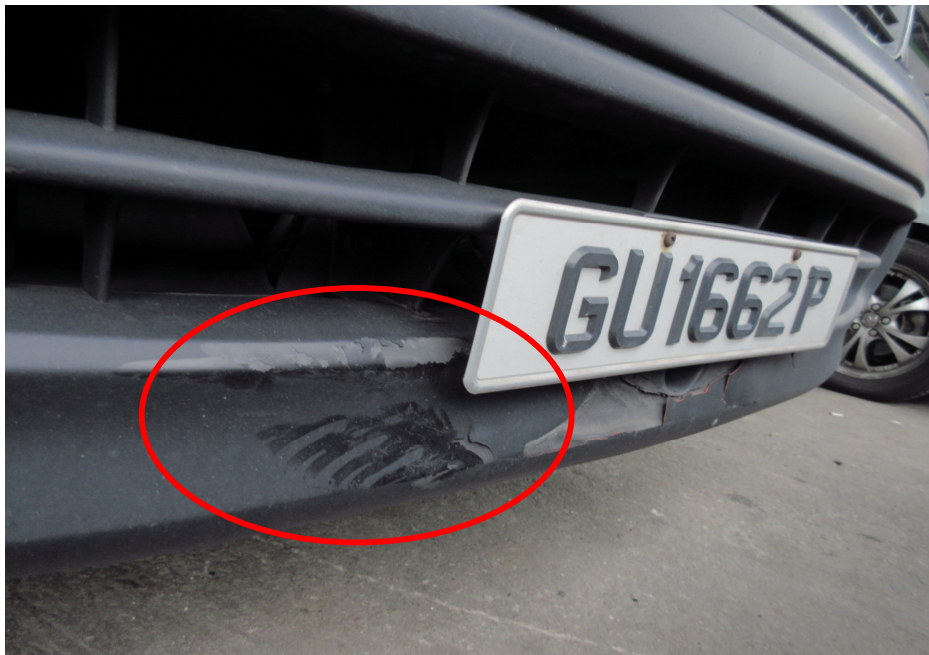
Photo 13 shows a closer view of the damage at the lower part of the Motor Van's front bumper (circled), at or below the area where its front number plate was fixed on. The part(s) at the entire front portion of the Motor Van above this area did not sustain any damage. The Motor Van had sustained a single area of damage at its front portion.

19. The damage to the front portion of the Motor Van was at a relatively low height above ground level and at a single area, as seen from the photographs. If the contact between the front portion of the Motor Van and the rear portion of the Motorcycle had occurred at a time when the Motorcycle was in an upright position, any damage to the front portion of the Motor Van would be at or around middle height level of the Motor Van and downwards. The damage would not be confined to the lower part of its front bumper only.

20. To put things into perspective, if the contact had occurred when the Motorcycle was in an upright position, I would expect to find damage to the front portion of the Motor Van at or around the corresponding height (above ground level) of the Motorcycle's rear box as the rear box was the most protruding part at the rear of the Motorcycle. The relatively low height (above ground level) of damage observed to the front portion of the Motor Van would suggest that the contact between the Motor Van had occurred after the Motorcycle had fallen.

21. Also, the single area of damage seen to the front of the Motor Van suggest that there was one and not multiple contacts/impacts between the Motor Van and the Motorcycle. Since the video recording had showed that the Motor Van was pushed forward upon the collision onto its rear by the Motor Lorry, the single contact or impact between the Motor Van and the Motorcycle had occurred when the Motor Van was pushed forward. If there was contact/impact before the Motor Van was pushed forward, the damage at the front of the Motor Van would not be confined to a single area.
