Your Ref: 4181986396SG-003
Our Ref : CI/AIG20001391/N

22 January 2020

MECHANICAL INSPECTION REPORT OF MOTOR LORRY GBB 5739K

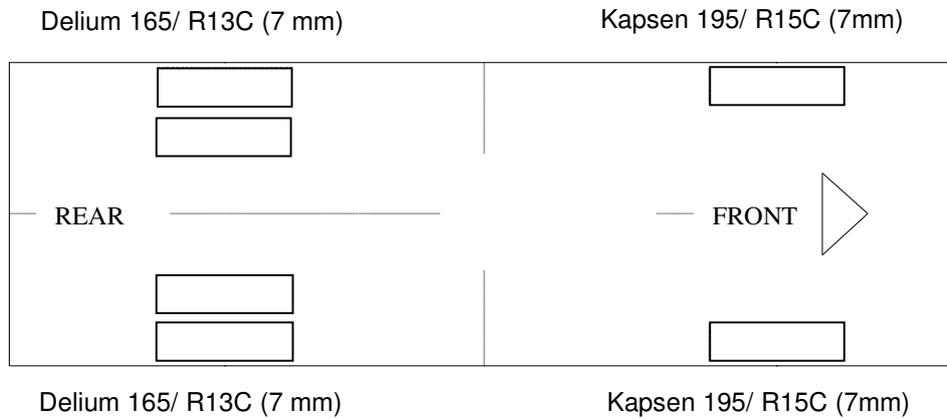
6. The 2 front tyres and 4 rear tyres of the Motor Lorry were observed to be in serviceable condition and sufficiently inflated for vehicular operation. We did not find any tear, cut or burst mark(s) on the outer and the inner sidewalls as well as across the tread of the 6 tyres. The tyre brand, tyre size and remaining tread depth of the 6 tyres of the Motor Lorry were recorded as follows:-

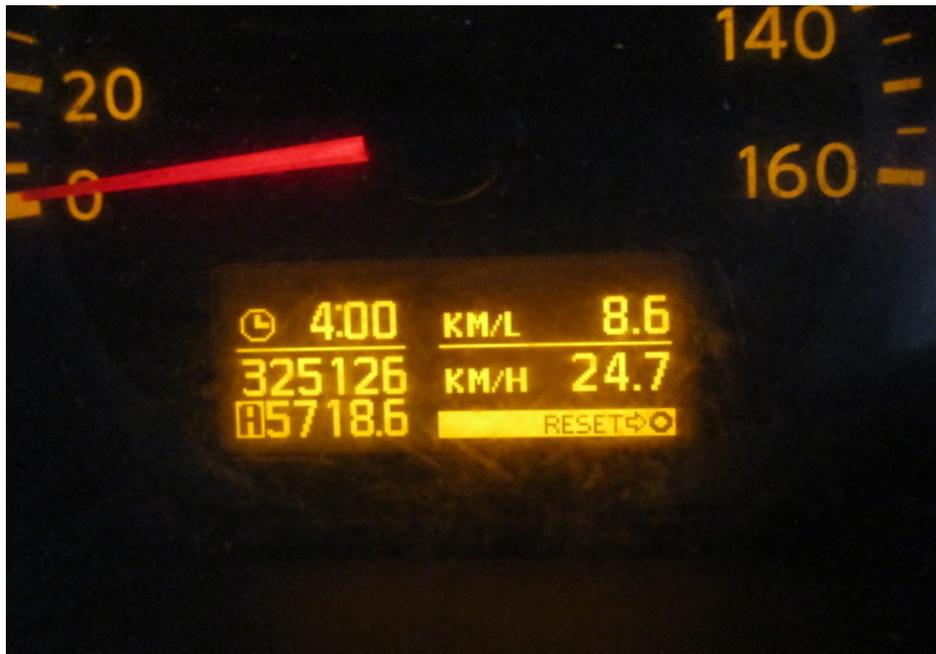
Photo 1 shows a general view of the instrument cluster of the Motor Lorry at the time of our inspection. The mileage of the Motor Lorry was 325,125km.

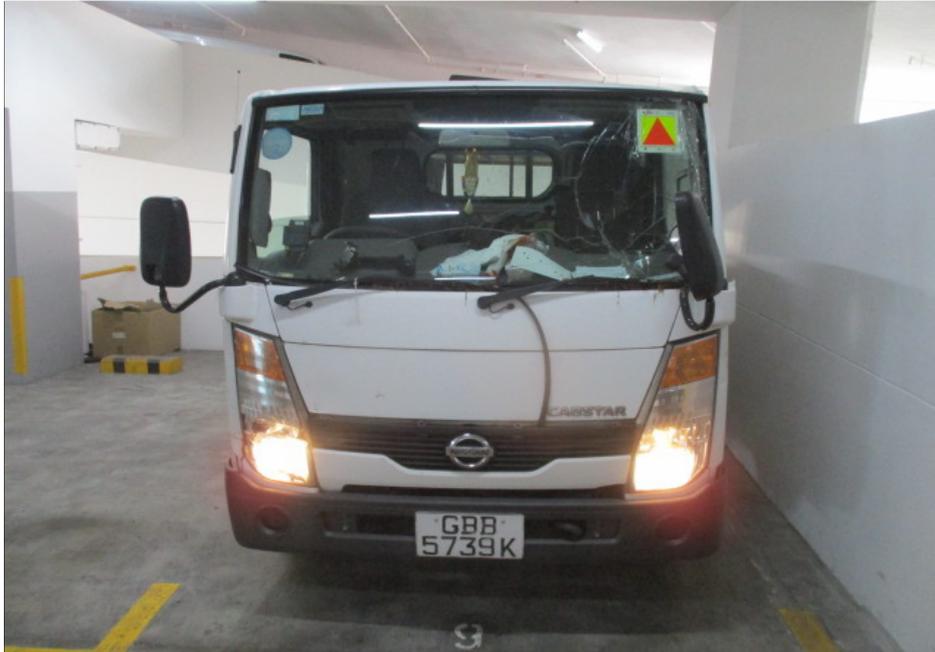
4. The mileage of the Motor Lorry at the time of our inspection was 325, 126km.
5. The Motor Lorry appeared to have sustained moderate damage at its front portion. Its front windscreen, front right headlamp, left and right door panel were damage as a result of the accident at the time of our inspection.

Photo 2 shows a general view of the Motor Lorry's front portion at the time of our inspection. Its front windscreen, front right headlamp, left and right door panel were damaged as a result of the accident at the time of our inspection.

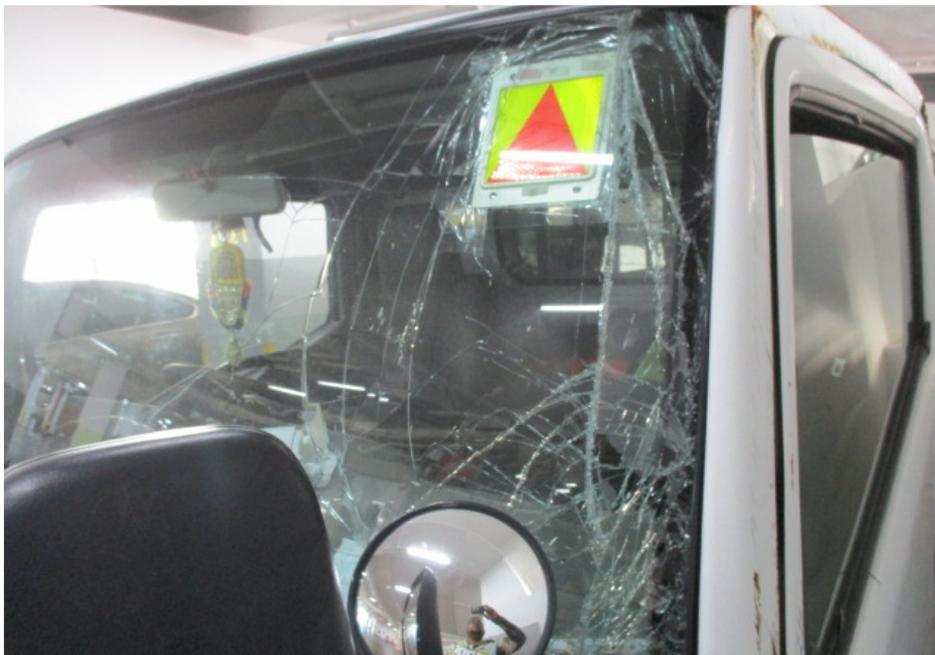
Photo 3 shows a close up view of the front portion of the Motor Lorry at the time of our inspection. Its front windscreen was damaged as a result of the accident at the time of our inspection.

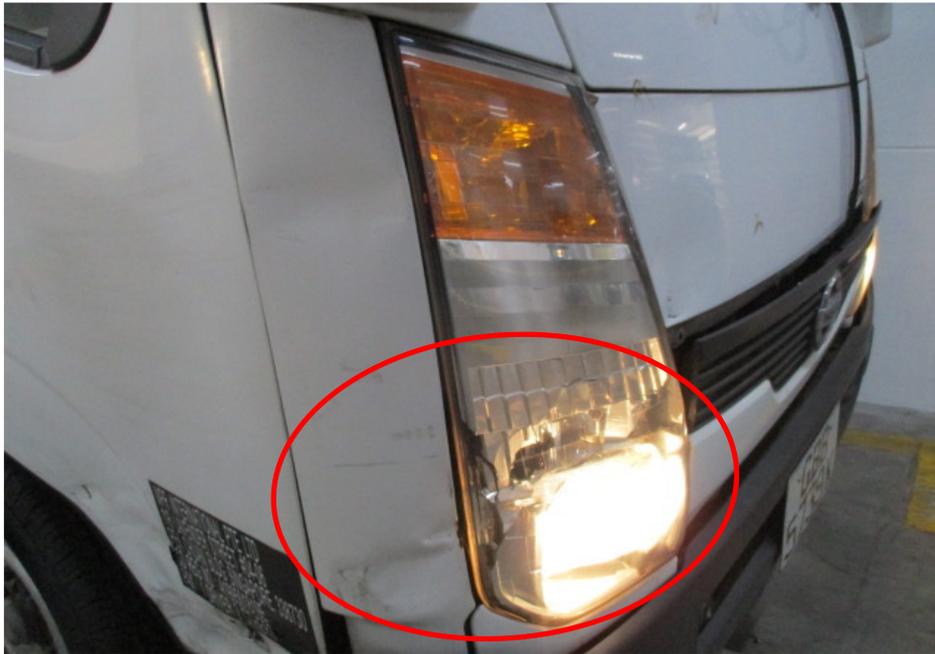
Photo 4 shows a close up view of the front portion of the Motor Lorry at the time of our inspection. Its front right headlamp and front right panel were damaged as a result of the accident at the time of our inspection (circled).

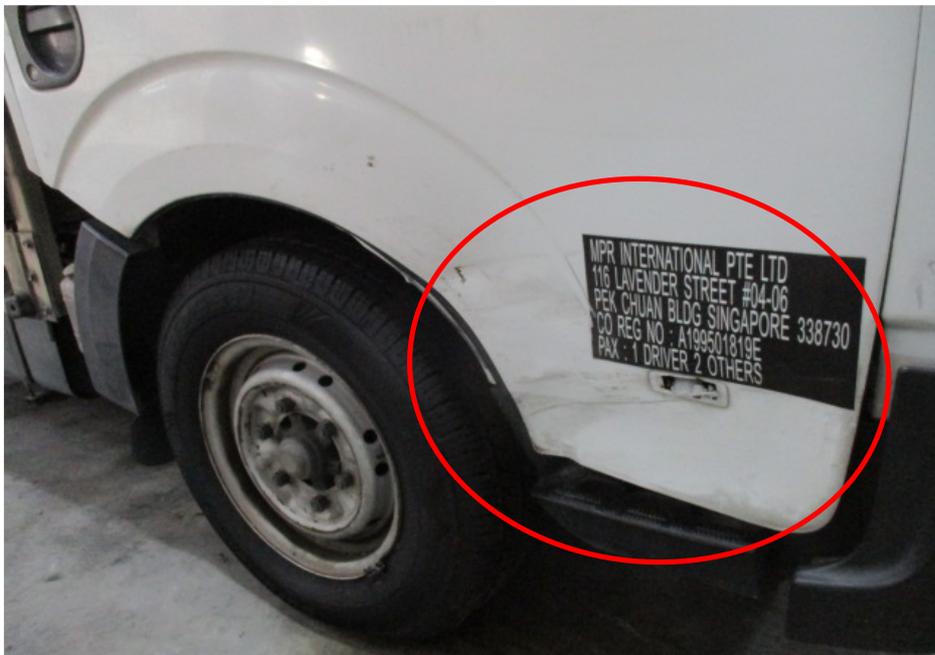
Photo 5 shows a close up view of the right front portion of the Motor Lorry at the time of our inspection. Its right front door panel was damaged as a result of the accident at the time of our inspection (circled).

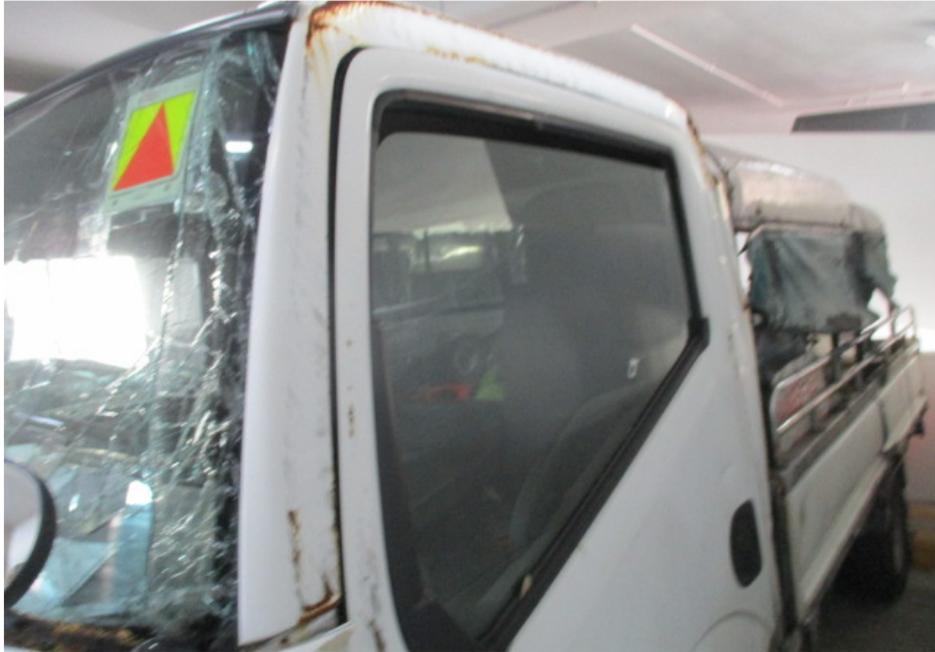
Photo 6 shows a general view of the left front portion of the Motor Lorry at the time of our inspection. Its left front door panel had sustained damages of grazing nature as a result of the accident.

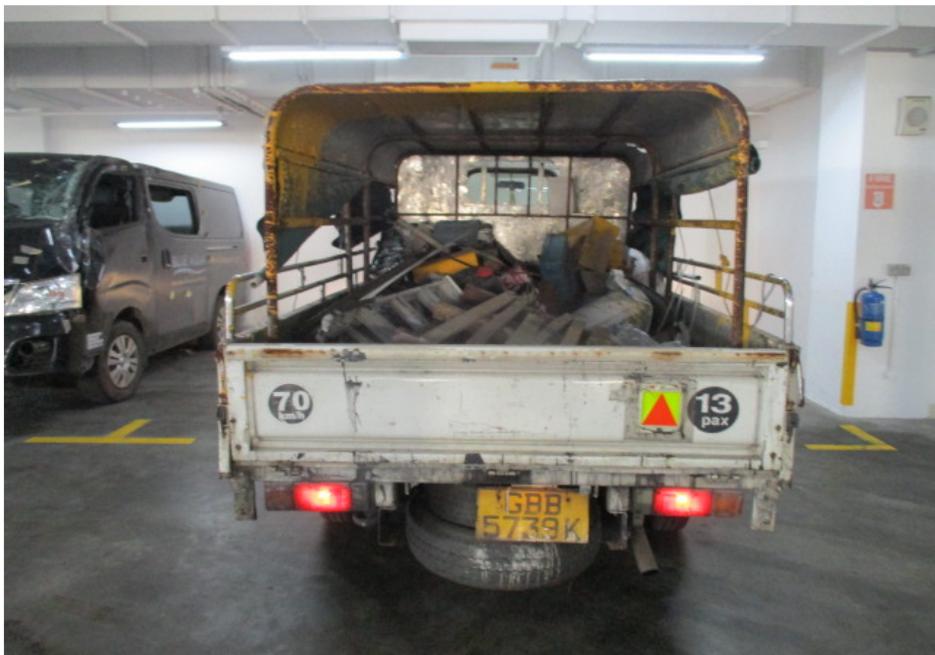
Photo 7 shows a general view of the rear portion body of the Motor Lorry at the time of our inspection. Its rear portion was observed to be intact and unaffected by the accident.

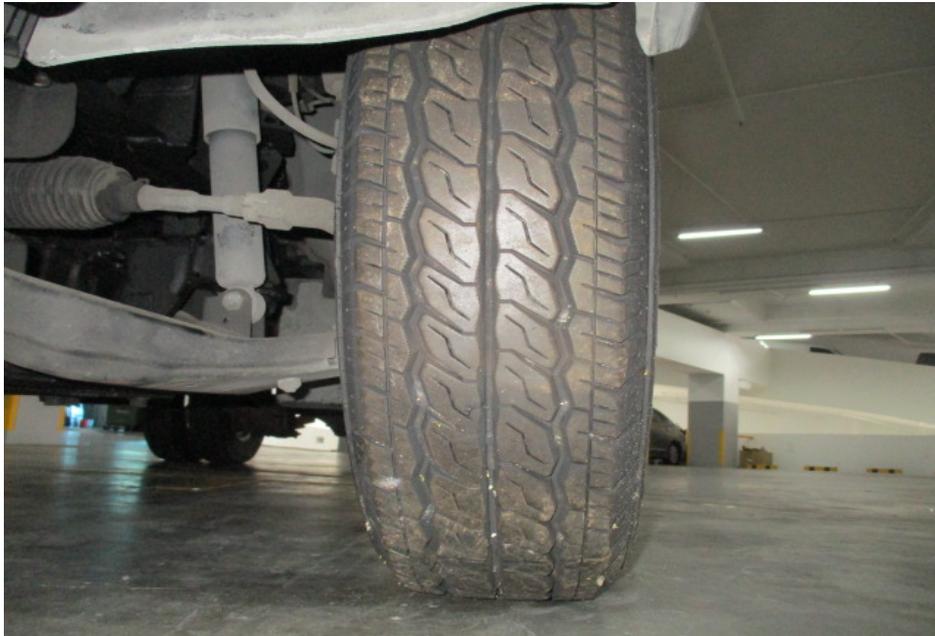
Photo 4 shows the condition of the front left tyre of the Motor Lorry, which was observed to be in serviceable condition with remaining tread depth of approximately 7mm. The tyre, which was wrapped around standard alloy wheel rim, was also observed to be sufficiently inflated for vehicular operation. There was no tear, cut or burst mark(s) on the outer and the inner sidewalls as well as across the tread of the 6 tyres that were fitted on the Motor Lorry.

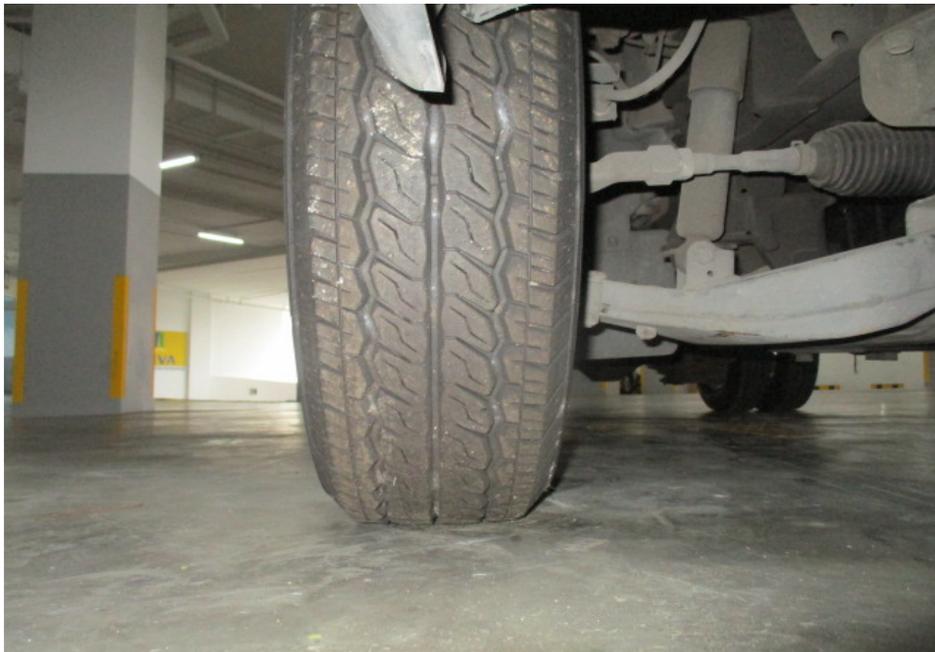
Photo 5 shows the condition of the front right tyre of the Motor Lorry, which was observed to be in serviceable condition with remaining tread depth of approximately 6mm. The tyre, which was wrapped around standard alloy wheel rim, was also observed to be sufficiently inflated for vehicular operation.

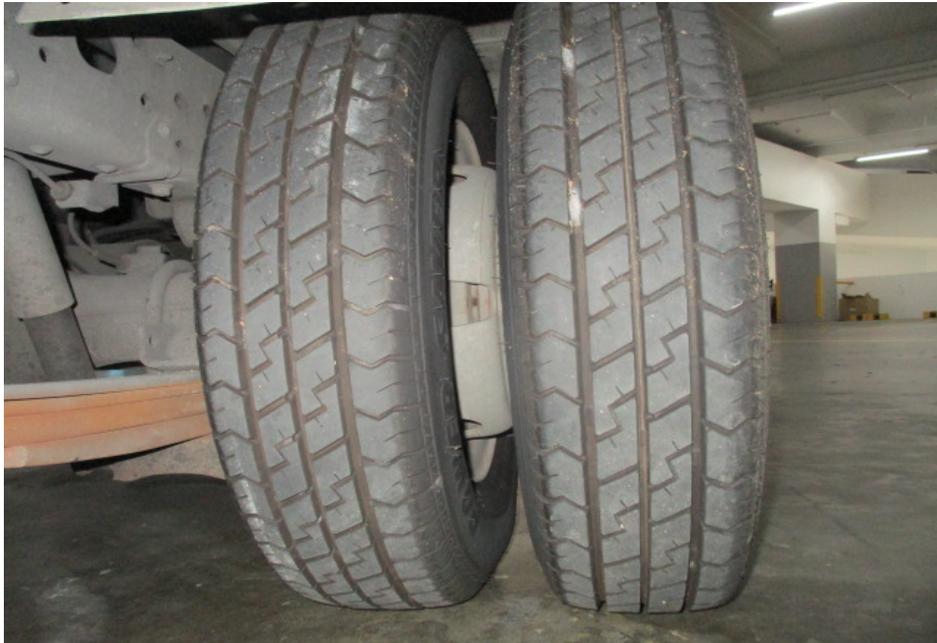
Photo 6 shows the condition of the rear left tyres of the Motor Lorry, which was observed to be in serviceable condition with remaining tread depth of approximately 7mm. The tyres, which were wrapped around standard alloy wheel rim, were also observed to be sufficiently inflated for vehicular operation. There was also no damage found on all 6 alloy wheel rims of the Motor Lorry.

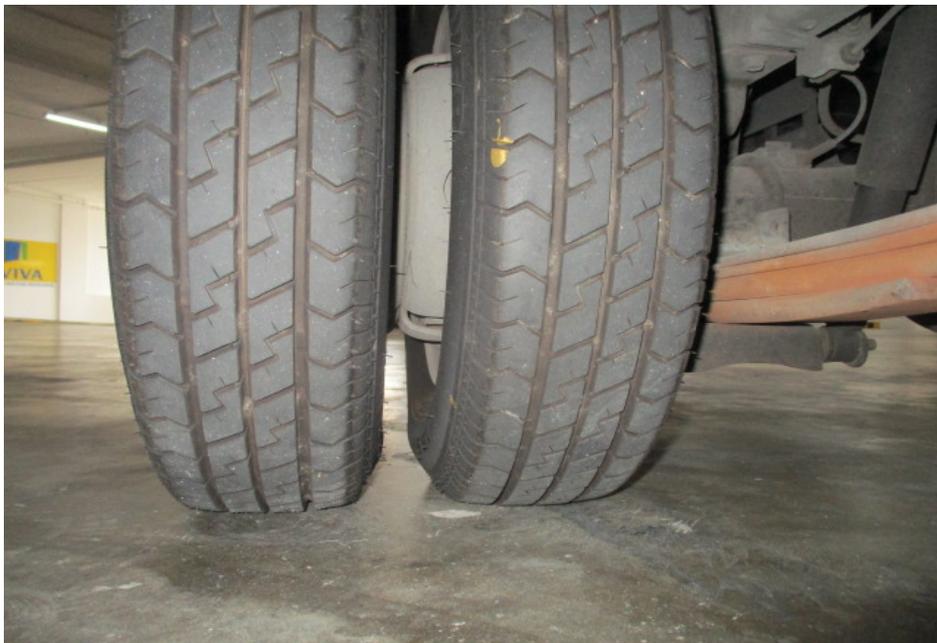
Photo 7 shows the condition of the rear right tyres of the Motor Lorry, which were observed to be in serviceable condition with remaining tread depth of approximately 7mm. There was also no tear, cut or burst mark(s) on the outer and the inner sidewalls as well as across the tread of the 6 tyres that were fitted on the Motor Lorry.

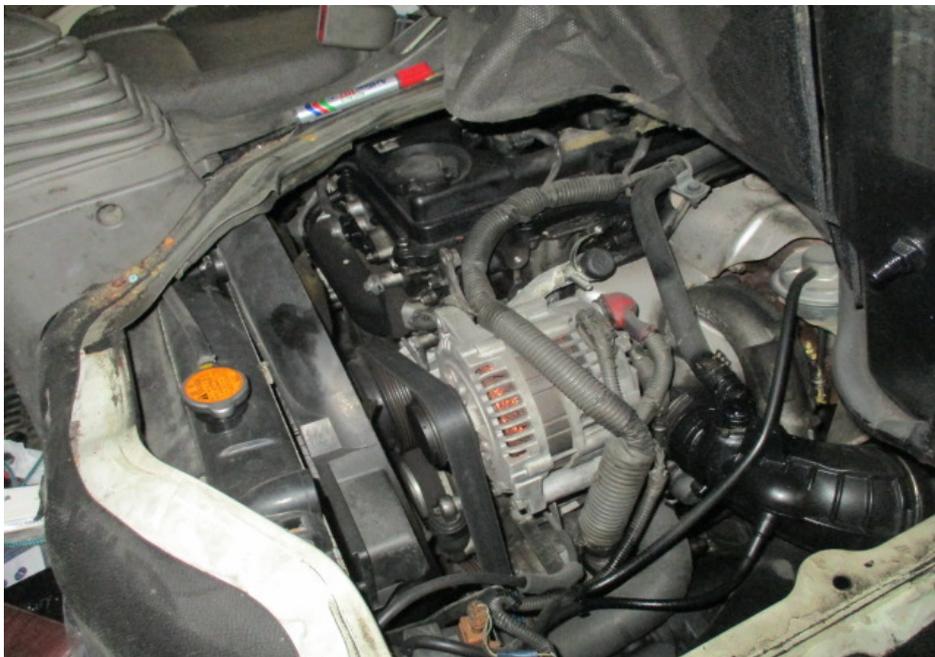
Photo 8 shows a general view of the Motor Lorry's engine compartment, which was accessed by lifting the front passenger seat of the Motor Lorry. The various parts and components inside the engine compartment were unaffected by the accident. There was also no sign(s) or indication(s) of fresh fluid leakage and/or fluid stain within the engine compartment (photograph shows the engine compartment as viewed from the left front side of the Motor Lorry).

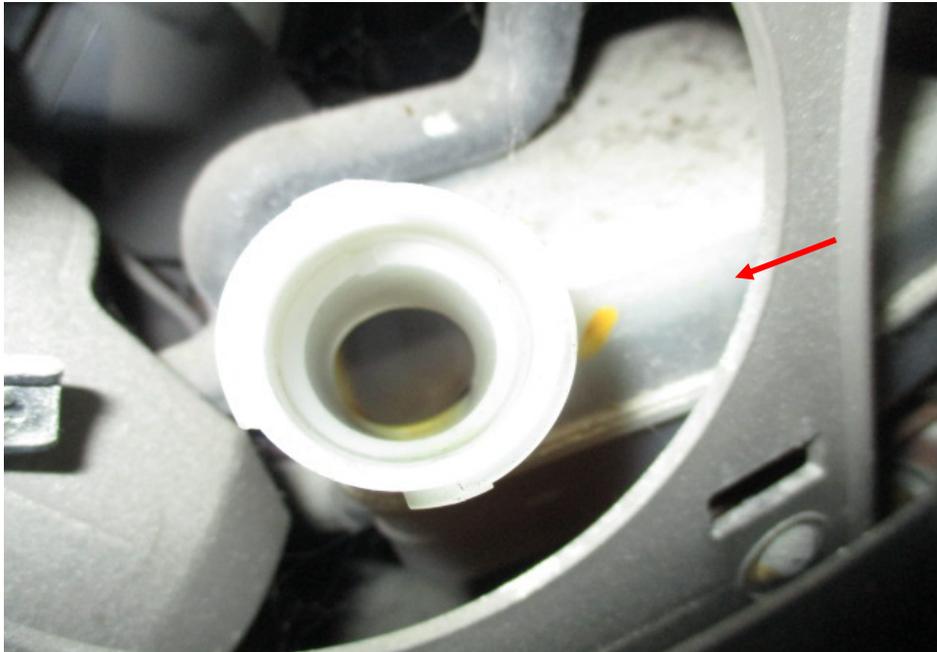
Photo 9 shows the brake fluid reservoir of the Motor Lorry at the time of our inspection. The brake fluid was observed to be of sufficient level (arrowed) and without any visible contamination.

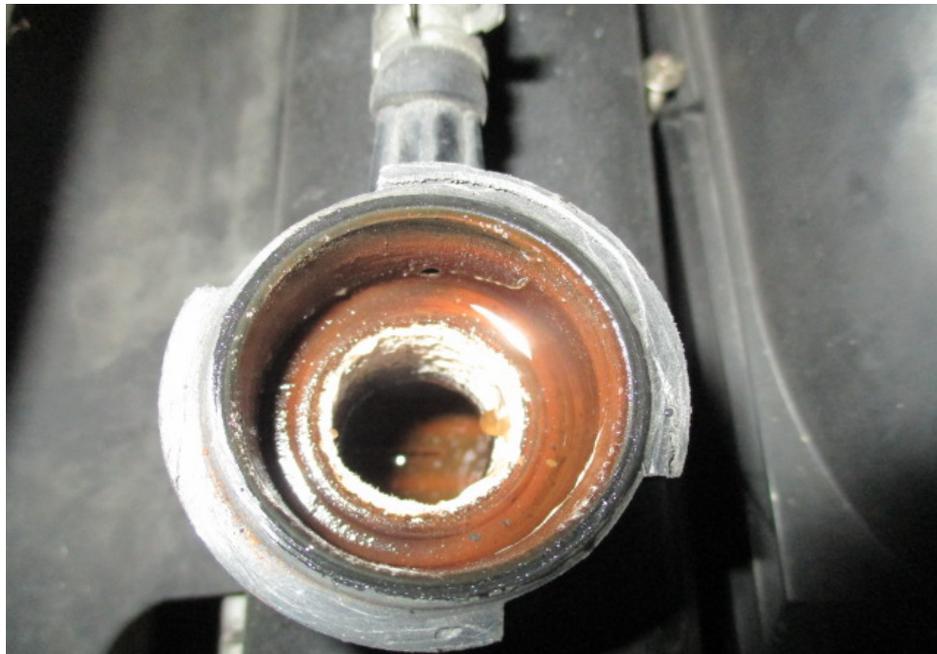
Photo 10 shows the engine coolant of the Motor Lorry at the time of our inspection. The engine coolant was observed to be of sufficient level and without any visible contamination.

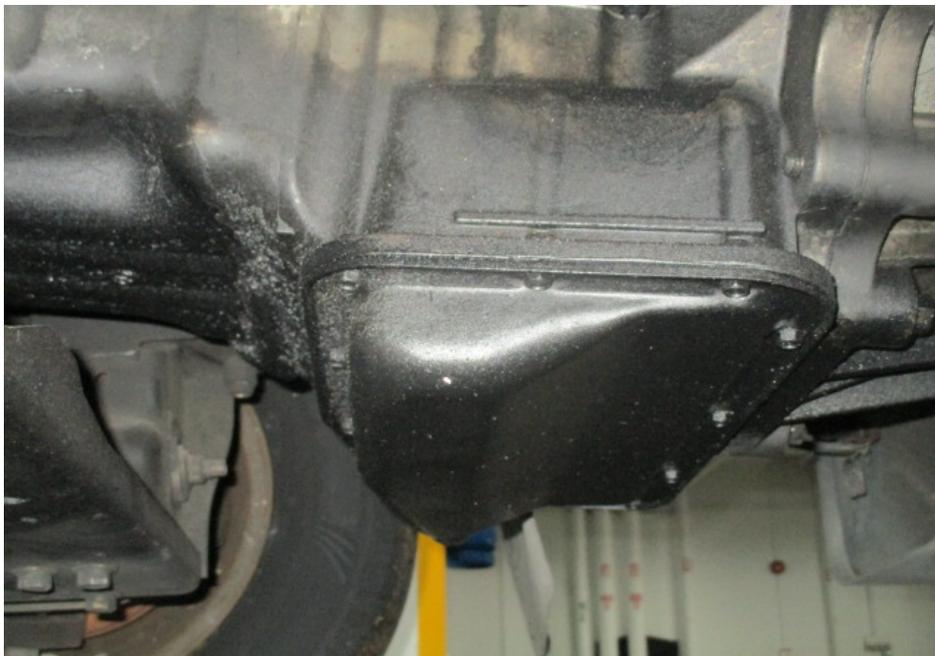
Photo 16 shows the undercarriage of the Motor Lorry, at the area where the engine housing and transmission housing are located. We observed minor old engine oil stains on the housing of the engine oil sump.

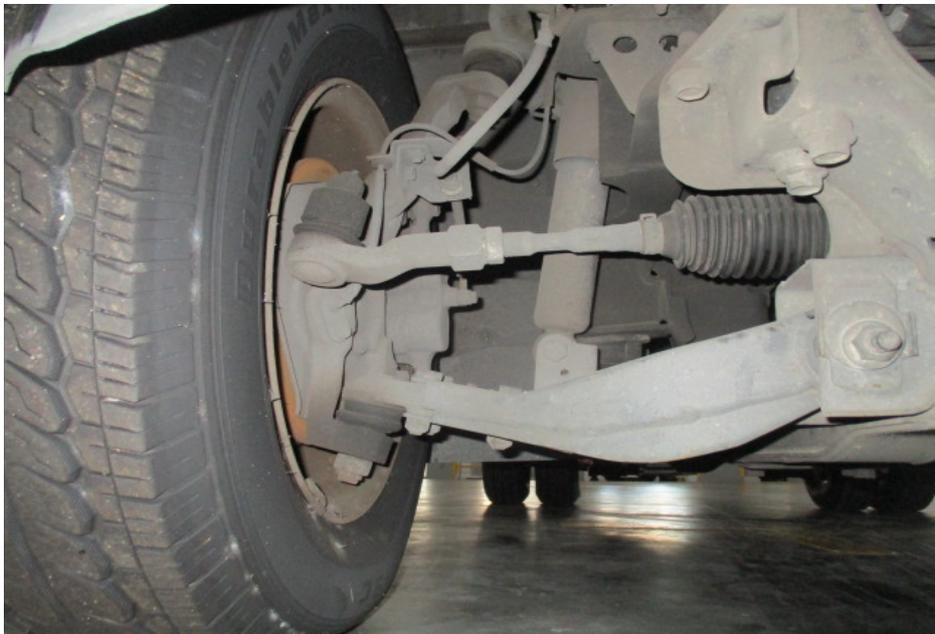
Photo 15 shows the various undercarriage components at the front right wheel of the Motor Lorry, in particular the steering tie rod end (arrowed). The various steering components were all found to be intact, suggesting that the steering system of the Motor Lorry was likely to be in serviceable condition at the material time of accident. There was also no sign of fluid stain(s) observed on the various undercarriage components.

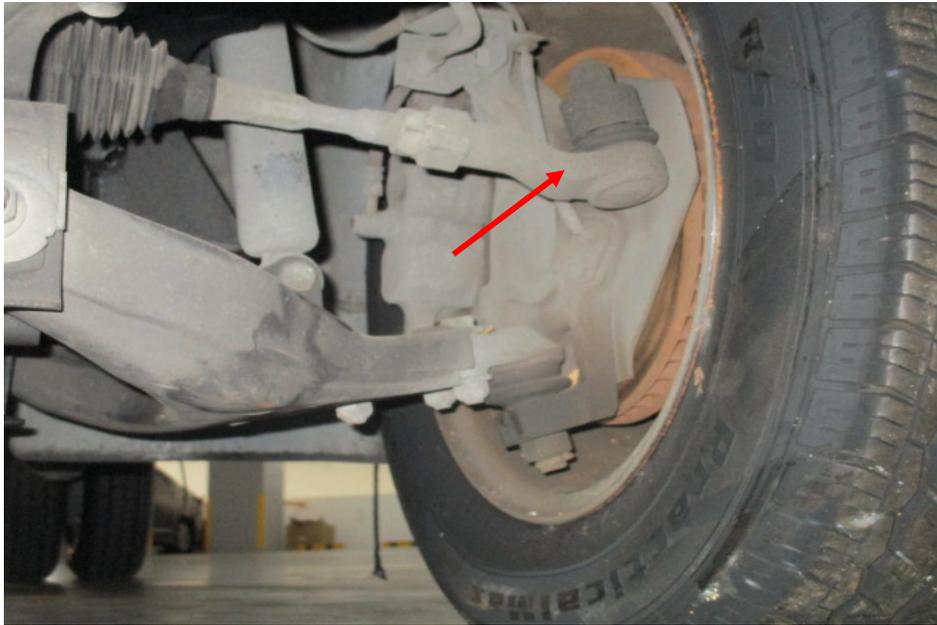
Photo 16 shows the various undercarriage components at the front left wheel of the Motor Lorry, in particular the steering tie rod end (arrowed). The various undercarriage components of the Motor Lorry were all found to be intact without any visible damage. There was also no sign of fluid stain(s) observed on the various undercarriage components.

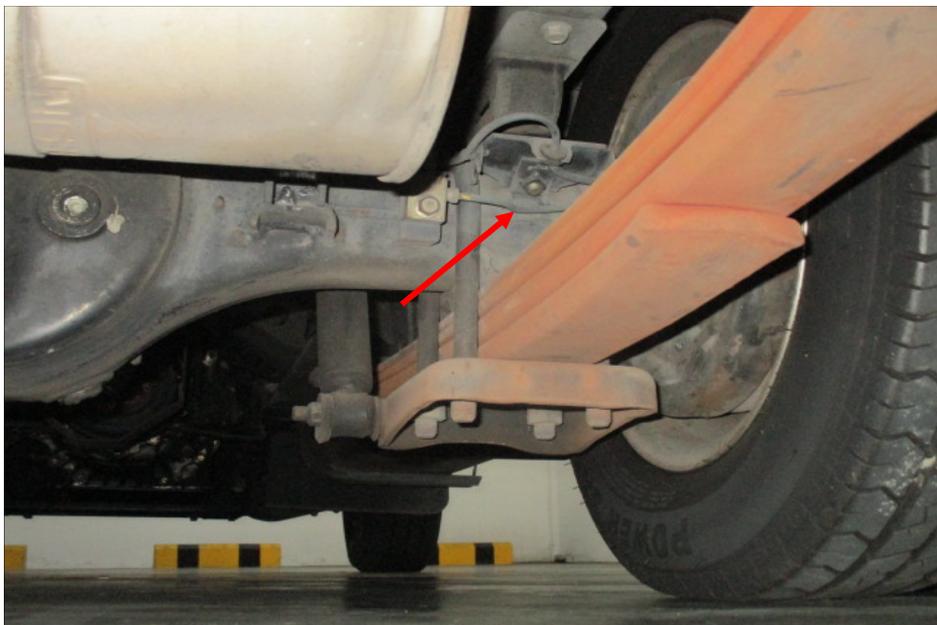
Photo 13 shows the brake pipe (arrowed) at the rear right wheel of the Motor Lorry. We did not observe any leakage of brake fluid at the time of our inspection of the Motor Lorry. Our static tests of the Motor Lorry's braking system, along with our visual examination of the various mechanical components in the braking system, had indicated that there was no internal leakage of pressure/vacuum. Hence the braking system of the Motor Lorry was likely to be in serviceable condition at the material time of accident.

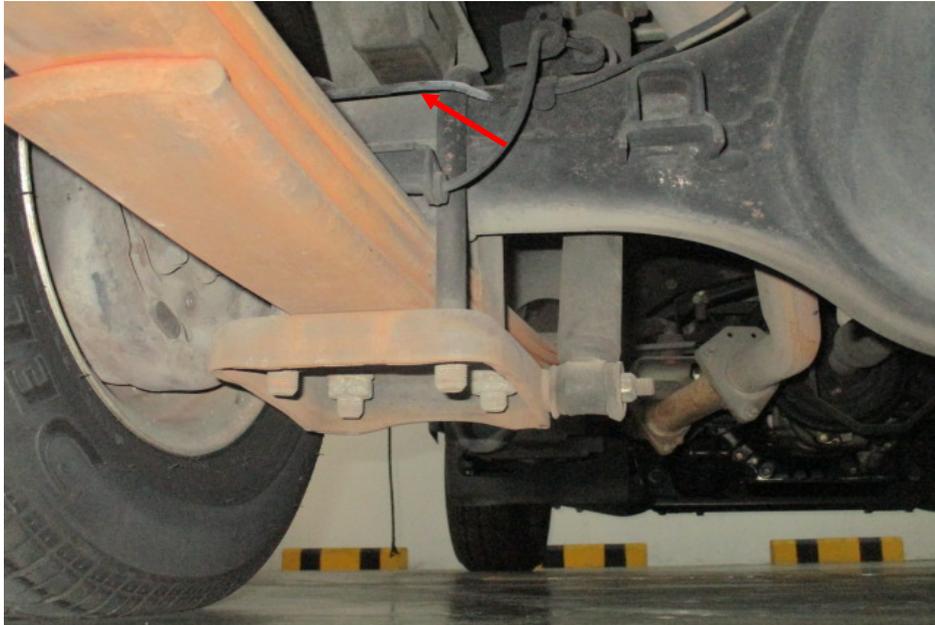
Photo 20 shows the brake pipe (arrowed) at the rear left wheel of the Motor Lorry. I did not observe any leakage of brake fluid at the time of my inspection of the Motor Lorry. My static tests of the Motor Lorry's braking system, along with my visual examination of the various mechanical components in the braking system had indicated that there was no internal leakage of pressure/vacuum. Hence the braking system of the Motor Lorry was likely to be in serviceable condition at the material time of accident.

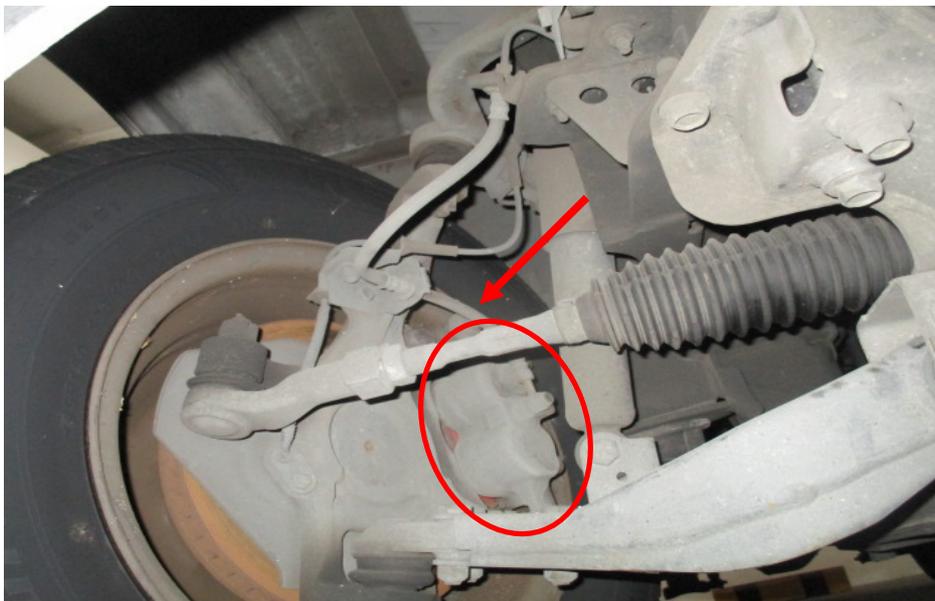
Photo 21 shows the brake hose/pipe (arrowed) at the front right wheel of the Motor Lorry. No leakage of brake fluid was observed. Visual examination of the various components of the braking system like the brake caliper (circled), brake booster, brake pedal etc had revealed all to be intact and without visible damage at the time of accident. There was also no sign of fluid stain(s) observed on the various undercarriage components.

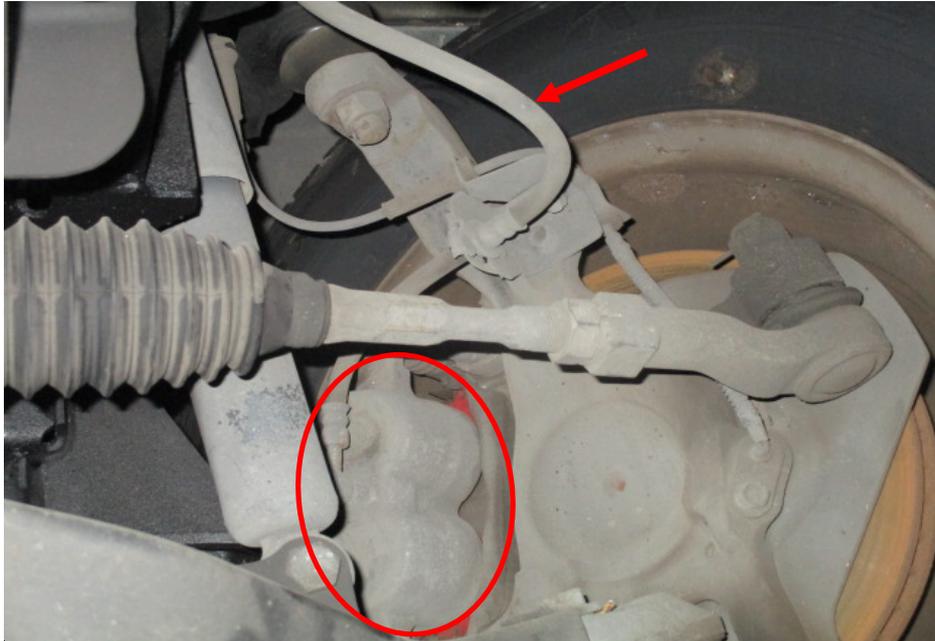
Photo 22 shows the brake hose/pipe (arrowed) at the front left wheel of the Motor Lorry. No leakage of brake fluid was observed. Visual examination of the various components of the braking system like the brake caliper (circled), brake booster, brake pedal etc had revealed all to be intact and without visible damage at the time of accident. There was also no sign of fluid stain(s) observed on the various undercarriage components.

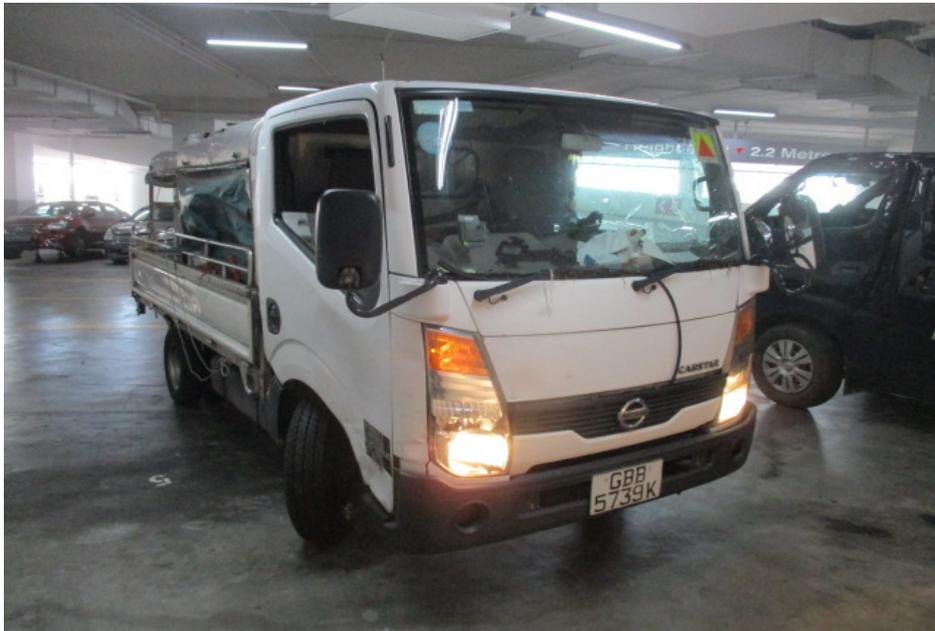
Photo 14 shows the front right wheel of the Motor Lorry turned to its full right. During our steering system test, we did not experience any abnormal free play and/or resistance when we had turned the steering wheel towards full left and full right. This would suggest that the steering system of the Motor Lorry was likely to be in serviceable condition at the material time of accident.

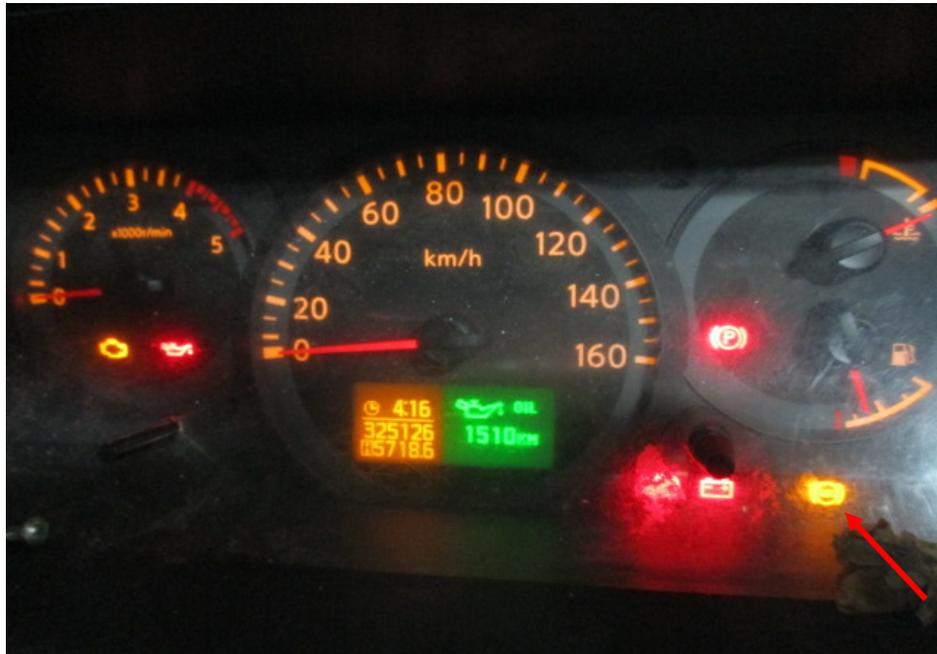
Photo 24 shows the warning light for the Anti-Lock Brake System (ABS) (arrowed) appearing on the instrument panel of the Motor Lorry during the self-test of its various electronic operating system when its engine was cranked.

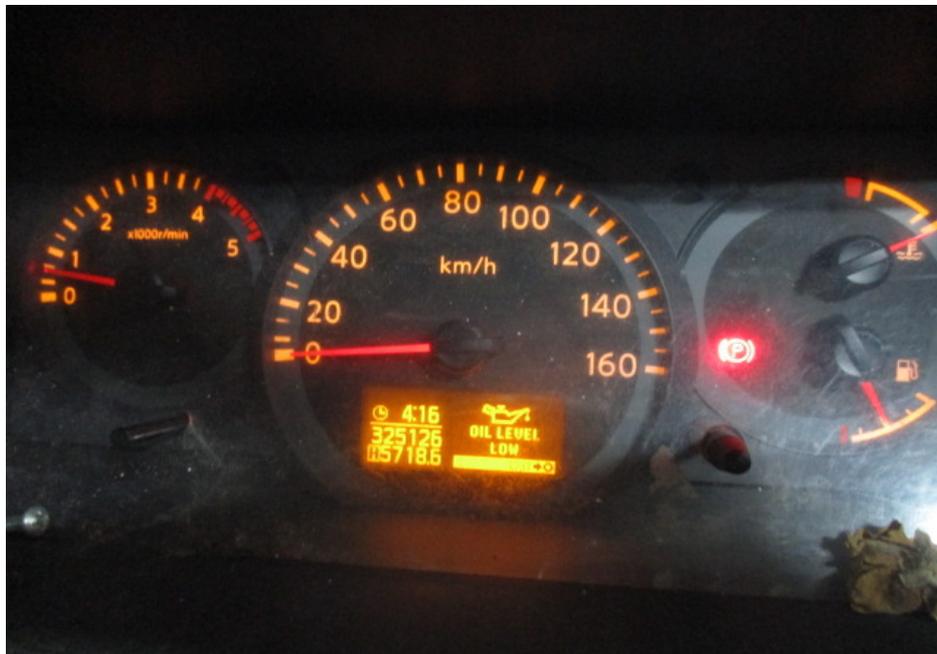
Photo 25 shows no warning lights illuminated on the instrument panel of the Motor Lorry after the engine was cranked. This would suggest that there was no abnormality to the various electronic operating system of the Motor Lorry, like the ABS and etc.
