Your Ref: 7497983040SG  
Our Ref : CI/AIG20001597/N

31 January 2020

**TECHNICAL INVESTIGATION REPORT OF FIRE INCIDENT INVOLVING THE  
INSURED VEHICLE SGU 629T ON 12 JANUARY 2020**

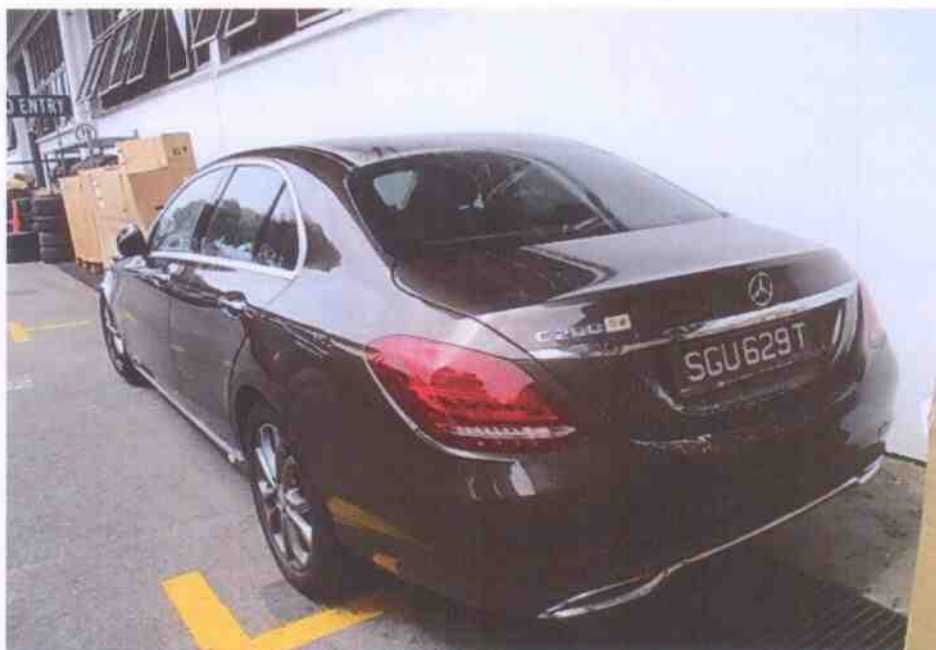
**Photo 1** shows the rear view of the Insured Vehicle. The rear portion of the Insured Vehicle was observed to be relatively unaffected by the fire.

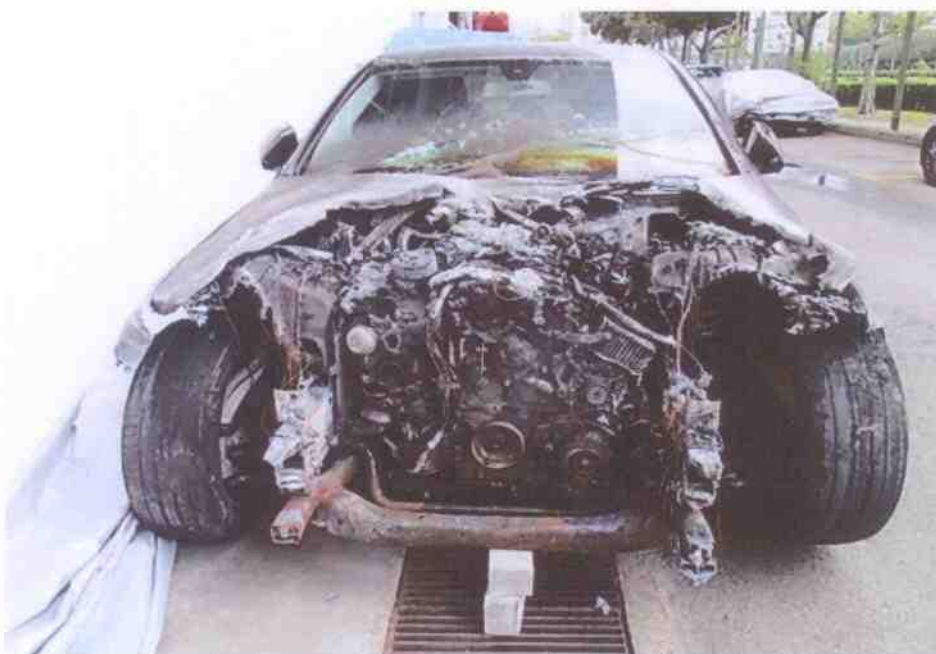
**Photo 2** shows the general view of the frontal portion of the Insured Vehicle at the time of our inspection. The exterior body of the Insured Vehicle had sustained visible fire damage. This included its front windscreen, front bonnet, front bumper, front bumper reinforcement panel, headlights and side panels.

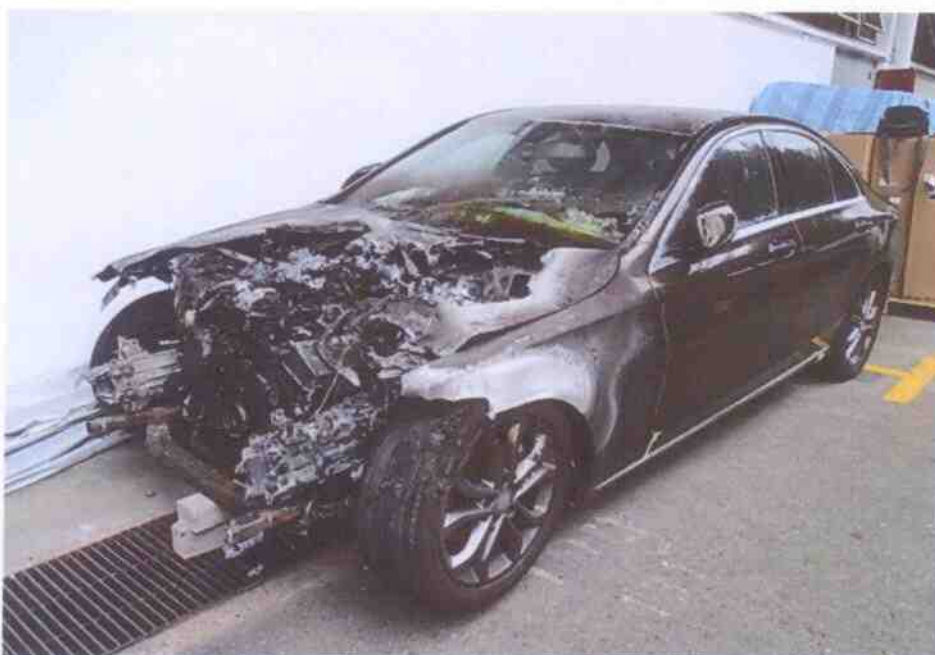
**Photo 3** shows the general view of the left portion of the Insured Vehicle at the time of our inspection. The exterior body of the Insured Vehicle had sustained visible fire damage. This included its front windscreen, front bonnet, left headlight, front bumper and left front panel.

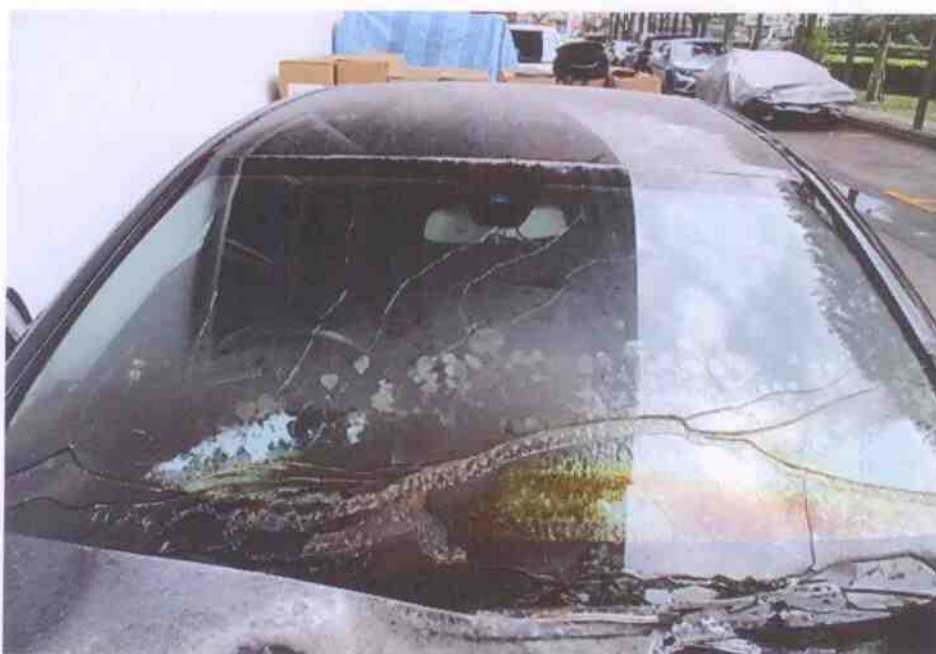
**Photo 4** shows a closer view of the front windscreen of the Insured Vehicle at the time of our inspection. The front windscreen had sustained extensive fire damage.

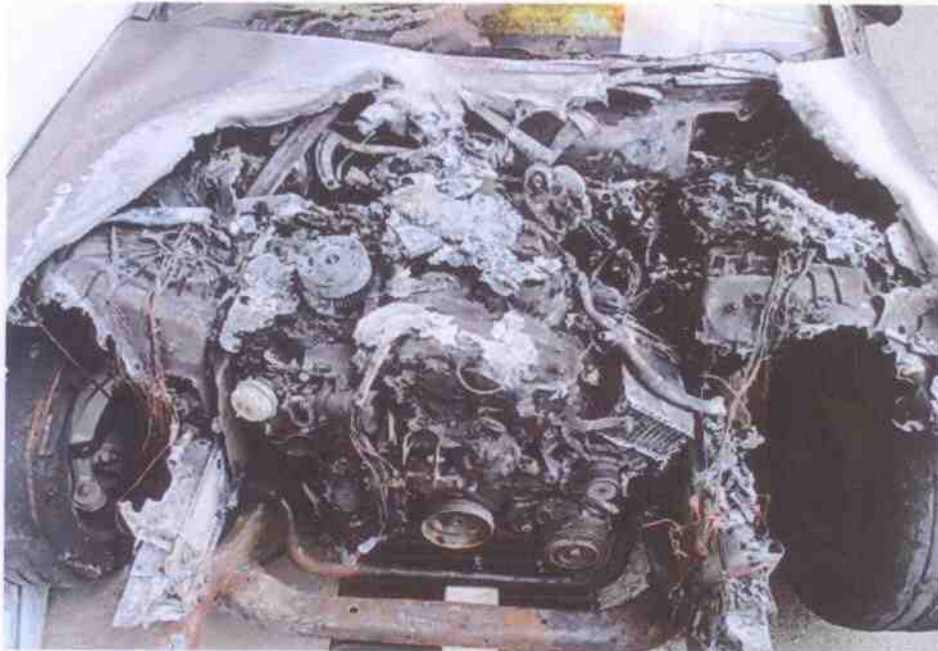
**Photo 5** shows a general view of the engine compartment of the Insured Vehicle at the time of our inspection. Most of the components inside the engine compartment were found to be severely burnt and/or melted as a result of the fire.

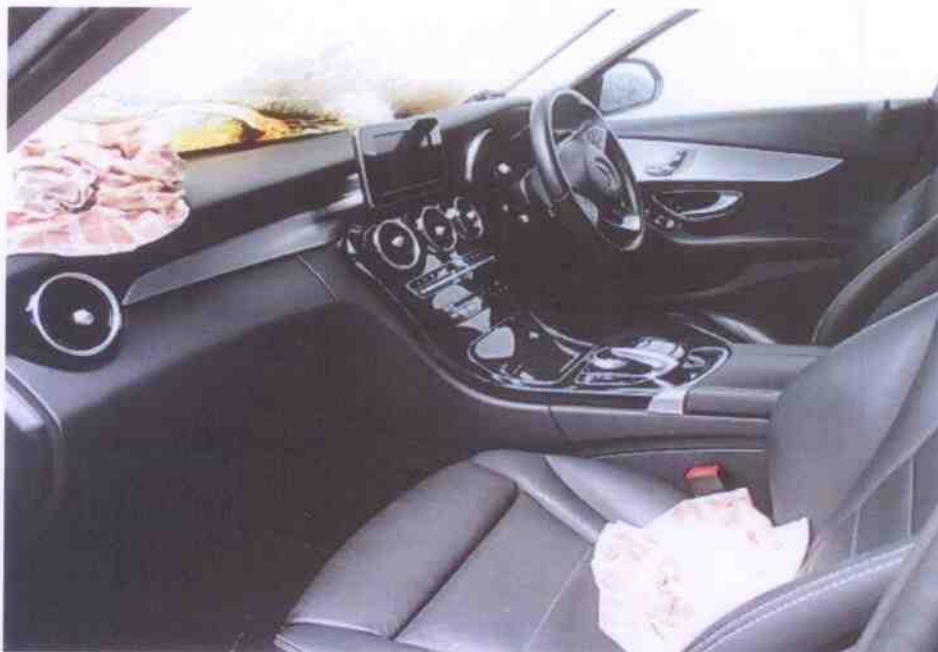
**Photo 6** shows the interior compartment of the Insured Vehicle, which was observed to be relatively unaffected by the fire.

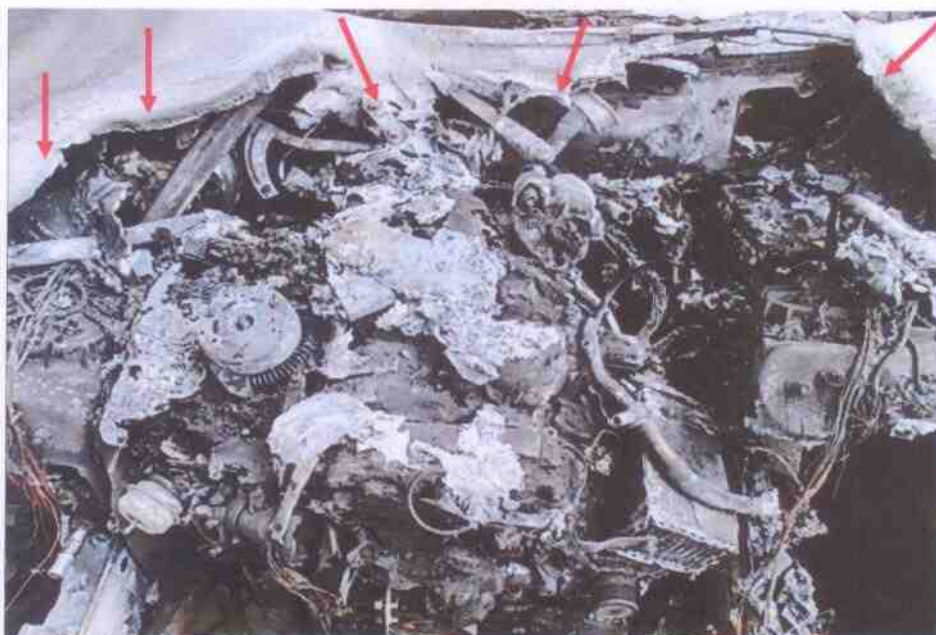
8. For this particular case, the fire appears to have originated within the engine compartment of the Insured Vehicle, somewhere around the left portion of the engine compartment due to the nature of the fire damage which was more extensive at the left portion. Furthermore, the intense whitish burn marks on the left front fender and hole found in the front bonnet of the Insured Vehicle indicate that the front left portion of the Insured Vehicle was exposed to prolonged high heat intensity. The right front fender had sustained minimal fire damage. Following the characteristic of heat (hot air rises), the origin of fire can then be determined to be from the engine compartment of the Insured Vehicle as the engine compartment is covered by the front bonnet and front fenders. Flames from the confined spaces of the engine compartment would travel outwards and upwards, exposing the front bonnet and front fenders of the Insured Vehicle to high heat intensity hence leaving a hole in the front bonnet as seen.

9. The whitish burn marks are a result of exposure to prolonged heat intensity. Rust would normally start to develop around these areas soon after a fire as prolonged exposure to high heat intensity usually causes steel/metal material body parts to be exposed to natural environmental condition. The rust that had developed on the left portion of the engine compartment is an indication that the left portion of the engine compartment had sustained exposure to prolonged high heat intensity. See photos 7 - 9 below.

**Photo 7** shows the hole found in the front bonnet of the Insured Vehicle which indicates that the front portion of the Insured Vehicle was exposed to prolonged high heat intensity. The whitish burn marks (arrowed) are a result of exposure to prolonged heat intensity.

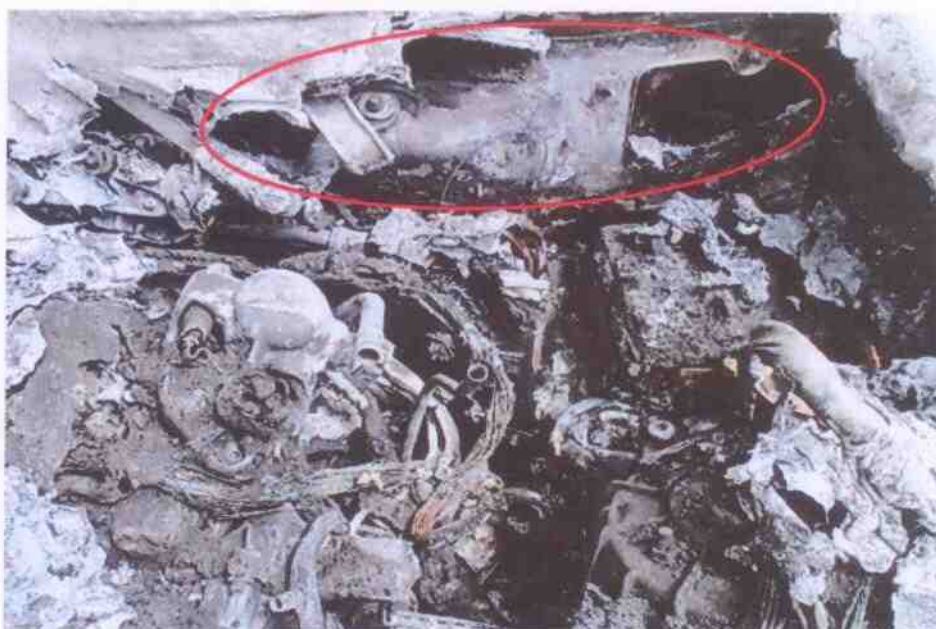
**Photo 8** shows a closer view of the rust that had developed on the left rear portion of the engine compartment (circled). The development of rust is an indication that this area was subjected to prolonged exposure to high heat intensity, which had caused the steel/metal material of the front bonnet to be exposed to natural environmental condition. Hence the fire to the Insured Vehicle can be determined to have originated towards the left portion of the engine compartment.

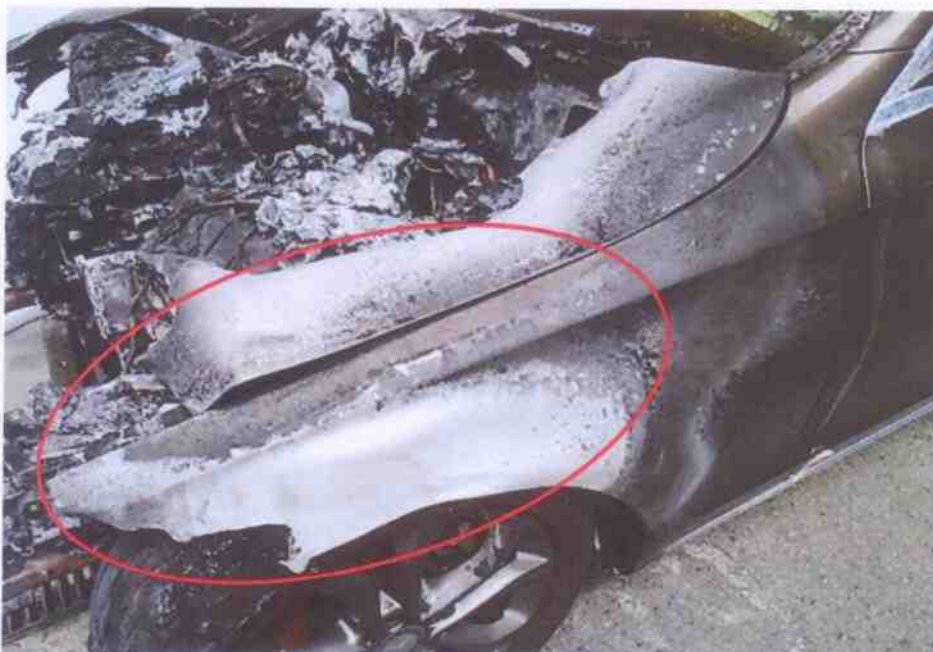
**Photo 9** shows the whitish burn marks that were found on the left front fender of the Insured Vehicle (circled). Such whitish burn marks are a result of exposure to prolonged heat intensity, which may indicate where the fire had started. Rust would also begin to develop on these areas soon after the fire.

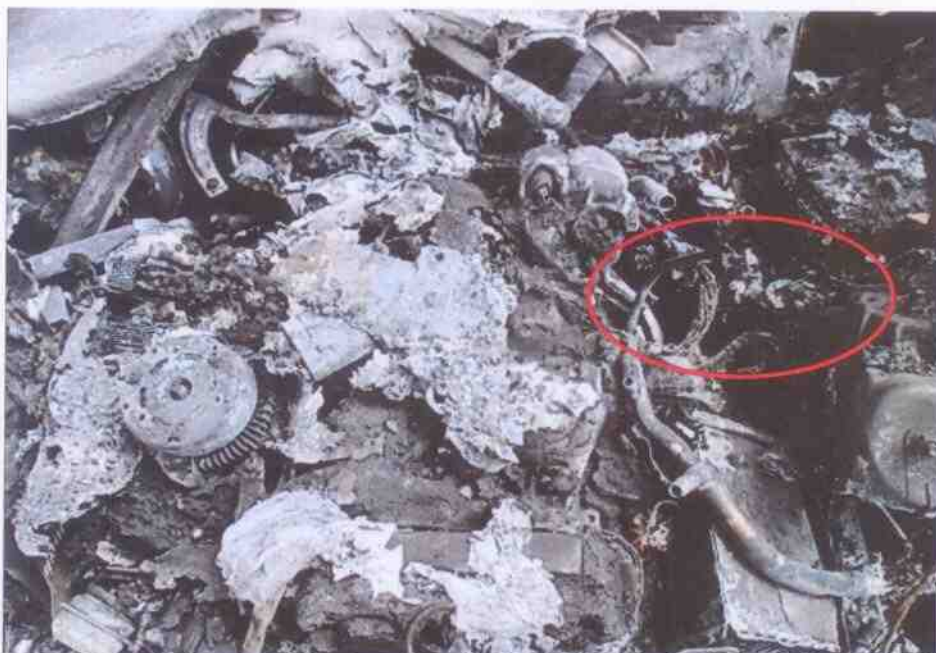
10. Upon closer examination of the left portion of the engine compartment, which was where the fire to the Insured Vehicle had likely started, we had found traces of greenish residue on several stretches of burnt wirings. The presence of greenish residue indicates internal heating of copper wires, a sign of an electrical short circuit occurring. The greenish residue is normally left behind from oxidation as a result of chemical reaction involving the copper wires. This physical evidence would then appear to suggest that the cause of fire to the Insured Vehicle could have possibly been due to electrical in nature. See photos 10 - 13 below.

Photo 10 shows the burnt wirings around the left portion of the engine compartment (circled), which is in the immediate vicinity where the fire to the Insured Vehicle had likely started.

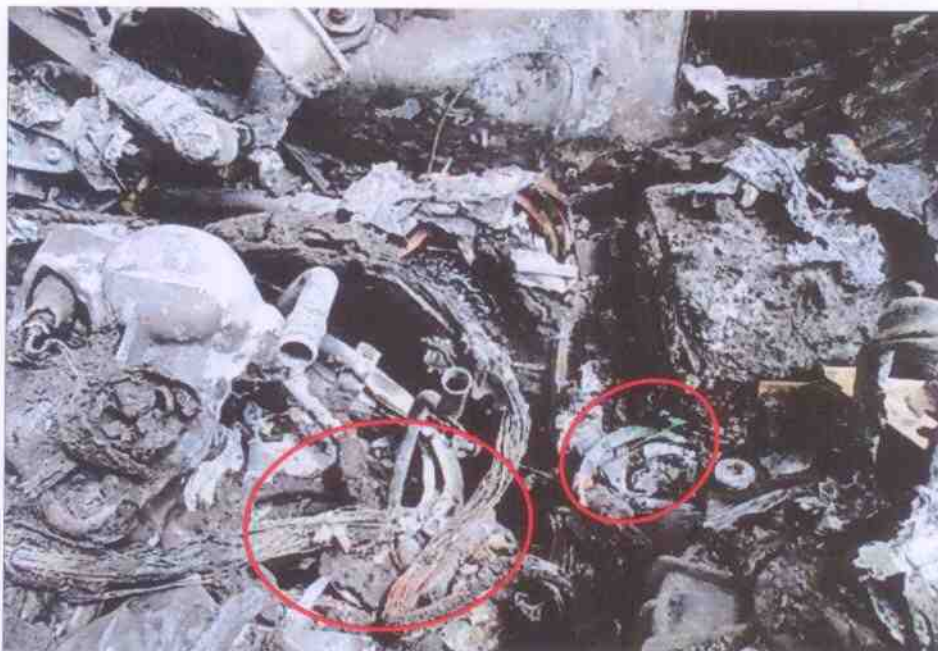
Photo 11 shows a closer view of the burnt wirings around the left portion of the engine compartment, which is in the immediate vicinity where the fire to the Insured Vehicle had likely started. We noticed greenish residue on several stretches of burnt wirings (circled). The presence of greenish residue indicates internal heating of copper wires, a sign of an electrical short circuit occurring. The greenish residue is normally left behind from oxidation as a result of chemical reaction involving the copper wires.

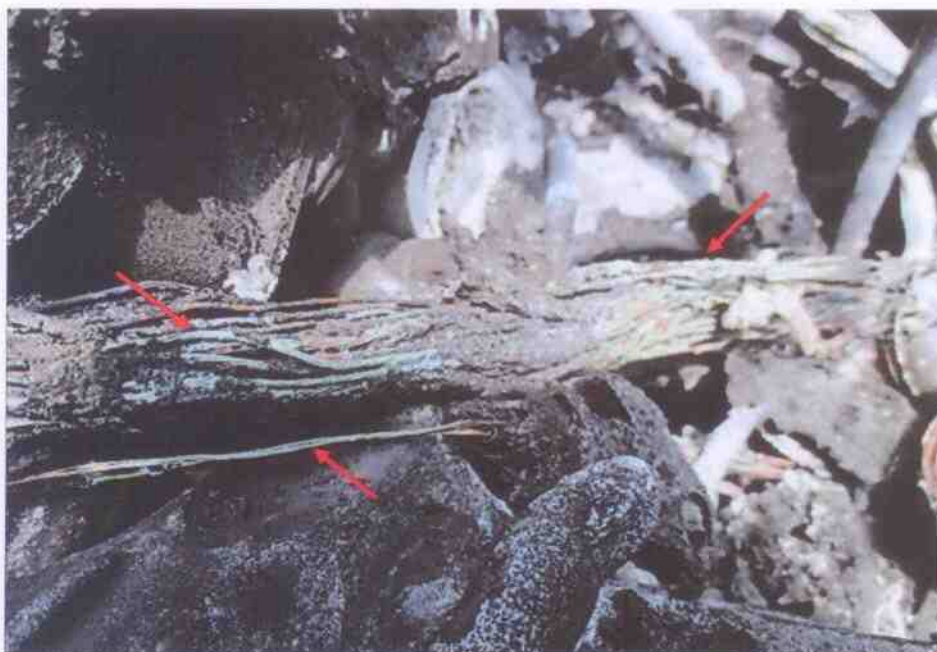
**Photo 12** shows a close up view of the greenish residue found on several stretches of burnt wirings (red arrows). The presence of such greenish residue suggests occurrence of an electrical short circuit.

25. The possibility of the fire being due to electrical in nature would then seem more likely given that engine overheating and external factors would both seem unlikely. The fire being due to electrical nature is also supported by the condition of the wirings that were found in the engine compartment of the Insured Vehicle, which was earlier discussed in paragraph 10 above.

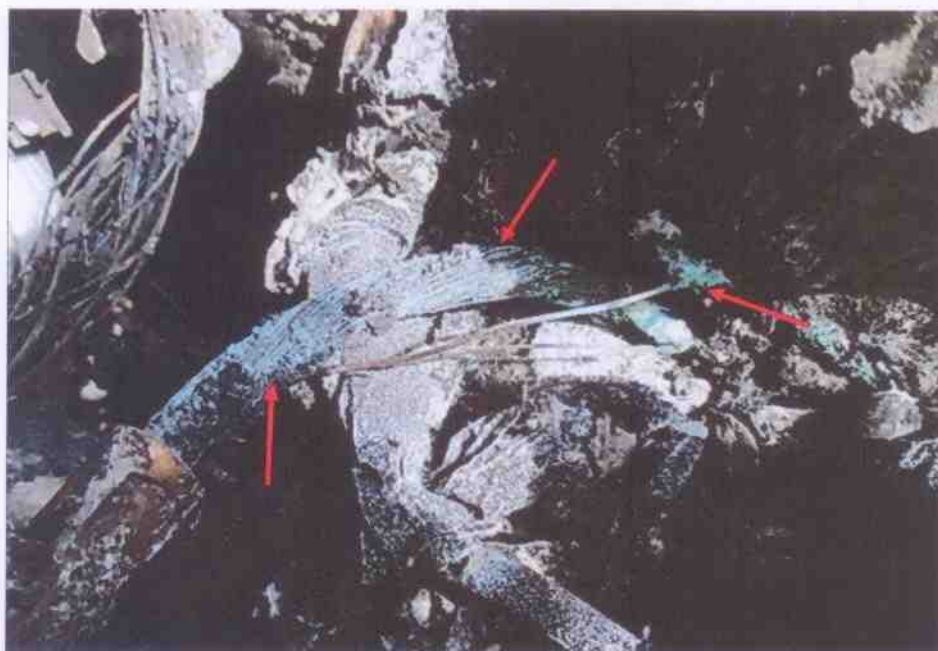
**Photo 13** shows a close up view of the greenish residue found on several stretches of burnt wirings (red arrows). The presence of such greenish residue suggests occurrence of an electrical short circuit.

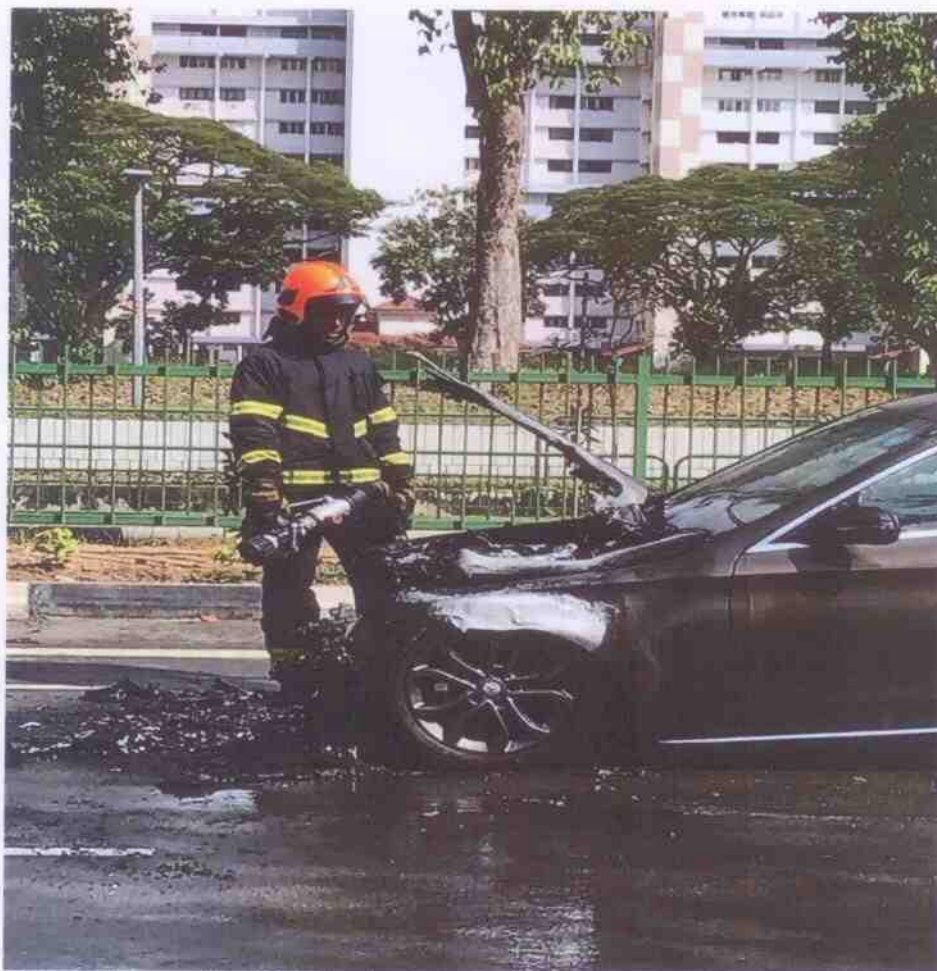
Photo 14 shows the SCDF having just put out the fire on the Insured Vehicle.

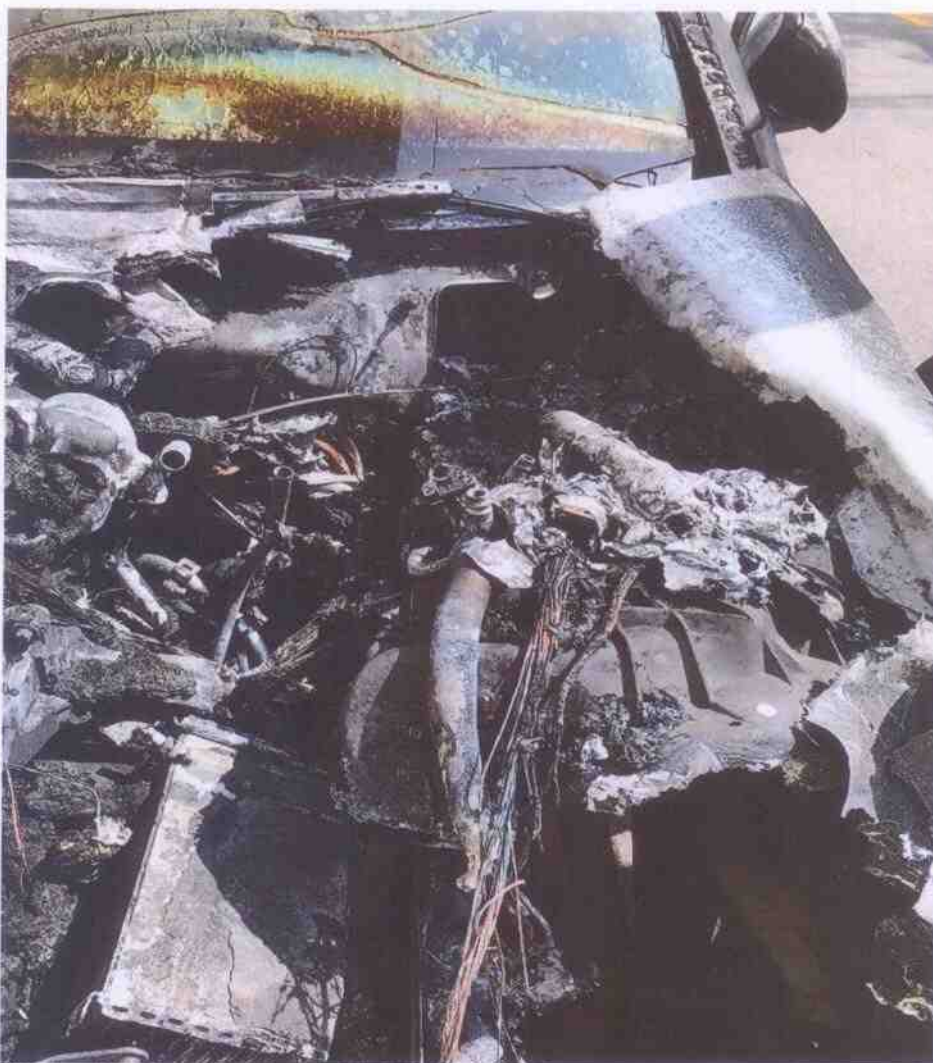
Photo 15 shows the Insured Vehicle at the incident scene after the fire was extinguished. In general, the information that could be gathered from this photograph had corresponded to the events that were related to us by Ms Florence. The extent of damage indicates that the fire had started in the left portion of the engine compartment.

24. The possibility of the fire being due to external factors (foreign material(s) stuck on hot surfaces, arson and sabotage amongst others) would also seem unlikely given that our examination of the available incident scene photographs did not reveal any unusual material(s)/object(s) found on the ground where the Insured Vehicle was positioned. The location of where the Insured Vehicle was positioned was also observed to be not at a secluded location.
