LKK Auto Consultants Pte Ltd

1. Policy Particulars :- THIRD PARTY CLAIM

ADJUSTMENT ON REPAIR COST FOR VEHICLE NO. SJW 7831H

PHOTOGRAPHS FOR VEHICLE NO. SJW 7831H

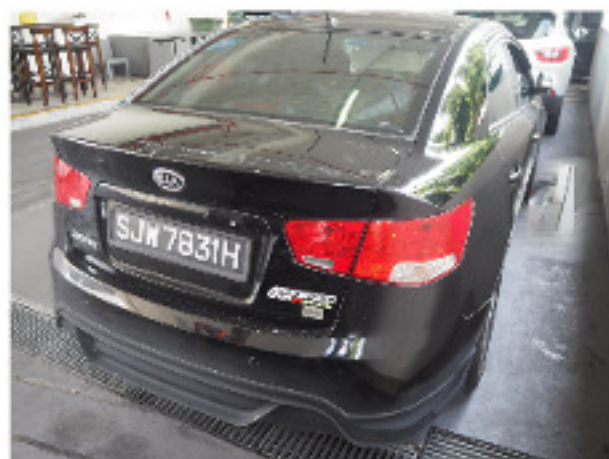
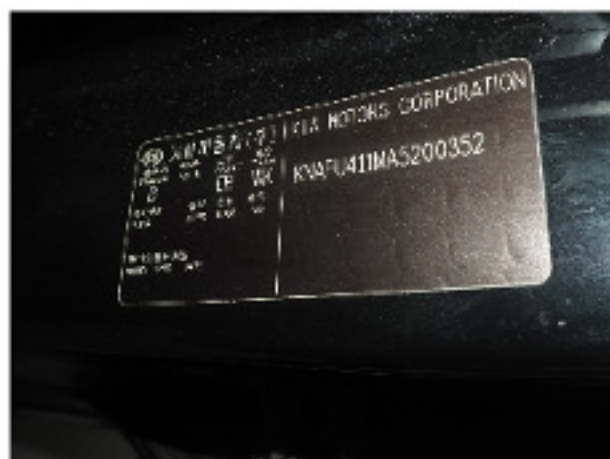
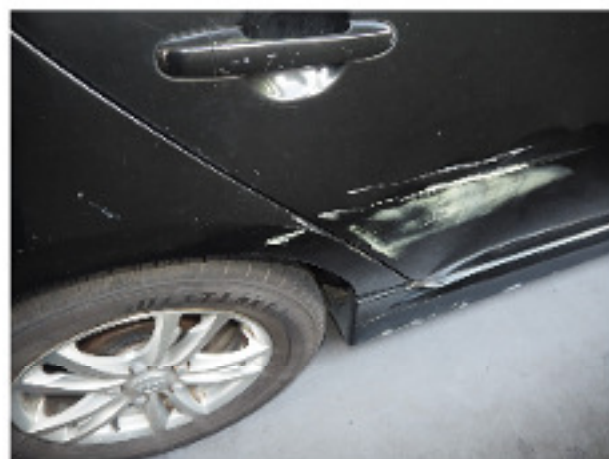
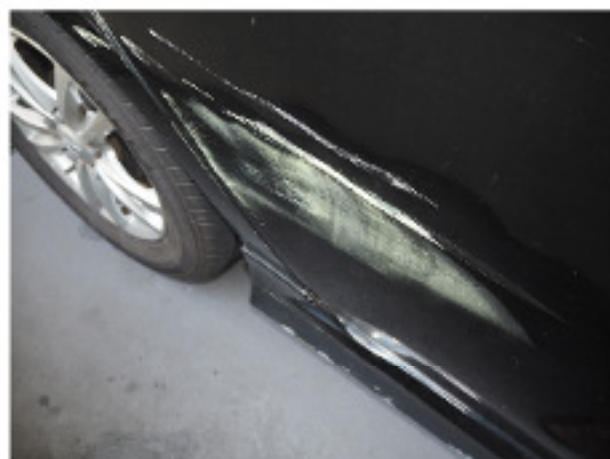
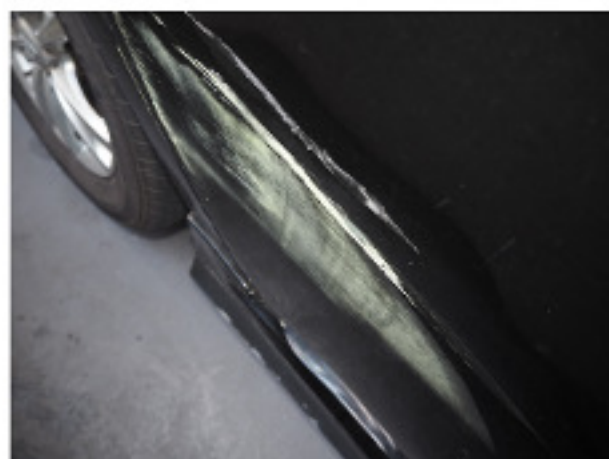
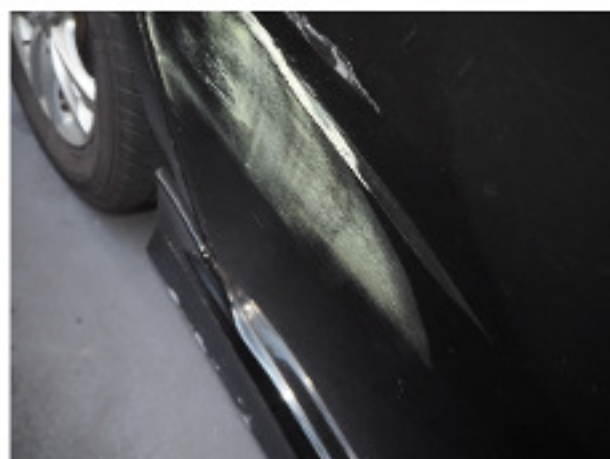
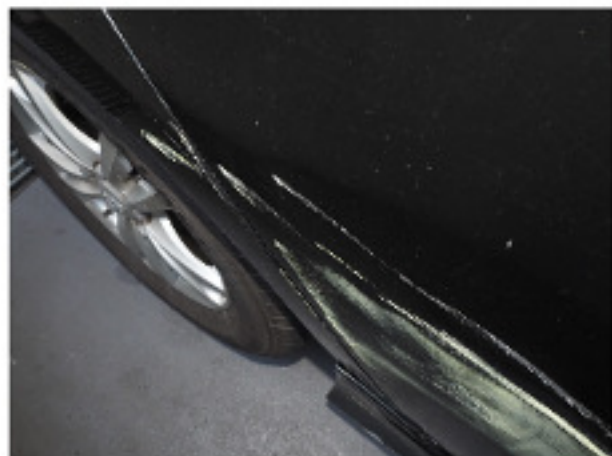
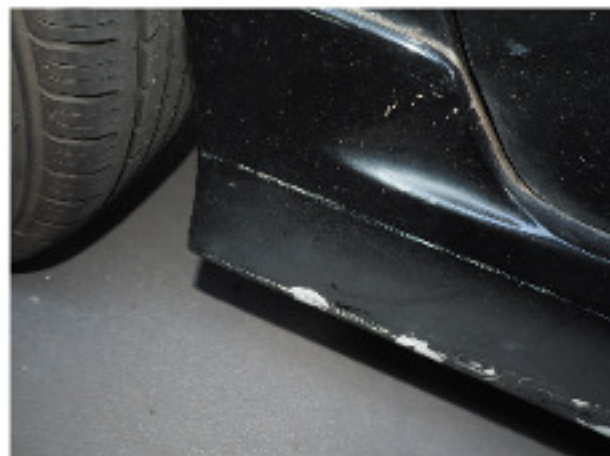
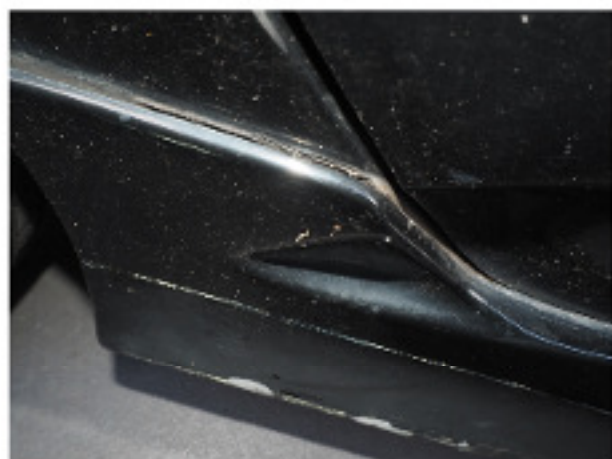
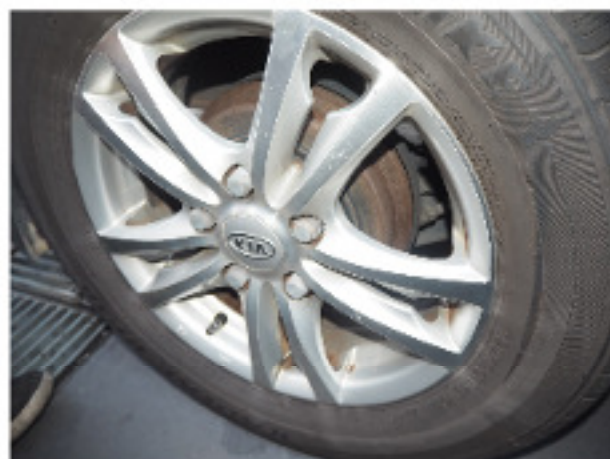
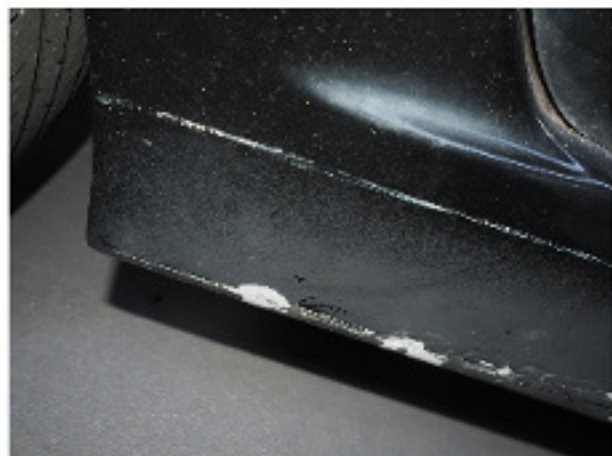
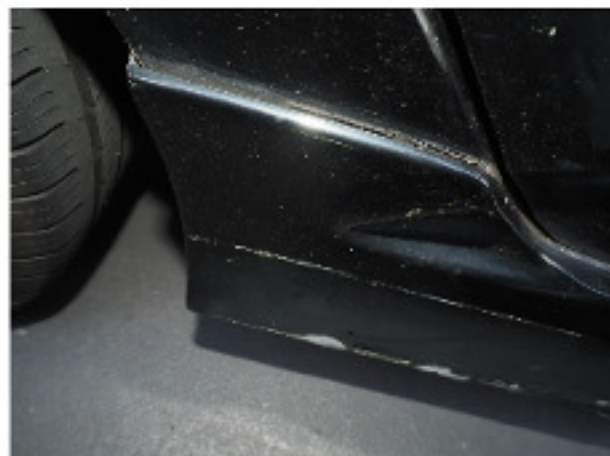
INSPECTION

THE VEHICLE SUSTAINED DAMAGES AT THE O/S BODY. DAMAGES SEE DETAILS.
--
