Insured Veh.	SHD 6788E	Veh. Inspected	SGF 8684J
Policy No.	D-20094922MFSH	Coverage (\$)	0.00
Claim No.	D20000712MFSH	Excess (\$)	0.00
Assign From	RACHEL WU	Assign Date	31/01/2020

Accident Date	30/01/2020	Inspection Date	31/01/2020
Survey held at	SLP MOTORING SERVICES 102 GERALD DRIVE #04-75 SELETAR SPRINGS CONDOMINIUM SINGAPORE 798593

ADJUSTMENT ON REPAIR COST FOR VEHICLE NO. SGF 8684J

PHOTOGRAPHS FOR VEHICLE NO. SGF 8684J

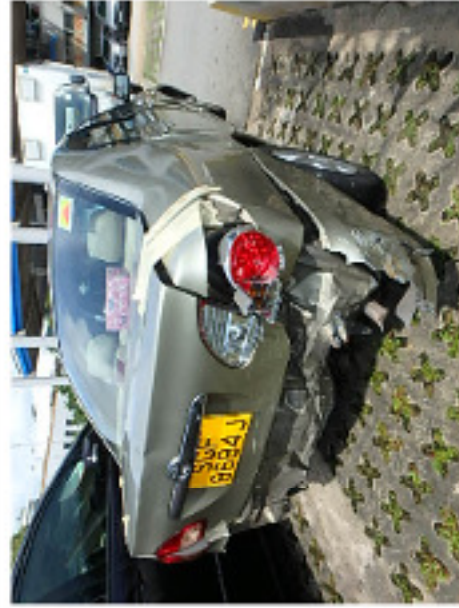
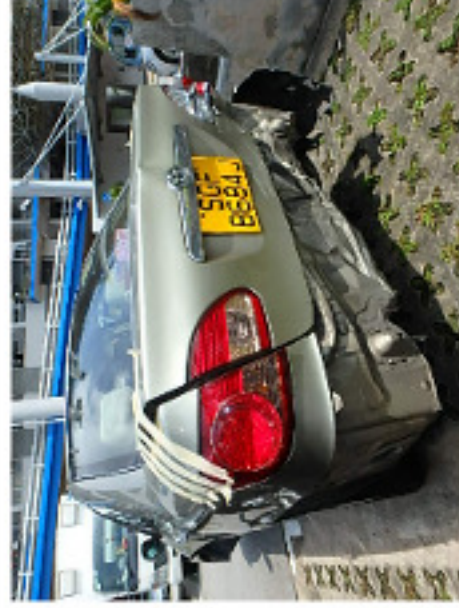
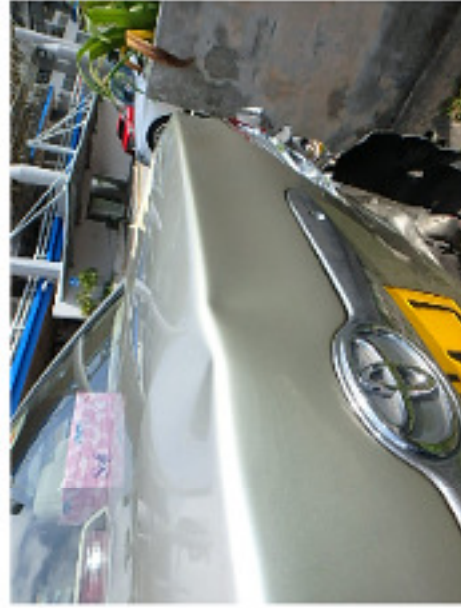
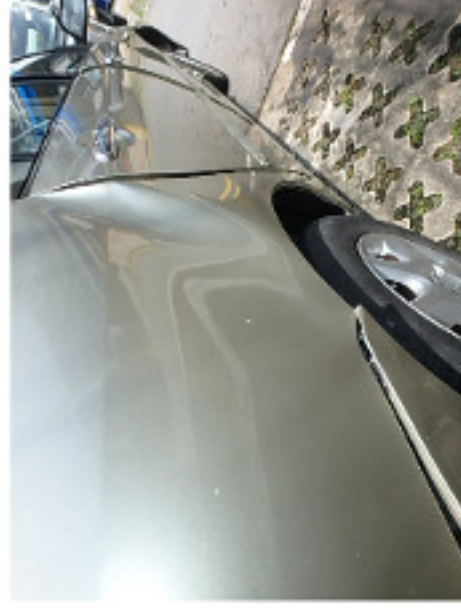
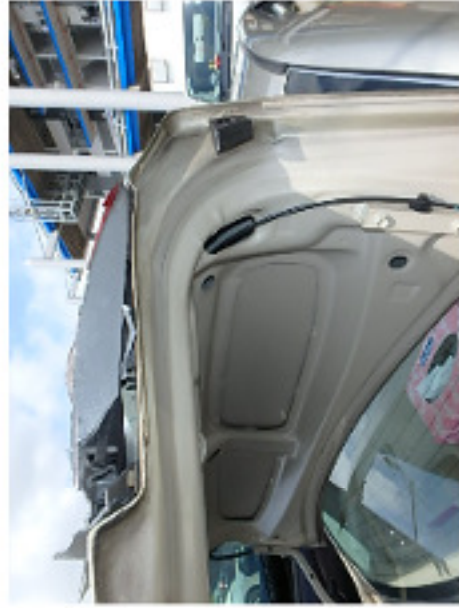
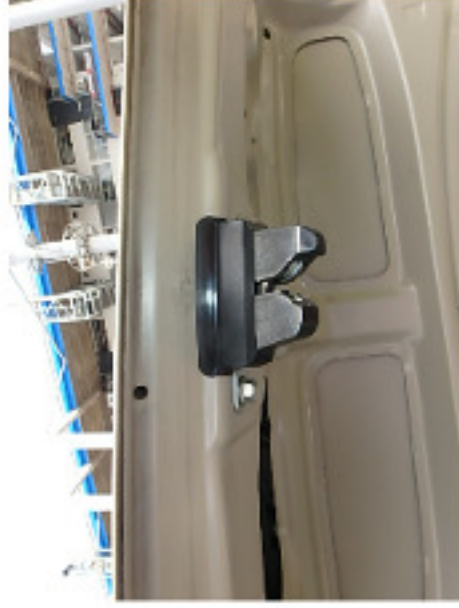
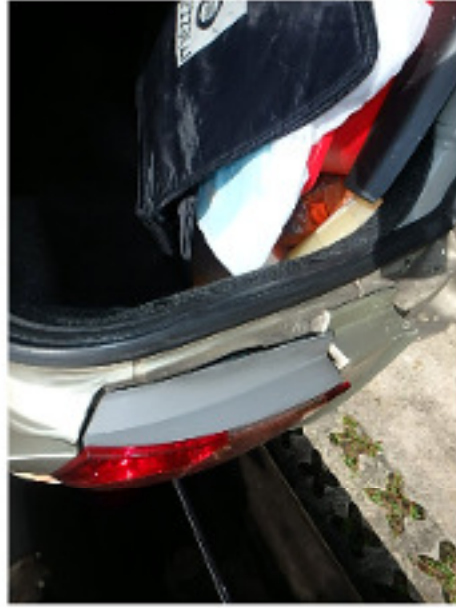
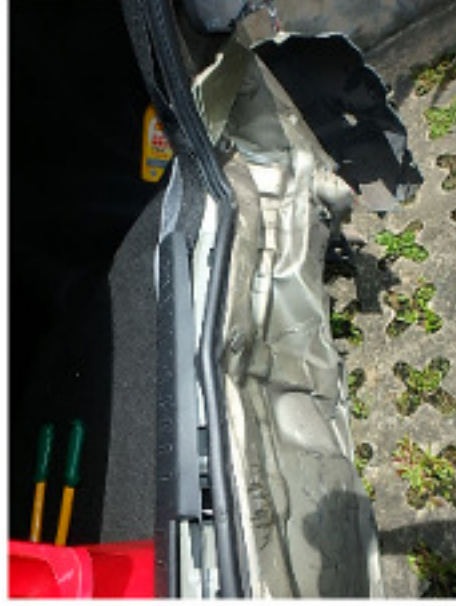
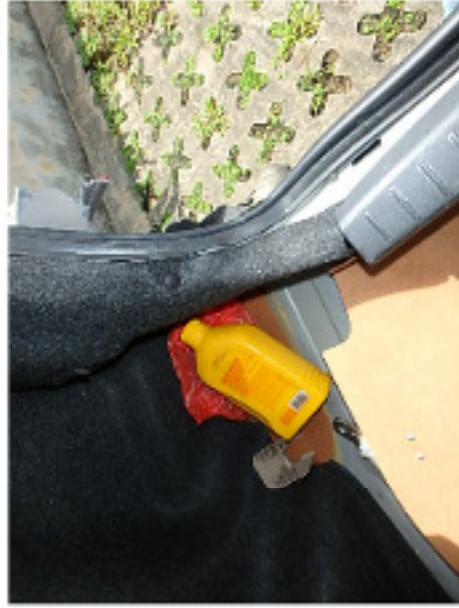
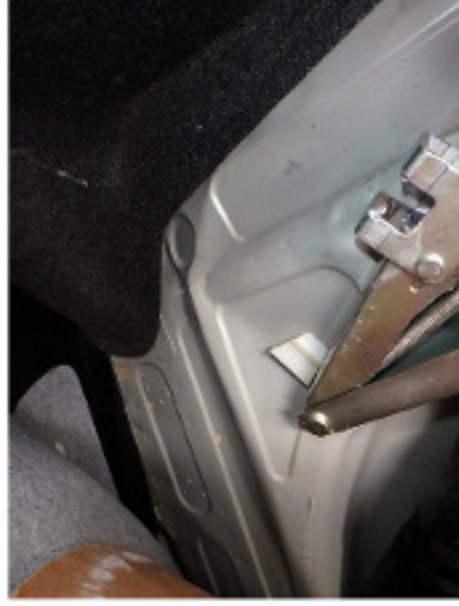
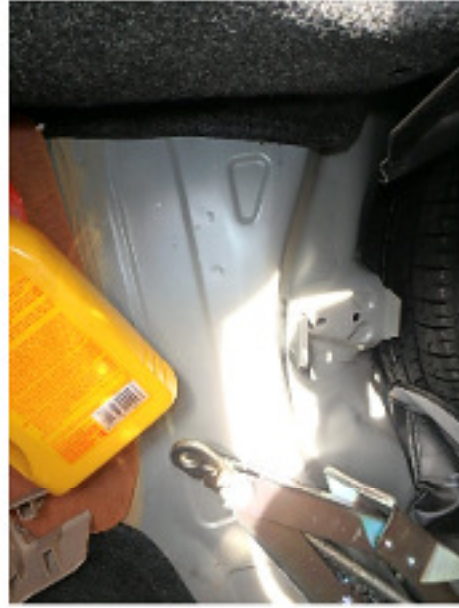
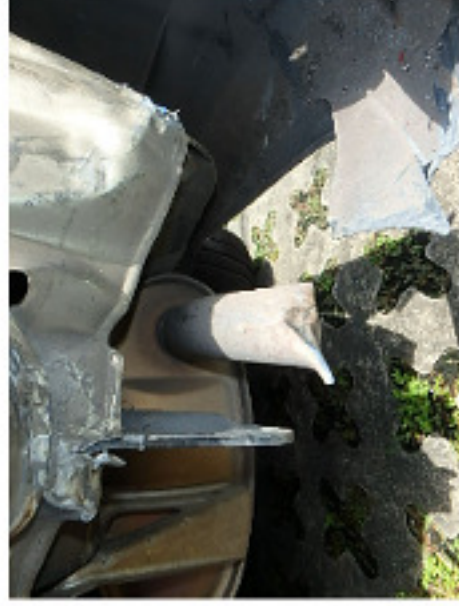
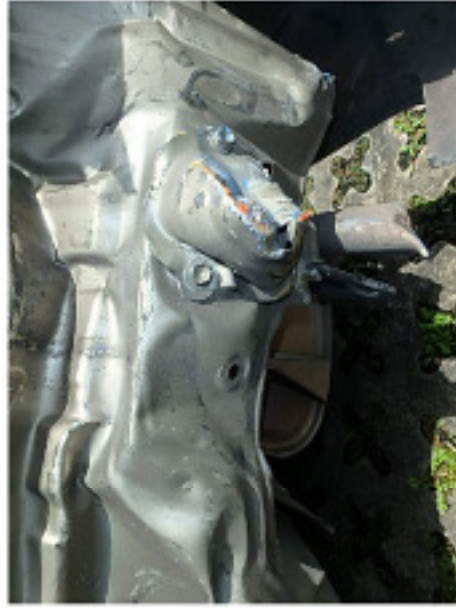
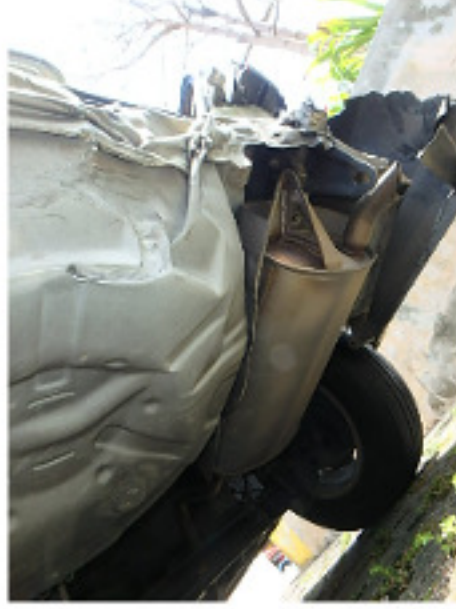
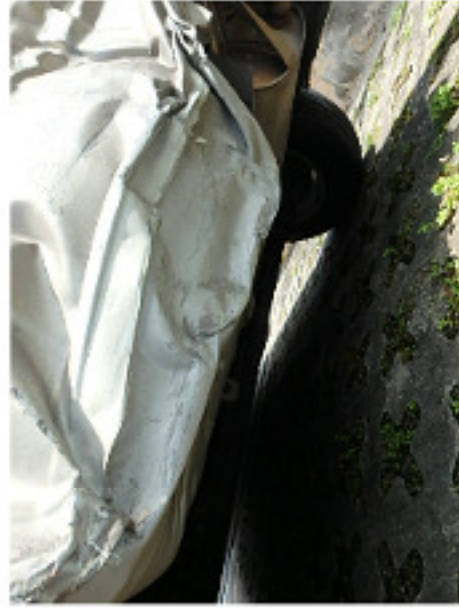
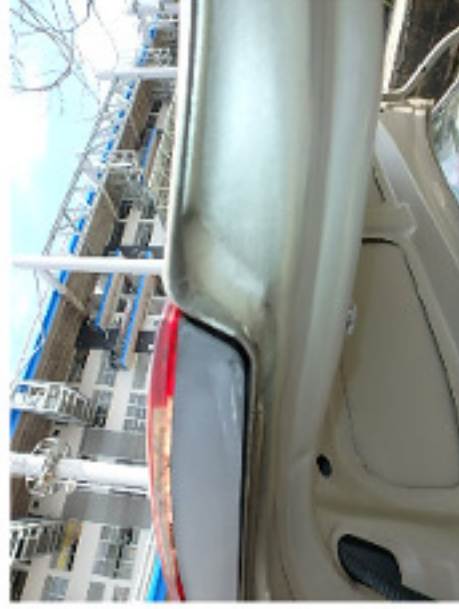
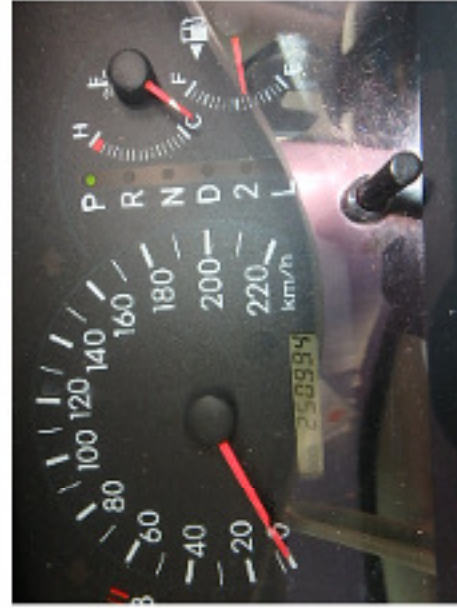
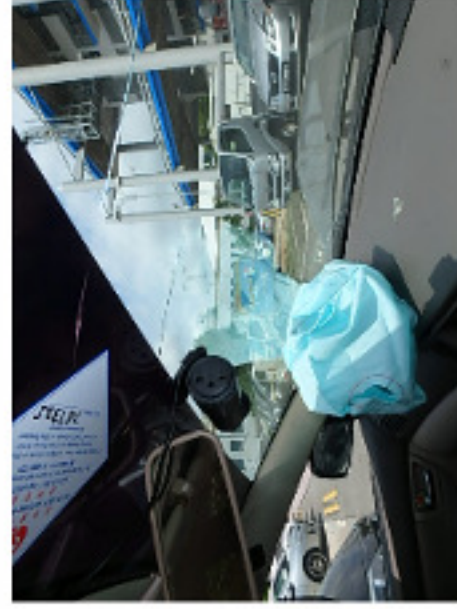
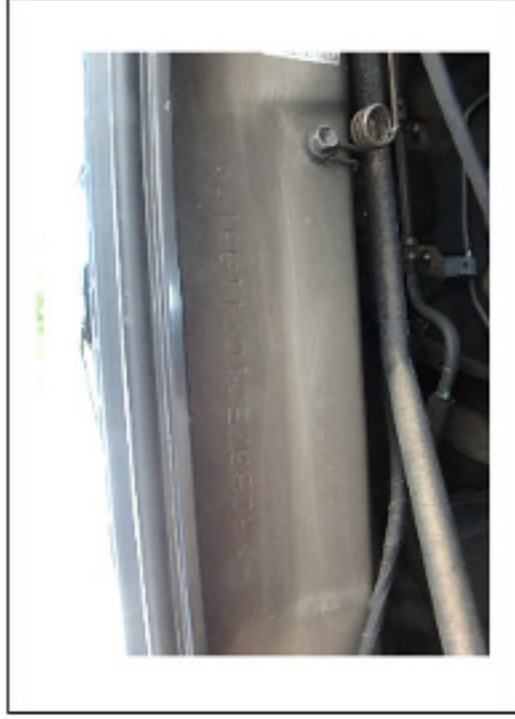
THE VEHICLE SUSTAINED DAMAGES AT THE REAR PORTION. DAMAGES SEE DETAILS.
--

RECOMMENDED COST OF LUMP SUM REPAIRS (TO ITS PRE-ACCIDENT CONDITION)			5,200.00
---	--	--	----------
