Your Ref: TP/IP/04019/2020  
Our Ref : CI/TPD20001844/N

7 July 2020

**Fatal Accident Investigation Team**

**MECHANICAL INSPECTION REPORT OF MOTORCYCLE FX 5957J**

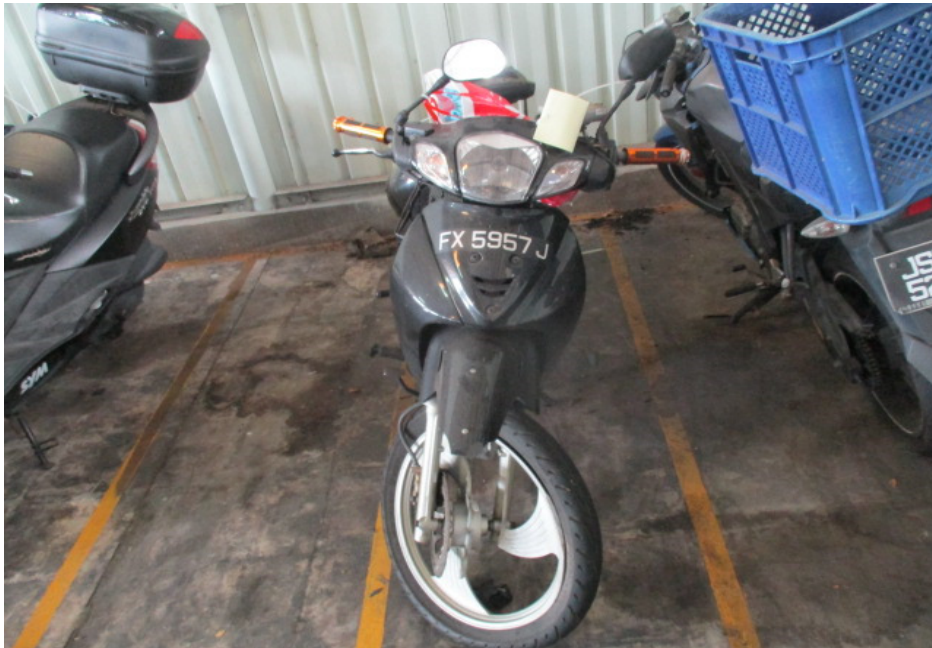
**Photo 1** shows a general view of the frontal portion of the Motorcycle at the time of our inspection. The Motorcycle had sustained damages all around. The mileage of the Motorcycle was not recorded at the time of our inspection despite several attempts to jump start the battery.

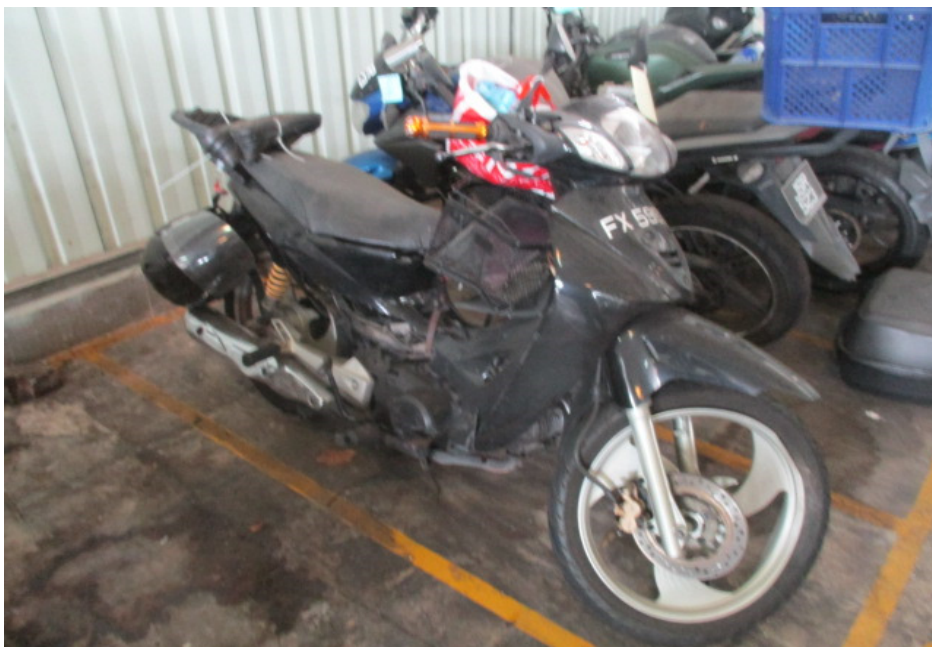
**Photo 2** shows a general view of the right body of the Motorcycle at the time of our inspection. Body parts that were found to have been damaged include its front wheel, front mudguard, side mirrors, handlebar ends, front brake lever, side cowlings, left rear side cover, rear brake pedal, gear shift pedal, left front footrest, right front footrest, seat, exhaust muffler and exhaust muffler heat shield, amongst others.

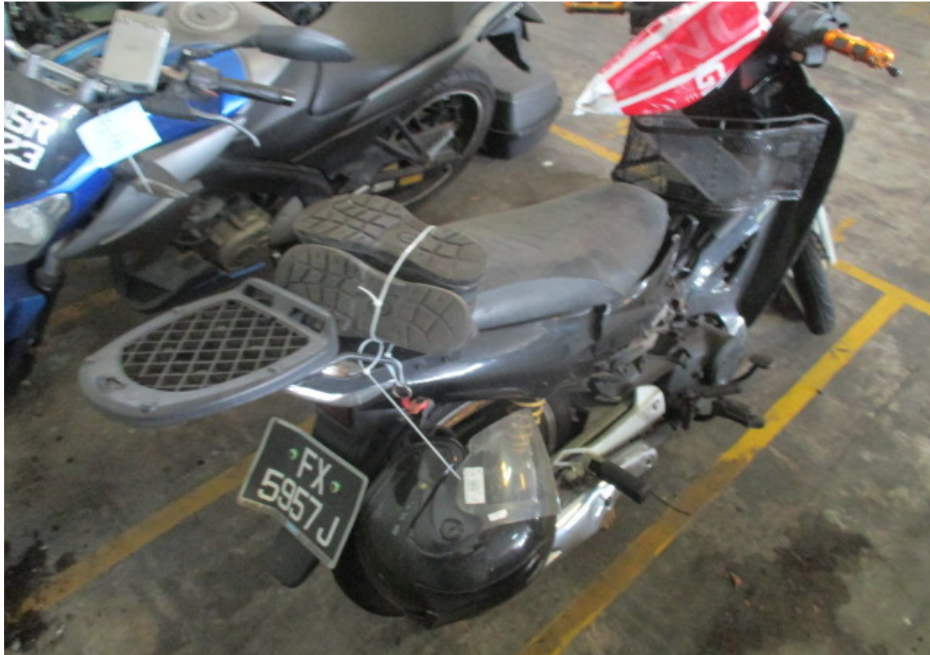
**Photo 3** shows a general view of the rear body of the Motorcycle at the time of our inspection. The Motorcycle had sustained damages all around. Body parts that were found to have been damaged include its front wheel, front mudguard, side mirrors, handlebar ends, front brake lever, side cowlings, left rear side cover, rear brake pedal, gear shift pedal, left front footrest, right front footrest, seat, exhaust muffler and exhaust muffler heat shield, amongst others.

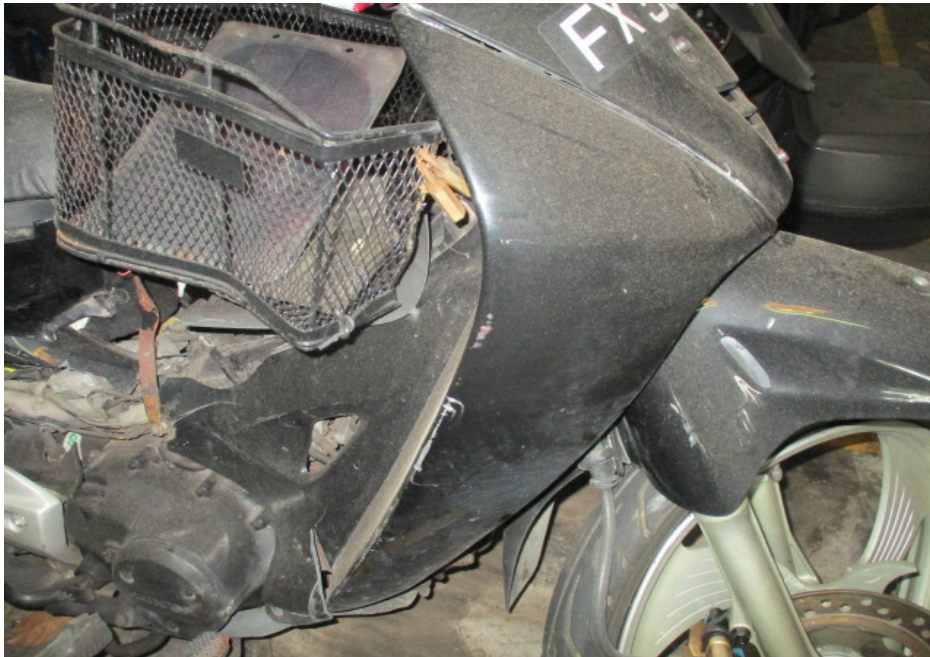
**Photo 4** shows the general view of the right cowl of the Motorcycle which was amongst the body parts of the Motorcycle that had sustained damage as a result of the accident.

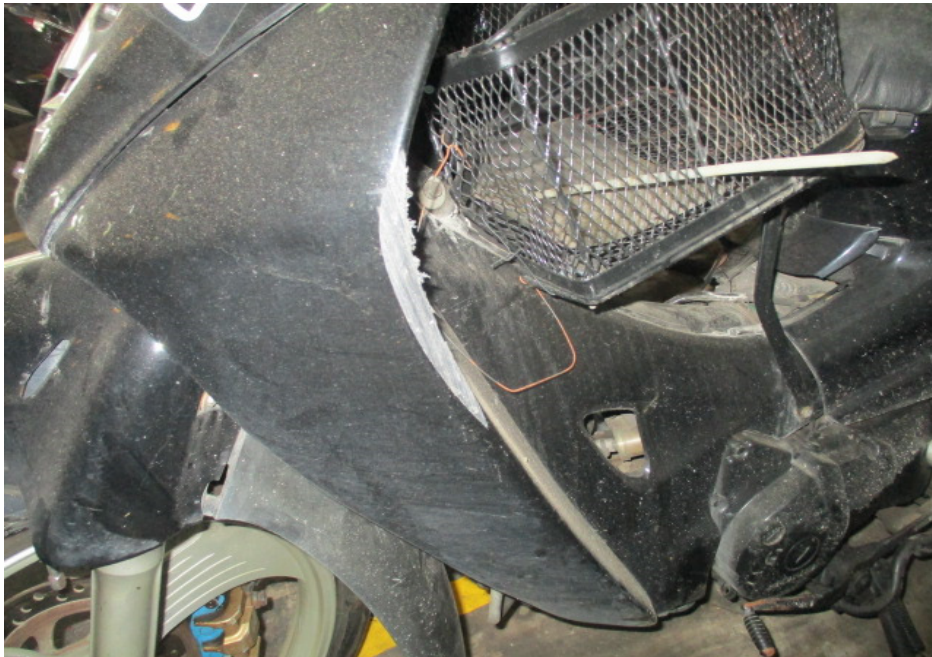
**Photo 5** shows the general view of the left cowling of the Motorcycle which was amongst the body parts of the Motorcycle that had sustained damage as a result of the accident.

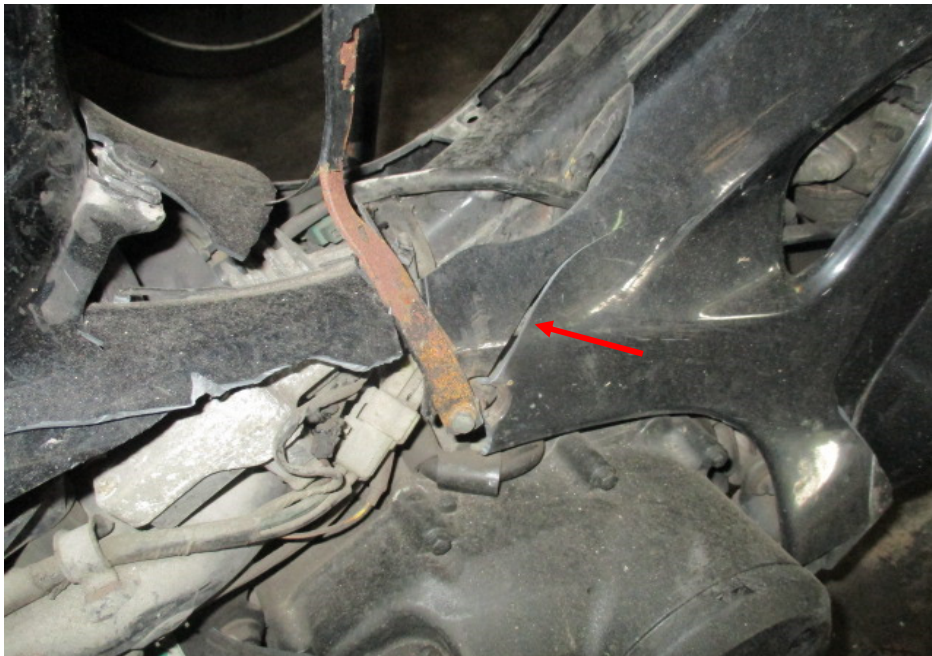
**Photo 6** shows the cracked right side cover of the Motorcycle as a result of the accident (arrowed).

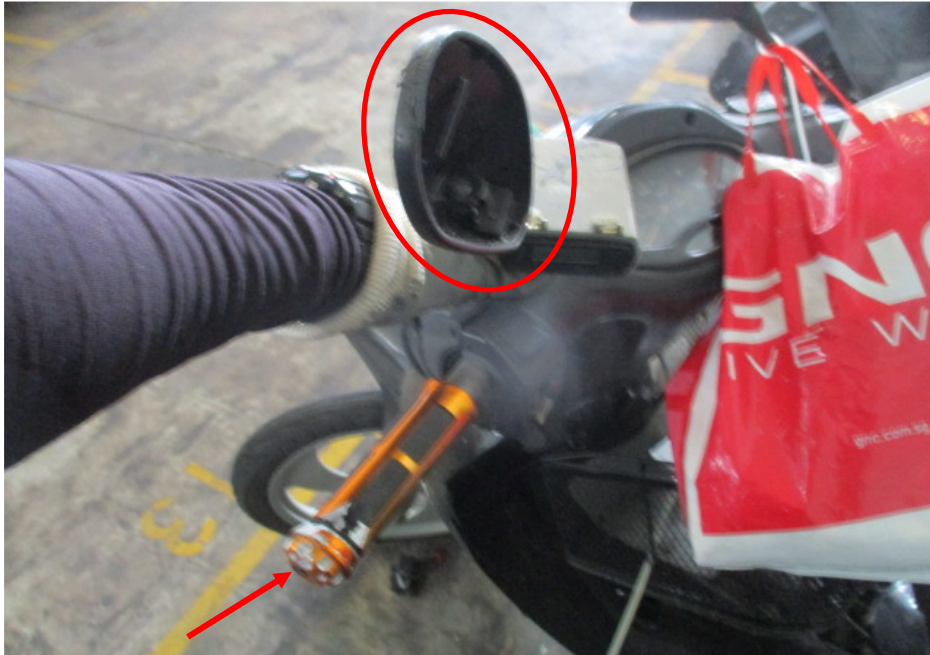
**Photo 7** shows a close up view of the left handlebar end as well as the left side mirror (circled) of the Motorcycle. These parts were amongst the body parts of the Motorcycle which were damaged as a result of the accident.

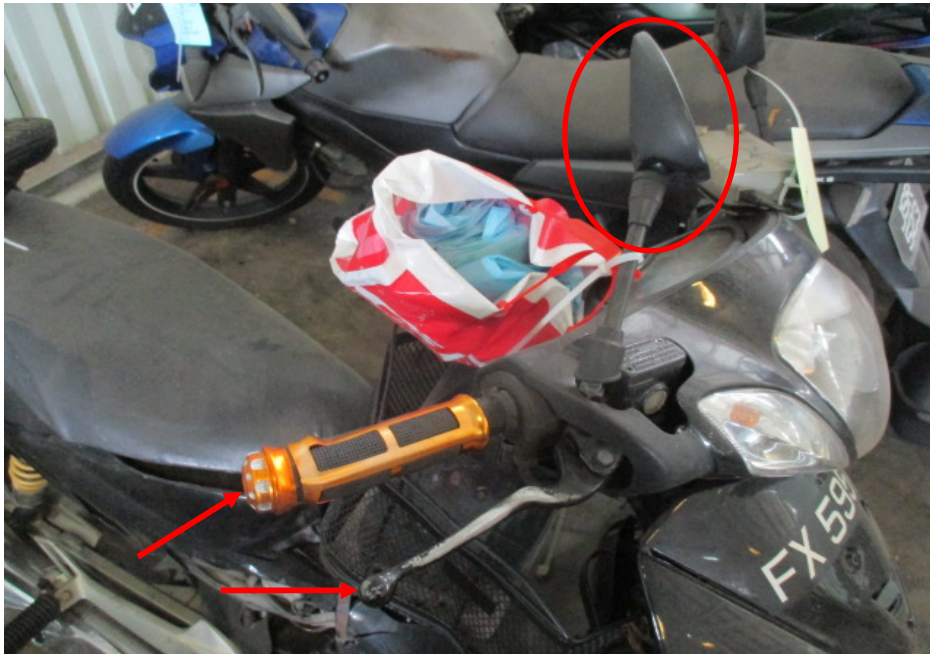
**Photo 8** shows a close up view of the right handlebar end and front brake lever (arrowed) as well as the right side mirror (circled) of the Motorcycle. These parts were amongst the body parts of the Motorcycle which were damaged as a result of the accident.

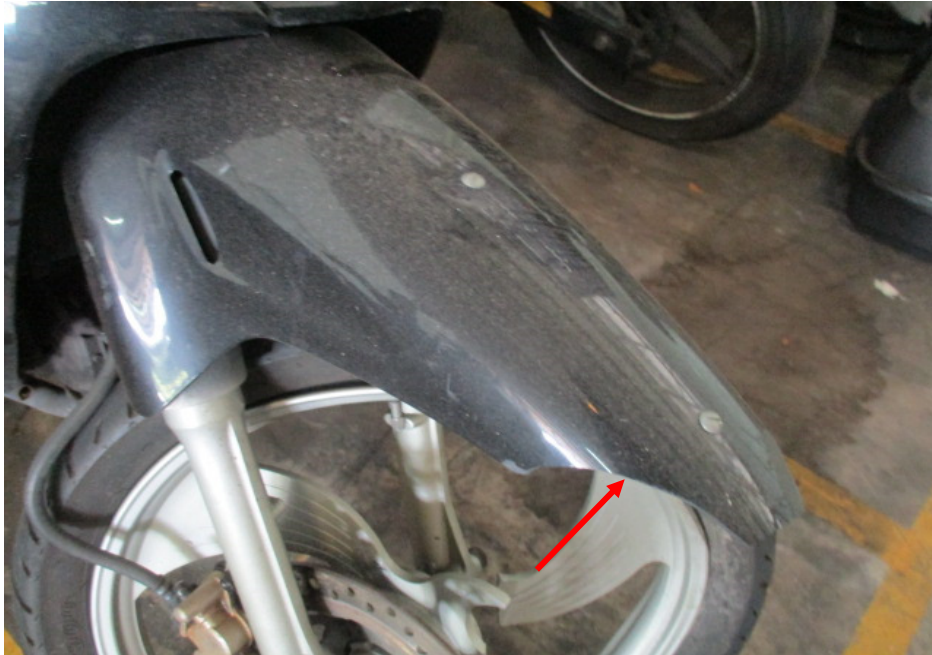
**Photo 9** shows a close up view of the cracked front mudguard of the Motorcycle as a result of the accident (arrowed).

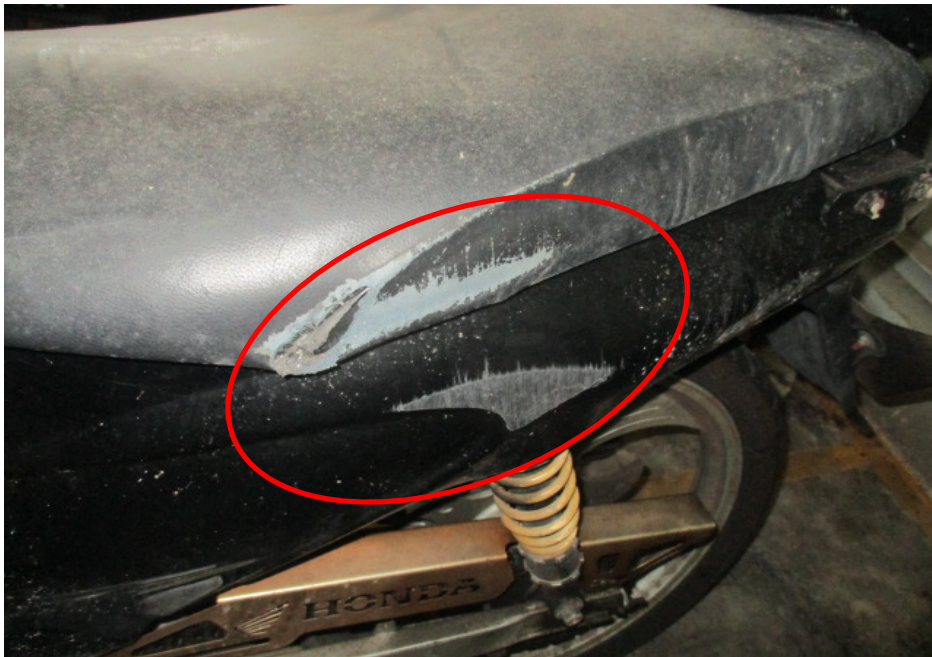
**Photo 10** shows a closer view of the seat and left rear side cover, which was amongst the body parts of the Motorcycle that had sustained damages of grazing nature as a result of the accident

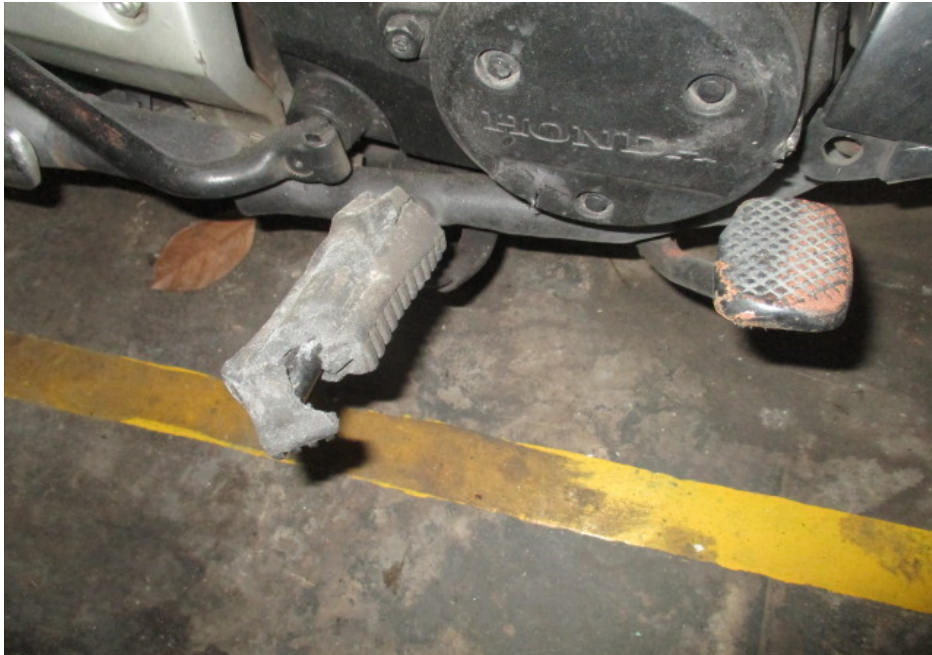
**Photo 11** shows the damaged rear brake pedal and right front footrest which were amongst the body parts of the Motorcycle that had sustained damage as a result of the accident.

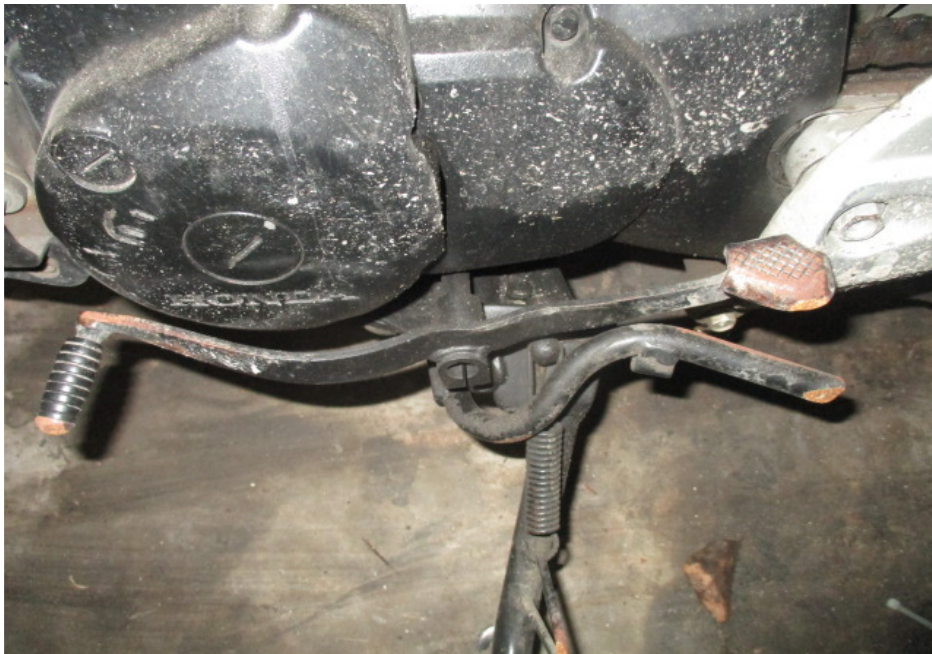
**Photo 12** shows the damaged gear shift pedal and left front footrest which were amongst the body parts of the Motorcycle that had sustained damage as a result of the accident.

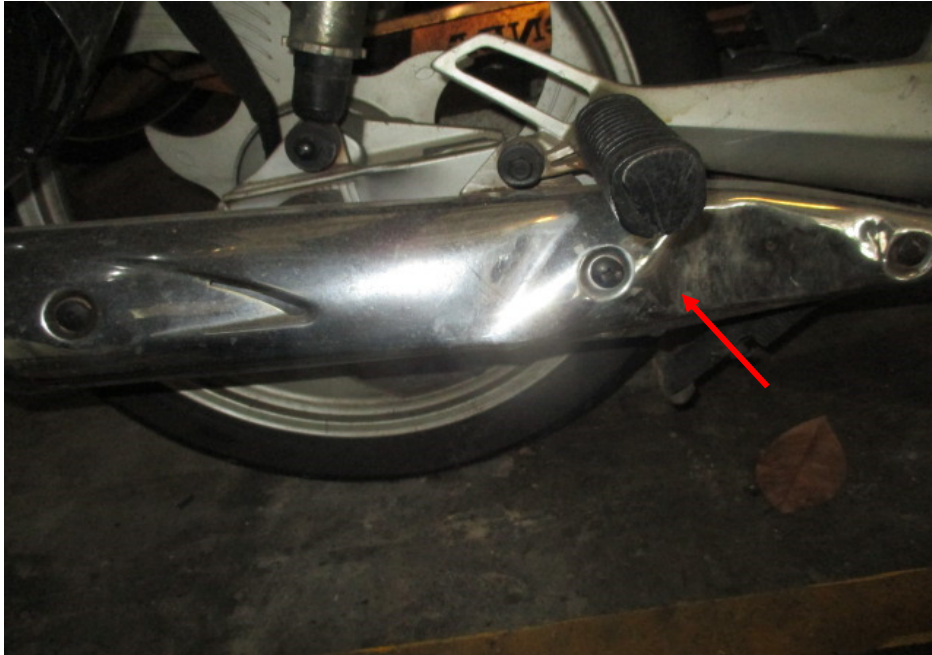
**Photo 13** shows the dented exhaust muffler and exhaust muffler heat shield (arrowed) of the Motorcycle as a result of the accident.

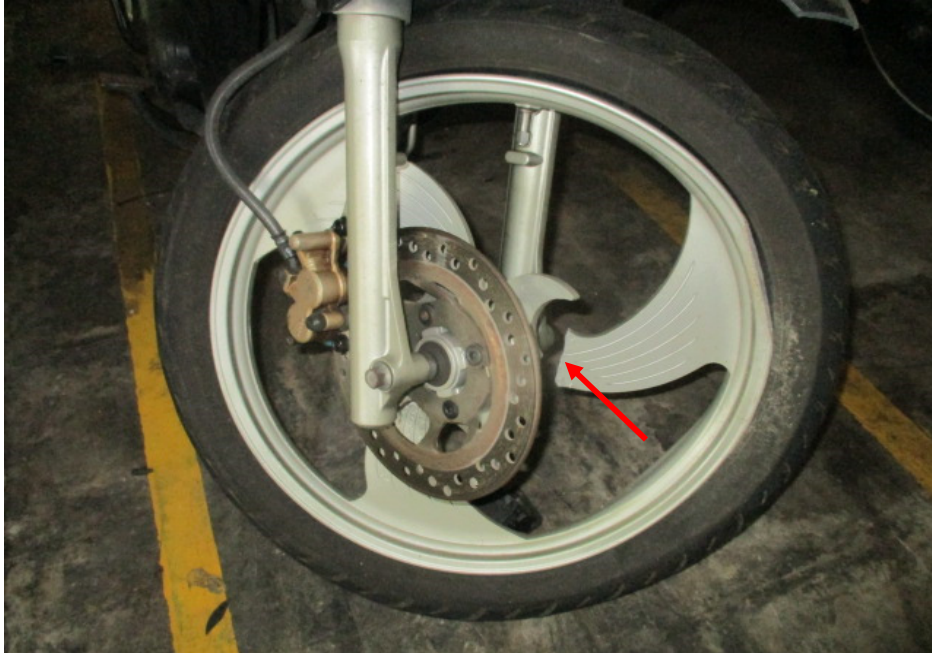
7. The 2 tyres were wrapped around alloy wheel rims. At the time of our inspection, we did not observe any visible damage on the rear wheel rim of the Motorcycle. However we did observe that the front wheel rim was broken as a result of the accident. See photos 1 – 16 below.

**Photo 14** shows a closer view of the broken front wheel rim of the Motorcycle as a result of the accident (arrowed).

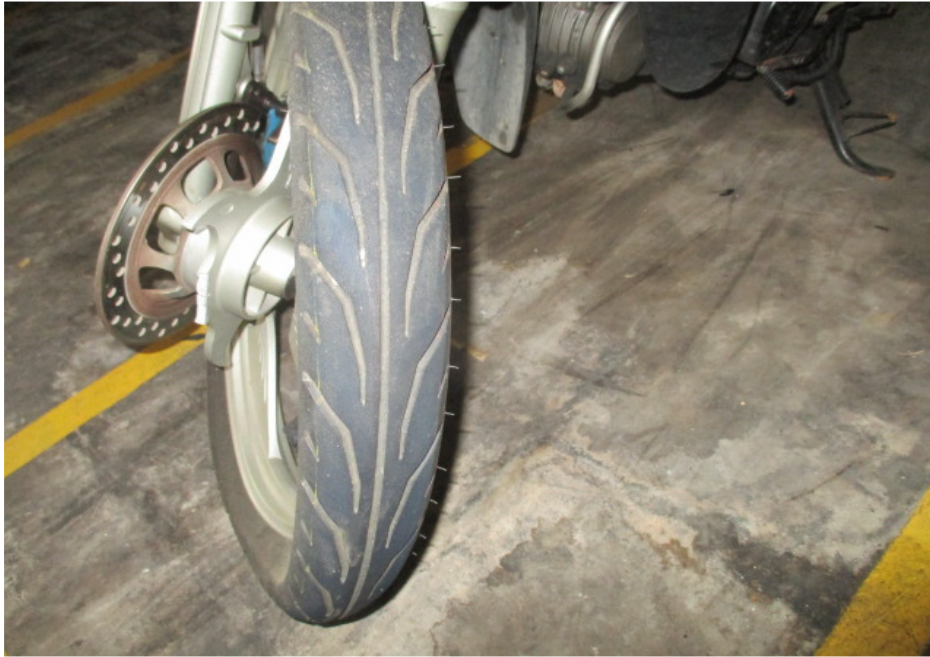
**Photo 15** shows the condition of the Motorcycle's front tyre. The front tyre was observed to be in serviceable condition with remaining tread depth of approximately 4mm. The tyre was also observed to be sufficiently inflated for vehicular operation. We did not observe any tear, burst mark(s) and/or punctured hole(s) on the sidewalls as well as across the tread of the front tyre.

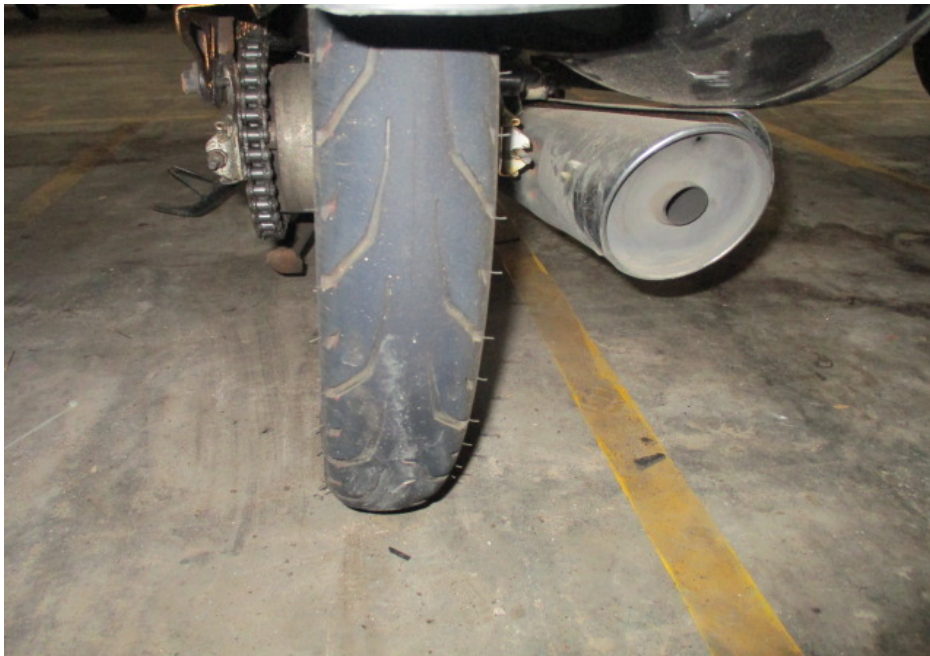
**Photo 16** shows the condition of the Motorcycle's rear tyre. The rear tyre was observed to be in serviceable condition with remaining tread depth of approximately 3mm. The tyre was also observed to be sufficiently inflated for vehicular operation. We did not observe any tear, burst mark(s) and/or punctured hole(s) on the sidewalls as well as across the tread of the rear tyre.

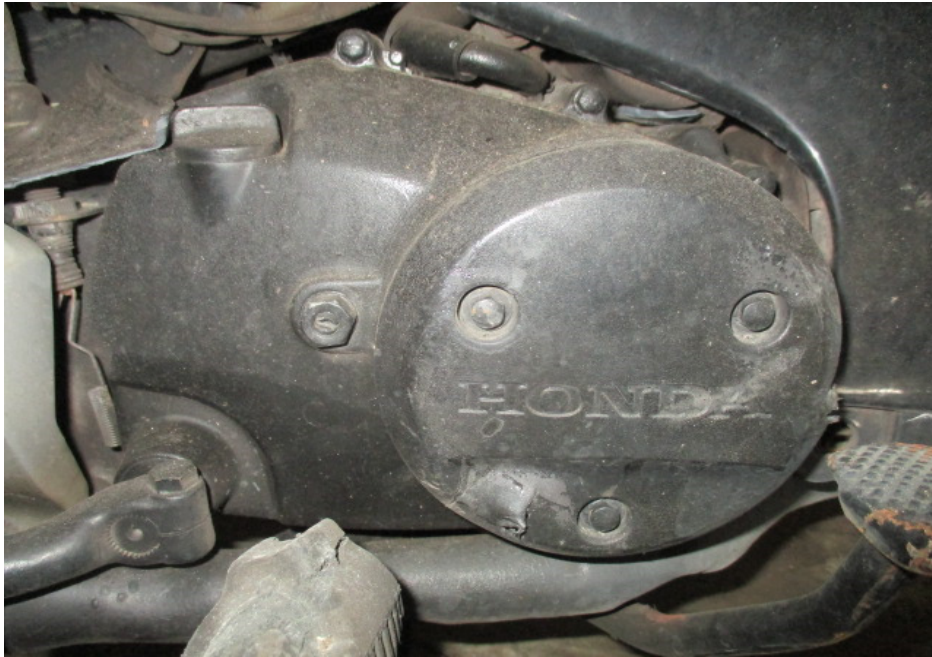
**Photo 17** shows the right side of the engine of the Motorcycle at the time of our inspection. The various engine related parts and components were found to be intact with no visible damage. There was also no sign(s) or indication(s) of fluid leak observed around the right engine area of the Motorcycle.

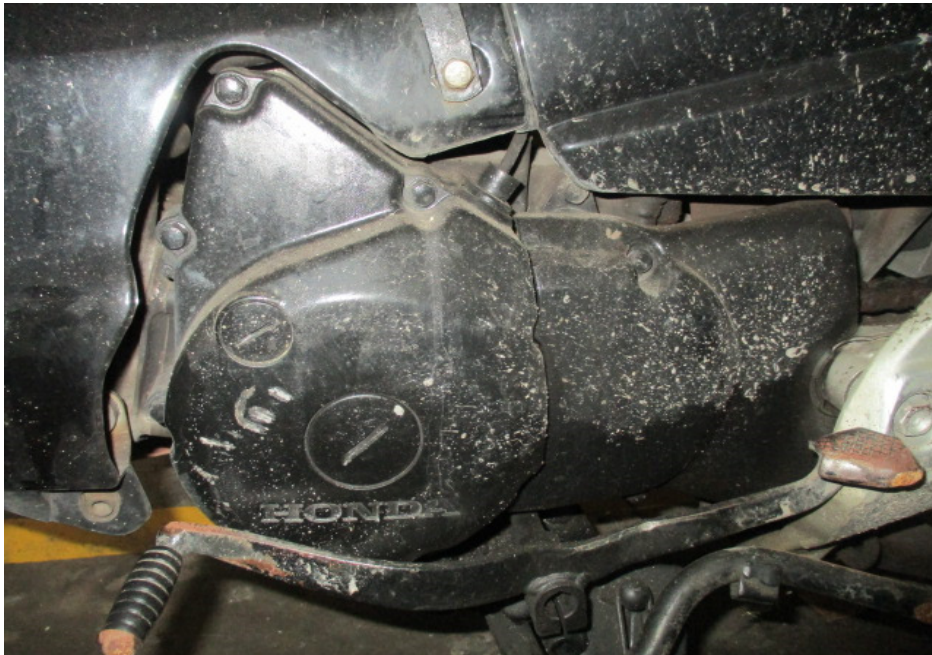
**Photo 18** shows the left side of the engine of the Motorcycle at the time of our inspection. The various engine related parts and components were found to be intact with no visible damage. There was also no sign(s) or indication(s) of fluid leak observed around the left engine area of the Motorcycle.

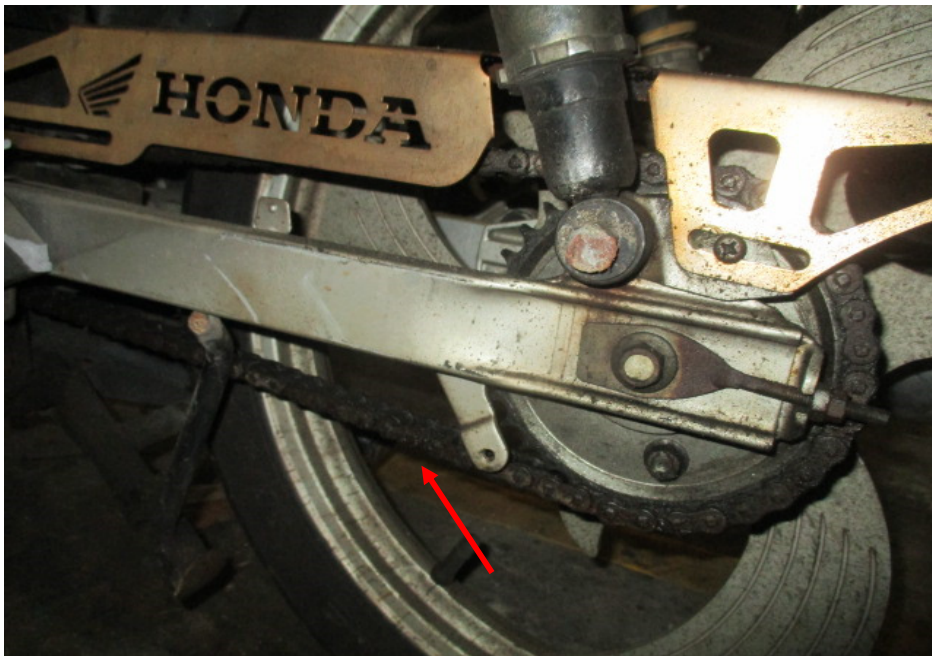
**Photo 19** shows the general view of the gear train (arrowed) of the Motorcycle, which was observed to be intact with no misalignment. It was also adequately lubricated for operating purposes.

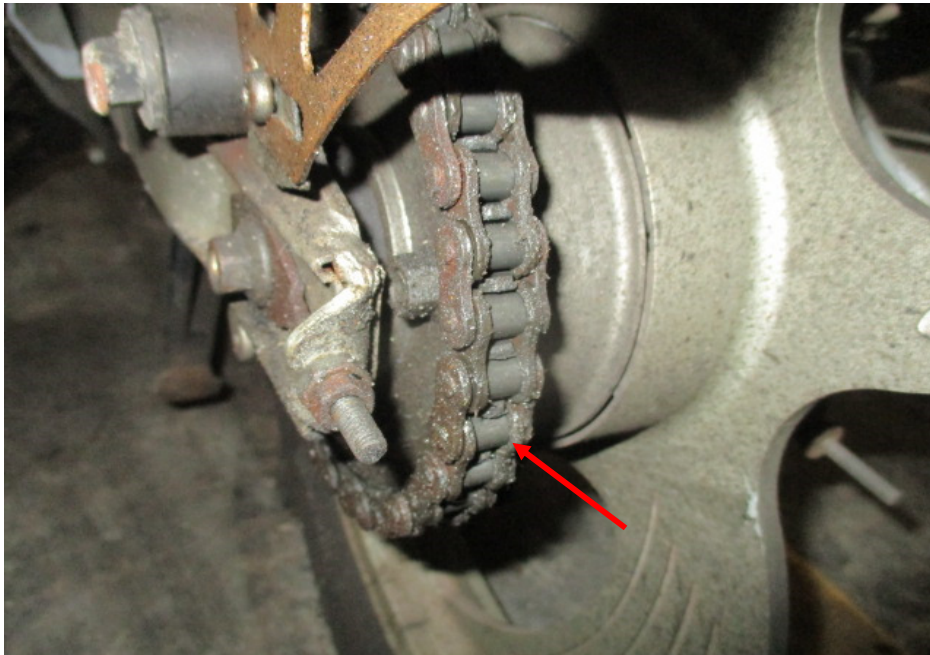
**Photo 20** shows a closer view of the gear train (arrowed) of the Motorcycle, which was observed to be intact with no misalignment. It was also adequately lubricated for operating purposes.

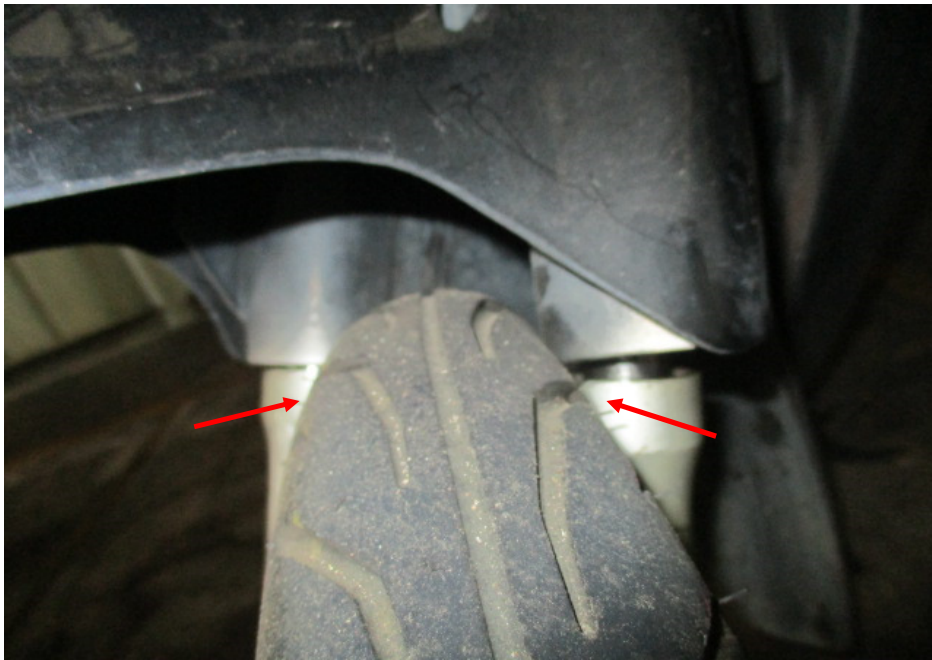
10. For this case, we were not able to conduct any test(s) on the steering system of the Motorcycle due to the damage to its front portion. The front wheel was found to be misalignment as a result of the accident.

**Photo 21** shows the front wheel of the Motorcycle. The front wheel (arrowed) was observed to be misaligned as a result of the accident. We were hence not able to conduct any tests on the steering system of the Motorcycle.

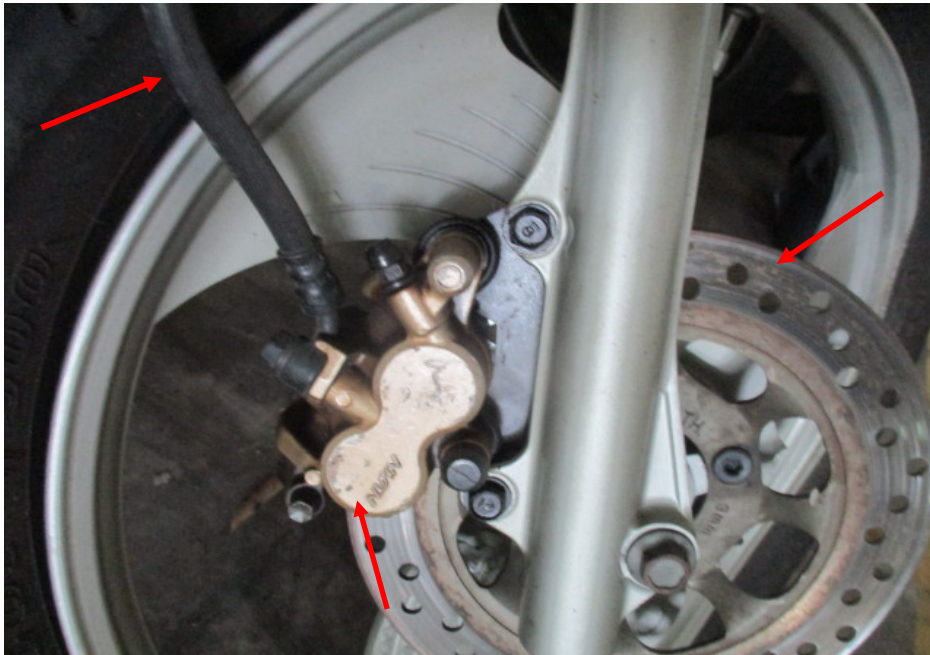
**Photo 22** shows a close up view of the front brake caliper, front brake disc and front brake hose (arrowed) of the Motorcycle, which are all part of the components in the hydraulic front brake system of the Motorcycle. Our visual checks of these various components had revealed all to be intact with no visible damage. No leakage of brake fluid was also observed.

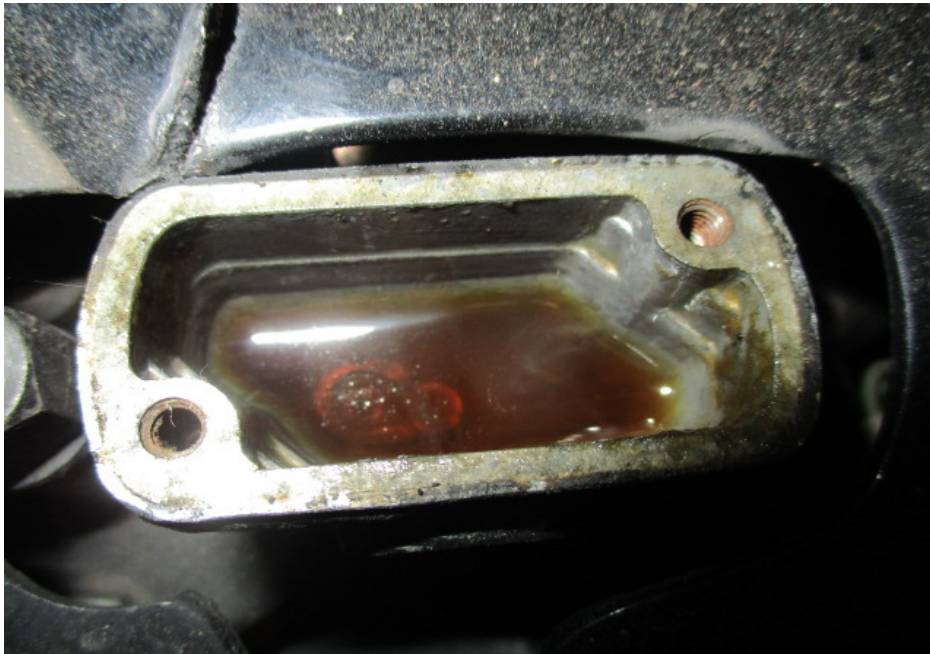
**Photo 23** shows the brake fluid reservoir for the front brake of the Motorcycle. The brake fluid was observed to be of sufficient level for operational purposes and without contamination for.

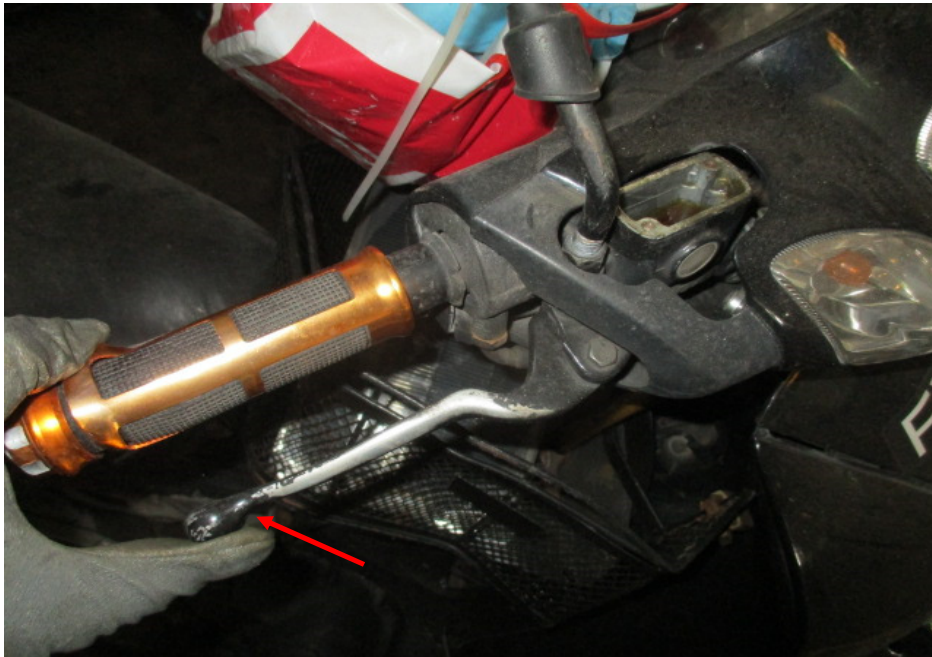
12. Static brake tests conducted on the Motorcycle had appear to indicate that the front braking system of the Motorcycle was in serviceable condition. There was some resistance felt (spongy like feel) upon pressing the brake lever. This would indicate that there was no leakage of pressure/vacuum in the front brake system.

**Photo 24** shows the front brake lever being depressed. There was some resistance felt (spongy like feel) upon pressing the front brake lever (arrowed). This would indicate that there is no leakage of pressure/vacuum in the brake system.

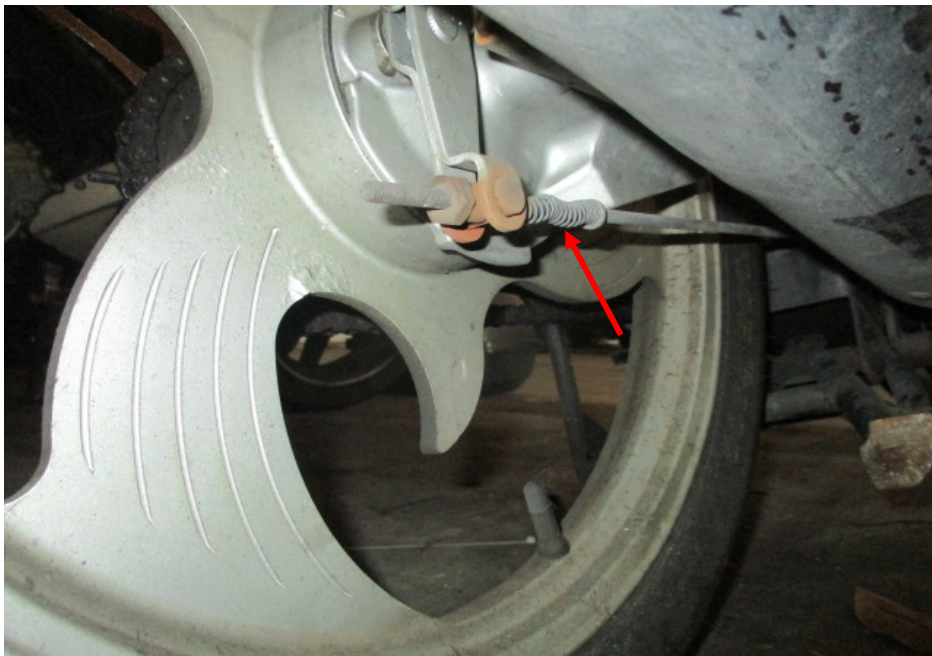
**Photo 25** shows the rear wheel of the Motorcycle. The type of brake system for the rear wheel was of a mechanical type, controlled by the brake foot pedal of the Motorcycle. Our checks of the cable (arrowed), spring and drum which are all part of the components in the rear brake system of the Motorcycle reveal all to be intact and without damage.
