Your Ref: TP/IP/01949/2020
Our Ref : CI/TPD20001846/N

7 July 2020

Fatal Accident Investigation Team

INSPECTION REPORT OF MOTORCYCLE FBK 9640L

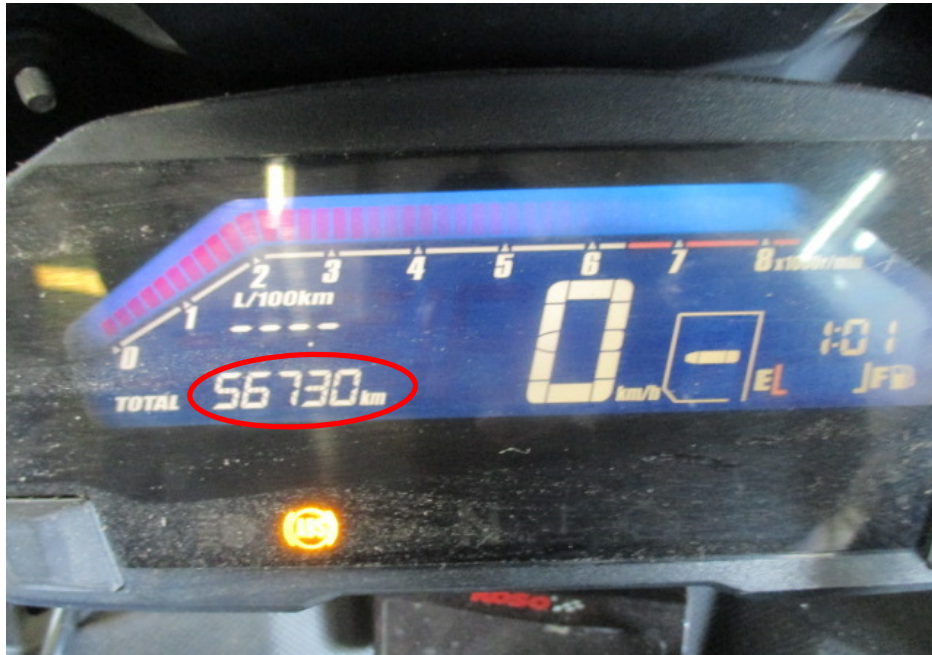
Photo 1 shows the speedometer gauge of the Motorcycle. The mileage of the Motorcycle at the time of our inspection was 56, 730km (circled).

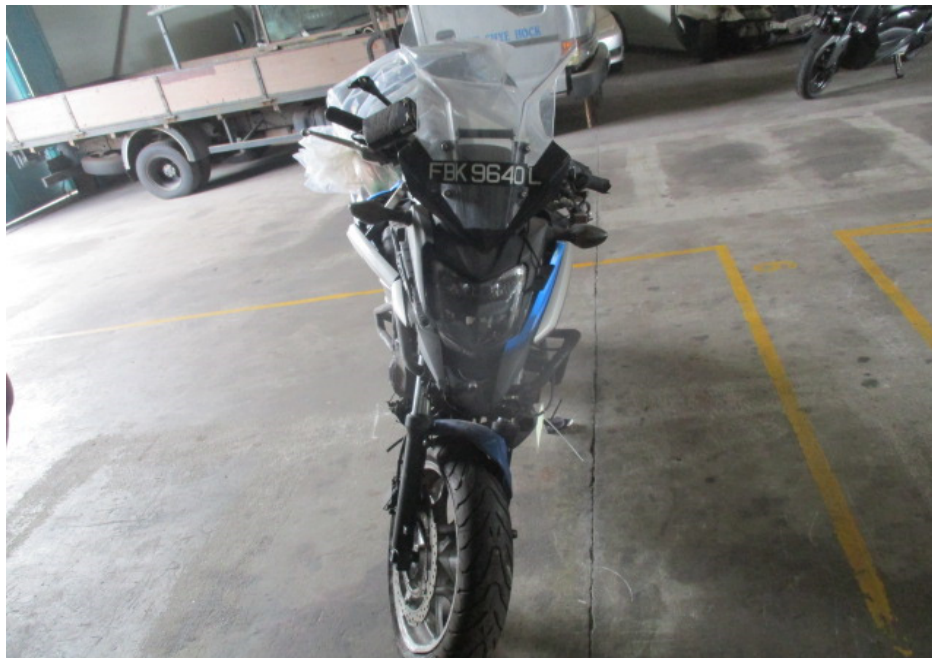
Photo 2 shows a general view of the frontal portion of the Motorcycle at the time of our inspection. The Motorcycle was observed to have sustained damages all around.

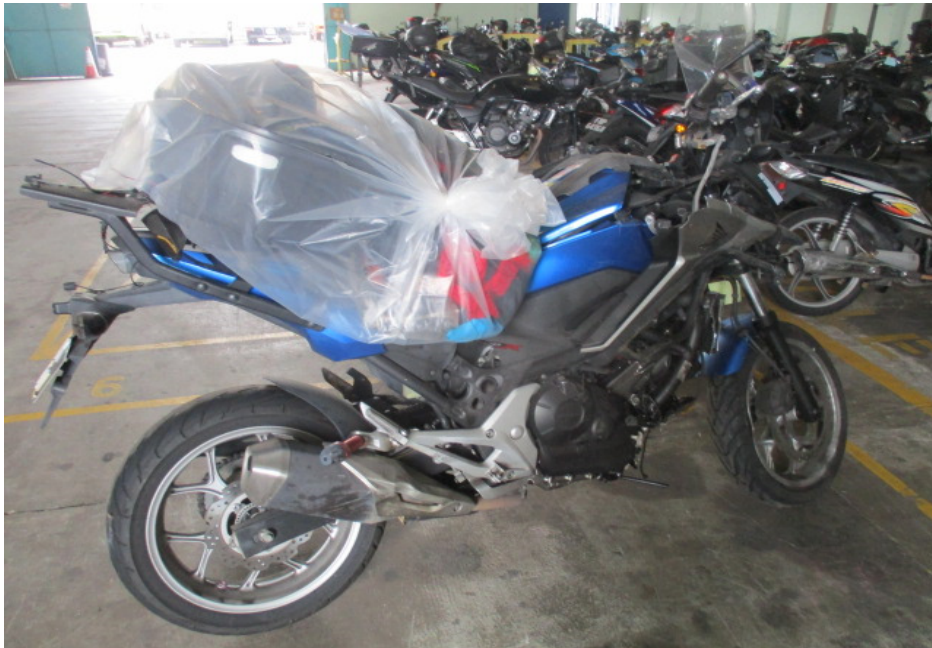
Photo 3 shows a general view of the right body of the Motorcycle at the time of our inspection. The Motorcycle was observed to have sustained damages all around.

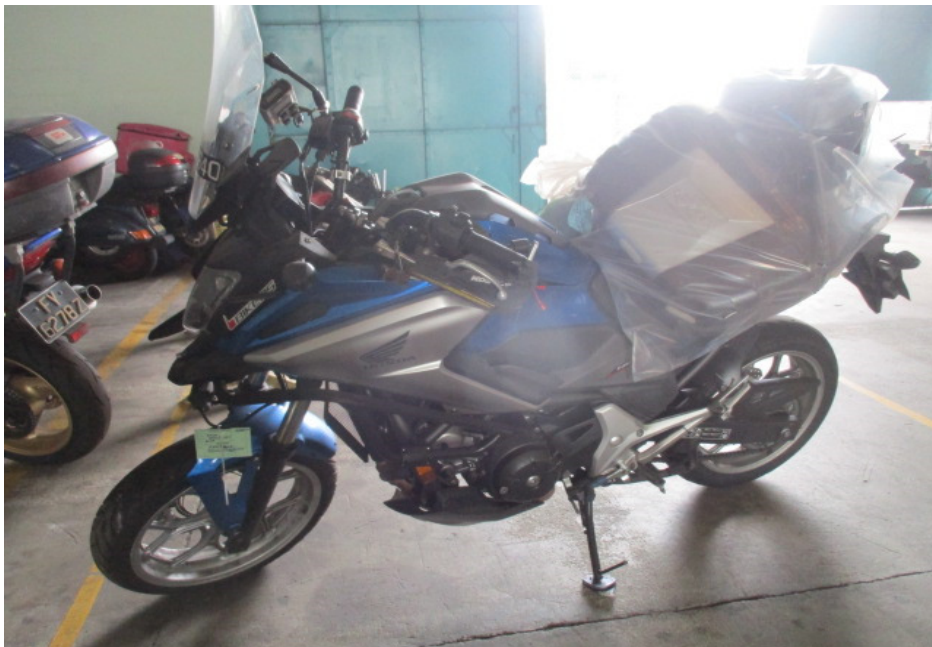
Photo 4 shows a general view of the left body of the Motorcycle at the time of our inspection. The Motorcycle was observed to have sustained damages all around. Amongst the body parts that were found to have been damaged include its headlight assembly, side covers, handlebar ends, front cowling, front mudguard, engine crash bars, handlebar ends, front brake lever, clutch lever, clutch lever guard, side stand enlarger, fuel tank cover, rear brake pedal, right front footrest, exhaust muffler and exhaust muffler slider, amongst others.

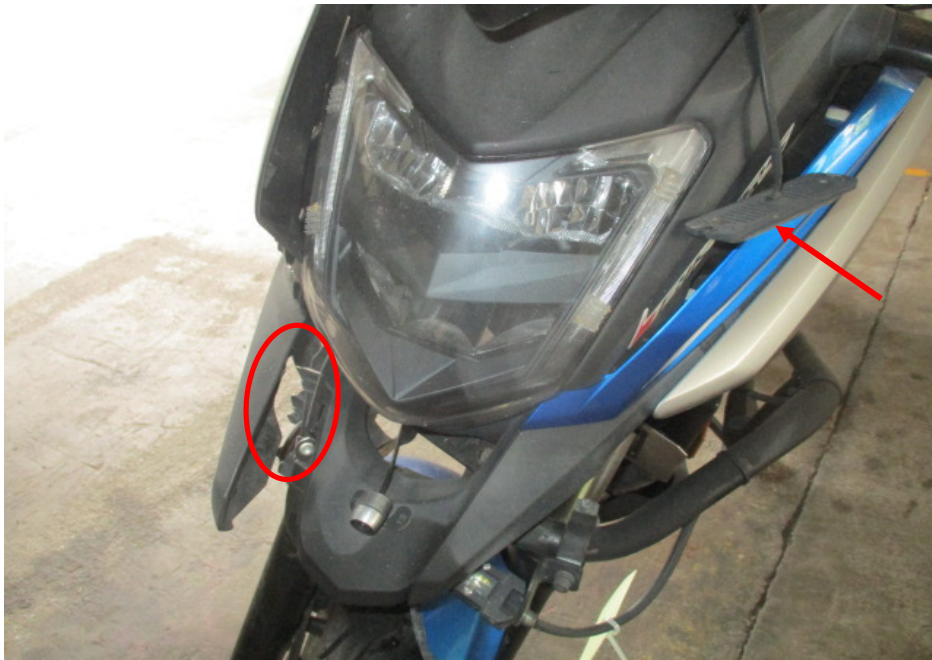
Photo 5 shows a closer view of the damaged headlight assembly (arrowed) and front cowling (circled) of the Motorcycle as a result of the accident.

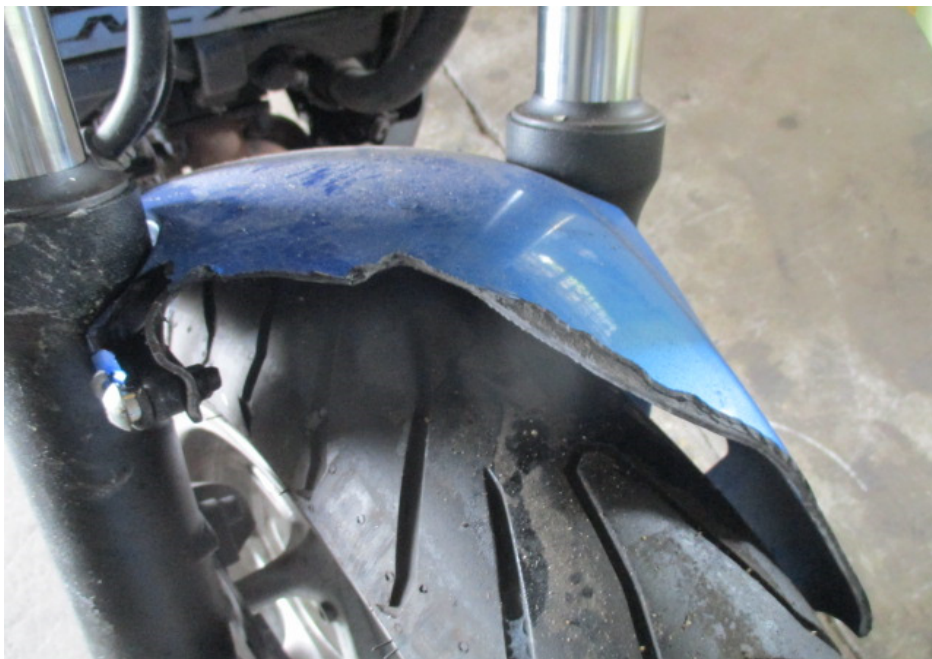
Photo 6 shows a close up view of the cracked front mudguard of the Motorcycle as a result of the accident.

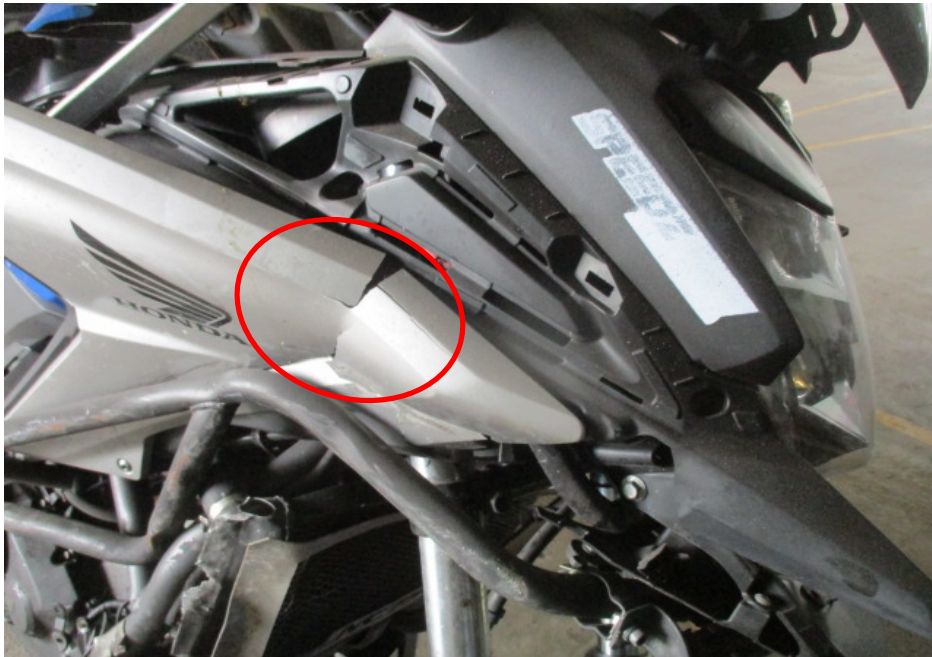
Photo 7 shows a closer view of the cracked right side cover of the Motorcycle as a result of the accident (circled).

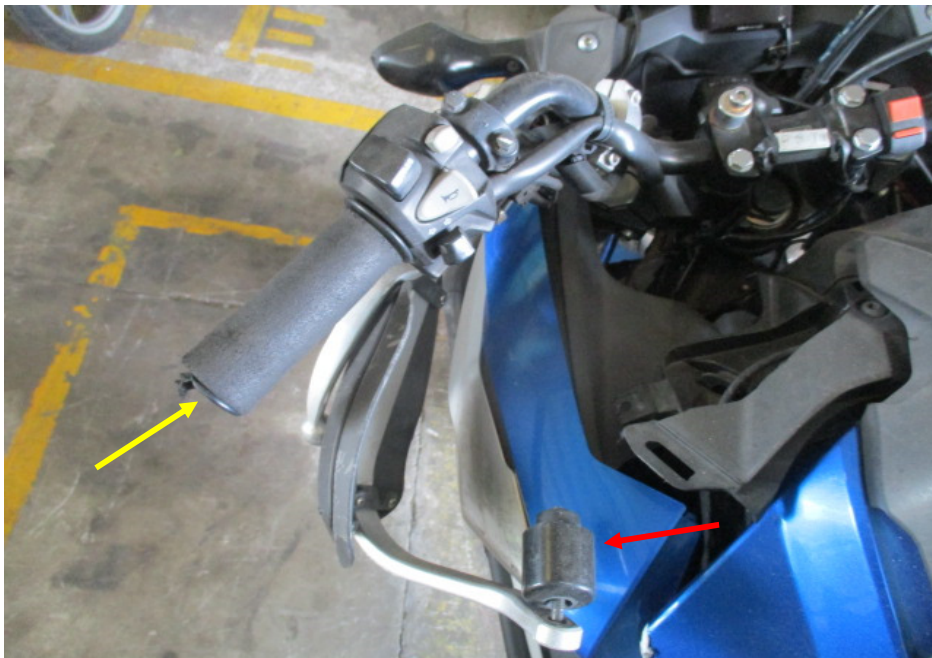
Photo 8 shows a closer view of the left handlebar end (yellow arrow) and clutch lever guard (red arrow) which were amongst the body parts of the Motorcycle that had sustained damage as a result of the accident.

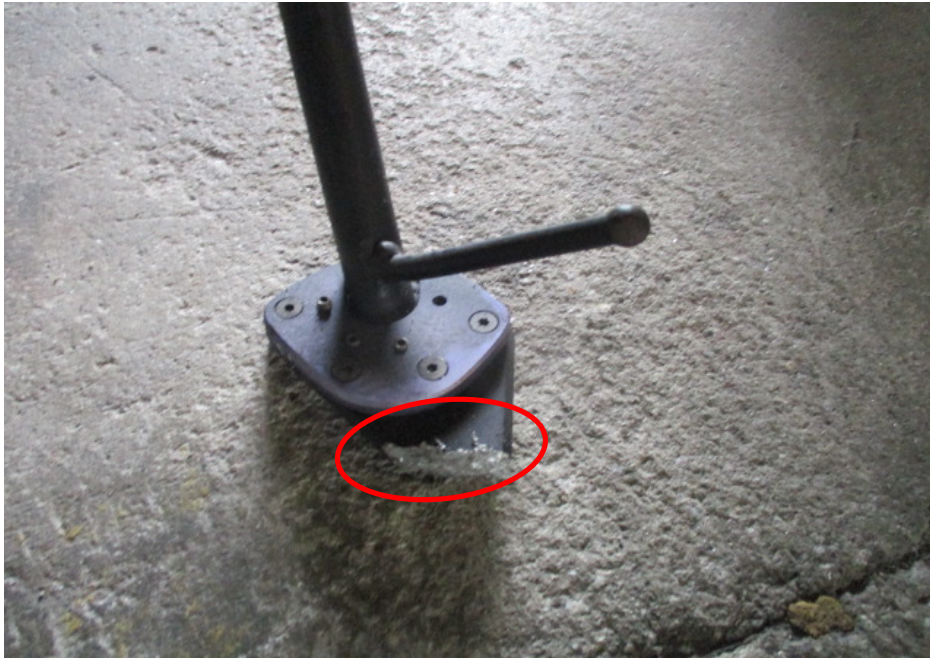
Photo 9 shows a closer view of the side stand enlarger of the Motorcycle which sustained damages of grazing nature as a result of the accident (circled).

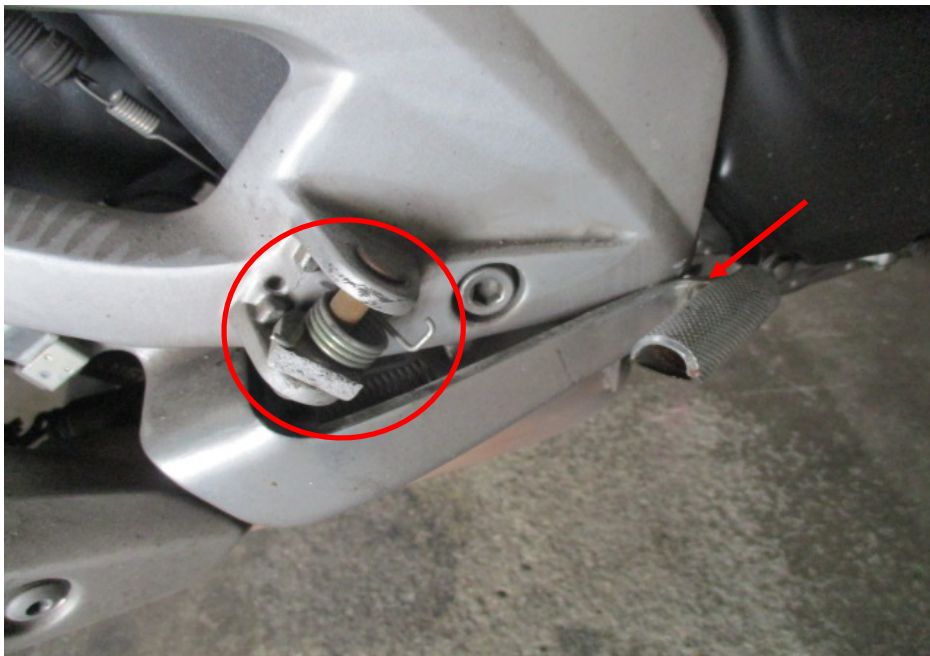
Photo 10 shows a closer view of the bent rear brake pedal (arrowed) and broken right front footrest (circled) which were amongst the body parts of the Motorcycle that had sustained damage as a result of the accident.

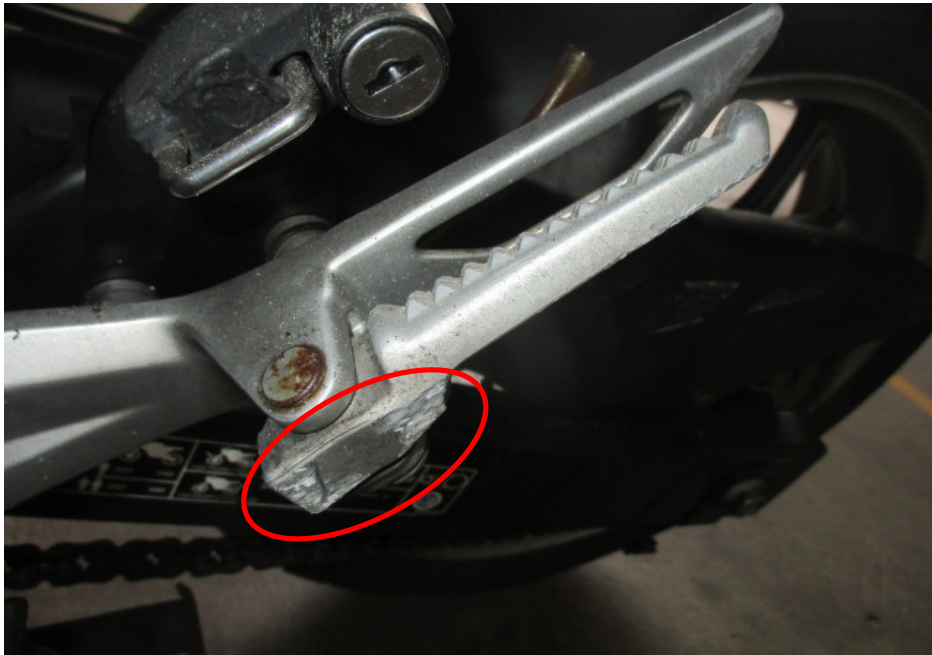
Photo 11 shows a closer view of the left pillion foot peg (circled) which was amongst the body parts of the Motorcycle that had sustained damage as a result of the accident.

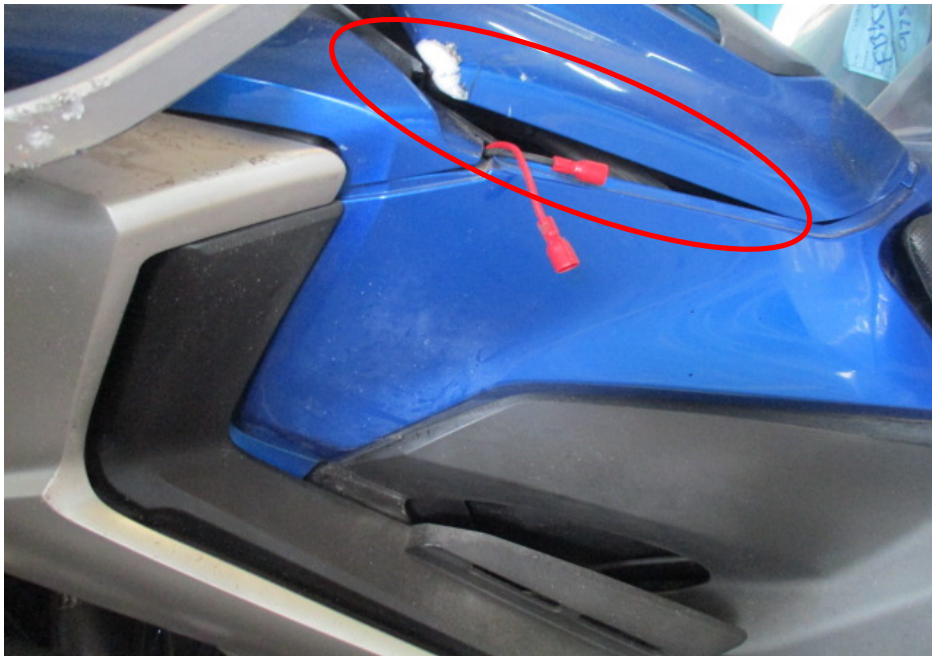
Photo 12 shows the damaged fuel tank cover Motorcycle as a result of the accident (circled).

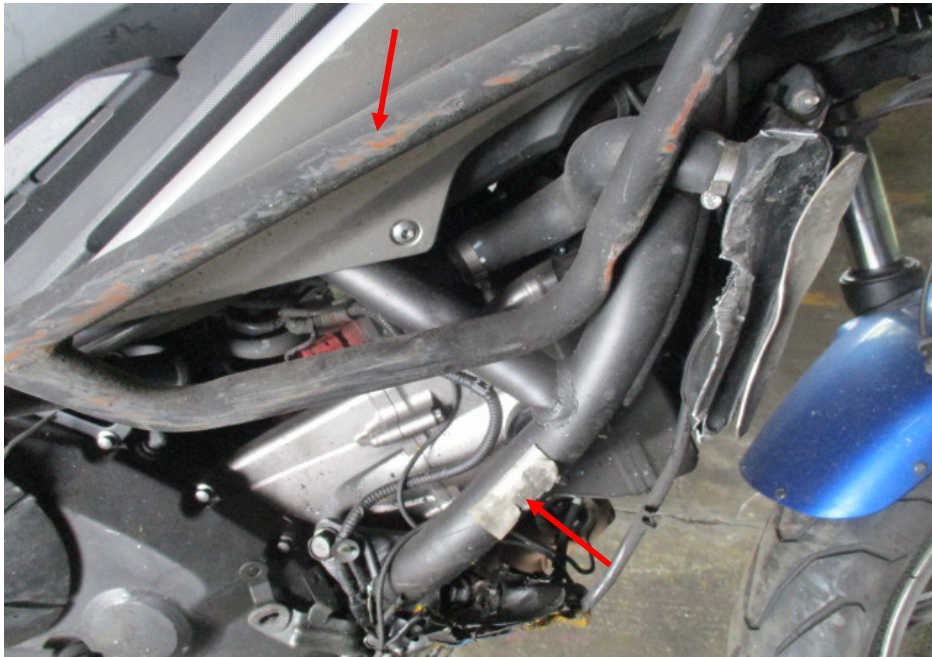
Photo 13 shows a closer view of the right crash bar of the Motorcycle that had sustained damages of grazing nature as a result of the accident (arrowed).

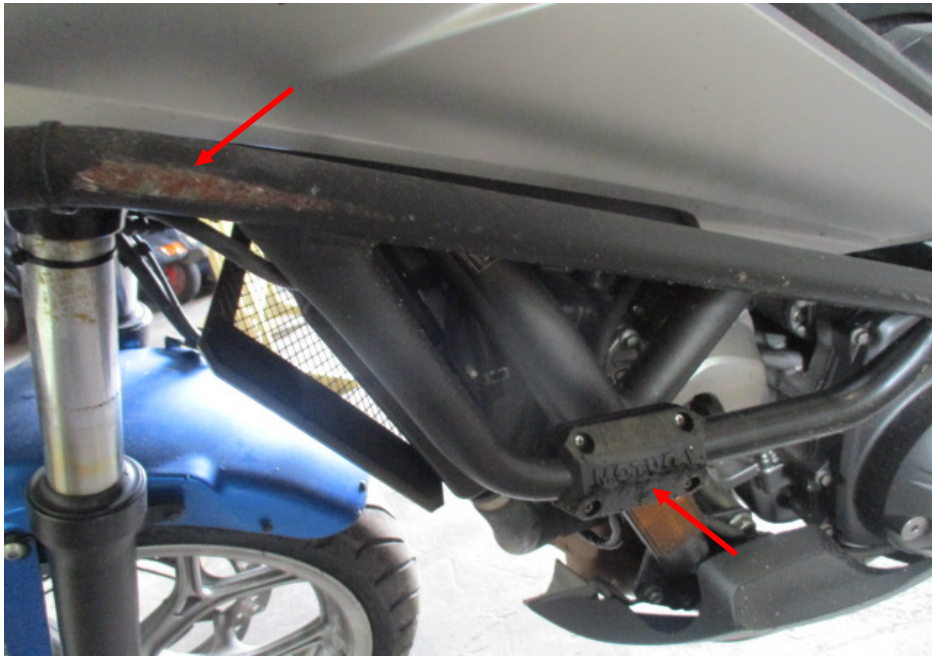
Photo 14 shows a closer view of the left crash bar of the Motorcycle that had sustained damages of grazing nature as a result of the accident (arrowed).

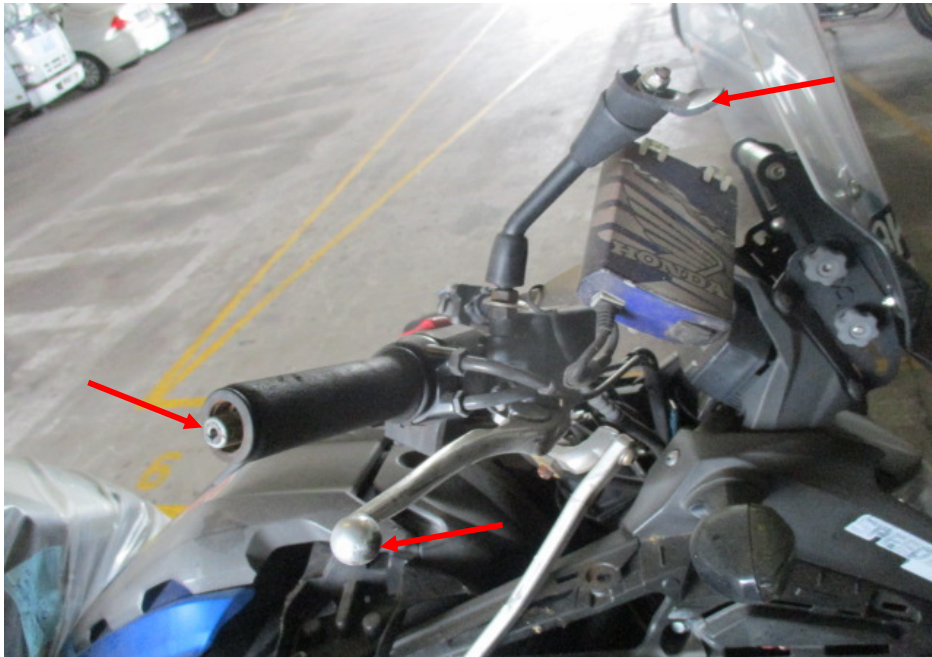
Photo 15 shows a closer view of the right handlebar end, right side mirror and front brake lever (arrowed) which were amongst the body parts of the Motorcycle that had sustained damage as a result of the accident.

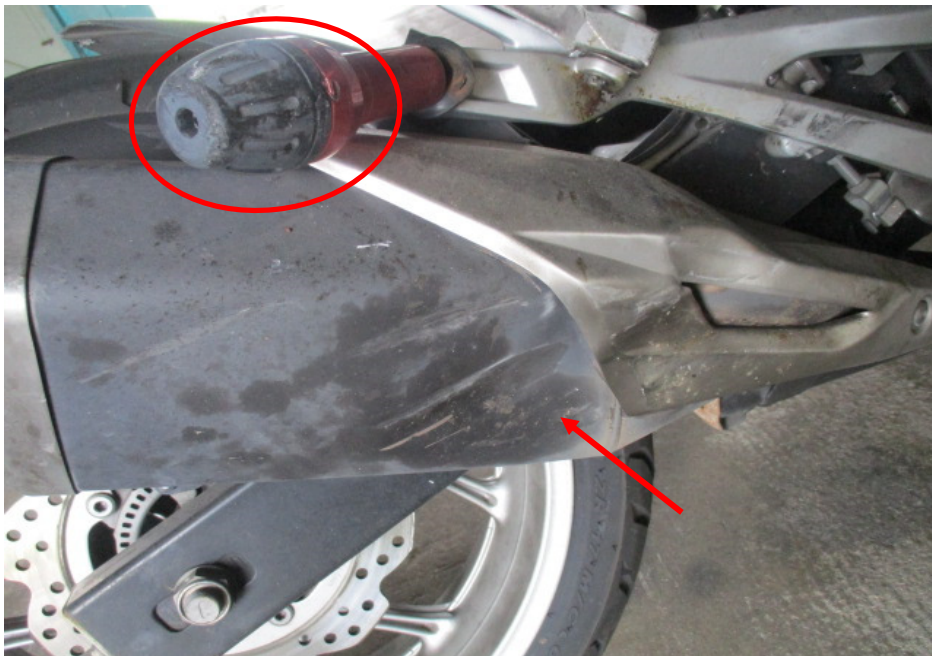
Photo 16 shows a closer view of the bent exhaust muffler slider (circled) and the damaged exhaust muffler (arrowed) which were amongst the body parts of the Motorcycle that had sustained damage as a result of the accident.

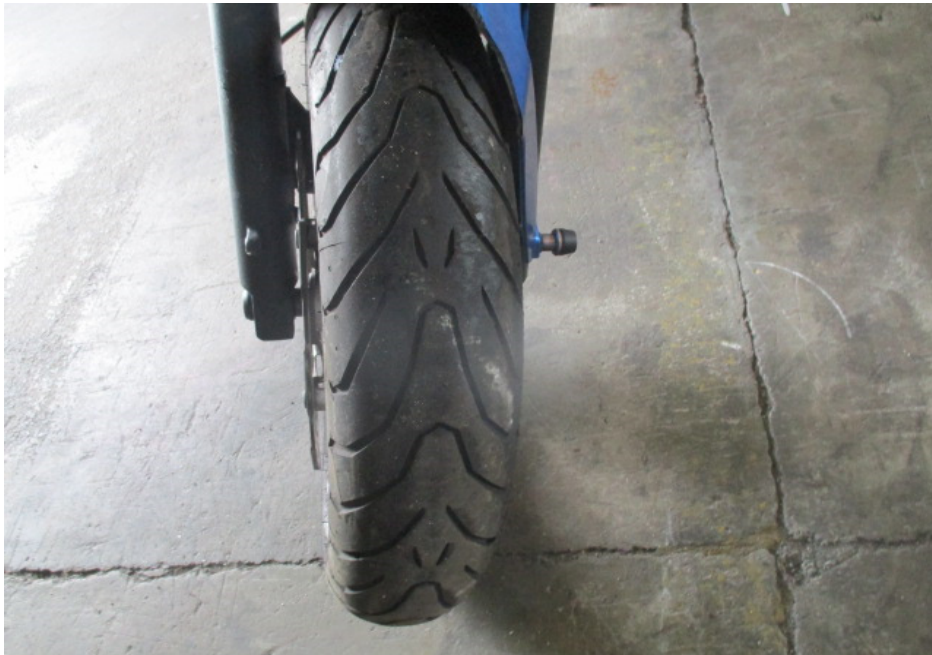
Photo 17 shows the condition of the Motorcycle's front tyre. The front tyre was observed to be in serviceable condition with remaining tread depth of approximately 3mm. There was no tear, burst mark(s) and/or punctured hole(s) on the sidewalls as well as across the tread of the front tyre.

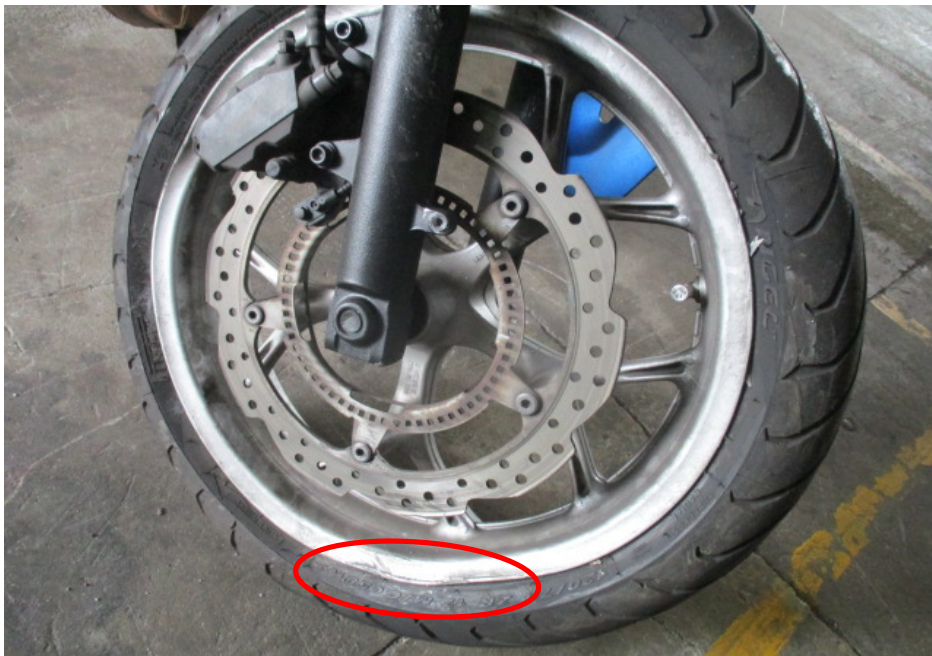
8. The 2 tyres were wrapped around alloy wheel rims. At the time of our inspection, we did not observe any visible damage on the rear wheel rim of the Motorcycle. We had however found some relatively minor marks of grazing nature on the edges of the front wheel rim, at the right side of the Motorcycle. See photos 1 – 19 below.

Photo 18 shows the front wheel rim of the Motorcycle at the time of our inspection. Some relatively minor marks of grazing nature were observed on the edges of the front wheel rim (circled), at the right side of the Motorcycle.

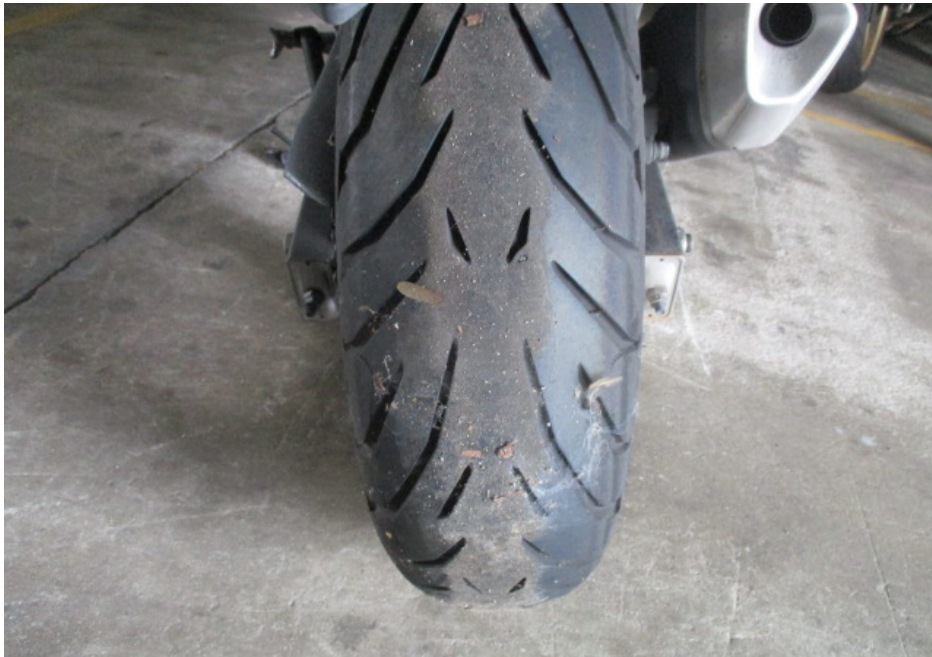
Photo 19 shows the condition of the Motorcycle's rear tyre. The rear tyre was observed to be in serviceable condition with remaining tread depth of approximately 4mm. The tyre was also observed to be sufficiently inflated for vehicular operation. We did not observe any tear, burst mark(s) and/or punctured hole(s) on the sidewalls as well as across the tread of the rear tyre.

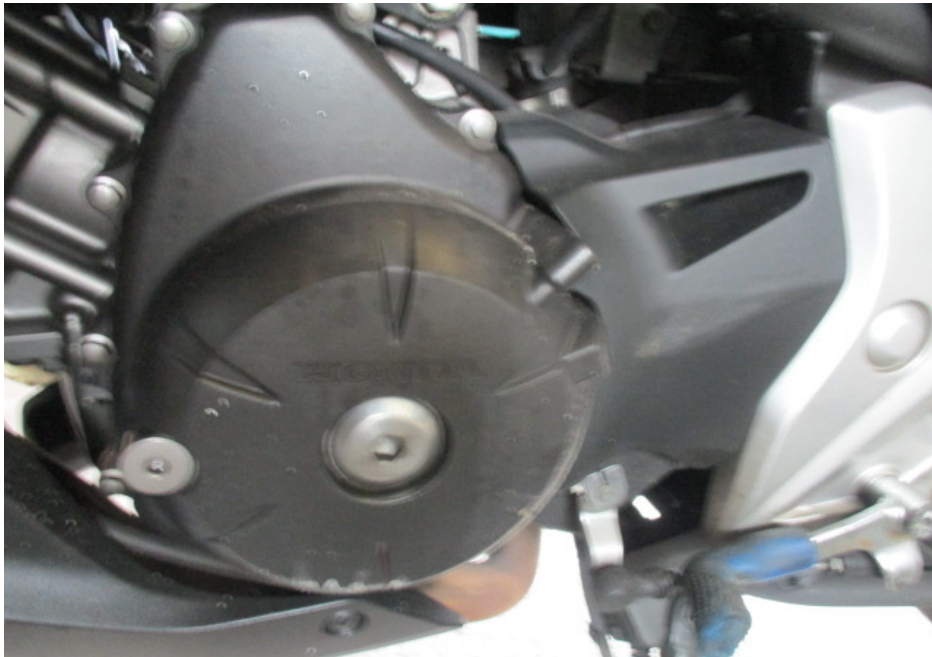
Photo 20 shows the left side of the engine of the Motorcycle at the time of our inspection. The various engine related parts and components were found to be intact with no visible damage. There was also no sign(s) or indication(s) of fluid leak observed around the left engine area of the Motorcycle.

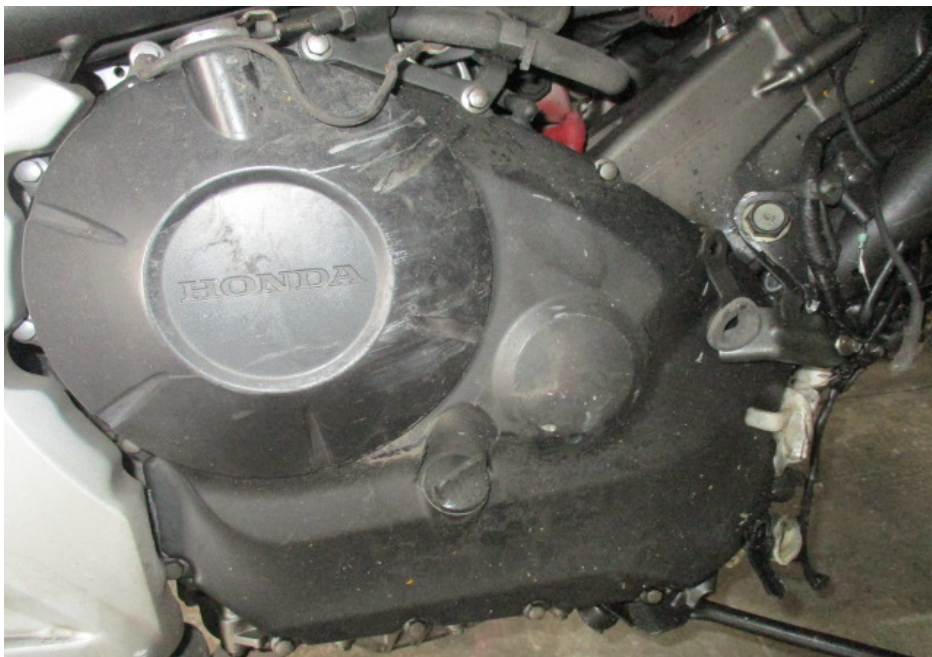
Photo 21 shows the right side of the engine of the Motorcycle at the time of our inspection. The various engine related parts and components were found to be intact with no visible damage. There was also no sign(s) or indication(s) of fluid leak observed around the right engine area of the Motorcycle.

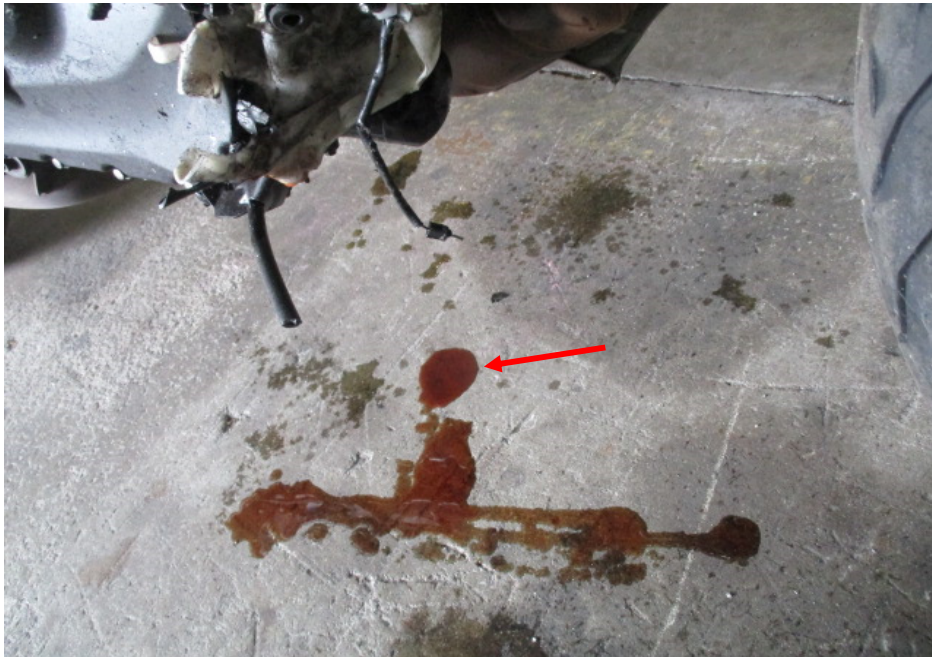
Photo 22 shows wet fluid stains observed on the ground directly below the engine cover of the Motorcycle (arrowed), indicating that a fluid leak had occurred as a result of the accident.

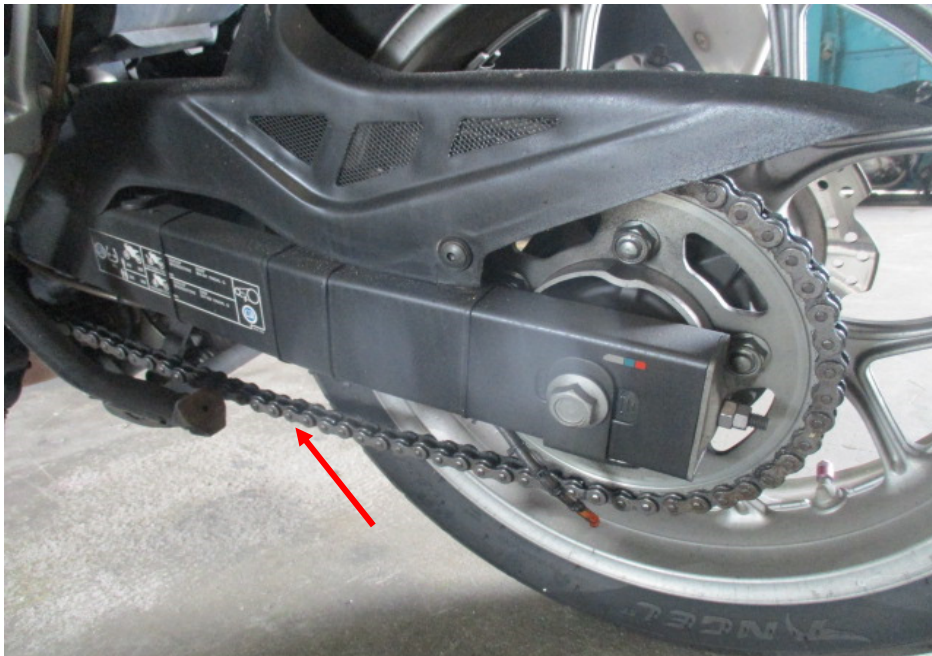
Photo 23 shows the general view of the gear train (arrowed) of the Motorcycle, which was observed to be intact with no misalignment. It was also adequately lubricated for operating purposes.

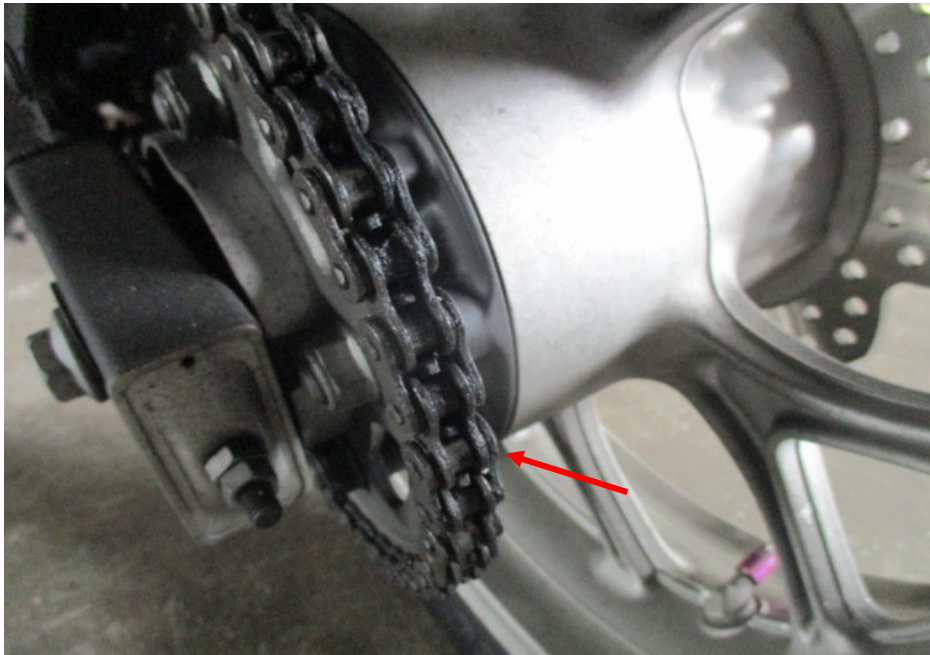
Photo 24 shows a closer view of the gear train (arrowed) of the Motorcycle, which was observed to be intact with no misalignment. It was also adequately lubricated for operating purposes.

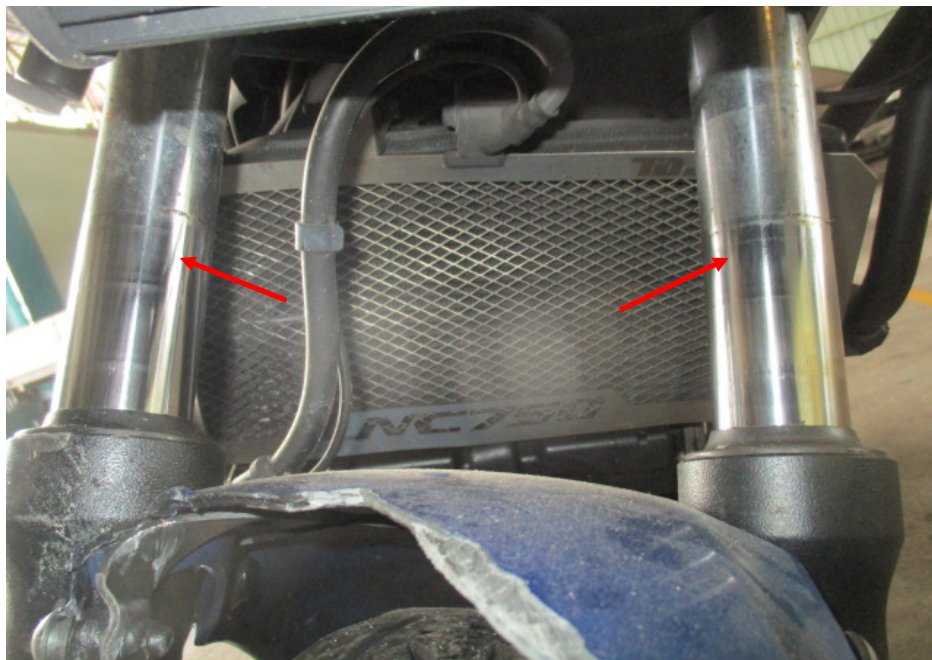
11. For this case, we were not able to conduct any test(s) on the steering system of the Motorcycle due to the damage to its front forks. The front forks were observed to be bent inwards as a result of the accident.

Photo 25 shows the front forks (arrowed) of the Motorcycle. The front forks were observed to be bent inwards as a result of the accident.

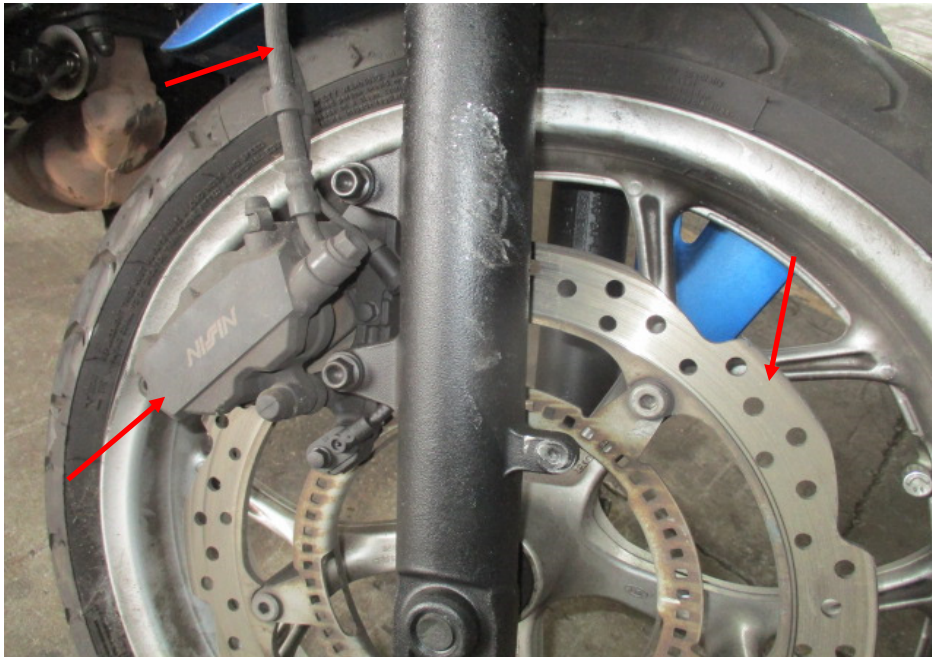
Photo 26 shows a close up view of the front brake caliper, front brake disc and front brake hose (arrowed) of the Motorcycle, which are all part of the components in the hydraulic front brake system of the Motorcycle. Our visual checks of these various components had revealed all to be intact with no visible damage. No leakage of brake fluid was also observed.

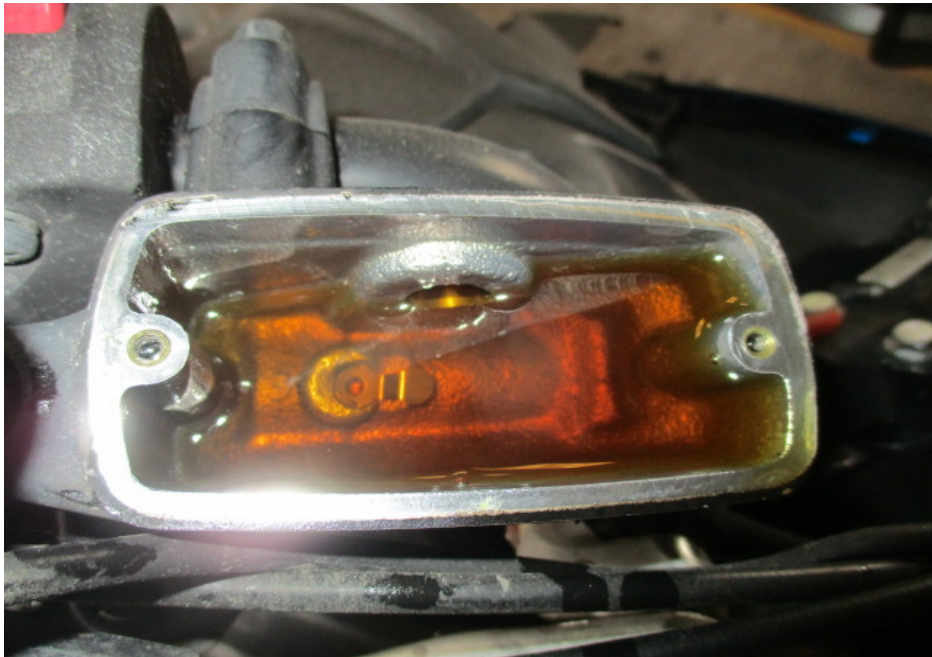
Photo 27 shows the brake fluid reservoir for the front brake of the Motorcycle. The brake fluid was observed to be of sufficient level and without contamination for operational purposes.

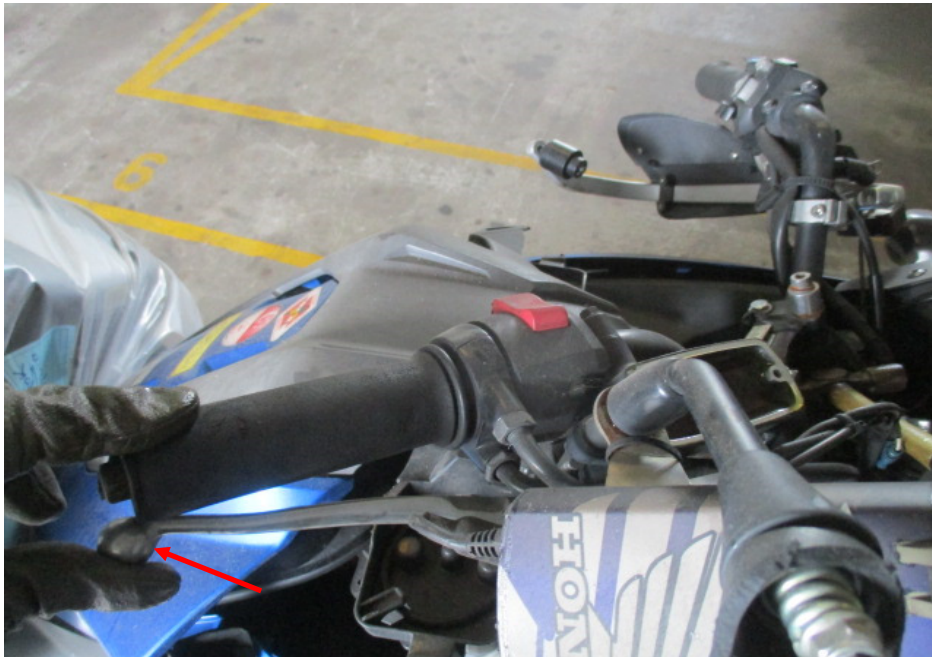
Photo 28 shows the front brake lever being depressed. There was some resistance felt (spongy like feel) upon pressing the front brake lever (arrowed). This would indicate that there is no leakage of pressure/vacuum in the brake system.

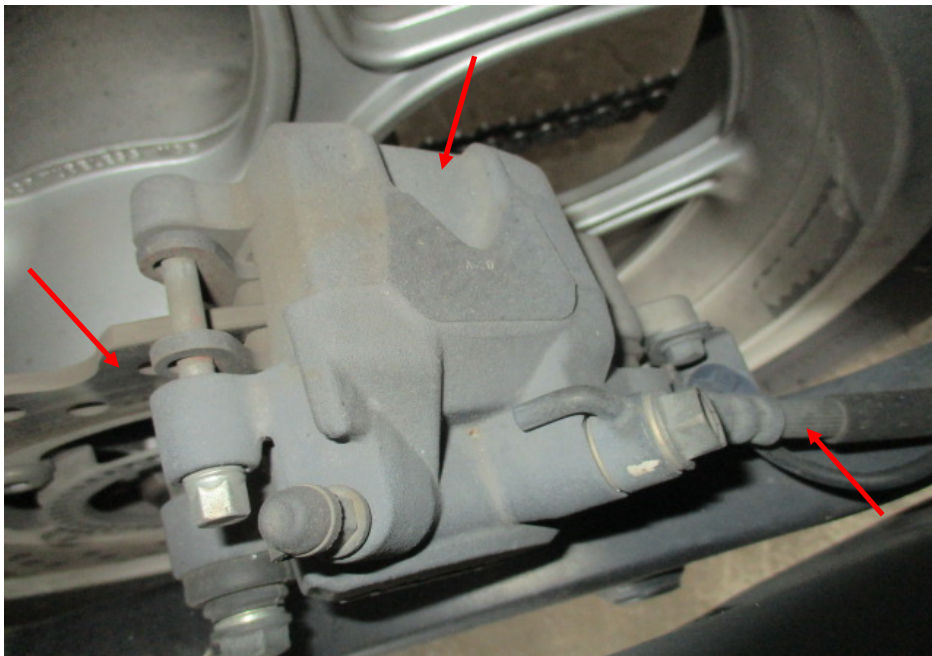
Photo 29 shows a close up view of the rear brake caliper, rear brake disc and rear brake hose (arrowed) of the Motorcycle, which are all part of the components in the hydraulic rear brake system of the Motorcycle. Our visual checks of these various components had revealed all to be intact with no visible damage. No leakage of brake fluid was also observed.
