Your Ref: TP/IP/01567/2020  
Our Ref : CI/TPD20001848/N

**Fatal Accident Investigation Team**

**INSPECTION REPORT OF MOTORCYCLE FBL 5613L**

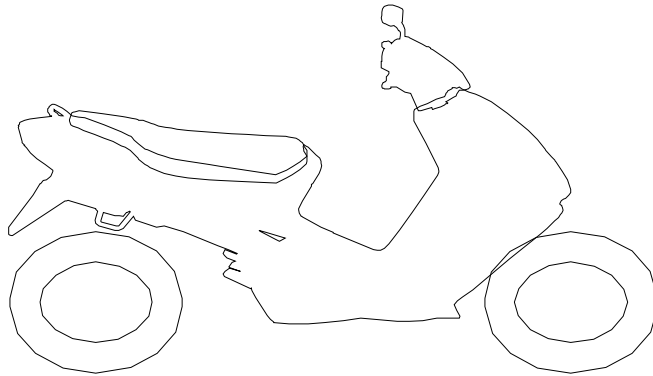
Bridgestone 150/60 - 17 (3mm)

Bridgestone 110/70 - 17 (3mm)

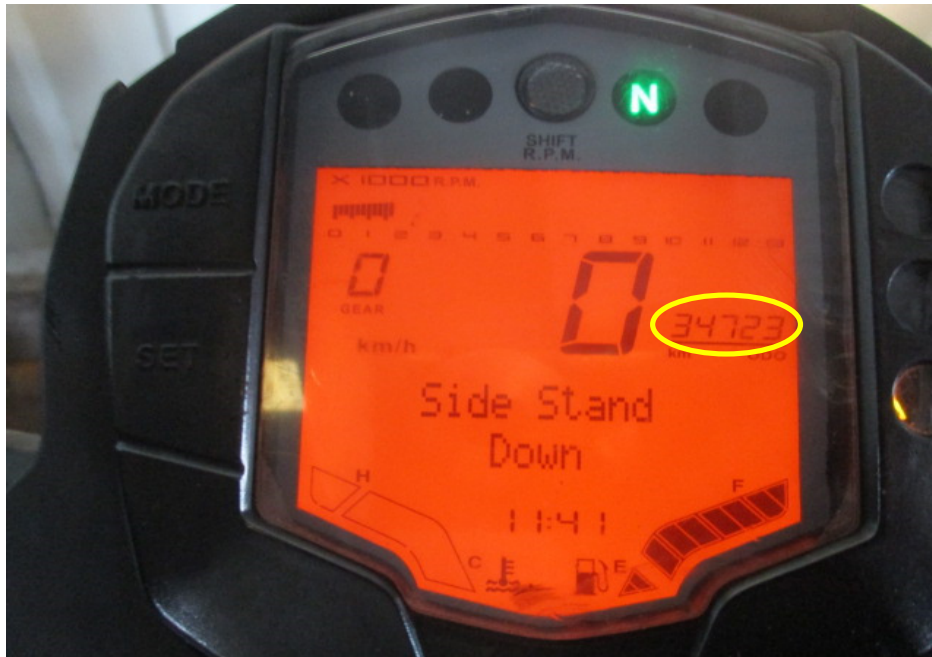
**Photo 1** shows the speedometer gauge of the Motorcycle where the mileage recorded at the time of our inspection was 34,723km (circled).

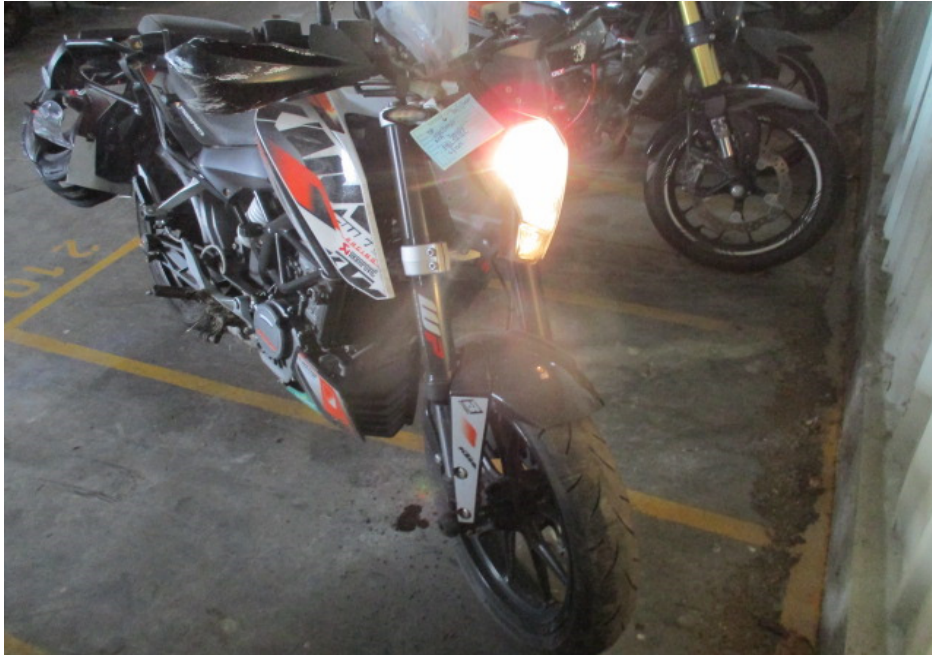
**Photo 2** shows a general view of the frontal portion of the Motorcycle at the time of our inspection. The Motorcycle was observed to have sustained damages all around.

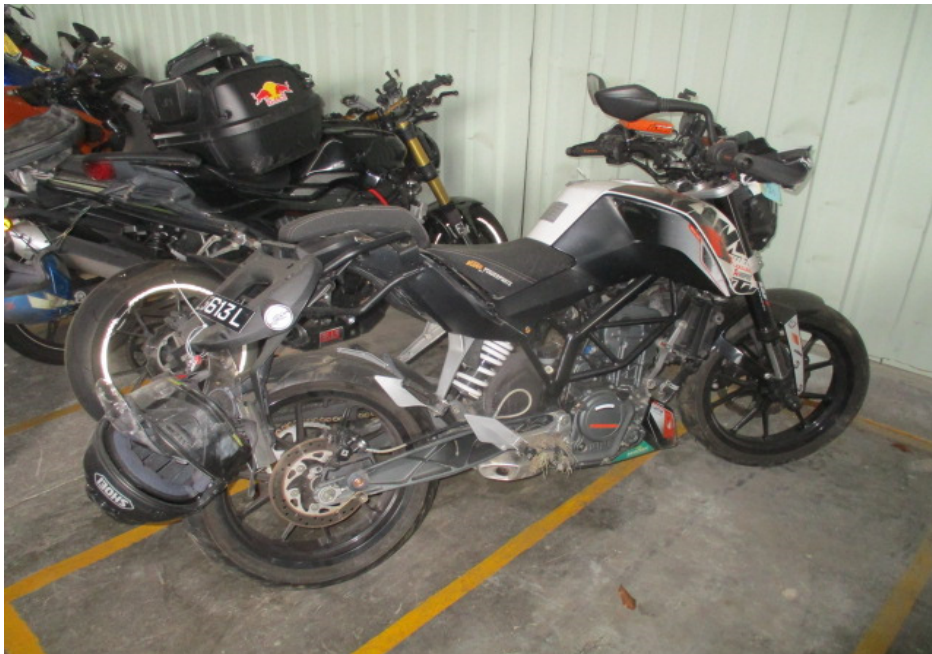
**Photo 3** shows a general view of the right body of the Motorcycle at the time of our inspection. The Motorcycle was observed to have sustained damages all around.

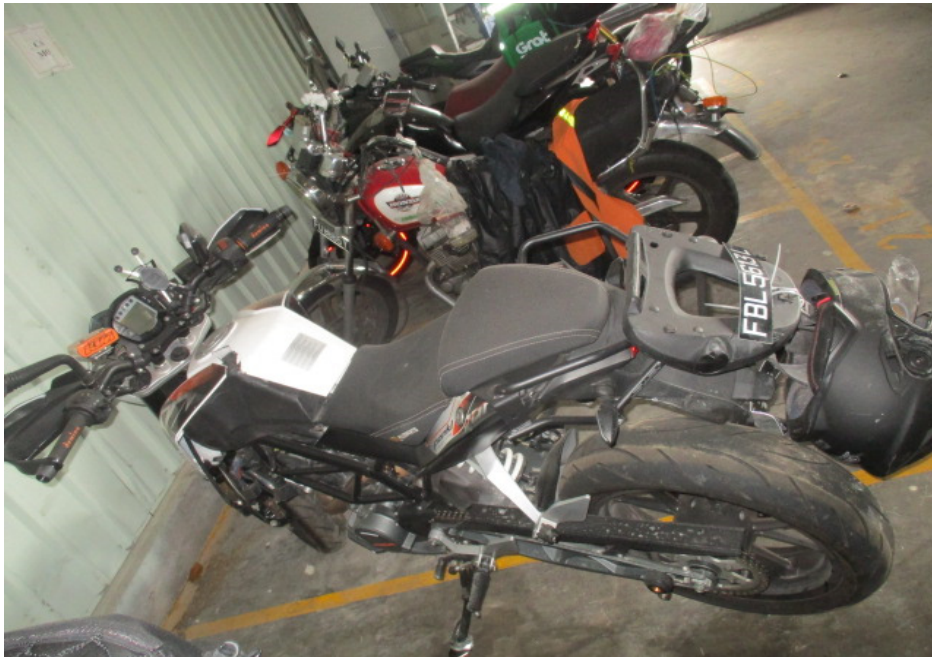
**Photo 4** shows a general view of the left body of the Motorcycle at the time of our inspection. The Motorcycle was observed to have sustained damages all around.

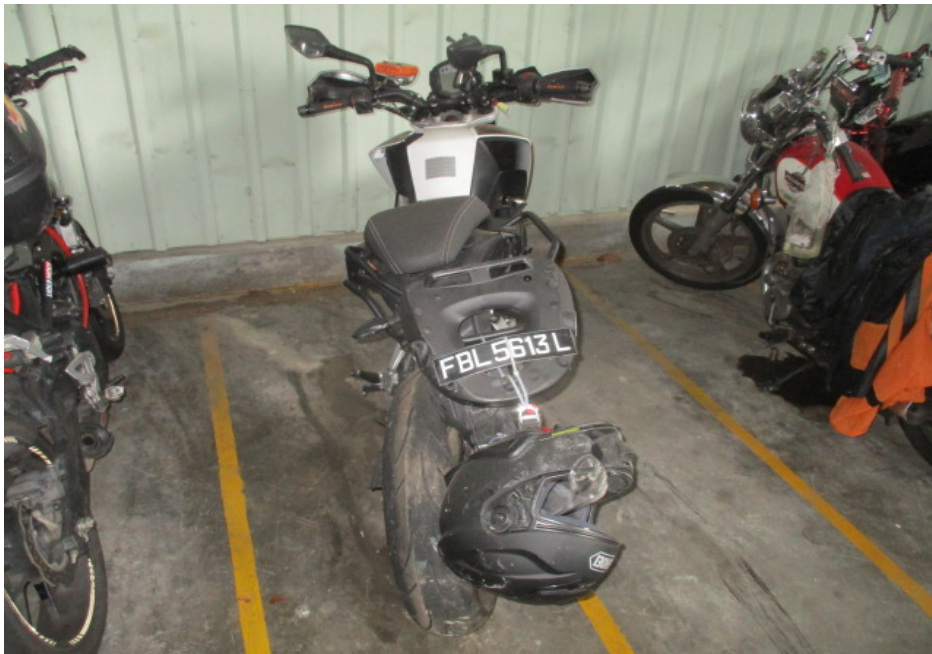
**Photo 5** shows a general view of the rear portion of the Motorcycle at the time of our inspection. The Motorcycle was observed to have sustained damages all around. Amongst the body parts that were found to have been damaged include its headlight assembly, head cowl, fuel tank cover, belly pan, rear brake pedal, right front footrest, left pillion foot peg, right rear side cover, top box rack and rear mudguard, amongst others.

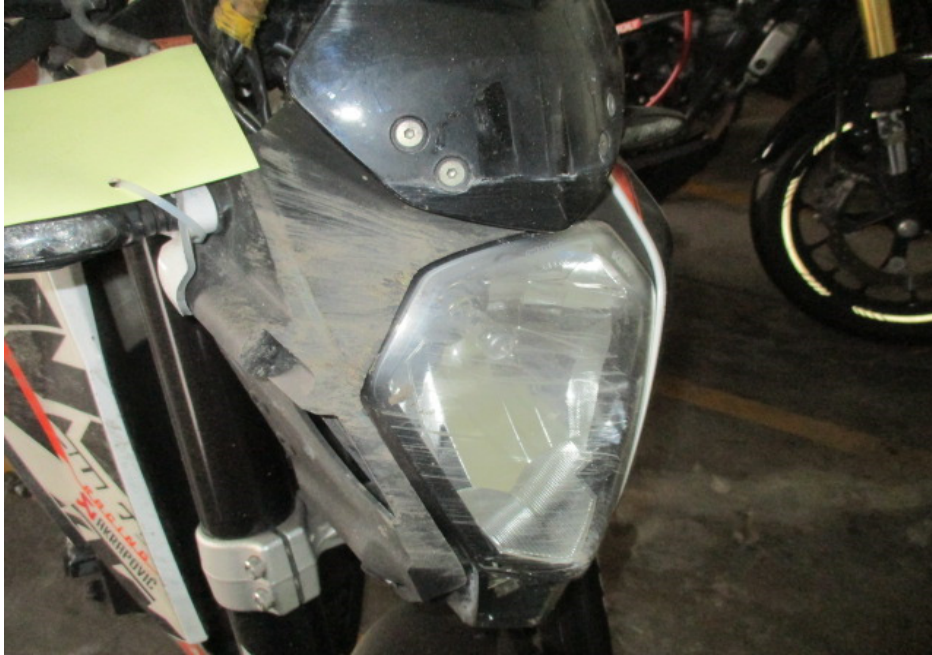
**Photo 6** shows a close up view of the head cowl and headlight assembly which were amongst the body parts of the Motorcycle that had sustained damages of grazing nature as a result of the accident.

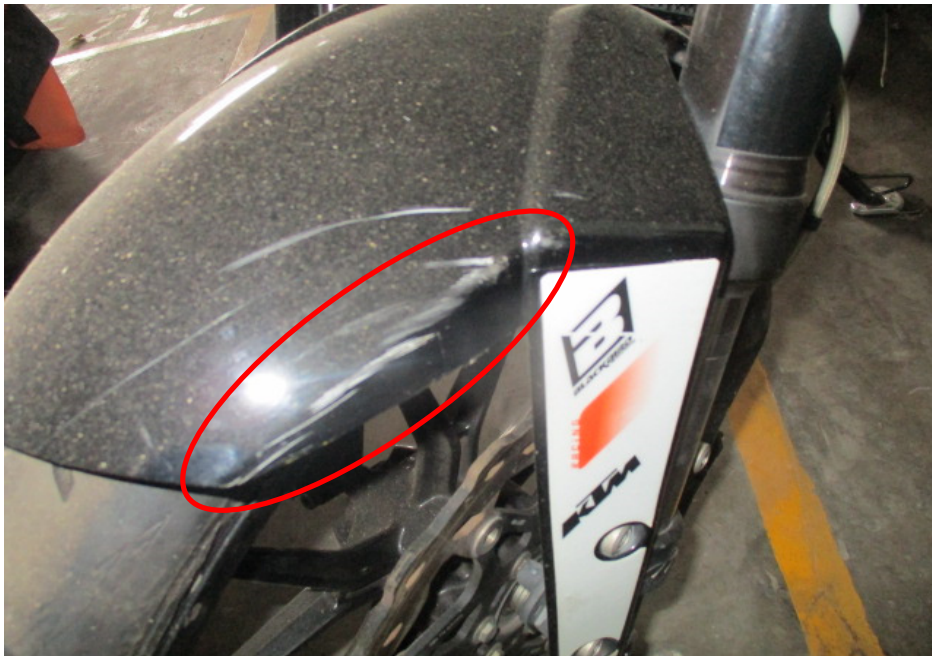
**Photo 7** shows a closer view of the front mudguard (circled) which was amongst the body parts at the front body of the Motorcycle that had sustained damage as a result of the accident.

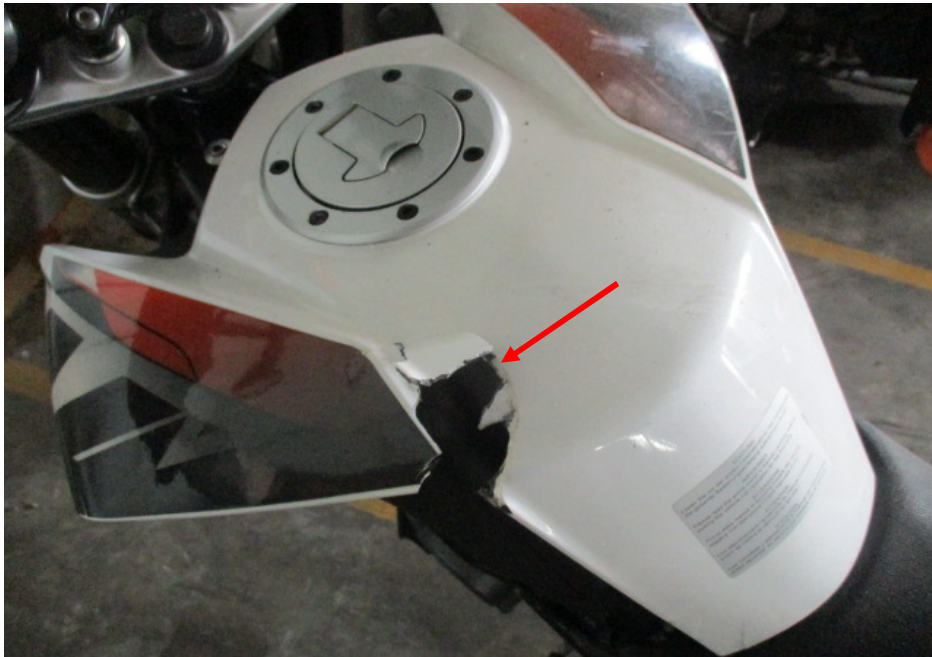
**Photo 8** shows a closer view of the cracked fuel tank cover (arrowed) of the Motorcycle as a result of the accident.

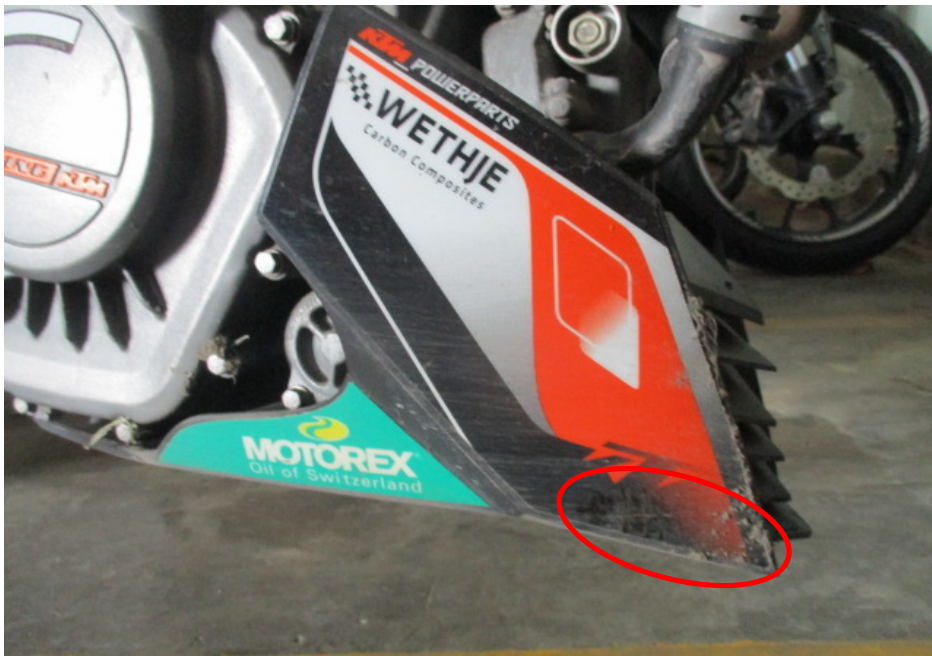
**Photo 9** shows a closer view of the belly pan (circled) which was amongst the body parts of the Motorcycle that had sustained damage as a result of the accident.

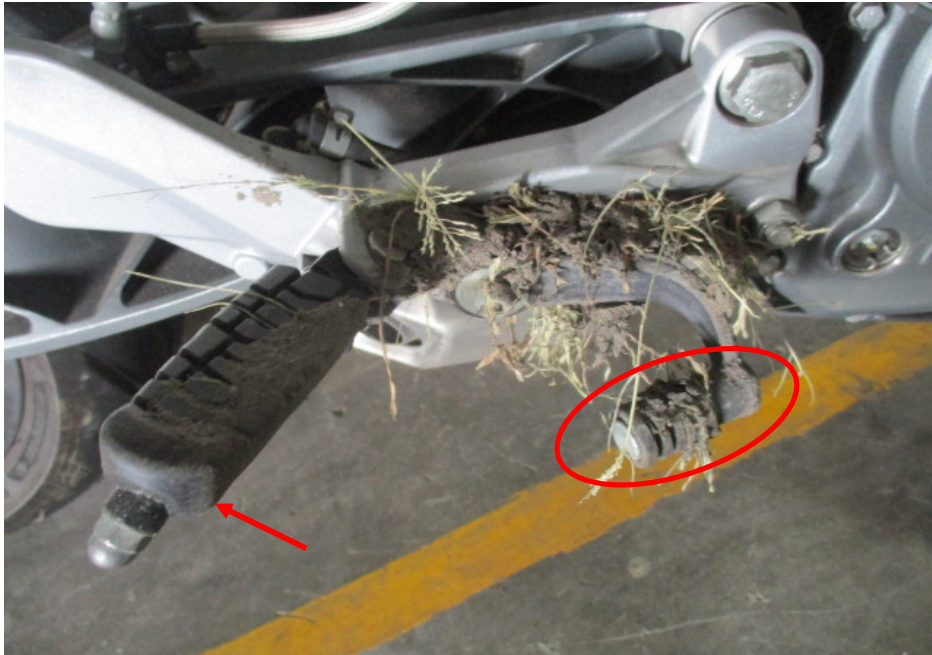
**Photo 10** shows a closer view of the rear brake pedal (circled) and right front footrest (arrowed) which were amongst the body parts of the Motorcycle that had sustained damage as a result of the accident.

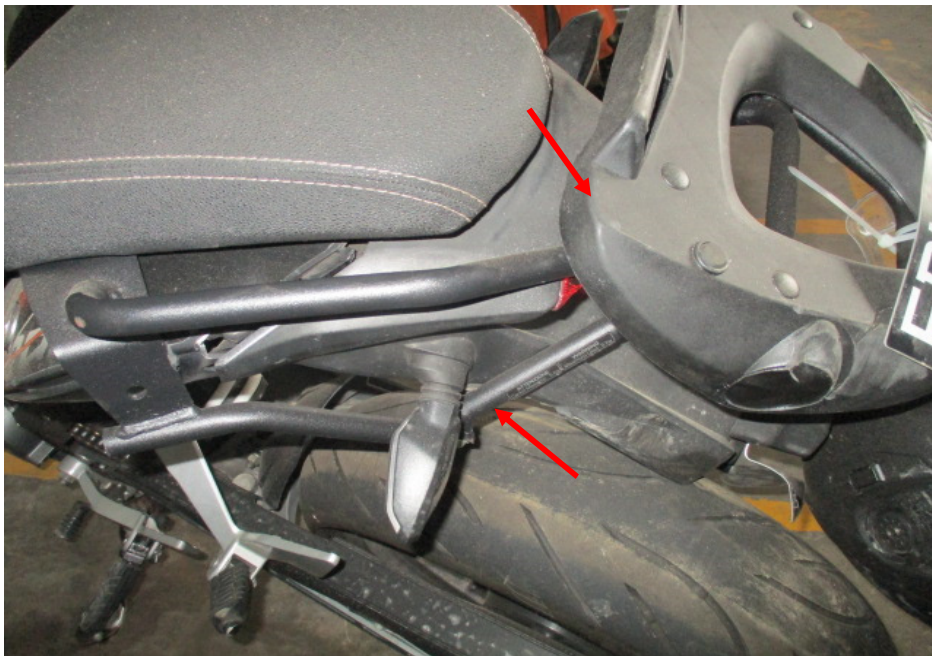
**Photo 11** shows the bent top box rack and top box base plate (arrowed) of the Motorcycle as a result of the accident.

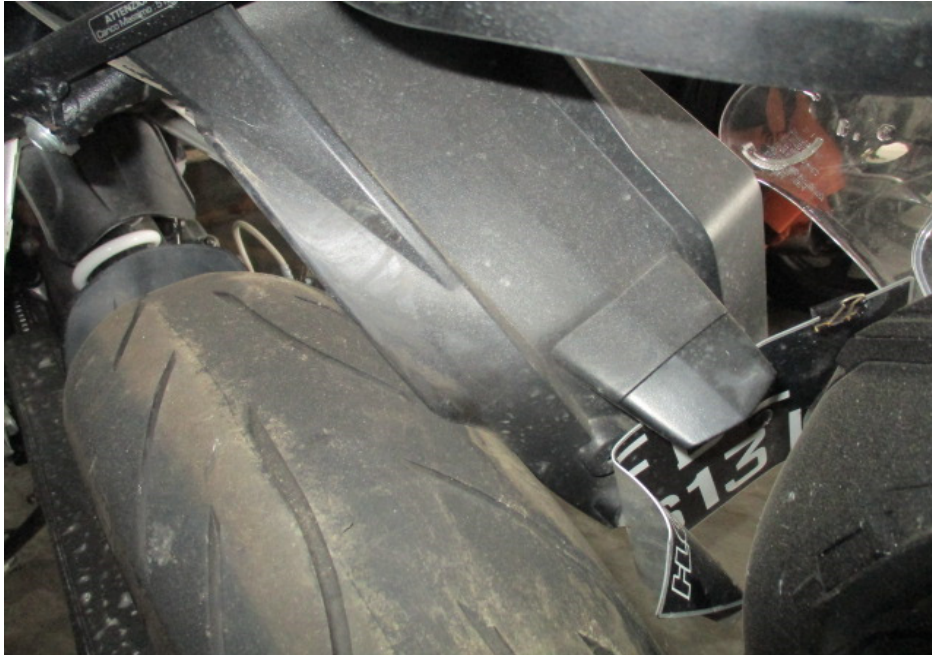
**Photo 12** shows a closer view of the deformed rear mudguard and dented rear number plate of the Motorcycle as a result of the accident.

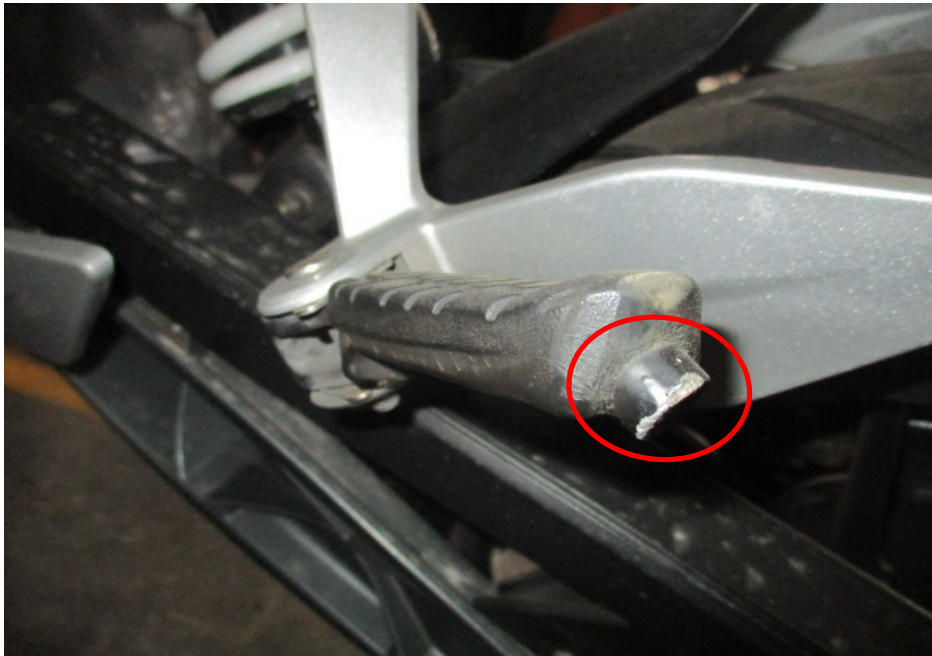
**Photo 13** shows a closer view of the broken left pillion foot peg of the Motorcycle (circled) as a result of the accident.

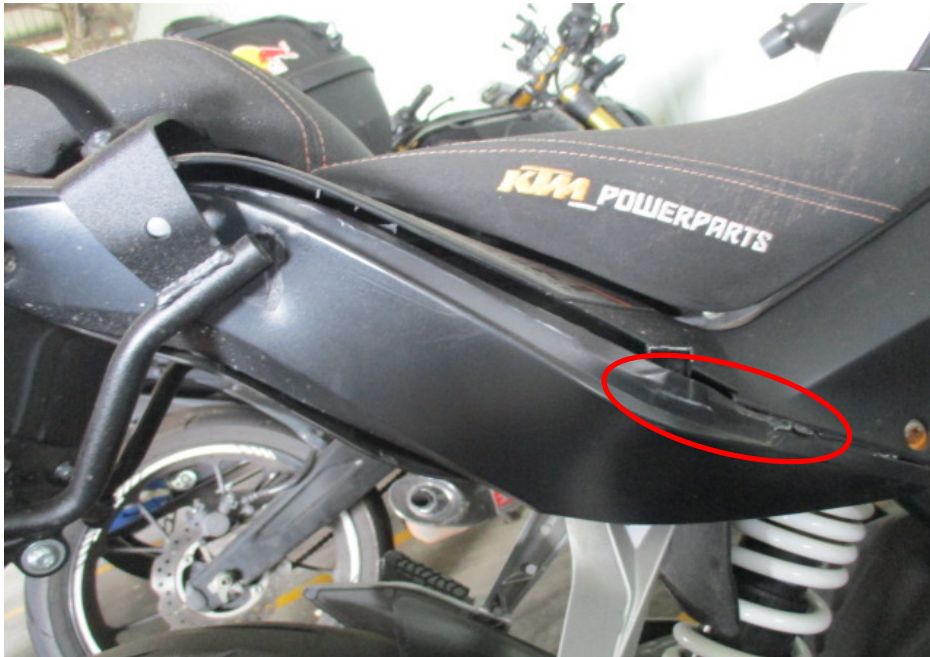
**Photo 14** shows a closer view of the cracked right rear side cover (circled) of the Motorcycle as a result of the accident.

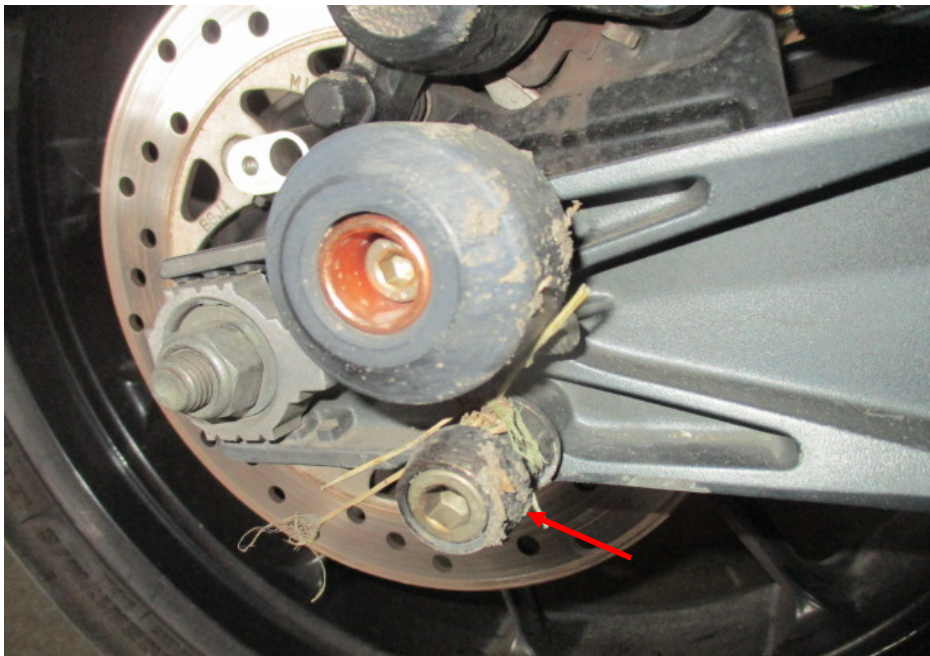
**Photo 15** shows a close up view of the right swingarm spool of the Motorcycle which was observed to be bent as a result of the accident (arrowed).

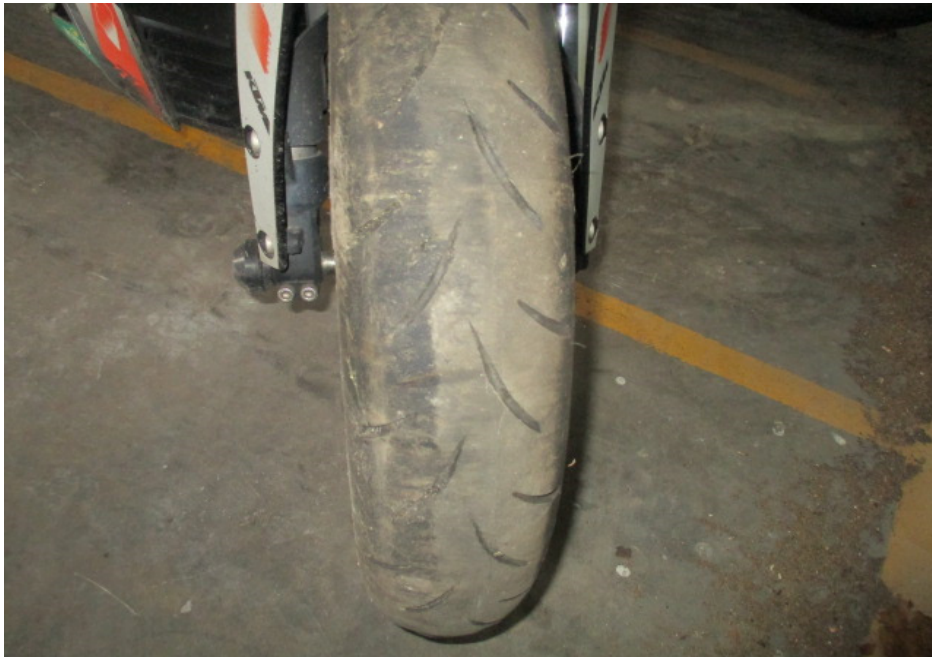
**Photo 16** shows the condition of the Motorcycle's front tyre. The front tyre was observed to be in serviceable condition with remaining tread depth of approximately 3mm. There was no tear, burst mark(s) and/or punctured hole(s) on the sidewalls as well as across the tread of the front tyre.

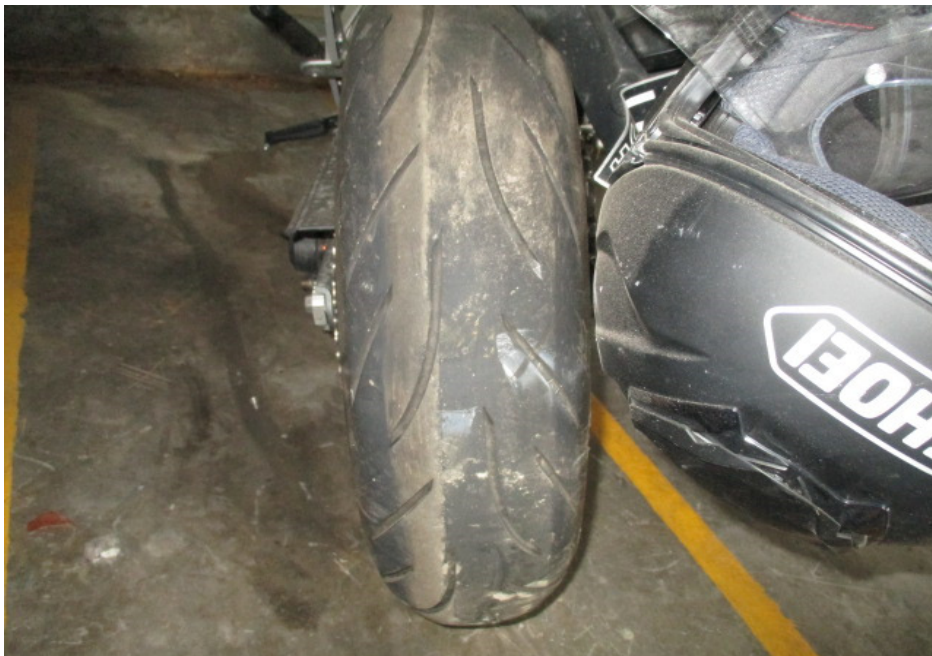
**Photo 17** shows the condition of the Motorcycle's rear tyre. The rear tyre was observed to be in serviceable condition with remaining tread depth of approximately 3mm. The tyre was also observed to be sufficiently inflated for vehicular operation. We did not observe any tear, burst mark(s) and/or punctured hole(s) on the sidewalls as well as across the tread of the rear tyre.

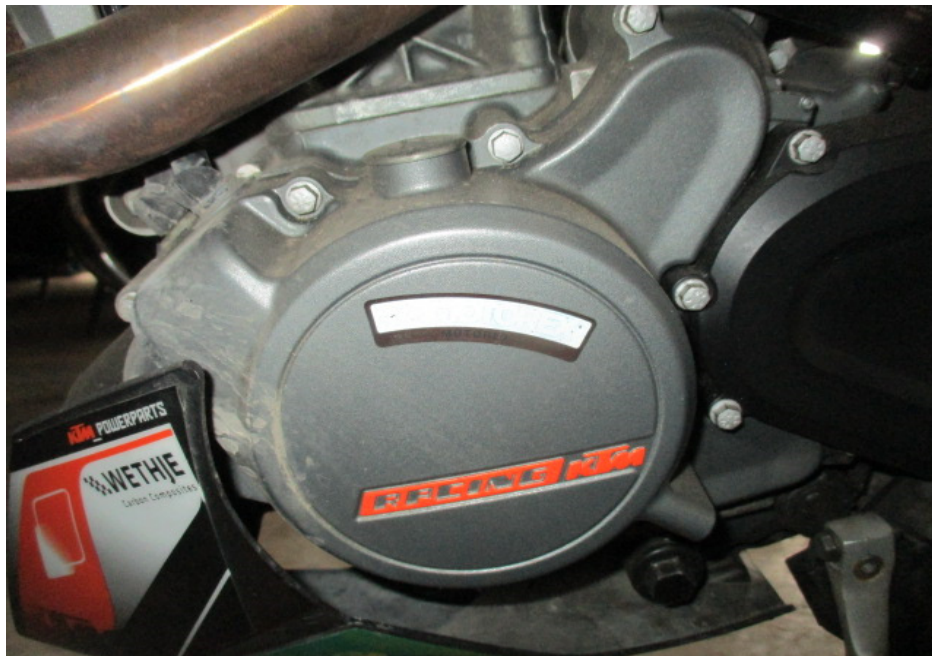
**Photo 18** shows the left side of the engine of the Motorcycle at the time of our inspection. The various engine related parts and components were found to be intact with no visible damage. There was also no sign(s) or indication(s) of fluid leak observed around the left engine area of the Motorcycle.

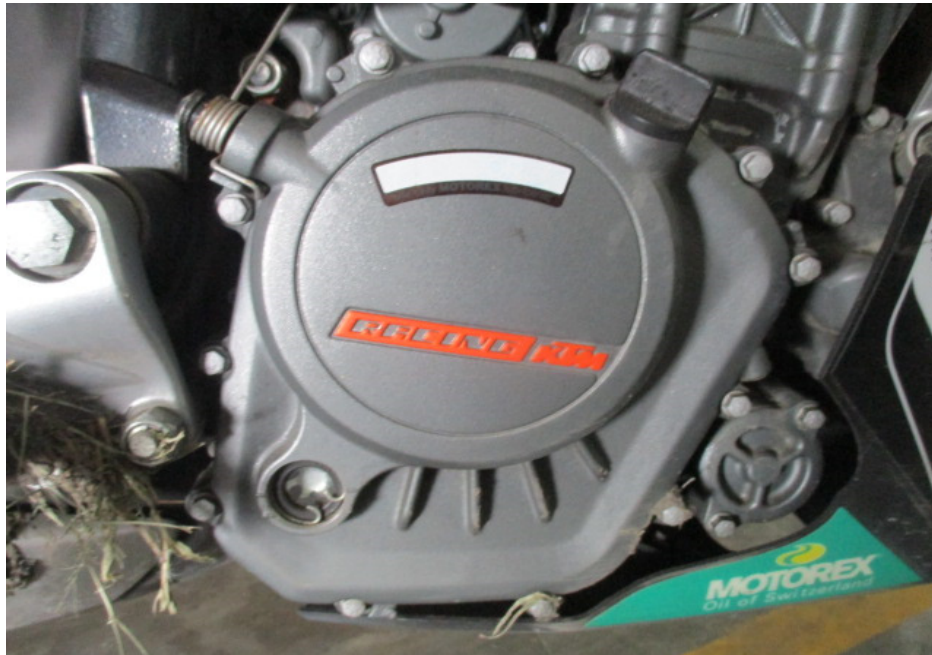
**Photo 19** shows the right side of the engine of the Motorcycle at the time of our inspection. The various engine related parts and components were found to be intact with no visible damage. There was also no sign(s) or indication(s) of fluid leak observed around the right engine area of the Motorcycle.

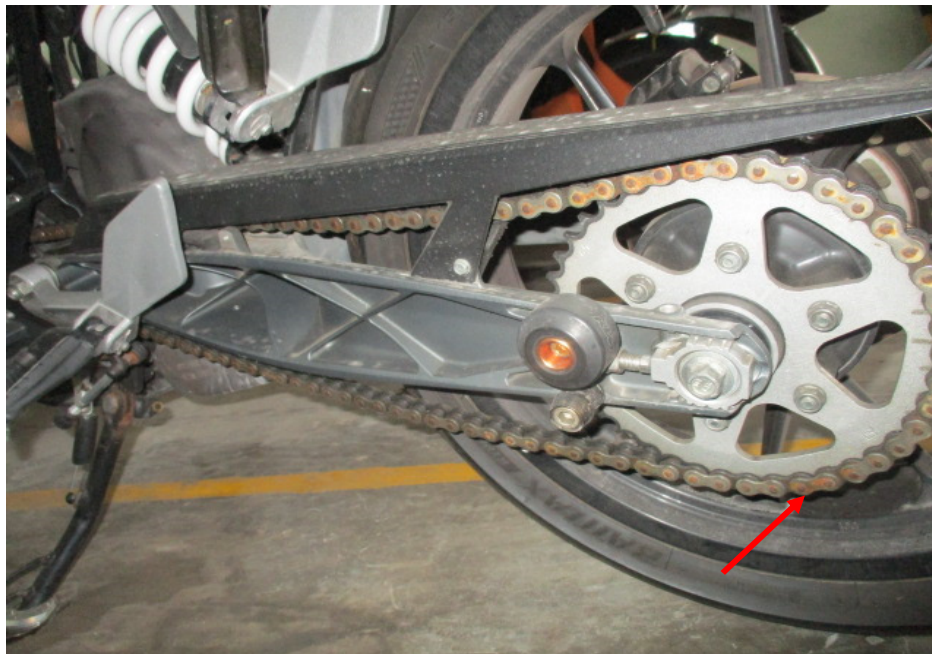
**Photo 20** shows the general view of the gear train (arrowed) of the Motorcycle, which was observed to be intact with no misalignment. It was also adequately lubricated for operating purposes.

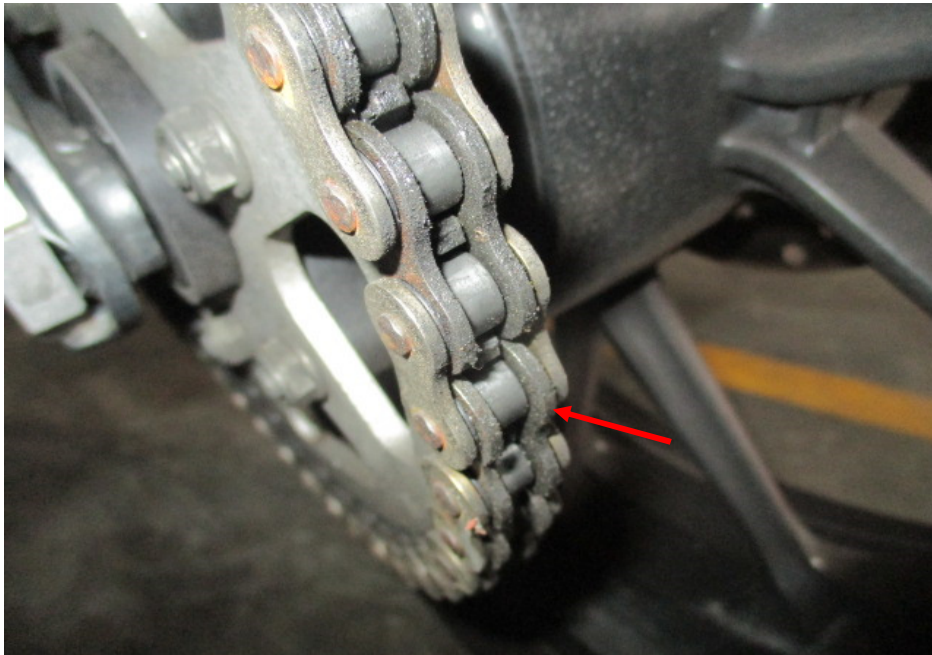
**Photo 21** shows a closer view of the gear train (arrowed) of the Motorcycle, which was observed to be intact with no misalignment. It was also adequately lubricated for operating purposes.

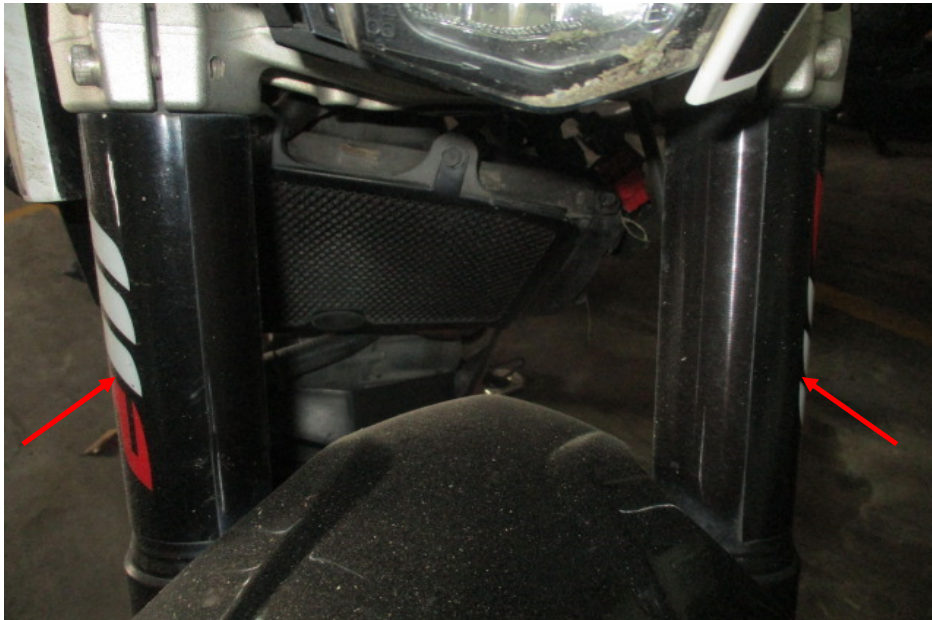
**Photo 22** shows the front fork (arrowed) of the Motorcycle. The front fork and fork bracket of the Motorcycle were both found to be intact and undamaged. Turning the Motorcycle's handle bar towards the left and right did not produce any abnormal free play and/or resistance. The steering system of the Motorcycle was in serviceable condition at the time of our inspection.

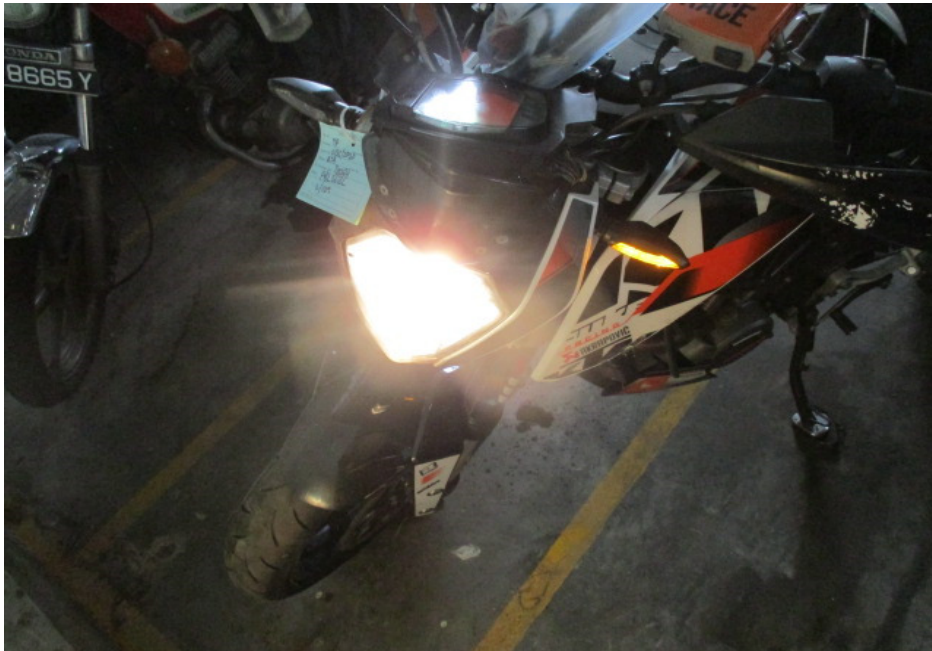
**Photo 23** shows the front wheel of the Motorcycle turned towards its full left. Turning the Motorcycle's handle bar towards the left and right did not produce any abnormal free play and/or resistance. This would indicate that the steering system of the Motorcycle was in serviceable condition at the time of our inspection.

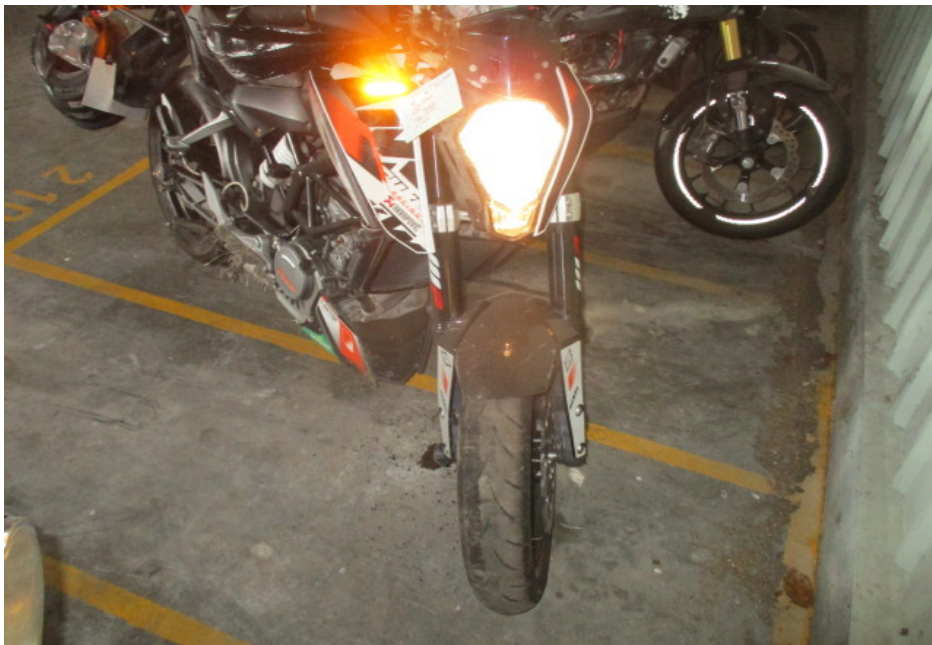
**Photo 24** shows the front wheel of the Motorcycle turned towards its full right. Turning the Motorcycle's handle bar towards the left and right did not produce any abnormal free play and/or resistance. This would indicate that the steering system of the Motorcycle was in serviceable condition at the time of our inspection.

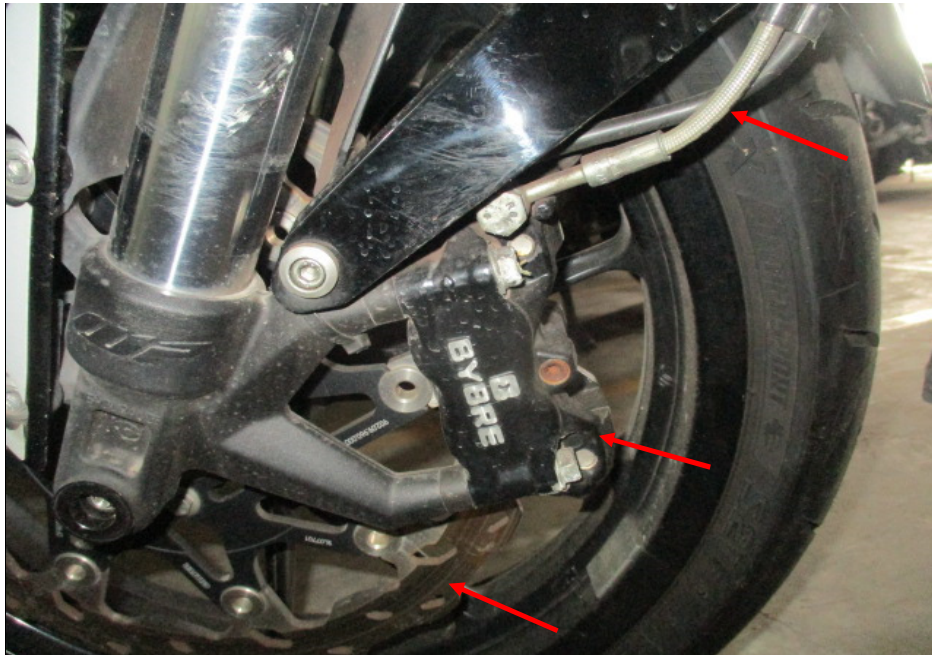
**Photo 25** shows a close up view of the front brake caliper, front brake disc and front brake hose (arrowed) of the Motorcycle, which are all part of the components in the hydraulic front brake system of the Motorcycle. Our visual checks of these various components had revealed all to be intact with no visible damage. No leakage of brake fluid was also observed.

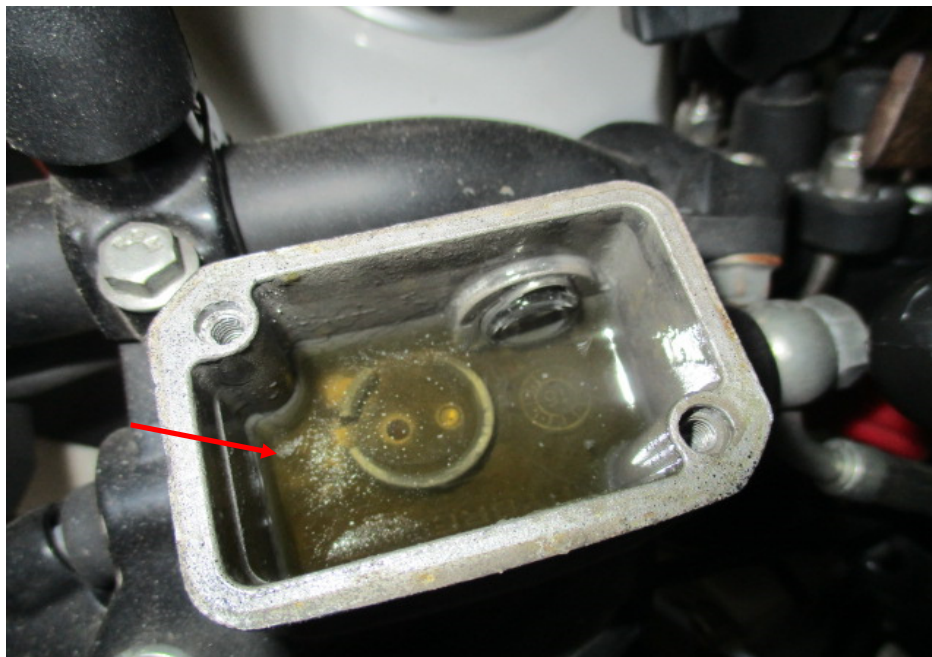
13. Our visual examination of the various components in the Motorcycle's braking system like the brake discs, brake calipers, brake lever, brake foot pedal and brake hoses revealed all to be intact and without damage. There was also no leakage of brake fluid observed along the brake hoses. This was from the respective brake fluid reservoirs to the front brake caliper and rear brake caliper of the Motorcycle. The brake fluid for the rear brake was also found to be of sufficiently level and without any contamination. The brake fluid for the front brake was found to be of sufficient level for operating purposes. However the brake fluid was found to be slightly contaminated.

**Photo 26** shows the brake fluid reservoir for the front brake of the Motorcycle. The brake fluid was found to be of sufficient level for operating purposes. However the brake fluid was found to be slightly contaminated (arrowed).

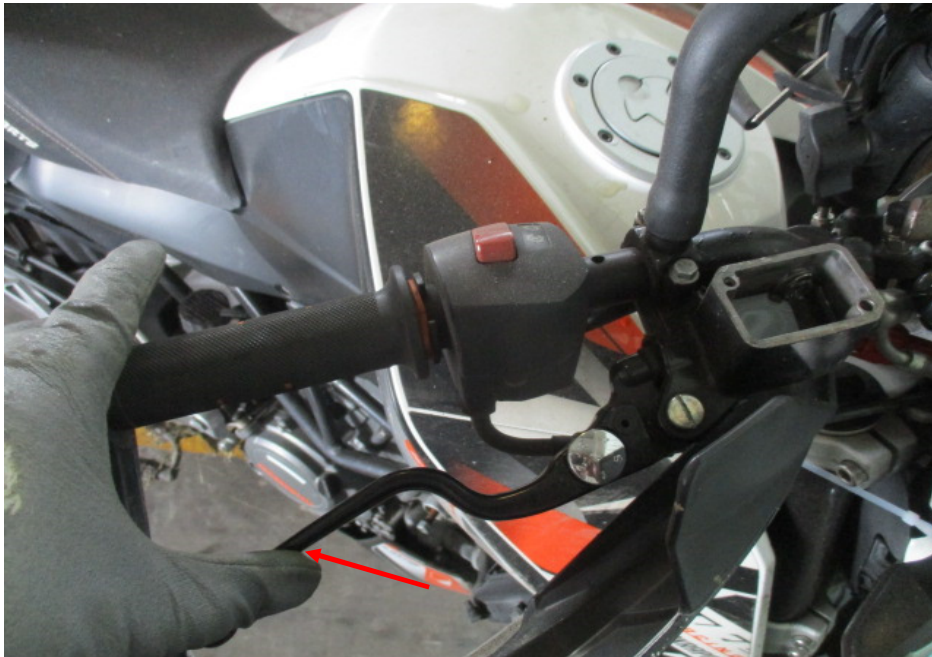
14. Static brake tests conducted on the Motorcycle had appear to indicate that the braking system of the Motorcycle was in serviceable condition. There was some resistance felt (spongy like feel) upon pressing the brake lever and upon stepping on the brake pedal. This would indicate that there was no leakage of pressure/vacuum in the brake system.

**Photo 27** shows the front brake lever being depressed. There was some resistance felt (spongy like feel) upon pressing the front brake lever (arrowed). This would indicate that there is no leakage of pressure/vacuum in the brake system.

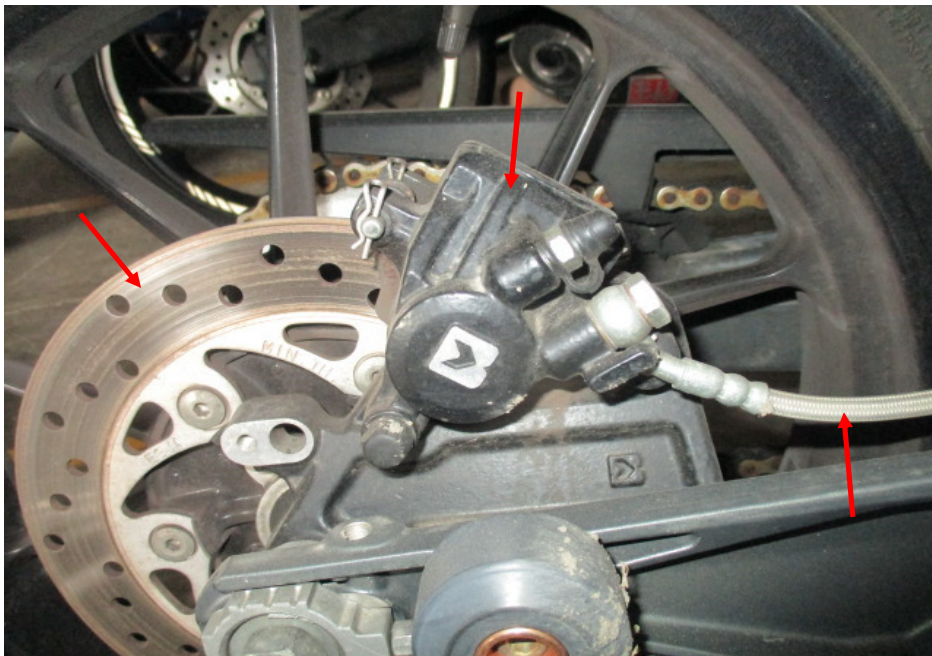
**Photo 28** shows a close up view of the rear brake caliper, rear brake disc and rear brake hose (arrowed) of the Motorcycle, which are all part of the components in the hydraulic rear brake system of the Motorcycle. Our visual checks of these various components had revealed all to be intact with no visible damage. No leakage of brake fluid was also observed.

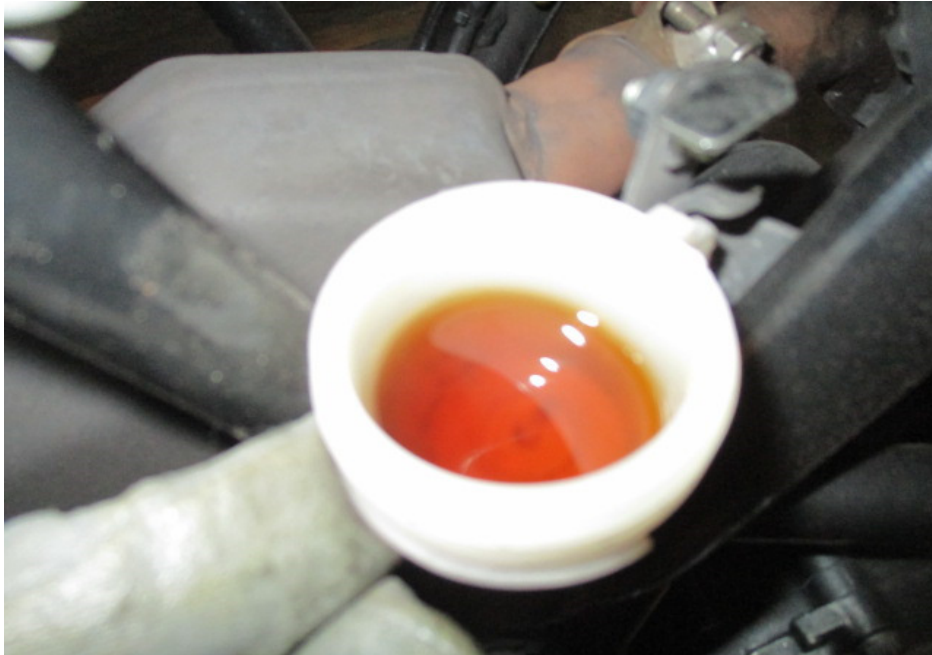
**Photo 29** shows the brake fluid reservoir for the rear brake of the Motorcycle. The brake fluid was observed to be of sufficient level and without contamination for operational purposes.

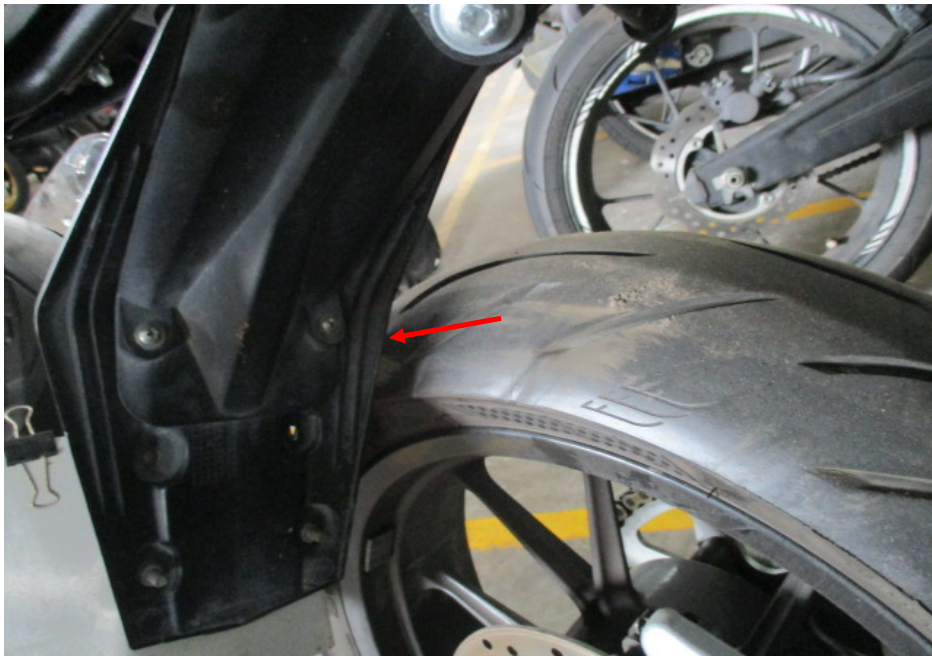
15. We were unable to carry out an operational test of the Motorcycle's braking system due to the deformed rear mudguard coming into contact with the rear tyre of the Motorcycle as a result of the accident, rendering the Motorcycle immobile. See photos 22 – 30 below.

**Photo 30** shows the deformed rear mudguard coming into contact with the rear tyre of the Motorcycle as a result of the accident (arrowed), rendering the Motorcycle immobile for the operational test.
