Your Ref: TP/IP/71925/2019  
Our Ref : CI/TPD20001850/N

9 March 2020

**Fatal Accident Investigation Team**

**INSPECTION REPORT OF MOTORCYCLE FY 7959K**

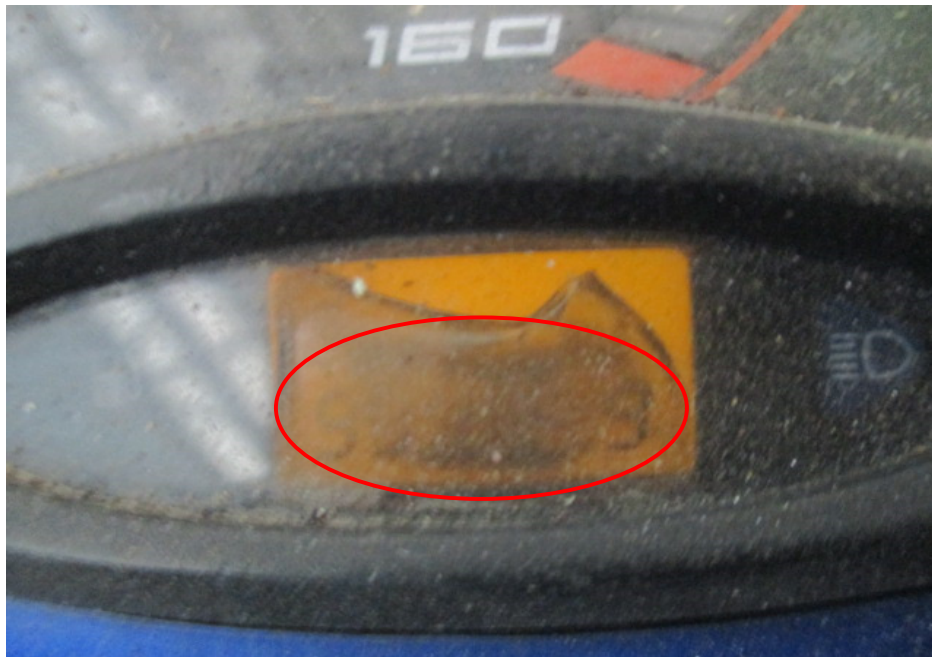
4. The mileage of the Motorcycle could not be recorded at the time of our inspection due to a damaged speedometer display.
5. The Motorcycle was observed to have sustained damages all around. The body parts that were found to have been damaged include its headlight assembly, front mudguard, front number plate, IU unit, left side mirror, left handlebar end, left cowling, left front footrest, exhaust muffler and top box, amongst others.

**Photo 1** shows the speedometer gauge of the Motorcycle. The mileage of the Motorcycle could not be recorded at the time of our inspection due to a damaged speedometer display (circled).

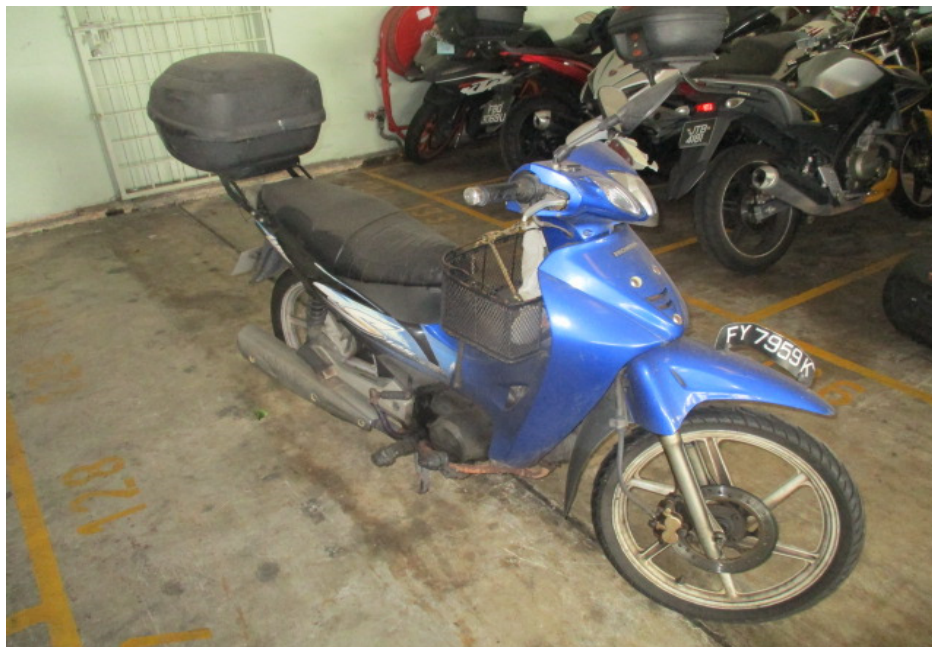
**Photo 2** shows a general view of the right body of the Motorcycle at the time of our inspection. The Motorcycle was observed to have sustained damages all around.

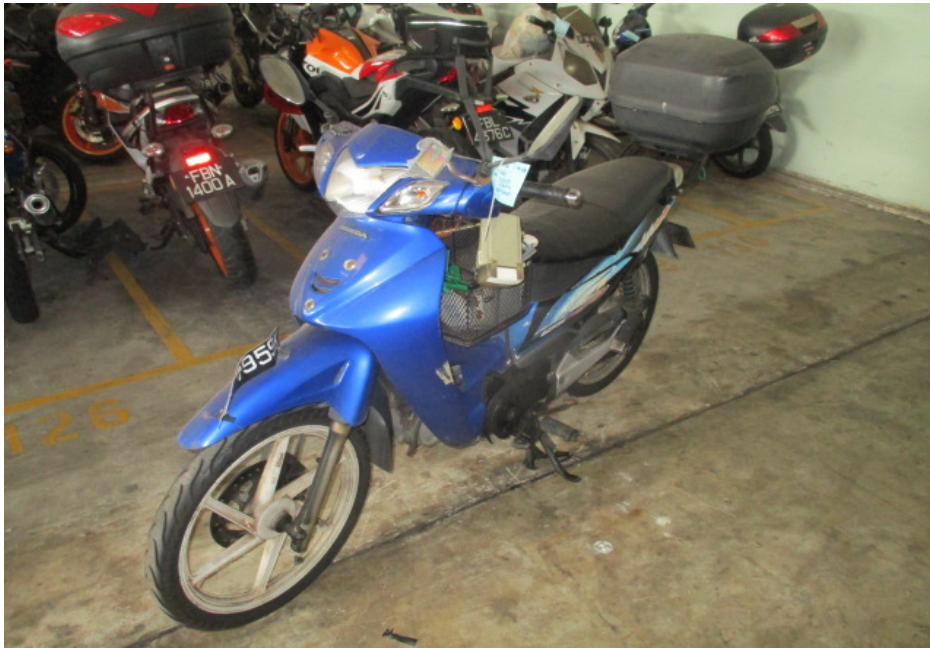
**Photo 3** shows a general view of the left front body of the Motorcycle at the time of our inspection. The Motorcycle was observed to have sustained damages all around. Amongst the body parts that were found to have been damaged include its headlight assembly, front mudguard, front number plate, IU unit, left side mirror, left handlebar end, left cowling, left front footrest, exhaust muffler and top box, amongst others.

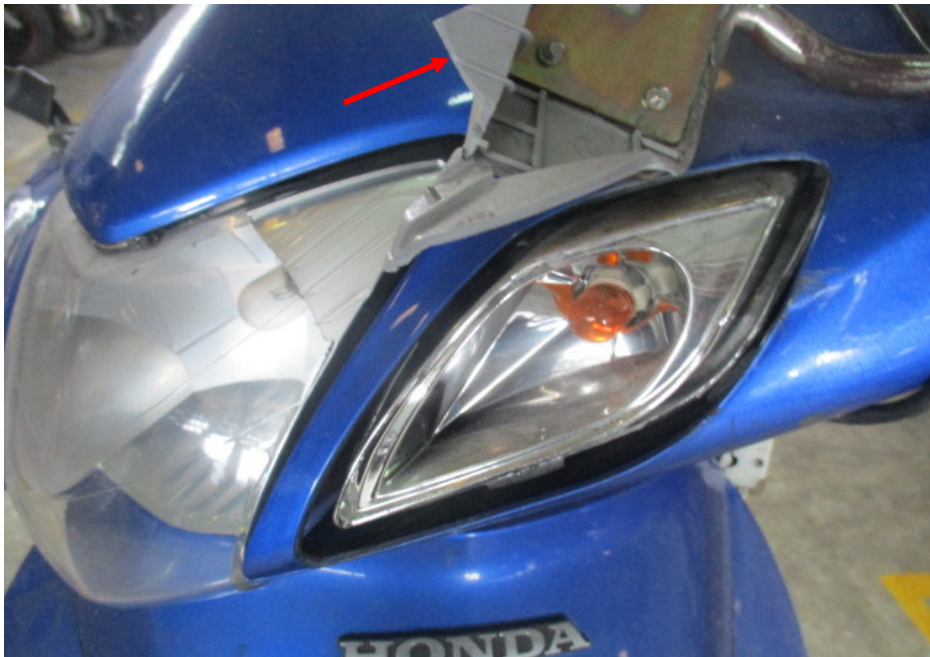
**Photo 4** shows a closer view of the headlight assembly and IU Unit (arrowed) which were amongst the body parts at the front body of the Motorcycle that had sustained damage as a result of the accident.

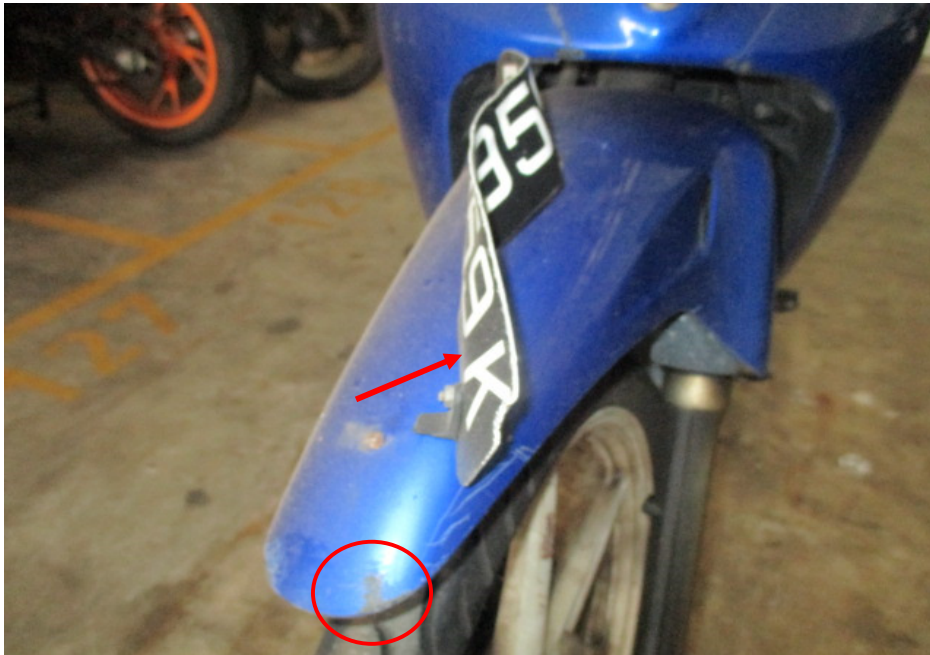
**Photo 5** shows a closer view of the front mudguard (circled) and front number plate (arrowed) which were amongst the body parts at the front body of the Motorcycle that had sustained damage as a result of the accident.

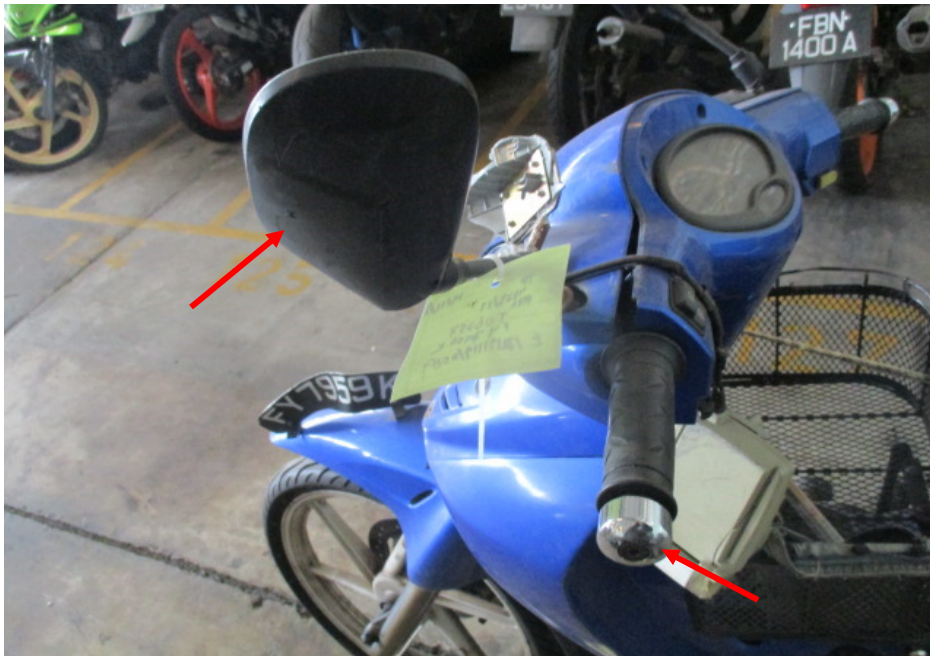
**Photo 6** shows a closer view of the left handlebar end as well as the left side mirror (arrowed) which were amongst the body parts of the Motorcycle that had sustained damage as a result of the accident.

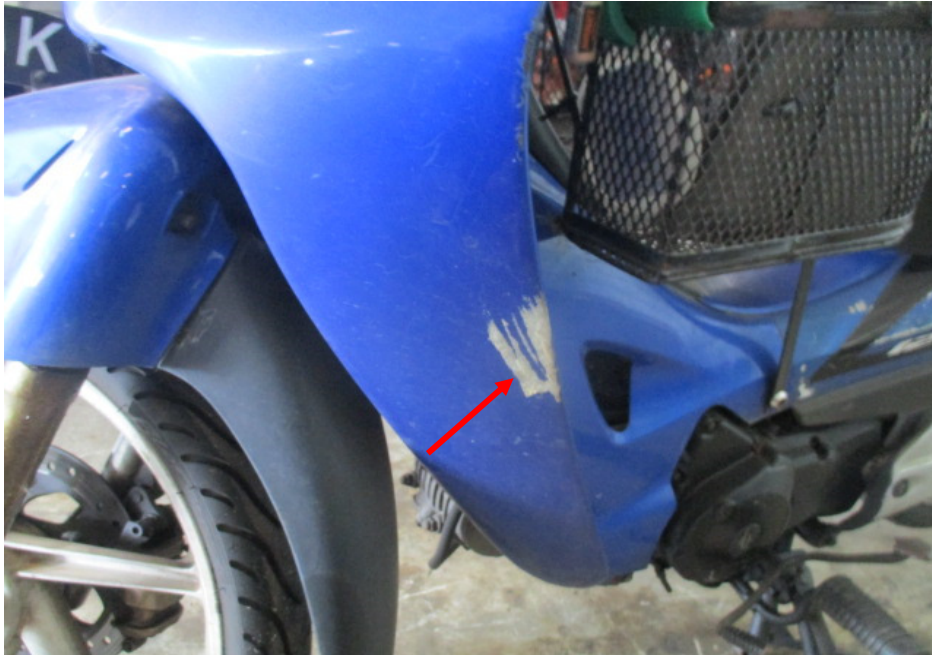
**Photo 7** shows a closer view of the left cowling of the Motorcycle that had sustained damage as a result of the accident (arrowed).

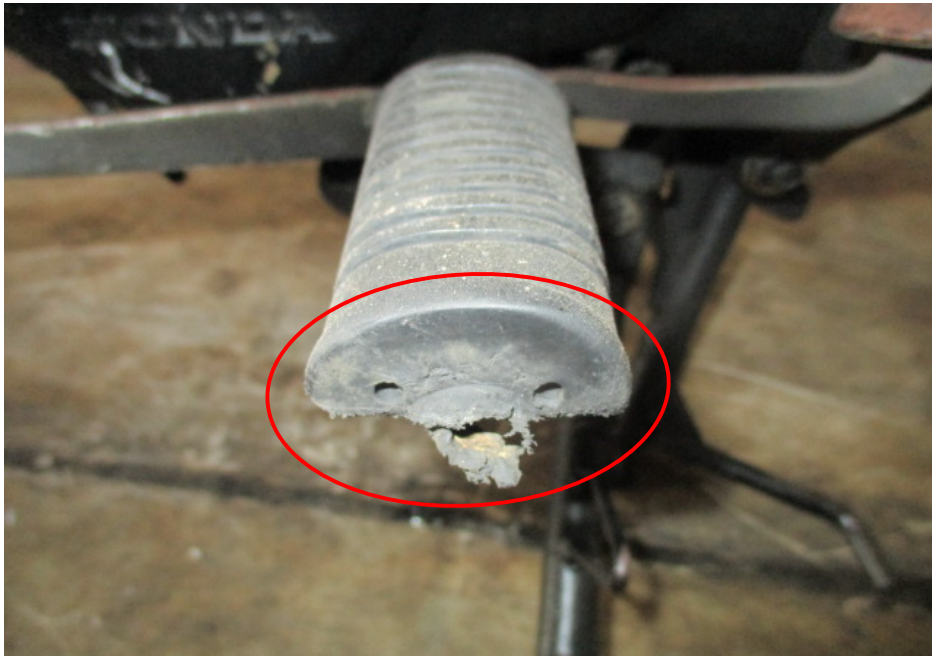
**Photo 8** shows a closer view of the left front footrest (circled) which was amongst the body parts of the Motorcycle that had sustained damage as a result of the accident.

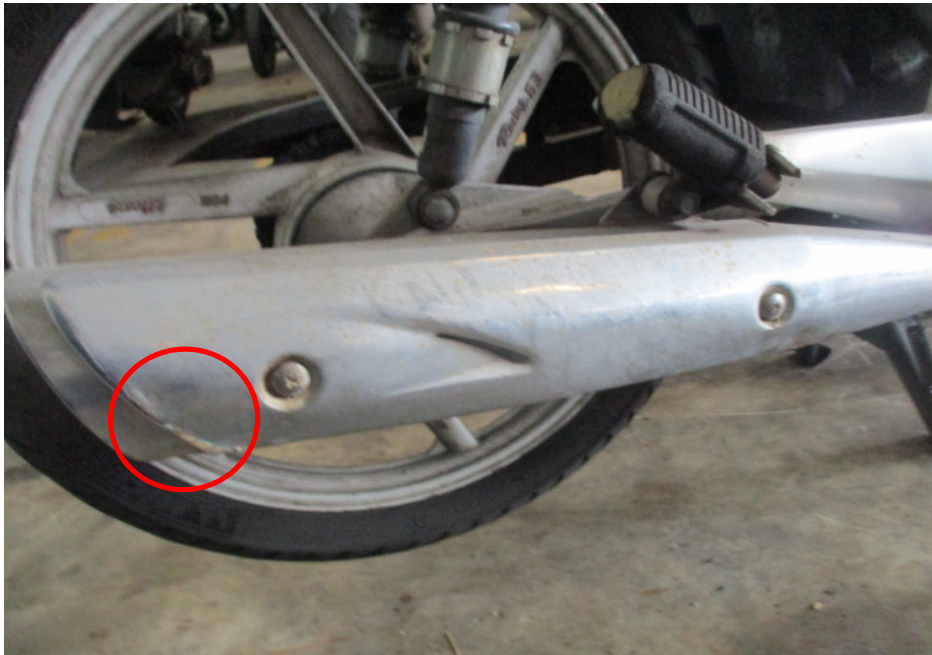
**Photo 9** shows a close up view of the exhaust muffler and exhaust muffler heat shield (circled) which were amongst the body parts of the Motorcycle that had sustained damage as a result of the accident.

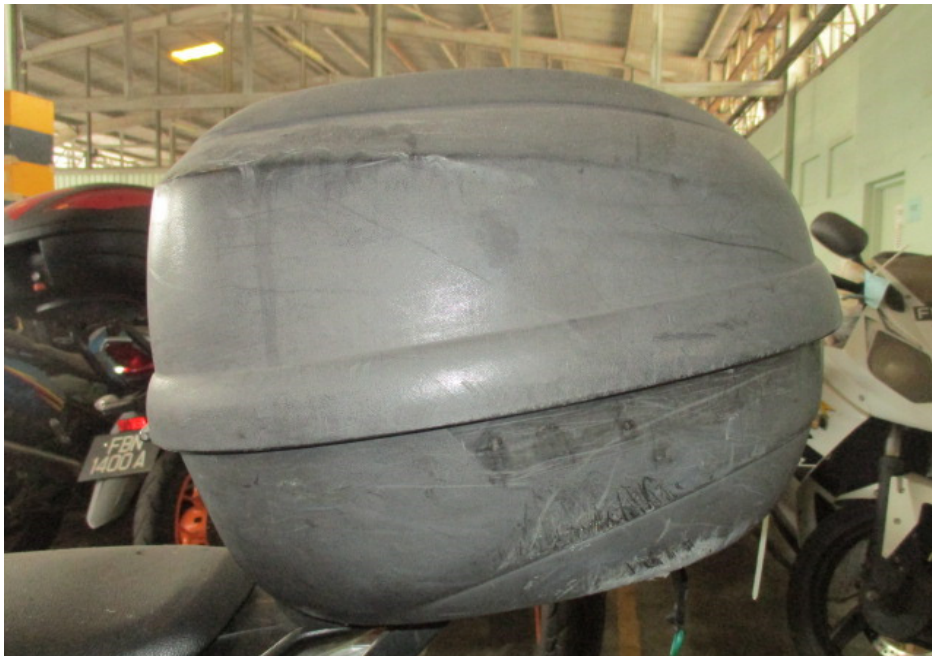
**Photo 10** shows the top box of the Motorcycle which was observed to have sustained damages of grazing nature as a result of the accident.

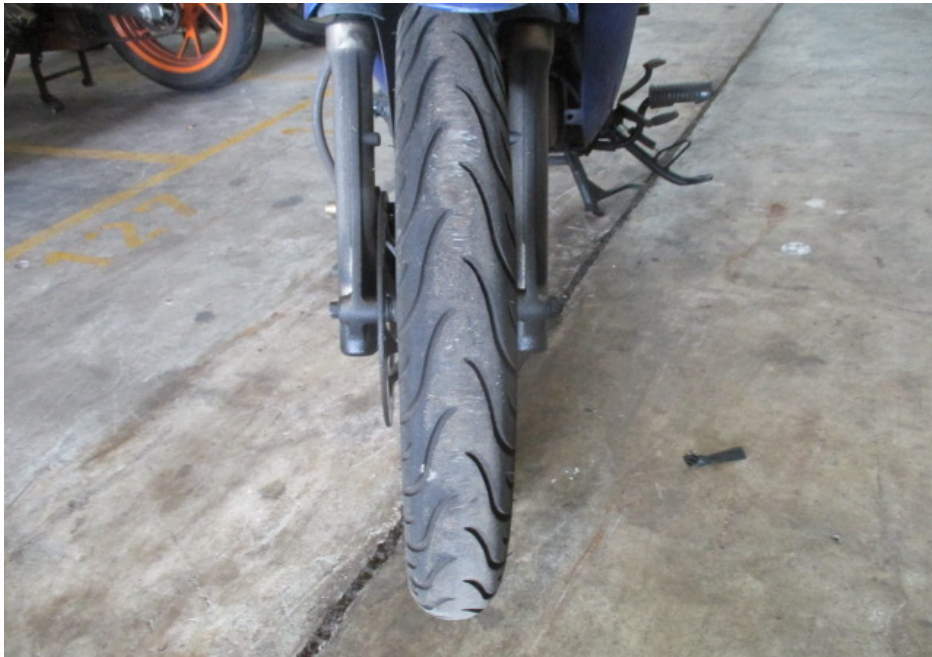
**Photo 11** shows the condition of the Motorcycle's front tyre. The front tyre was observed to be in serviceable condition with remaining tread depth of approximately 4mm. There was no tear, burst mark(s) and/or punctured hole(s) on the sidewalls as well as across the tread of the front tyre.

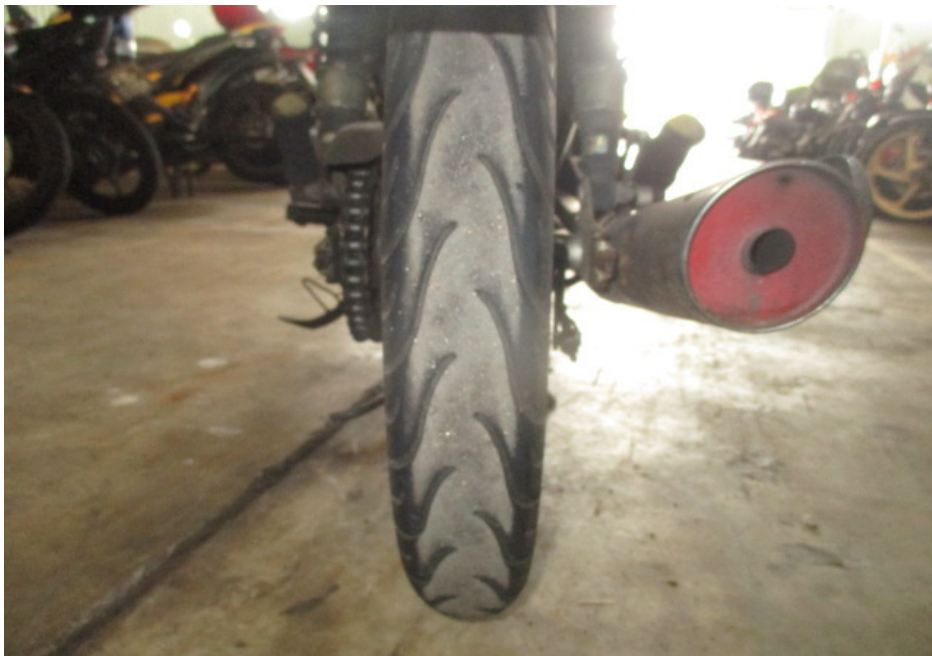
**Photo 12** shows the condition of the Motorcycle's rear tyre. The rear tyre was observed to be in serviceable condition with remaining tread depth of approximately 3mm. The tyre was also observed to be sufficiently inflated for vehicular operation. We did not observe any tear, burst mark(s) and/or punctured hole(s) on the sidewalls as well as across the tread of the rear tyre.

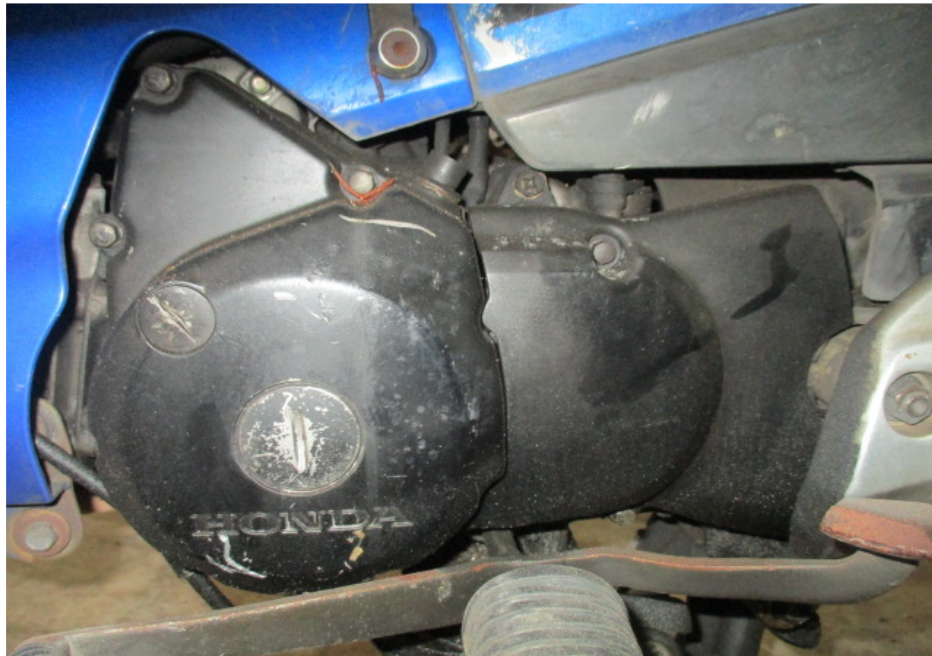
**Photo 13** shows the left side of the engine of the Motorcycle at the time of our inspection. The various engine related parts and components were found to be intact with no visible damage. There was also no sign(s) or indication(s) of fluid leak observed around the left engine area of the Motorcycle.

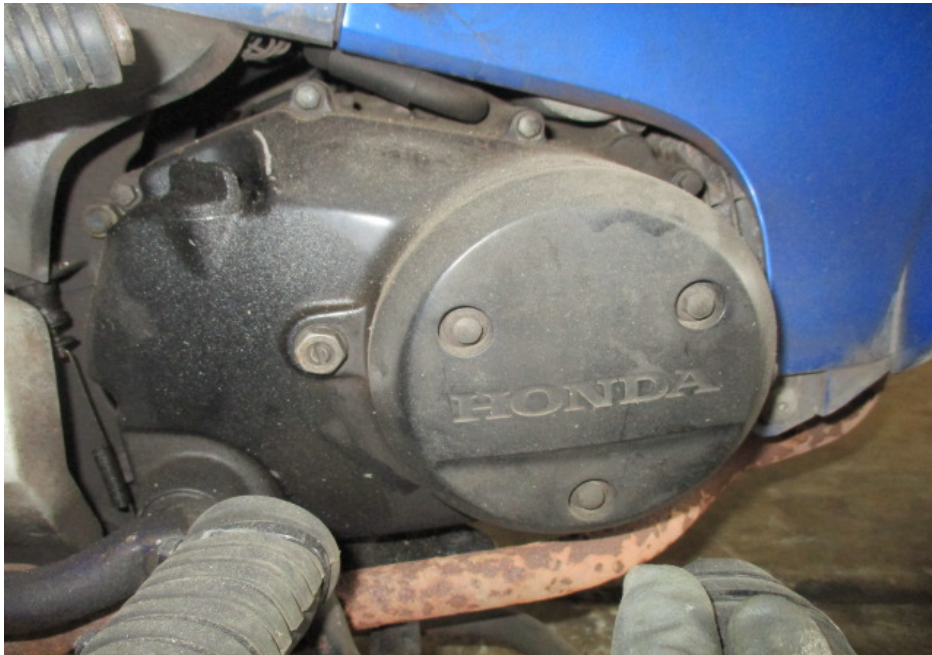
**Photo 14** shows the right side of the engine of the Motorcycle at the time of our inspection. The various engine related parts and components were found to be intact with no visible damage. There was also no sign(s) or indication(s) of fluid leak observed around the right engine area of the Motorcycle.

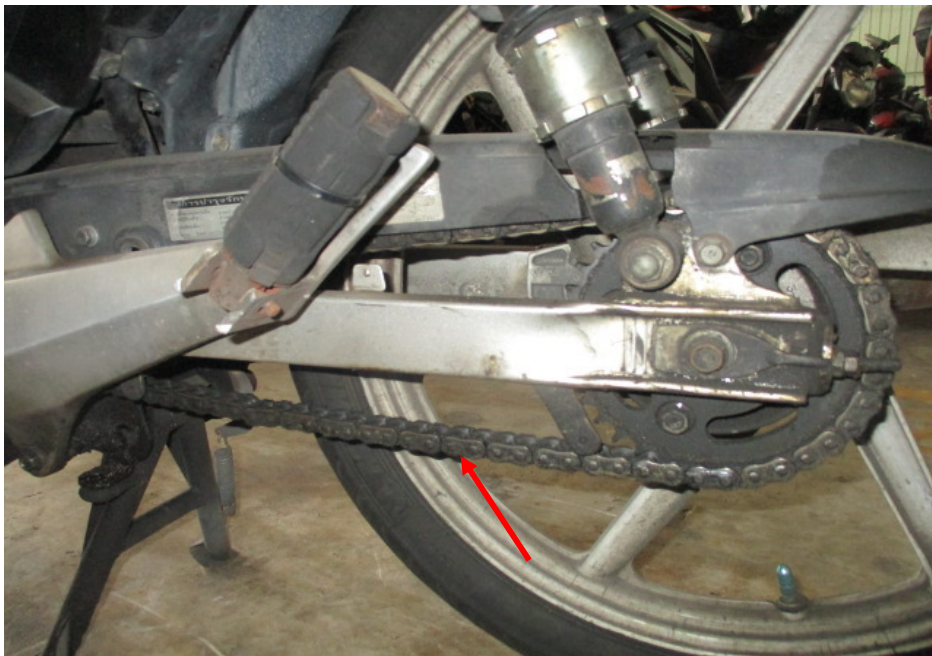
**Photo 15** shows the general view of the gear train (arrowed) of the Motorcycle, which was observed to be intact with no misalignment. It was also adequately lubricated for operating purposes.

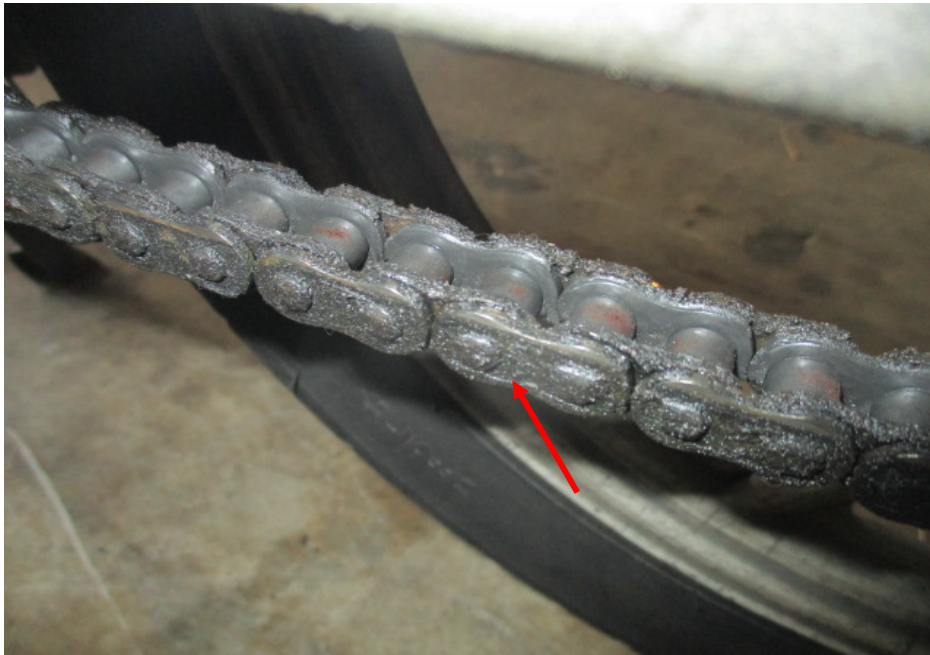
**Photo 16** shows a closer view of the gear train (arrowed) of the Motorcycle, which was observed to be intact with no misalignment. It was also adequately lubricated for operating purposes.

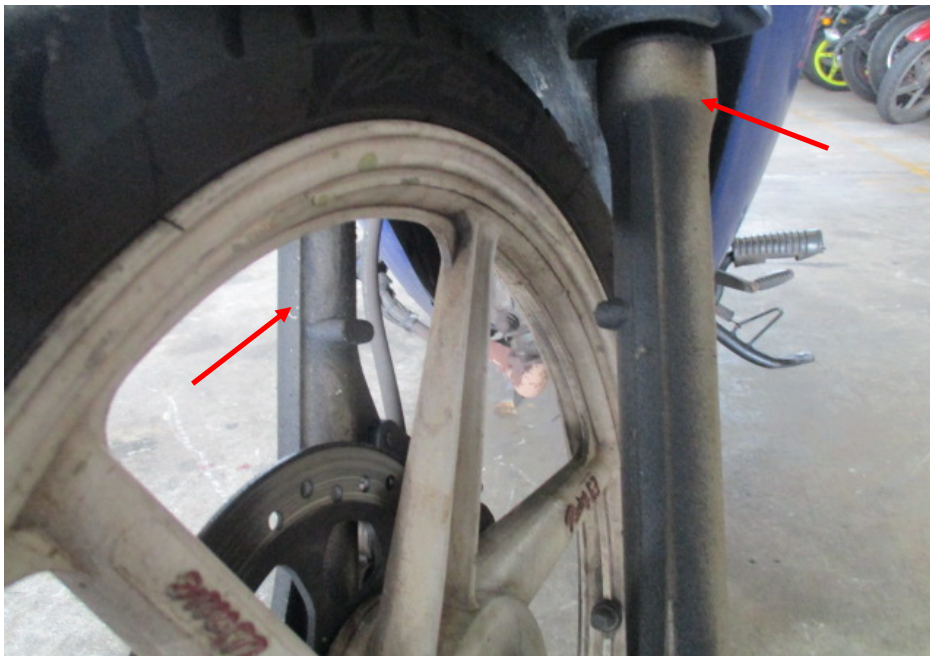
**Photo 17** shows the front fork (arrowed) of the Motorcycle. The front fork and fork bracket of the Motorcycle were both found to be intact and undamaged. Turning the Motorcycle's handle bar towards the left and right did not produce any abnormal free play and/or resistance. The steering system of the Motorcycle was in serviceable condition at the time of our inspection.

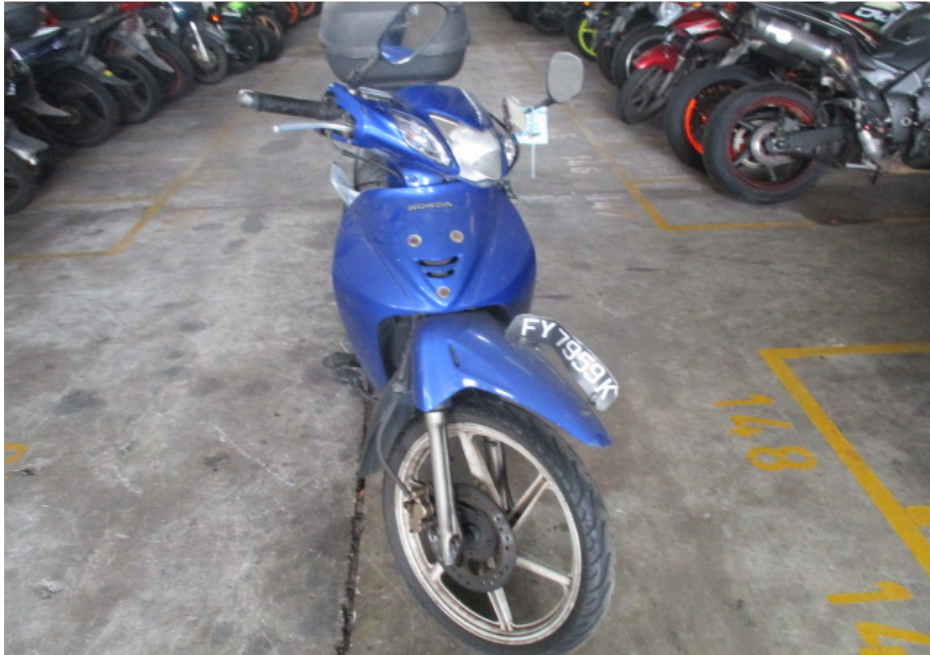
**Photo 18** shows the front wheel of the Motorcycle turned towards its full left. Turning the Motorcycle's handle bar towards the left and right did not produce any abnormal free play and/or resistance. This would indicate that the steering system of the Motorcycle was in serviceable condition at the time of our inspection.

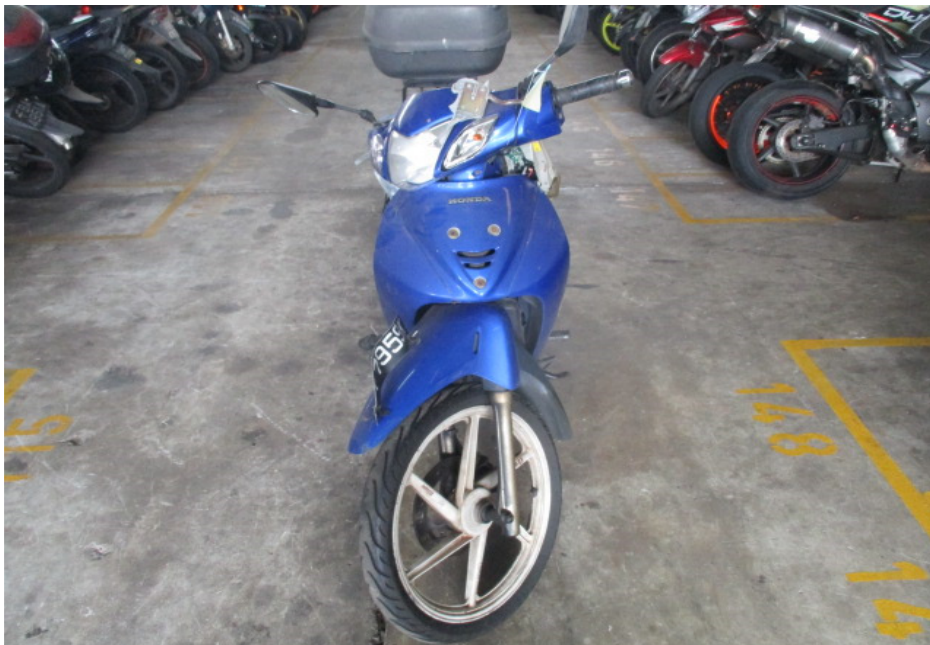
**Photo 19** shows the front wheel of the Motorcycle turned towards its full right. Turning the Motorcycle's handle bar towards the left and right did not produce any abnormal free play and/or resistance. This would indicate that the steering system of the Motorcycle was in serviceable condition at the time of our inspection.

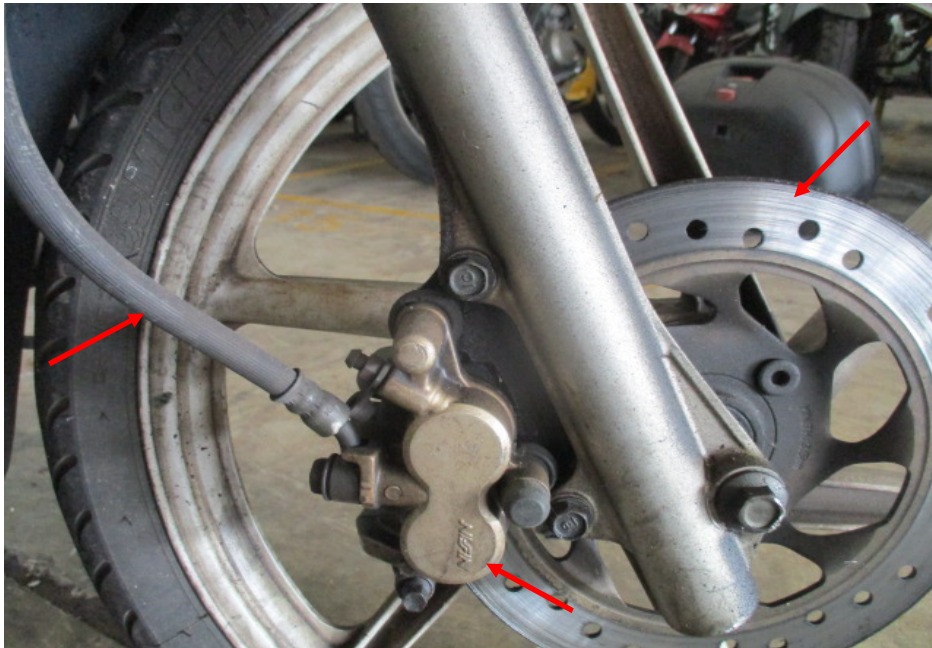
**Photo 20** shows a close up view of the front brake caliper, front brake disc and front brake hose (arrowed) of the Motorcycle, which are all part of the components in the hydraulic front brake system of the Motorcycle. Our visual checks of these various components had revealed all to be intact with no visible damage. No leakage of brake fluid was also observed.

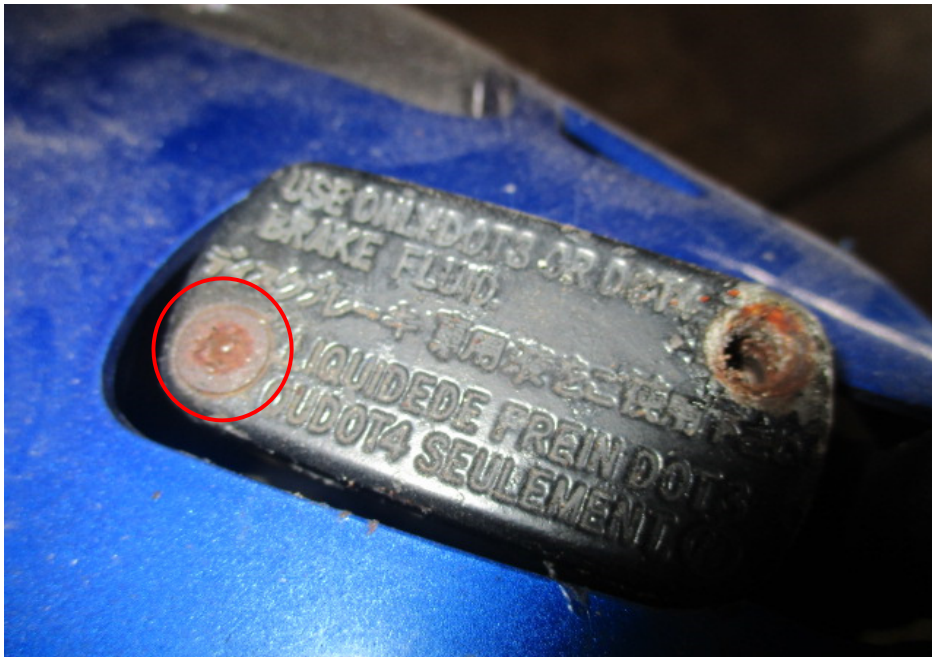
12. The brake system of the Motorcycle was of a semi-hydraulic type, where hydraulic (brake fluid) pressure controls the brake for the front wheel while the brake for the rear wheel is controlled by mechanical means (cables and springs). Our visual examination of the various components in the brake system, like the brake disc, brake caliper, drum, brake lever and brake foot pedal, revealed all to be intact and without damage. There was also no leakage of brake fluid observed along the brake hose. This was from the respective brake fluid reservoir to the front brake caliper of the Motorcycle. There was also no visible tear or cut observed on the connecting hoses and cables. However we were unable to remove the front brake reservoir cover to examine whether the brake fluid was of sufficient level and without contamination for operational purposes due to a worn out screw.

**Photo 21** shows the brake fluid reservoir cover for the front brake of the Motorcycle. We were unable to examine whether the brake fluid was of sufficient level and without contamination for operational purposes due to the worn out screw (circled).

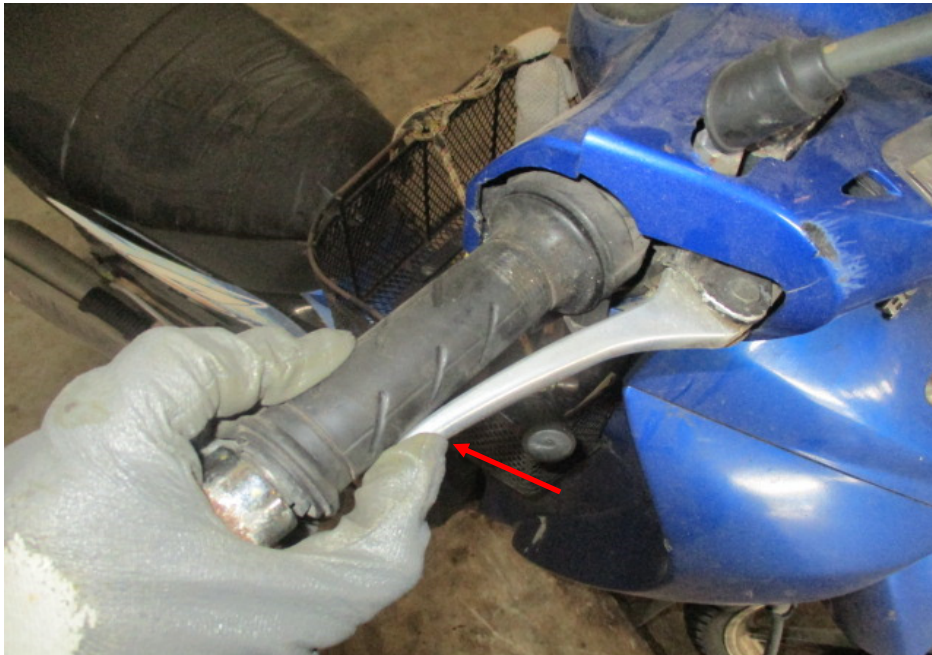
13. Static brake tests conducted on the Motorcycle had appear to indicate that the front braking system of the Motorcycle was not in serviceable condition. There was no resistance felt (spongy like feel) upon pressing the brake lever. This would indicate that there may be a leakage of pressure/vacuum in the front brake system.

14. We subsequently carried out an operational test of the Motorcycle's braking system. This was done by manually pushing the Motorcycle forward and backward, simulating the Motorcycle in motion, and thereafter engaging the front brake and rear brake of the Motorcycle. At the end of the short operational test, we did not observe any abnormal behaviour of the Motorcycle's rear braking system. The rear wheel of the Motorcycle was able to stop rotating immediately upon stepping on the brake pedal. However we observed that the front wheel of the Motorcycle was unable to stop rotating upon depressing the brake lever.

**Photo 22** shows the front brake lever being depressed. There was no resistance felt (spongy like feel) upon pressing the front brake lever (arrowed). This would indicate that there may be a leakage of pressure/vacuum in the brake system.

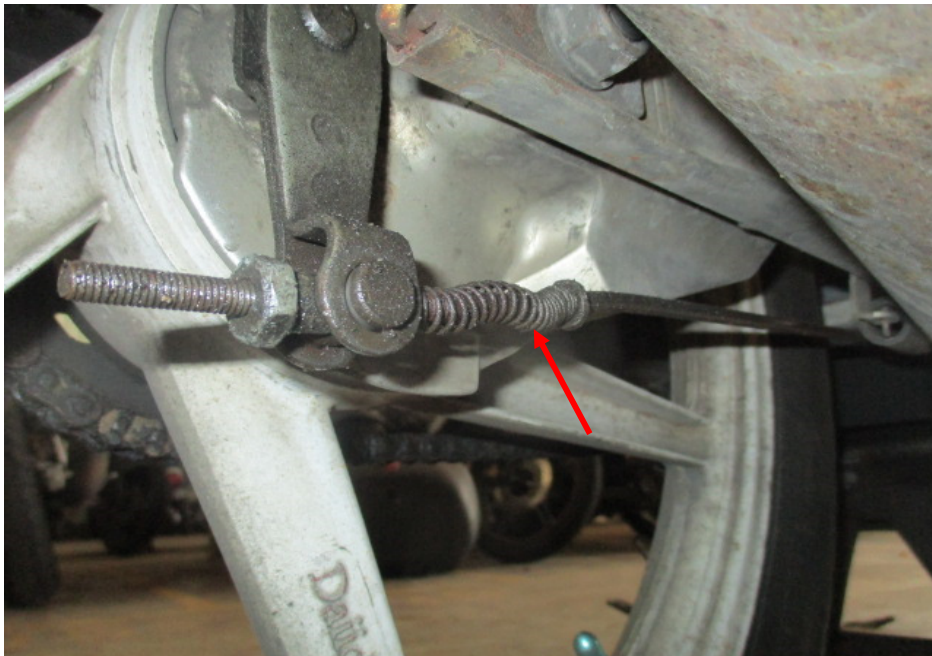
15. In general, the observations gathered during the brake test had indicated that the rear braking system of the Motorcycle was in serviceable condition. See photos 17 – 23 below.

**Photo 23** shows the rear wheel of the Motorcycle. The type of brake system for the rear wheel was of a mechanical type, controlled by the brake foot pedal of the Motorcycle. Our checks of the cable (arrowed), spring and drum which are all part of the components in the rear brake system of the Motorcycle reveal all to be intact and without damage.
