Your Ref: TP/IP/74229/2019  
Our Ref :CI/TPD20001851/N

28 April 2020

**Fatal Accident Investigation Team**

**INSPECTION REPORT OF BICYCLE (SILVER) - TRAFFIC POLICE POUND  
REPORT NO. 5032/19**

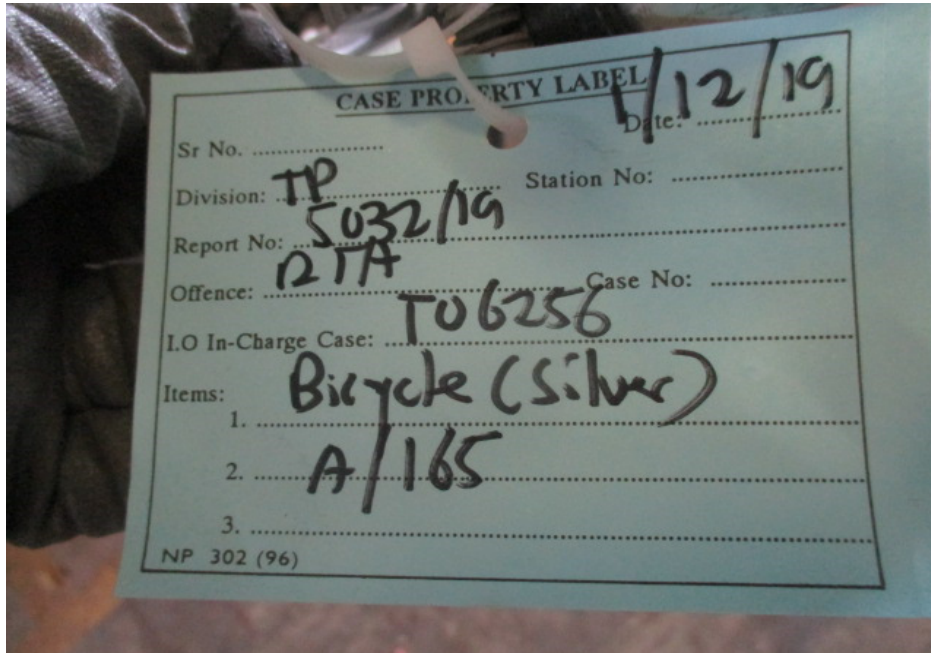
**Photo 1** shows the identification of the Bicycle with reference to Traffic Police Pound Report No. 5032/19.

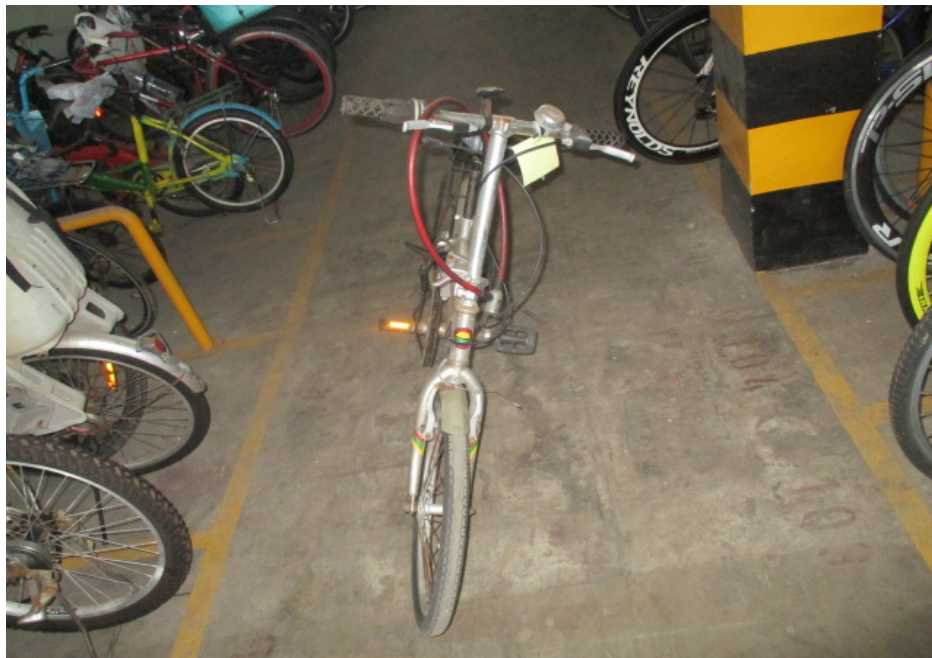
**Photo 2** shows the front portion of the Bicycle at time of our inspection. The Bicycle had sustained damages all around.

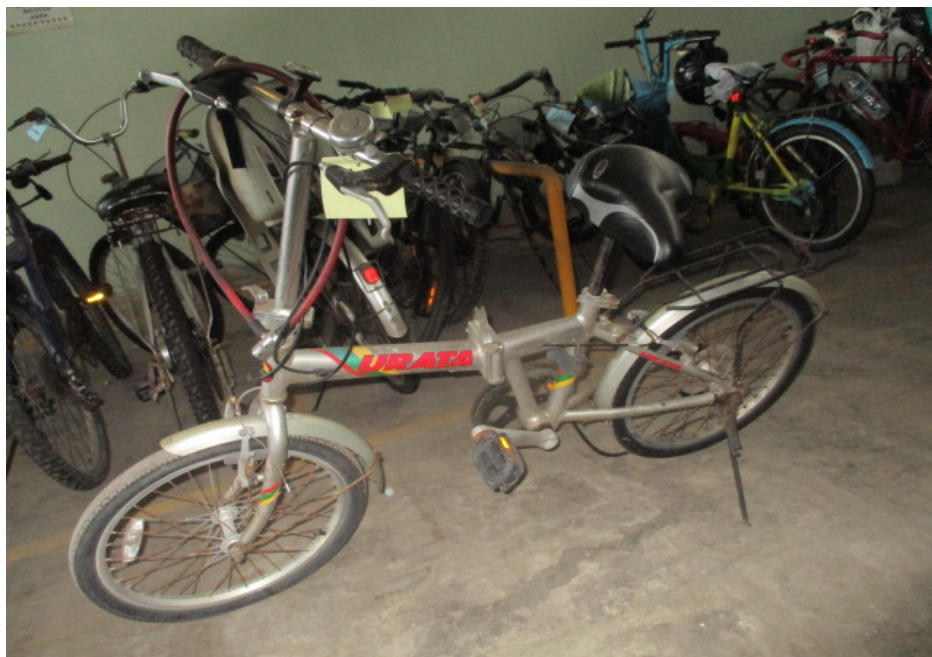
**Photo 3** shows the left body of the Bicycle at time of our inspection. The Bicycle had sustained damages all around.

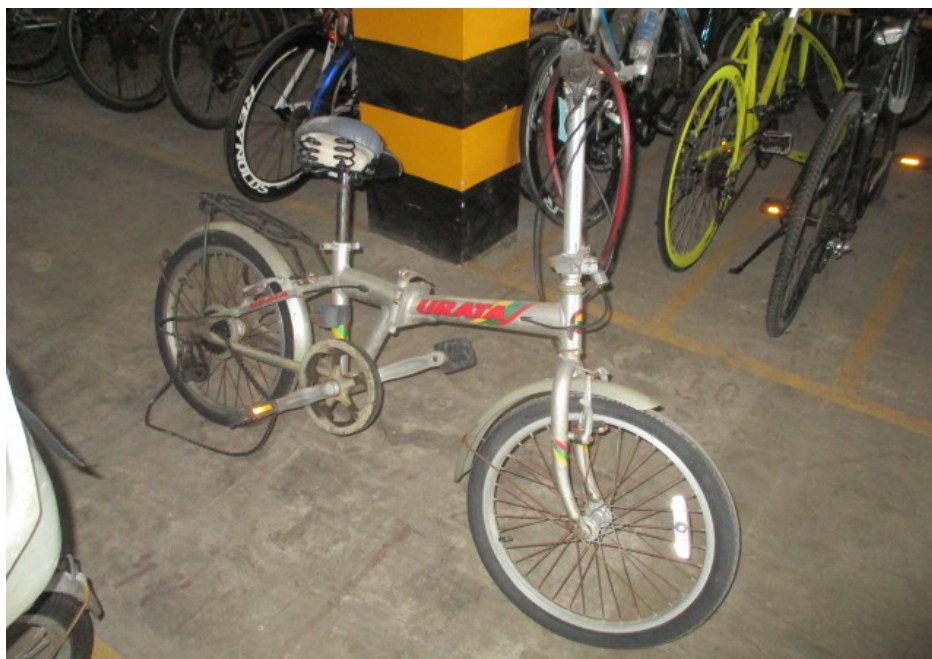
**Photo 4** shows the right body of the Bicycle at time of our inspection. The Bicycle had sustained damages all around. The body parts that were found to have been damaged include its right handlebar grip, front left fork, pedals, seat and rear mudguard, amongst others as a result of the accident.

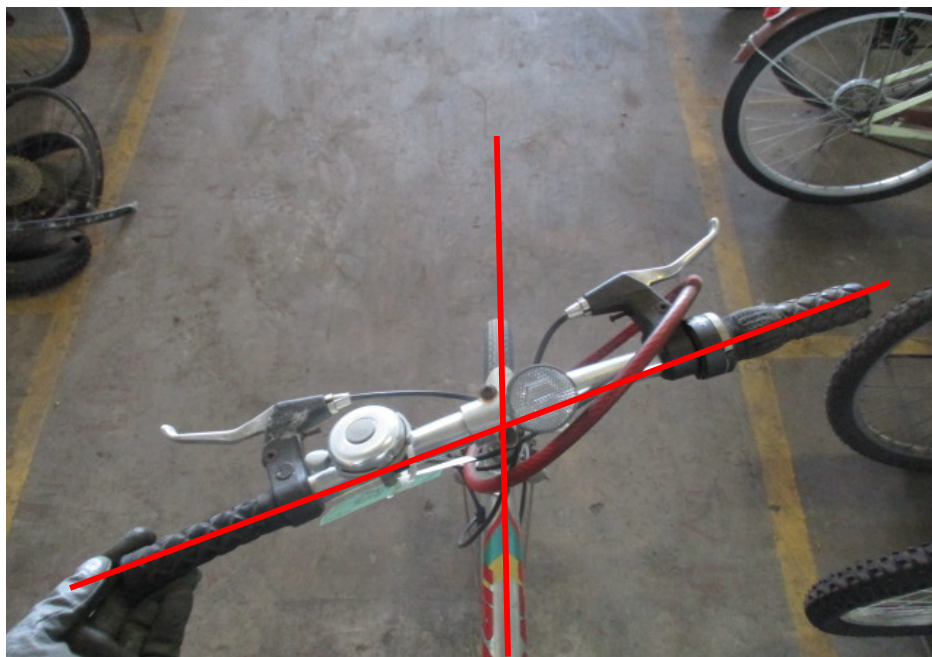
**Photo 5** shows the frontal portion of the Bicycle (top view) at the time of our inspection. There was a misalignment of the handle bar & front tyre observed as a result of the accident.

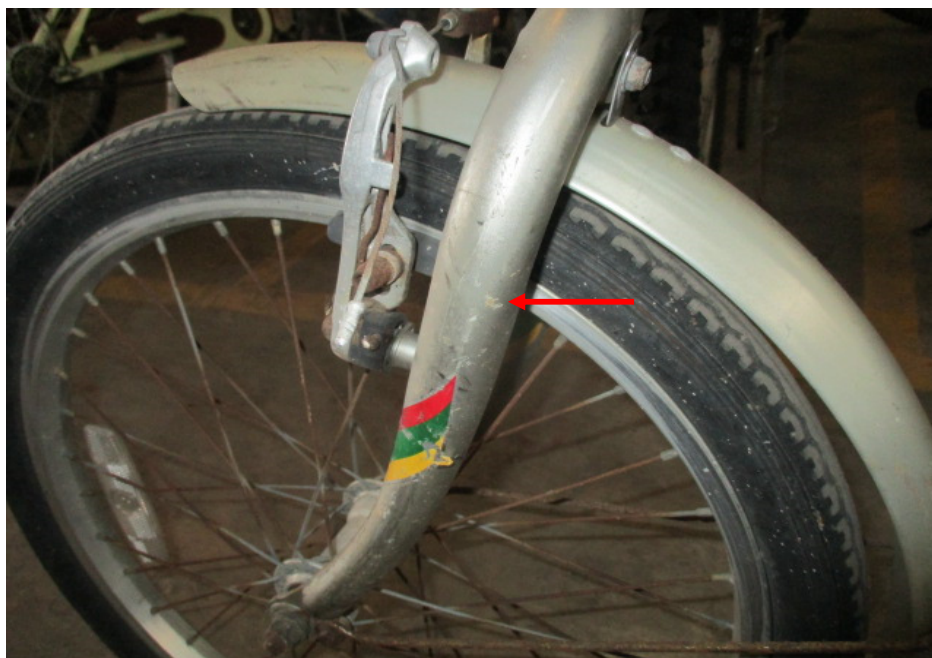
**Photo 6** shows the damages of grazing nature sustained to the front left fork (arrowed) of the Bicycle at the time of our inspection.

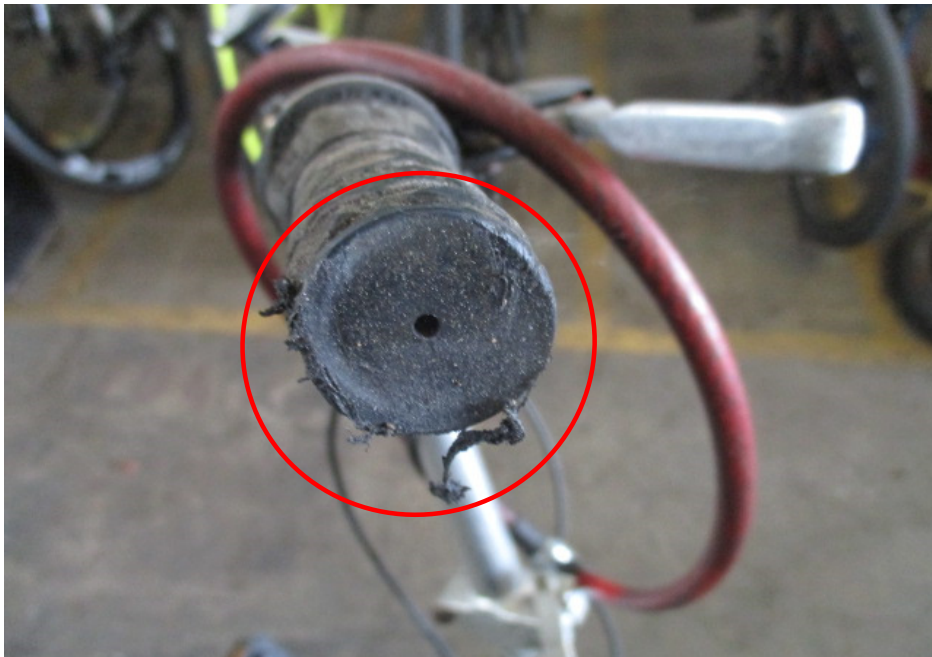
**Photo 7** shows the damaged right handlebar grip (circled) of the Bicycle at the time of our inspection.

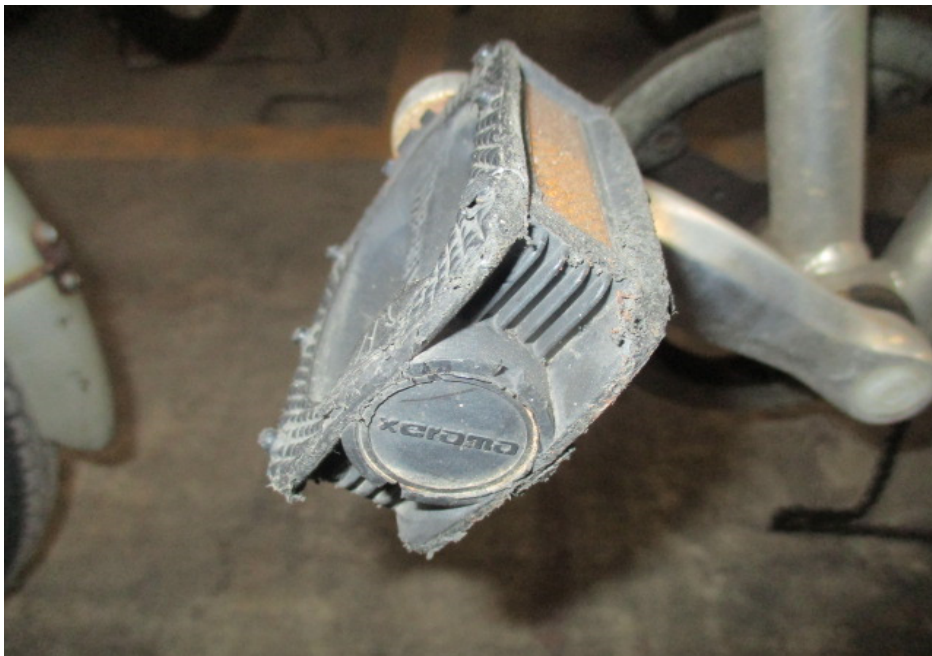
**Photo 8** shows the damaged left pedal of the Bicycle at the time of our inspection.

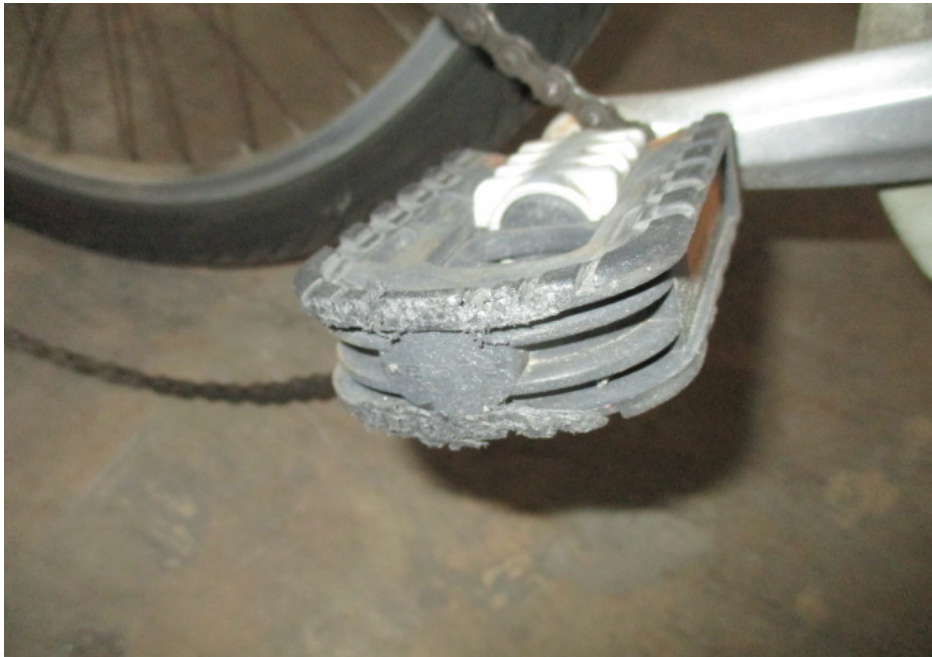
**Photo 9** shows the damaged right pedal of the Bicycle at the time of our inspection.

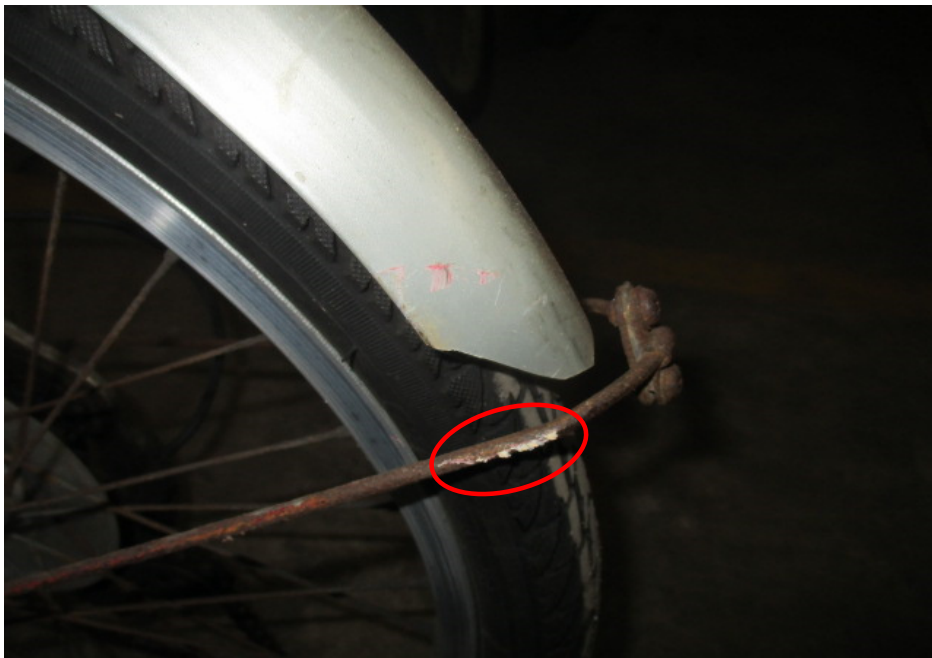
**Photo 10** shows the damages of grazing nature on the rear mudguard (circled) of the Bicycle at the time of our inspection.

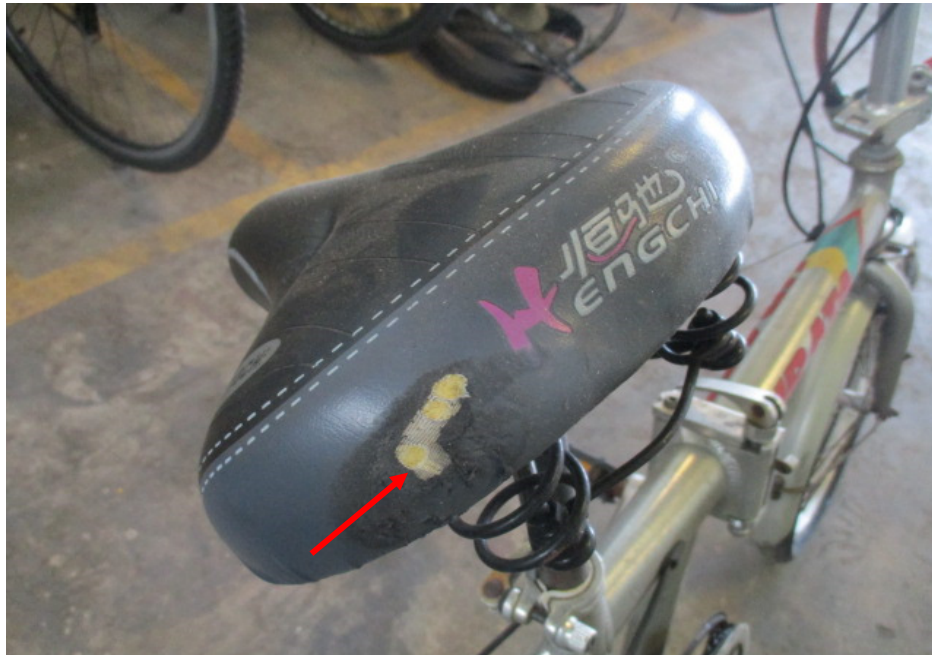
**Photo 11** shows a close-up view of the torn seat (arrowed) of the Bicycle as a result of the accident.

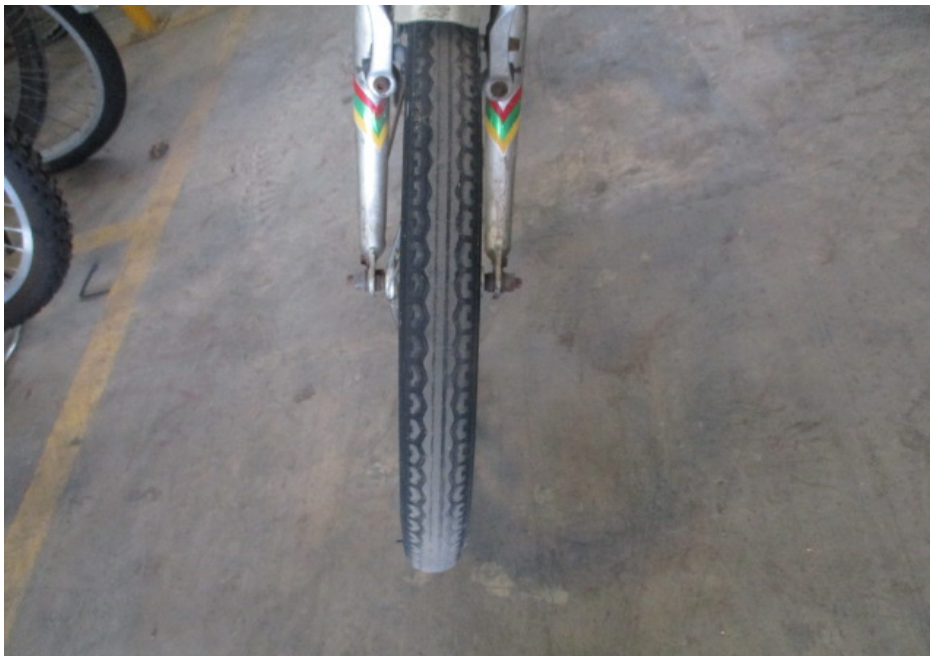
**Photo 12** shows the front tyre of the Bicycle. We had observed a cut/tear on the tread area of this tyre. The front tyre was observed to be deflated at the time of our inspection.

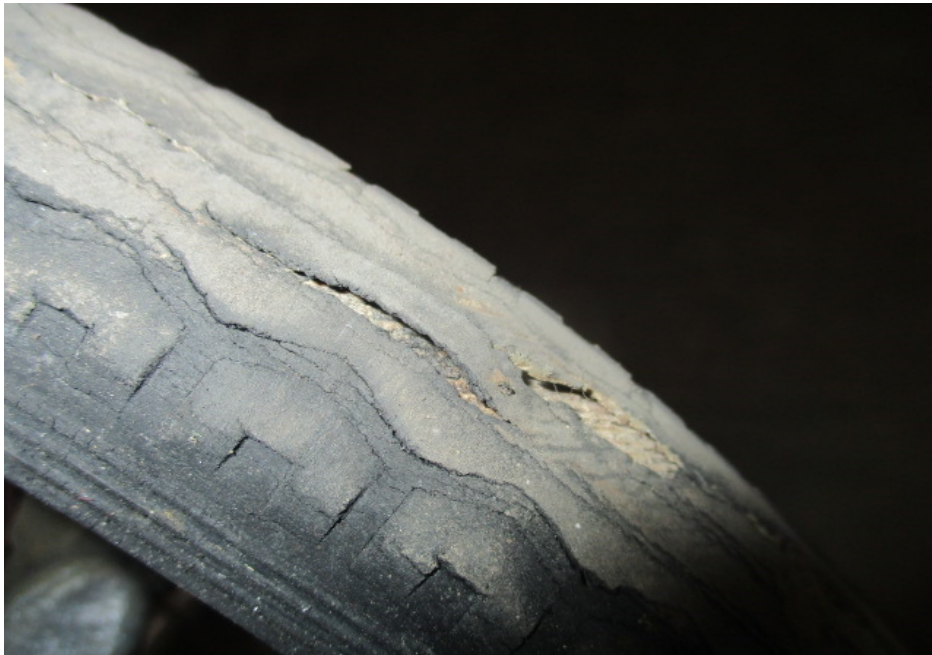
**Photo 13** shows a closer view of the cut/tear on the tread area of the front tyre of the Bicycle observed upon our inspection.

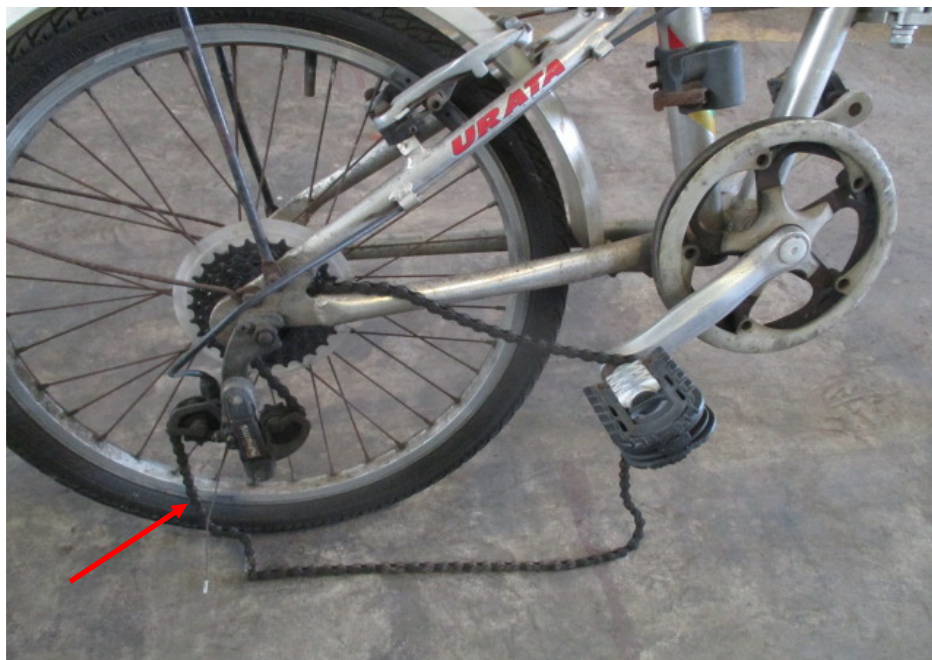
**Photo 15** shows the general view of the gear train of the Bicycle, which was observed to be intact with no misalignment. It was also adequately lubricated for operating purposes. However the chain was observed to be dislodged from the gear train most likely as a result of the accident (arrowed).

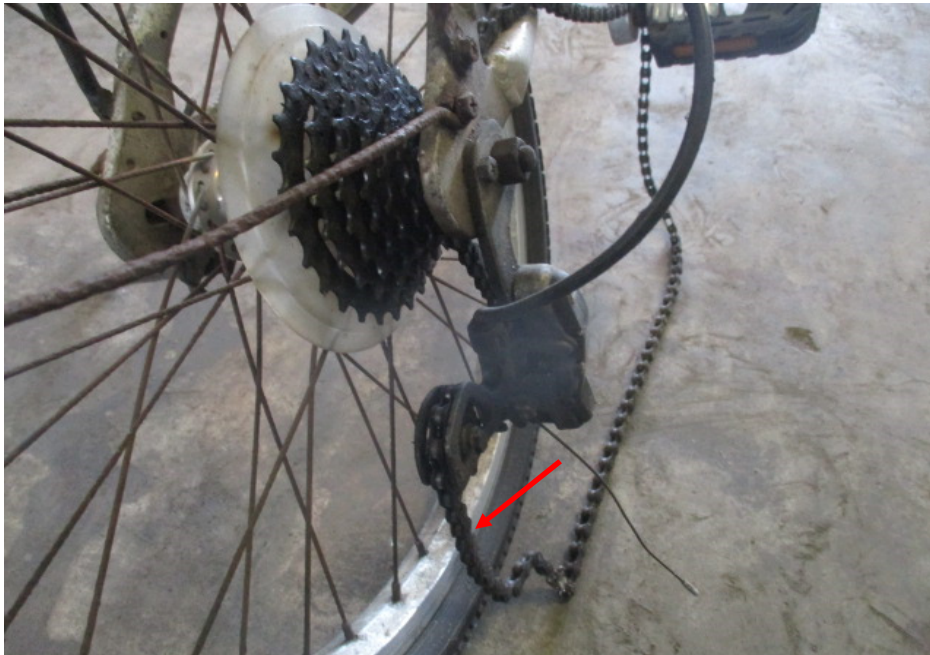
**Photo 16** shows a closer view of the dislodged chain from the gear train of the Bicycle, most likely as a result of the accident. It was found to be adequately lubricated for operating purposes (arrowed).

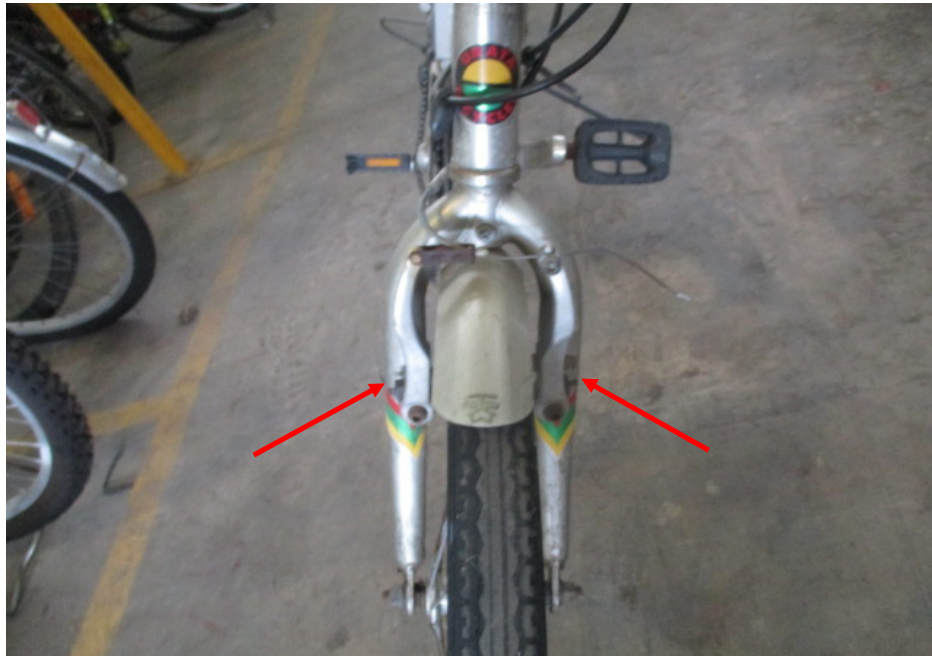
**Photo 17** shows the front forks (arrowed) of the Bicycle. The front fork and fork bracket of the Bicycle were both found to be intact and undamaged. Turning the Bicycle's handle bar towards the left and right did not produce any abnormal free play. The steering system of the Bicycle was in serviceable condition at the time of our inspection.

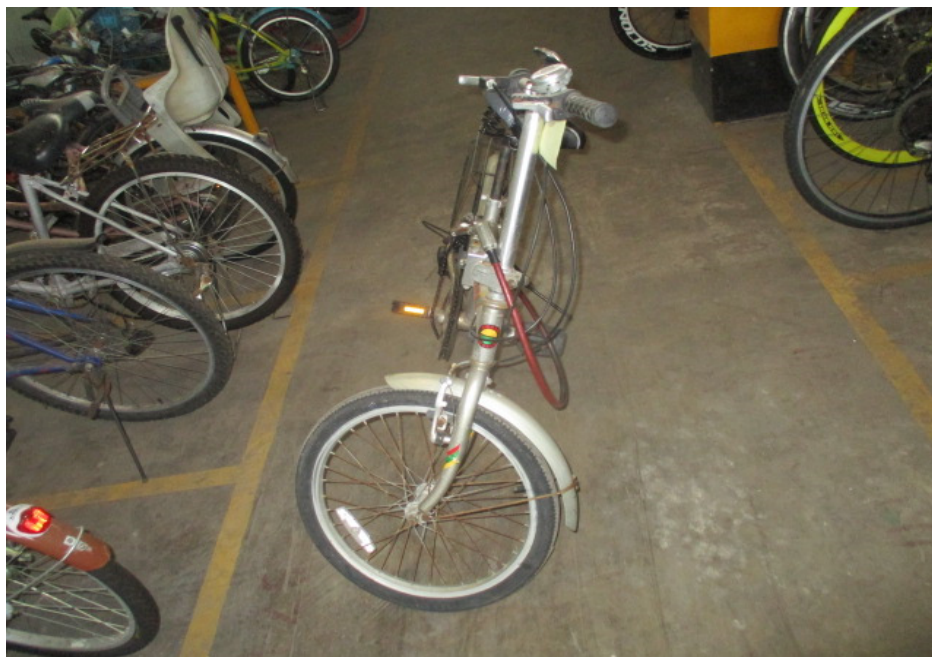
**Photo 18** shows the front wheel of the Bicycle turned towards its full right. Turning the Bicycle's handle bar towards the right did not produce any abnormal free play and/or resistance. This would indicate that the steering system of the Bicycle was in serviceable condition at the time of our inspection.

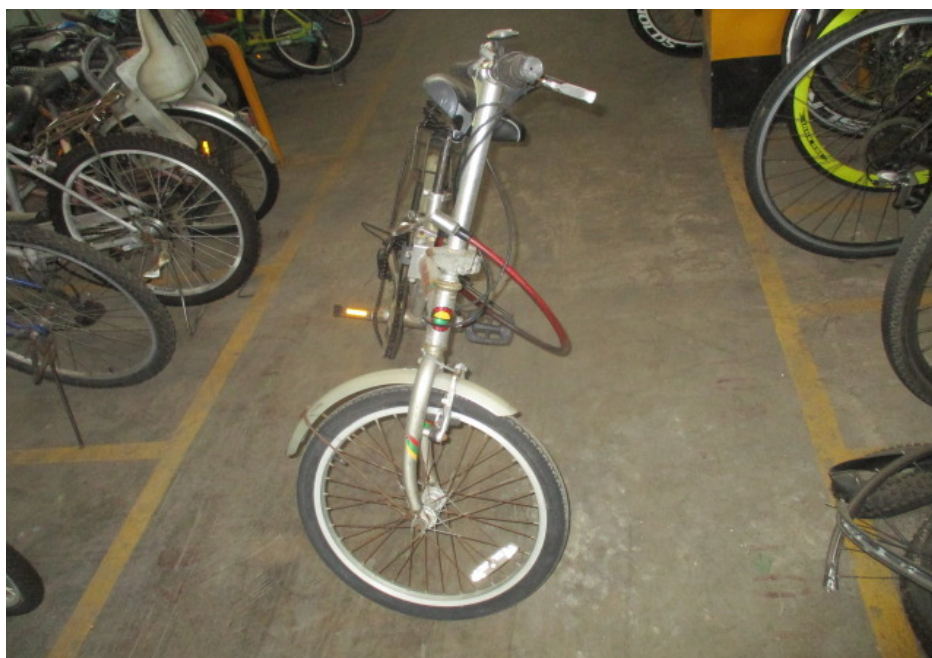
**Photo 19** shows the front wheel of the Bicycle turned towards its full left. Turning the Bicycle's handle bar towards the left did not produce any abnormal free play and/or resistance. This would indicate that the steering system of the Bicycle was in serviceable condition at the time of our inspection.

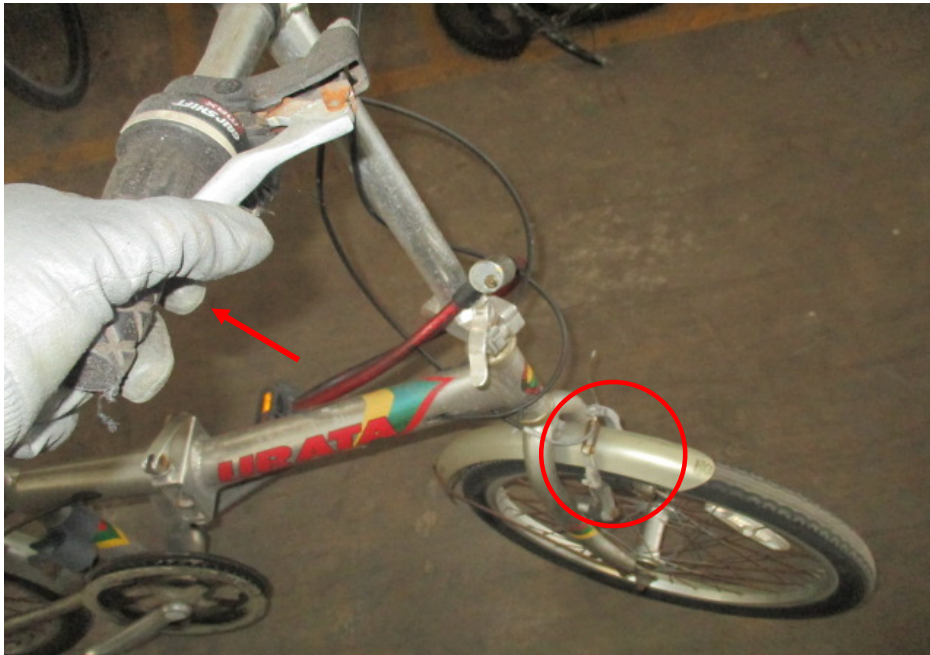
**Photo 20** shows a static brake test conducted on the Bicycle's front brake. There was some resistance felt upon pressing the right hand brake lever (arrowed). It also shows that the front brake clamps responded to the gripping action (circled) after depressing the right hand brake lever.

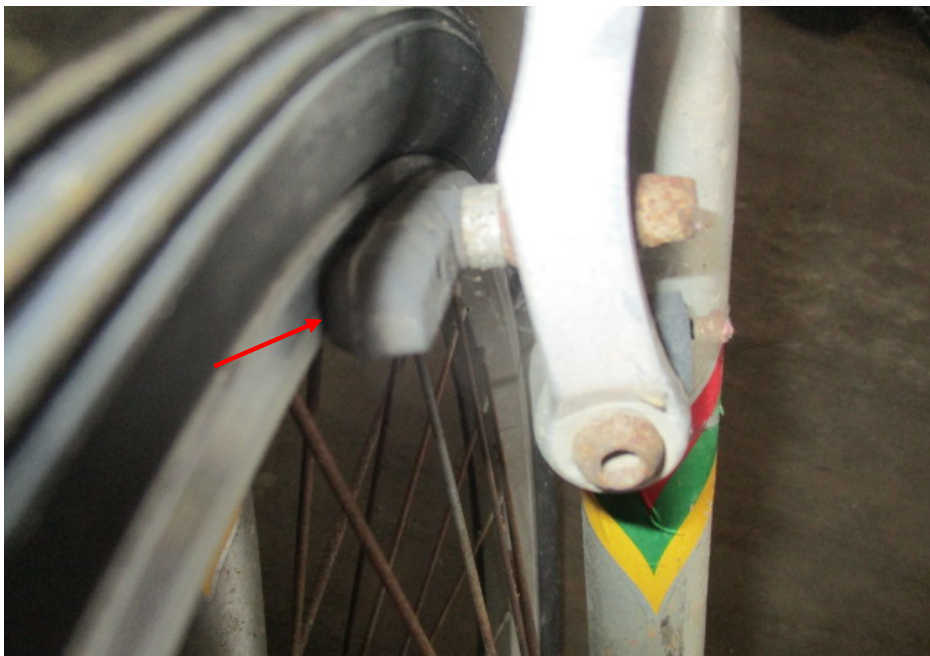
**Photo 21** shows a close up view of the front brake clamps responding to the gripping action. The rubber brake blocks pressed against the front wheel rim upon depressing the right hand brake lever (arrowed). This had appeared to indicate that the front brake was in serviceable condition.

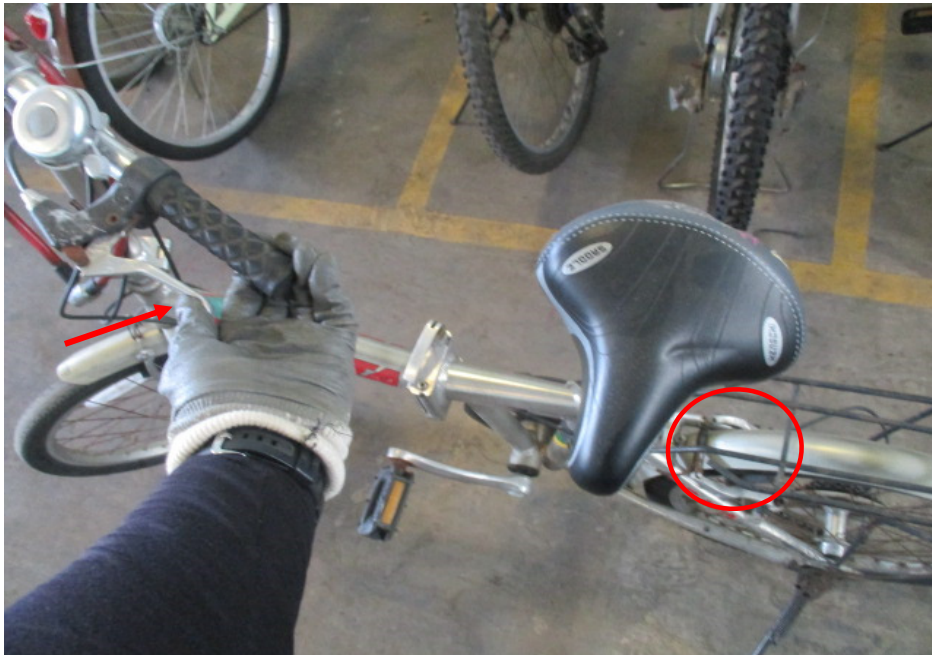
**Photo 22** shows a static brake test conducted on the Bicycle's rear brake. There was some resistance felt upon pressing the left hand brake lever (arrowed). It also shows that the rear brake clamps responded to the gripping action (circled) after depressing the left hand brake lever.

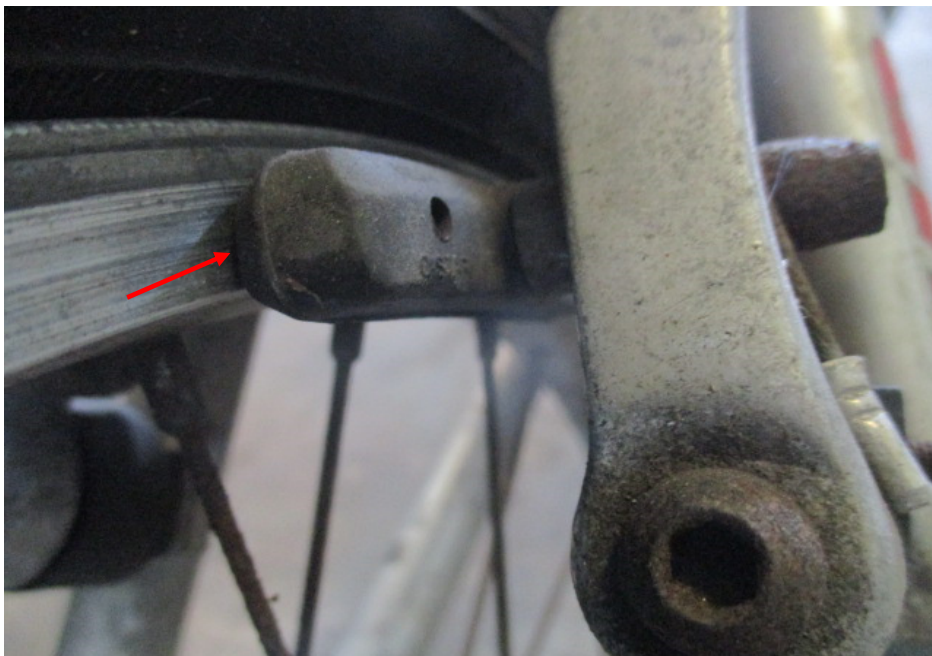
**Photo 23** shows a close up view of the rear brake clamps responding to the gripping action. The rubber brake blocks pressed against the rear wheel rim upon depressing the left hand brake lever (arrowed). This had appeared to indicate that the rear brake was in serviceable condition.
