Your Ref: TP/IP/72053/2019
Our Ref : CI/TPD20001852/N

Fatal Accident Investigation Team

MECHANICAL INSPECTION REPORT OF MOTORCYCLE JSJ 1562

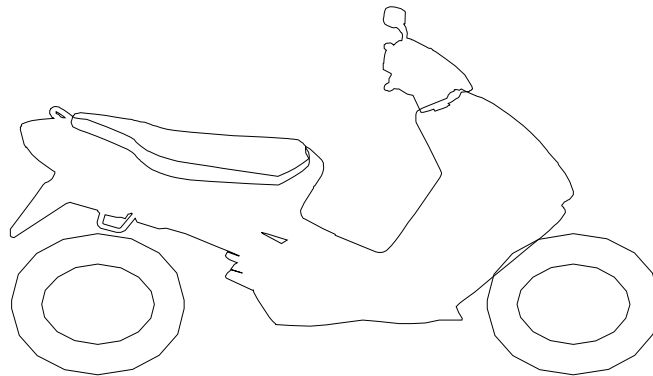
Maxxis 80/90 - 17 (3mm)

Michelin 70/90 - 17 (3mm)
(Deflated)

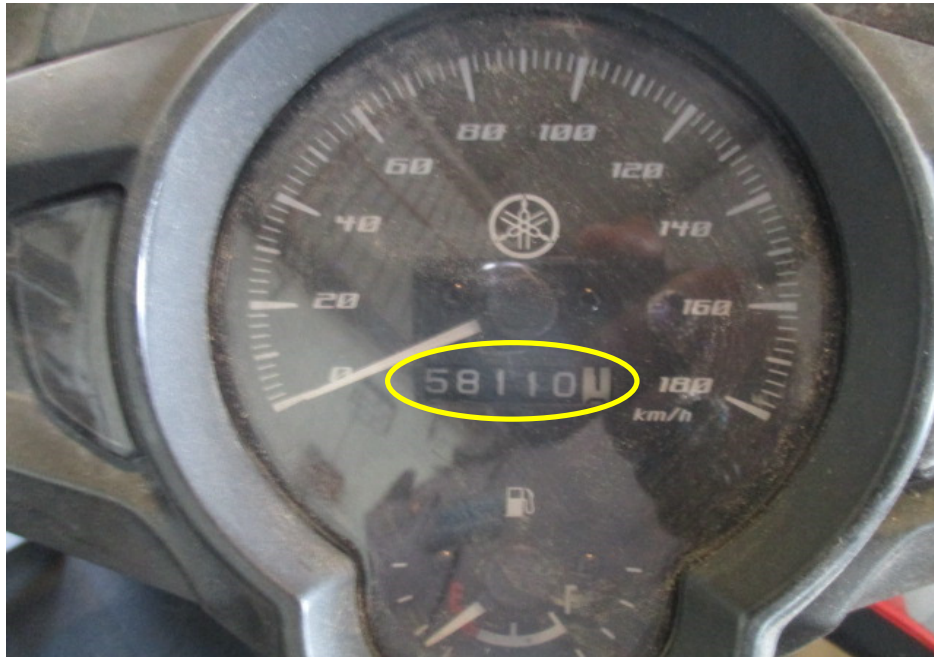
Photo 1 shows the speedometer gauge of the Motorcycle where the mileage recorded at the time of our inspection was 58, 110km (circled).

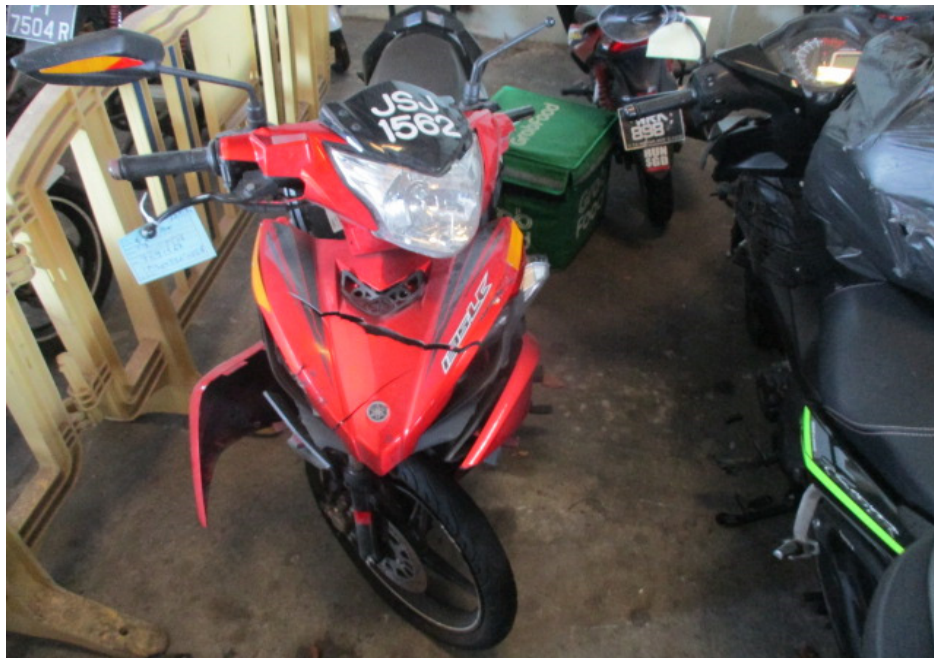
Photo 2 shows a general view of the frontal portion of the Motorcycle at the time of our inspection. The Motorcycle had sustained damages at its frontal portion.

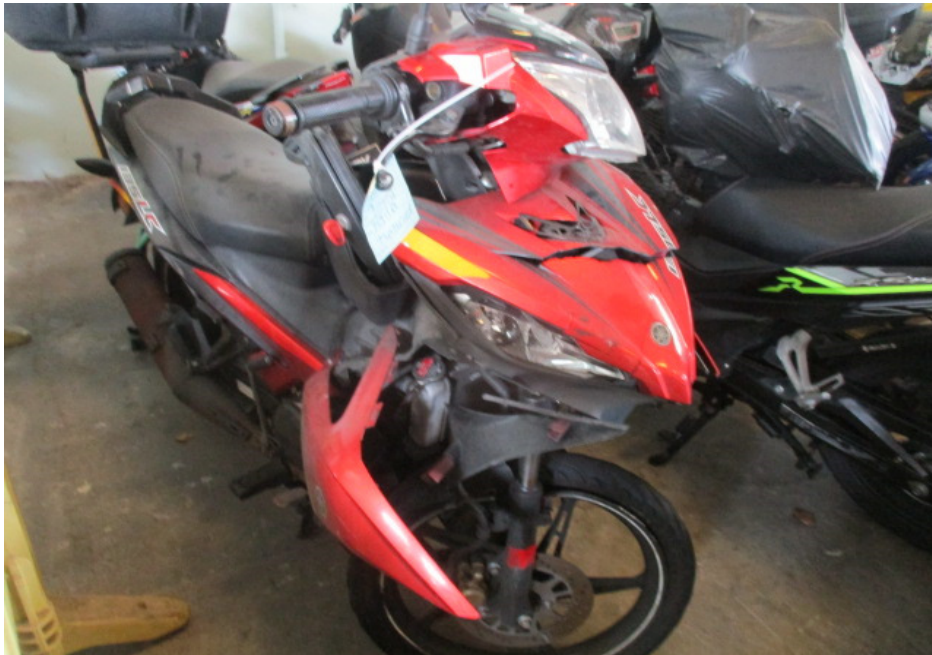
Photo 3 shows a general view of the right front body of the Motorcycle at the time of our inspection. The Motorcycle had sustained damages at its frontal portion. Body parts that were found to have been damaged include its headlight assembly, front cowlings, front fork assembly, side cowlings, side mirrors, front brake lever, right handlebar end, left handlebar grip and top box, amongst others.

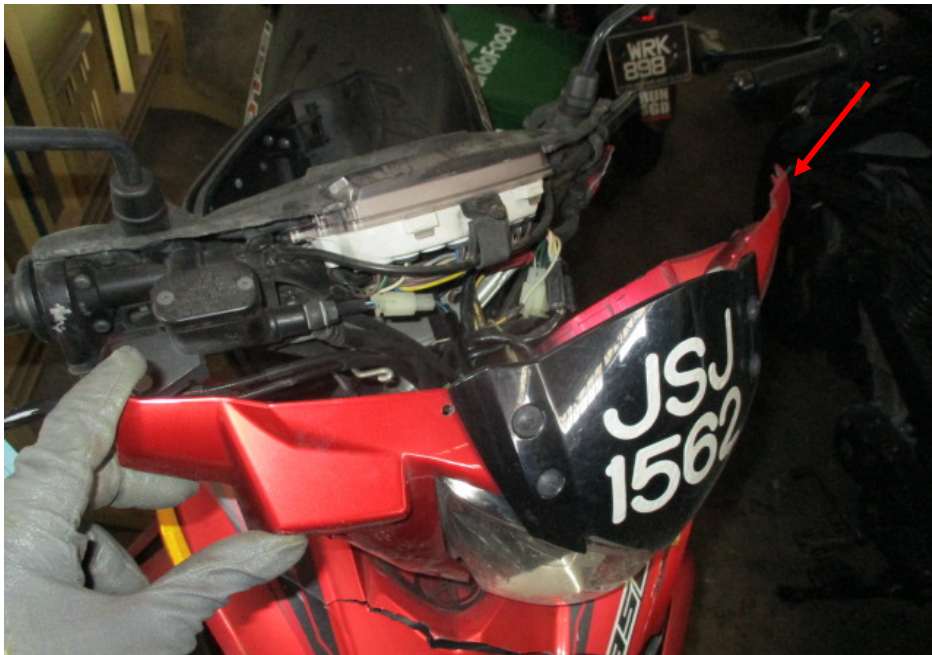
Photo 4 shows a closer view of the headlight assembly which was amongst the body parts at the front body of the Motorcycle that had sustained damages as a result of the accident (arrowed).

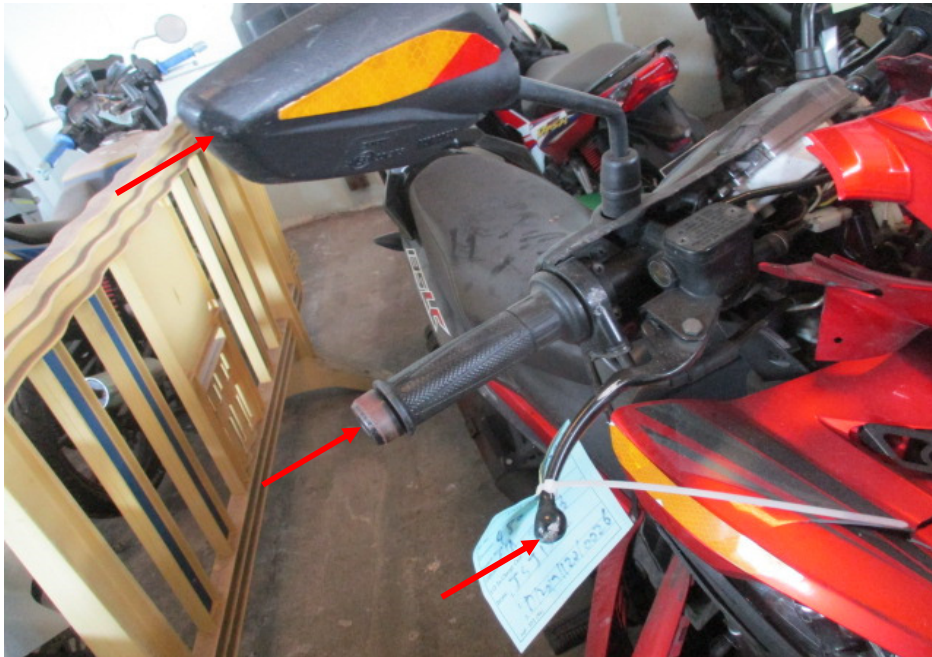
Photo 5 shows a closer view of the front brake lever, right side mirror and right handlebar end (arrowed) of the Motorcycle. These parts were amongst the body parts of the Motorcycle which were damaged as a result of the accident.

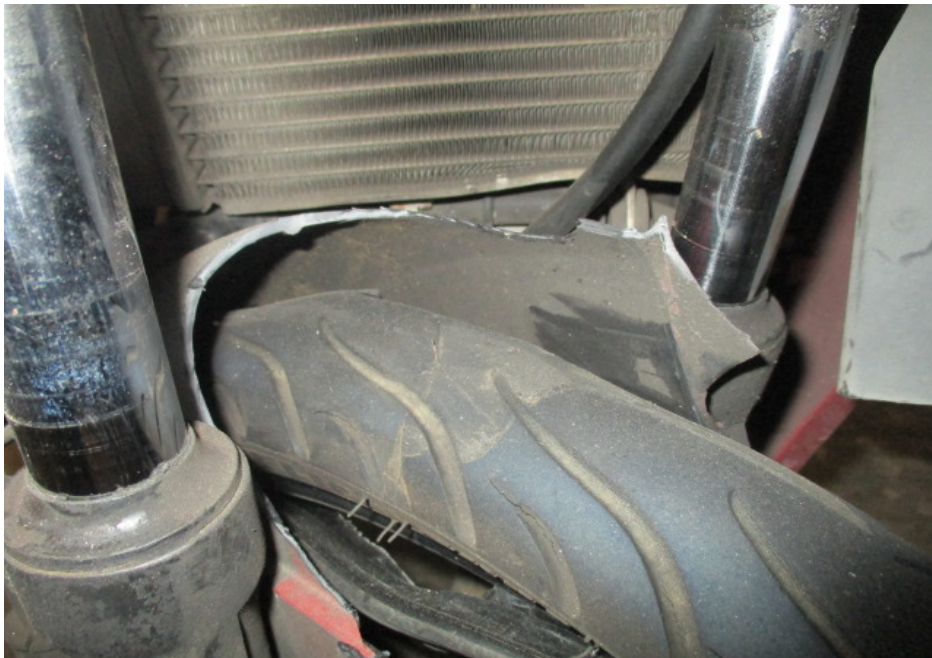
Photo 6 shows a closer view of the front mudguard, which was amongst the body parts of the Motorcycle that had sustained damage as a result of the accident.

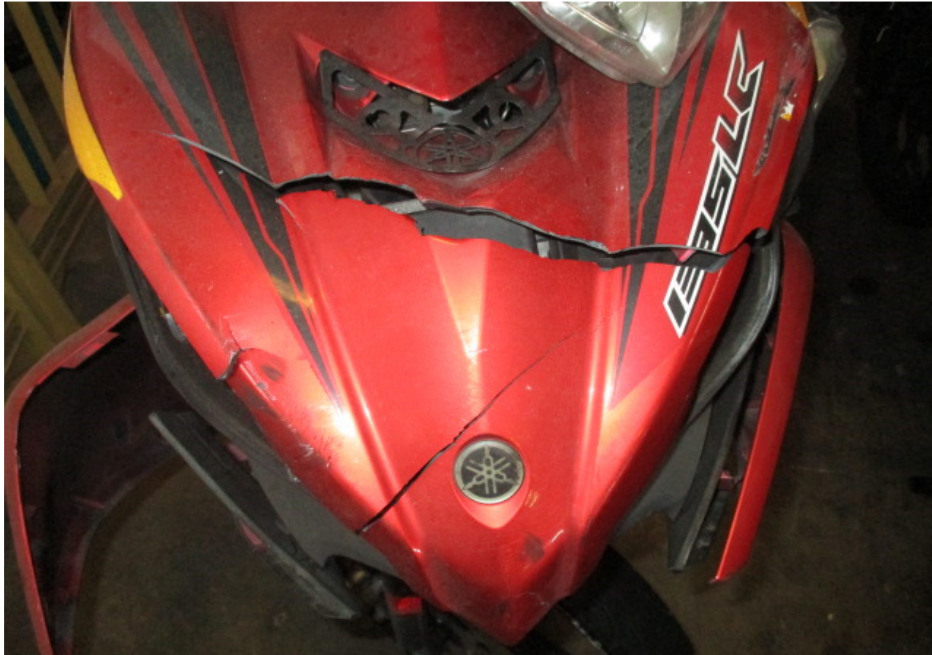
Photo 7 shows a closer view of the front cowling which was amongst the body parts at the front body of the Motorcycle that had sustained damages as a result of the accident.

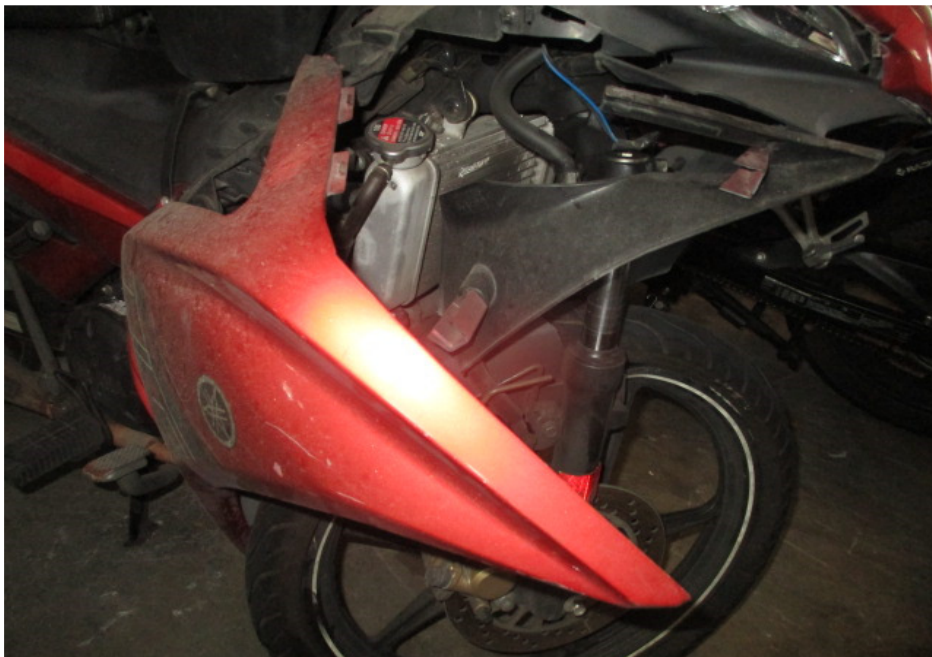
Photo 8 shows a closer view of the right cowling which was amongst the body parts at the front body of the Motorcycle that had sustained damages as a result of the accident.

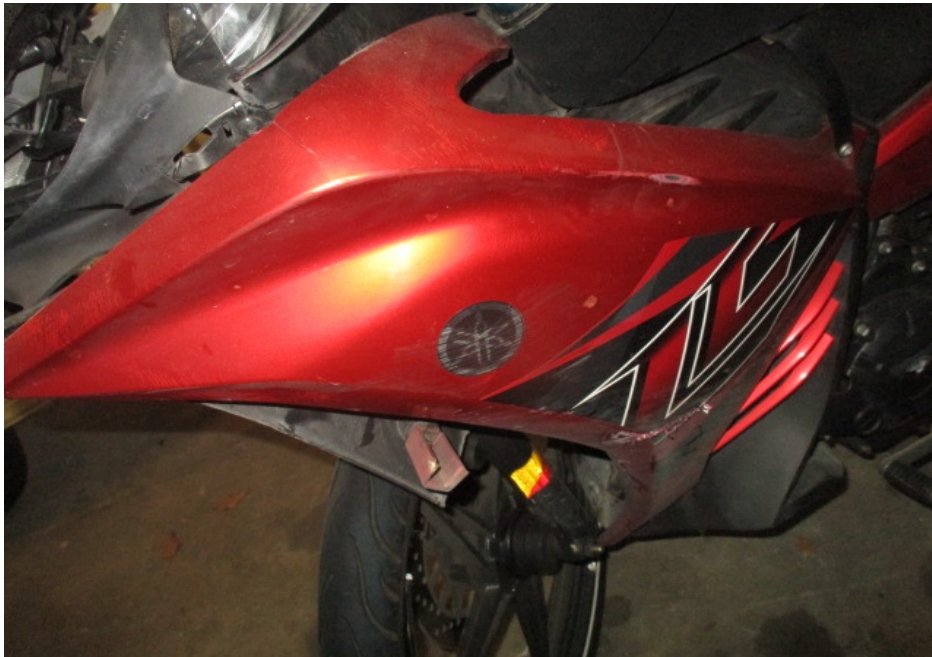
Photo 9 shows a closer view of the left cowling which was amongst the body parts at the front body of the Motorcycle that had sustained damages as a result of the accident.

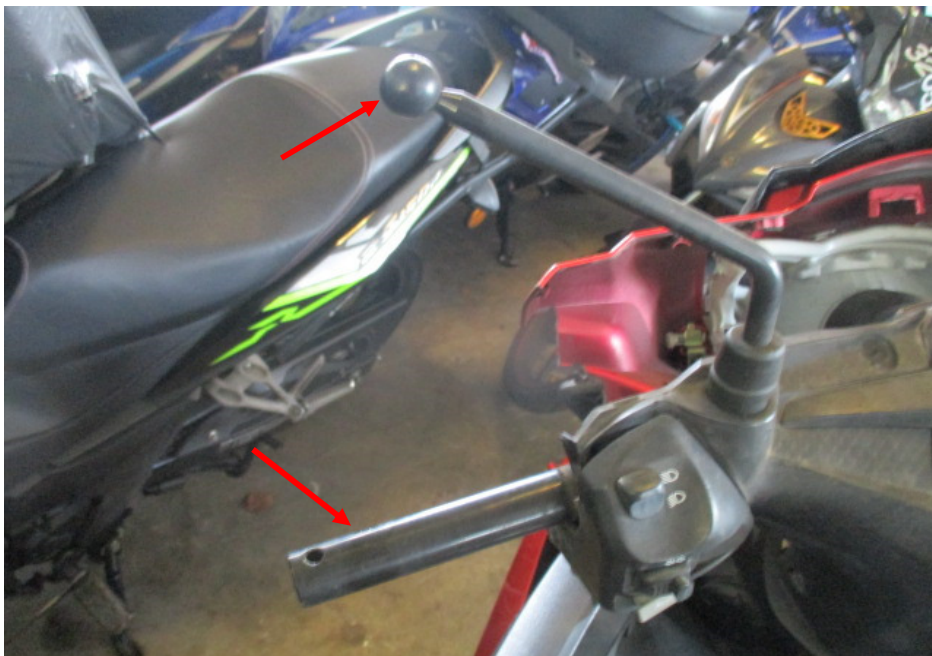
Photo 10 shows a closer view of the missing left side mirror and left handlebar grip (arrowed), which were amongst the body parts of the Motorcycle that had sustained damage as a result of the accident (circled).

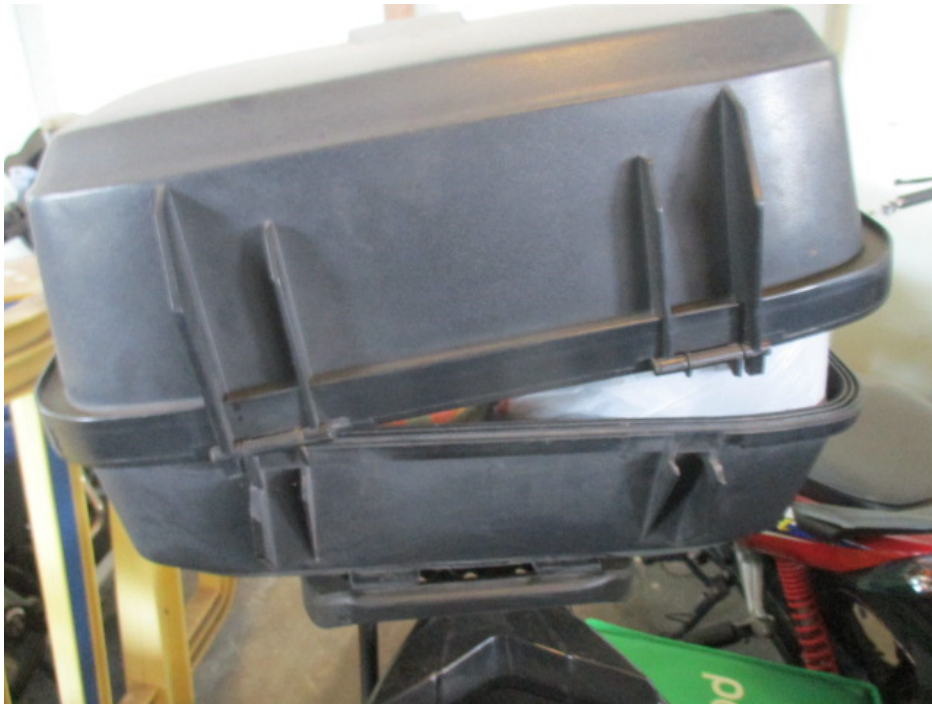
Photo 11 shows the broken top box of the Motorcycle as a result of the accident.

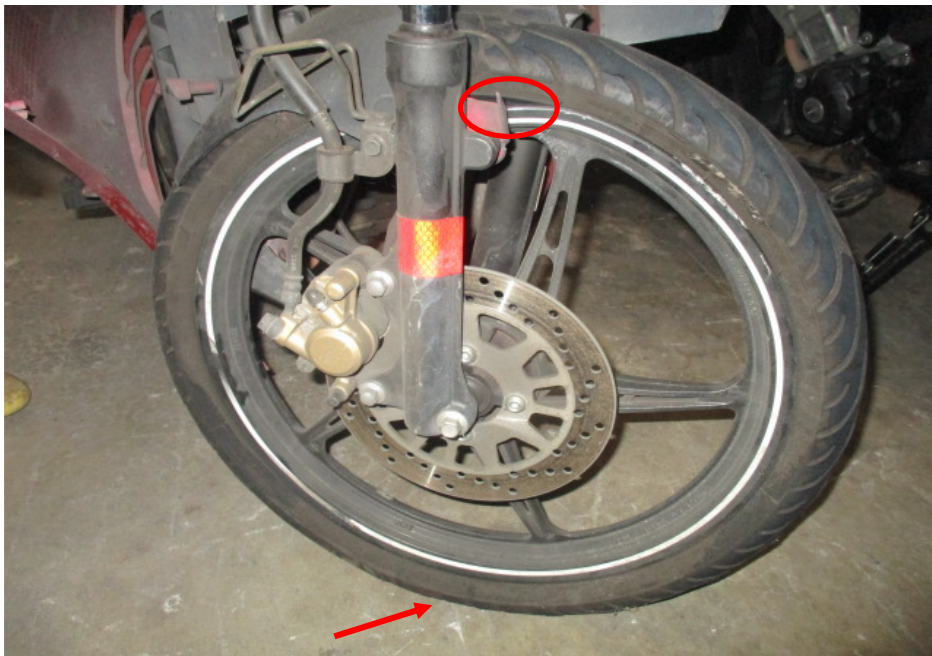
9. The 2 tyres were wrapped around alloy wheel rims. At the time of our inspection, we did not observe any visible damage on the rear wheel rim of the Motorcycle. However we did observe that the front wheel rim was bent. See photos 1 – 14 below.

Photo 12 shows the bent front wheel rim (circled) and deflated front tyre (arrowed) of the Motorcycle as a result of the accident at the time of our inspection.

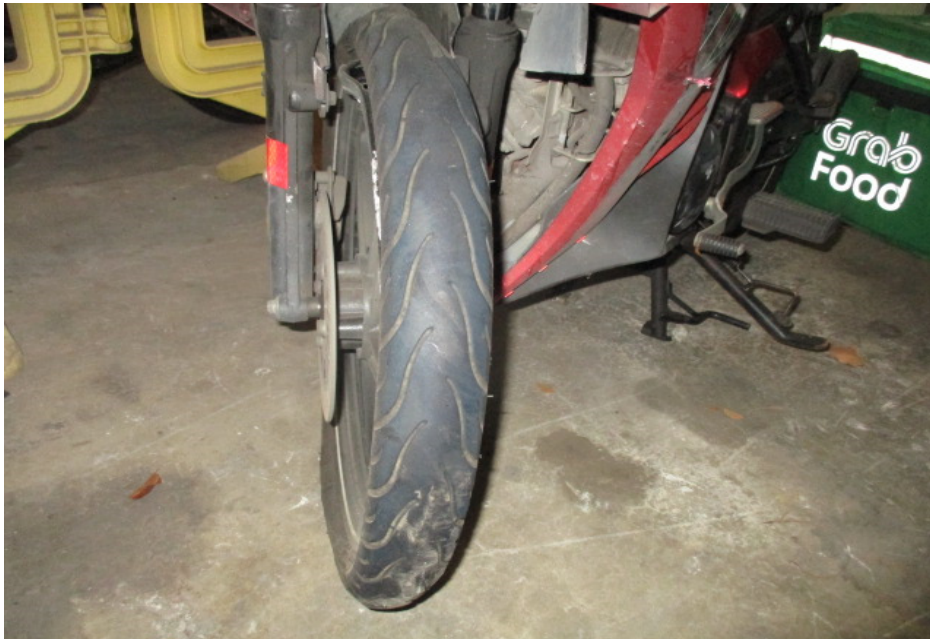
Photo 13 shows the punctured front tyre of the Motorcycle most likely as a result of the accident at the time of our inspection. The front tyre was observed to be in serviceable condition with remaining tread depth of approximately 3mm. The pattern of the tread was also clearly visible. There was no tear, burst mark(s) and/or punctured hole(s) on the sidewalls as well as across the tread of the front tyre.

17. The 2 tyres of the Motorcycle were found to be in serviceable condition (which included the deflated front tyre). There was no tear, cut or burst mark(s) on the outer and the inner sidewalls as well as across the tread of the 2 tyres. The rear tyre was sufficiently inflated for vehicular operation. Both tyres had remaining tread depth of approximately 3mm each.

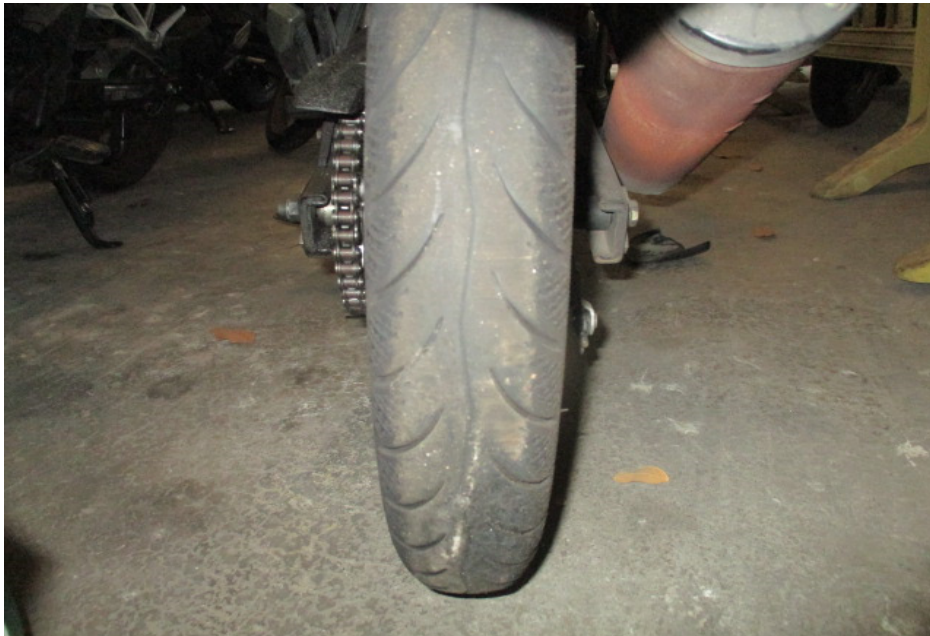
Photo 14 shows the condition of the Motorcycle's rear tyre. The rear tyre was observed to be in serviceable condition with remaining tread depth of approximately 3mm. The tyre was also observed to be sufficiently inflated for vehicular operation. We did not observe any tear, burst mark(s) and/or punctured hole(s) on the sidewalls as well as across the tread of the rear tyre.

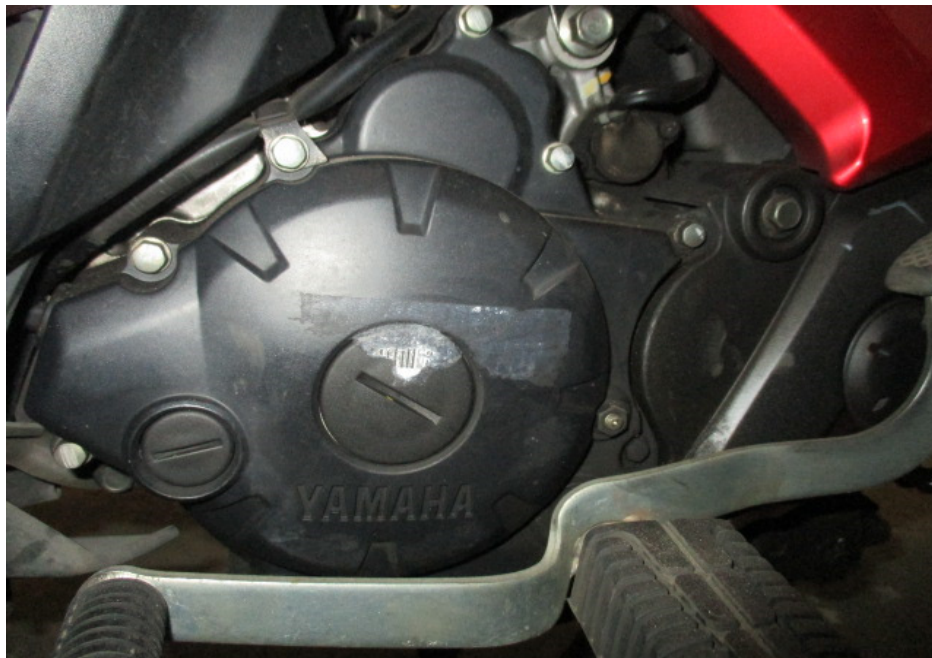
Photo 15 shows the left side of the engine of the Motorcycle at the time of our inspection. The various engine related parts and components were found to be intact with no visible damage. There was also no sign(s) or indication(s) of fluid leak observed around the left engine area of the Motorcycle.

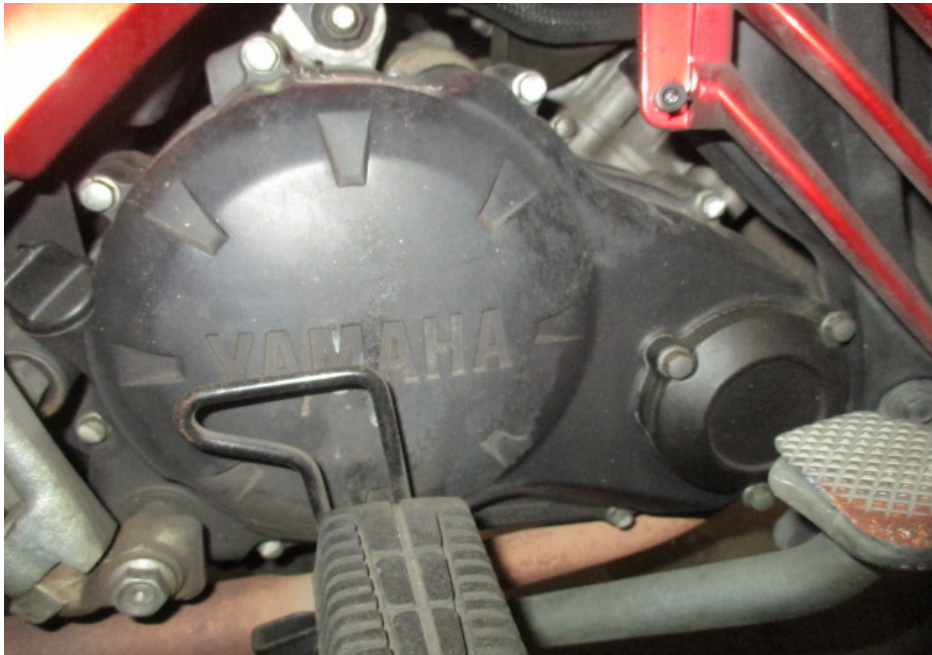
Photo 16 shows the right side of the engine of the Motorcycle at the time of our inspection. The various engine related parts and components were found to be intact with no visible damage. There was also no sign(s) or indication(s) of fluid leak observed around the right engine area of the Motorcycle.

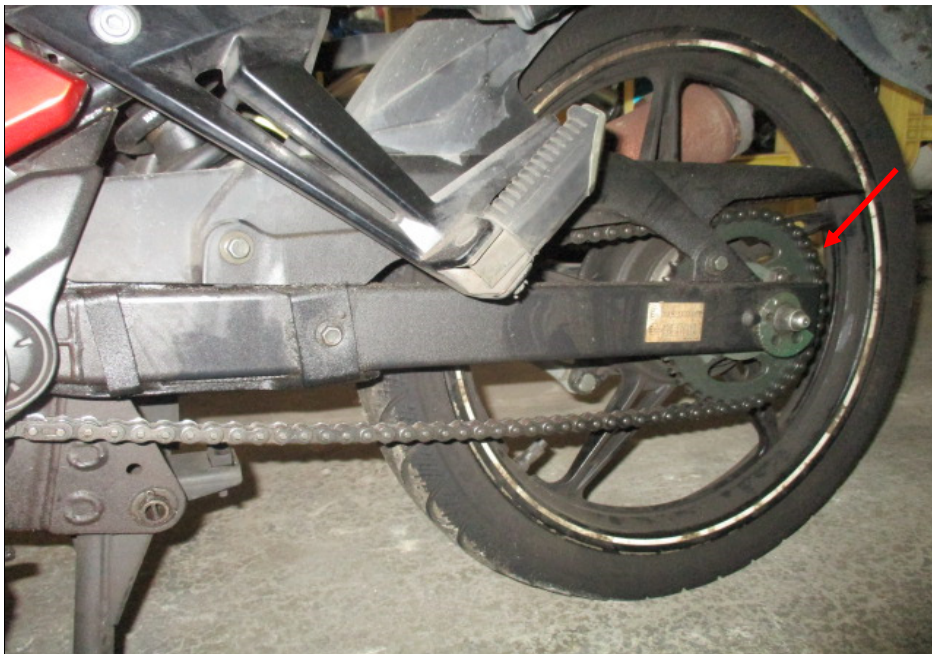
Photo 17 shows the gear chain (arrowed) of the Motorcycle, which was observed to be intact with no misalignment. It was also adequately lubricated for operating purposes. The gear chain rotates the rear wheel of the Motorcycle.

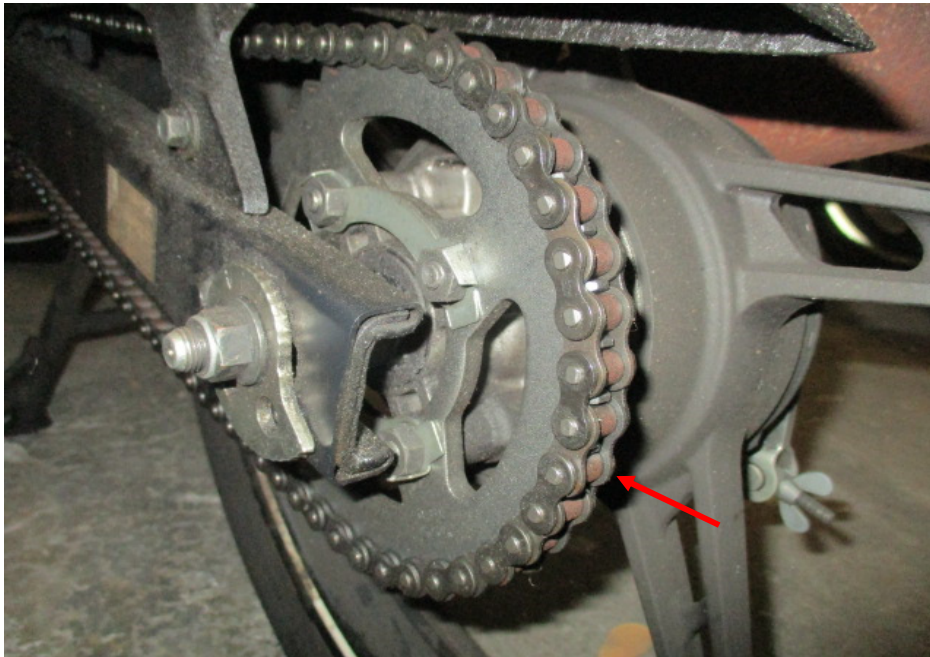
Photo 18 shows the closer view of the gear chain (arrowed) of the Motorcycle, which was observed to be intact with no misalignment. It was also adequately lubricated for operating purposes.

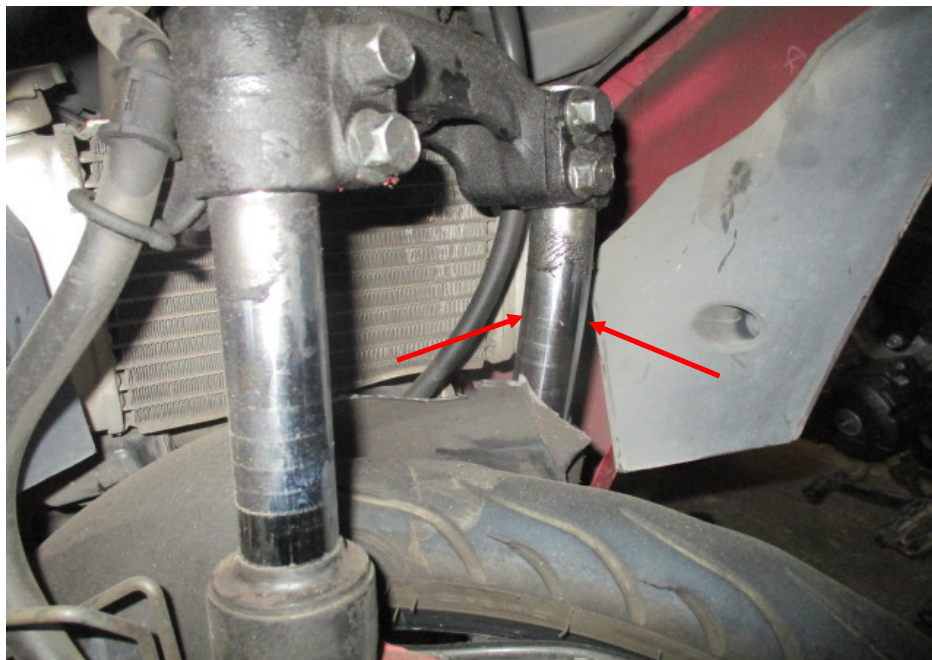
12. For this case, we were not able to conduct any test(s) on the steering system of the Motorcycle due to the damage of its front forks and steering stem. The left front fork was found to be bent inwards as a result of the accident. The steering system was observed to be broken as a result of the accident.

Photo 19 shows the front forks of the Motorcycle. The front left fork (arrowed) was observed to be bent inwards as a result of the accident. We were hence not able to conduct any tests on the steering system of the Motorcycle.

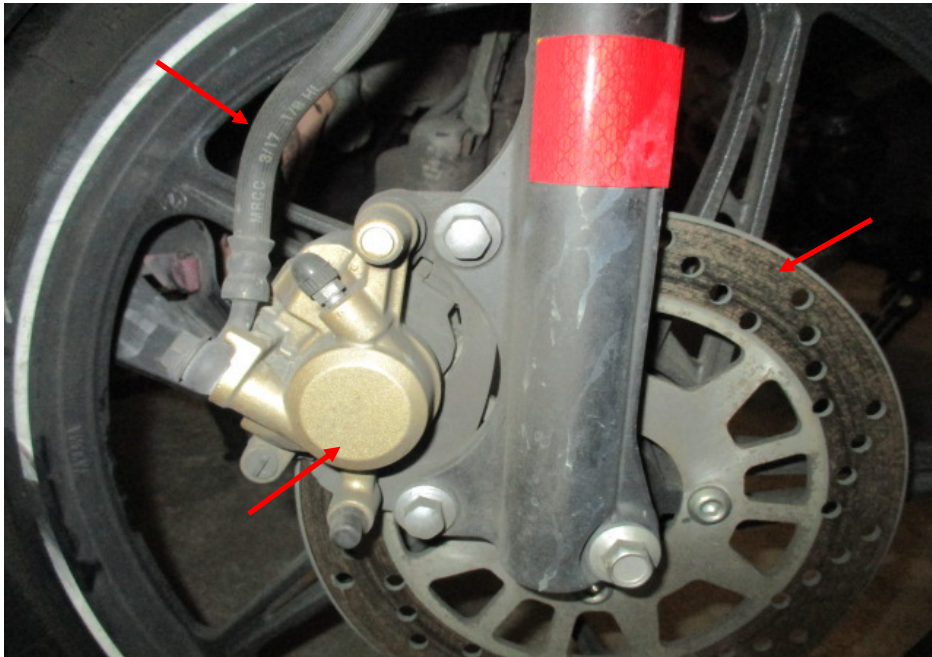
Photo 20 shows a close up view of the front brake caliper, front brake disc and front brake hose (arrowed) of the Motorcycle, which are all part of the components in the hydraulic front brake system of the Motorcycle. Our visual checks of these various components had revealed all to be intact with no visible damage. No leakage of brake fluid was also observed.

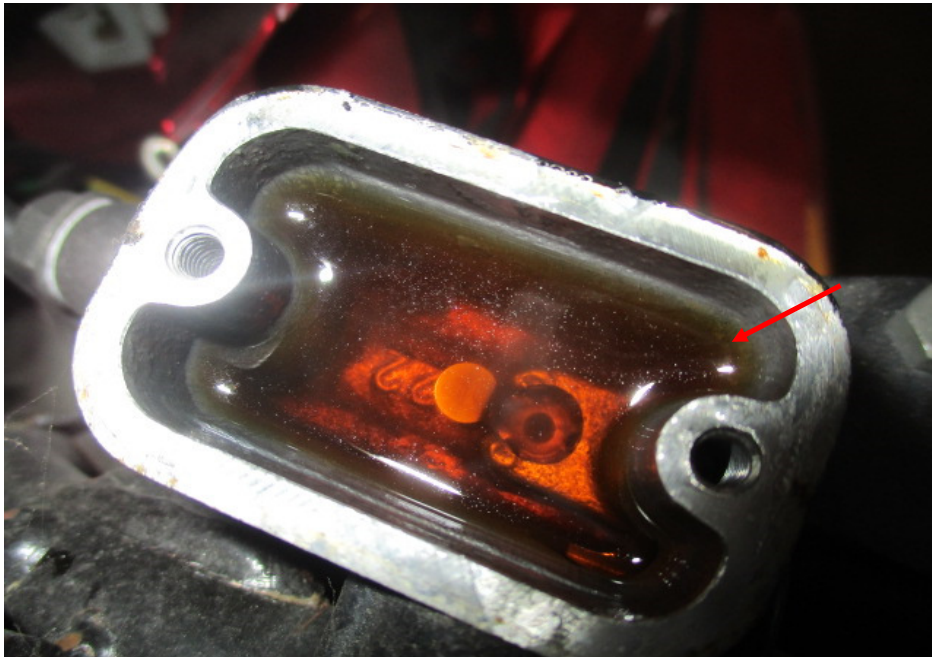
Photo 21 shows the brake fluid reservoir for the front brake of the Motorcycle. The brake fluid was found to be of sufficient level for operating purposes. However the brake fluid was found to be slightly contaminated (arrowed).

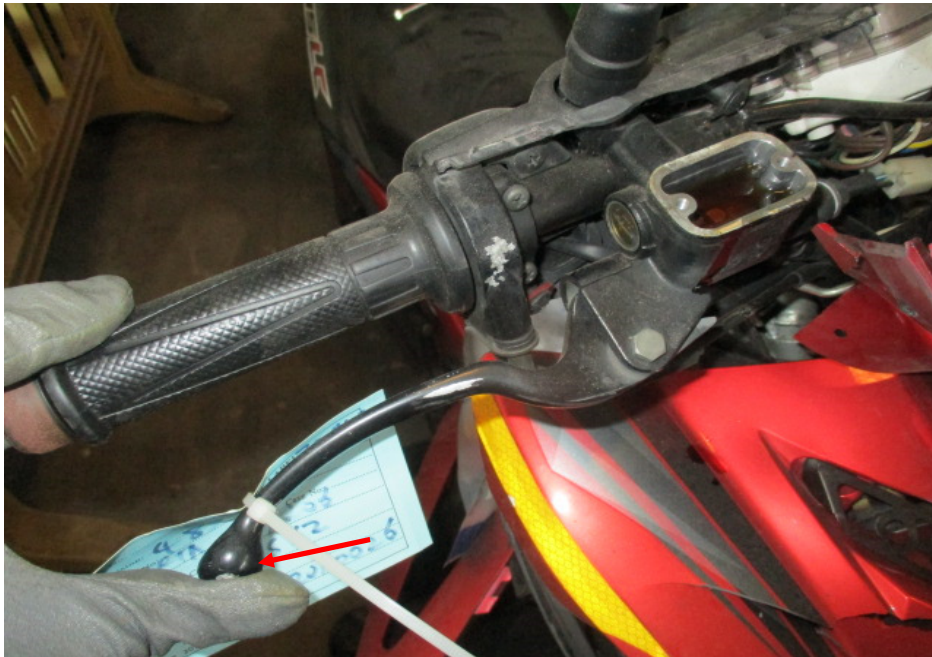
Photo 22 shows the front brake lever being depressed. There was some resistance felt (spongy like feel) upon pressing the front brake lever (arrowed). This would indicate that there is no leakage of pressure/vacuum in the brake system.

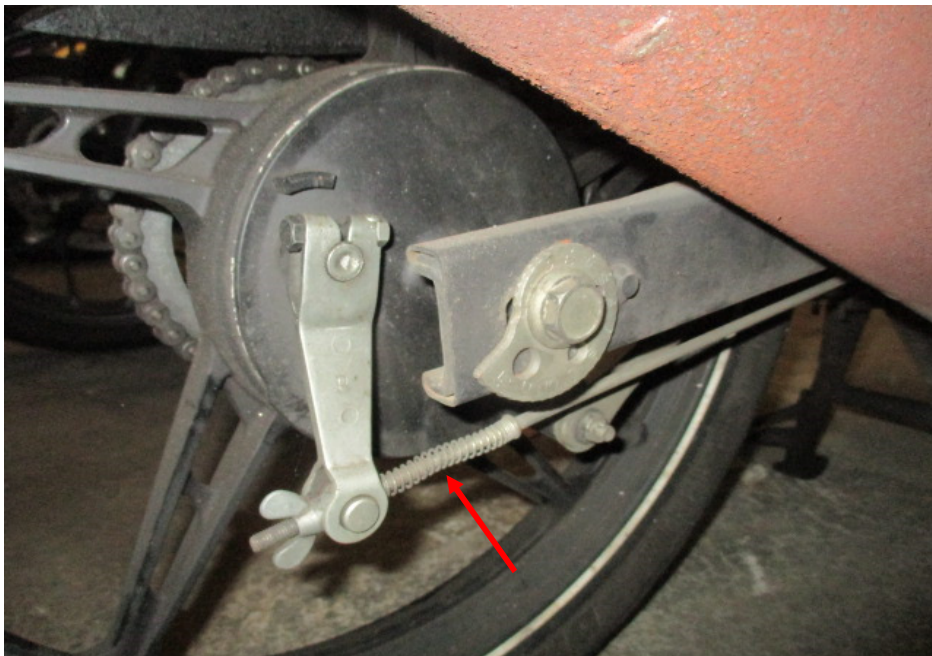
Photo 23 shows the rear wheel of the Motorcycle. The type of brake system for the rear wheel was of a mechanical type, controlled by the brake foot pedal of the Motorcycle. Our checks of the cable (arrowed), spring and drum which are all part of the components in the rear brake system of the Motorcycle reveal all to be intact and without damage.
