Your Ref: TP/IP/00573/2020
Our Ref :CI/TPD20001856/N

3 April 2020

INSPECTION REPORT OF MOTORCYCLE FBG 6445A

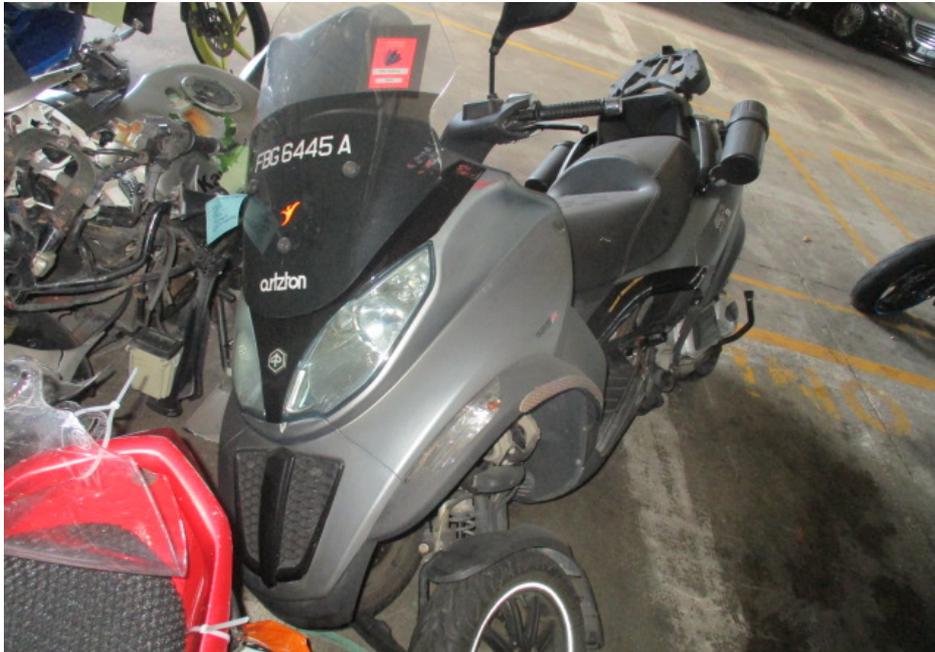
Photo 1 shows a general view of the front body of the Motorcycle at the time of our inspection. The Motorcycle was observed to have sustained damages all around.

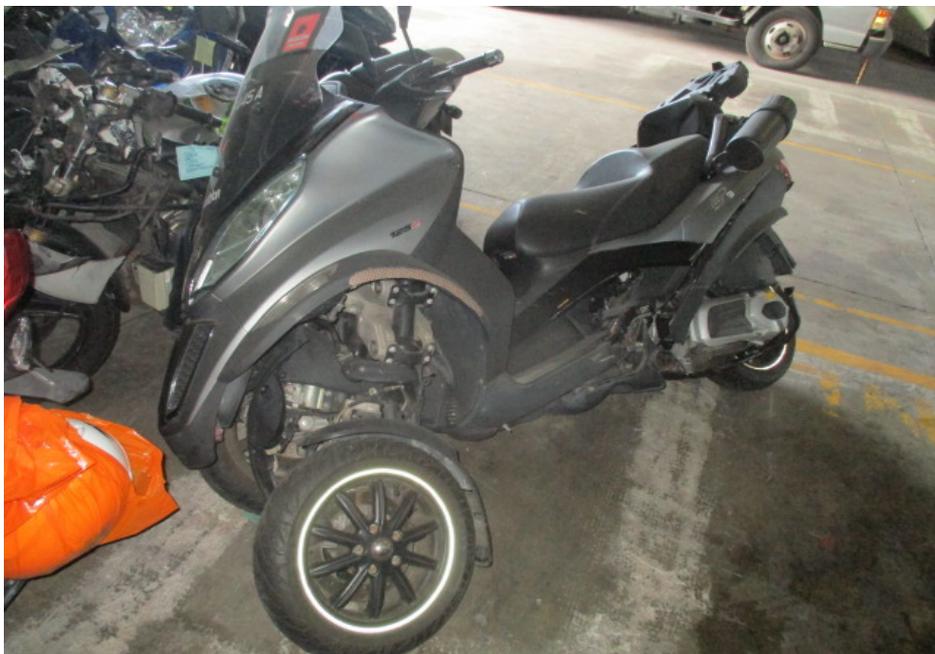
Photo 2 shows a general view of the left body of the Motorcycle at the time of our inspection. The Motorcycle was observed to have sustained damages all around.

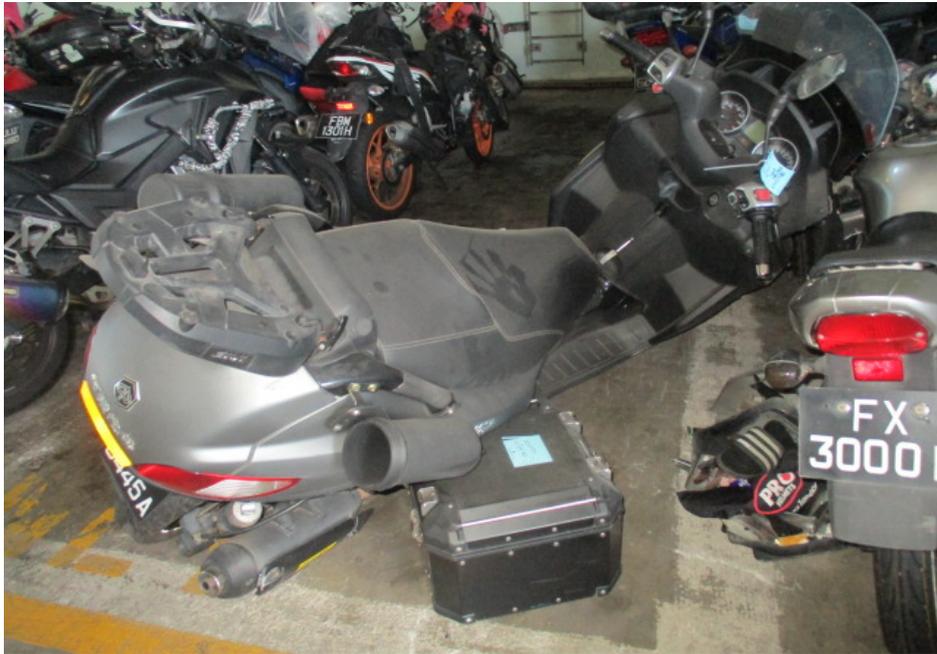
Photo 3 shows a general view of the right rear body of the Motorcycle at the time of our inspection. The Motorcycle was observed to have sustained damages all around.

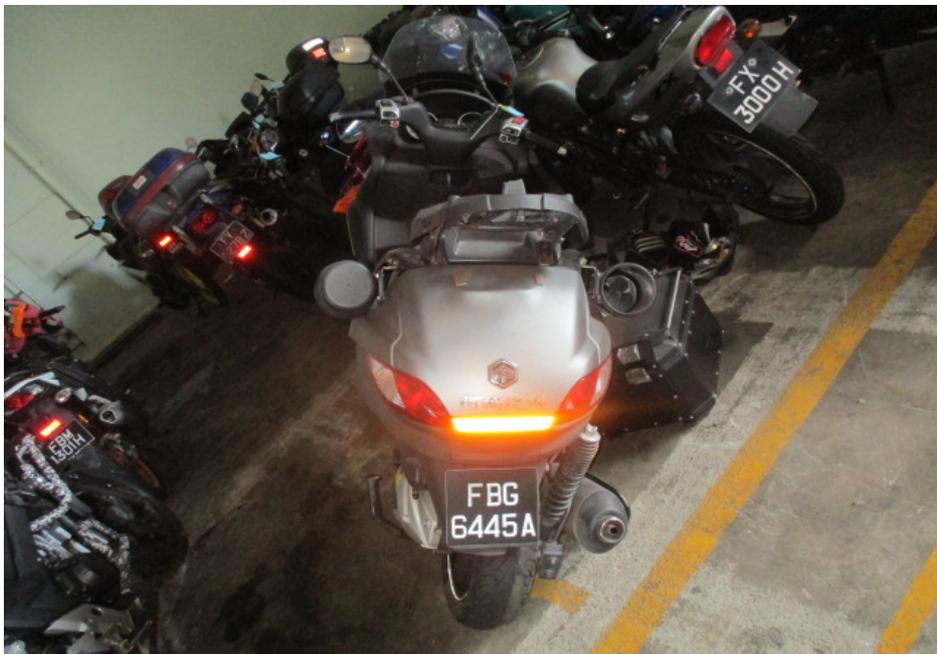
Photo 4 shows a general view of the rear portion of the Motorcycle at the time of our inspection. The Motorcycle was observed to have sustained damages all around. The body parts that were found to have been damaged include its windshield, front cowling, front brake lever, clutch lever, side mirrors, side cowlings, rear side covers, shock absorbers, exhaust muffler and exhaust muffler heat shield, amongst others as a result of the accident.

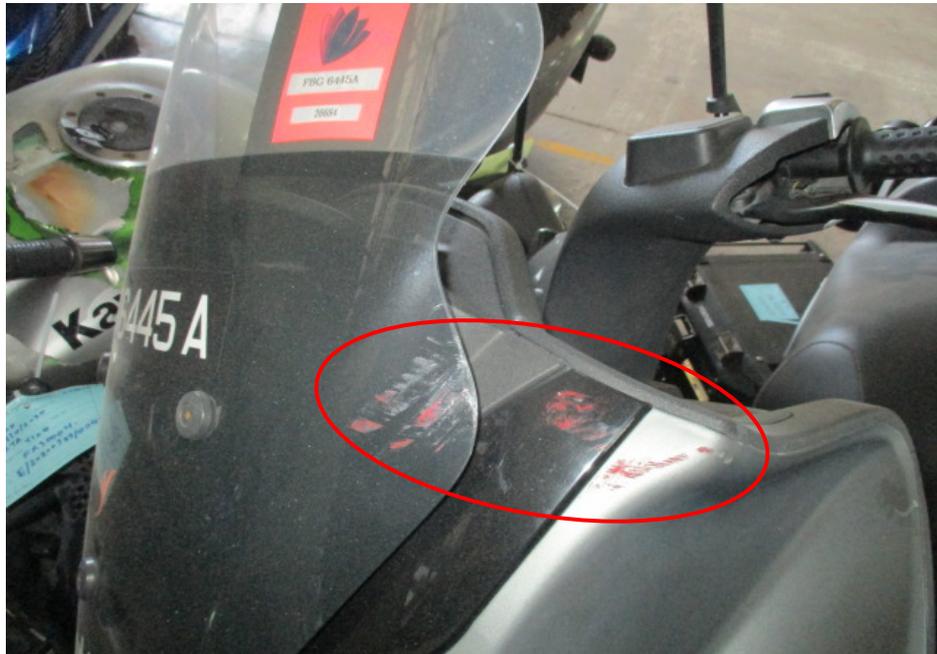
Photo 5 shows a closer view of the windshield and front cowling (circled) which were amongst the body parts at the front of the Motorcycle that had sustained damage as a result of the accident.

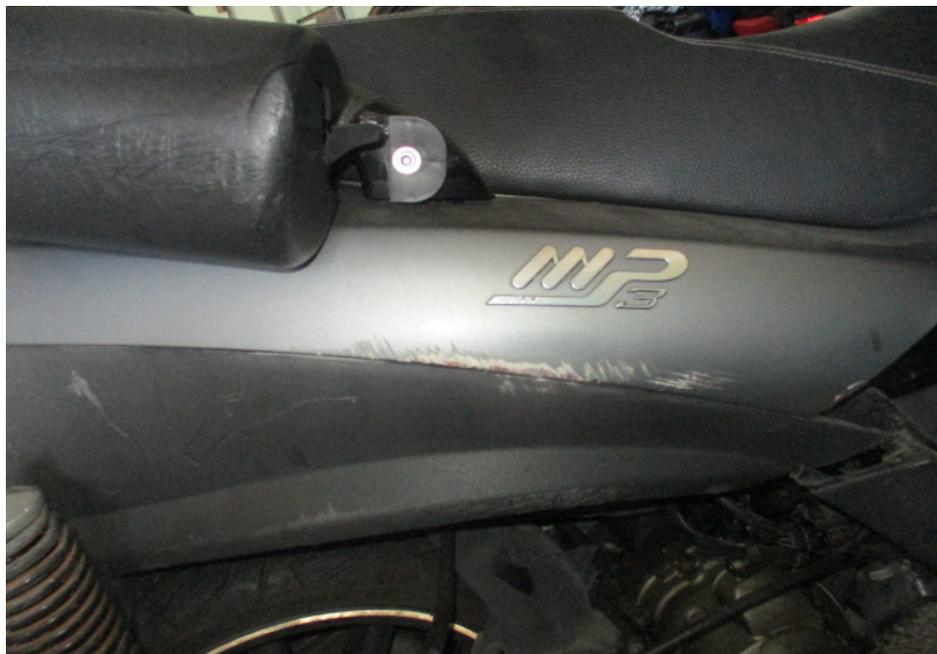
Photo 6 shows a closer view of the right rear side cover which was amongst the body parts at the rear body of the Motorcycle that had sustained damage as a result of the accident.

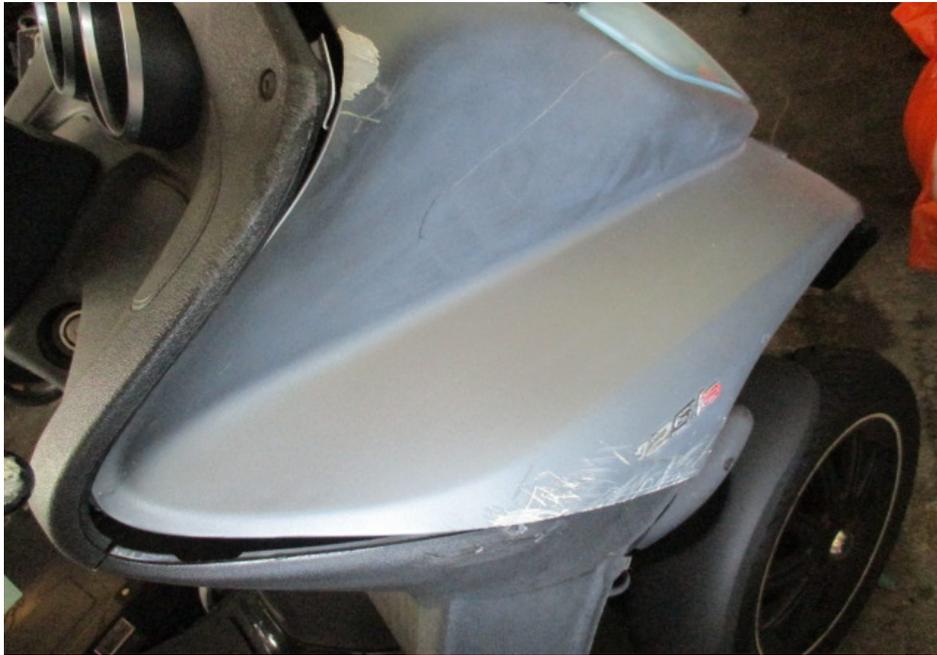
Photo 7 shows a closer view of the right cowling of the Motorcycle which was observed to be damaged due to the accident.

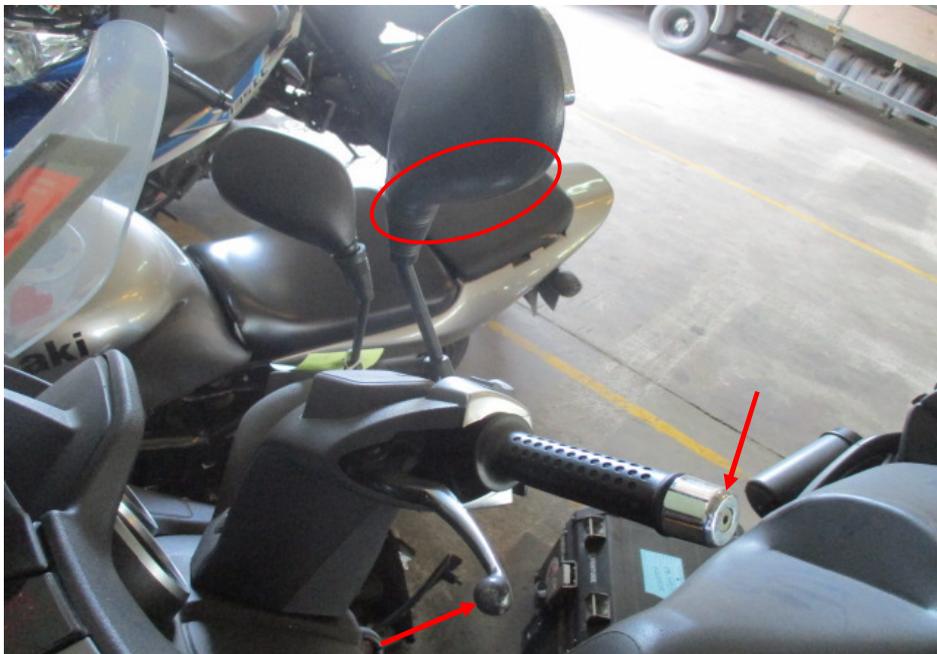
Photo 8 shows a closer view of the rear brake lever and left handlebar end (arrowed) as well as the left side mirror (circled) of the Motorcycle which were observed to be damaged due to the accident

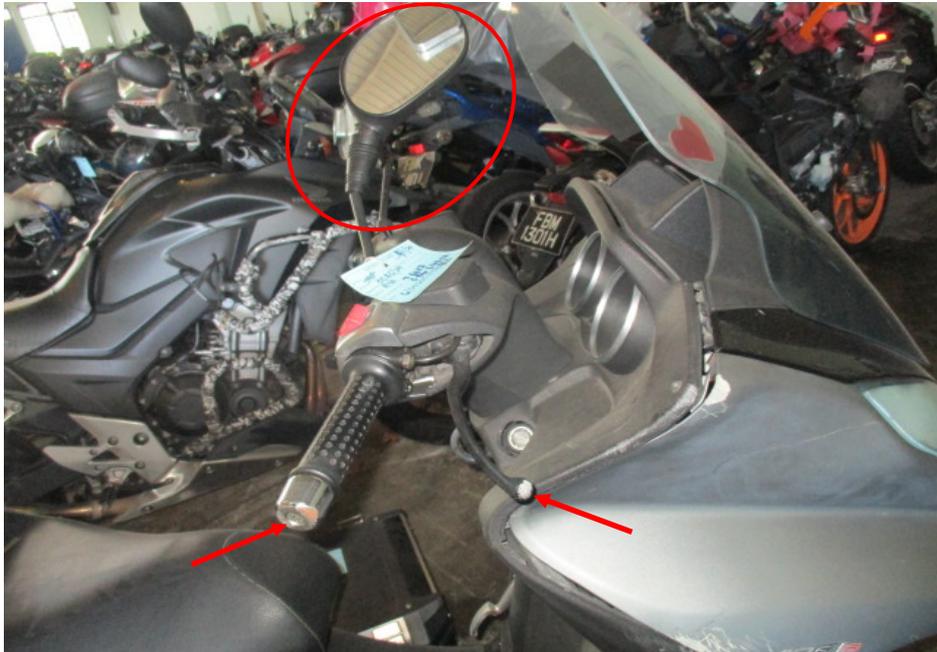
Photo 9 shows a closer view of the front brake lever and right handlebar end (arrowed) as well as the right side mirror (circled) of the Motorcycle which were observed to be damaged due to the accident

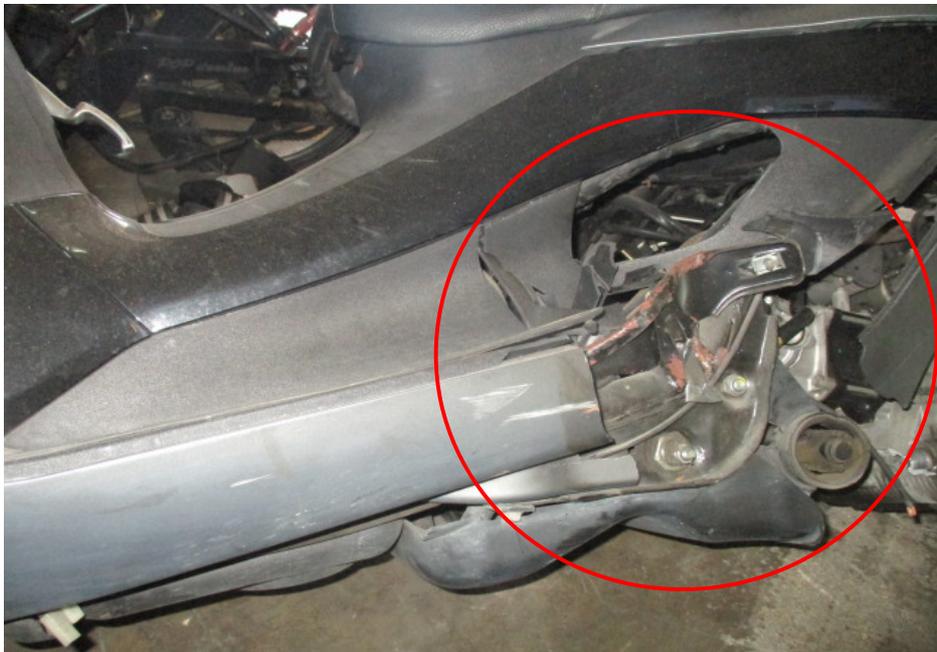
Photo 10 shows a closer view of the damaged left cowling (circled) of the Motorcycle at the time of our inspection.

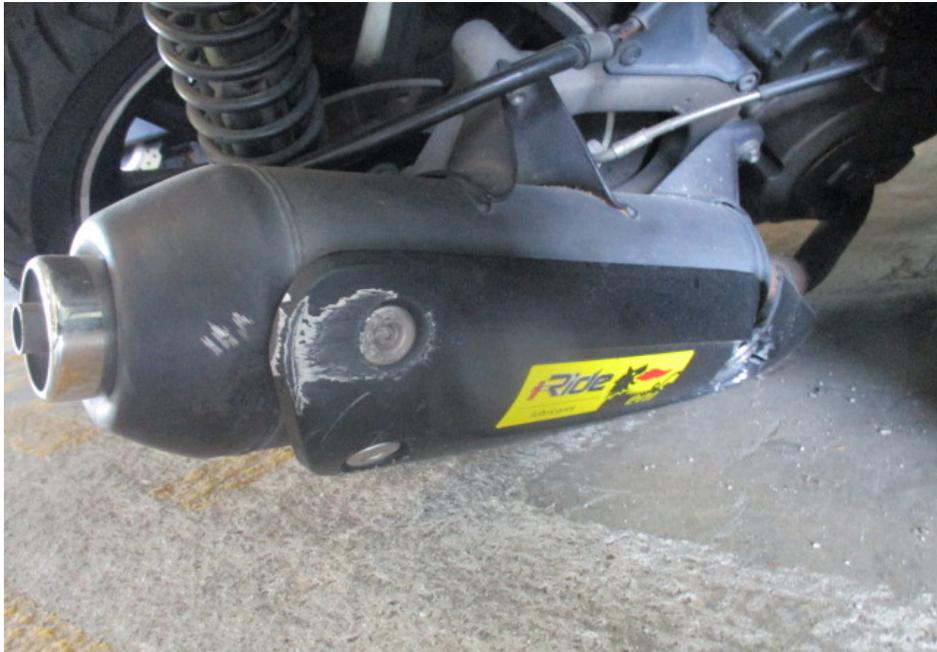
Photo 11 shows a closer view of the exhaust muffler and exhaust muffler heat shield of the Motorcycle which had sustained damage due to the accident.

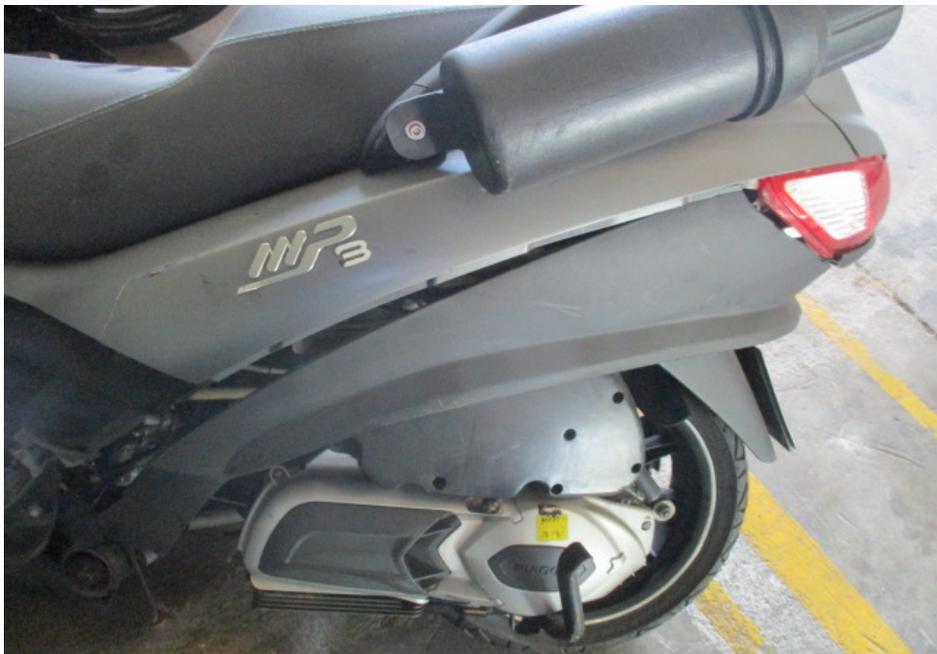
Photo 12 shows a closer view of the left rear side cover which was amongst the body parts at the front body of the Motorcycle that had sustained damage as a result of the accident.

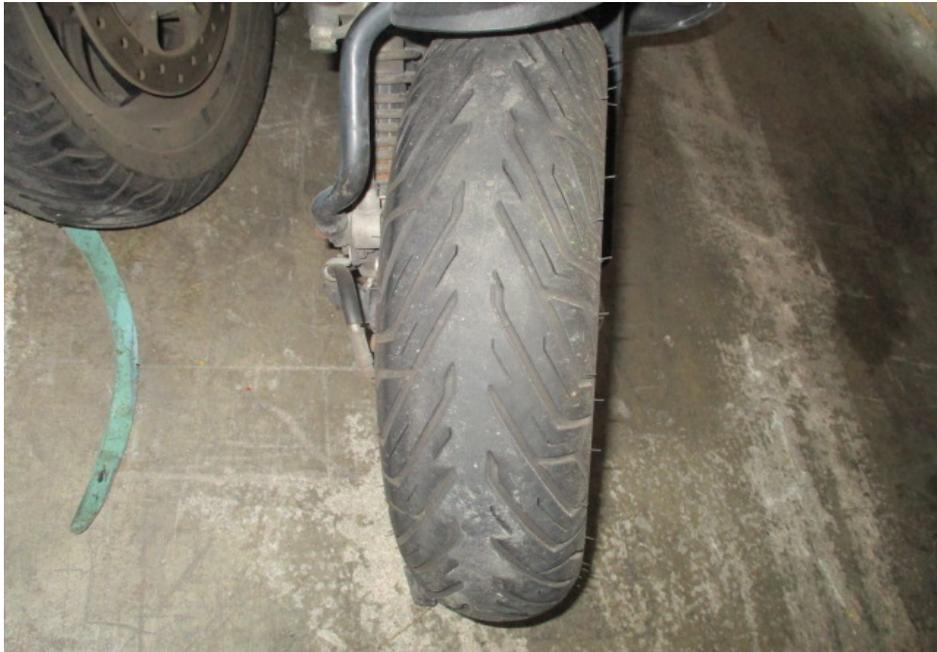
Photo 13 shows the condition of the Motorcycle's front left tyre. The front left tyre was observed to be in serviceable condition with remaining tread depth of approximately 3mm. There was no tear, burst mark(s) and/or punctured hole(s) on the sidewalls as well as across the tread of the front left tyre.

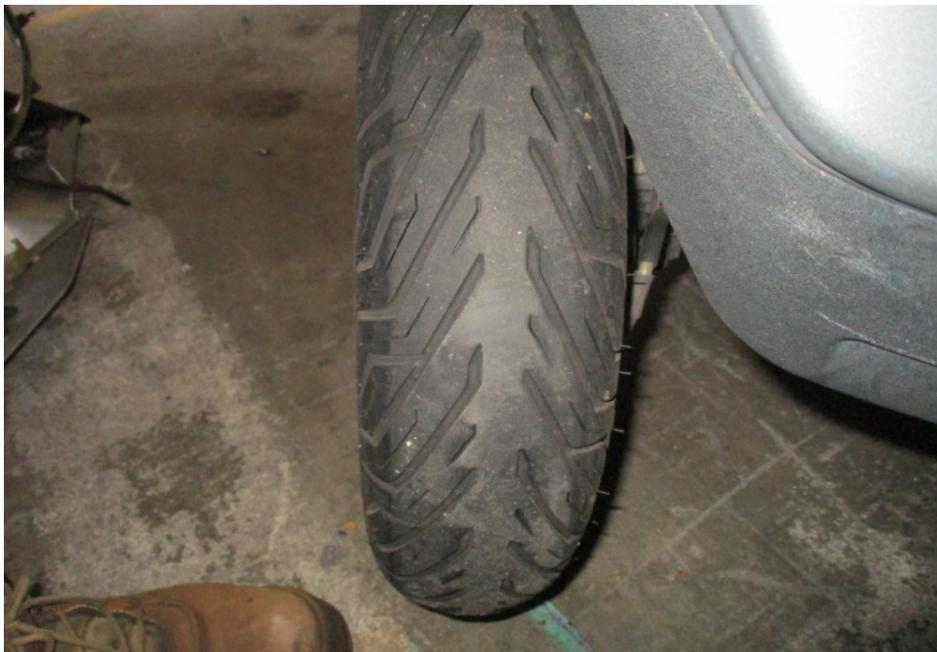
Photo 14 shows the condition of the Motorcycle's front right tyre. The front right tyre was observed to be in serviceable condition with remaining tread depth of approximately 3mm. There was no tear, burst mark(s) and/or punctured hole(s) on the sidewalls as well as across the tread of the front right tyre.

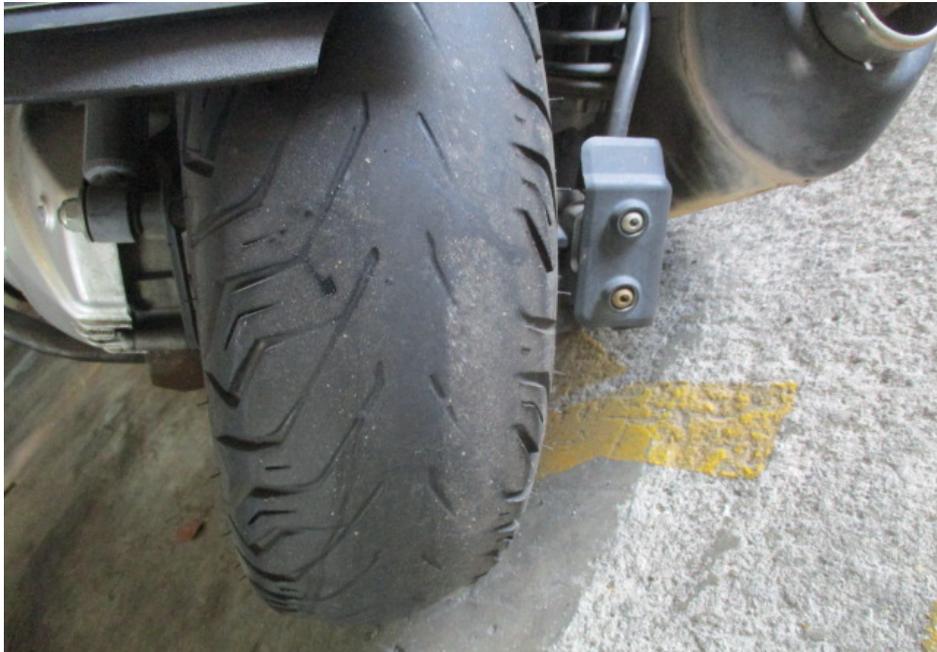
Photo 15 shows the condition of the Motorcycle's rear tyre. The rear tyre was observed to be in serviceable condition with remaining tread depth of approximately 3mm. The tyre was also observed to be sufficiently inflated for vehicular operation. We did not observe any tear, burst mark(s) and/or punctured hole(s) on the sidewalls as well as across the tread of the rear tyre.

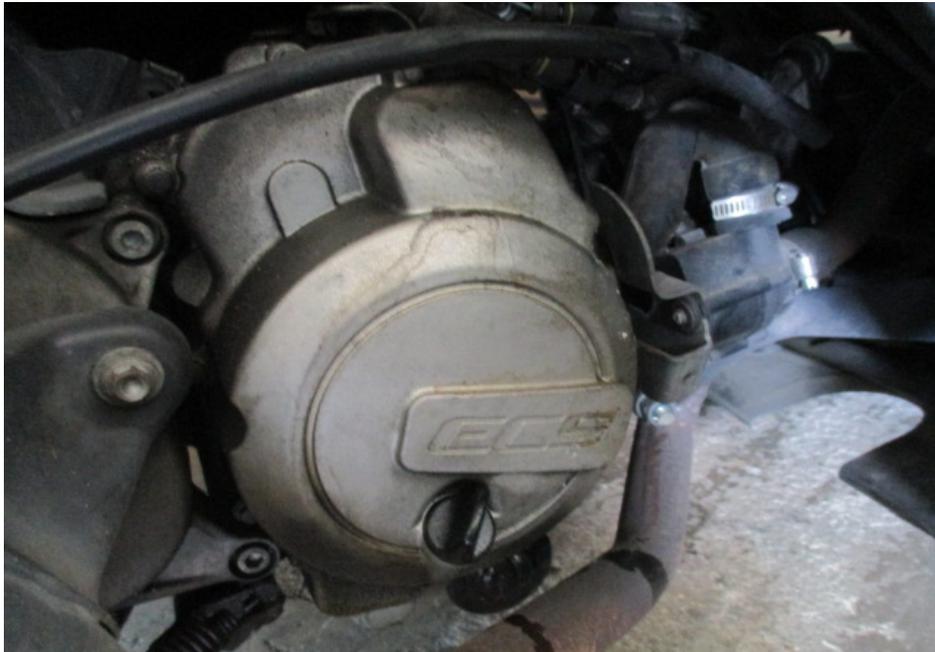
Photo 16 shows the right side of the engine of the Motorcycle at the time of our inspection. The various engine related parts and components were found to be intact with no visible damage. There was also no sign(s) or indication(s) of fluid leak observed around the right engine area of the Motorcycle.

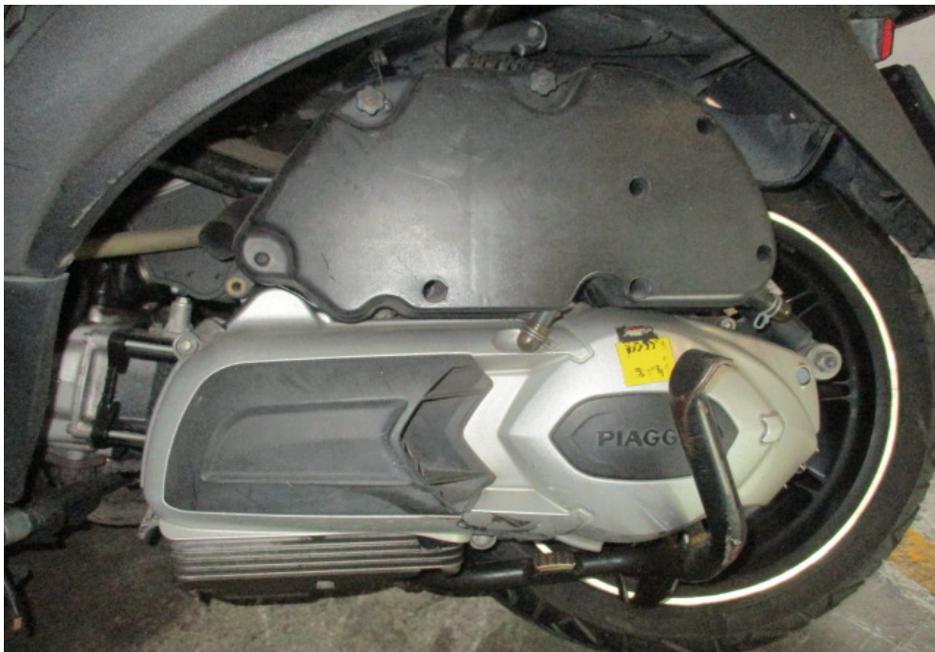
Photo 17 shows the drive train of the Motorcycle which was found to be intact without any misalignment.

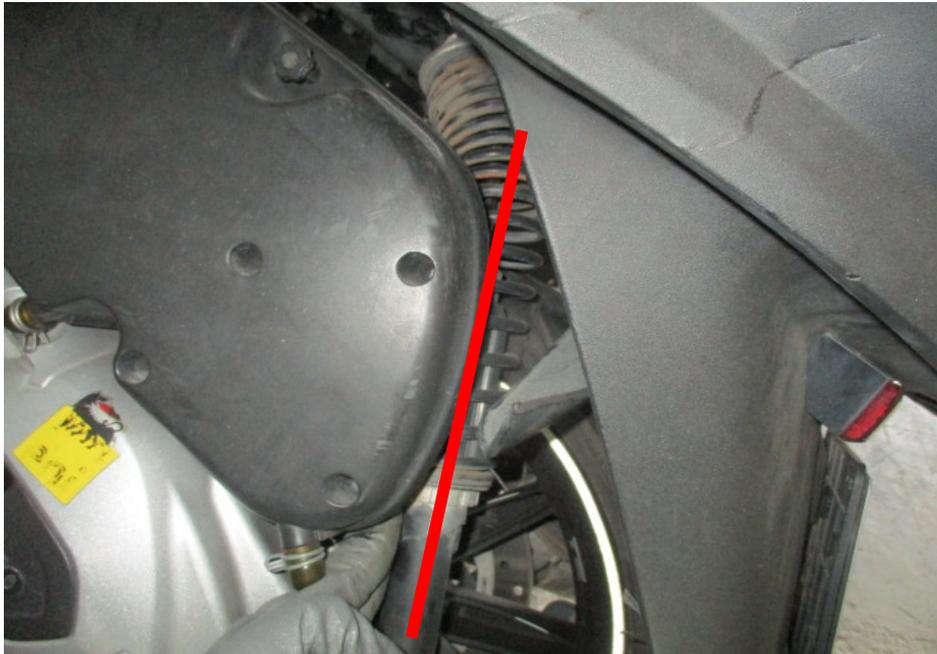
Photo 18 shows the left shock absorber of the motorcycle which was found to be intact but observed to be bent as a result of the accident.

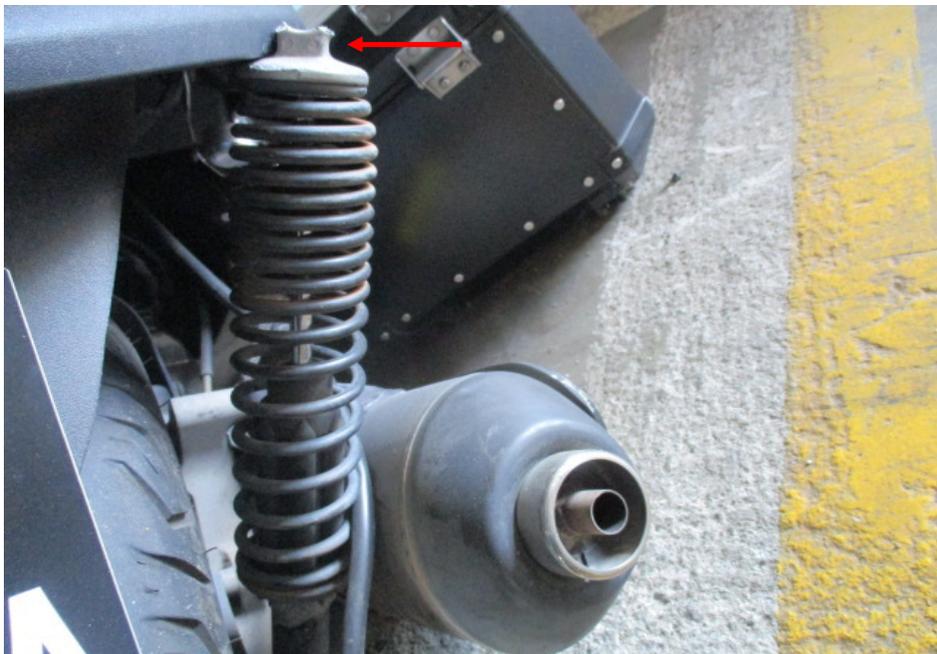
Photo 19 shows the right shock absorber of the Motorcycle which was found to be broken as a result of the accident (arrowed).

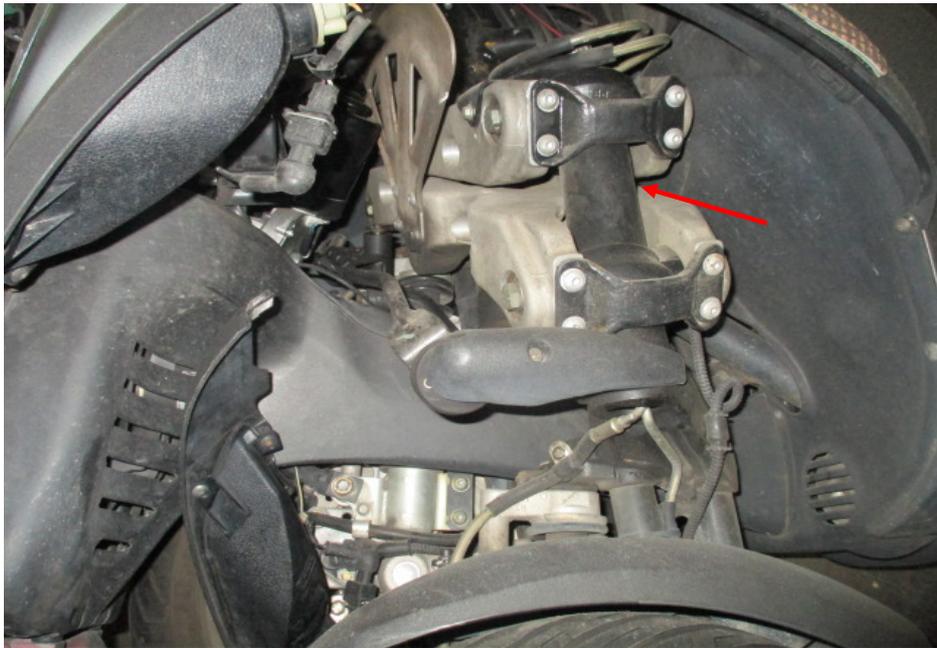
Photo 20 shows the left front fork (arrowed) of the Motorcycle. The left front fork and fork bracket of the Motorcycle were both found to be intact and undamaged. Turning the Motorcycle's handle bar towards the left and right did not produce any abnormal free play and/or resistance. The steering system of the Motorcycle was in serviceable condition at the time of our inspection.

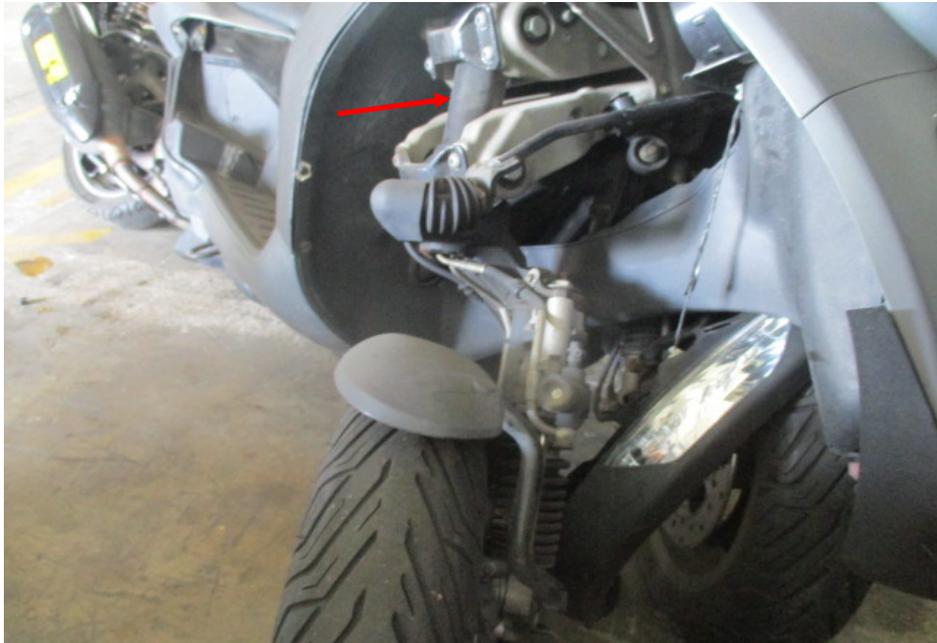
Photo 21 shows the right front fork (arrowed) of the Motorcycle. The right front fork and fork bracket of the Motorcycle were both found to be intact and undamaged. Turning the Motorcycle's handle bar towards the left and right did not produce any abnormal free play and/or resistance. The steering system of the Motorcycle was in serviceable condition at the time of our inspection.

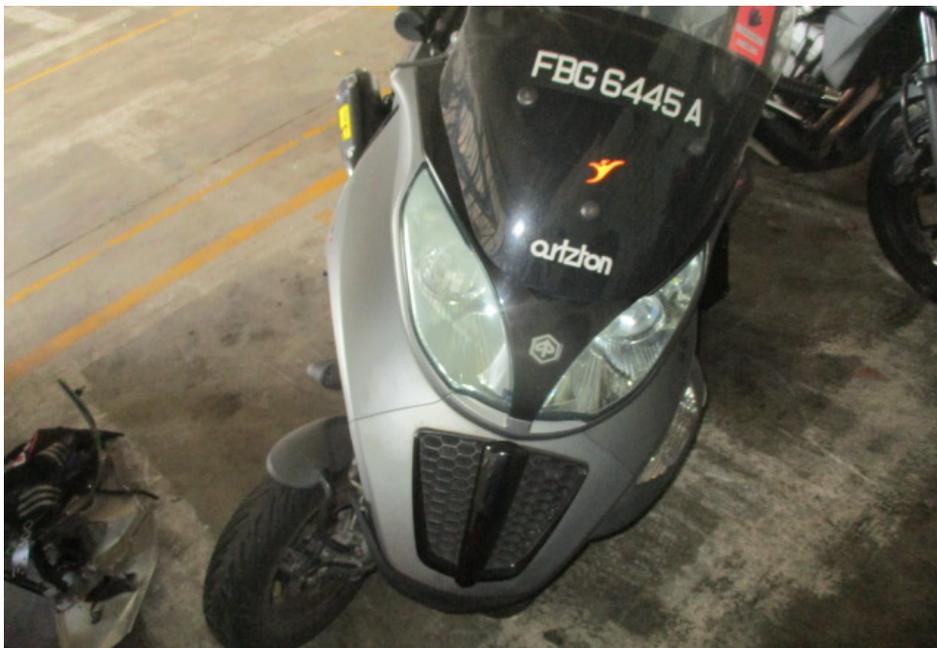
Photo 22 shows the front right wheel of the Motorcycle turned towards its full right. Turning the Motorcycle's handle bar towards the left and right did not produce any abnormal free play and/or resistance. This would indicate that the steering system of the Motorcycle was in serviceable condition at the time of our inspection.

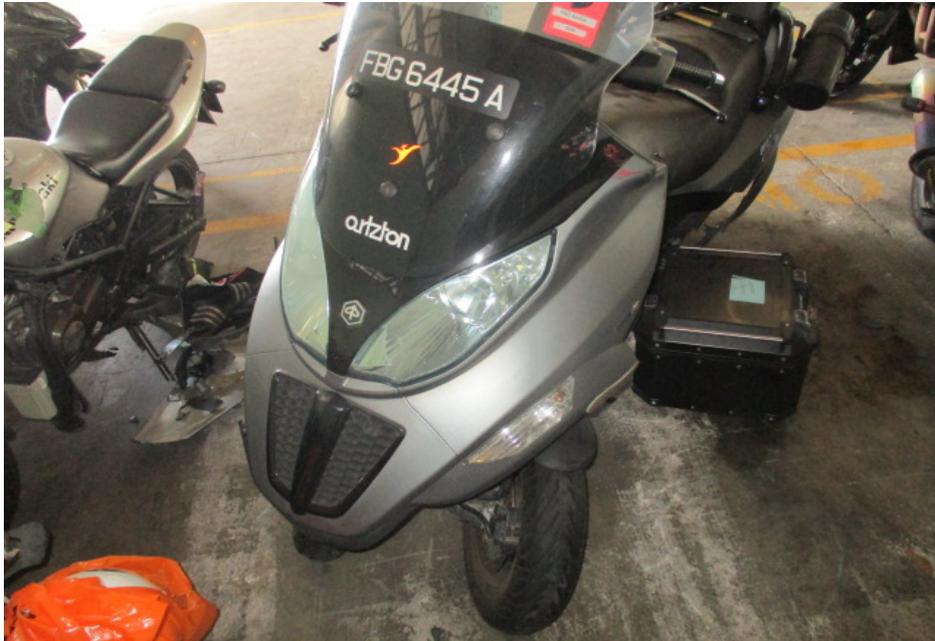
Photo 23 shows the front left wheel of the Motorcycle turned towards its full left. Turning the Motorcycle's handle bar towards the left and right did not produce any abnormal free play and/or resistance. This would indicate that the steering system of the Motorcycle was in serviceable condition at the time of our inspection.

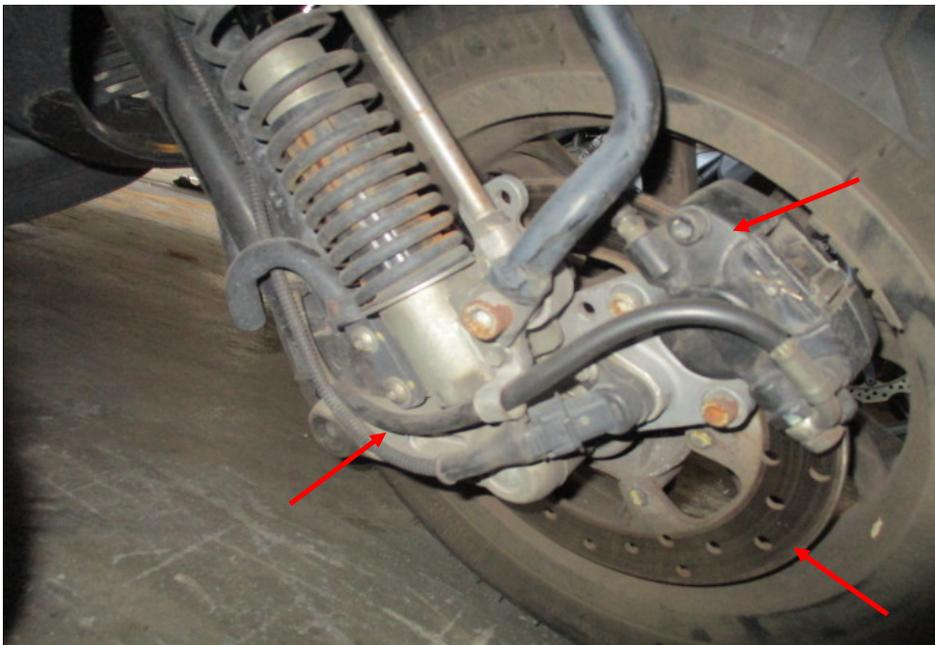
Photo 24 shows a close up view of the front brake caliper, front brake disc and front brake hose (arrowed) of the front left wheel of the Motorcycle, which are all part of the components in the hydraulic front brake system of the Motorcycle. Our visual checks of these various components had revealed all to be intact with no visible damage. No leakage of brake fluid was also observed.

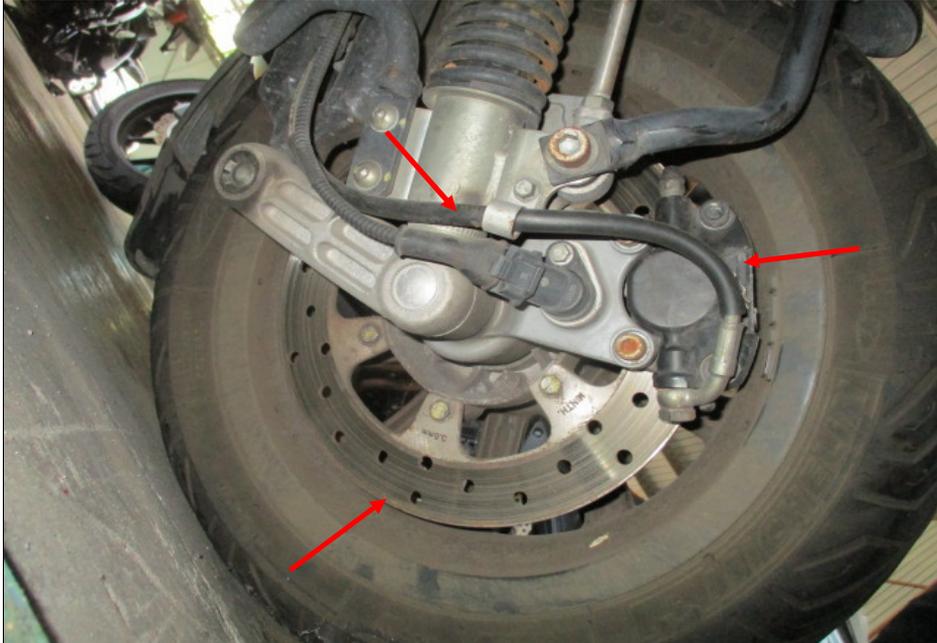
Photo 25 shows a close up view of the front brake caliper, front brake disc and front brake hose (arrowed) of the front right wheel of the Motorcycle, which are all part of the components in the hydraulic front brake system of the Motorcycle. Our visual checks of these various components had revealed all to be intact with no visible damage. No leakage of brake fluid was also observed.

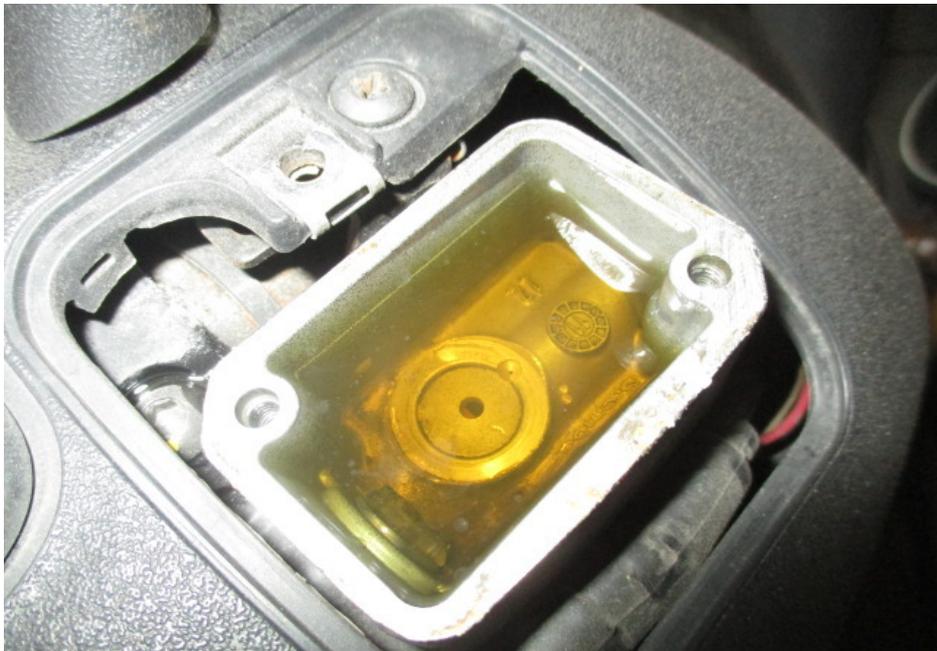
Photo 26 shows a close up view of the brake fluid reservoir for the front brake of the Motorcycle. The brake fluid was observed to be of sufficient level and without contamination for operational purposes.

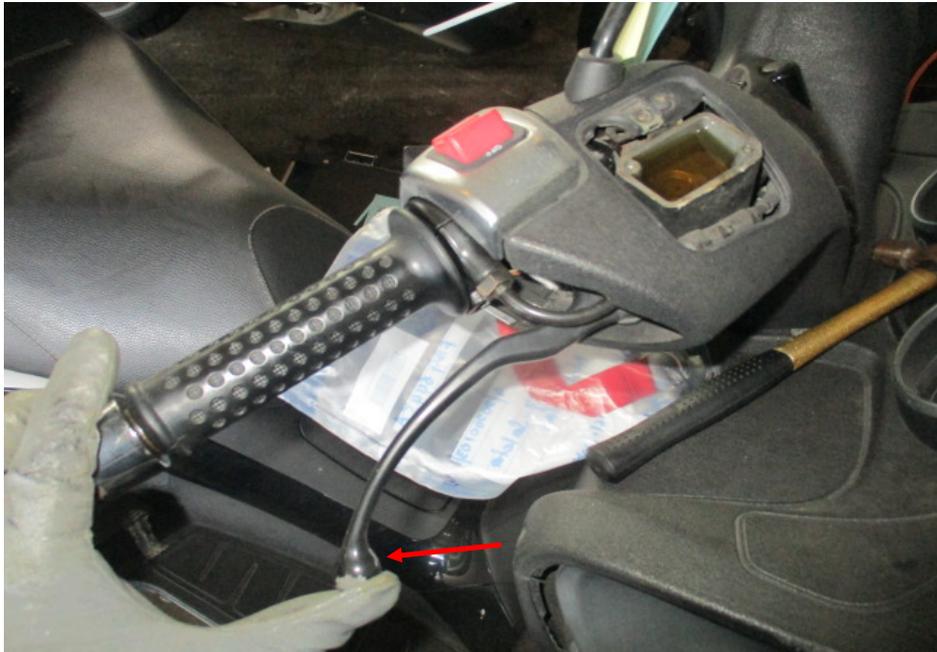
13. Static brake tests conducted on the Motorcycle had appeared to indicate that the front braking system of the Motorcycle was in serviceable condition. There was some resistance felt (spongy like feel) upon pressing the front brake lever. This would indicate that there's no leakage of pressure/vacuum in the front braking system. Our checks on the brake fluid had also indicated that the brake fluid was of sufficient level for operational purposes, and without contamination.

Photo 27 shows the front brake lever being depressed. There was some resistance felt (spongy like feel) upon pressing the front brake lever (arrowed). This would indicate that there is no leakage of pressure/vacuum in the front braking system.

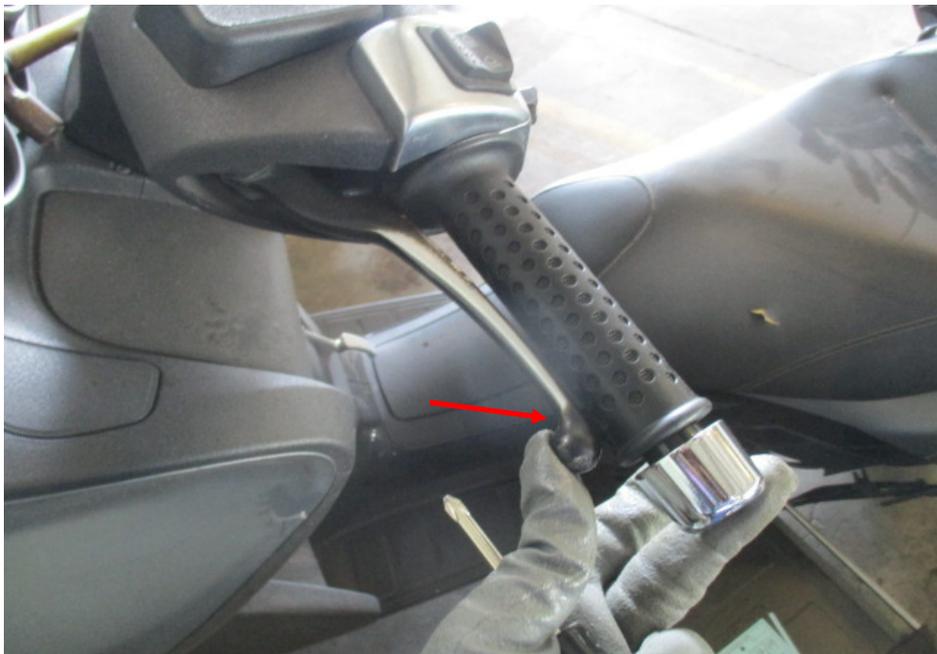
14. Static brake tests conducted on the Motorcycle had appeared to indicate that the rear braking system of the Motorcycle was not in serviceable condition. There was no resistance felt (spongy like feel) upon pressing the rear brake lever. This would indicate that there may be a leakage of pressure/vacuum in the rear braking system.

Photo 28 shows the rear brake lever being depressed. There was no resistance felt (spongy like feel) upon pressing the rear brake lever (arrowed). This would indicate that there may be a leakage of pressure/vacuum in the rear braking system.

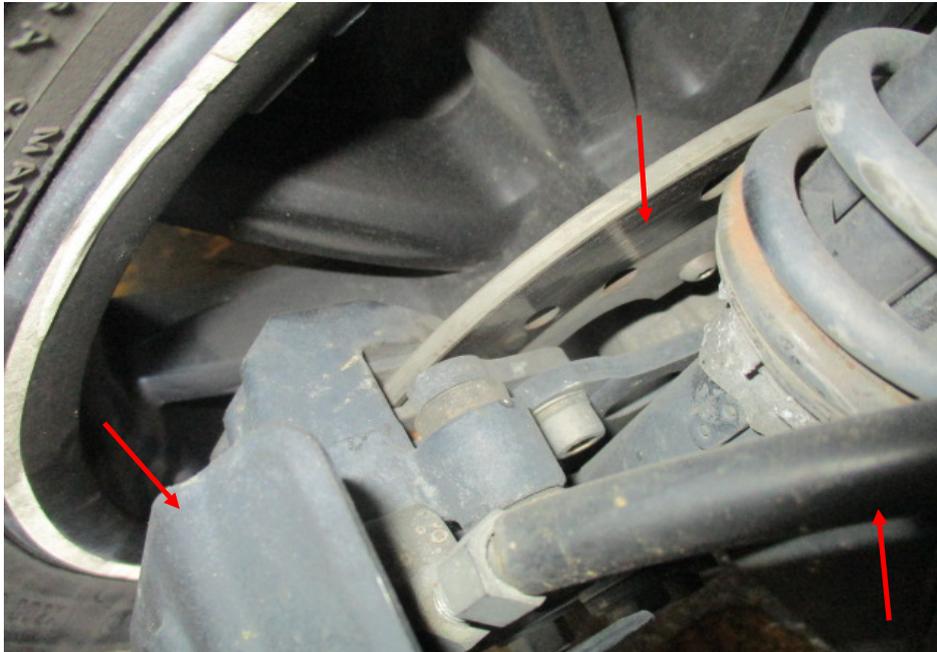
Photo 29 shows a close up view of the rear brake caliper, rear brake disc and rear brake hose (arrowed) of the Motorcycle, which are all part of the components in the hydraulic rear brake system of the Motorcycle. Our visual checks of these various components revealed all to be intact with no visible damage. No leakage of brake fluid was also observed.

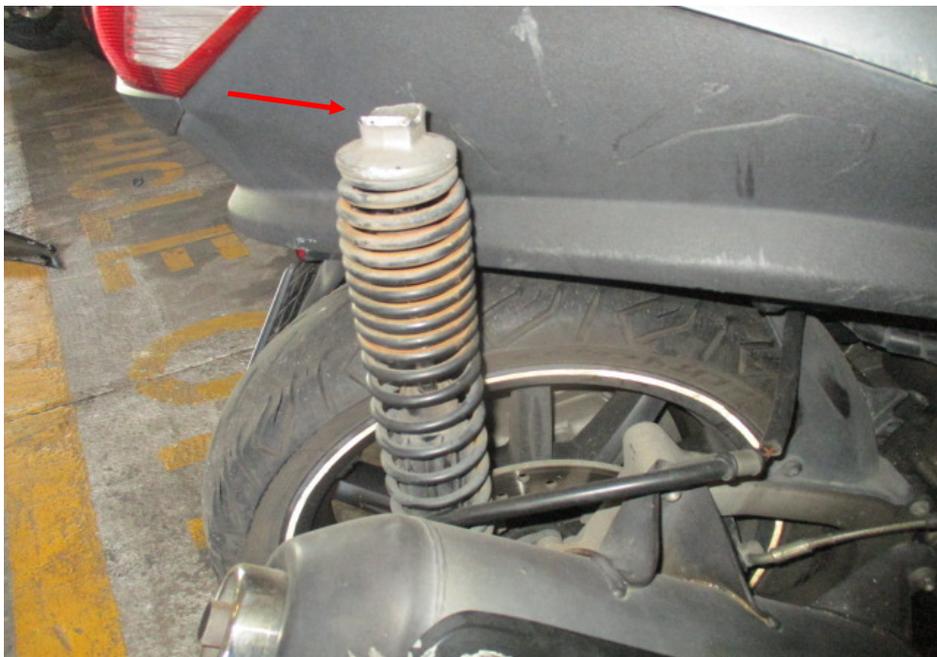
15. For this case, we were not able to carry out any operational tests to the steering system and braking system of the Motorcycle due to the damages sustained to its rear shock absorbers, which had rendered the Motorcycle immobile for the operational tests. We were not able to push the Motorcycle manually forward and backward, simulating movement of the Motorcycle, for the operational tests. See photos 20 – 30 below.

Photo 30 shows the broken rear right shock absorber as a result of the accident (arrowed), which had rendered the Motorcycle immobile for the operational tests. We were not able to push the Motorcycle manually forward and backward, simulating movement of the Motorcycle, for the operational tests.
