Your Ref: TP/IP/04631/2020
Our Ref : CI/TPD20001857/N

13 April 2020

MECHANICAL INSPECTION REPORT OF MOTORCYCLE FL 9170Z

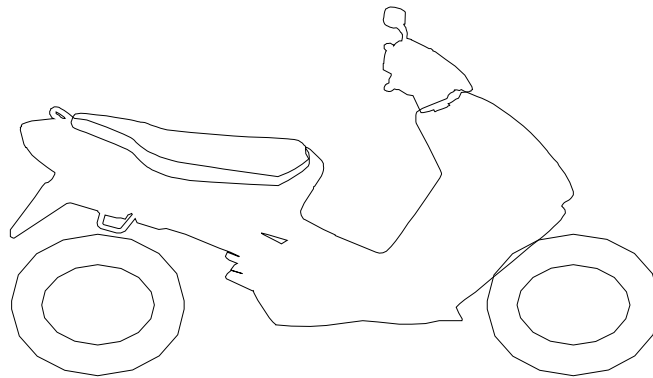
6. The condition of the 2 tyres of the Motorcycle was observed to be in serviceable condition. We did not observe any tear, burst mark(s) and/or punctured hole(s) on the sidewalls as well as across the tread of the 2 tyres. Both the tyres were observed to be sufficiently inflated for vehicular operation. The tyre brand, tyre size and remaining tread depth of the 2 tyres of the Motorcycle were recorded as follows:-

Bridgestone 160/60 - 17 (4mm)

Bridgestone 120/70 - 17 (4mm)

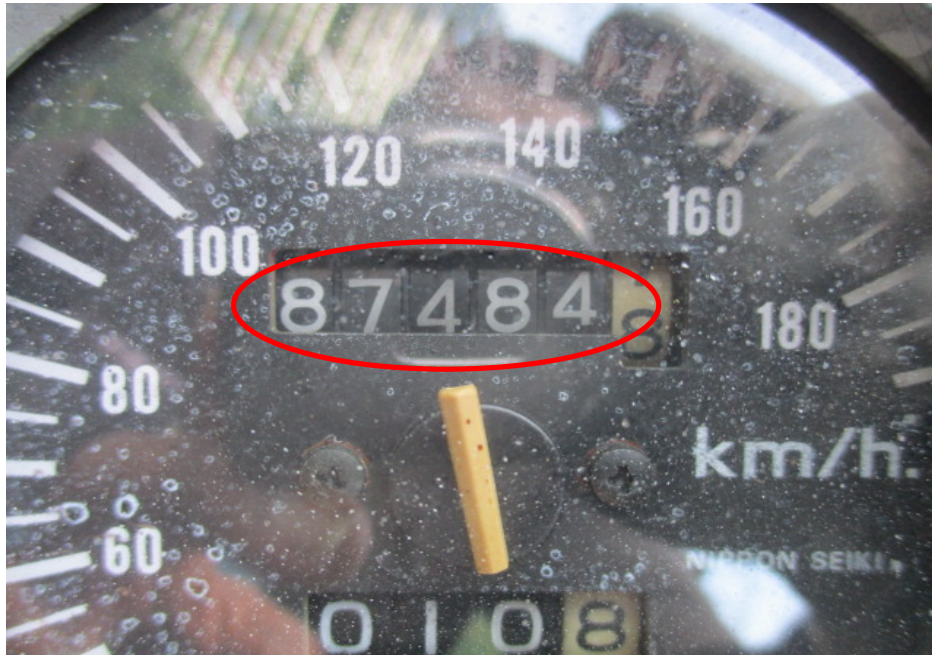
Photo 1 shows the speedometer gauge of the Motorcycle where the mileage recorded at the time of our inspection was 87,484km (circled).

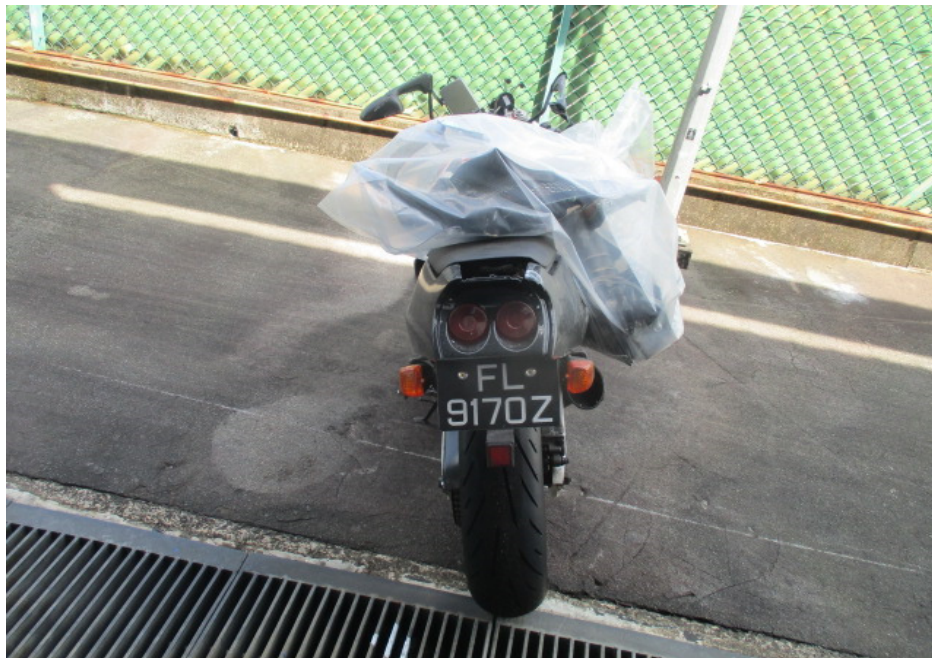
Photo 2 shows a general view of the rear portion of the Motorcycle at the time of our inspection. The Motorcycle had sustained damages all around.

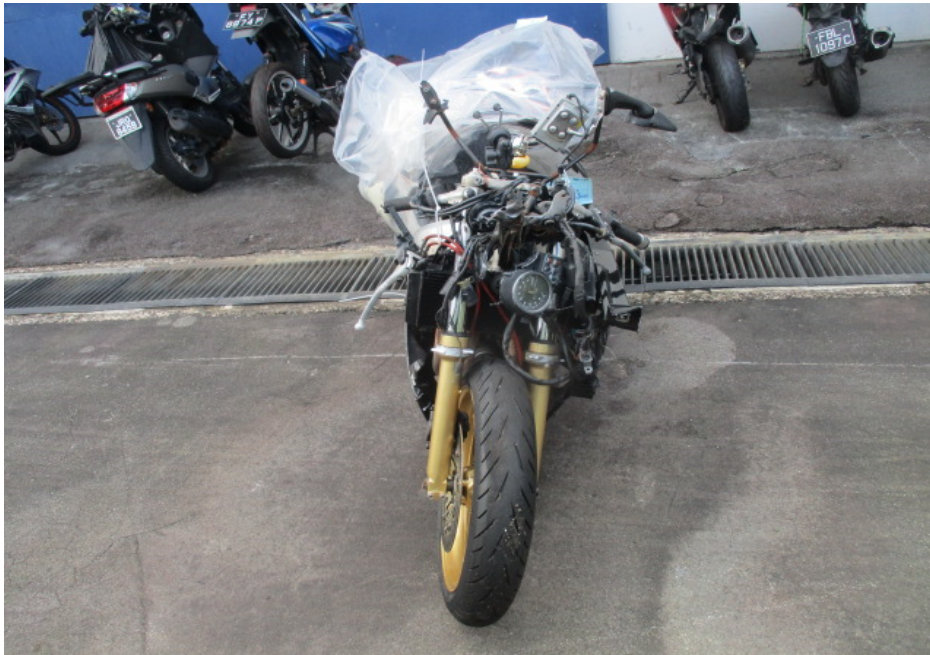
Photo 3 shows a general view of the frontal portion of the Motorcycle at the time of our inspection. The Motorcycle had sustained damages all around. Body parts that were found to have been damaged include its headlight assembly, speedometer, side mirrors, clutch lever, front brake lever, right side frame, petrol tank, rear brake pedal, right front footrest, exhaust muffler and rear side covers, amongst others.

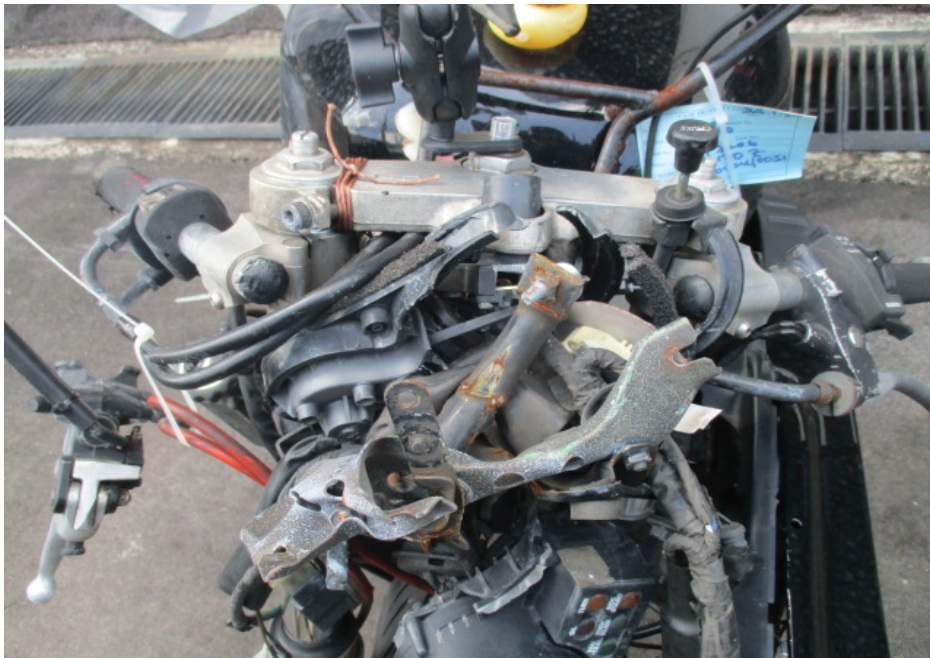
Photo 4 shows a closer view of the headlight assembly which was amongst the body parts at the front body of the Motorcycle that had sustained damages as a result of the accident.

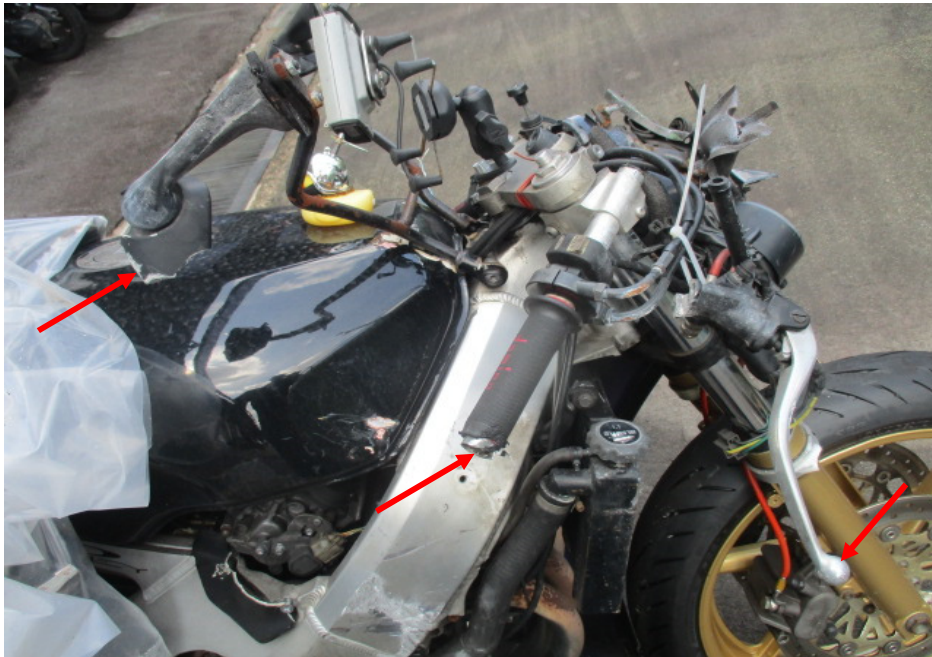
Photo 5 shows a closer view of the front brake lever, right side mirror and right handlebar end (arrowed) of the Motorcycle. These parts were amongst the body parts of the Motorcycle which were damaged as a result of the accident.

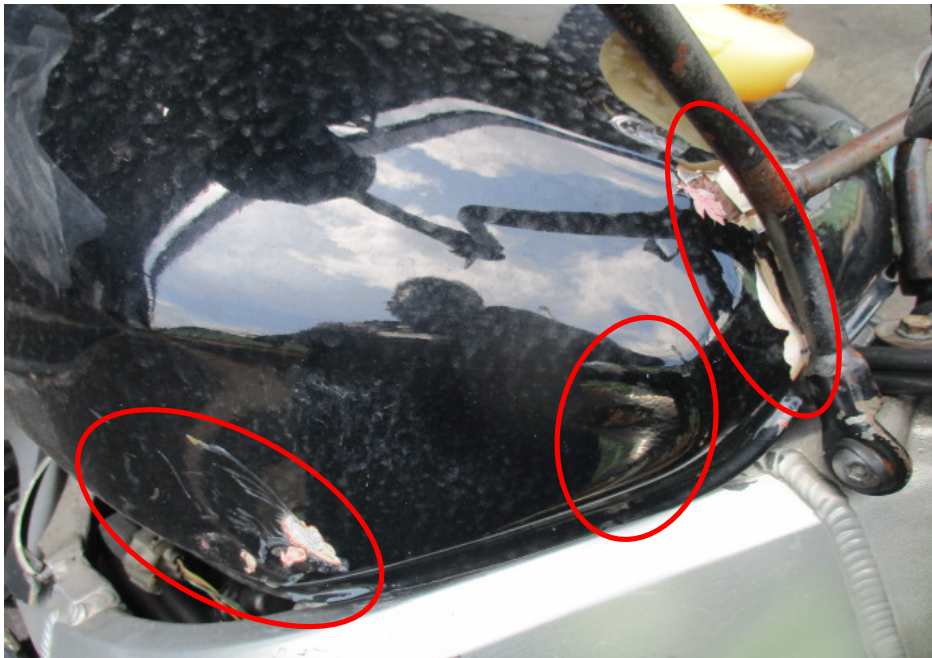
Photo 6 shows a closer view of the dented petrol tank, which was amongst the body parts of the Motorcycle that had sustained damage as a result of the accident.

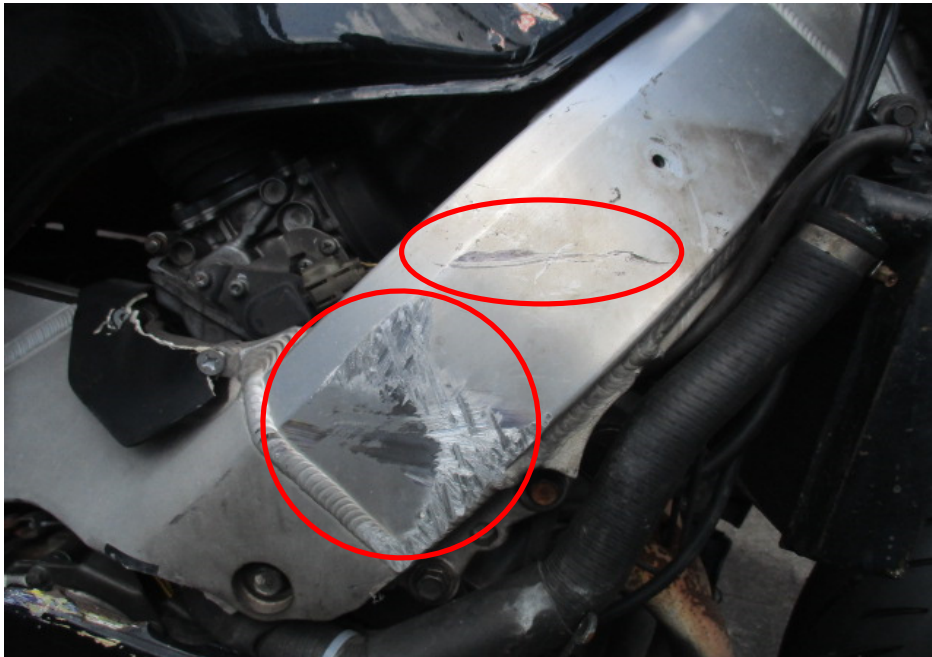
Photo 7 shows the damaged right side frame (circled) of the Motorcycle. The damage sustained at the side frame of the Motorcycle was mainly of grazing nature.

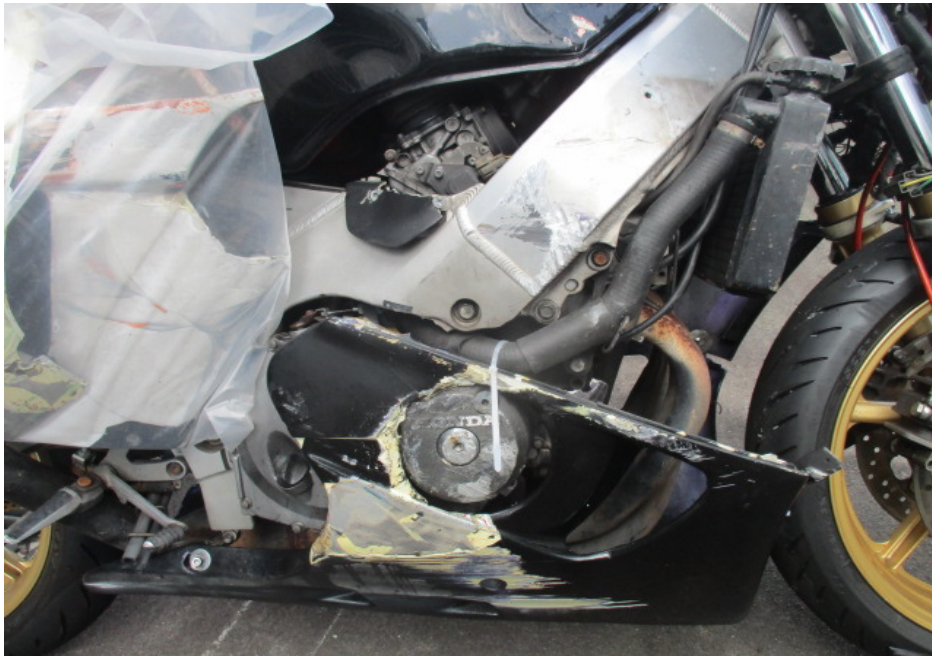
Photo 8 shows a closer view of the right cowling which was amongst the body parts at the front body of the Motorcycle that had sustained damages as a result of the accident.

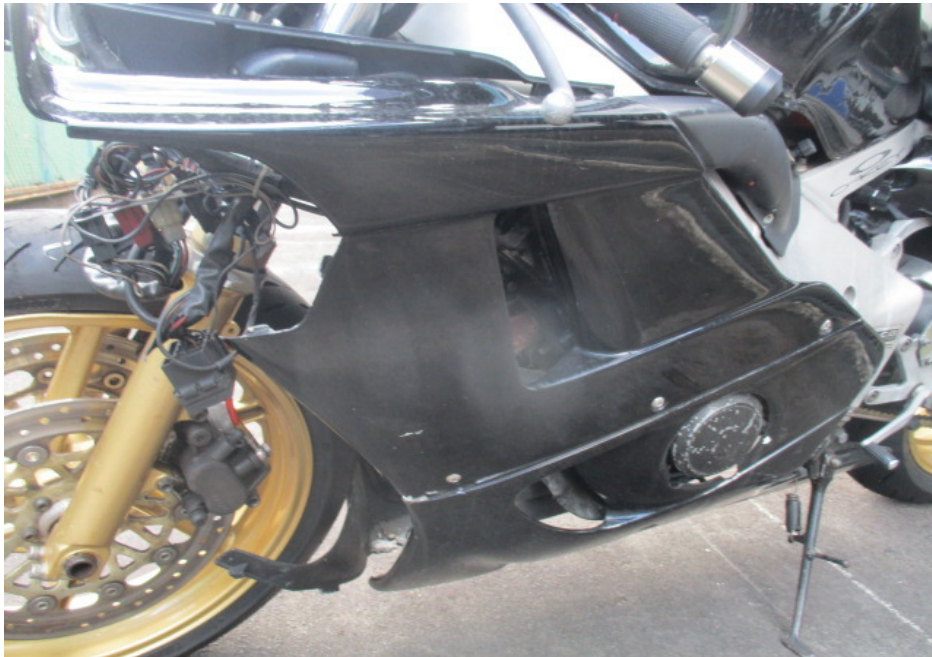
Photo 9 shows a closer view of the left cowling which was amongst the body parts at the front body of the Motorcycle that had sustained damages as a result of the accident.

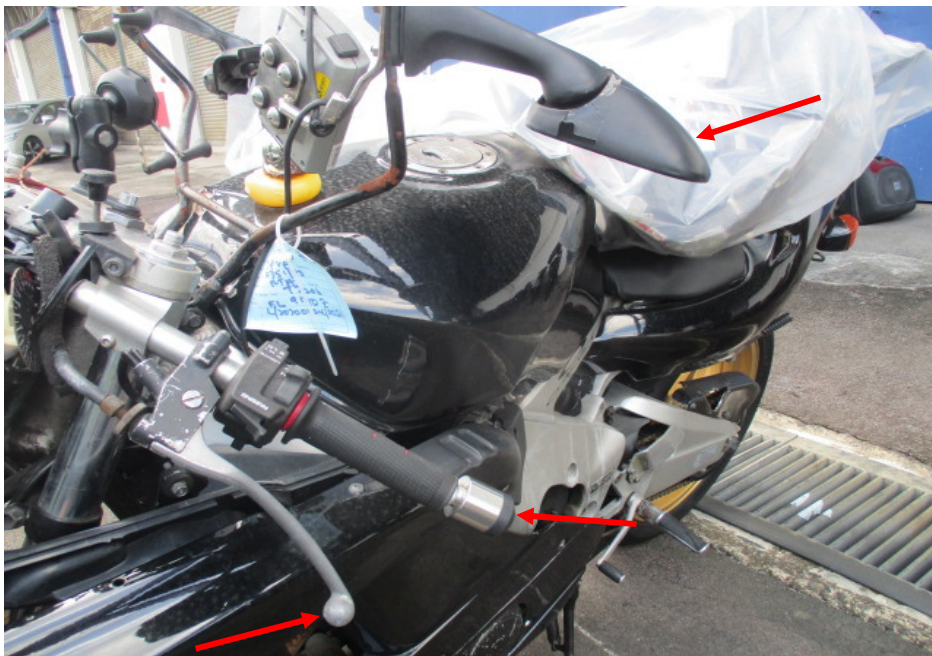
Photo 10 shows a closer view of the left side mirror, clutch lever and left handlebar end (arrowed), which were amongst the body parts of the Motorcycle that had sustained damage as a result of the accident.

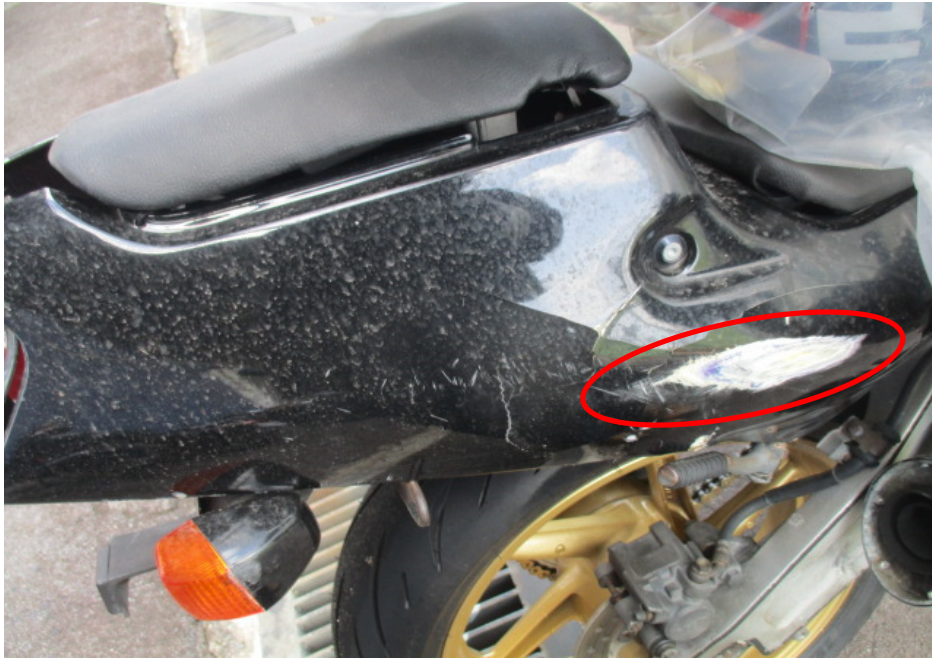
Photo 11 shows the right rear cover (circled) which was amongst the body parts at the rear body of the Motorcycle that had sustained damages as a result of the accident.

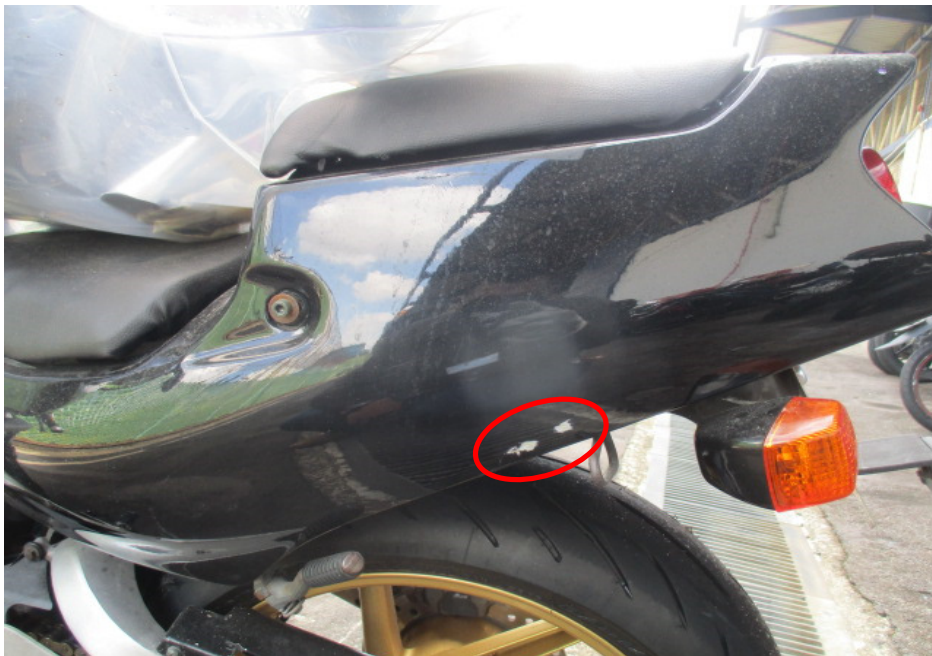
Photo 12 shows the right rear cover (circled) which was amongst the body parts at the rear body of the Motorcycle that had sustained damages as a result of the accident.

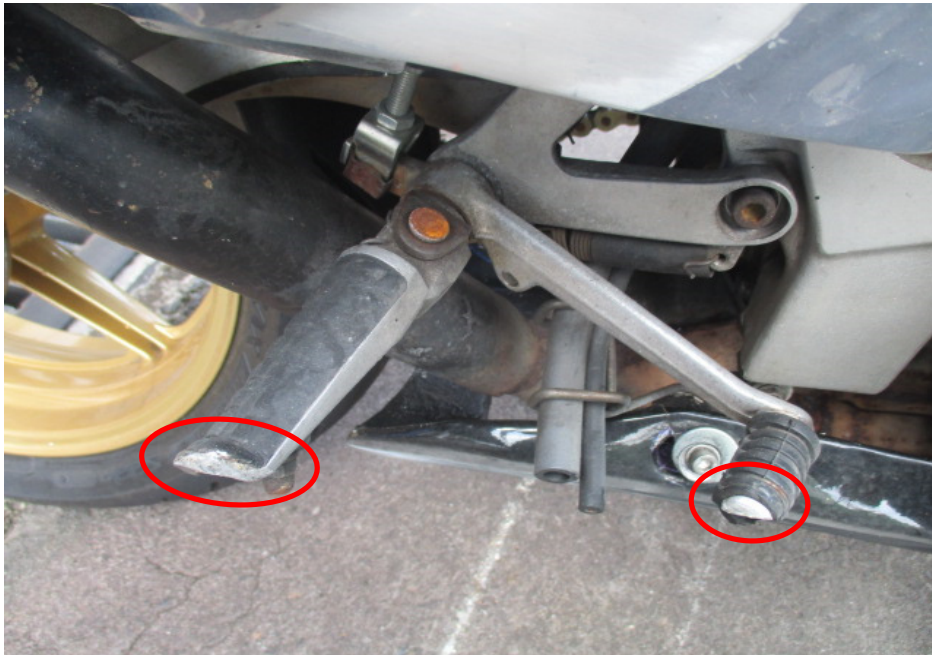
Photo 13 shows the damaged rear brake pedal and right front footrest (circled) of the Motorcycle.

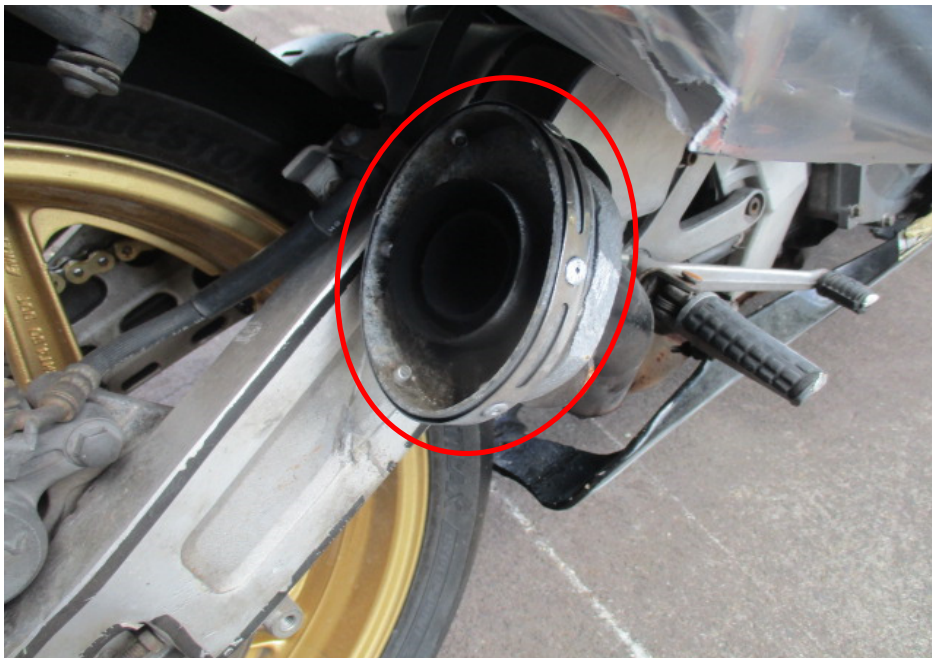
Photo 14 shows the exhaust muffler (circled) which was amongst the body parts of the Motorcycle that had sustained damage as a result of the accident.

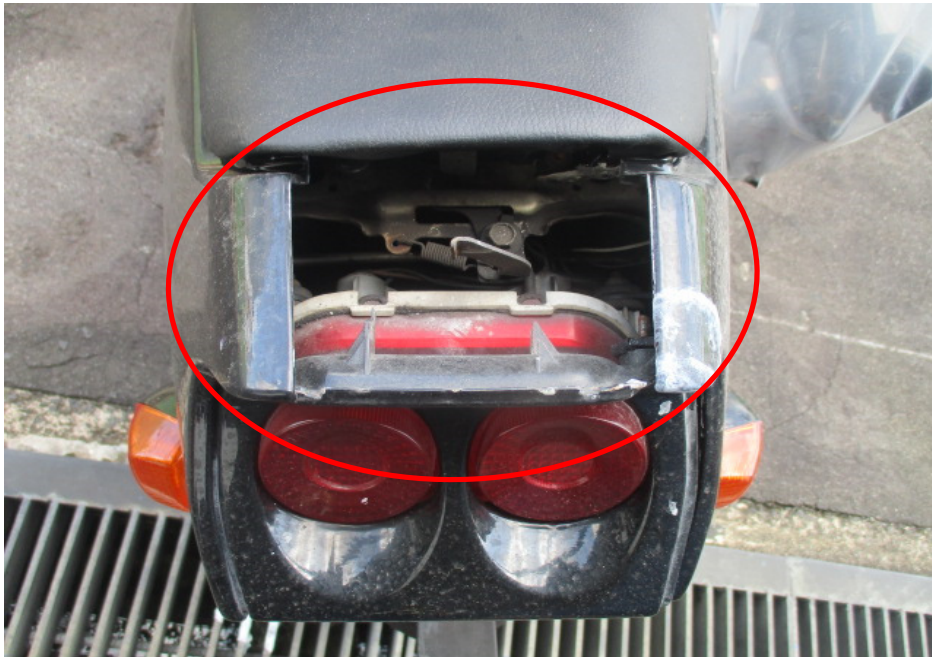
Photo 15 shows the damaged rear cover (circled) of the Motorcycle as a result of the accident.

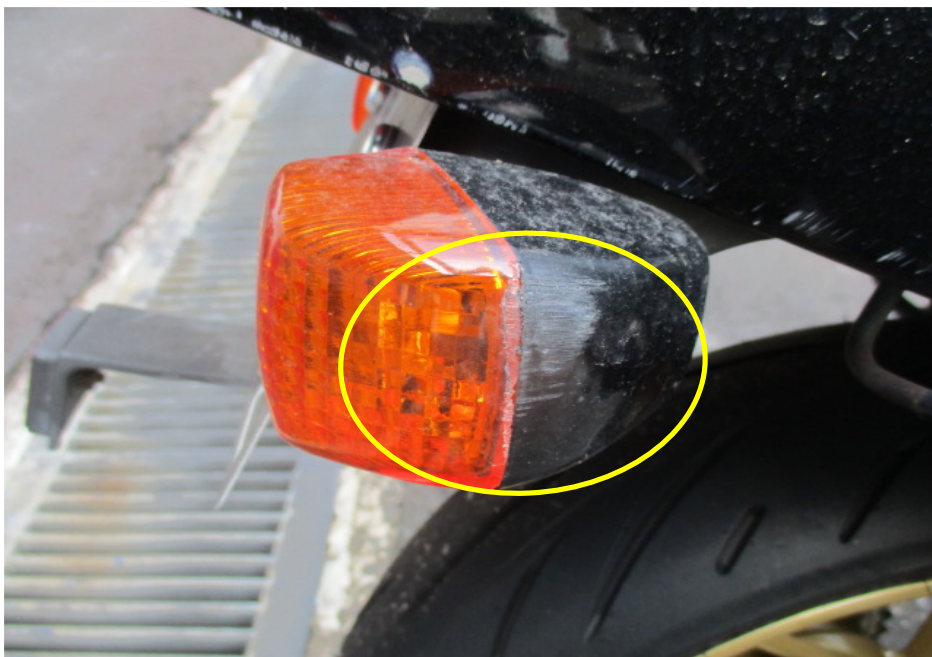
Photo 16 shows the damaged right rear signal lamp (circled) of the Motorcycle as a result of the accident.

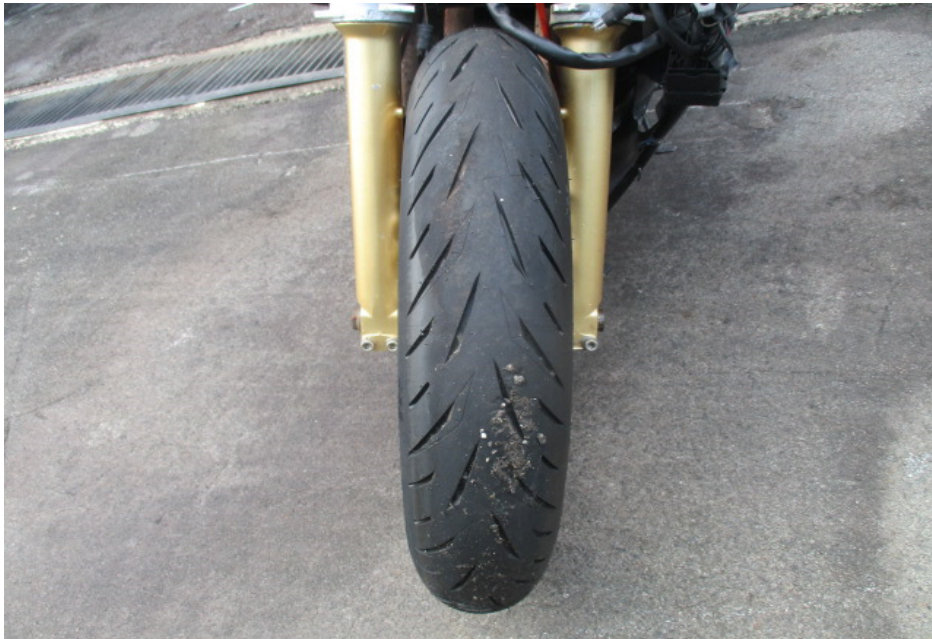
Photo 17 shows the front tyre of the Motorcycle at the time of our inspection. The front tyre was observed to be in serviceable condition with remaining tread depth of approximately 4mm. The pattern of the tread was also clearly visible. There was no tear, burst mark(s) and/or punctured hole(s) on the sidewalls as well as across the tread of the front tyre.

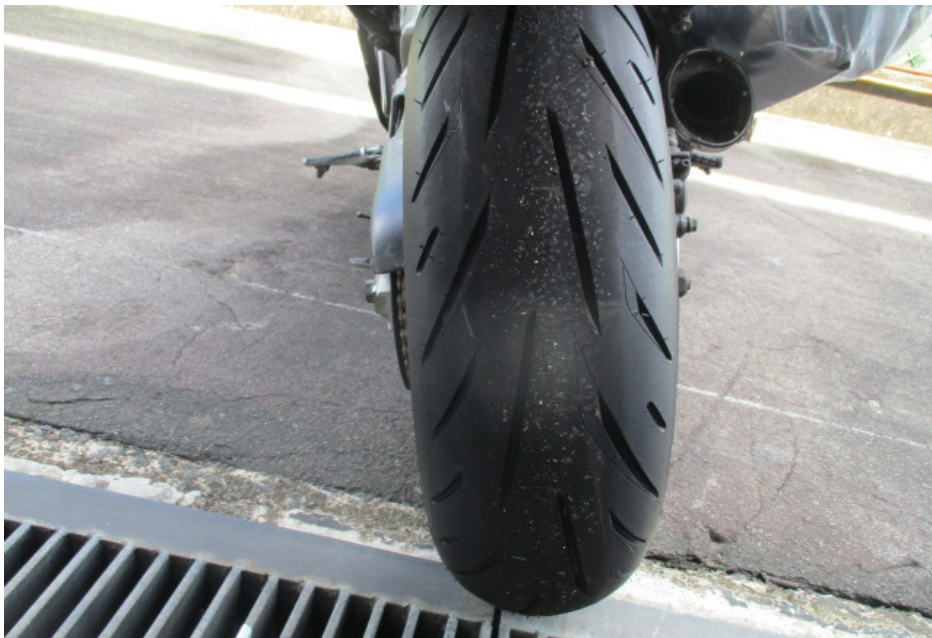
Photo 18 shows the condition of the Motorcycle's rear tyre. The rear tyre was observed to be in serviceable condition with remaining tread depth of approximately 4mm. The tyre was also observed to be sufficiently inflated for vehicular operation. We did not observe any tear, burst mark(s) and/or punctured hole(s) on the sidewalls as well as across the tread of the rear tyre.

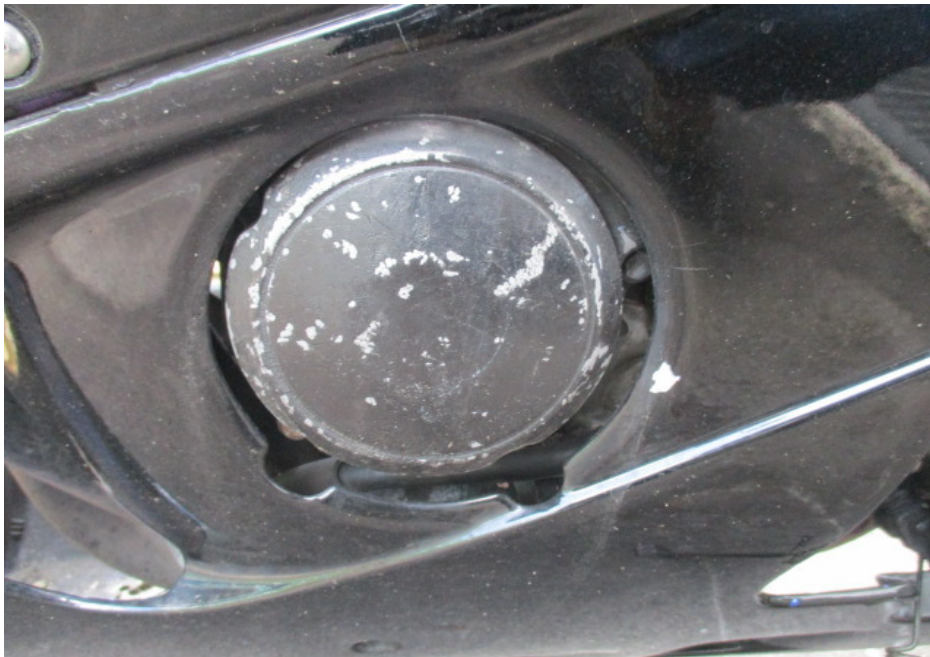
Photo 19 shows the left side of the engine of the Motorcycle at the time of our inspection. The various engine related parts and components were found to be intact with no visible damage. There was also no sign(s) or indication(s) of fluid leak observed around the left engine area of the Motorcycle.

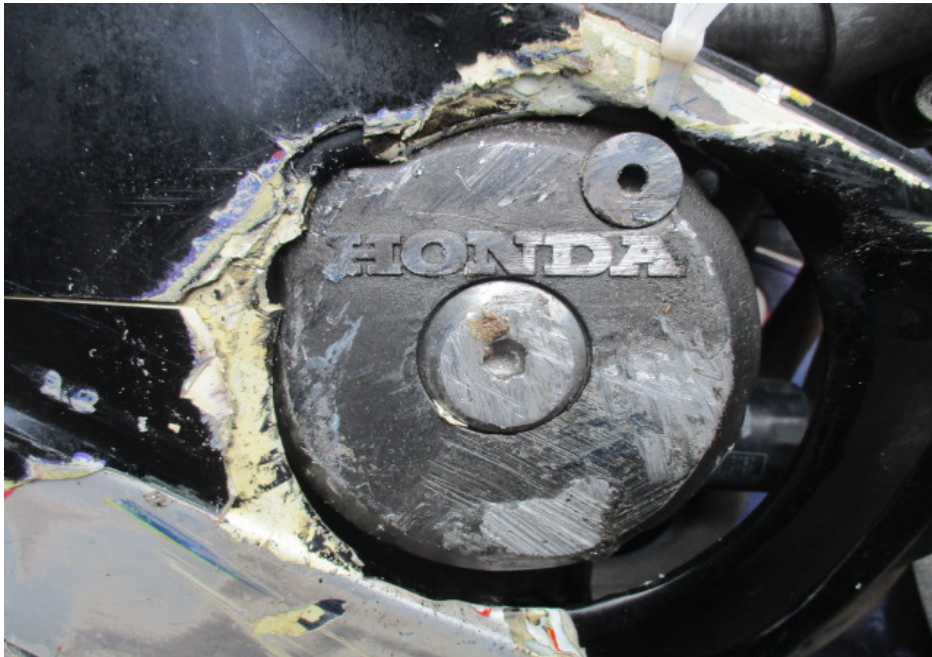
Photo 20 shows the right side of the engine of the Motorcycle at the time of our inspection. The various right engine components had sustained damage of grazing nature as a result of the accident however the engine components were still intact. There was also no fluid leak and/or fluid stain found around the right engine area of the Motorcycle.

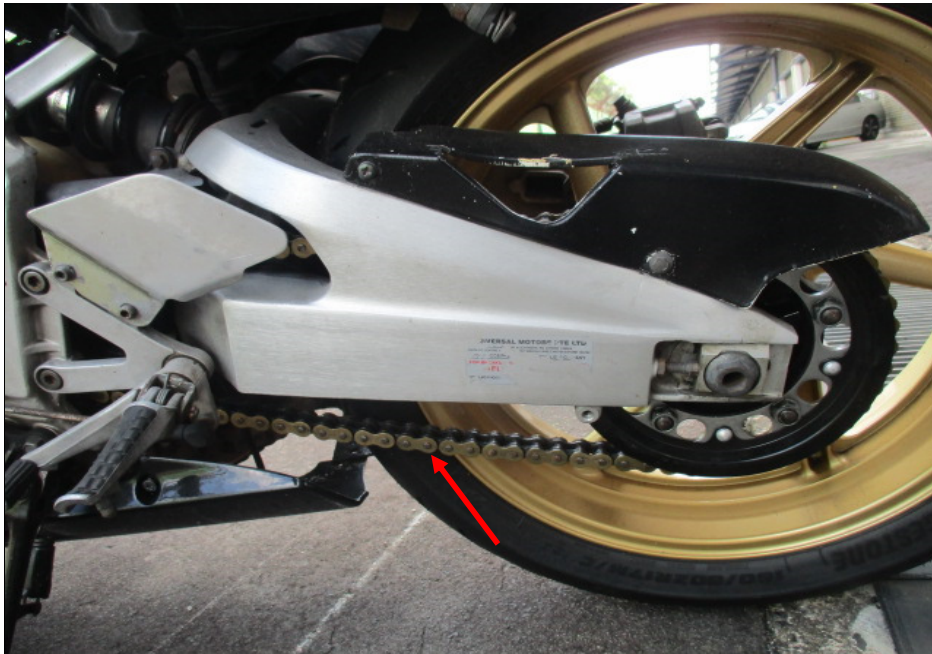
Photo 21 shows the gear chain (arrowed) of the Motorcycle, which was observed to be intact with no misalignment. It was also adequately lubricated for operating purposes. The gear chain rotates the rear wheel of the Motorcycle.

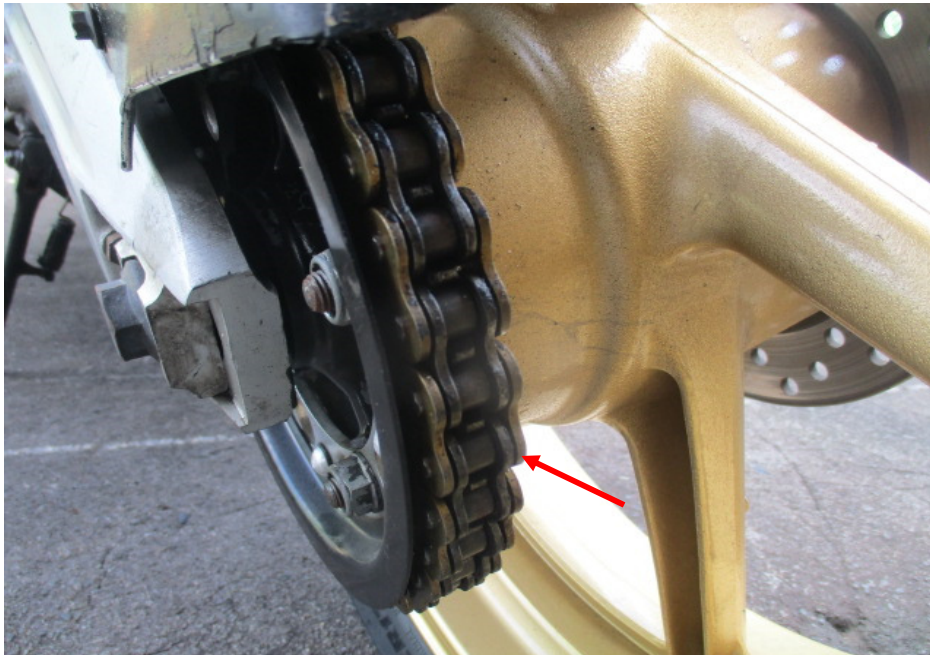
Photo 22 shows the closer view of the gear chain (arrowed) of the Motorcycle, which was observed to be intact with no misalignment. It was also adequately lubricated for operating purposes.

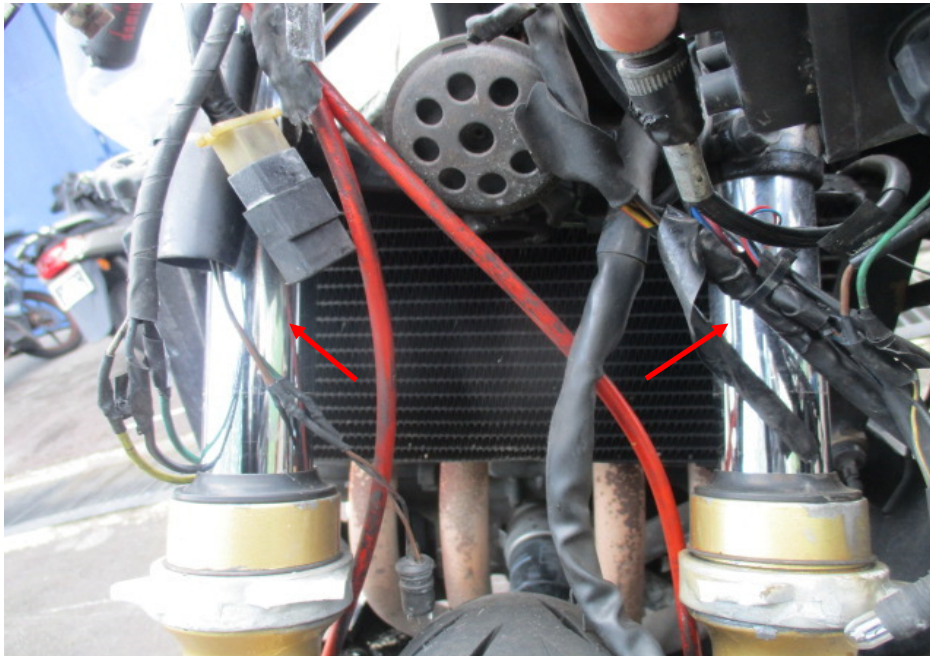
10. Our checks on the various steering components of the Motorcycle revealed that its steering system was in serviceable condition. Its front fork was found to be intact and undamaged. Turning the handle bar towards the left and right also did not produce any abnormal free play and/or resistance.

Photo 23 shows the front fork (arrowed) of the Motorcycle. The front fork and fork bracket of the Motorcycle were both found to be intact and undamaged. Turning the Motorcycle's handle bar towards the left and right did not produce any abnormal free play and/or resistance. The steering system of the Motorcycle was in serviceable condition at the time of our inspection.

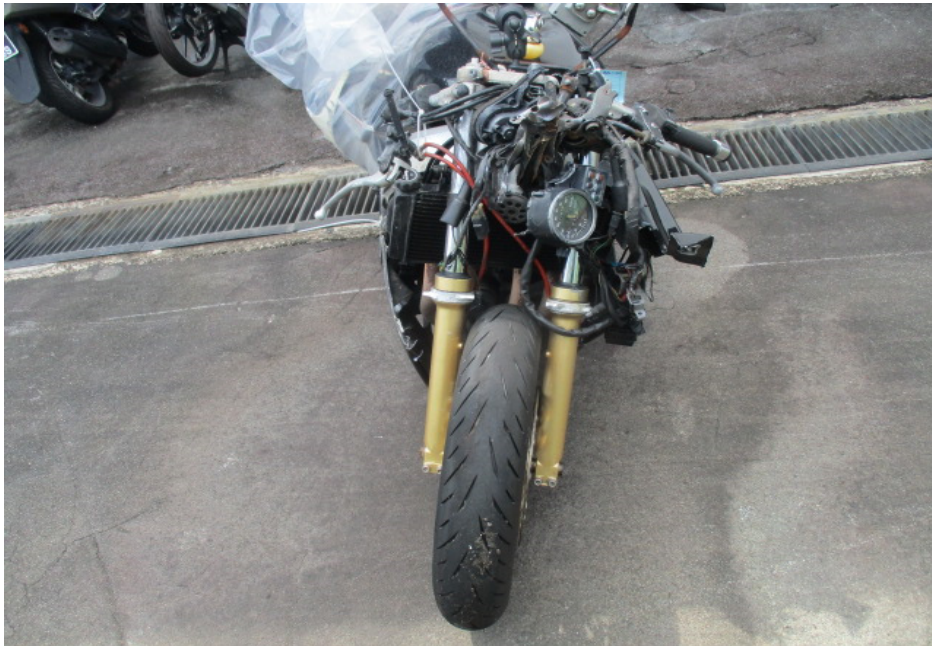
Photo 24 shows the front wheel of the Motorcycle turned towards its full right. Turning the Motorcycle's handle bar towards the left and right did not produce any abnormal free play and/or resistance. This would indicate that the steering system of the Motorcycle was in serviceable condition at the time of our inspection.

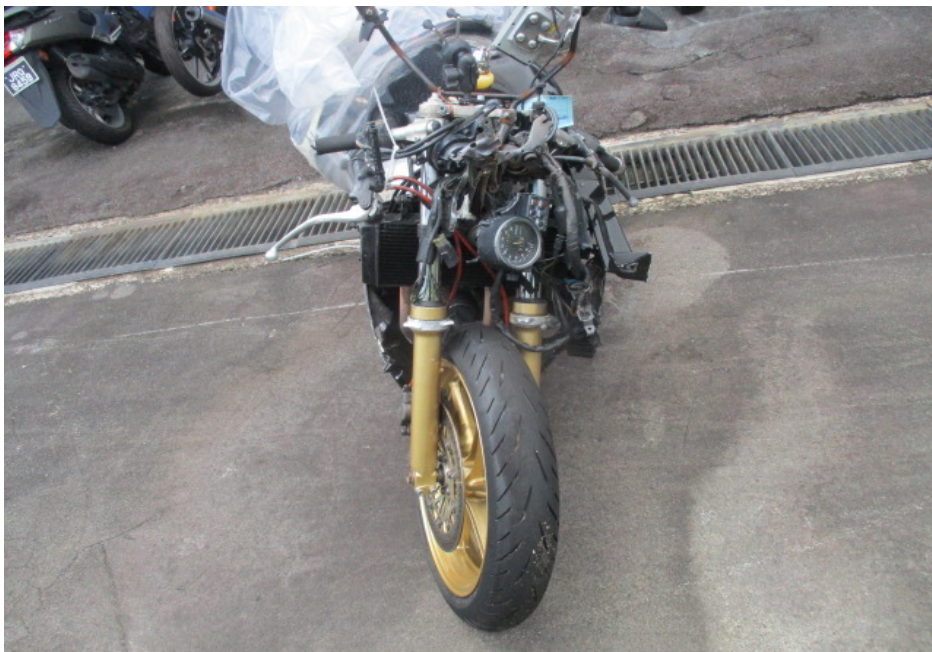
Photo 25 shows the front wheel of the Motorcycle turned towards its full left. Turning the Motorcycle's handle bar towards the left and right did not produce any abnormal free play and/or resistance. This would indicate that the steering system of the Motorcycle was in serviceable condition at the time of our inspection.

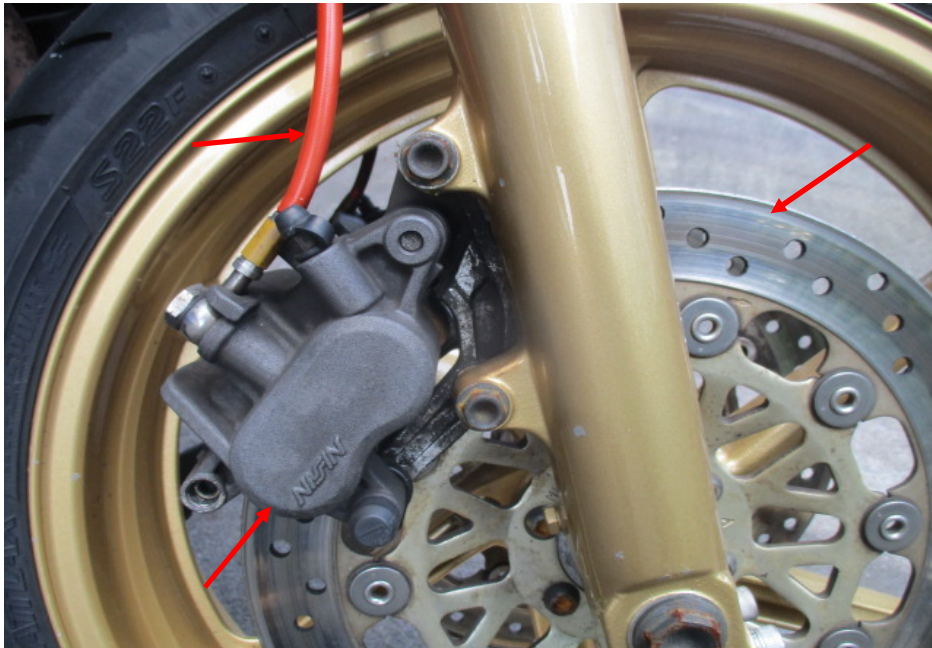
Photo 26 shows a close up view of the front brake caliper, front brake disc and front brake hose (arrowed) at the right side of the Motorcycle's front wheel, which are all part of the components in the hydraulic front brake system of the Motorcycle. Our visual checks of these various components had revealed all to be intact with no visible damage. No leakage of brake fluid was also observed.

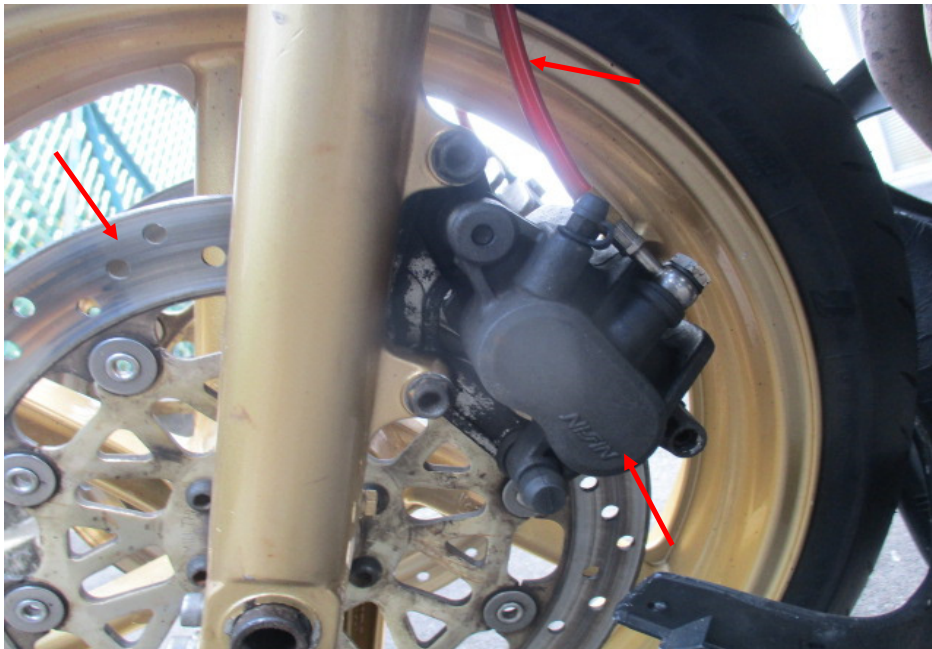
Photo 27 shows a close up view of the front brake caliper, front brake disc and front brake hose (arrowed) at the left side of the Motorcycle's front wheel, which are all part of the components in the hydraulic front brake system of the Motorcycle. Our visual checks of these various components had revealed all to be intact with no visible damage. No leakage of brake fluid was also observed.

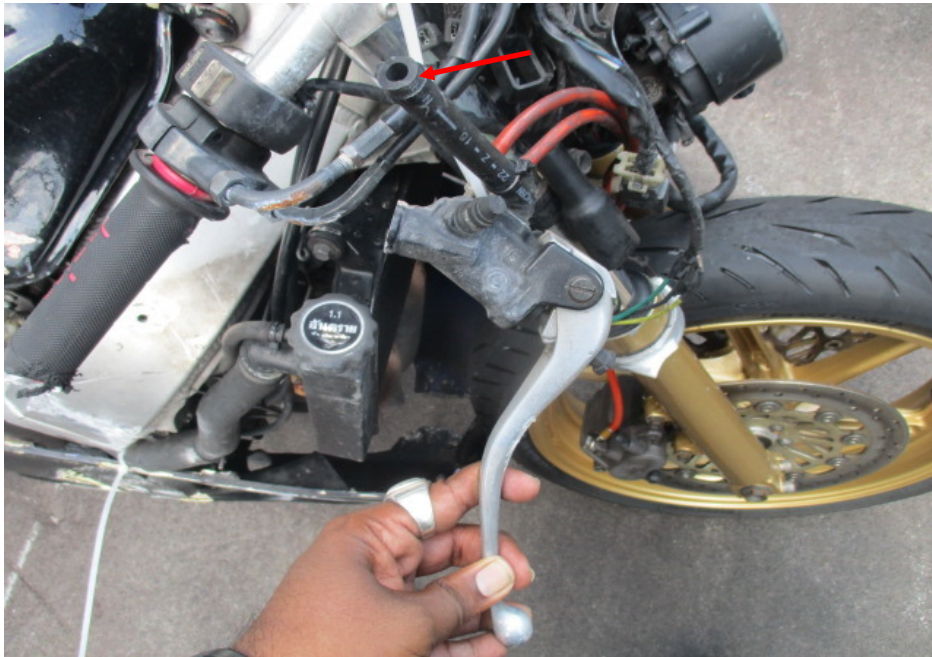
13. However we observed that the front brake reservoir was missing as a result of the accident.
14. Static brake tests conducted on the Motorcycle had appear to indicate that the rear braking system of the Motorcycle was in serviceable condition. There was some resistance felt (spongy like feel) upon stepping on the brake pedal. This would indicate that there was no leakage of pressure/vacuum in the rear brake system. We were unable to conduct any static brake test on the front braking system of the Motorcycle due to the missing front brake reservoir.

Photo 28 shows the front brake lever of the Motorcycle. However we observed that the front brake reservoir was missing as a result of the accident (arrowed). Therefore we were unable to conduct any static brake test on the front braking system of the Motorcycle.

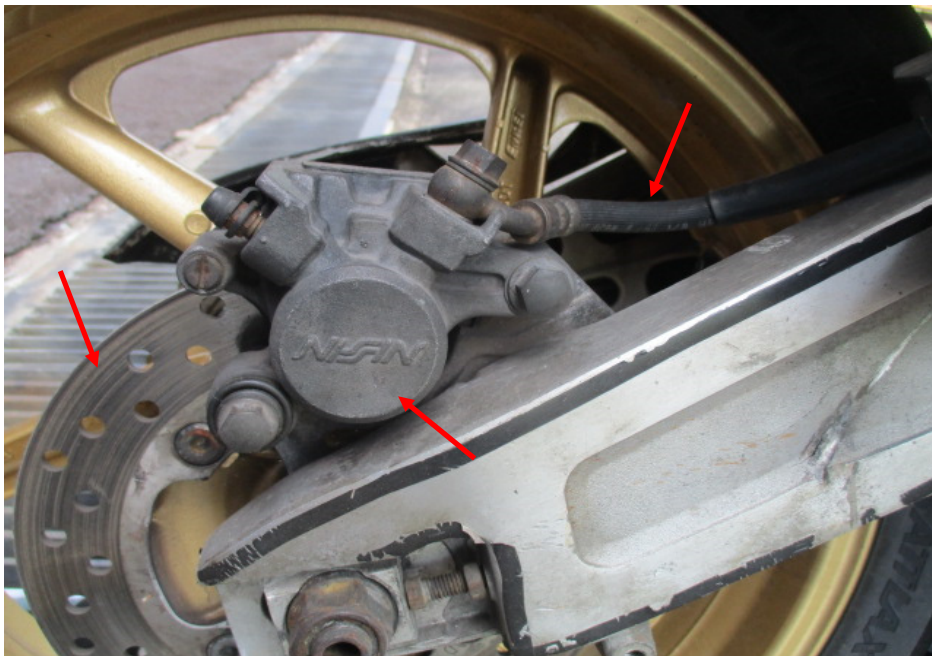
Photo 29 shows a close up view of the rear brake caliper, rear brake disc and rear brake hose (arrowed) of the Motorcycle, which are all part of the components in the hydraulic rear brake system of the Motorcycle. Our visual checks of these various components had revealed all to be intact with no visible damage. No leakage of brake fluid was also observed.
