Your Ref: TP/IP/00589/2020
Our Ref : CI/TPD20001928/P

18th March 2020

MECHANICAL INSPECTION REPORT OF MOTOR CAR SCY 8827L

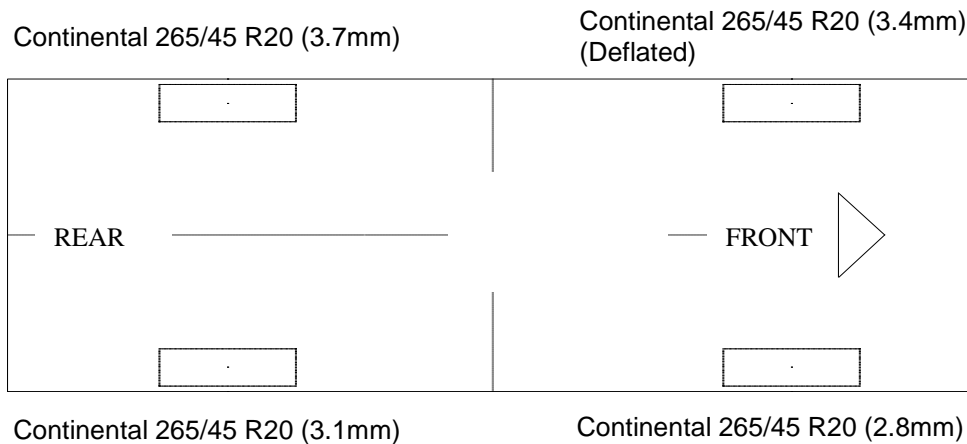
6. The front left tyre was observed to be deflated as a result of the accident. However the condition of the Motor car's other 3 tyres was observed to be in serviceable condition. I did not find any tear, cut or burst mark(s) on the outer and the inner sidewalls as well as across the tread of the 4 tyres. The 3 tyres were also observed to be sufficiently inflated for vehicular operation. The tyre brand, tyre size and remaining tread depth of the 4 tyres were recorded as follows:-

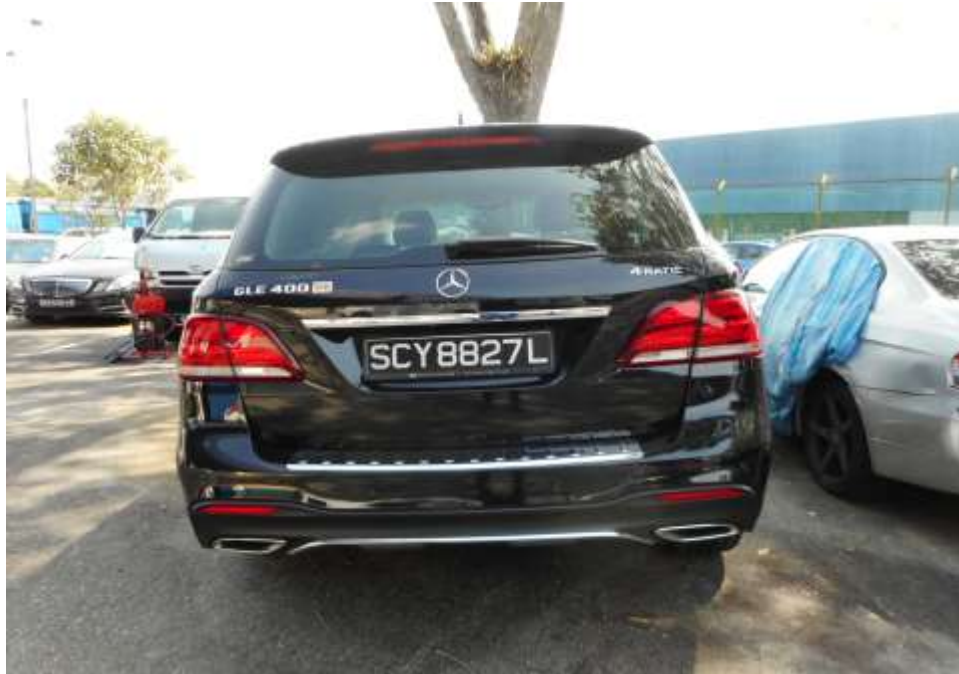
Photo 1 shows a general view of the Motor Car's rear body at the time of my inspection. The rear portion of the Motor Car was observed to have been undamaged by the accident.

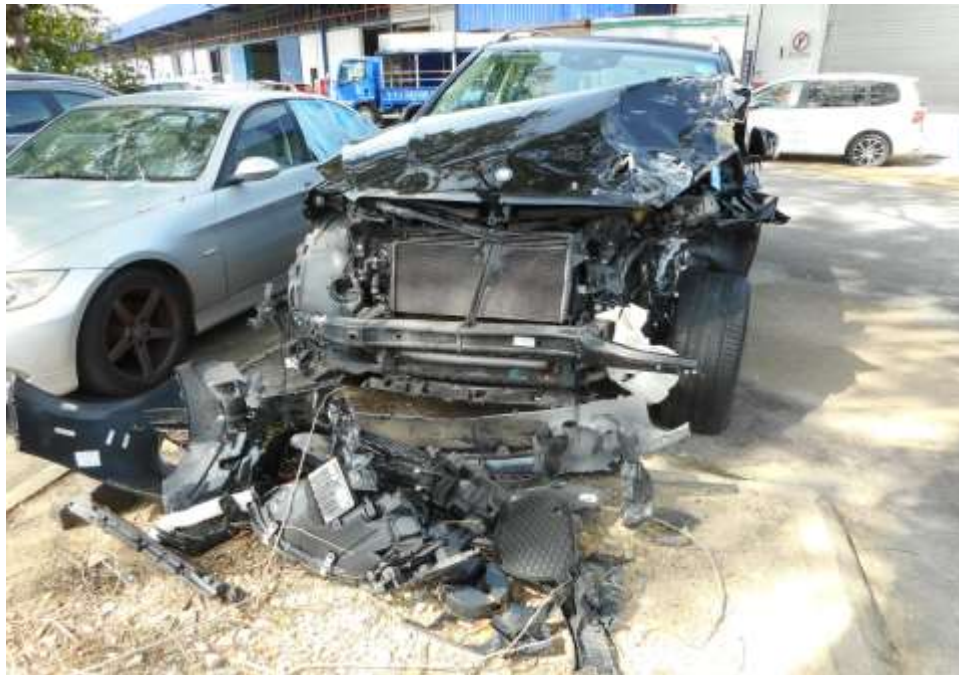
Photo 2 shows a general view of the Motor Car's front body at the time of my inspection. The Motor car was observed to have sustained damage at its front portion. Its front bonnet, front bumper and both front headlamp was amongst the body parts and various components in the engine compartments were also damaged as a result of the accident. The Supplemental Restraint System (SRS) was activated as a result of the accident.

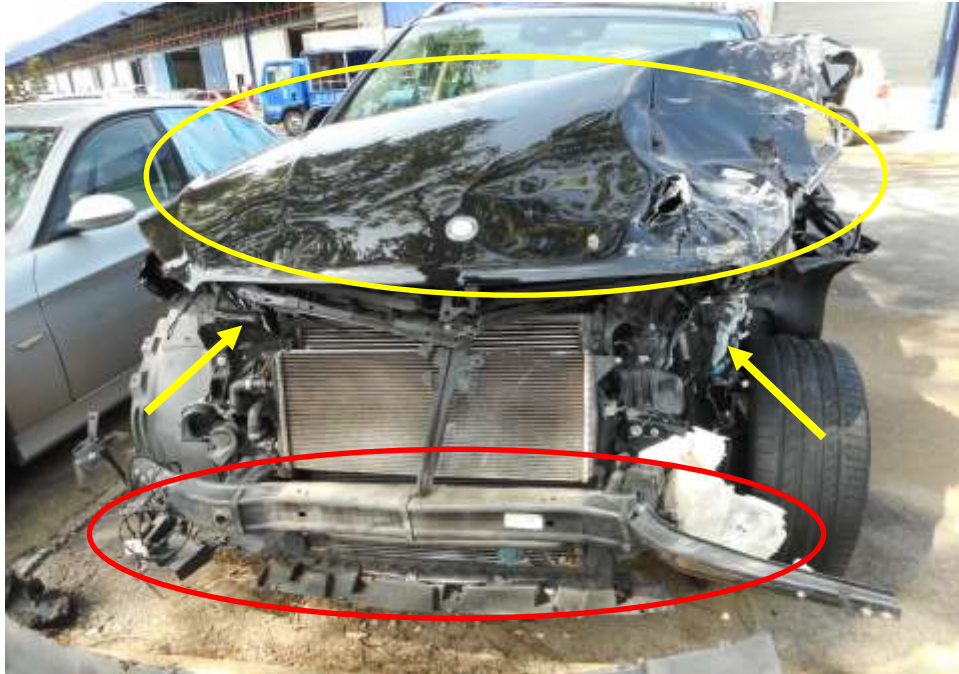
Photo 3 shows the close up view of the Motor Car's front body at the time of my inspection. The Motor car was observed to have sustained damage at its front portion. Its front bonnet (red circle), front bumper (red circle) and both front headlamp (yellow arrow) was amongst the body parts and various components in the engine compartments were also damaged as a result of the accident.

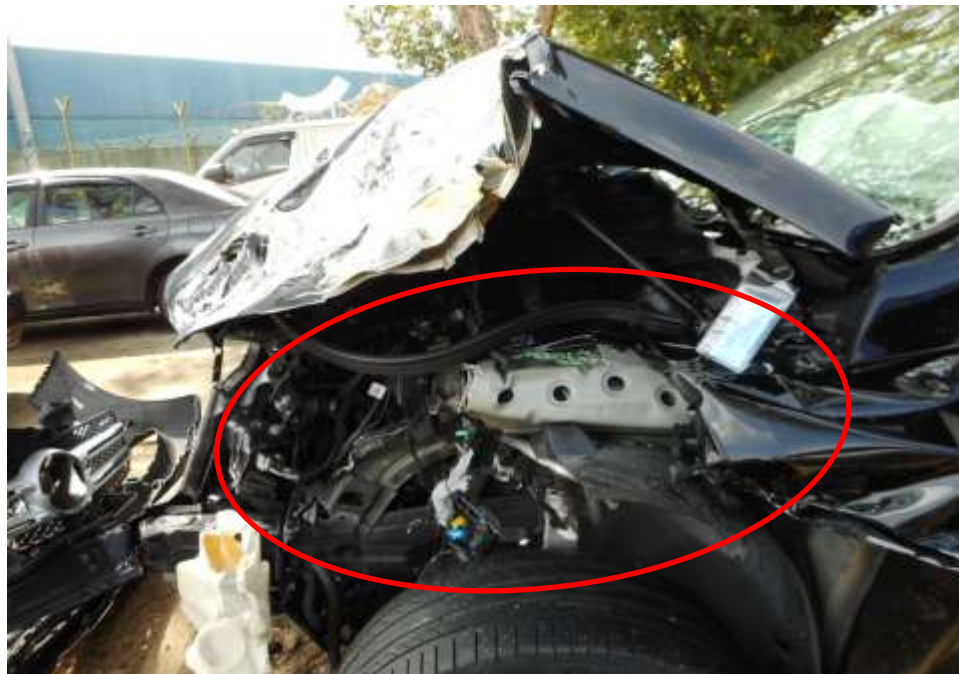
Photo 4 shows a close up view of the Motor Car's engine compartment at the time of my inspection. Due to the induced impact of the accident, the Motor Car's engine system, ignition system, cooling system (circled) and various components in the engine compartments were also damaged as a result of the accident.

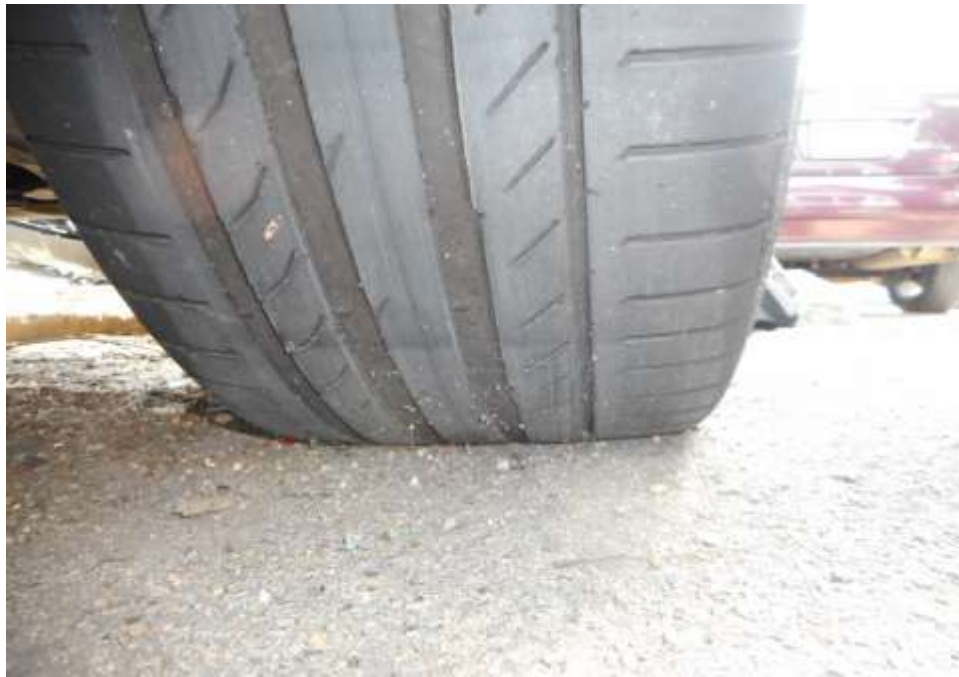
Photo 5 shows the condition of the front right tyre of the Motor Car, which was observed to be in serviceable condition with remaining tread depth of approximately 2.8mm. The tyre, which was wrapped around alloy wheel rim, was also observed to be sufficiently inflated for vehicular operation.

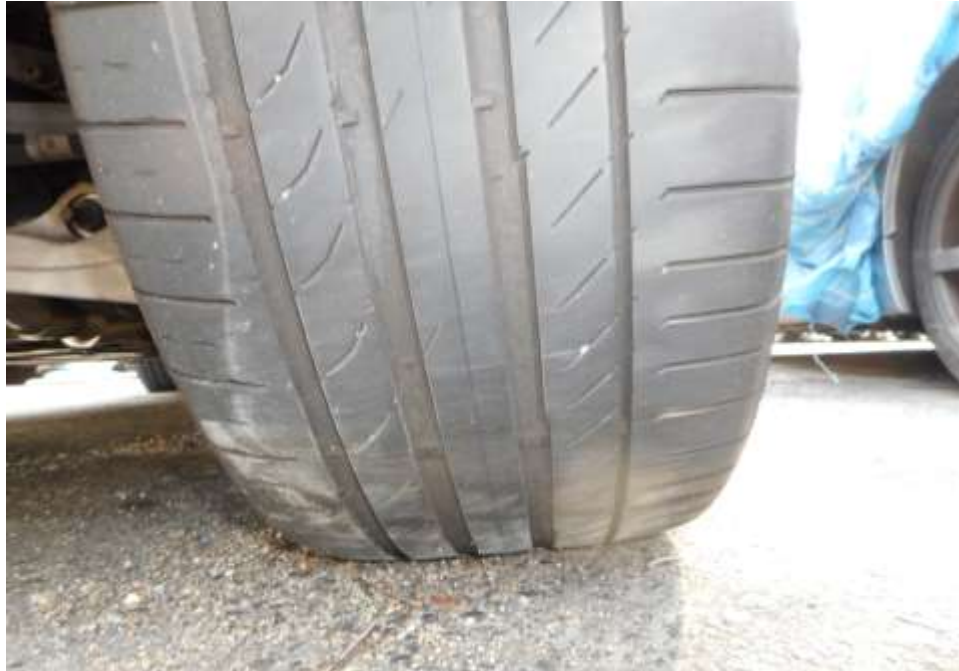
Photo 6 shows the condition of the rear right tyre of the Motor Car, which was observed to be in serviceable condition with remaining tread depth of approximately 3.1mm. The tyre was also observed to be sufficiently inflated for vehicular operation with no tear, cut or burst mark(s).

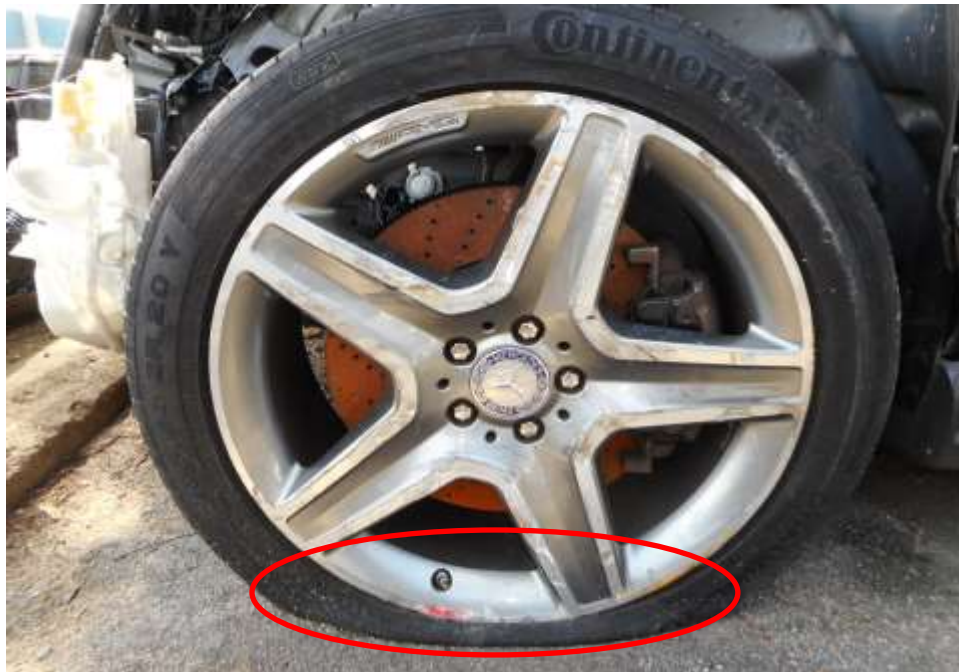
7. The 4 tyres were observed to be wrapped around alloy wheel rims however the front right rim was found to be damaged as a result of the accident. See photo 1 – 9 below.

Photo 8 shows the condition of the front left tyre of the Motor Car, the rim was observed to be damaged (circled) as a result of the accident and the tyre was observed to be in deflated condition due to the air leakage from the damaged rim. The remaining tread depth of the tyre was approximately 3.4mm. There was also no tear, cut or burst mark(s) on the outer and the inner sidewalls as well as across the tread of the Motor Car's 4 tyres.

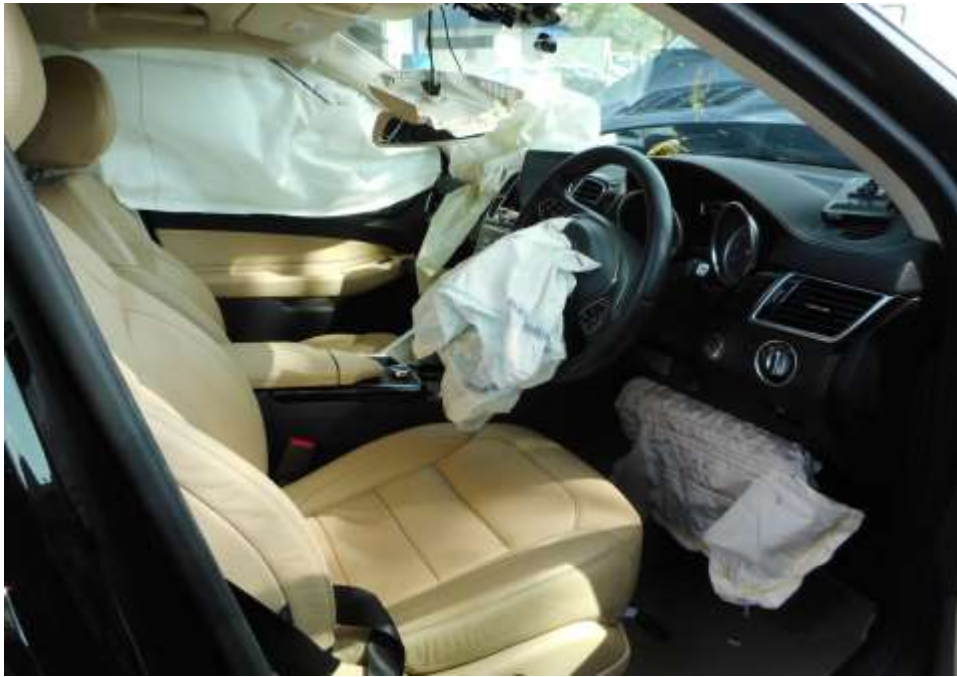
Photo 9 shows the deployment of the Supplemental Restraint System (SRS) airbag (arrowed) in the Motor Car as a result of the accident.

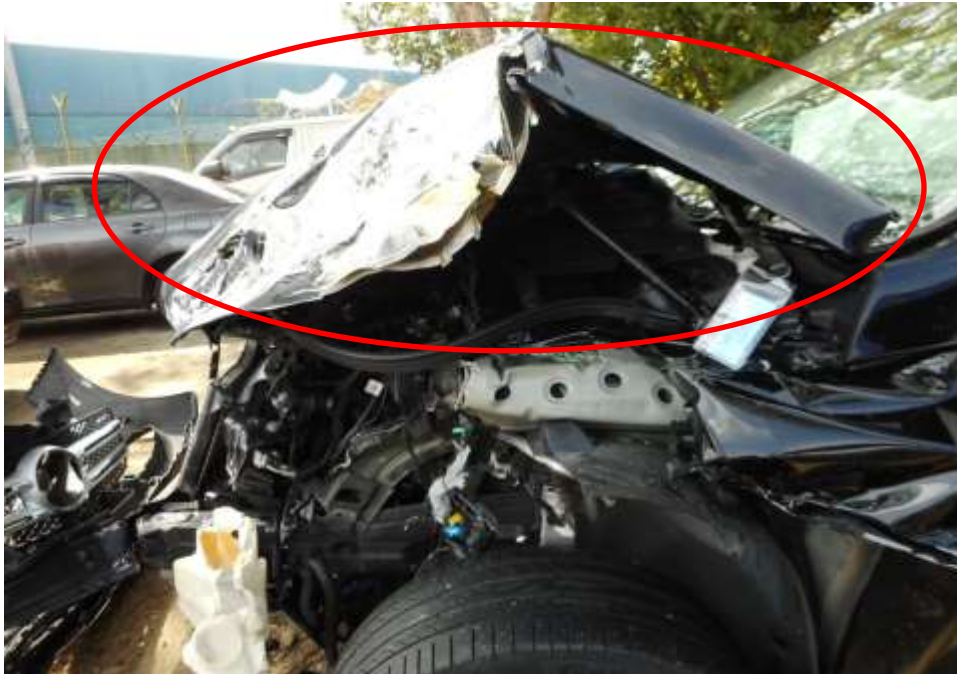
8. We were unable to raise the front bonnet of the Motor car to conduct the examination of the Motor Car's engine compartment because the damage caused by the accident had resulted in the damages to the lock mechanism of the bonnet and the structure of the engine compartment. (unable to open)
See photo 10 below

Photo 10 shows a close up view of the damaged front bonnet lock mechanism and the structure of the engine compartment of the Motor Car at the time of my inspection resulting it unable to open a result of the accident. (circled) (Unable to open)

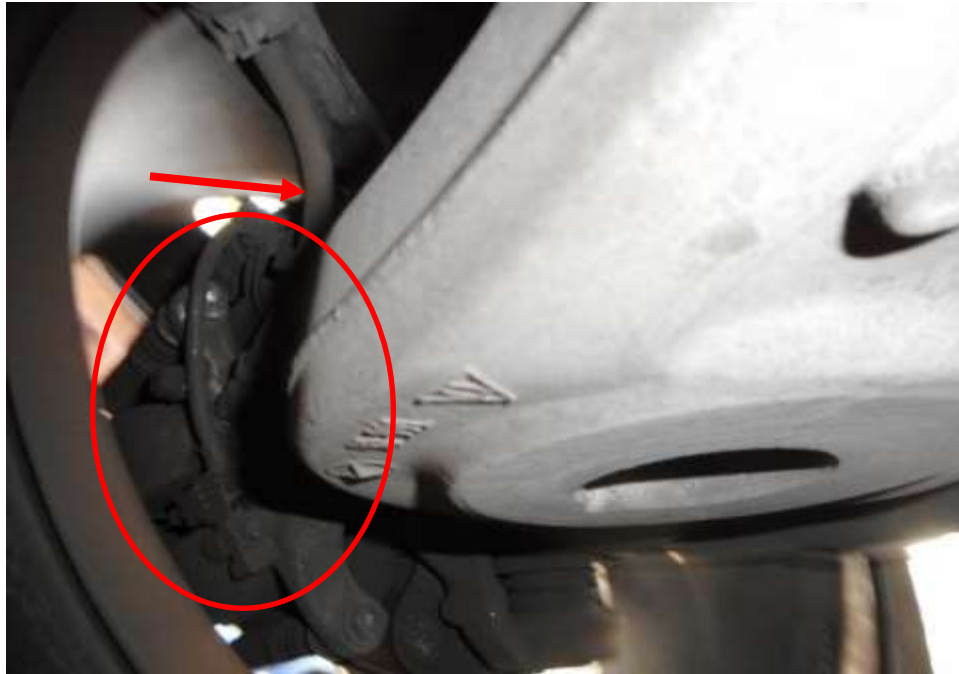
Photo 11 shows the brake caliper (circled) and brake hose/pipe (arrowed) at the rear left wheel of the Motor Car and it was observed to be intact

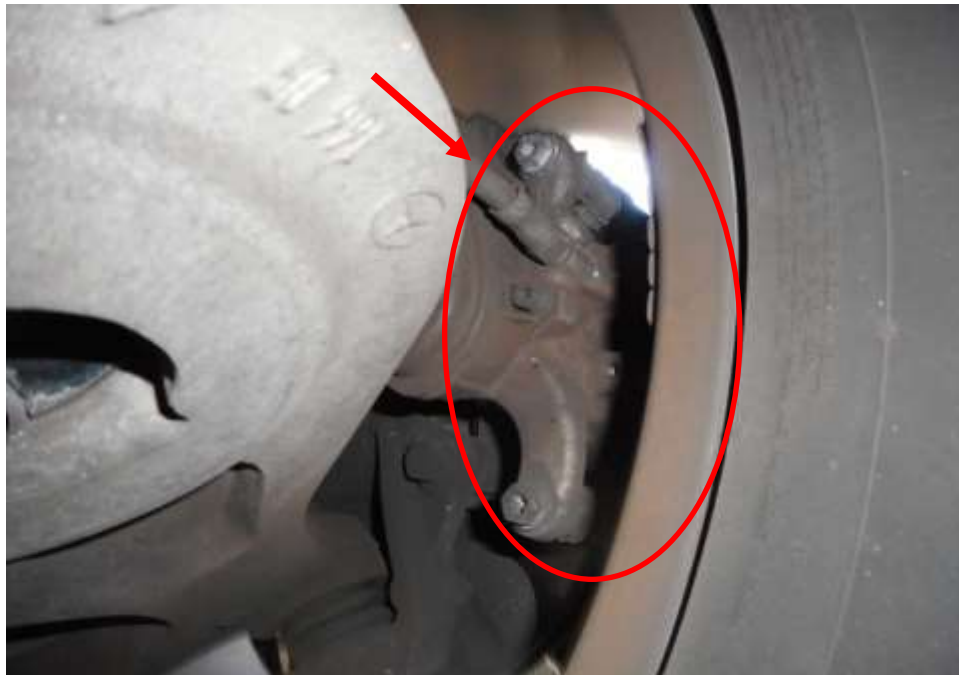
Photo 12 shows the brake caliper (circled) brake hose/pipe (arrowed) at the rear right wheel of the Motor Car and it was observed to be intact

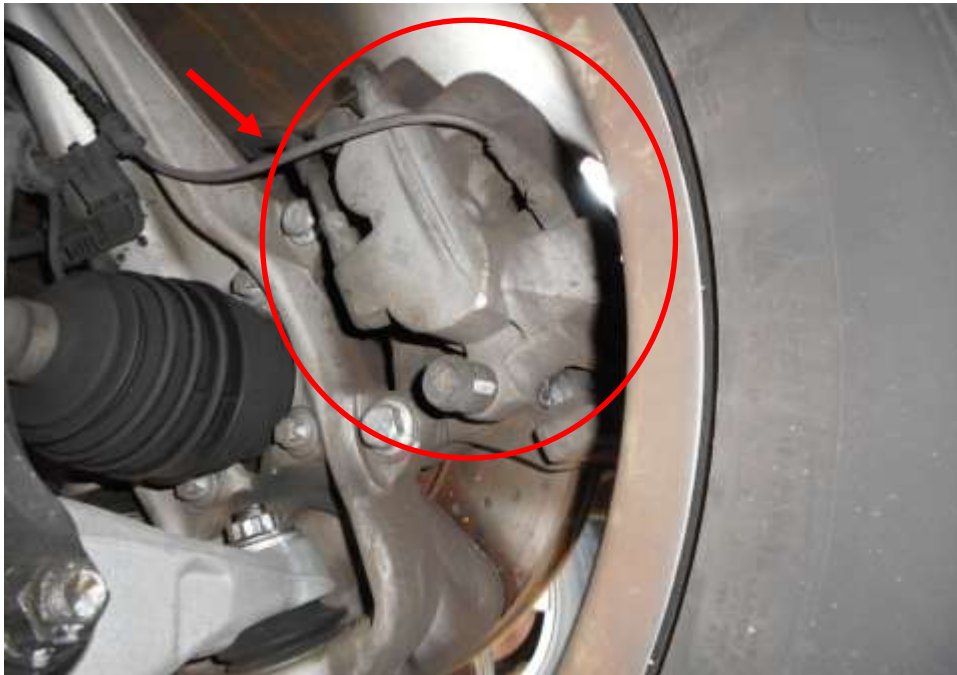
Photo 13 shows the brake hose/pipe (arrowed) at the front right wheel of the Motor Car. No leakage of brake fluid was observed. Visual examination of the various components of the braking system like the brake caliper (circled), brake booster, brake pedal etc had revealed all to be intact and without visible damage at the time of accident. There was also no sign of fluid stain(s) observed on the various undercarriage components.

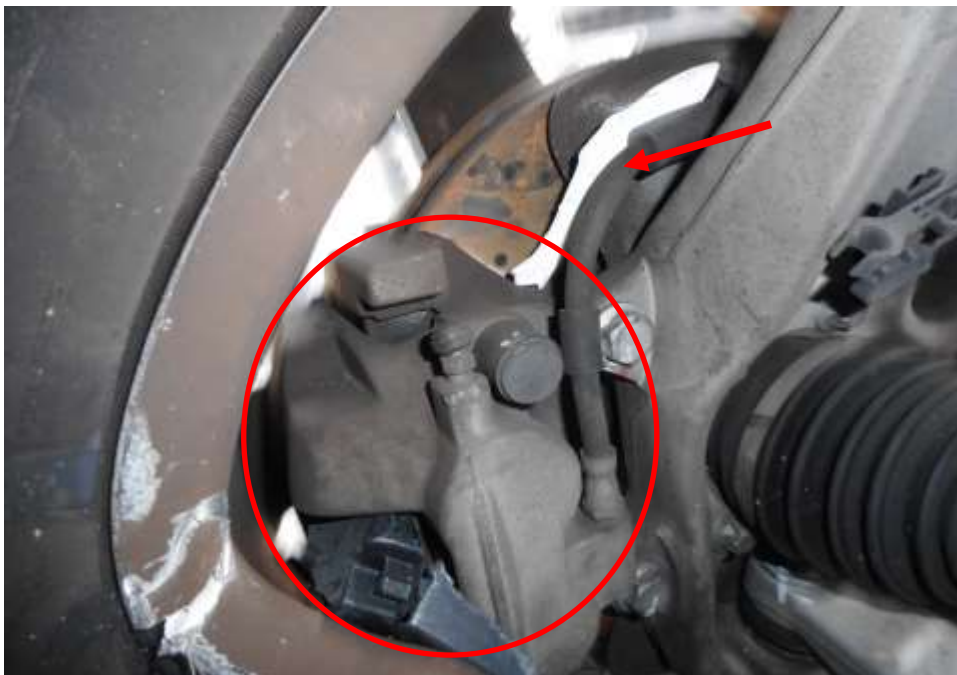
Photo 14 shows the brake hose/pipe (arrowed) at the front left wheel of the Motor Car. No leakage of brake fluid was observed. Visual examination of the various components of the braking system like the brake caliper (circled), brake booster, brake pedal etc had revealed all to be intact and without visible damage at the time of accident. There was also no sign of fluid stain(s) observed on the various undercarriage components.

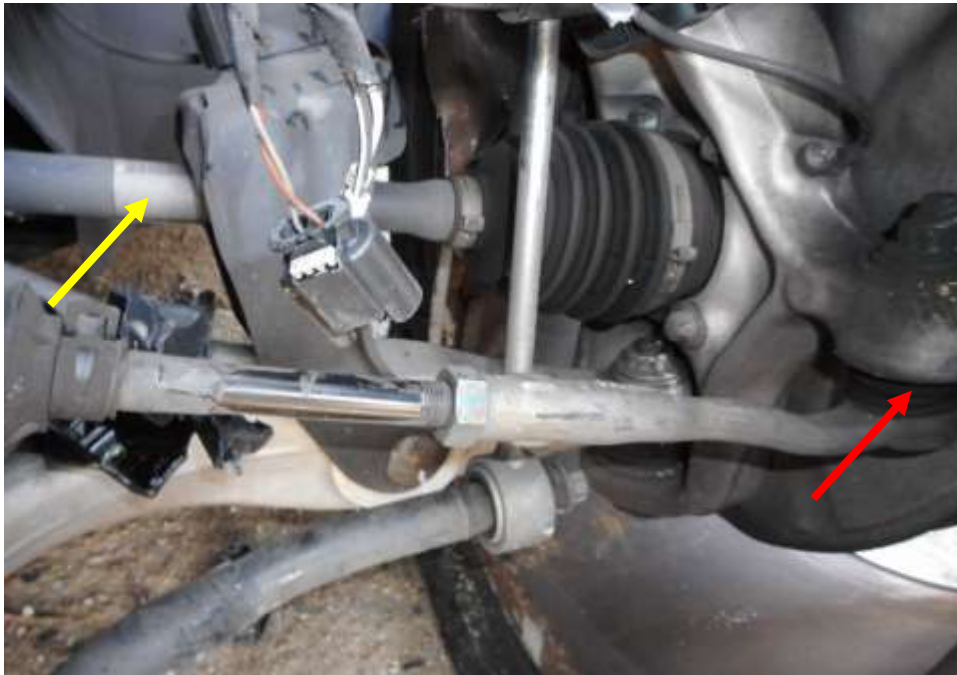
Photo 15 shows the various undercarriage components at the front right wheel of the Motor Car, in particular the steering tie rod end (arrowed) and drive shaft (yellow arrow). The various steering components were all found to be intact, suggesting that the steering system of the Motor Car was likely to be in serviceable condition at the material time of accident. There was also no sign of fluid stain(s) observed on the various undercarriage components.

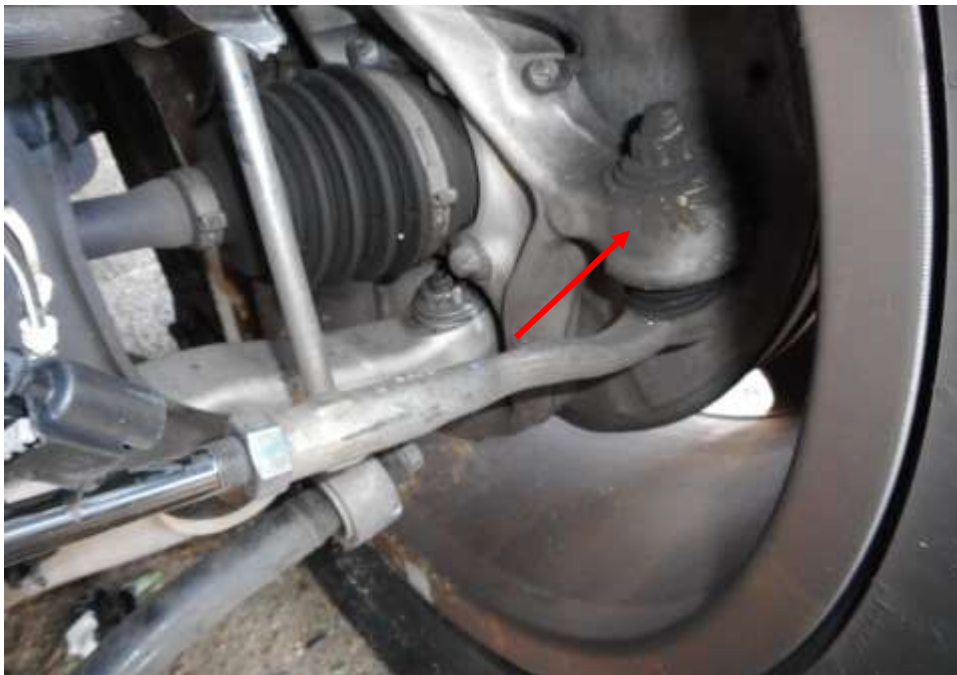
Photo 16 shows the various undercarriage components at the front left wheel of the Motor Car, in particular the steering tie rod end (arrowed). The various Undercarriage components of the Motor Car were all found to be intact without any visible damage. There was also no sign of fluid stain(s) observed on the various undercarriage components.
