Your Ref: TP/IP/01893/2020  
Our Ref : CI/TPD20001930/P

**Fatal Accident Investigation Team**

**MECHANICAL INSPECTION REPORT OF MOTOR TAXI SHD 1099T**

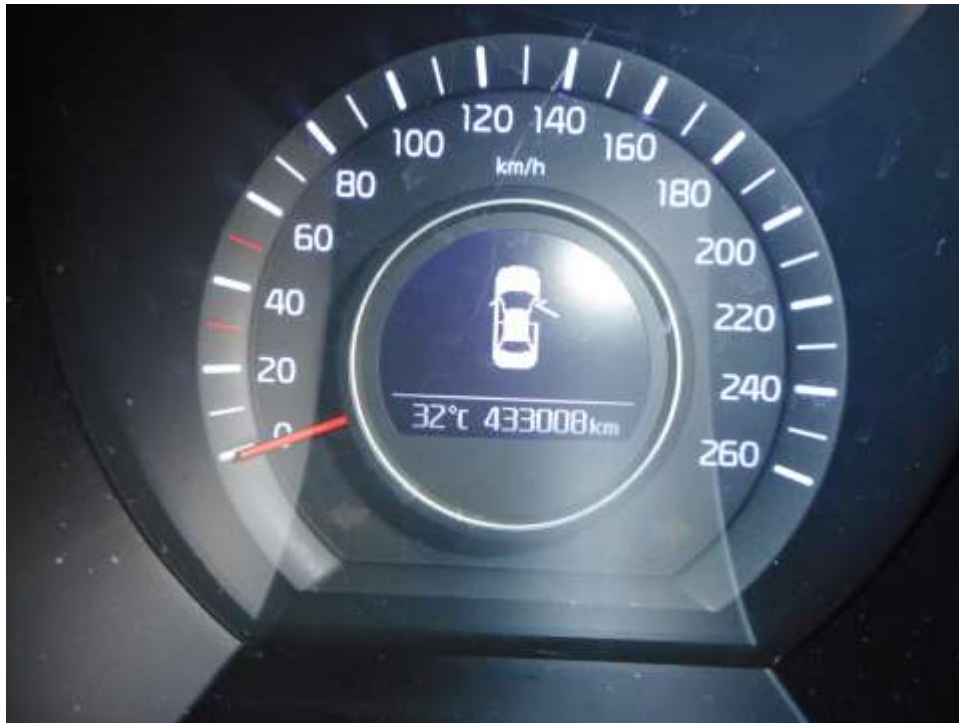
4. The mileage of the Motor Taxi at the time of my inspection was 433,008km.
5. There was visible damage observed on Motor Taxi's front right bumper and fender portion at the time of my inspection.

**Photo 1** shows a general view of the instrument cluster of the Motor Taxi at the time of my inspection. The mileage of the Motor Taxi was 433,008km

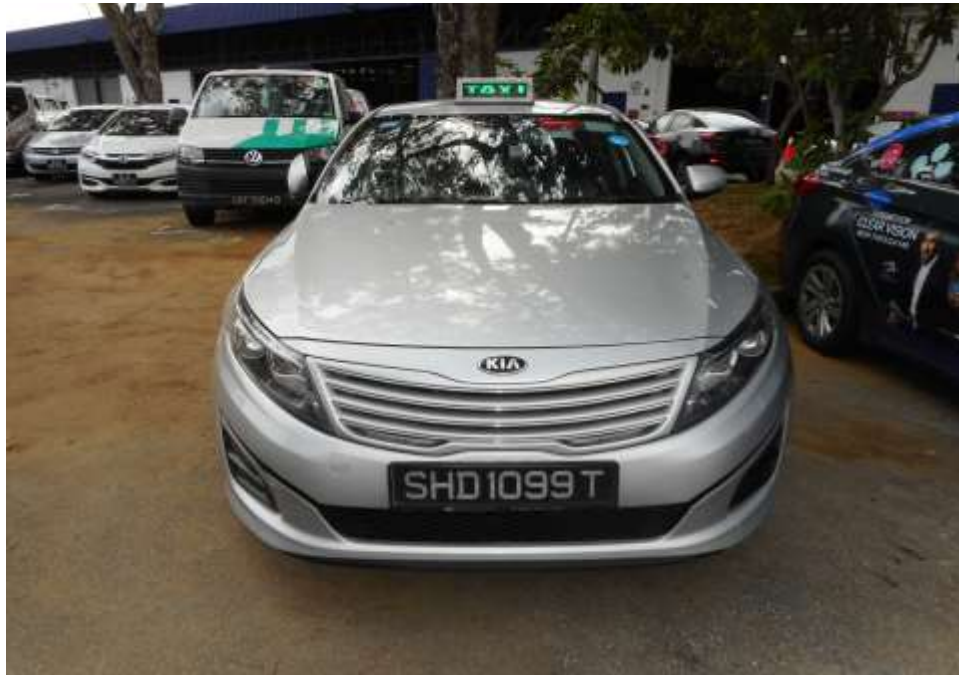
**Photo 2** shows a general view of the Motor Taxi front portion at the time of my inspection. The Motor Taxi was observed to be intact and unaffected by the accident

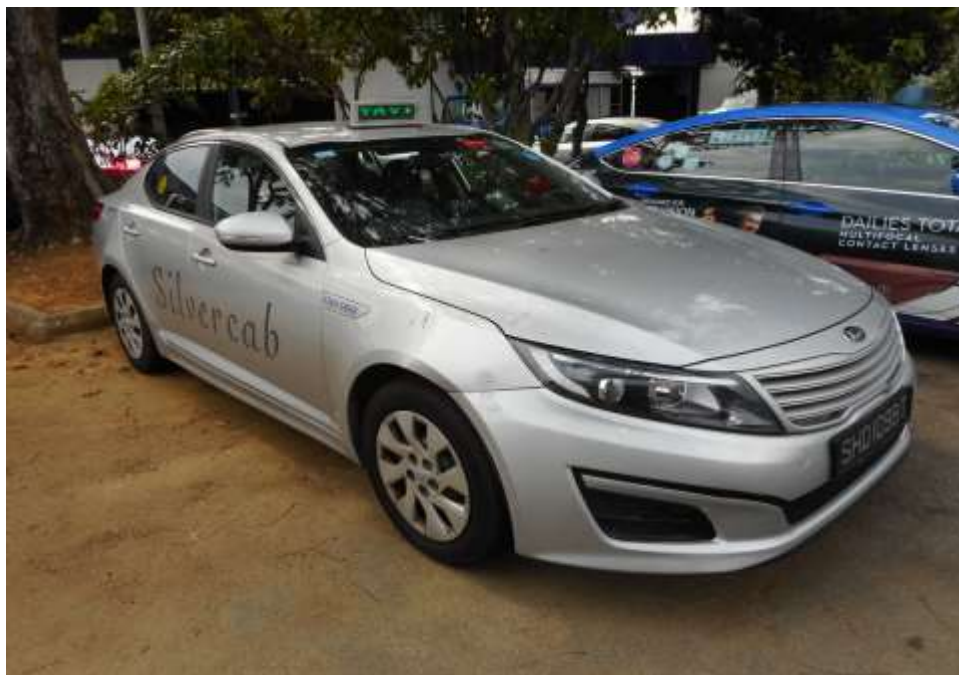
**Photo 3** shows a general view of the right body of the Motor Taxi at the time of my inspection. The Motor Taxi was observed to visually sustain damage at its front right bumper and fender portion.

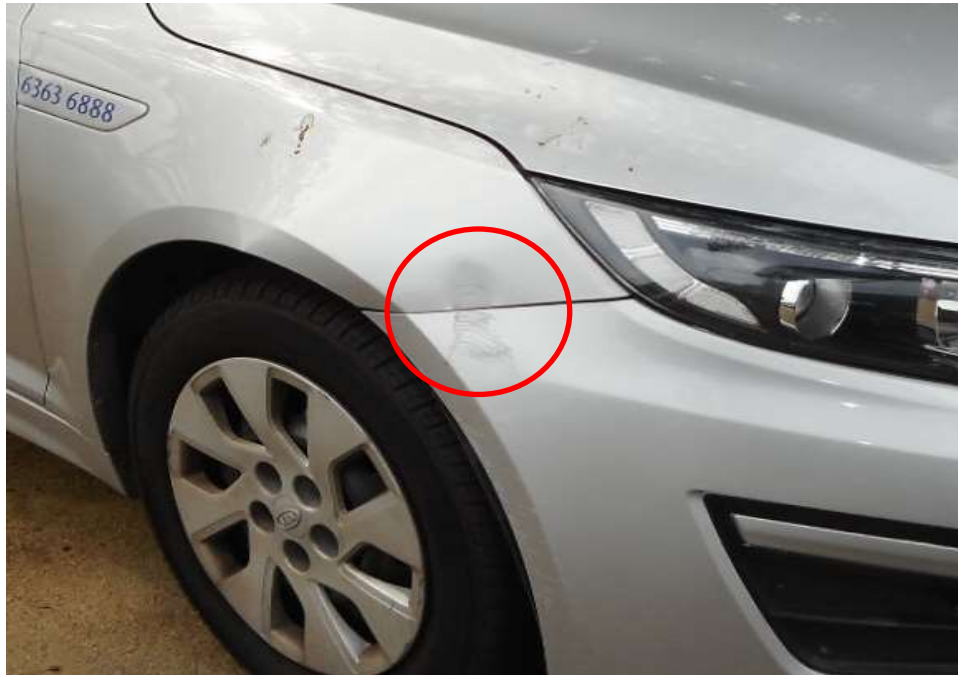
**Photo 4** shows a close up view of the right body of the Motor Taxi at the time of my inspection. The Motor Taxi was observed to visually sustain damage at its front right bumper and fender portion (circled).

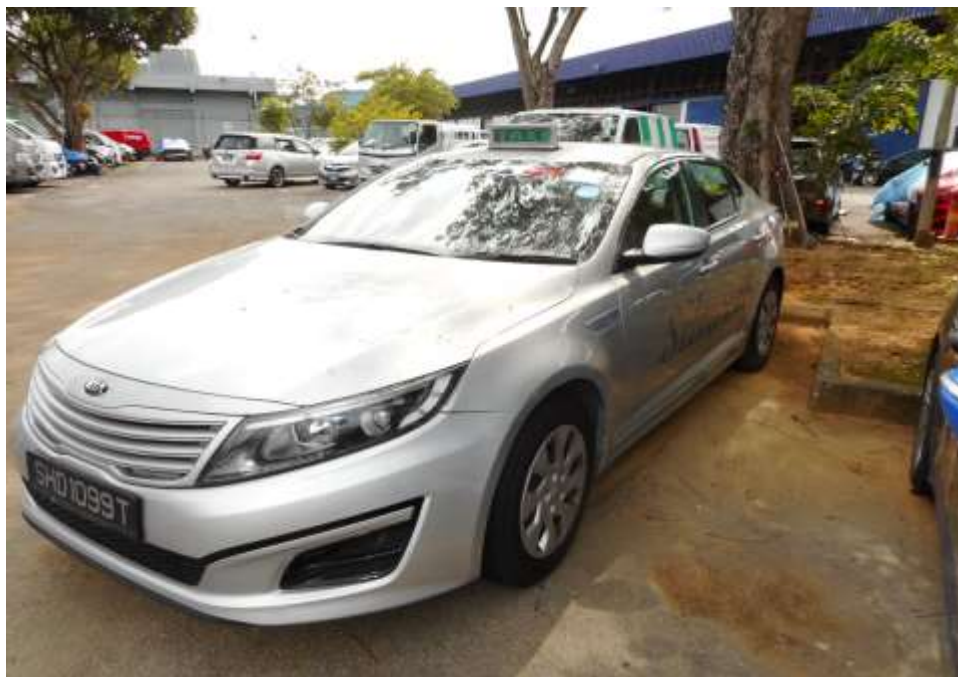
**Photo 5** shows a general view of the left body of the Motor Taxi at the time of my inspection. The Motor Taxi was observed to be intact and unaffected by the accident.

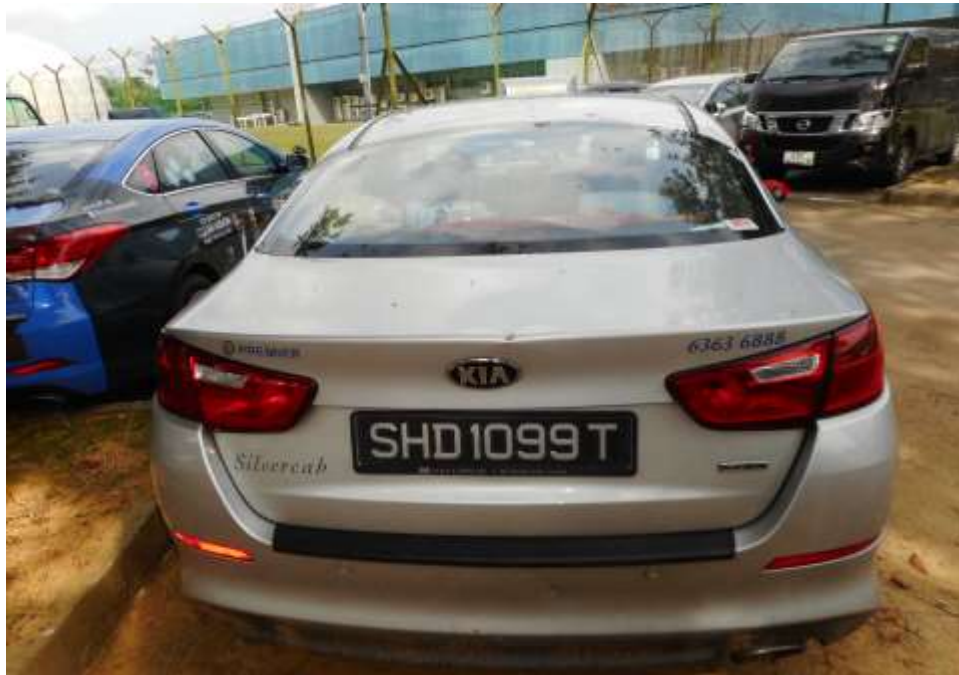
**Photo 6** shows a general view of the rear body of the Motor Taxi at the time of my inspection. The Motor Taxi was observed to be intact and unaffected by the accident.

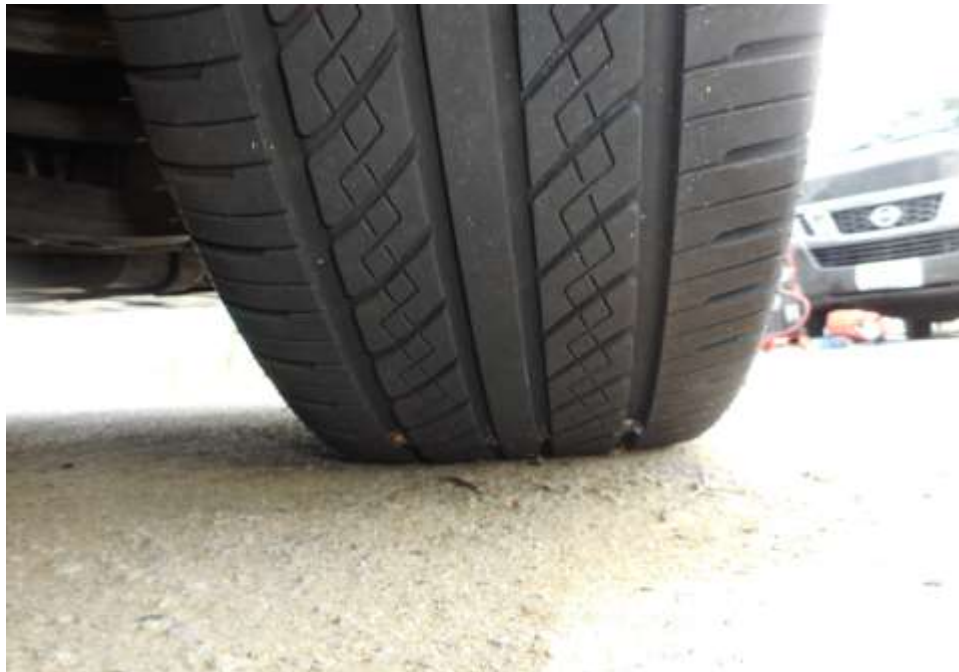
**Photo 7** shows the condition of the front right tyre of the Motor Taxi, which was observed to be in serviceable condition with remaining tread depth of approximately 6.2mm. The tyre, which was wrapped around standard alloy wheel rim, was also observed to be sufficiently inflated for vehicular operation. There was no tear, cut or burst mark(s) on the outer and the inner sidewalls as well as across the tread of the 4 tyres that were fitted on the Motor Taxi.

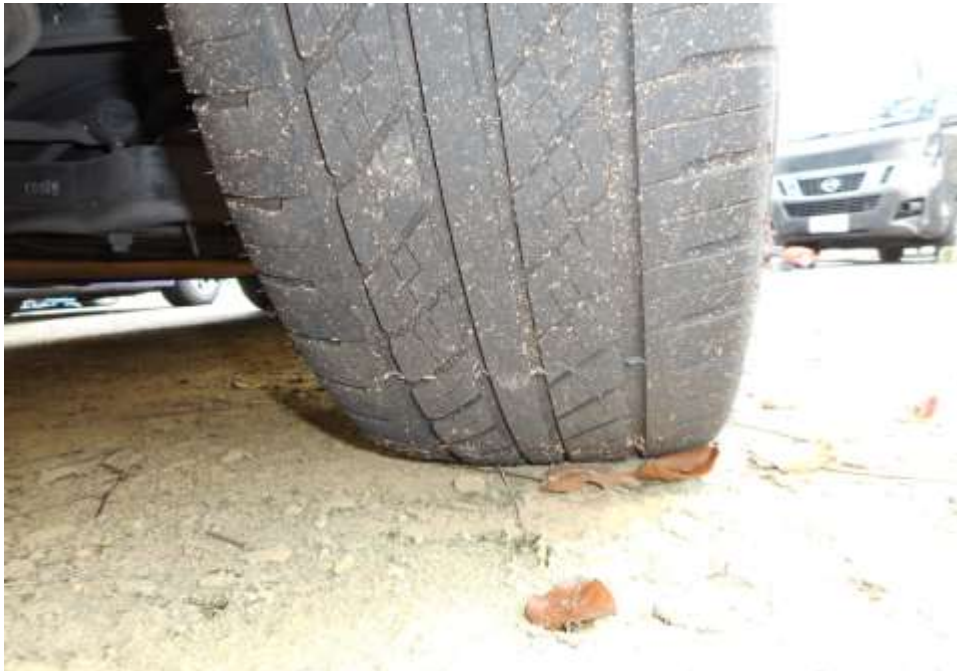
**Photo 8** shows the condition of the rear right tyre of the Motor Taxi, which was observed to be in serviceable condition with remaining tread depth of approximately 6.9mm. The tyre, which was wrapped around standard alloy wheel rim, was also observed to be sufficiently inflated for vehicular operation.

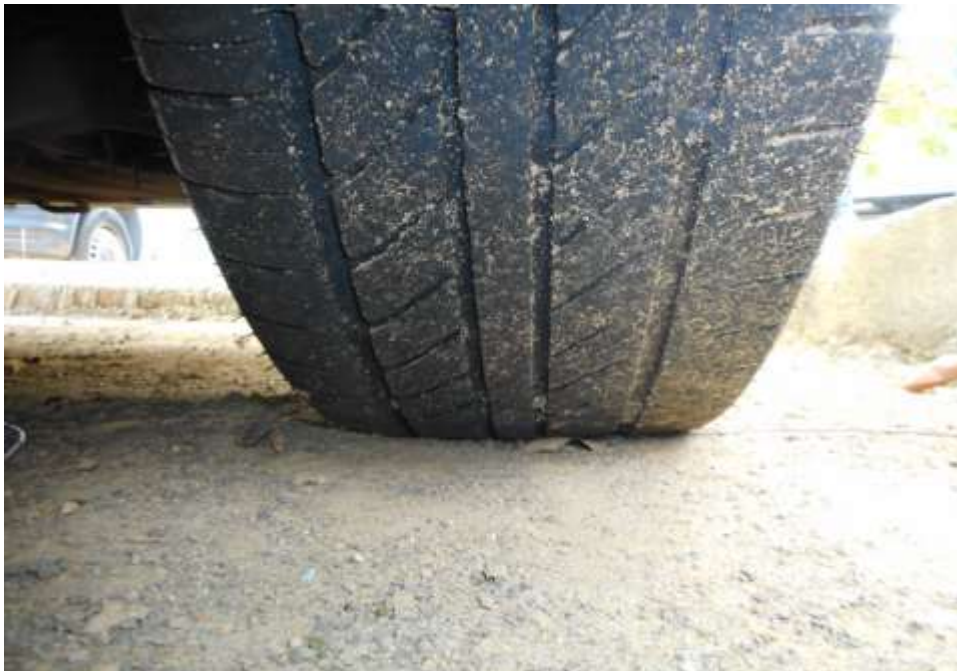
**Photo 9** shows the condition of the rear left tyres of the Motor Taxi, which was observed to be in serviceable condition with remaining tread depth of approximately 6.8mm. The tyres, which were wrapped around standard alloy wheel rim, were also observed to be sufficiently inflated for vehicular operation. There was also no damage found on all 4 alloy wheel rims of the Motor Taxi.

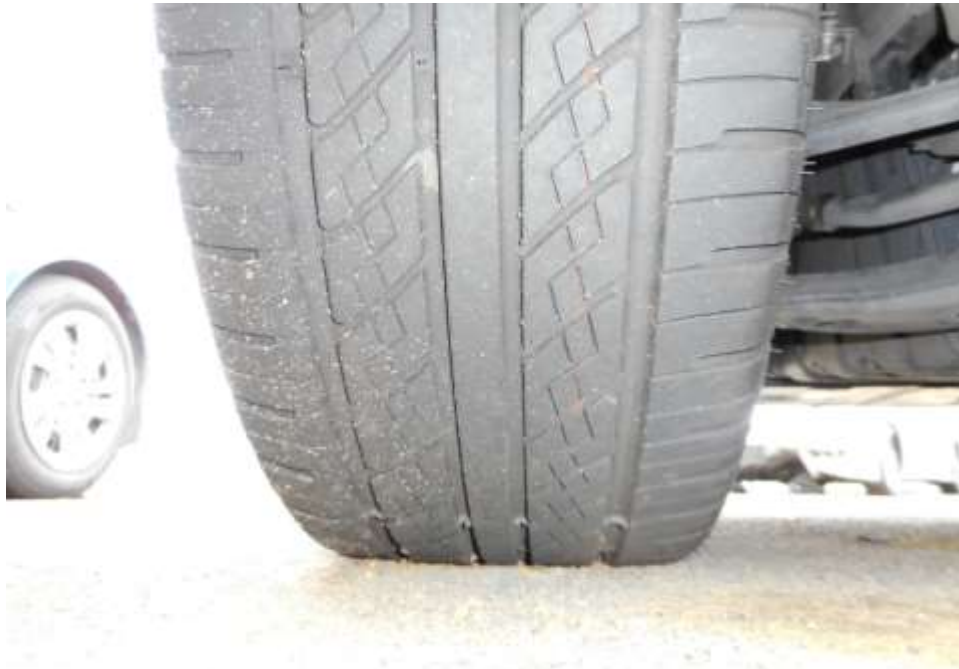
**Photo 10** shows the condition of the rear right tyres of the Motor Taxi, which were observed to be in serviceable condition with remaining, tread depth of approximately 6.6mm. There was also no tear, cut or burst mark(s) on the outer and the inner sidewalls as well as across the tread of the 4 tyres that were fitted on the Motor Taxi.

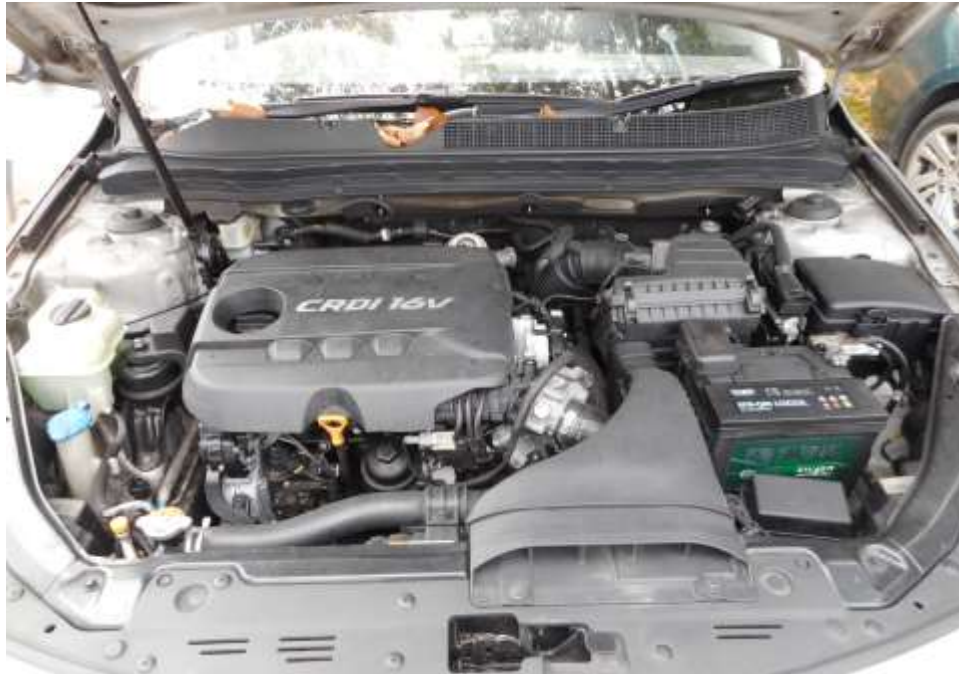
**Photo 11** shows a general view of the Motor Taxi's engine compartment, which was accessed by lifting the front cabin of the Motor Taxi. The various parts and components inside the engine compartment were unaffected by the accident. There was also no sign(s) or indication(s) of fresh fluid leakage and/or fluid stain within the engine compartment

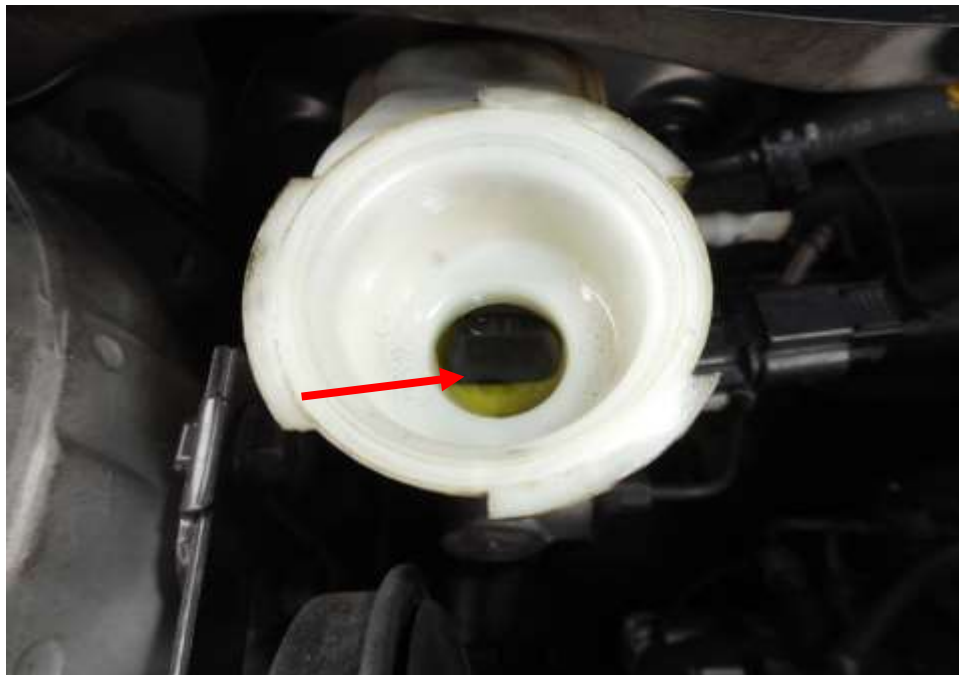
**Photo 12** shows the brake fluid reservoir of the Motor Taxi at the time of my inspection. The brake fluid was observed to be of sufficient level (arrowed) and without any visible contamination.

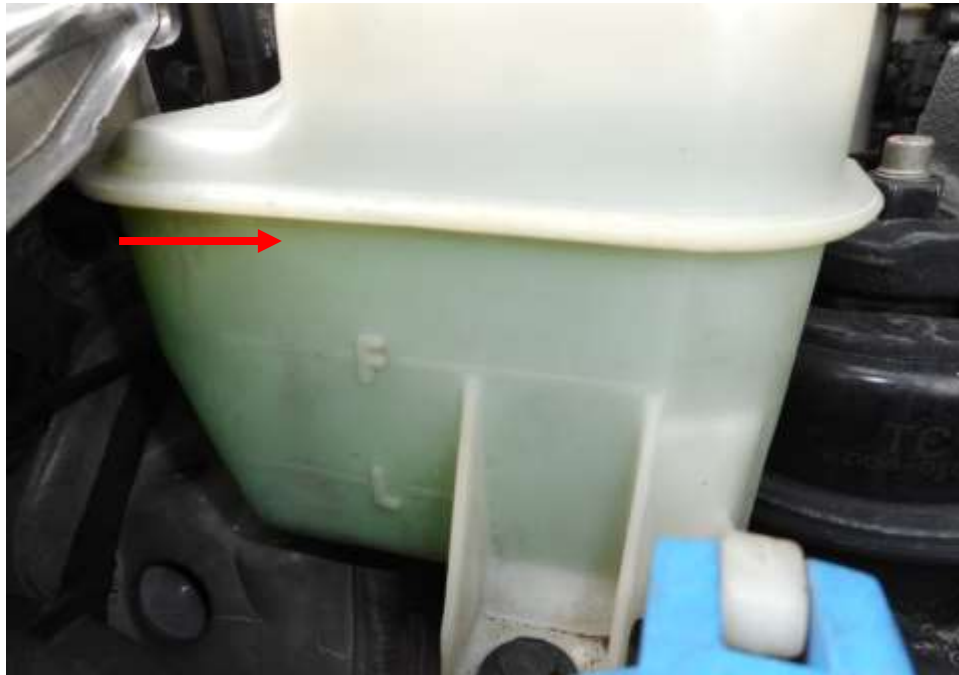
**Photo 13** shows the engine coolant reservoir of the Motor Taxi at the time of my inspection. The engine coolant was observed to be of sufficient level (arrowed) and without any visible contamination.

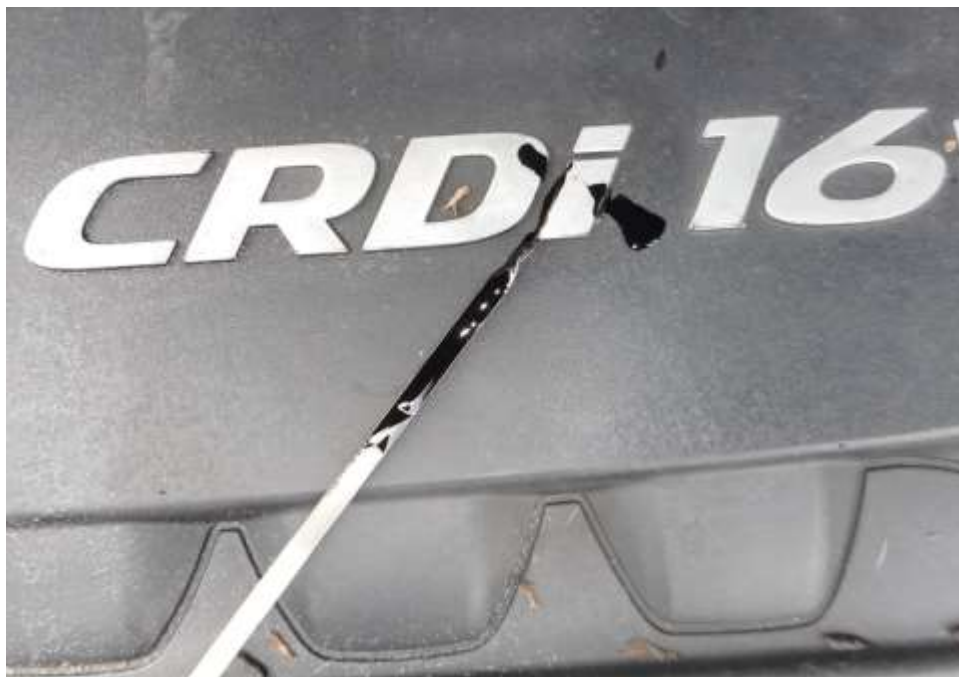
**Photo 14** shows the engine oil dip stick of the Motor Taxi at the time of my inspection. The engine oil was observed to be of sufficient level and without any visible contamination.

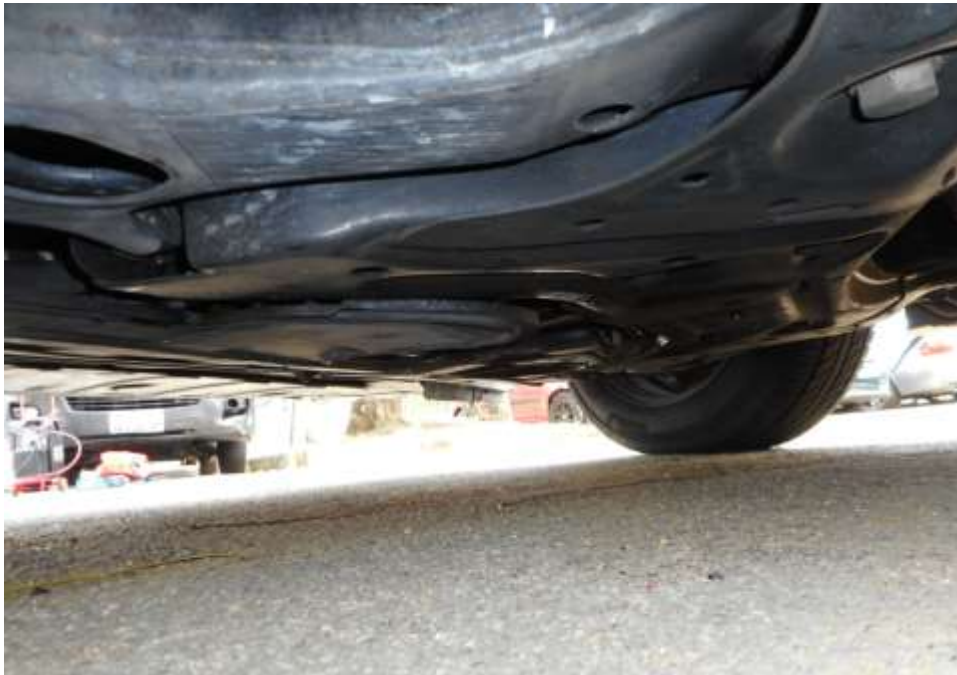
**Photo 15** shows the undercarriage of the Motor Taxi, at the area where the engine housing and transmission housing are located. . I did not find any sign(s) or indication(s) of fluid leak and/or fluid stain(s) on the underside of the Motor Taxi.

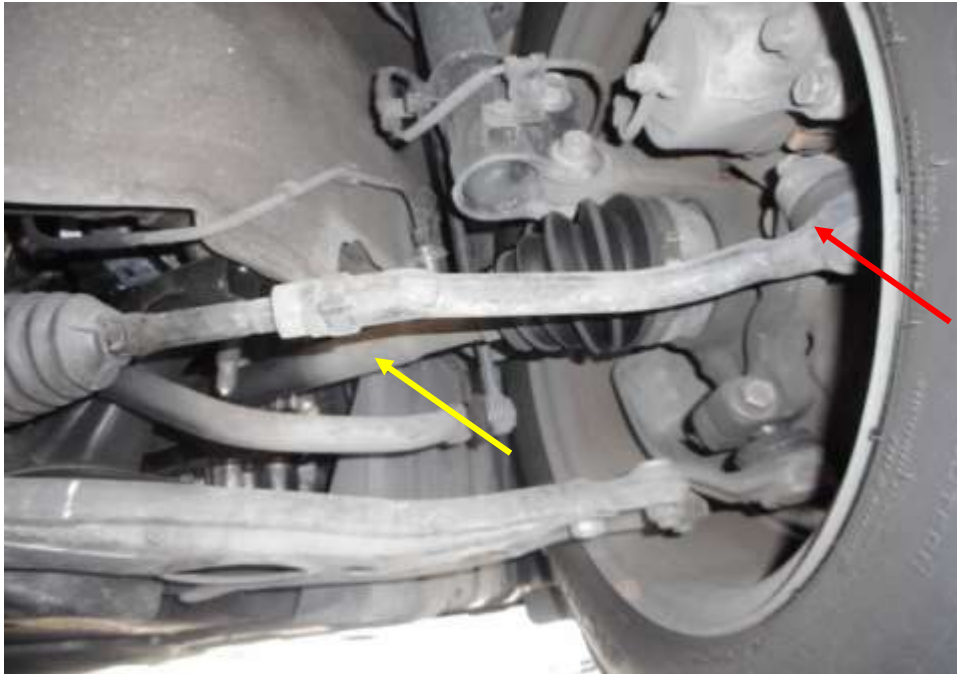
**Photo 16** shows the various undercarriage components at the front right wheel of the Motor Taxi, in particular the steering tie rod end (arrowed) and drive shaft (yellow arrow). The various steering components were all found to be intact, suggesting that the steering system of the Motor Taxi was likely to be in serviceable condition at the material time of accident. There was also no sign of fluid stain(s) observed on the various undercarriage components.

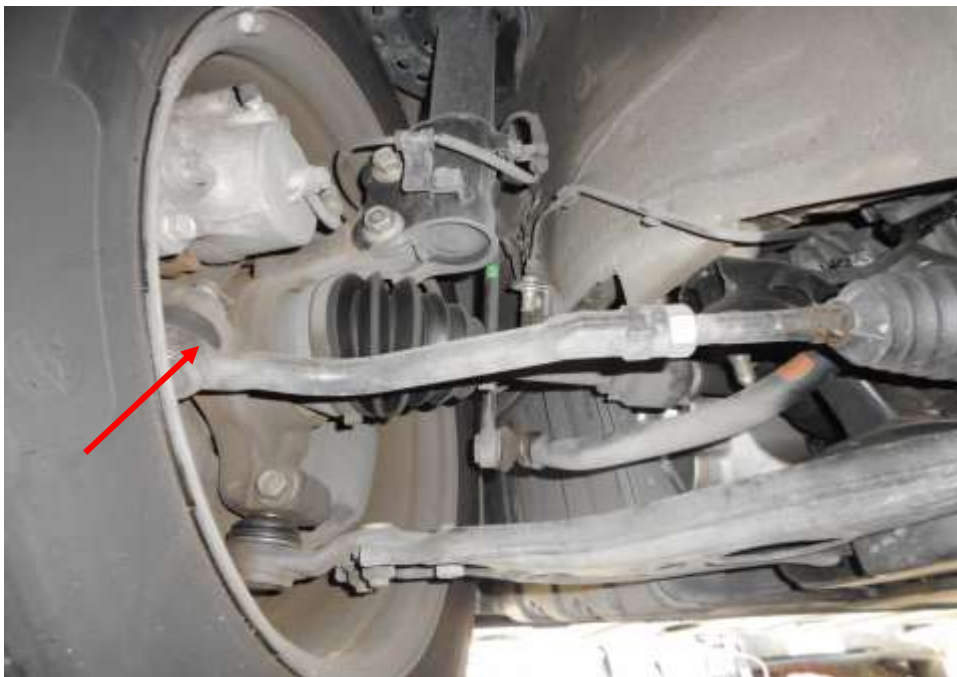
**Photo 17** shows the various undercarriage components at the front left wheel of the Motor Taxi, in particular the steering tie rod end (arrowed). The various Undercarriage components of the Motor Taxi were all found to be intact without any visible damage. There was also no sign of fluid stain(s) observed on the various undercarriage components.

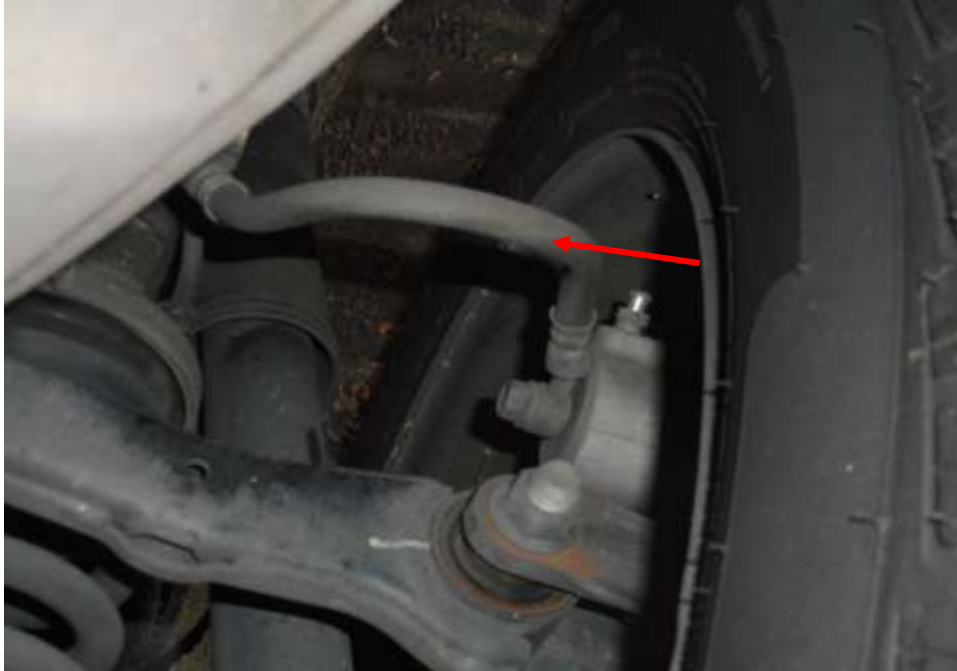
**Photo 18** shows the brake pipe (arrowed) at the rear right wheel of the Motor Taxi. I did not observe any leakage of brake fluid at the time of my inspection of the Motor Taxi. My static tests of the Motor Taxi's braking system, along with my visual examination of the various mechanical components in the braking system, had indicated that there was no internal leakage of pressure/vacuum. Hence the braking system of the Motor Taxi was likely to be in serviceable condition at the material time of accident.

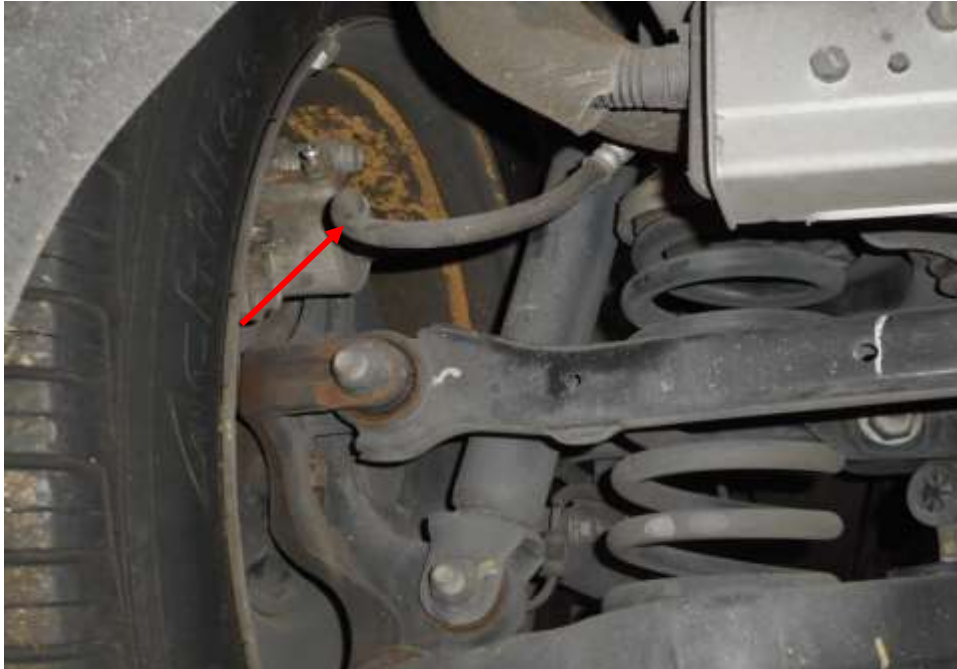
**Photo 19** shows the brake pipe (arrowed) at the rear left wheel of the Motor Taxi. I did not observe any leakage of brake fluid at the time of my inspection of the Motor Taxi. My static tests of the Motor Taxi's braking system, along with my visual examination of the various mechanical components in the braking system had indicated that there was no internal leakage of pressure/vacuum. Hence the braking system of the Motor Taxi was likely to be in serviceable condition at the material time of accident.

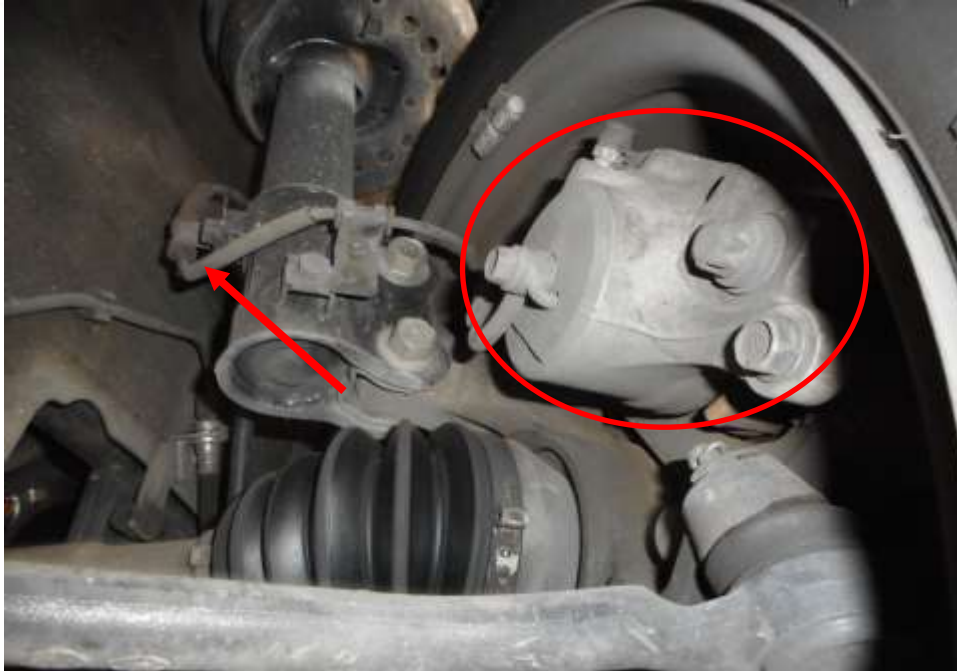
**Photo 20** shows the brake hose/pipe (arrowed) at the front right wheel of the Motor Taxi. No leakage of brake fluid was observed. Visual examination of the various components of the braking system like the brake caliper (circled), brake booster, brake pedal etc had revealed all to be intact and without visible damage at the time of accident. There was also no sign of fluid stain(s) observed on the various undercarriage components.

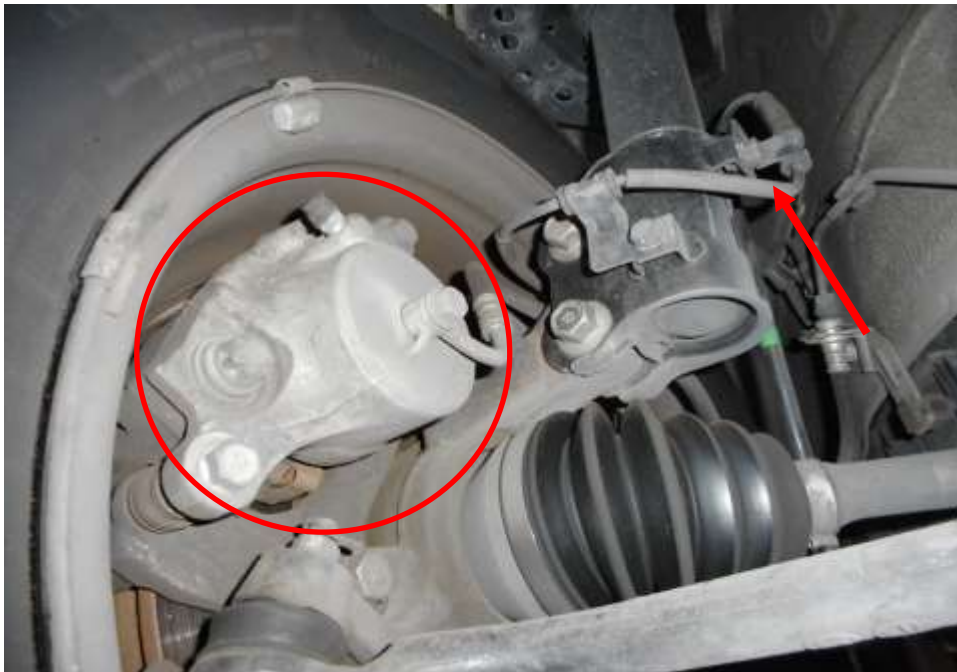
**Photo 21** shows the brake hose/pipe (arrowed) at the front left wheel of the Motor Taxi. No leakage of brake fluid was observed. Visual examination of the various components of the braking system like the brake caliper (circled), brake booster, brake pedal etc had revealed all to be intact and without visible damage at the time of accident. There was also no sign of fluid stain(s) observed on the various undercarriage components.

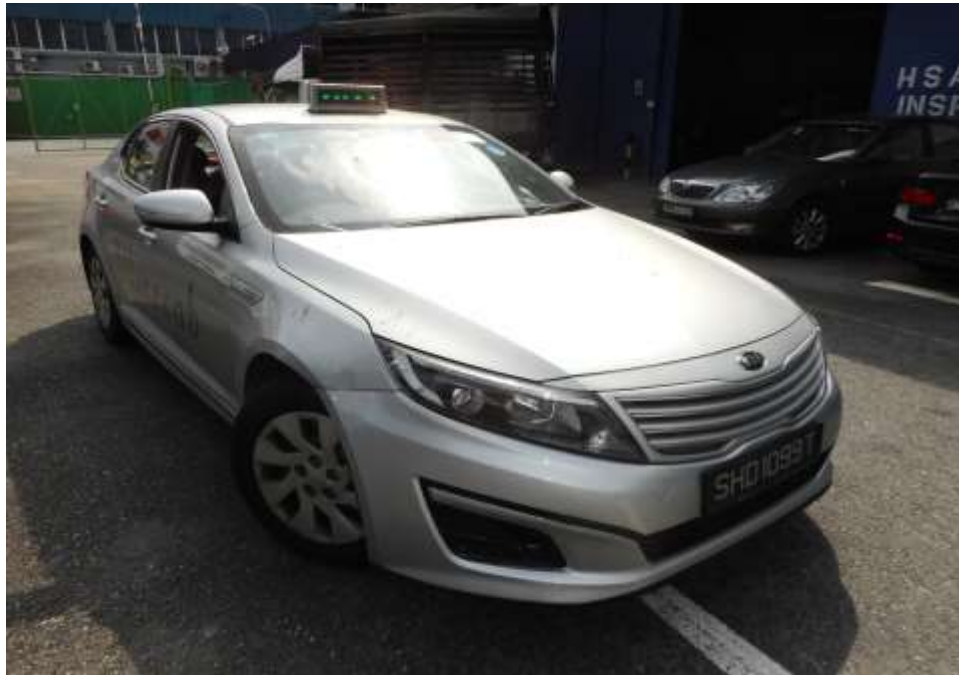
**Photo 22** shows the front right wheel of the Motor Taxi turned to its full left. During my steering system test, I did not experience any abnormal free play and/or resistance when I had turned the steering wheel towards full left and full right. This would suggest that the steering system of the Motor Taxi was likely to be in serviceable condition at the material time of accident.

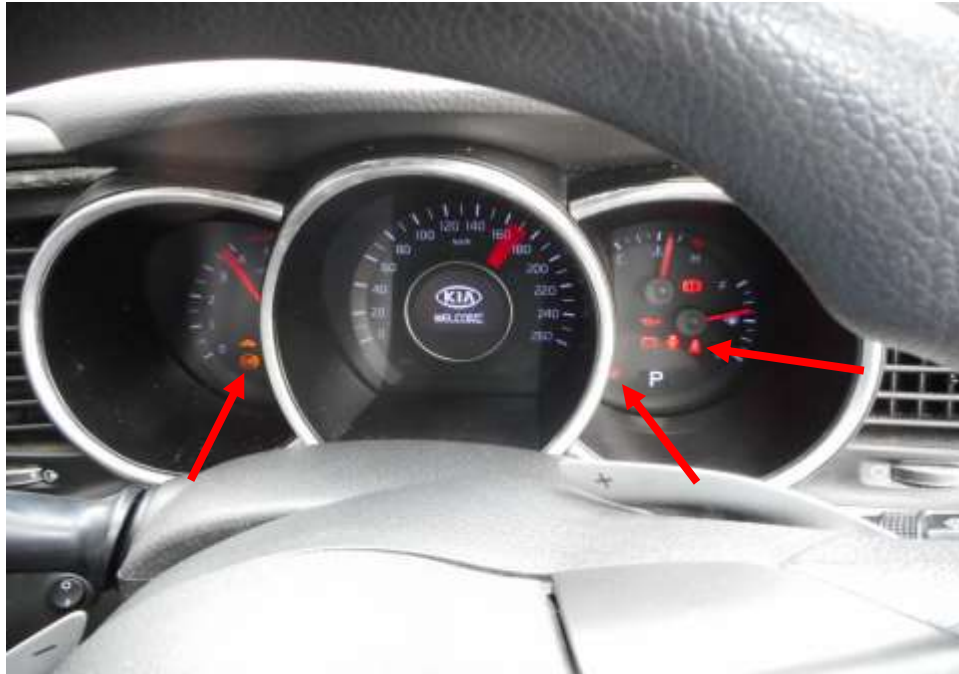
**Photo 23** shows the warning light for Anti-Lock Brake System (ABS), Supplemental Restraint System (SRS) and Electric Power Steering System (EPS) appearing on the instrument panel of the Motor Taxi during the self-test of its various electronic operating systems when its engine was cranked.

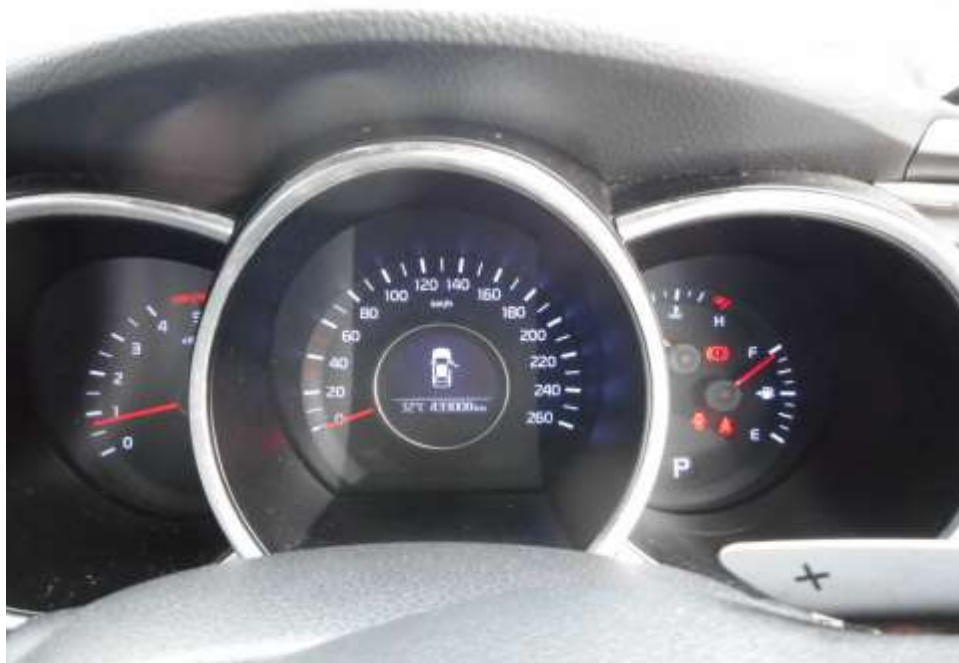
**Photo 24** shows no warning lights illuminated on the instrument panel of the Motor Taxi after the engine was cranked. This would suggest that there was no abnormality to the various electronic operating systems of the Motor Taxi, like the ABS, SRS and EPS.
