Your Ref: TP/IP/04019/2020
Our Ref : CI/TPD20001932/P

Fatal Accident Investigation Team

MECHANICAL INSPECTION REPORT OF MOTOR VAN GBF 4732P

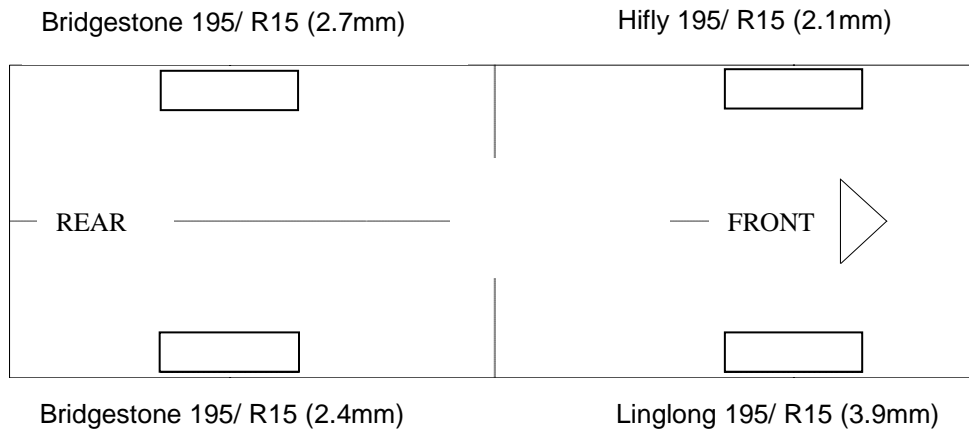
6. The 4 tyres of the Motor Van were observed to be in serviceable condition and sufficiently inflated for vehicular operation. I did not find any tear, cut or burst mark(s) on the outer and the inner sidewalls as well as across the tread of the 4 tyres. The tyre brand, tyre size and remaining tread depth of the 4 tyres of the Motor Van were recorded as follows:-

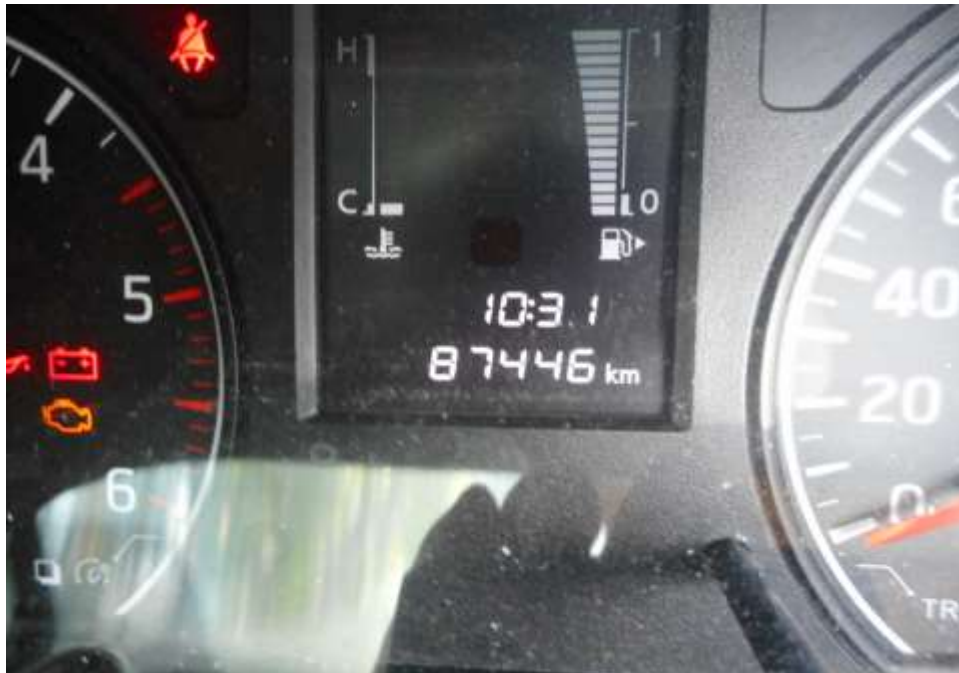
Photo 1 shows a general view of the instrument cluster of the Motor Van at the time of my inspection. The mileage of the Motor Van was 87,446km

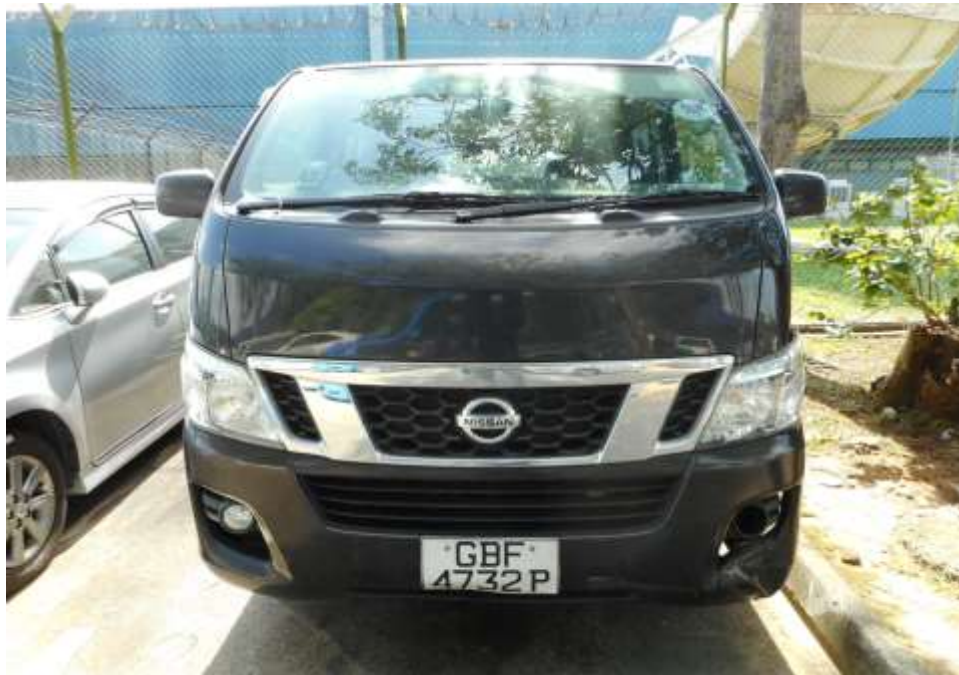
4. The mileage of the Motor Van at the time of my inspection was 87,446km.
5. The Motor Van appeared to have sustained damage at its frontal portion. Its front bumper and front left head lamp were damaged at the time of my inspection.

Photo 2 shows a general view of the Motor Van's frontal portion at the time of my inspection. It appeared to have sustained damage at its frontal portion. Its front bumper and front left head lamp were damage at the time of my inspection.

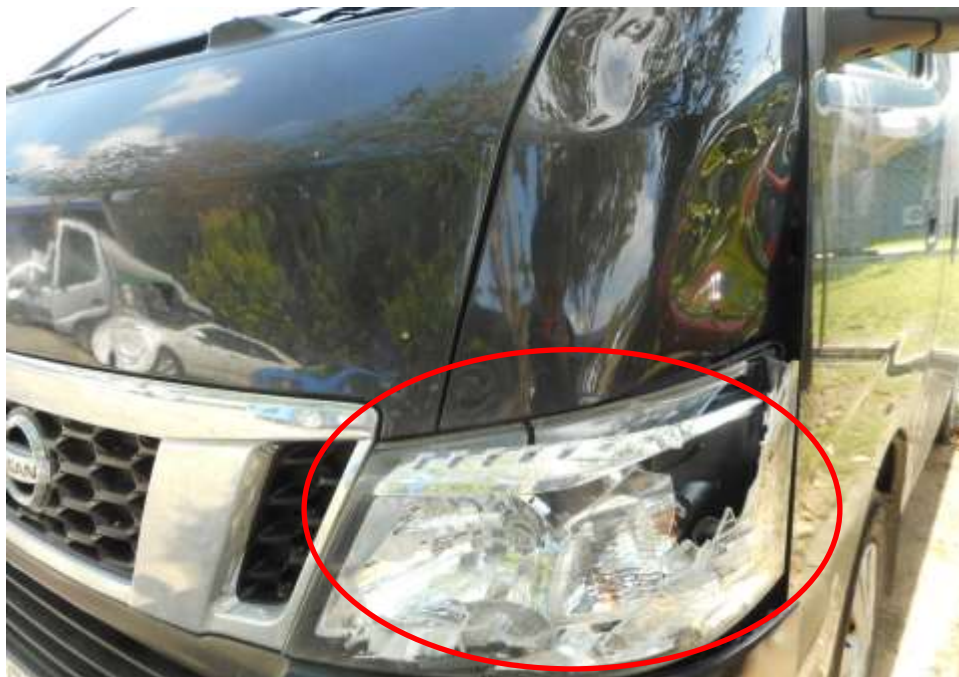
Photo 3 shows a close up view of the Motor Van's frontal portion at the time of my inspection. It appeared to have sustained damage at its frontal portion. Its front left head lamp (circled) was damage at the time of my inspection as a result of the accident.

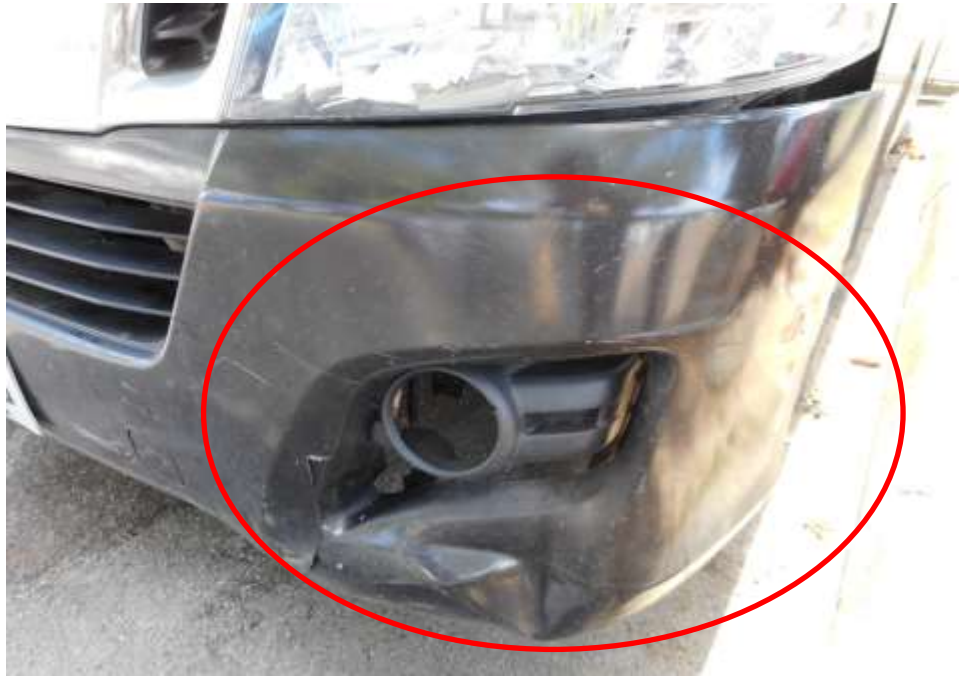
Photo 4 shows a close up view of the Motor Van's frontal portion at the time of my inspection. It appeared to have sustained damage at its frontal portion. Its front bumper (circled) was damaged at the time of my inspection as a result of the accident.

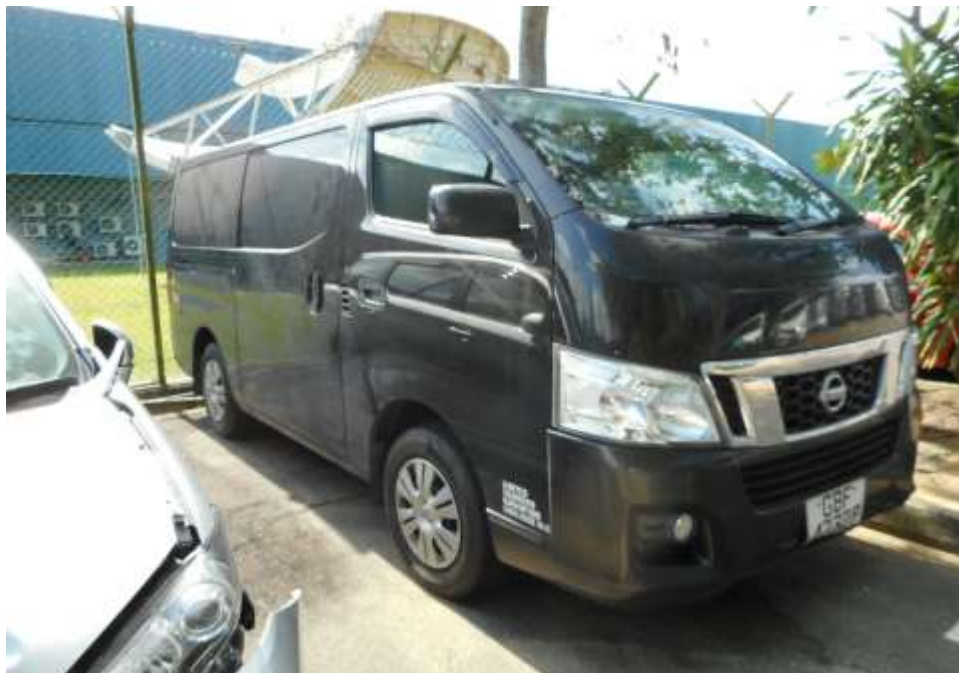
Photo 5 shows a general view of the right body of the Motor Van at the time of my inspection. The Motor Van was observed to be intact and unaffected by the accident.

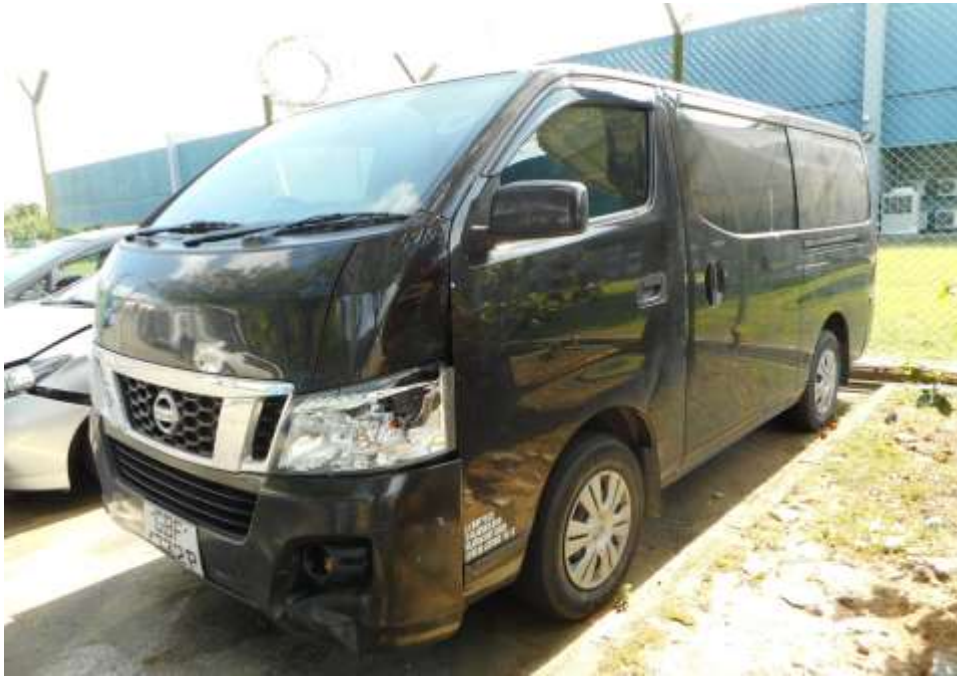
Photo 6 shows a general view of the left body of the Motor Van at the time of my inspection. The Motor Van was observed to be intact and unaffected by the accident.

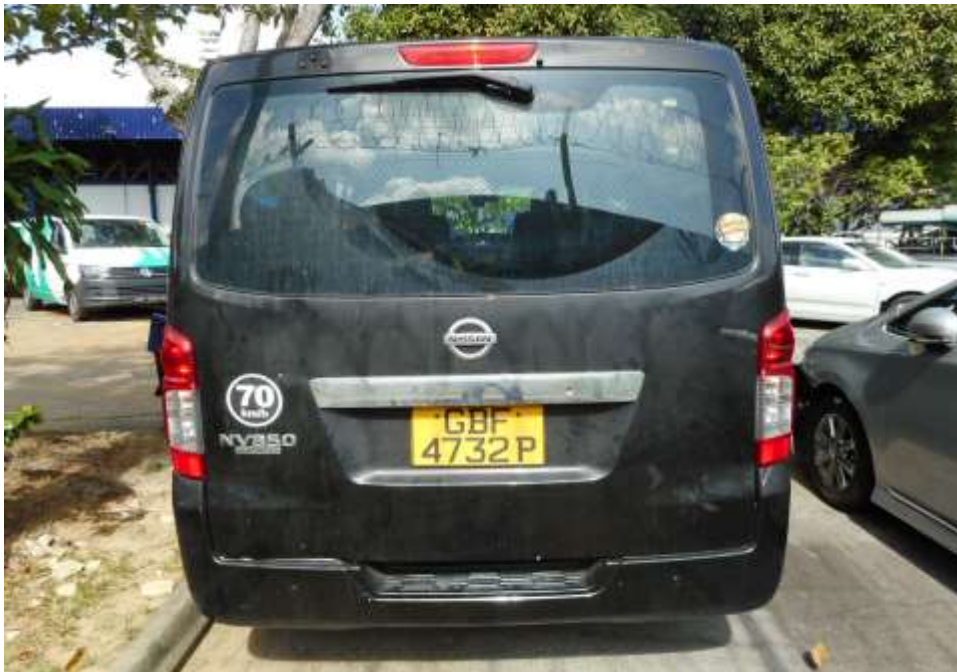
Photo 7 shows a general view of the rear body of the Motor Van at the time of my inspection. The Motor Van was observed to be intact and unaffected by the accident.

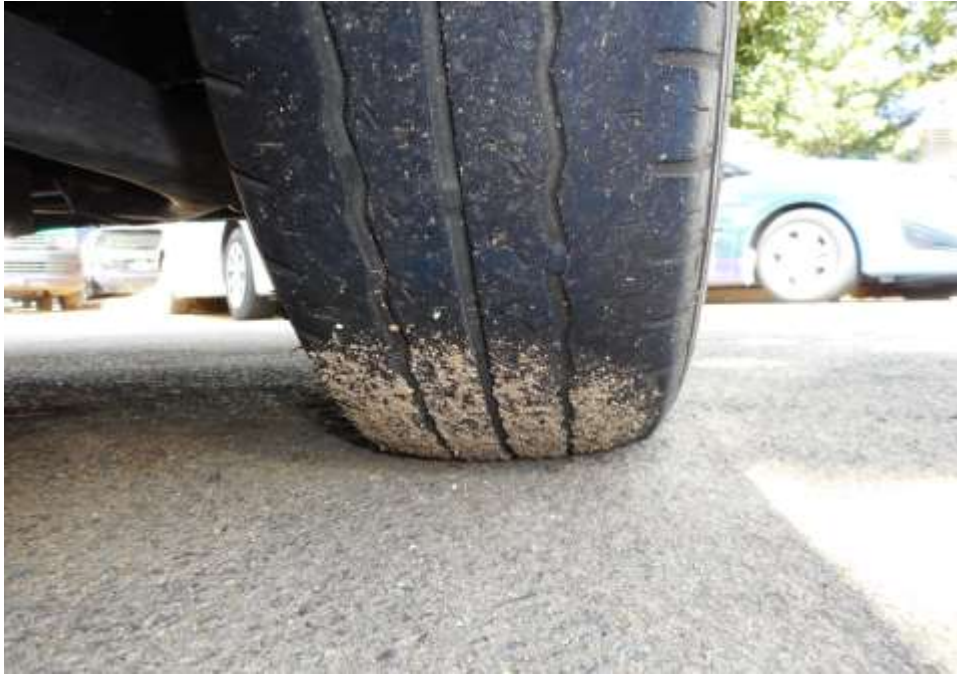
Photo 8 shows the condition of the front right tyre of the Motor Van, which was observed to be in serviceable condition with remaining tread depth of approximately 3.9mm. The tyre, which was wrapped around standard steel wheel rim, was also observed to be sufficiently inflated for vehicular operation. There was no tear, cut or burst mark(s) on the outer and the inner sidewalls as well as across the tread of the 4 tyres that were fitted on the Motor Van.

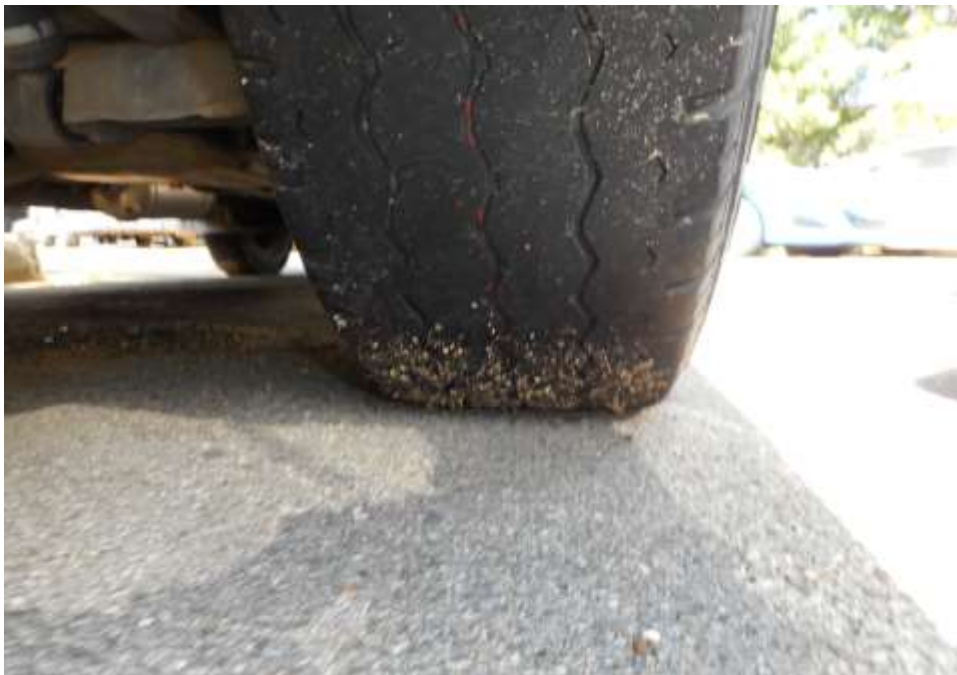
Photo 9 shows the condition of the rear right tyre of the Motor Van, which was observed to be in serviceable condition with remaining tread depth of approximately 2.4mm. The tyre, which was wrapped around standard steel wheel rim, it was observed to be sufficiently inflated for vehicular operation.

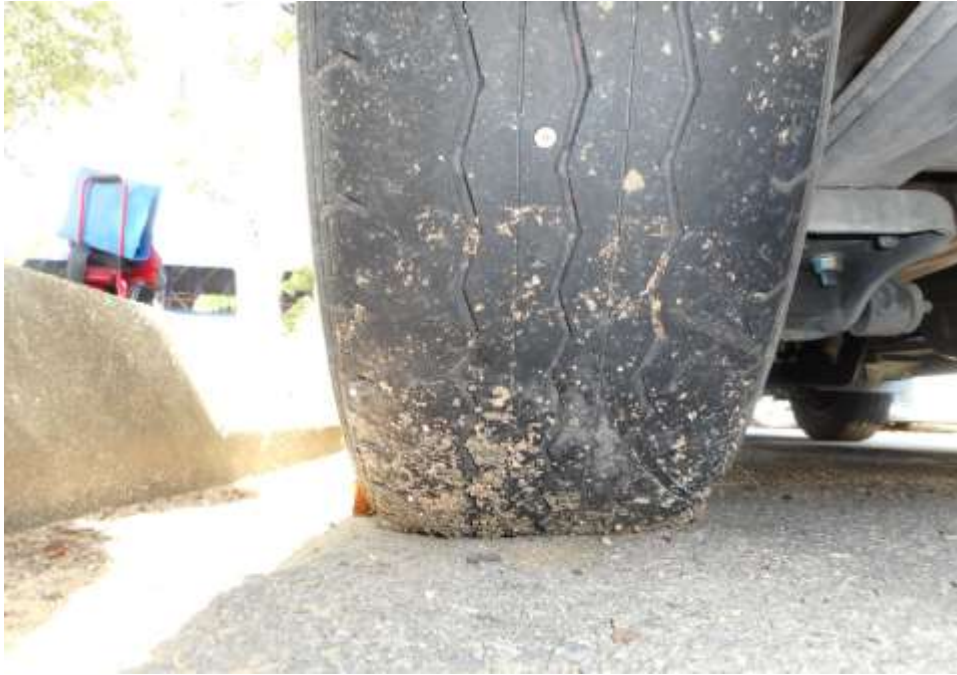
Photo 10 shows the condition of the rear left tyres of the Motor Van, which was observed to be in serviceable condition with remaining tread depth of approximately 2.7mm. The tyres, which were wrapped around standard steel wheel rim, were also observed to be sufficiently inflated for vehicular operation. There was also no damage found on all 4 steel wheel rims of the Motor Van.

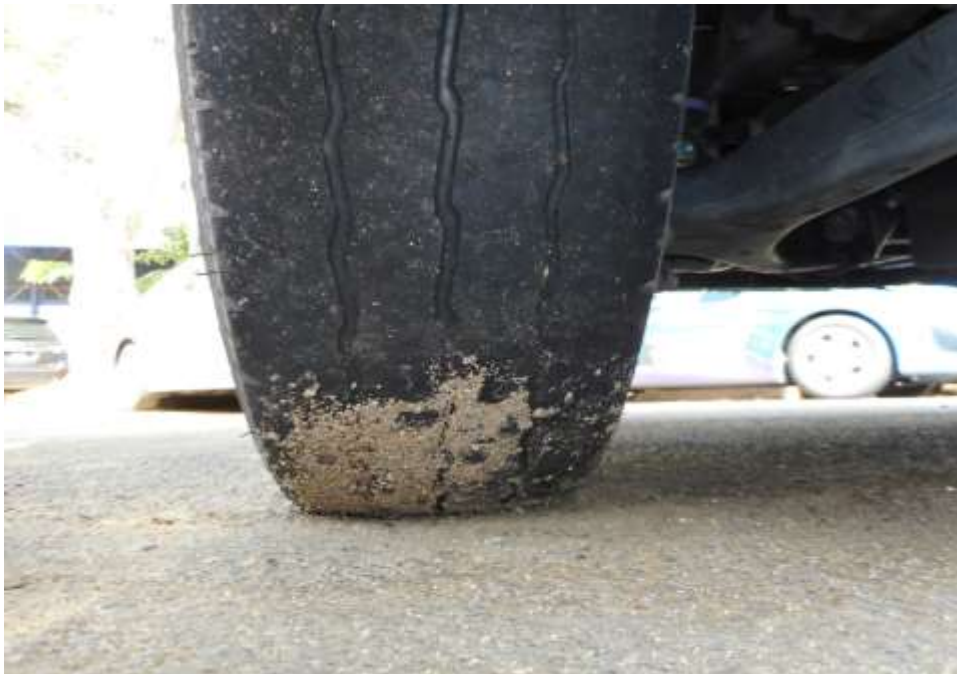
Photo 11 shows the condition of the rear right tyres of the Motor Van, which were observed to be in serviceable condition with remaining, tread depth of approximately 2.1mm. There was also no tear, cut or burst mark(s) on the outer and the inner sidewalls as well as across the tread of the 4 tyres that were fitted on the Motor Van.

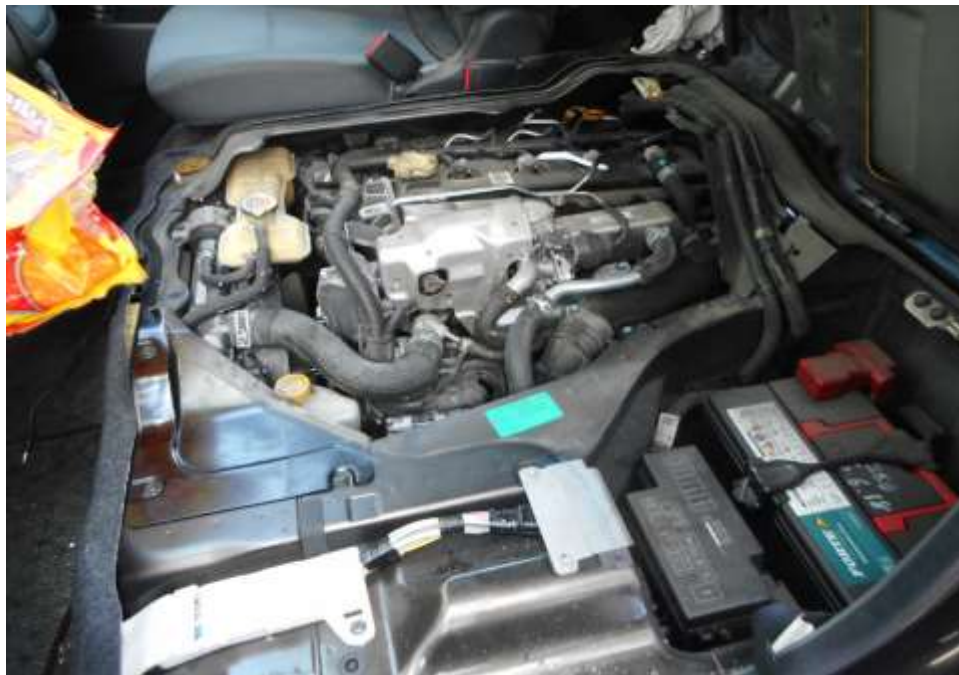
Photo 12 shows a general view of the Motor Van's engine compartment, which was accessed by lifting the front cabin of the Motor Van. The various parts and components inside the engine compartment were unaffected by the accident. There was also no sign(s) or indication(s) of fresh fluid leakage and/or fluid stain within the engine compartment

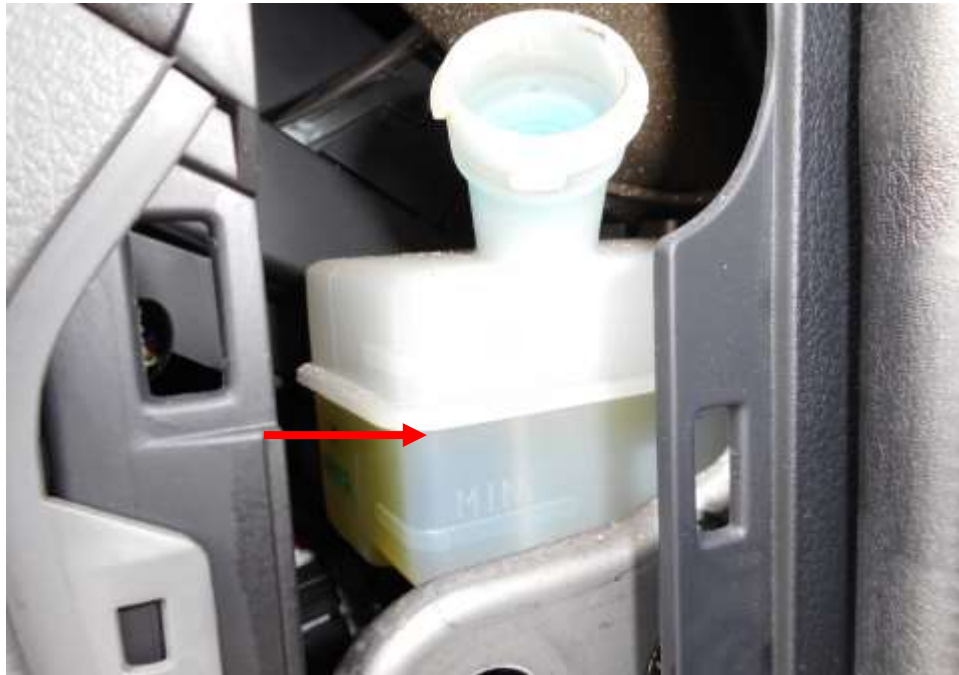
Photo 13 shows the brake fluid reservoir of the Motor Van at the time of my inspection. The brake fluid was observed to be of sufficient level (arrowed) and without any visible contamination.

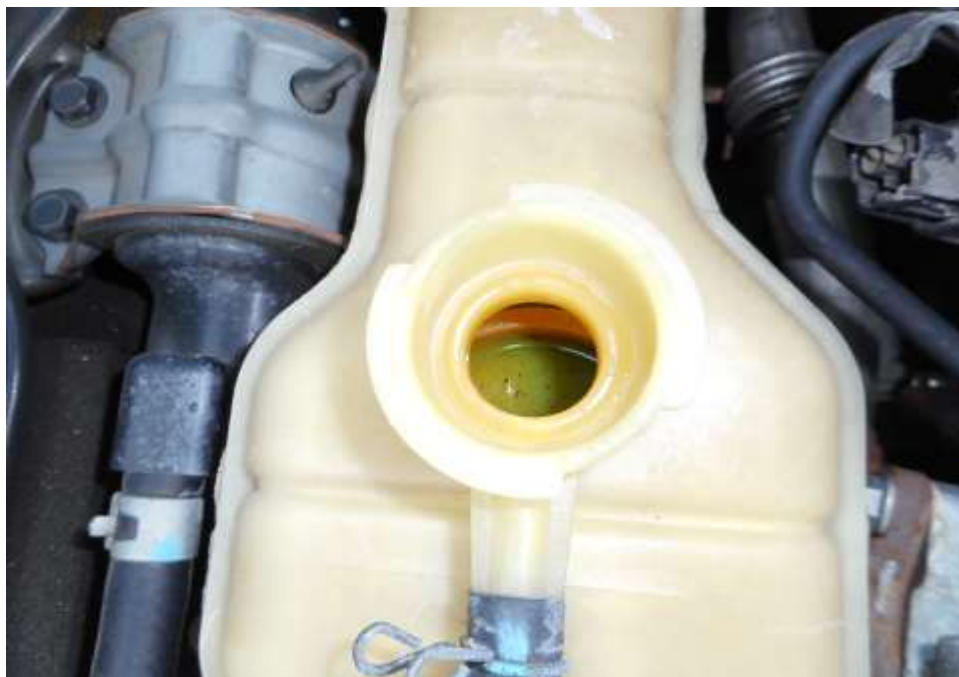
Photo 14 shows the engine coolant reservoir of the Motor Van at the time of my inspection. The engine coolant was observed to be of sufficient level and without any visible contamination.

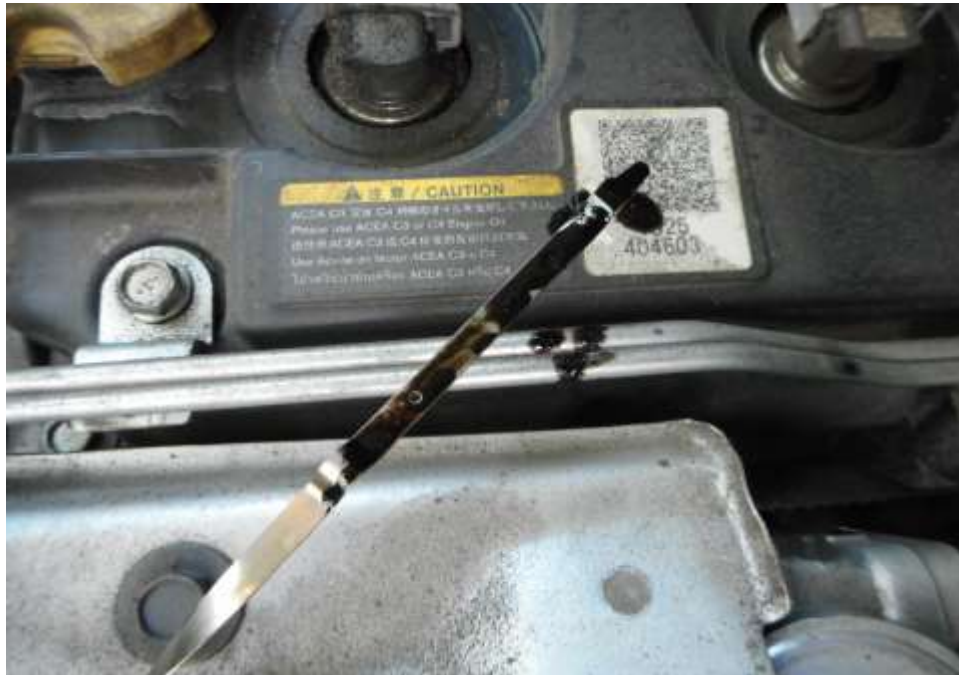
Photo 15 shows the engine oil dip stick of the Motor Van at the time of my inspection. The engine oil was observed to be of sufficient level and without any visible contamination.

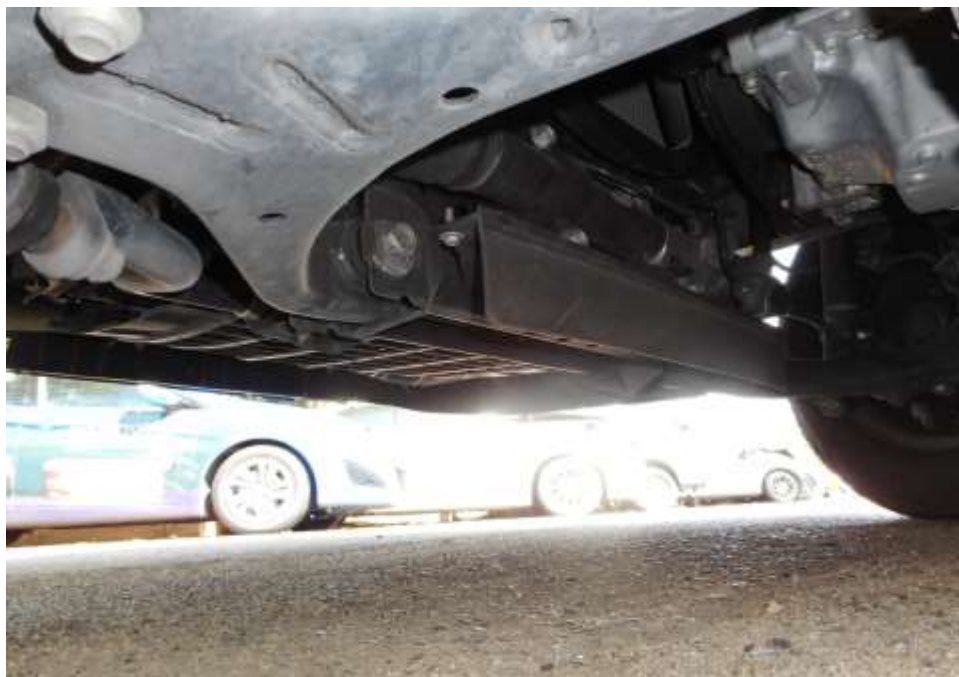
Photo 16 shows the undercarriage of the Motor Van, at the area where the engine housing and transmission housing are located. . I did not find any sign(s) or indication(s) of fluid leak and/or fluid stain(s) on the underside of the Motor Van.

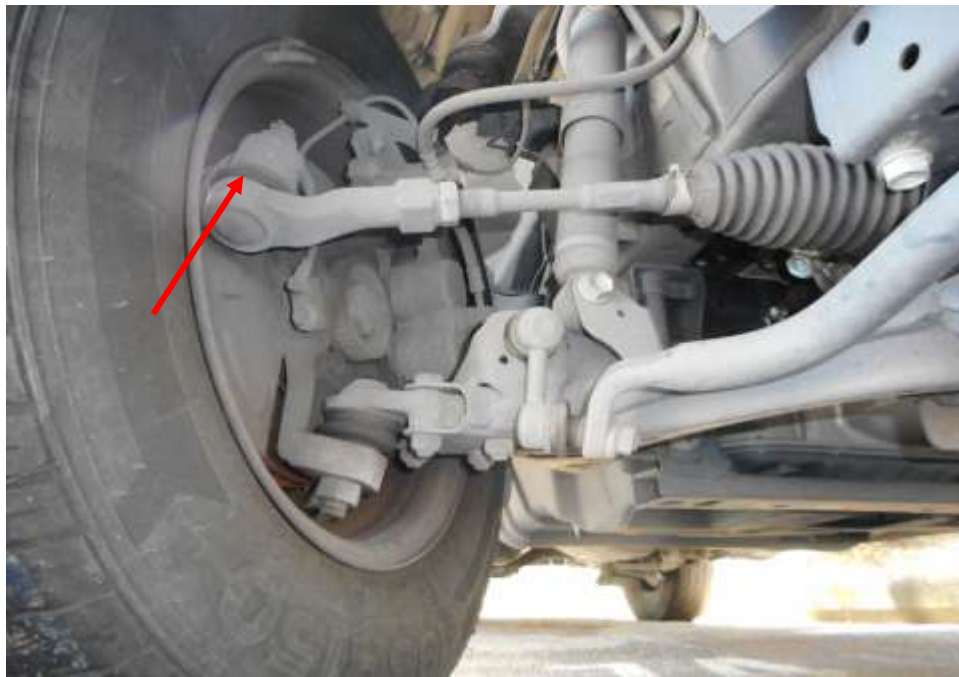
Photo 17 shows the various undercarriage components at the front right wheel of the Motor Van, in particular the steering tie rod end (arrowed). The various steering components were all found to be intact, suggesting that the steering system of the Motor Van was likely to be in serviceable condition at the material time of accident. There was also no sign of fluid stain(s) observed on the various undercarriage components.

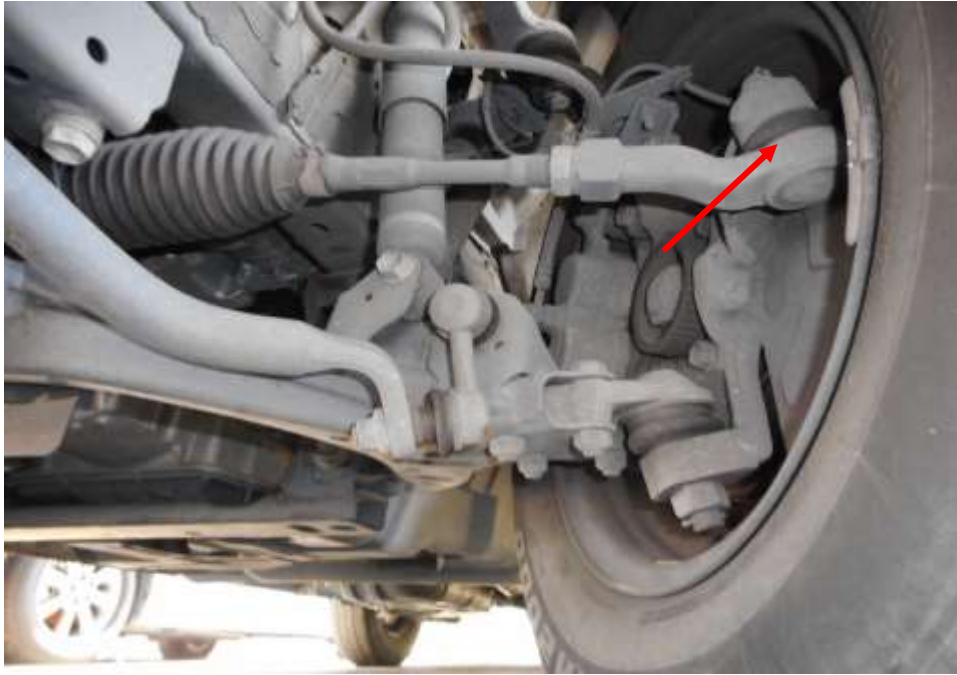
Photo 18 shows the various undercarriage components at the front left wheel of the Motor Van, in particular the steering tie rod end (arrowed). The various undercarriage components of the Motor Van were all found to be intact without any visible damage. There was also no sign of fluid stain(s) observed on the various undercarriage components.

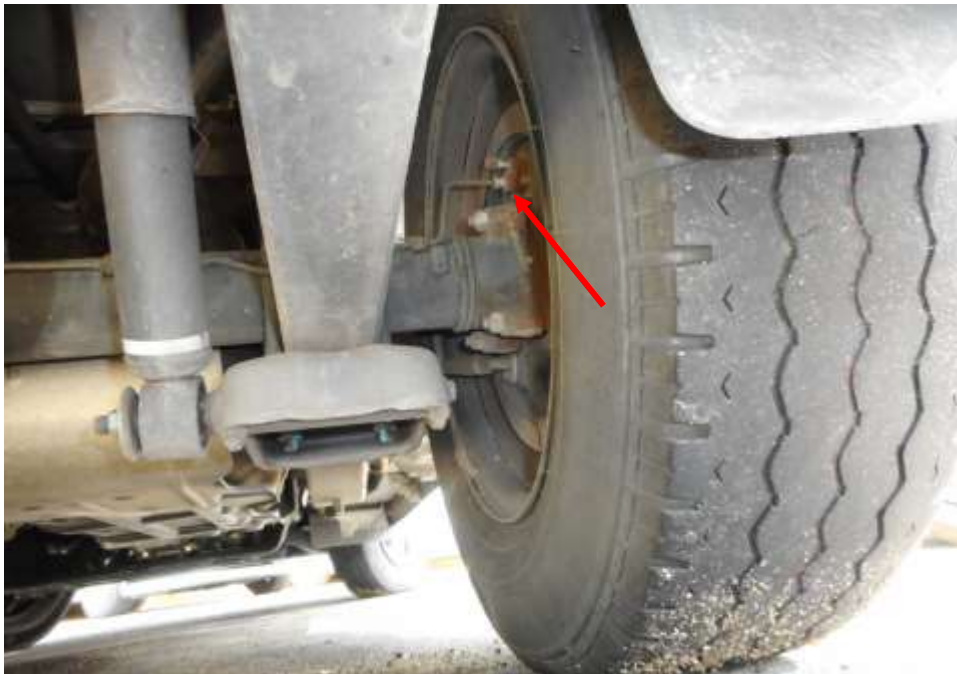
Photo 19 shows the brake pipe (arrowed) at the rear right wheel of the Motor Van. I did not observe any leakage of brake fluid at the time of my inspection of the Motor Van. My static tests of the Motor Van's braking system, along with my visual examination of the various mechanical components in the braking system, had indicated that there was no internal leakage of pressure/vacuum. Hence the braking system of the Motor Van was likely to be in serviceable condition at the material time of accident.

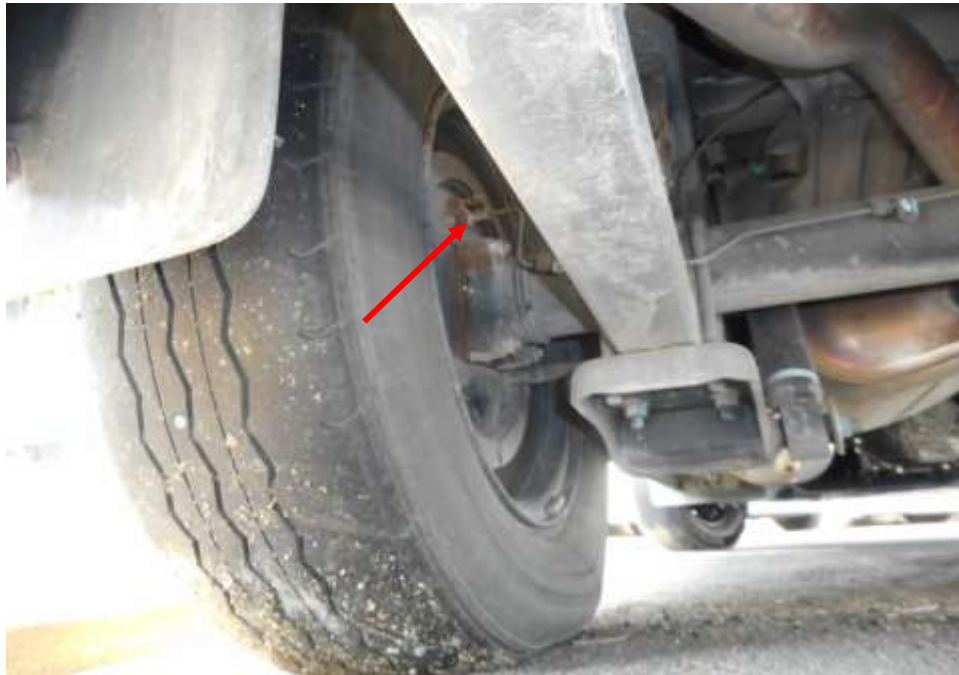
Photo 20 shows the brake pipe (arrowed) at the rear left wheel of the Motor Van. I did not observe any leakage of brake fluid at the time of my inspection of the Motor Van. My static tests of the Motor Van's braking system, along with my visual examination of the various mechanical components in the braking system had indicated that there was no internal leakage of pressure/vacuum. Hence the braking system of the Motor Van was likely to be in serviceable condition at the material time of accident.

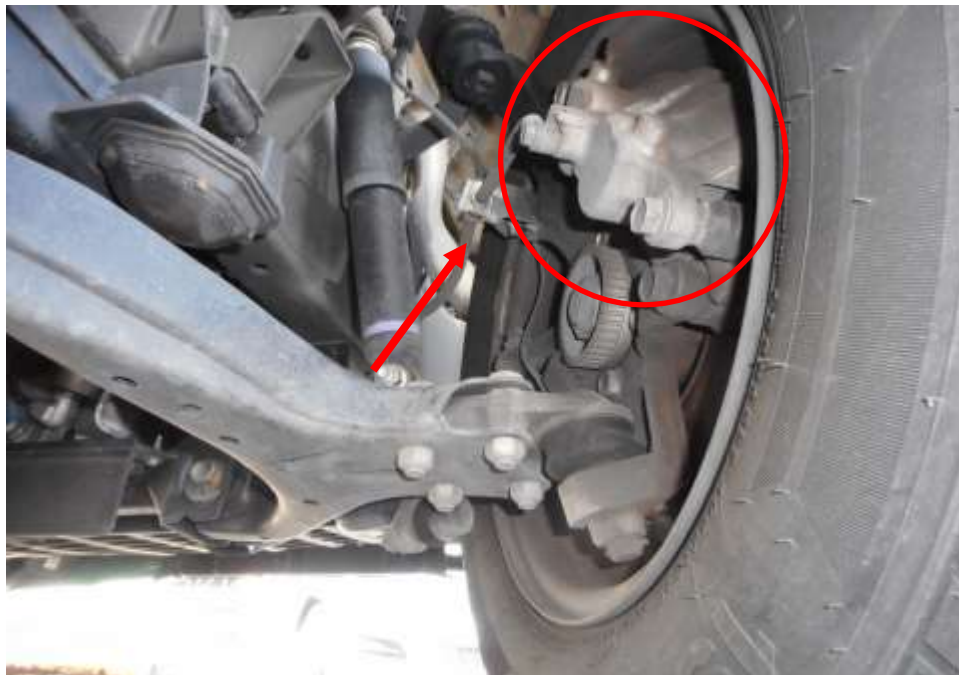
Photo 21 shows the brake hose/pipe (arrowed) at the front right wheel of the Motor Van. No leakage of brake fluid was observed. Visual examination of the various components of the braking system like the brake caliper (circled), brake booster, brake pedal etc had revealed all to be intact and without visible damage at the time of accident. There was also no sign of fluid stain(s) observed on the various undercarriage components.

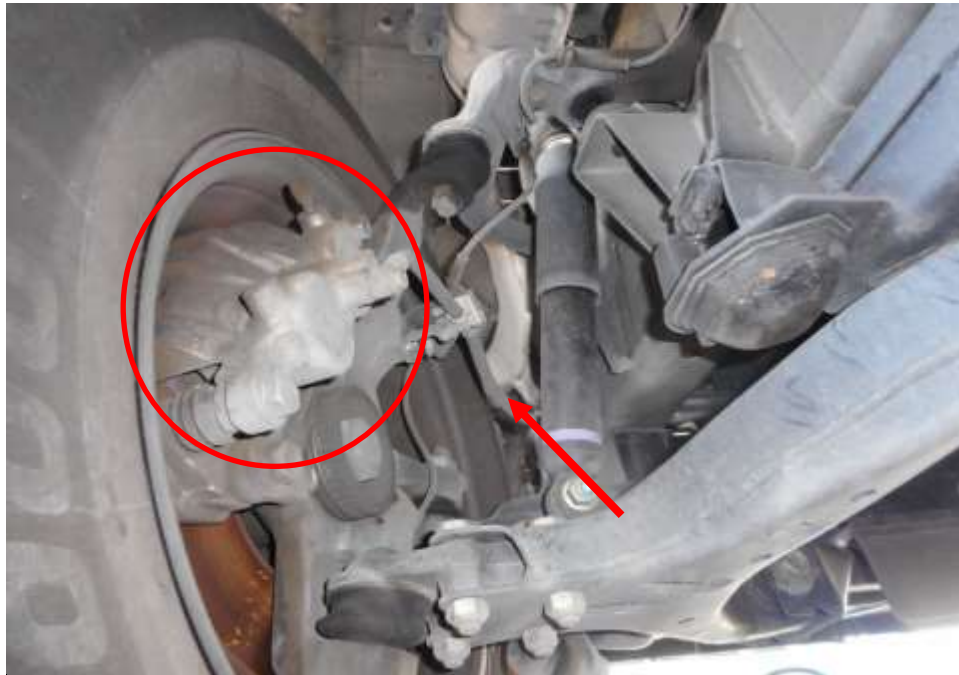
Photo 22 shows the brake hose/pipe (arrowed) at the front left wheel of the Motor Van. No leakage of brake fluid was observed. Visual examination of the various components of the braking system like the brake caliper (circled), brake booster, brake pedal etc had revealed all to be intact and without visible damage at the time of accident. There was also no sign of fluid stain(s) observed on the various undercarriage components.

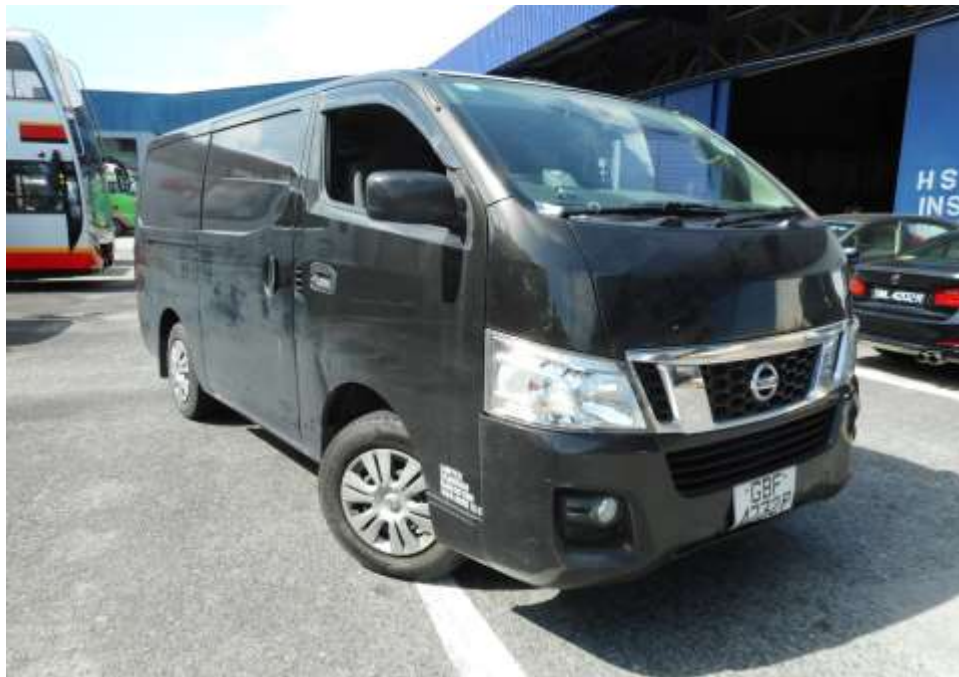
Photo 23 shows the front right wheel of the Motor Van turned to its full left. During my steering system test, I did not experience any abnormal free play and/or resistance when I had turned the steering wheel towards full left and full right. This would suggest that the steering system of the Motor Van was likely to be in serviceable condition at the material time of accident.

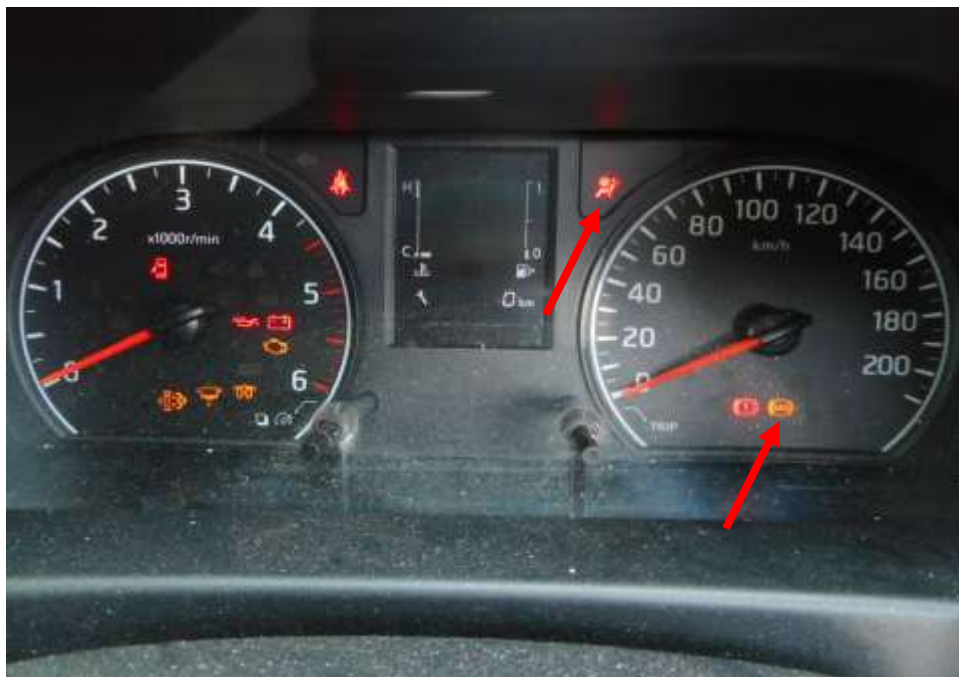
Photo 24 shows the warning light for Anti-Lock Brake System (ABS) and Supplemental Restraint System (SRS) (arrowed) appearing on the instrument panel of the Motor Van during the self-test of its various electronic operating systems when its engine was cranked.

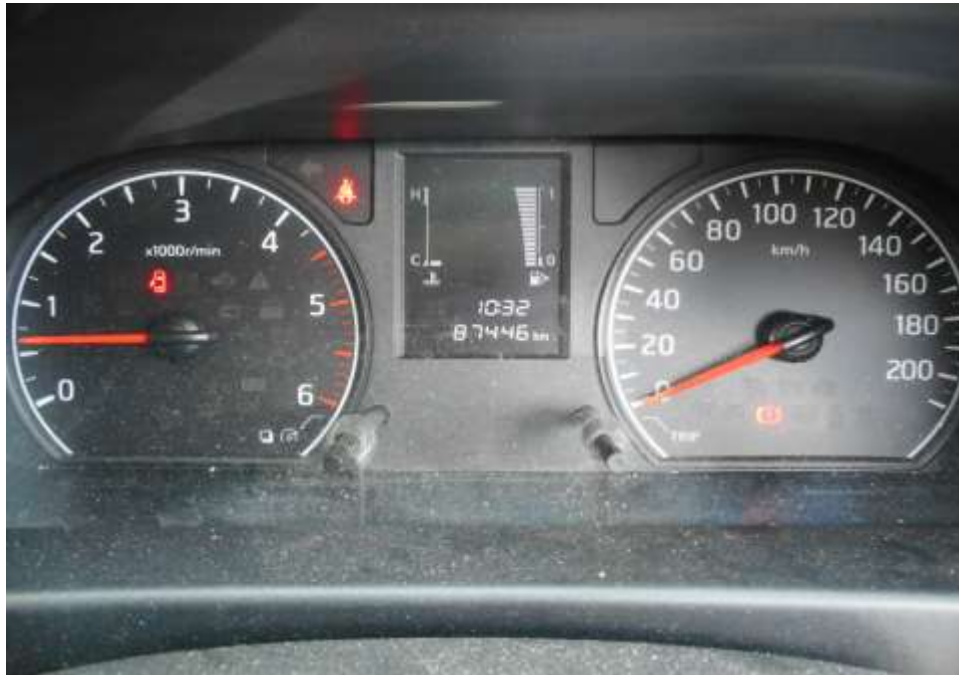
Photo 25 shows no warning lights illuminated on the instrument panel of the Motor Van after the engine was cranked. This would suggest that there was no abnormality to the electronic operating system of the Motor Van, like the ABS and SRS etc.
