Your Ref: TP/IP/77615/2019
Our Ref : CI/TPD20001933/P

Fatal Accident Investigation Team

MECHANICAL INSPECTION REPORT OF MOTOR CAR SKP 8441T

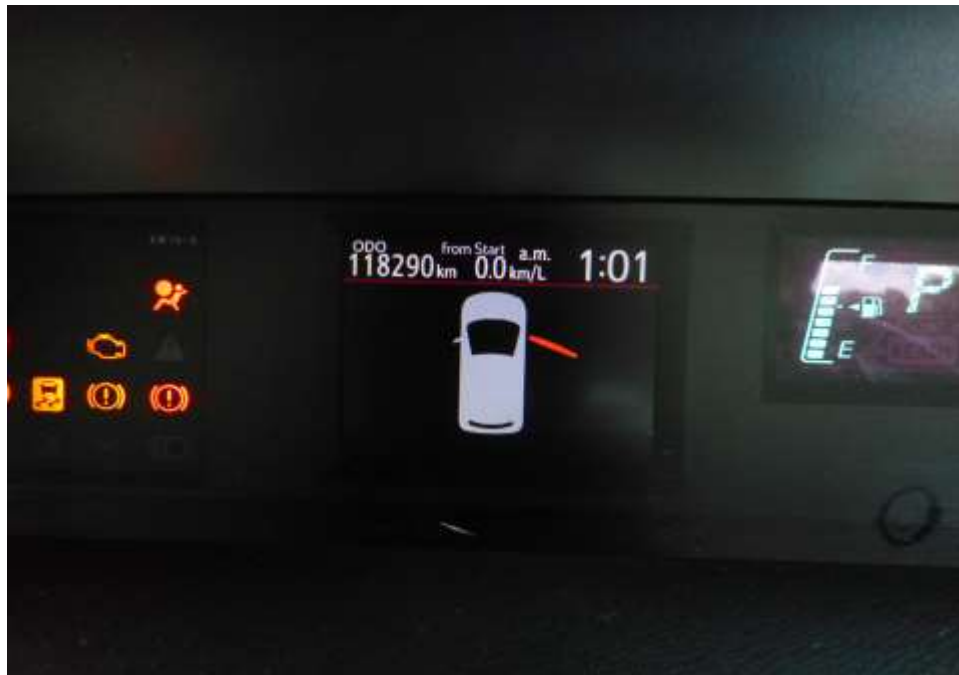
Photo 1 shows the mileage of the Motor Car at the time of my inspection recorded at 118,290km.

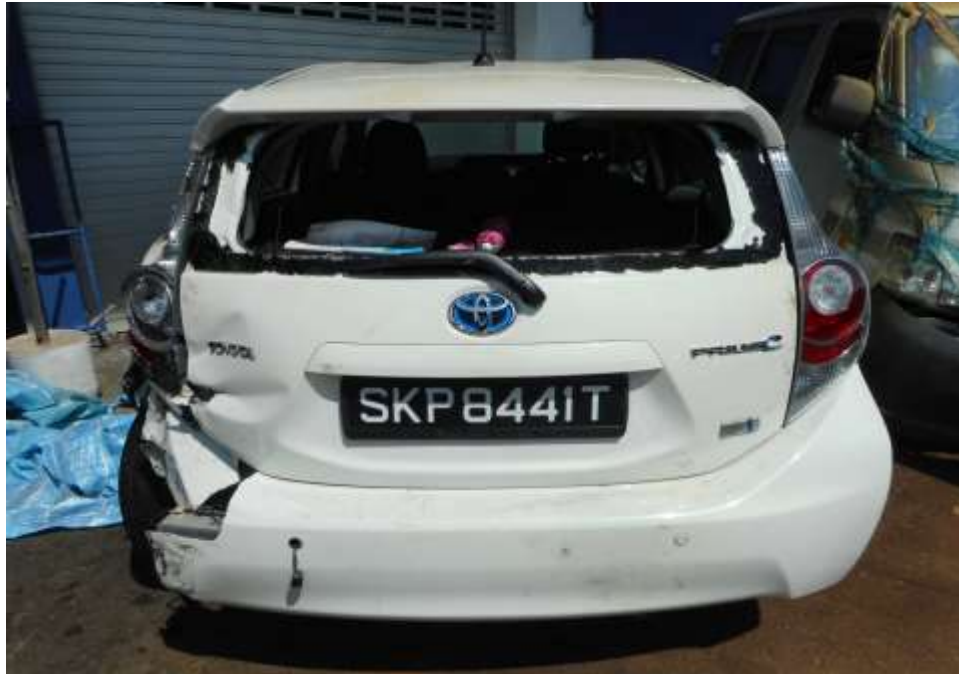
4. The mileage of the Motor car at the time of my inspection was recorded as 118,290km
5. The Motor car was observed to sustain major damage at its rear and rear left portion. Its rear windscreen, rear bonnet, rear bumper, rear left body panel and its rear left headlamp was damaged at the time of my inspection.

Photo 2 shows a general view of the Motor Car's rear portion at the time of my inspection. The rear and rear left portion of the Motor Car was observed to sustain major damage. Its rear windscreen, rear bonnet, rear bumper, rear left body panel and its rear left headlamp was damaged at the time of my inspection.

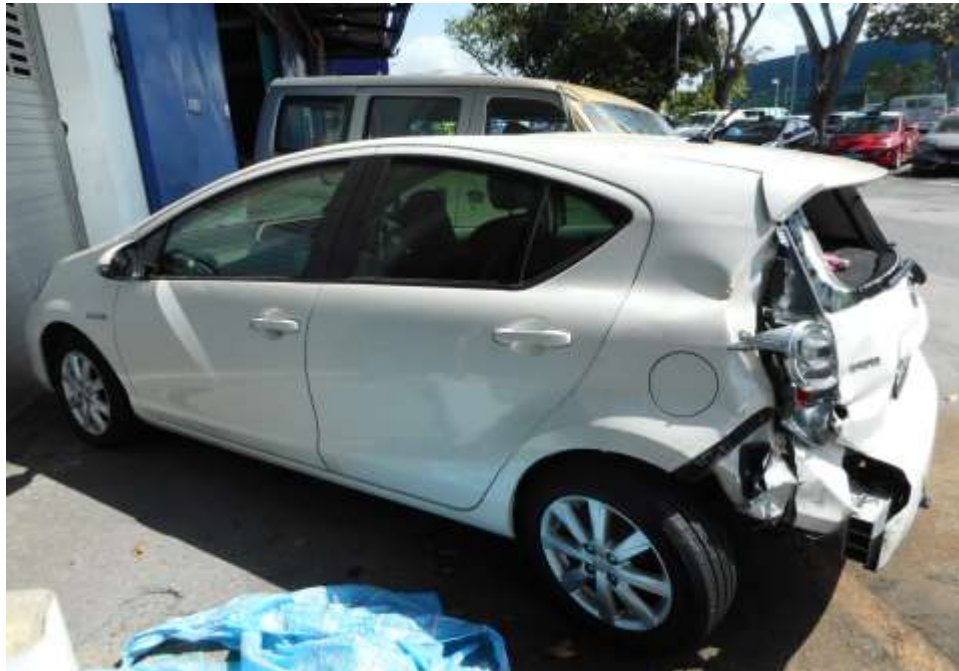
Photo 3 shows a general view of the Motor Car's left portion at the time of my inspection. The rear and rear left portion of the Motor Car was observed to sustain major damage. Its rear windscreen, rear bonnet, rear bumper, rear left body panel and its rear left headlamp was damaged at the time of my inspection.

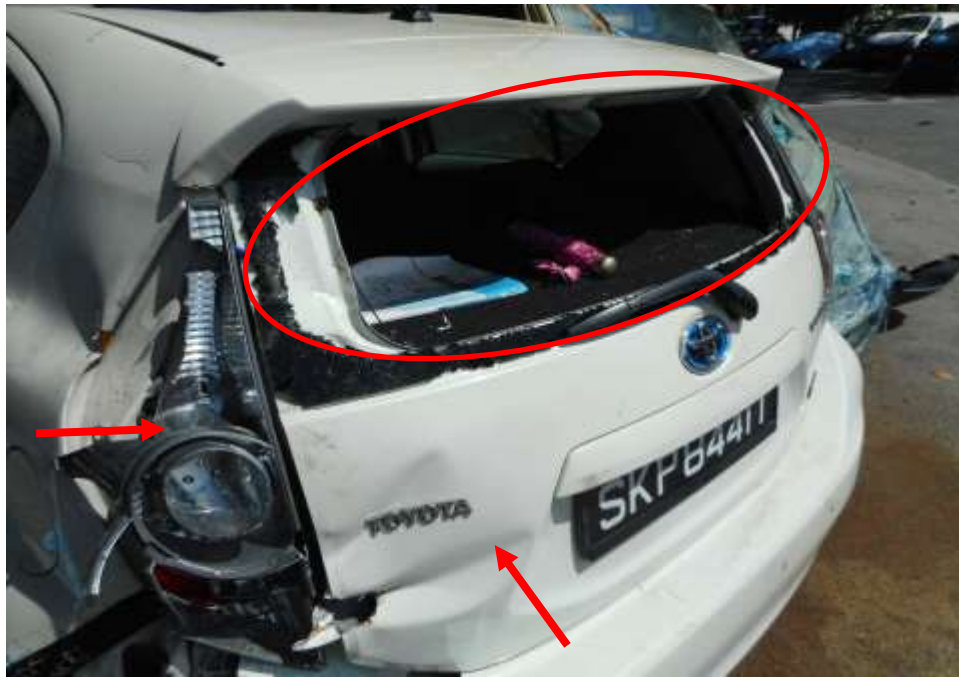
Photo 4 shows a close up view of the Motor Car's rear portion at the time of my inspection. The rear and rear left portion of the Motor Car was observed to sustain major damage. Its rear windscreen (circled), rear bonnet, and its rear left headlamp (arrowed) were damaged as a result of the accident.

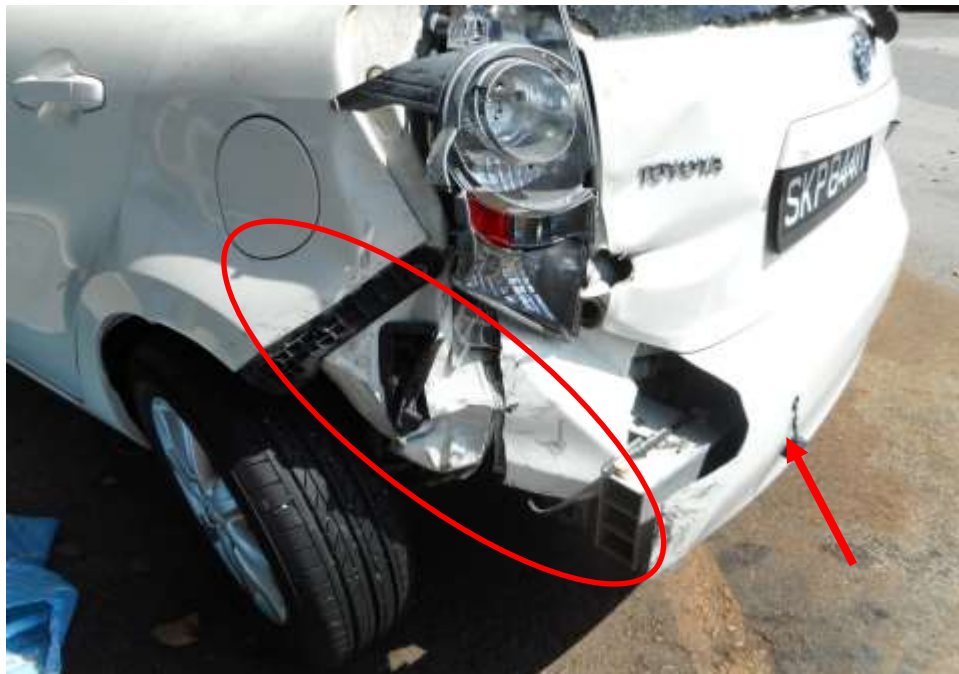
Photo 5 shows a close up view of the Motor Car's left portion at the time of my inspection. The rear portion of the Motor Car was observed to sustain moderate damage at its rear left portion. Its rear bumper (arrowed) and rear left body panel (circled) was damaged as a result of the accident.

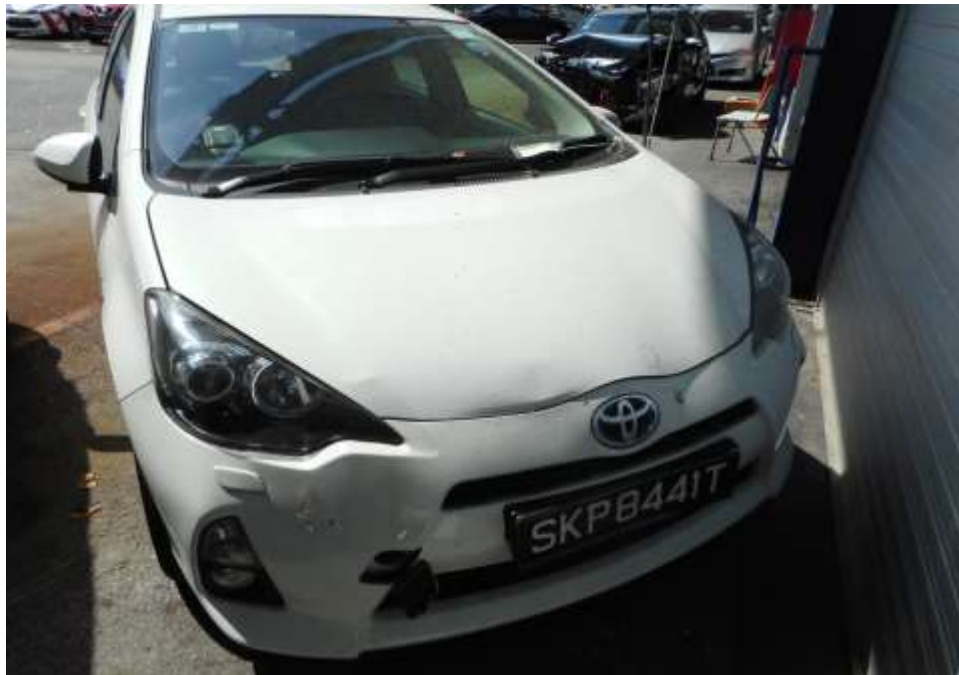
Photo 6 shows a general view of the Motor Car's front at the time of my inspection. The front portion of the Motor Car was observed to have been unaffected by the accident.

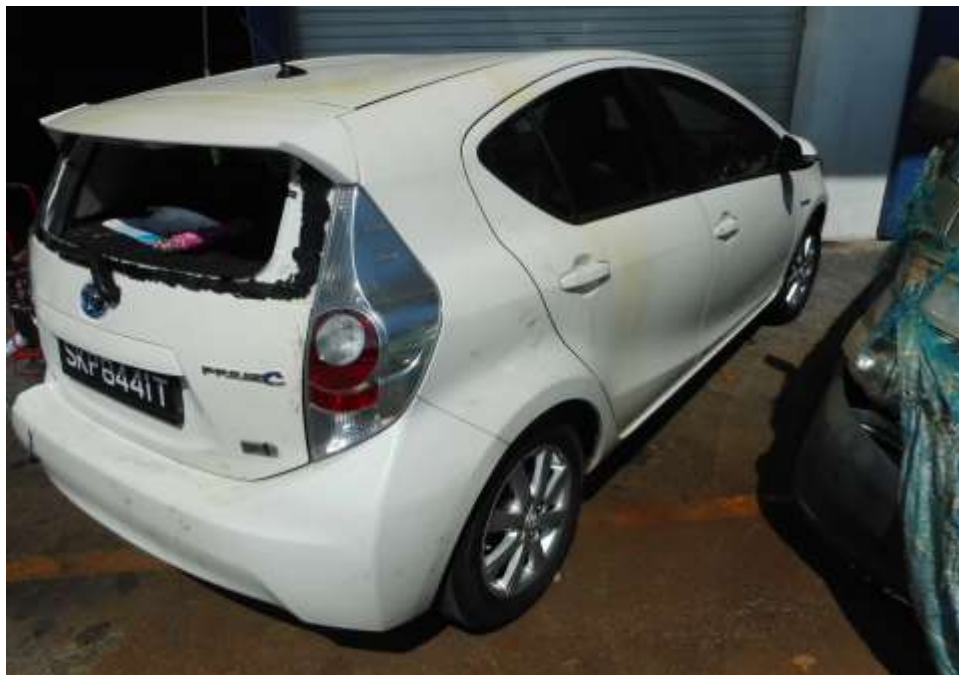
Photo 7 shows a general view of the Motor Car's right body at the time of my inspection. The right portion of the Motor Car was observed to have been unaffected by the accident.

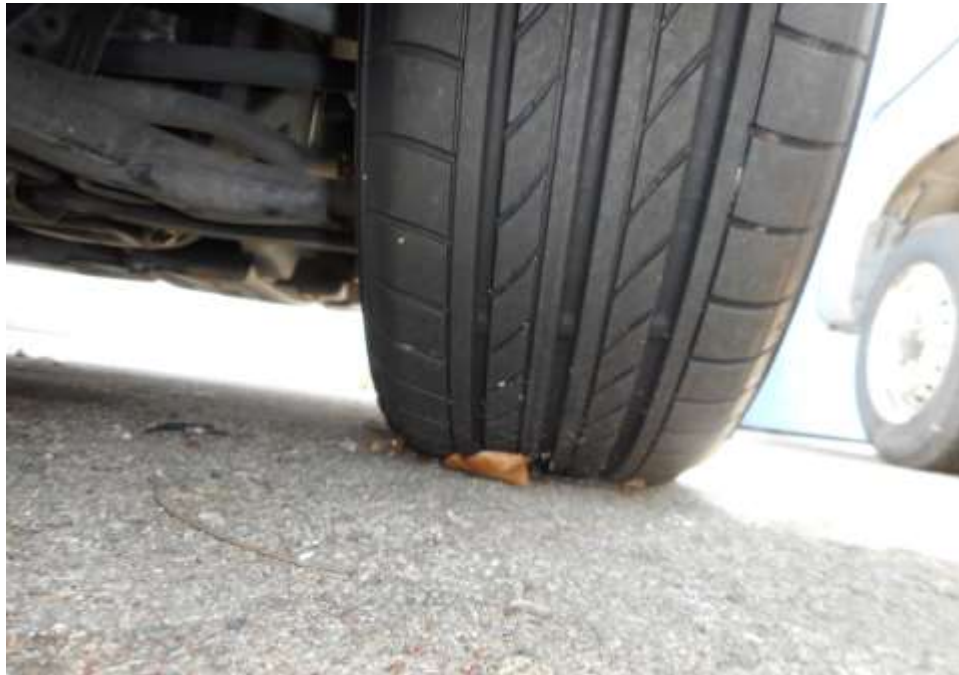
Photo 8 shows the condition of the front right tyre of the Motor Car, which was observed to be in serviceable condition with remaining tread depth of approximately 5.6mm. The tyre was sufficiently inflated for vehicular operation with no tear, cut or burst mark(s) on the outer and the inner sidewalls as well as across the tread. The 4 tyres of the Motor Car were wrapped around standard alloy wheel rims without any damage.

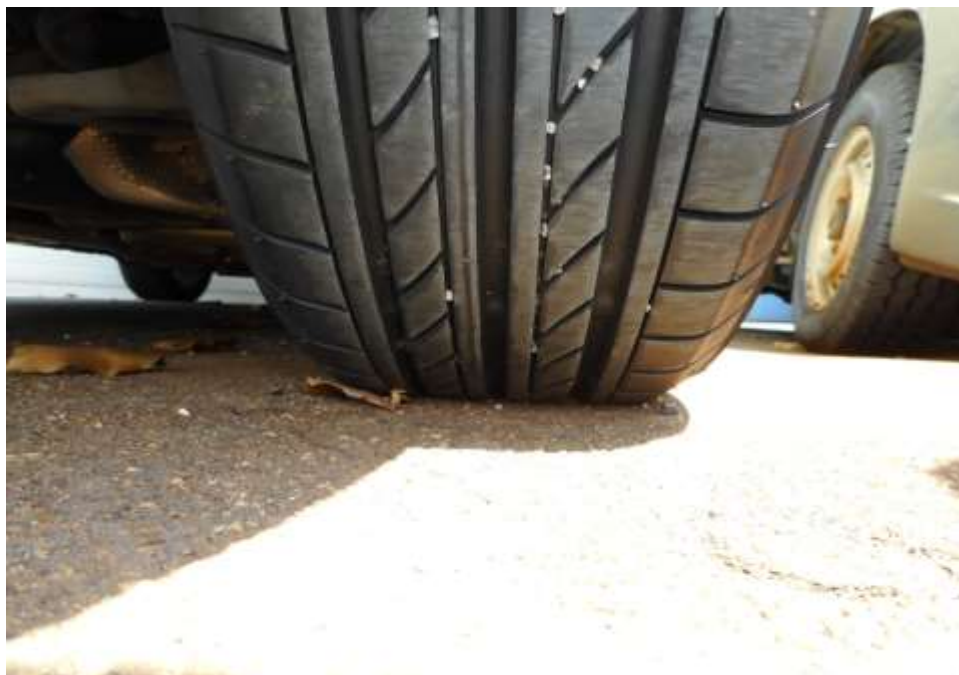
Photo 9 shows the condition of the rear right tyre of the Motor Car, which was observed to be in serviceable condition with remaining tread depth of approximately 6.1mm. The tyre was also observed to be sufficiently inflated for vehicular operation with no tear, cut or burst mark(s).

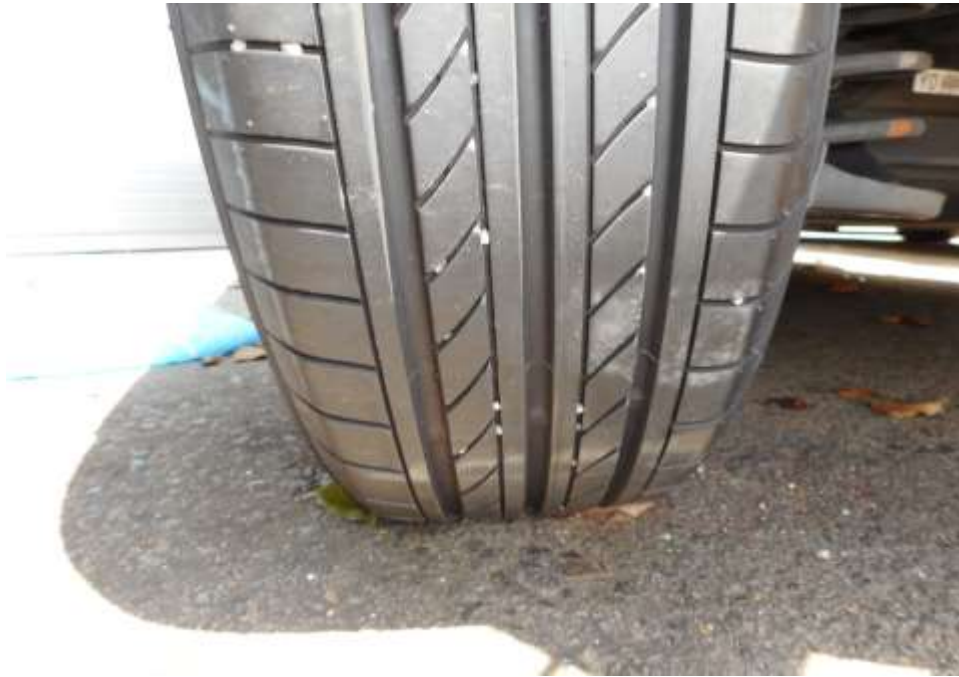
Photo 10 shows the condition of the rear left tyre of the Motor Car, which was observed to be in serviceable condition with remaining tread depth of approximately 5.9mm. The tyre, which was wrapped around alloy wheel rim, was also observed to be sufficiently inflated for vehicular operation. The 4 tyres of the Motor Car were wrapped around standard alloy wheel rims.

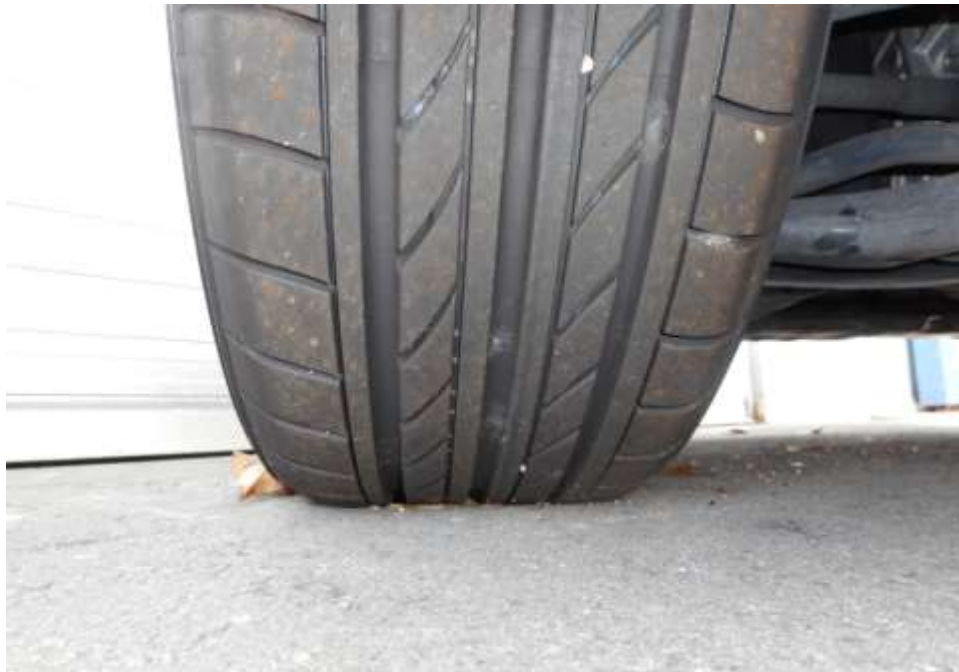
Photo 11 shows the condition of the front left tyre of the Motor Car, which was observed to be in serviceable condition with remaining tread depth of approximately 5.6mm. There was also no tear, cut or burst mark(s) on the outer and the inner sidewalls as well as across the tread of the Motor Car's 4 tyres.

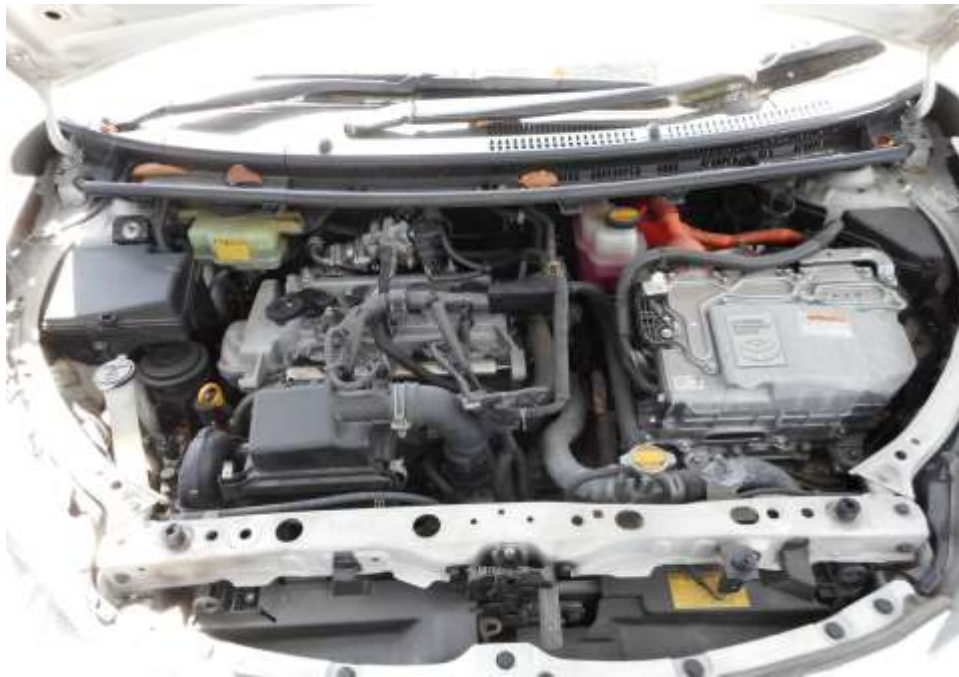
Photo 12 shows a general view of the Motor Car's engine compartment. The various parts and components inside the engine compartment were unaffected by the accident. There was also no sign(s) or indication(s) of fluid leakage and/or fluid stain within the engine compartment.

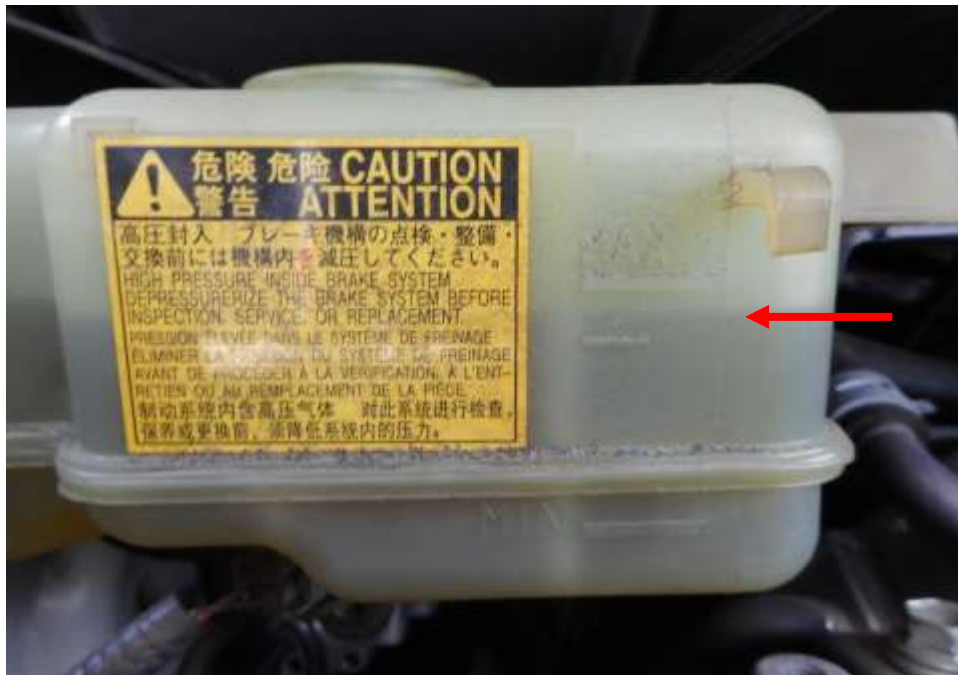
Photo 13 shows the brake fluid reservoir of the Motor Car at the time of my inspection. The brake fluid was observed to be of sufficient level (arrowed) and without any visible contamination.

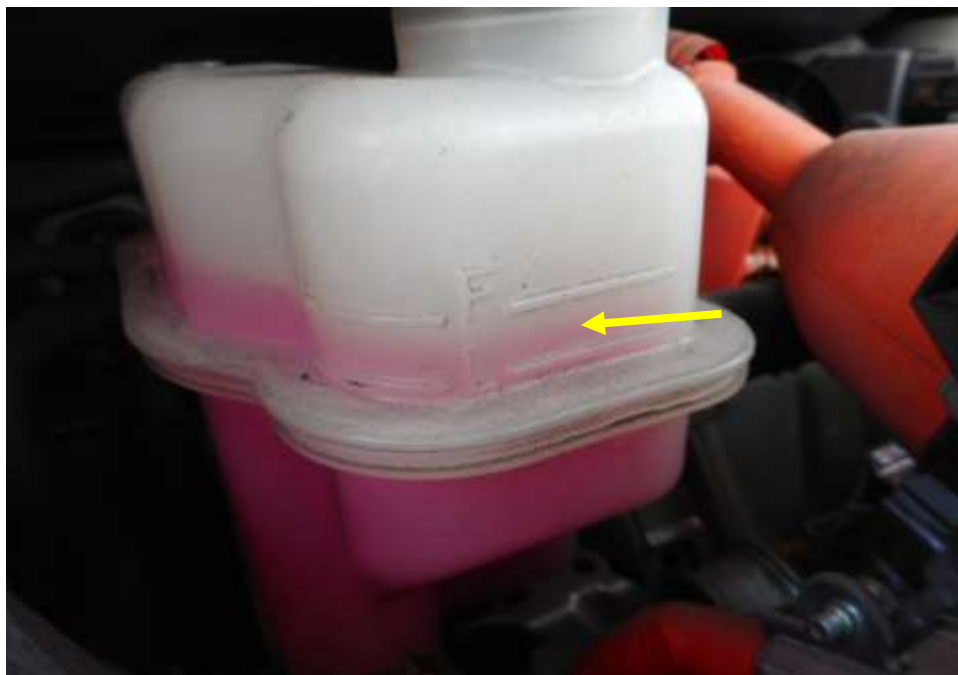
Photo 14 shows checks being carried out to the engine coolant of the Motor Car at the time of my inspection. The engine coolant was observed to be of sufficient level (arrowed) and without any visible contamination.

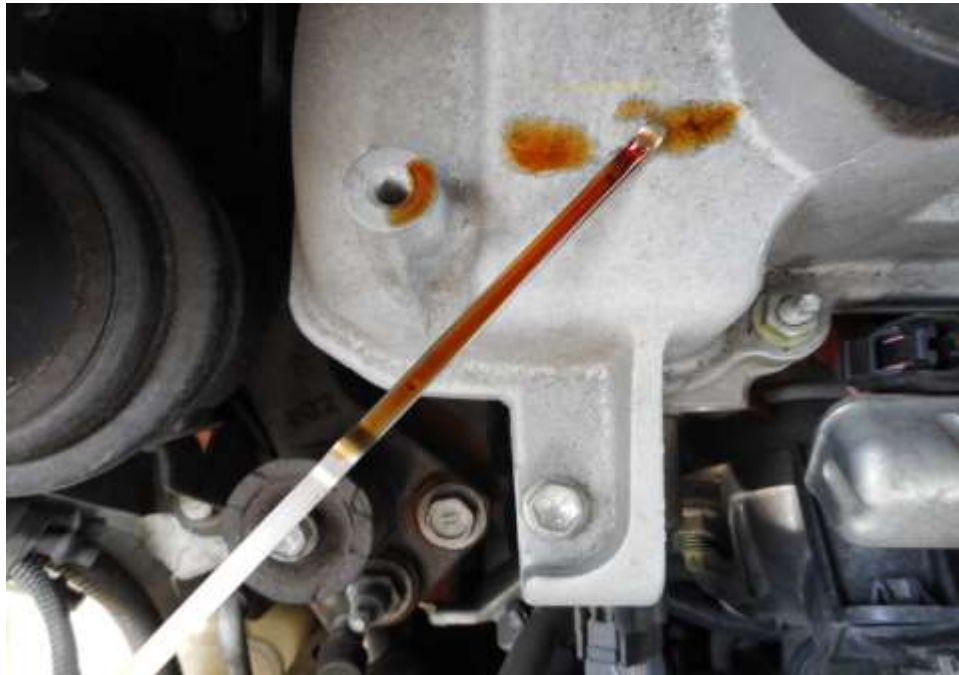
Photo 15 shows the engine oil dip stick of the Motor Car at the time of my inspection. The engine oil was observed to be of sufficient level and without any visible contamination.

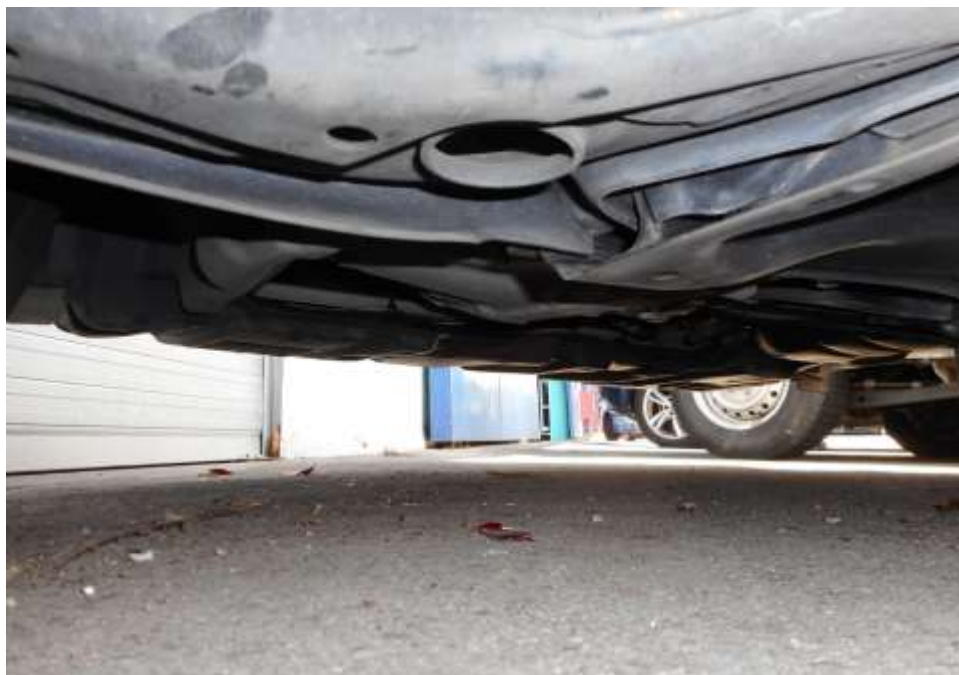
Photo 16 shows the undercarriage of the Motor Car, at the area where the engine housing and transmission housing are located. I did not find any sign(s) or indication(s) of fluid leak and/or fluid stain(s) on the underside of the Motor Car.

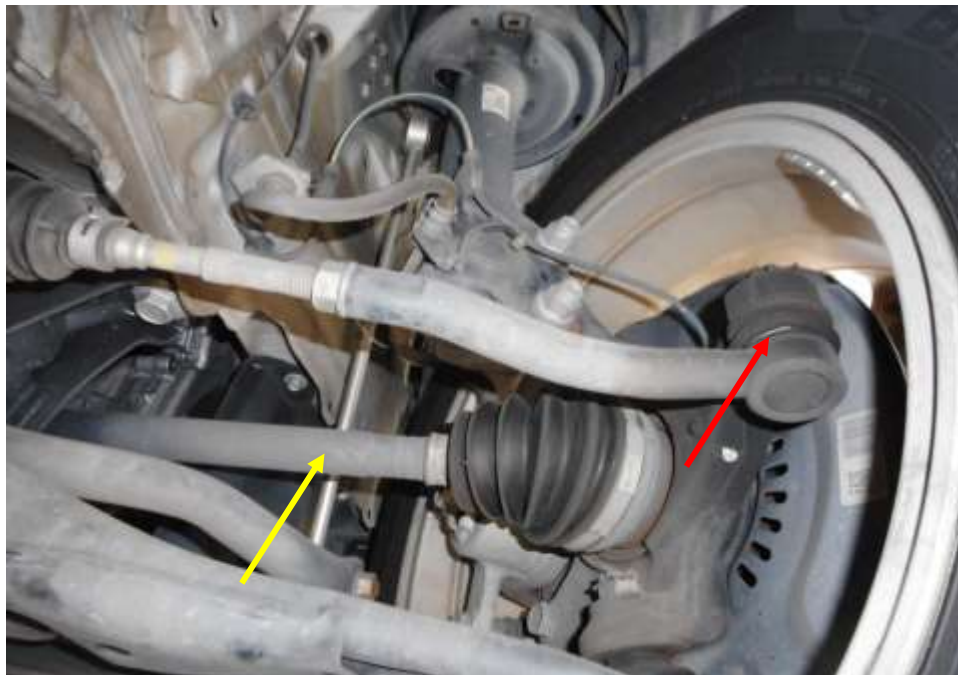
Photo 17 shows the various undercarriage components at the front right wheel of the Motor Car, in particular the steering tie rod (red arrow) and drive shaft (yellow arrow). The various steering components were all found to be intact, suggesting that the steering system of the Motor Car was likely to be in serviceable condition at the material time of accident. There was also no sign of fluid stain observed on the various undercarriage components at the front right wheel of the Motor Car.

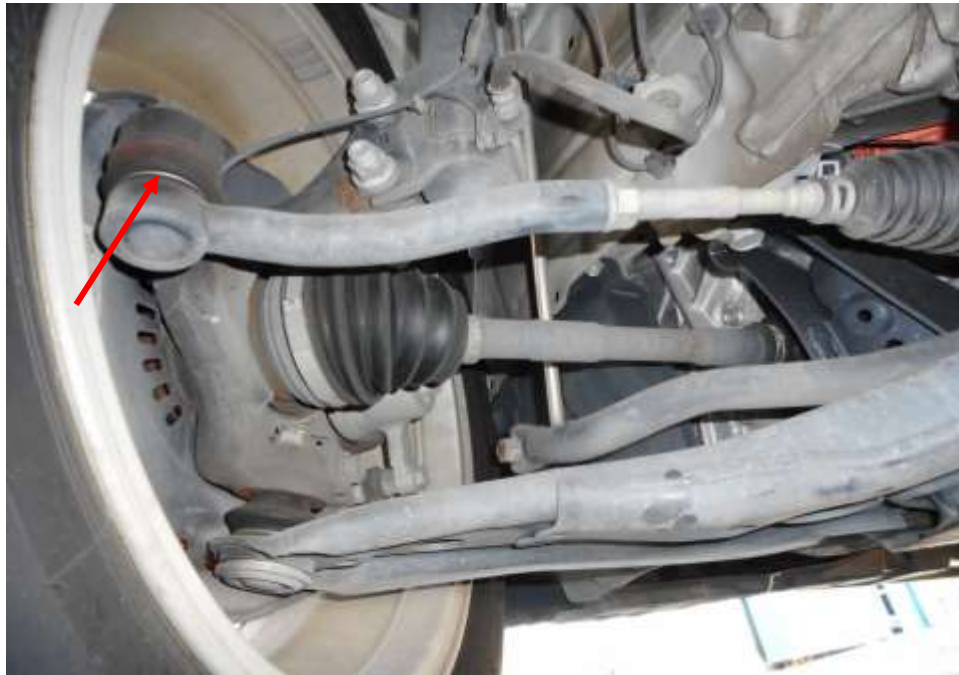
Photo 18 shows the various undercarriage components at the front left wheel of the Motor Car, which had included the steering tie rod (red arrow). The various undercarriage components of the Motor Car were all found to be intact without any visible damage.

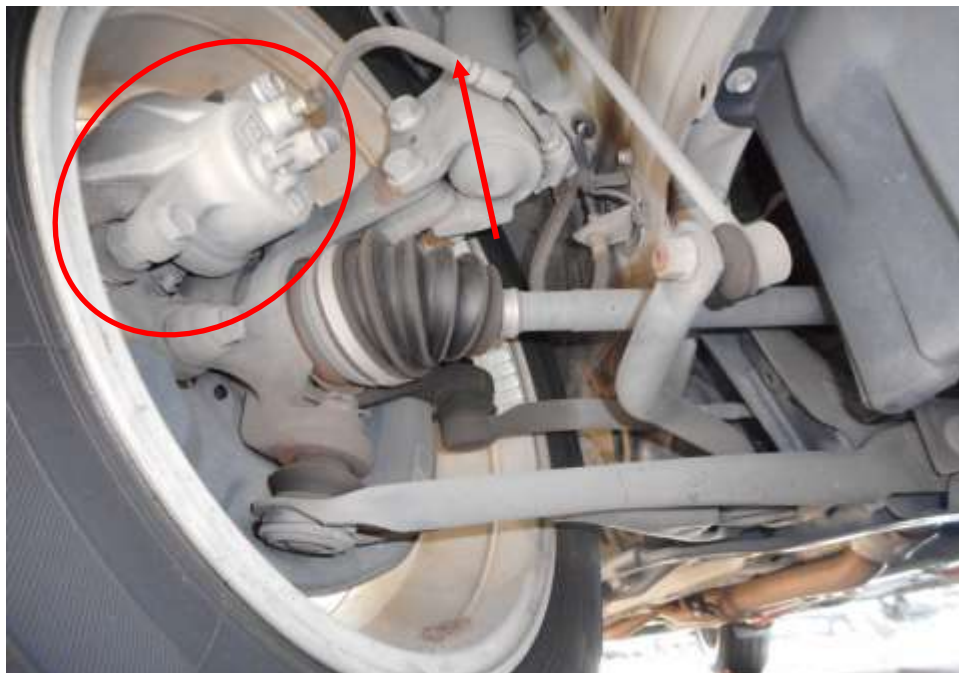
Photo 19 shows the brake hose/pipe (arrowed) at the front right wheel of the Motor Car. I did not observe any leakage of brake fluid at the time of my inspection of the Motor Car. Static tests of the Motor Car's braking system had indicated that there was no internal leakage of pressure/vacuum. The undercarriage components of the Motor Car were also all found to be intact and without any visible damage.

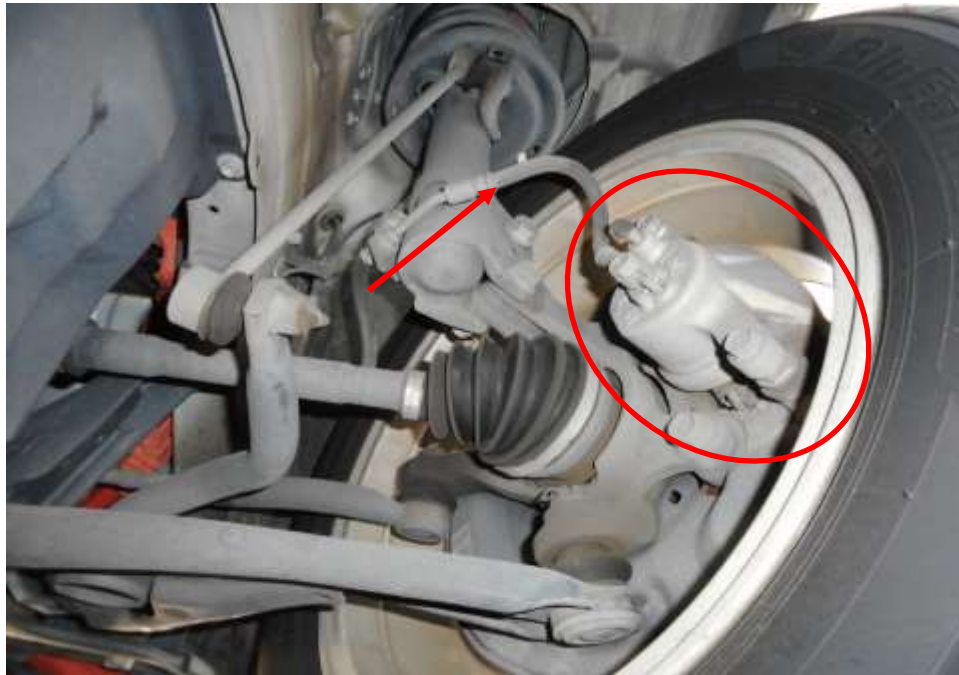
Photo 20 shows the brake hose/pipe (arrowed) at the front left wheel of the Motor Car. No leakage of brake fluid was observed. Visual examination of the various components of the braking system like the brake caliper (circled), brake booster, brake pedal etc had revealed all to be intact and without visible damage.

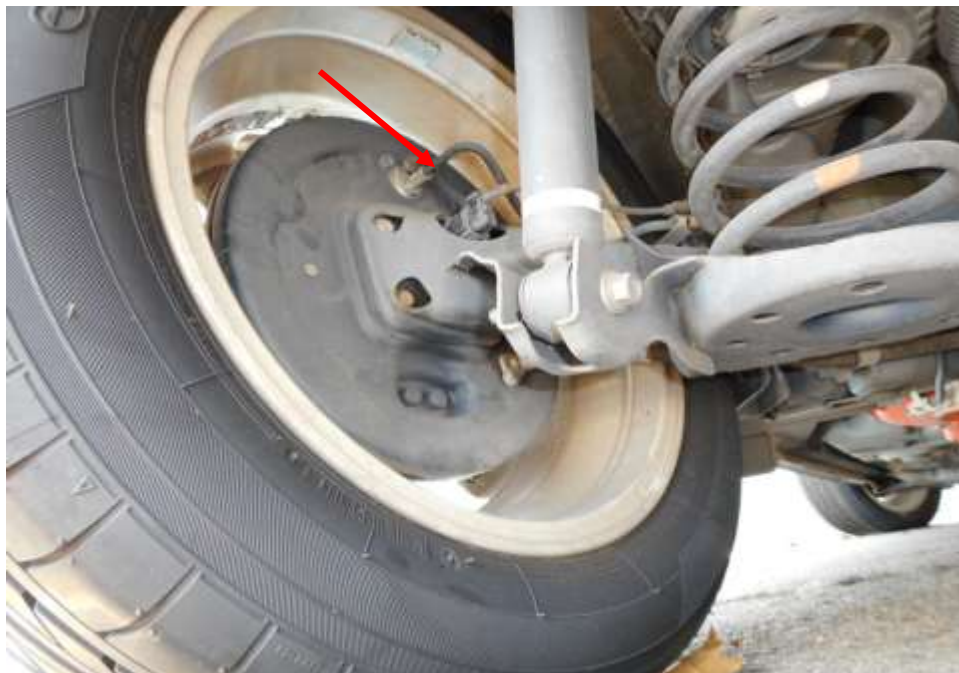
Photo 21 shows the brake hose/pipe (arrowed) at the rear left wheel of the Motor Car. I did not observe any leakage of brake fluid at the time of my inspection of the Motor Car. Static tests of the Motor Car's braking system had indicated that there was no internal leakage of pressure/vacuum. The undercarriage components of the Motor Car were also all found to be intact and without any visible damage.

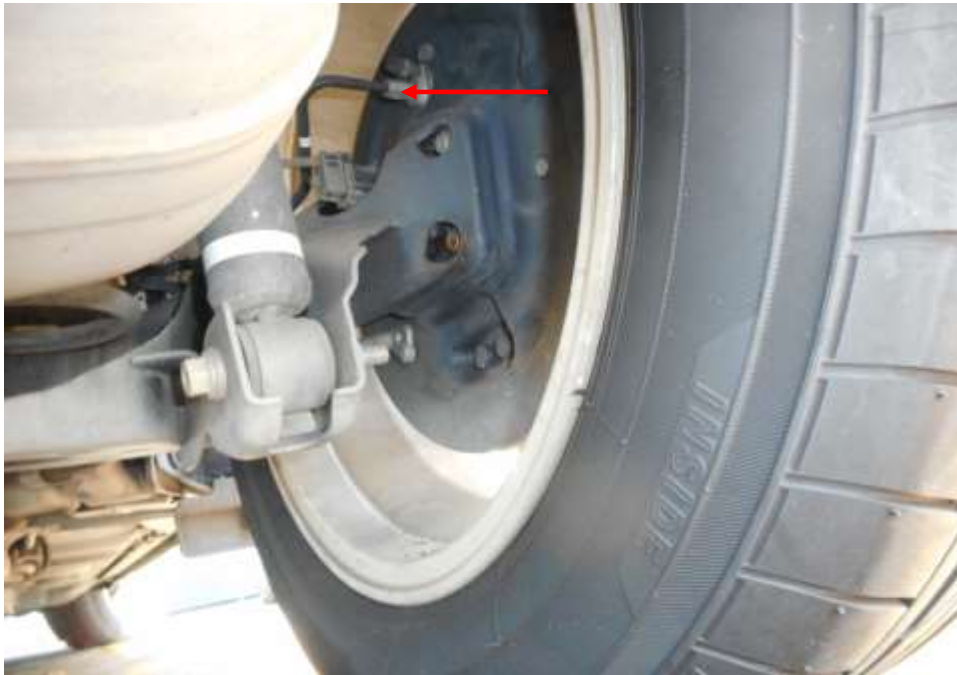
Photo 22 shows the brake hose/pipe (arrowed) at the rear right wheel of the Motor Car. No leakage of brake fluid was observed. Visual examination of the various components of the braking system like the drum brake, brake booster, brake pedal etc had revealed all to be intact and without visible damage.

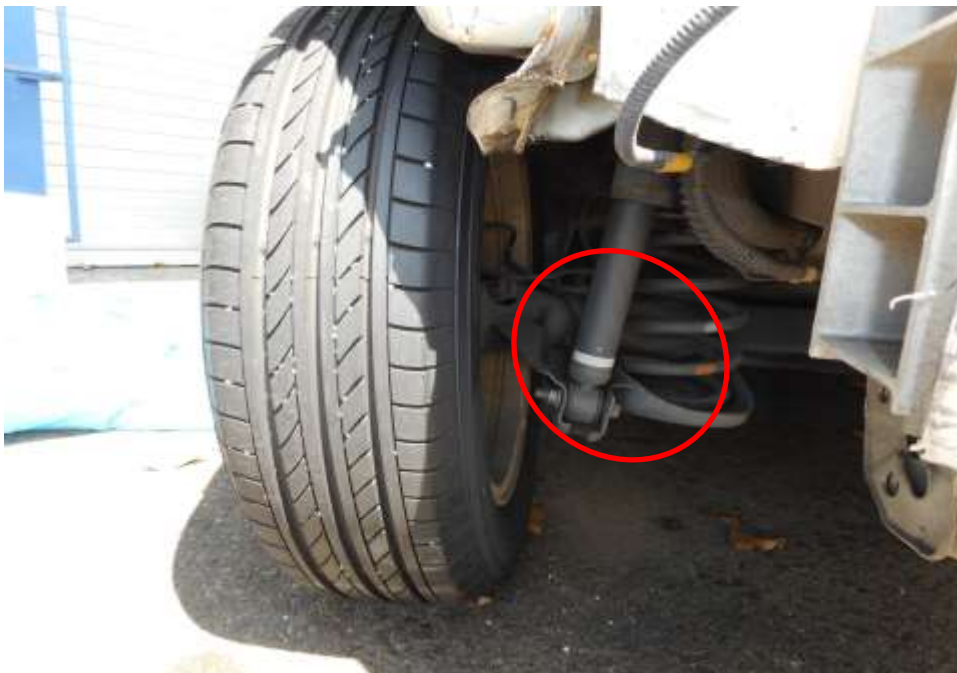
13. Upon closer inspection of the Motor Car, the rear axle on the rear left wheel was found to be damaged as a result of the accident. See photo 17 - 24 below.

Photo 23 shows the general view of the Motor Car's rear axle at the time of my inspection. The rear axle (circled) of the Motor Car was observed to sustain damaged and shifted out of position as a result of the accident.

15. Operational test by driving the Motor Car to primarily determine whether there was any abnormality to the engine system, transmission system and braking system of the Motor Car could not be conducted given the extent of damage that it had sustained had render it unsafe for operation. (Undercarriage component as the rear axle was damaged).

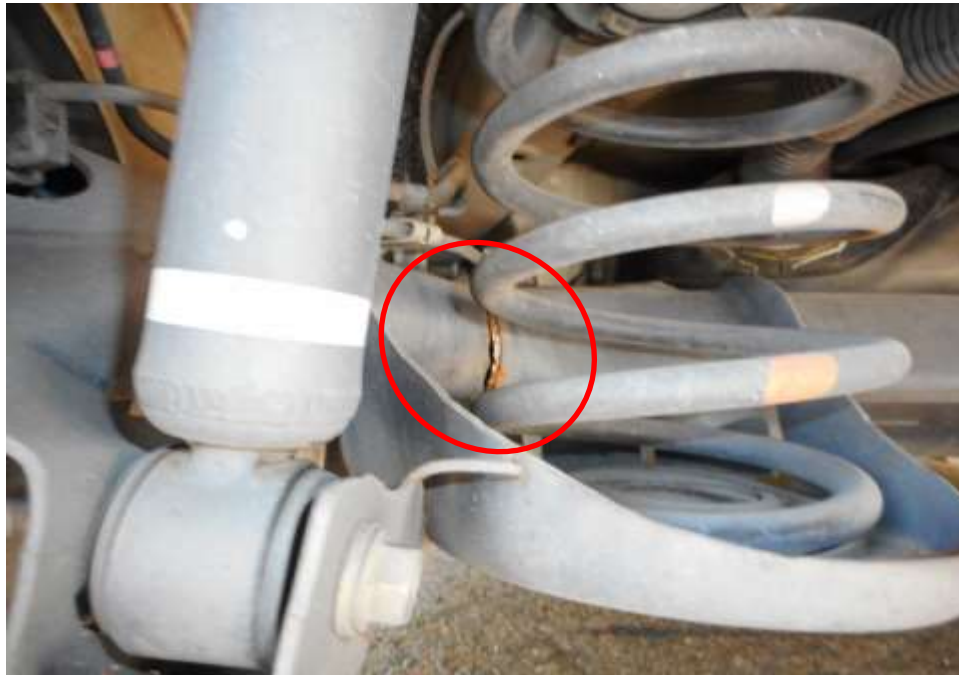
Photo 24 shows the close up view of the Motor Car's rear axle at the time of my inspection. The rear axle (circled) of the Motor Car was observed to sustain damaged and shifted out of position as a result of the accident.

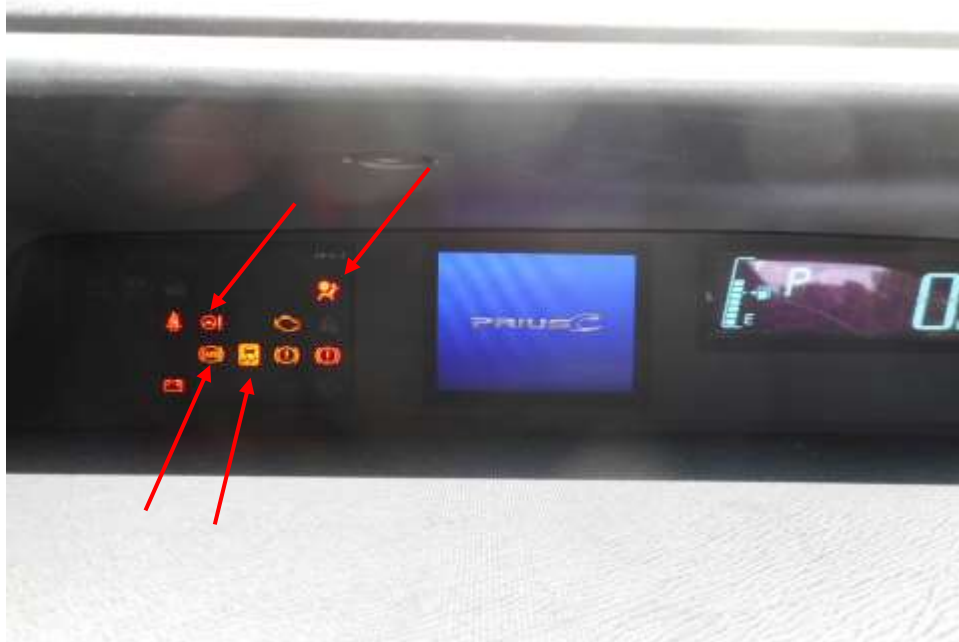
Photo 25 shows the warning light for Anti-Lock Brake System (ABS), Electric Power Steering System (EPS) Supplemental Restraint System (SRS) and Traction Control (TC) appearing on the instrument panel of the Motor Car during the self-test of its various electronic operating systems when its engine was cranked.

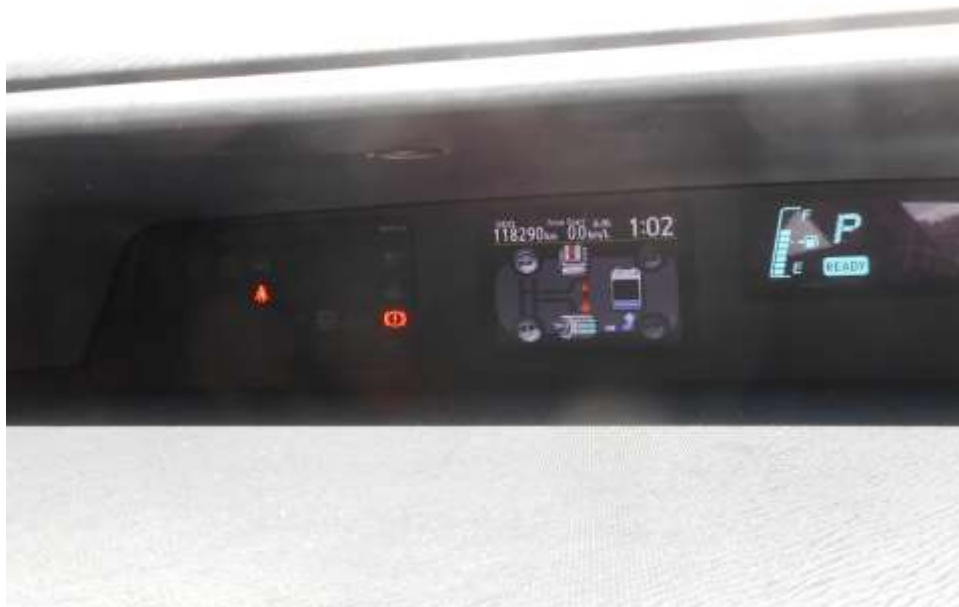
Photo 26 shows no warning lights illuminated on the instrument panel of the Motor Car after the engine was cranked. This would suggest that there was no abnormality to the various electronic operating systems of the Motor Car, like the ABS, EPS SRS and TC etc.
