Your Ref: TP/IP/77615/2019
Our Ref : CI/TPD20001934/P

MECHANICAL INSPECTION REPORT OF MOTOR TRAILER MCT 9184

1. I refer to your request on 3rd February 2020 to conduct a physical inspection of a Motor Trailer bearing registration number MCT 9184 (herein referred to as "**Motor Trailer**"), which was involved in a fatal road traffic accident on 16th December 2019.
2. The objective of this inspection is to determine if there was any possible mechanical failure to the Motor Trailer that may have contributed to the accident.
3. Following the request, I had carried out a visual inspection of the Motor Trailer on 14th May 2020 at the premises of Traffic Police vehicle pound, 517 Airport Road Singapore 539942. I now set out below my observations and comments with respect to this inspection.

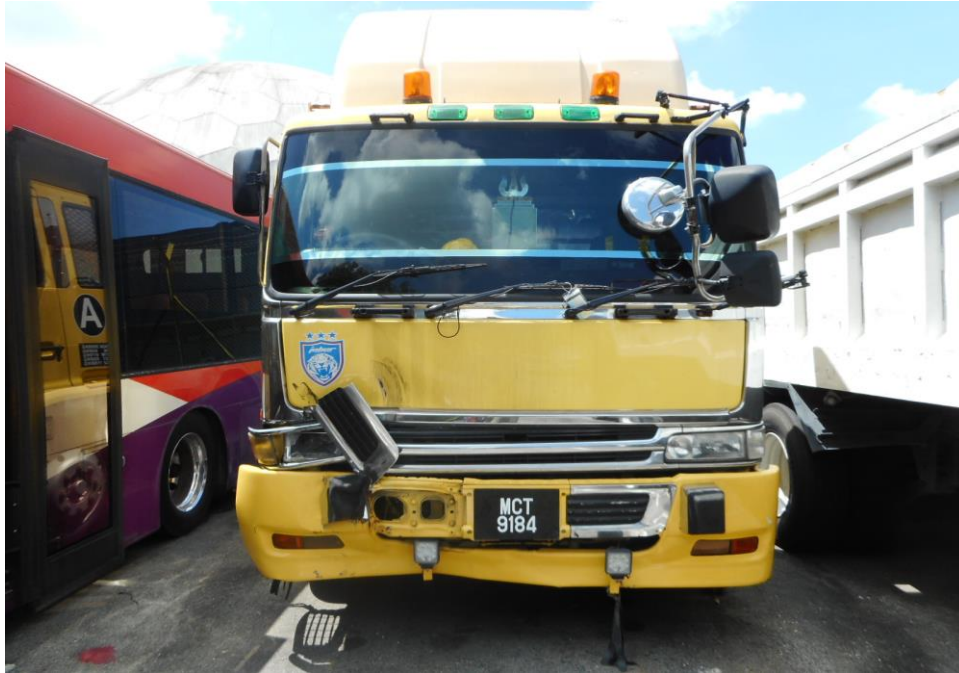
4. The mileage of the Motor Trailer at the time of my inspection was not recorded due to a flat battery.
5. There Motor Trailer was observed to have sustained damage at its front portion. Its front right body panel & front right headlamp was damaged.

Photo 1 shows a general view of the front body of the Motor Trailer at the time of my inspection. The Motor Trailer was observed to sustain damage at its front portion. Its front body panel & front right headlamp was damaged.

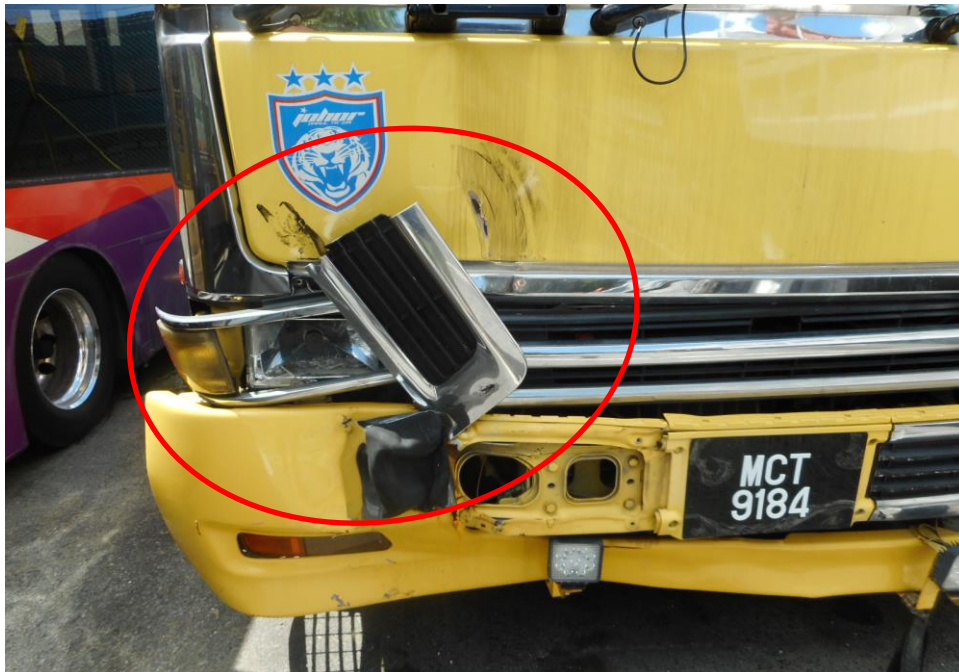
Photo 2 shows a close up view of the front body of the Motor Trailer at the time of my inspection. The Motor Trailer was observed to sustain damage at its front portion. Its front body panel & front right headlamp (circled) was damaged.

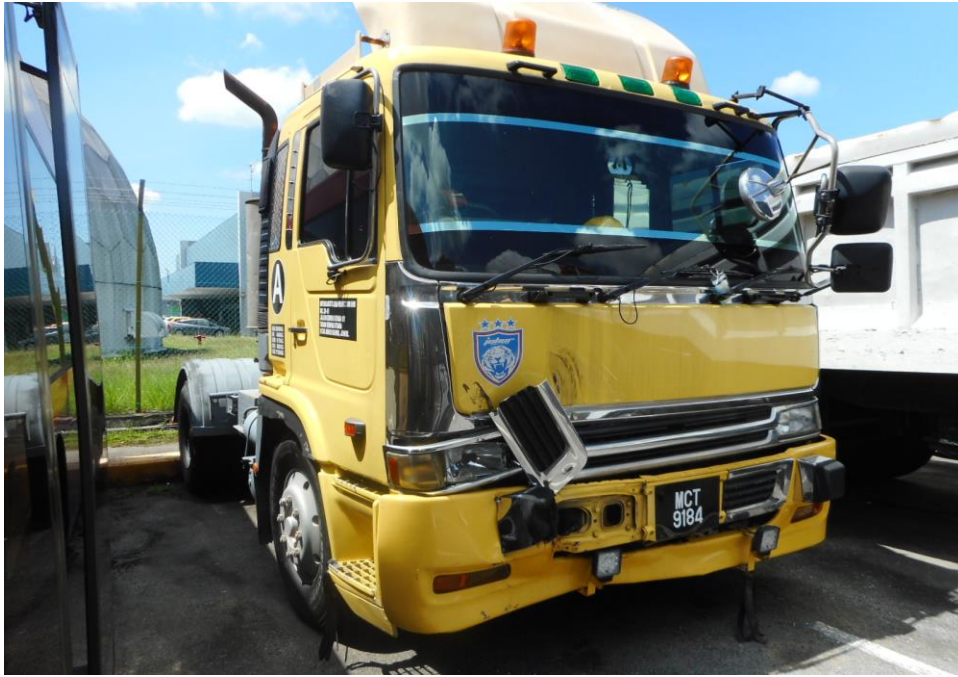
Photo 3 shows a general view of the front right body of the Motor Trailer at the time of my inspection. The Motor Trailer was observed to be intact and unaffected by the accident.

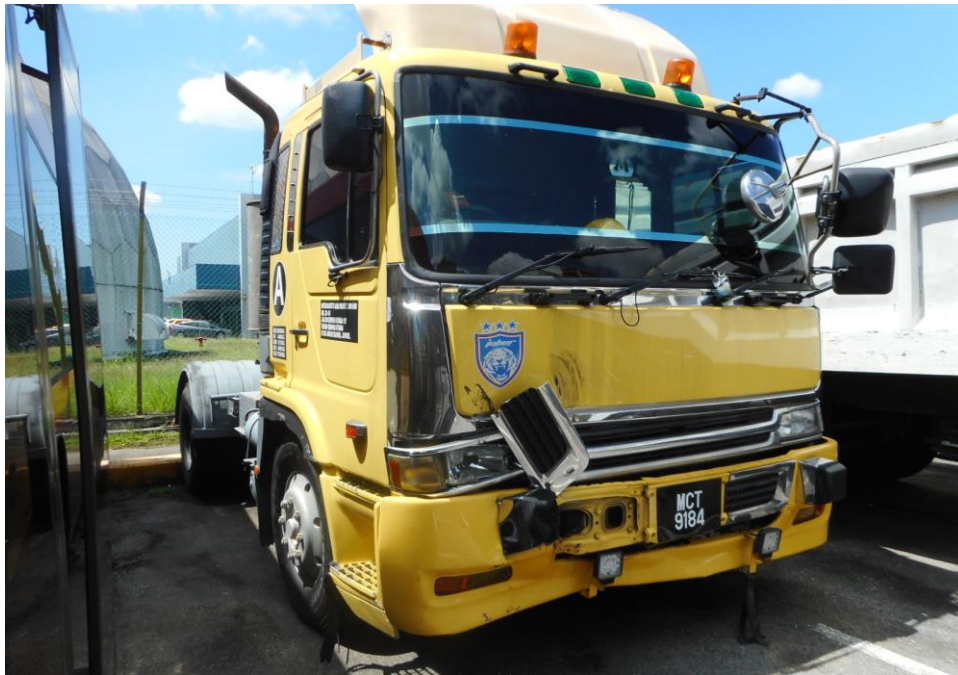
Photo 4 shows a general view of the front left body of the Motor Trailer at the time of my inspection. The Motor Trailer was observed to be intact and unaffected by the accident.

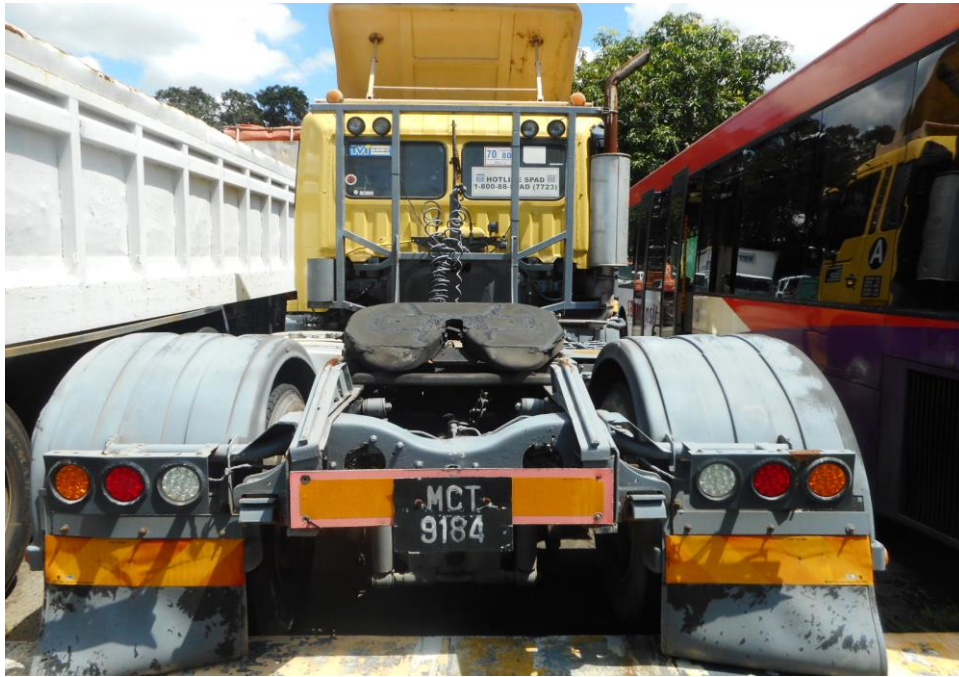
Photo 5 shows a general view of the Motor Trailer's rear body at the time of my inspection. The Motor Trailer was observed to be intact and unaffected by the accident.

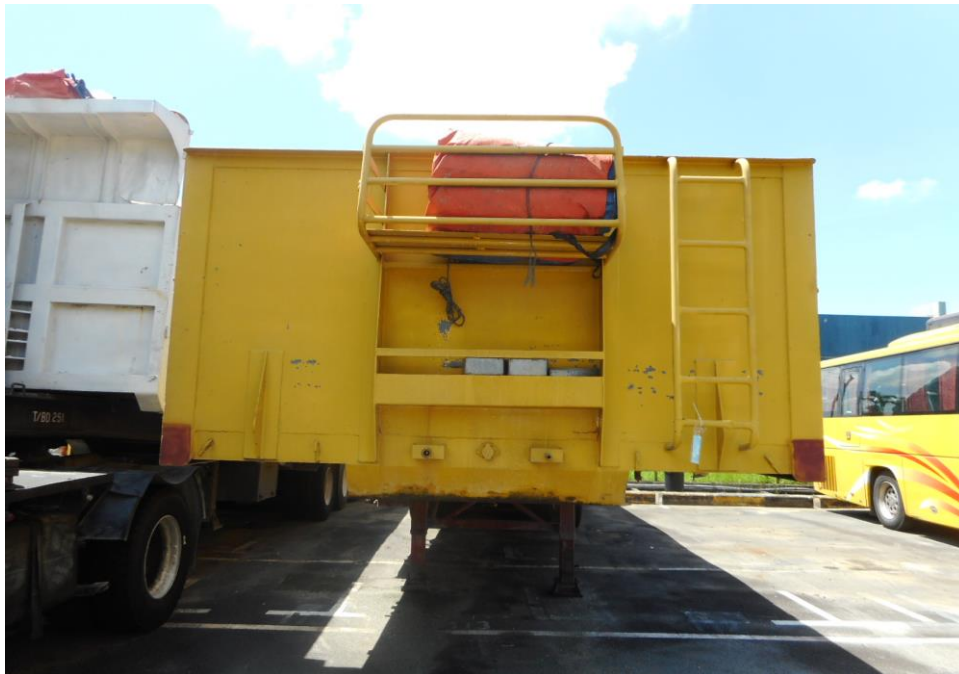
Photo 6 shows a general view of the front body of the trailer at the time of my inspection. The Motor Trailer was observed to be intact and unaffected by the accident.

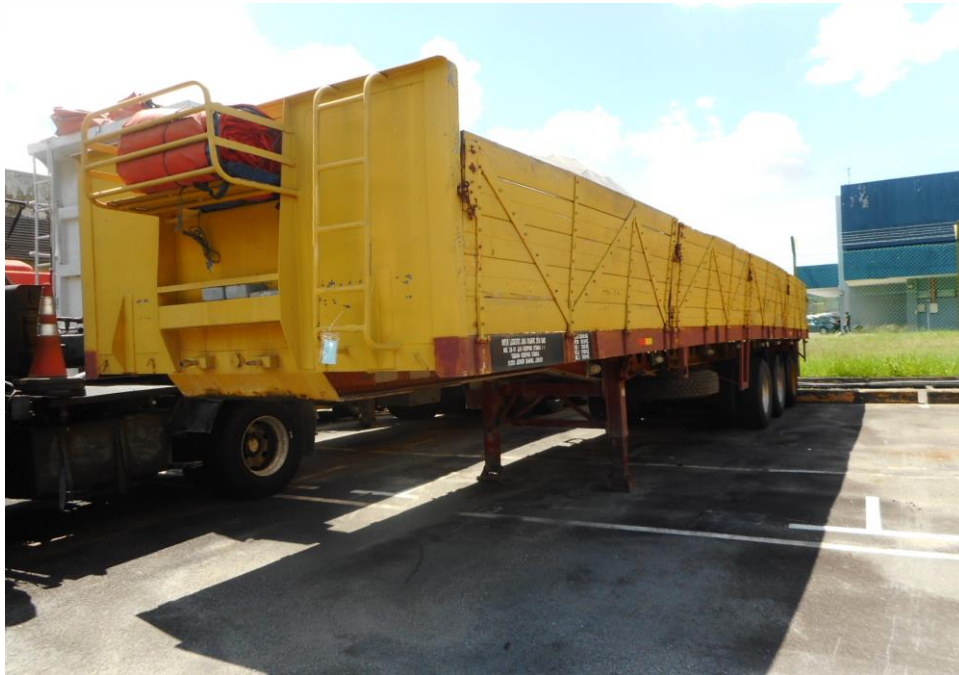
Photo 7 shows a general view of the trailer's left body at the time of my inspection. The Motor Trailer was observed to be intact and unaffected by the accident.

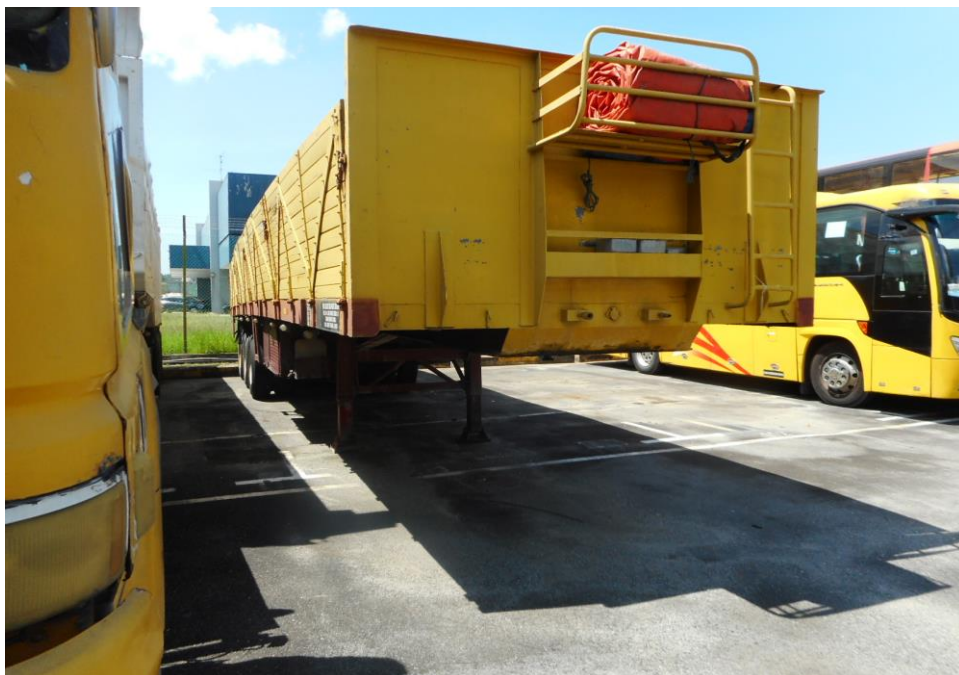
Photo 8 shows a general view of the trailer's right body at the time of my inspection. The Motor Trailer was observed to be intact and unaffected by the accident.

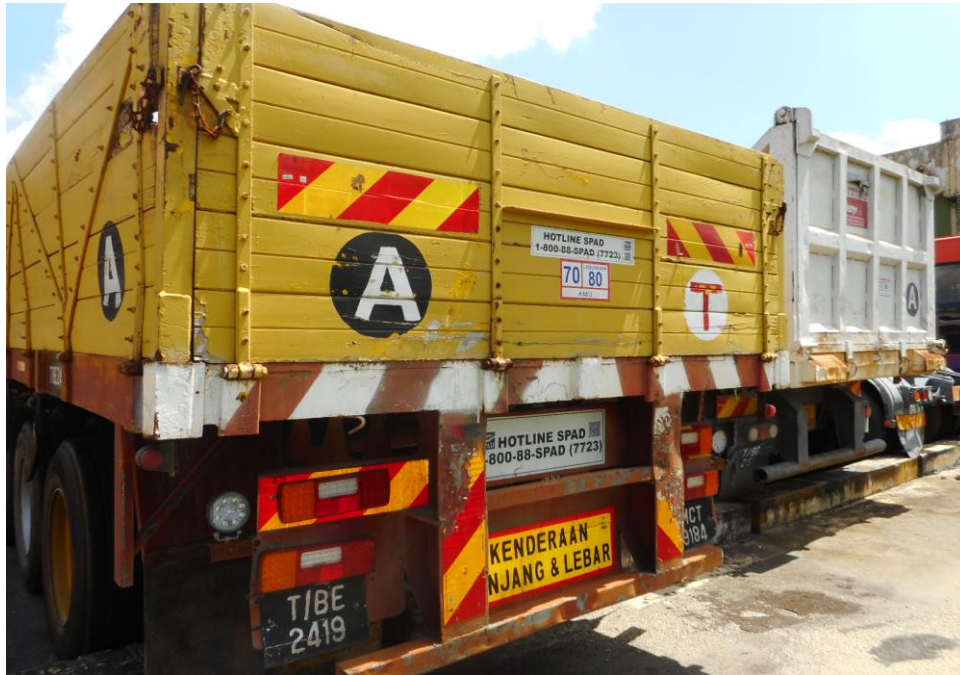
Photo 9 shows a general view of the trailer's rear body at the time of my inspection. The Motor Trailer was observed to be intact.

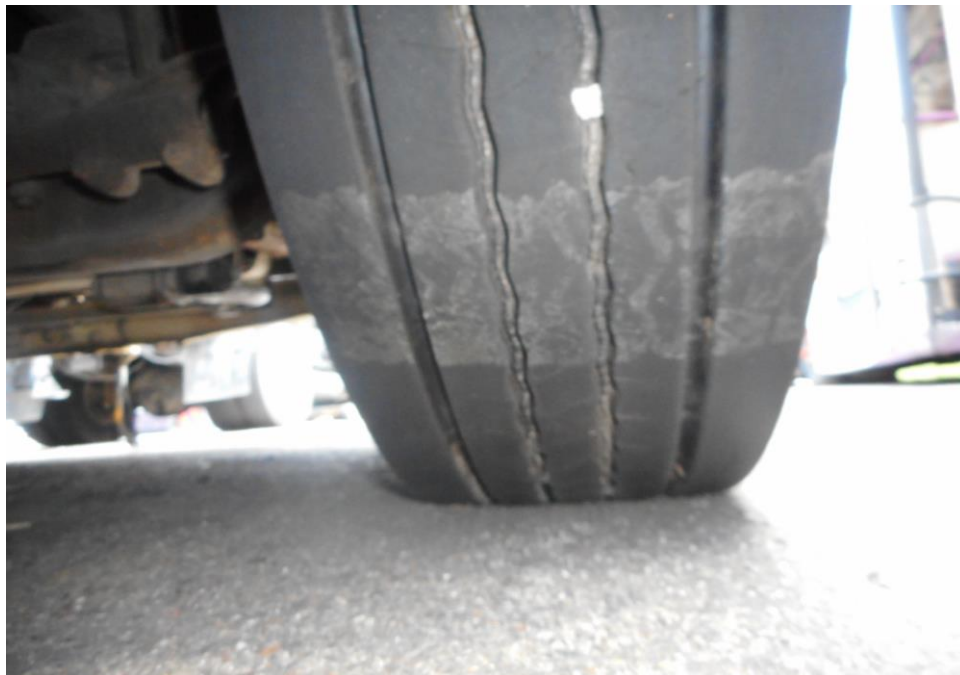
Photo 10 shows the condition of the front right tyre of the Motor Trailer, which was observed to be in serviceable condition with remaining tread depth of approximately 11mm. The tyre, which was wrapped around standard steel wheel rim, was also observed to be sufficiently inflated for vehicular operation. There was no tear, cut or burst mark(s) on the outer and the inner sidewalls as well as across the tread of the 22 tyres that were fitted on the Motor Trailer.

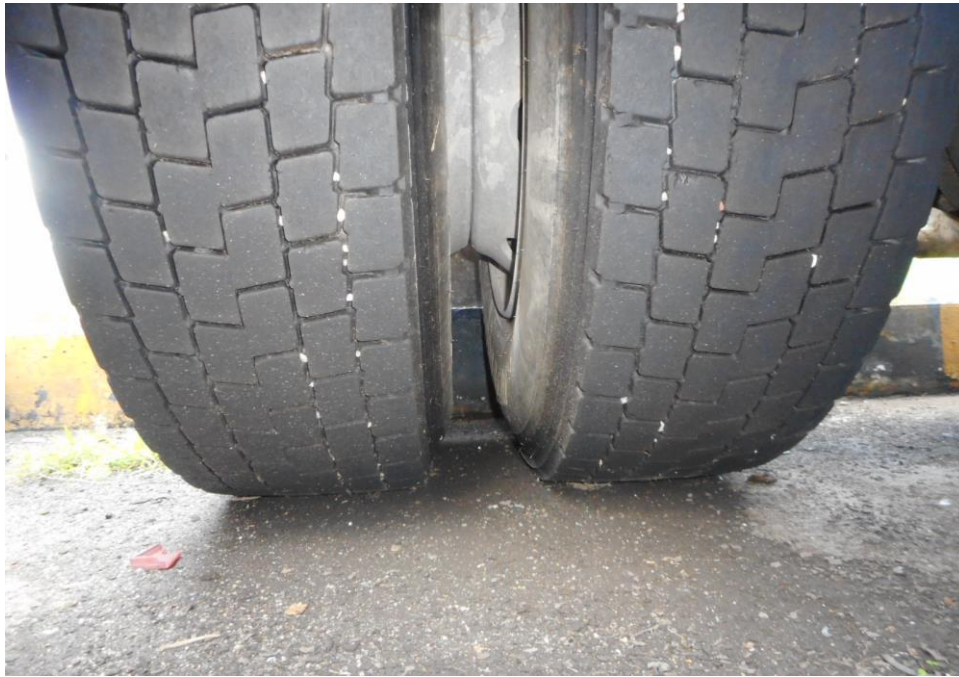
Photo 11 shows the condition of the rear right tyre of the Motor Trailer, which was observed to be in serviceable condition with remaining tread depth of approximately 9mm. The tyre, which was wrapped around standard steel wheel rim, was also observed to be sufficiently inflated for vehicular operation.

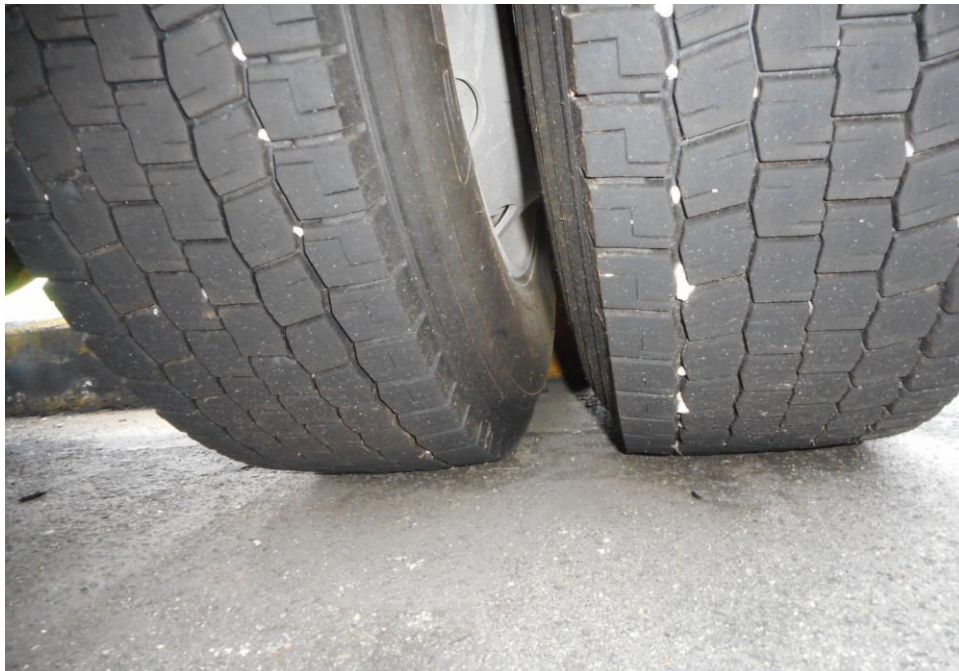
Photo 12 shows the condition of the rear left tyres of the Motor Trailer, which was observed to be in serviceable condition with remaining tread depth of approximately 10.9mm. The tyres, which were wrapped around standard steel wheel rim, were also observed to be sufficiently inflated for vehicular operation. There was also no damage found on all 6 steel wheel rims of the Motor Trailer.

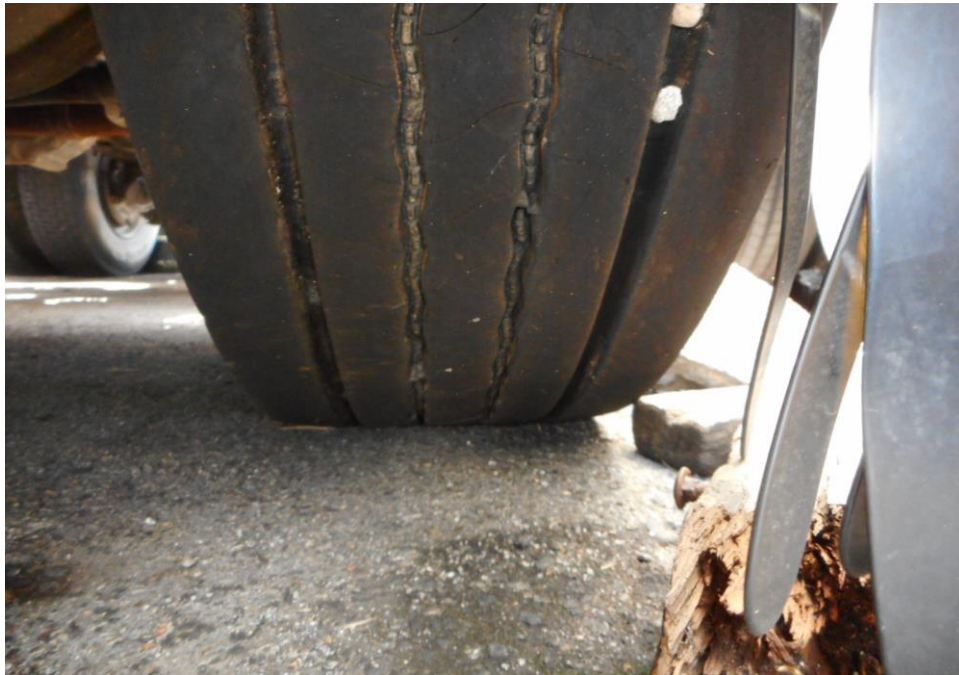
Photo 13 shows the condition of the front left tyres of the Motor Trailer, which were observed to be in serviceable condition with remaining tread depth of approximately 11.4mm. There was also no tear, cut or burst mark(s) on the outer and the inner sidewalls as well as across the tread of the 6 tyres that were fitted on the Motor Trailer.

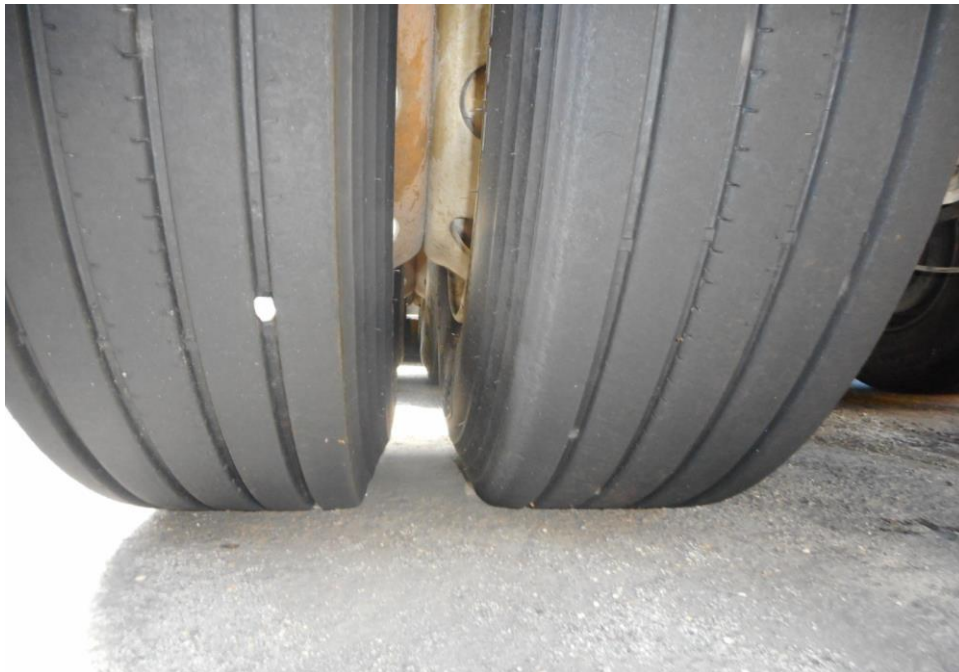
Photo 14 shows the condition of the right tyres of the trailer, which was observed to be in serviceable condition with remaining, tread depth of approximately 6.8mm. The tyre, which was wrapped around standard steel wheel rim, was also observed to be sufficiently inflated for vehicular operation.

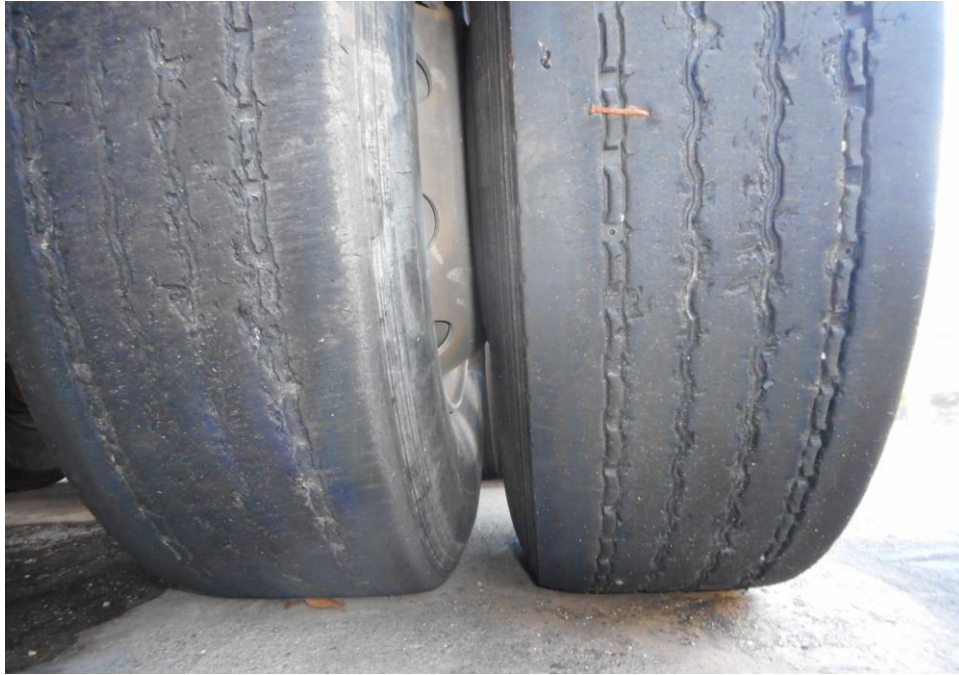
Photo 15 shows the condition of the left tyres of the trailer, which was observed to be in serviceable condition with remaining tread depth of approximately 4mm. The tyres, which were wrapped around standard steel wheel rim, were also observed to be sufficiently inflated for vehicular operation. There was also no damage found on all 22 steel wheel rims of the Motor Trailer.

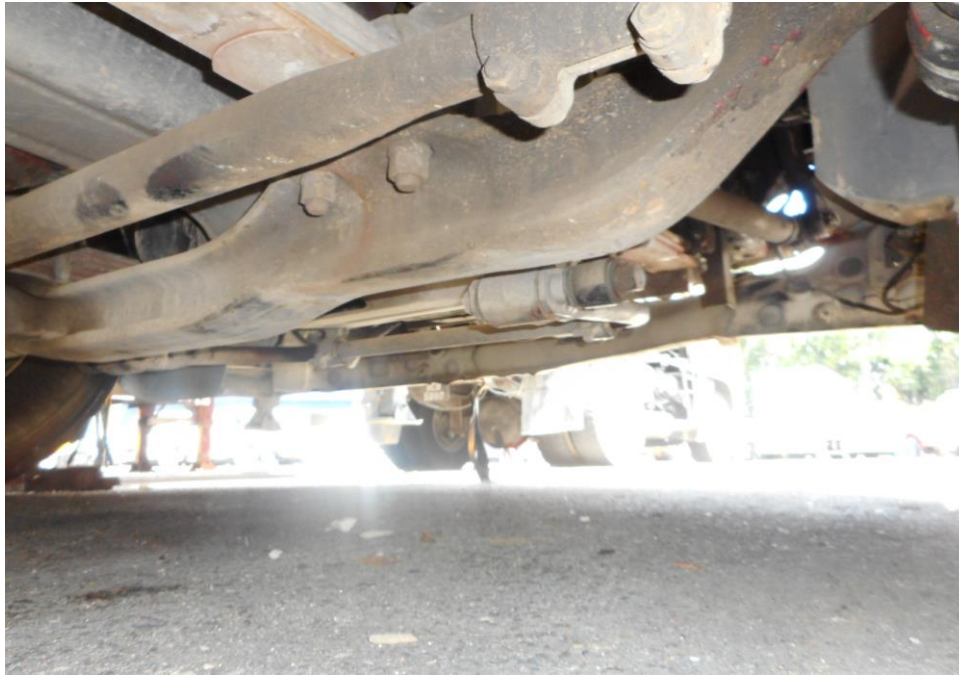
Photo 16 shows the undercarriage of the Motor Trailer, at the area where the engine housing located. I did not find any sign(s) or indication(s) of fluid leak, or fluid stain(s) was observed on the underside of the Motor Trailer.

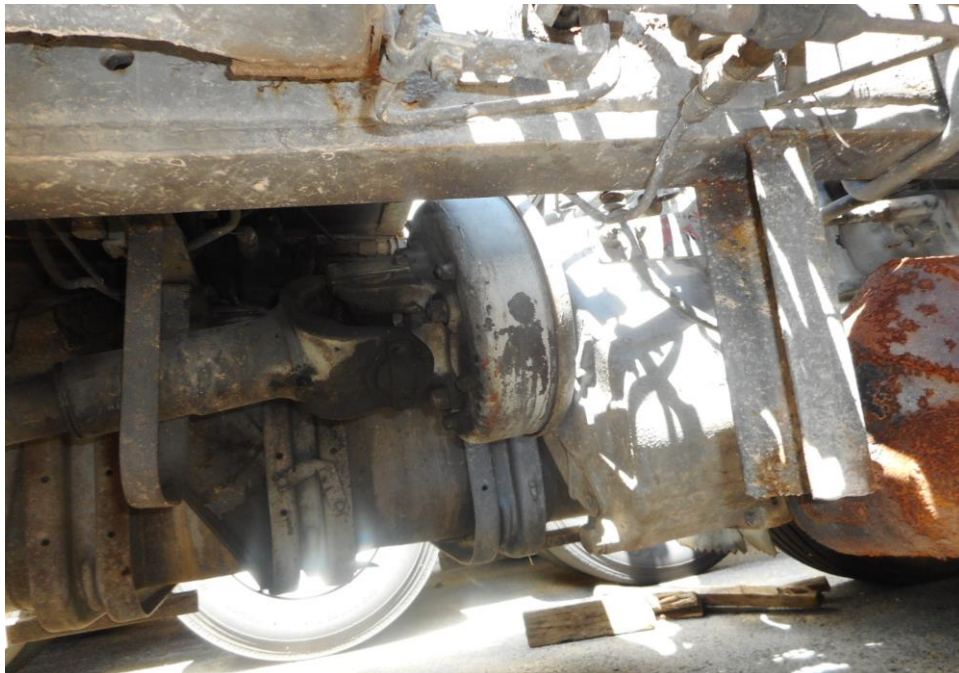
Photo 17 shows the undercarriage of the Motor Trailer, at the area where the transmission housing located. I did not find any sign(s) or indication(s) of fluid leak, or fluid stain(s) was observed on the underside of the Motor Trailer.

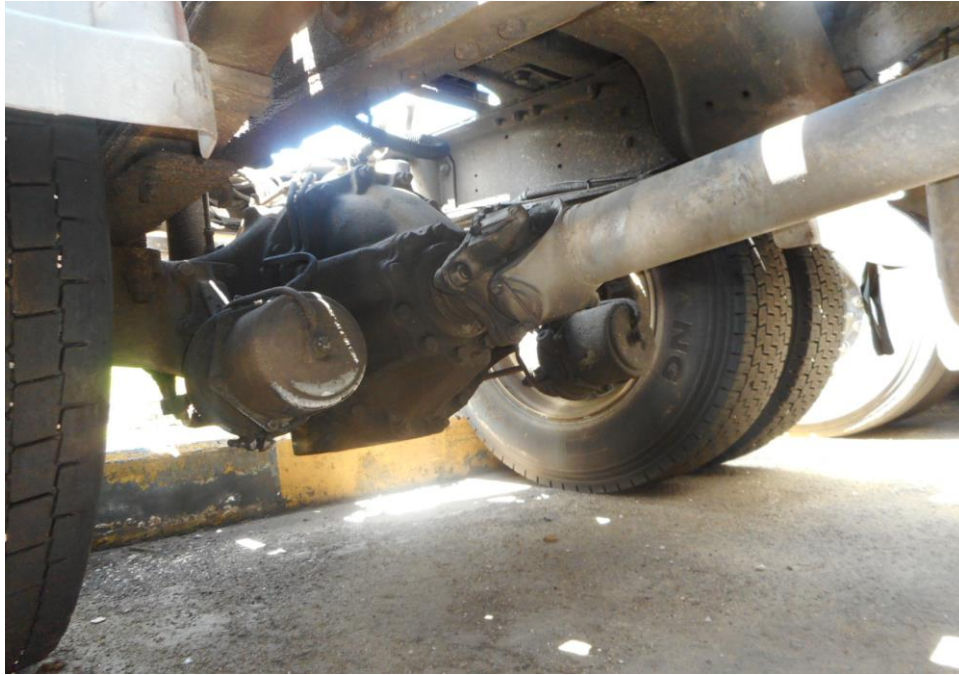
Photo 18 shows the undercarriage of the Motor Trailer, at the area where the rear differential housing located. I did not find any sign(s) or indication(s) of fluid leak, or fluid stain(s) was observed on the underside of the Motor Trailer.

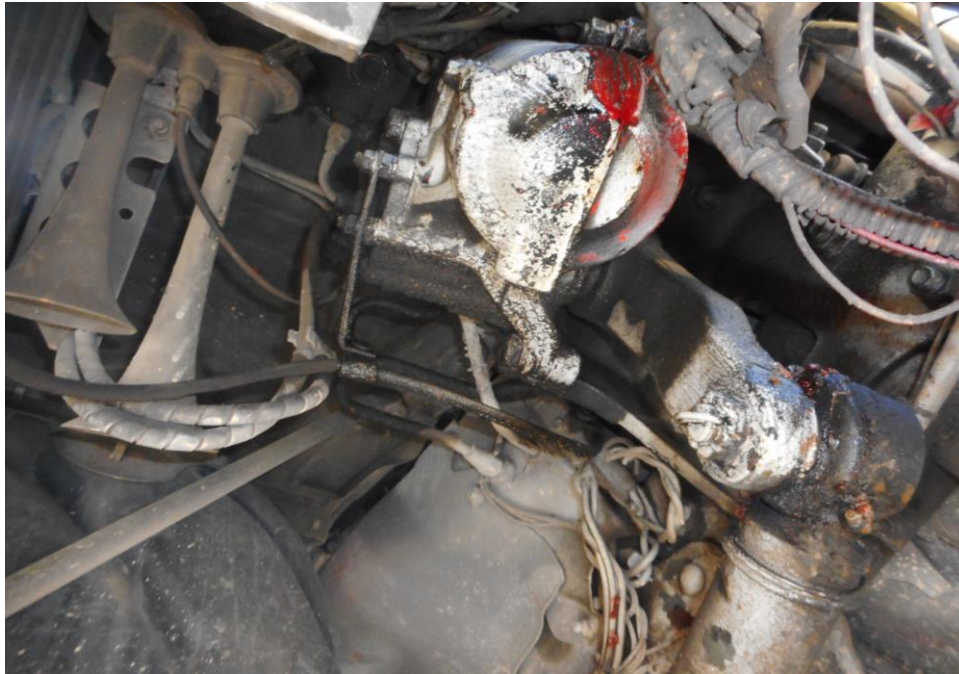
Photo 19 shows the front underside of the Motor Trailer. I was not able to conduct any test(s) on the steering system of the Motor Trailer as the engine of the Motor Trailer could not be started. However my visual checks on the various mechanical components of the steering system like the steering box, steering shaft and steering linkages (arrowed) amongst others revealed all to be intact

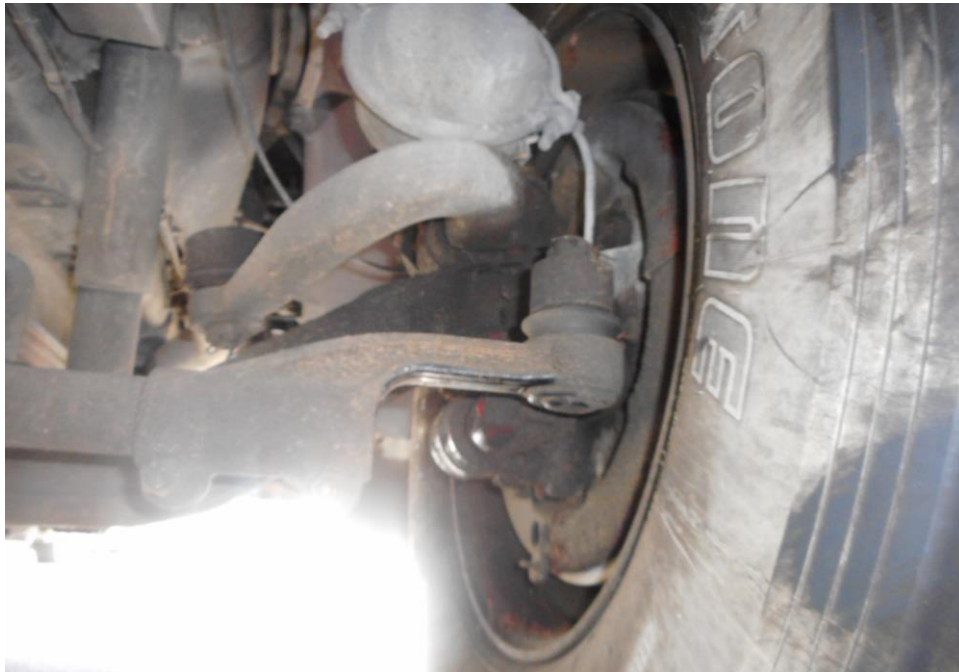
Photo 20 shows the various undercarriage components at the front right wheel of the Motor Trailer, in particular the steering tie rod end (arrowed). The various undercarriage components of the Motor Trailer were all found to be intact without any visible damage. There was also no sign of fluid stain(s) observed on the various undercarriage components to indicate that the Motor Trailer's steering system was in serviceable condition.

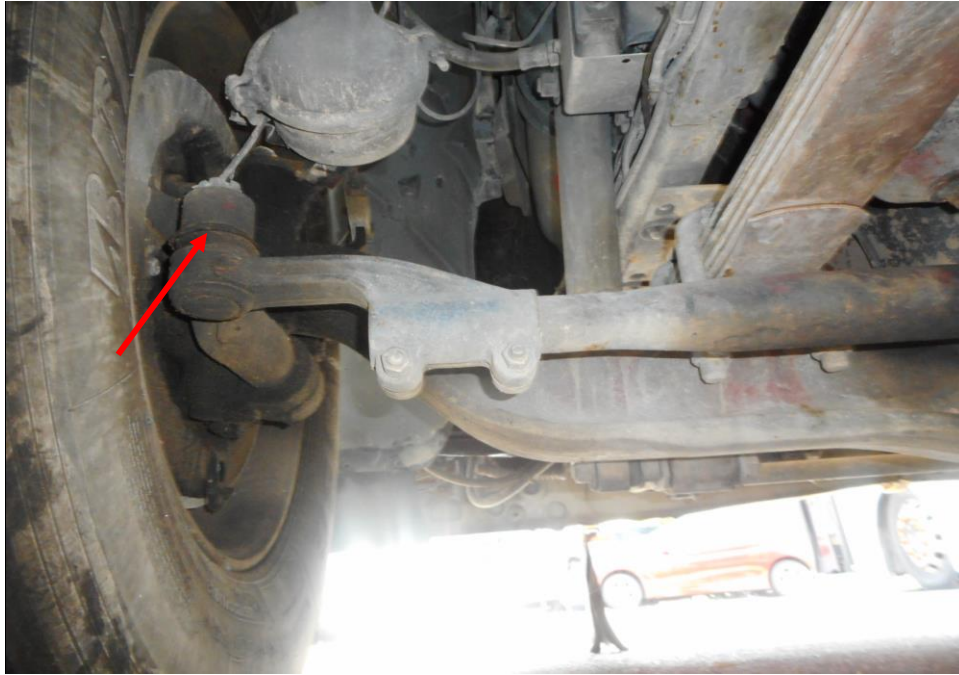
Photo 21 shows the various undercarriage components at the front left wheel of the Motor Trailer, in particular the steering tie rod end (arrowed). The various undercarriage components of the Motor Trailer were all found to be intact without any visible damage. There was also no sign of fluid stain(s) observed on the various undercarriage components to indicate that the Motor Trailer's steering system was in serviceable condition.

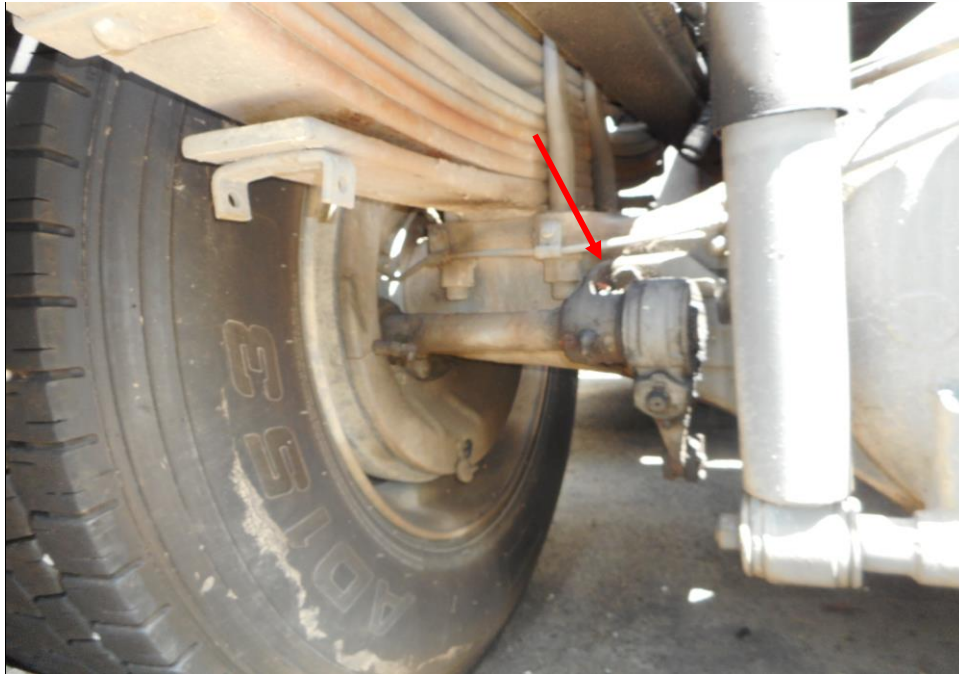
Photo 22 shows the brake pipe (arrowed) at the rear right wheel of the Motor Trailer. I did not observe any leakage of brake fluid at the time of my inspection of the Motor Trailer. My visual examination of the various mechanical components in the braking system, had indicated that there was no internal leakage of pressure/vacuum and were generally intact to suggest that its braking system was in serviceable condition at the material time of accident.

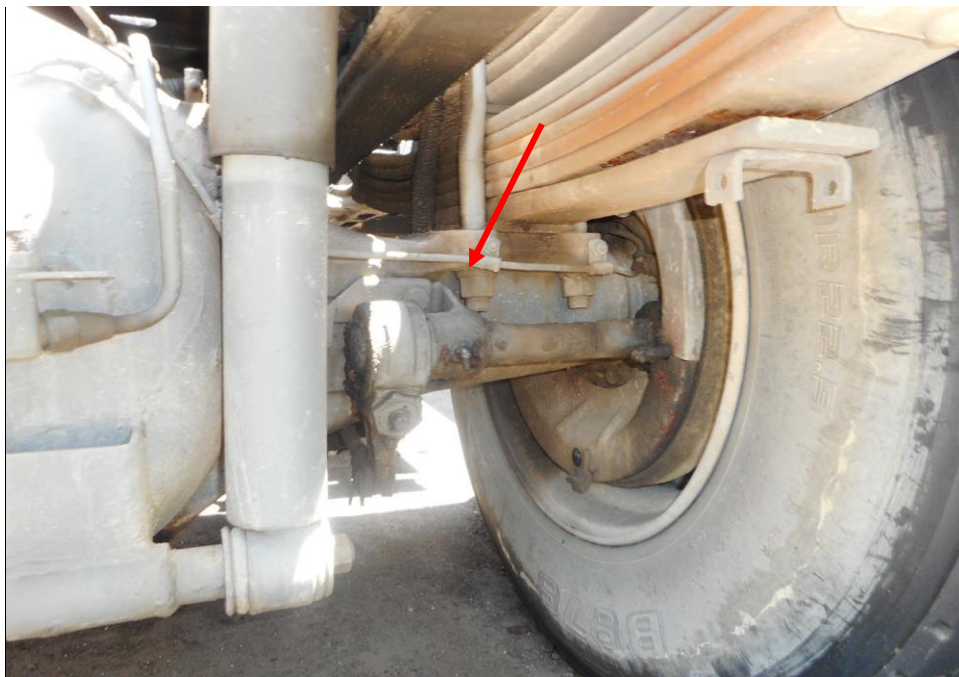
Photo 23 shows the brake pipe (arrowed) at the rear left wheel of the Motor Trailer. I did not observe any leakage of brake fluid at the time of my inspection of the Motor Trailer. My visual examination of the various mechanical components in the braking system, had indicated that there was no internal leakage of pressure/vacuum and were generally intact to suggest that its braking system was in serviceable condition at the material time of accident.

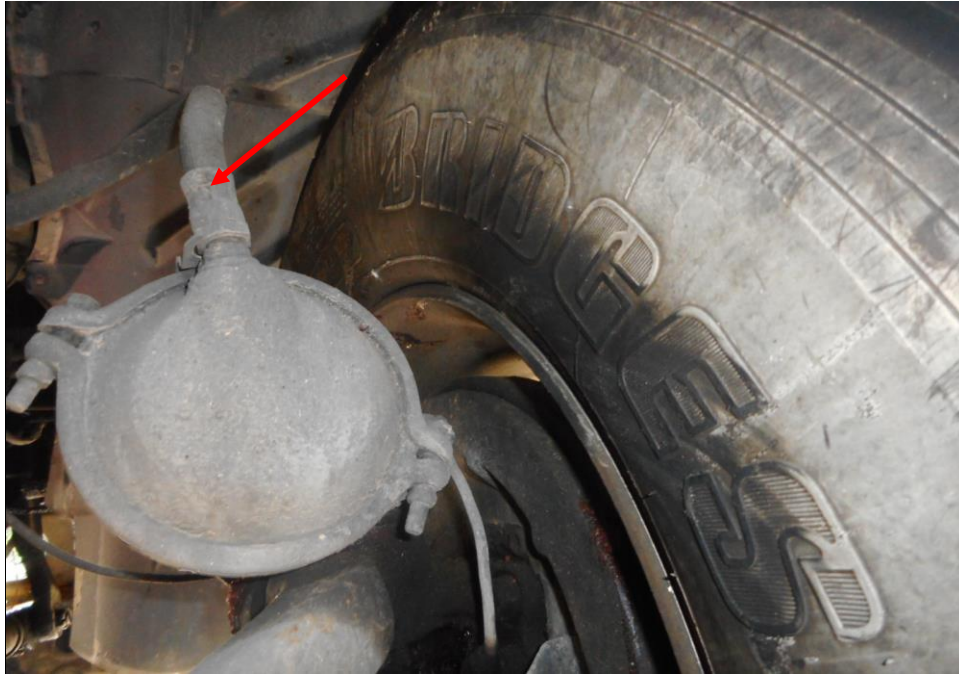
Photo 24 shows the brake pipe (arrowed) at the front right wheel of the Motor Trailer. I did not observe any leakage of brake fluid at the time of my inspection of the Motor Trailer. My visual examination of the various mechanical components in the braking system, had indicated that there was no internal leakage of pressure/vacuum and were generally intact to suggest that its braking system was in serviceable condition at the material time of accident.

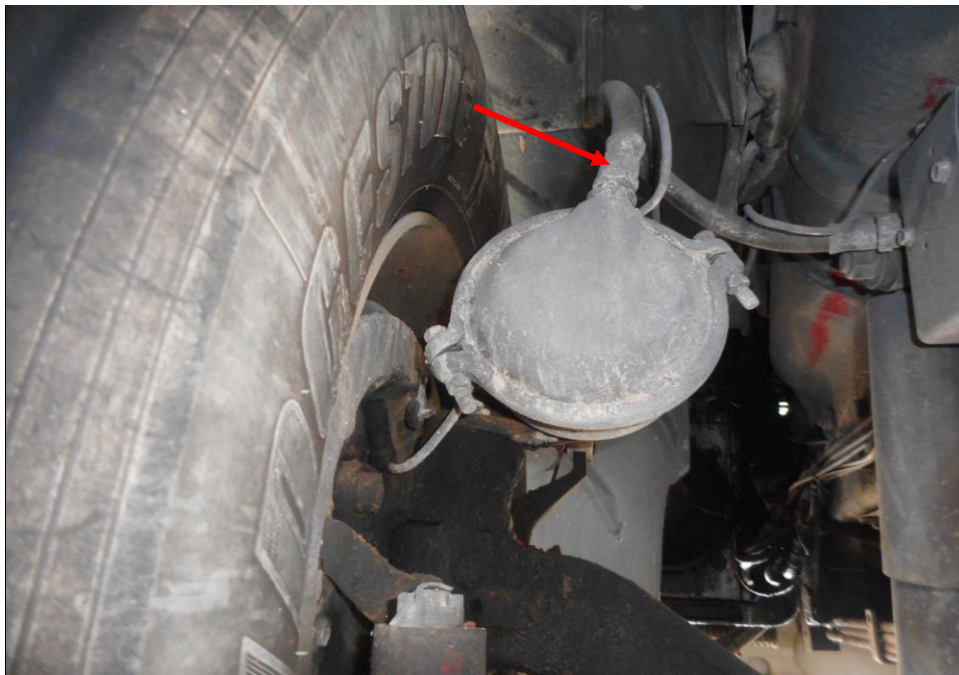
Photo 25 shows the brake pipe (arrowed) at the front left wheel of the Motor Trailer. I did not observe any leakage of brake fluid at the time of my inspection of the Motor Trailer. My visual examination of the various mechanical components in the braking system, had indicated that there was no internal leakage of pressure/vacuum and were generally intact to suggest that its braking system was in serviceable condition at the material time of accident.

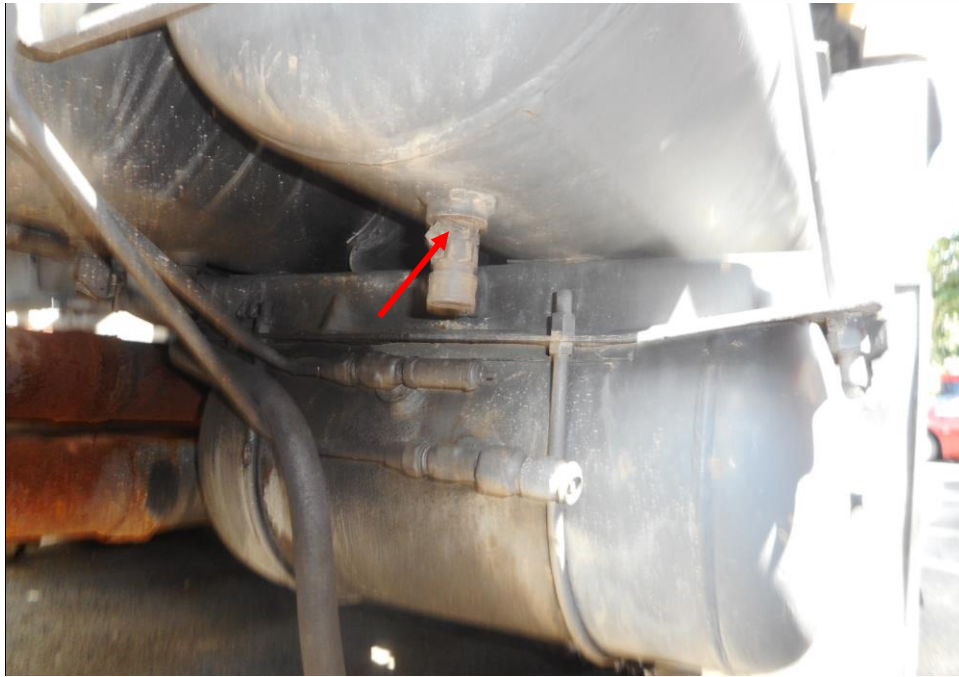
Photo 26 shows the air brake cylinders (arrowed) at the undercarriage of the Motor Trailer. I did not observe any leakage of air brake fluid at the time of my inspection of the Motor Trailer. My visual examination of the various mechanical components in the braking system, had indicated that there was no internal leakage of pressure/vacuum and were generally intact
