Your Ref: TP/IP/01949/2020  
Our Ref: CI/TPD20001935/P

**Fatal Accident Investigation Team**

**MECHANICAL INSPECTION REPORT OF MOTOR LORRY GBC 5887K**

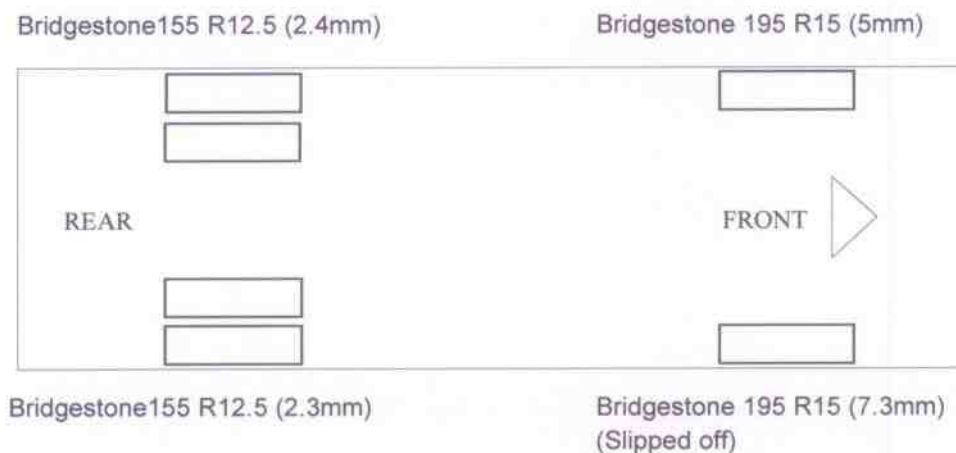
6. The front right tyre and rims were found to have dislodged off from the Motor Lorry as a result of the accident, the rest of the tyres of the Motor Lorry were observed to be in serviceable condition and sufficiently inflated for vehicular operation. We did not find any tear, cut or burst mark(s) on the outer and the inner sidewalls as well as across the tread of the tyres. The tyre brand, tyre size and remaining tread depth of the 6 tyres of the Motor Lorry were recorded as follows:-

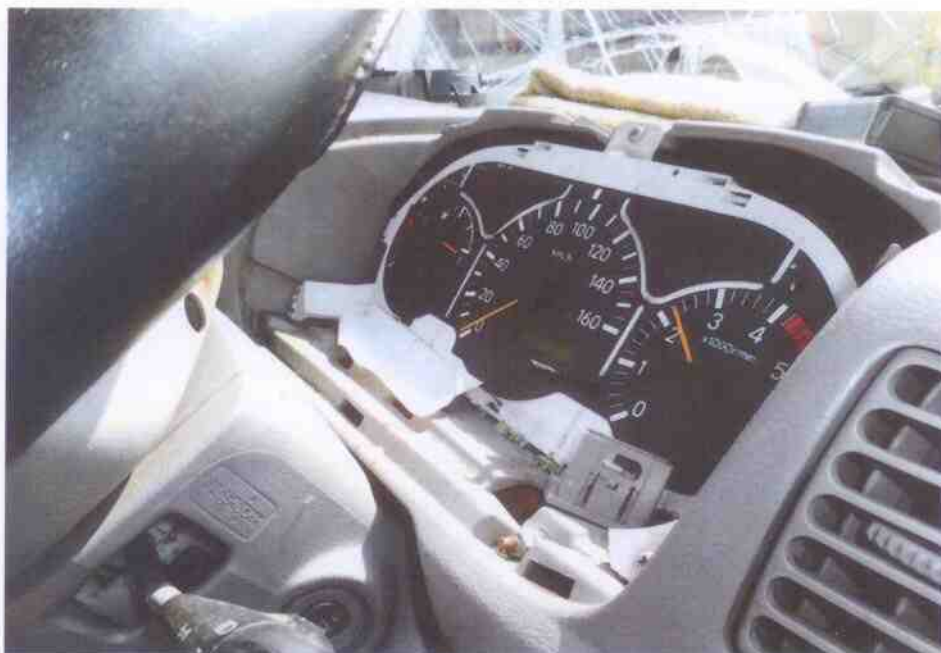
4. The mileage of the Motor Lorry was not able to be recorded as the odometer in the instrument cluster has been damaged due to the accident at the time of our inspection.
5. The Motor Lorry was observed to have sustained major damage at its front portion. Its front windscreen, front bumper, front right head lamp and its right doors as a result of the accident.

**Photo 1** shows no mileage readings were recorded due to the damaged to the instrument cluster which holds the odometer of the Motor Lorry at the time of our inspection.

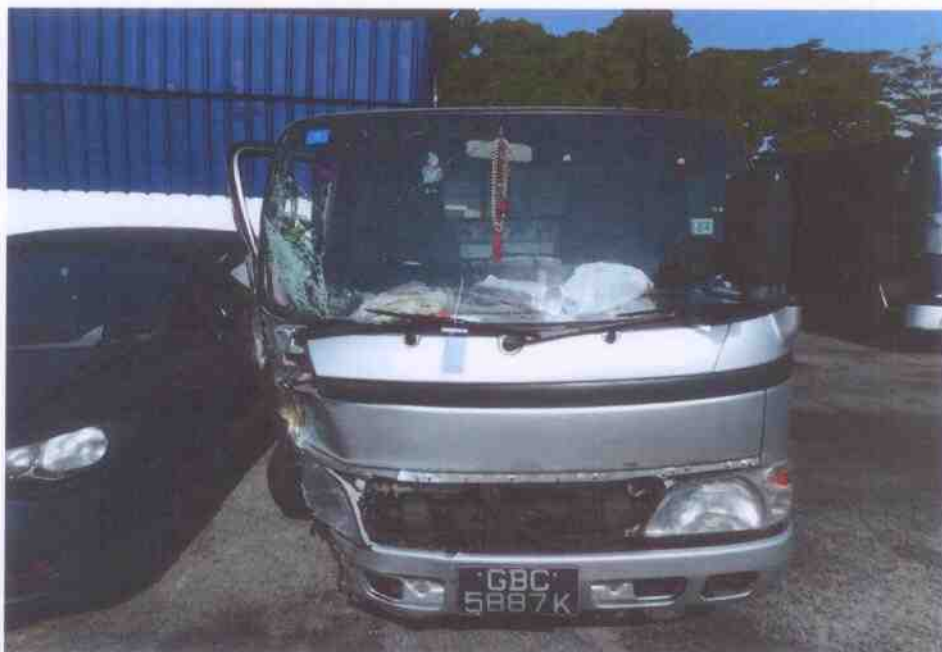
**Photo 2** shows a general view of the front portion of the Motor Lorry. Its front windscreen, front bumper, front right head lamp and its right doors as a result of the accident.

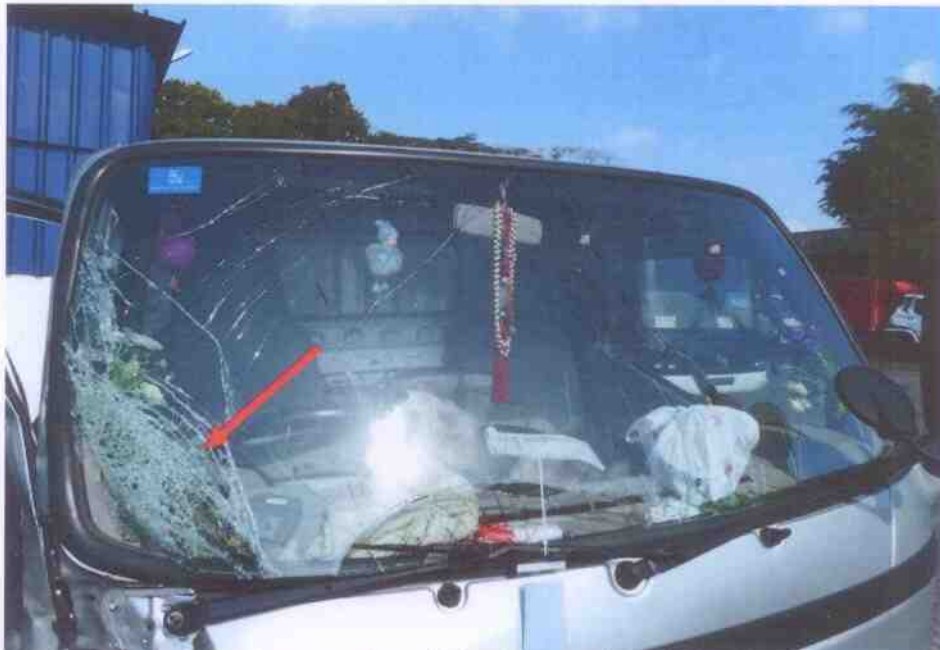
**Photo 3** shows the close up view of the front portion of the Motor Lorry at the time of our inspection. Its front windscreen (arrowed) was damaged as a result of the accident.

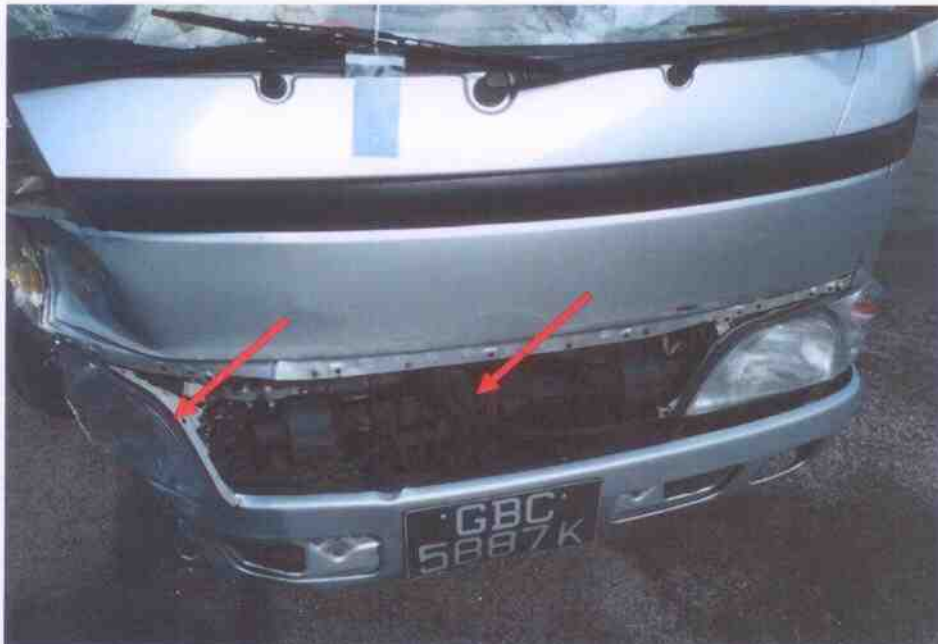
**Photo 4** shows the close up view of the front portion of the Motor Lorry at the time of our inspection. Its front bumper and left head lamp (arrowed) was damaged as a result of the accident.

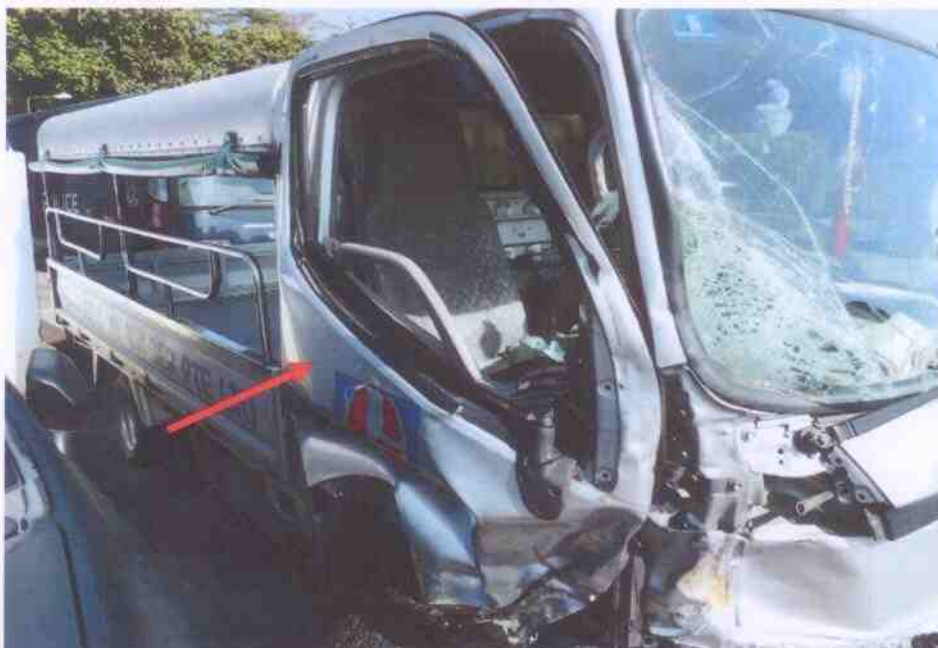
**Photo 5** shows the close up view of the right portion of the Motor Lorry at the time of our inspection. Its right door was damaged as a result of the accident.

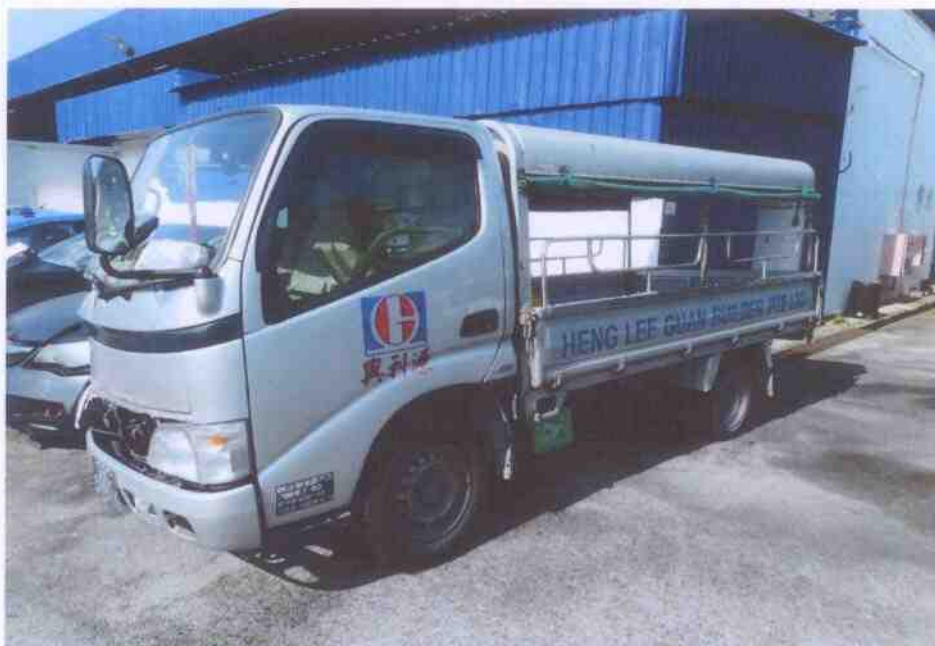
**Photo 6** shows a general view of the left body of the Motor Van at the time of my inspection. The Motor Van was observed to be unaffected by the accident.

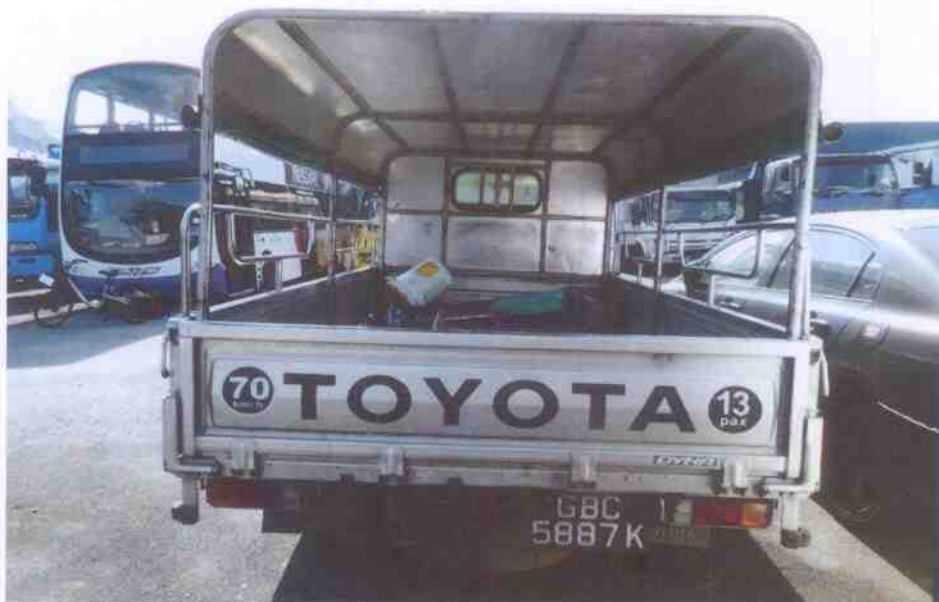
**Photo 7** shows a general view of the rear body of the Motor Van at the time of my inspection. The Motor Van was observed to be unaffected by the accident.

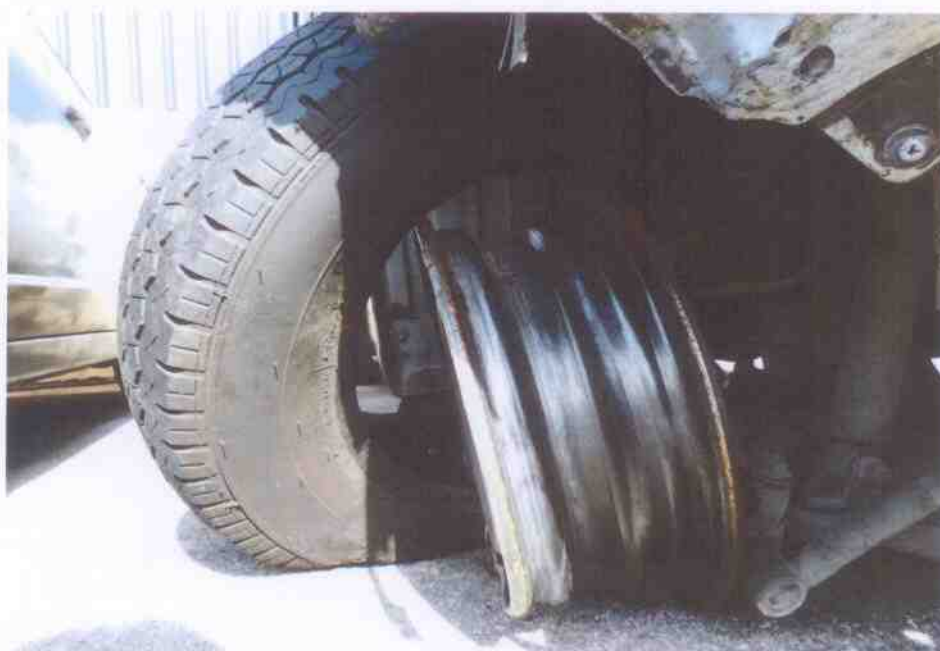
**Photo 8** shows the condition of the front right tyre and rims of the Motor Lorry, which was observed to have been dislodged as a result of the accident. The remaining tread depth of approximately 7.3mm. The tyre was wrapped around standard alloy wheel rim.

16. The front right tyre and rim were found to be dislodged as a result of the accident. However, the other tyres fitted on the Motor Lorry were found to be in serviceable condition. We did not find any tear, cut or burst mark(s) on the outer and the inner sidewalls as well as across the tread of the 6 tyres. The 5 tyres were also observed to be sufficiently inflated for vehicular operation with remaining tread depth of 2.3mm to 7.3mm.

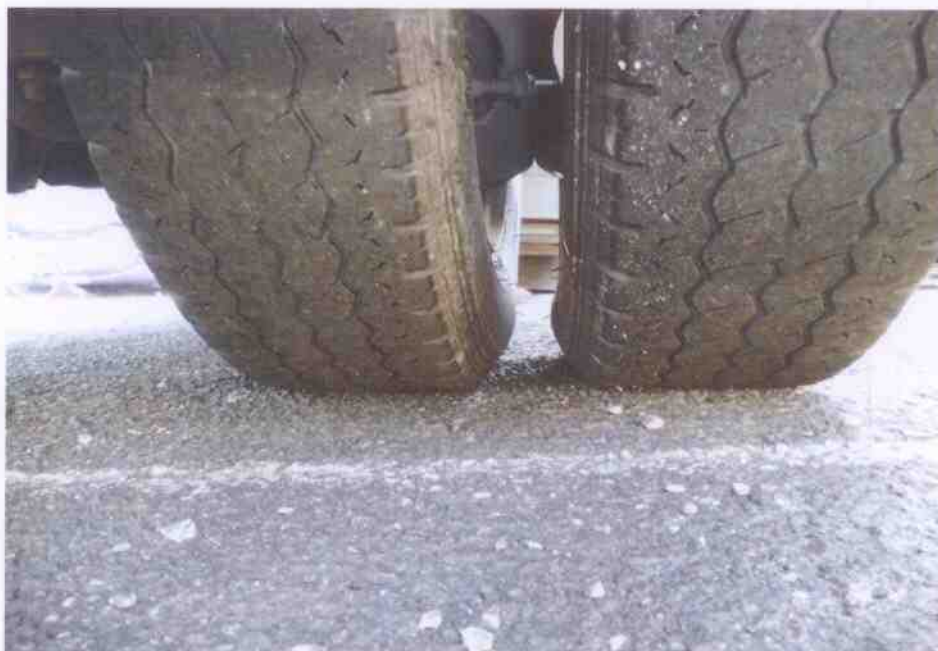
**Photo 9** shows the condition of the rear right tyre of the Motor Lorry, which observed to be in serviceable condition with remaining tread depth of approximately 2.3mm. The tyre, which was wrapped around standard alloy wheel rim, was also observed to be sufficiently inflated for vehicular operation.

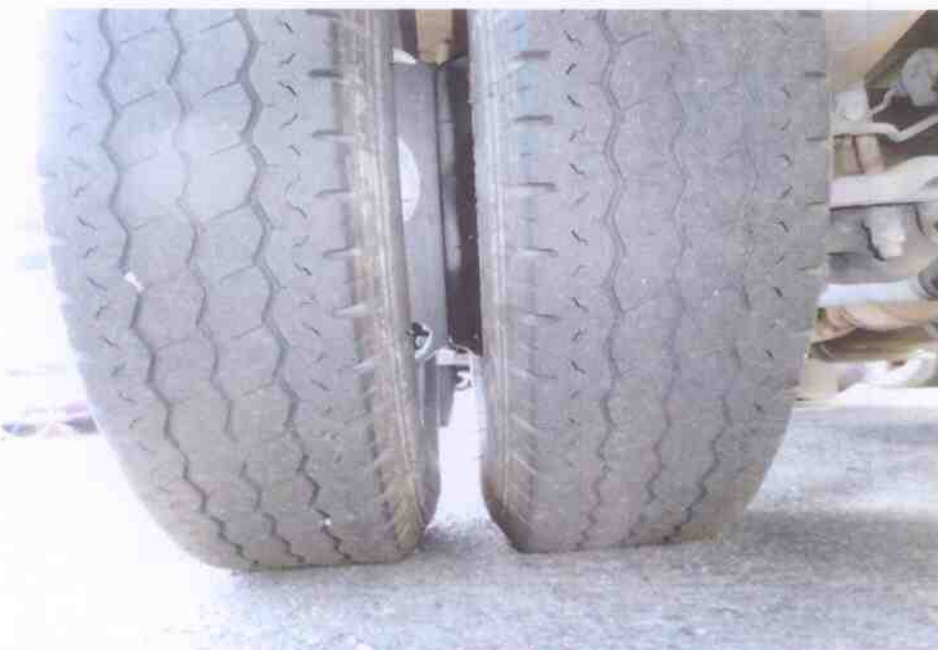
**Photo 10** shows the condition of the front left tyre of the Motor Lorry, which observed to be in serviceable condition with remaining tread depth of approximately 2.4mm. The tyre, which was wrapped around standard alloy wheel rim, was also observed to be sufficiently inflated for vehicular operation.

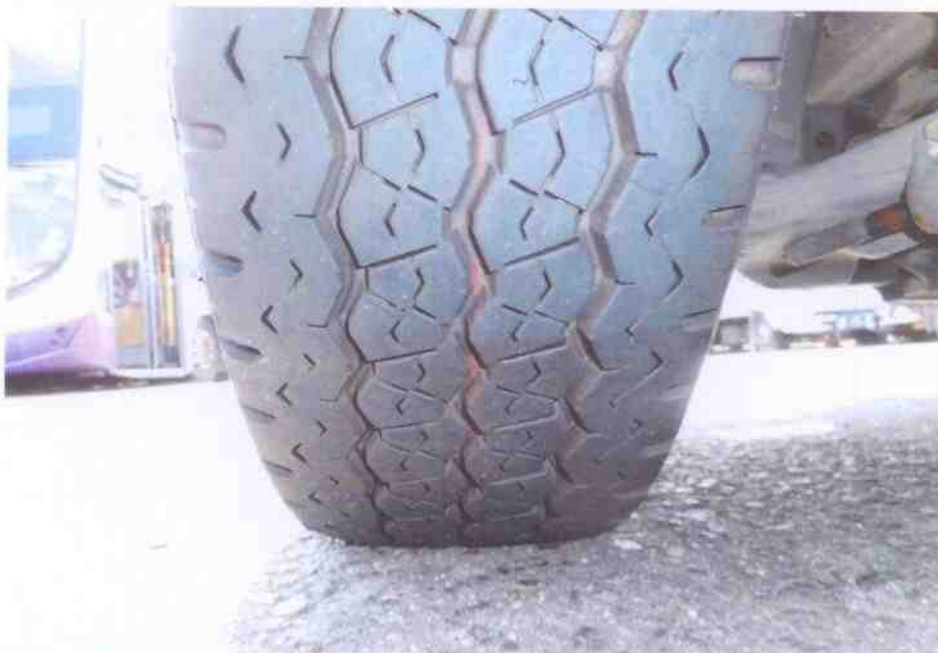
**Photo 11** shows the condition of the front left tyre of the Motor Lorry, which observed to be in serviceable condition with remaining tread depth of approximately 5mm. The tyre, which was wrapped around standard alloy wheel rim, was also observed to be sufficiently inflated for vehicular operation.

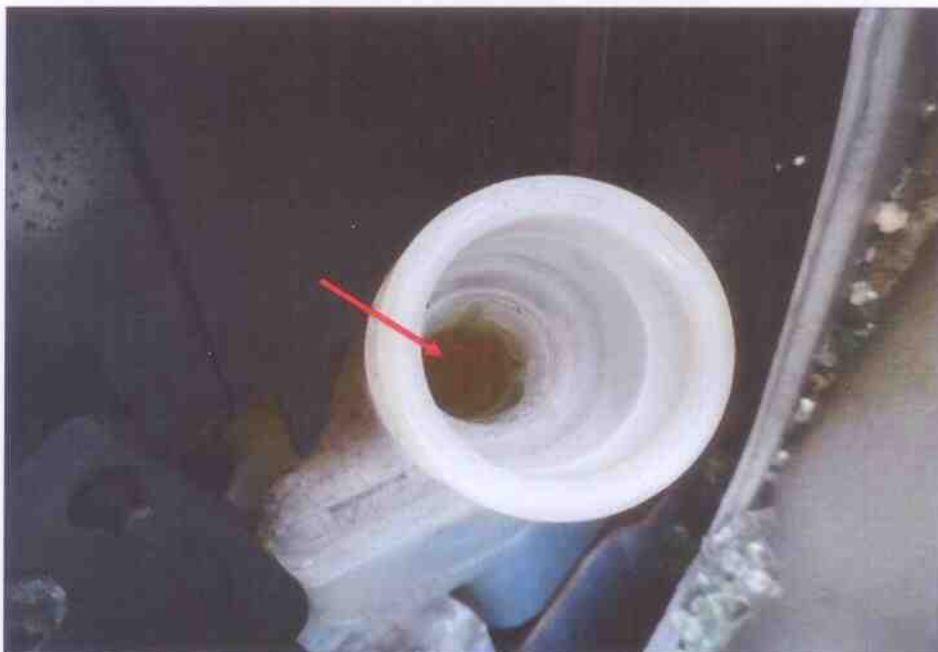
**Photo 12** shows the brake fluid reservoir of the Motor Van at the time of my inspection. The brake fluid was observed to be of sufficient level (arrowed) and without any visible contamination.

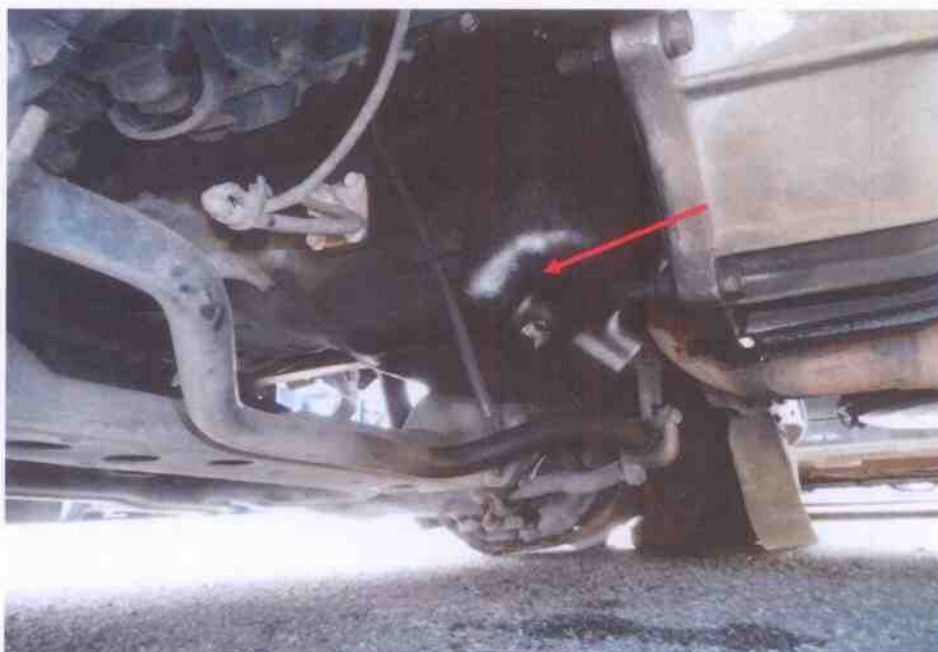
**Photo 13** shows the undercarriage of the engine of the Motor Lorry at the time of our inspection. There was also no sign(s) or indication(s) of fresh fluid leakage and/or fluid stain within the engine area.

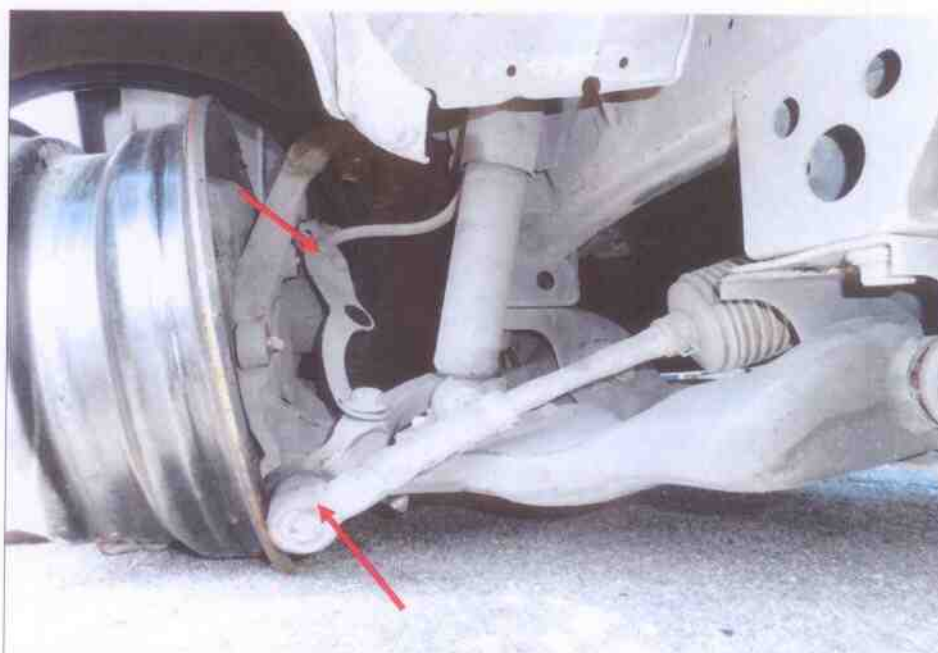
10. The mechanical components of the Motor Lorry's right steering tie rods and brake drum were found to be damaged and dislodged off from the steering knuckle. However the steering tie rods and brake caliper of the Motor Lorry were observed to be intact.

**Photo 14** shows the various undercarriage components at the front right wheel of the Motor Lorry, in particular the steering tie rod end and brake caliper (arrowed). The various undercarriage components of the Motor Lorry were all found to be damaged as a result of the accident.

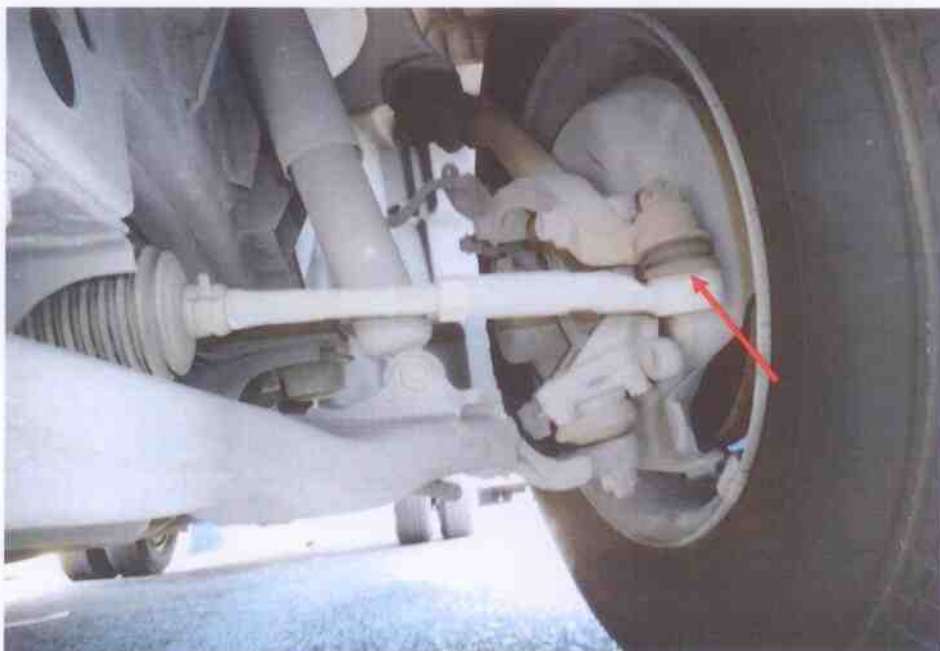
**Photo 15** shows the various undercarriage components at the front left wheel of the Motor Lorry, in particular the steering tie rod end and ball joints (arrowed). The various undercarriage components of the Motor Lorry were all found to be intact without any visible damage. There was also no sign of fluid stain(s) observed on the various undercarriage components.

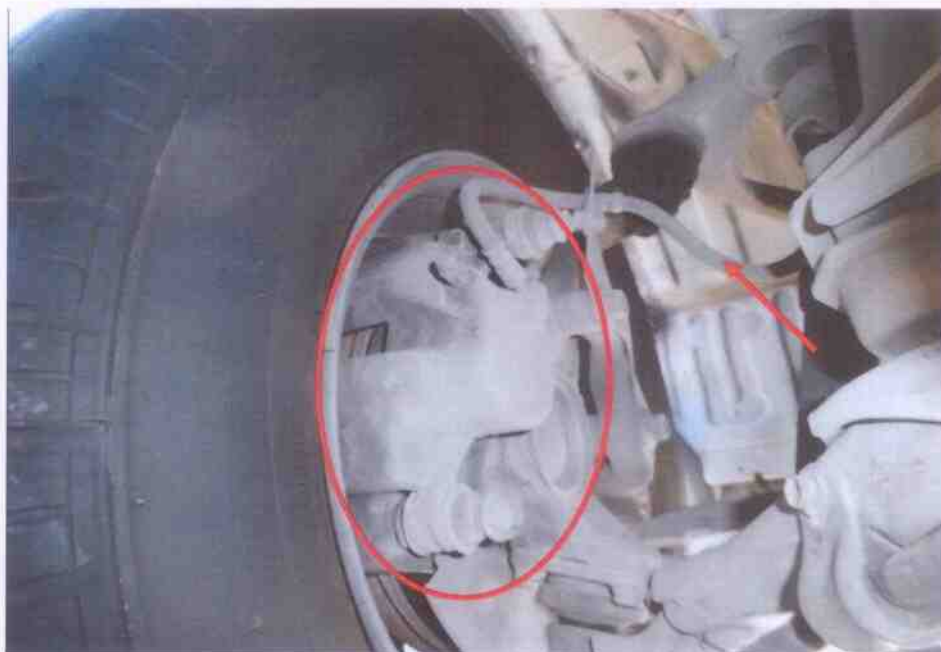
**Photo 16** shows the various undercarriage components at the front left wheel of the Motor Lorry, in particular the brake hose and caliper (arrowed). The various undercarriage components of the Motor Lorry were all found to be intact without any visible damage. There was also no sign of fluid stain(s) observed on the various undercarriage components.

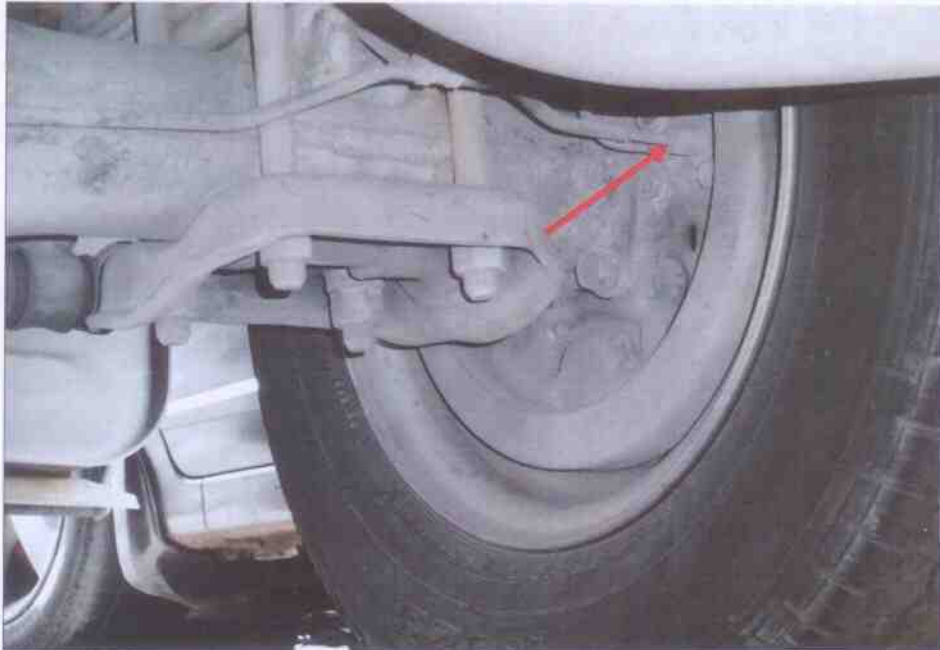
**Photo 17** shows the various undercarriage components at the rear right wheel of the Motor Lorry, in particular the brake hose and drum brake (arrowed). The various undercarriage components of the Motor Lorry were all found to be intact without any visible damage. There was also no sign of fluid stain(s) observed on the various undercarriage components.

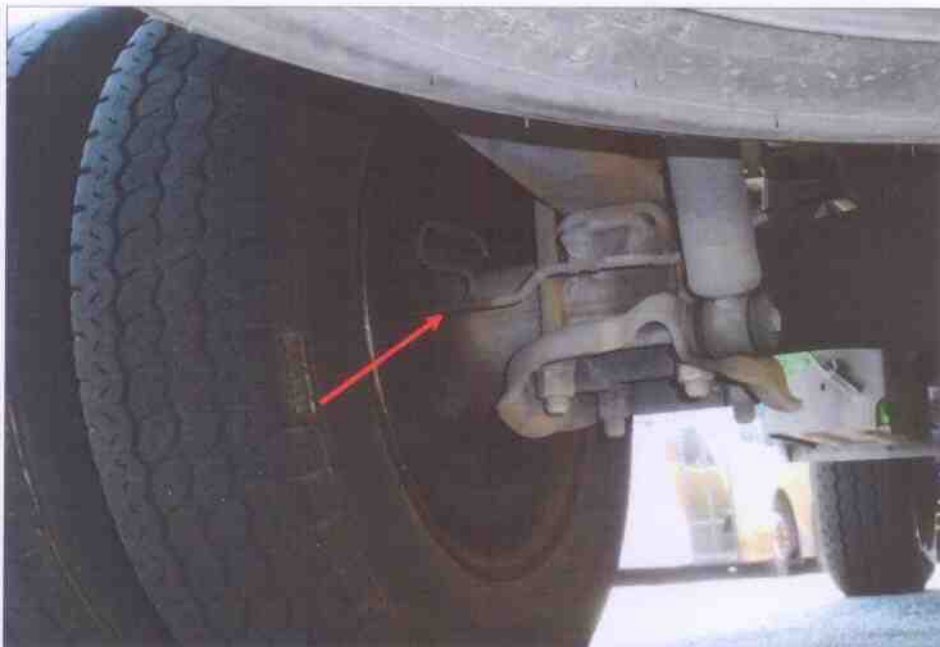
**Photo 18** shows the various undercarriage components at the rear left wheel of the Motor Lorry, in particular the brake hose and drum brake (arrowed). The various undercarriage components of the Motor Lorry were all found to be intact without any visible damage. There was also no sign of fluid stain(s) observed on the various undercarriage components.
