Your Ref: TP/IP/74229/2019
Our Ref : CI/TPD20001938/P

Fatal Accident Investigation Team

MECHANICAL INSPECTION REPORT OF MOTOR BUS PC 1244B

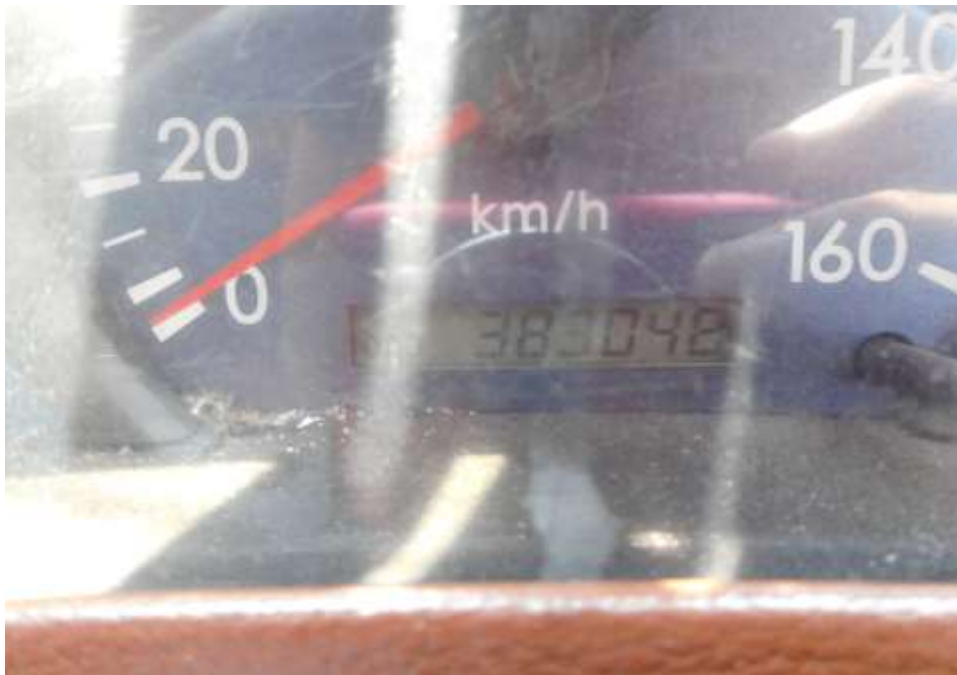
Photo 1 shows a general view of the instrument cluster of the Motor Bus at the time of my inspection. The mileage of the Motor Bus was 380,048km

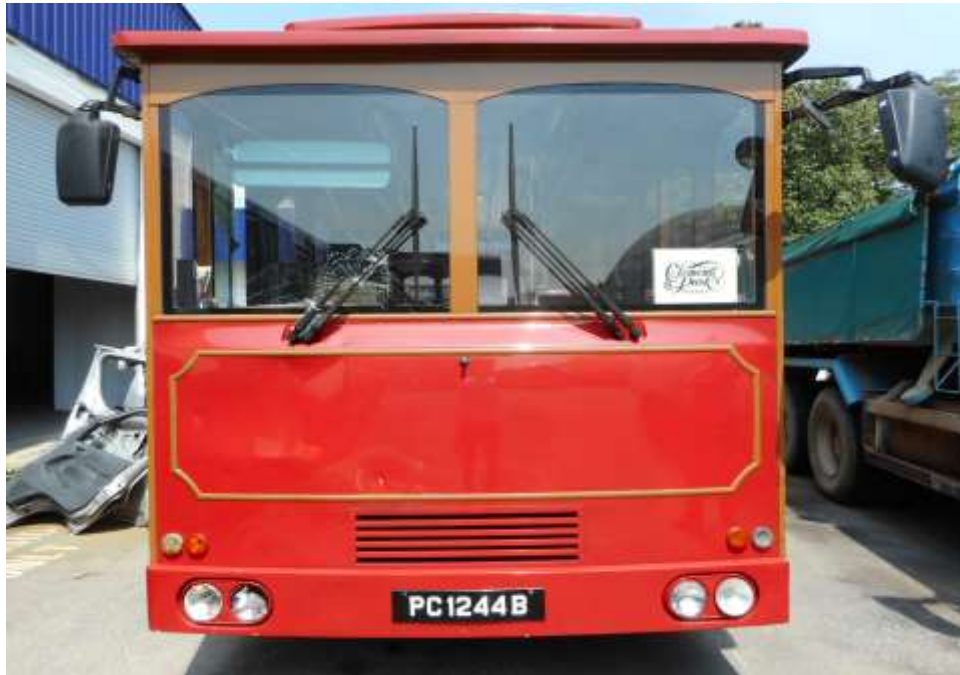
4. The mileage of the Motor Bus at the time of my inspection was 380,048km.
5. The Motor Bus was observed to have sustained damage at its front portion. Its front windscreen, front body panel and front right headlamp were amongst the body parts that were damaged as a result of the accident.

Photo 2 shows a general view of the front body of the Motor Bus front body at the time of my inspection. The Motor Bus was observed to have sustained damage at its frontal portion. Its front windscreen, front body panel and front right headlamp were amongst the body parts that were damaged as a result of the accident.

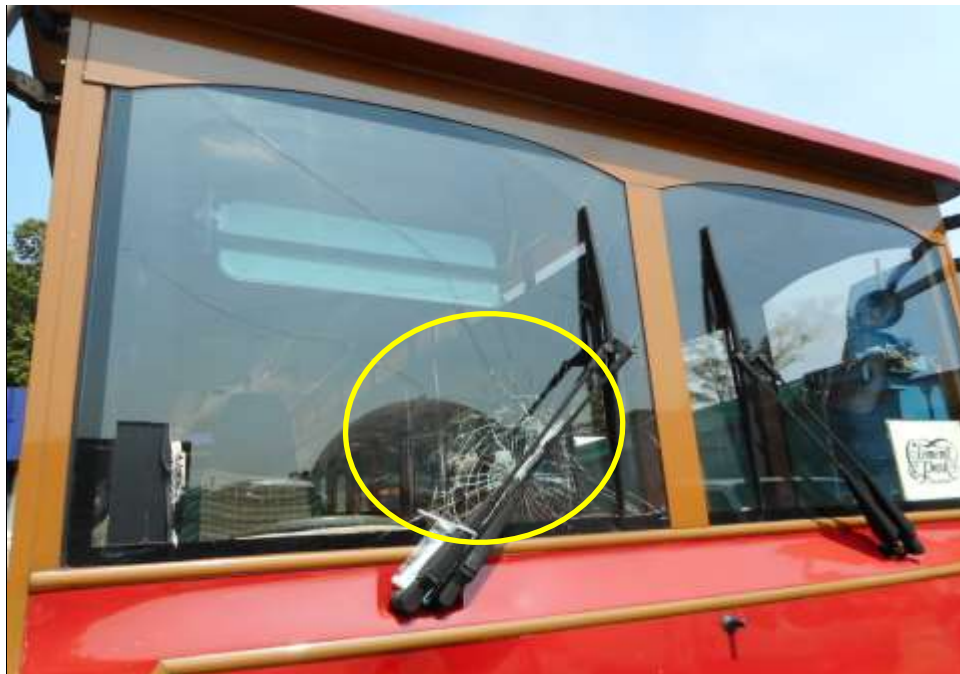
Photo 3 shows the close up view of the Motor Bus front body at the time of my inspection. The Motor Bus was observed to have sustained damage at its front windscreen (circled), as a result of the accident.

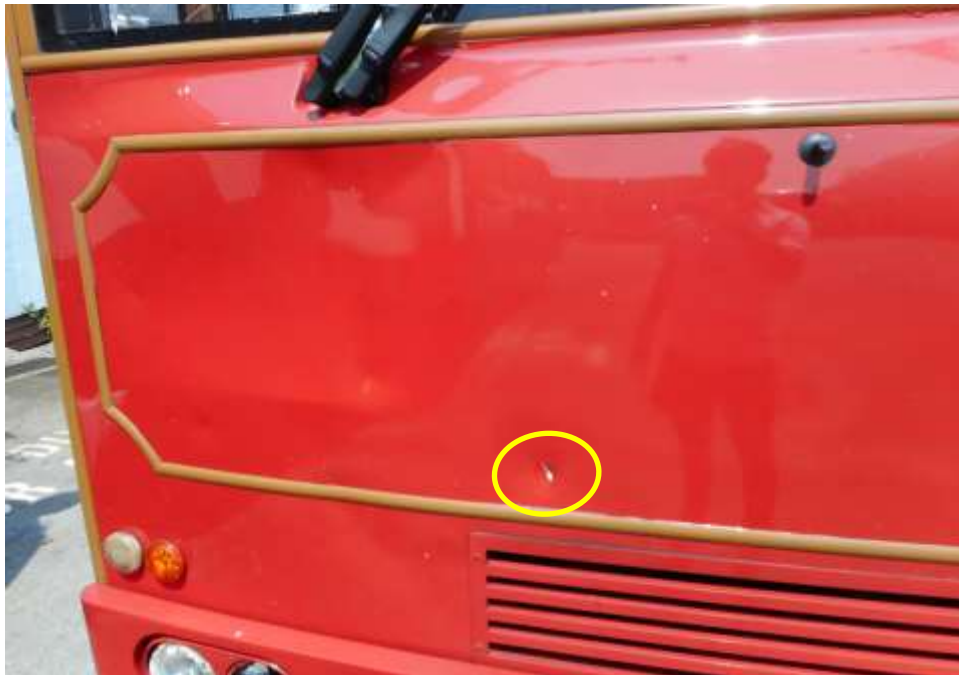
Photo 4 shows the close up view of the Motor Bus front body at the time of my inspection. The Motor Bus was observed to have sustained damage at its front body panel (circled), as a result of the accident.

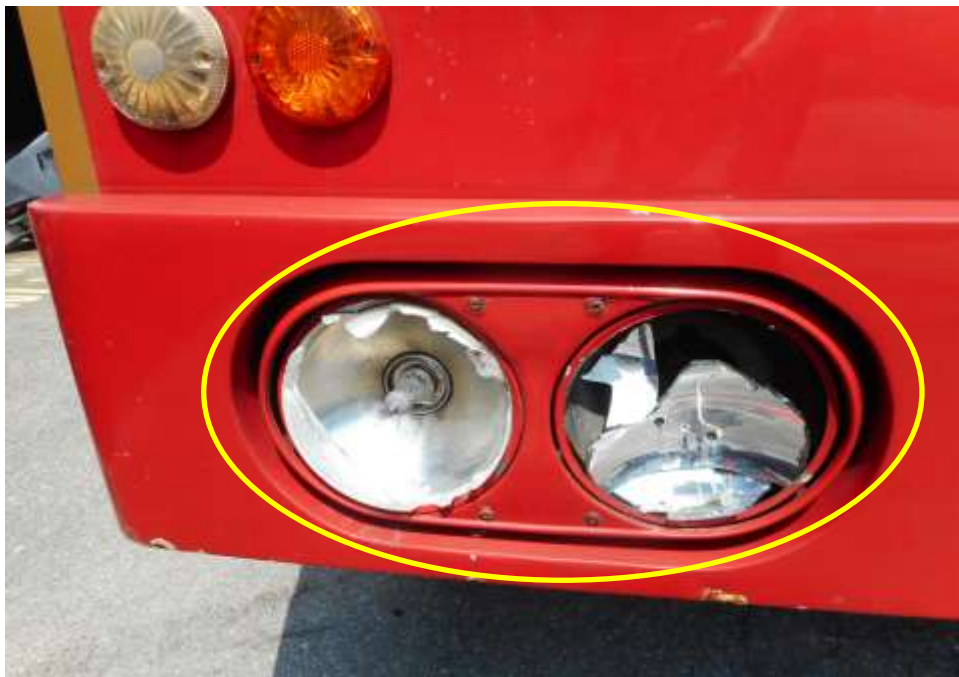
Photo 5 shows the close up view of the Motor Bus front body at the time of my inspection. The Motor Bus was observed to have sustained damage at its front right head lamp (circled), as a result of the accident.

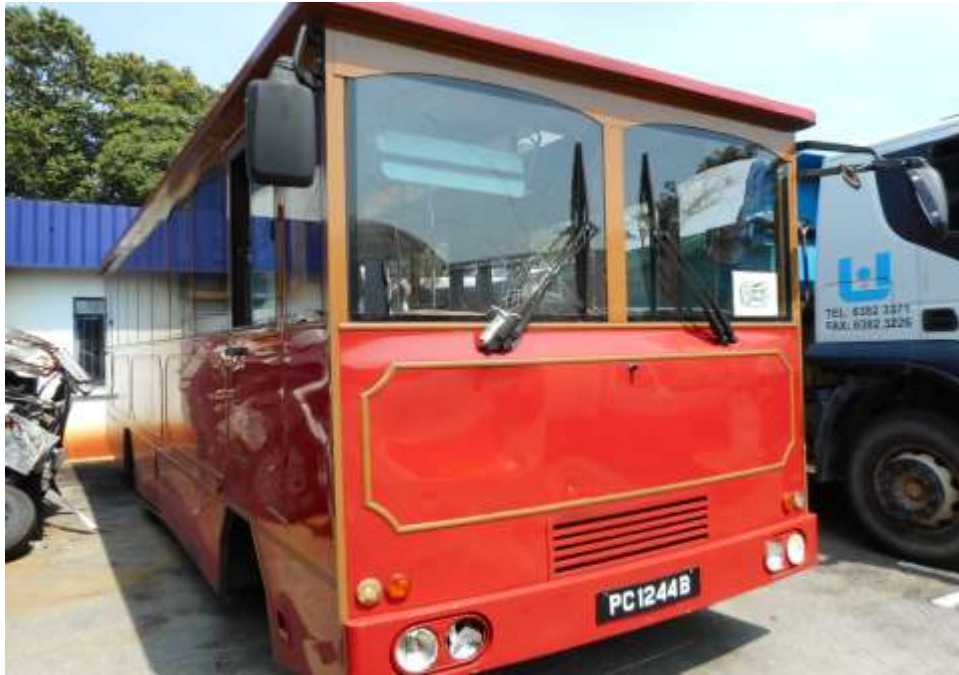
Photo 6 shows a general view of the front right body of the Motor Bus at the time of my inspection, observed to have been unaffected by the accident.

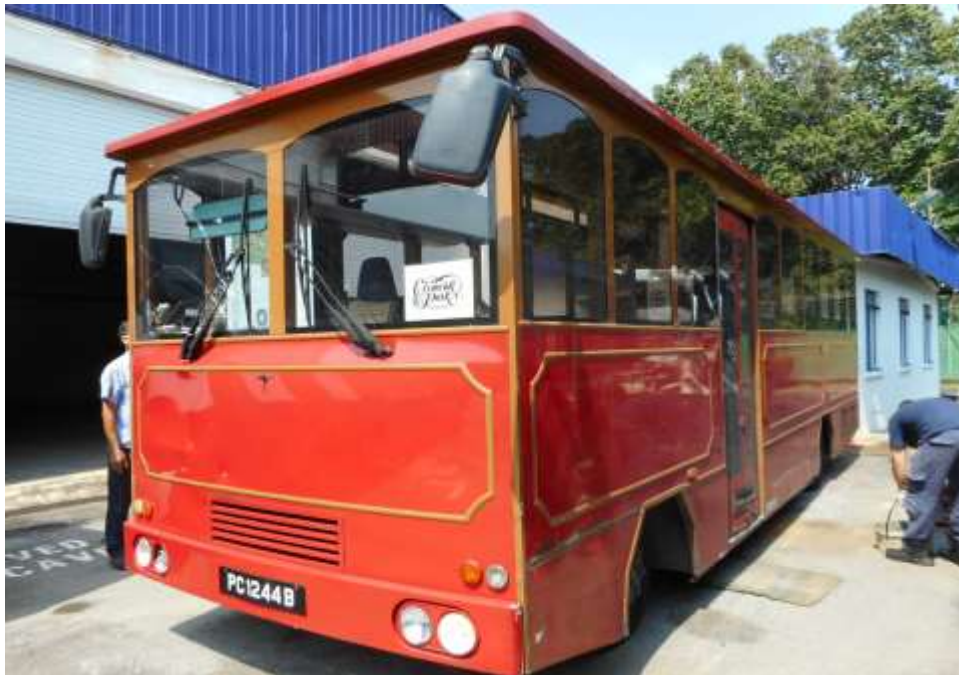
Photo 7 shows a general view of the front right body of the Motor Bus at the time of my inspection, observed to have been unaffected by the accident.

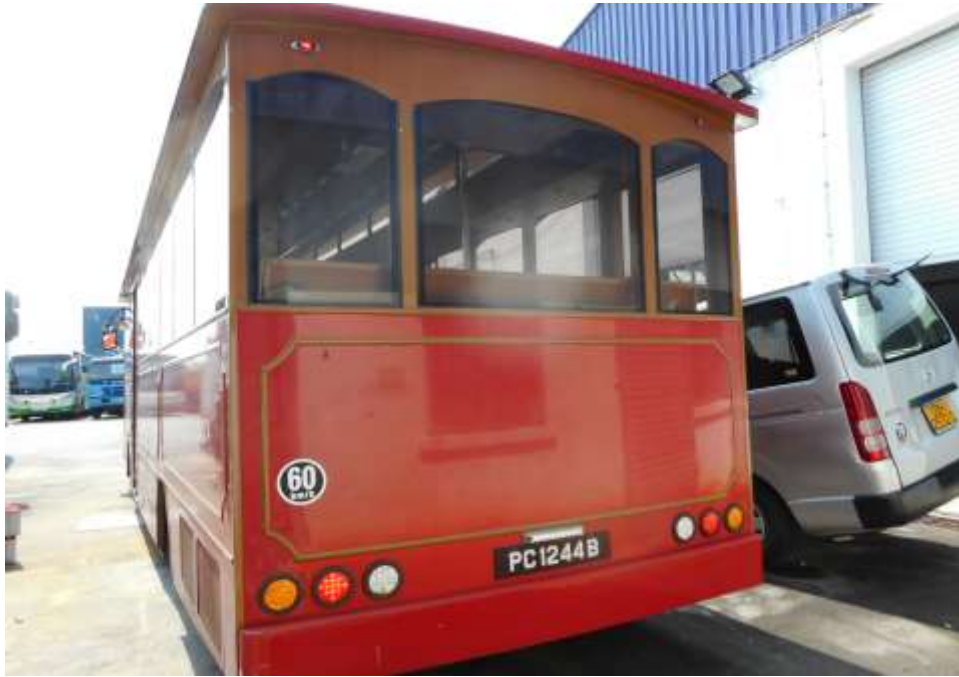
Photo 8 shows a general view of the Motor Bus's rear body at the time of my inspection. There was no damage found to the rear portion of the Motor Bus.

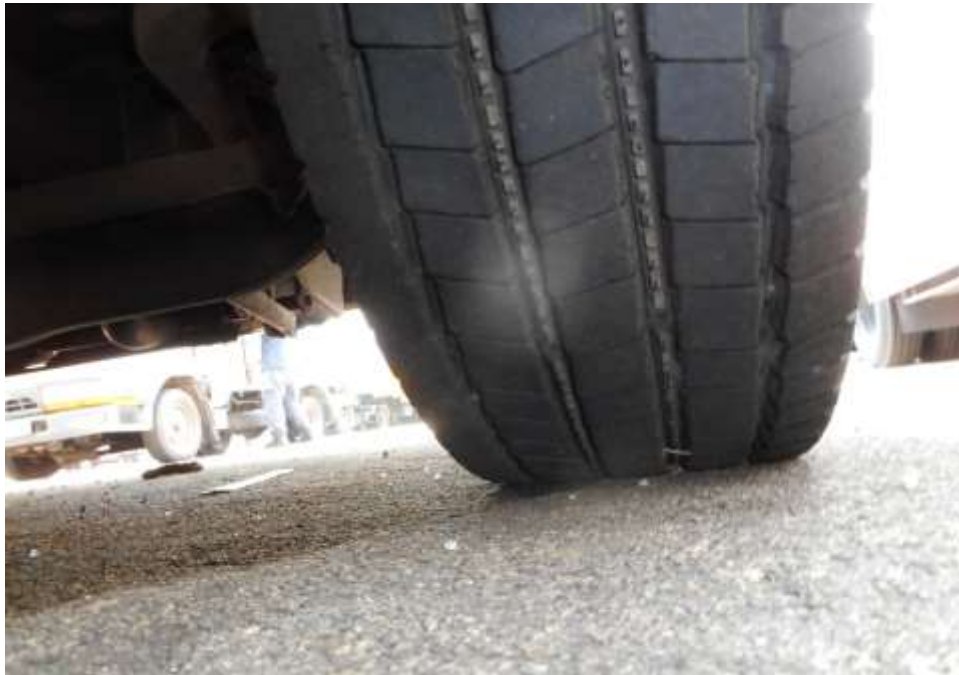
Photo 9 shows the condition of the front right tyre of the Motor Bus, which was observed to be in serviceable condition with remaining tread depth of approximately 10.3 mm. The tyre, which was wrapped around standard steel wheel rim, was also observed to be sufficiently inflated for vehicular operation. There was no tear, cut or burst mark(s) on the outer and the inner sidewalls as well as across the tread of the 6 tyres that were fitted on the Motor Bus.

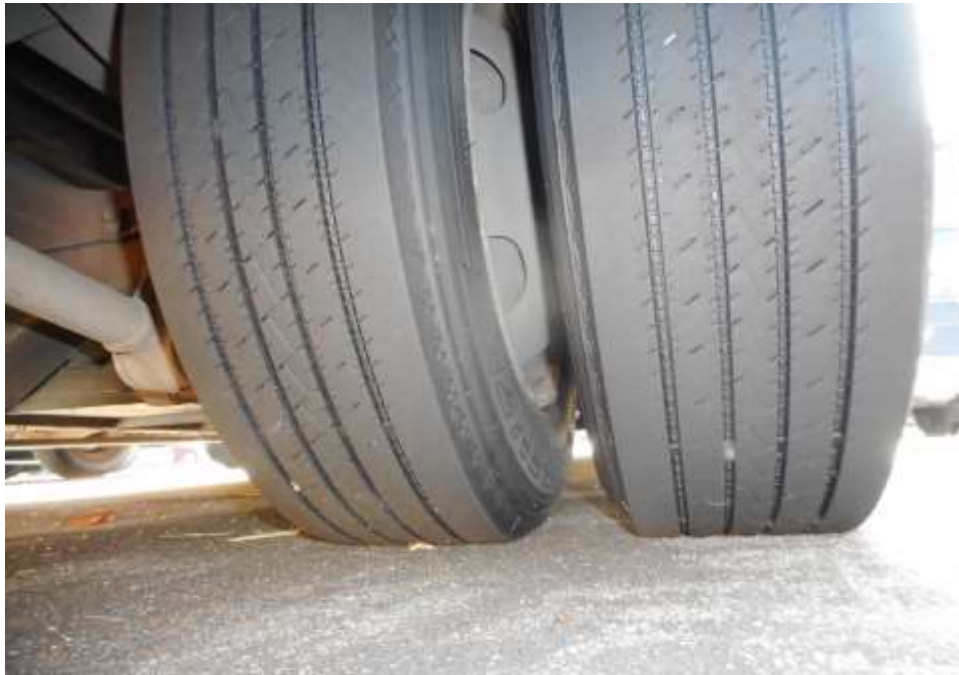
Photo 10 shows the condition of the rear right tyre of the Motor Bus, which was observed to be in serviceable condition with remaining tread depth of approximately 5.6mm. The tyre, which was wrapped around standard steel wheel rim, was also observed to be sufficiently inflated for vehicular operation.

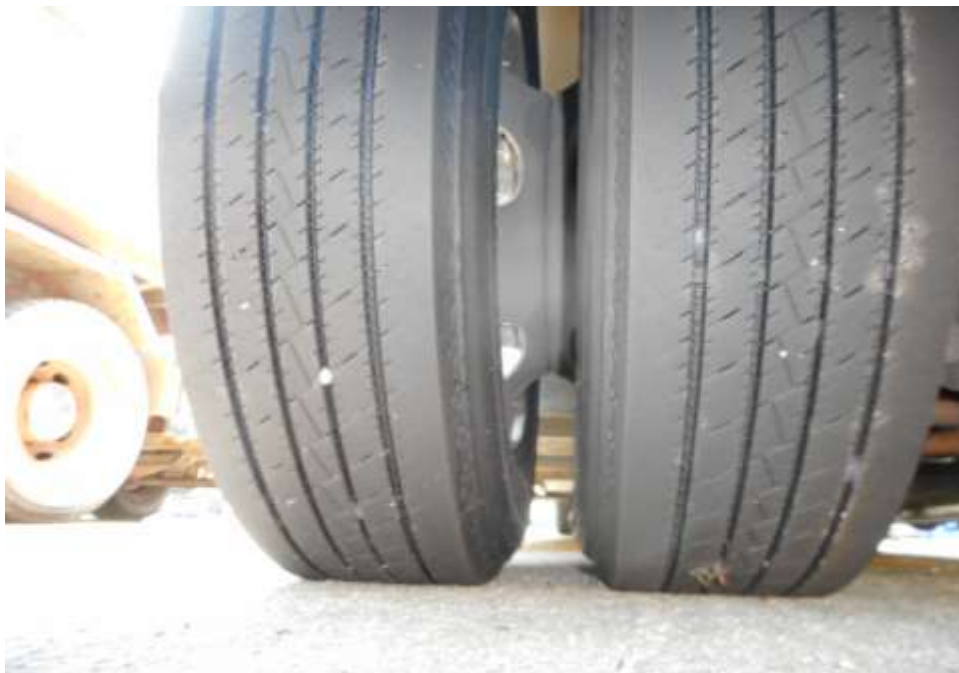
Photo 11 shows the condition of the rear left tyres of the Motor Bus, which was observed to be in serviceable condition with remaining tread depth of approximately 4.9mm. The tyres, which were wrapped around standard steel wheel rim, were also observed to be sufficiently inflated for vehicular operation. There was also no damage found on all 6 steel wheel rims of the Motor Bus.

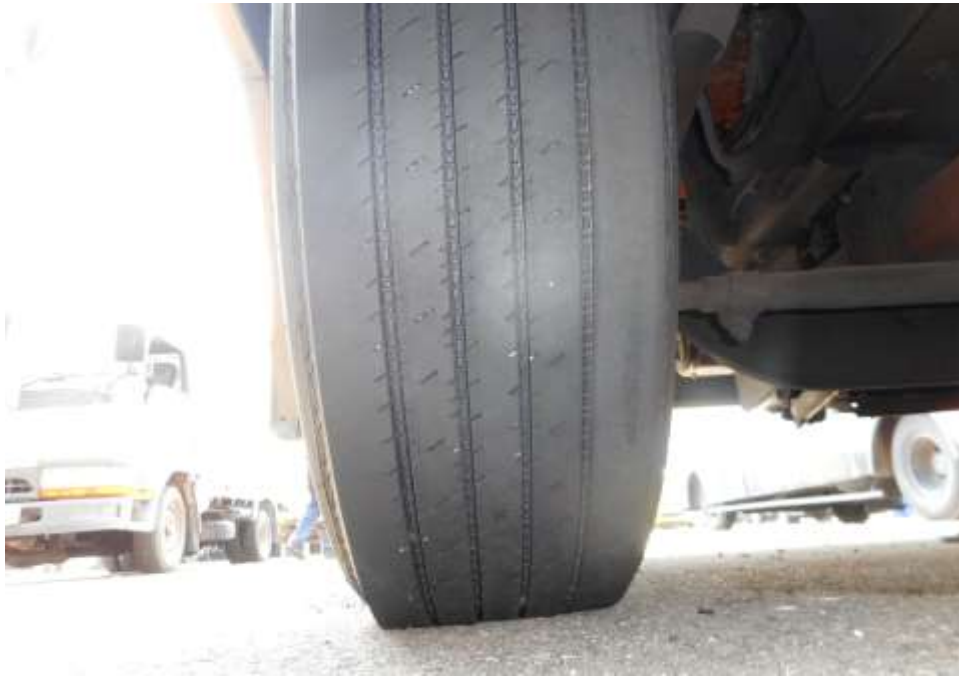
Photo 12 shows the condition of the front left tyres of the Motor Bus, which were observed to be in serviceable condition with remaining tread depth of approximately 5.4mm. There was also no tear, cut or burst mark(s) on the outer and the inner sidewalls as well as across the tread of the 6 tyres that were fitted on the Motor Bus.

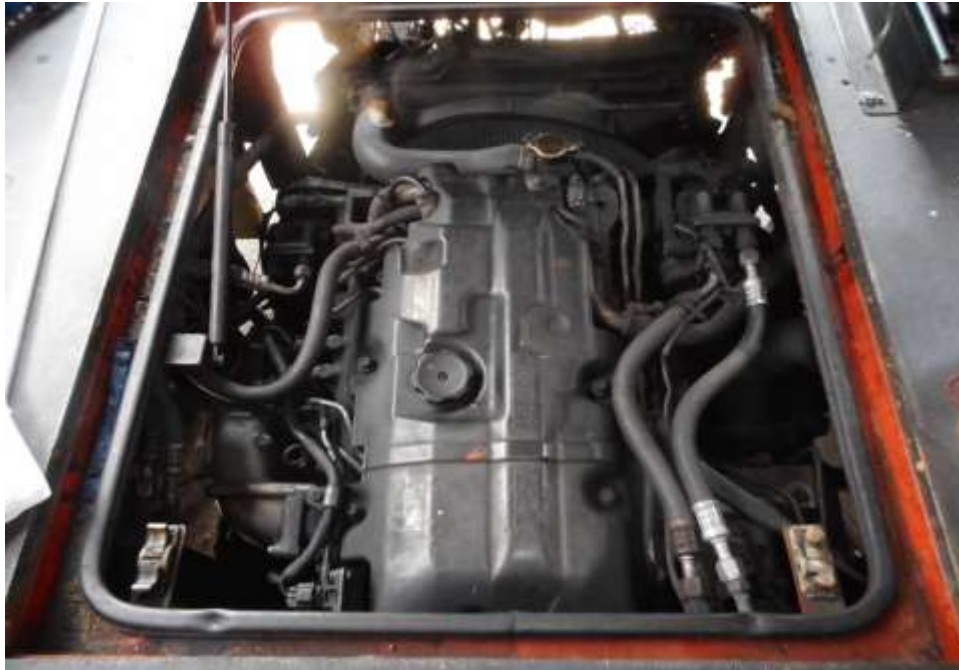
Photo 13 shows a general view of the Motor Bus's engine compartment, which was accessed by lifting the front cabin of the Motor Bus. The various parts and components inside the engine compartment were unaffected by the accident. There was also no sign(s) or indication(s) of fresh fluid leakage and/or fluid stain within the engine compartment

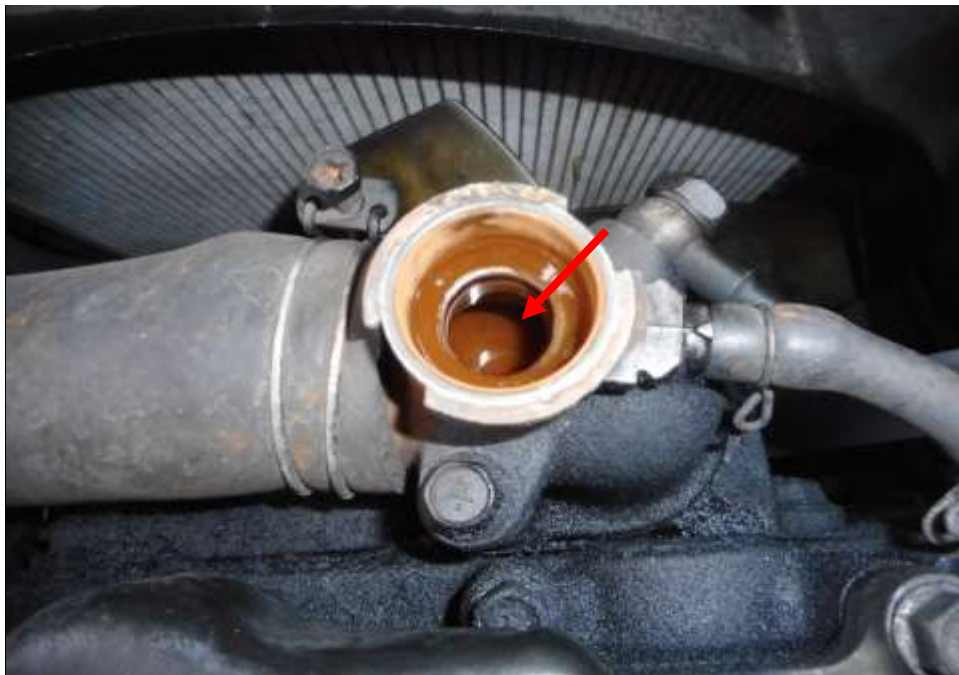
Photo 14 shows the engine coolant reservoir of the Motor Bus at the time of my inspection. The engine coolant was observed to be of sufficient level (arrowed) and without any visible contamination.

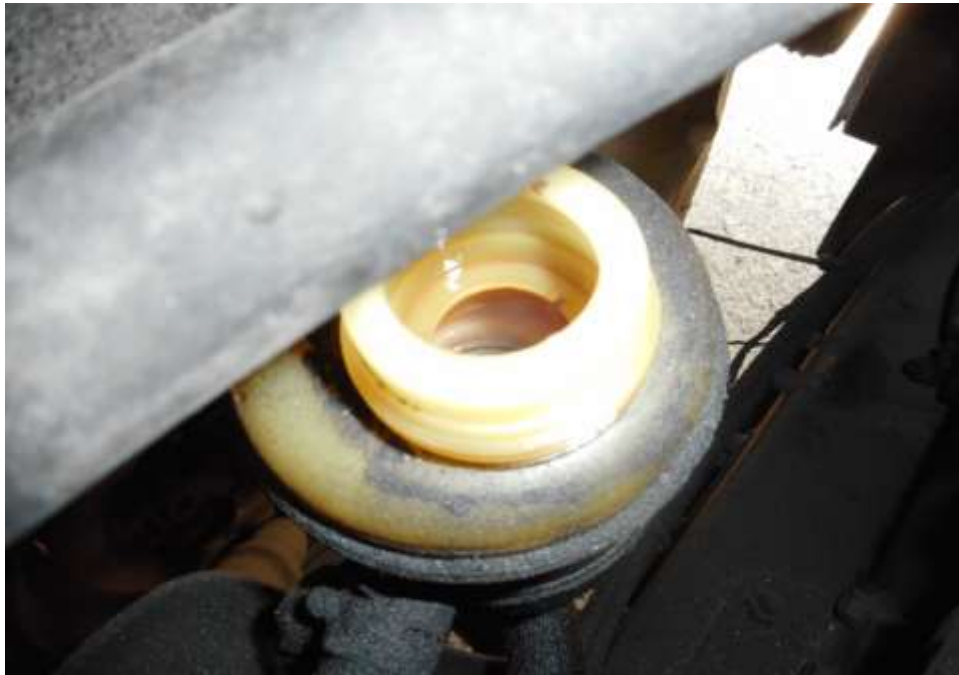
Photo 15 shows the brake fluid reservoir of the Motor Bus at the time of my inspection. The brake fluid was observed to be of sufficient level and without any visible contamination.

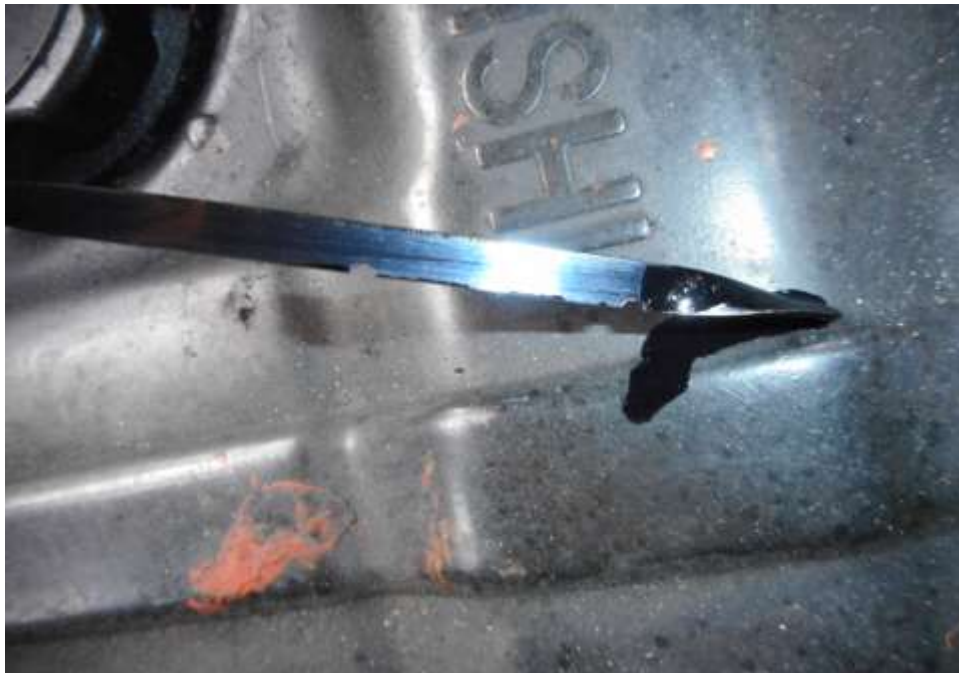
Photo 16 shows the engine oil level display of the Motor Bus at the time of my inspection. The engine oil was observed to be of sufficient level.

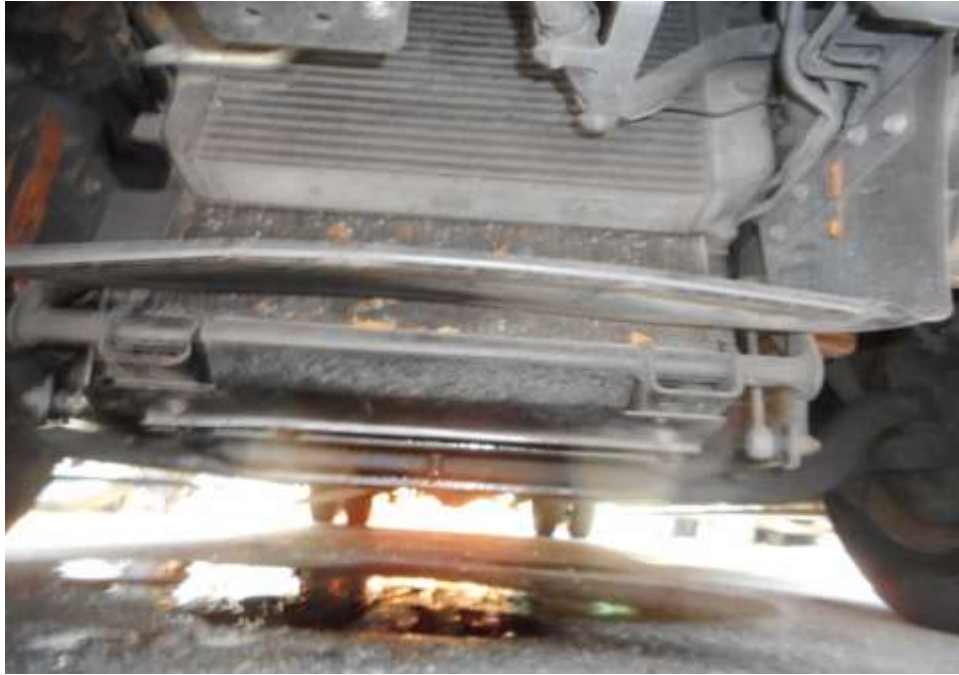
Photo 17 shows the undercarriage of the Motor Bus, at the area where the engine housing located. I did not find any sign(s) or indication(s) of fluid leak and/or fluid stain(s) on the underside of the Motor Bus.

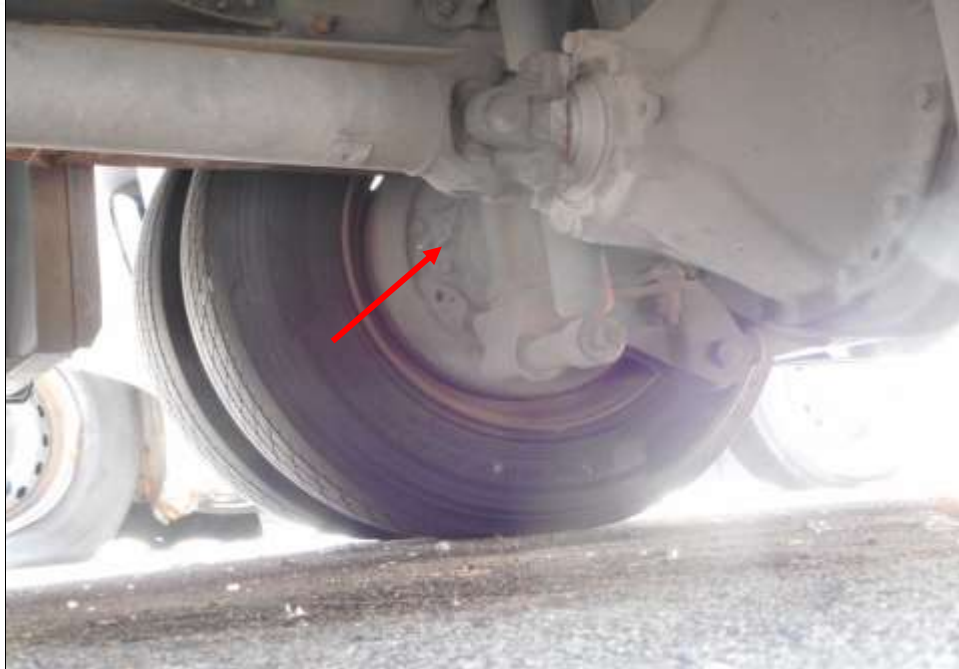
Photo 18 shows the brake pipe (arrowed) at the rear right wheel of the Motor Bus. I did not observe any leakage of brake fluid at the time of my inspection of the Motor Bus. My static tests of the Motor Bus's braking system, along with my visual examination of the various mechanical components in the braking system, had indicated that there was no internal leakage of pressure/vacuum. Hence the braking system of the Motor Bus was likely to be in serviceable condition at the material time of accident.

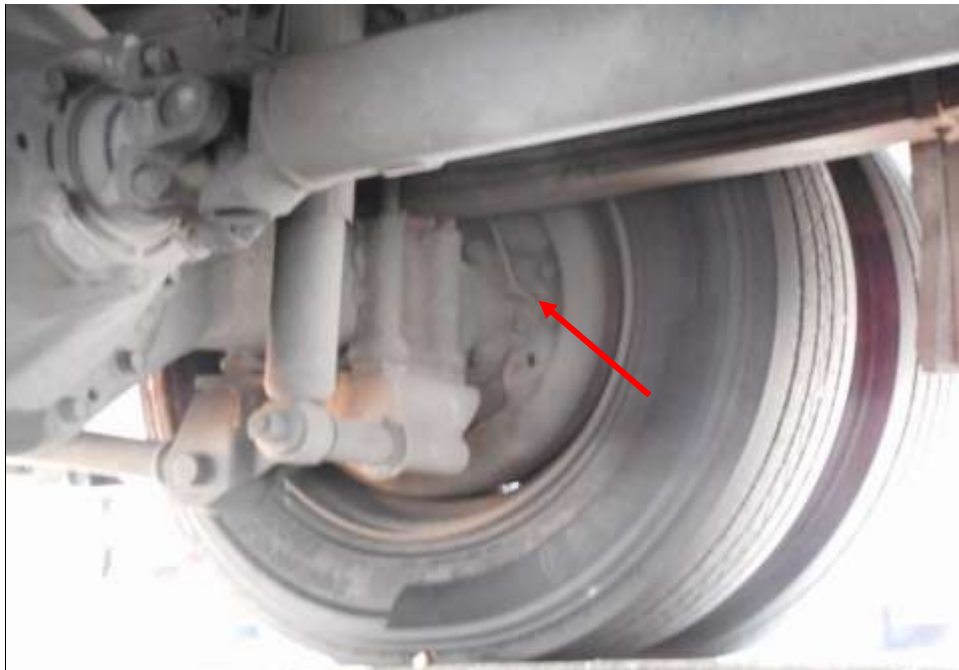
Photo 19 shows the brake pipe (arrowed) at the rear left wheel of the Motor Bus. I did not observe any leakage of brake fluid at the time of my inspection of the Motor Bus. My static tests of the Motor Bus's braking system, along with my visual examination of the various mechanical components in the braking system, had indicated that there was no internal leakage of pressure/vacuum. Hence the braking system of the Motor Bus was likely to be in serviceable condition at the material time of accident.

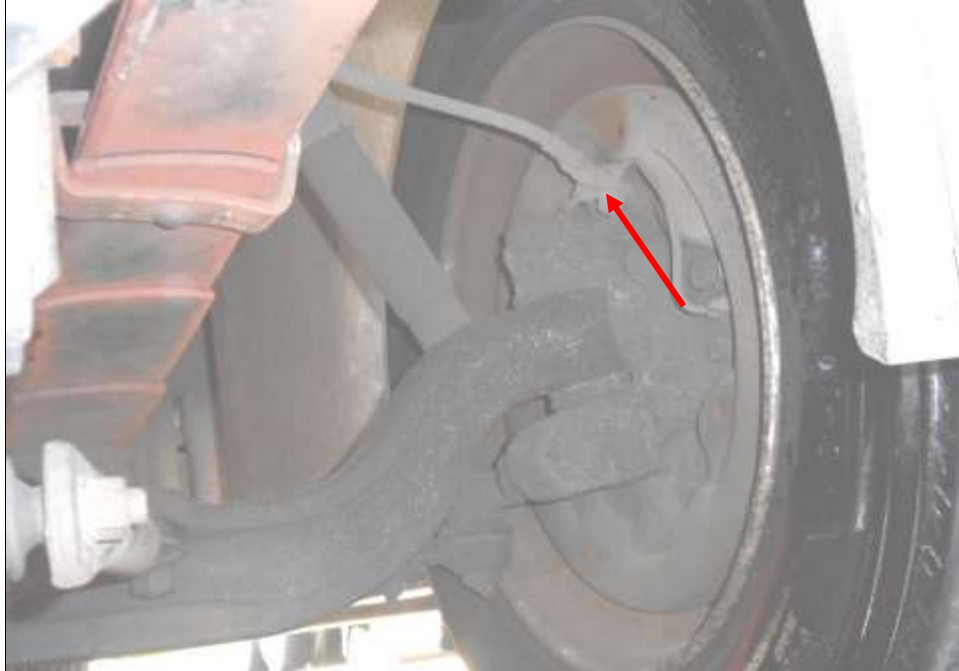
Photo 20 shows the brake pipe (arrowed) at the front left wheel of the Motor Bus. I did not observe any leakage of brake fluid at the time of my inspection of the Motor Bus. My static tests of the Motor Bus's braking system, along with my visual examination of the various mechanical components in the braking system, had indicated that there was no internal leakage of pressure/vacuum. Hence the braking system of the Motor Bus was likely to be in serviceable condition at the material time of accident.

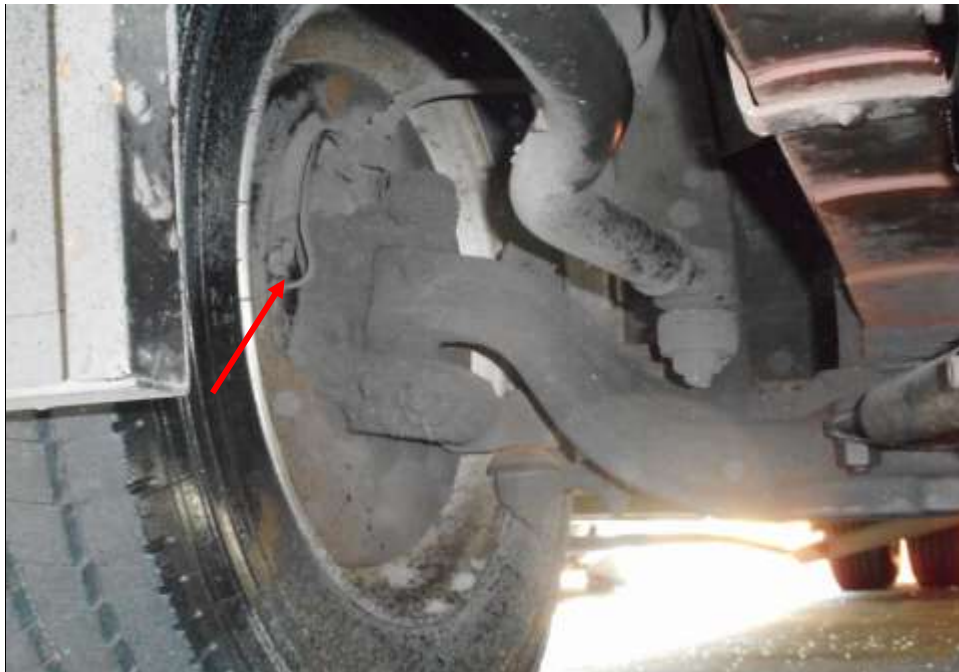
Photo 21 shows the brake pipe (arrowed) at the front right wheel of the Motor Bus. I did not observe any leakage of brake fluid at the time of my inspection of the Motor Bus. My static tests of the Motor Bus's braking system, along with my visual examination of the various mechanical components in the braking system had indicated that there was no internal leakage of pressure/vacuum. Hence the braking system of the Motor Bus was likely to be in serviceable condition at the material time of accident.

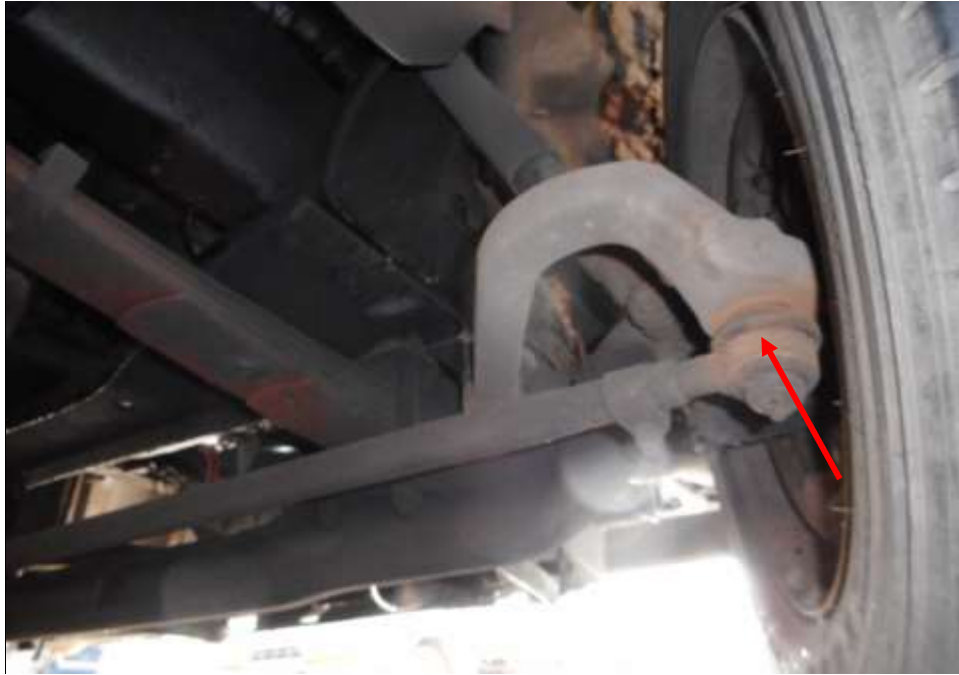
Photo 22 shows the various undercarriage components at the front right wheel of the Motor Bus, in particular the steering tie rod end (arrowed). The various steering components were all found to be intact, suggesting that the steering system of the Motor Bus was likely to be in serviceable condition at the material time of accident. There was also no sign of fluid stain(s) observed on the various undercarriage components.

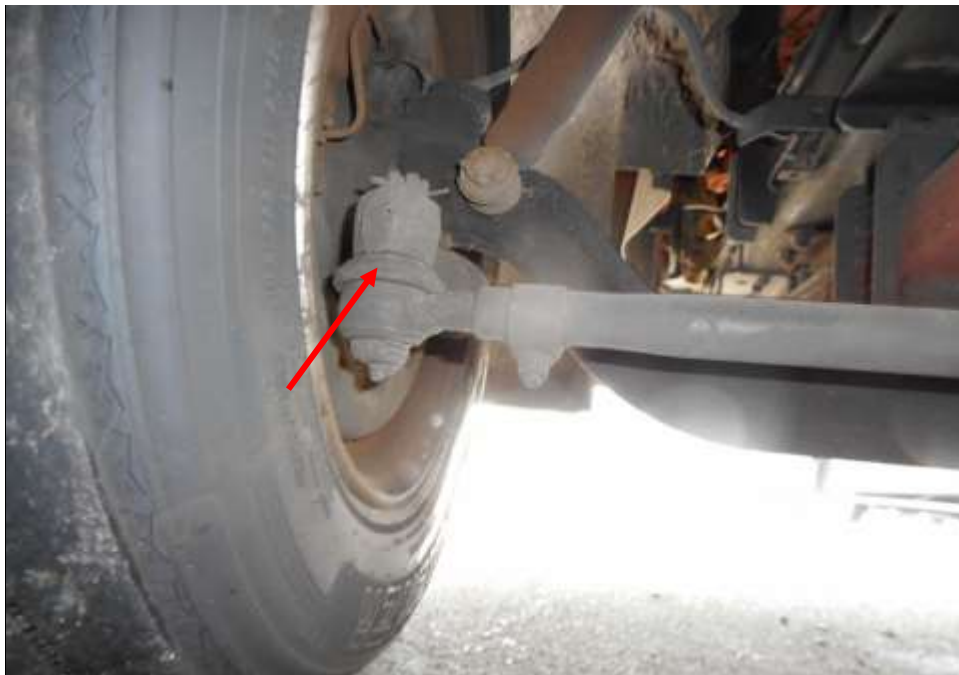
Photo 23 shows the various undercarriage components at the front left wheel of the Motor Bus, in particular the steering tie rod end (arrowed). The various undercarriage components of the Motor Bus were all found to be intact without any visible damage. There was also no sign of fluid stain(s) observed on the various undercarriage components.

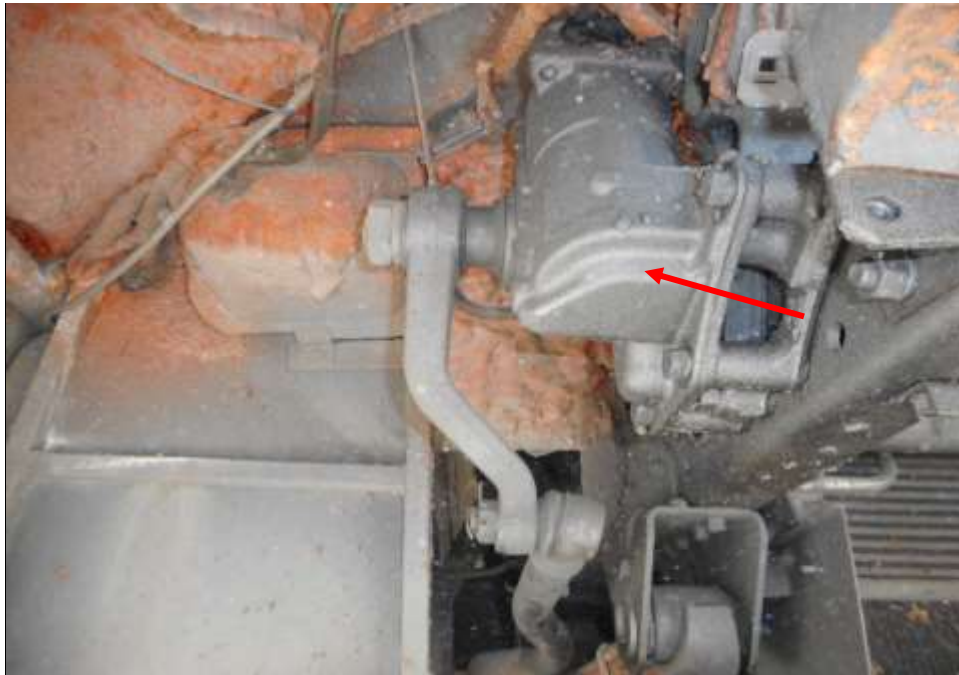
Photo 24 shows the steering box component (arrowed) at the undercarriage of the Motor Bus was found to be intact without any visible damage. There was also no sign of fluid stain(s) observed on the various undercarriage components.

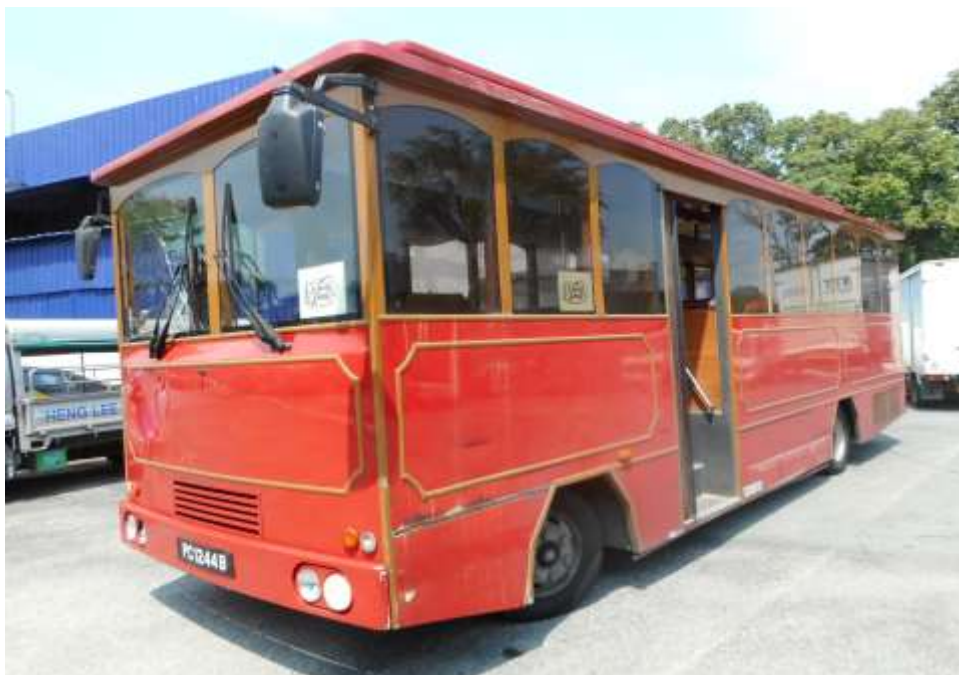
Photo 25 shows the front left of the steering wheel of the Motor Bus turned to its full right. During my steering system test, I did not experience any abnormal free play and/or resistance when I had turned the steering wheel towards full left and full right. This would suggest that the steering system of the Motor Bus was likely to be in serviceable condition at the material time of accident.
