Your Ref: TP/IP/77337/2019
Our Ref : CI/TPD20001940/P

16th March 2020

Fatal Accident Investigation Team

MECHANICAL INSPECTION REPORT OF MOTOR TRAILER CDC 8018

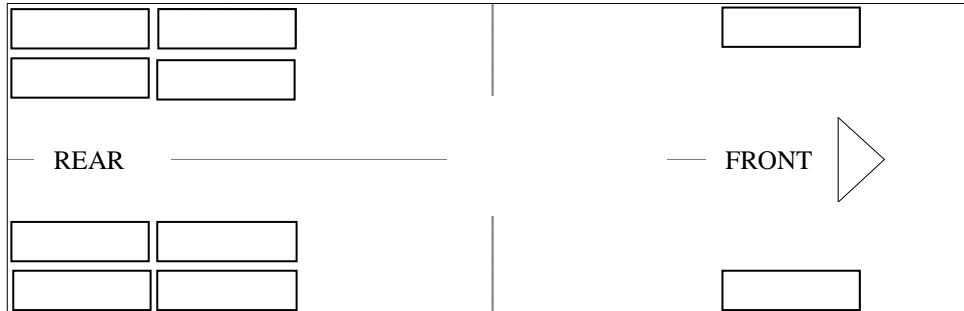
Aufine 295/80 R22.5 (10.2mm)

Aufine 295/80 R22.5 (9.7mm)

Aufine 295/80 R22.5 (12.3mm)

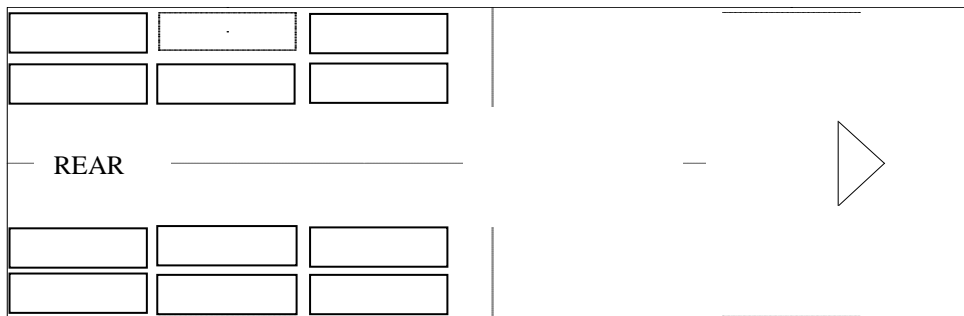
Suretrac 295/80 R22.5 (12.5mm)

Suretrac 295/80 R22.5 (12.1mm)

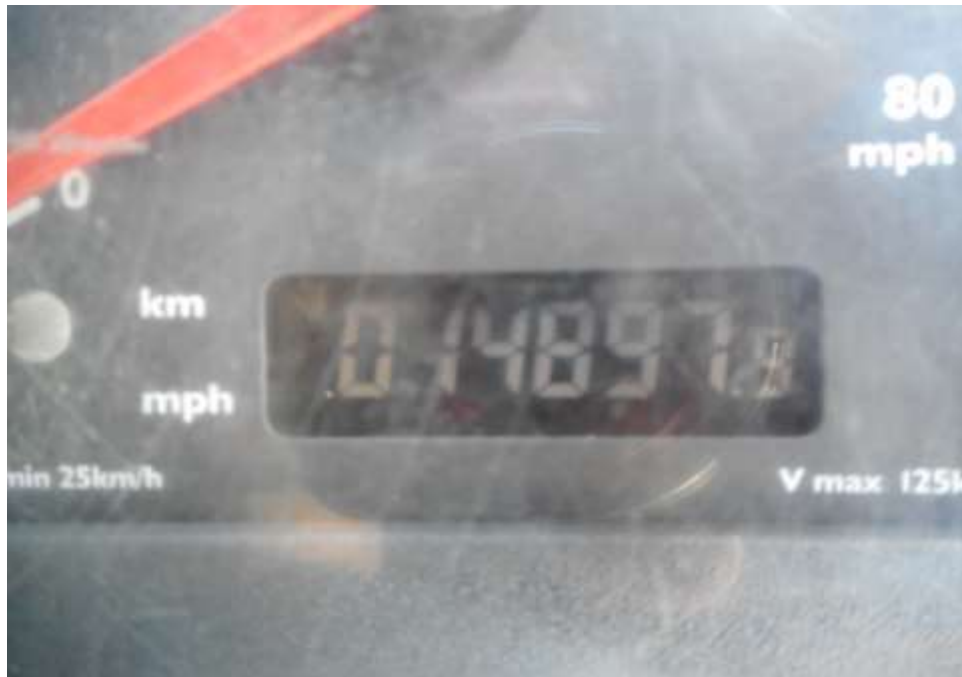
Photo 1 shows a general view of the instrument cluster of the Motor Trailer at the time of my inspection. The mileage of the Motor Trailer was 14,897km

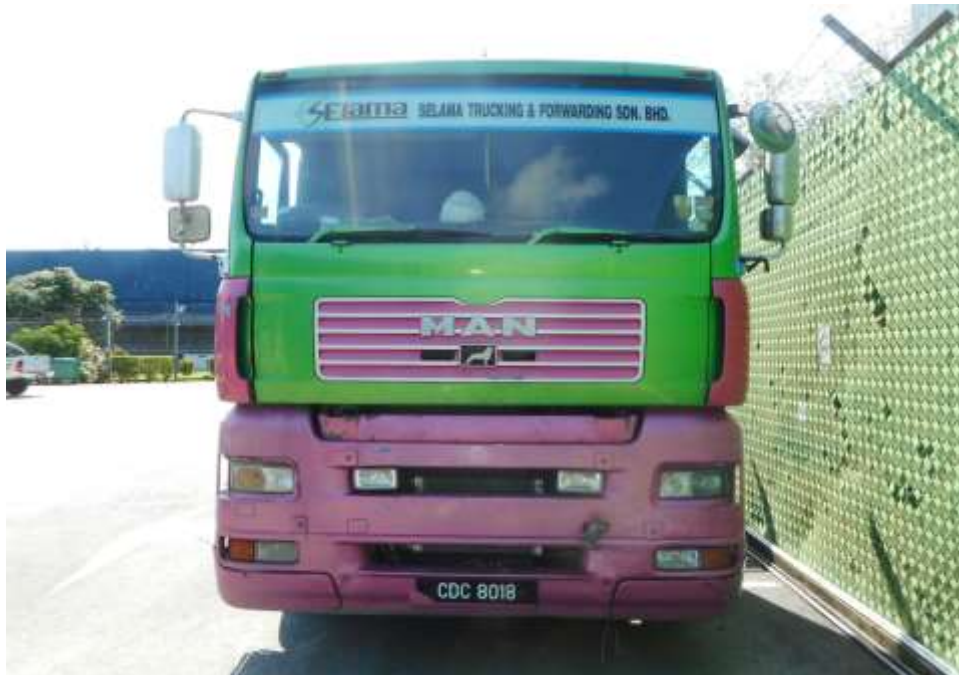
Photo 2 shows a general view of the front body of the Motor Trailer at the time of my inspection. The Motor Trailer was observed to be intact and unaffected by the accident.

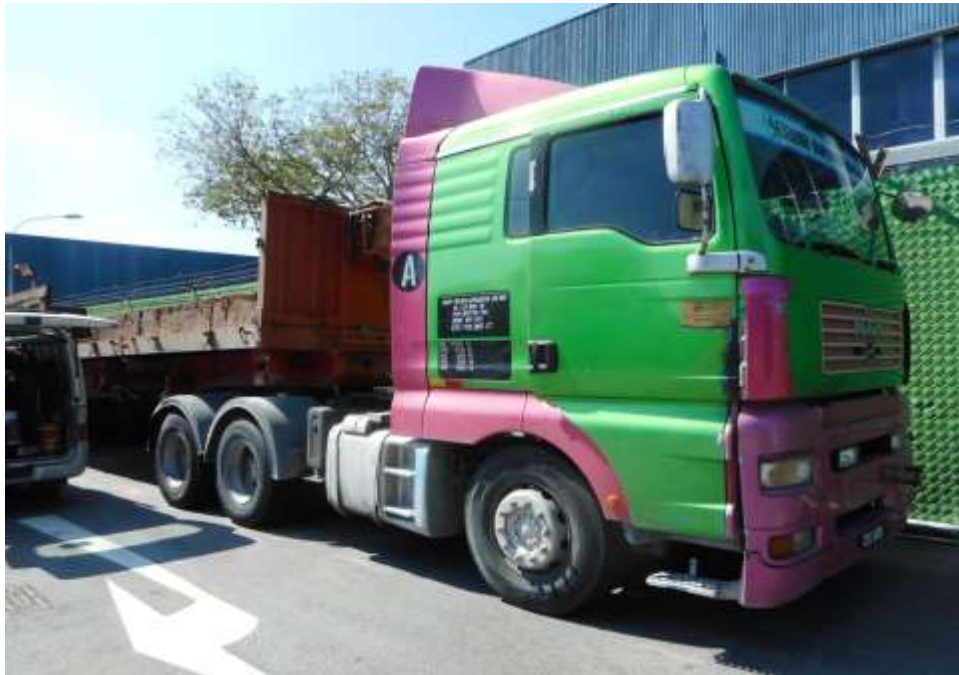
Photo 3 shows a general view of the front right body of the Motor Trailer at the time of my inspection. The Motor Trailer was observed to be intact and unaffected by the accident.

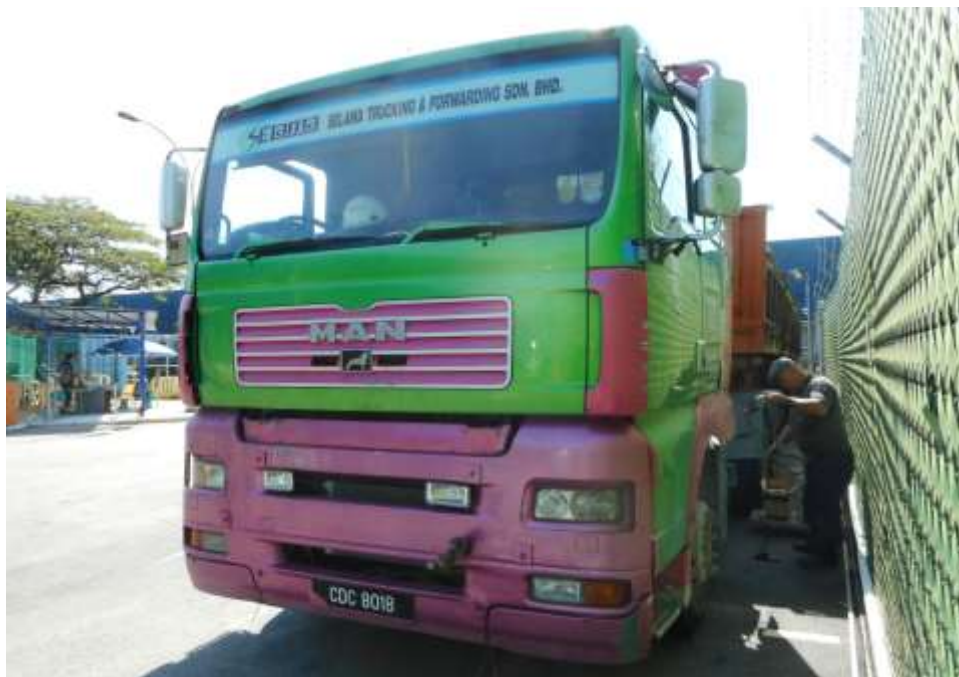
Photo 4 shows a general view of the front left body of the Motor Trailer at the time of my inspection. The Motor Trailer was observed to be intact and unaffected by the accident.

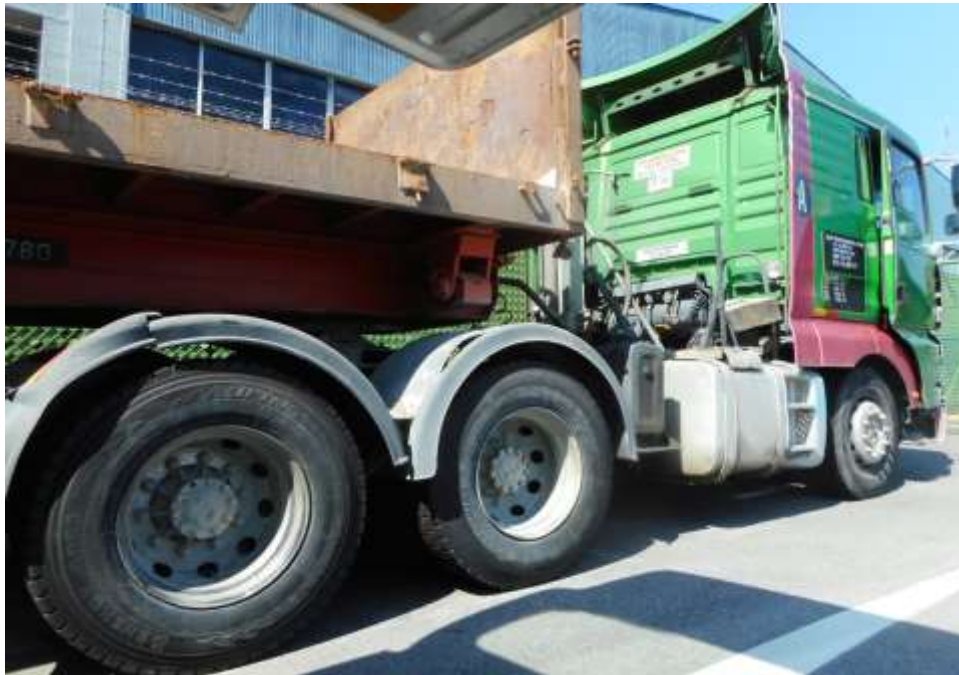
Photo 5 shows a general view of the Motor Trailer's rear body at the time of my inspection. The Motor Trailer was observed to be intact and unaffected by the accident.

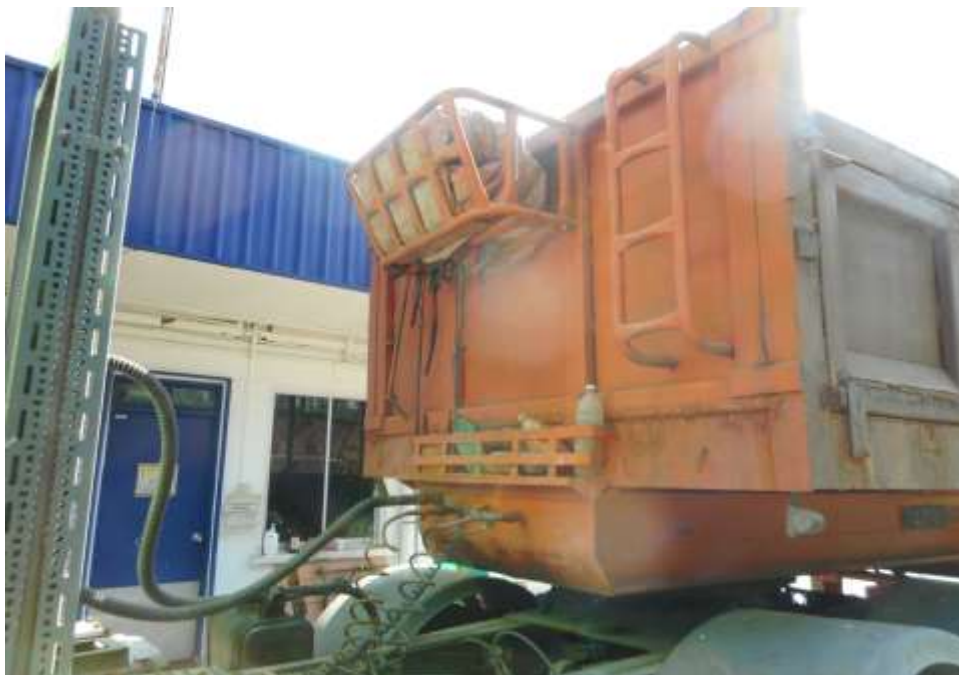
Photo 6 shows a general view of the front body of the trailer at the time of my inspection. The Motor Trailer was observed to be intact and unaffected by the accident.

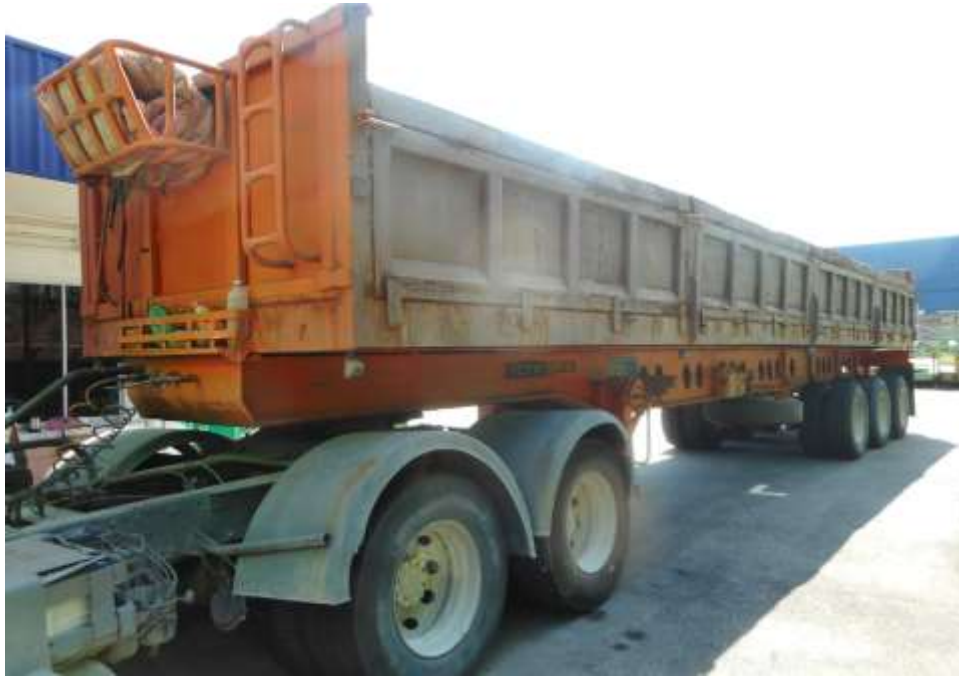
Photo 7 shows a general view of the trailer's left body at the time of my inspection. The Motor Trailer was observed to be intact and unaffected by the accident.

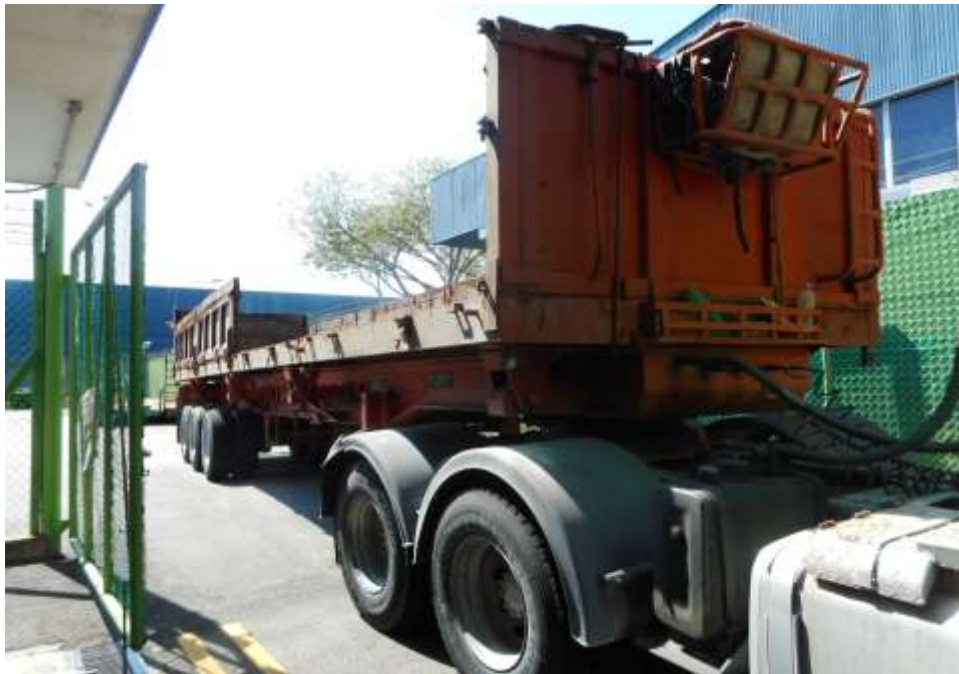
Photo 8 shows a general view of the trailer's right body at the time of my inspection. The Motor Trailer was observed to be intact and unaffected by the accident.

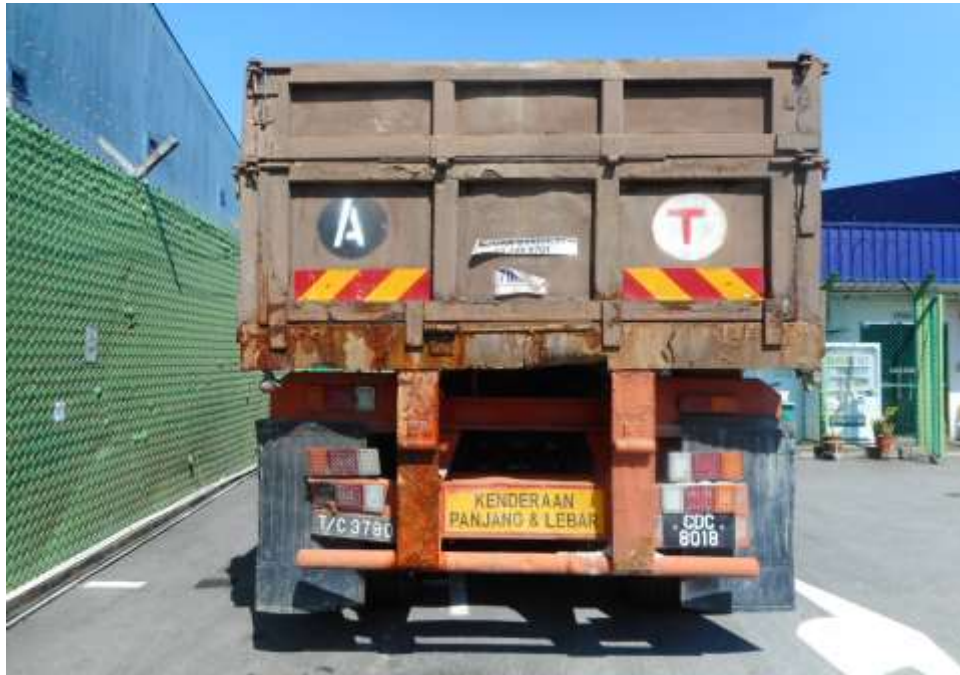
Photo 9 shows a general view of the trailer's rear body at the time of my inspection. The Motor Trailer was observed to be intact.

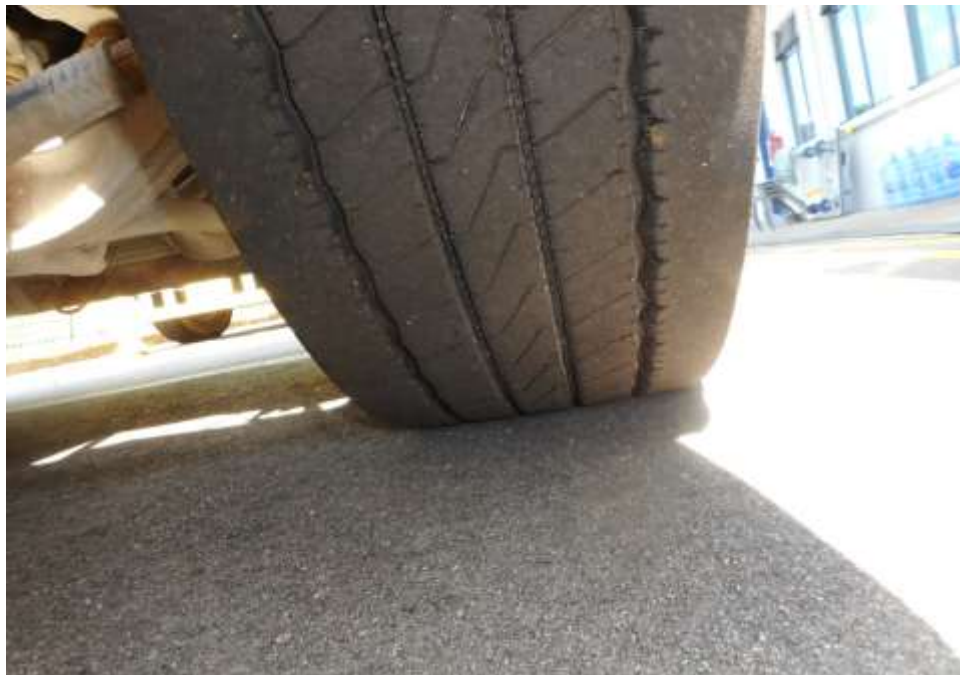
Photo 10 shows the condition of the front right tyre of the Motor Trailer, which was observed to be in serviceable condition with remaining tread depth of approximately 9.7 mm. The tyre, which was wrapped around standard steel wheel rim, was also observed to be sufficiently inflated for vehicular operation. There was no tear, cut or burst mark(s) on the outer and the inner sidewalls as well as across the tread of the 22 tyres that were fitted on the Motor Trailer.

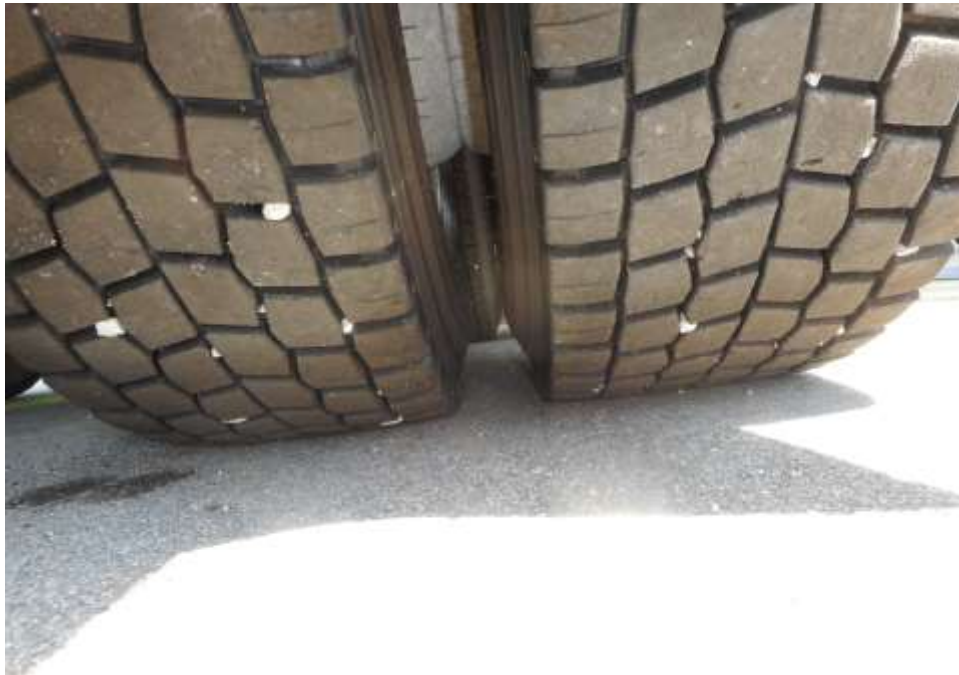
Photo 11 shows the condition of the rear right tyre of the Motor Trailer, which was observed to be in serviceable condition with remaining tread depth of approximately 12.3mm. The tyre, which was wrapped around standard steel wheel rim, was also observed to be sufficiently inflated for vehicular operation.

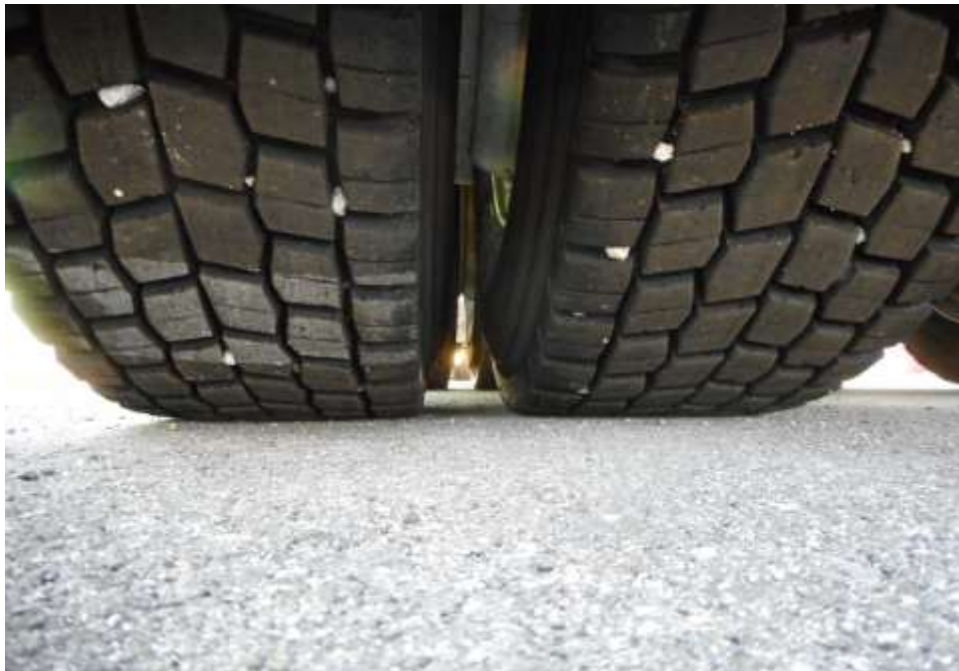
Photo 12 shows the condition of the rear left tyres of the Motor Trailer, which was observed to be in serviceable condition with remaining tread depth of approximately 10.2mm. The tyres, which were wrapped around standard steel wheel rim, were also observed to be sufficiently inflated for vehicular operation. There was also no damage found on all 6 steel wheel rims of the Motor Trailer.

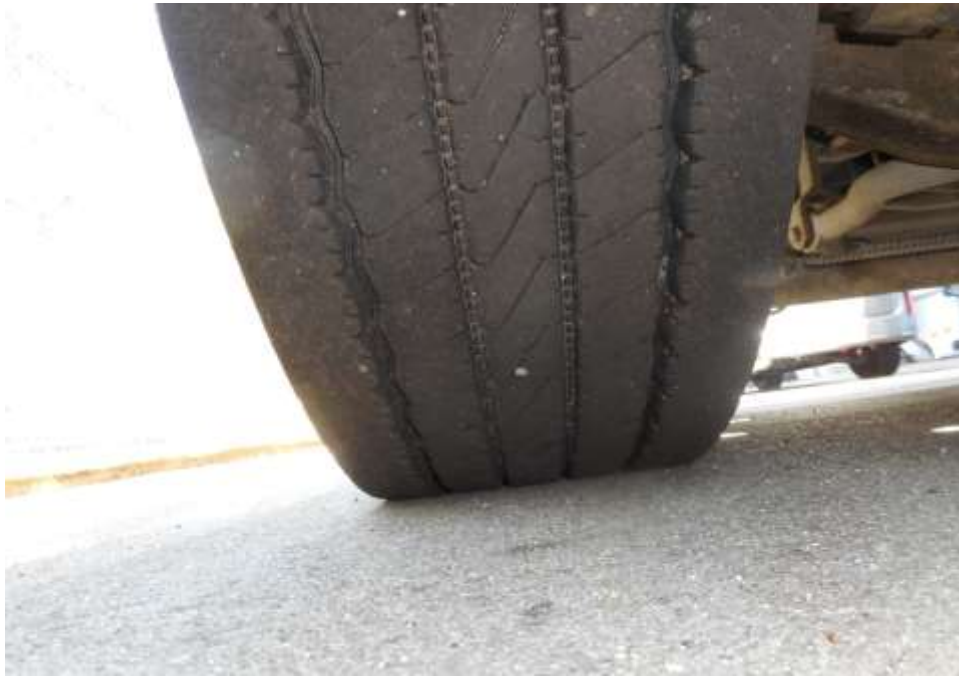
Photo 13 shows the condition of the front left tyres of the Motor Trailer, which were observed to be in serviceable condition with remaining tread depth of approximately 9.7mm. There was also no tear, cut or burst mark(s) on the outer and the inner sidewalls as well as across the tread of the 6 tyres that were fitted on the Motor Trailer.

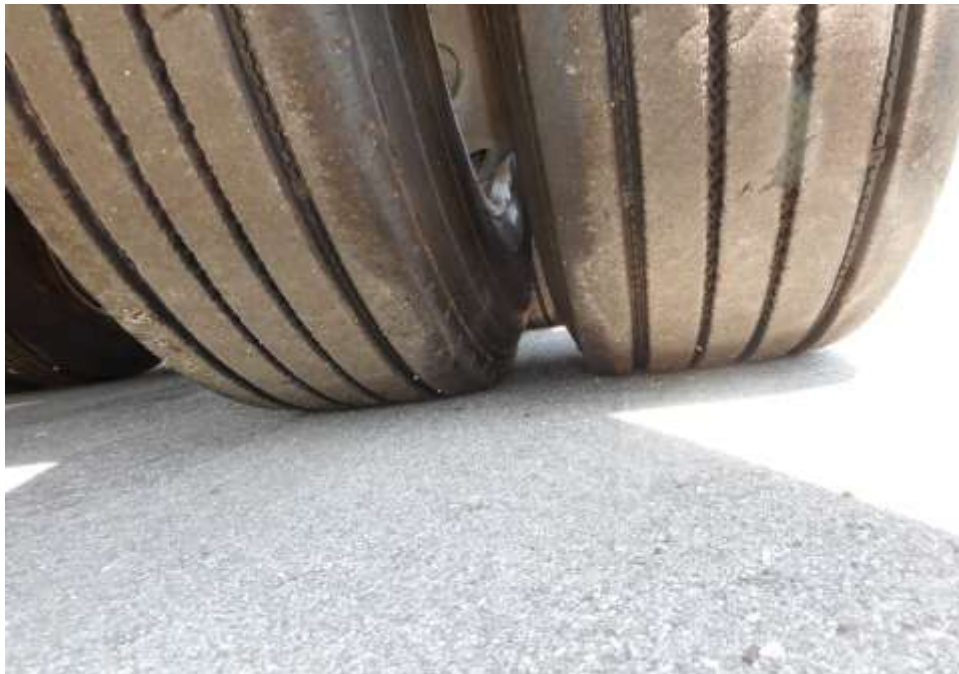
Photo 14 shows the condition of the right tyres of the trailer, which was observed to be in serviceable condition with remaining, tread depth of approximately 12.1mm. The tyre, which was wrapped around standard steel wheel rim, was also observed to be sufficiently inflated for vehicular operation.

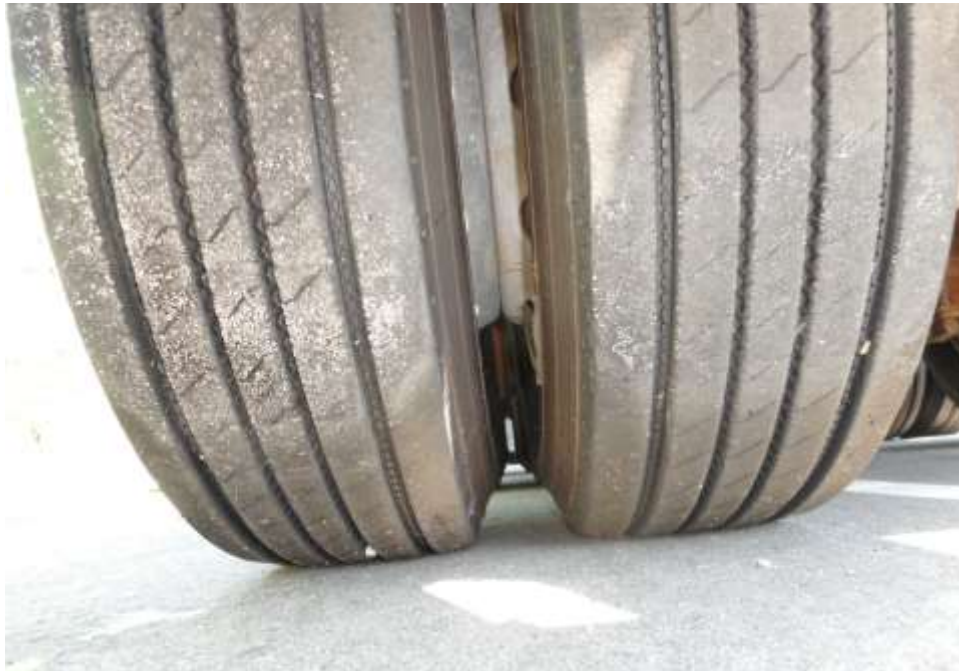
Photo 15 shows the condition of the left tyres of the trailer, which was observed to be in serviceable condition with remaining tread depth of approximately 12.5mm. The tyres, which were wrapped around standard steel wheel rim, were also observed to be sufficiently inflated for vehicular operation. There was also no damage found on all 22 steel wheel rims of the Motor Trailer.

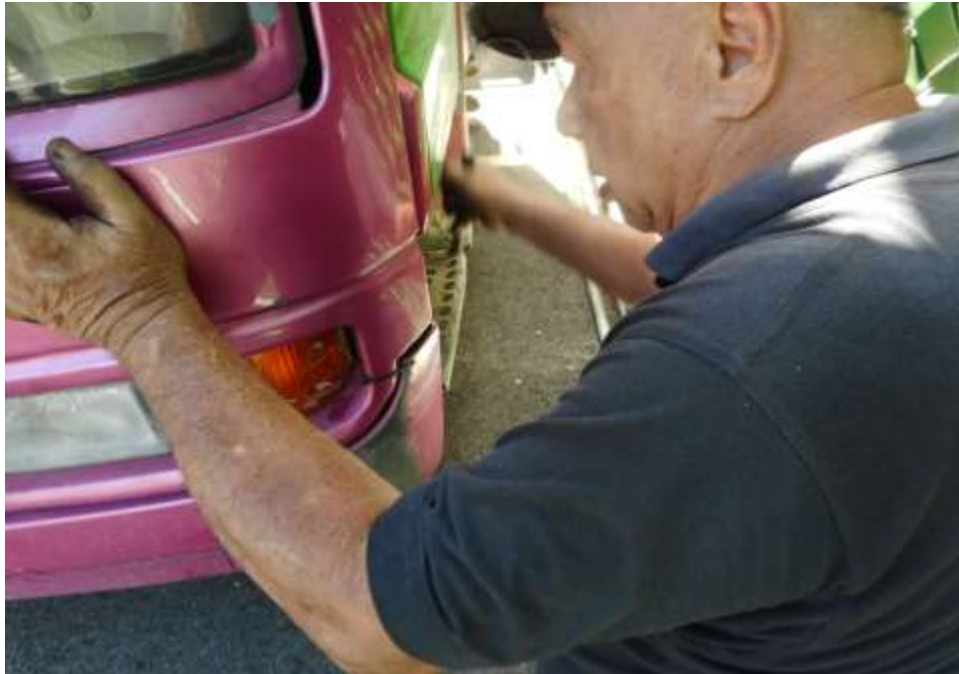
8. The examination of the Motor Trailer's engine compartment, was not able to be conducted to the engine oil, power steering fluid and engine coolant as the front cabin above the engine could not be lifted up despite multiple attempts, due a fault in the lifting mechanism. However, I was able to observed the reading of the air brake cylinder on the instrument panel of the Motor Trailer to be of sufficient level for operating purposes.
9. My subsequent checks on the underside of the Motor Trailer also revealed no fluid stain. Visually, the various undercarriage components of the Motor Trailer were all observed to be intact and without any visible damage. See photo 16 – 18 below.

Photo 16 shows the attempt to lifting the front cabin of Motor Trailer's to above engine compartment, however the front cabin could not lift due to a fault in the lifting mechanism.

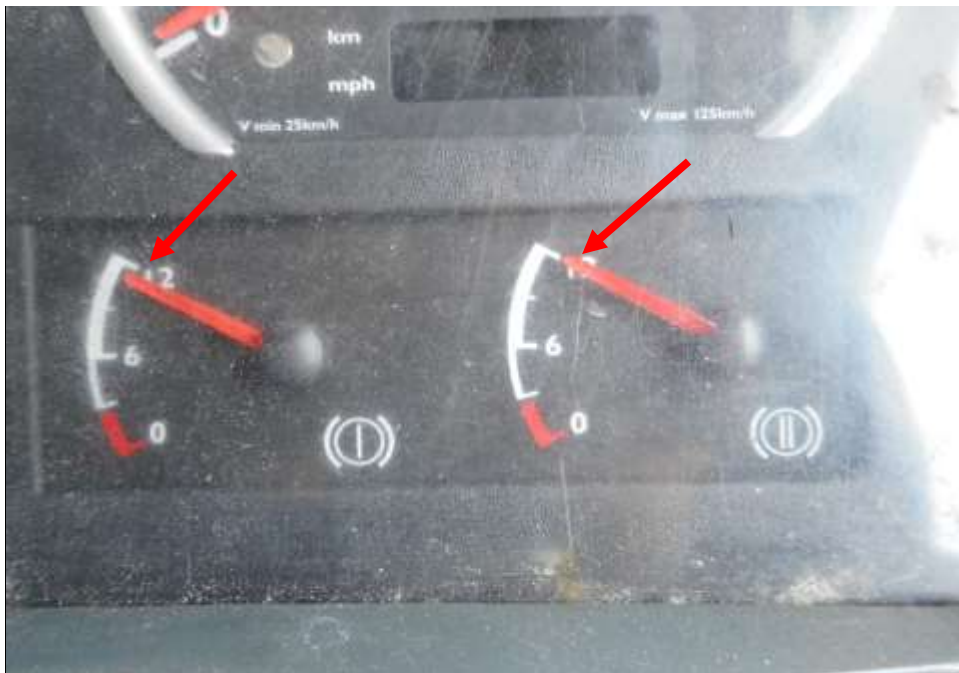
Photo 17 shows the air in the air brake cylinders of the Motor Trailer at the time of my inspection. The air in the cylinder was observed to be of sufficient level & serviceable at the time of the accident.

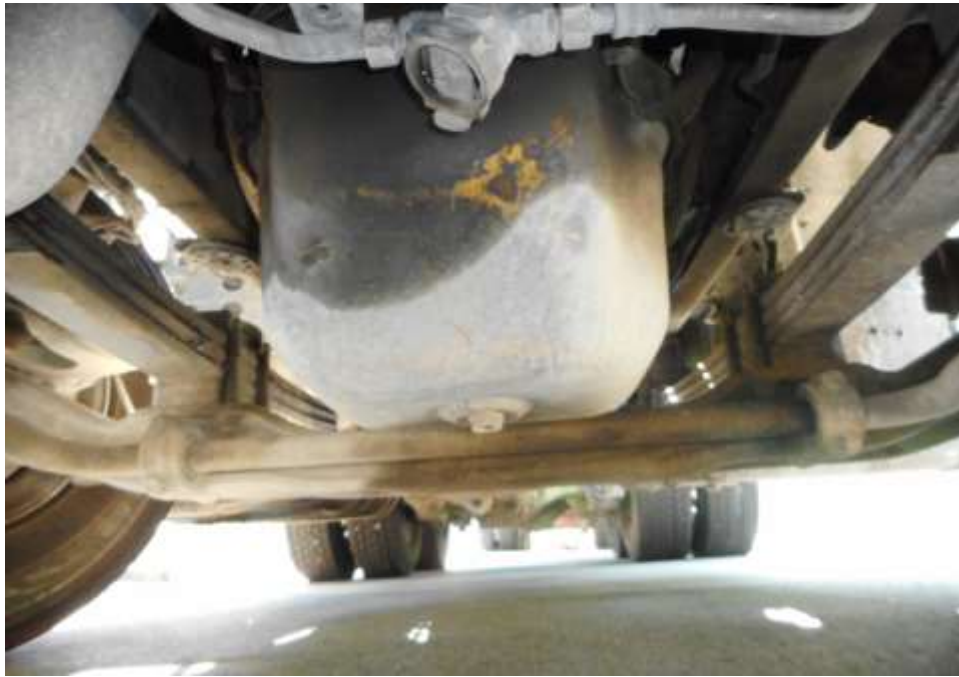
Photo 18 shows the undercarriage of the Motor Trailer, at the area where the engine housing located. I did not find any sign(s) or indication(s) of fluid leak, or fluid stain(s) was observed on the underside of the Motor Trailer.

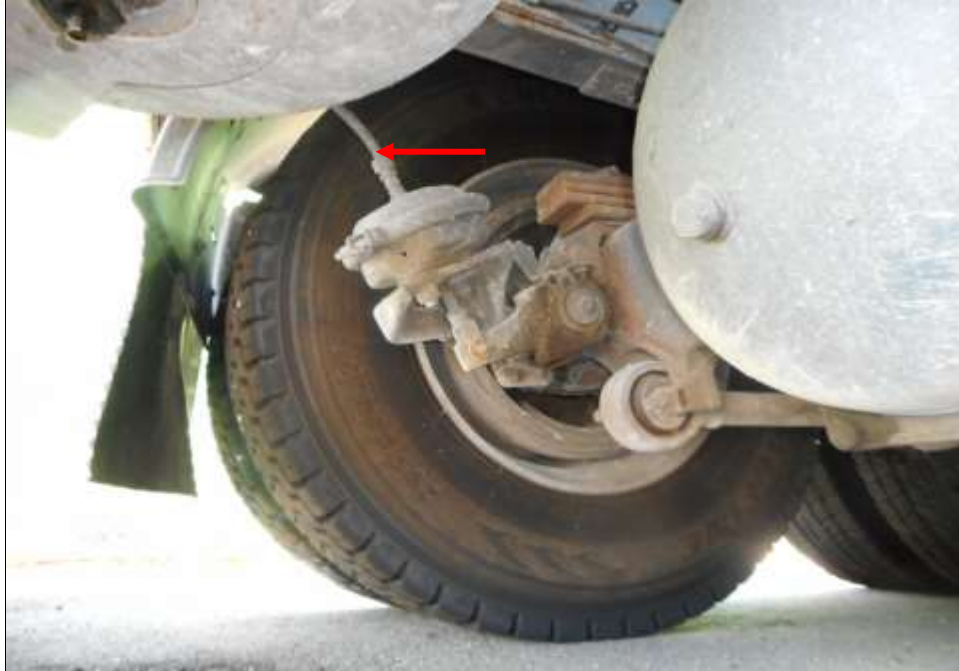
Photo 19 shows the brake pipe (arrowed) at the rear right wheel of the Motor Trailer. I did not observe any leakage of brake fluid at the time of my inspection of the Motor Trailer. My static tests of the Motor Trailer's braking system, along with my visual examination of the various mechanical components in the braking system, had indicated that there was no internal leakage of pressure/vacuum. Hence the braking system of the Motor Trailer was likely to be in serviceable condition at the material time of accident.

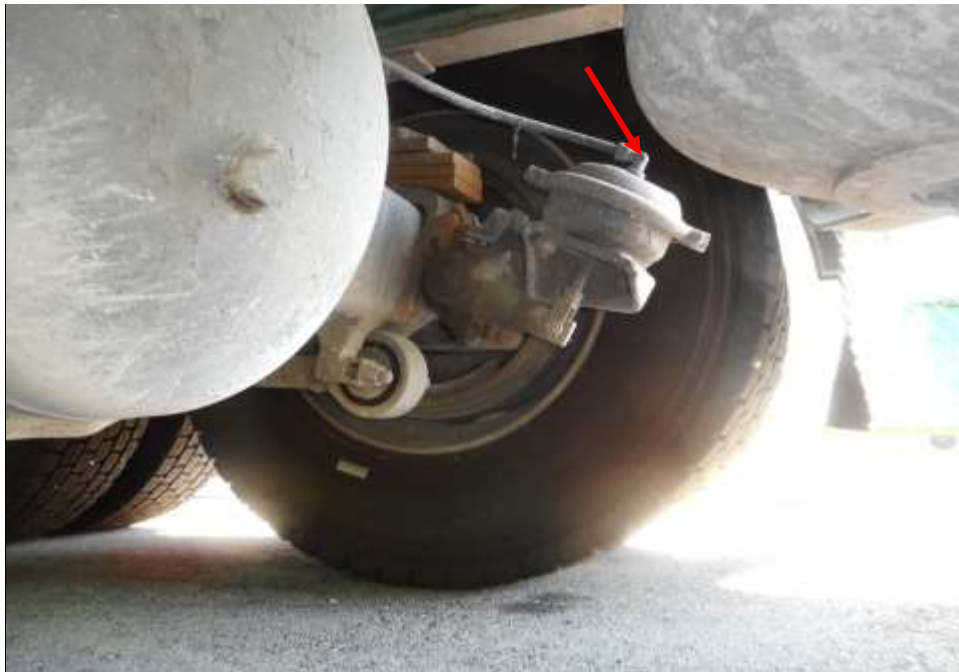
Photo 20 shows the brake pipe (arrowed) at the rear left wheel of the Motor Trailer. I did not observe any leakage of brake fluid at the time of my inspection of the Motor Trailer. My static tests of the Motor Trailer's braking system, along with my visual examination of the various mechanical components in the braking system, had indicated that there was no internal leakage of pressure/vacuum. Hence the braking system of the Motor Trailer was likely to be in serviceable condition at the material time of accident.

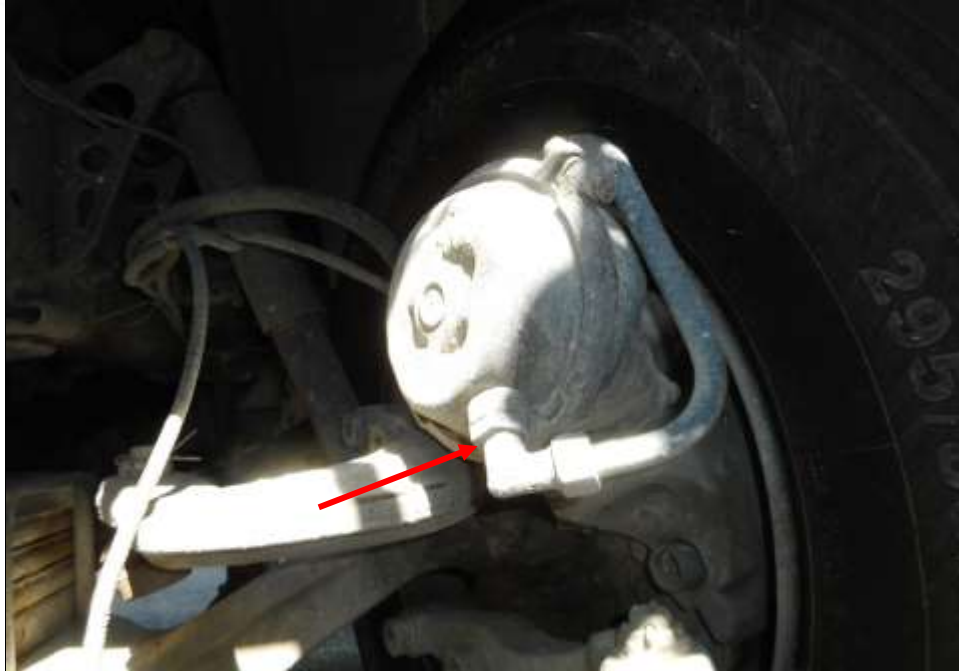
Photo 21 shows the brake pipe (arrowed) at the front right wheel of the Motor Trailer. I did not observe any leakage of brake fluid at the time of my inspection of the Motor Trailer. My static tests of the Motor Trailer's braking system, along with my visual examination of the various mechanical components in the braking system, had indicated that there was no internal leakage of pressure/vacuum. Hence the braking system of the Motor Trailer was likely to be in serviceable condition at the material time of accident.

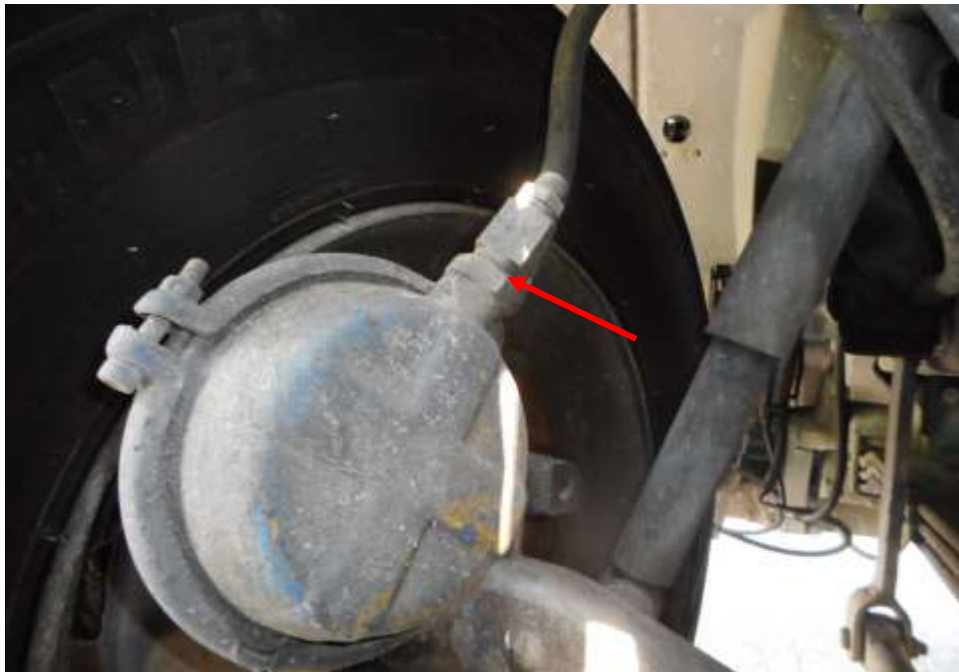
Photo 22 shows the brake pipe (arrowed) at the front left wheel of the Motor Trailer. I did not observe any leakage of brake fluid at the time of my inspection of the Motor Trailer. My static tests of the Motor Trailer's braking system, along with my visual examination of the various mechanical components in the braking system had indicated that there was no internal leakage of pressure/vacuum. Hence the braking system of the Motor Trailer was likely to be in serviceable condition at the material time of accident.

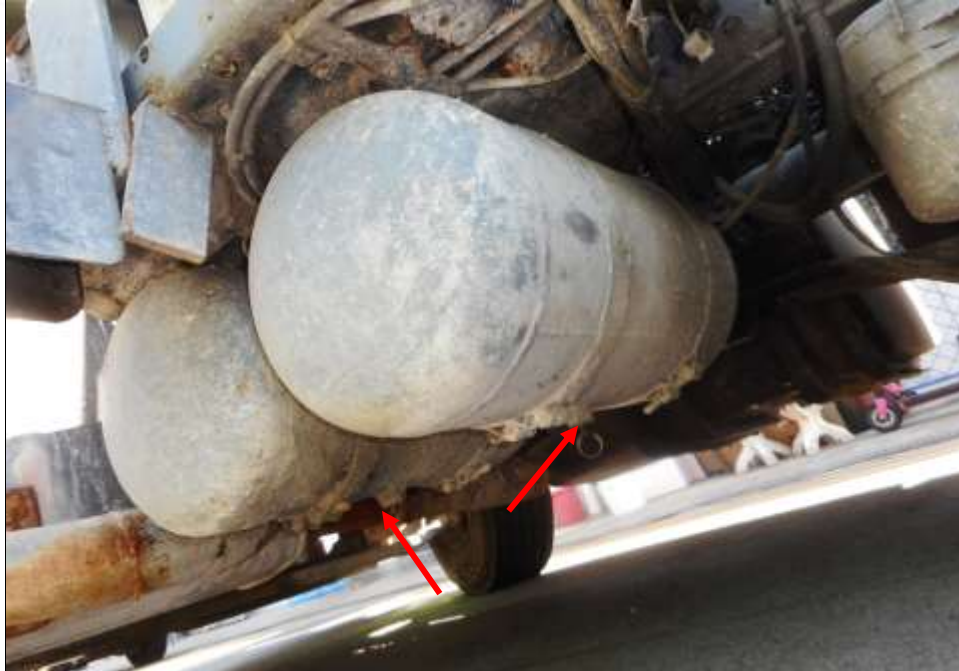
Photo 23 shows the air brake cylinders (arrowed) at the undercarriage of the Motor Trailer. I did not observe any leakage of air brake fluid at the time of my inspection of the Motor Trailer. My static tests of the Motor Trailer's braking system, along with my visual examination of the various mechanical components in the braking system had indicated that there was no internal leakage of pressure/vacuum. Hence the braking system of the Motor Trailer was likely to be in serviceable condition at the material time of accident.

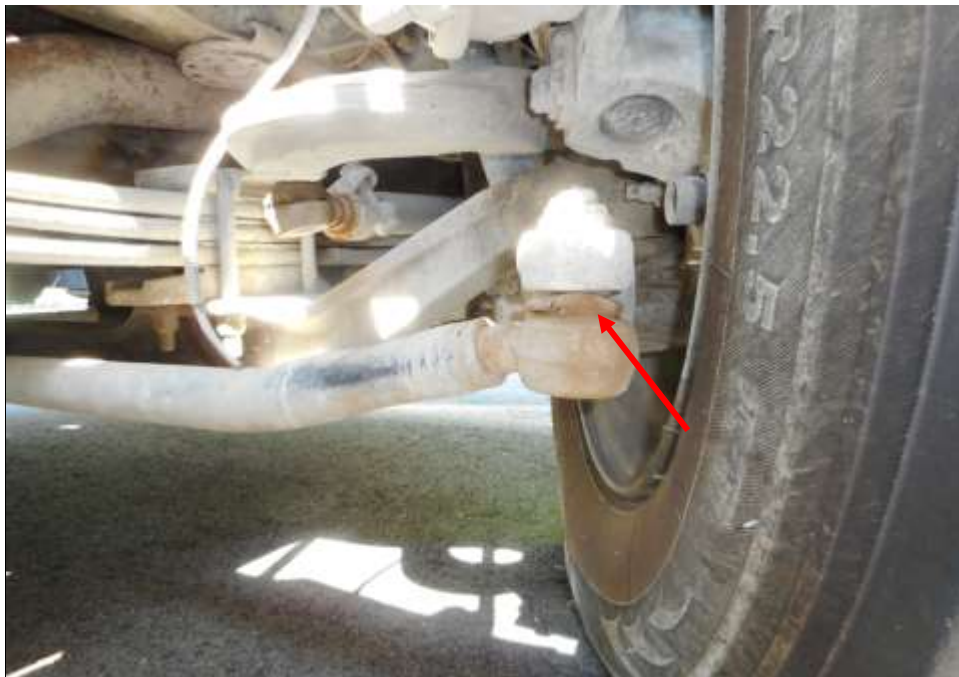
Photo 24 shows the various undercarriage components at the front right wheel of the Motor Trailer, in particular the steering tie rod end (arrowed). The various steering components were all found to be intact, suggesting that the steering system of the Motor Trailer was likely to be in serviceable condition at the material time of accident. There was also no sign of fluid stain(s) observed on the various undercarriage components.

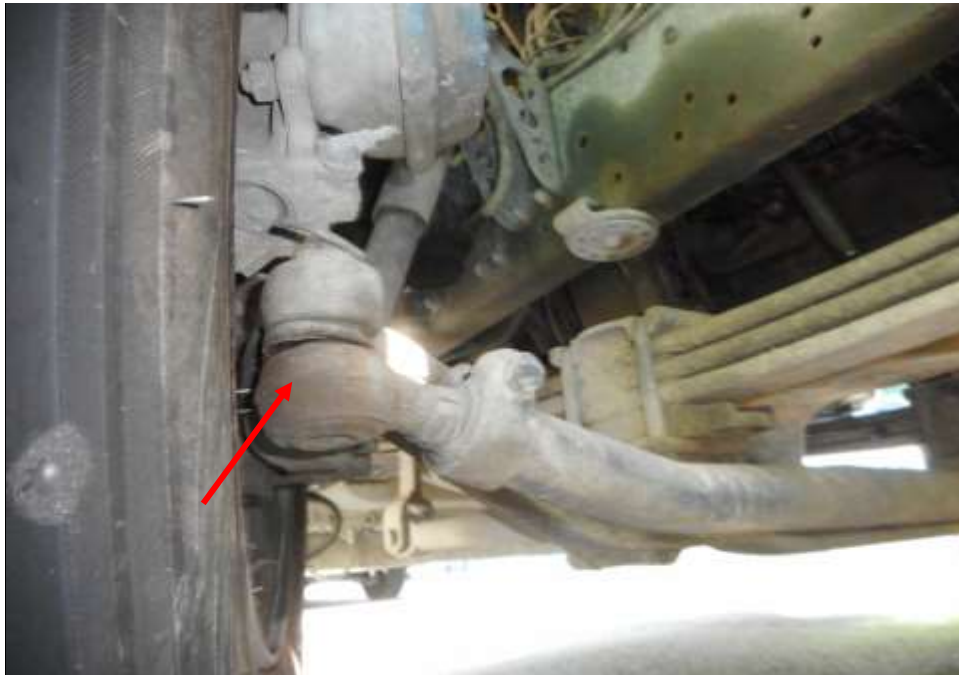
Photo 25 shows the various undercarriage components at the front left wheel of the Motor Trailer, in particular the steering tie rod end (arrowed). The various undercarriage components of the Motor Trailer were all found to be intact without any visible damage. There was also no sign of fluid stain(s) observed on the various undercarriage components.

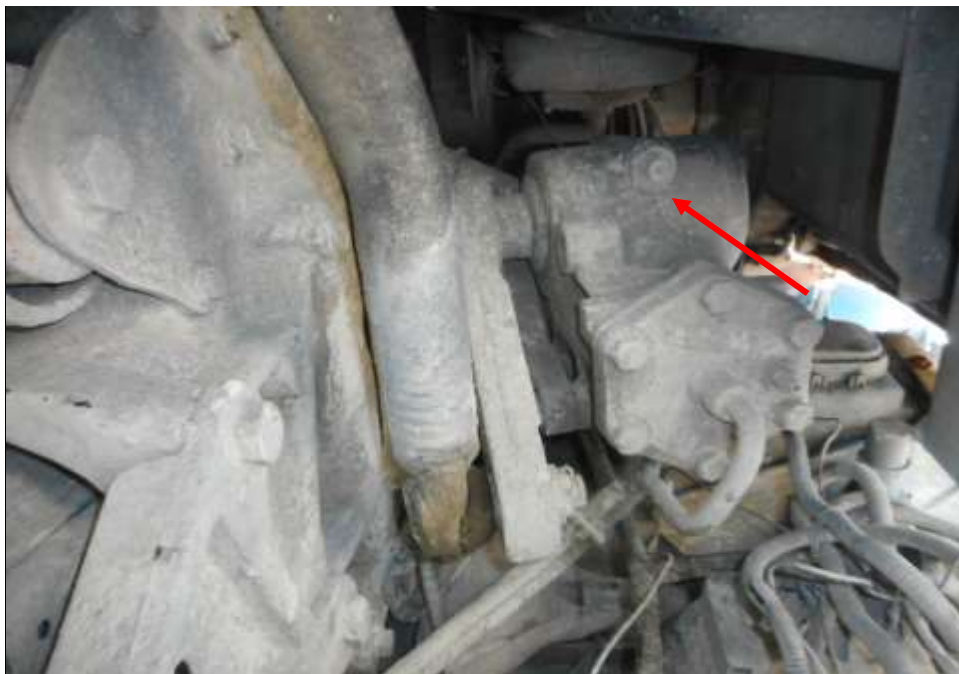
Photo 26 shows the steering box component (arrowed) at the undercarriage of the Motor Trailer was found to be intact without any visible damage. There was also no sign of fluid stain(s) observed on the various undercarriage components.

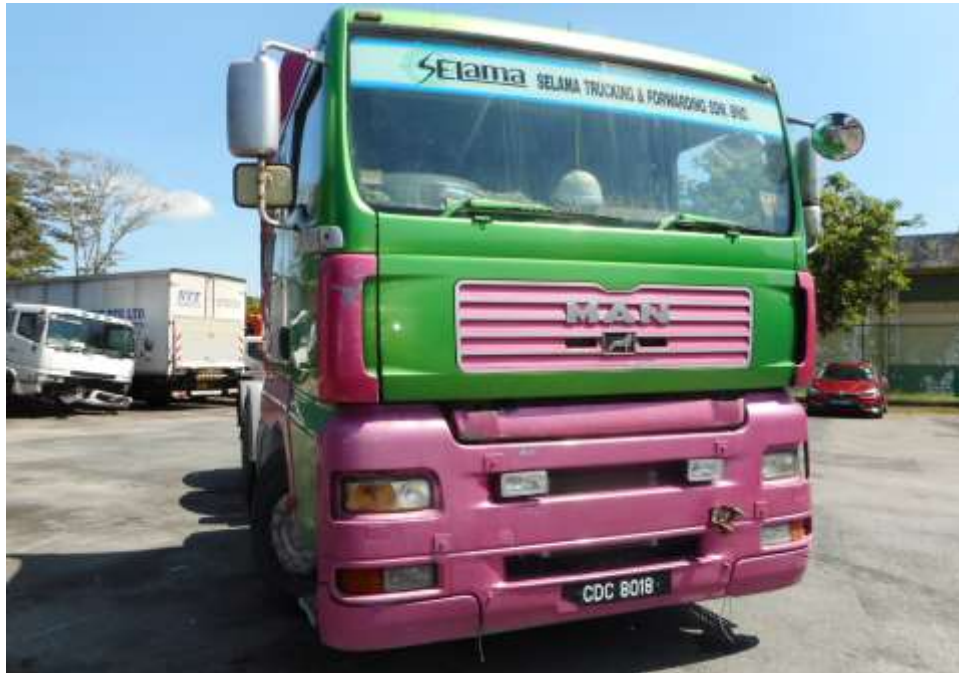
Photo 27 shows the front right wheel of the Motor Trailer turned to its full left. During my steering system test, I did not experience any abnormal free play and/or resistance when I had turned the steering wheel towards full left and full right. This would suggest that the steering system of the Motor Trailer was likely to be in serviceable condition at the material time of accident.

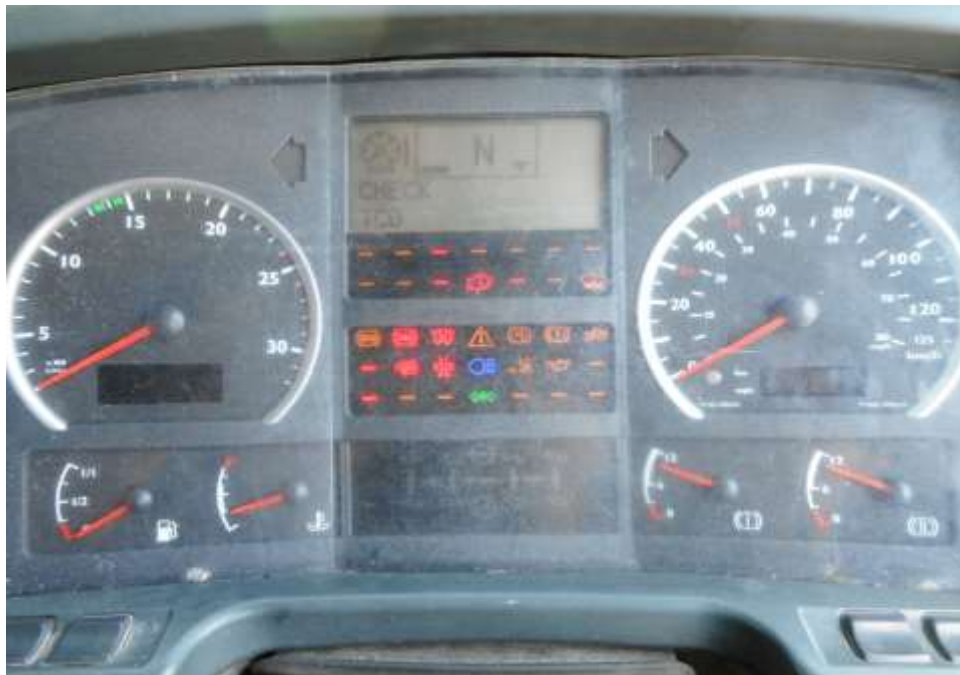
12. The Motor Trailer automatic self-test of the functionality of its various electronic operating systems like the Anti-Lock Brake System (ABS) and Traction Control (TC) during cranking of the engine had remained lighted on the instrument panel after the self-test this due a fault in the electrical system of the Motor Trailer See photo 28 & 29 below.

Photo 20 shows the warning light for Anti-Lock Brake System (ABS) and Traction Control (TC) appearing on the instrument panel of the Motor Trailer during the self-test of its various electronic operating systems when its engine was cranked.

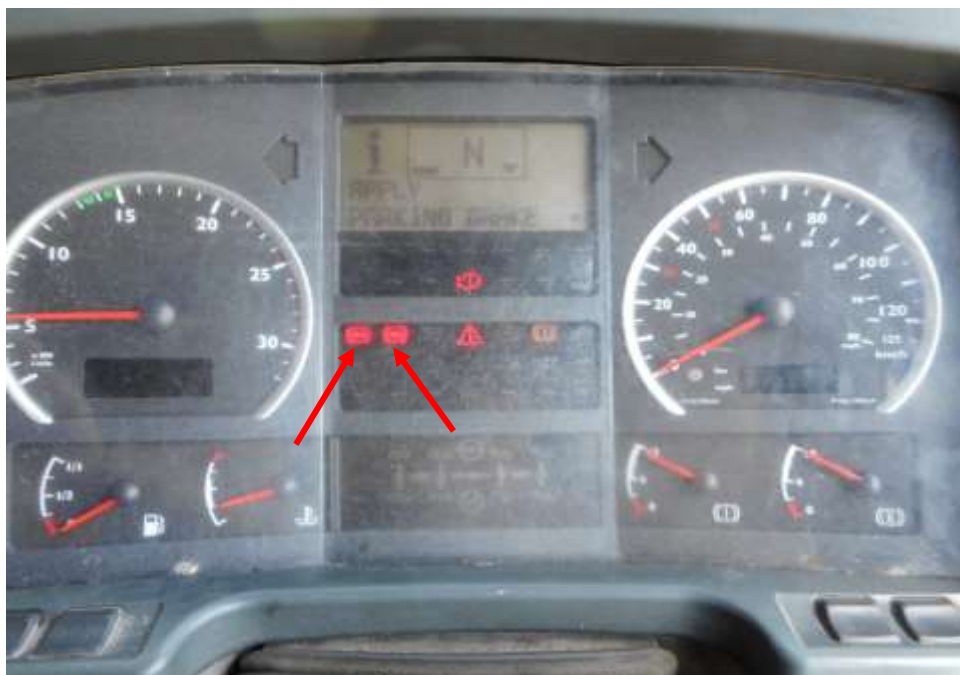
Photo 21 shows warning lights of the Anti-Lock Brake System (ABS) and Traction Control (TC) (arrowed) remained illuminated on the instrument panel of the Motor Trailer after the engine was cranked. This due a fault in the electrical system of the Motor Trailer.
