Your Ref: TP/IP/02927/2020
Our Ref : CI/TPD20001941/P

Fatal Accident Investigation Team

MECHANICAL INSPECTION REPORT OF MOTOR VAN PC 256Z

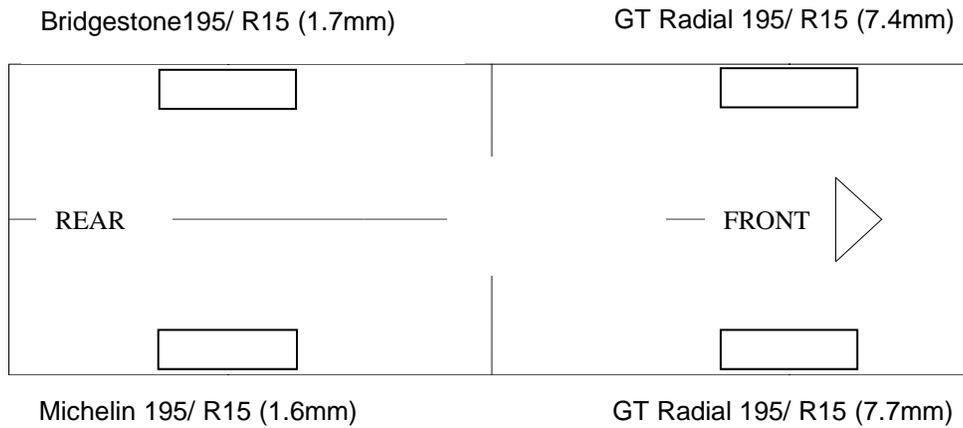
6. The 4 tyres of the Motor Van were observed to be in serviceable condition and sufficiently inflated for vehicular operation. I did not find any tear, cut or burst mark(s) on the outer and the inner sidewalls as well as across the tread of the 4 tyres. The tyre brand, tyre size and remaining tread depth of the 4 tyres of the Motor Van were recorded as follows:-

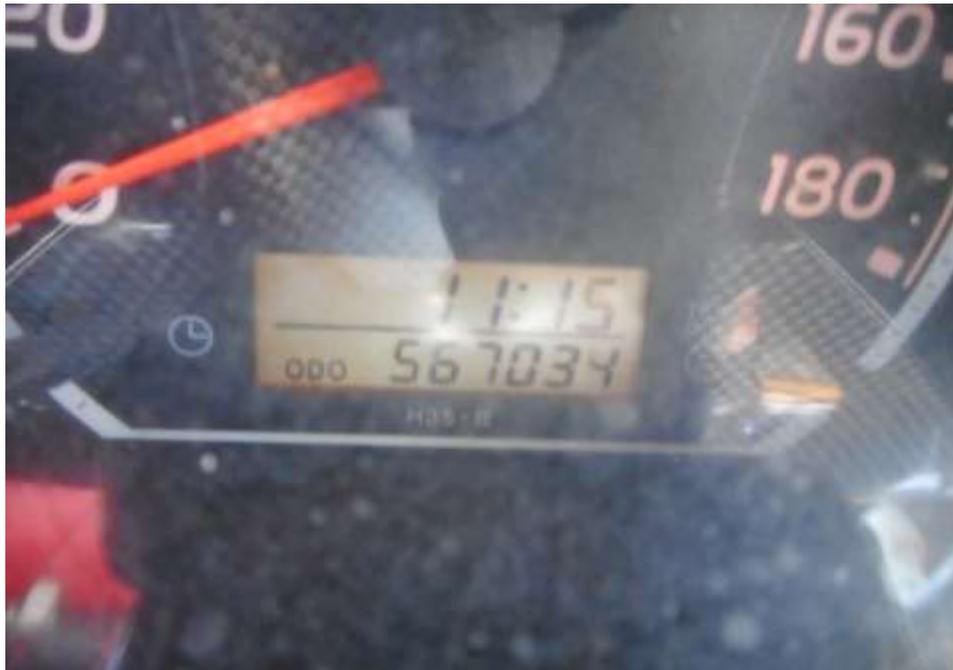
Photo 1 shows a general view of the instrument cluster of the Motor Van at the time of my inspection. The mileage of the Motor Van was 567,034km

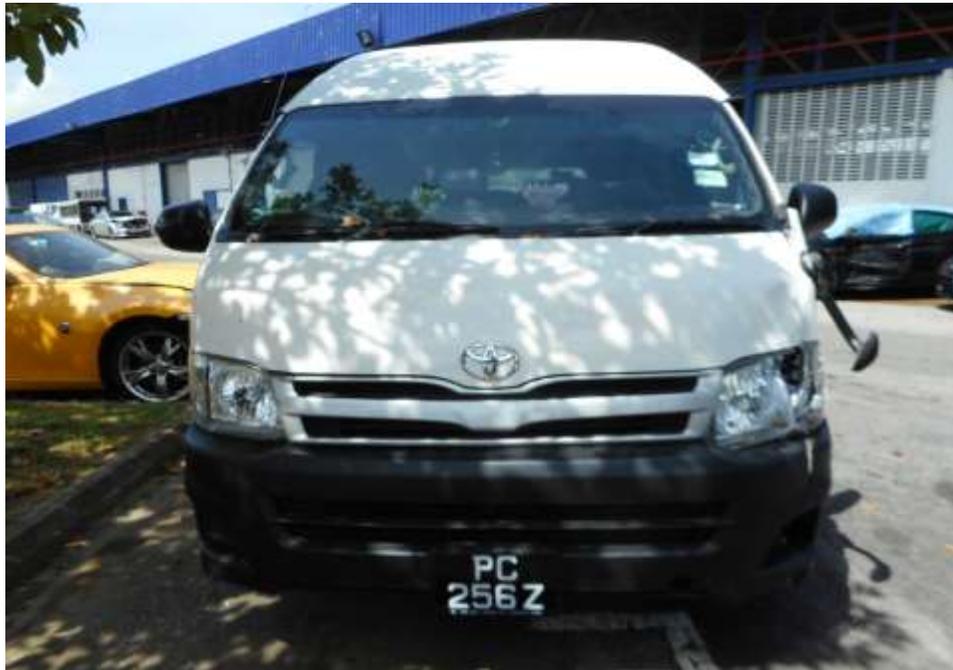
4. The mileage of the Motor Van at the time of my inspection was 567,034km.
5. The Motor Van appeared to have sustained damage at its frontal portion. Its front bumper, front bonnet, front left head lamp and front left rear view mirror were damage at the time of my inspection.

Photo 2 shows a general view of the Motor Van's frontal portion at the time of my inspection. It appeared to have sustained damage at its frontal portion. Its front bumper, front bonnet, front left head lamp and front left rear view mirror were damage at the time of my inspection.

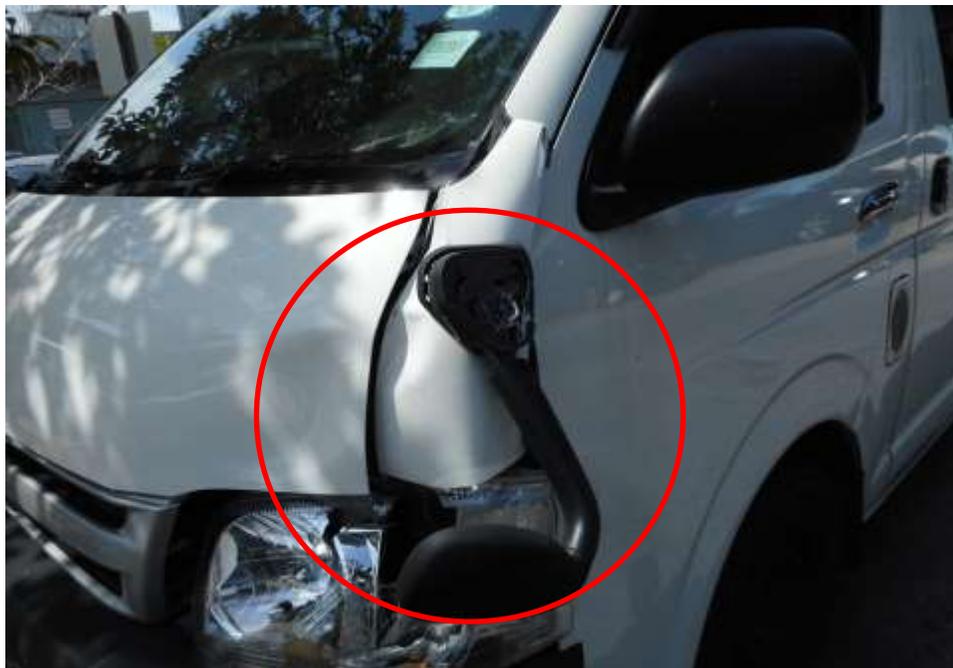
Photo 3 shows a close up view of the Motor Van's frontal portion at the time of my inspection. It appeared to have sustained damage at its frontal portion. Its front bonnet and front left rear view mirror (circled) were damage at the time of my inspection.

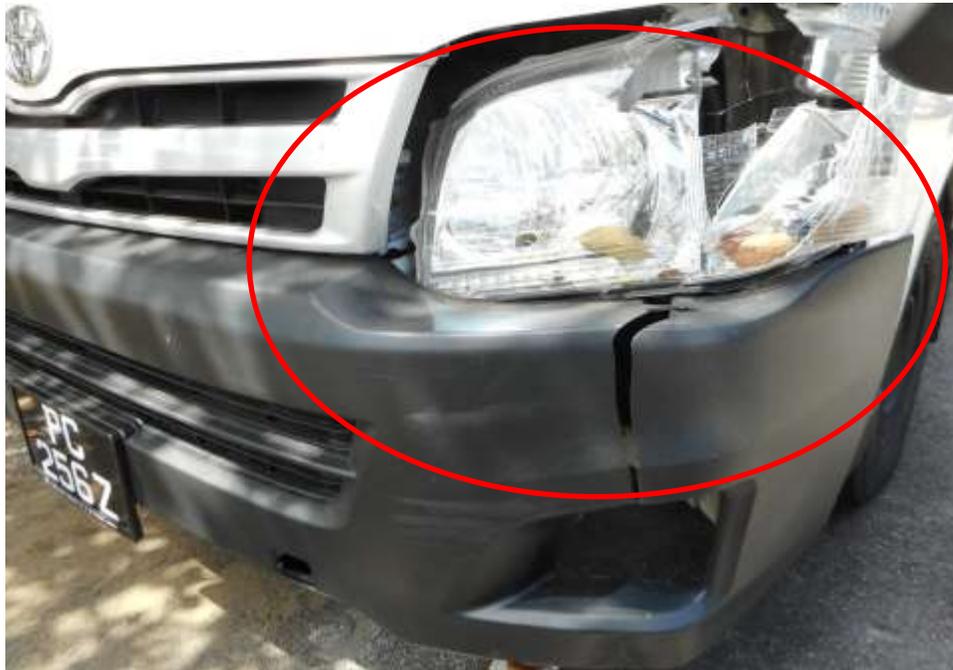
Photo 4 shows a close up view of the Motor Van's frontal portion at the time of my inspection. It appeared to have sustained damage at its frontal portion. Its front bumper and front left head lamp (circled) were damage at the time of my inspection.

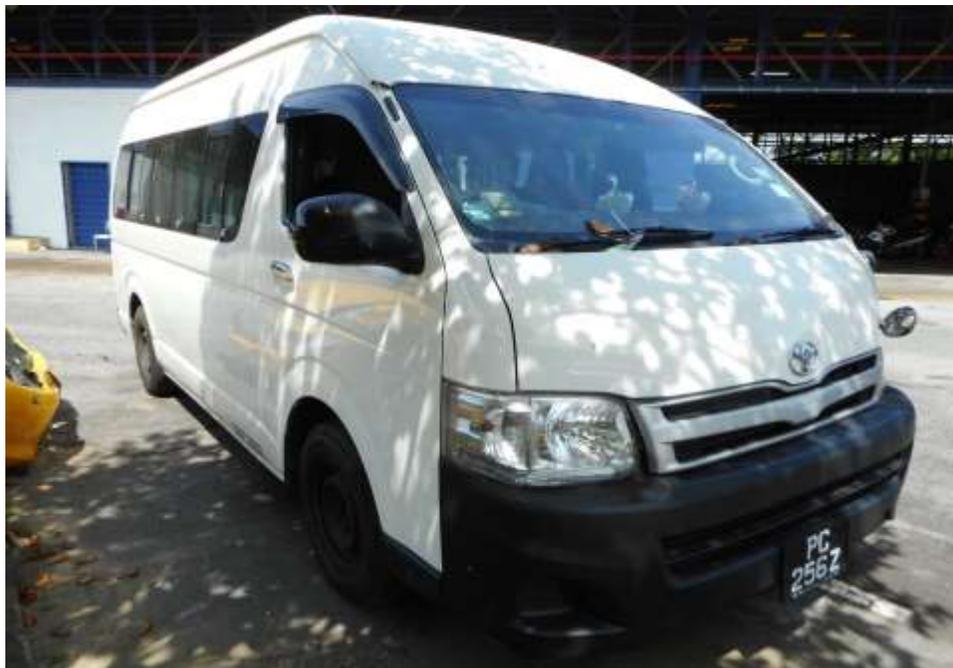
Photo 5 shows a general view of the right body of the Motor Van at the time of my inspection. The Motor Van was observed to be intact and unaffected by the accident.

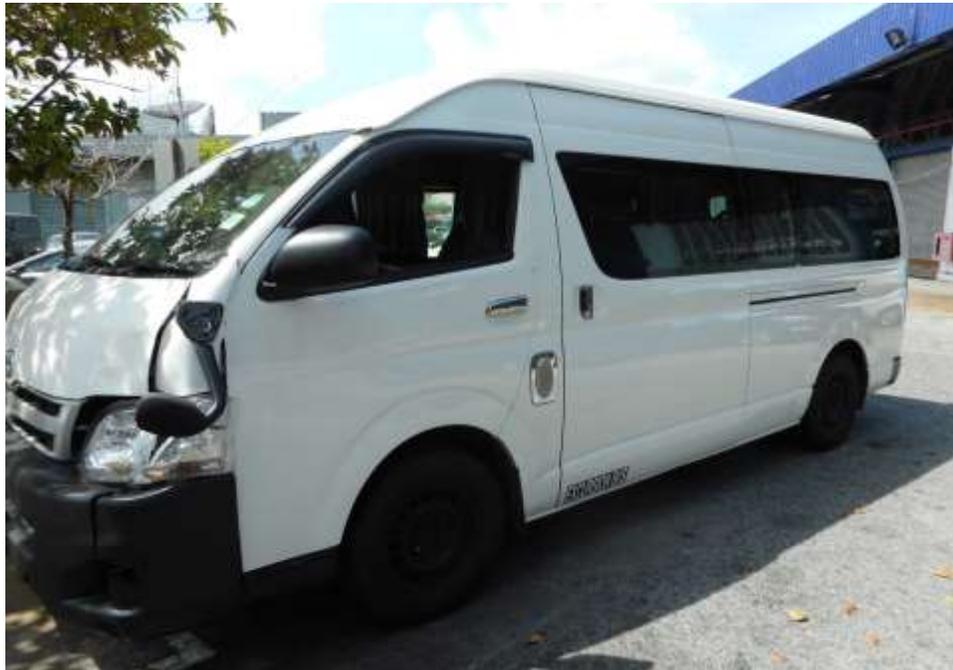
Photo 6 shows a general view of the left body of the Motor Van at the time of my inspection. The Motor Van was observed to be intact and unaffected by the accident.

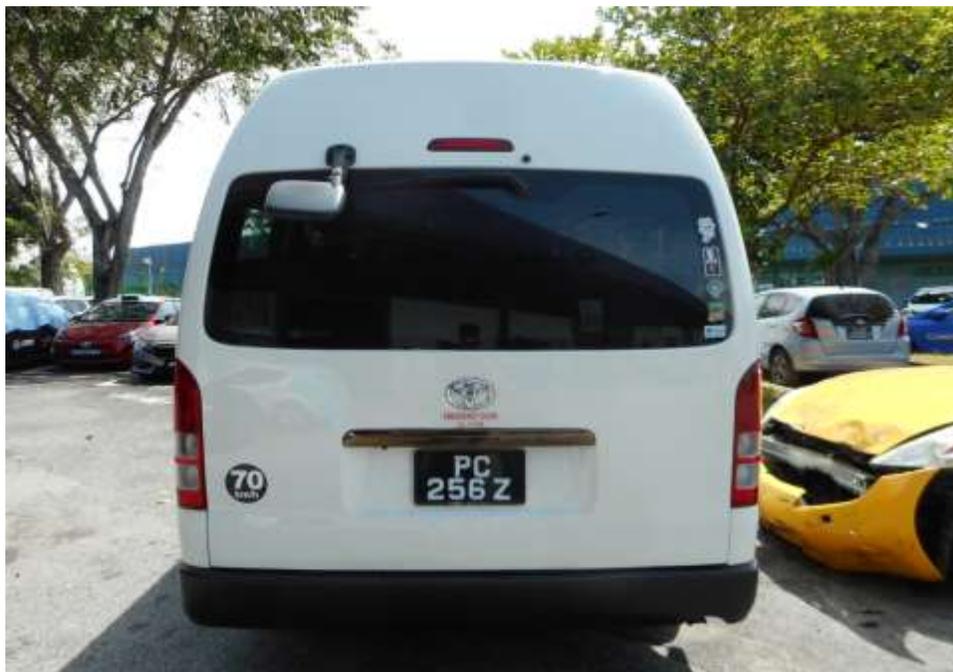
Photo 7 shows a general view of the rear body of the Motor Van at the time of my inspection. The Motor Van was observed to be intact and unaffected by the accident.

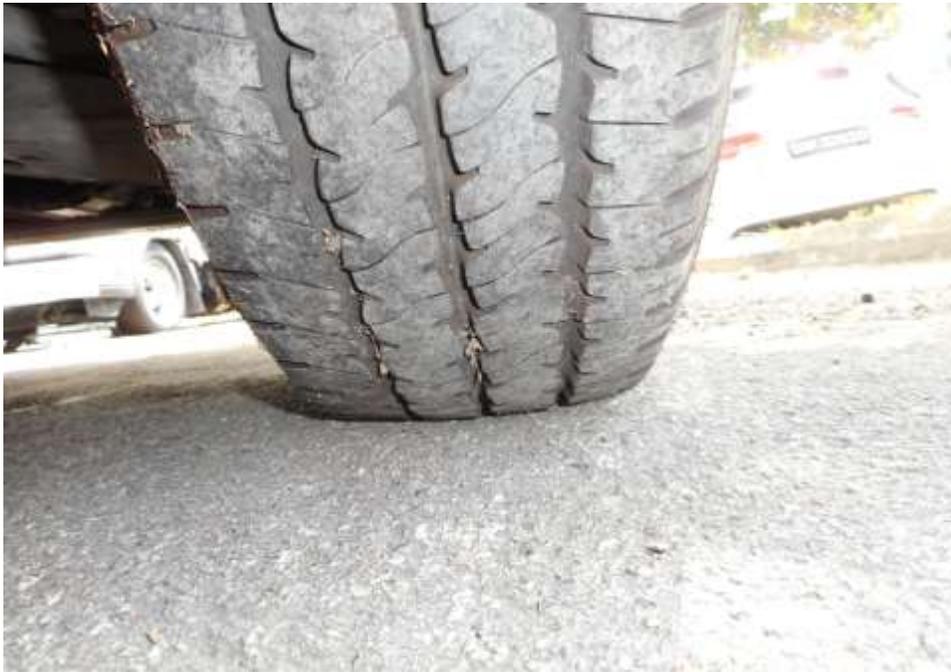
Photo 8 shows the condition of the front right tyre of the Motor Van, which was observed to be in serviceable condition with remaining tread depth of approximately 7.7mm. The tyre, which was wrapped around standard steel wheel rim, was also observed to be sufficiently inflated for vehicular operation. There was no tear, cut or burst mark(s) on the outer and the inner sidewalls as well as across the tread of the 4 tyres that were fitted on the Motor Van.

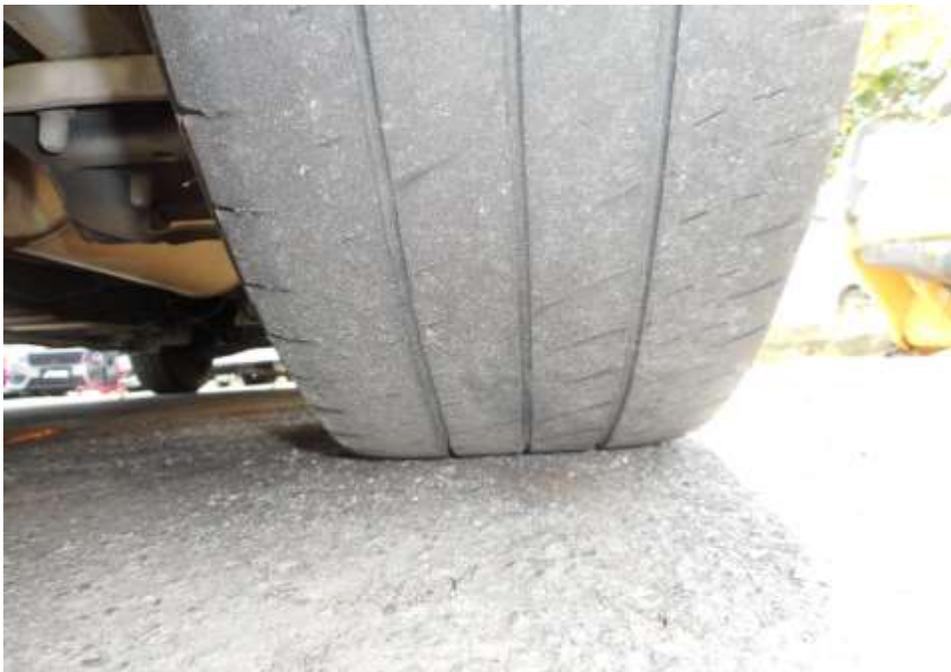
Photo 9 shows the condition of the rear right tyre of the Motor Van, which was observed to be in serviceable condition with remaining tread depth of approximately 1.6mm. The tyre, which was wrapped around standard steel wheel rim, it was observed to be sufficiently inflated for vehicular operation.

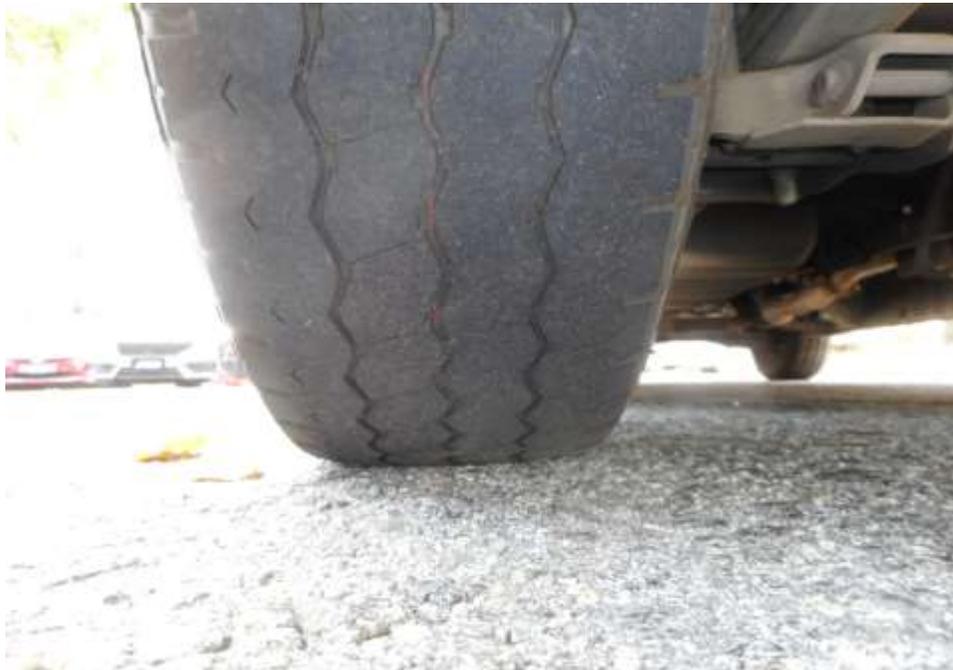
Photo 10 shows the condition of the rear left tyres of the Motor Van, which was observed to be in serviceable condition with remaining tread depth of approximately 1.7mm. The tyres, which were wrapped around standard steel wheel rim, were also observed to be sufficiently inflated for vehicular operation. There was also no damage found on all 4 steel wheel rims of the Motor Van.

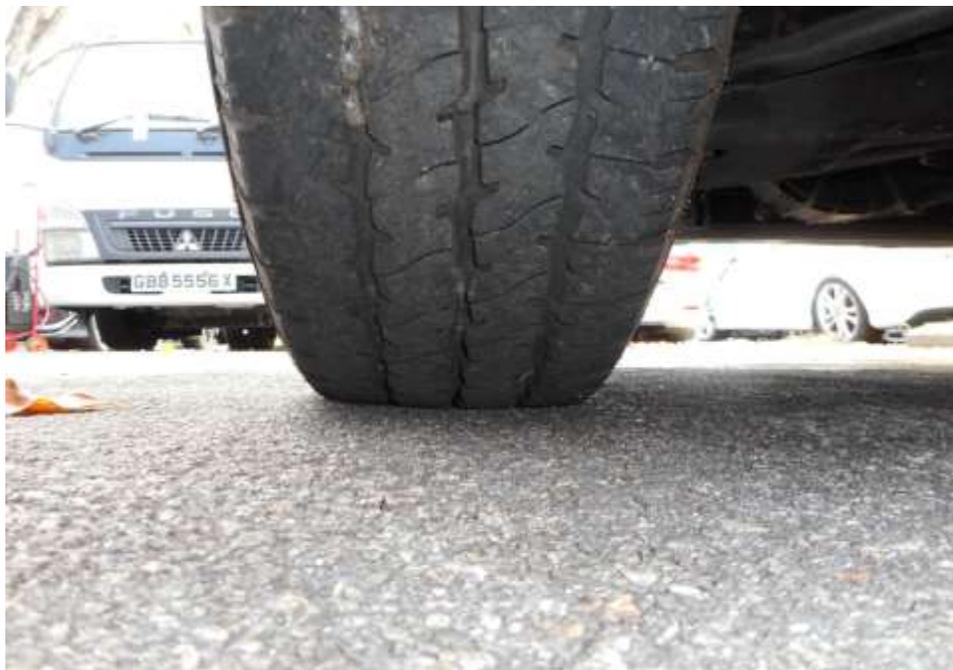
Photo 11 shows the condition of the rear right tyres of the Motor Van, which were observed to be in serviceable condition with remaining, tread depth of approximately 7.4mm. There was also no tear, cut or burst mark(s) on the outer and the inner sidewalls as well as across the tread of the 4 tyres that were fitted on the Motor Van.

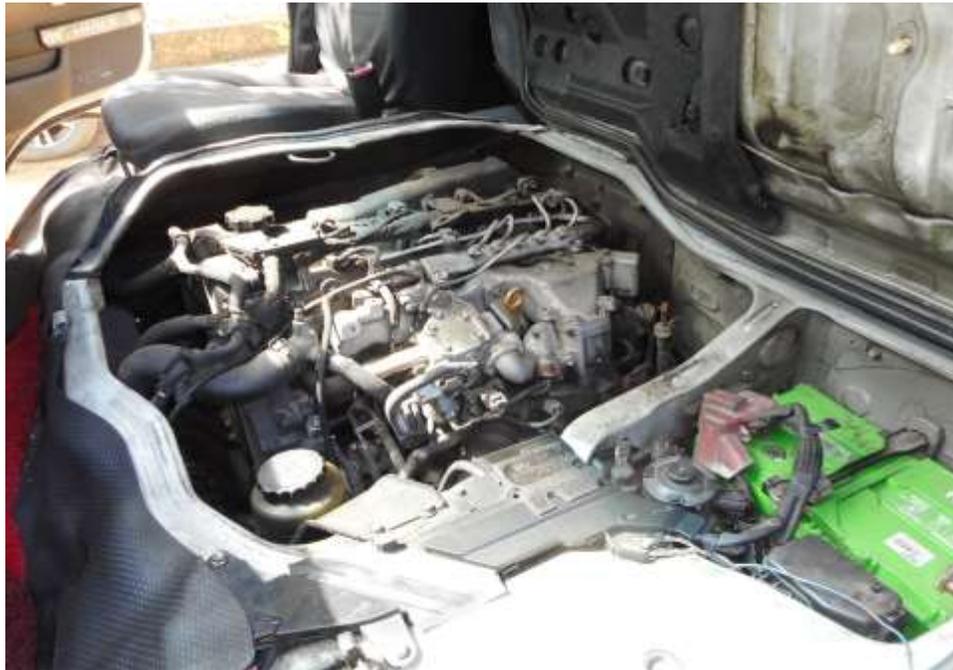
Photo 12 shows a general view of the Motor Van's engine compartment, which was accessed by lifting the front cabin of the Motor Van. The various parts and components inside the engine compartment were unaffected by the accident. There was also no sign(s) or indication(s) of fresh fluid leakage and/or fluid stain within the engine compartment

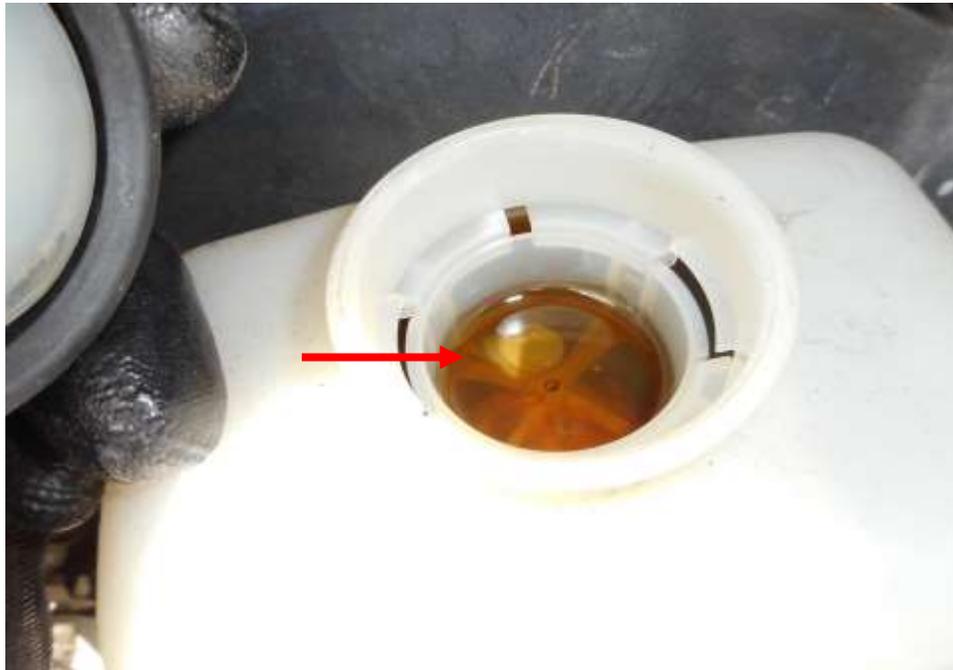
Photo 13 shows the brake fluid reservoir of the Motor Van at the time of my inspection. The brake fluid was observed to be of sufficient level (arrowed) and without any visible contamination.

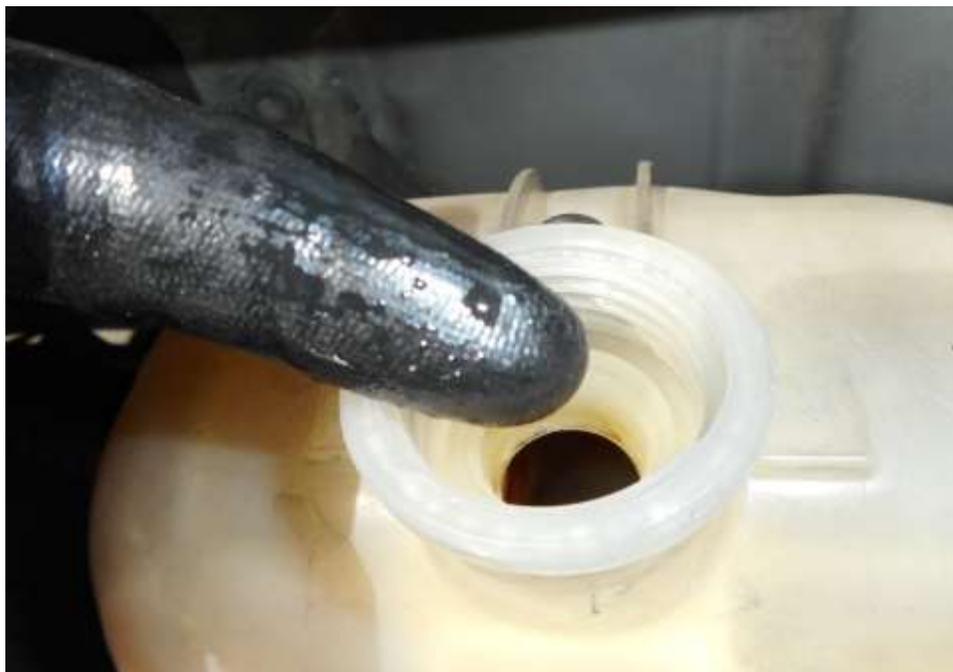
Photo 14 shows the engine coolant reservoir of the Motor Van at the time of my inspection. The engine coolant was observed to be of sufficient level and without any visible contamination.

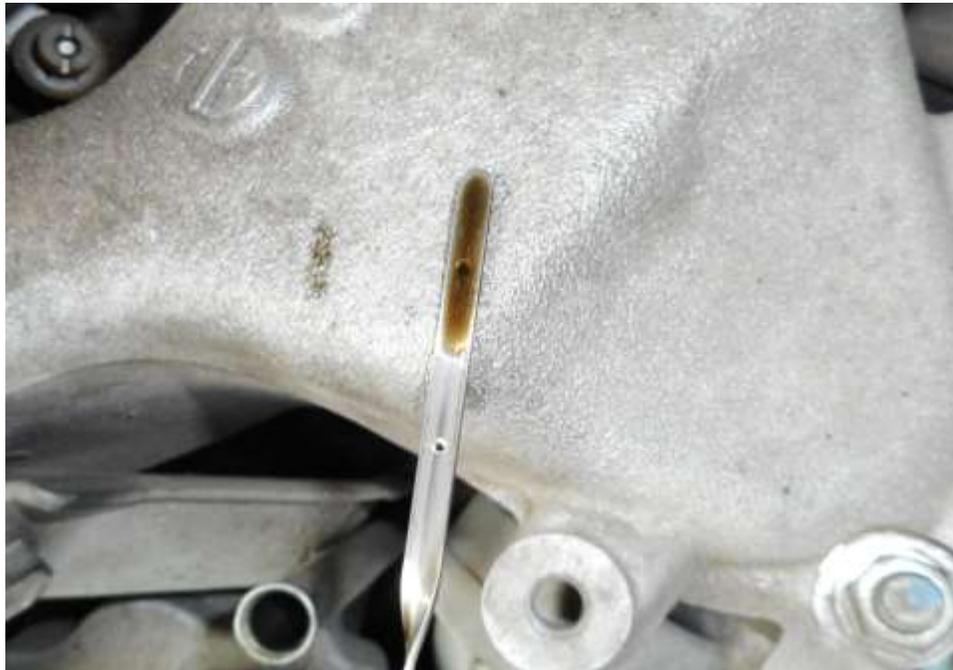
Photo 15 shows the engine oil dip stick of the Motor Van at the time of my inspection. The engine oil was observed to be of sufficient level and without any visible contamination.

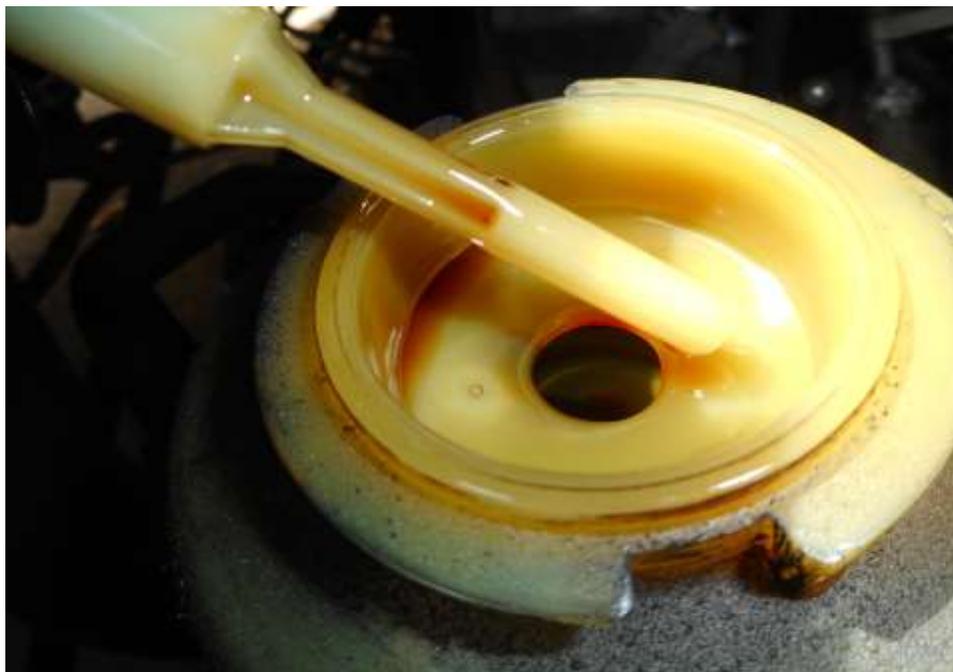
Photo 16 shows the power steering fluid dip stick of the Motor Van at the time of my inspection. The power steering fluid was observed to be of sufficient level and without any visible contamination.

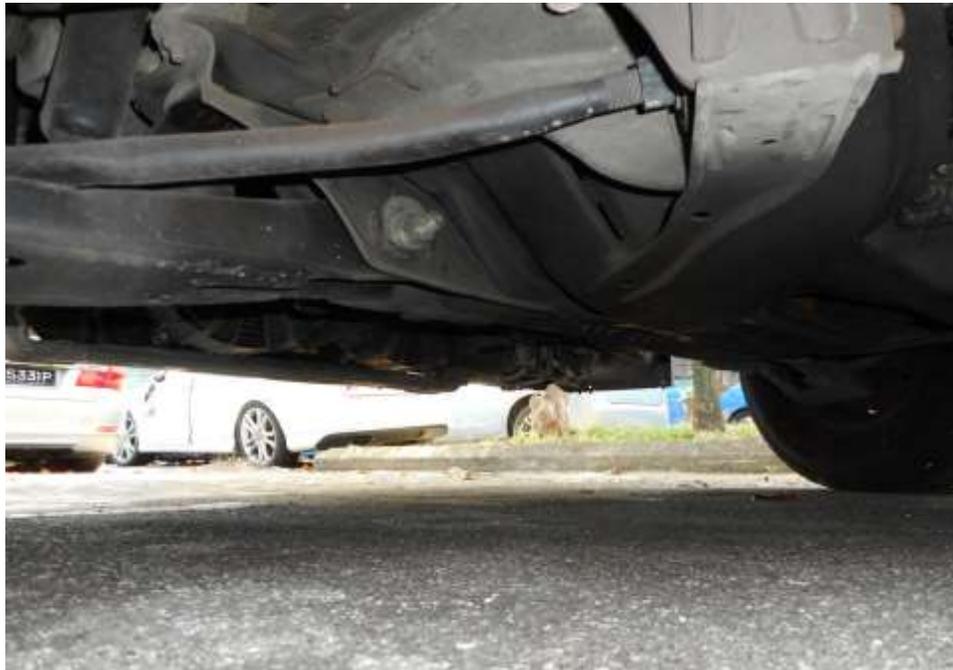
Photo 17 shows the undercarriage of the Motor Van, at the area where the engine housing and transmission housing are located. . I did not find any sign(s) or indication(s) of fluid leak and/or fluid stain(s) on the underside of the Motor Van.

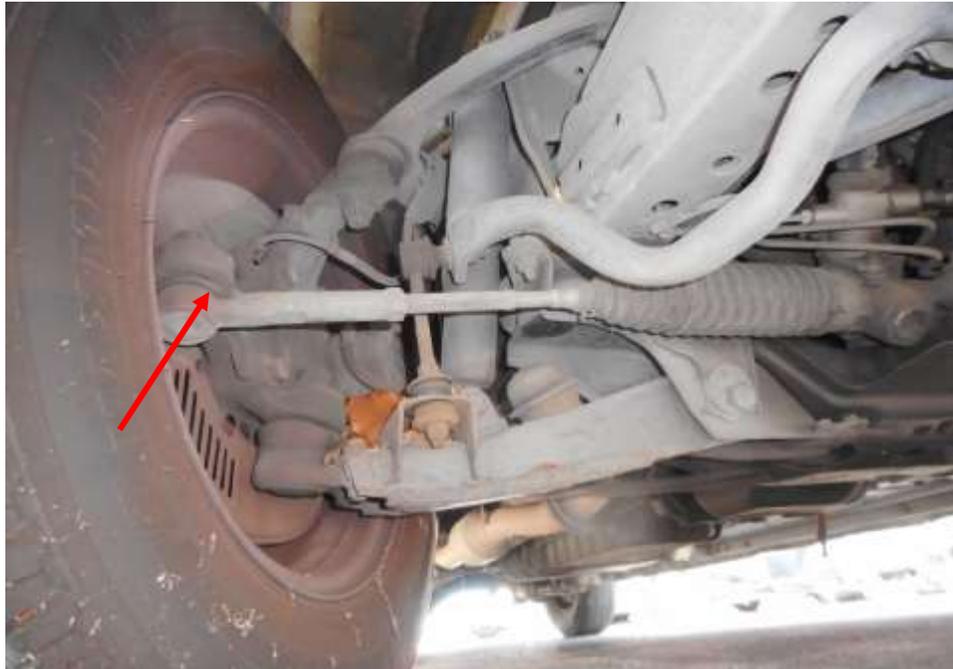
Photo 18 shows the various undercarriage components at the front right wheel of the Motor Van, in particular the steering tie rod end (arrowed). The various steering components were all found to be intact, suggesting that the steering system of the Motor Van was likely to be in serviceable condition at the material time of accident. There was also no sign of fluid stain(s) observed on the various undercarriage components.

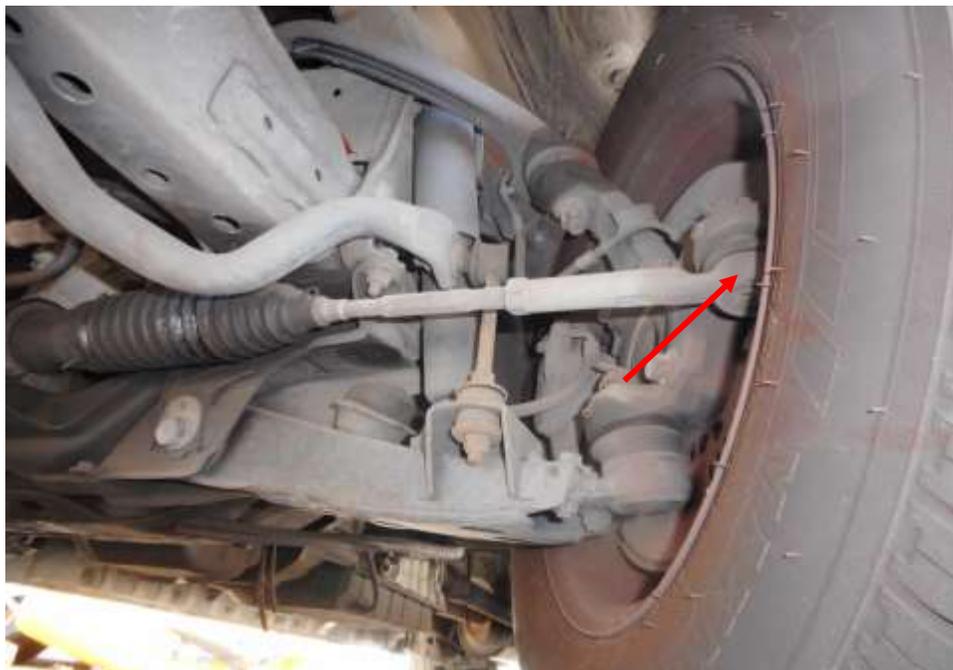
Photo 19 shows the various undercarriage components at the front left wheel of the Motor Van, in particular the steering tie rod end (arrowed). The various undercarriage components of the Motor Van were all found to be intact without any visible damage. There was also no sign of fluid stain(s) observed on the various undercarriage components.

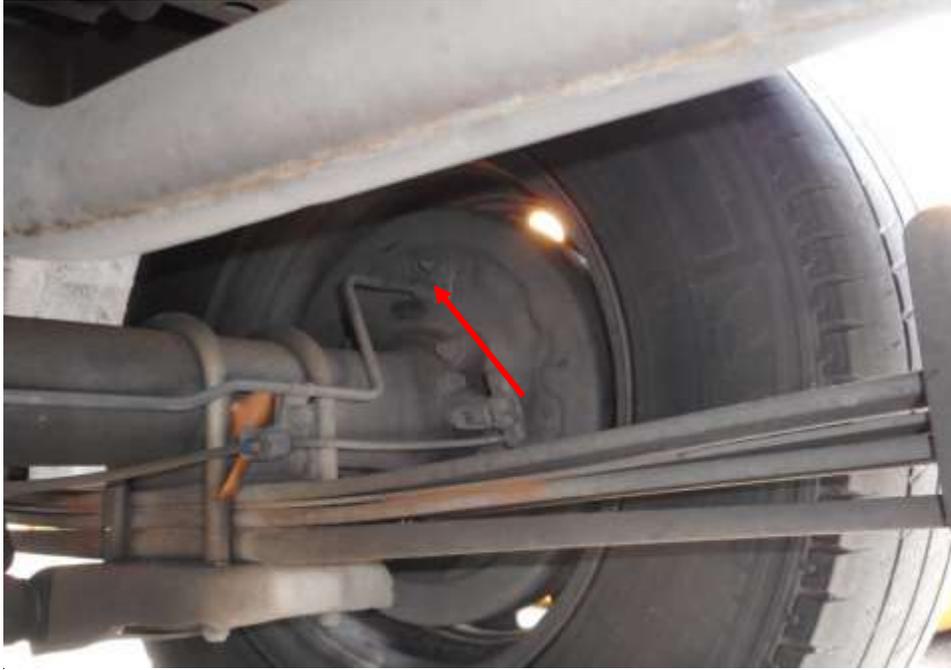
Photo 20 shows the brake pipe (arrowed) at the rear right wheel of the Motor Van. I did not observe any leakage of brake fluid at the time of my inspection of the Motor Van. My static tests of the Motor Van's braking system, along with my visual examination of the various mechanical components in the braking system, had indicated that there was no internal leakage of pressure/vacuum. Hence the braking system of the Motor Van was likely to be in serviceable condition at the material time of accident.

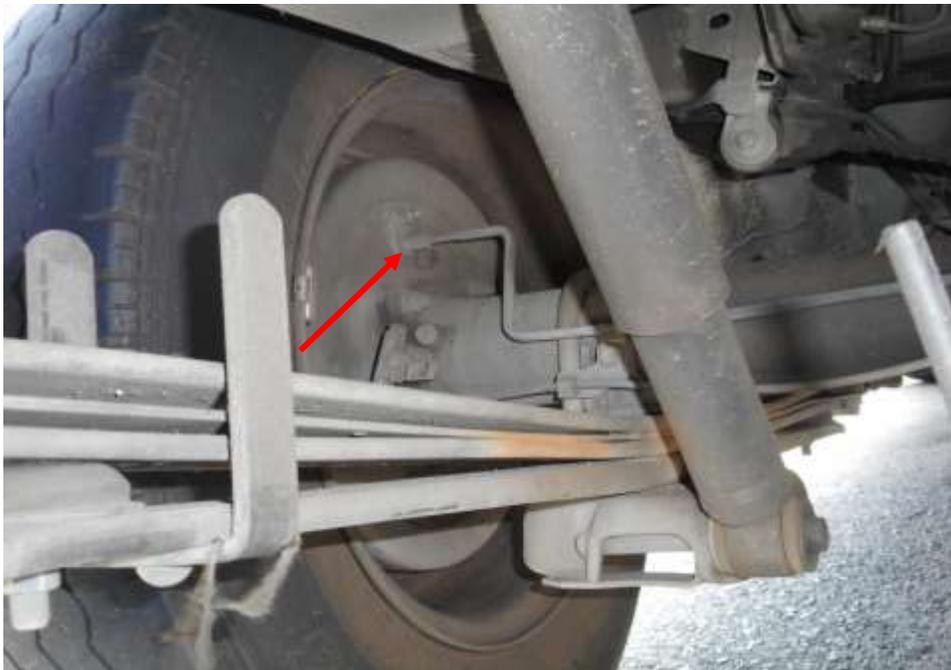
Photo 21 shows the brake pipe (arrowed) at the rear left wheel of the Motor Van. I did not observe any leakage of brake fluid at the time of my inspection of the Motor Van. My static tests of the Motor Van's braking system, along with my visual examination of the various mechanical components in the braking system had indicated that there was no internal leakage of pressure/vacuum. Hence the braking system of the Motor Van was likely to be in serviceable condition at the material time of accident.

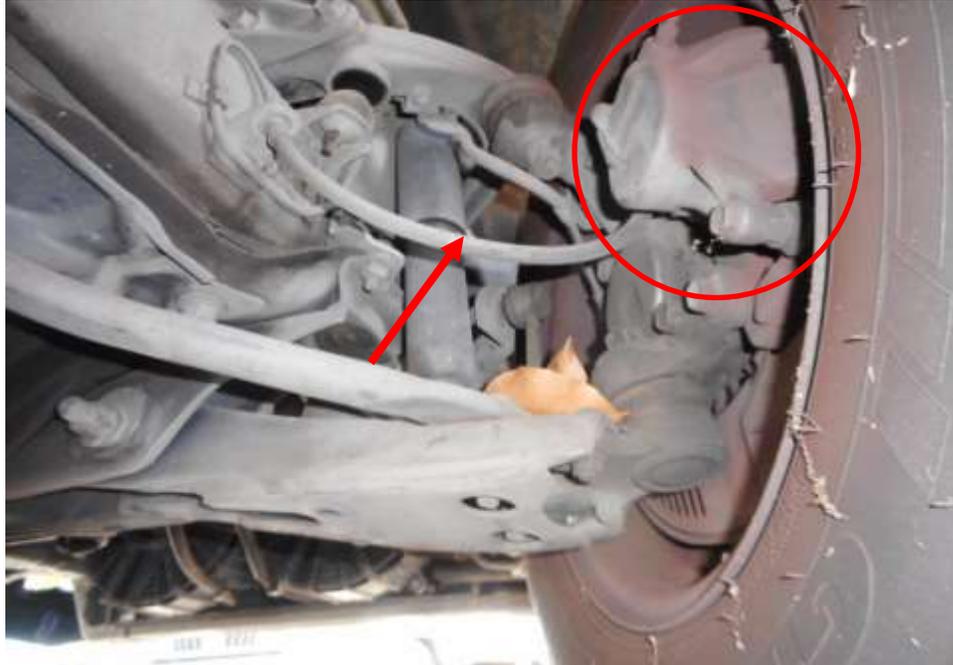
Photo 22 shows the brake hose/pipe (arrowed) at the front right wheel of the Motor Van. No leakage of brake fluid was observed. Visual examination of the various components of the braking system like the brake caliper (circled), brake booster, brake pedal etc had revealed all to be intact and without visible damage at the time of accident. There was also no sign of fluid stain(s) observed on the various undercarriage components.

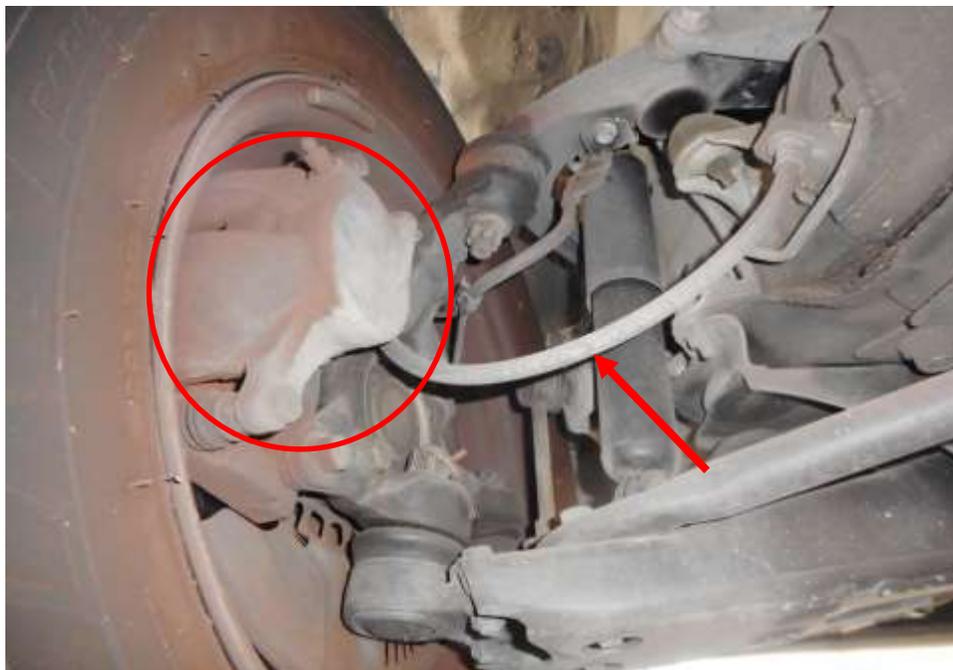
Photo 23 shows the brake hose/pipe (arrowed) at the front left wheel of the Motor Van. No leakage of brake fluid was observed. Visual examination of the various components of the braking system like the brake caliper (circled), brake booster, brake pedal etc had revealed all to be intact and without visible damage at the time of accident. There was also no sign of fluid stain(s) observed on the various undercarriage components.

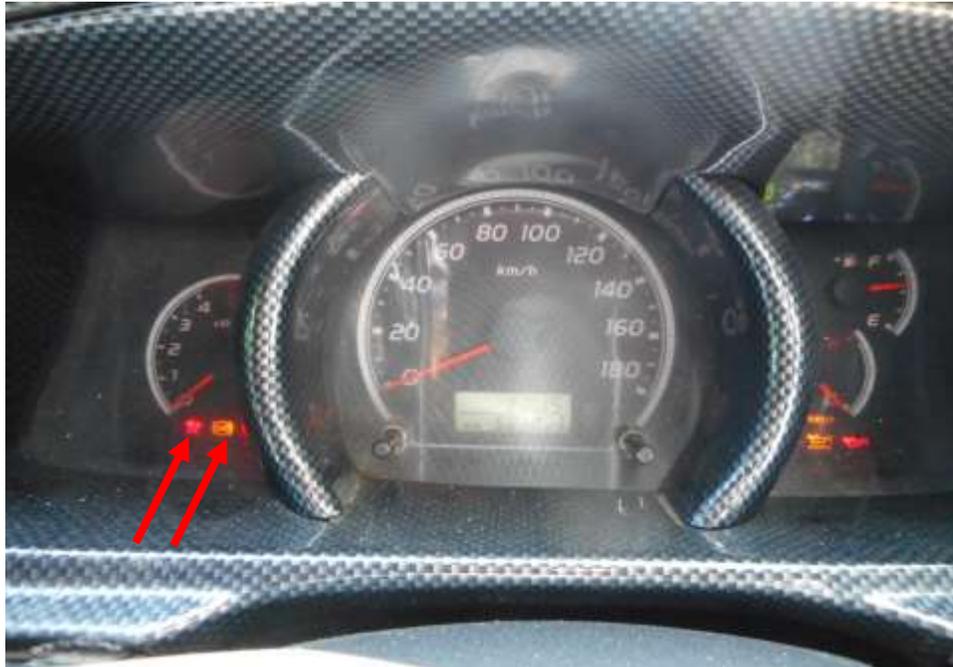
Photo 25 shows the warning light for Anti-Lock Brake System (ABS) and Supplemental Restraint System (SRS) (arrowed) appearing on the instrument panel of the Motor Van during the self-test of its various electronic operating systems when its engine was cranked.

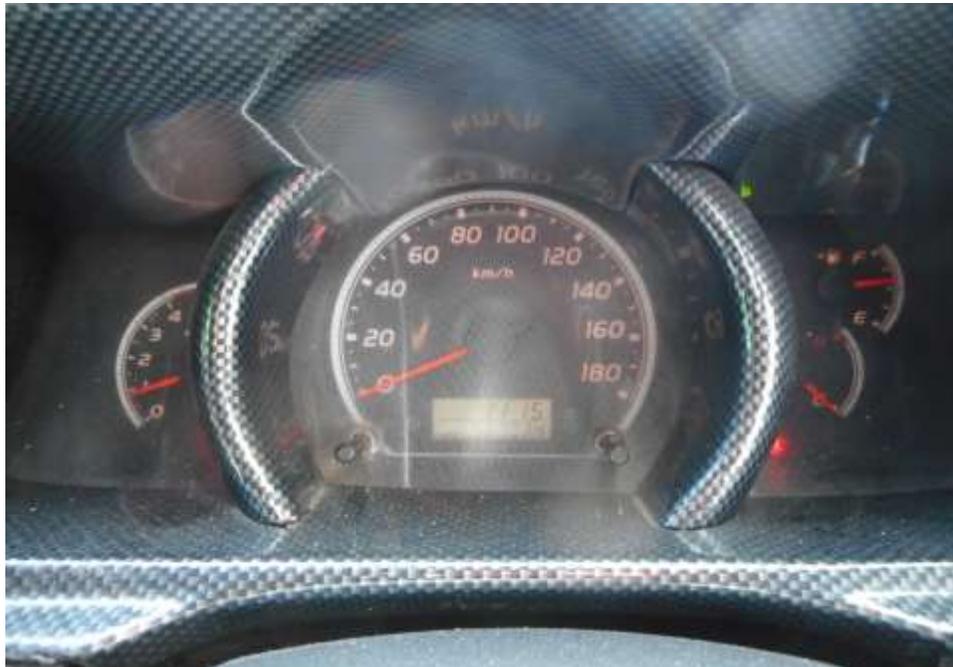
Photo 26 shows no warning lights illuminated on the instrument panel of the Motor Van after the engine was cranked. This would suggest that there was no abnormality to the electronic operating system of the Motor Van, like the ABS and SRS etc.
