Your Ref: TP/IP/00693/2020  
Our Ref : CI/TPD20001942/P

4<sup>th</sup> February 2020

**Fatal Accident Investigation Team**

**MECHANICAL INSPECTION REPORT OF MOTOR CAR SMG 27H**

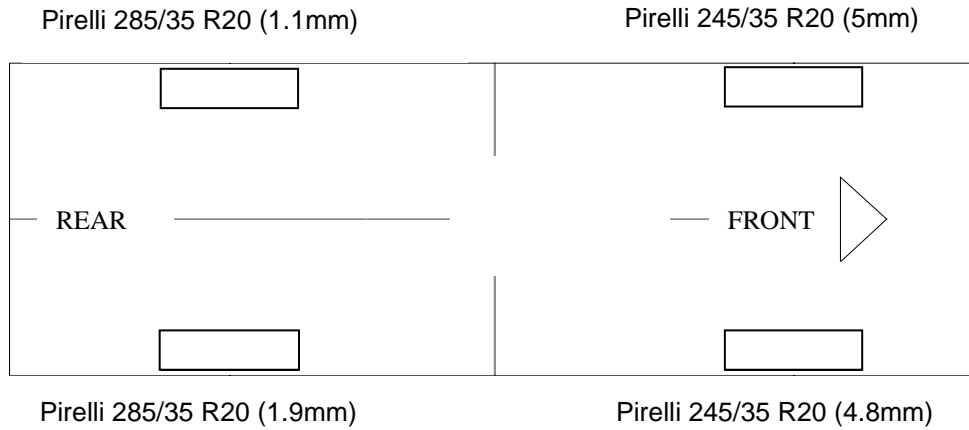
6. The rear left tyre of the Motor Car were observed to be in unserviceable condition as the tread depth has exceeded the minimum legal limit, however the other 3 tyres are observed to be in serviceable condition and sufficiently inflated for vehicular operation. I did not find any tear, cut or burst mark(s) on the outer and the inner sidewalls as well as across the tread of the 4 tyres. The tyre brand, tyre size and remaining tread depth of the 4 tyres of the Motor Car were recorded as follows:-

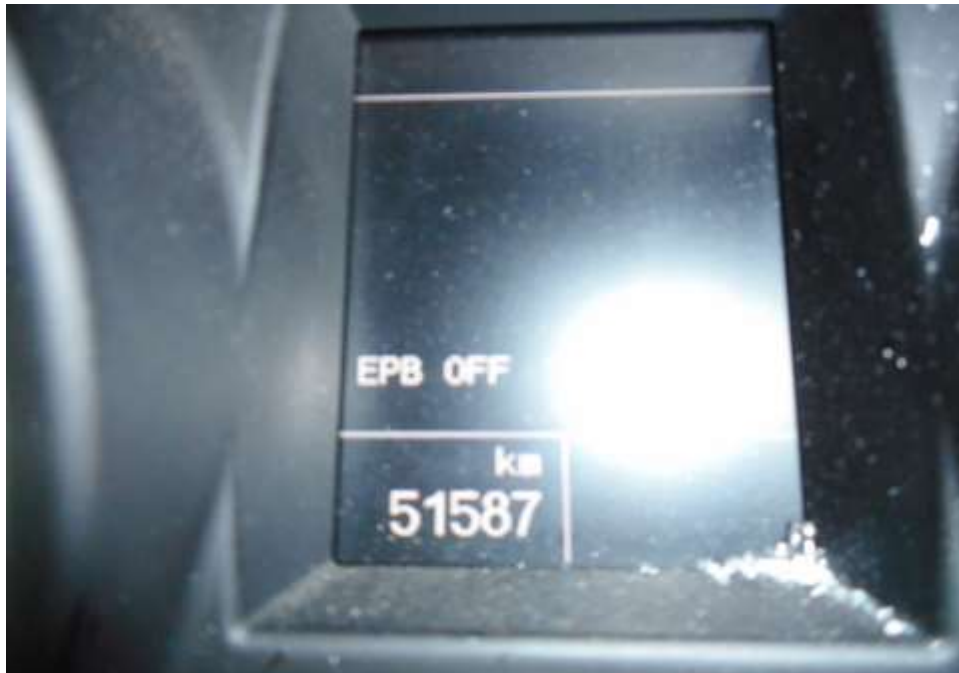
**Photo 1** shows a general view of the instrument cluster of the Motor Car at the time of my inspection. The mileage of the Motor Car was 51,587km

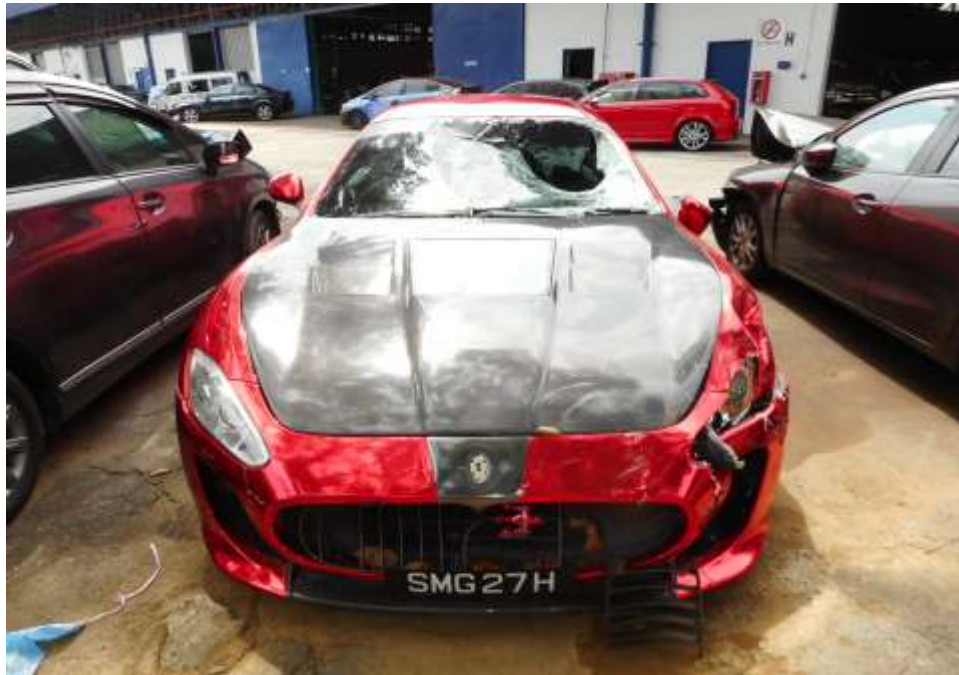
4. The mileage of the Motor Car at the time of my inspection was 51,587km.
5. The Motor Car appeared to have sustained damage at its frontal portion. Its front windscreen, front bonnet, front bumper, front grille, front left headlamp, front left fender and left rear view mirror were damage at the time of my inspection.

**Photo 2** shows a general view of the Motor Car's frontal portion at the time of my inspection. It appeared to have sustained moderate damage at its frontal portion. Its front windscreen, front bonnet, front bumper, front grille, front left headlamp, front left fender and left rear view mirror were damage at the time of my inspection.

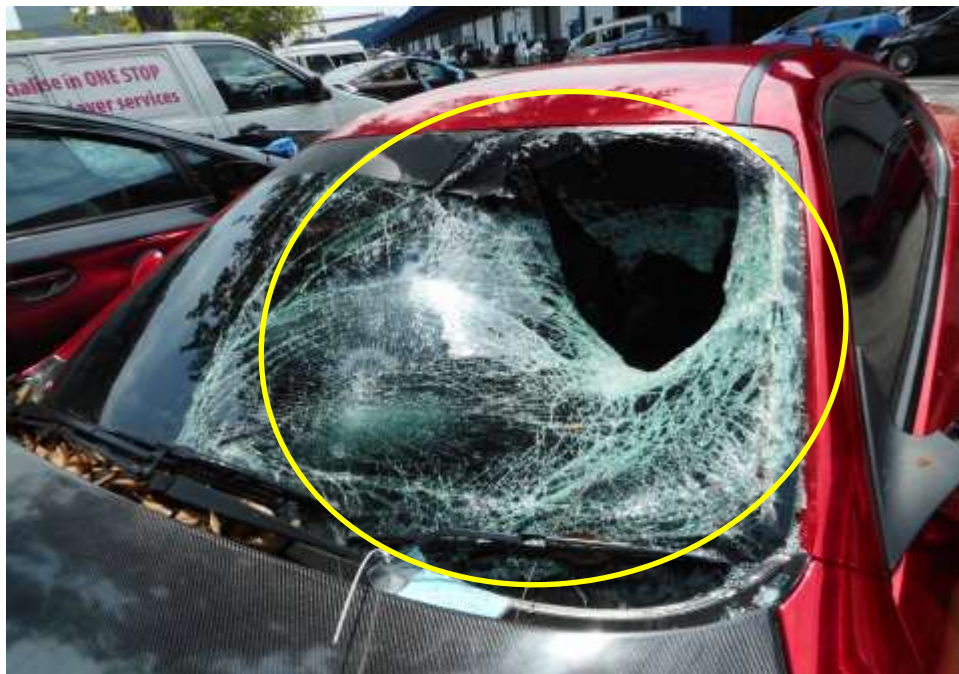
**Photo 3** shows a close up view of the Motor Car's frontal portion at the time of my inspection. Its front windscreen (circled) was damage at the time of my inspection.

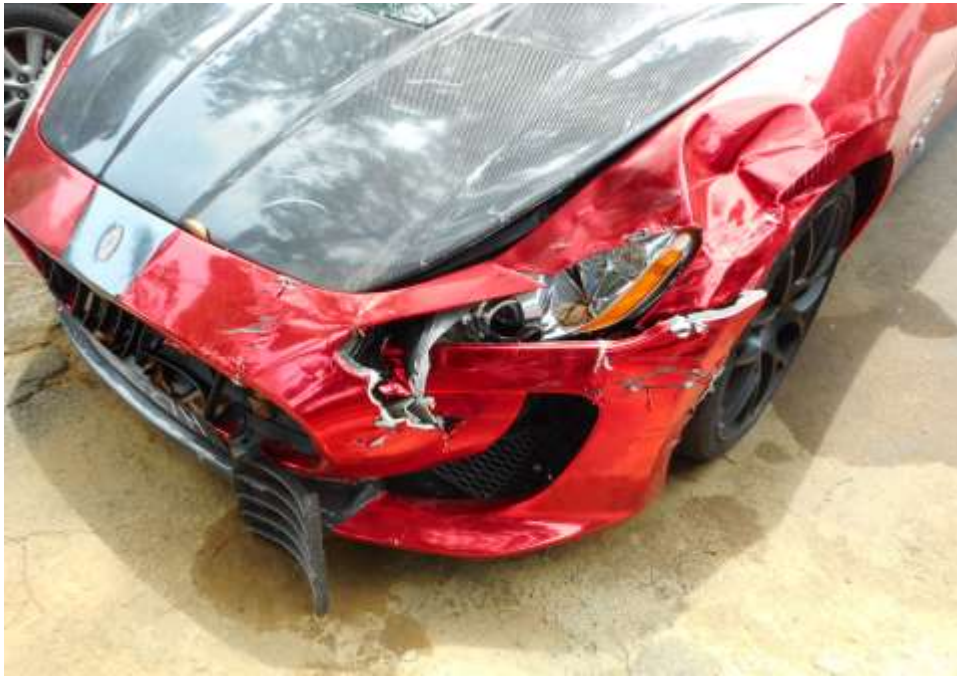
**Photo 4** shows a general view of the Motor Car's frontal portion at the time of my inspection. Its front bonnet, front bumper, front grille, front left headlamp, front left fender and left rear view mirror were damage at the time of my inspection.

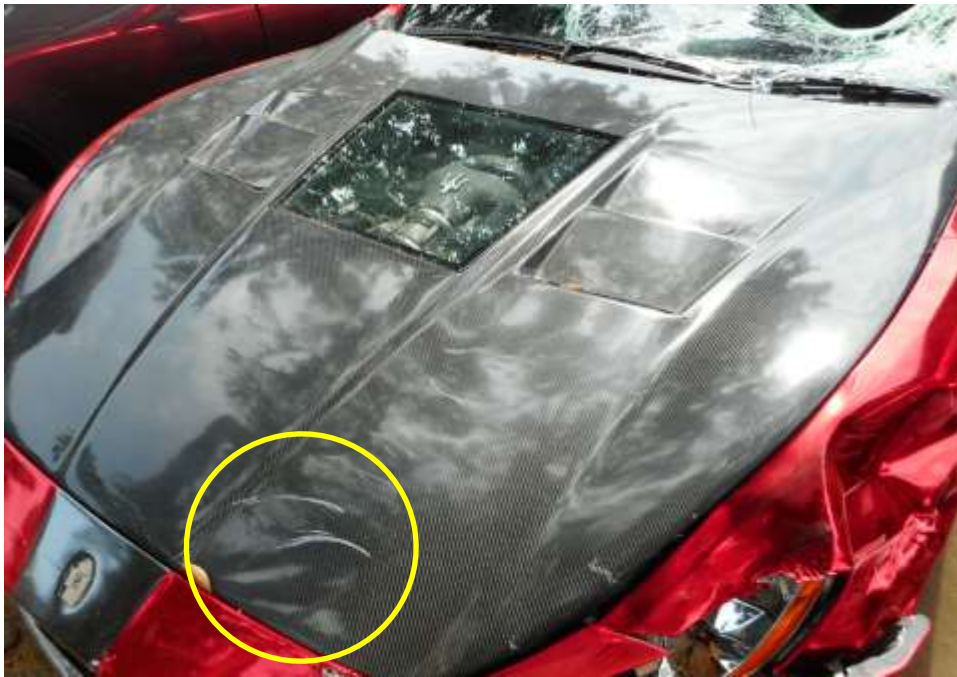
**Photo 5** shows a close up view of the Motor Car's frontal portion at the time of my inspection. Its front bonnet (circled) was damage at the time of my inspection.

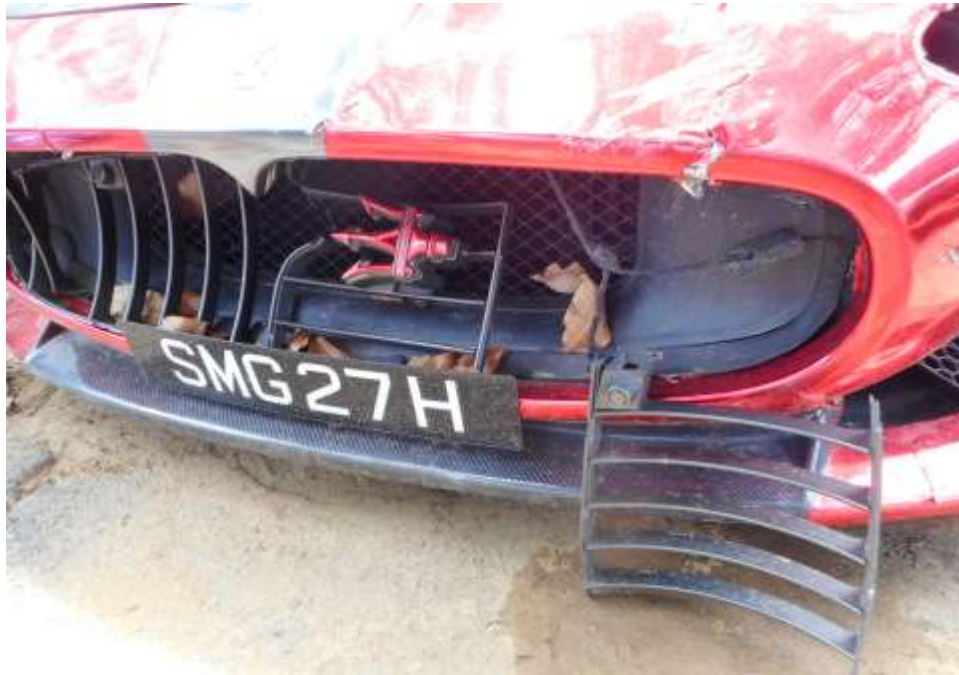
**Photo 6** shows a close up view of the Motor Car's frontal portion at the time of my inspection. Its front grille was damage at the time of my inspection.

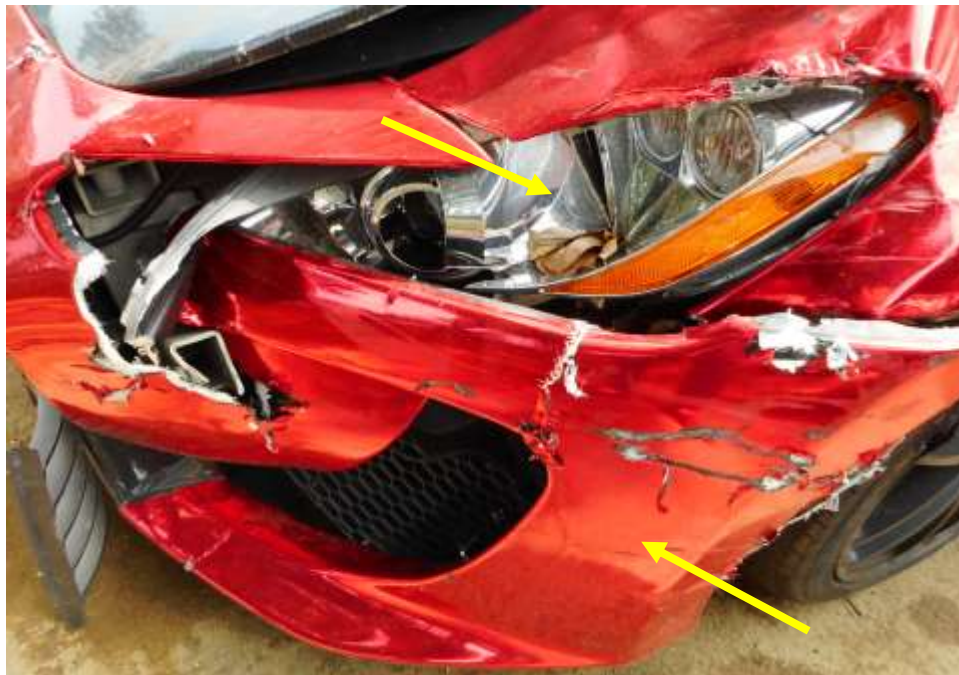
**Photo 7** shows a close up view of the Motor Car's frontal portion at the time of my inspection. Its front bumper (arrowed) and front left headlamp (arrowed) were damage at the time of my inspection.

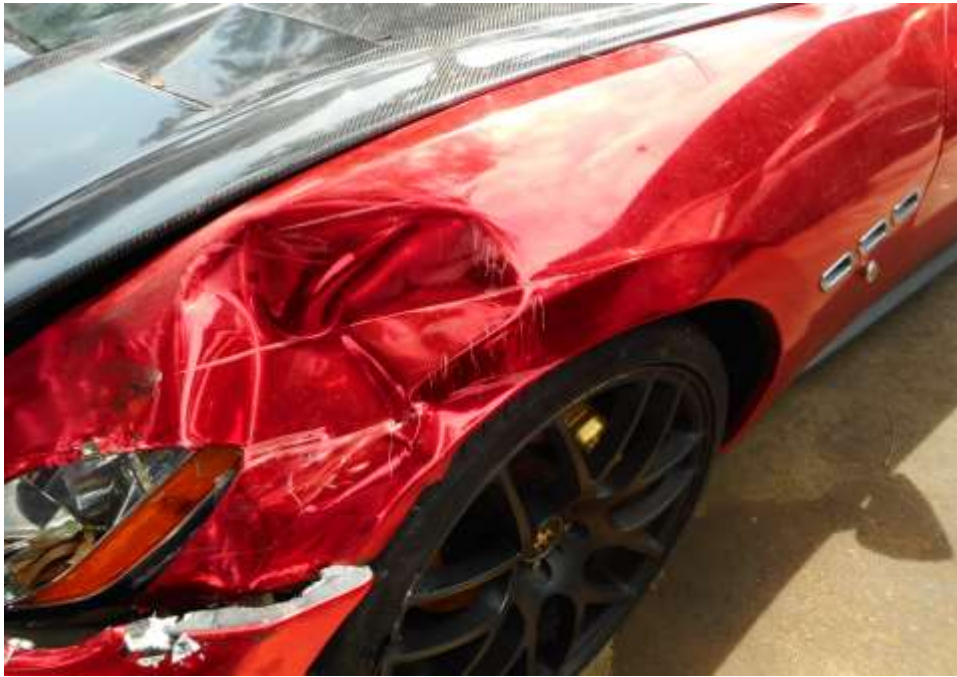
**Photo 8** shows a close up view of the Motor Car's frontal portion at the time of my inspection. Its front left fender was damage at the time of my inspection.

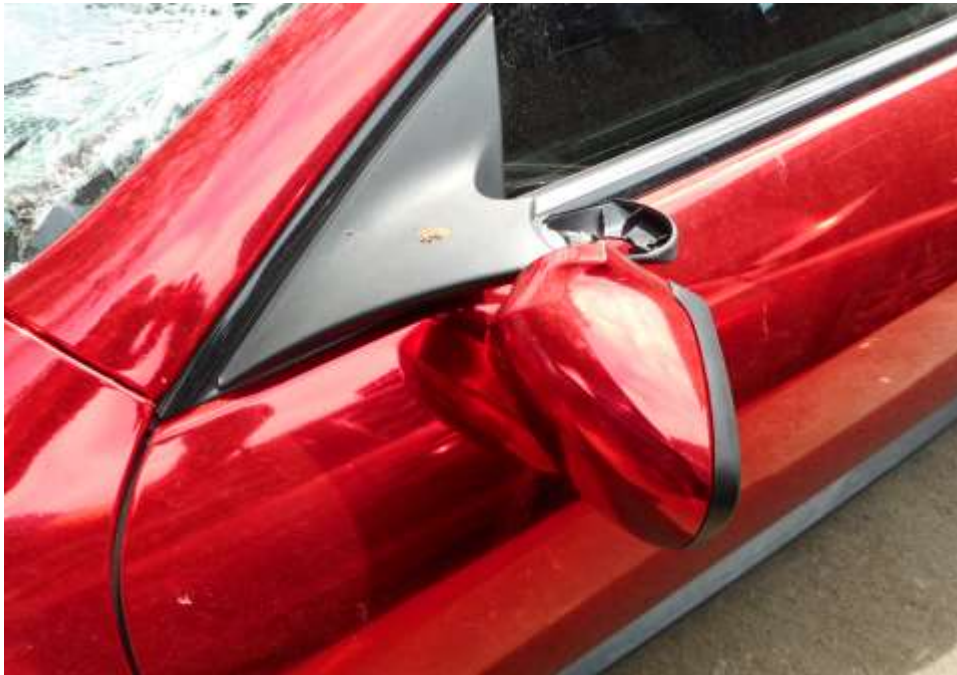
**Photo 9** shows a close up view of the Motor Car's frontal portion at the time of my inspection. Its left rear view mirror was damage at the time of my inspection.

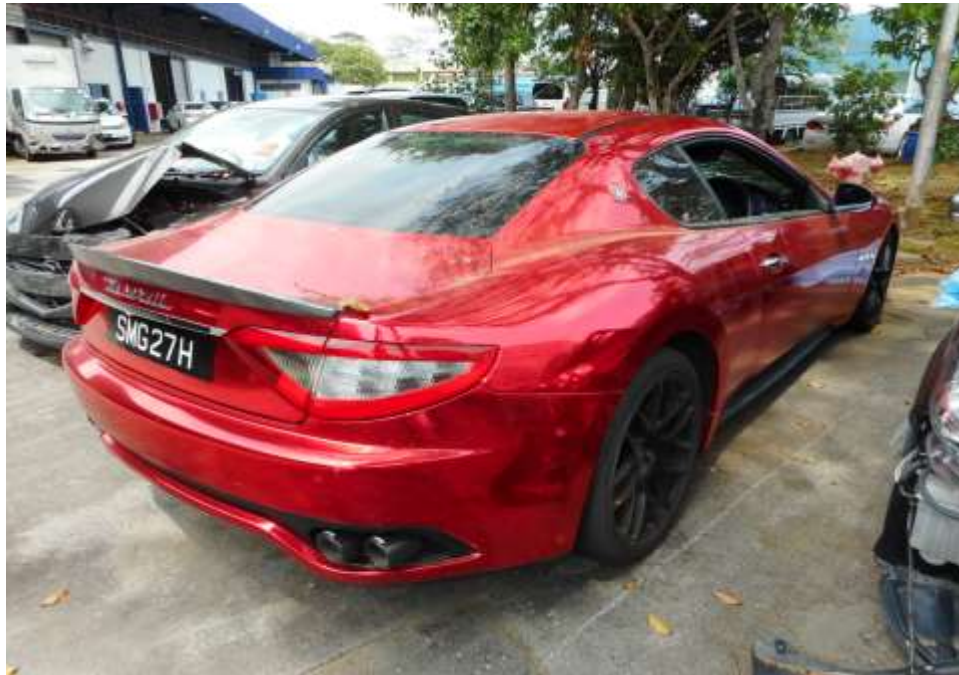
**Photo 10** shows a general view of the front right body of the Motor Car at the time of my inspection. The Motor Car was observed to be intact and unaffected by the accident.

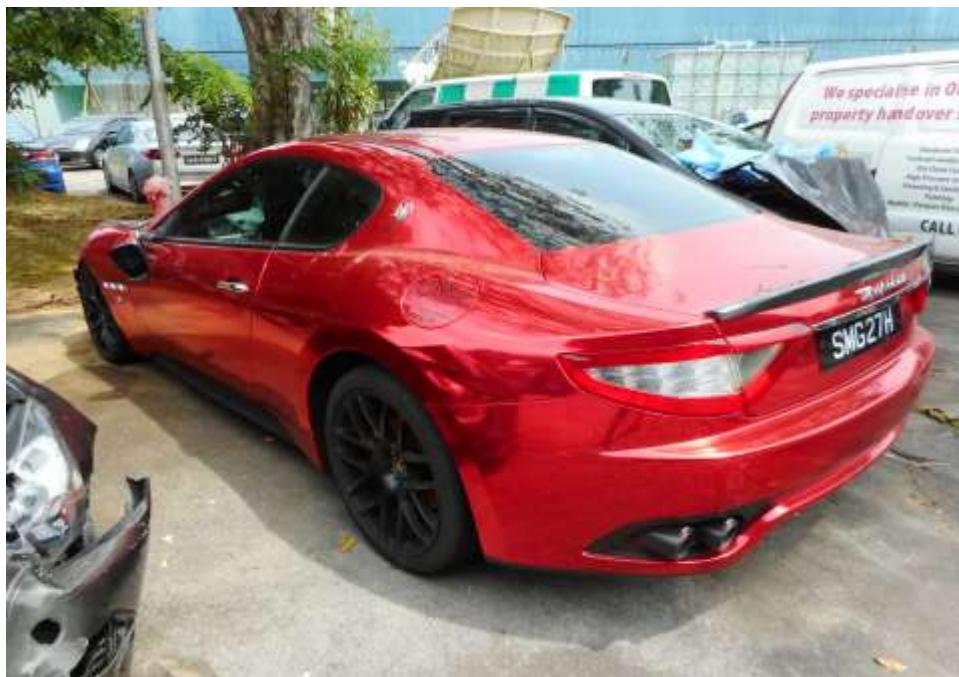
**Photo 11** shows a general view of the front left body of the Motor Car at the time of my inspection. The Motor Car was observed to be intact and unaffected by the accident.

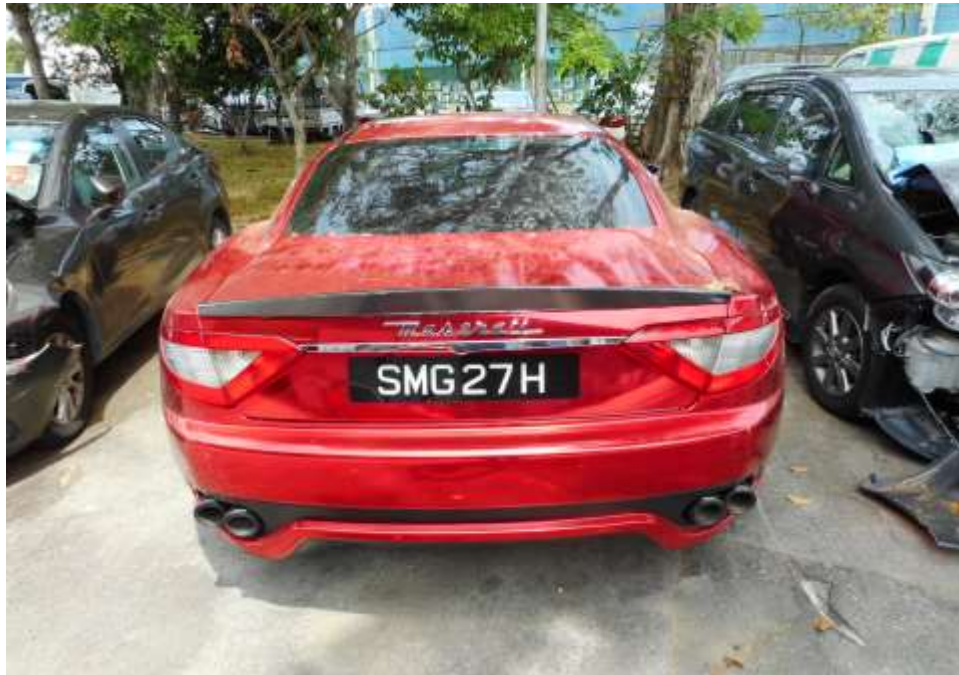
**Photo 12** shows a general view of the rear body of the Motor Car at the time of my inspection. The Motor Car was observed to be intact and unaffected by the accident.

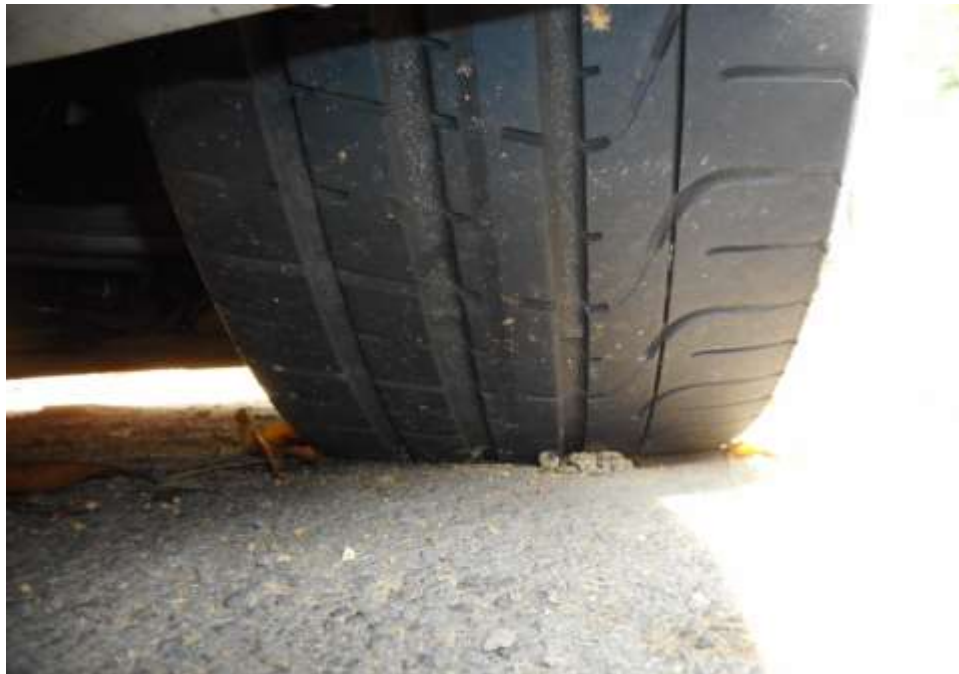
**Photo 13** shows the condition of the front right tyre of the Motor Car, which was observed to be in serviceable condition with remaining tread depth of approximately 4.8mm. The tyre, which was wrapped around standard alloy wheel rim, was also observed to be sufficiently inflated for vehicular operation. There was no tear, cut or burst mark(s) on the outer and the inner sidewalls as well as across the tread of the 4 tyres that were fitted on the Motor Car.

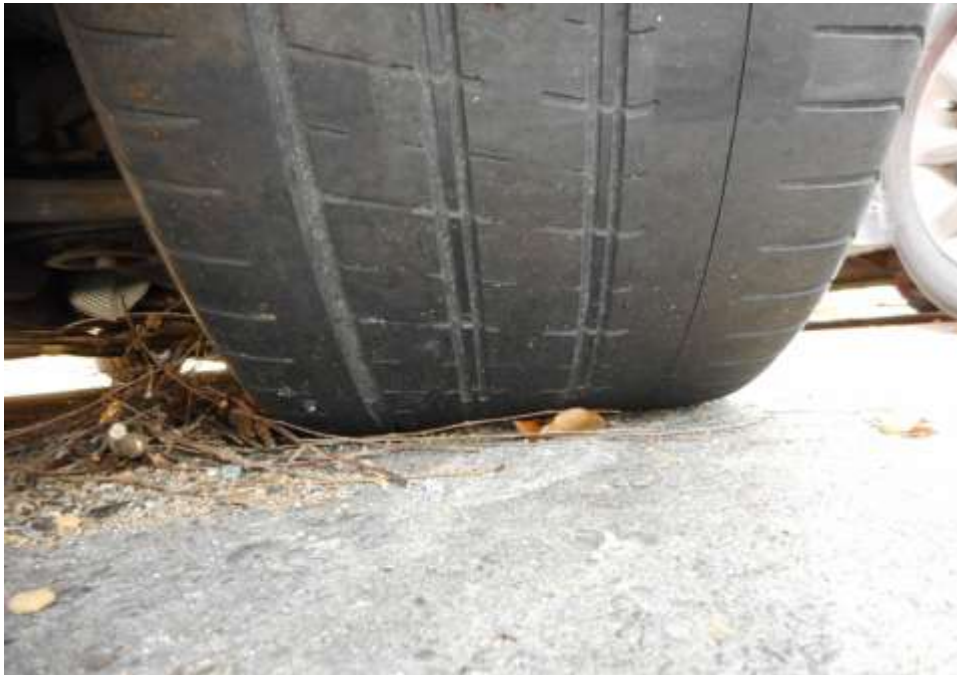
**Photo 14** shows the condition of the rear right tyre of the Motor Car, which was observed to be in serviceable condition with remaining tread depth of approximately 1.9mm. The tyre, which was wrapped around standard alloy wheel rim, was also observed to be sufficiently inflated for vehicular operation.

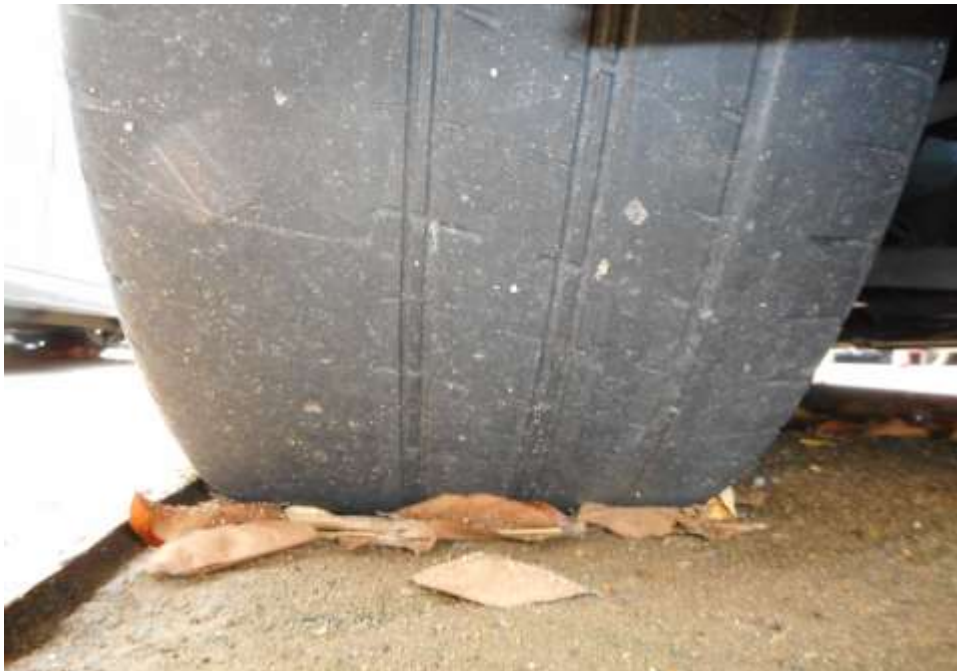
**Photo 15** shows the condition of the rear left tyres of the Motor Car, which was observed to be in unserviceable condition with remaining tread depth of approximately 1.1mm which has exceeded the minimum legal limit. The tyres, which were wrapped around standard alloy wheel rim. There was no damage found on all 4 alloy wheel rims of the Motor Car.

18. The left rear tyre of the Motor Car were observed to be in unserviceable condition as the tread depth was measured at 1.1mm which had exceeded the minimum legal limit. However the other 3 tyres fitted on the Motor Car were found to be in serviceable condition. I did not find any tear, cut or burst mark(s) on the outer and the inner sidewalls as well as across the tread of the 4 tyres. The 3 tyres were also observed to be sufficiently inflated for vehicular operation with remaining tread depth of approximately 1.9mm – 5mm.

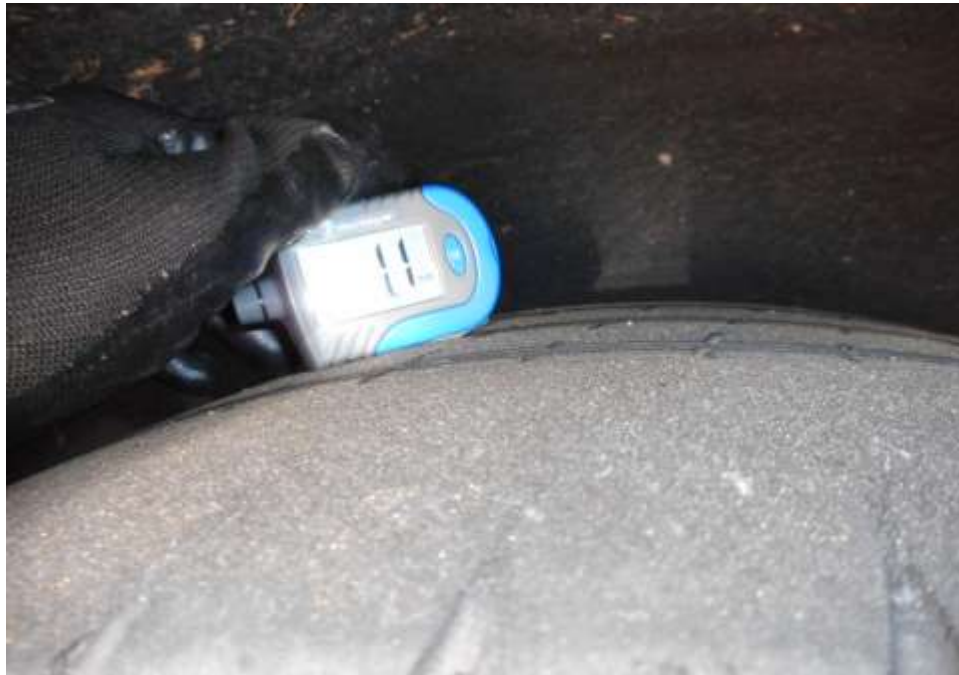
**Photo 16** shows the condition of the rear left tyres of the Motor Car, which was observed to be in unserviceable condition with remaining tread depth of approximately 1.1mm which has exceeded the minimum legal limit.

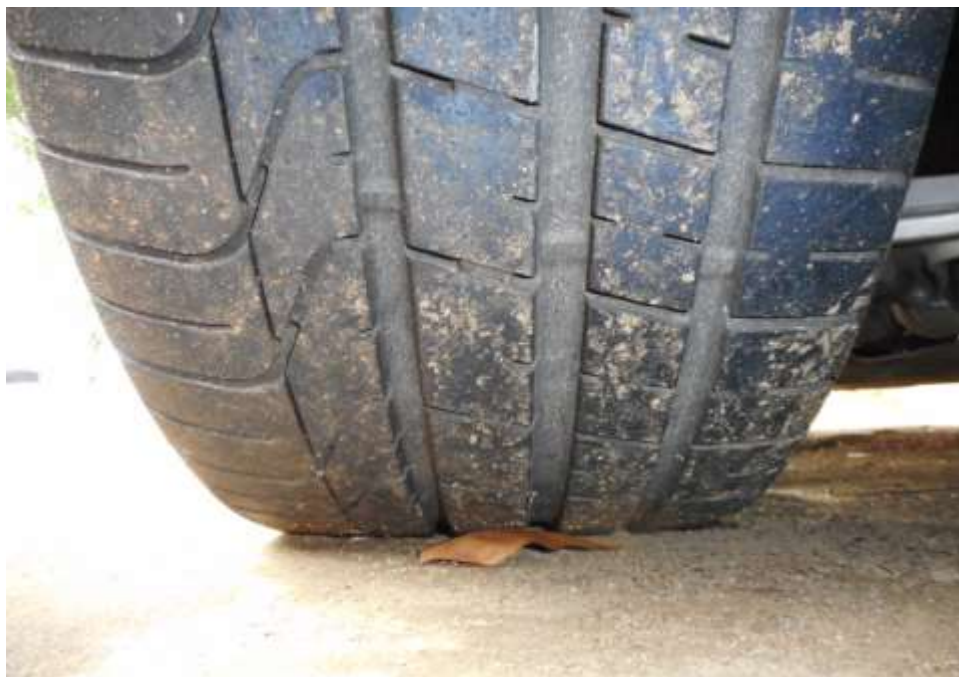
**Photo 17** shows the condition of the rear right tyres of the Motor Car, which were observed to be in serviceable condition with remaining, tread depth of approximately 5mm. There was also no tear, cut or burst mark(s) on the outer and the inner sidewalls as well as across the tread of the 4 tyres that were fitted on the Motor Car.

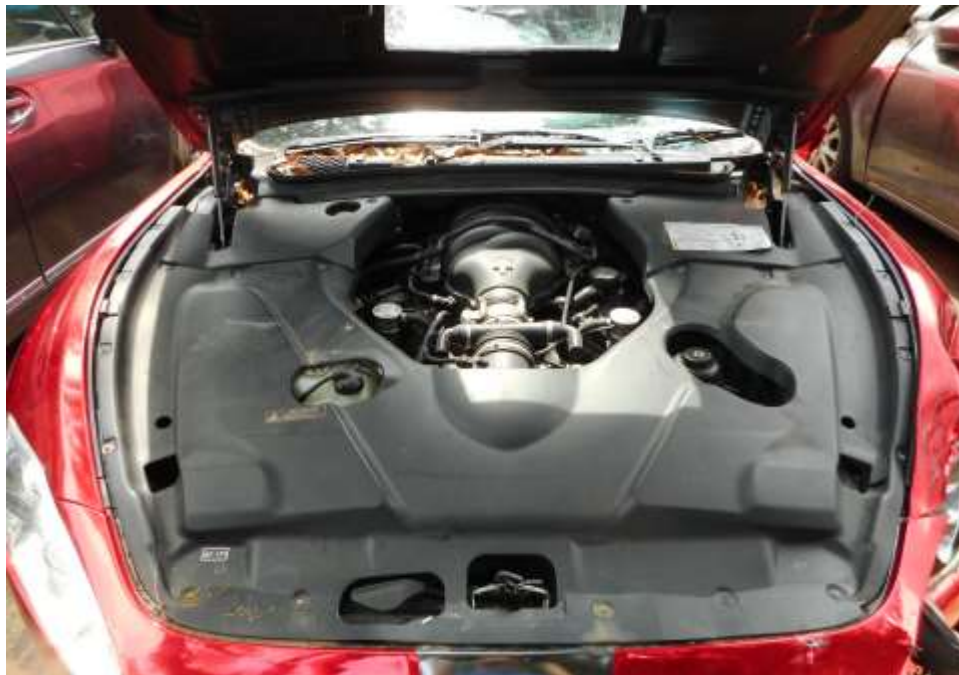
**Photo 18** shows a general view of the Motor Car's engine compartment, which was accessed by lifting the front cabin of the Motor Car. The various parts and components inside the engine compartment were unaffected by the accident. There was also no sign(s) or indication(s) of fresh fluid leakage and/or fluid stain within the engine compartment

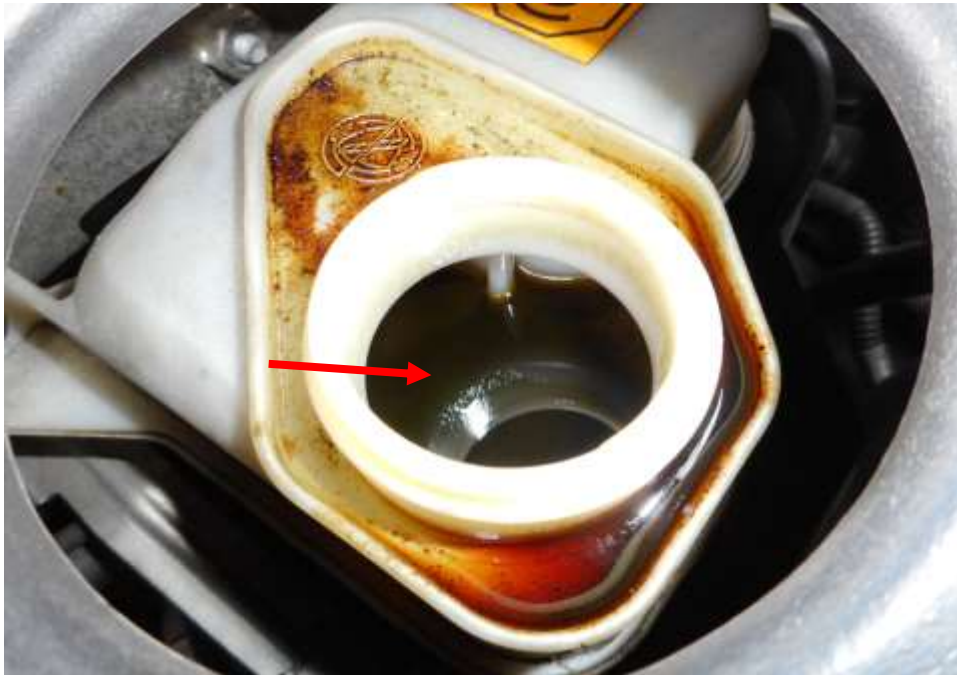
**Photo 19** shows the brake fluid reservoir of the Motor Car at the time of my inspection. The brake fluid was observed to be of sufficient level (arrowed) and without any visible contamination.

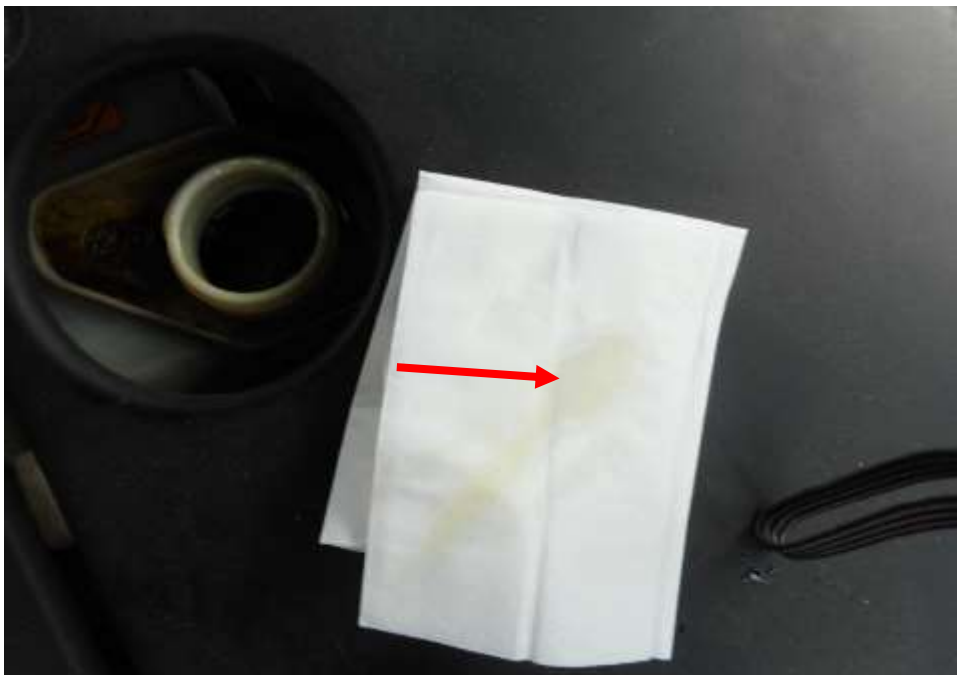
**Photo 20** shows the brake fluid reservoir of the Motor Car at the time of my inspection. The brake fluid was observed to be of sufficient level and without any visible contamination (arrowed).

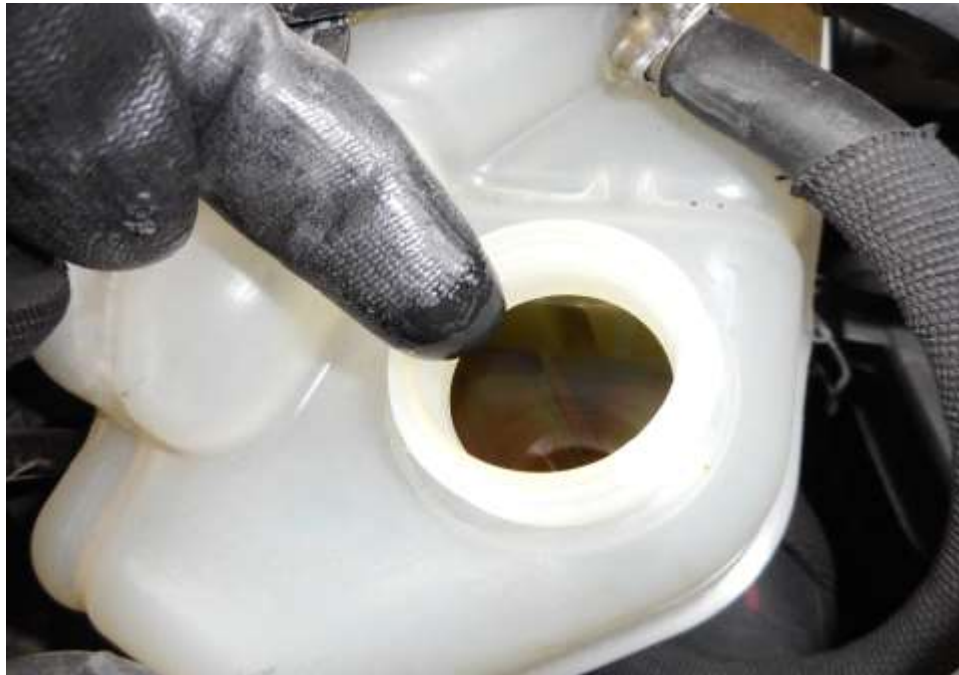
**Photo 21** shows the engine coolant reservoir of the Motor Car at the time of my inspection. The engine coolant was observed to be of sufficient level and without any visible contamination.

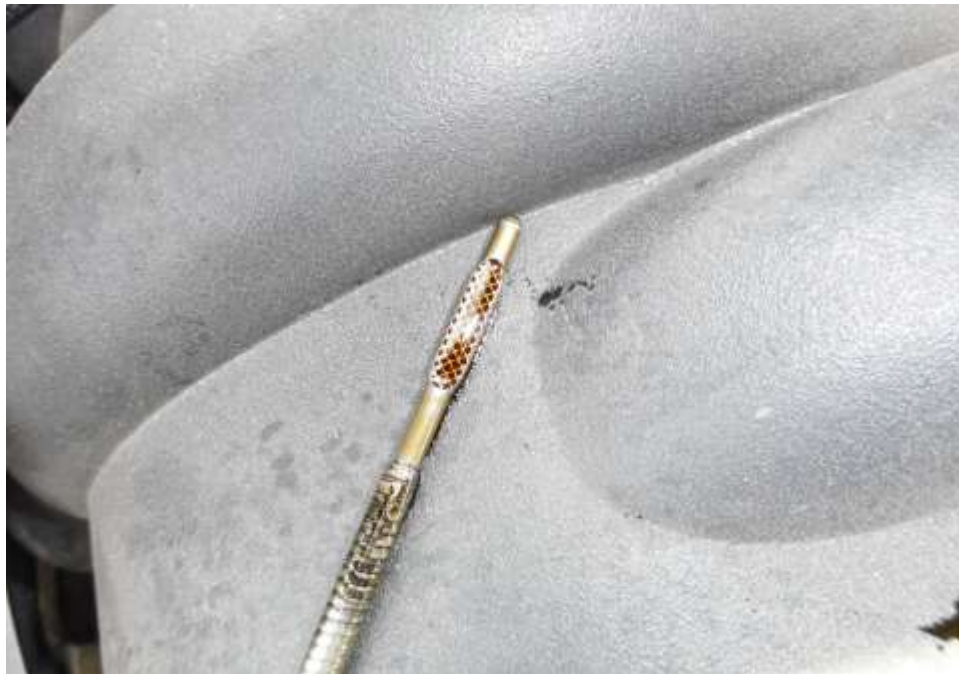
**Photo 22** shows the engine oil dip stick of the Motor Car at the time of my inspection. The engine oil was observed to be of sufficient level and without any visible contamination.

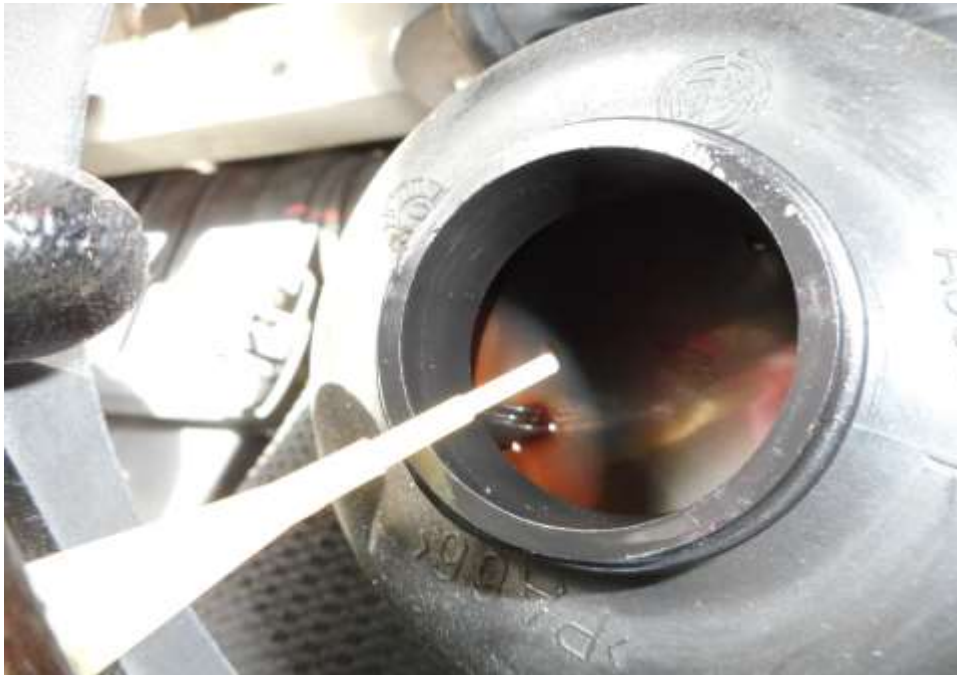
8. Upon examination of the Motor Car's engine compartment, the power steering fluid was observed to be of lower level but sufficient for operating purposes.
9. I had observed all the other parts and components inside the engine compartment to be intact and unaffected by the accident. The engine oil and engine coolant and brake fluid were all found to be of sufficient level for operating purposes. Visually, there was also no contamination found to these fluids.
10. Further examination of the engine compartment revealed, there was no sign(s) or indication(s) of fresh fluid leakage and/or fluid stain within the engine compartment of the Motor Car.
11. My subsequent checks on the underside of the Motor Car also revealed no fluid stain. Visually, the various undercarriage components of the Motor Car were all observed to be intact and without any visible damage. See photo 18 – 24 below.

**Photo 23** shows the power steering dip stick of the Motor Car at the time of my inspection. The power steering fluid was observed to be of lower level but sufficient for operating purposes.

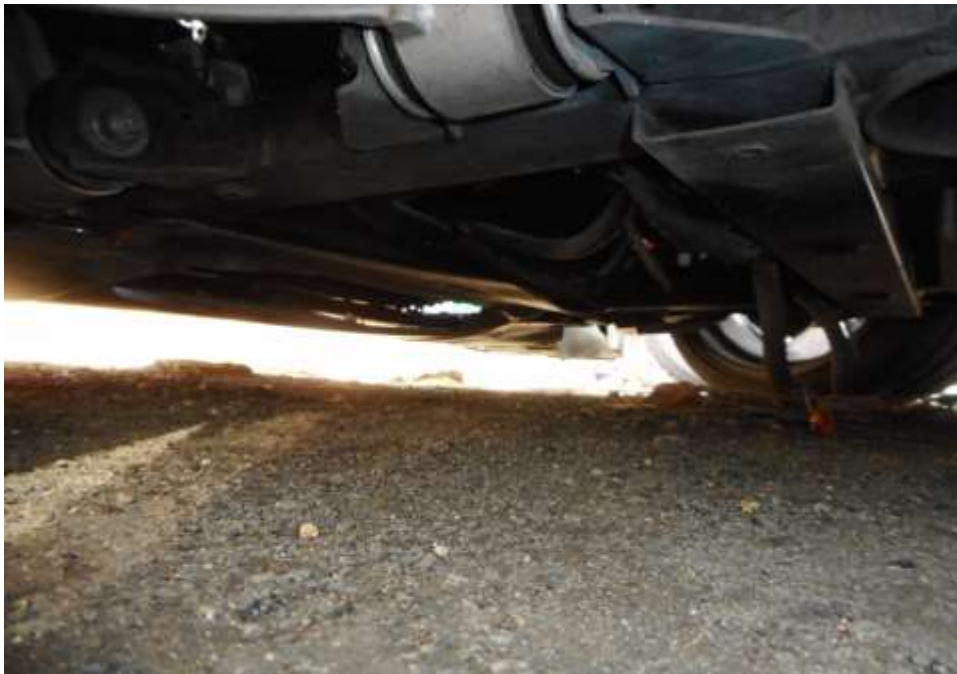
**Photo 24** shows the undercarriage of the Motor Car, at the area where the engine housing and transmission housing are located. . I did not find any sign(s) or indication(s) of fluid leak and/or fluid stain(s) on the underside of the Motor Car.

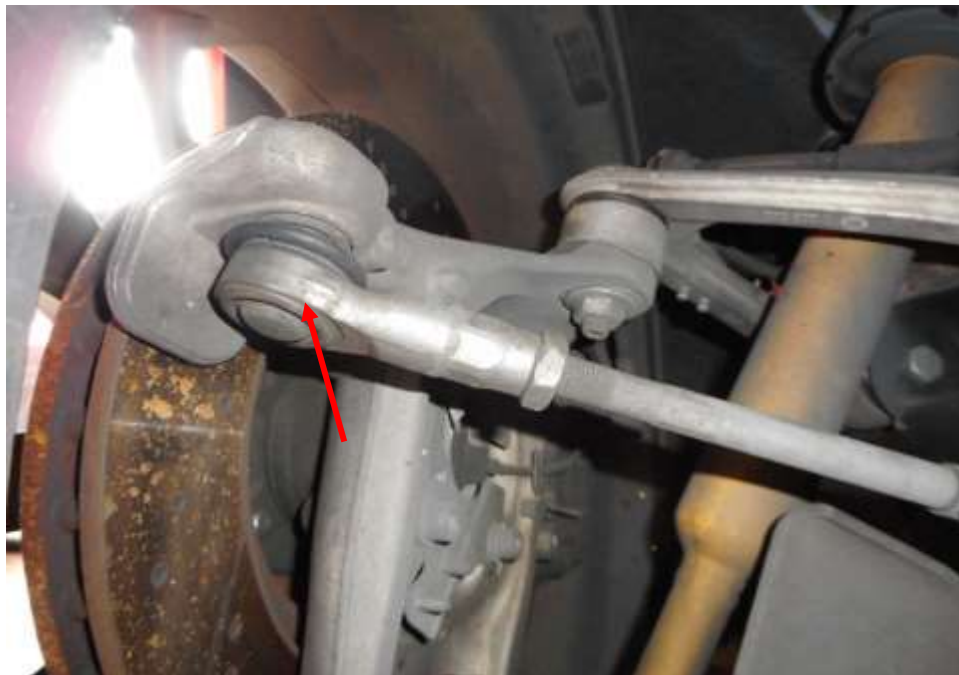
**Photo 25** shows the various undercarriage components at the front right wheel of the Motor Car, in particular the steering tie rod end (arrowed). The various steering components were all found to be intact, suggesting that the steering system of the Motor Car was likely to be in serviceable condition at the material time of accident. There was also no sign of fluid stain(s) observed on the various undercarriage components.

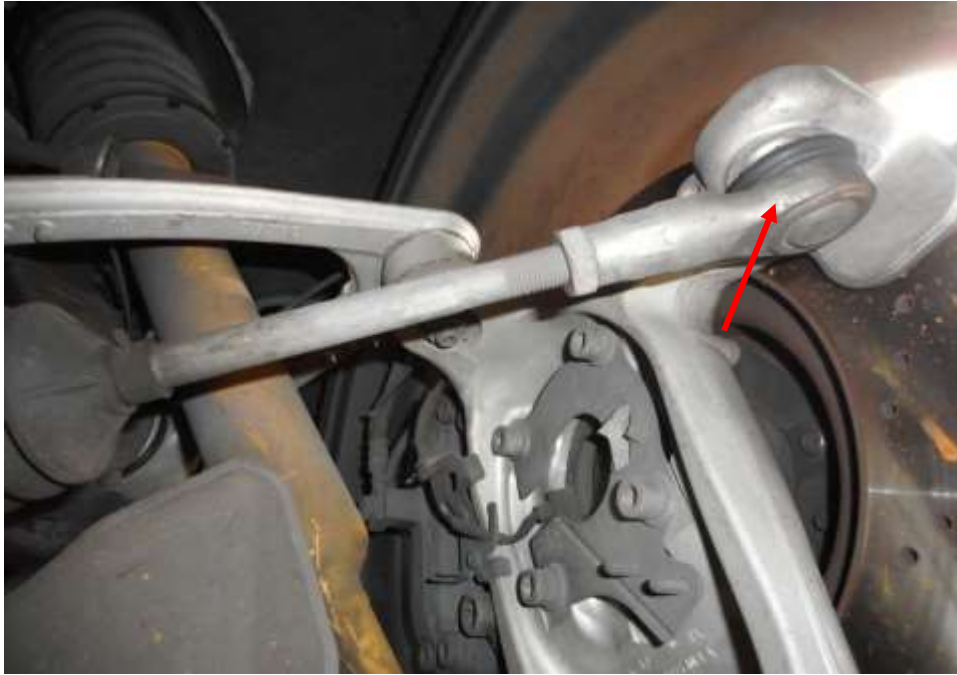
**Photo 26** shows the various undercarriage components at the front left wheel of the Motor Car, in particular the steering tie rod end (arrowed). The various Undercarriage components of the Motor Car were all found to be intact without any visible damage. There was also no sign of fluid stain(s) observed on the various undercarriage components.

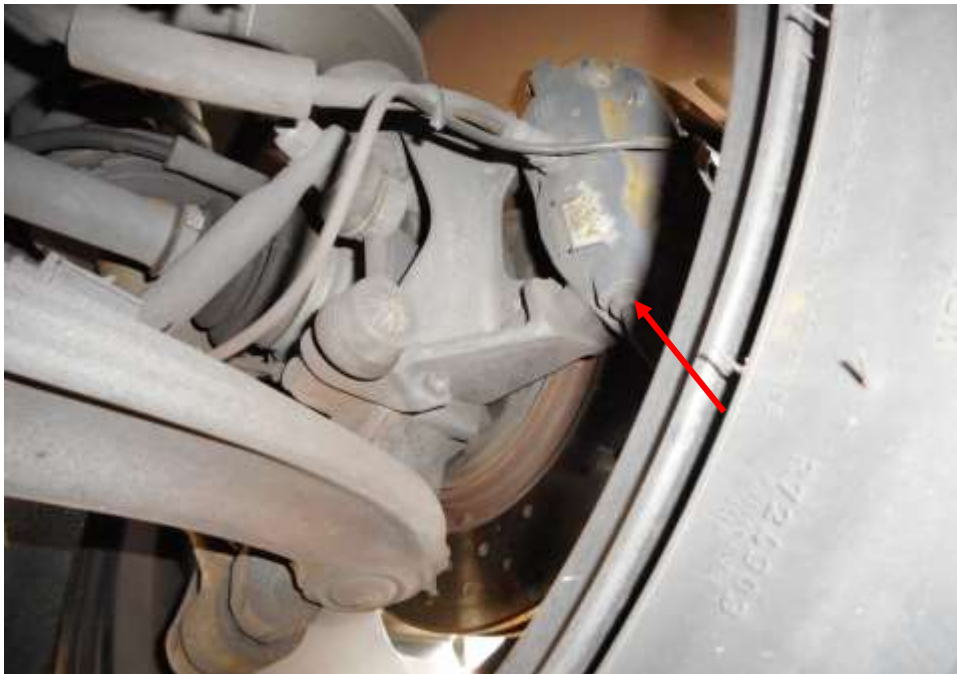
**Photo 27** shows the brake pipe (arrowed) at the rear right wheel of the Motor Car. I did not observe any leakage of brake fluid at the time of my inspection of the Motor Car. My static tests of the Motor Car's braking system, along with my visual examination of the various mechanical components in the braking system, had indicated that there was no internal leakage of pressure/vacuum. Hence the braking system of the Motor Car was likely to be in serviceable condition at the material time of accident.

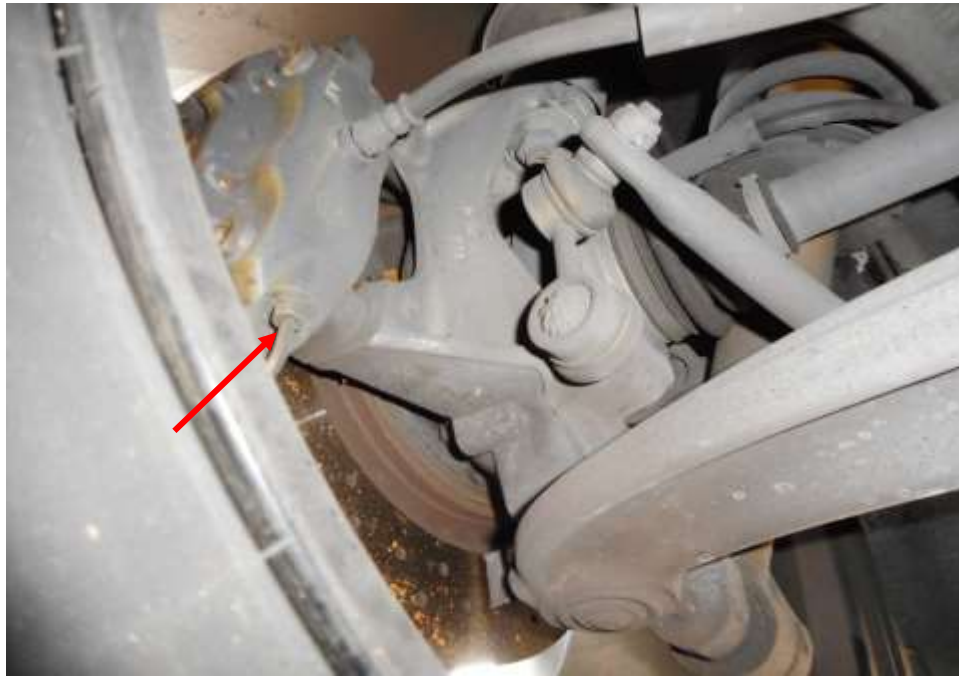
**Photo 28** shows the brake pipe (arrowed) at the rear left wheel of the Motor Car. I did not observe any leakage of brake fluid at the time of my inspection of the Motor Car. My static tests of the Motor Car's braking system, along with my visual examination of the various mechanical components in the braking system had indicated that there was no internal leakage of pressure/vacuum. Hence the braking system of the Motor Car was likely to be in serviceable condition at the material time of accident.

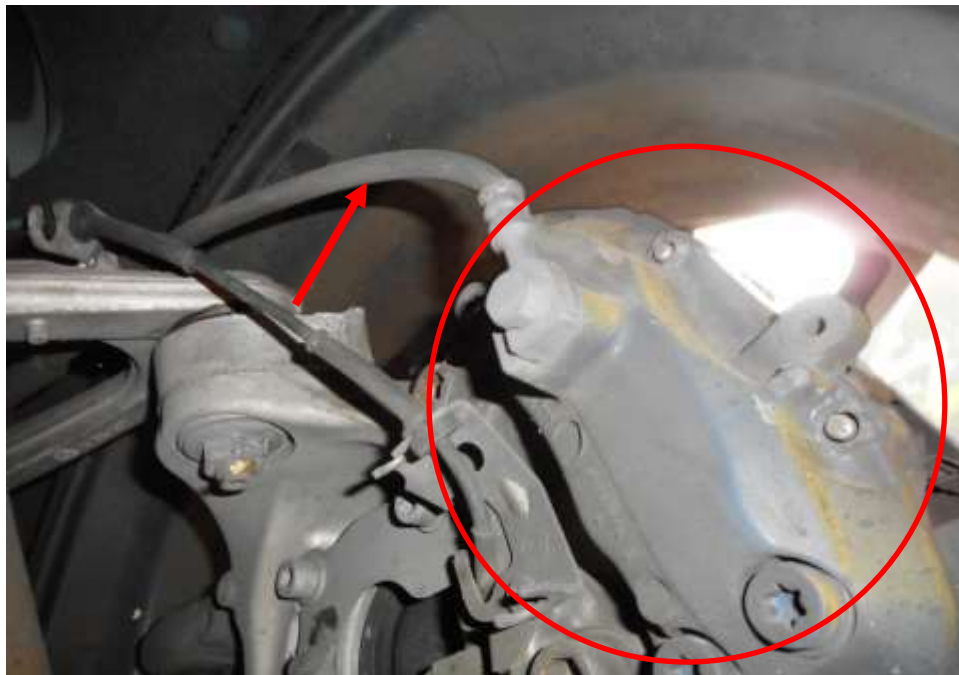
**Photo 29** shows the brake hose/pipe (arrowed) at the front right wheel of the Motor Car. No leakage of brake fluid was observed. Visual examination of the various components of the braking system like the brake caliper (circled), brake booster, brake pedal etc had revealed all to be intact and without visible damage at the time of accident. There was also no sign of fluid stain(s) observed on the various undercarriage components.

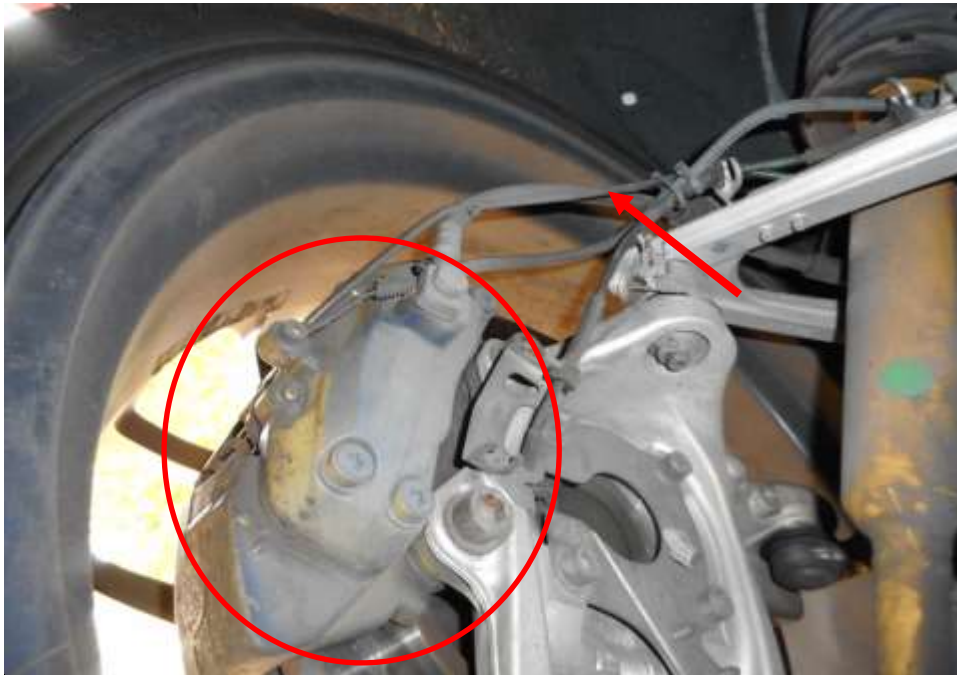
**Photo 30** shows the brake hose/pipe (arrowed) at the front left wheel of the Motor Car. No leakage of brake fluid was observed. Visual examination of the various components of the braking system like the brake caliper (circled), brake booster, brake pedal etc had revealed all to be intact and without visible damage at the time of accident. There was also no sign of fluid stain(s) observed on the various undercarriage components.
