Your Ref: TP/IP/00693/2020  
Our Ref : CI/TPD20001942/P

4<sup>th</sup> February 2020

**Fatal Accident Investigation Team**

**MECHANICAL INSPECTION REPORT OF MOTOR CAR SMG 27H**

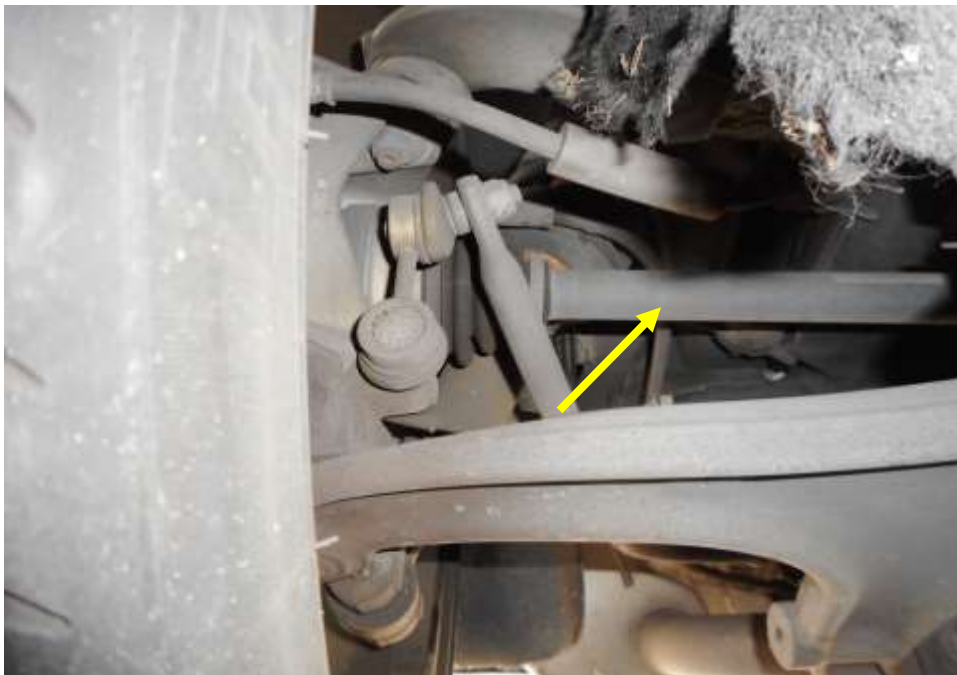
**Photo 31** shows the various undercarriage components at the rear left wheel of the Motor Car. The drive shaft (yellow arrow) was found to be intact and there was no sign of fluid stain(s) observed on the various undercarriage components.

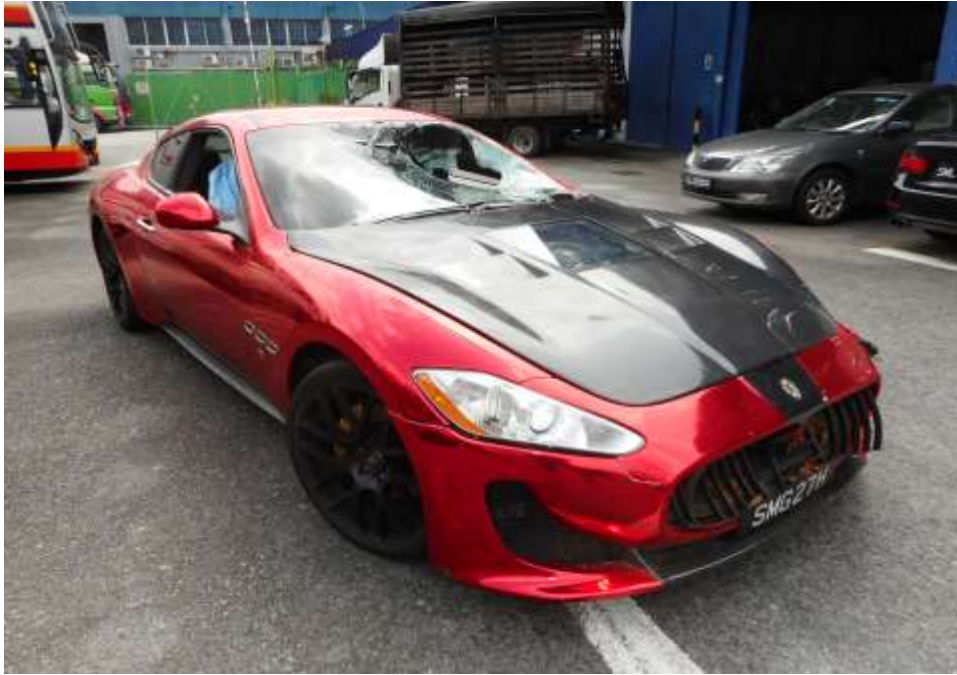
**Photo 32** shows the front right wheel of the Motor Car turned to its full left. During my steering system test, I did not experience any abnormal free play and/or resistance when I had turned the steering wheel towards full left and full right. This would suggest that the steering system of the Motor Car was likely to be in serviceable condition at the material time of accident.

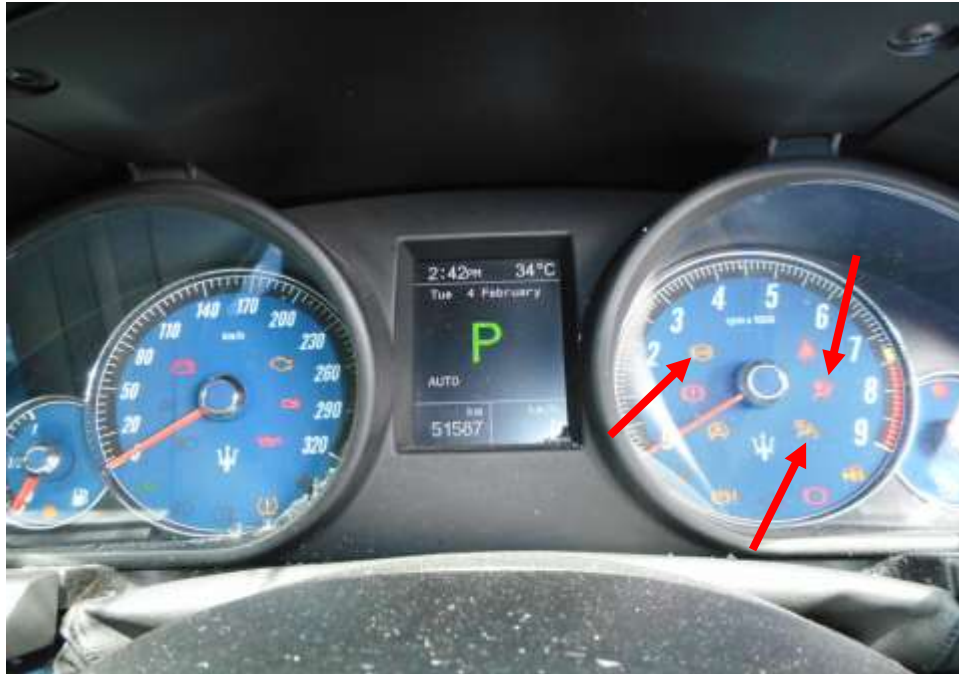
**Photo 33** shows the warning light for Anti-Lock Brake System (ABS) and Supplemental Restraint System (SRS) and Traction Control System (TC) appearing on the instrument panel of the Motor Car during the self-test of its various electronic operating systems when its engine was cranked.

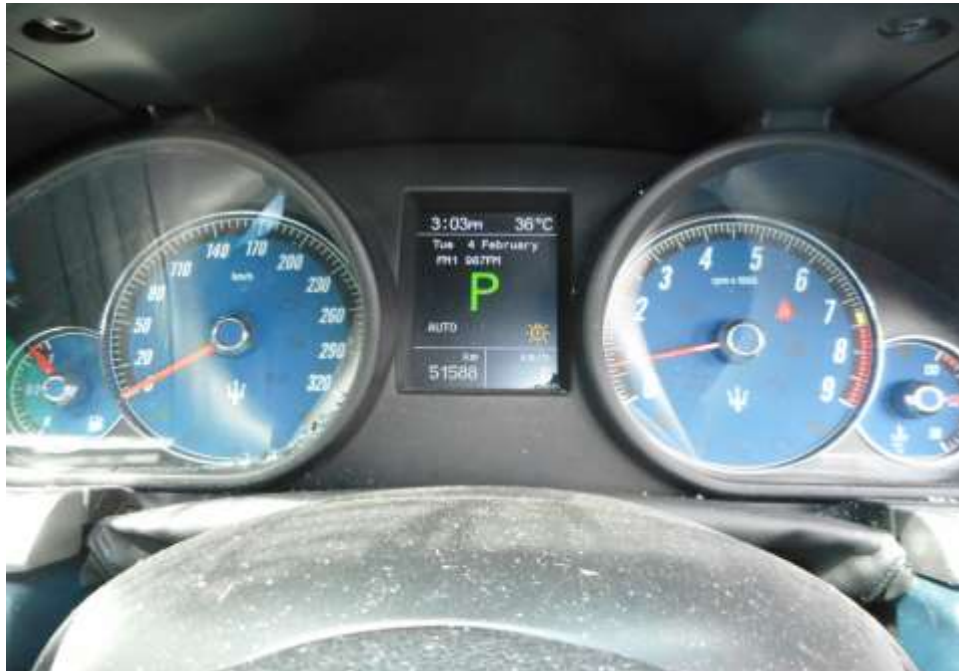
**Photo 34** shows no warning lights illuminated on the instrument panel of the Motor Car after the engine was cranked. This would suggest that there was no abnormality to the various electronic operating systems of the Motor Car, like the ABS, SRS and TC.
