Your Ref: TP/IP/00693/2020  
Our Ref : CI/TPD20001943/P

1<sup>st</sup> April 2020

**MECHANICAL INSPECTION REPORT OF MOTOR CAR SMN 5606S**

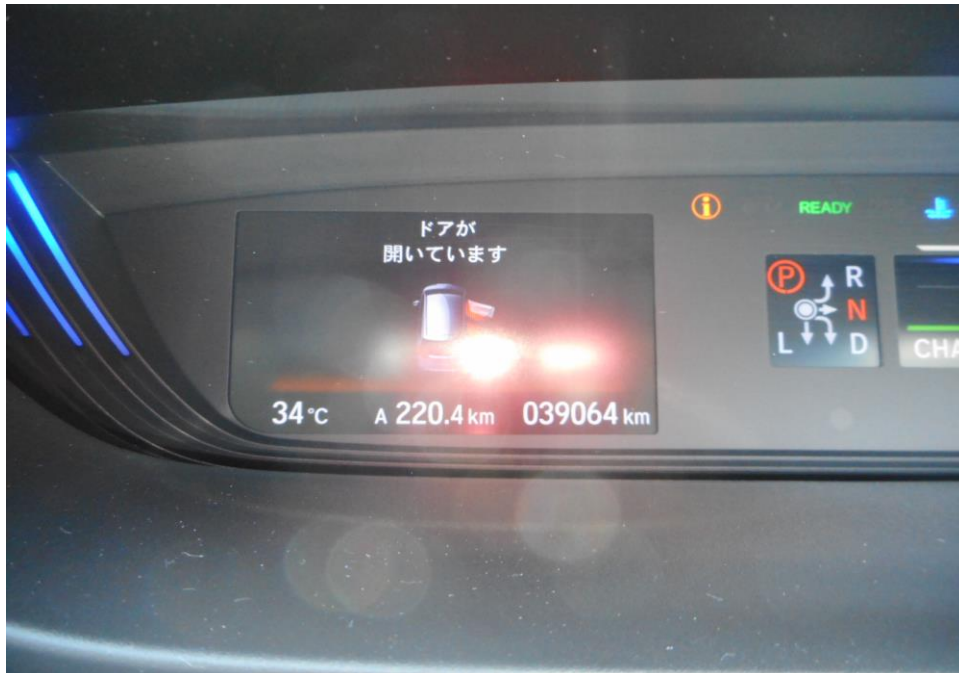
4. The mileage of the Motor Car at the time of my inspection was 39,064km.
5. There was no visible damage observed on Motor Car at the time of my inspection.

**Photo 1** shows a general view of the instrument cluster of the Motor Car at the time of my inspection. The mileage of the Motor Car was 39,064km

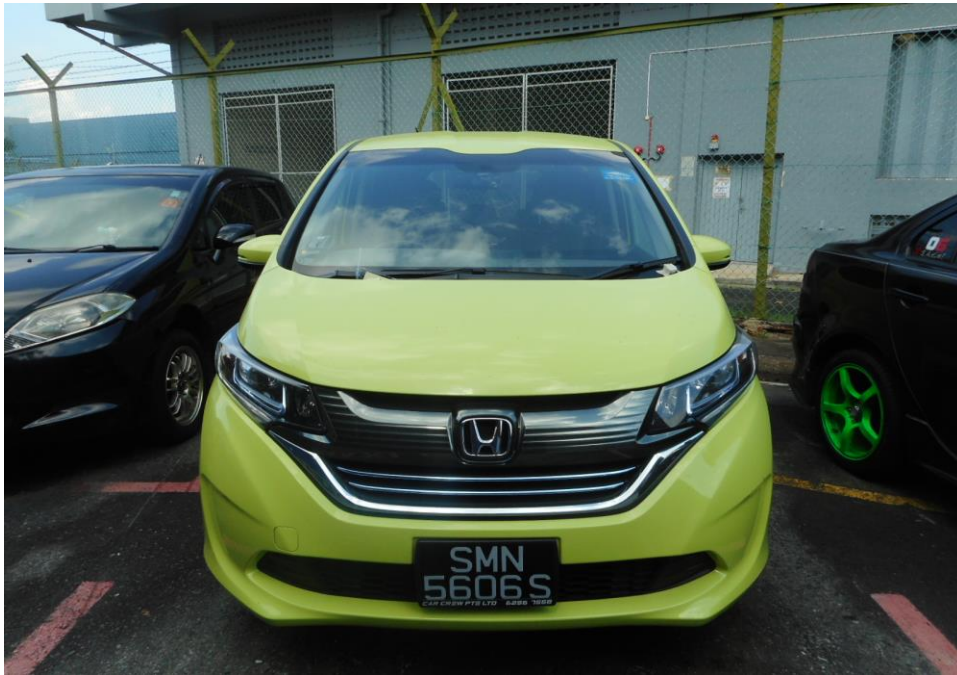
**Photo 2** shows a general view of the Motor Car at the time of my inspection. The Motor Car was observed to be intact and unaffected by the accident.

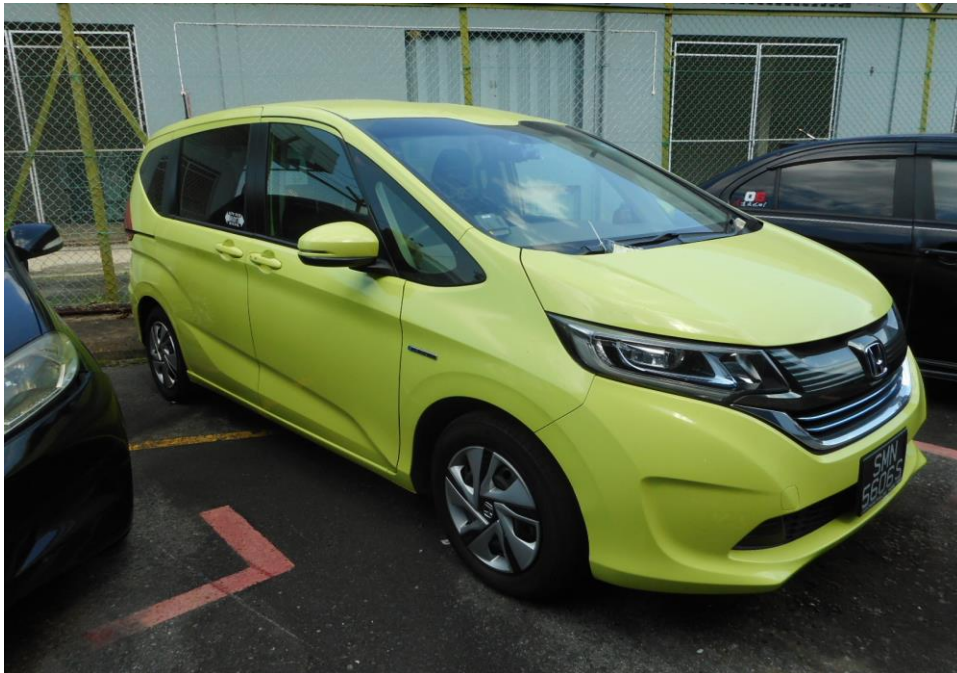
**Photo 3** shows a general view of the right body of the Motor Car at the time of my inspection. The Motor Car was observed to be intact and unaffected by the accident.

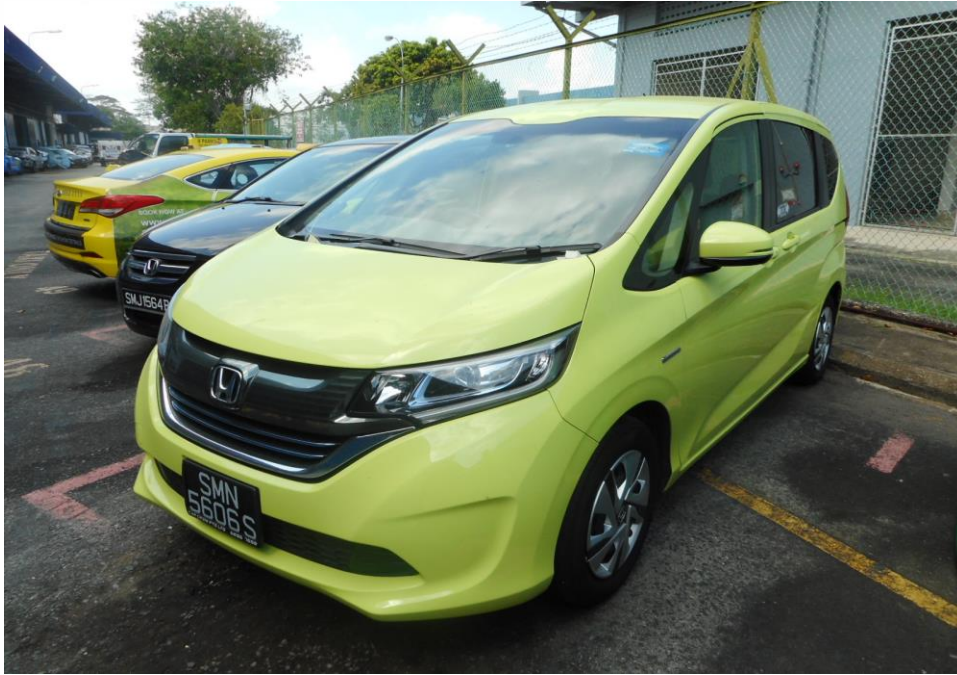
**Photo 4** shows a general view of the left body of the Motor Car at the time of my inspection. The Motor Car was observed to be intact and unaffected by the accident.

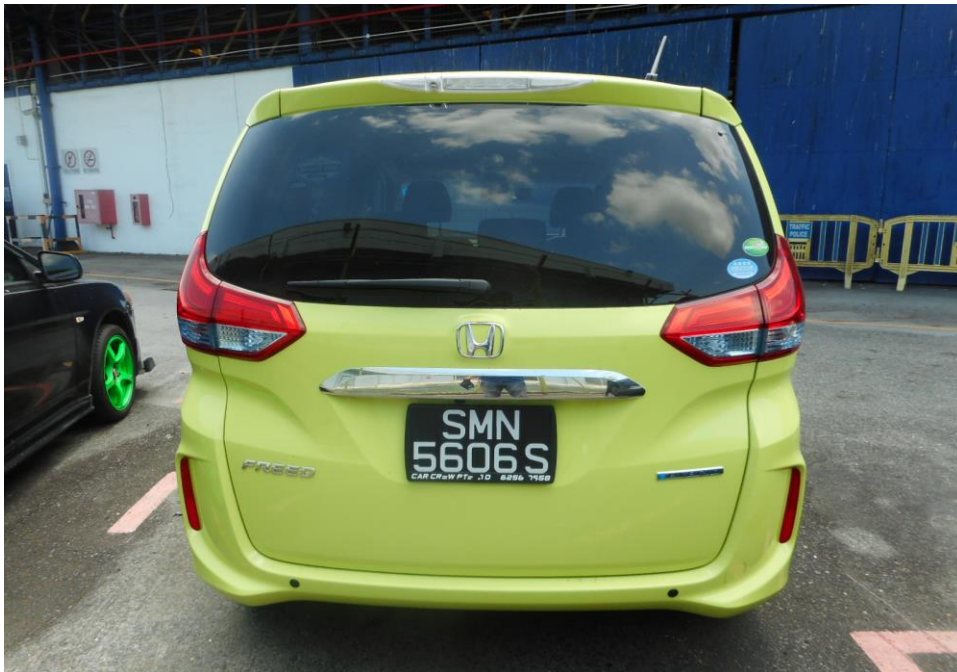
**Photo 5** shows a general view of the rear body of the Motor Car at the time of my inspection. The Motor Car was observed to be intact and unaffected by the accident.

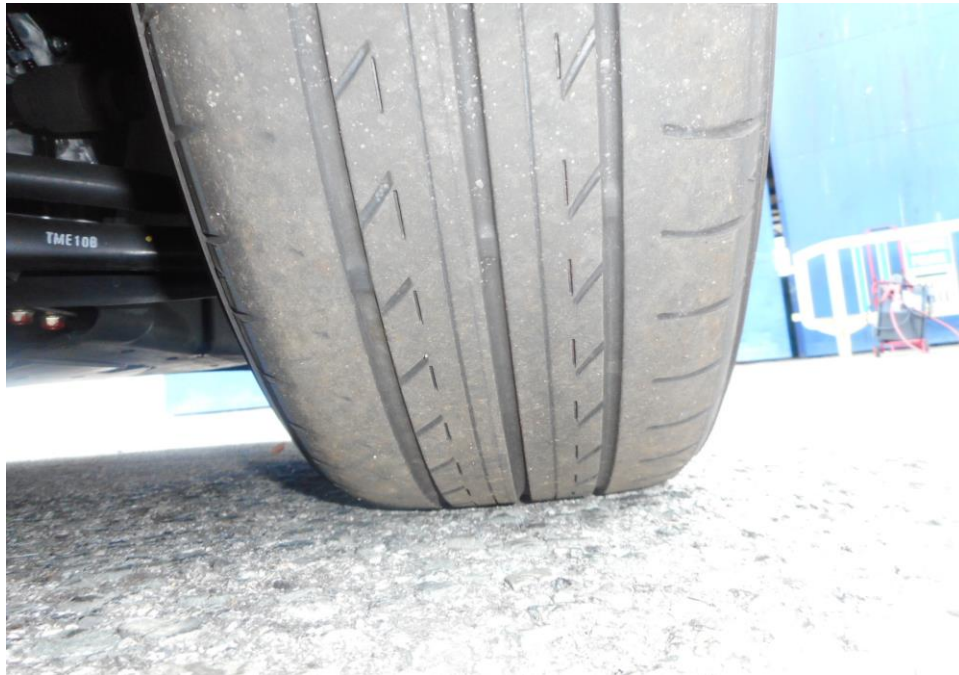
**Photo 6** shows the condition of the front right tyre of the Motor Car, which was observed to be in serviceable condition with remaining tread depth of approximately 3.3mm. The tyre, which was wrapped around standard alloy wheel rim, was also observed to be sufficiently inflated for vehicular operation. There was no tear, cut or burst mark(s) on the outer and the inner sidewalls as well as across the tread of the 4 tyres that were fitted on the Motor Car.

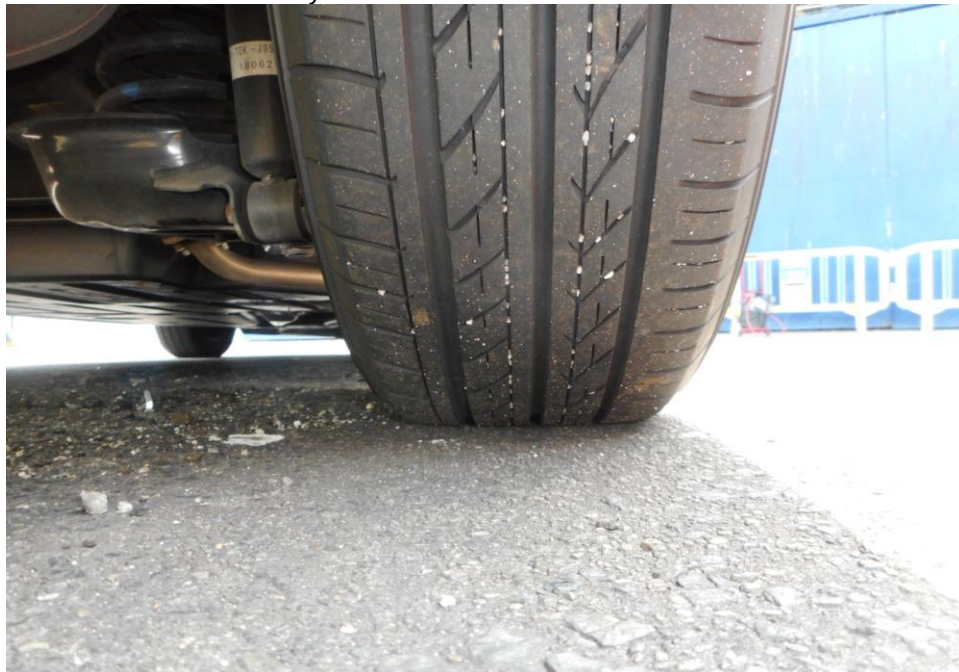
**Photo 7** shows the condition of the rear right tyre of the Motor Car, which was observed to be in serviceable condition with remaining tread depth of approximately 5.1mm. The tyre, which was wrapped around standard alloy wheel rim, was also observed to be sufficiently inflated for vehicular operation.

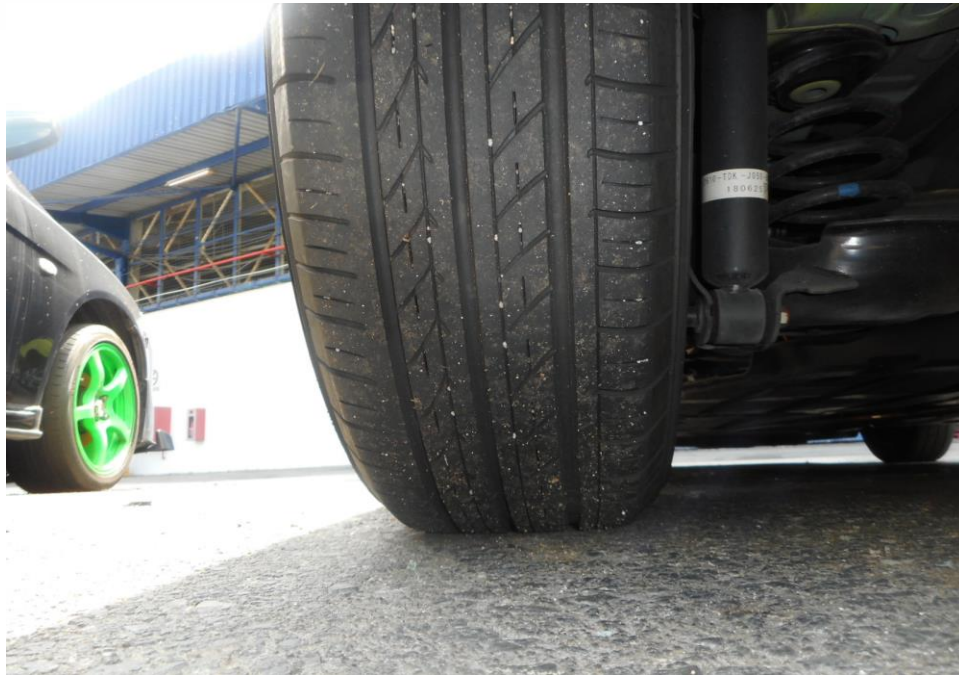
**Photo 8** shows the condition of the rear left tyres of the Motor Car, which was observed to be in serviceable condition with remaining tread depth of approximately 4mm. The tyres, which were wrapped around standard alloy wheel rim, were also observed to be sufficiently inflated for vehicular operation. There was also no damage found on all 4 alloy wheel rims of the Motor Car.

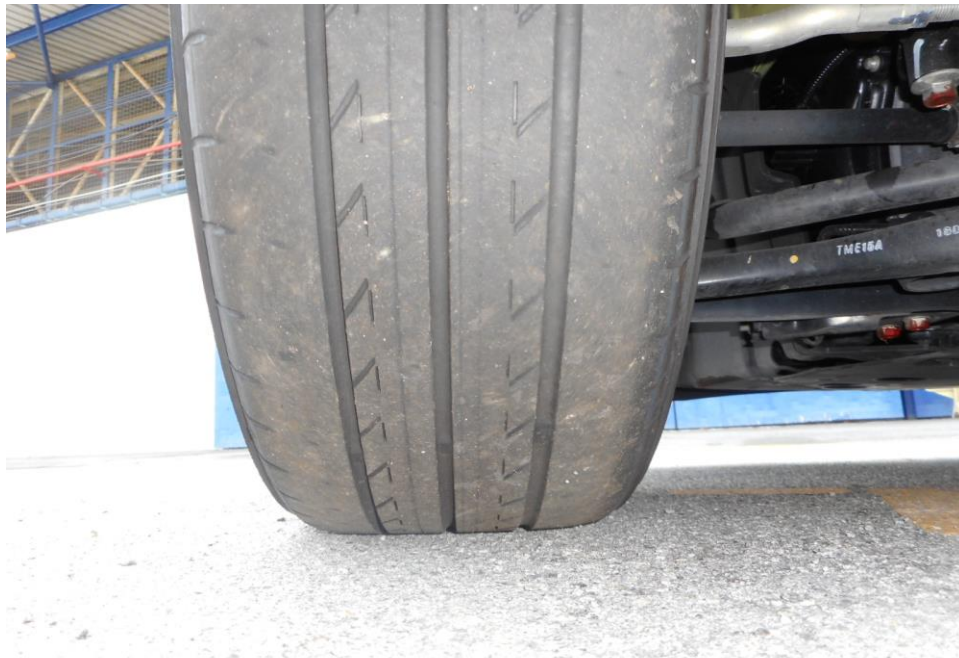
**Photo 9** shows the condition of the rear right tyres of the Motor Car, which were observed to be in serviceable condition with remaining, tread depth of approximately 2.9mm. There was also no tear, cut or burst mark(s) on the outer and the inner sidewalls as well as across the tread of the 4 tyres that were fitted on the Motor Car.

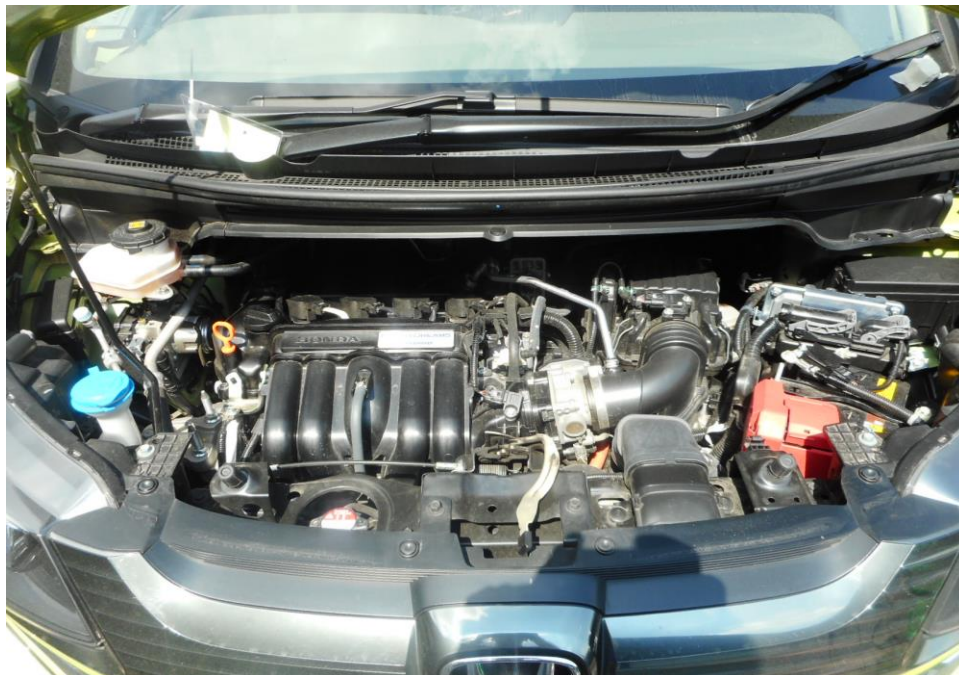
**Photo 10** shows a general view of the Motor Car's engine compartment, which was accessed by lifting the front cabin of the Motor Car. The various parts and components inside the engine compartment were unaffected by the accident. There was also no sign(s) or indication(s) of fresh fluid leakage and/or fluid stain within the engine compartment

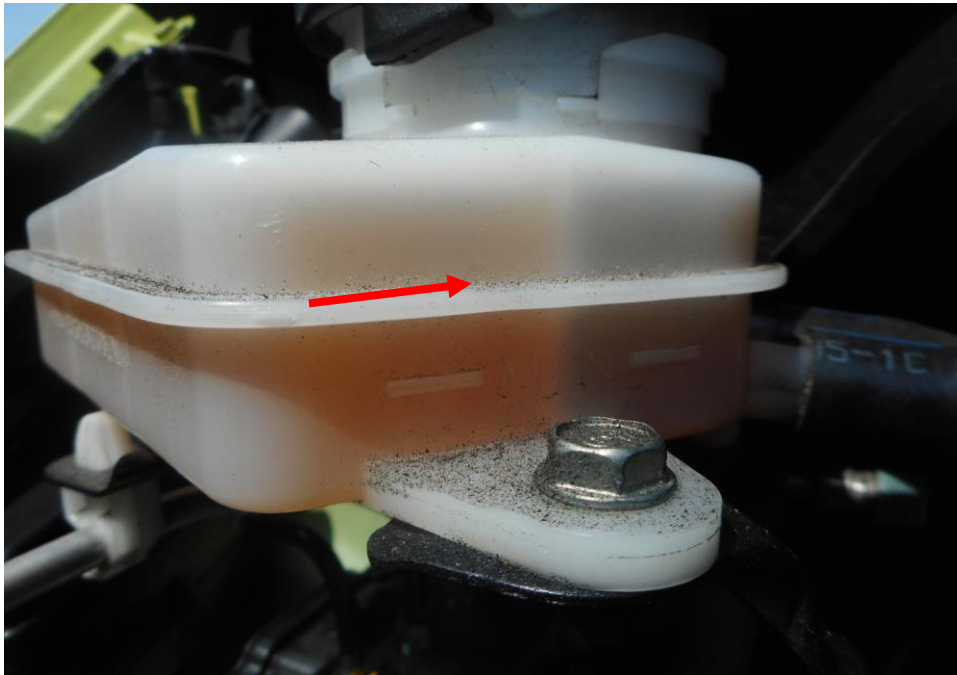
**Photo 11** shows the brake fluid reservoir of the Motor Car at the time of my inspection. The brake fluid was observed to be of sufficient level (arrowed) and without any visible contamination.

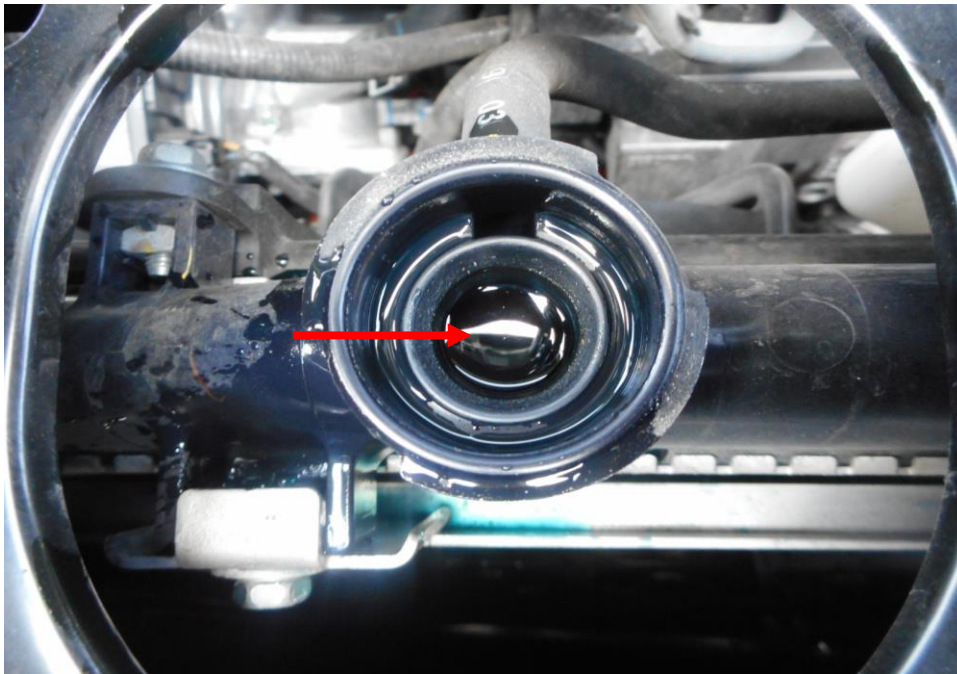
**Photo 12** shows the engine coolant reservoir of the Motor Car at the time of my inspection. The engine coolant was observed to be of sufficient level (arrowed) and without any visible contamination.

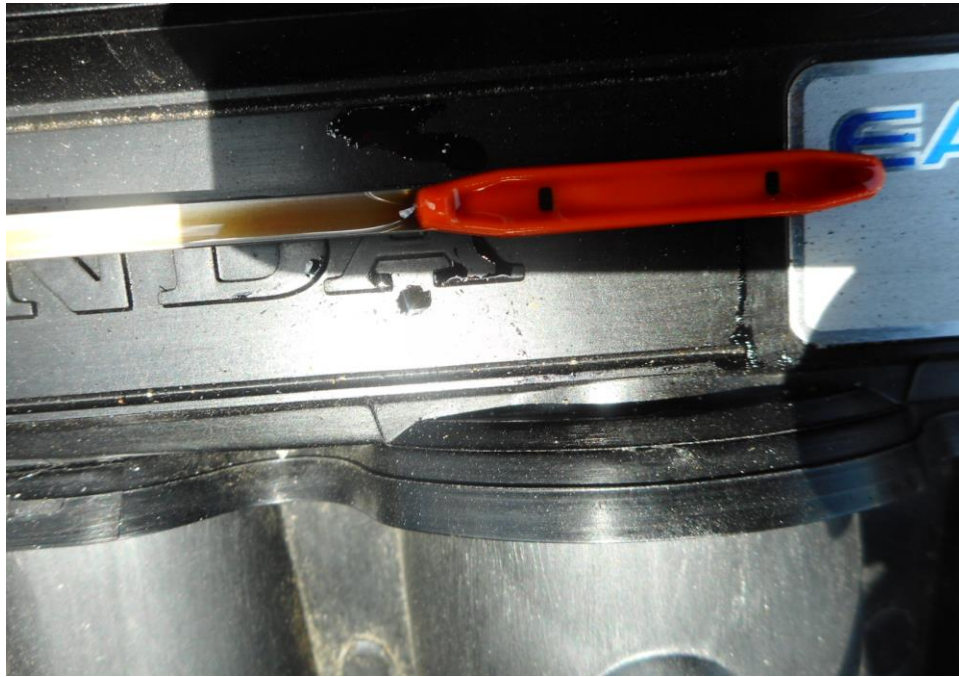
**Photo 13** shows the engine oil dip stick of the Motor Car at the time of my inspection. The engine oil was observed to be of sufficient level and without any visible contamination.

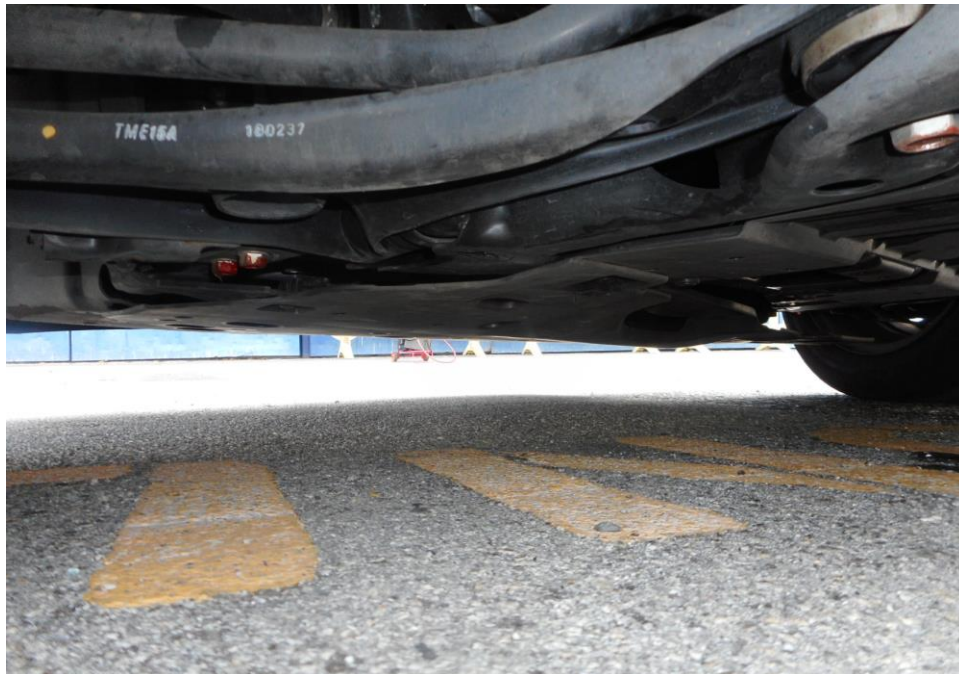
**Photo 14** shows the undercarriage of the Motor Car, at the area where the engine housing and transmission housing are located. . I did not find any sign(s) or indication(s) of fluid leak and/or fluid stain(s) on the underside of the Motor Car.

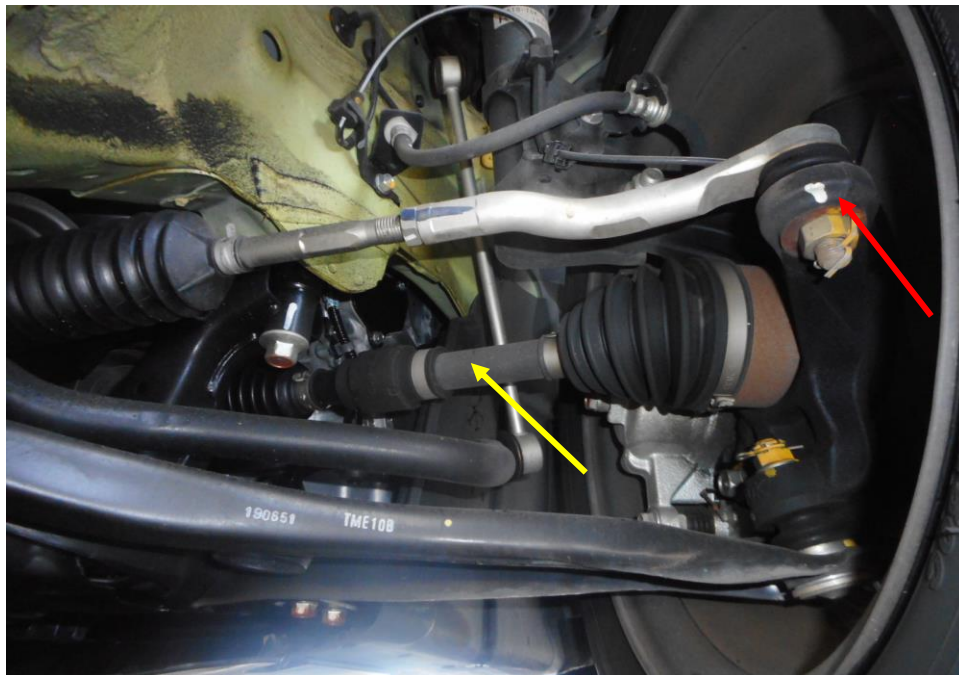
**Photo 15** shows the various undercarriage components at the front right wheel of the Motor Car, in particular the steering tie rod end (arrowed) and drive shaft (yellow arrow). The various steering components were all found to be intact, suggesting that the steering system of the Motor Car was likely to be in serviceable condition at the material time of accident. There was also no sign of fluid stain(s) observed on the various undercarriage components.

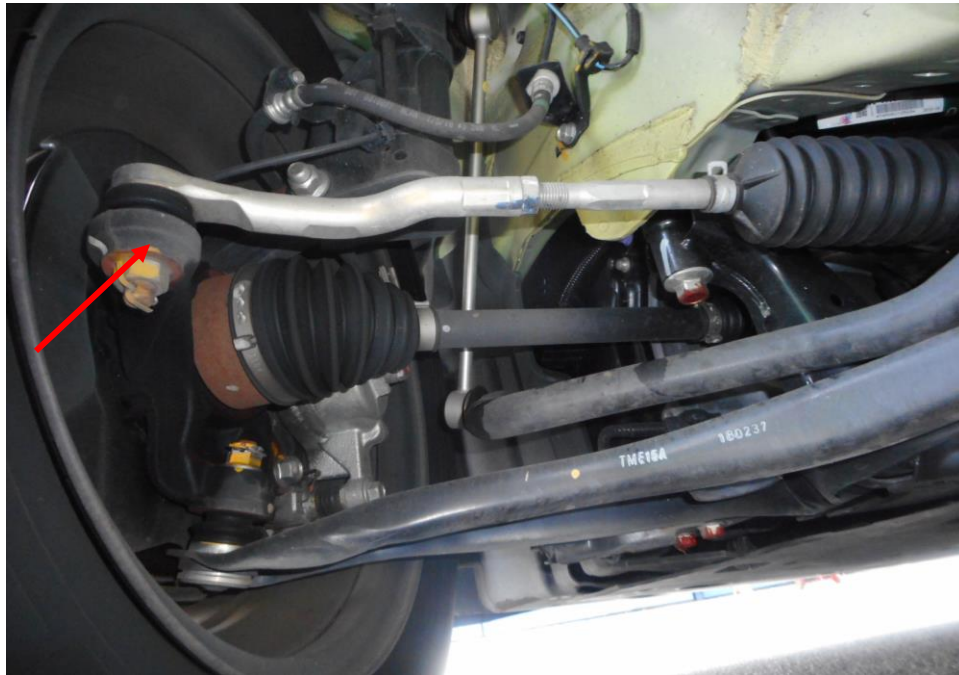
**Photo 16** shows the various undercarriage components at the front left wheel of the Motor Car, in particular the steering tie rod end (arrowed). The various Undercarriage components of the Motor Car were all found to be intact without any visible damage. There was also no sign of fluid stain(s) observed on the various undercarriage components.

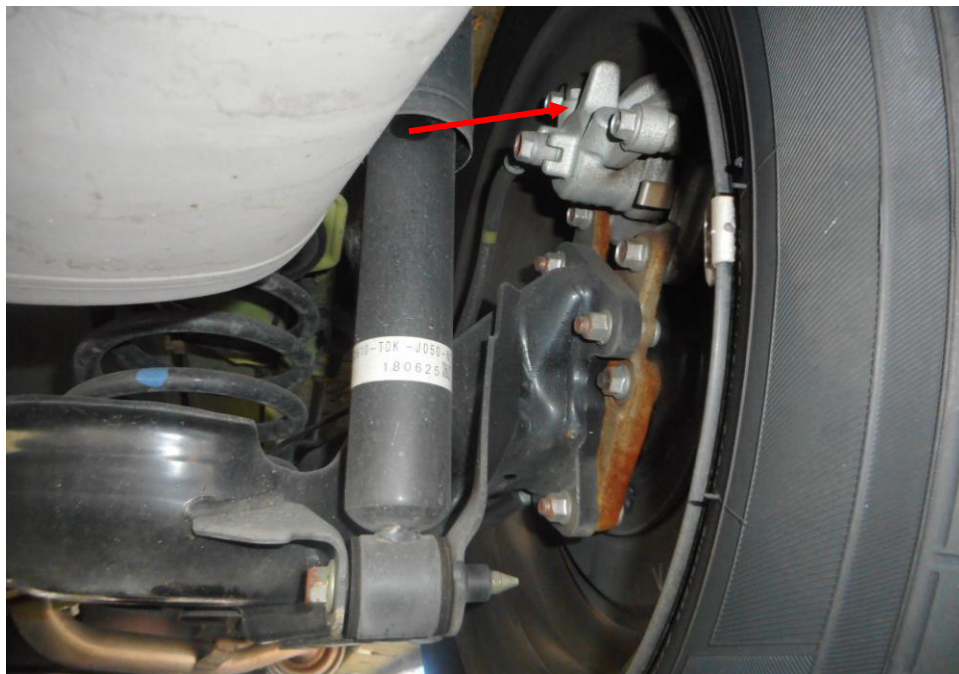
**Photo 17** shows the brake pipe (arrowed) at the rear right wheel of the Motor Car. I did not observe any leakage of brake fluid at the time of my inspection of the Motor Car. My static tests of the Motor Car's braking system, along with my visual examination of the various mechanical components in the braking system, had indicated that there was no internal leakage of pressure/vacuum. Hence the braking system of the Motor Car was likely to be in serviceable condition at the material time of accident.

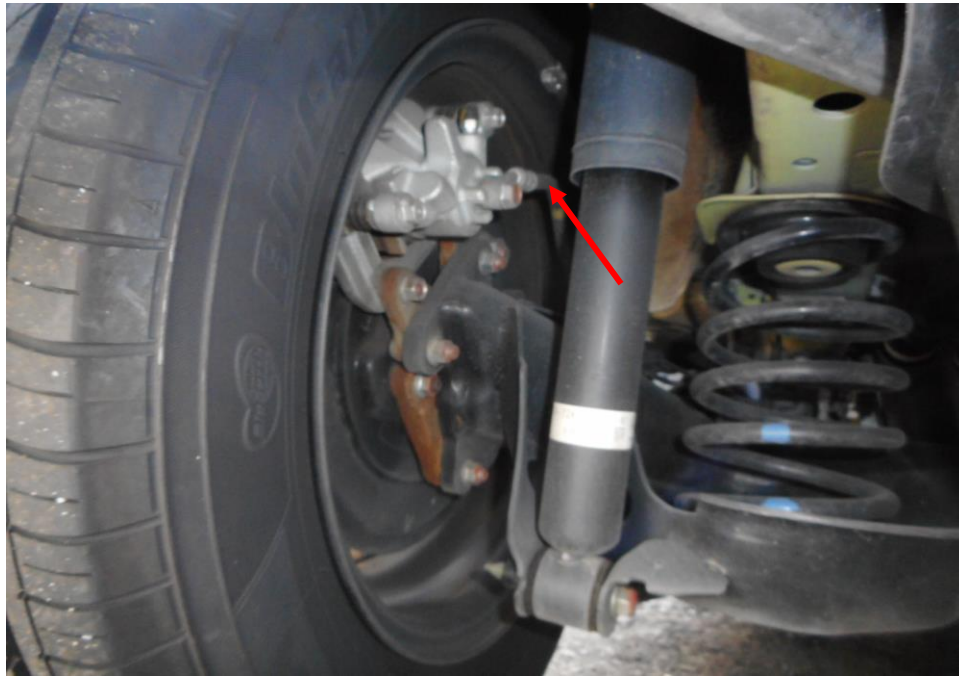
**Photo 18** shows the brake pipe (arrowed) at the rear left wheel of the Motor Car. I did not observe any leakage of brake fluid at the time of my inspection of the Motor Car. My static tests of the Motor Car's braking system, along with my visual examination of the various mechanical components in the braking system had indicated that there was no internal leakage of pressure/vacuum. Hence the braking system of the Motor Car was likely to be in serviceable condition at the material time of accident.

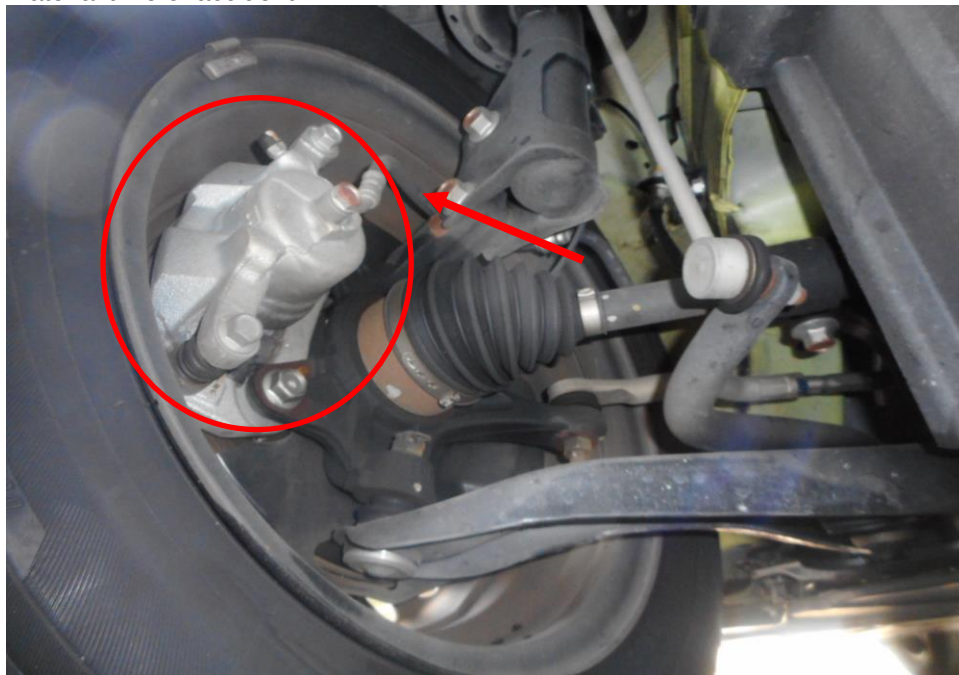
**Photo 19** shows the brake hose/pipe (arrowed) at the front right wheel of the Motor Car. No leakage of brake fluid was observed. Visual examination of the various components of the braking system like the brake caliper (circled), brake booster, brake pedal etc had revealed all to be intact and without visible damage at the time of accident. There was also no sign of fluid stain(s) observed on the various undercarriage components.

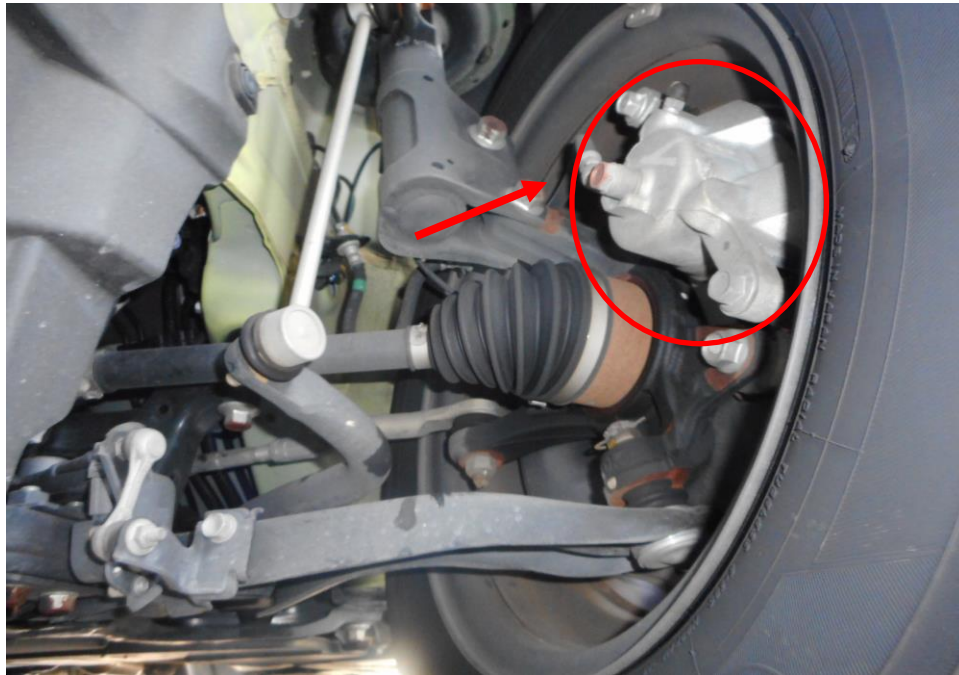
**Photo 20** shows the brake hose/pipe (arrowed) at the front left wheel of the Motor Car. No leakage of brake fluid was observed. Visual examination of the various components of the braking system like the brake caliper (circled), brake booster, brake pedal etc had revealed all to be intact and without visible damage at the time of accident. There was also no sign of fluid stain(s) observed on the various undercarriage components.

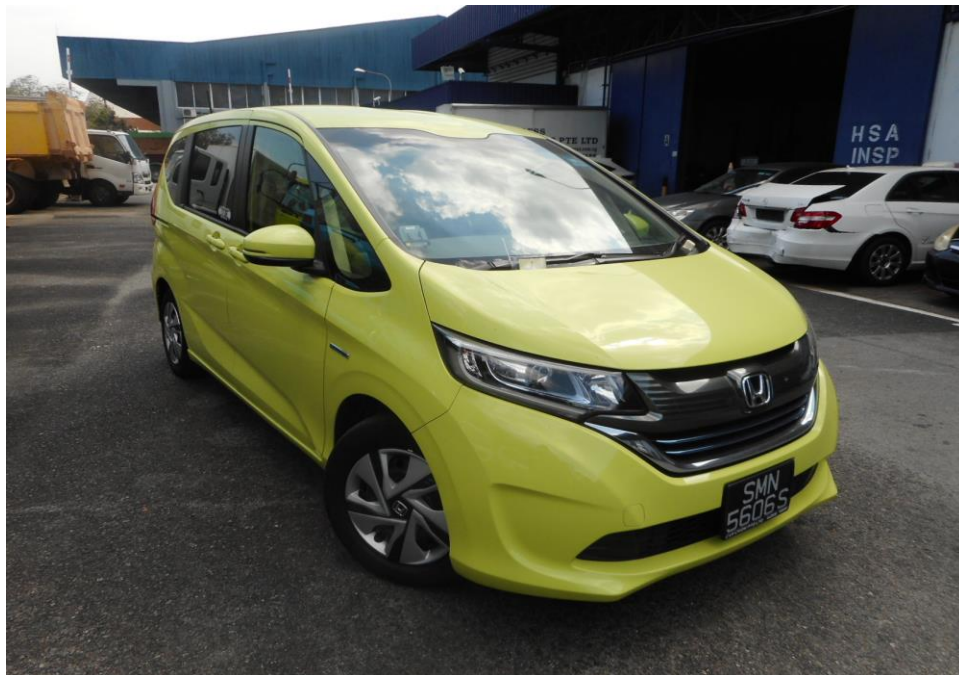
**Photo 21** shows the front right wheel of the Motor Car turned to its full left. During my steering system test, I did not experience any abnormal free play and/or resistance when I had turned the steering wheel towards full left and full right. This would suggest that the steering system of the Motor Car was likely to be in serviceable condition at the material time of accident.

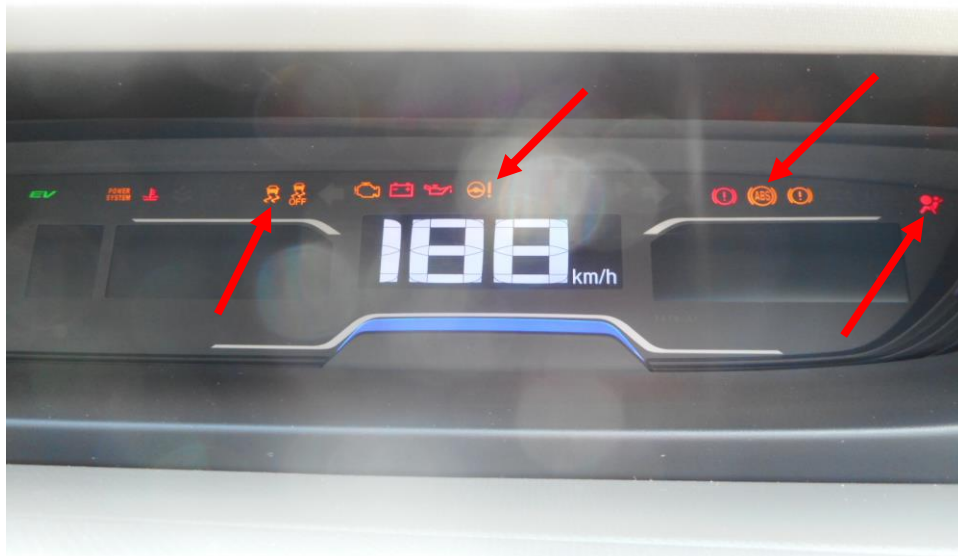
**Photo 22** shows the warning light for Anti-Lock Brake System (ABS), Traction Control (TC), Supplemental Restraint System (SRS) and Electric Power Steering System (EPS) appearing on the instrument panel of the Motor Car during the self-test of its various electronic operating systems when its engine was cranked.

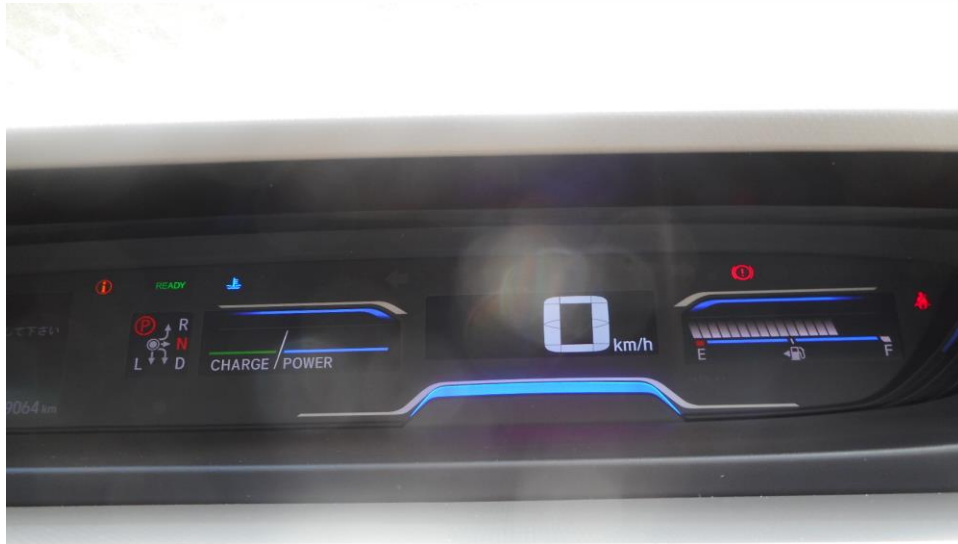
**Photo 23** shows no warning lights illuminated on the instrument panel of the Motor Car after the engine was cranked. This would suggest that there was no abnormality to the various electronic operating systems of the Motor Car, like the ABS, TC, SRS and EPS.
