Your Ref: TP/IP/00693/2020  
Our Ref : CI/TPD20001943/P

### **Fatal Accident Investigation Team**

### **MECHANICAL INSPECTION REPORT OF MOTOR CAR SMN 5606S**

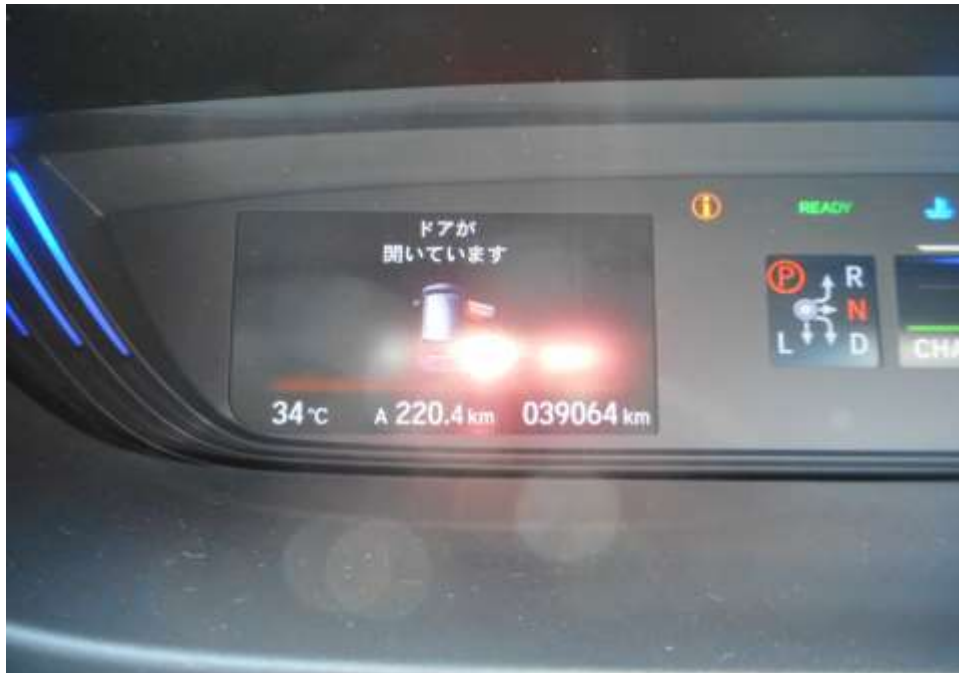
**Photo 1** shows a general view of the instrument cluster of the Motor Car at the time of my inspection. The mileage of the Motor Car was 39,064km

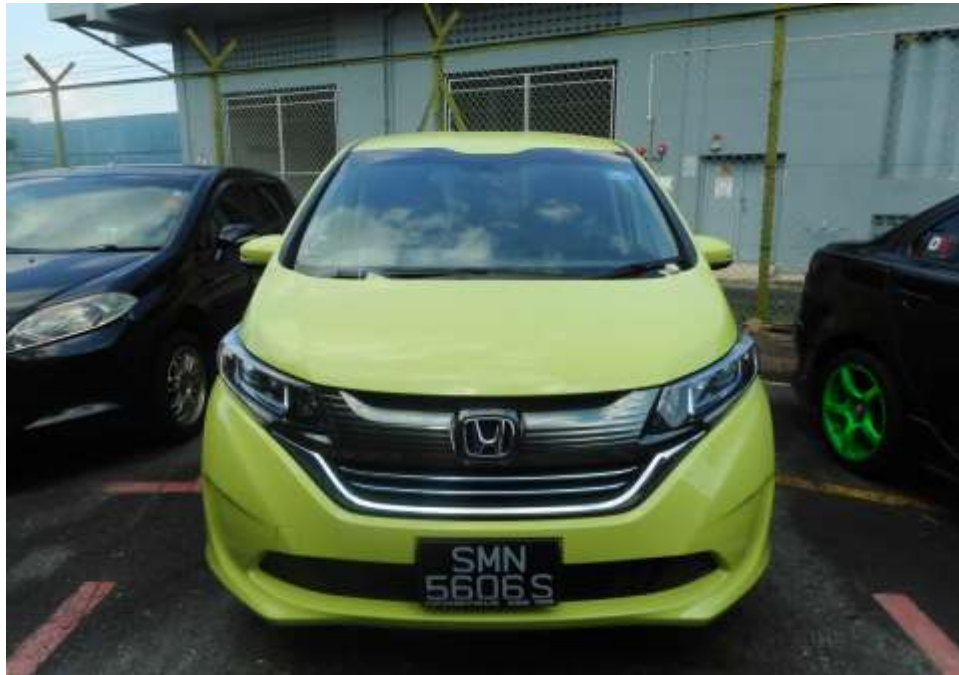
**Photo 2** shows a general view of the Motor Car at the time of my inspection. The Motor Car was observed to be intact and unaffected by the accident.

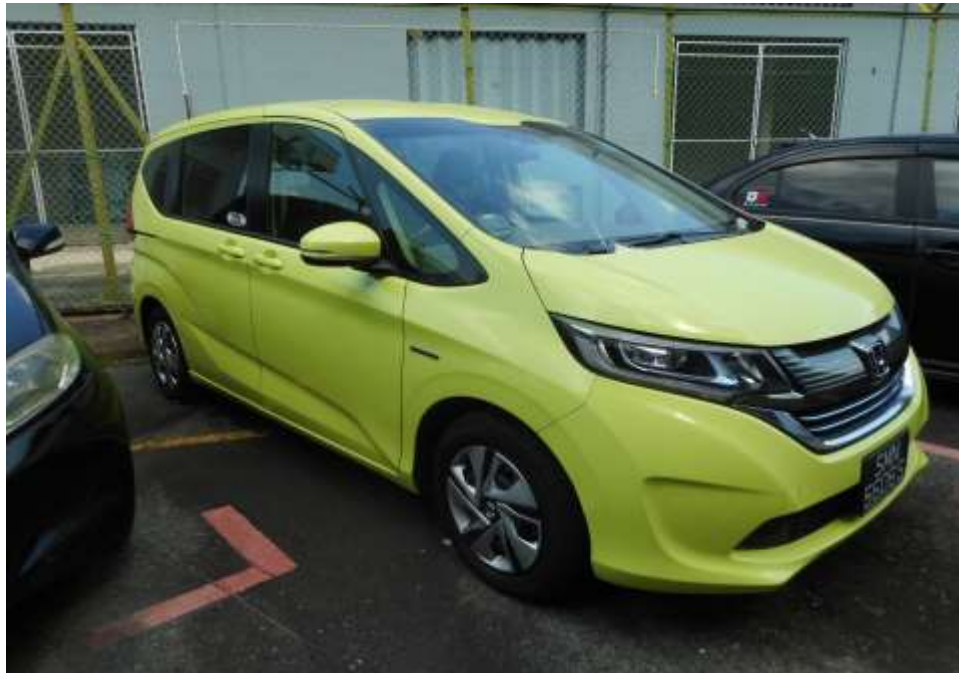
**Photo 3** shows a general view of the right body of the Motor Car at the time of my inspection. The Motor Car was observed to be intact and unaffected by the accident.

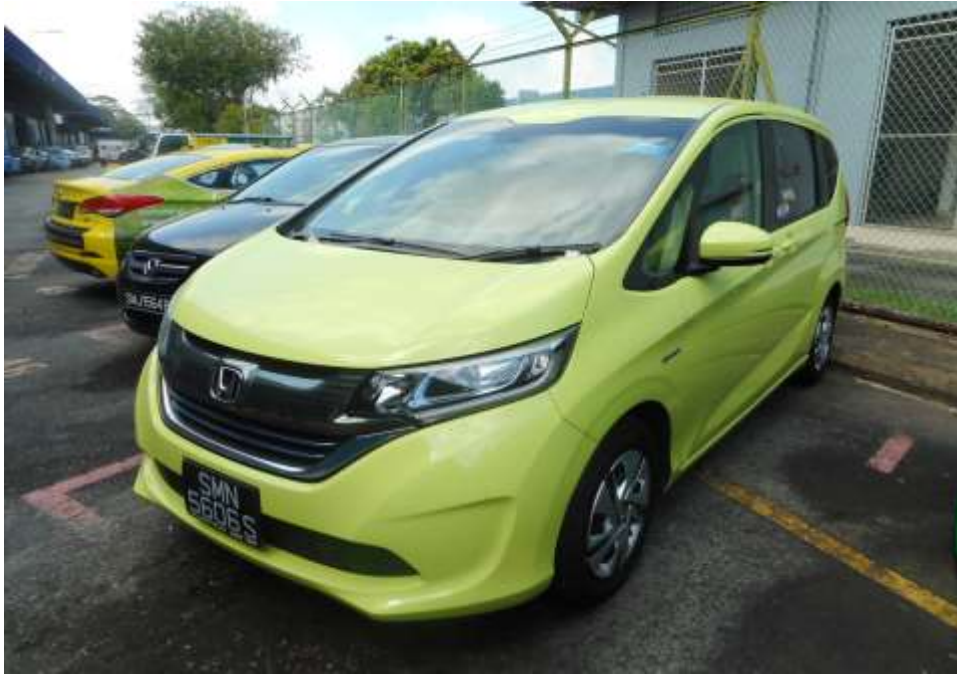
**Photo 4** shows a general view of the left body of the Motor Car at the time of my inspection. The Motor Car was observed to be intact and unaffected by the accident.

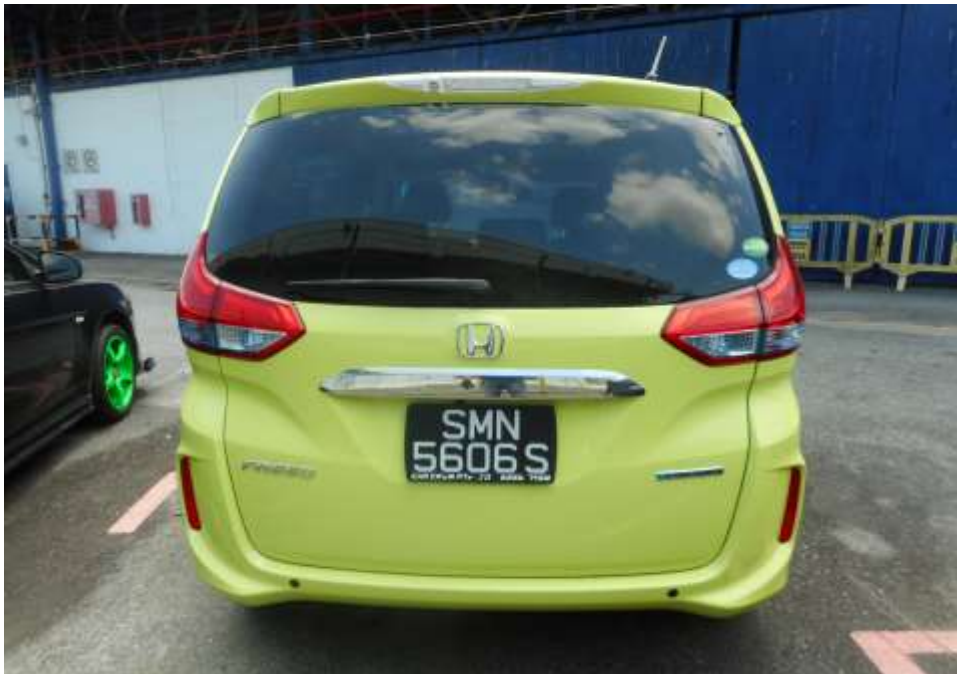
**Photo 5** shows a general view of the rear body of the Motor Car at the time of my inspection. The Motor Car was observed to be intact and unaffected by the accident.

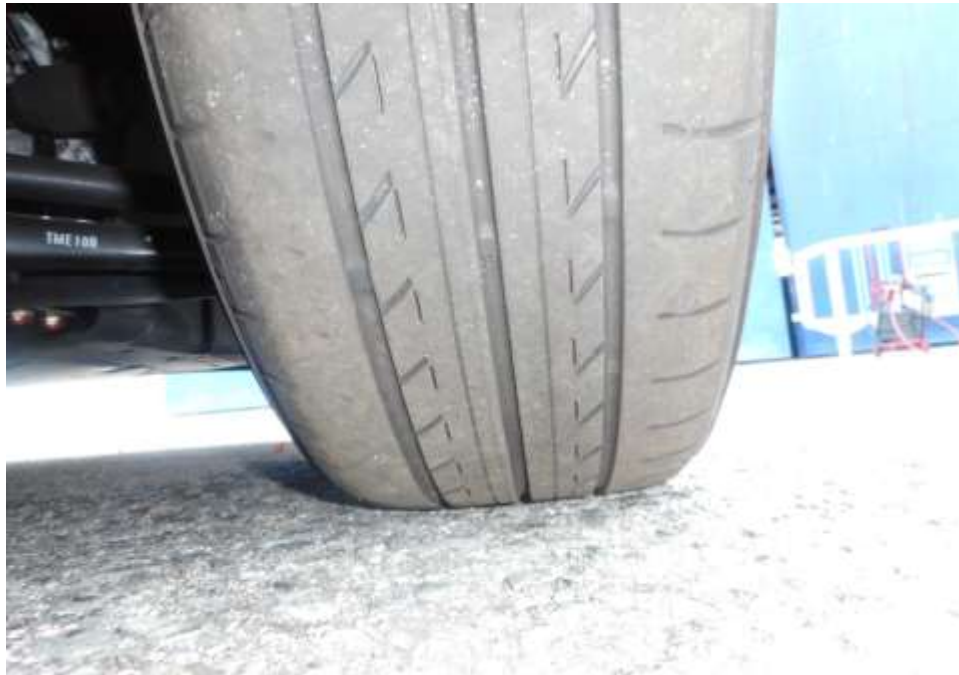
**Photo 6** shows the condition of the front right tyre of the Motor Car, which was observed to be in serviceable condition with remaining tread depth of approximately 3.3mm. The tyre, which was wrapped around standard alloy wheel rim, was also observed to be sufficiently inflated for vehicular operation. There was no tear, cut or burst mark(s) on the outer and the inner sidewalls as well as across the tread of the 4 tyres that were fitted on the Motor Car.

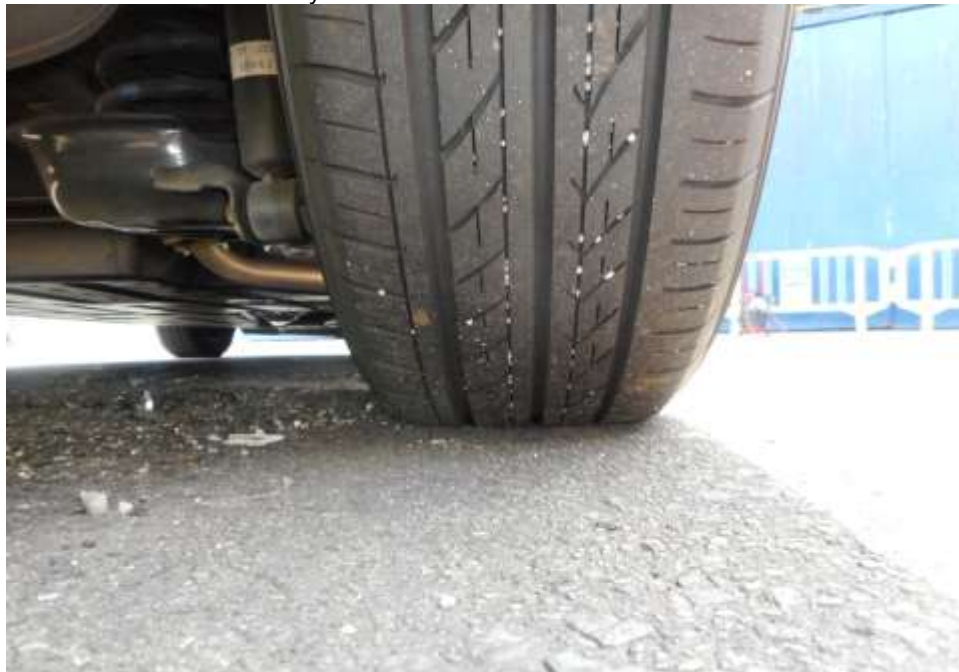
**Photo 7** shows the condition of the rear right tyre of the Motor Car, which was observed to be in serviceable condition with remaining tread depth of approximately 5.1mm. The tyre, which was wrapped around standard alloy wheel rim, was also observed to be sufficiently inflated for vehicular operation.

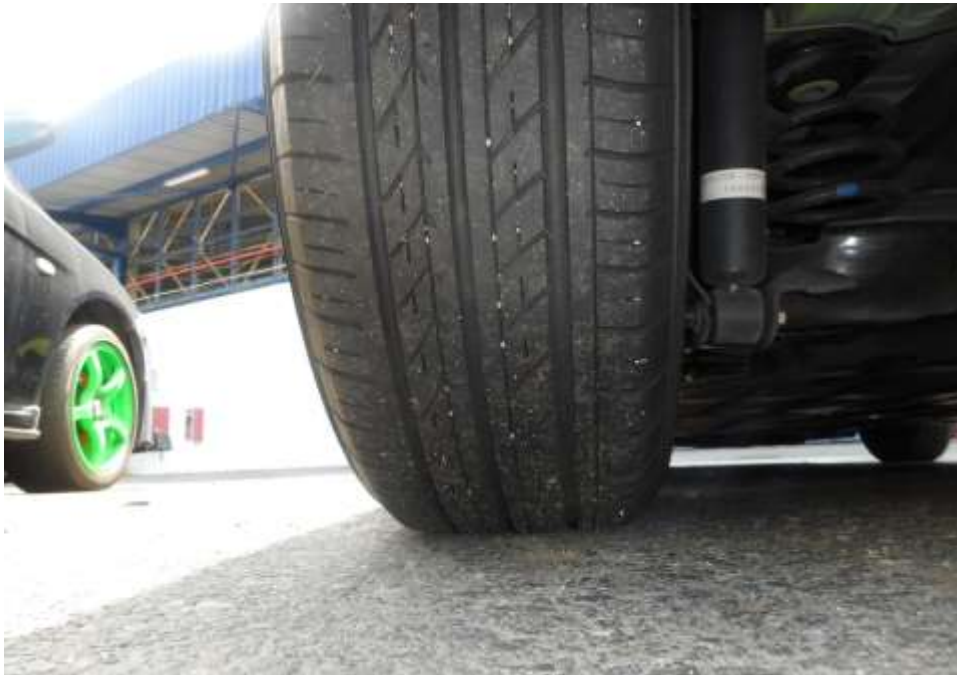
**Photo 8** shows the condition of the rear left tyres of the Motor Car, which was observed to be in serviceable condition with remaining tread depth of approximately 4mm. The tyres, which were wrapped around standard alloy wheel rim, were also observed to be sufficiently inflated for vehicular operation. There was also no damage found on all 4 alloy wheel rims of the Motor Car.

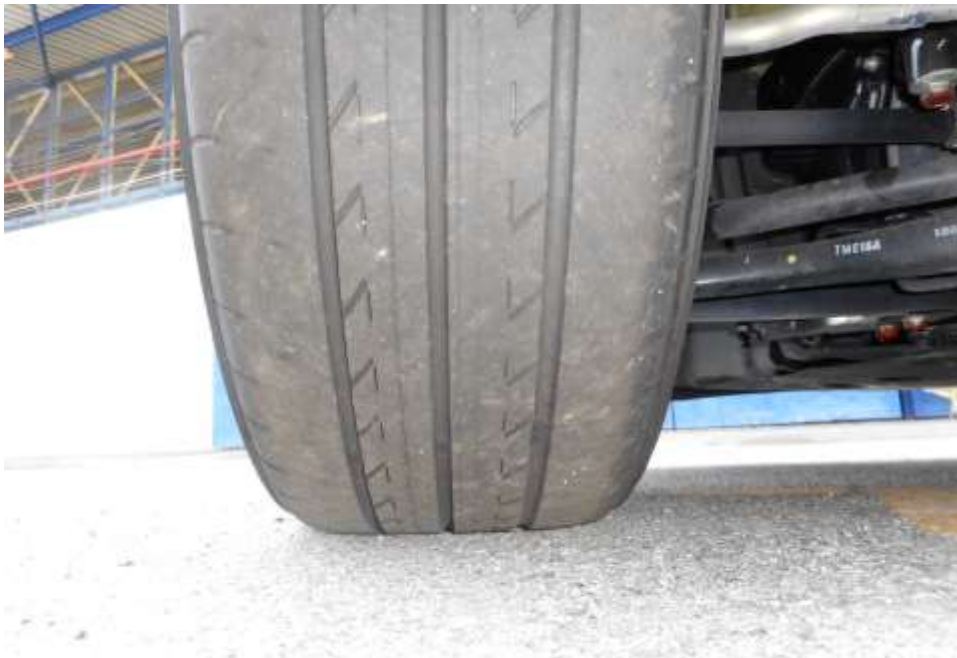
**Photo 9** shows the condition of the rear right tyres of the Motor Car, which were observed to be in serviceable condition with remaining, tread depth of approximately 2.9mm. There was also no tear, cut or burst mark(s) on the outer and the inner sidewalls as well as across the tread of the 4 tyres that were fitted on the Motor Car.

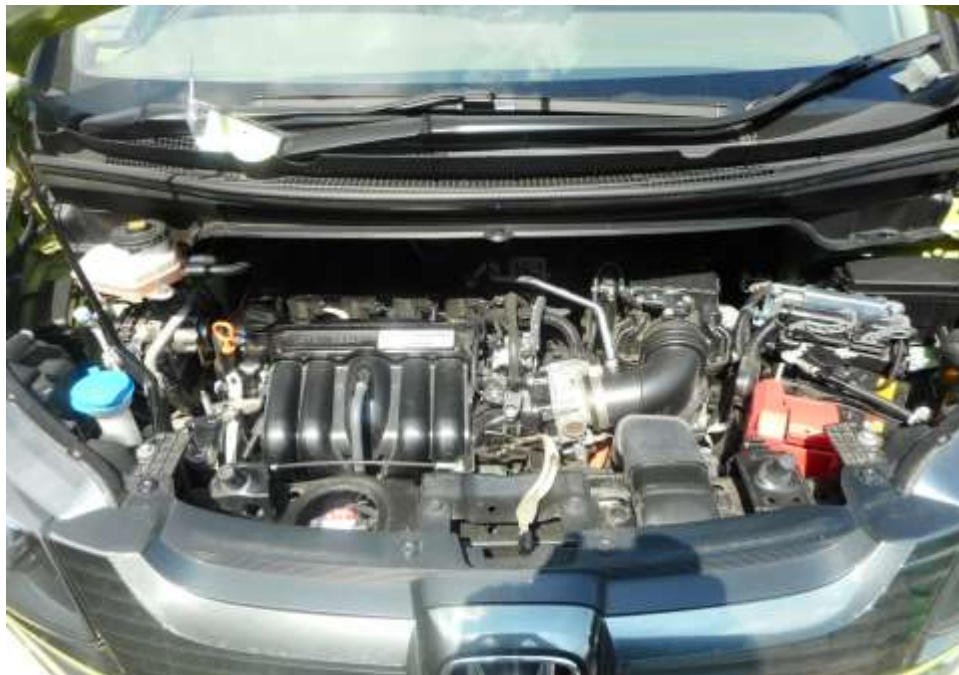
**Photo 10** shows a general view of the Motor Car's engine compartment, which was accessed by lifting the front cabin of the Motor Car. The various parts and components inside the engine compartment were unaffected by the accident. There was also no sign(s) or indication(s) of fresh fluid leakage and/or fluid stain within the engine compartment

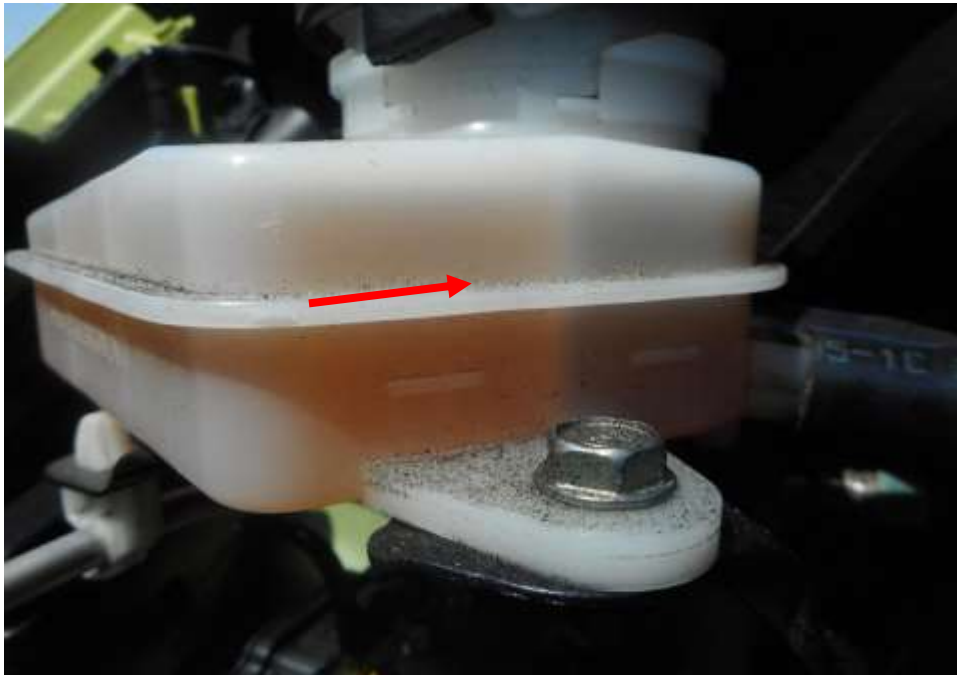
**Photo 11** shows the brake fluid reservoir of the Motor Car at the time of my inspection. The brake fluid was observed to be of sufficient level (arrowed) and without any visible contamination.

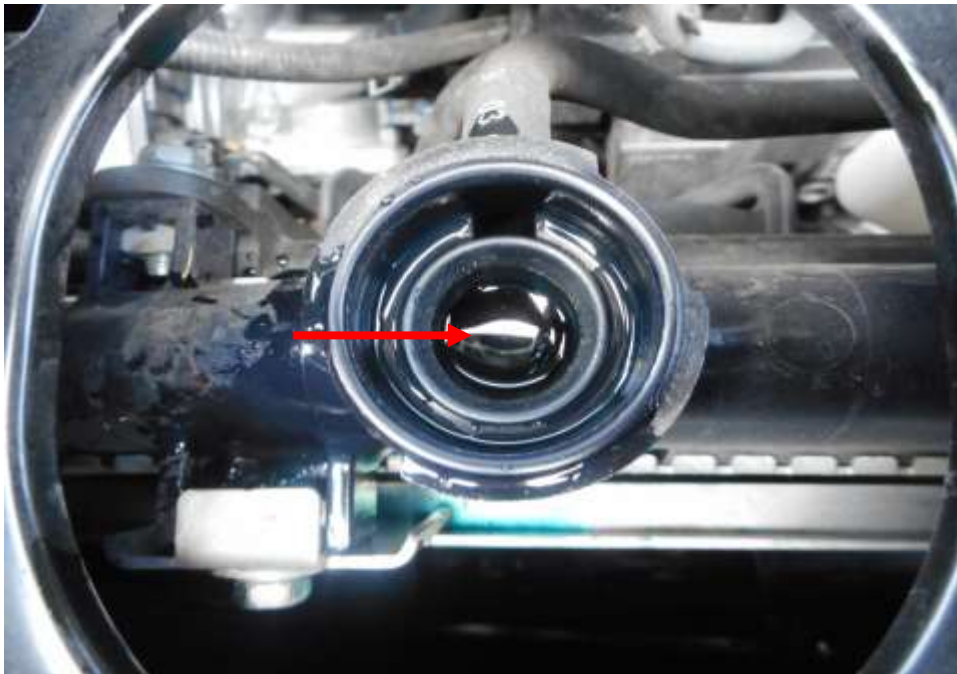
**Photo 12** shows the engine coolant reservoir of the Motor Car at the time of my inspection. The engine coolant was observed to be of sufficient level (arrowed) and without any visible contamination.

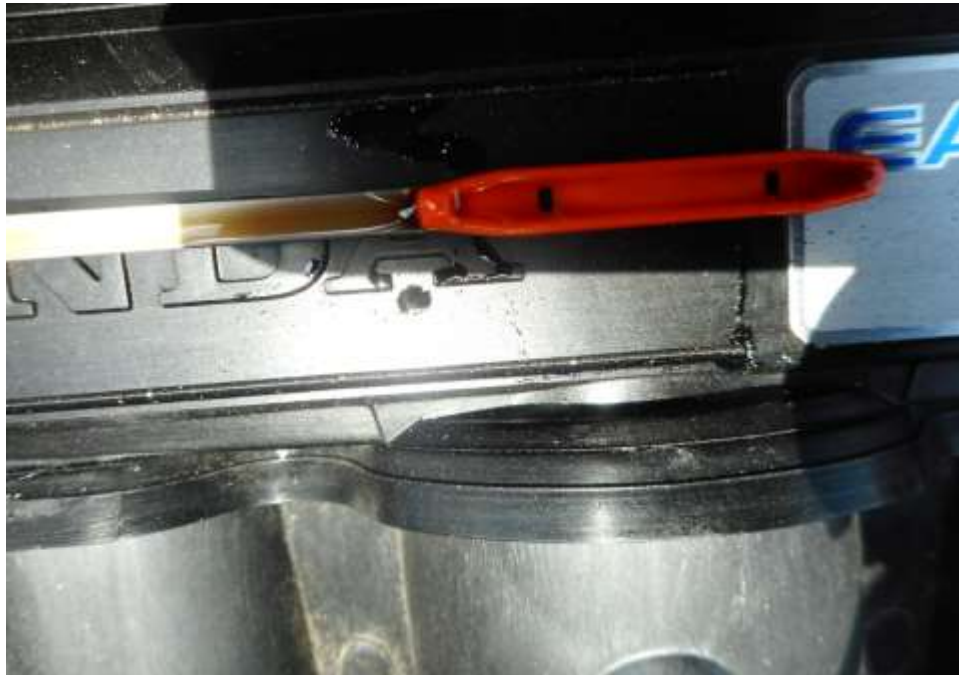
**Photo 13** shows the engine oil dip stick of the Motor Car at the time of my inspection. The engine oil was observed to be of sufficient level and without any visible contamination.

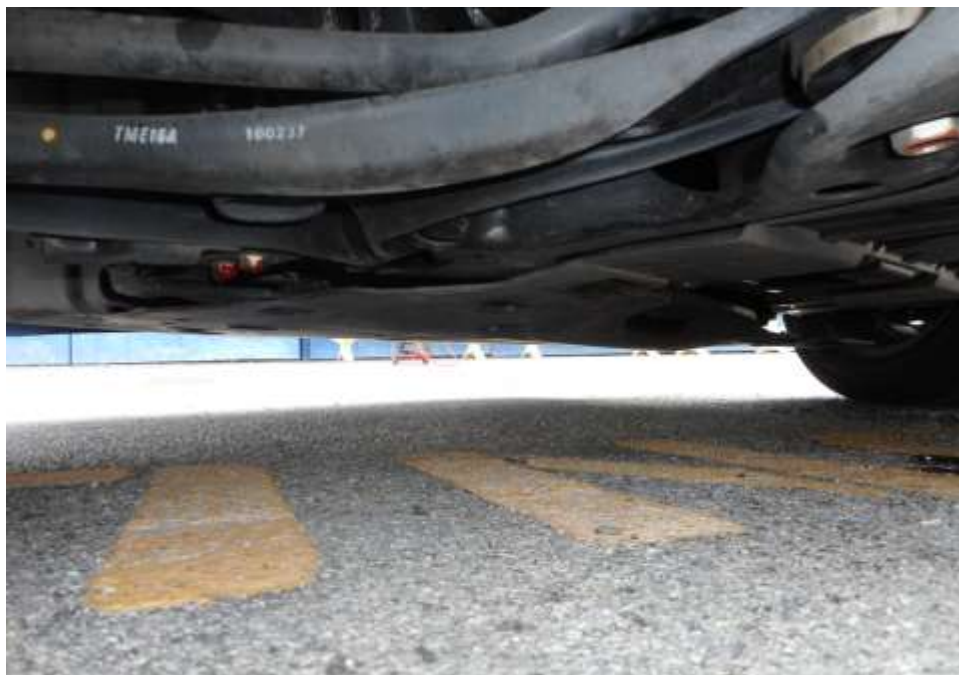
**Photo 14** shows the undercarriage of the Motor Car, at the area where the engine housing and transmission housing are located. . I did not find any sign(s) or indication(s) of fluid leak and/or fluid stain(s) on the underside of the Motor Car.

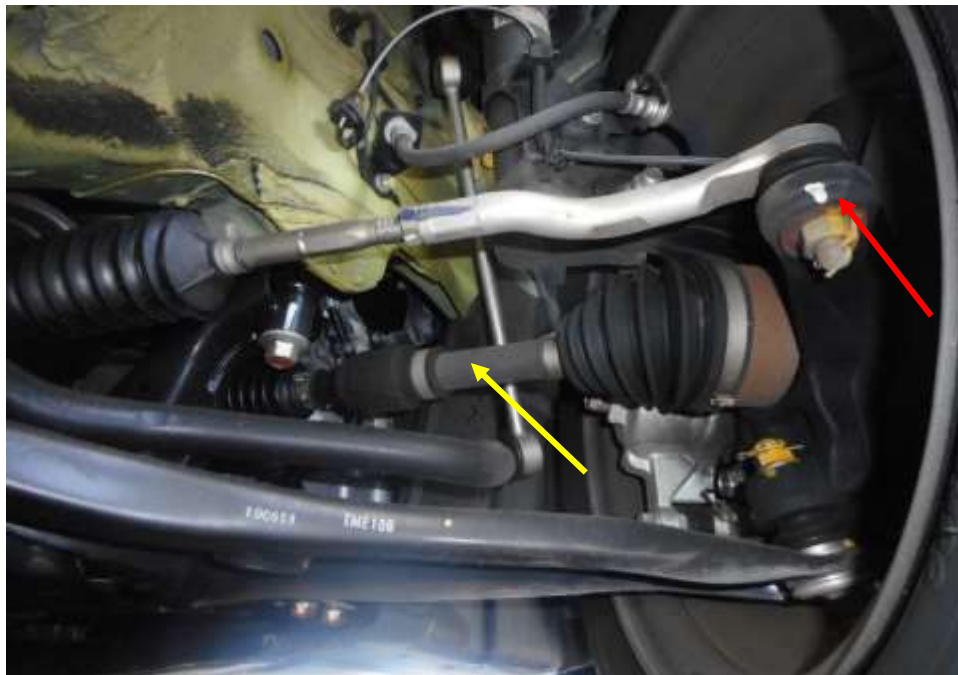
**Photo 15** shows the various undercarriage components at the front right wheel of the Motor Car, in particular the steering tie rod end (arrowed) and drive shaft (yellow arrow). The various steering components were all found to be intact, suggesting that the steering system of the Motor Car was likely to be in serviceable condition at the material time of accident. There was also no sign of fluid stain(s) observed on the various undercarriage components.

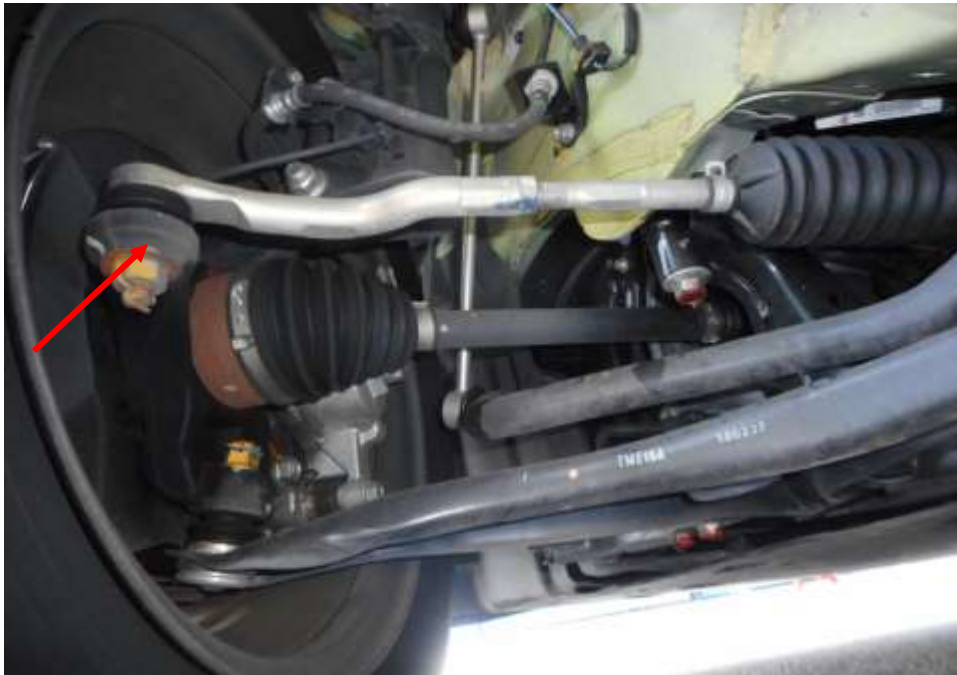
**Photo 16** shows the various undercarriage components at the front left wheel of the Motor Car, in particular the steering tie rod end (arrowed). The various Undercarriage components of the Motor Car were all found to be intact without any visible damage. There was also no sign of fluid stain(s) observed on the various undercarriage components.

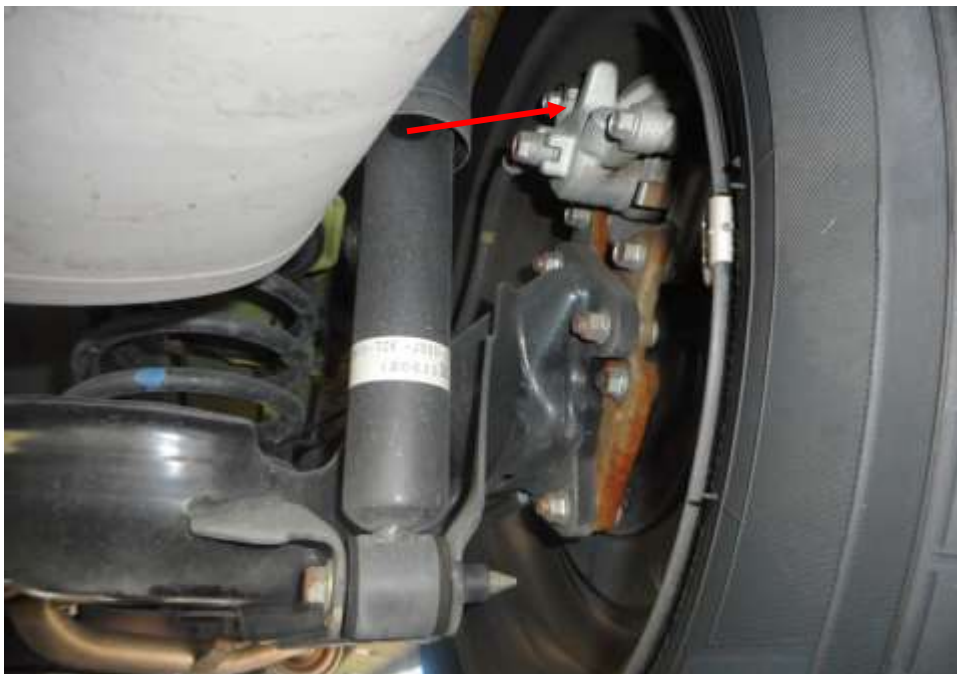
**Photo 17** shows the brake pipe (arrowed) at the rear right wheel of the Motor Car. I did not observe any leakage of brake fluid at the time of my inspection of the Motor Car. My static tests of the Motor Car's braking system, along with my visual examination of the various mechanical components in the braking system, had indicated that there was no internal leakage of pressure/vacuum. Hence the braking system of the Motor Car was likely to be in serviceable condition at the material time of accident.

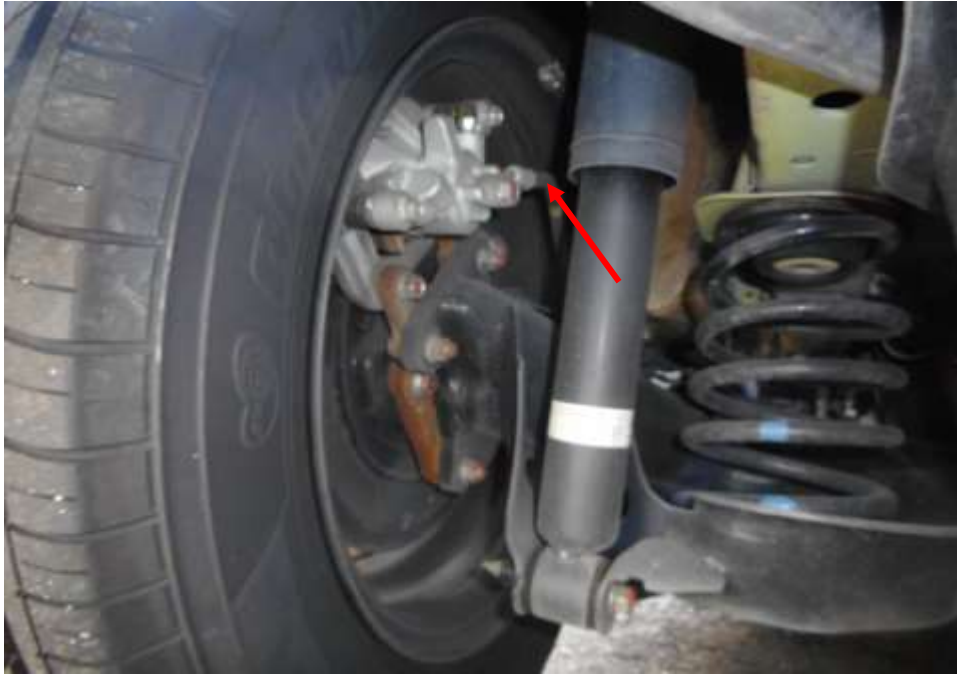
**Photo 18** shows the brake pipe (arrowed) at the rear left wheel of the Motor Car. I did not observe any leakage of brake fluid at the time of my inspection of the Motor Car. My static tests of the Motor Car's braking system, along with my visual examination of the various mechanical components in the braking system had indicated that there was no internal leakage of pressure/vacuum. Hence the braking system of the Motor Car was likely to be in serviceable condition at the material time of accident.

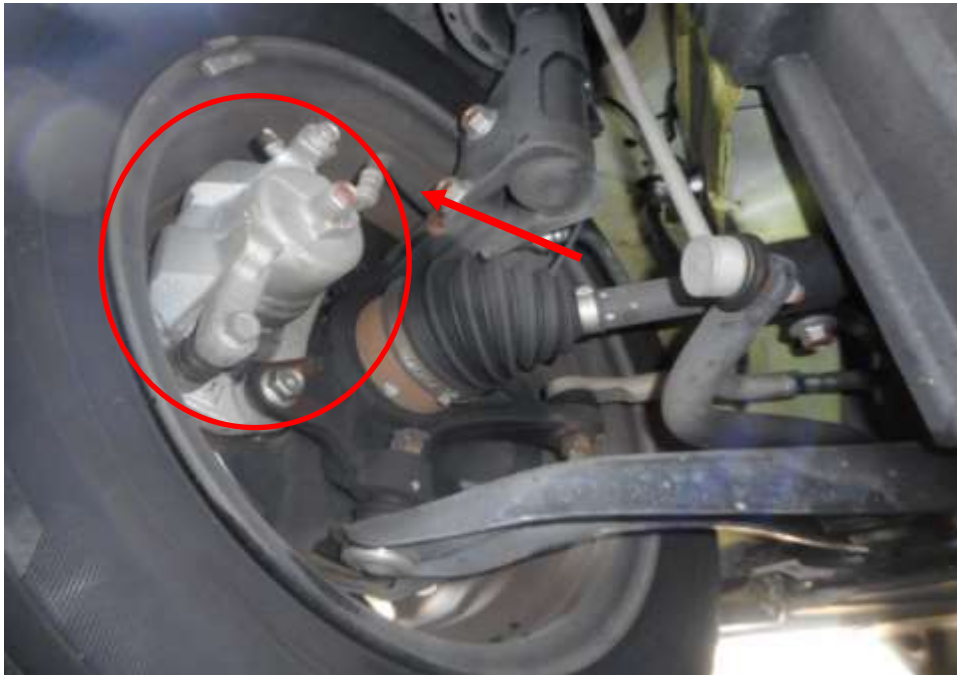
**Photo 19** shows the brake hose/pipe (arrowed) at the front right wheel of the Motor Car. No leakage of brake fluid was observed. Visual examination of the various components of the braking system like the brake caliper (circled), brake booster, brake pedal etc had revealed all to be intact and without visible damage at the time of accident. There was also no sign of fluid stain(s) observed on the various undercarriage components.

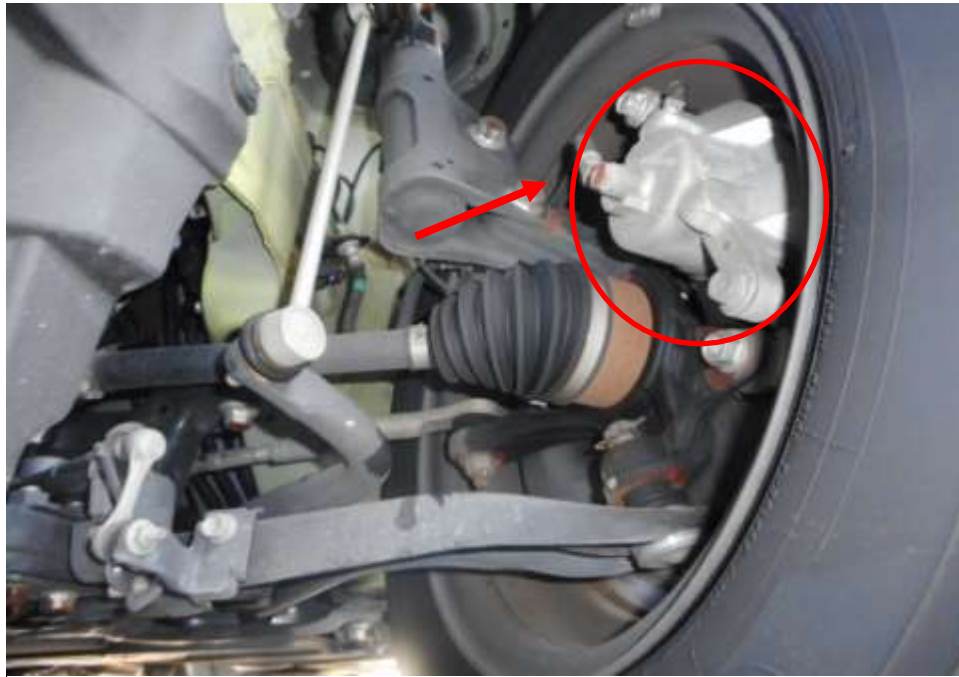
**Photo 20** shows the brake hose/pipe (arrowed) at the front left wheel of the Motor Car. No leakage of brake fluid was observed. Visual examination of the various components of the braking system like the brake caliper (circled), brake booster, brake pedal etc had revealed all to be intact and without visible damage at the time of accident. There was also no sign of fluid stain(s) observed on the various undercarriage components.

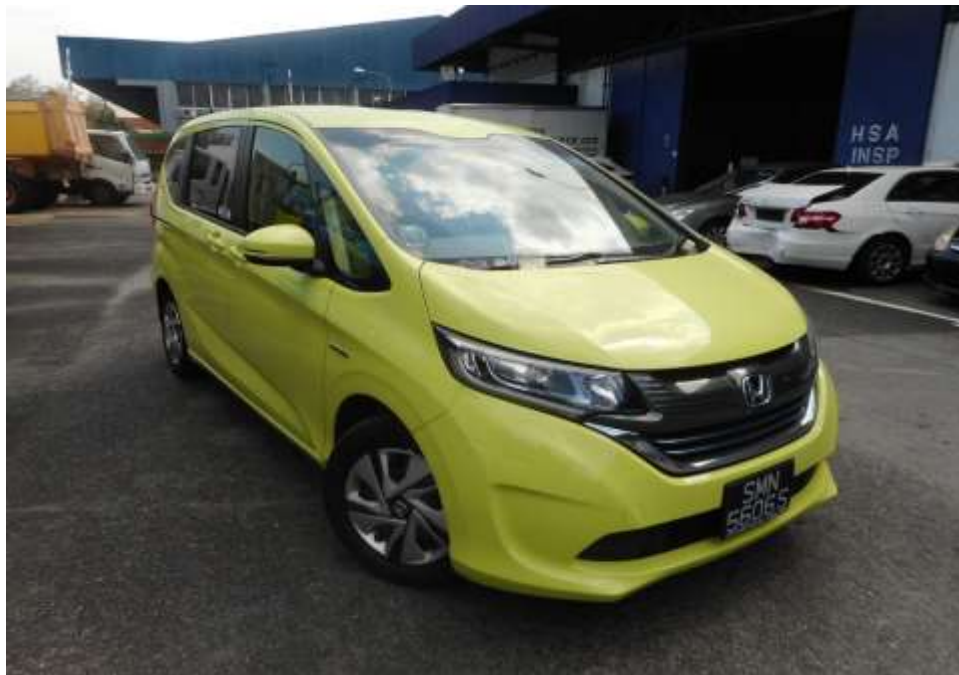
**Photo 21** shows the front right wheel of the Motor Car turned to its full left. During my steering system test, I did not experience any abnormal free play and/or resistance when I had turned the steering wheel towards full left and full right. This would suggest that the steering system of the Motor Car was likely to be in serviceable condition at the material time of accident.

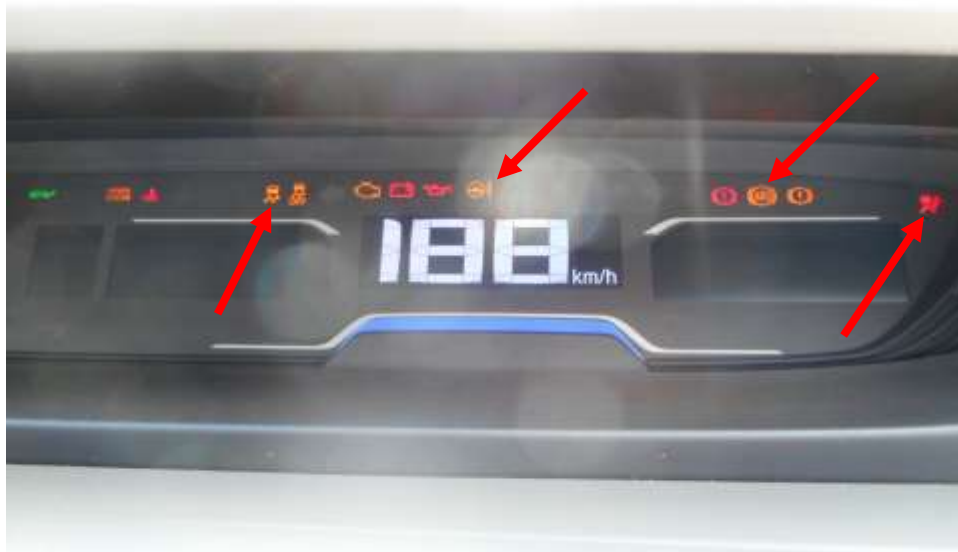
**Photo 22** shows the warning light for Anti-Lock Brake System (ABS), Traction Control (TC), Supplemental Restraint System (SRS) and Electric Power Steering System (EPS) appearing on the instrument panel of the Motor Car during the self-test of its various electronic operating systems when its engine was cranked.

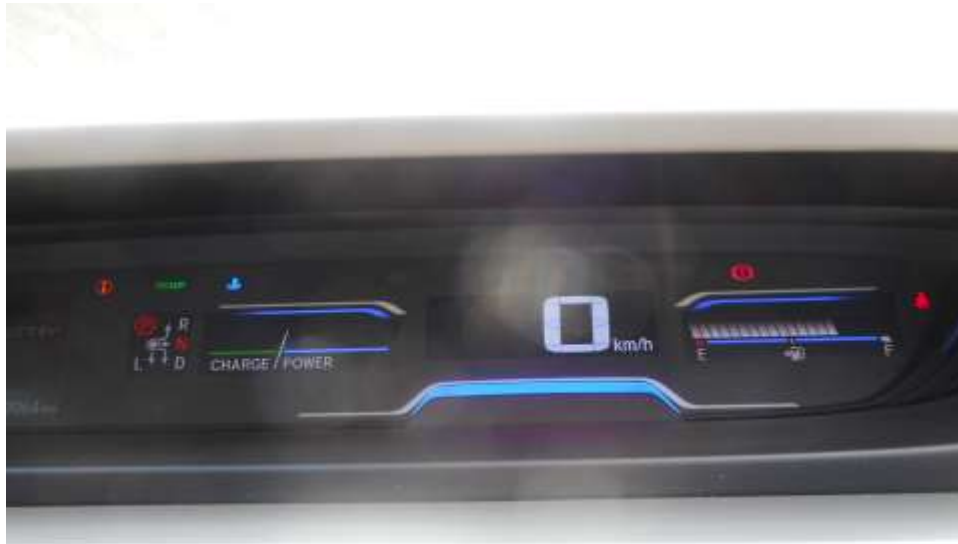
**Photo 23** shows no warning lights illuminated on the instrument panel of the Motor Car after the engine was cranked. This would suggest that there was no abnormality to the various electronic operating systems of the Motor Car, like the ABS, TC, SRS and EPS.
