LKK Auto Consultants Pte Ltd

Vehicle No. GBJ 7776Y
Insured Veh. SHC 2987D
Claim No. D20000592MFSH
Policy No. D-20094922MFSH
Accident Date 22/01/2020
Inspection Date 04/02/2020

ADJUSTMENT ON REPAIR COST FOR VEHICLE NO. GBJ 7776Y

PHOTOGRAPHS FOR VEHICLE NO. GBJ 7776Y

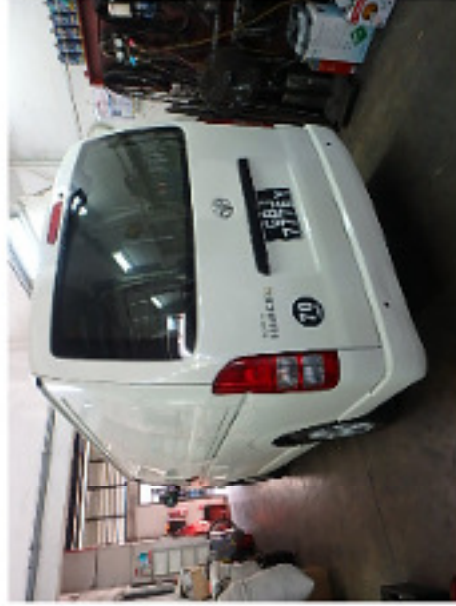
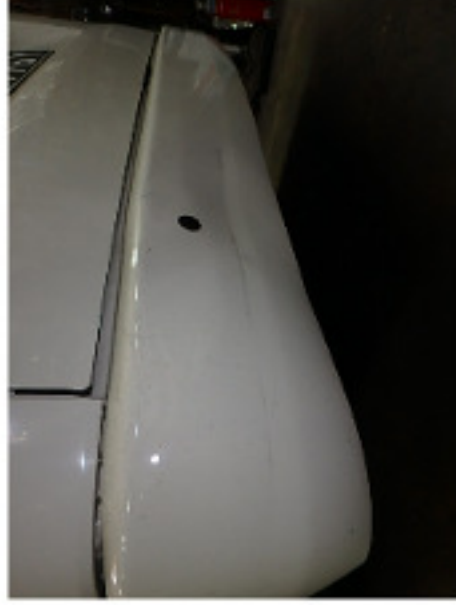
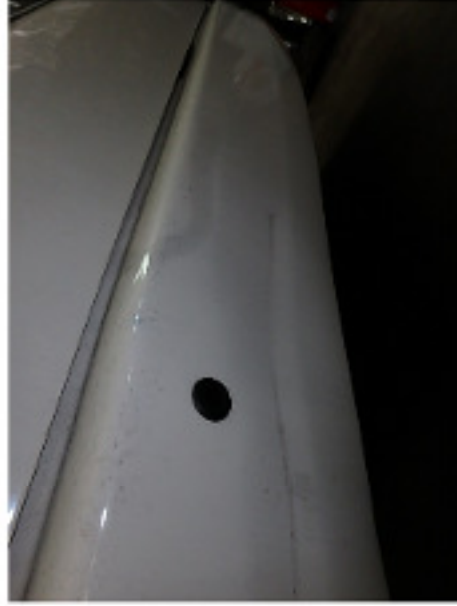
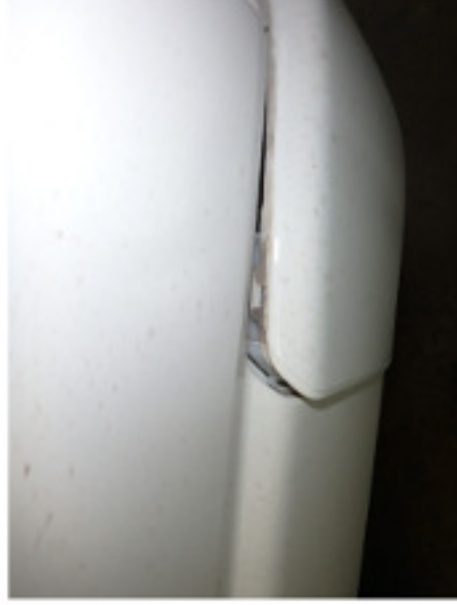
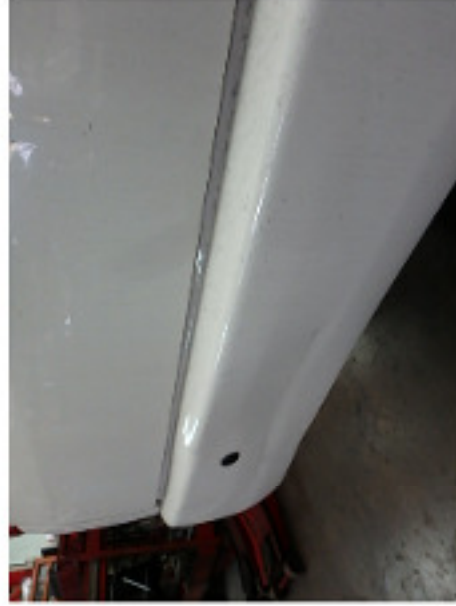
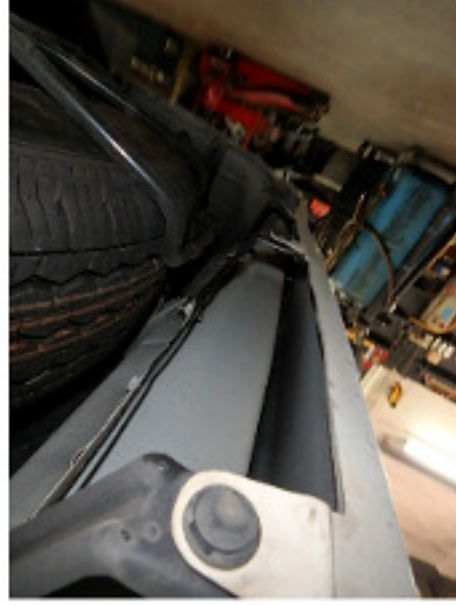
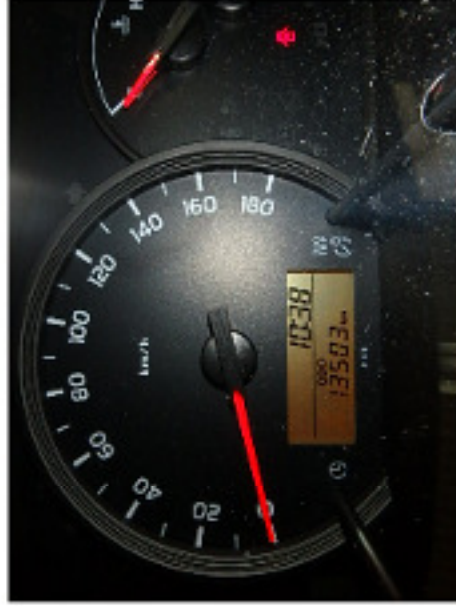
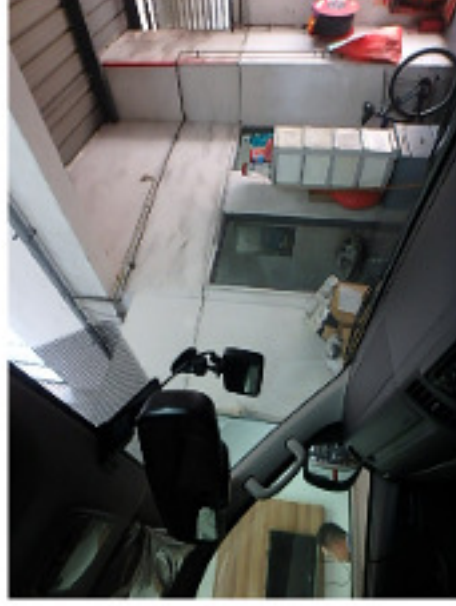
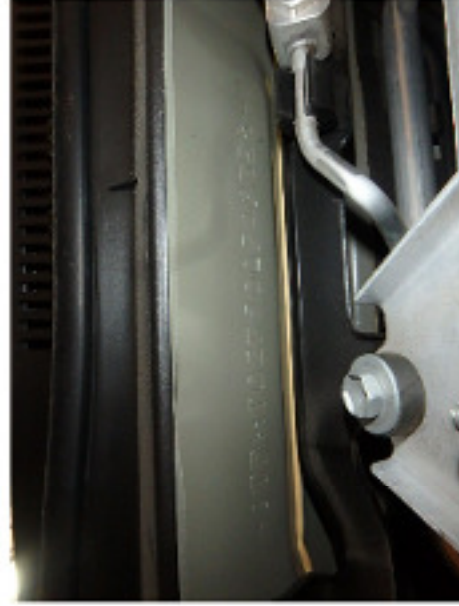
4. Description of Damages				
THE VEHICLE SUSTAINED DAMAGES AT THE REAR N/S PORTION. DAMAGES SEE DETAILS.				
5. General Information				
Accident Date	22/01/2020	Inspection Date	04/02/2020	
Survey held at	ESTEEM PERFORMANCE PTE LTD BLK 5033 ANG MO KIO INDUSTRIAL PARK 2 #01-259 SINGAPORE 569536			
5a. Remarks				
A)THE INSPECTION WAS CONDUCTED ON A"WITHOUT PREJUDICE" BASIS. B)IN ACCORDANCE TO YOUR INSTRUCTIONS, WE HAVE NOT AUTHORISED REPAIRS.				
5b. Estimate Days of Repair				
ESTIMATED NORMAL PERIOD FOR REPAIR:		2 Working Days
