Vehicle No. SKW 2905A  
Insured Veh. SHB 2382D  
Claim No. D20000835MFSH/1  
Policy No. D-20094921MFSH  
Accident Date 04/02/2020  
Inspection Date 02/03/2020

| Affiliated to Federation Internationale Des Experts En Automobile | | | | |
|---|---|---|---|--|
| <b>1. Policy Particulars :- THIRD PARTY CLAIM</b> | | | | |

## ADJUSTMENT ON REPAIR COST FOR VEHICLE NO. SKW 2905A

PHOTOGRAPHS FOR VEHICLE NO. SKW 2905A

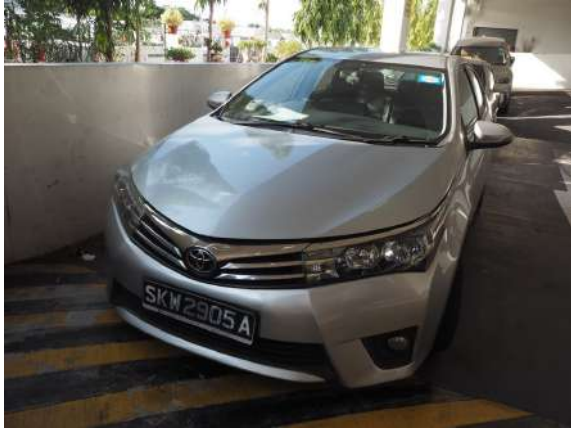
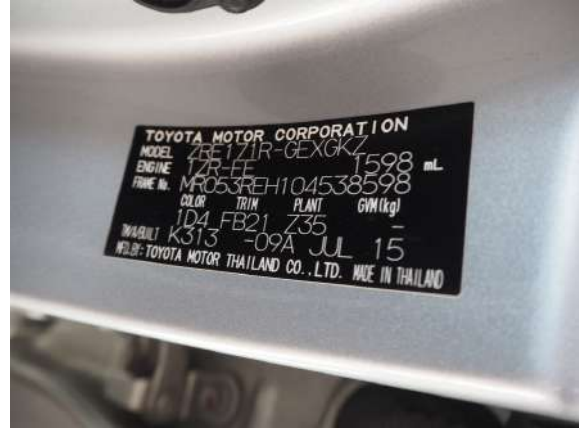
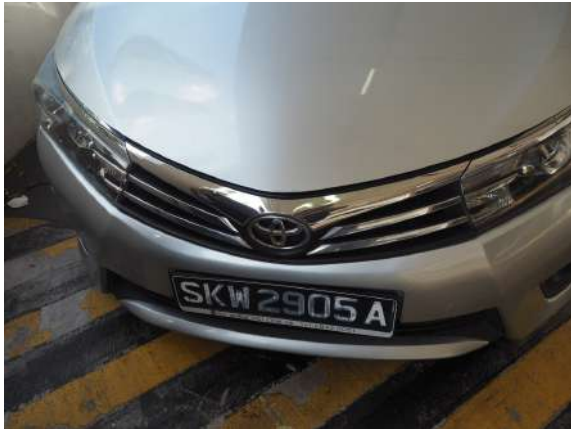
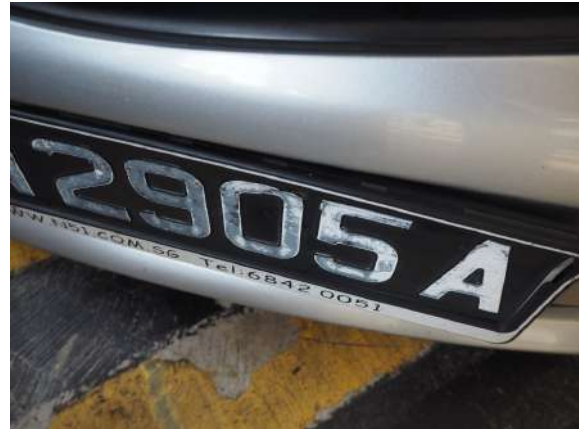
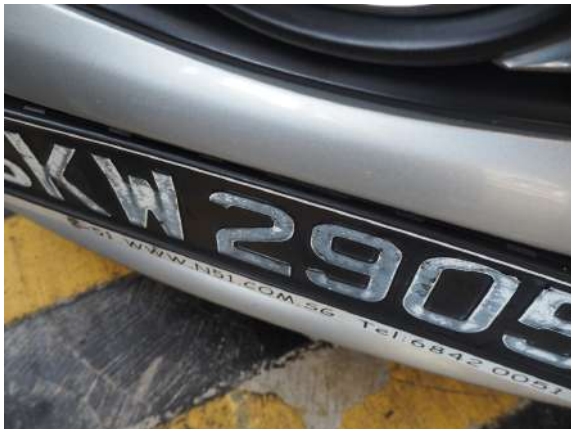
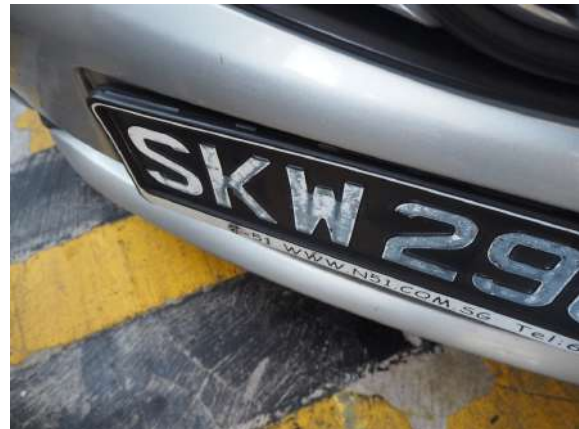
INSPECTION

| Affiliated to Federation Internationale Des Experts En Automobile | | | | |
|---|---|---|---|--|
| THE VEHICLE SUSTAINED DAMAGES AT THE FRONT PORTION.<br><br>DAMAGES SEE DETAILS. | | | | |
