VEHICLE APPRAISAL REPORT

Registration No.	: SMN 5844X	Chassis Frame No.	: GP7-2002487
Make / Model	: Honda Shuttle Hybrid 1.5(A)	Engine No. (Logcard)	: LEB7103295
Year of Manufacture/Reg	: 2019	Odometer Reading	: 50,927 KM
Colour	: Silver		
Class / Type	: MPV		1796 cc

**EVALUATION REPORT (PAPER SURVEY) OF ACCIDENT VEHICLE NO: SMN 5844X
INSURED VEHICLE: YN 3998G ACCIDENT DATE: 13/12/2019**

ADJUSTMENT ON REPAIR COST FOR VEHICLE NO. SMN 5844X

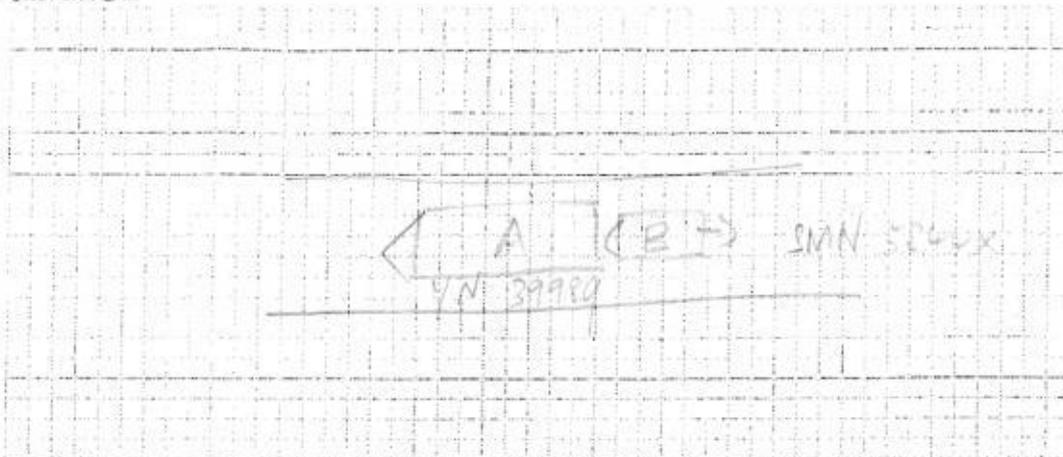
SKETCH PLAN

I was travelling along Kallang Airport Way.

I was about to enter the tunnel and I stopped when I realised I was in the wrong direction but then I decided to drive forward but I used reversed gear instead I hit onto vehicle behind me

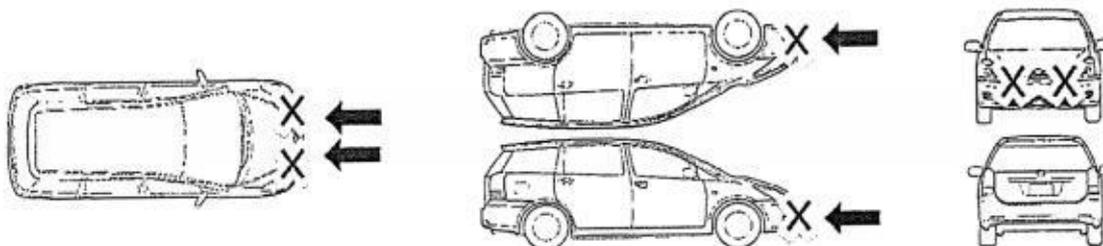
Damages sustained were consistent with the subject vehicle being involved in a collision with another vehicle and the impact was delivered **Squarely to the Front** portion of the vehicle.

The general area of damages is at the **Front portion**
(Please refer to the parts list and photographs as attached for more information)
